# The Effects of Traffic Calming Measures on Pedestrian and Motorist Behavior

REPORT NO. FHWA-RD-00-104

August 2001

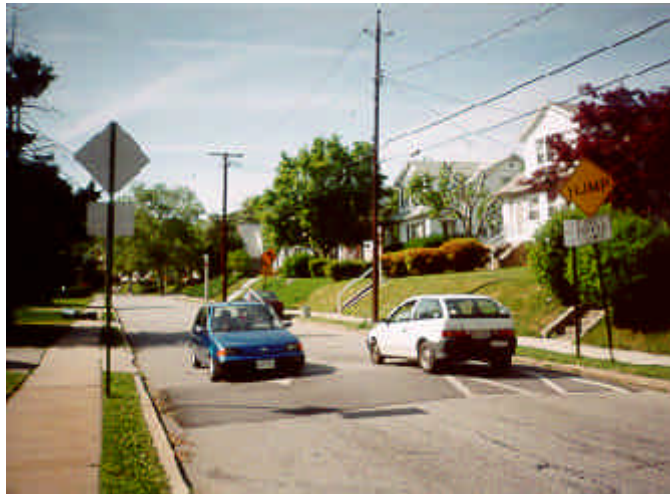
**Figure 1. Two vehicles slow down as they pass over a speed hump.**

Also known as road humps, undulations, or "sleeping policemen," the purpose of speed humps is to promote the smooth flow of traffic at slow speeds of about 32 to 40 km/h (20 to 25 mi/h). The speed hump is an elongated hump with a circular-arc cross-section (round-top) or flat-top, rising to a height of 76 mm (3 in) above the normal pavement surface and having a length of 3.7 m to 6.7 m (12 ft to 22 ft) in the direction of vehicular travel (Figure 1). Speed humps usually extend the full width of the road, excluding the gutter to allow for drainage (1).

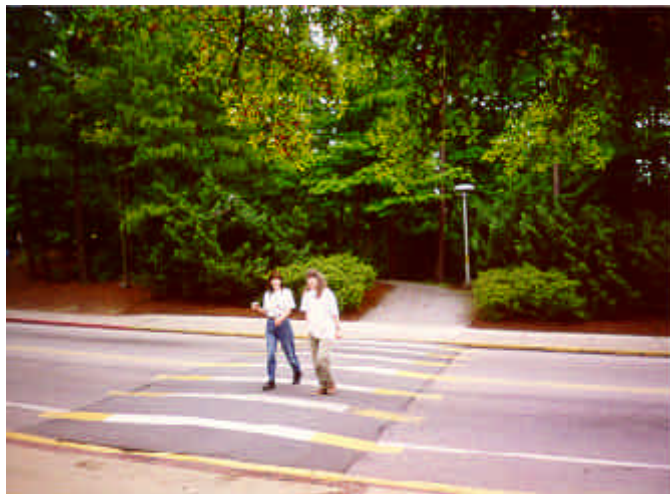
**Figure 2. Pedestrians using a raised crosswalk.**

Raised crosswalks are flat-top speed humps with crosswalk markings painted on the top (Figure 2). Raised crosswalks elevate pedestrians above the surface of the roadway and can make them more visible to motorists. Raised crosswalks cause motorists to slow at the most critical location, where pedestrians cross. They are generally designed to keep pedestrians at one level so that there is no need for curb ramps. Drainage is accommodated by pipes along the gutter or other design features.

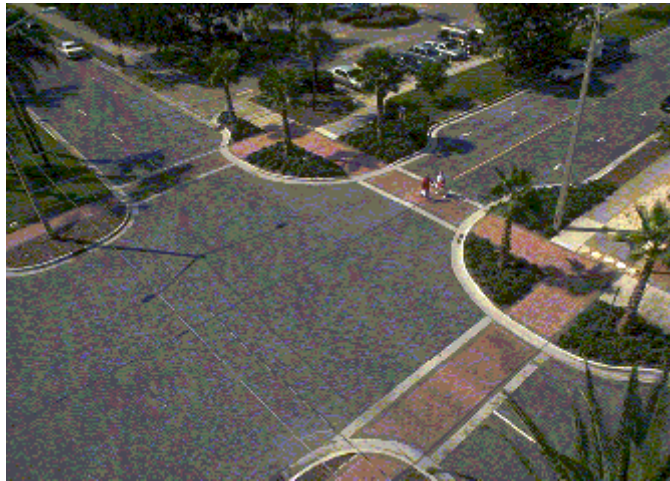
**Figure 3. Bulbouts shorten crossing distances for pedestrians, improve sight distances, and may slow vehicle speeds.**

The purpose of a bulbout (also known as a choker, curb bulb, neckdown, nub, or gateway) is to reduce the width of vehicle travel way at an intersection or a mid-block pedestrian crossing. Bulbouts shorten the street crossing distance for pedestrians, may slow vehicle speeds, and provide pedestrians and motorists with an improved view of one another, thereby reducing the risk of a motor vehicle-pedestrian collision (Figure 3).

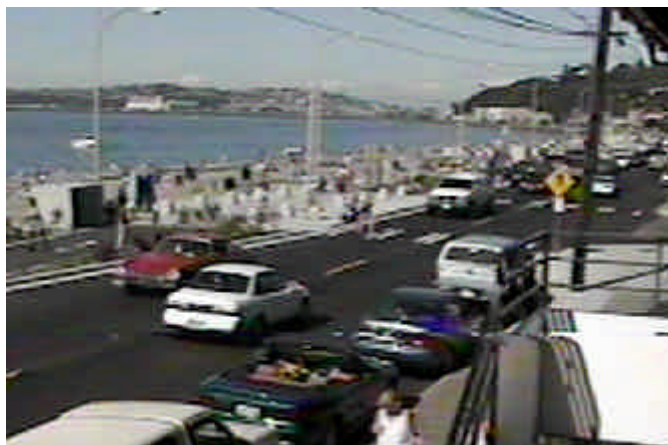
**Figure 4. A motorist yielding to pedestrians, Alki at 59<sup>th</sup>, Seattle.**

By constricting the roadway, bulbouts are intended to slow vehicles down and increase the likelihood that motorists will see pedestrians sooner than they would otherwise. Therefore, it was hypothesized that bulbouts would increase the number of pedestrians for whom motorists yielded. In other words, more pedestrians would have the benefit of motorists yielding to them (Figure 4).

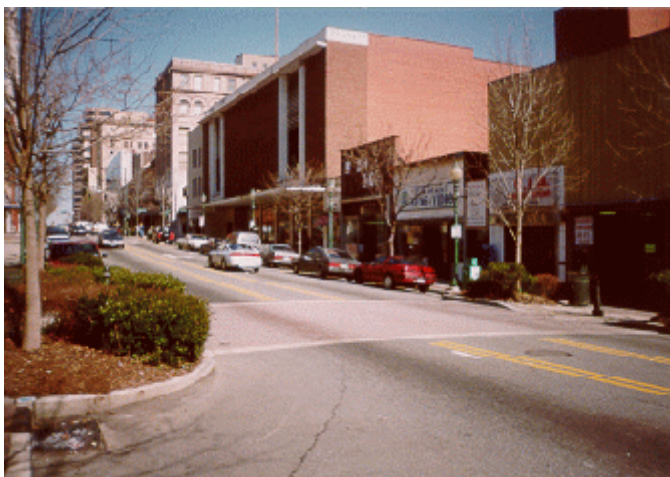
**Figure 5. Bulbout and textured crosswalk, Greensboro, North Carolina.**

Elm Street in Greensboro is the main north-south downtown arterial. Both bulbouts and the control site between Market Street and Friendly Avenue are downtown. The control site at Martin Luther King Jr. Drive is on the southern edge of downtown. Elm Street is generally two-way, with one lane in each direction. There is usually parking on both sides. The crosswalks are made of textured pavement. Elm Street is lined with shops, offices, and several vacant buildings (Figure 5).

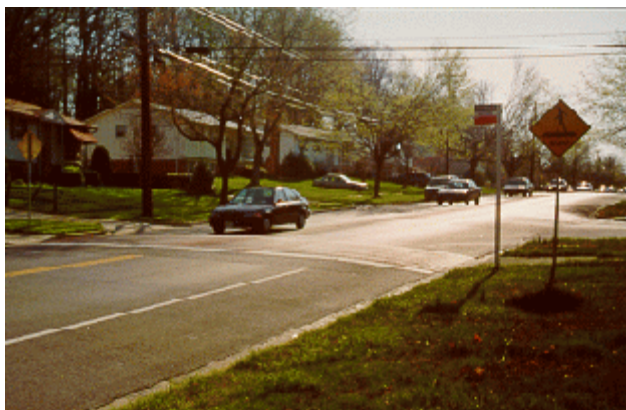
**Figure 7. Raised crosswalk, Bel Pre Road at Merton Road, Montgomery County, Maryland.**

Bel Pre Road at Merton Road is in a residential area just outside of Rockville, MD. Bel Pre is a northwest-southeast collector, with one lane of traffic in each direction and parking lanes on both sides. Merton Road is a local street that approaches from the southwest and forms a T-intersection with Bel Pre Road. The raised crosswalk is on the northwest leg of the intersection, and the control site is on the southeast leg of the same intersection (Figure 7).

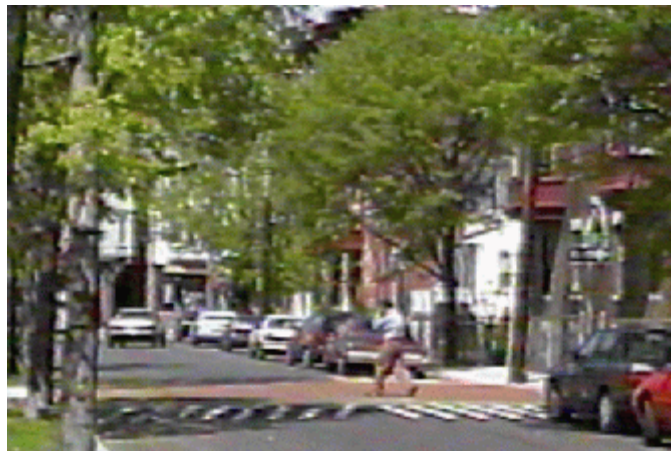
**Figure 8. Raised intersection, Berkshire Street and Marcella Street, Cambridge, Massachusetts.**

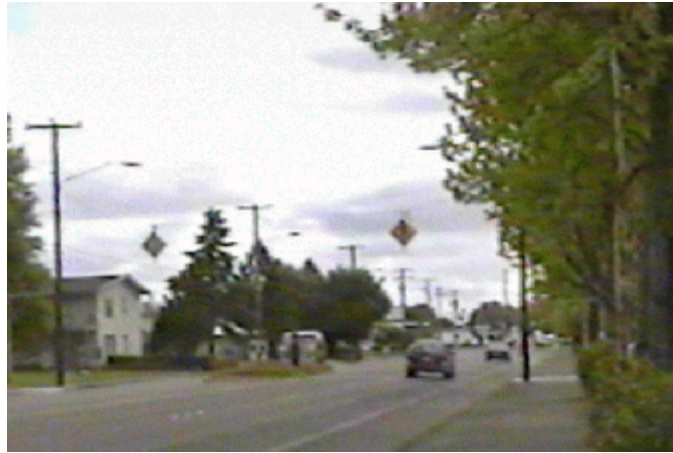
**Figure 9. Refuge island, Circle Boulevard, Corvallis, Oregon.**

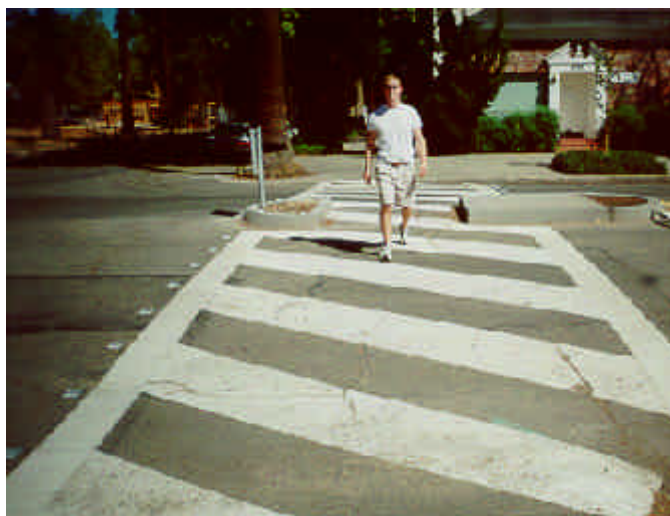
**Figure 10. Pedestrian in crosswalk with refuge island, Sacramento, California.**
