U.S. Department
of Transportation
**Federal Railroad
Administration**

TREAD METAL BUILDUP ON RAILROAD FREIGHT CAR WHEELS – Dynamometer Simulation

DOT/FRA/ORD-03/25

June 2003
Final Report

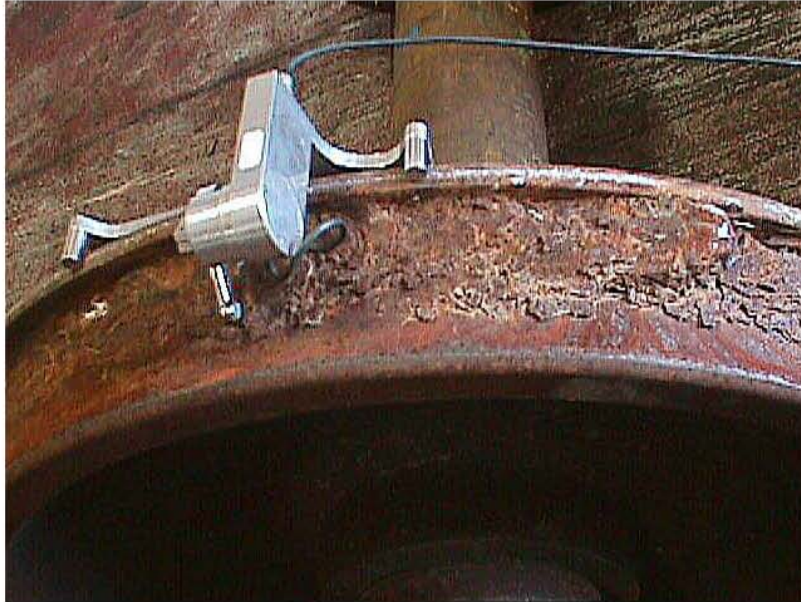
Figure 1. Built-up Metal on the Tread of a Wheel

There is a limited history of documented information on the formation of wheel tread metal buildup. The occurrence of tread metal buildup in service is infrequent. However, its presence can influence the performance and safety of the vehicle, as shown for the wheel in Figure 1. The tread metal buildup shown here is excessive, and eliminates the presence of the wheel flange by nearly reaching its height. Thus, positioning may be a problem as the wheel travels through curves on the rail. Additionally, the metal buildup on the tread produces an out-of-round condition, which can lead to high impact loads into the track structure as well as the rolling stock. The impact loading can produce premature failure of these components also imposing a safety risk. Most tread buildups are smaller than the one shown in Figure 1. But any buildup poses a safety hazard for the same reasons, only to a lesser extent.

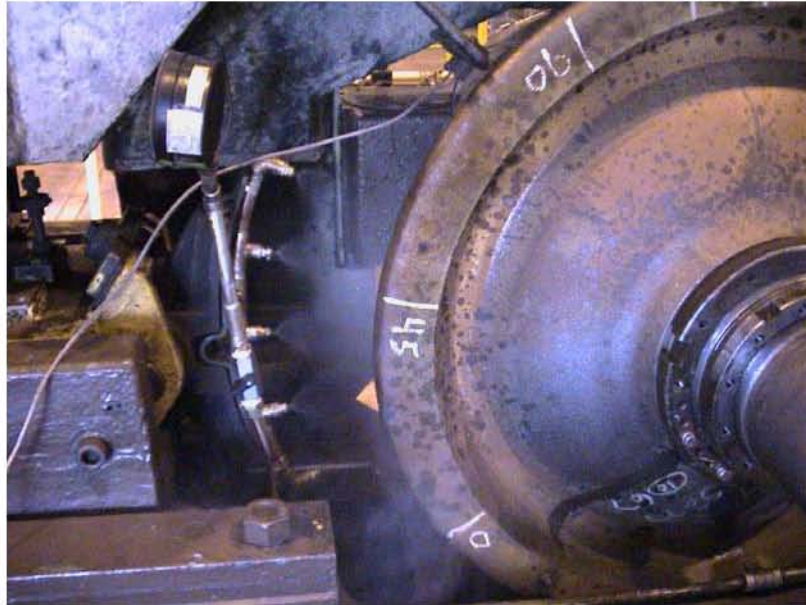
Figure 2. Dynamometer Spray Apparatus

A series of dynamometer tests were conducted to determine if tread buildup could be induced under a matrix of varying conditions of brake shoe force and moisture. Moisture was controlled and applied by a spray system that was capable of producing a fine spray at rates up to 24 ounces/min. Figure 2 shows the spray system.

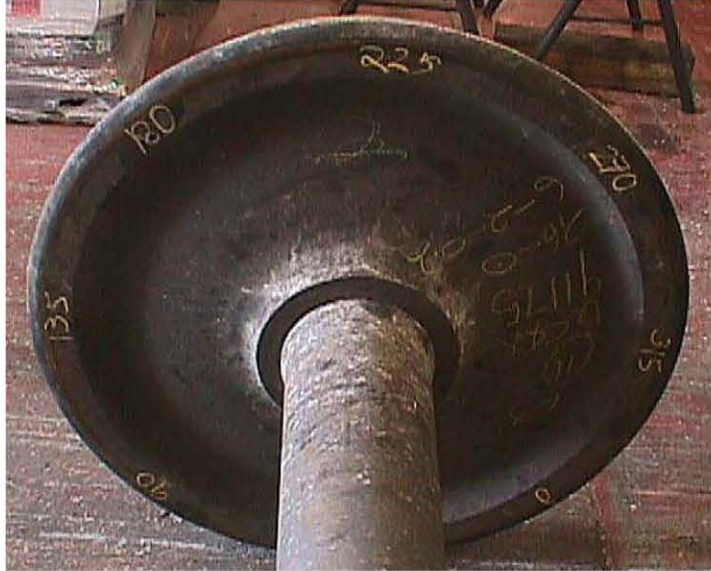
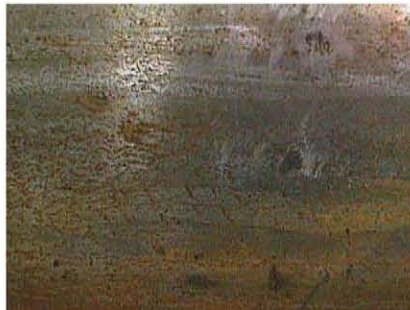
Wheel 07534 No Tread Buildup

FRA TREAD BUILDUP TEST
 SURFACE CONDITION and HARDNESS READINGS
 WHEEL # 07534 Progress Rail Services Corp., Sidney, NE
 June 5, 2002

The maximum range of gauss in this wheel was from -4.1 to +1.9 or 6 gauss.

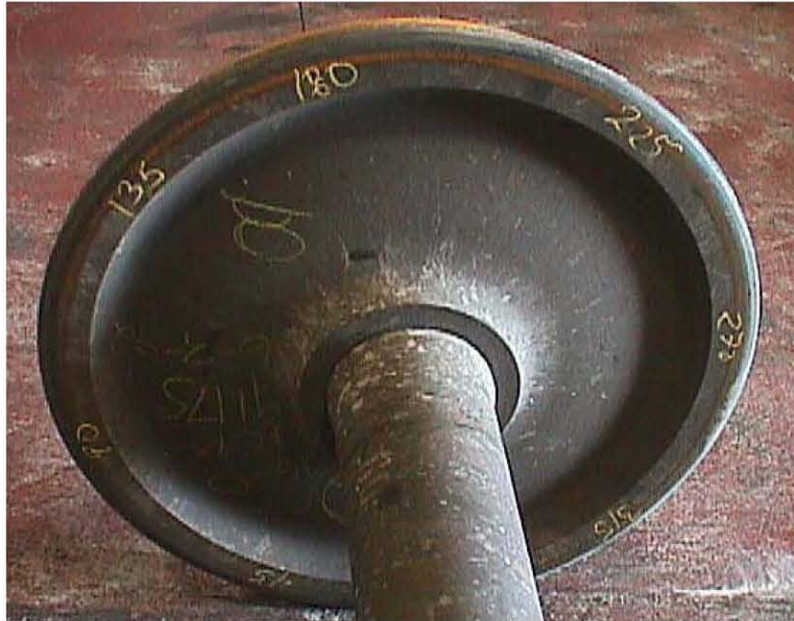
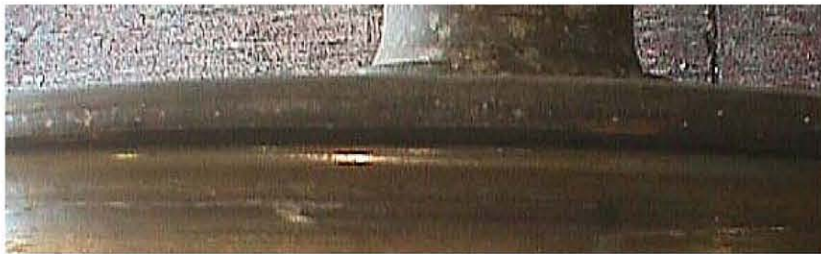
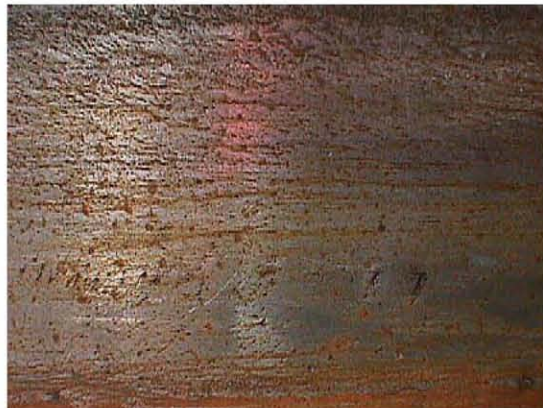
Wheel 07598
No Tread Buildup
(Revenue Service Wheel Evaluation)

FRA TREAD BUILDUP TEST
SURFACE CONDITION and HARDNESS READINGS
WHEEL # 07598 Progress Rail Services Corp., Sidney, NE June 5, 2002

The maximum range of gauss in this wheel was from -4.6 to $+ 1.7$ or 6.3 gauss.

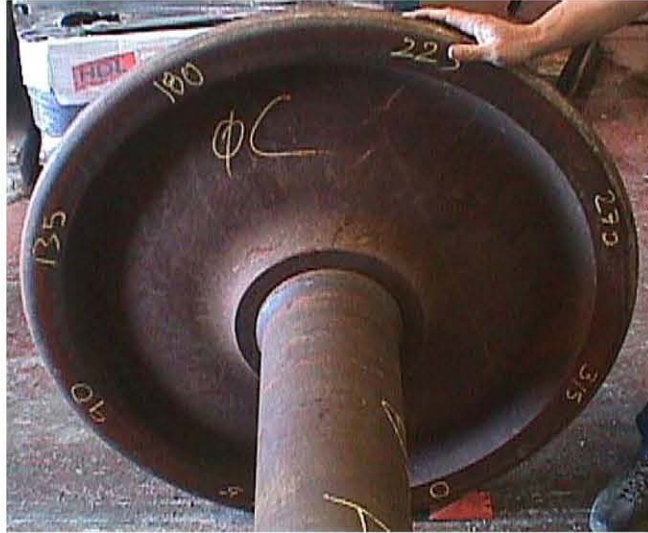
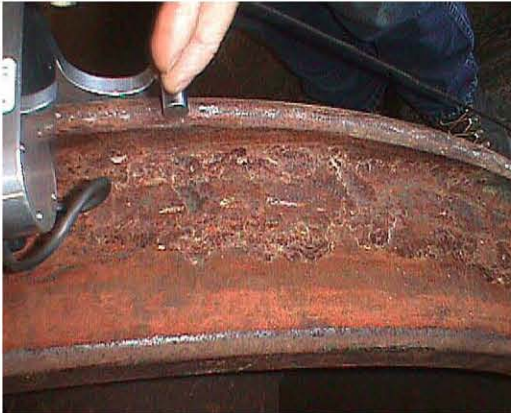
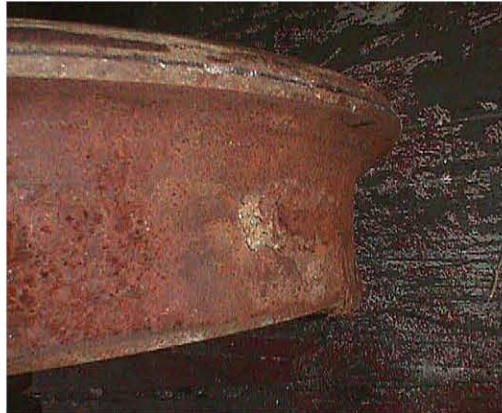
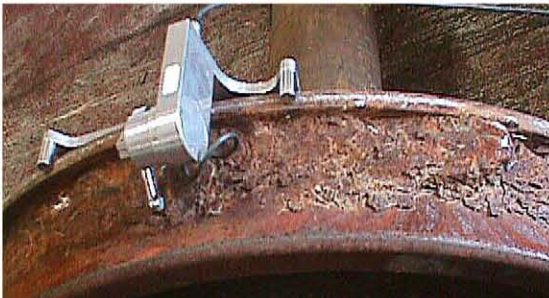
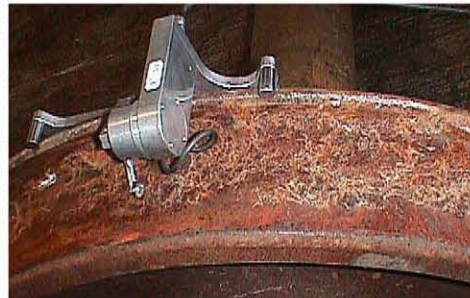
Wheel 10988
Heavy Tread Buildup
(Revenue Service Wheel Evaluation)

FRA TREAD BUILD-UP TEST
 SURFACE CONDITION and HARDNESS READINGS
 WHEEL # 10988 Progress Rail Services Corp., Sidney, NE June 5, 2002

0 degrees. Flange rim around to tread rim. Gauss range read: -3.5 to $+3.0 = 6.5$
45 degrees. Flange rim around to tread rim. Gauss range read: -1.0 to $+4.0 = 5.0$
90 degrees. Flange rim around to tread rim. Gauss range read: -4.0 to $+7.0 = 11.0$
135 degrees. Flange rim around to tread rim. Gauss range read: -28.0 to $+8.5 = 36.5$
180 degrees. Flange rim around to tread rim. Gauss range read: -26.0 to $+0.0 = 26.0$
225 degrees. Flange rim around to tread rim. Gauss range read: -5.0 to $+0.0 = 5.0$
270 degrees. Flange rim around to tread rim. Gauss range read: -9.0 to $+0.0 = 9.0$
315 degrees. Flange rim around to tread rim. Gauss range read: -8.0 to $+0.0 = 8.0$
The maximum range of gauss in this wheel was from -28.0 to $+8.5$ or 36.5 gauss.

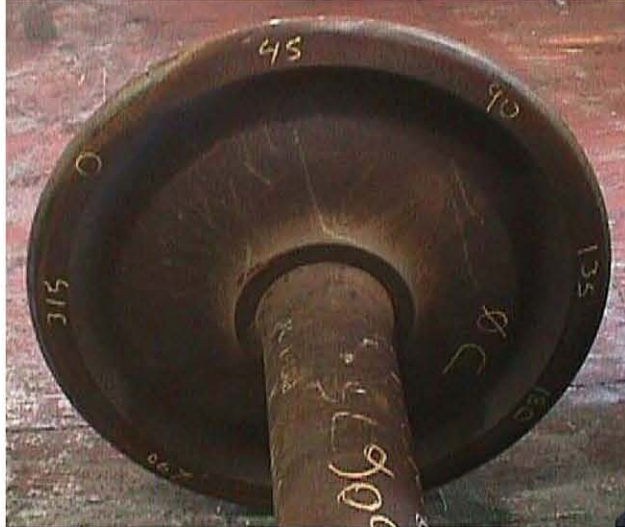
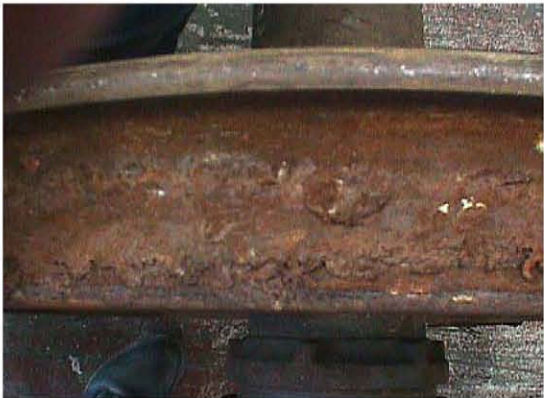
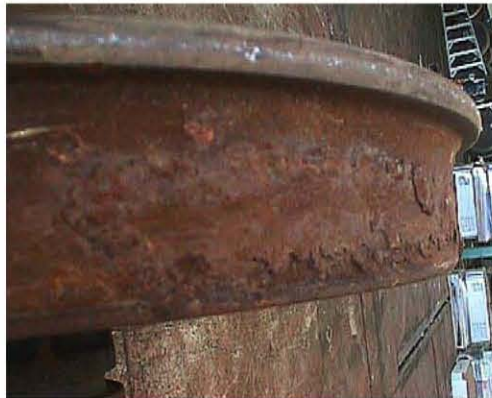
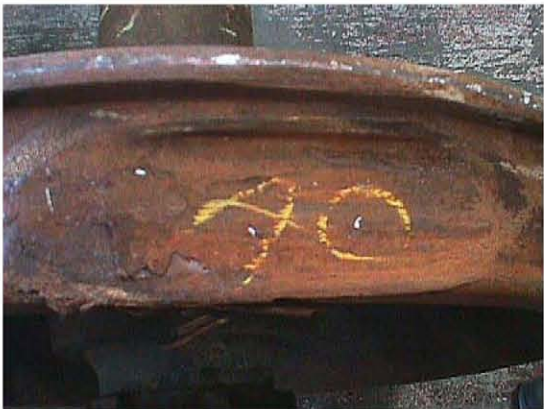
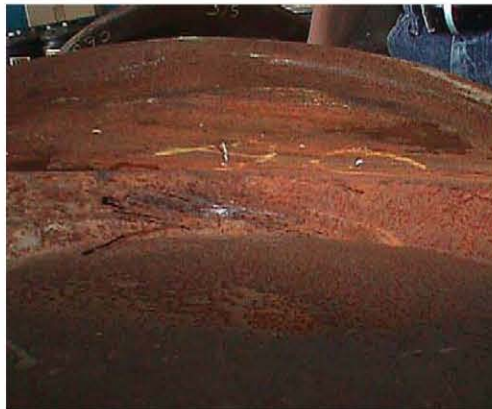
Wheel 10989
Heavy Tread Buildup
(Revenue Service Wheel Evaluation)

Wheel #10989 a tread damaged wheel at Progress Wheel Shop

FRA TREAD BUILDUP TEST
 SURFACE CONDITION and HARDNESS READINGS
 WHEEL # 10989 Progress Rail Services Corp., Sidney, NE June 5, 2002

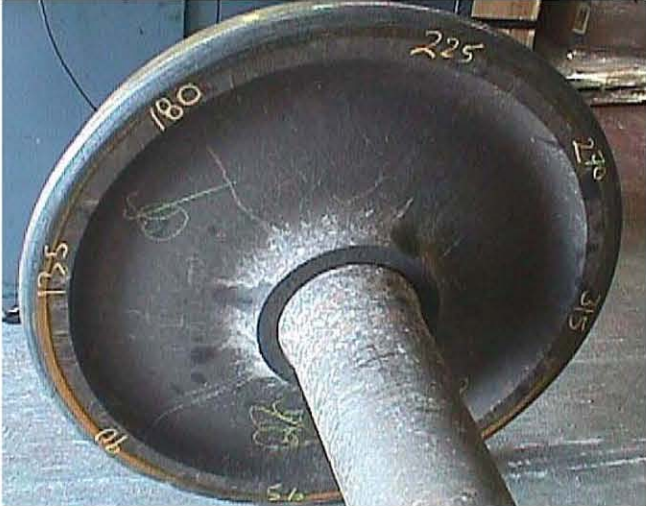
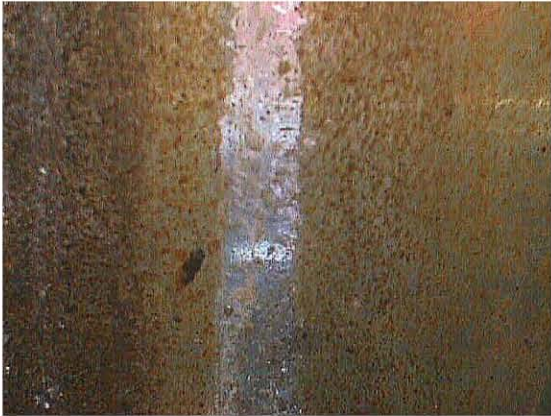
Wheel #12222 a “No tread damage” wheel at Progress Wheel Shop

FRA TREAD BUILD-UP TEST
 SURFACE CONDITION and HARDNESS READINGS
 WHEEL # 12222 Progress Rail Services Corp., Sidney, NE June 5, 2002

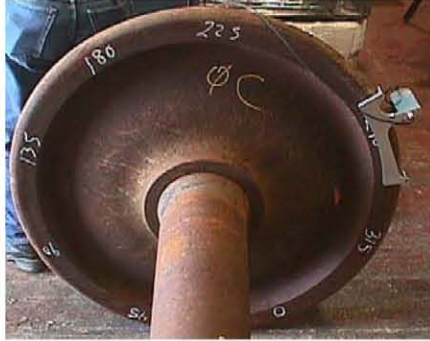
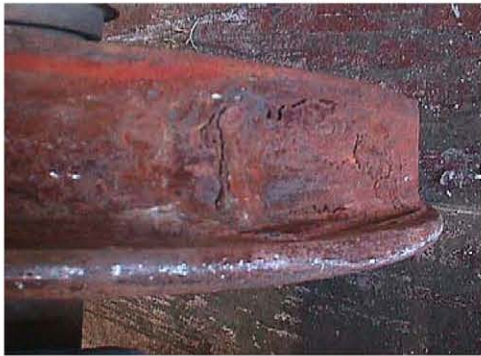
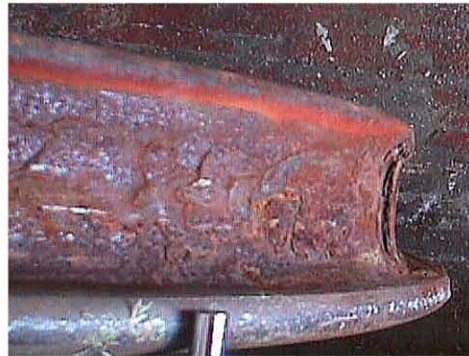
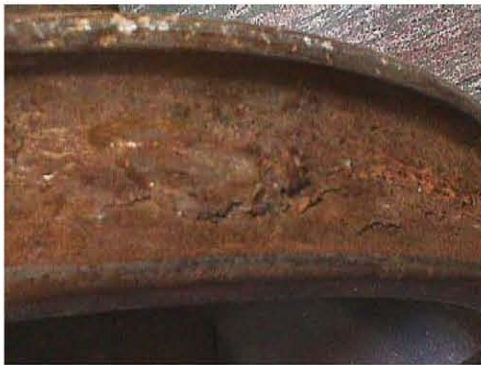
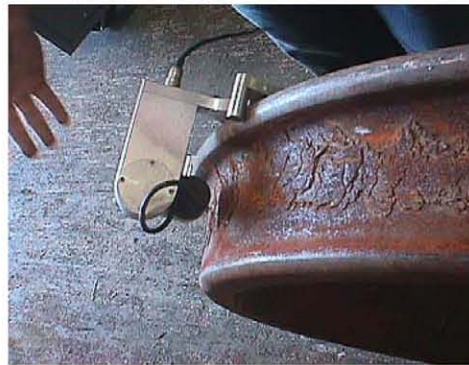
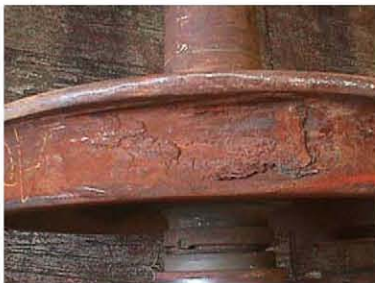
Wheel 14073
Heavy Tread Buildup
(Revenue Service Wheel Examination)
FRA TREAD BUILDUP TEST

Wheel #14073 a tread damaged wheel at Progress Wheel Shop

FRA TREAD BUILD-UP TEST
 SURFACE CONDITION and HARDNESS READINGS
 WHEEL # 14073 Progress Rail Services Corp., Sidney, NE June 5, 2002

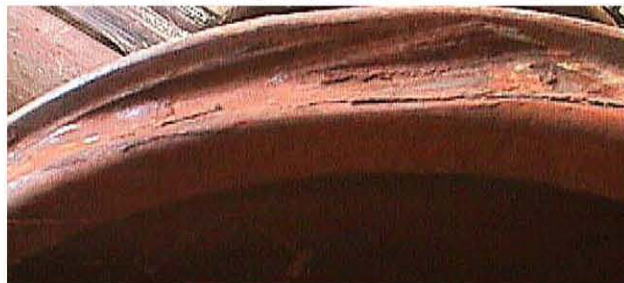
SURFACE CONDITION READINGS of TREAD SURFACE

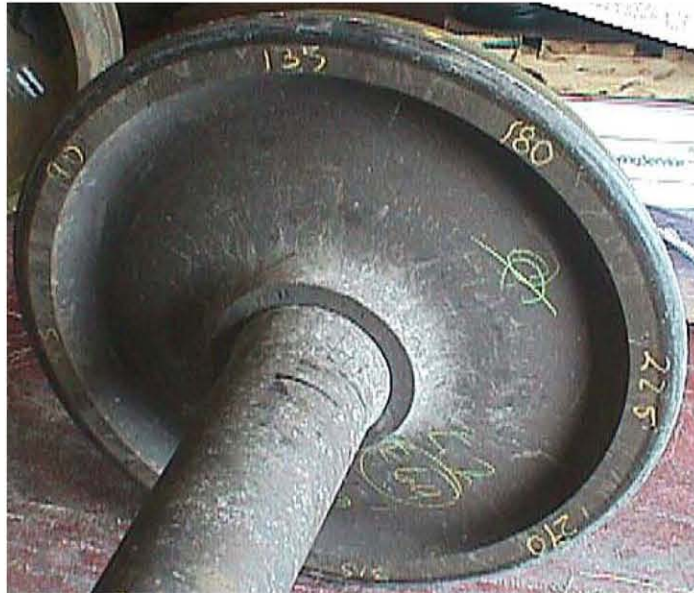
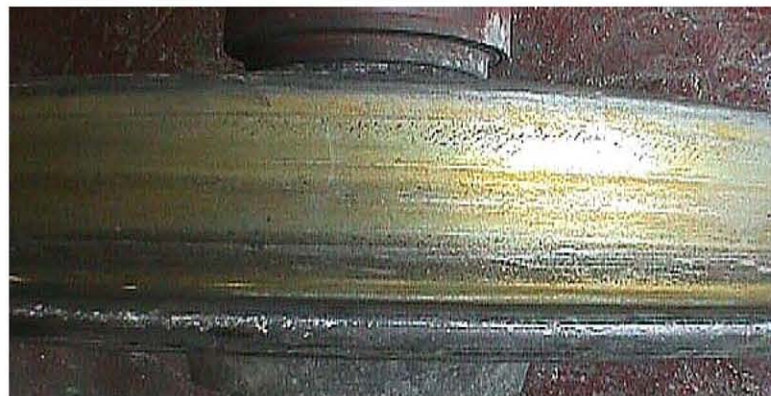
Wheel 15489 Thermal Cracks on Tread

Wheel #15489 a "No tread damage" wheel at Progress Wheel Shop

FRA TREAD BUILDUP TEST
 SURFACE CONDITION and HARDNESS READINGS
 WHEEL # 15489 Progress Rail Services Corp., Sidney, NE June 5, 2002

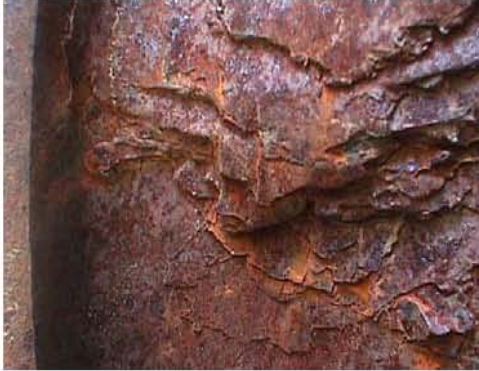
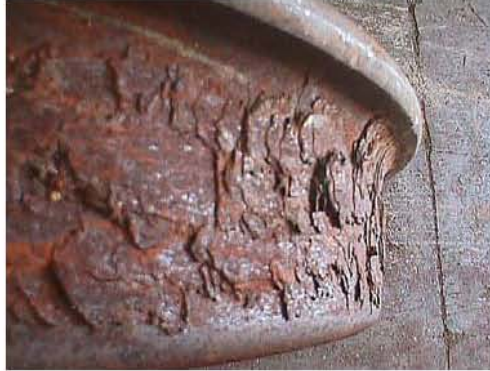
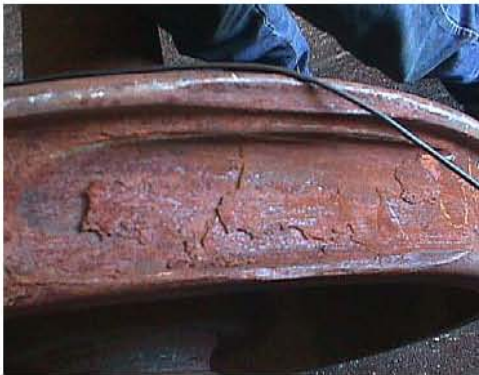
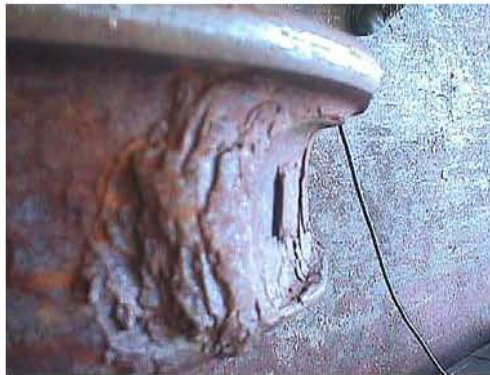
Wheel 38299
Heavy Metal Tread Buildup
(Revenue Service Wheel Evaluation)
FRA TREAD BUILDUP TEST

Wheel #38299 a tread damaged wheel at Progress Wheel Shop

FRA TREAD BUILDUP TEST
 SURFACE CONDITION and HARDNESS READINGS
 WHEEL # 38299 Progress Rail Services Corp., Sidney, NE June 5, 2002

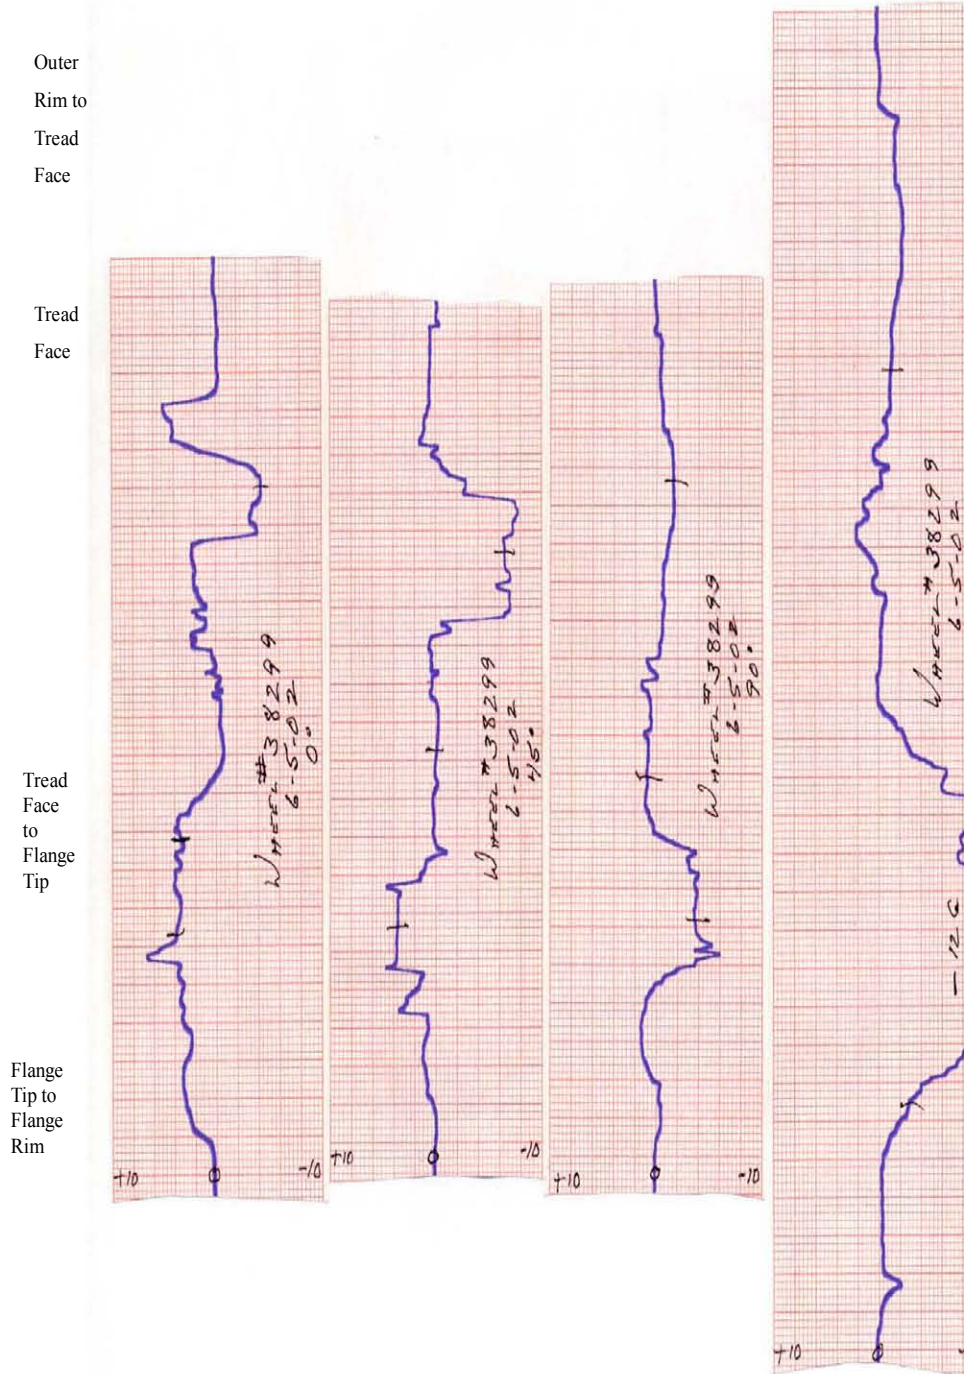
GAUSSMETER READINGS OF WHEEL #38299 (on axle #6767)

June 5, 2002 Progress Wheel Shop, Sidney, NE 0 to 135 degree readings

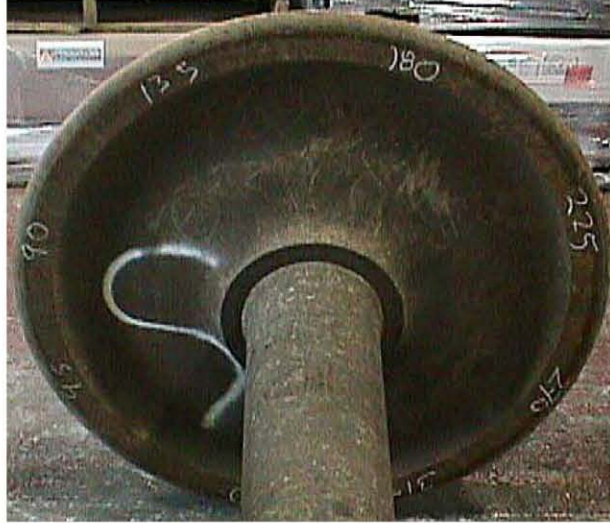
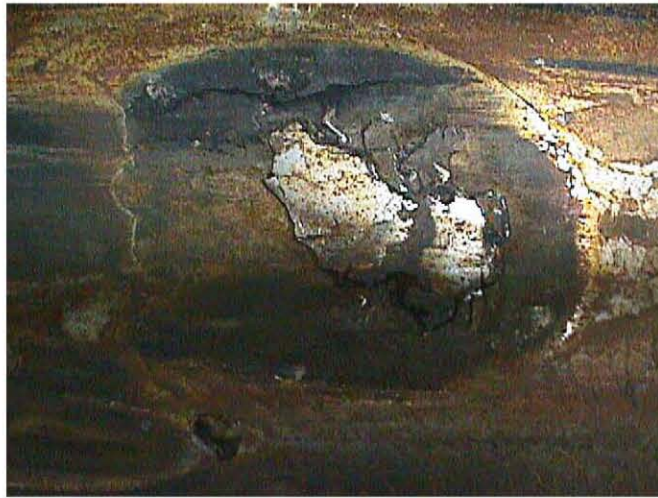
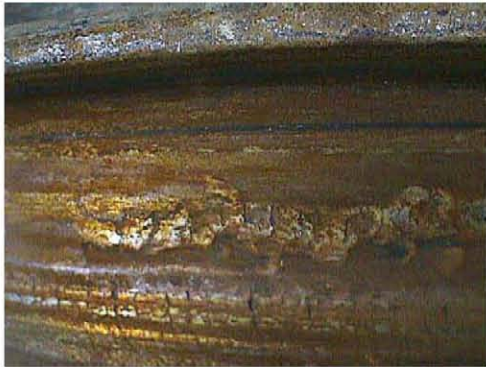
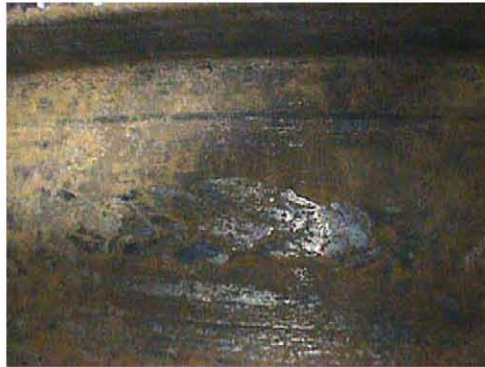
Wheel 49933
Slight Tread Metal Buildup
(Revenue Service Wheel Evaluation)
FRA TREAD BUILDUP TEST

Wheel #49933 a tread damaged wheel at Progress Wheel Shop

FRA TREAD BUILDUP TEST
 SURFACE CONDITION and HARDNESS READINGS
 WHEEL # 49933 Progress Rail Services Corp., Sidney, NE June 4, 2002

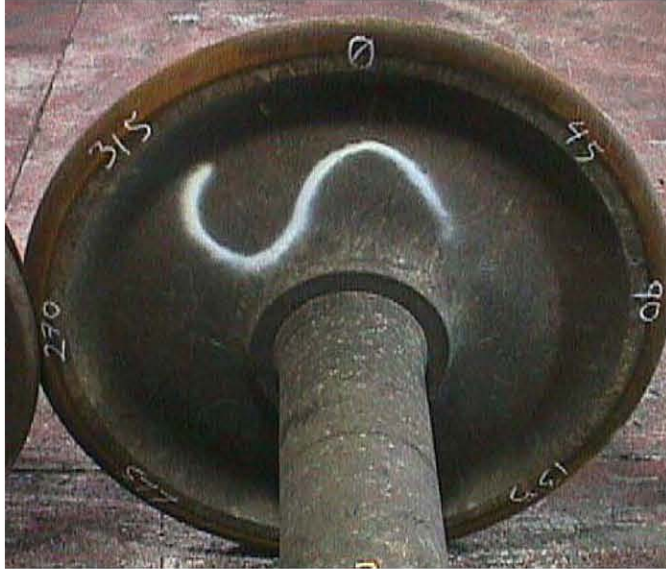
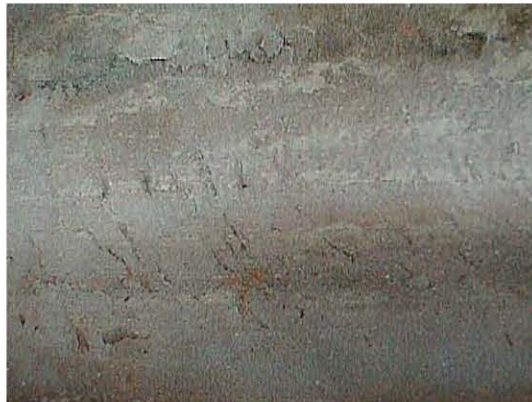
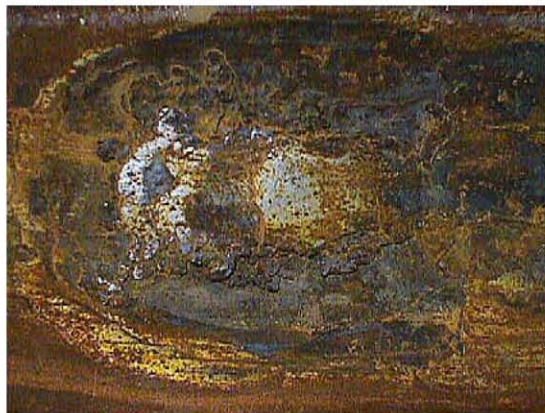
Wheel 50469
No Tread Buildup
(Revenue Service Wheel Evaluation)
FRA TREAD BUILDUP TEST

Wheel #50469 a tread damaged wheel at Progress Wheel Shop

FRA TREAD BUILDUP TEST
 SURFACE CONDITION and HARDNESS READINGS
 WHEEL # 50469 Progress Rail Services Corp., Sidney, NE June 4, 2002

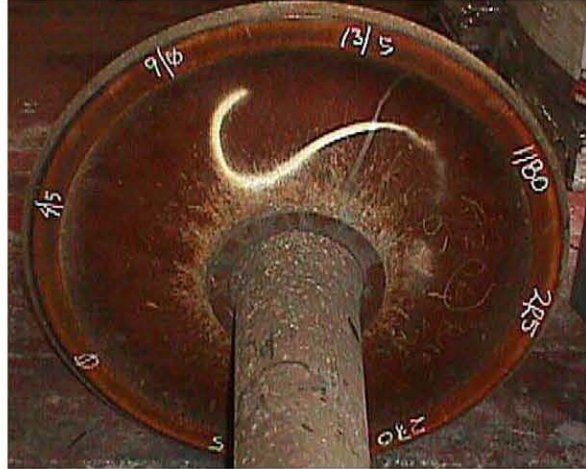
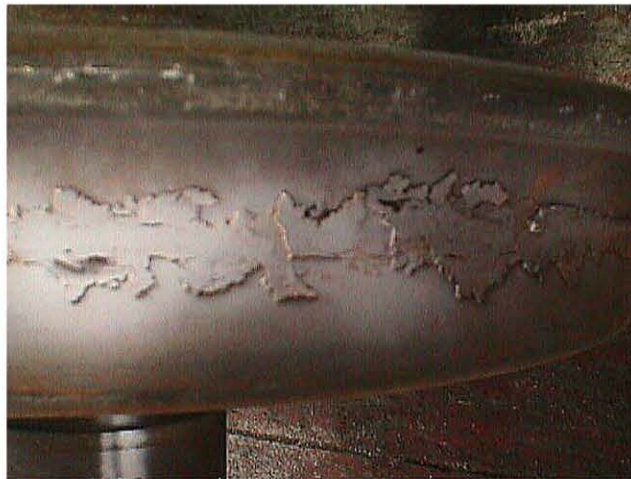
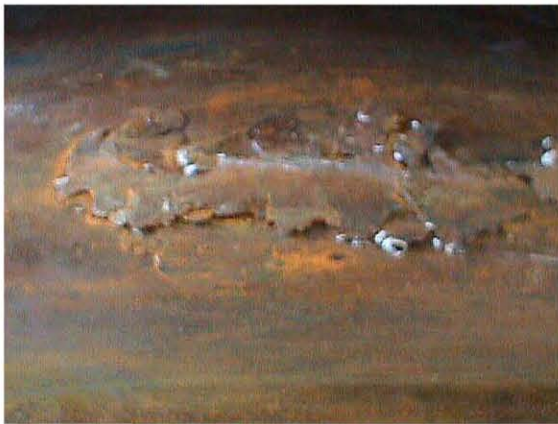
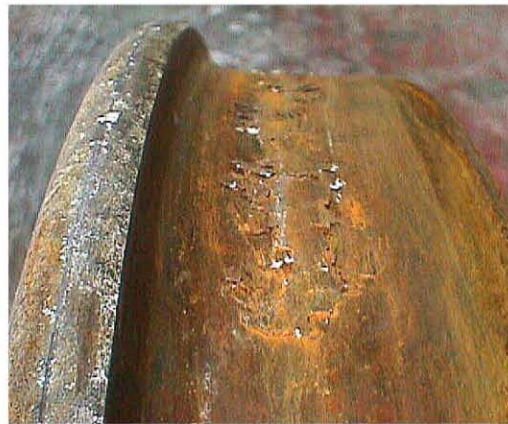
Wheel 51124
Moderate Tread Metal Buildup
(Revenue Service Wheel Evaluation)
FRA TREAD BUILDUP TEST

Wheel #51124 a tread damaged wheel at Progress Wheel Shop

FRA TREAD BUILDUP TEST
 SURFACE CONDITION and HARDNESS READINGS
 WHEEL # 51124 Progress Rail Services Corp., Sidney, NE June 4, 2002

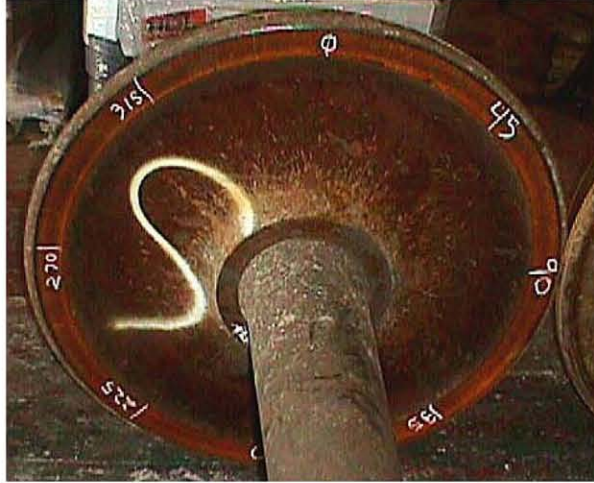
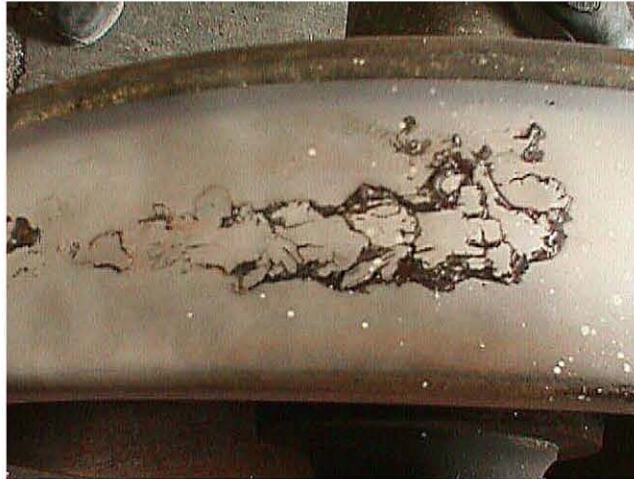
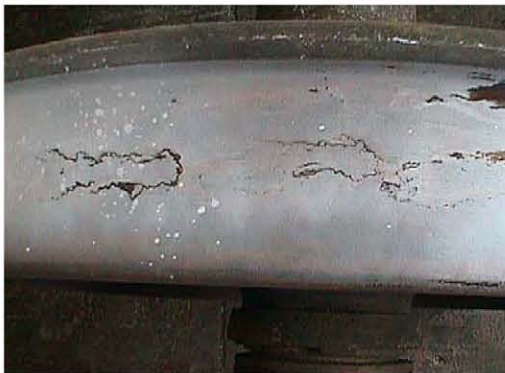
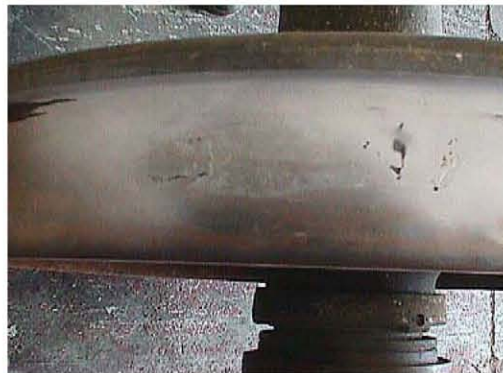
Wheel #53168 a tread damaged wheel at Progress Wheel Shop

FRA TREAD BUILDUP TEST
 SURFACE CONDITION and HARDNESS READINGS
 WHEEL # 53168 Progress Rail Services Corp., Sidney, NE June 4, 2002

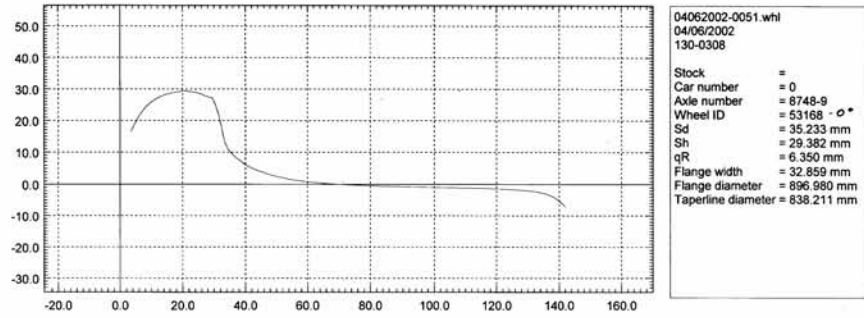
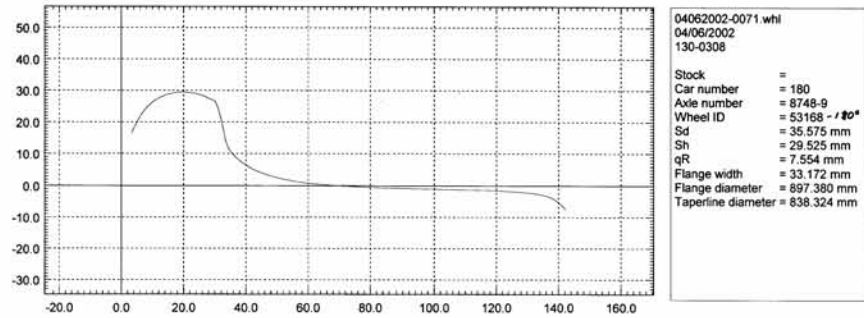
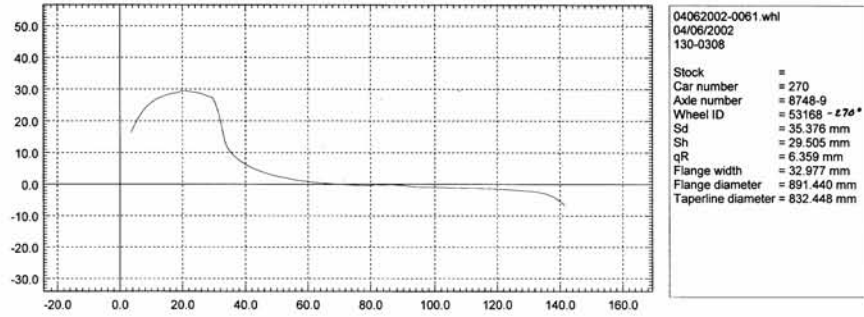
Inspected wheel MiniProf™ profiles showing transverse view of wheel tread
(x and y axes in millimeters)
