**EFFECTS OF ENVIRONMENTAL EXPOSURE
ON TIMBER RAILROAD BRIDGE/TRACK
MEMBERS AND CONNECTORS**

Travis Burgers
Jeno Balogh, Ph.D
Richard Gutkowski, Ph.D., P.E.

December 2004

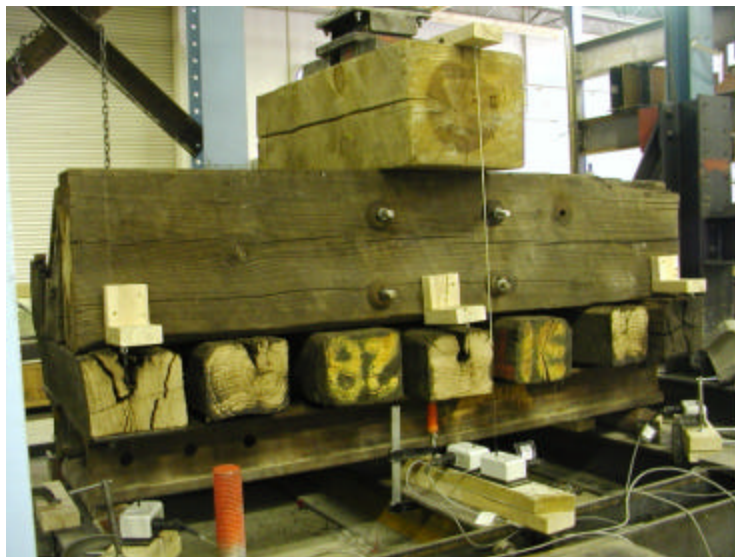
Figure 4. Side view of the (upside down) specimen load test setup

Figure 4 shows the test setup of the specimen.

After construction, the cap was removed from the specimen so that a load could be applied to each individual ply rather than the three plies simultaneously through the cap.

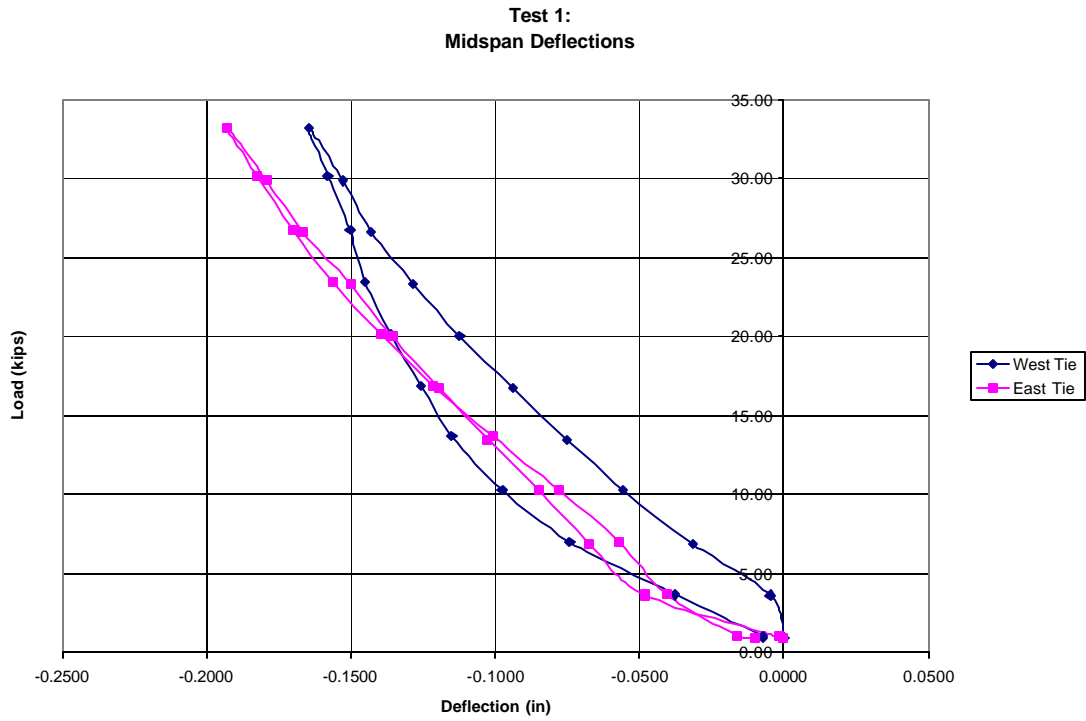
Figure 7. Midspan deflections due to loading on center ply (Test 1)

The measured load versus deflection plots for the midspan of the plies are shown in Figures 7 through 12. A negative deflection is vertically downward. Test 1 in these figures corresponds to the initial test after the initial exposure period (55.5 hours over 20 days) and Test 2 corresponds to the test after the specimen was exposed in the environmental chamber the second time (for 134 hours over 41 days).

For the first test, the measured load versus deflection graph shows that the 27 kip load on the center ply causes a vertical downward deflection of 0.1700 and 0.1475 inches in the east and west plies respectively (Figure 7). When the load is applied to the east ply, 2.7 kips are required to make it deflect downward 0.1700 inches, the same deflection that occurs when the 27 kip load is applied to the center ply (Figure 9). When the load is applied to the west ply, 2.5 kips are required to make it deflect downward 0.1475 inches, the same deflection that occurs when the 27 kip load is applied to the center ply (Figure 8).

From the comparison of the midspan deflections because of center ply loading in Figures 7 and 10, the test specimen showed significant degradation in the east ply but little in the west. In the first test, the east ply deflected 0.17 inches and the west ply 0.15 inches at a load of 27 kips. In the second test, the east deflected 0.31 inches and the west 0.16 inches under the same load. This corresponds to an 82 percent deflection increase in the east ply and a 7 percent increase in the west ply.
