ROAD SAFETY AUDITS: CASE STUDIES

1. Report No. FHWA-SA-06-17

March 2007

Road Safety Audits: Case Studies

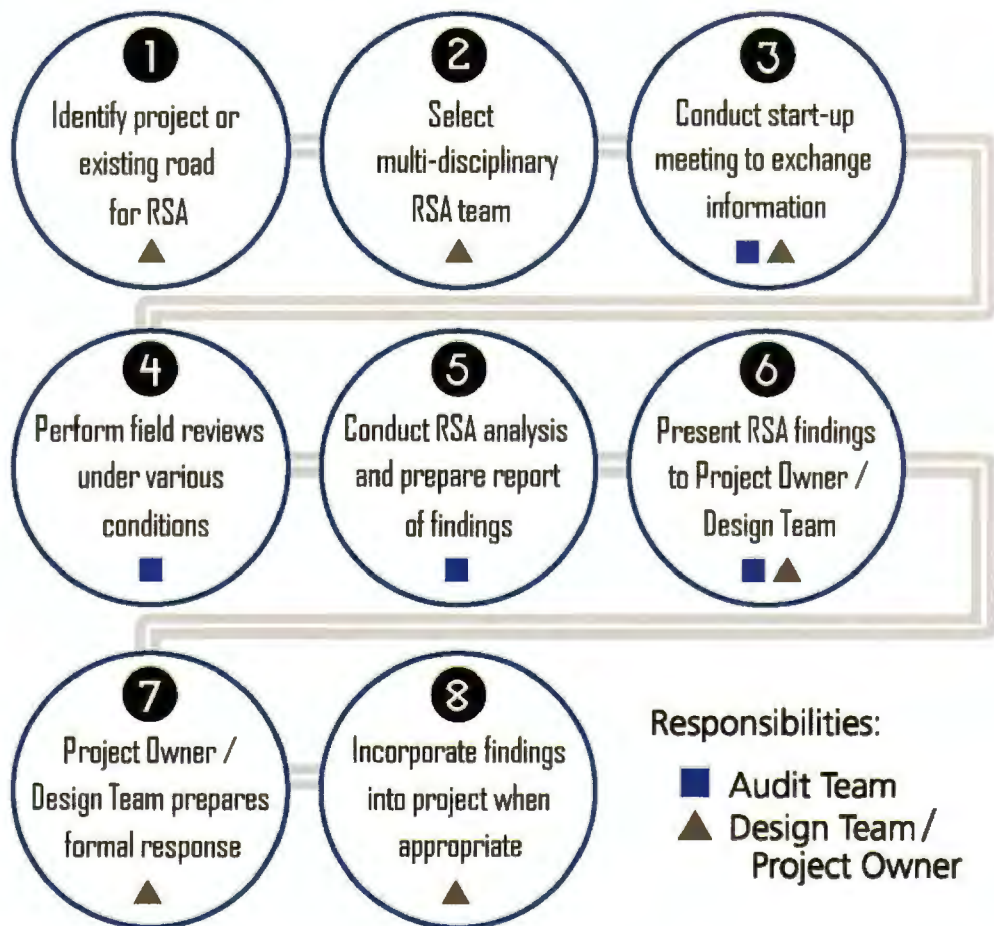
FIGURE 1 RSA PROCESS

The eight steps of an RSA are shown in Figure 1, and are discussed below with reference to the case studies.

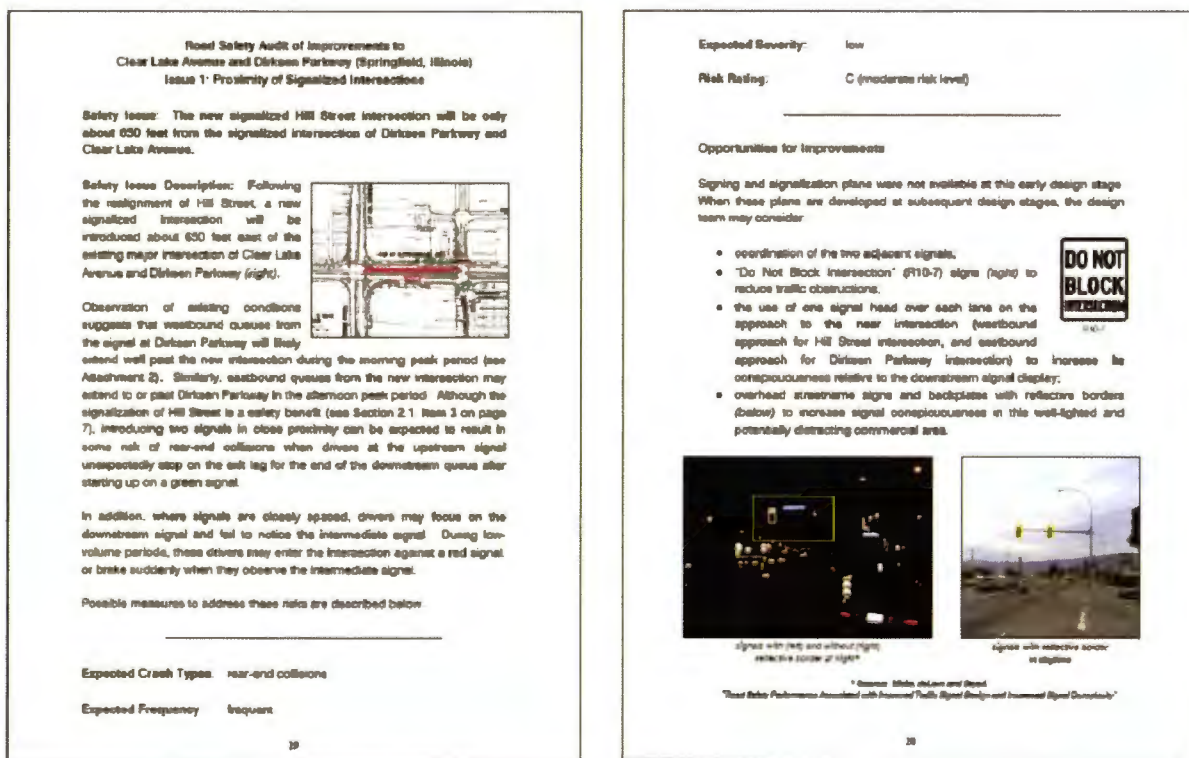
FIGURE 6 EXAMPLE DISCUSSION OF AN RSA SAFETY ISSUE

- *RSA findings*: a listing of safety issues and suggested mitigation, usually one or two pages each. A two-page example is shown in FIGURE 6. A safety issue has been identified in a single sentence at the top of the page. A description of the safety issue follows, describing the nature of the safety concern and how it may contribute to collisions. A figure has been used to illustrate the safety issue. Prioritization of the safety issue follows, using the prioritization matrix described earlier, and ways to address the safety issue are suggested.

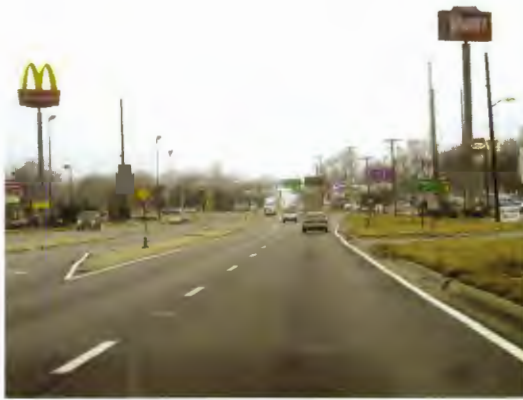
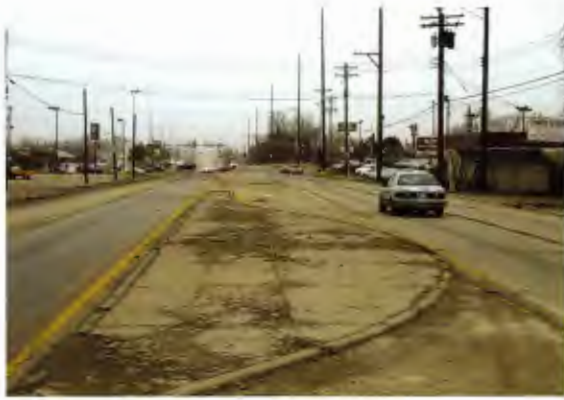
FIGURE A.1 VIEWS OF RSA SITE (ILLINOIS DOT RSA)

Clear Lake Avenue (looking west toward intersection with Dirksen Parkway)

Dirksen Parkway (looking south toward intersection with Clear Lake Avenue)

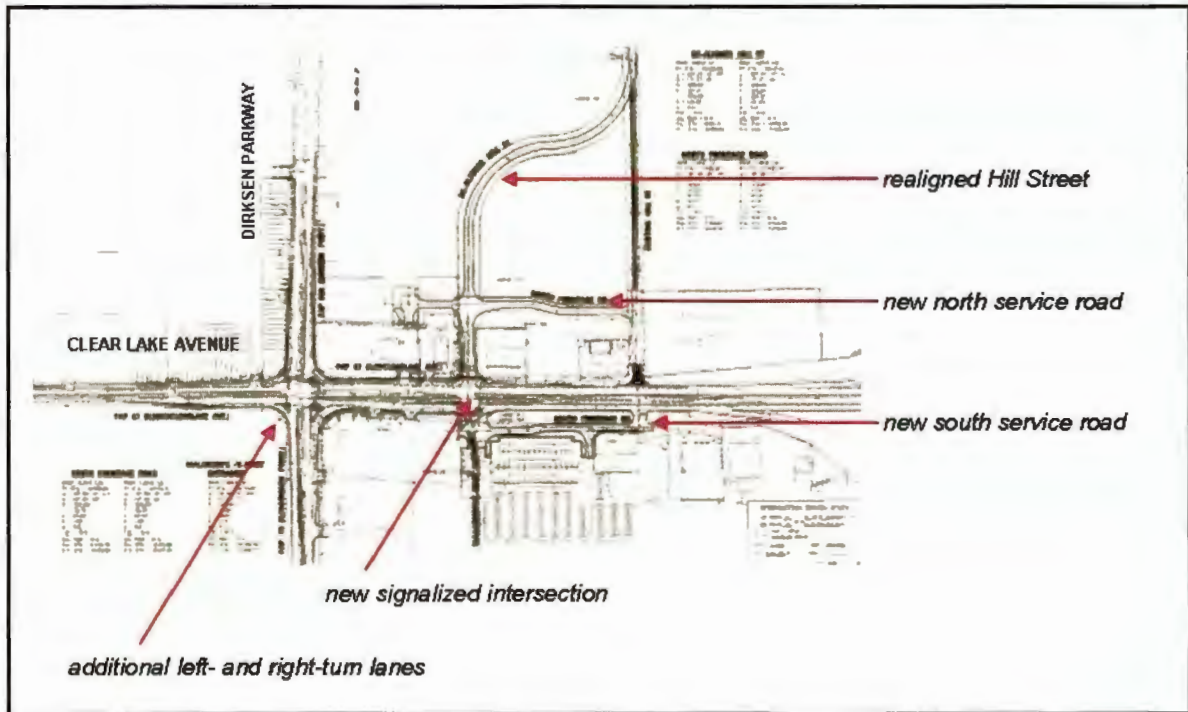
FIGURE A.2 RSA PROJECT (ILLINOIS DOT RSA)

The intersection of Clear Lake Avenue and Dirksen Parkway was designated a high accident location for six consecutive years (1998 through 2003), and the intersection of Hill Street and Clear Lake Avenue was designated a high accident location in 2003. In response, the Illinois Department of Transportation (IDOT) developed plans to upgrade Clear Lake Avenue between Dirksen Parkway and the I-72/I-55 interchange. The scope of the planned improvements, shown in FIGURE A.2, included:

- access consolidation and construction of two new service roads intersecting Clear Lake Avenue at a new signalized intersection east of Dirksen Parkway;
- realignment of Hill Street (a local road) to intersect Clear Lake Avenue at new signalized intersection;
- dual left turn lanes on all legs of the intersection of Clear Lake Avenue and Dirksen Parkway, and dual right turn lanes on the southeast corner of the intersection.

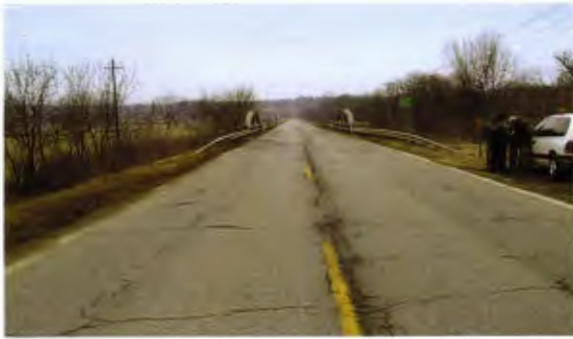
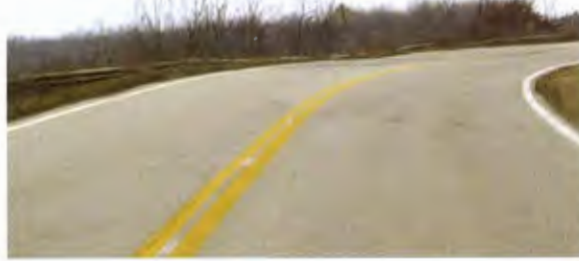
FIGURE A.3 VIEWS OF RSA SITE (OKLAHOMA DOT RSA)

*Buck Creek bridge
(planned improvements include repaving, bridge
improvements, and 8' paved shoulders)*

*Adjacent "incidental" section
(planned improvements include repaving and 2' paved
shoulders)*

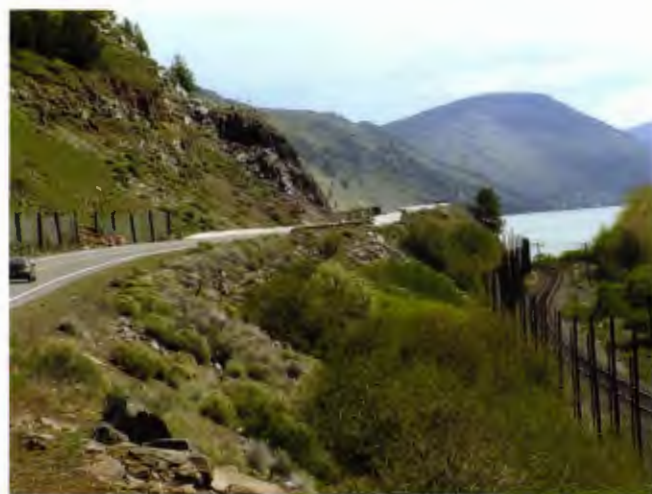
FIGURE A.4 RSA SEGMENT OF US 97

The project, along US Highway 97 between Modoc Point and Algoma, was located in Klamath County in South Central Oregon. In this area, the US 97 alignment passes along the east side of Upper Klamath Lake and the Union Pacific Railroad (FIGURE A.4). The Oregon Department of Transportation (ODOT) identified several safety issues along this section of US 97, including a fatality rate of 5.3 per million vehicle miles, almost double the average rate for similar Oregon highways. The DOT noted the presence of narrow substandard shoulders widths, substandard cut and fill slopes, and unprotected safety issues within clear

the zone, including barriers, guardrail, and guardrail end terminals that did not meet current standards.

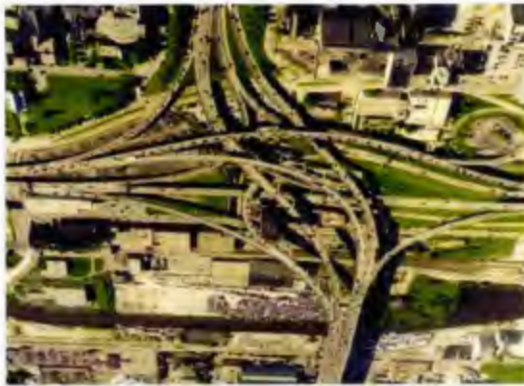
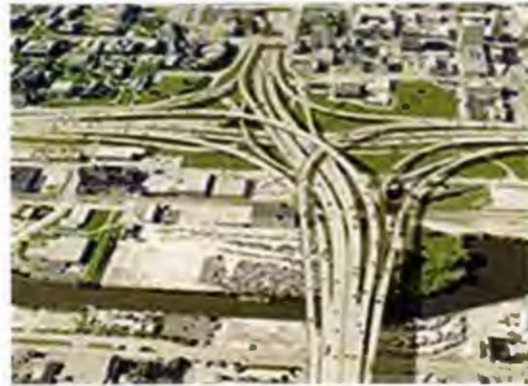
FIGURE A.5 EXISTING INTERCHANGE AND PROPOSED IMPROVEMENTS

Existing Interchange

Improved Interchange (simulation)

- replacement of left-side ramps with conventional right-side ramps,
- lengthening or elimination of existing short weaving sections,
- increased curve radii on ramps,
- lane continuity and consistency for through traffic,
- increased capacity on system ramps,
- increased barrier height.

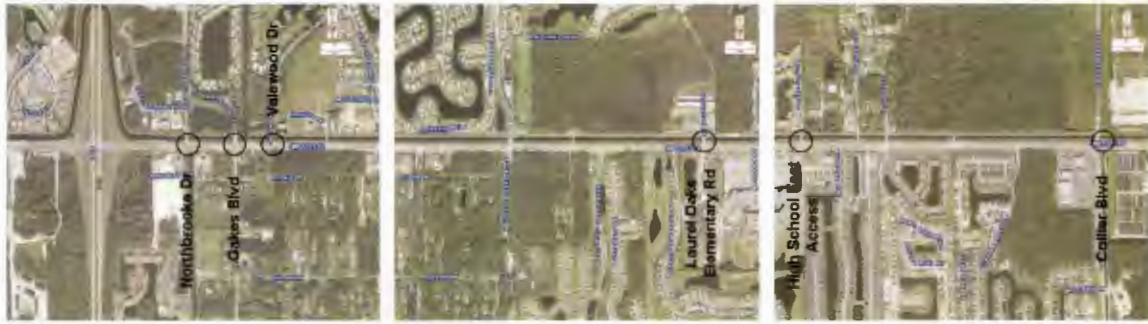
FIGURE A.8 RSA SEGMENT (COLLIER COUNTY RSA)

Immokalee Road, a County road, is a major east/west arterial connecting residential areas in western Collier County with I-75, US Highway 41, and the City of Naples. The RSA section of the roadway, shown in FIGURE A.8, was widened from two lanes to four lanes in 2002. The four-lane cross-section, shown in FIGURE A.9, was a divided arterial roadway with two through lanes in each direction, a grass median (up to about 40 feet wide), and turning lanes at signalized intersections. The corridor was adjacent to low-density residential, commercial, and institutional land uses, including the North Naples Fire Station No. 42, Gulf Coast High School, Laurel Oaks Elementary School, and several churches.

Signalized intersections shown.

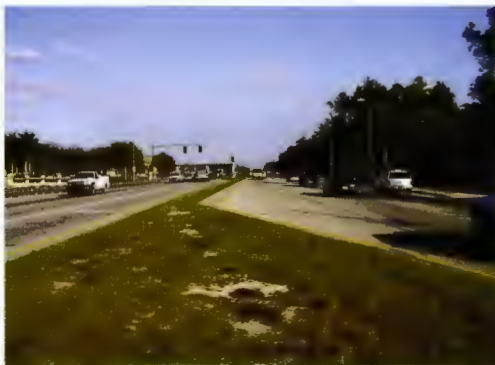
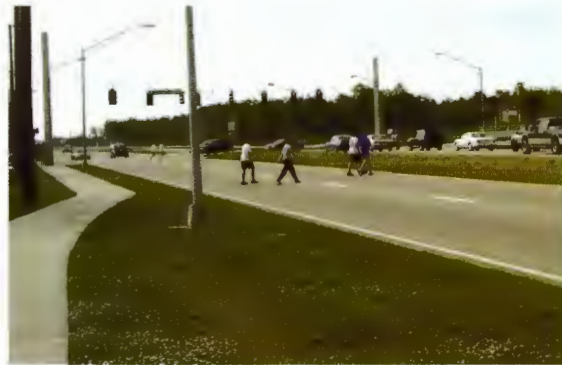
FIGURE A.9 VIEWS OF RSA SITE (COLLIER COUNTY RSA)

Immokalee Road near Valewood Drive

Immokalee Road in front of schools

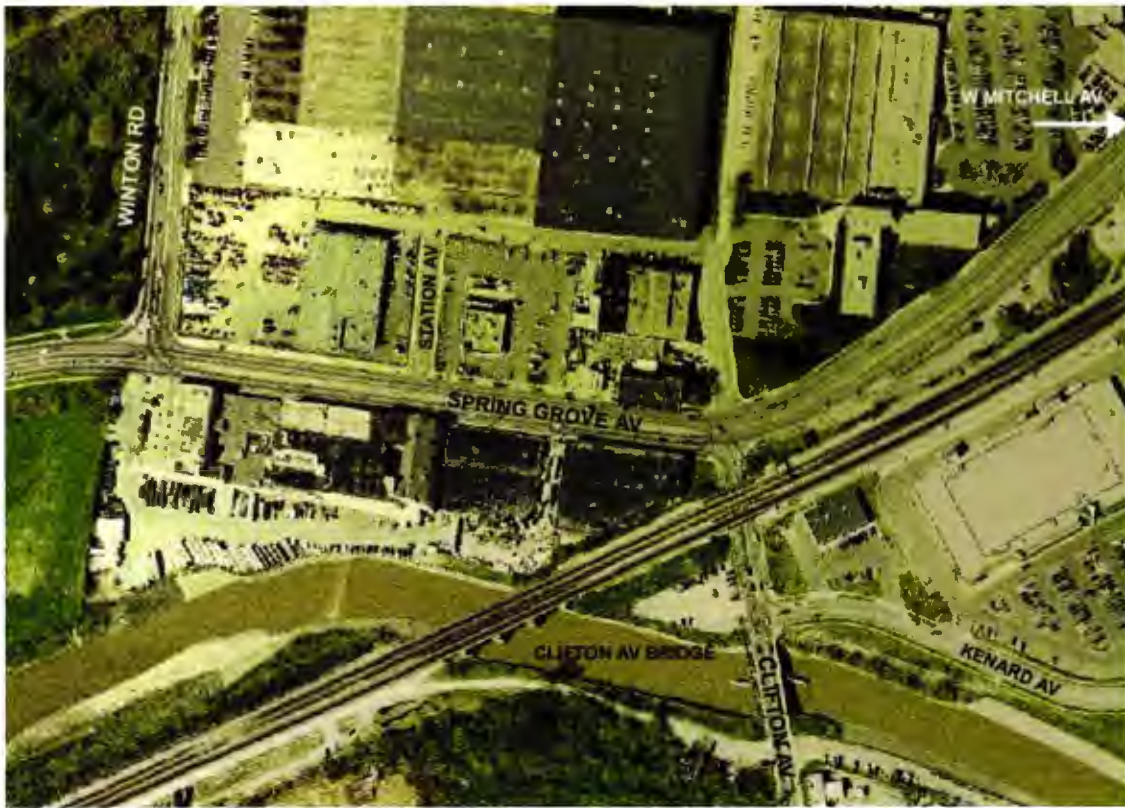
FIGURE A.10 RSA SITE (CITY OF CINCINNATI)

- Clifton Avenue bridge widening to accommodate four 10-foot lanes and a 10-foot painted median strip,
- traffic signal improvements at the intersection of Spring Grove Avenue and West Mitchell Avenue,
- other possible improvements to Spring Grove Avenue in connection with the planned upgrade.

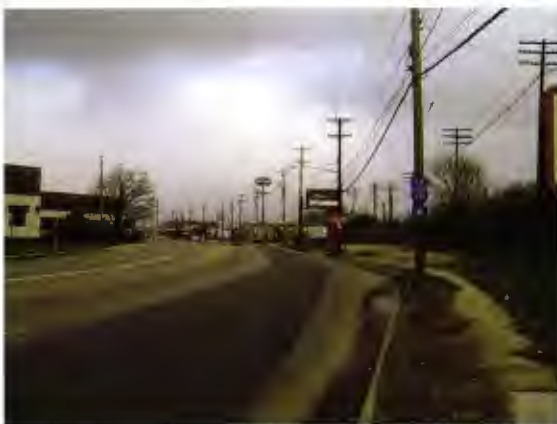
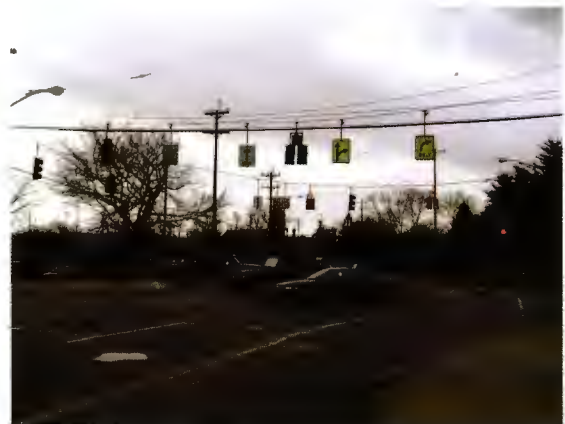
FIGURE A.11 VIEWS OF RSA SITE (CINCINNATI RSA)

Spring Grove Avenue

Intersection of Winton Road and Spring Grove Avenue

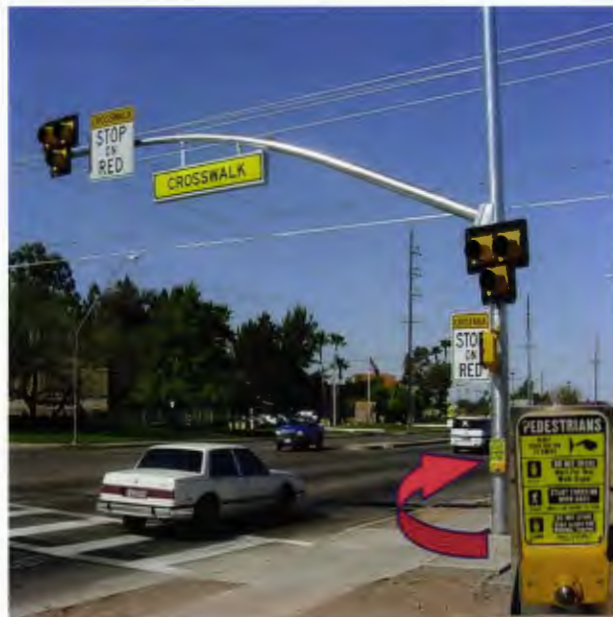
FIGURE A.12 HAWK PEDESTRIAN SIGNAL

HAWK (**H**igh-Intensity **A**ctivated **C**ross**W**alk) signals are a type of traffic control beacon for marked pedestrian crosswalks, developed by the City of Tucson and implemented in Tucson and elsewhere in Arizona. The City of Tucson received approval from FHWA to experiment with this device; it is not yet adopted in the *Manual of Uniform Traffic Control Devices*. The innovative HAWK signal, shown in FIGURE A.12, incorporates elements from fire station signals and school bus flashing displays, as well as from European pedestrian signal displays, to provide a familiar signal sequence for drivers and pedestrians. The HAWK signal is activated by a pedestrian pushbutton. The activated signal progresses from a dark display through flashing amber, solid amber, solid red, and flashing red, ending with a

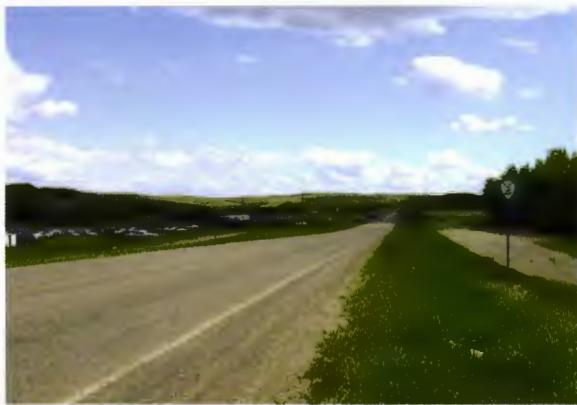
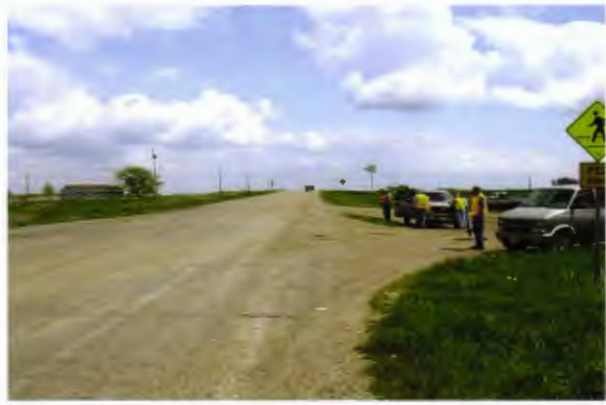
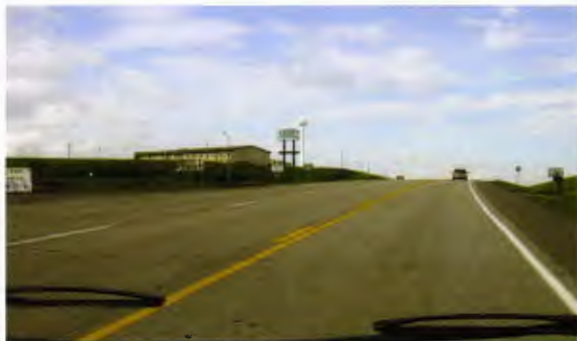
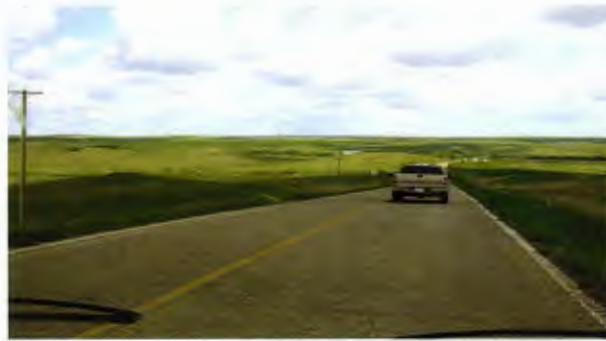
FIGURE A.13 VIEWS OF RSA SITES (STANDING ROCK SIOUX TRIBE RSA)

Roads studied during this RSA included ND 24 and Highway 1806 (part of BIA 3), US 12, and community access roads. Typical reservation roadways are shown in FIGURE A.13. The RSA team drove these roads to identify safety issues associated with road geometry, traffic operations, and maintenance. Although bridge inspection is not a usual part of the RSA process, the RSA team was asked to observe possible maintenance issues associated with a bridge on BIA 3 at Four-Mile Creek. RSA findings associated with the bridge were included in the RSA report.

BIA3 at intersection with ND24 south of Fort Yates, ND

BIA 3 / Hwy 1806 in Kenel, SD

US 12 at Grand River Casino (left), near Mobridge, SD

BIA 44 west of Mahto, SD

SELECTED SAFETY ISSUE (Number and Description)	RISK RATING	SUGGESTIONS
1	<i>Road Maintenance:</i> Limited maintenance on reservation roads contributes to poor pavement conditions and concern regarding bridge stability.	B to D	<ul style="list-style-type: none"> • control cracking with sawcut and fill • accommodate future overlays • bridge inspection and repair
2	<i>Access to Grand River Casino:</i> Drivers turning into and out of the Grand River Casino may interfere with crossing, opposing, and following traffic on US12.	D	<ul style="list-style-type: none"> • speed reduction • improved signing • westbound left turn bay • access relocation
3	<i>BIA 31 and ND 24 (School Frontage):</i> Driver workload is potentially high near the intersection of BIA 31 and ND 24, which accommodates local, school, and through traffic.	B to D	<ul style="list-style-type: none"> • no-passing zone • crosswalk maintenance • enhanced signing • turning lanes on ND24 • improved lighting • access consolidation • urban cross section

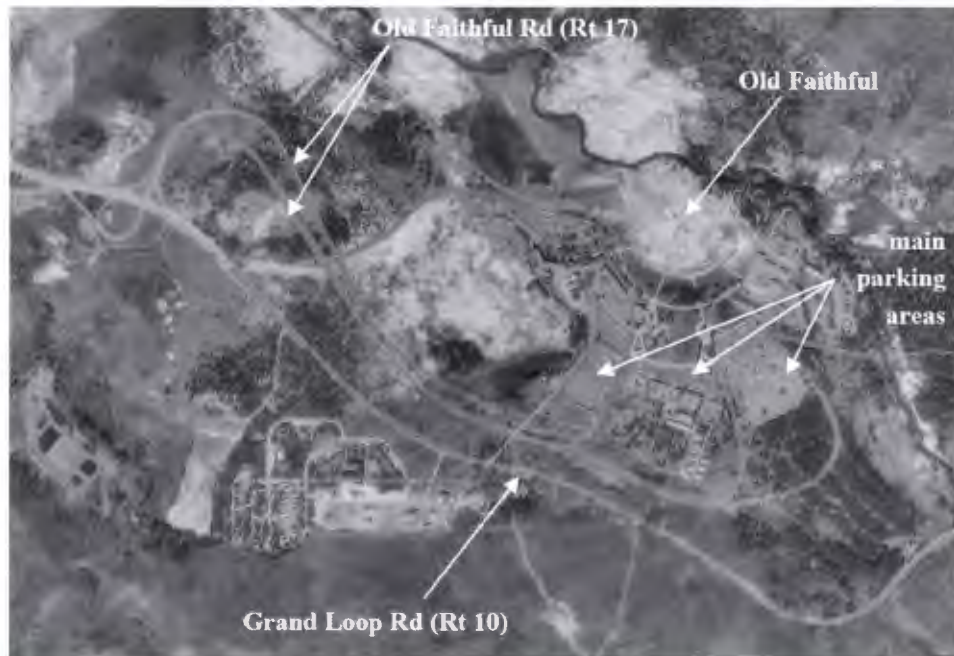
FIGURE A.14 RSA SITE (YELLOWSTONE NATIONAL PARK)

At the time of the RSA, two planning-level concepts (FIGURE A.16) had been developed to replace the existing Old Faithful interchange, which provided the only public access to Old Faithful Road from the Grand Loop Road:

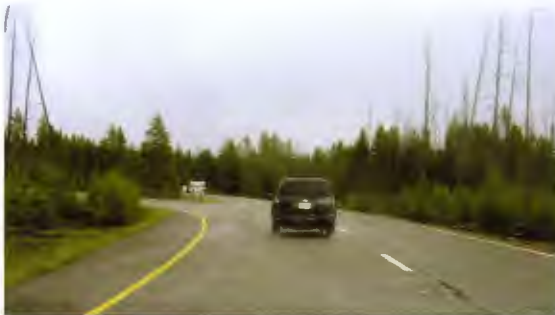
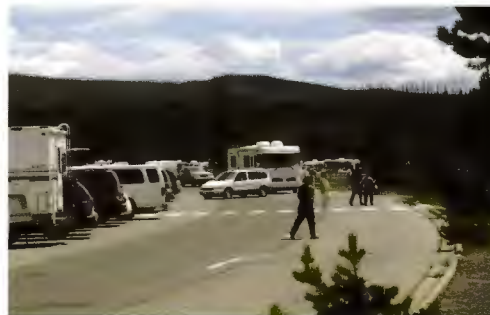
FIGURE A.15 VIEWS OF RSA SITE (YELLOWSTONE NATIONAL PARK)

Old Faithful Road

Part of main parking area near Old Faithful geyser

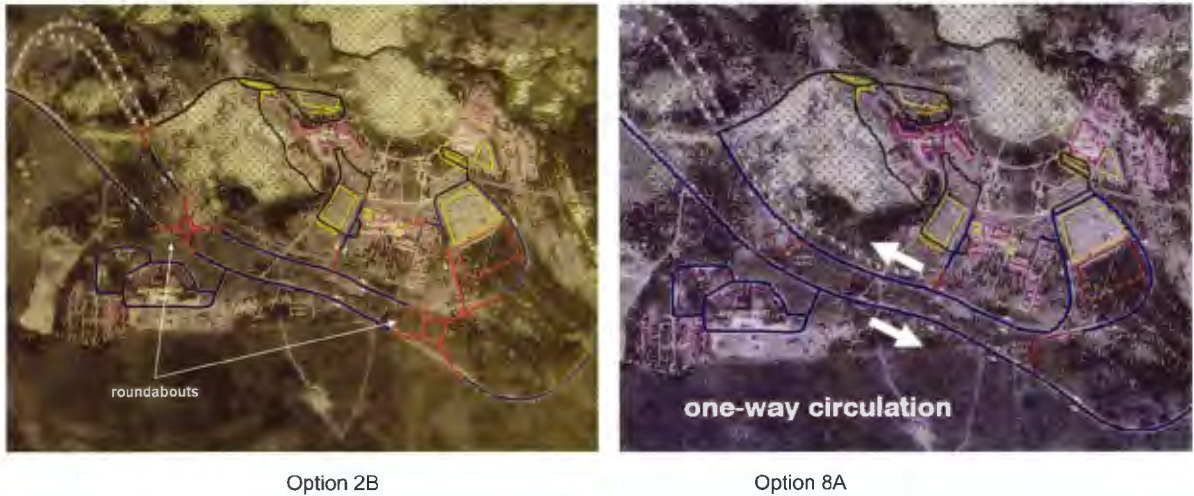
FIGURE A.16 PROPOSED IMPROVEMENTS TO OLD FAITHFUL AREA

- new east and west entry/exit points using two two-lane roundabouts that provide access to and from Grand Loop Road and Old Faithful Road ("Concept 2B"),
- a one-way circulation scheme connecting the Grand Loop Road and Old Faithful Road with ramps ("Concept 8/8A").

These two concepts were reviewed as part of the RSA. At the time of the RSA, these and other alternative concepts were still under development, and were subject to substantial changes pending completion of resource surveys and other data collection efforts.
