REPORT NO. UMTA-MA-06-0025-75-7

SOAC
STATE-OF-THE-ART CAR
ENGINEERING TESTS AT
DEPARTMENT OF TRANSPORTATION
HIGH SPEED GROUND TEST CENTER

Volume VII. Post-Repair Tests

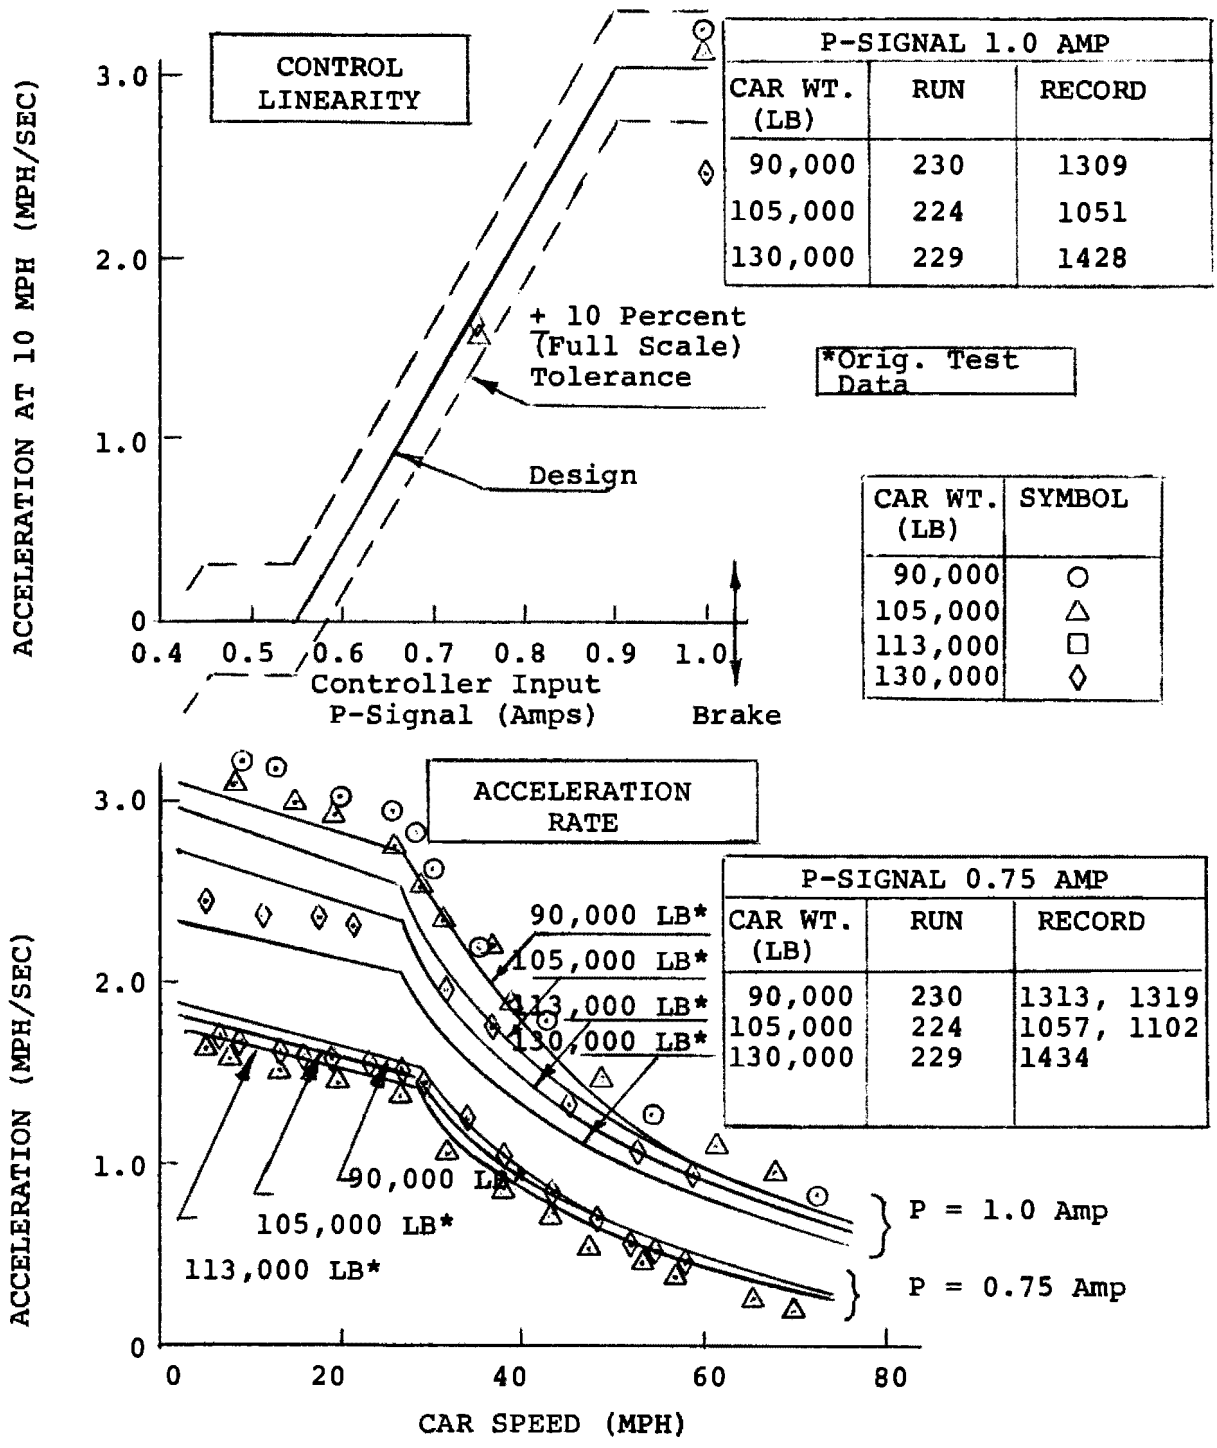
Figure 3—2. Acceleration versus Car Weight

In Figure 3-2, there are some noticeable differences
between the original SOAC test data and the repaired SOAC
data.   These could be due to a zero shift of the accelero-
meter or may be due to the type of filters used in digi-
tizing the magnetic data tapes.

The acceleration test results for the repaired SOAC cars
are sufficiently close to those obtained from the original
tests to conclude that there was no appreciable change in
the acceleration characteristics of the SOAC cars due to
the repair modifications.

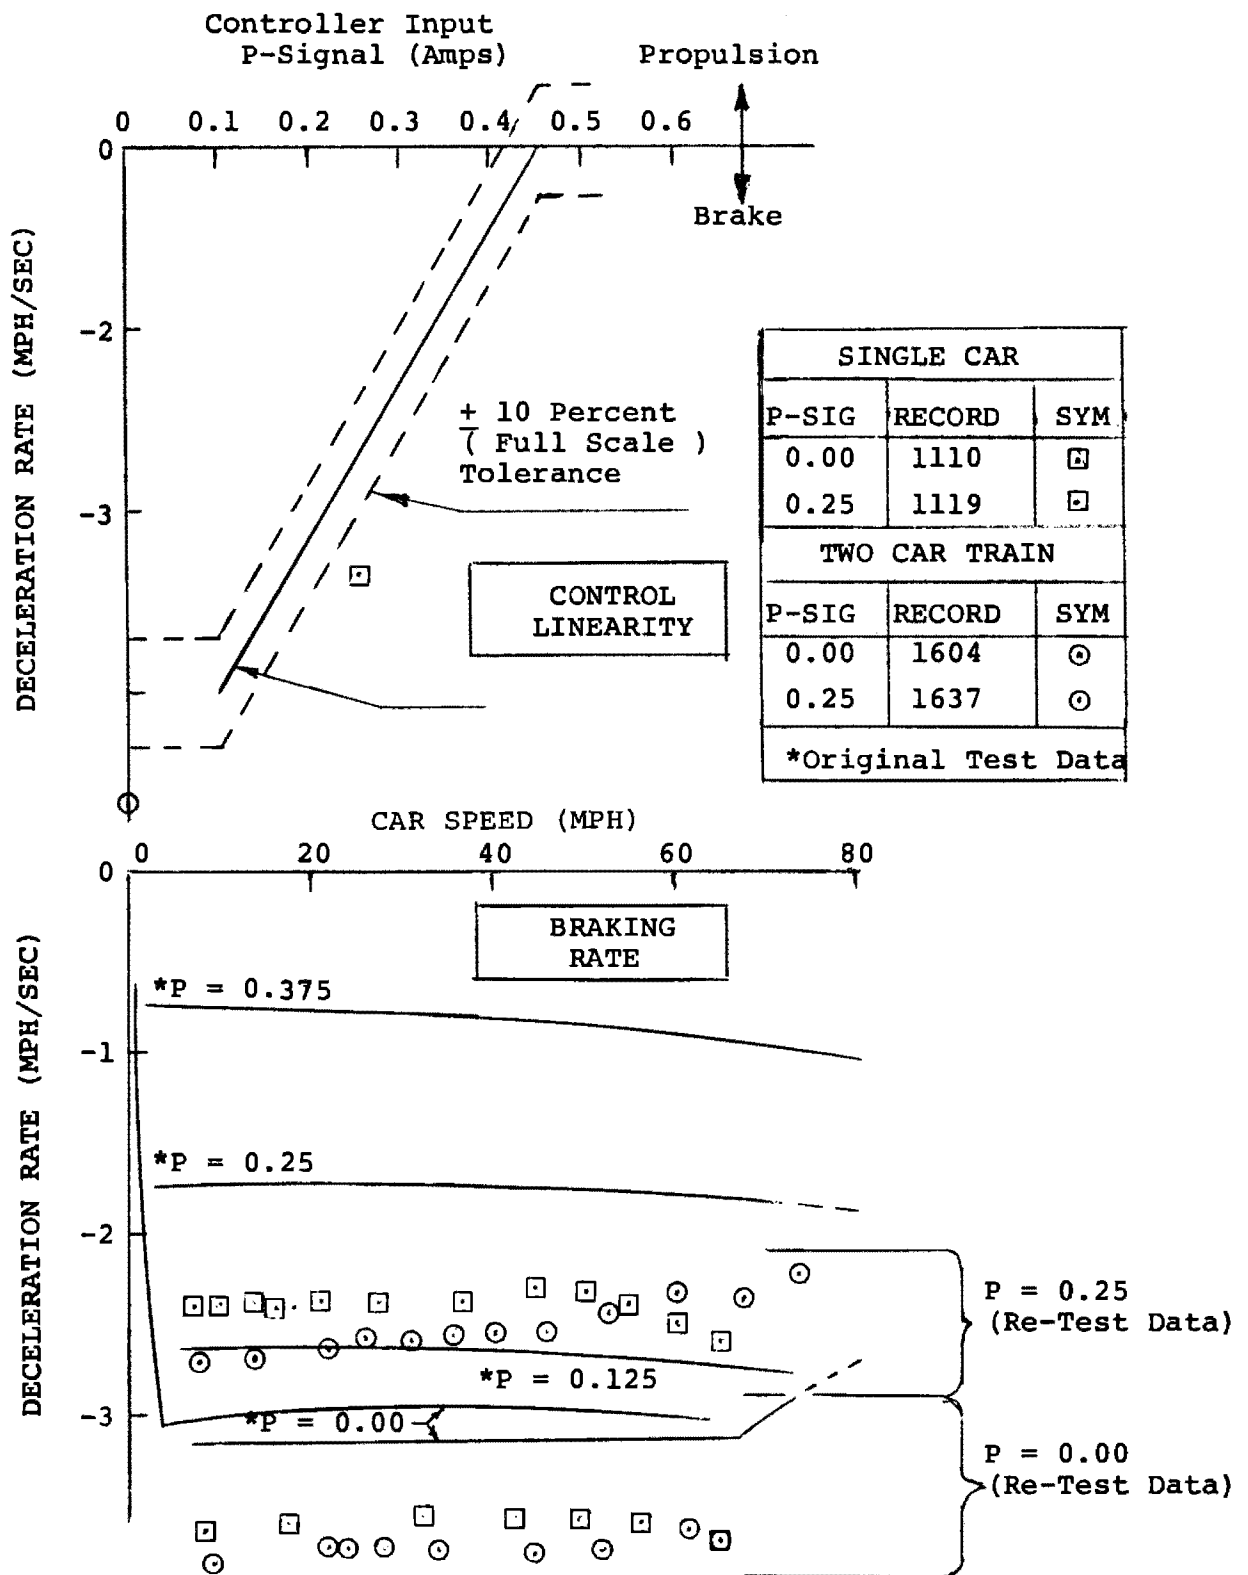
Figure 4—2. Blended Braking Control Characteristics (105,000-lb Car Weight)

Figure 4-2 presents the blended braking load weight compensation control characteristics from the original tests and the repaired car tests for various car weights in single car configuration, and for "P" signal control inputs of 0.0 amps and 0.25 amps. It was noted that the distance required to stop the 90,000-lb car from a brake entry speed of approximately 80 mph was 1,450 ft. the same as for the 105,000-lb car.

The deceleration rates for all the repaired car tests exceeded those measured during the original test program and also exceeded the SOAC specification rates. In addition, the control linearity for the repaired car tests exceeded the ± 10% (full scale) tolerance band.

This result is significant, but no adjustments were made to the SOAC control system during the test program at the HSGTC. The SOAC Transit Property Demonstration Program allows the SOAC acceleration and deceleration rates to be set to property limits.

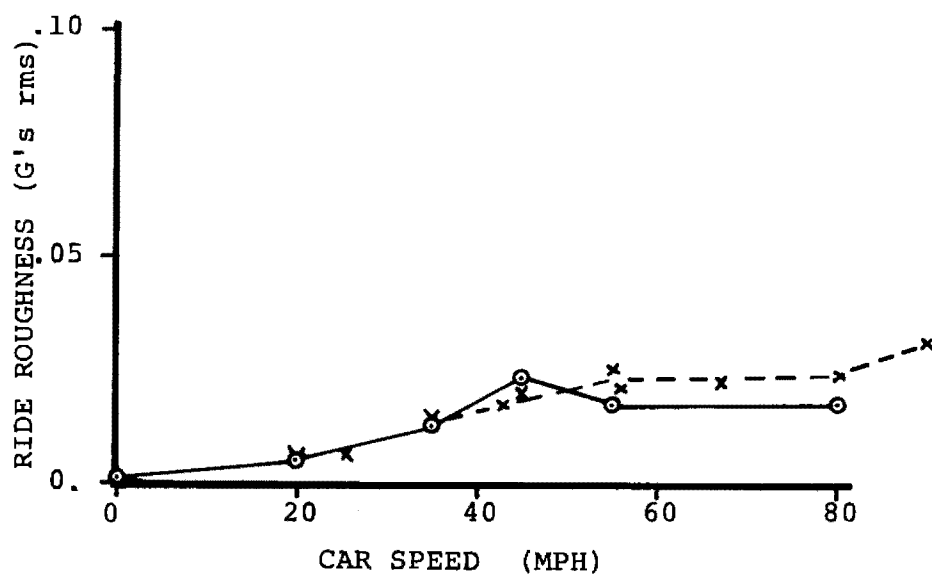
Figure 6—3. Effect of Speed on Forward Car Centerline Vertical Ride Roughness (High Density Car, 90,000 Pounds)

Figure 6-3 shows the effect of speed for the SOAC forward car vertical ride roughness. The data between the two tests is very similar. The retest levels diverge and become higher than the original test levels above 50 mph. The journal box accelerations reveal that the test track or wheels were rougher during the re-

test period. The values of the car body ride roughness and the car speeds at these higher values is consistant with their being induced by these "rougher" conditions.

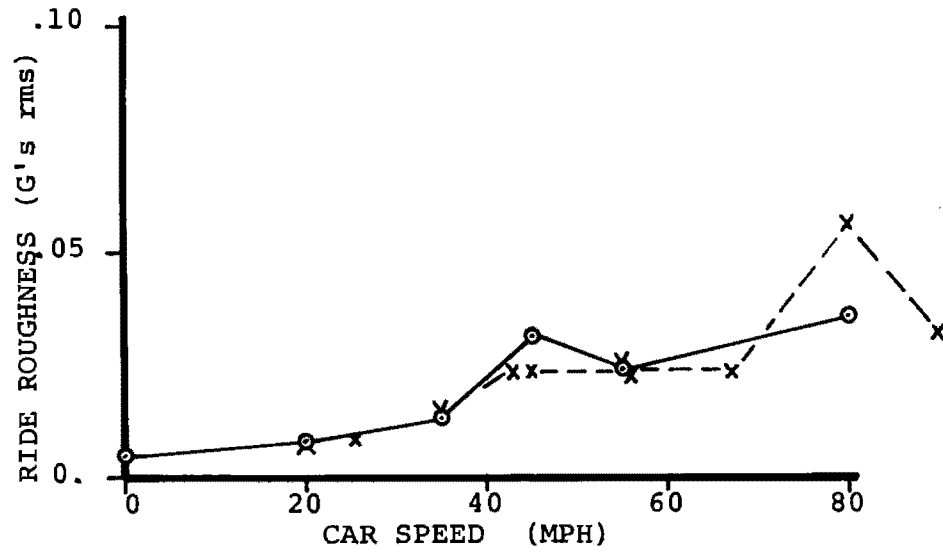
Figure 6—4. Effect of Speed on Mid Car Centerline Vertical Ride Roughness (High Density Car, 90,000 Pounds)

The mid car vertical ride roughness as a function of speed is shown in Figure 6-4. The two sets of test data are very similar except at the 80 mph point. This is the point where the wheel revolution frequency induces the second car body bending response. The "rougher" test conditions appears to have excited a greater response than in the original tests. Examination of the peak amplitude spectral analysis plot for this data point (Figure B-71 of Appendix B) reveals that the 15.0 Hz response is strongly dominant in the 80 mph test, and supports the conclusion above.

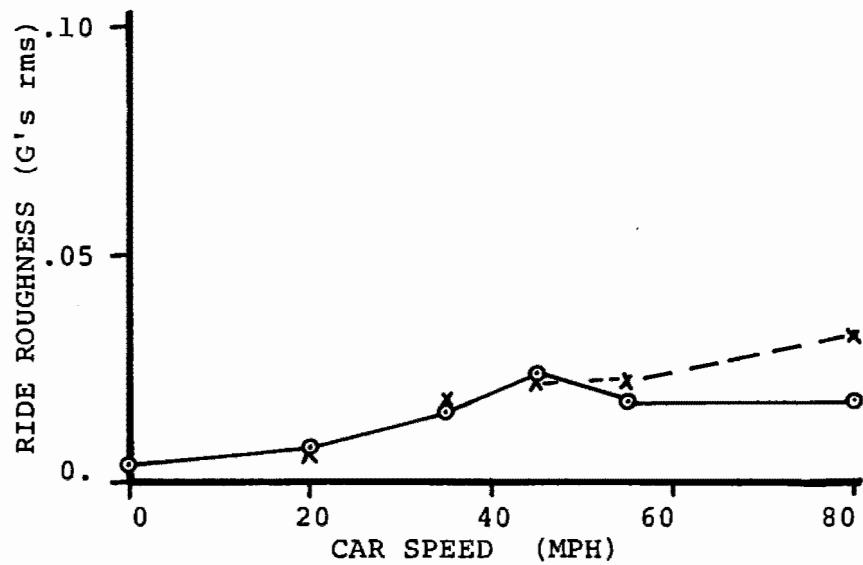
Figure 6—7. Effect of Speed on Mid Car Centerline Vertical Ride Roughness (High Density Car, 105,000 Pounds)

Figure 6-7 shows the mid-car vertical ride roughness levels as a function of speed. The divergence of the ride roughness levels for the higher speeds is consistent with the "rougher" test conditions described above for the 90,000-pound car tests and for the journal box accelerations described below.

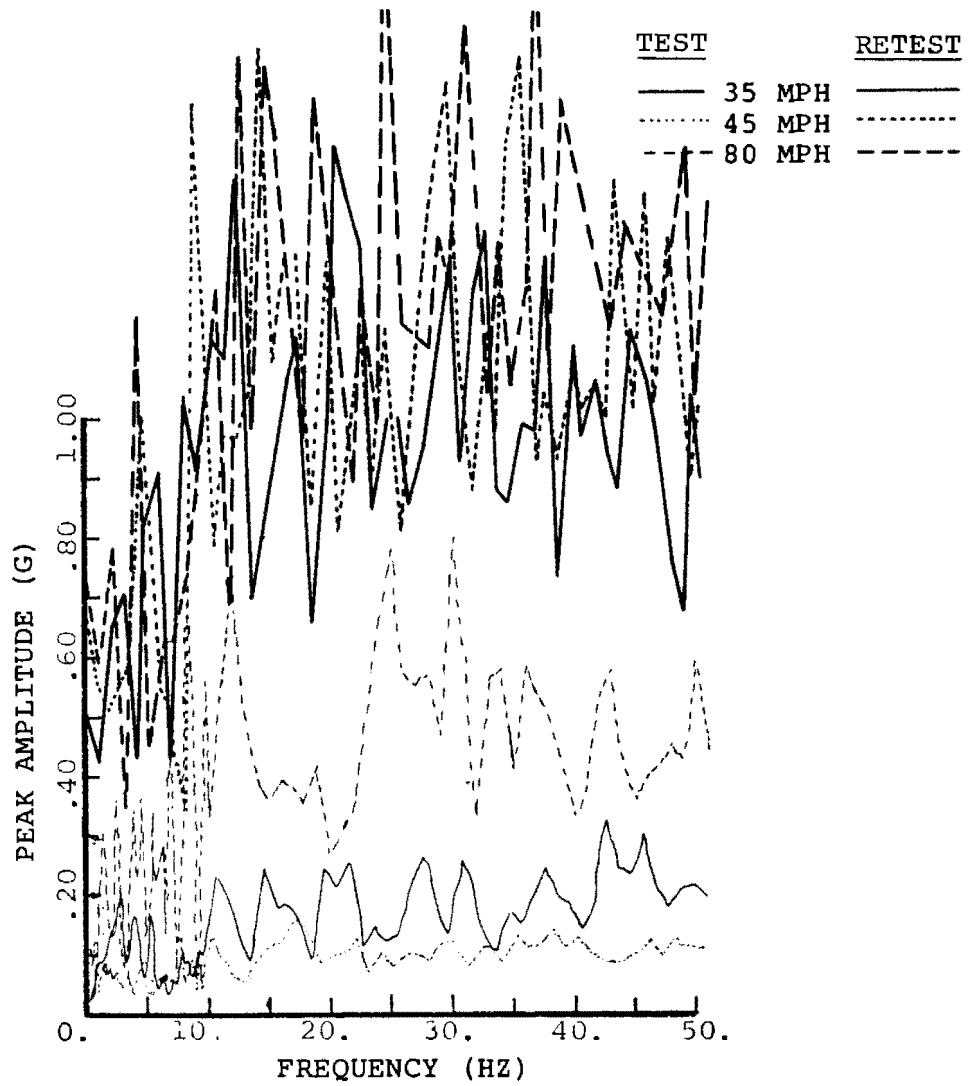
Figure 6—8. *Effect of Speed on No. 1 Axle Lateral Acceleration (High-Density Car, 90,000 Pounds)*

Figures 6-8 through 6-10 show the journal box acceleration levels for the 90,000- and 105,000-lb car tests. As shown, the levels are twice as high as the original data, but in a low significance range. The reason for these level changes may be found in the test track use during the interim between the original and retest programs (August to December 1973). Track Section I is the only access rail between the Test Center and the commercial rail lines. This section of track saw a great deal of heavy freight traffic due to the FRA construction at the Test Center. The rails over Track Section I were therefore rougher, or more irregular, than they were during the original tests. It is obvious that in order to ensure more accurate repeatability in the test data, considerably more attention must be made with respect to track

condition, even for an isolated test track such as the Rail Transit Test Track. If the Retest journal levels shown were more significant, or if more accurate repeatability were required, the track would have to be corrected and the tests repeated.

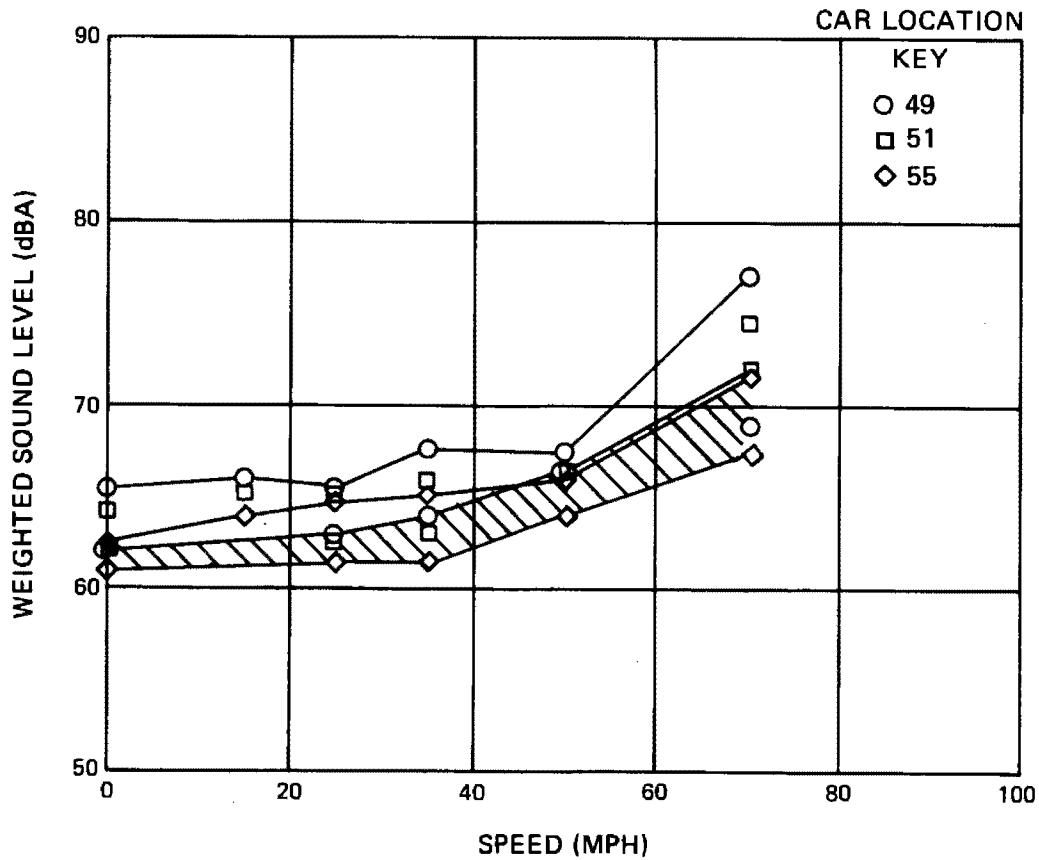
Figure 7–4. Comparison of Interior Noise Levels of SOAC No. 2 Car Before and After Repair

Figure 7-4 shows sound levels for the post-repair testing to be higher than the original test by 2-4 dB, including the car at rest. The reasons for this difference are not known but the following items are pertinent:

(a) The noise from the air conditioning system blower at the forward end of the car near Location 49 (see Figure 7-2) may be greater after the repair than before. No airflow or noise data were obtained during the original test program which would bear this out.

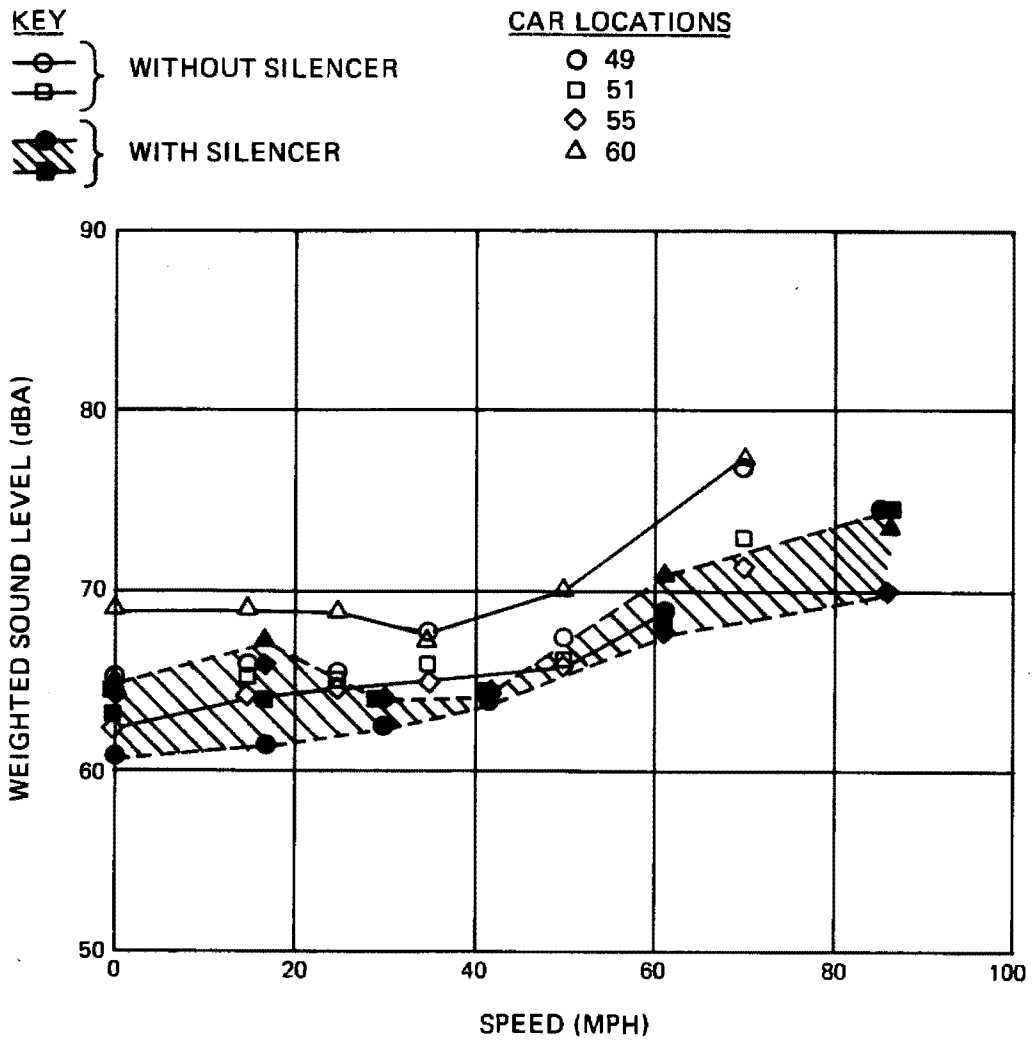
Figure 7—5. Comparison of Interior Noise Levels Before and After Silencer Installation

presents the sound levels with and without the air conditioning duct silencer installation, as obtained during the post-repair testing.

The post-repair measured sound levels without the silencer installation fall within the total envelope of the baseline data measured in both SOAC cars. Additionally, it may be concluded that the air conditioning air duct silencer installation did have a beneficial effect in providing more uniform sound levels throughout the car.

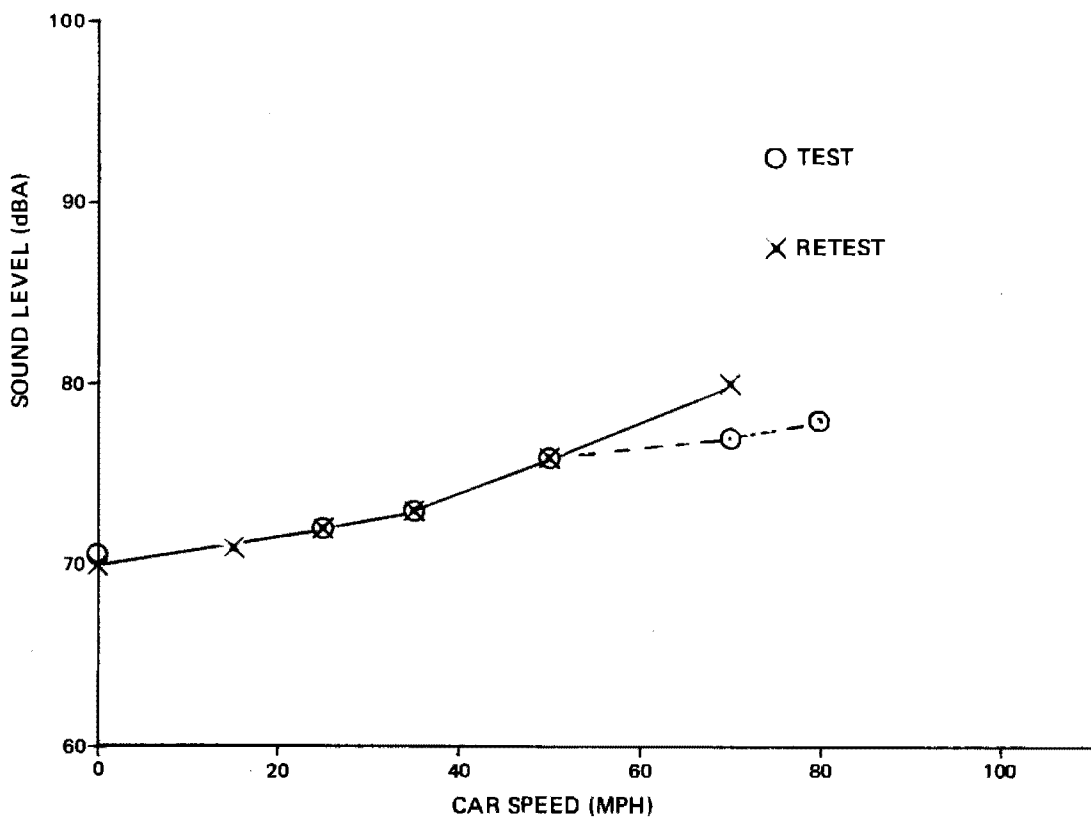
Figure 8—2. Comparison of Wayside Noise Levels Measured 50 Feet from Track for Post-Repair and Original Tests

A review of the post-repair test data in Figure 8-2 in comparison to the original data, shows the former to be slightly higher from 50 mph up to 70 mph. This has been attributed, in some measure, to slight wheel flats which were audible during the tests.

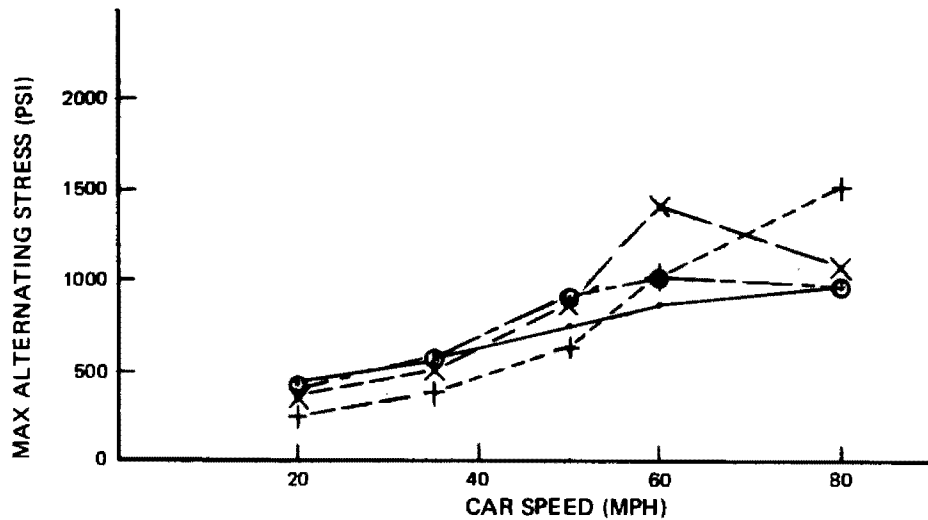
Figure 9—5. Upper Truck Frame Stress vs Speed

Figure 9-5 compares one of the truck frame strain gage levels to the original data. Although the 80 mph data is slightly higher than the original data, it remains well below the design criteria for truck loads.
