THE CONTINUING CHALLENGE

THE NORTHRIDGE EARTHQUAKE OF JANUARY 17, 1994

Report to the Director,
California Department of Transportation

by the
Seismic Advisory Board

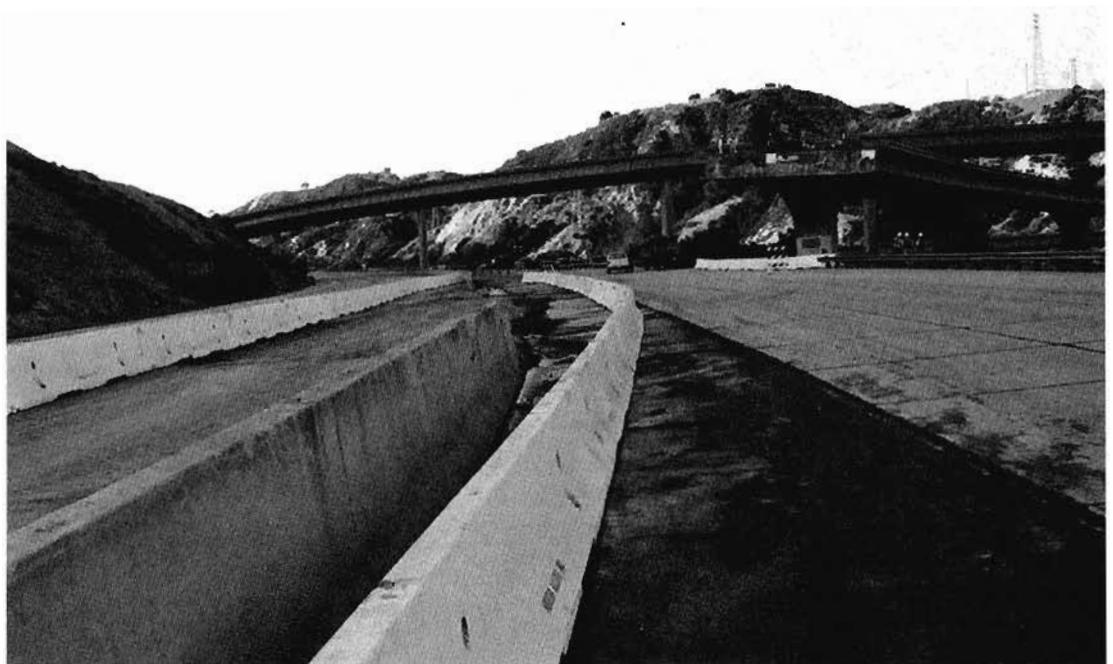
Figure 3-8. Completed demolition of the southbound connector at the Antelope Valley I-5/SR-14 Interchange five days after the earthquake (photo: F. Seible)

At the Antelope Valley I-5/SR-14 Interchange, demolition of the collapsed portions of the south and north connectors was already completed (Figure 3-8), but abutment and expansion joint damage in the separation structures provided a graphic reminder of the encountered force and displacement levels (Figures 3-9 and 3-10).
