Southern California Rapid Transit District  
Metro Rail Project

Analysis of  
Fireproofing Repairs  
to Main Shop Building  
Contract A112  
November 14, 1989

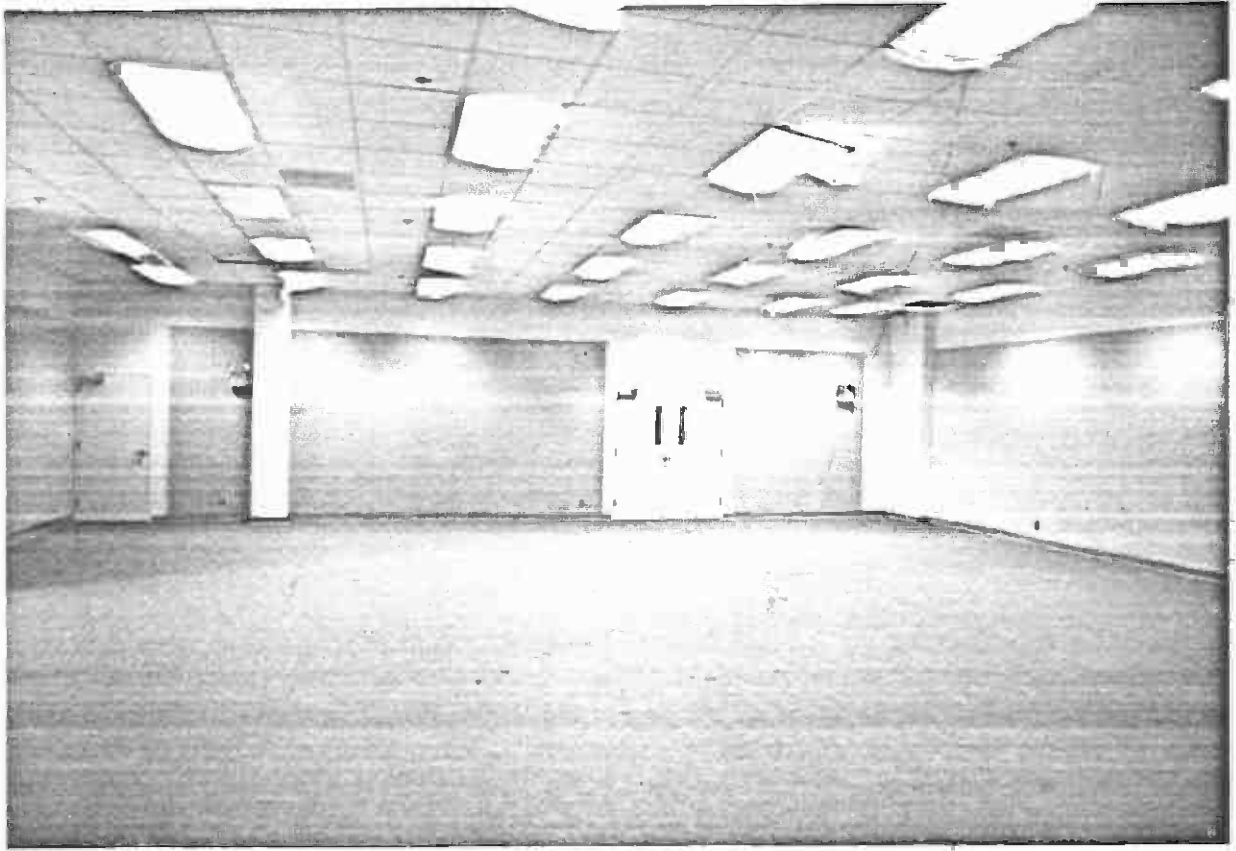
RM. 245- GWB WALL FINISH W/ SUSPENDED ACOUSTICAL CEILING.

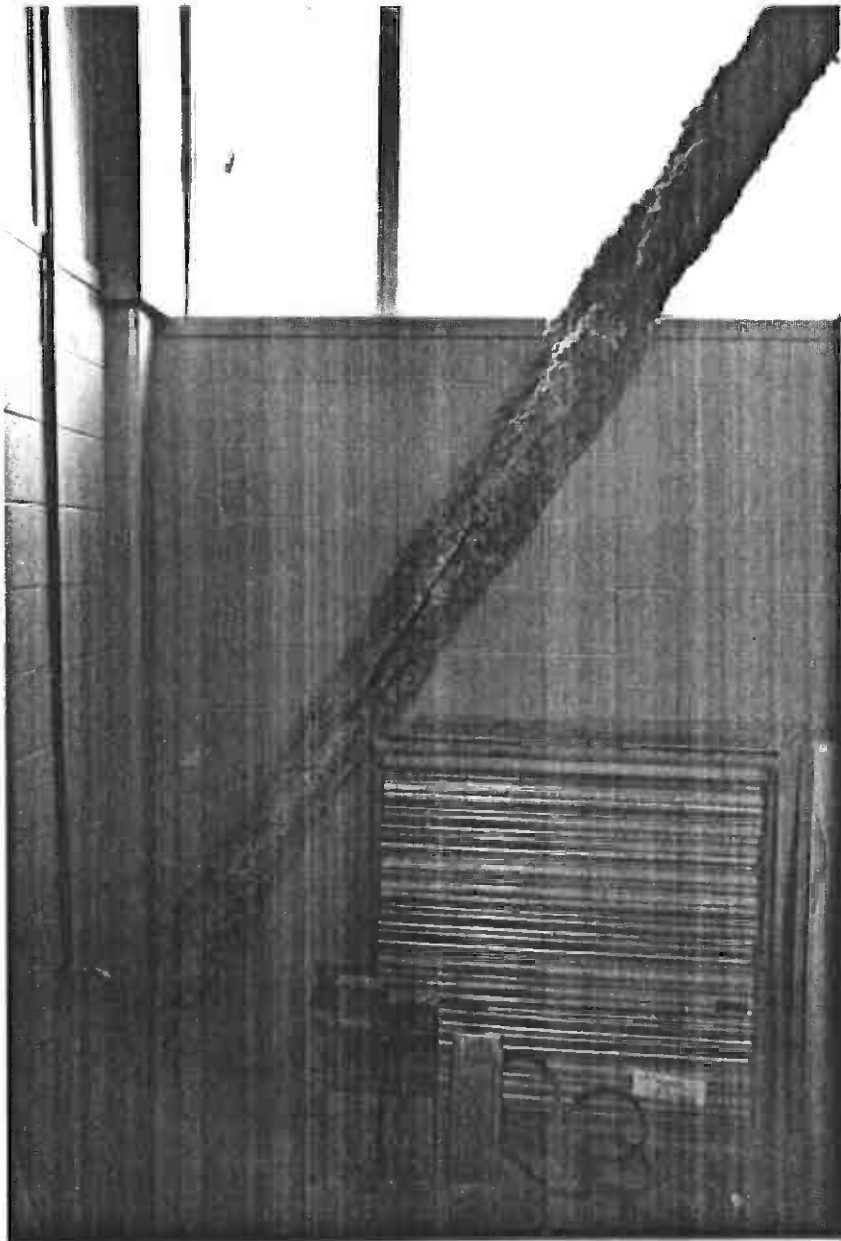
RM. 104- COLUMN G-7 W/ K-BRACING

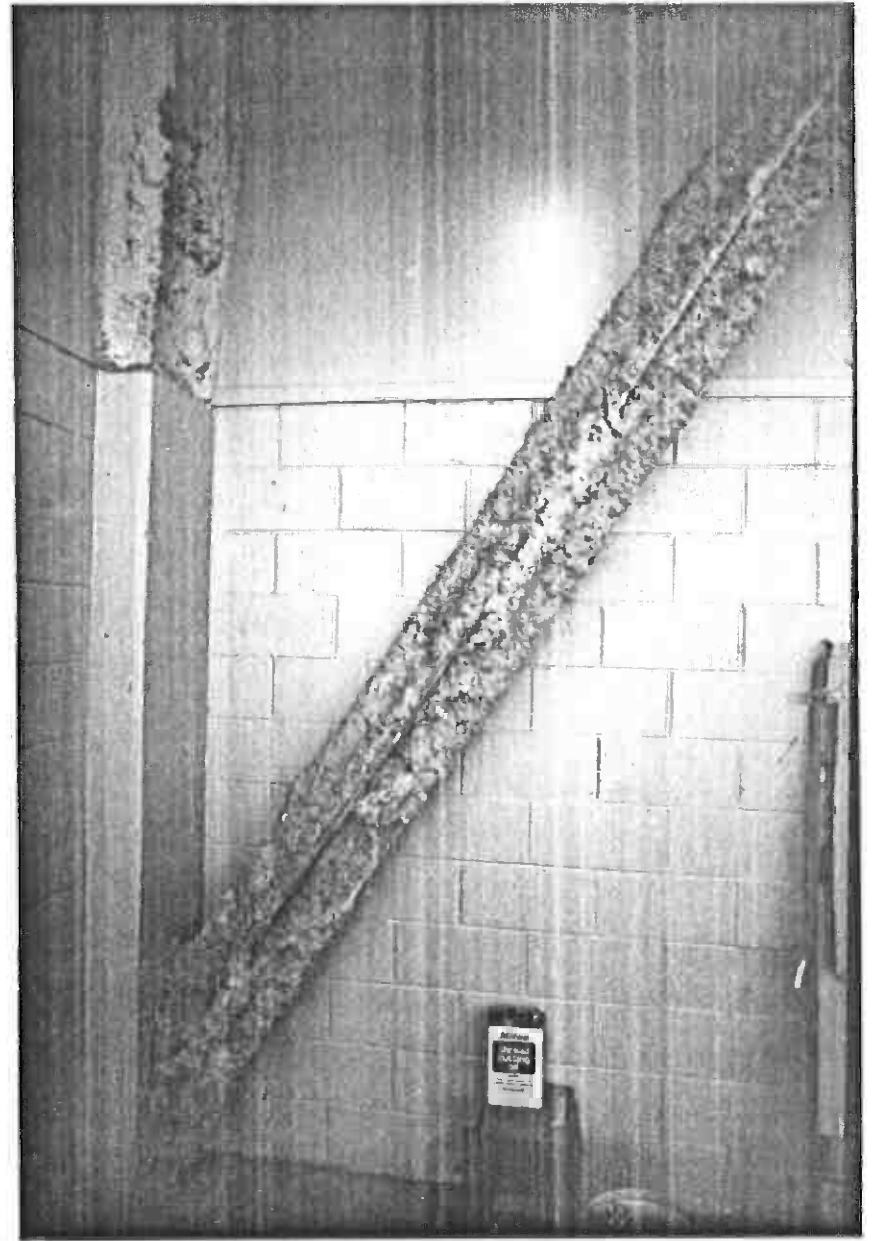
RM. 104- COLUMN F.6-6 W/ K-BRACING

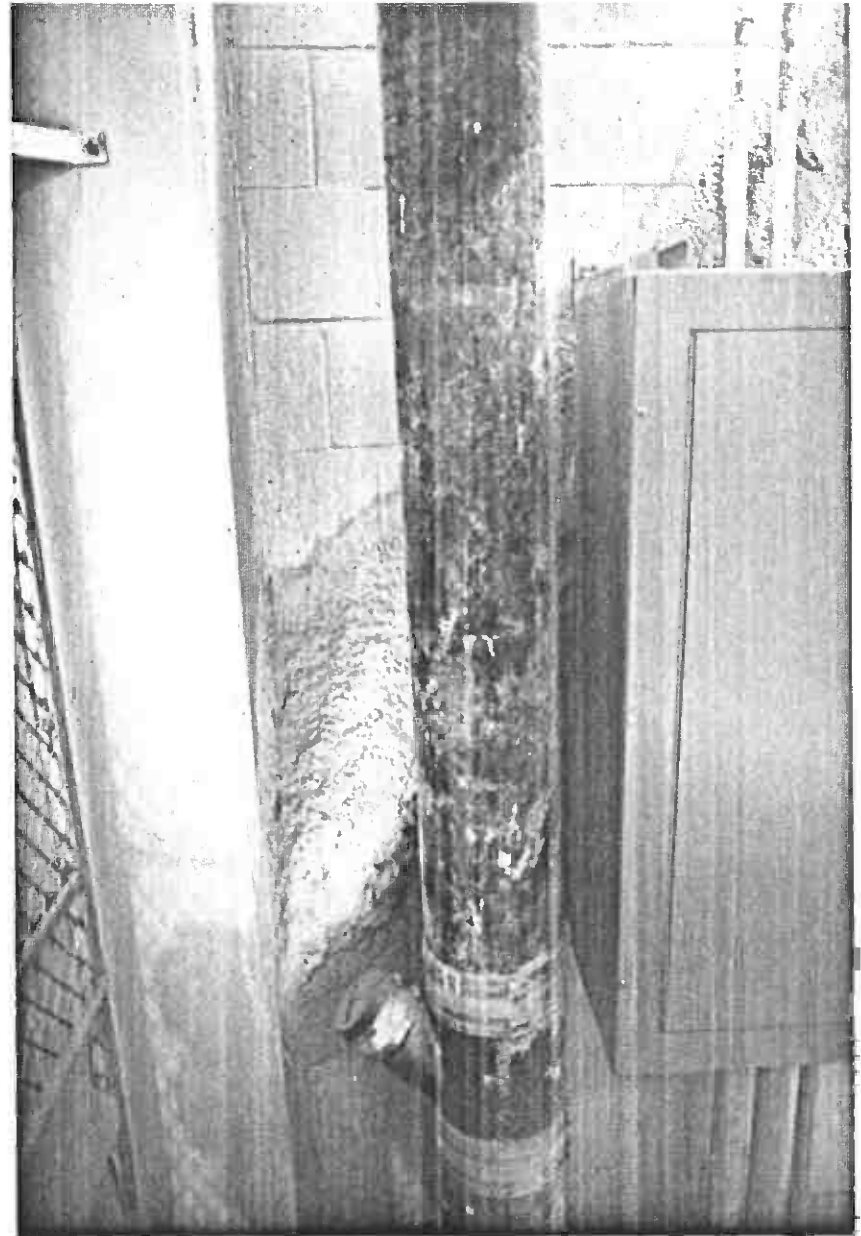
RM. 134- COL. G-18 BRACE BEHIND DRAIN LINE

There are columns and K-bracing along gridline G in Systemwide Stores with exposed mineral fiber-type fireproofing that have been touched up with a cementitious-type fireproofing. Provide gypsum board finish on metal stud furring for columns from top of concrete encasement to steel deck above. At the K-braces provide the same gypsum board finish from finish floor to steel deck. Where columns and K-braces span across windows, the gypsum board finish shall enclose all four sides. (Repair Type II.) (Photos Nos. 59, 60, 61, 62, 63, 64.)

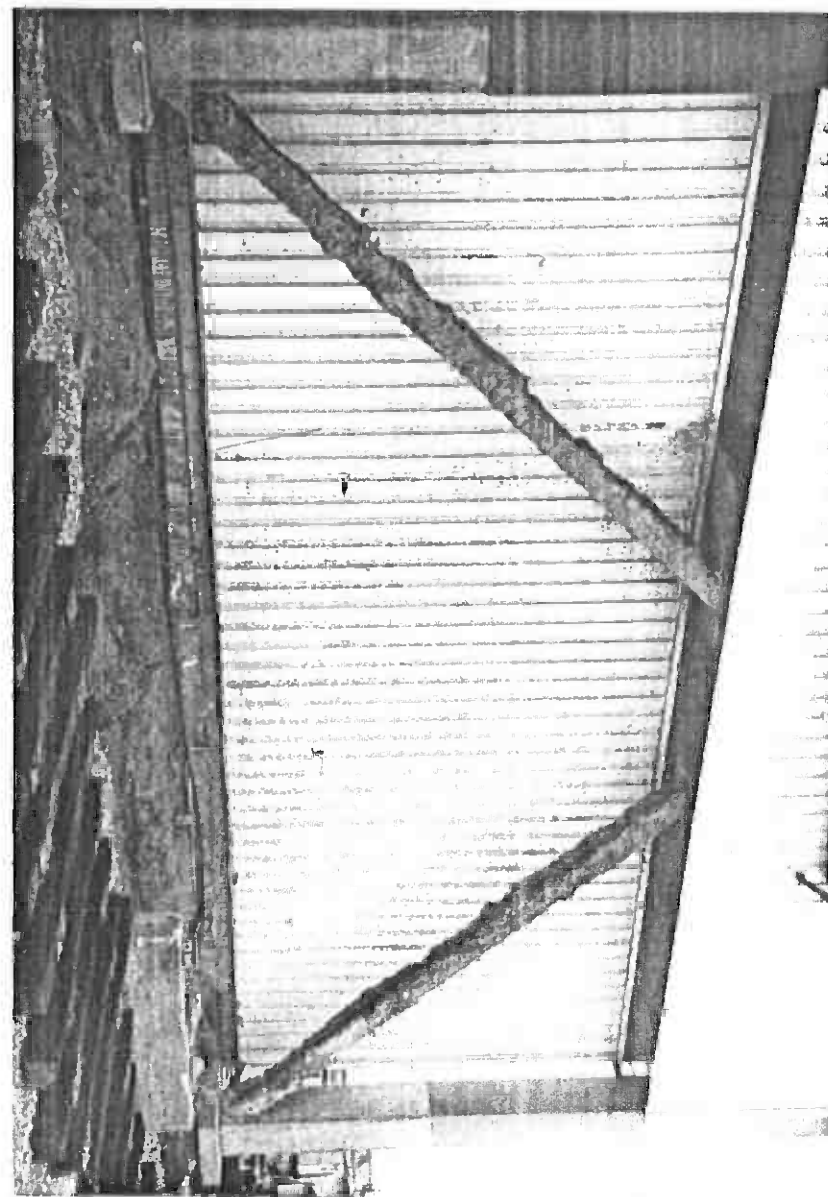
EXTERIOR K-BRACE AT GRIDLINE 1A
