CRENSHAW/LAX PHOTOGRAPHIC UPDATE

October 30, 2020

Crenshaw/LAX Transit Project

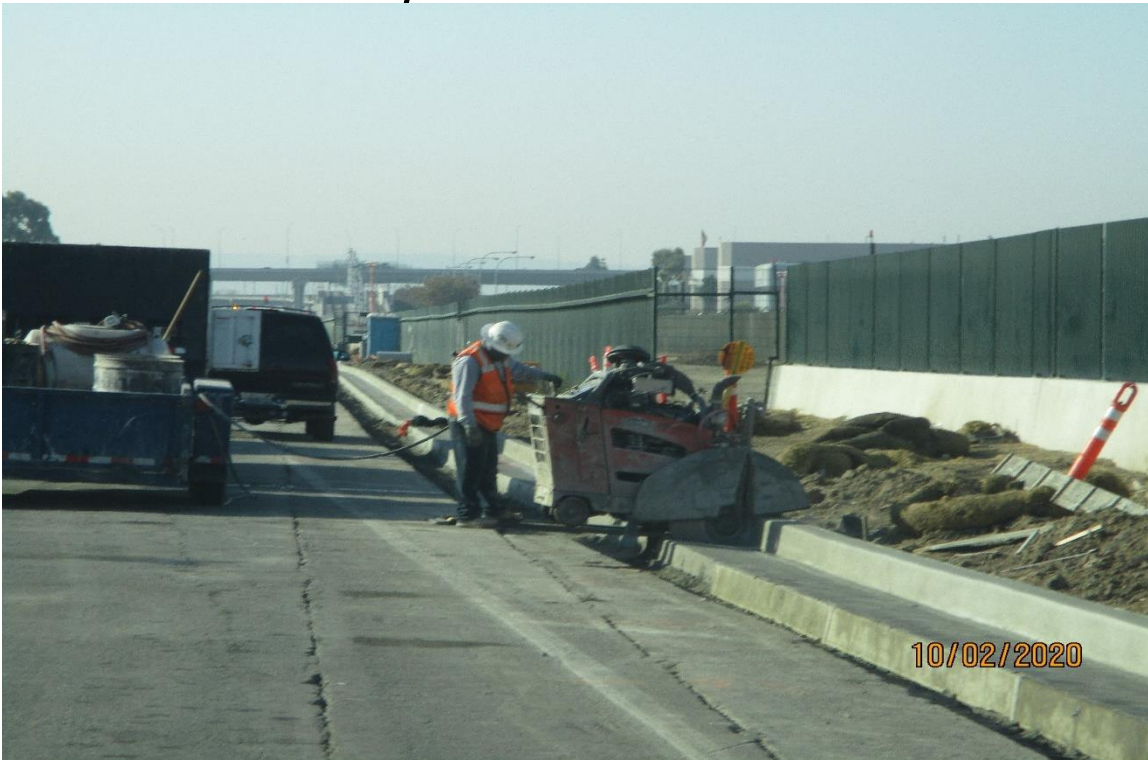
AVIATION/CENTURY - Saw cutting to remove some curb and gutter on Aviation.

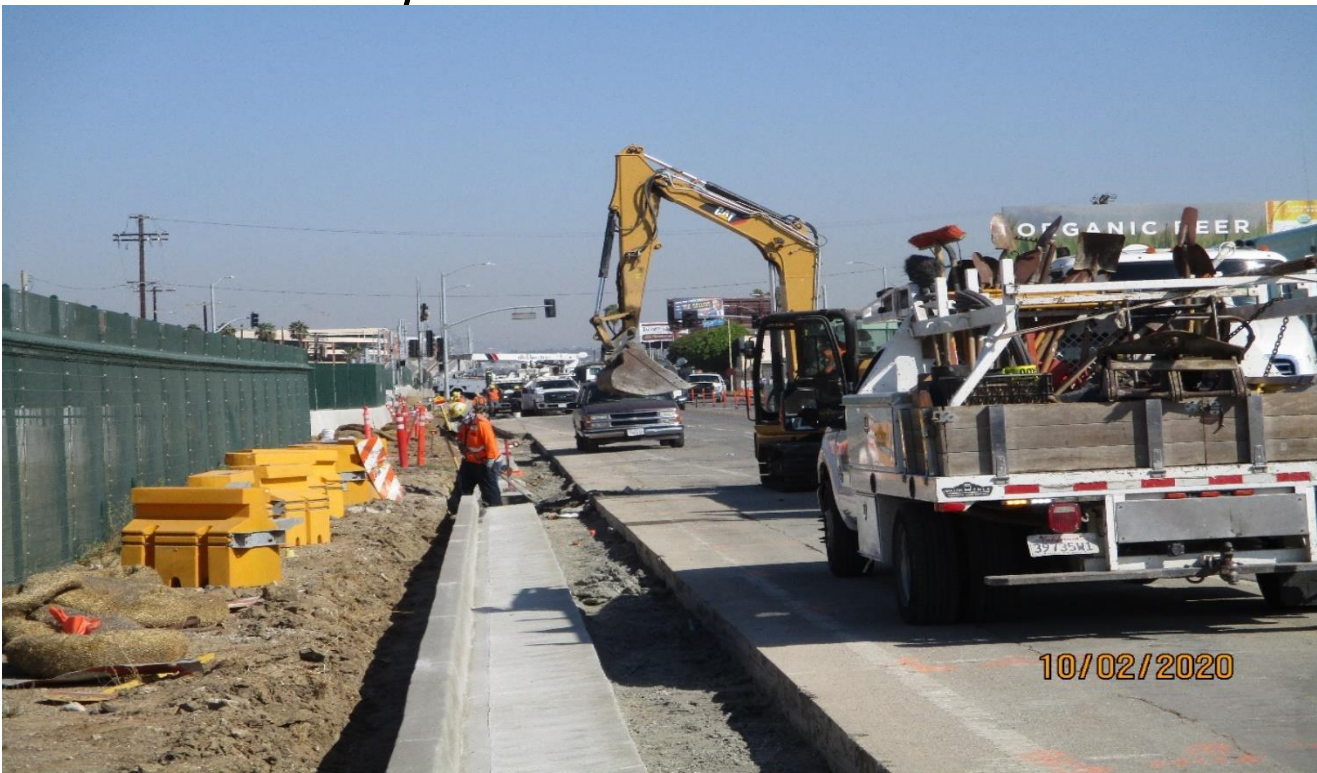
AVIATION/CENTURY- Curb and gutter removal on Aviation.

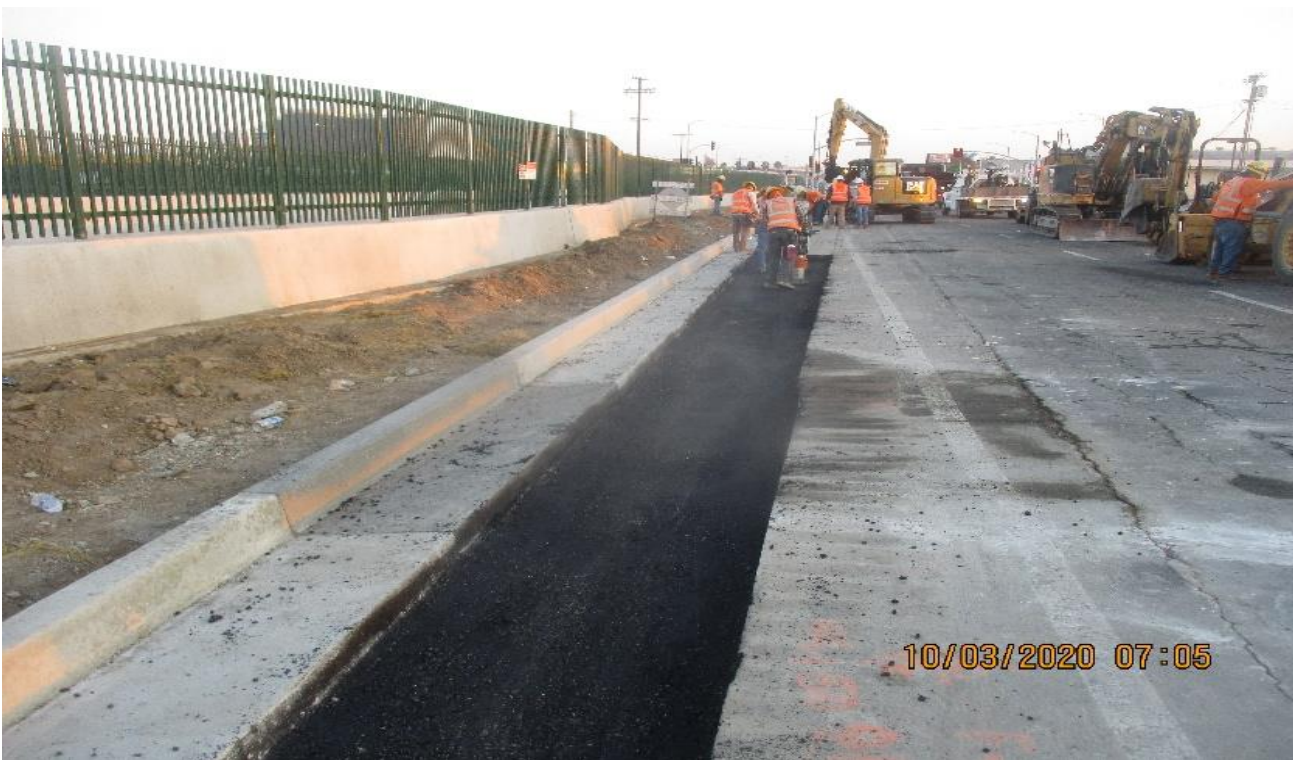
AVIATION/CENTURY- WSCC Slot paved along gutter out 104th to S/end of UG-1 on S/B Aviation.

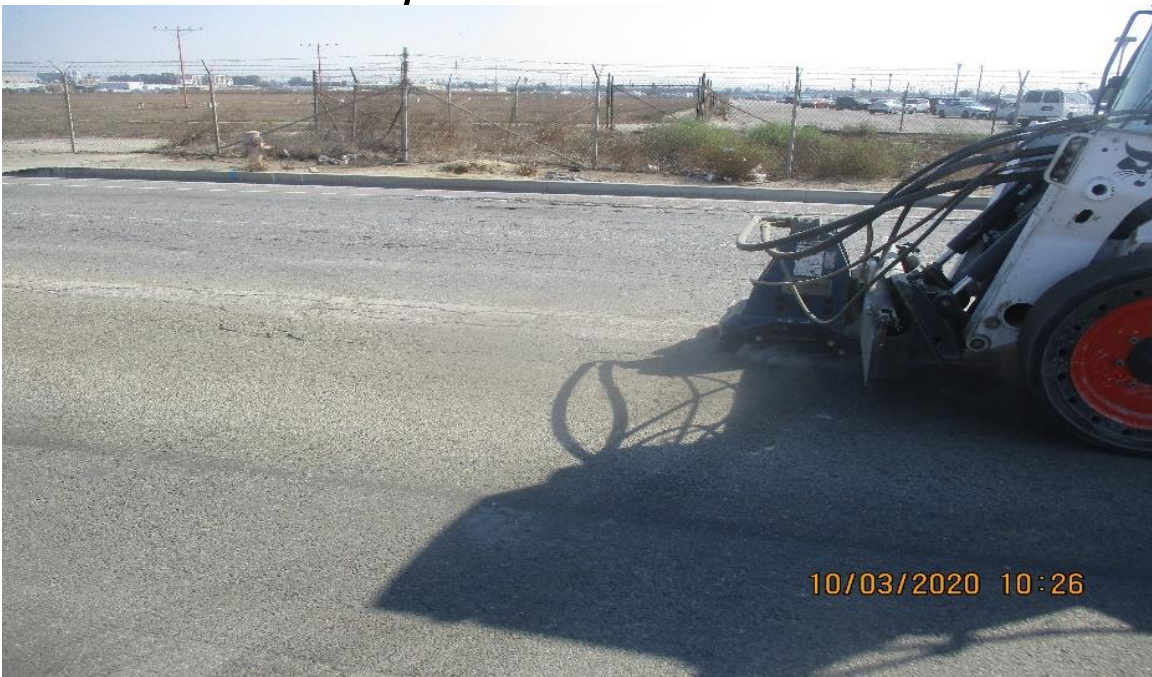
AVIATION/CENTURY- SCI Removed all stripping on S/B Aviation from 104th to 111th ST.

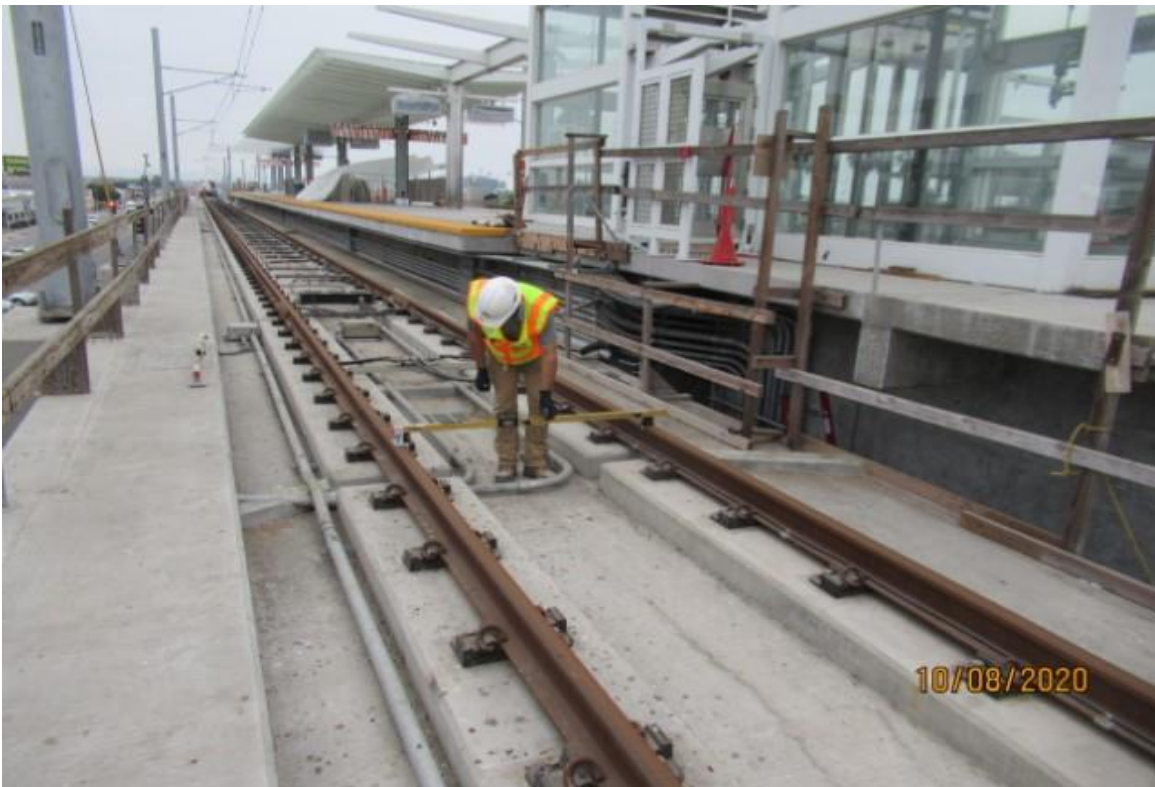
AVIATION/CENTURY- Metro QA track inspector verifying track cross level & gauge on SB track on Century/Aviation OP. Part of field walk (looking northeast)

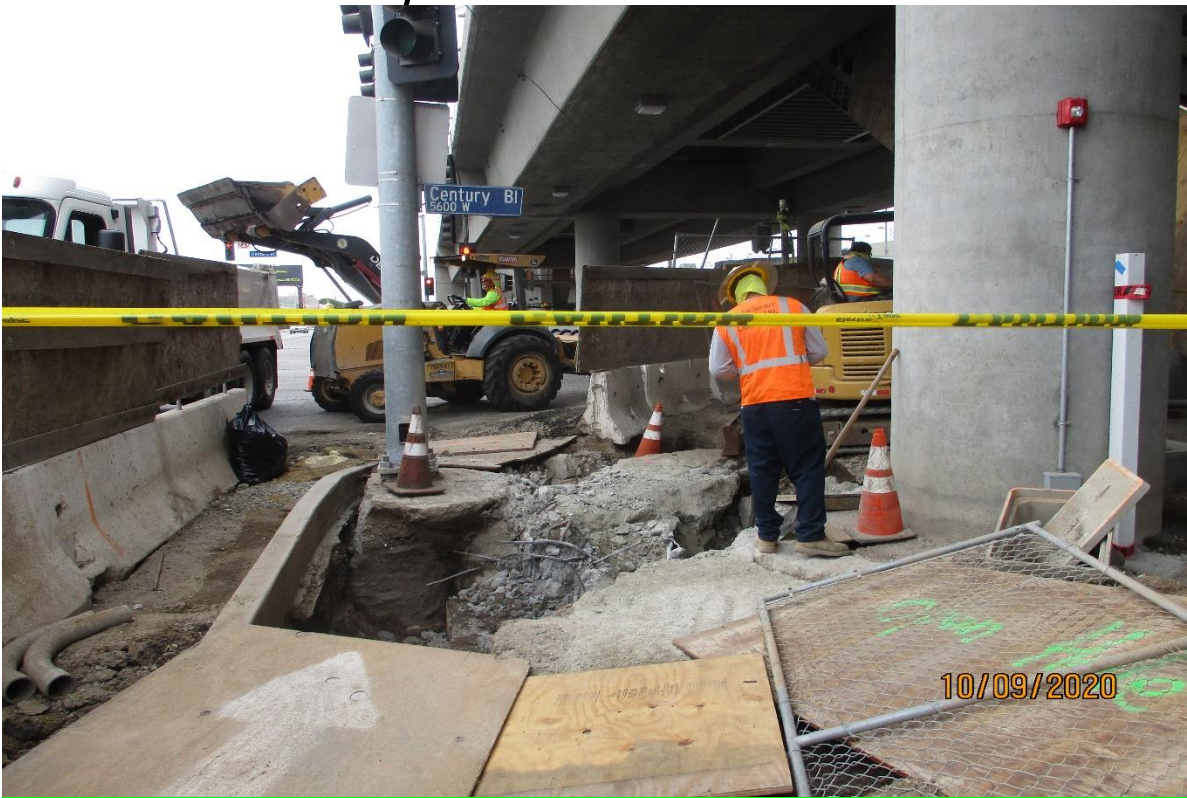
AVIATION/CENTURY- Concrete construction removal at Aviation and Century.

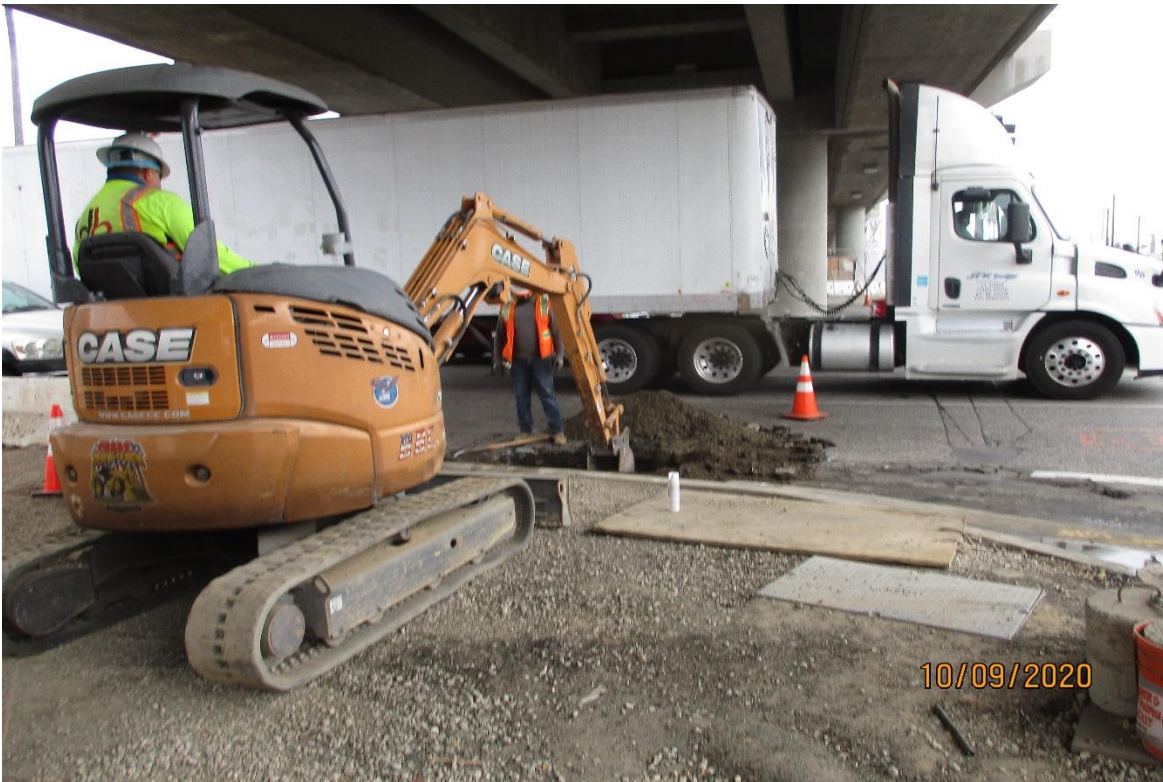
AVIATION/CENTURY- Trenching for the traffic loop stub out at Aviation and Century.

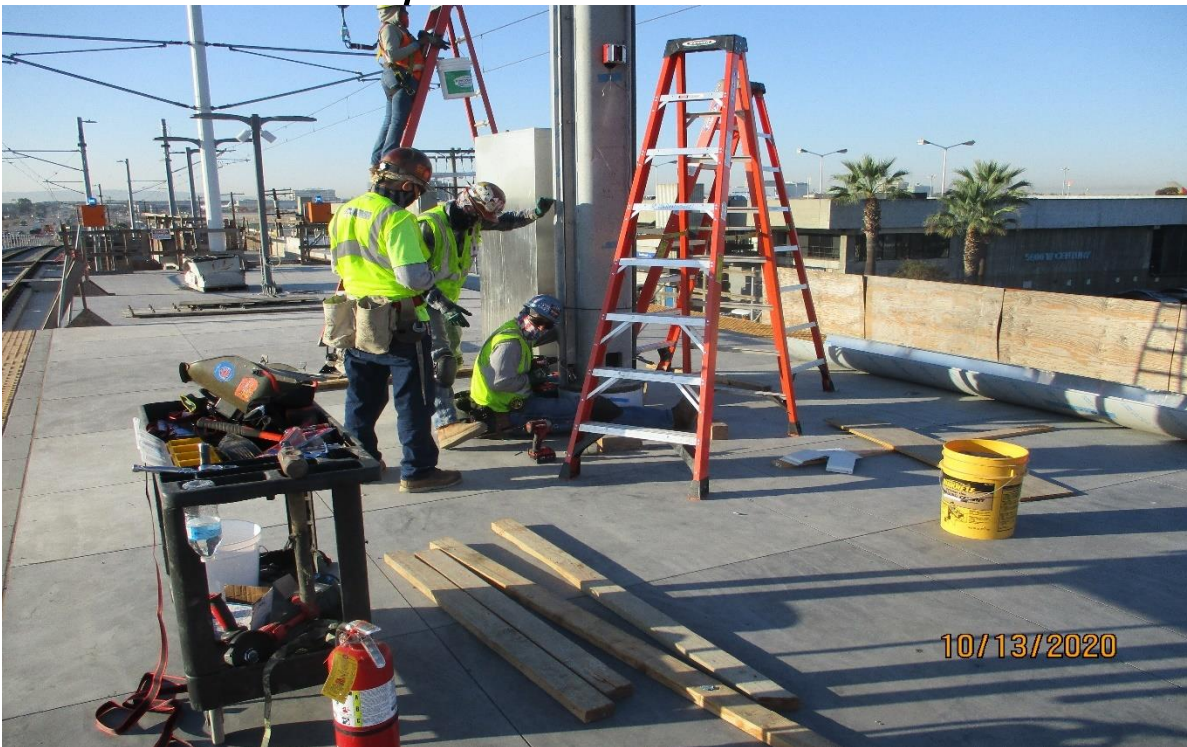
AVIATION/CENTURY- Drilling holes for the stainless steel cladding that mounts on the Aviation Station platform columns

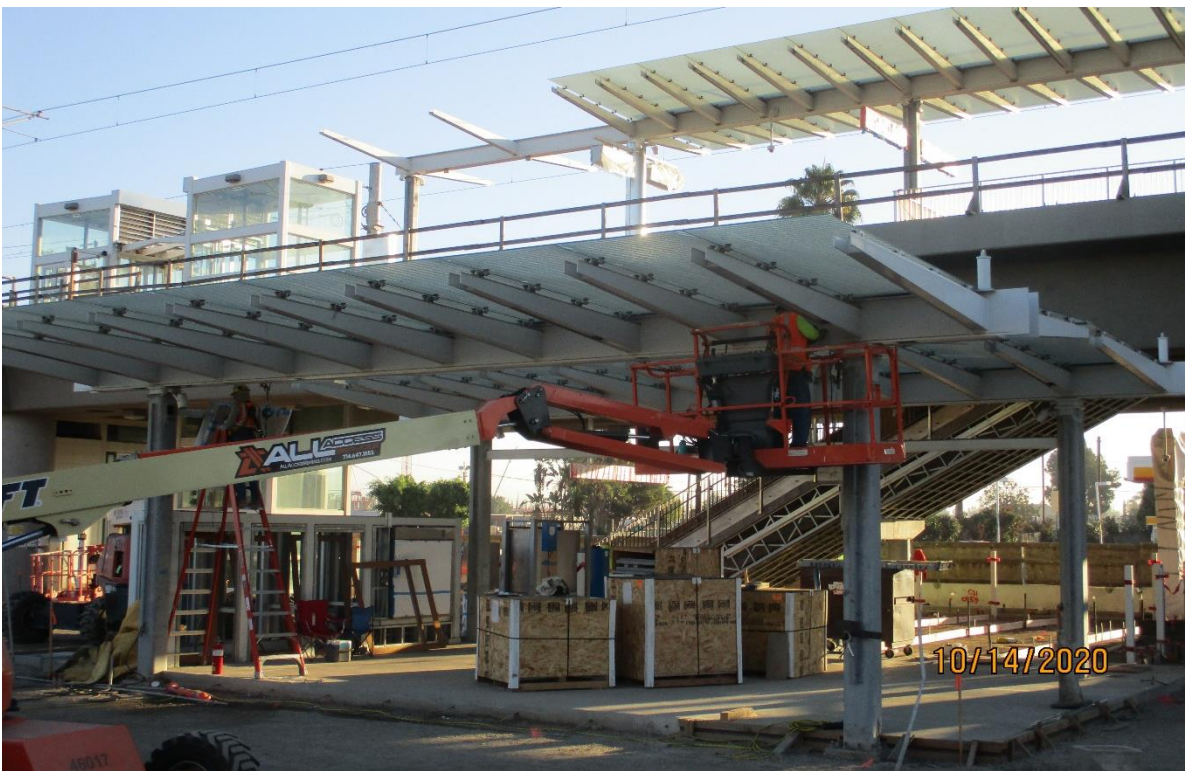
AVIATION/CENTURY- Fire alarm strobe light installation at the Aviation Station ticket kiosk.

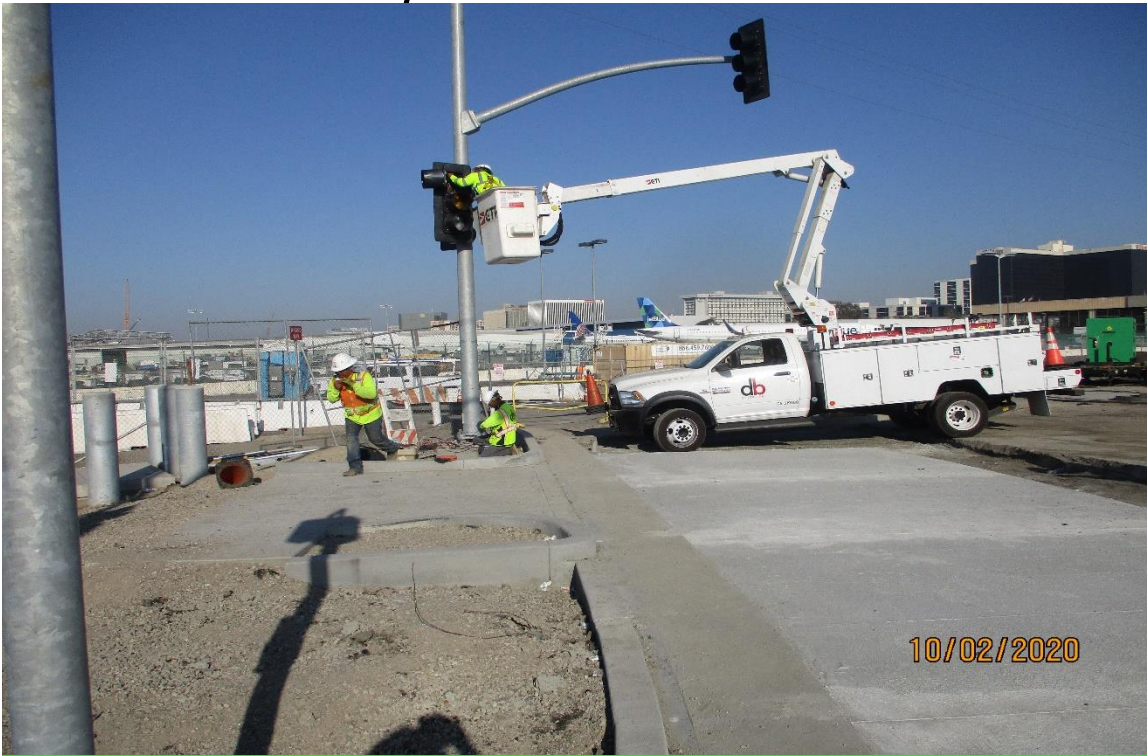
104th street- Wiring the traffic signal lights at 104th street.

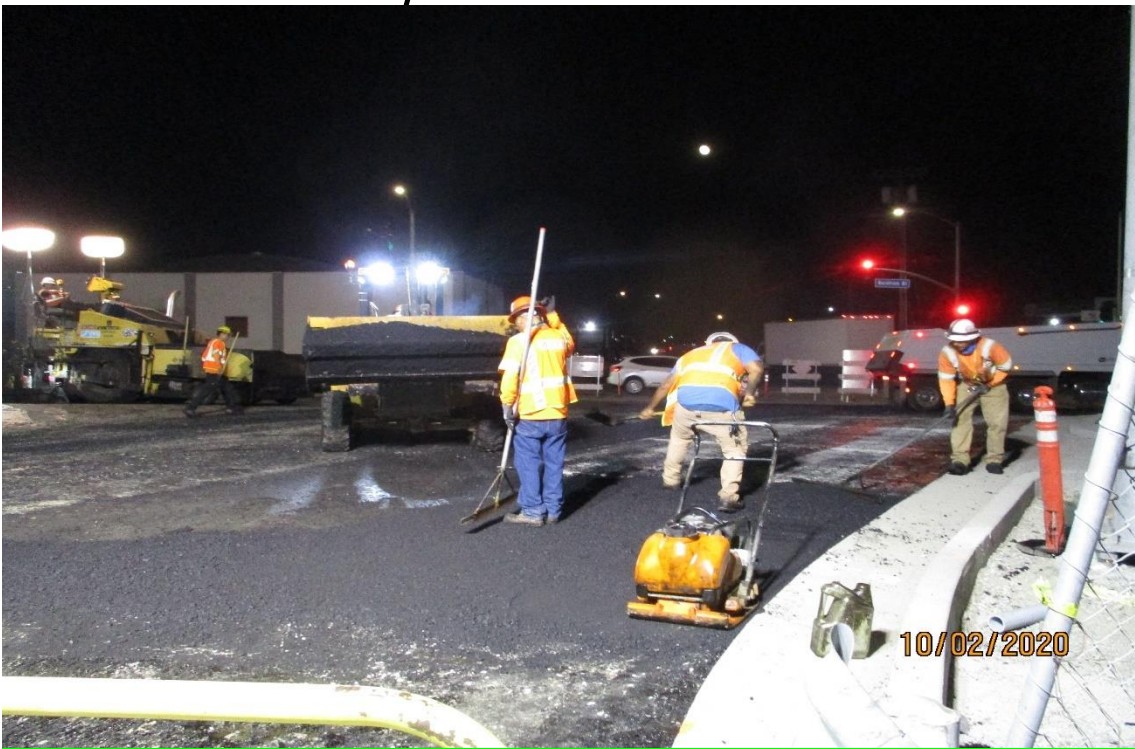
104th street- Placing the base course of AC on 104th street.

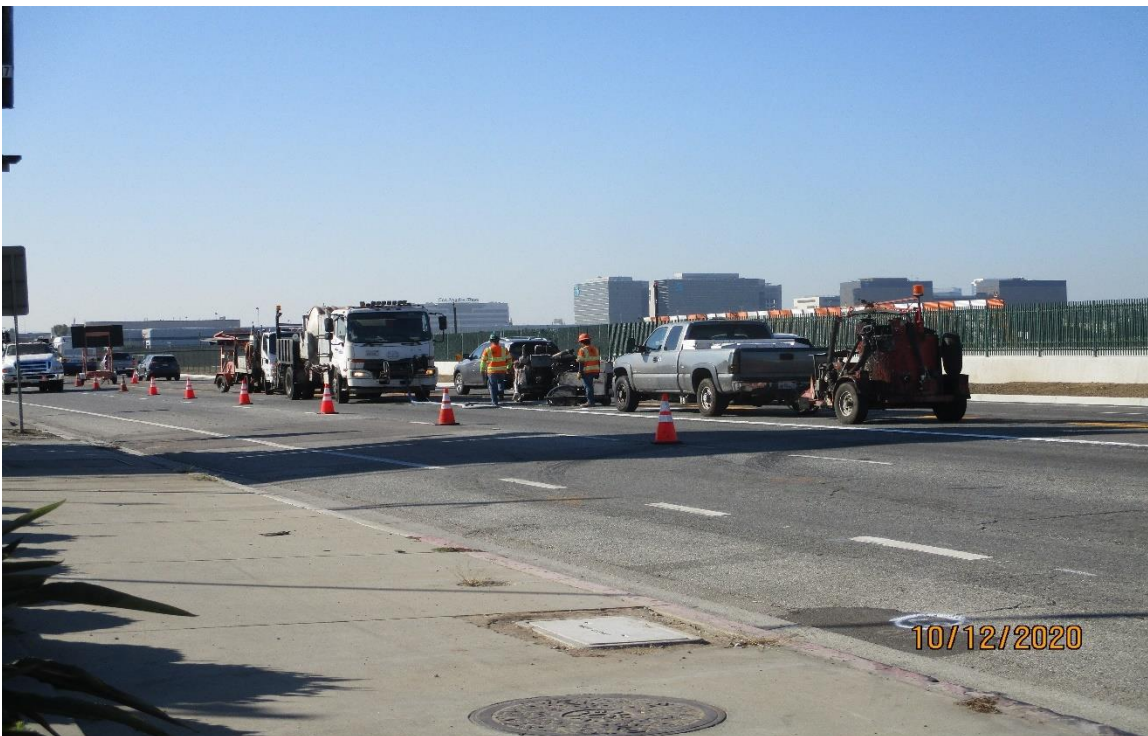
104th street- Cutting vehicle detection loops on Aviation near 104th street.

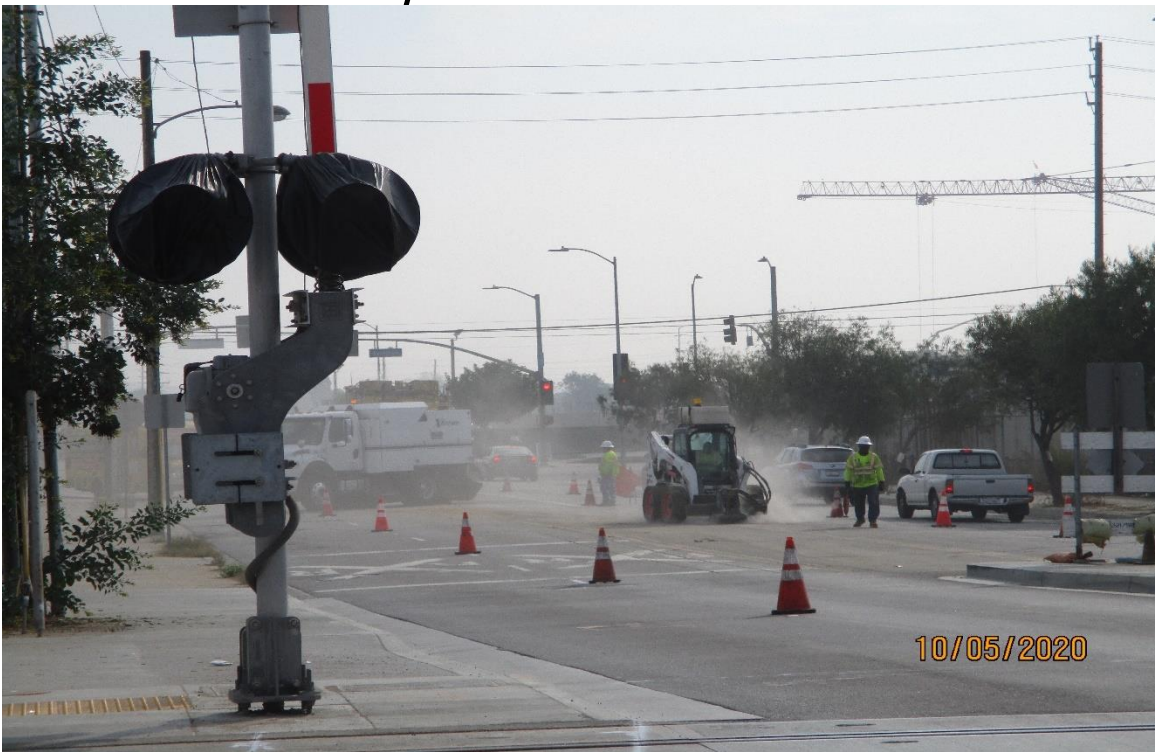
Arbor Vitae- Grinding off the temporary stripping on Arbor Vitae.

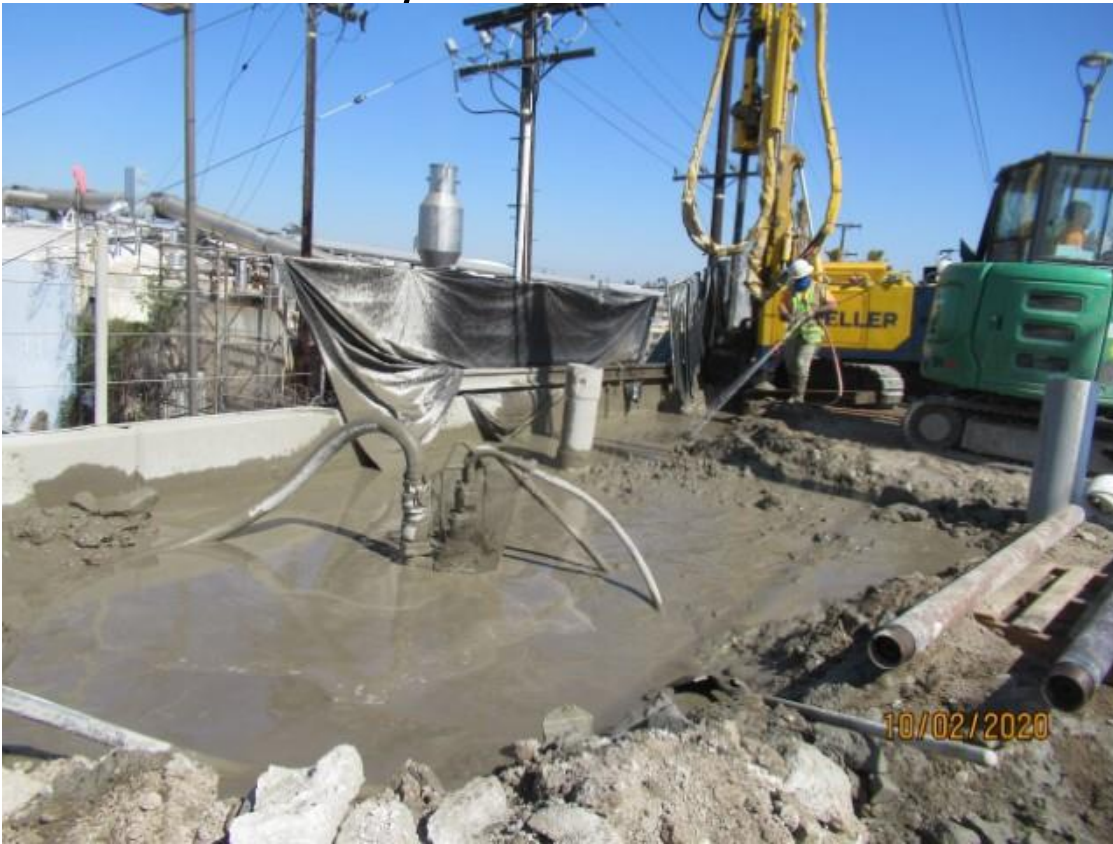
Jet Grouting of Wall #202 continues.

La Brea – MSE wall 202 La Brea SB track STA 207+50 on-going jet grout operation (looking northwest) Rework NCR B-089.

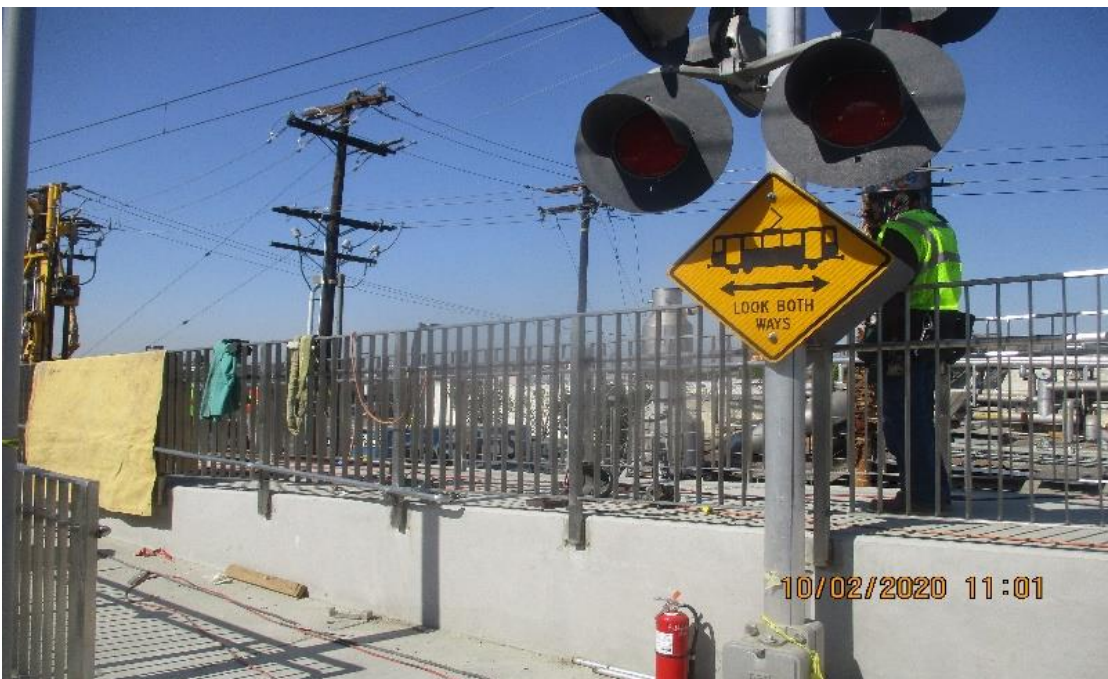
La Brea – McMahan Welding and placing handrails at S/La Brea handy capped ramps.

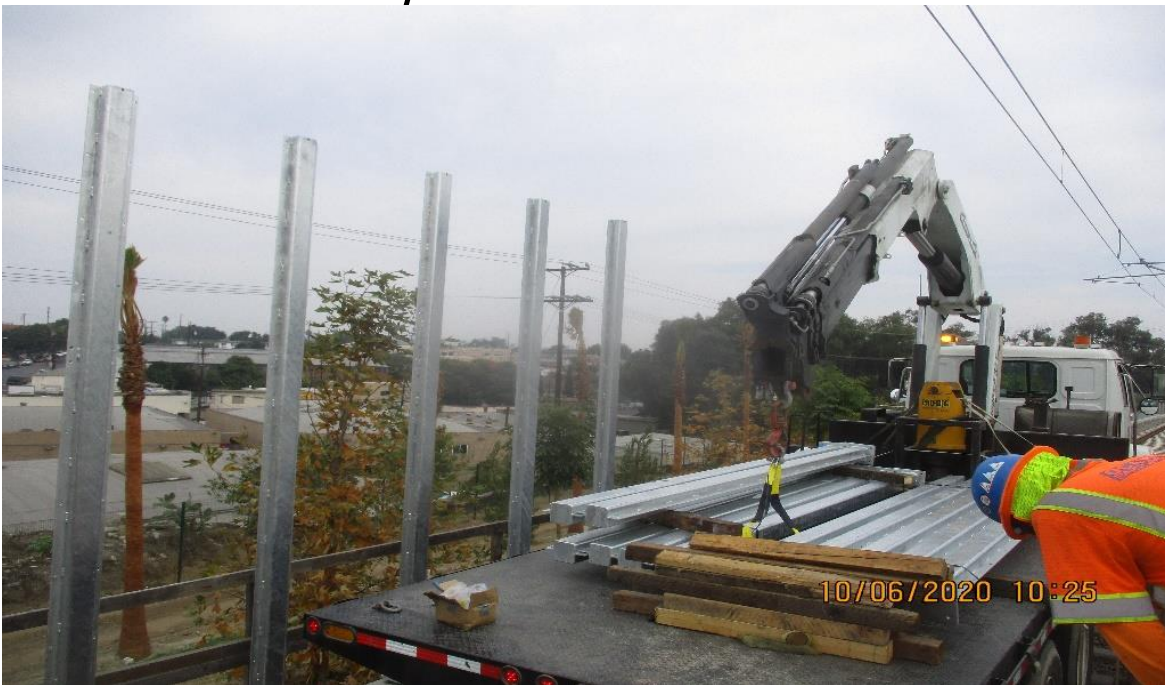
La Brea – Ace Fence placing extra strength fence post at wall 202 at La Brea Sta.

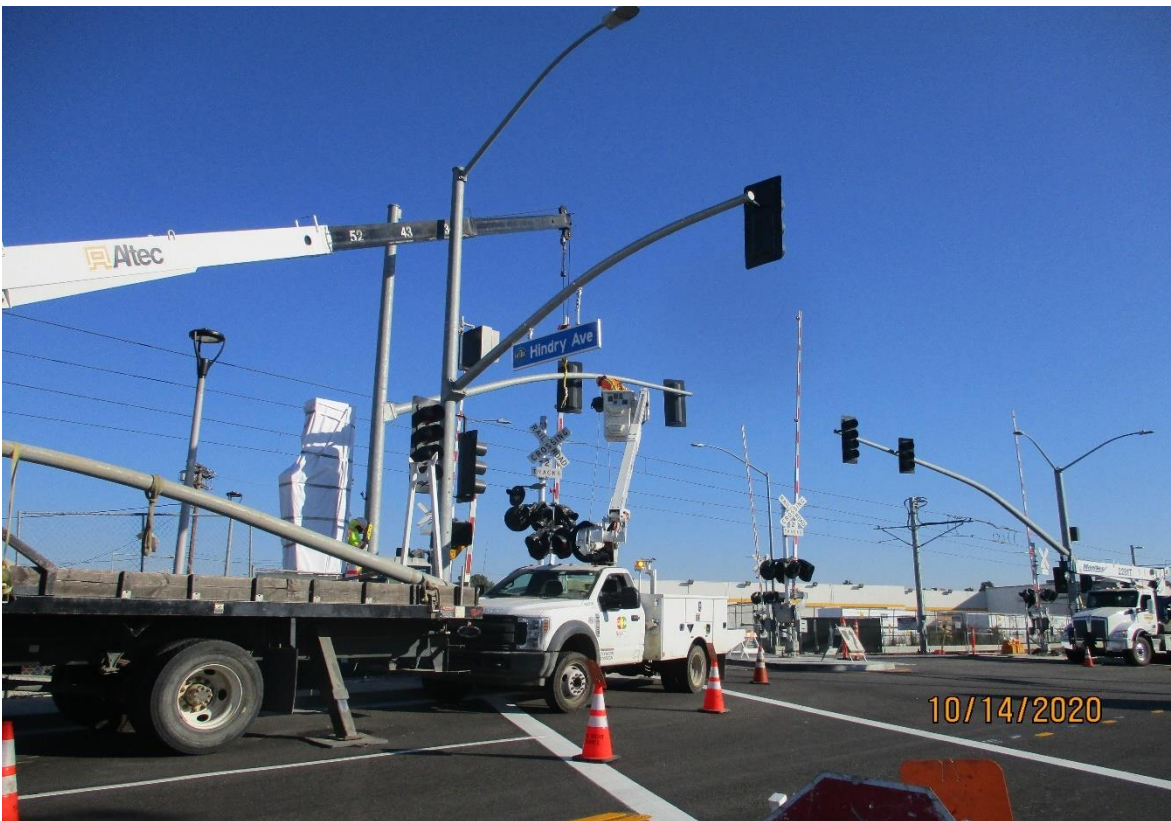
Hindry – Hanging a traffic signal mast arm at Hindry.

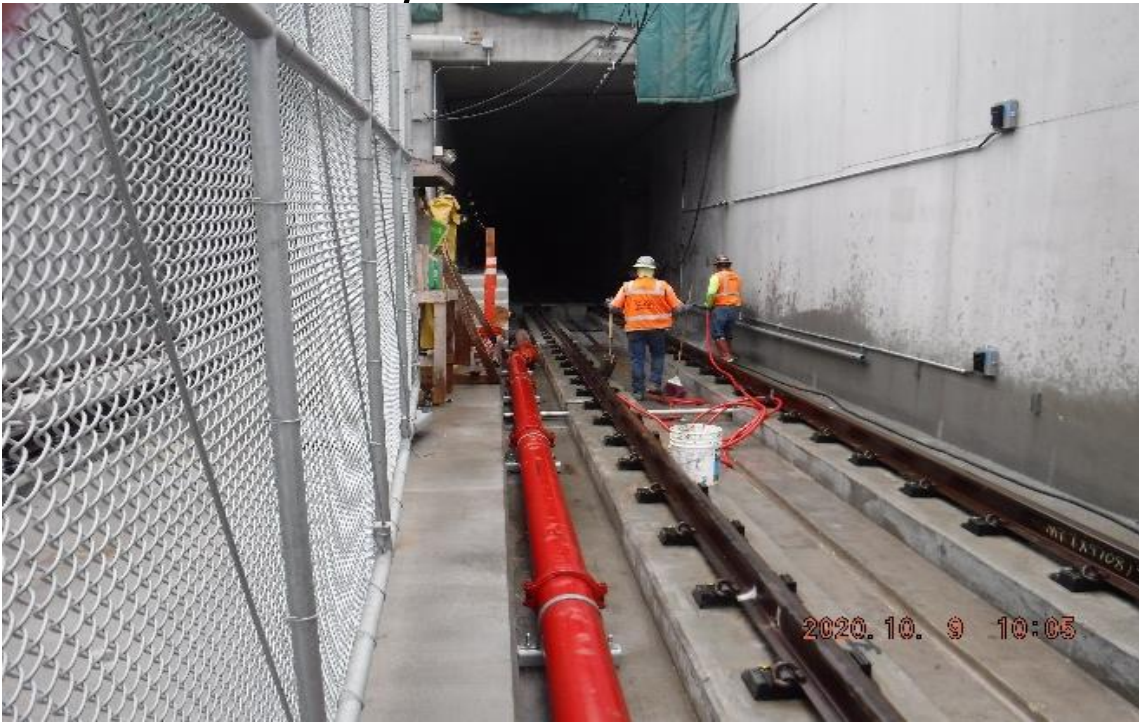
UG3 – STA 311+35 TK#3/SB looking south – invert cleaning UG3 in progress (north portal).

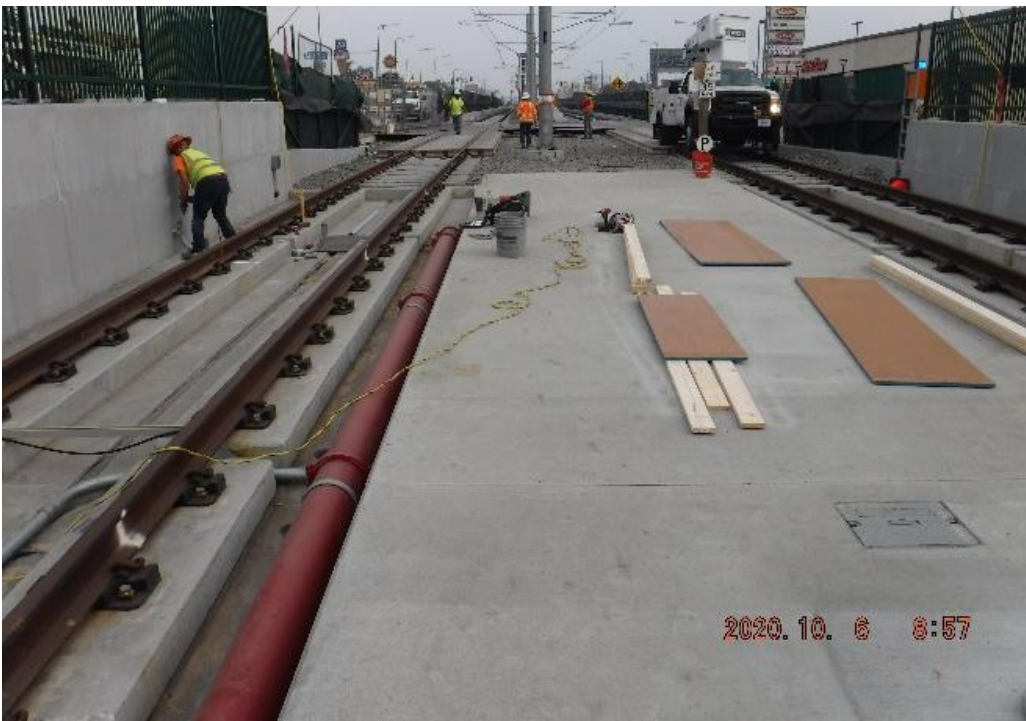
59th Street – STA 316+00 TK#3/SB looking north – form work and conduits set-up for traffic control loops, north end of UG3 at 59th St at grade Xing

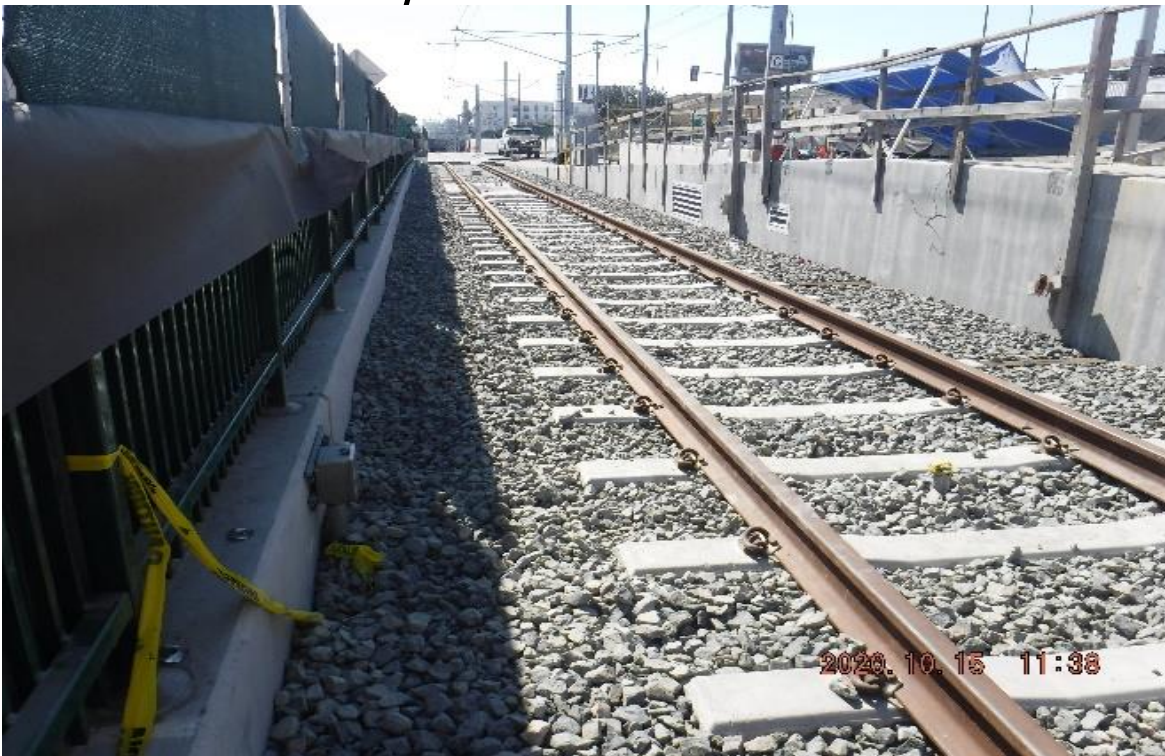
59th Street – STA 319+16 TK#4/NB looking south – north limit of current track structure disturbance (backfilled) – 59th St at grade crossing to set conduits for traffic loops Slauson.

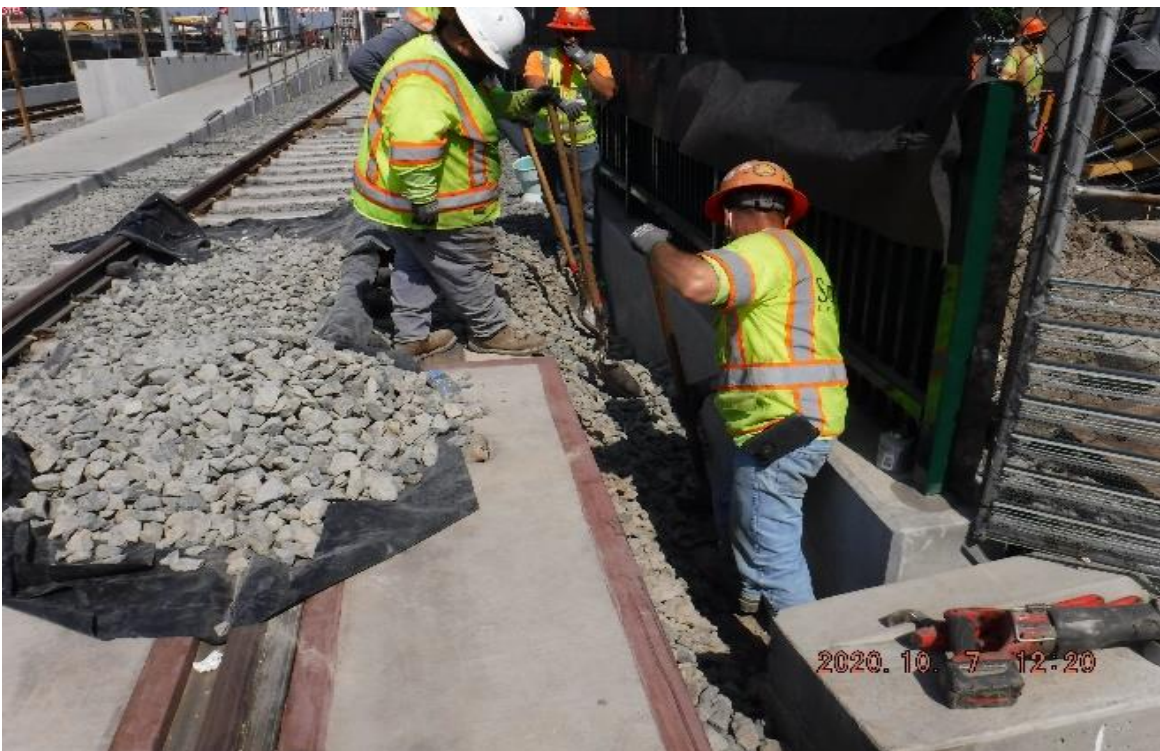
59th Street – STA 317+70 TK#4/NB looking north – track structure disturbance – 59th St at grade crossing to set conduits for traffic loops .

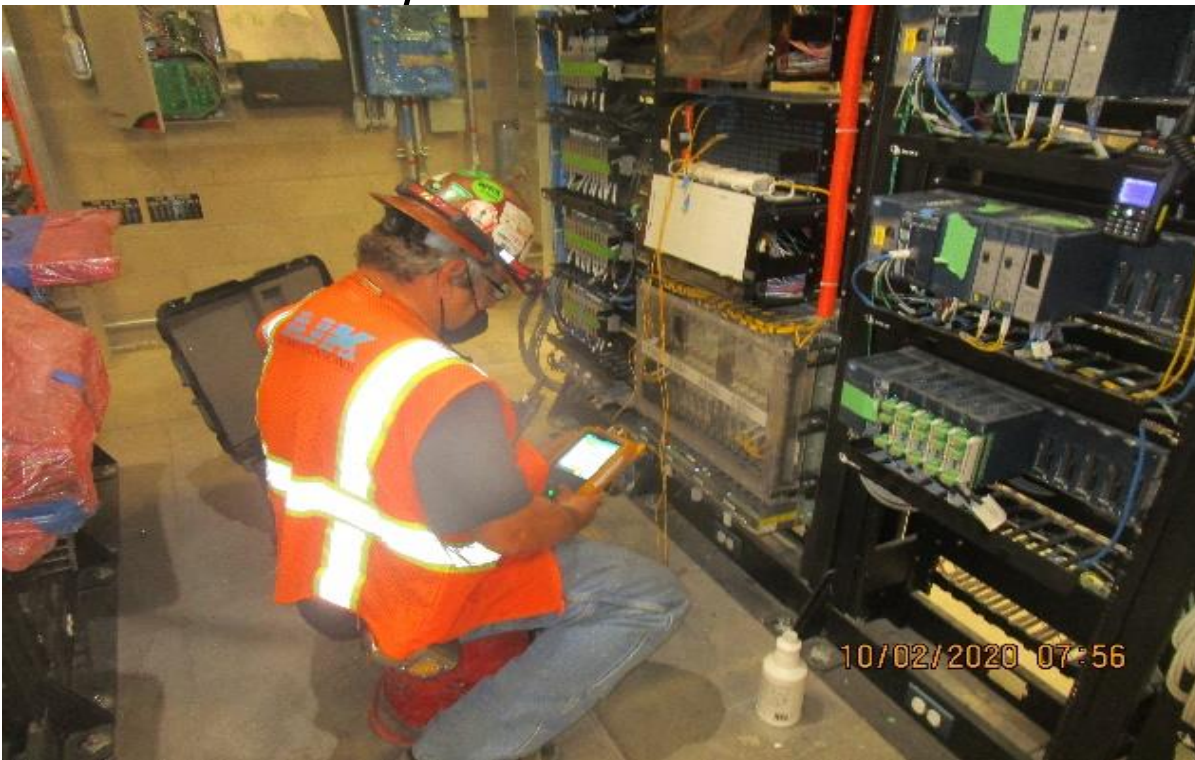
Crenshaw/Vernon – Vernon, TC&C Room C112, CTS Rack testing fiber optic (end to end) to SRI intrusion panel at UG4 Sta 371+05.

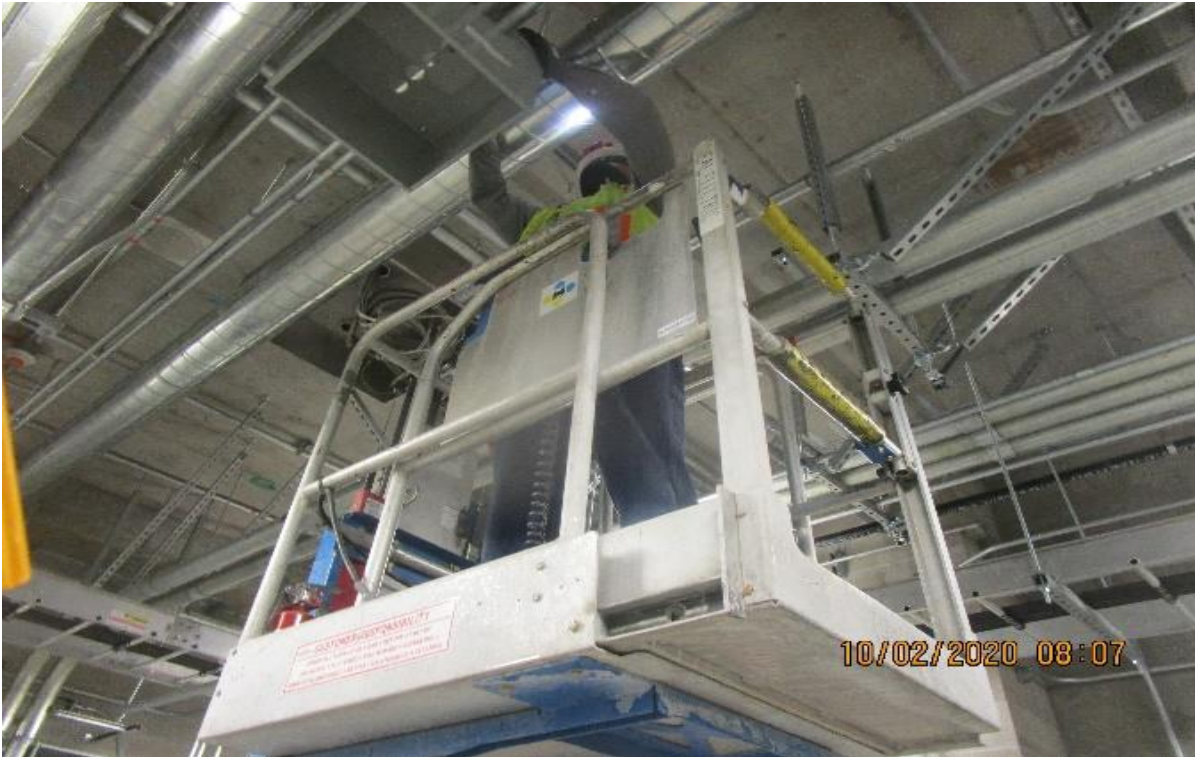
Crenshaw/Vernon – Vernon, Aux power (N) C119 Continued 1-1/4” GRC tie in 18”x18”x12” SCADA PBs MCC2/N to MCC3/N

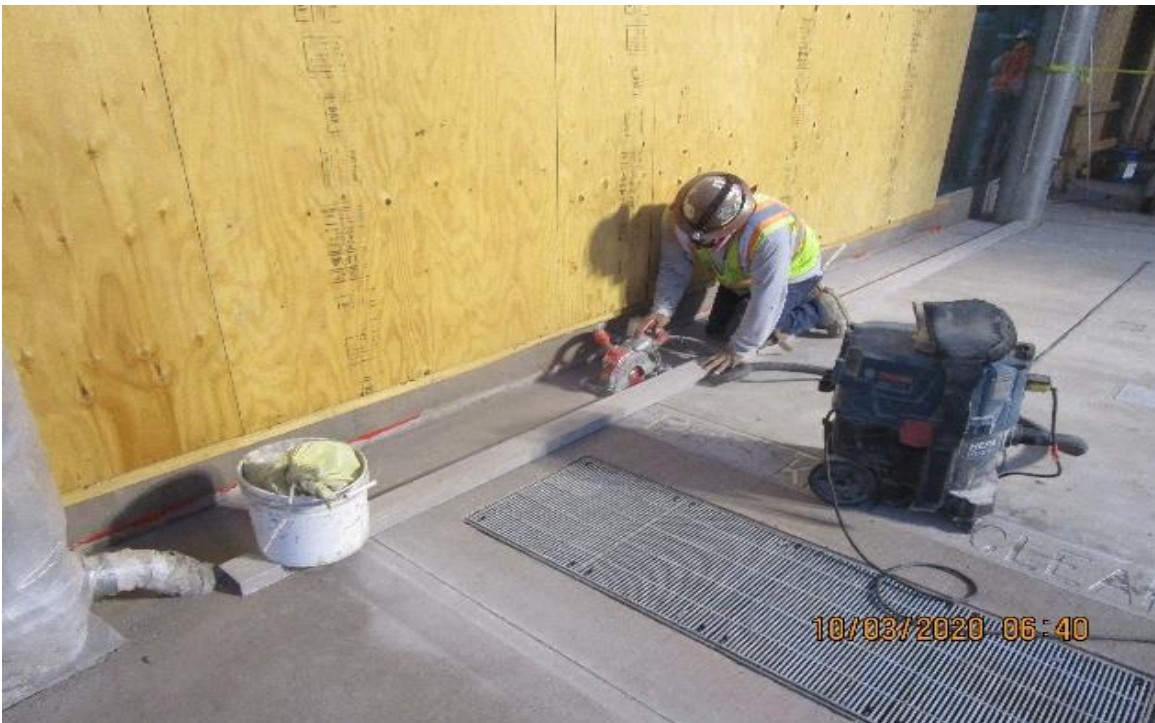
Crenshaw/Vernon – Vernon Plaza level, continued saw cutting 3/16” expansion joints at architectural concrete & stripping of form work

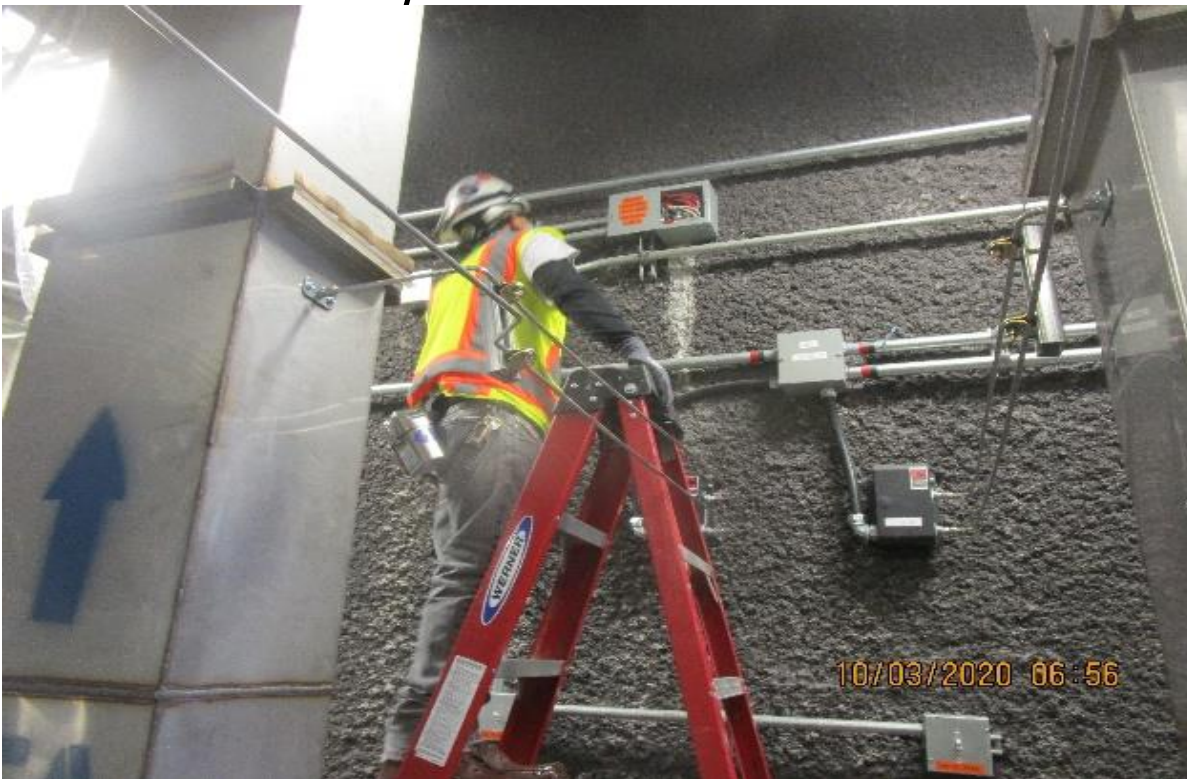
Crenshaw/Vernon – Vernon Mechanical room (S) C114 EF-6-8A & 8B, Pipping 1" GRC & 3/4" seal tight for FSD limit switch control wiring.
