CRENSHAW/LAX PHOTOGRAPHIC UPDATE

October 30, 2020

Crenshaw/LAX Transit Project

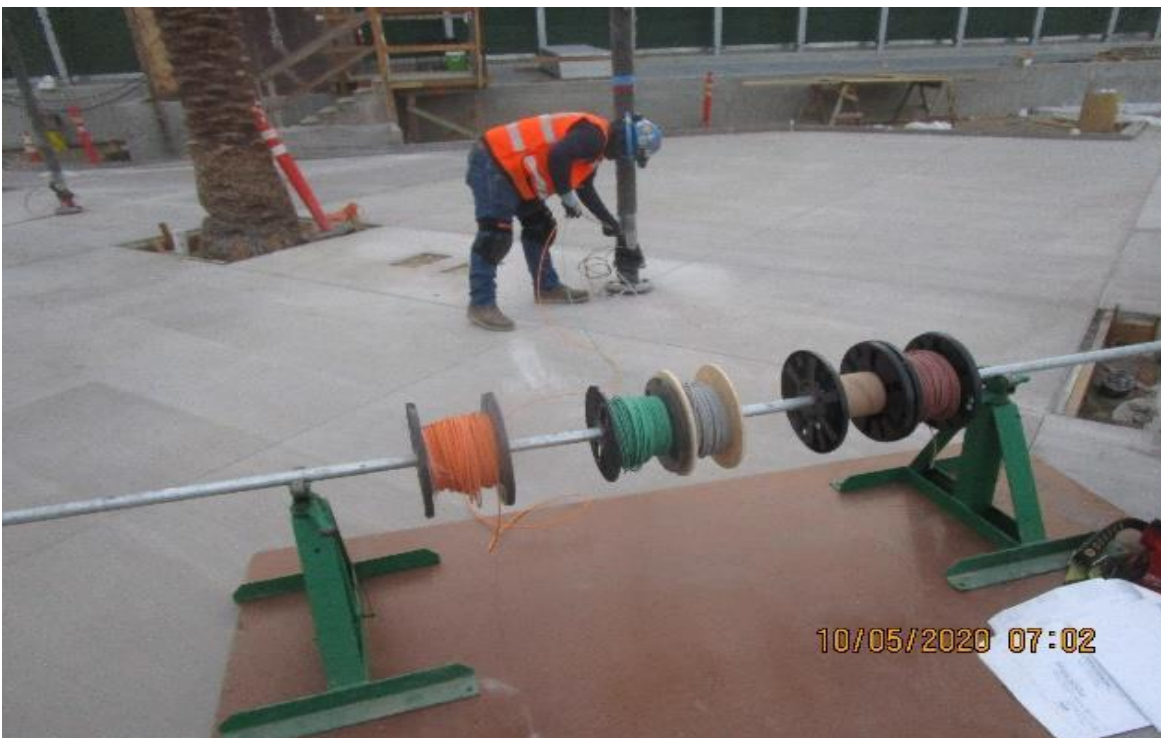
Crenshaw/Vernon – Vernon Plaza, continued pulling (3) #10 XHHW-2 wiring to Pedestrian light standards from embedded PB's.

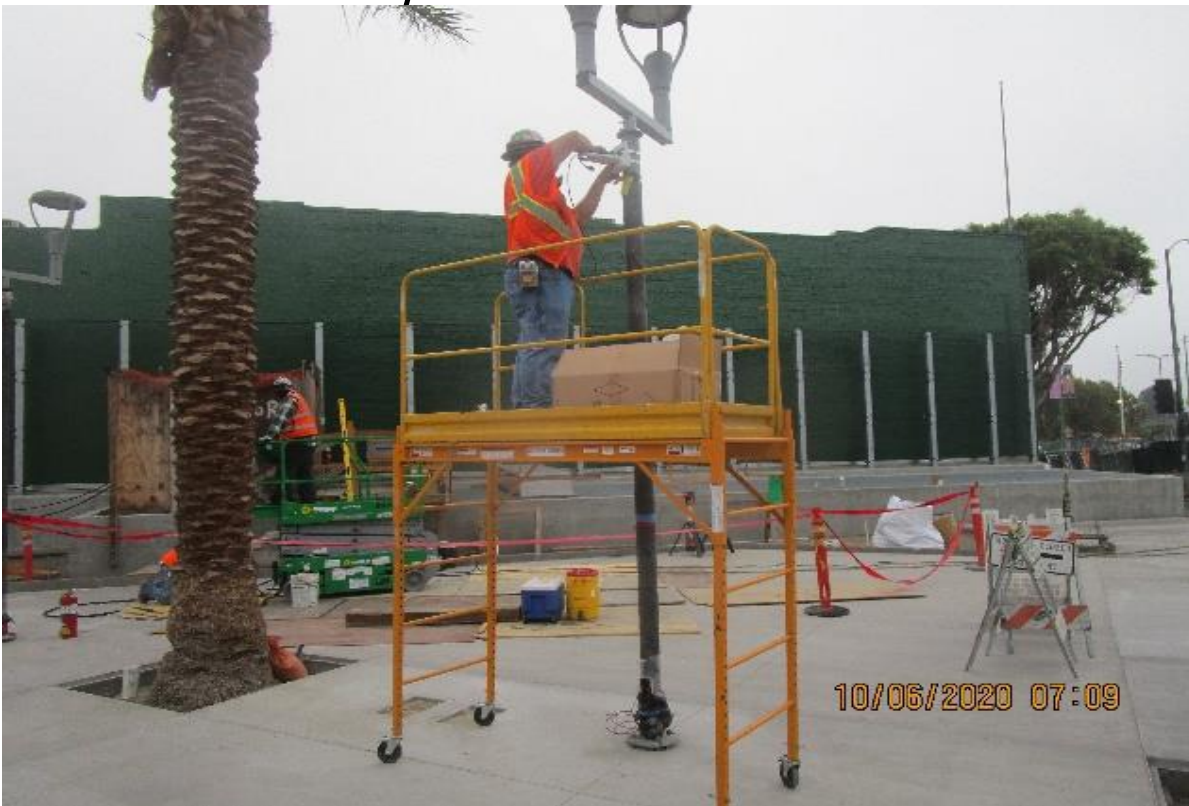
Crenshaw/Vernon – Vernon Plaza, began installing CCTV Camera support brackets at pedestrians' light standard poles.

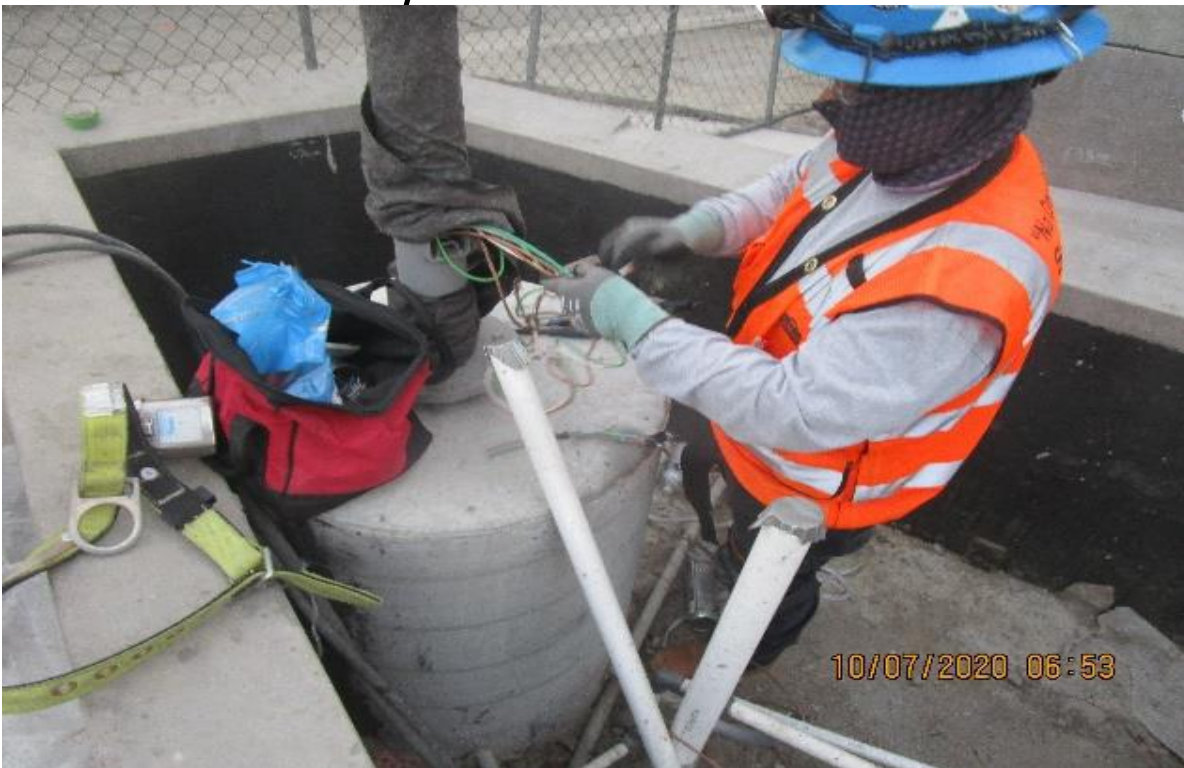
Crenshaw/Vernon – Vernon Plaza, began terminating #10 XHHW-2 load conductors at pedestrian light standard poles.

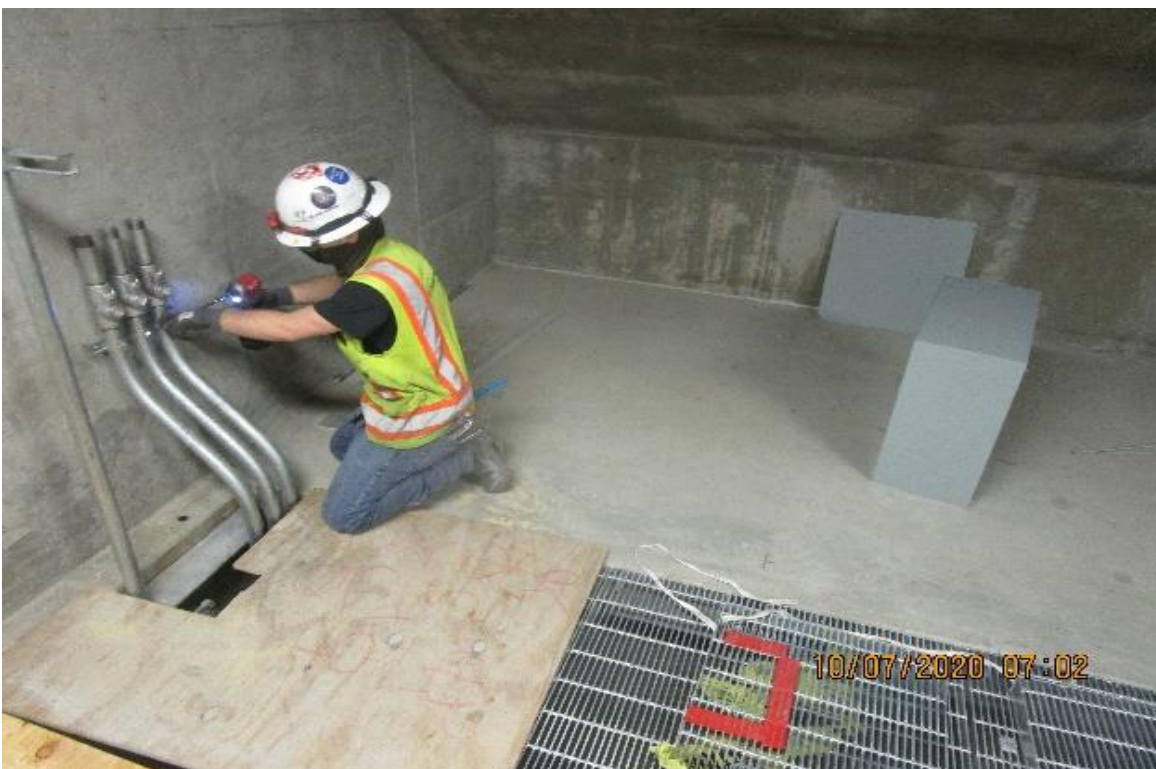
Crenshaw/Vernon – Vernon, Ejector room C134, Continued piping (3) 1-1/4" GRC from SE to 24" PB to SE-6-2X control panel.

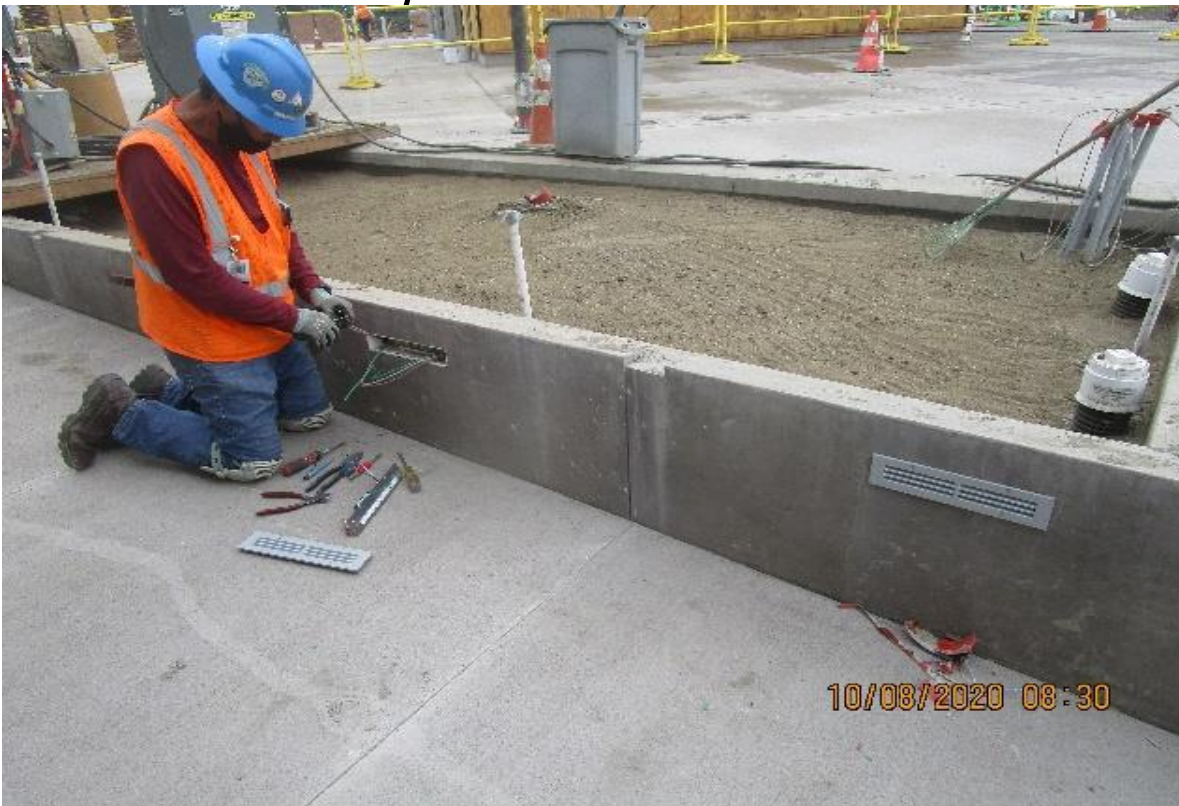
Crenshaw/Vernon – Vernon Plaza, began installing foreign (made in chine) recessed ramp & stair lighting without UL listing.

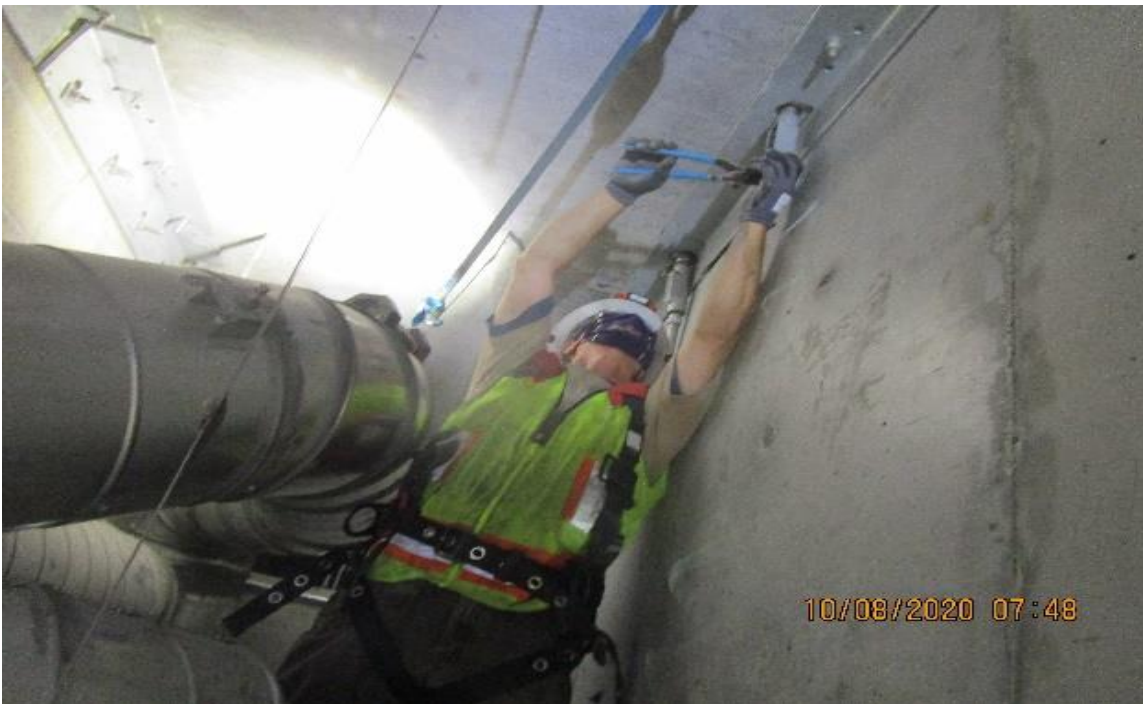
Crenshaw/Vernon – Vernon, above em stair (S) #1 C103 piping 1" GRC & ¾" seal tight conduit to FSD-6-405E & 405F limit switches.

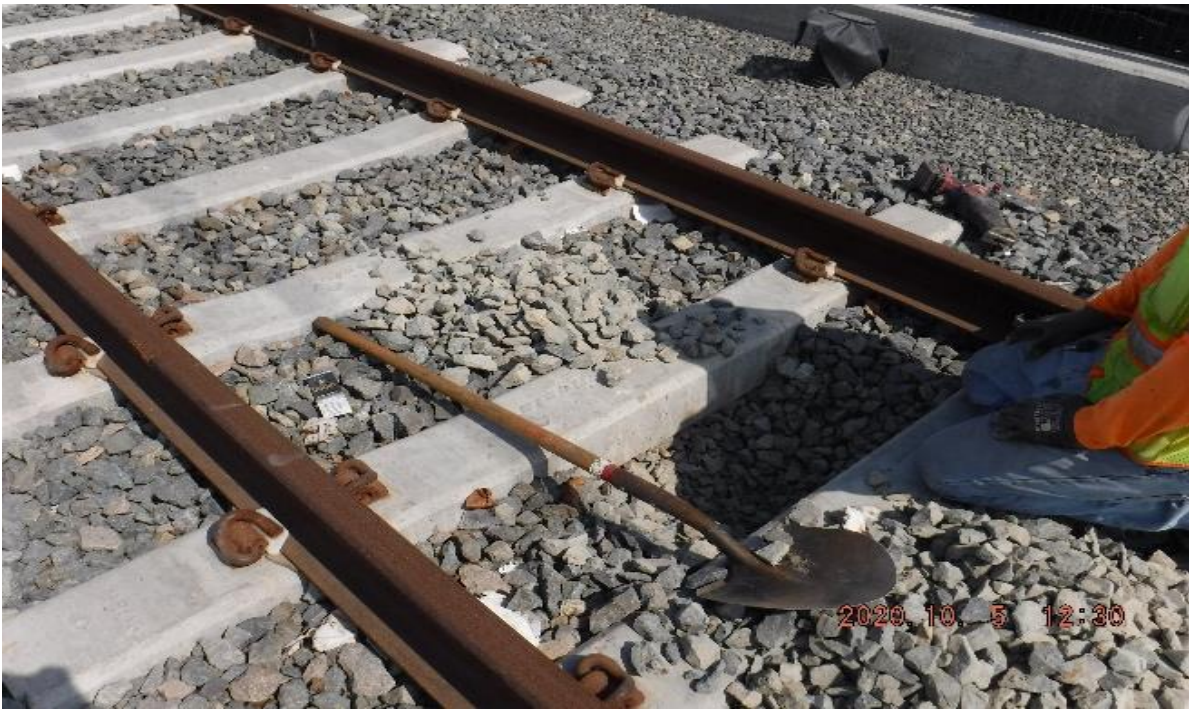
57th Street – STA 331+15 TK#4/NB looking north – track ballast disturbance in search for traffic loops conduits north of 57th at grade crossing – PUNCH LIST

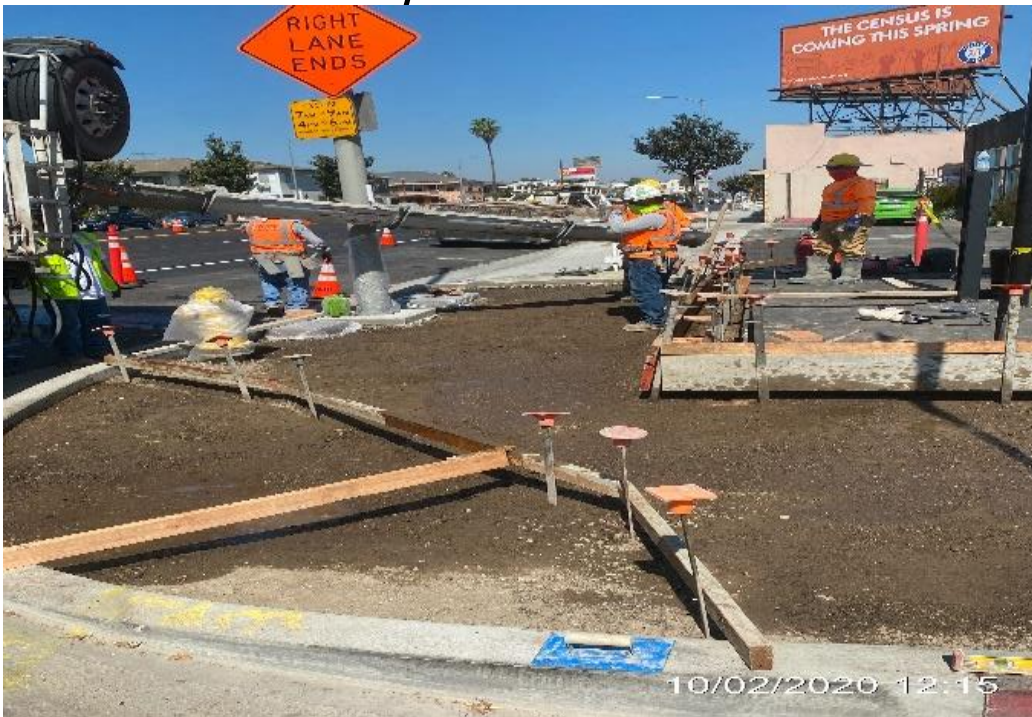
PARK MESA – Placing concrete for new sidewalk and ADA ramp on the northeast corner of 66th St and Crenshaw Blvd.

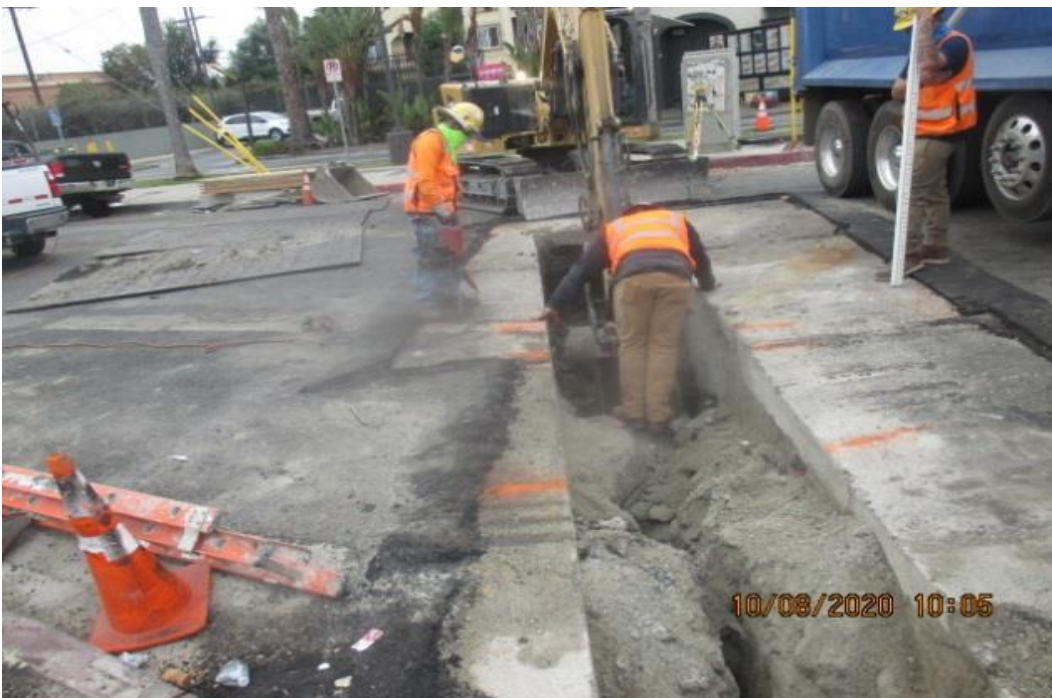
PARK MESA – Excavating for Storm Drain Line F on the northeast corner of Crenshaw Blvd and 60th St.

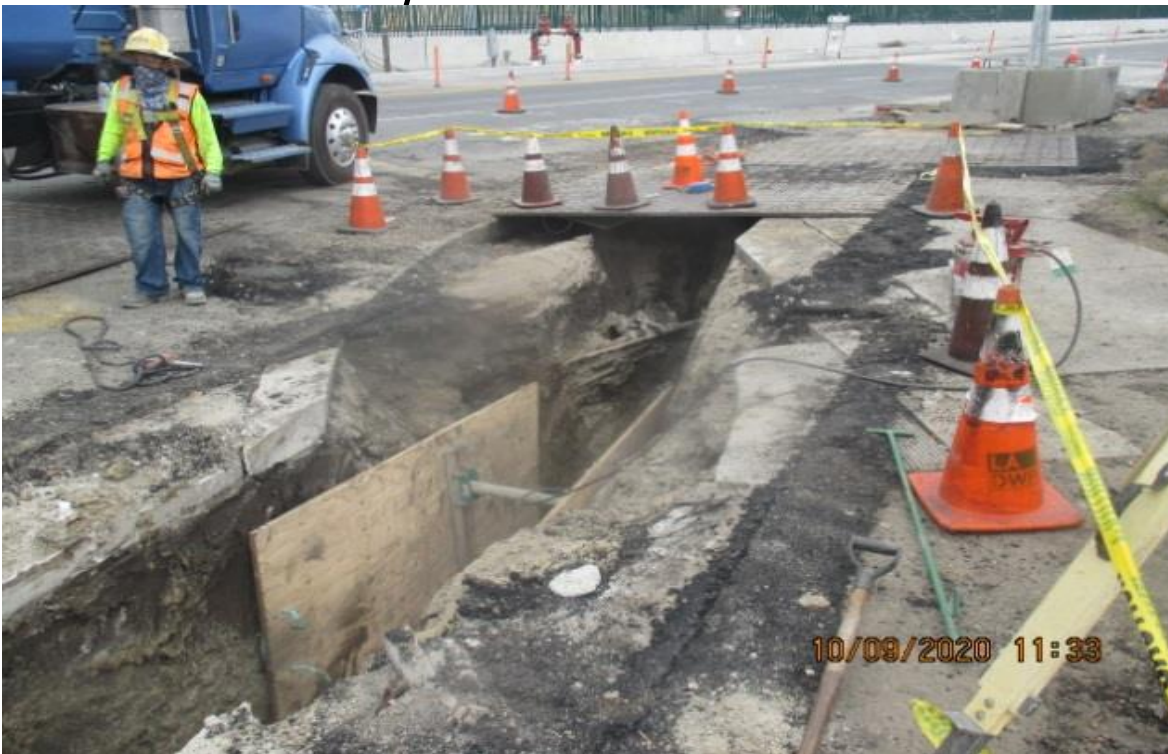
PARK MESA – Continue excavating for Storm Drain Line F on the northeast corner of Crenshaw Blvd and 60th St.

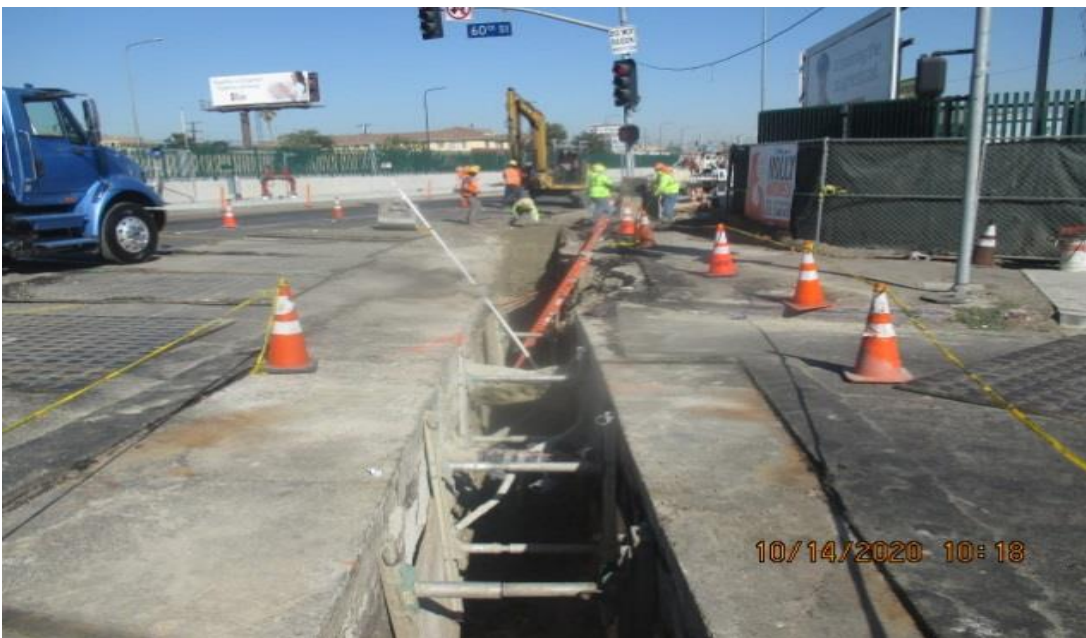
PARK MESA – Continue excavating for Storm Drain Line F on the northeast corner of Crenshaw Blvd and 60th St.

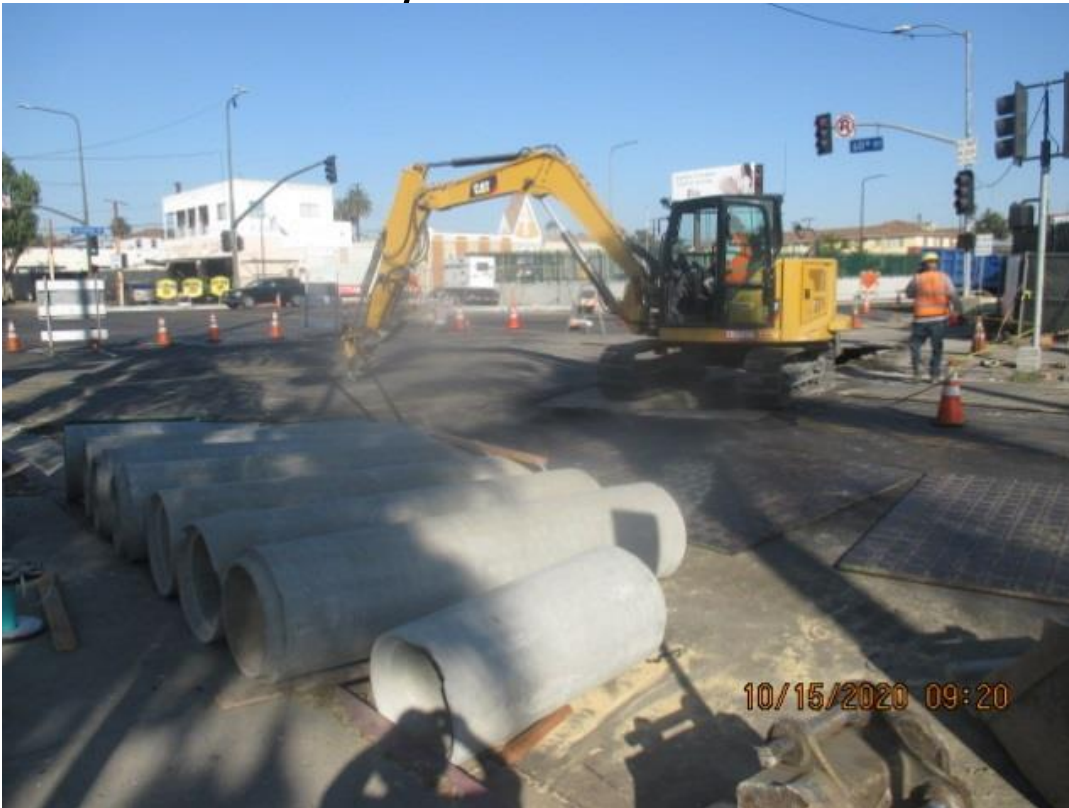
PARK MESA – Continue excavating for Storm Drain Line F on the northeast corner of Crenshaw Blvd and 60th St.

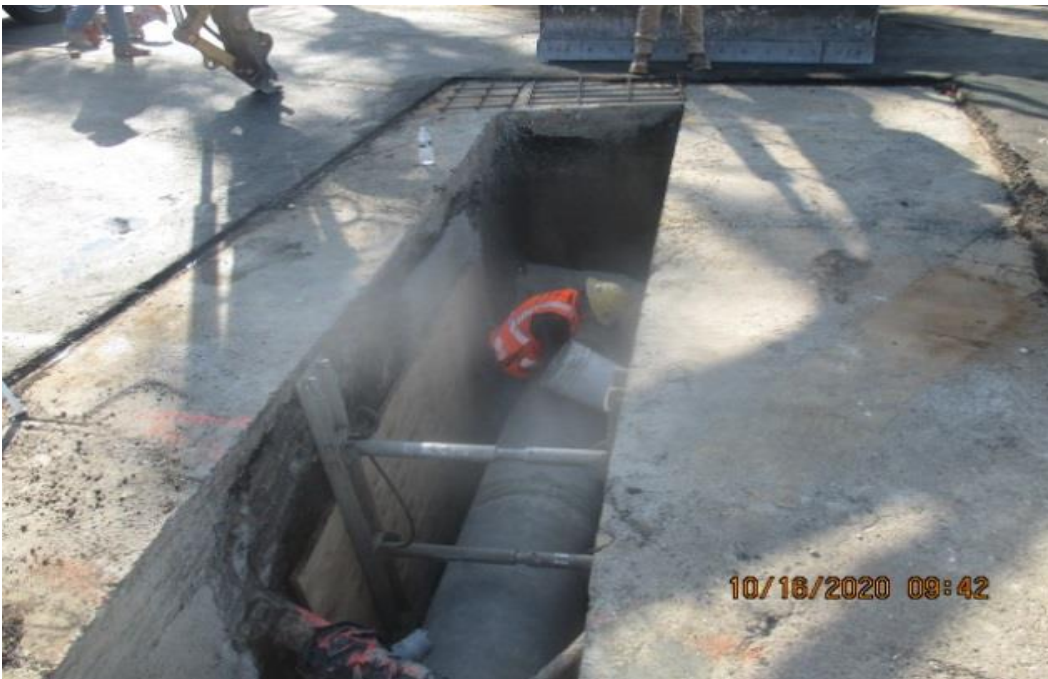
PARK MESA – Installing Storm Drain Line F on northbound Crenshaw Blvd and 60th St.

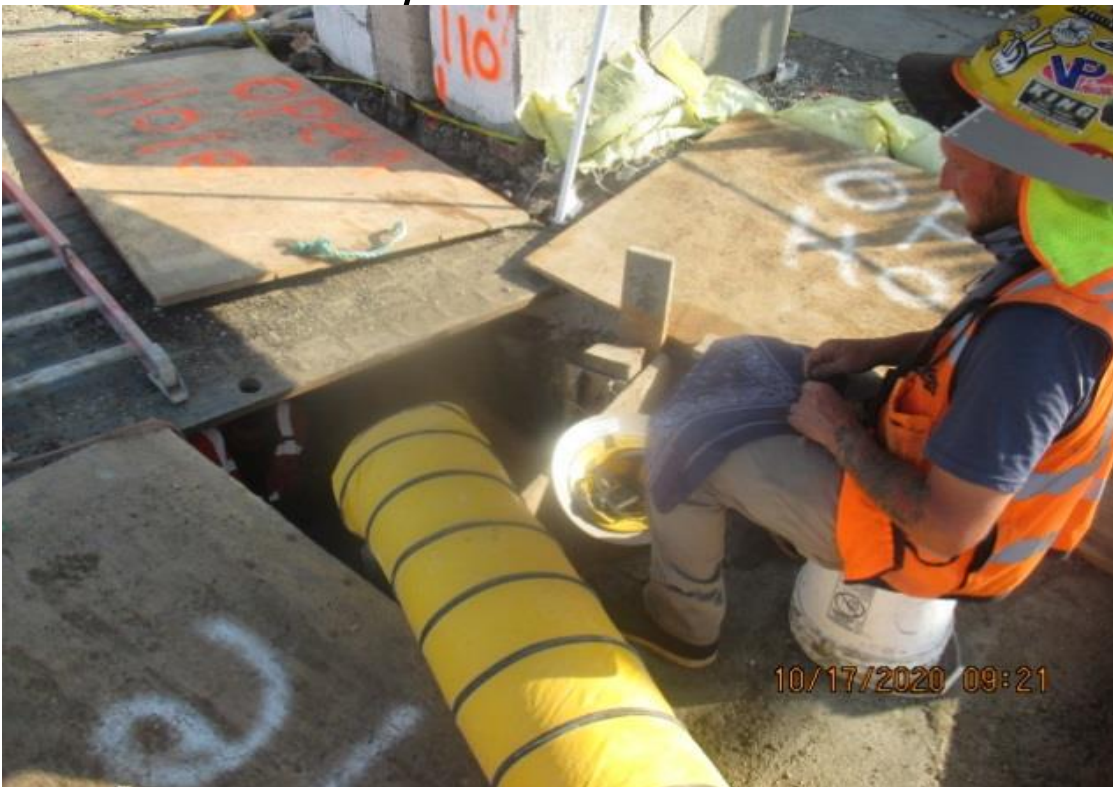
PARK MESA – Sealing interior seams of Storm Drain Line F on northbound Crenshaw Blvd and 60th St.

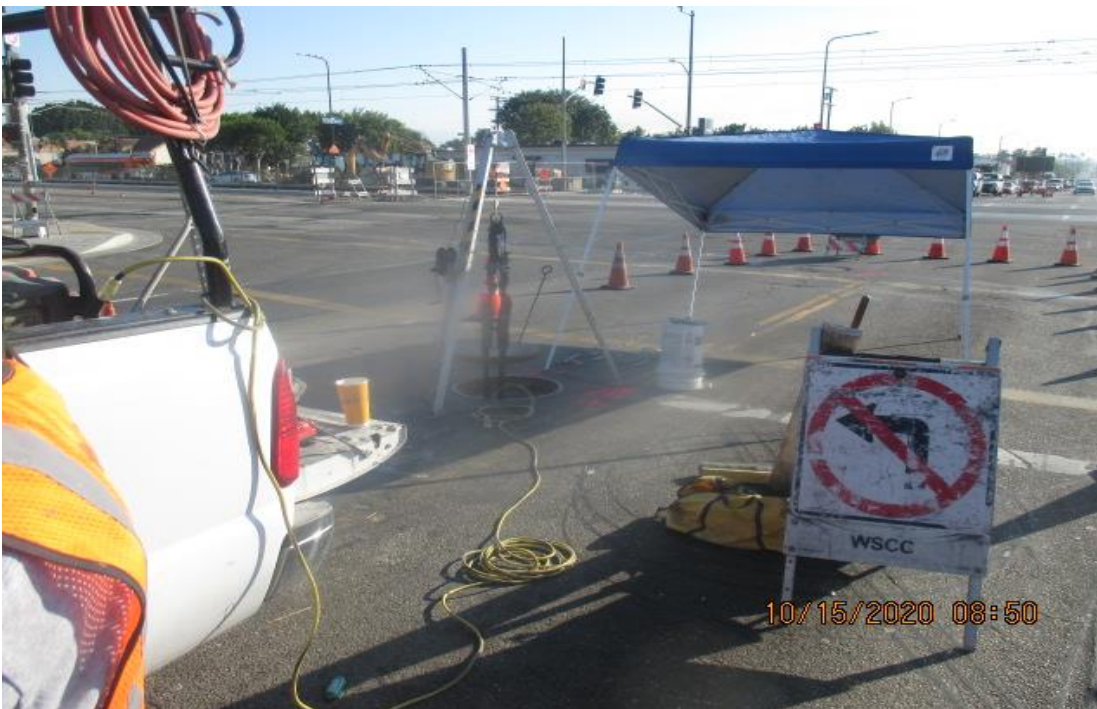
PARK MESA – Sacking and patching and installing ladder rungs to Manhole #12 and #16 on southbound Crenshaw Blvd and Slauson Ave.

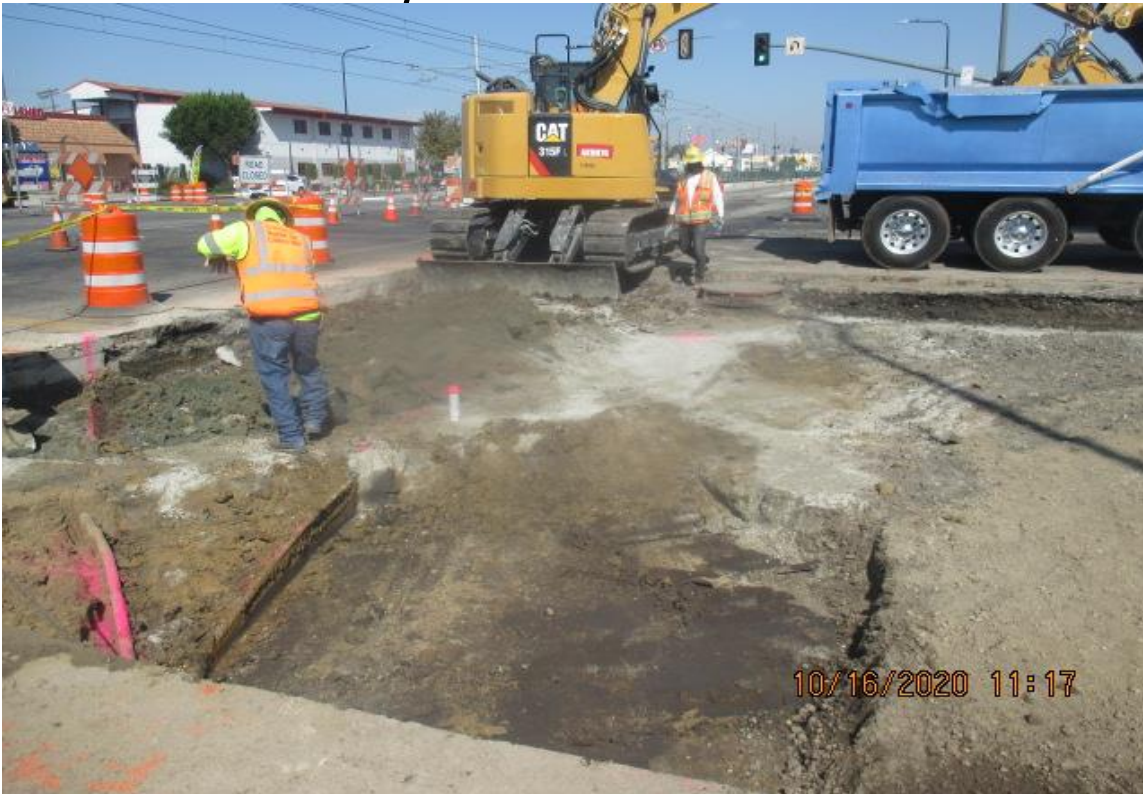
PARK MESA – Excavating/removing road pavement on both north and southbound Crenshaw Blvd and Slauson Ave.

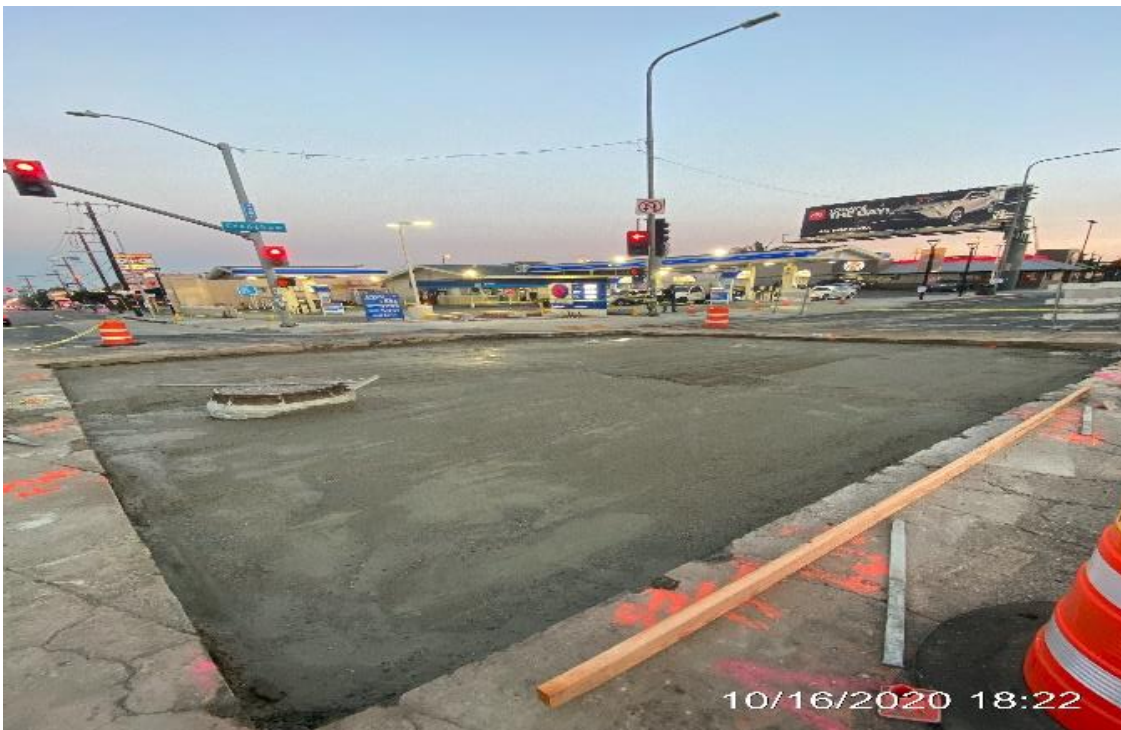
PARK MESA – Built formwork, placed rebar and concrete over north and southbound lanes on Crenshaw Blvd and Slauson Ave.

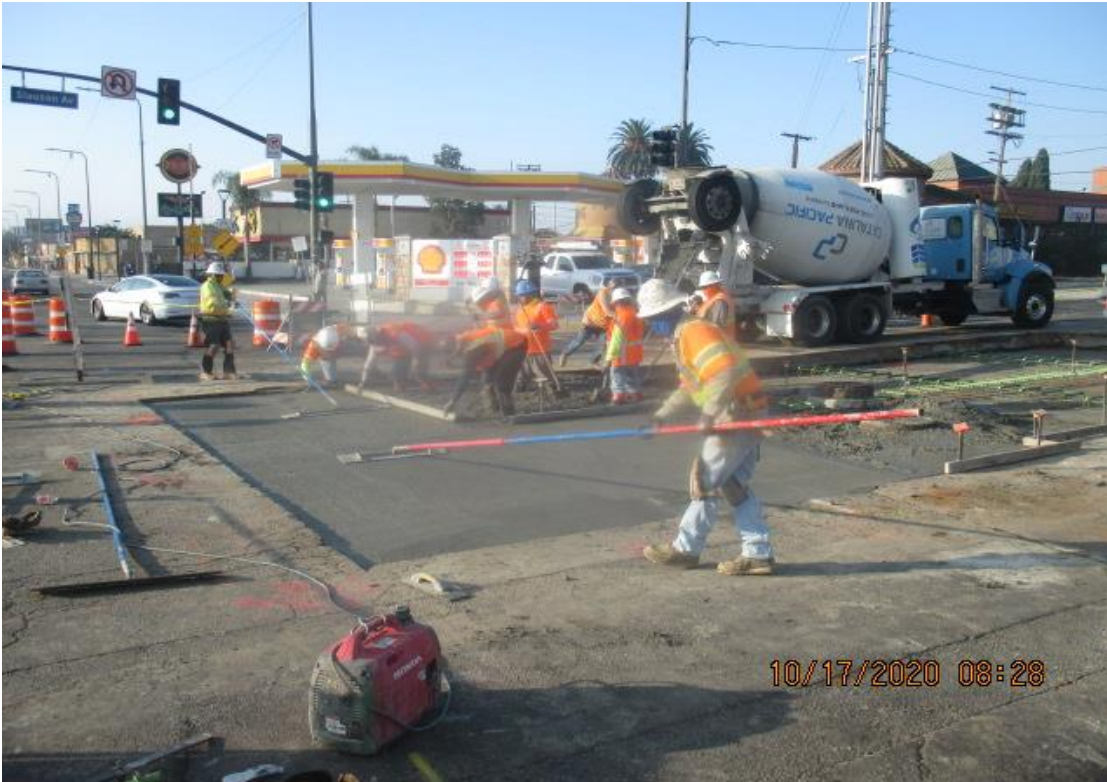
PARK MESA – Continue placing rebar and concrete over north and southbound lanes on Crenshaw Blvd and Slauson Ave.

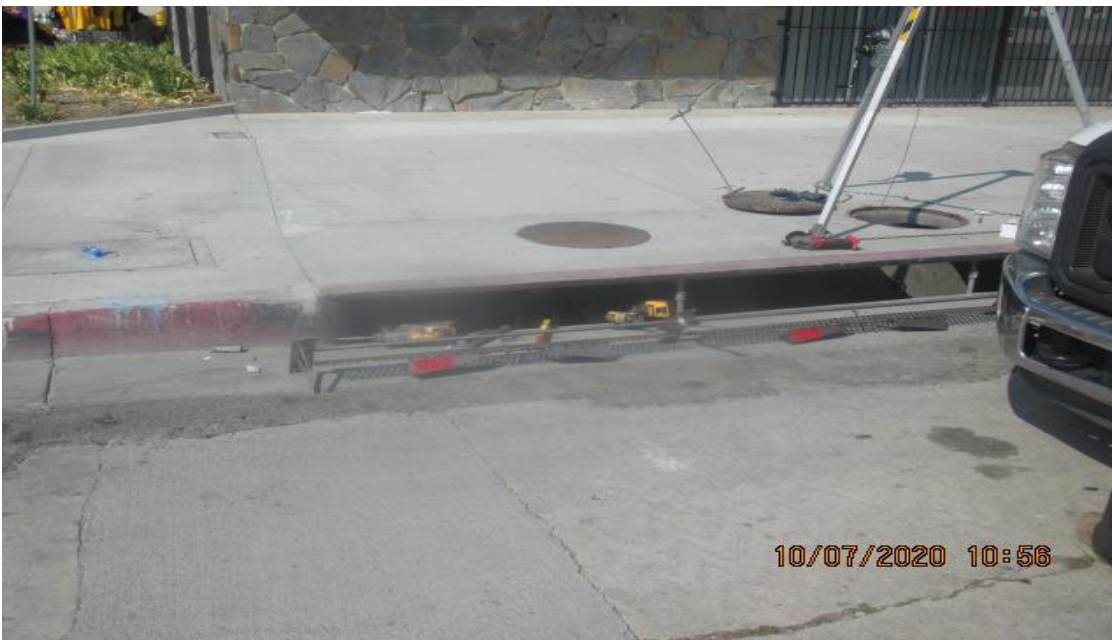
PARK MESA – Installing protective gratings for opening of Catch Basin #33 on Crenshaw Blvd and 57th St.

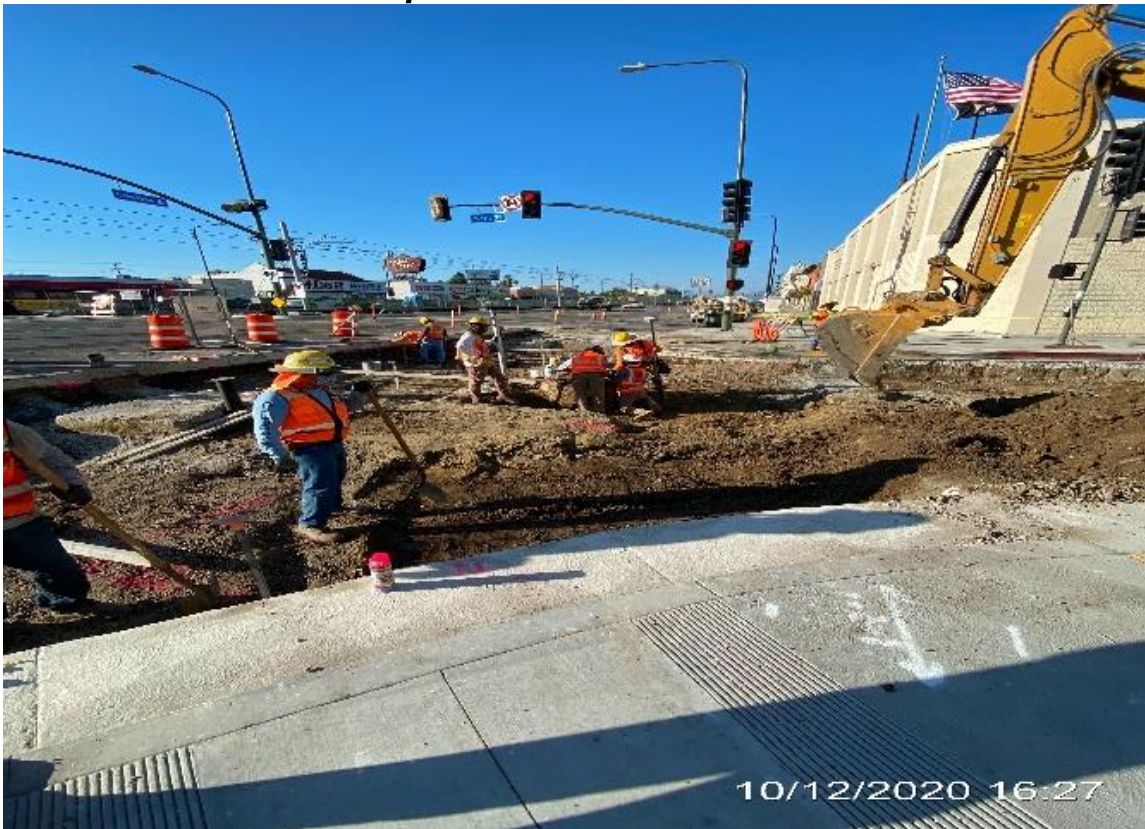
PARK MESA – Excavating north and southbound lanes for restoration on the intersection of Crenshaw Blvd and 57th St.

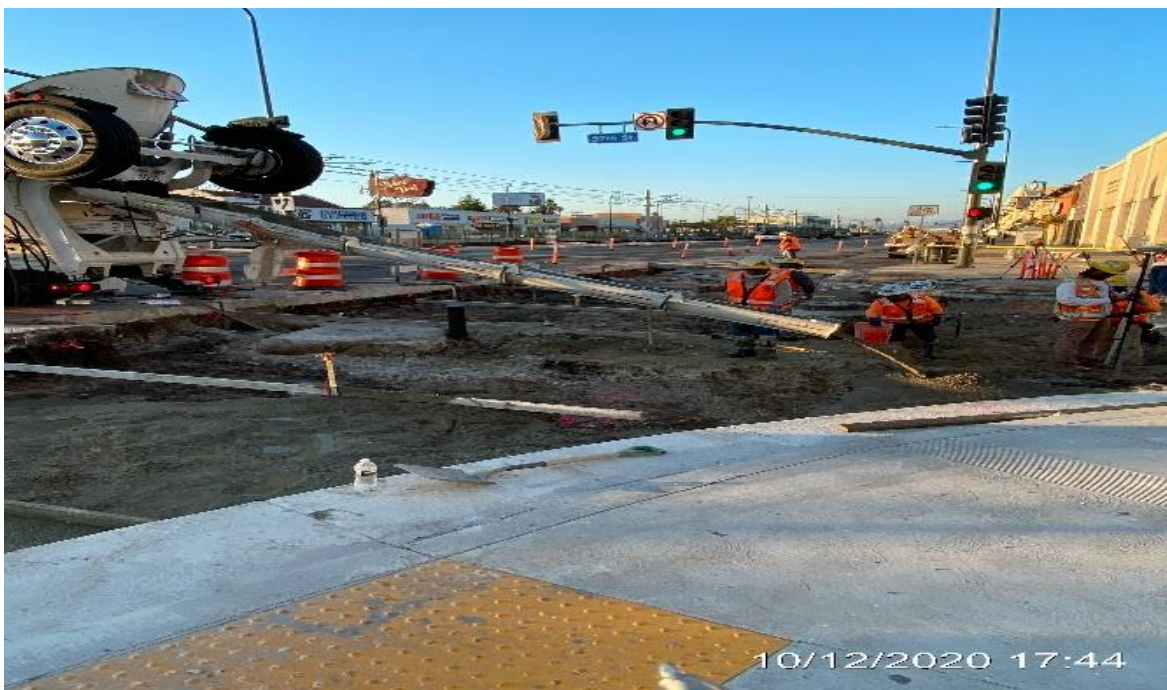
PARK MESA – Building formwork and placing concrete on the north and southbound lanes for restoration at the intersection of Crenshaw Blvd and 57th St.

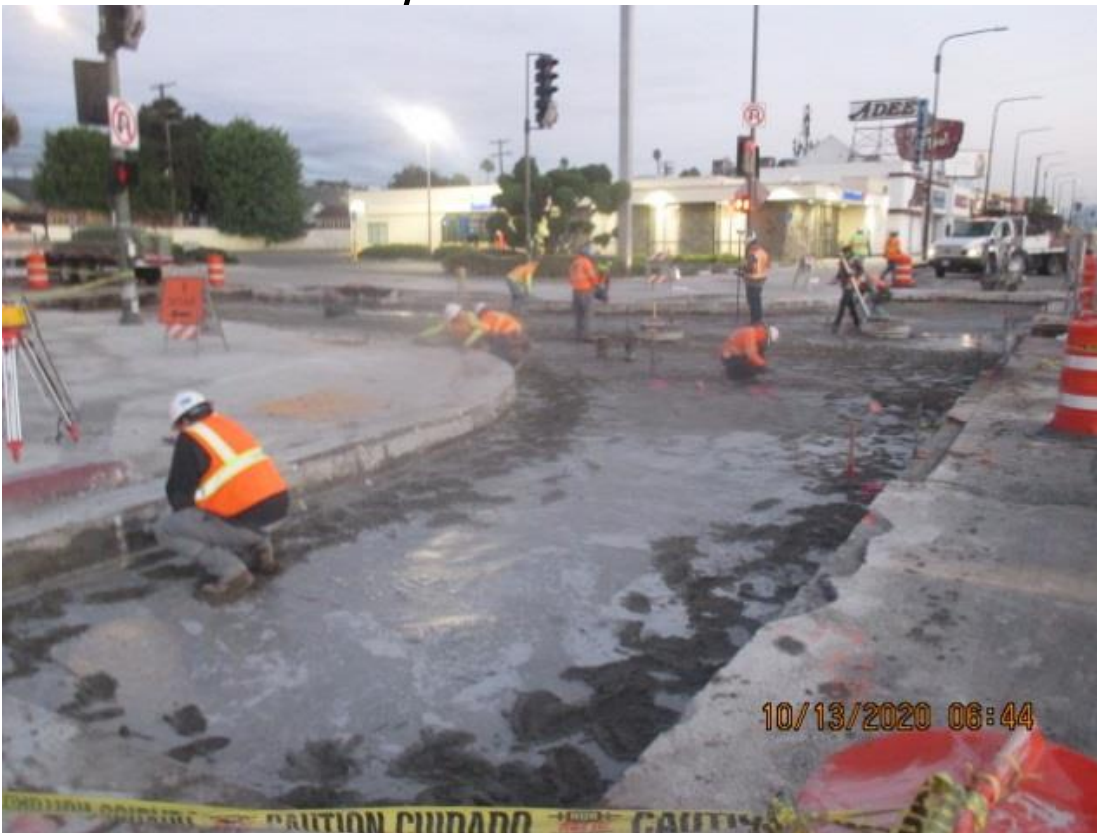
PARK MESA – Continue building formwork and placing slurry on the north and southbound lanes for restoration at the intersection of Crenshaw Blvd and 57th St.

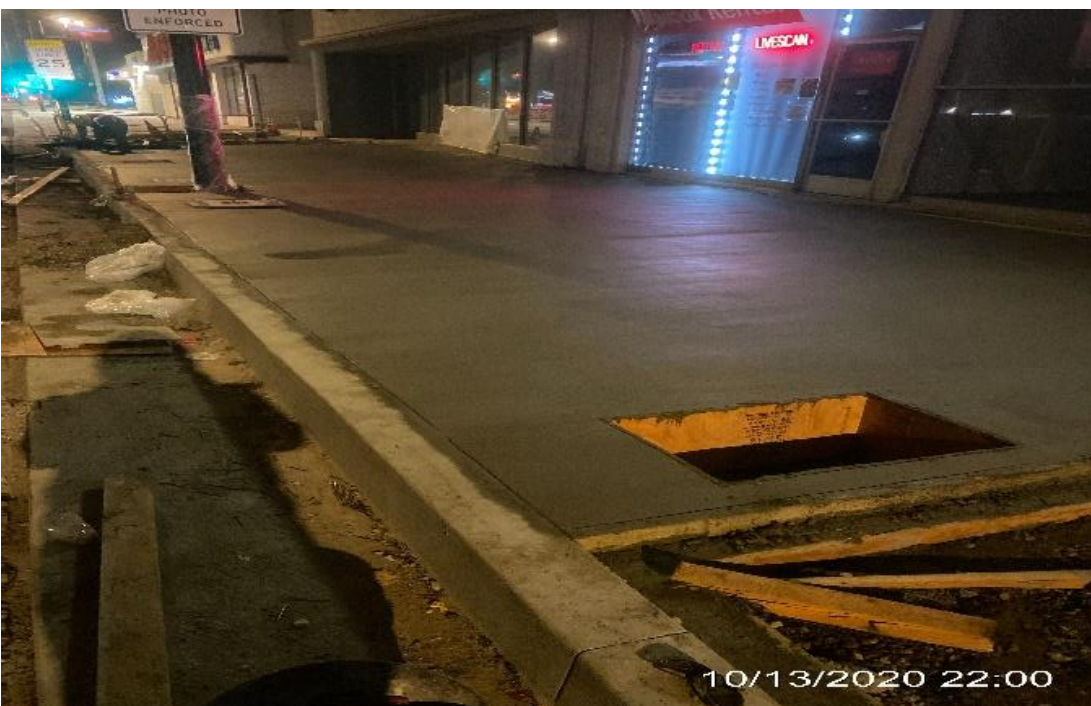
PARK MESA – Build formwork and placed concrete for new sidewalk installation on southbound Crenshaw Blvd and 57th St.

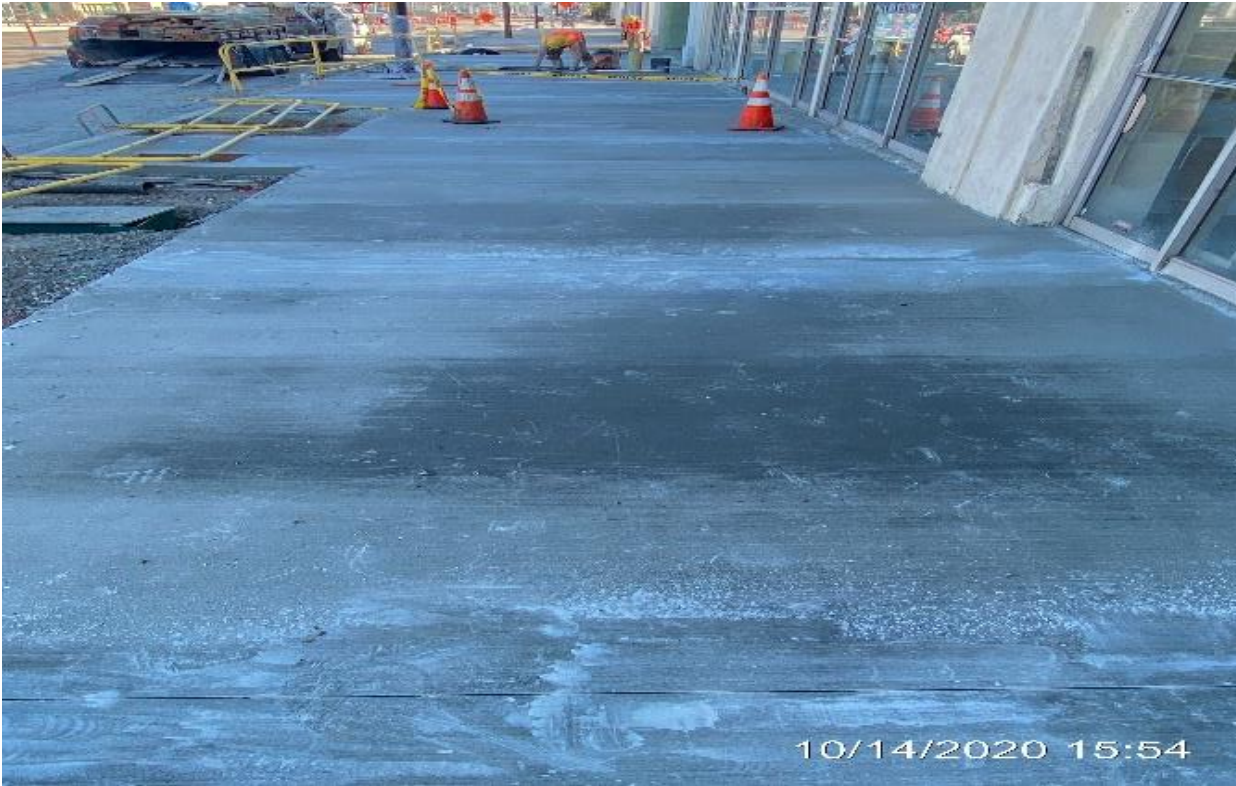
PARK MESA – Saw cut new sidewalk panels on southbound Crenshaw Blvd and 57th St.

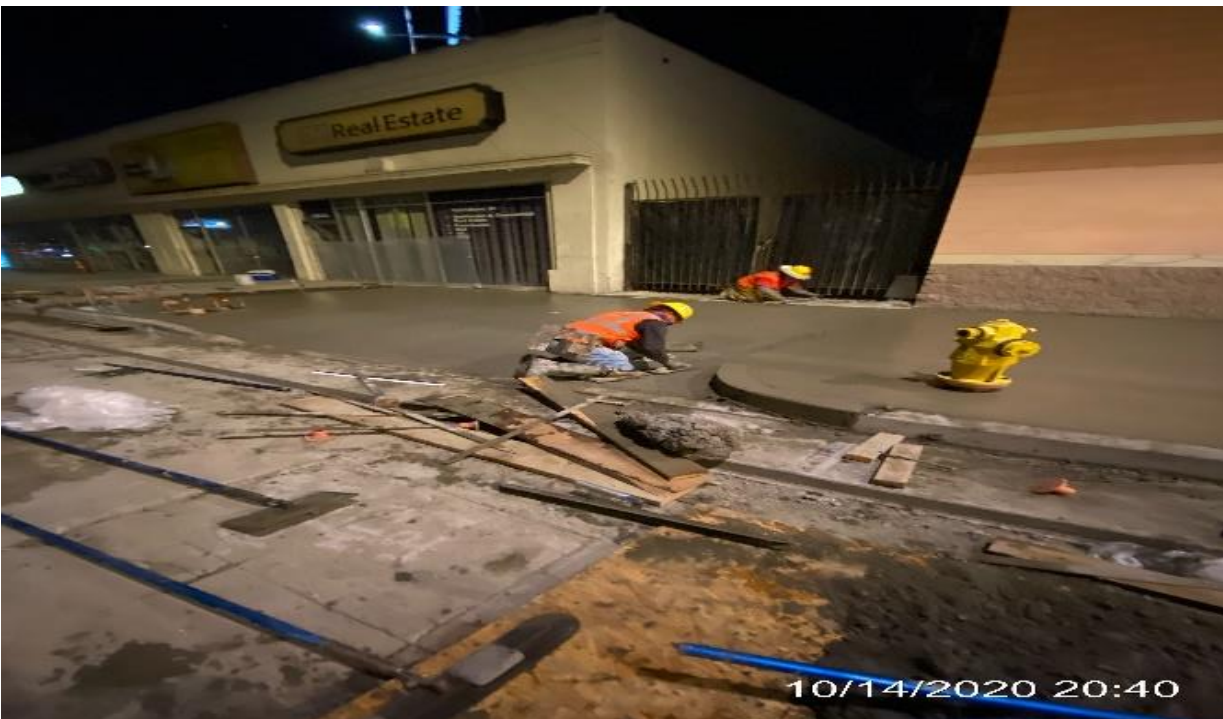
PARK MESA – Continue building formwork and placing concrete for new sidewalk installation along southbound Crenshaw Blvd north of 57th St.

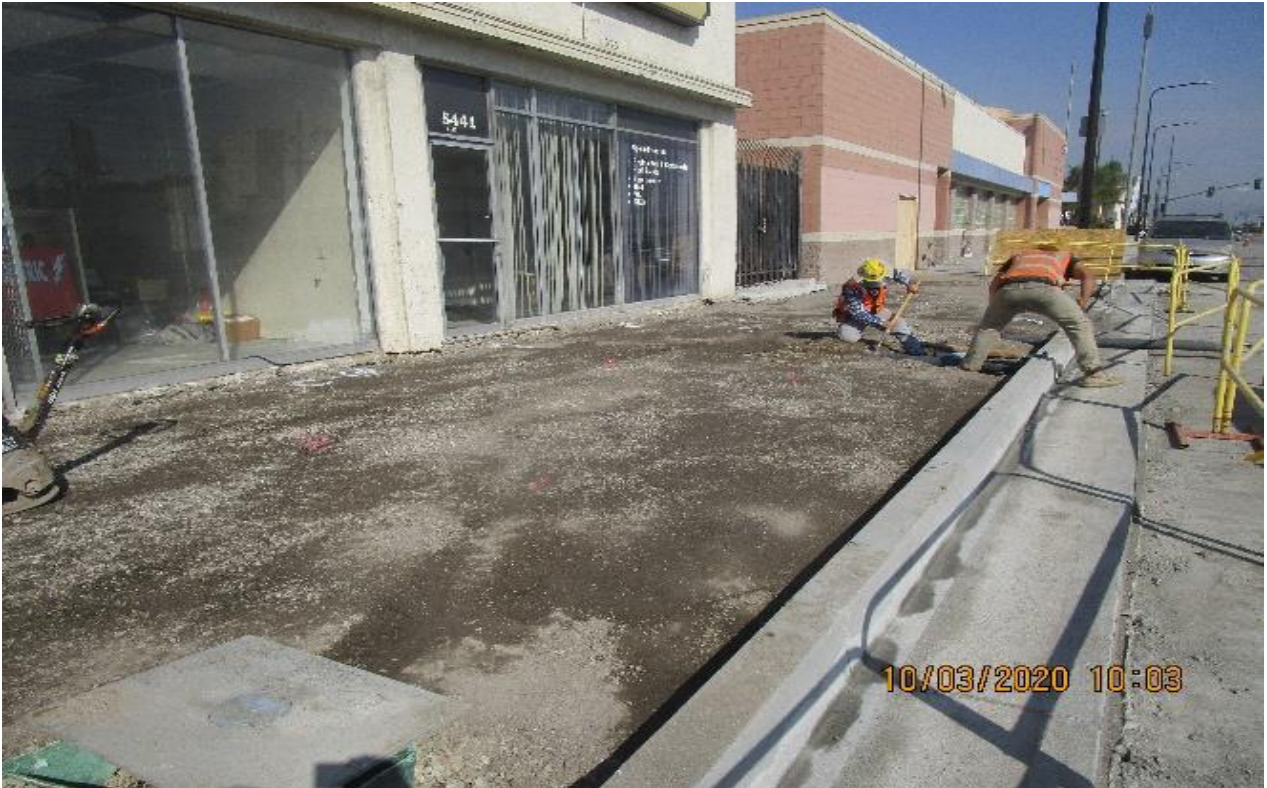
PARK MESA – Installed drains at the curb and gutter along SB Crenshaw Blvd between 54th and 57th St.
