CRENSHAW/LAX PHOTOGRAPHIC UPDATE

October 30, 2020

Crenshaw/LAX Transit Project

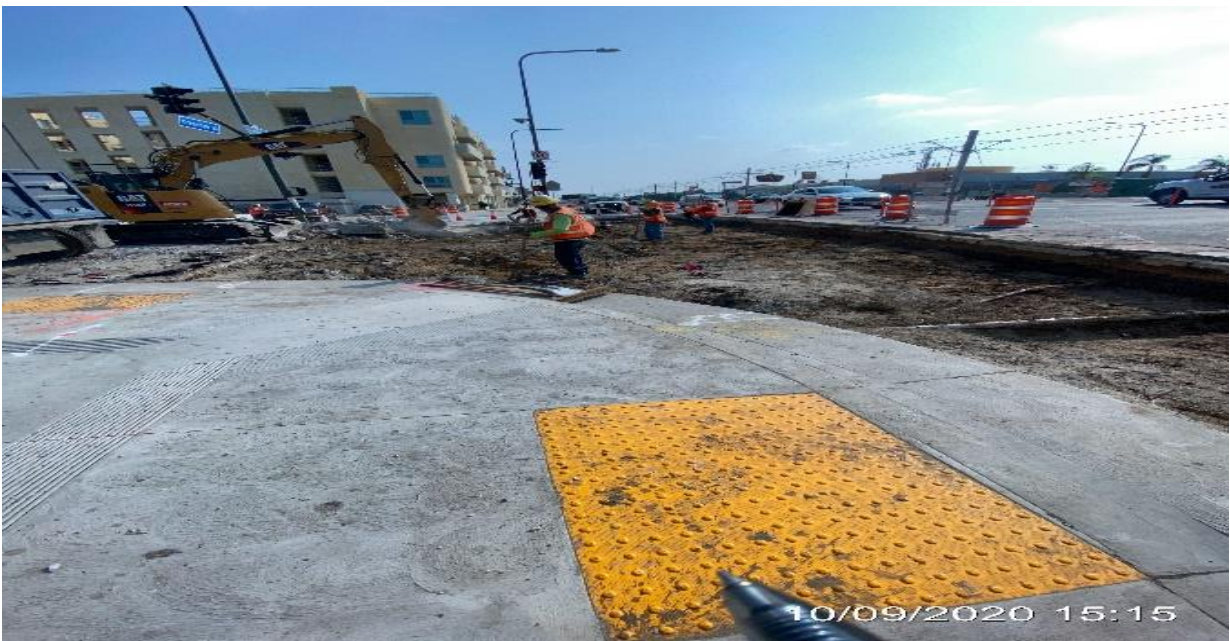
PARK MESA – Excavated/removed 3 concrete road slab sections on the intersection of Crenshaw Blvd and 54th St.

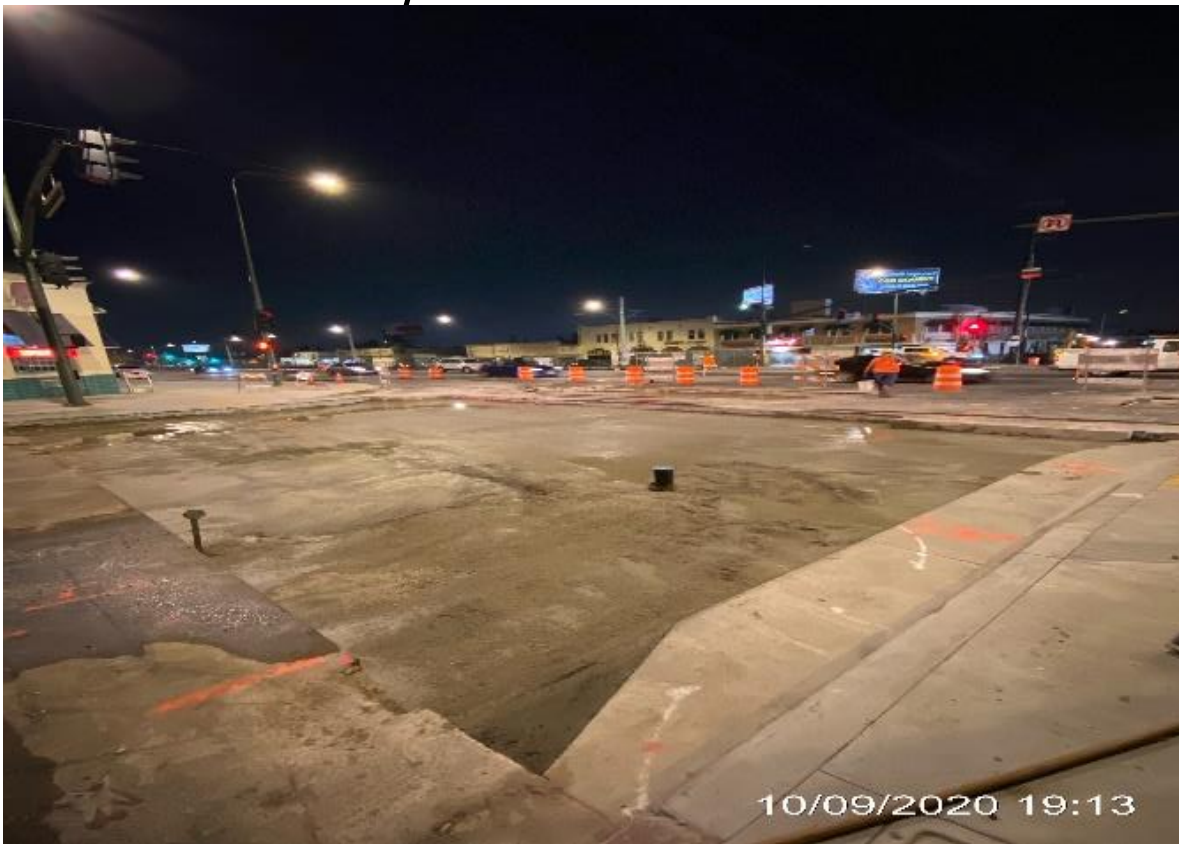
PARK MESA – Placed forms and slurry for 3 sections on the intersection of Crenshaw Blvd and 54th St.

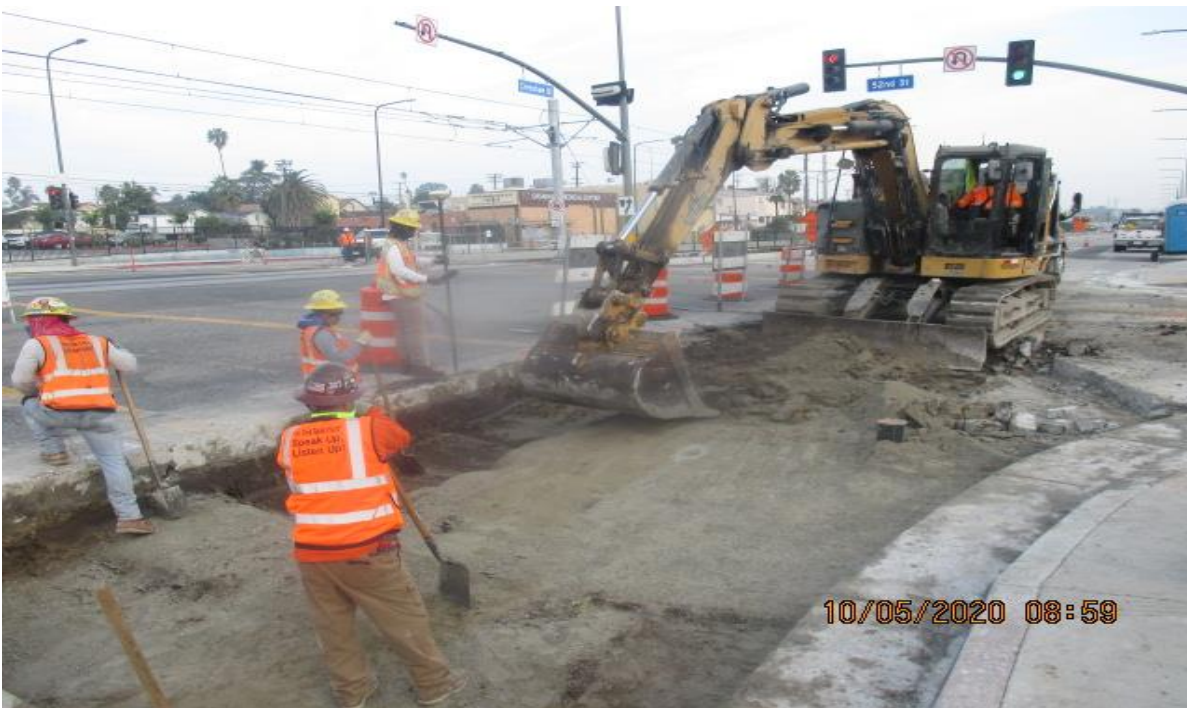
PARK MESA – Excavating northbound lanes for restoration on Crenshaw Blvd and 52nd St.

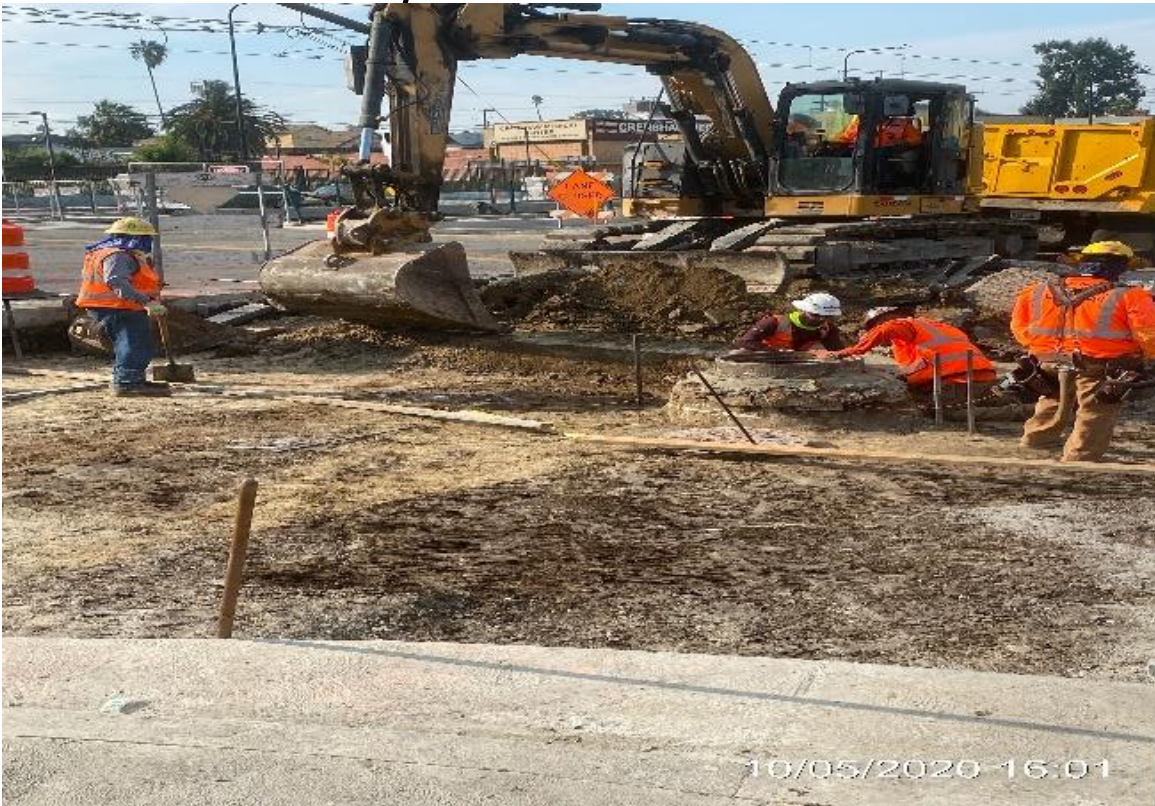
PARK MESA – Sacking and patching sewer maintenance hole on northbound Crenshaw Blvd and 52nd St.

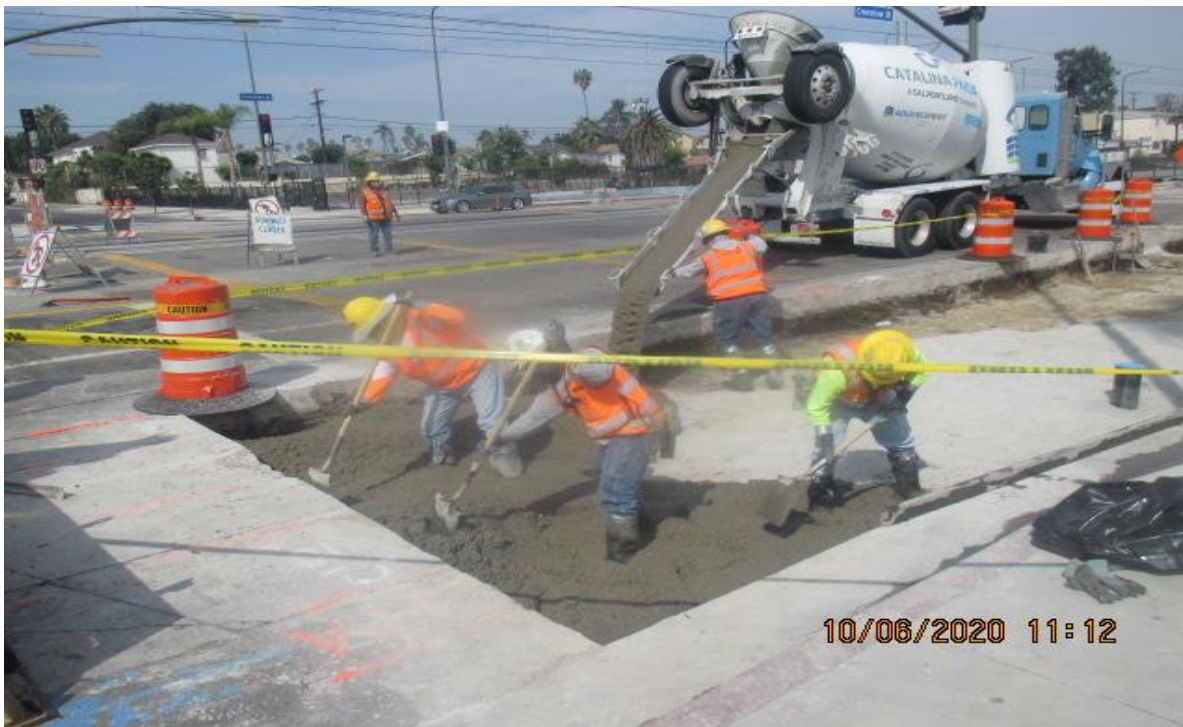
PARK MESA – Placing slurry backfill and concrete over the northbound lanes on Crenshaw Blvd and 52nd St.

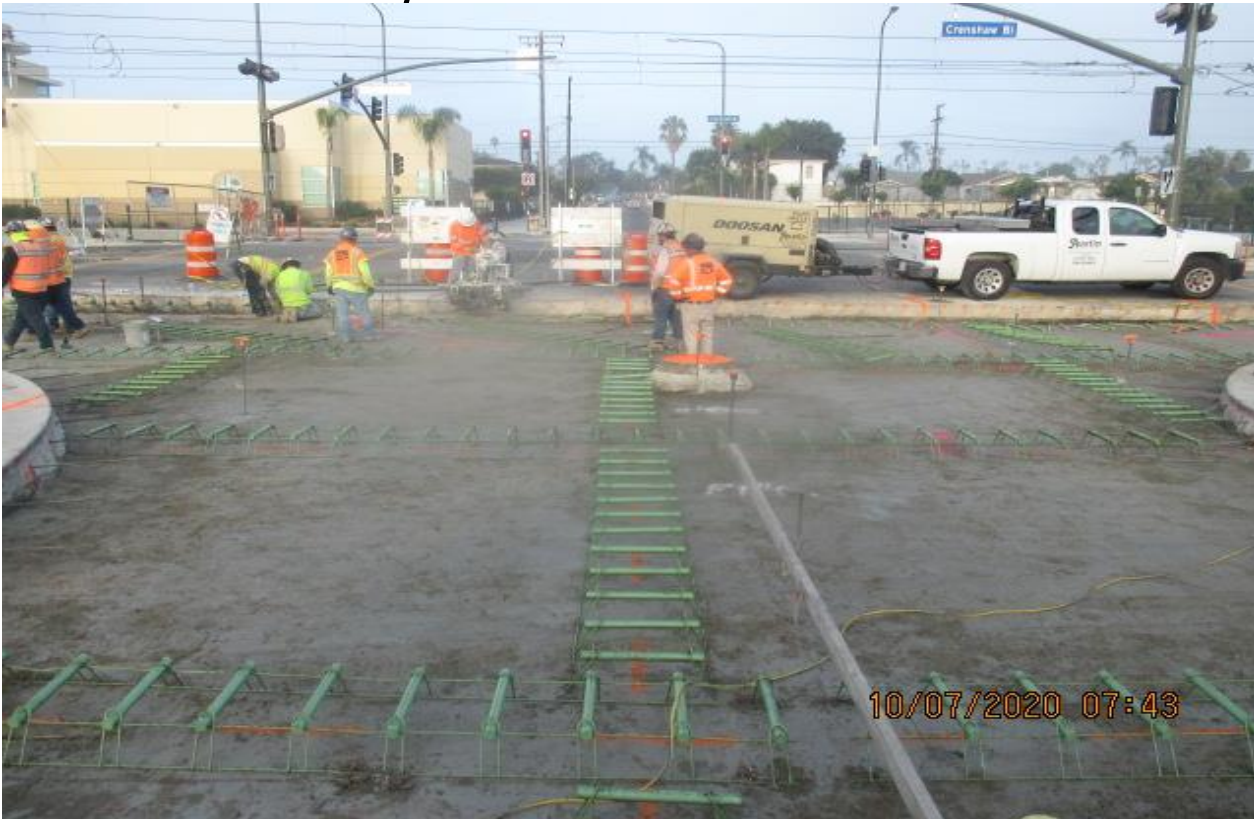
PARK MESA – Placing rebar in preparation for concrete placement of the existing roadway slab on Crenshaw Blvd and 52nd St.

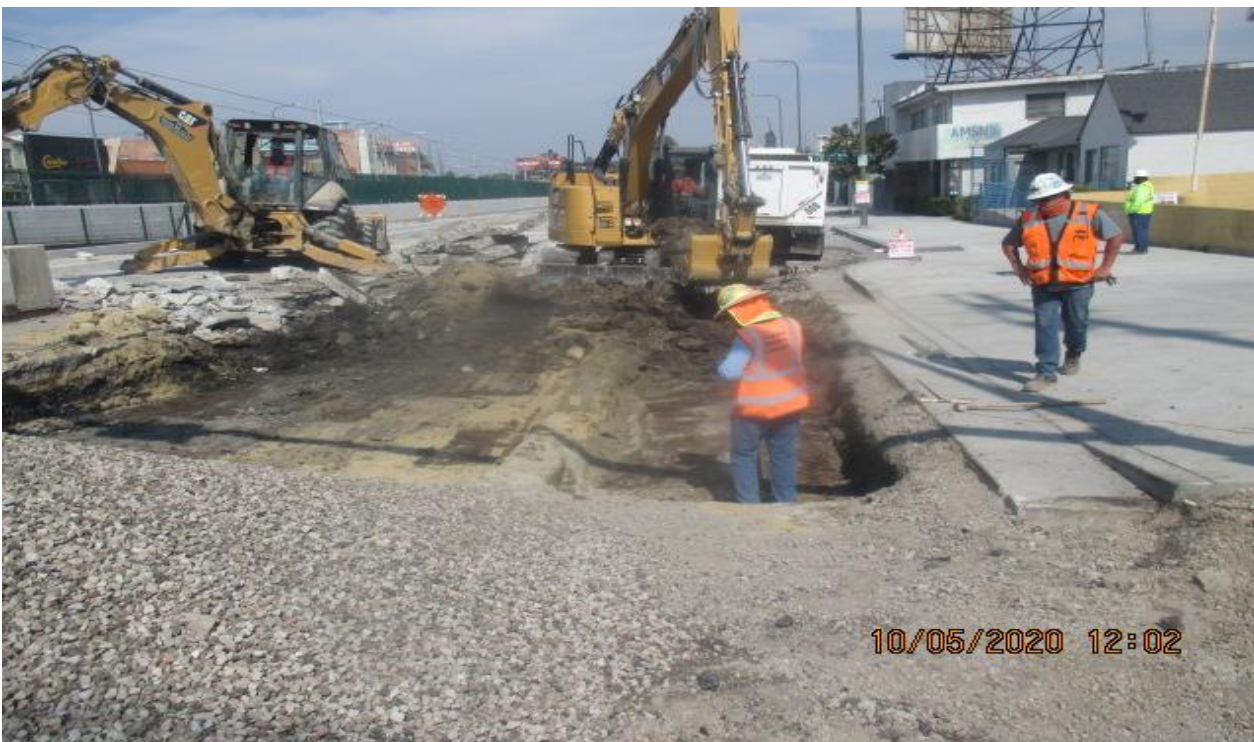
PARK MESA – Excavating northbound lanes for restoration on Crenshaw Blvd and 48th St.

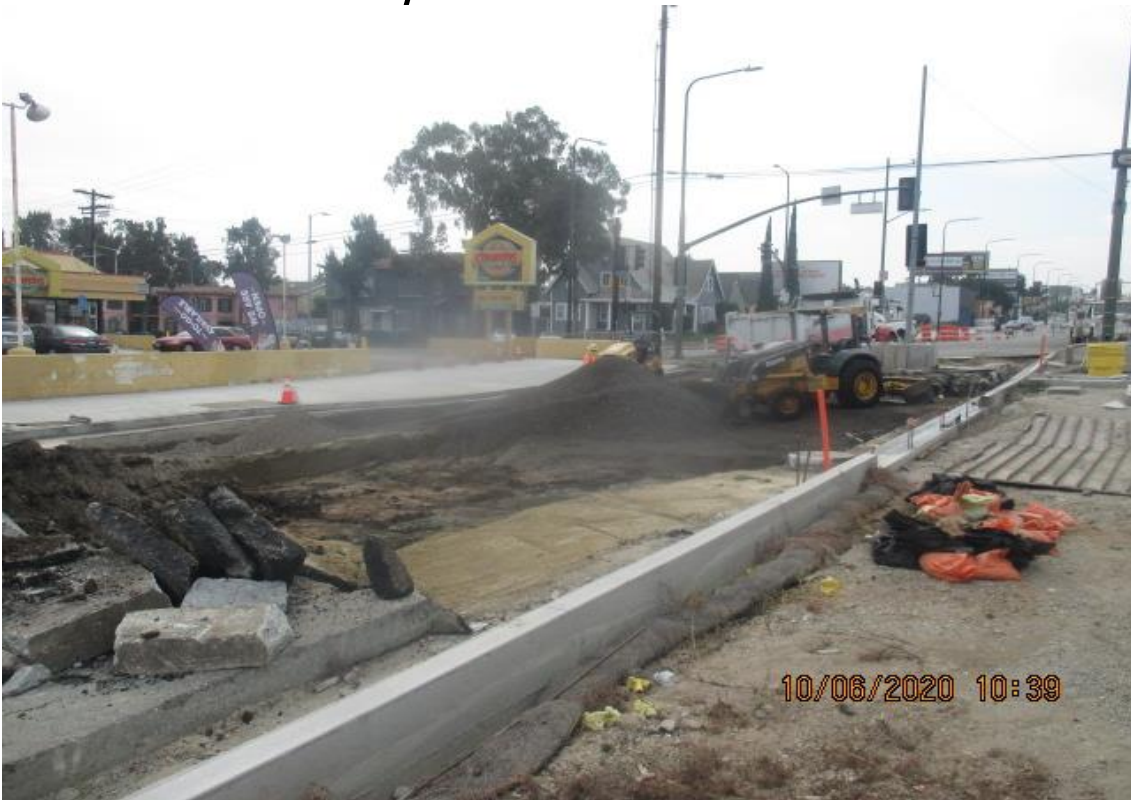
PARK MESA – Continue excavating northbound lanes and backfilled on Crenshaw Blvd and 48th St.

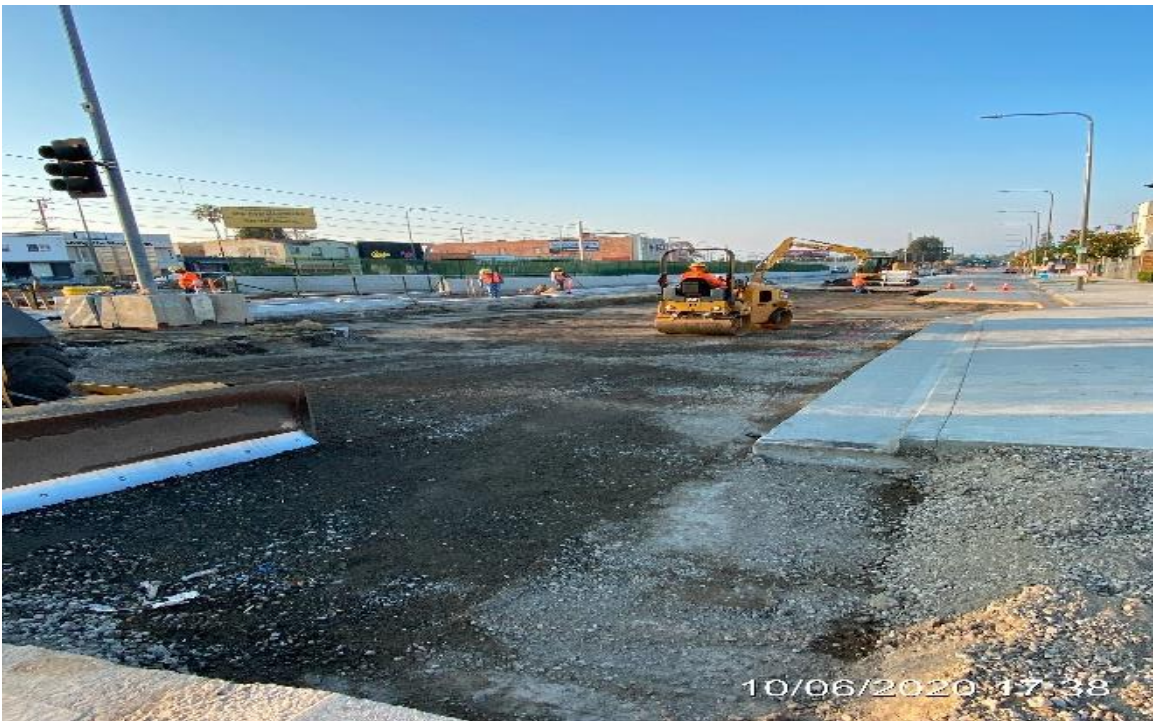
PARK MESA – Continue backfilling and compacting the northbound lanes on Crenshaw Blvd and 48th St.

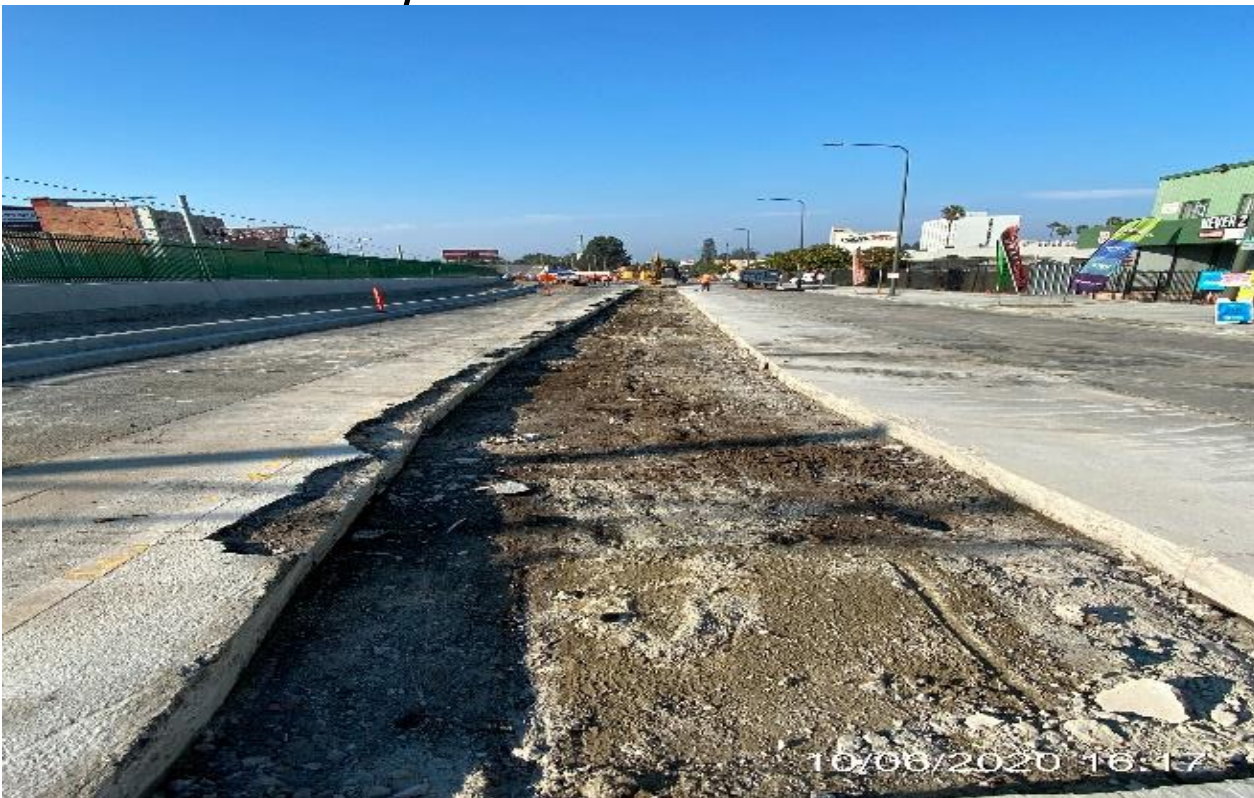
PARK MESA – Excavating northbound lanes for restoration on Crenshaw Blvd from 48th St to 46th St.

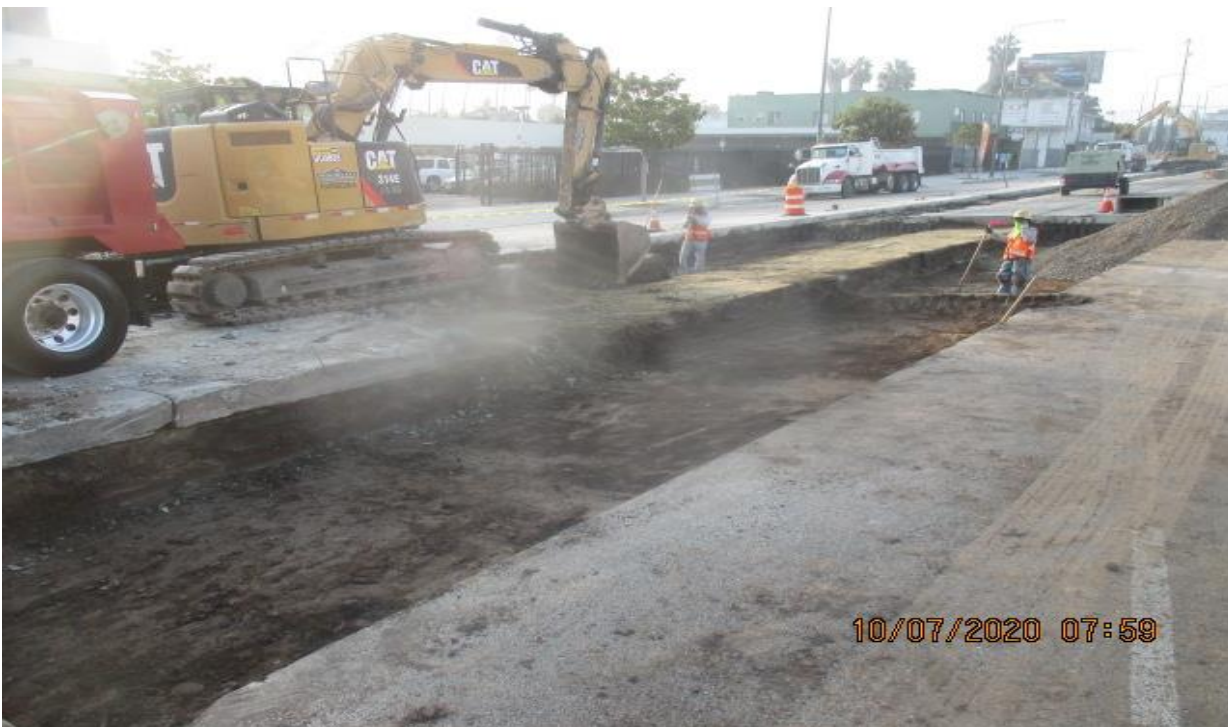
PARK MESA – Backfilling/compacting the northbound lanes and placed rebar on Crenshaw Blvd from 48th St to 46th St.

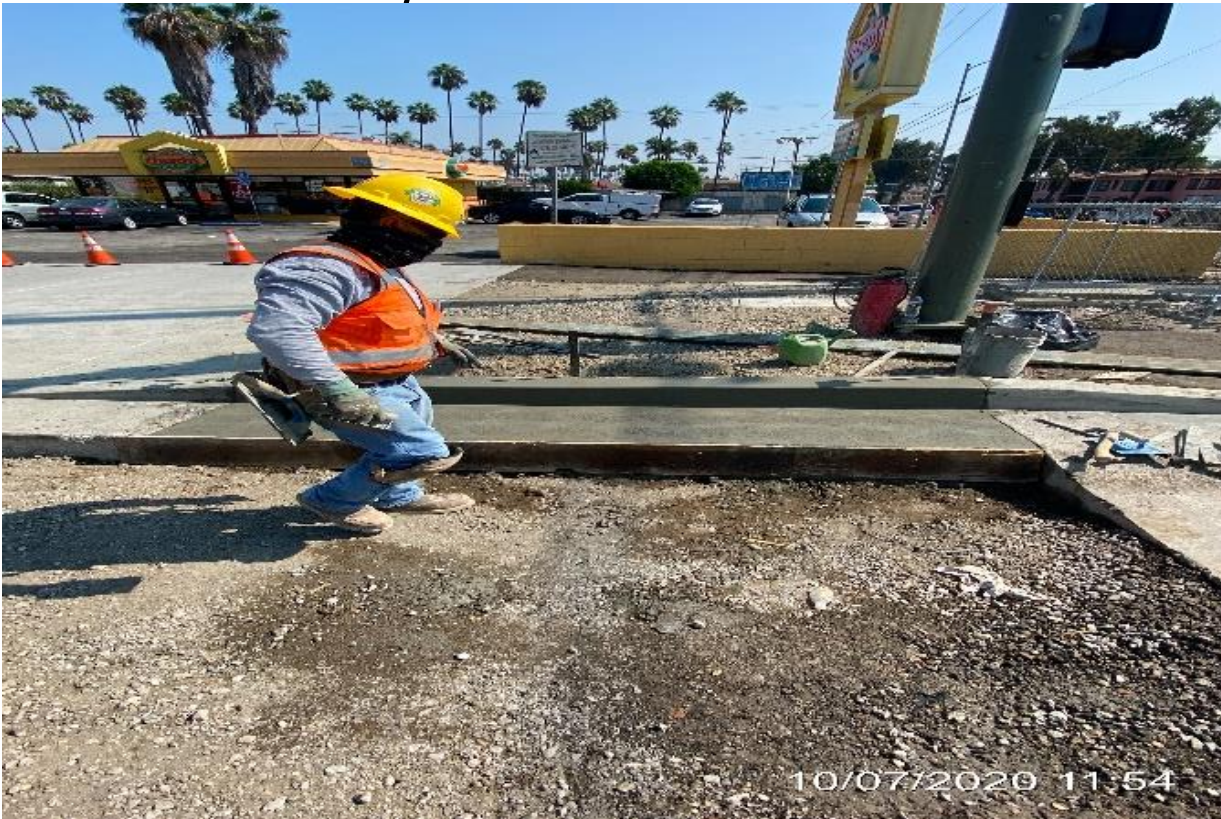
PARK MESA – Placed concrete for new curb/gutter installation on the northeast corner of Crenshaw Blvd and 48th St.

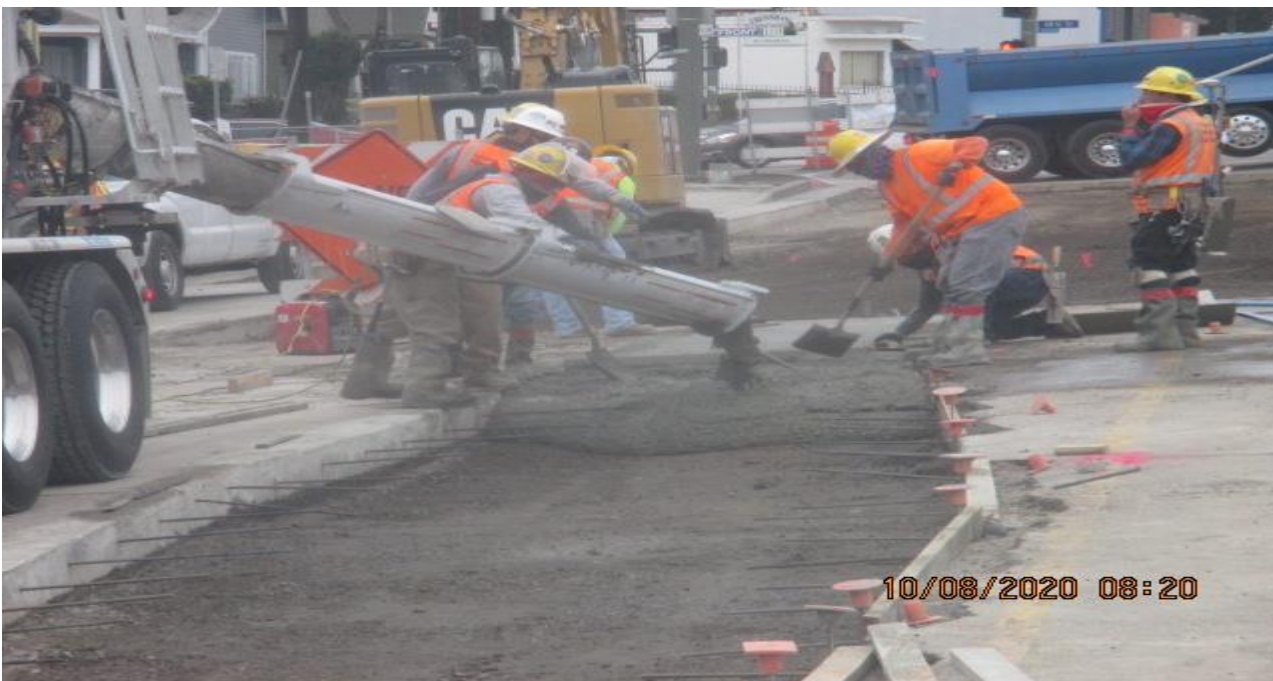
PARK MESA – Placing concrete for the northbound lanes on Crenshaw Blvd from 48th St to 46th St.

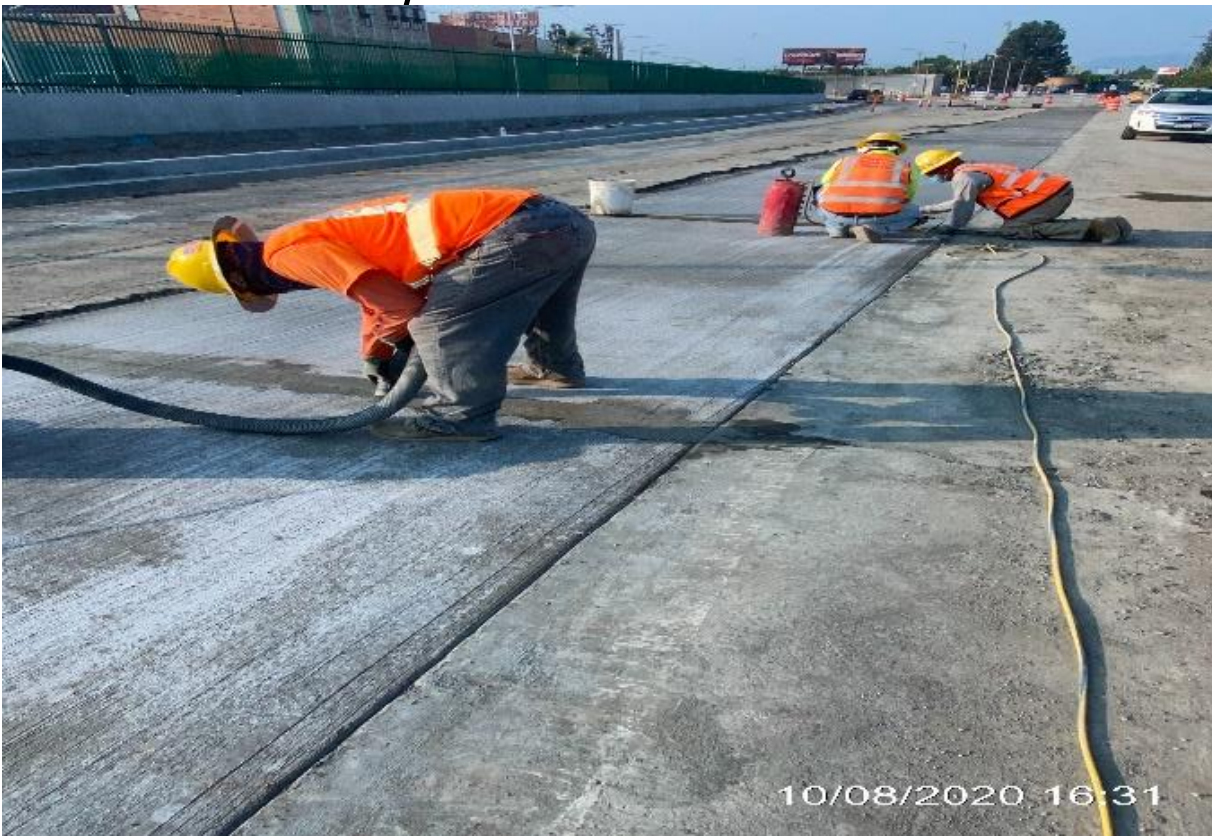
PARK MESA – Saw cutting the northbound lanes on Crenshaw Blvd from 48th St to 46th St.

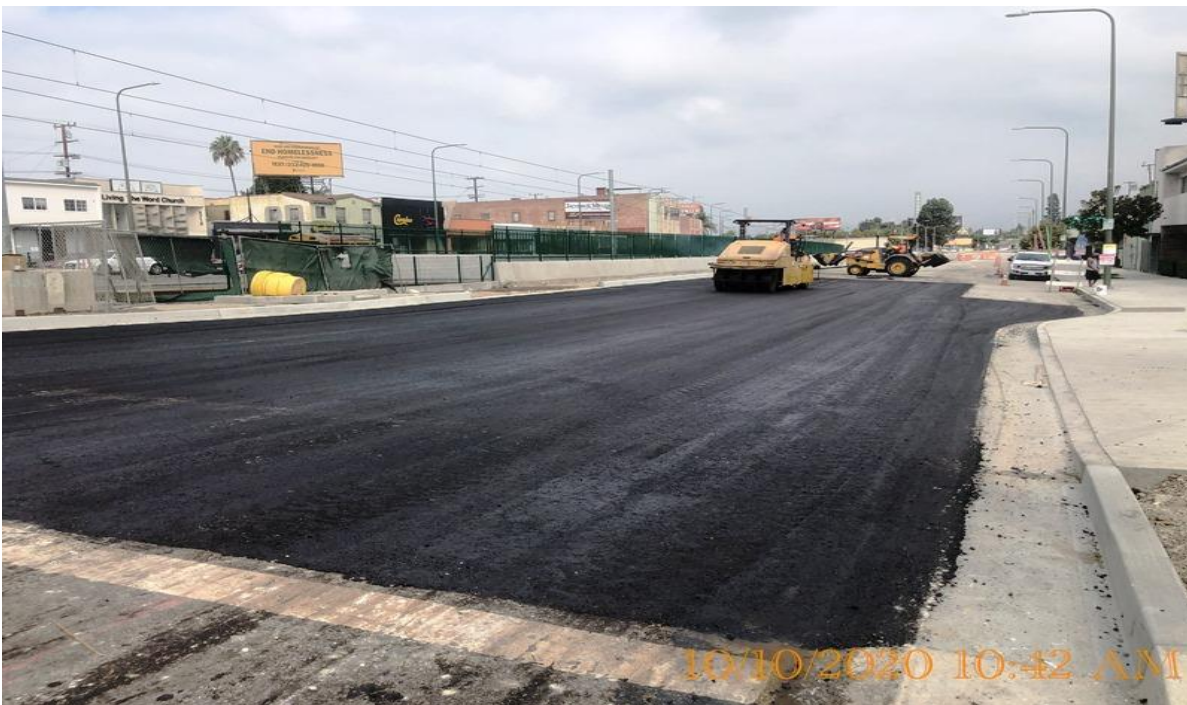
PARK MESA – Placed asphalt concrete and compacted the northbound lanes on Crenshaw Blvd from 48th St to 46th St.

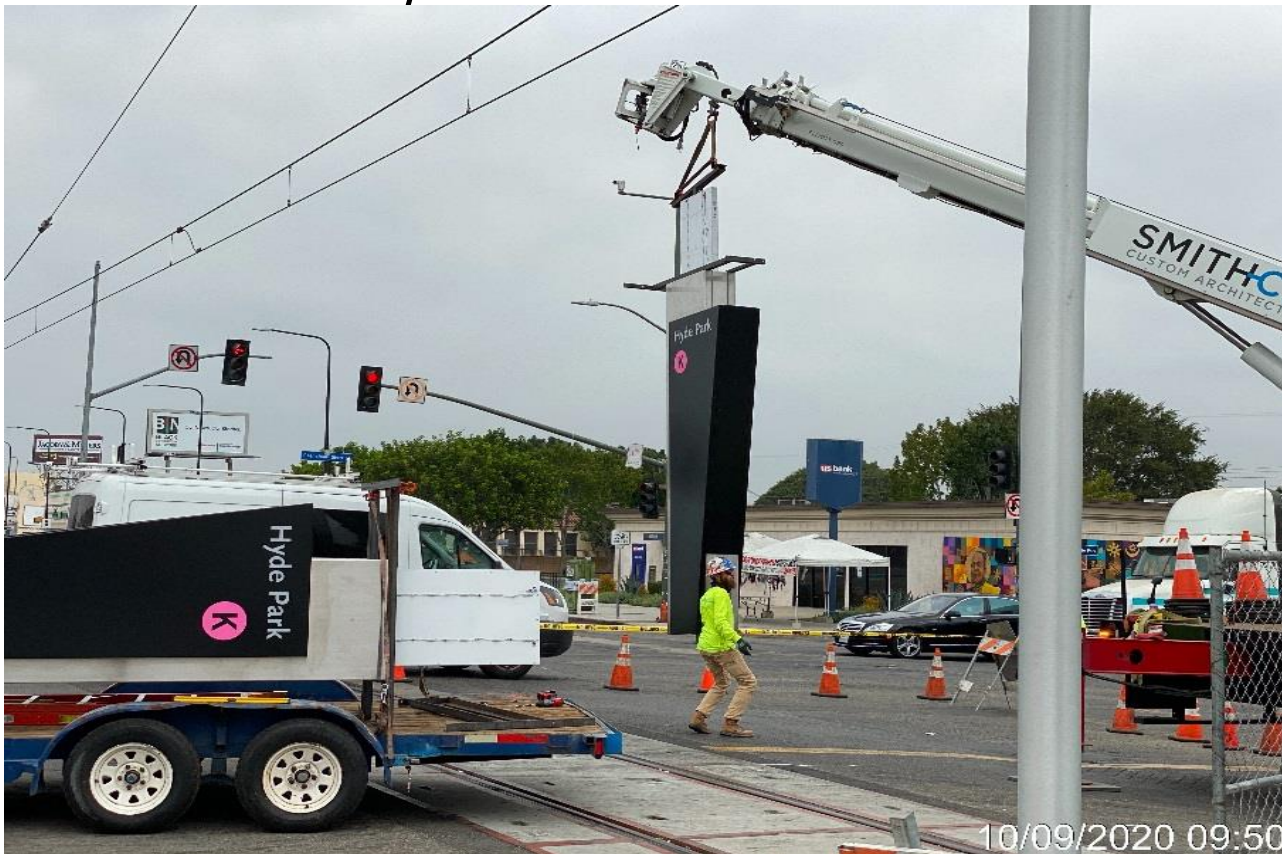
HYDE PARK STATION – Installing the North Grand Pylon sign near Slauson Ave.

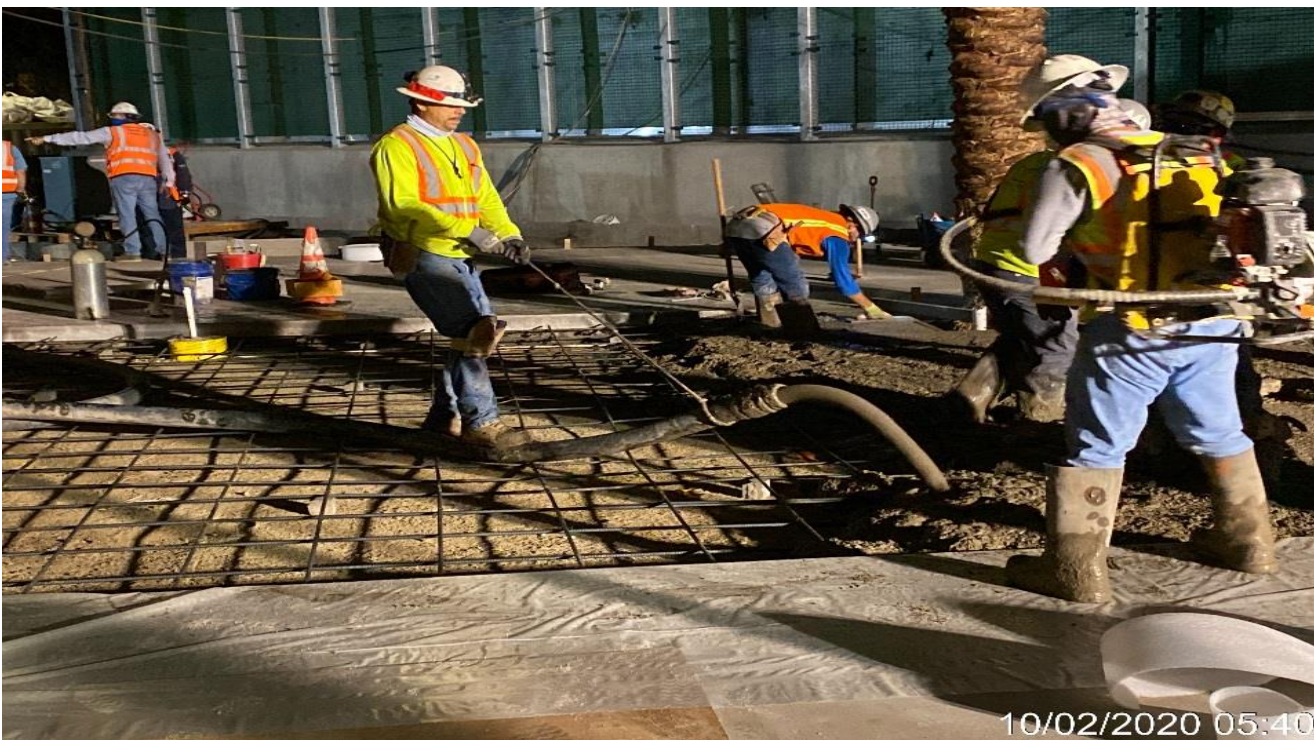
LEIMERT PARK STATION SITE – Continue placing concrete for the architectural topping slab throughout the plaza level.

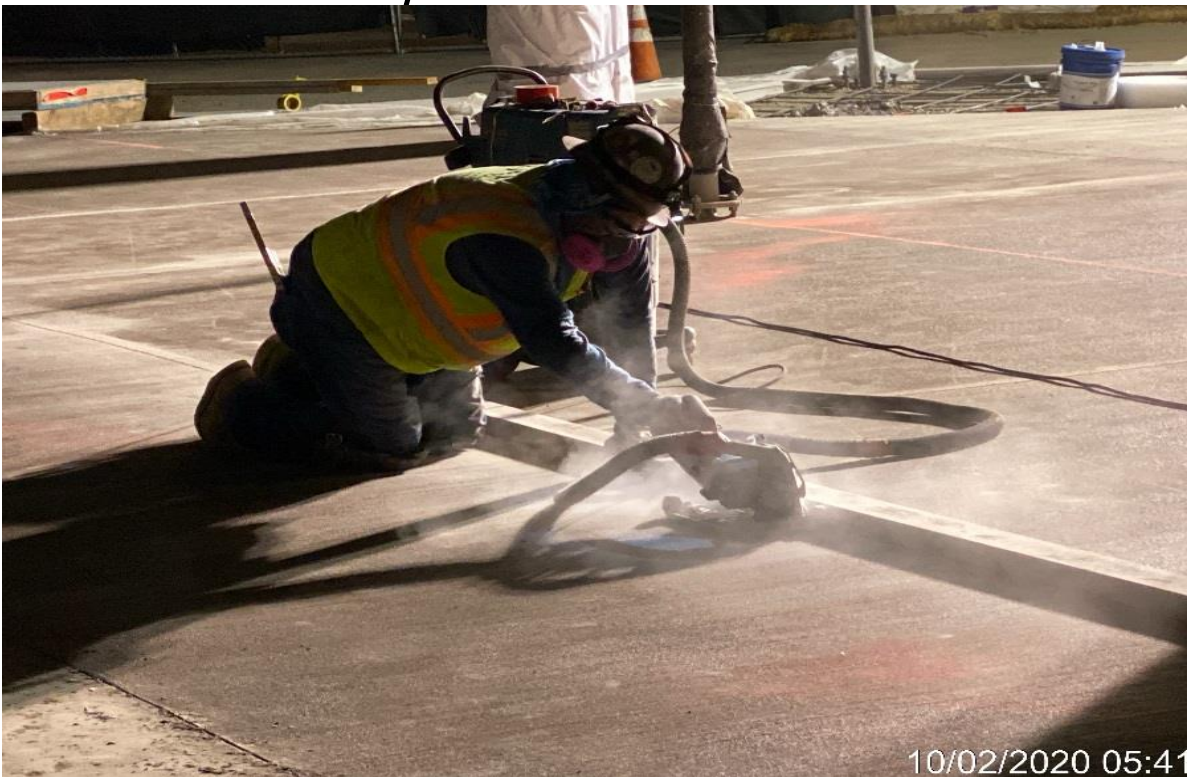
LEIMERT PARK STATION – Continue saw cutting control joints for the architectural topping slab throughout the plaza level.

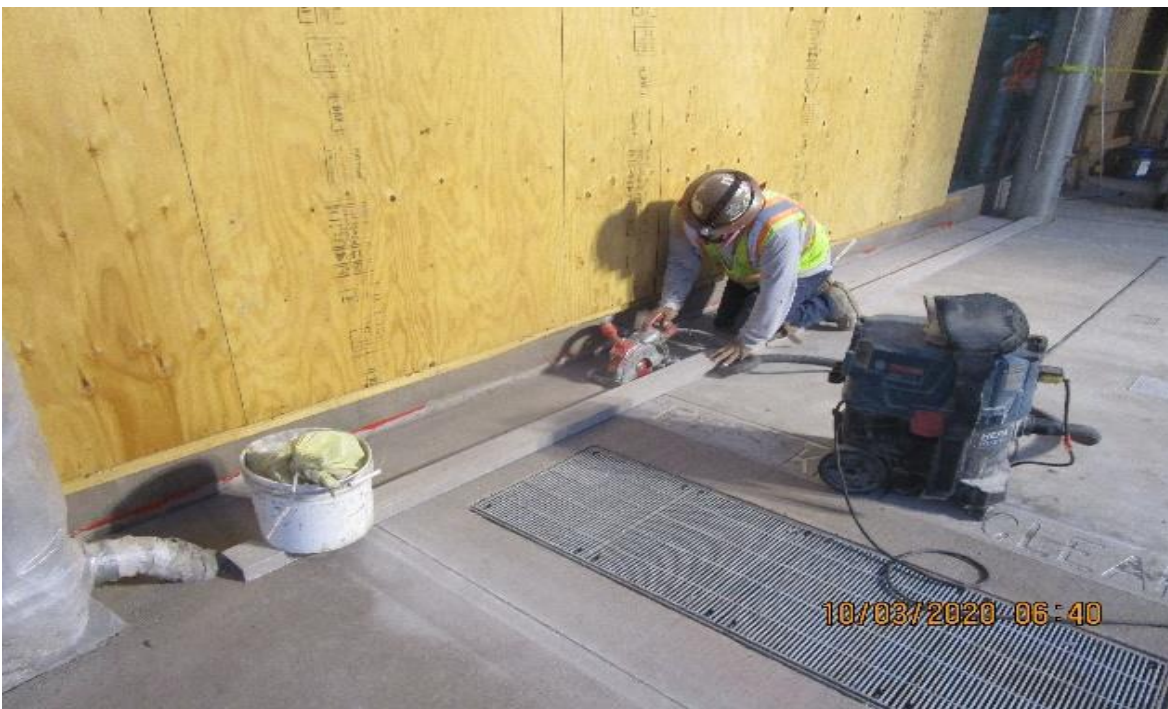
LEIMERT PARK STATION – Continue saw cutting control joints for the architectural topping slab throughout the plaza level.

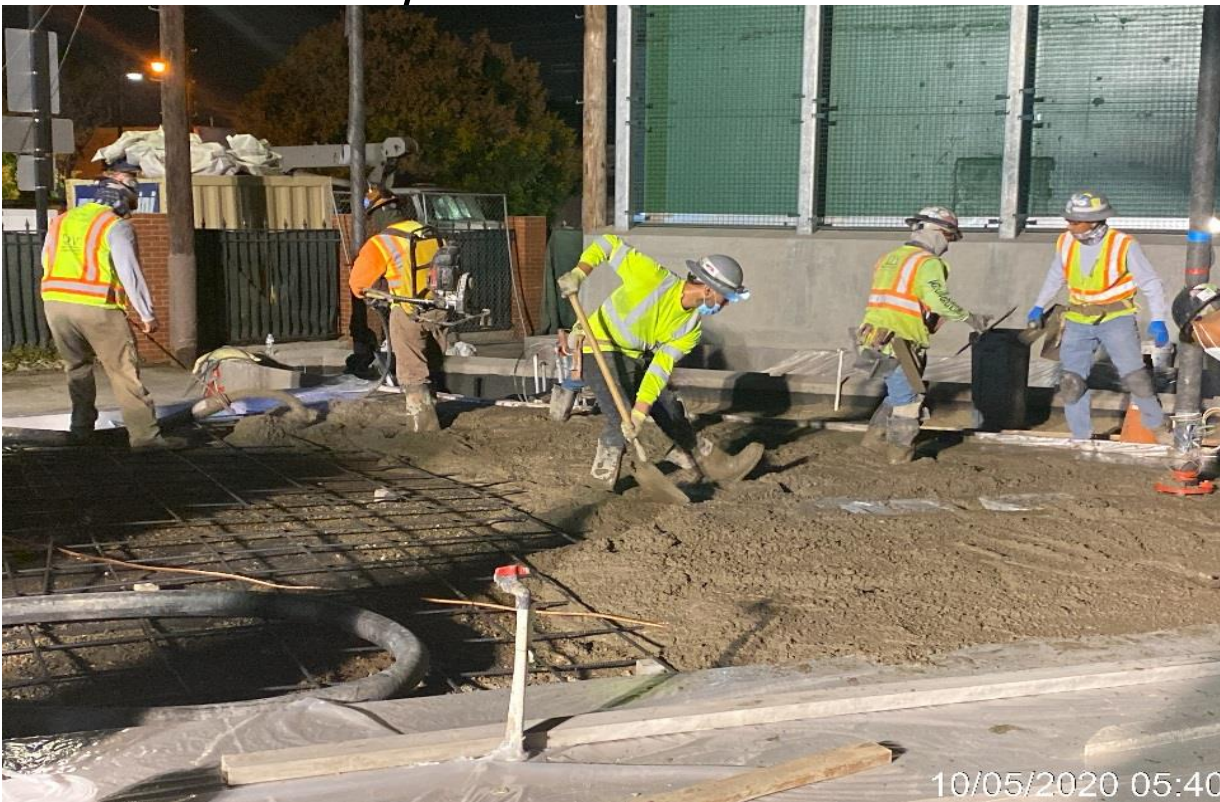
LEIMERT PARK STATION – Continue placing concrete for the architectural topping slab throughout the plaza level.

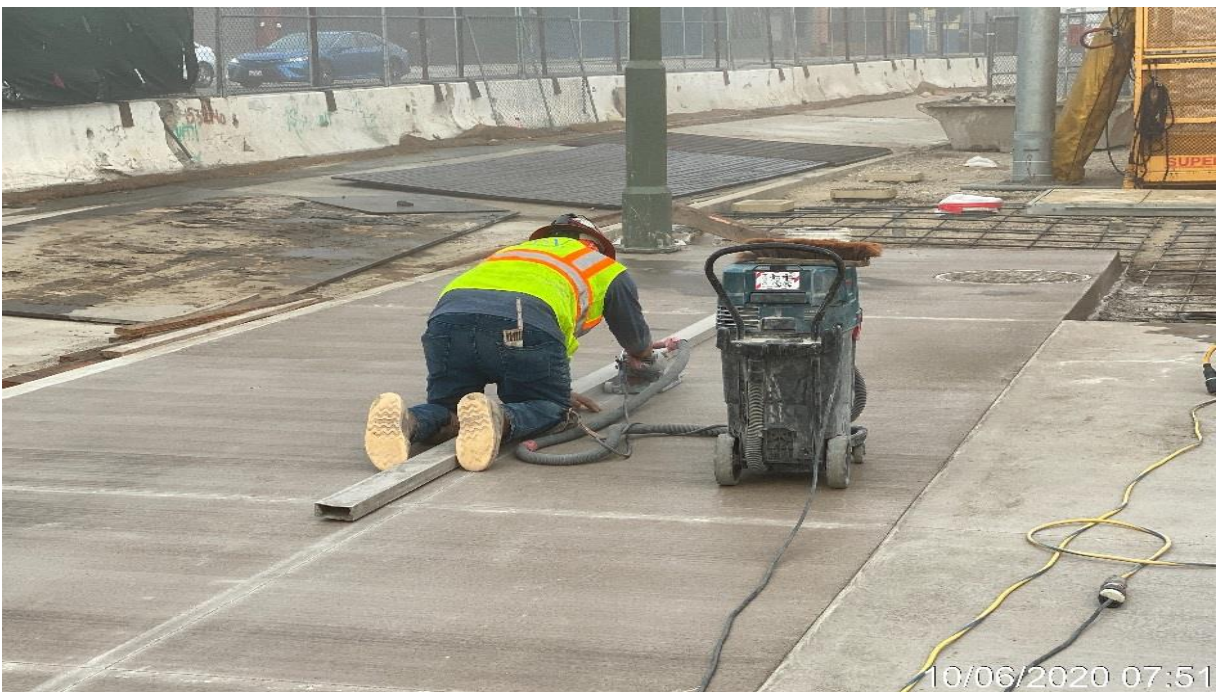
LEIMERT PARK STATION – Continue saw cutting control joints for the architectural topping slab throughout the plaza level.

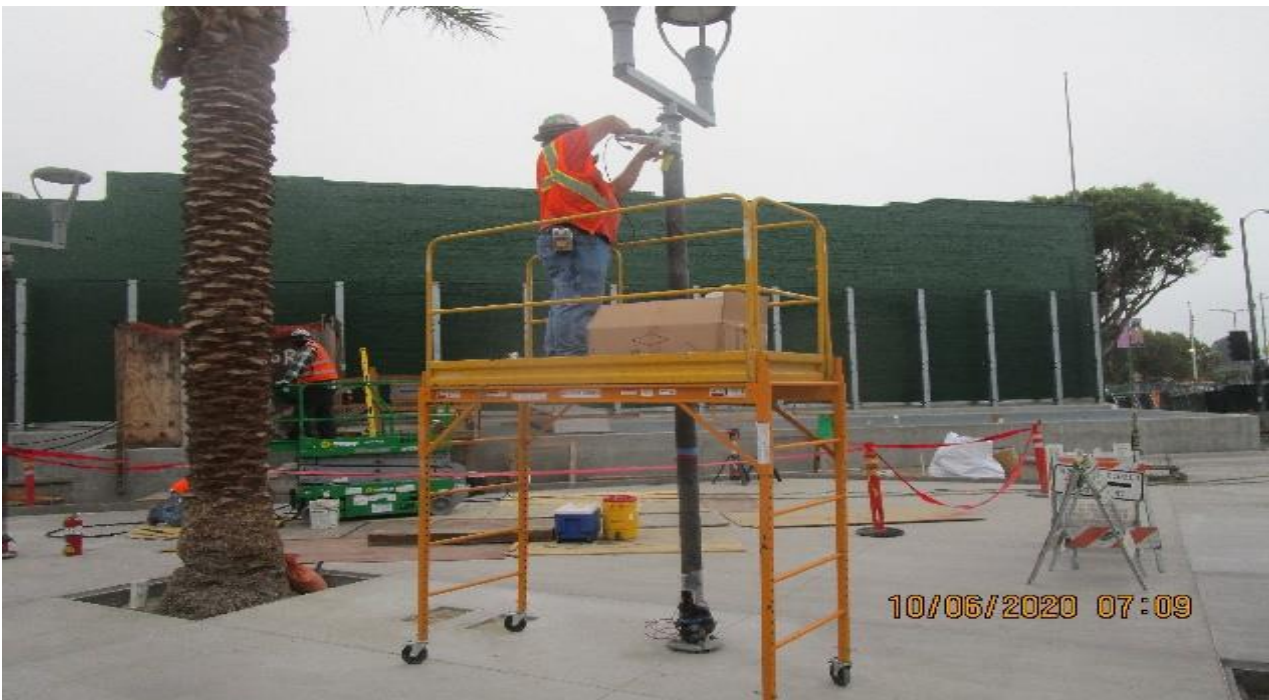
LEIMERT PARK STATION – Installing bracket supports for CCTV installation on the pedestrian light poles at the plaza.

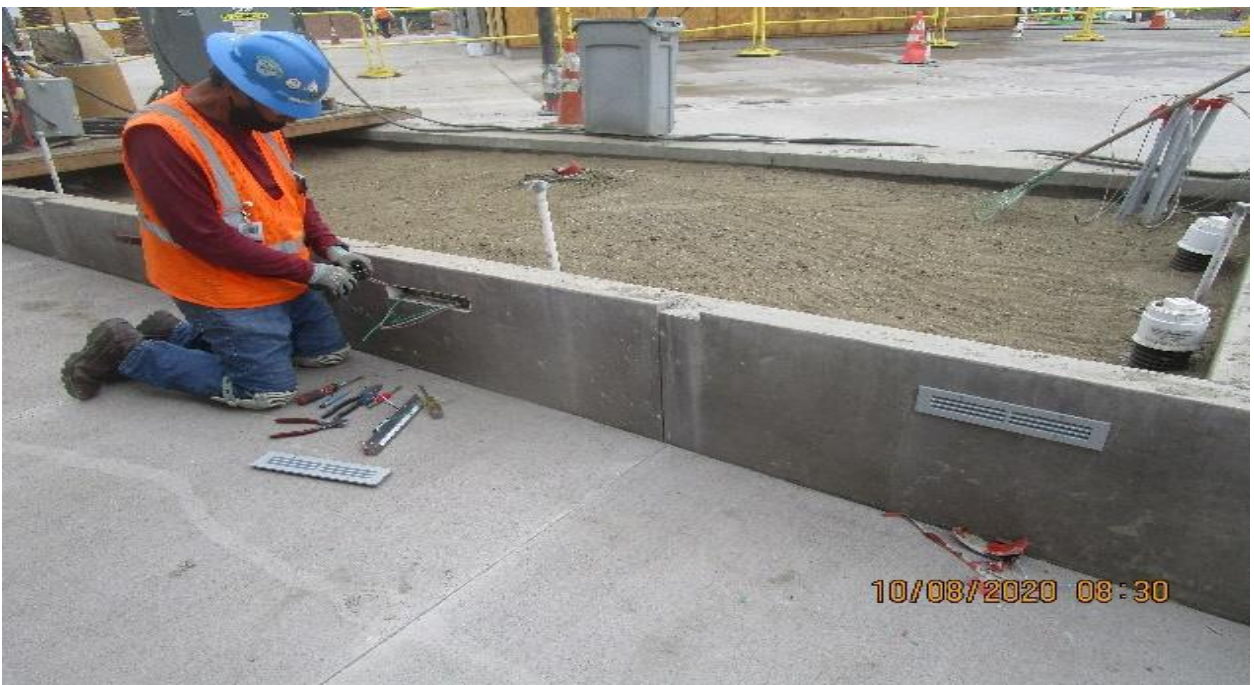
LEIMERT PARK STATION – Installing recessed LED lighting to the entry northern stairs at the plaza.

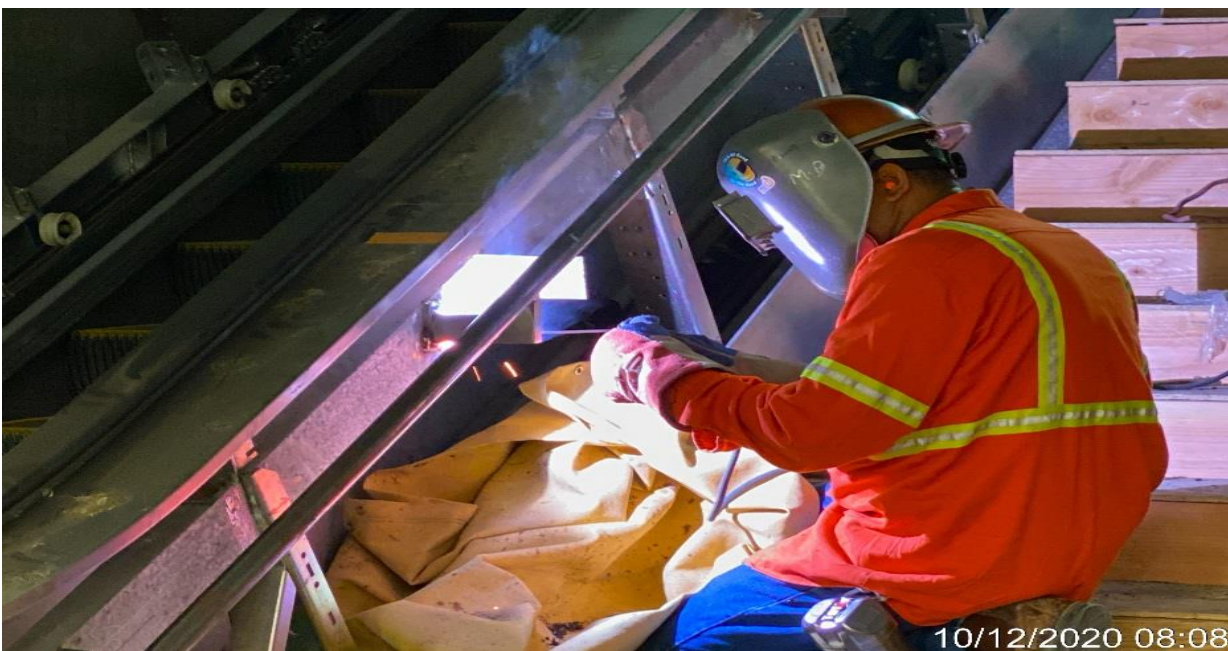
LEIMERT PARK STATION – Continue installing brackets for handrails at Staircase #2 from intermediate landing to platform level.
