CRENSHAW/LAX PHOTOGRAPHIC UPDATE

October 30, 2020

Crenshaw/LAX Transit Project

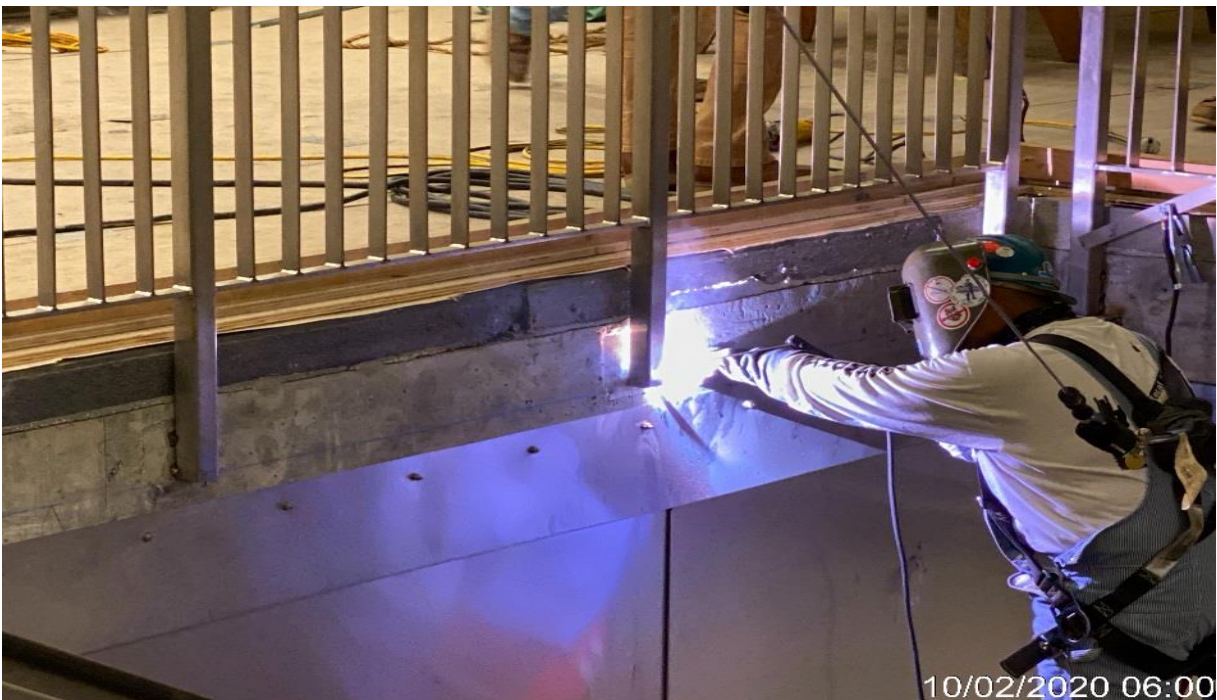
LEIMERT PARK STATION – Continue welding guardrails around the opening entrance of Staircase #4 and Escalator #6 at the concourse.

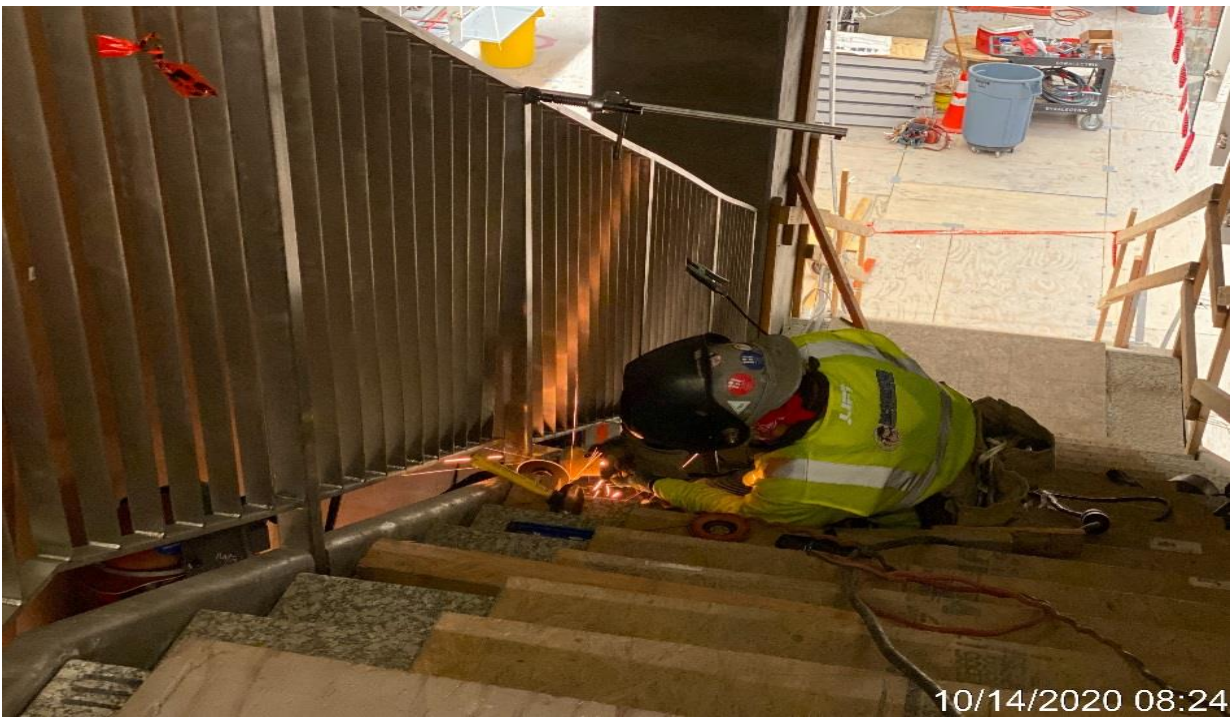
LEIMERT PARK STATION – Continue welding guardrails for Staircases 3&4 from concourse to platform level.

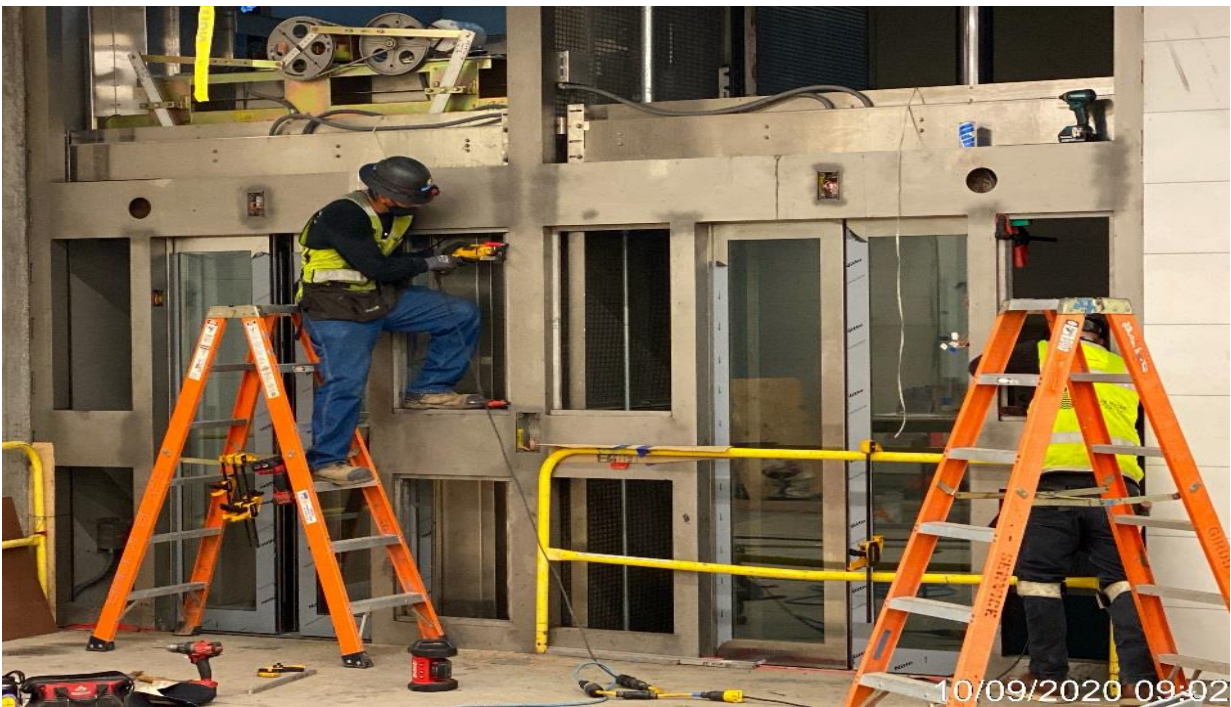
LEIMERT PARK STATION – Installing glass tracks for all 4 Elevators at the concourse level.

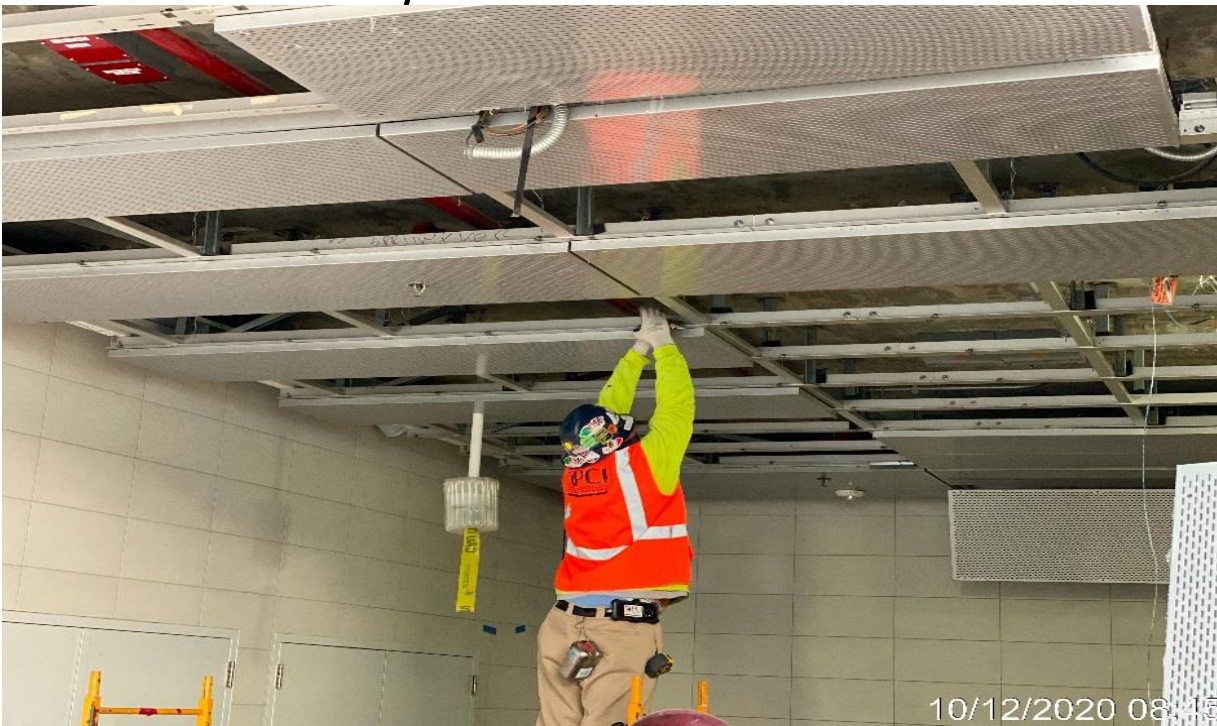
LEIMERT PARK STATION – Resume ceiling panel installation throughout the Free & Paid Area of the concourse level.

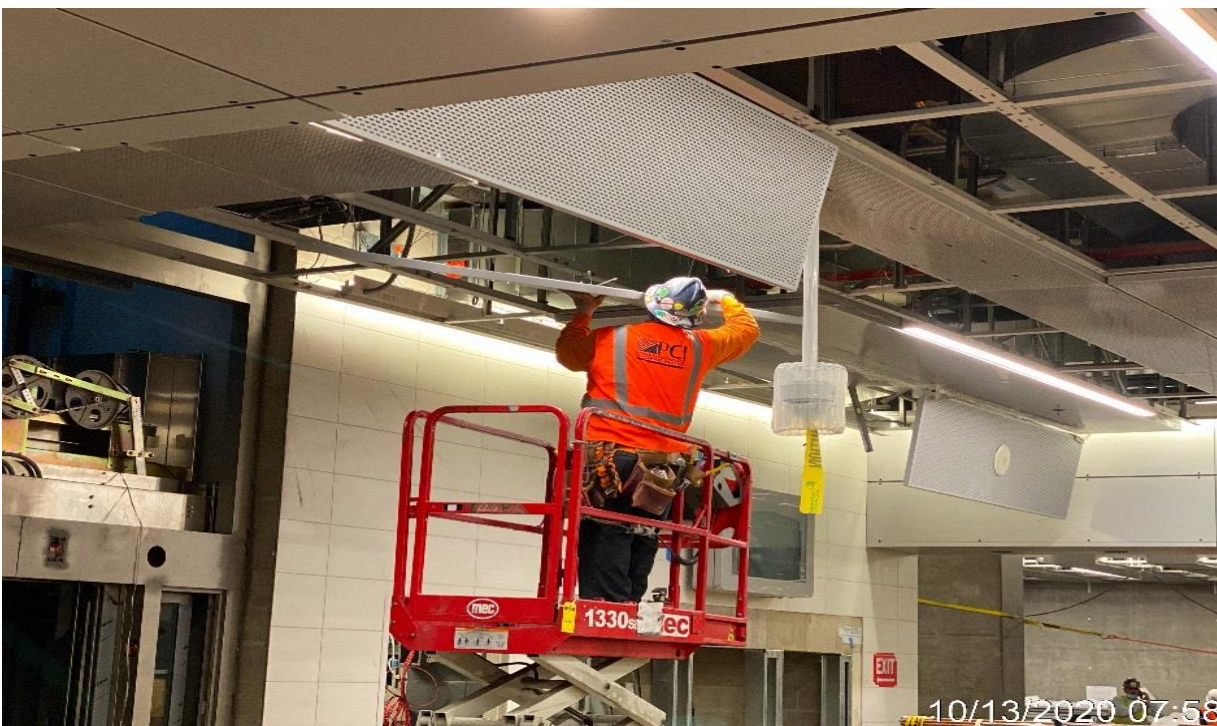
LEIMERT PARK STATION – Continue ceiling panel installation throughout the Free & Paid Area of the concourse level.

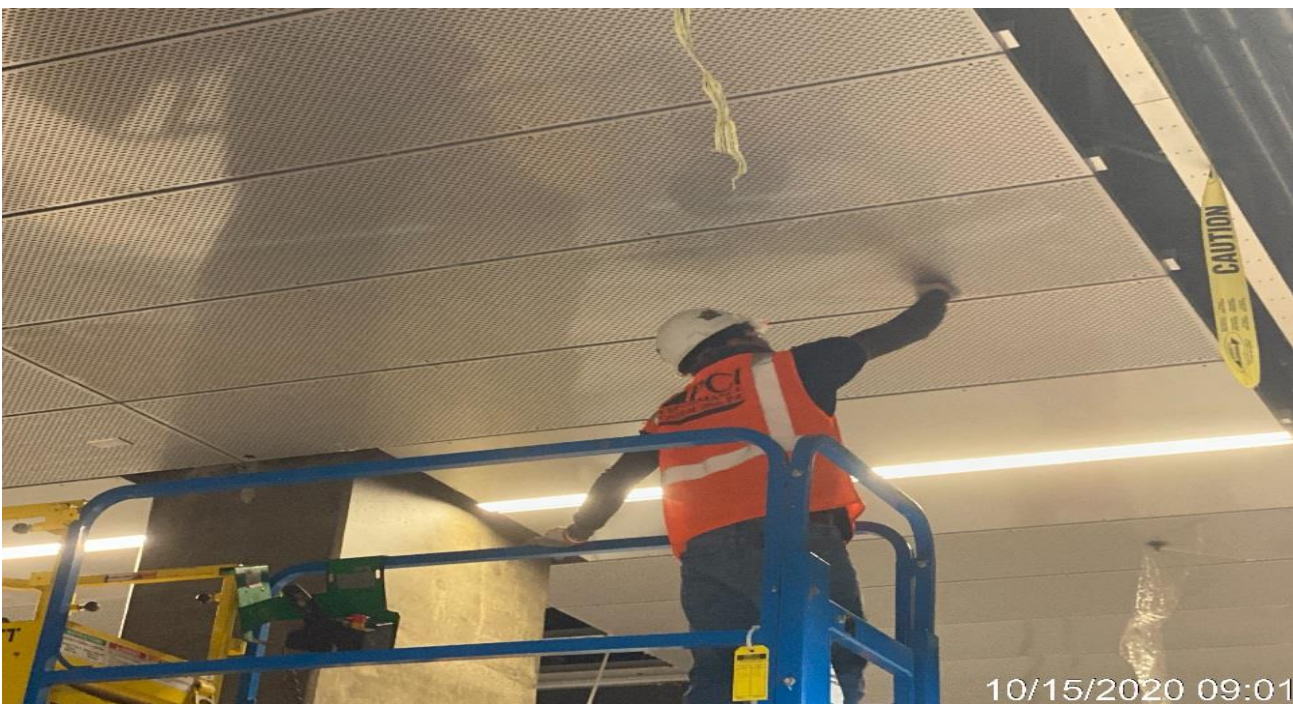
LEIMERT PARK STATION – Continue ceiling panel installation throughout the Free & Paid Area of the concourse level.

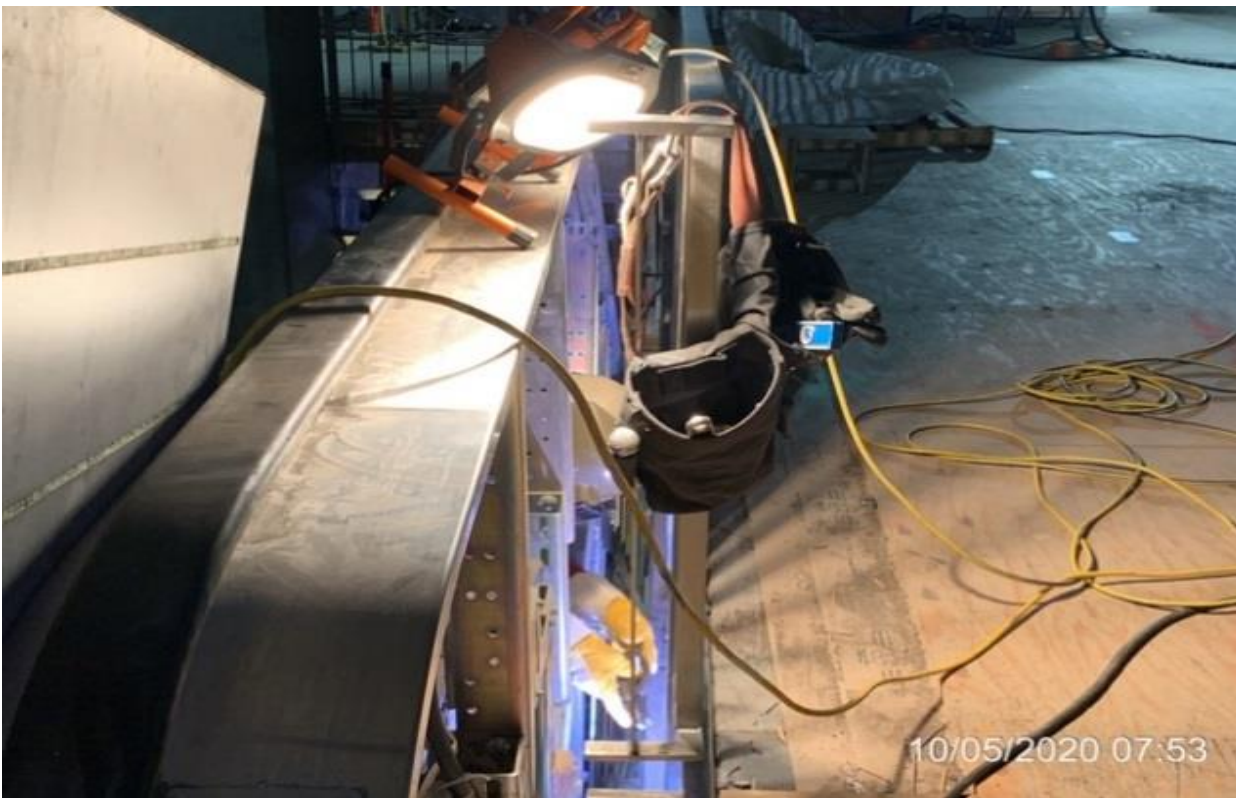
MLK STATION – McMahon cosmetic welding and grinding at stair #3.

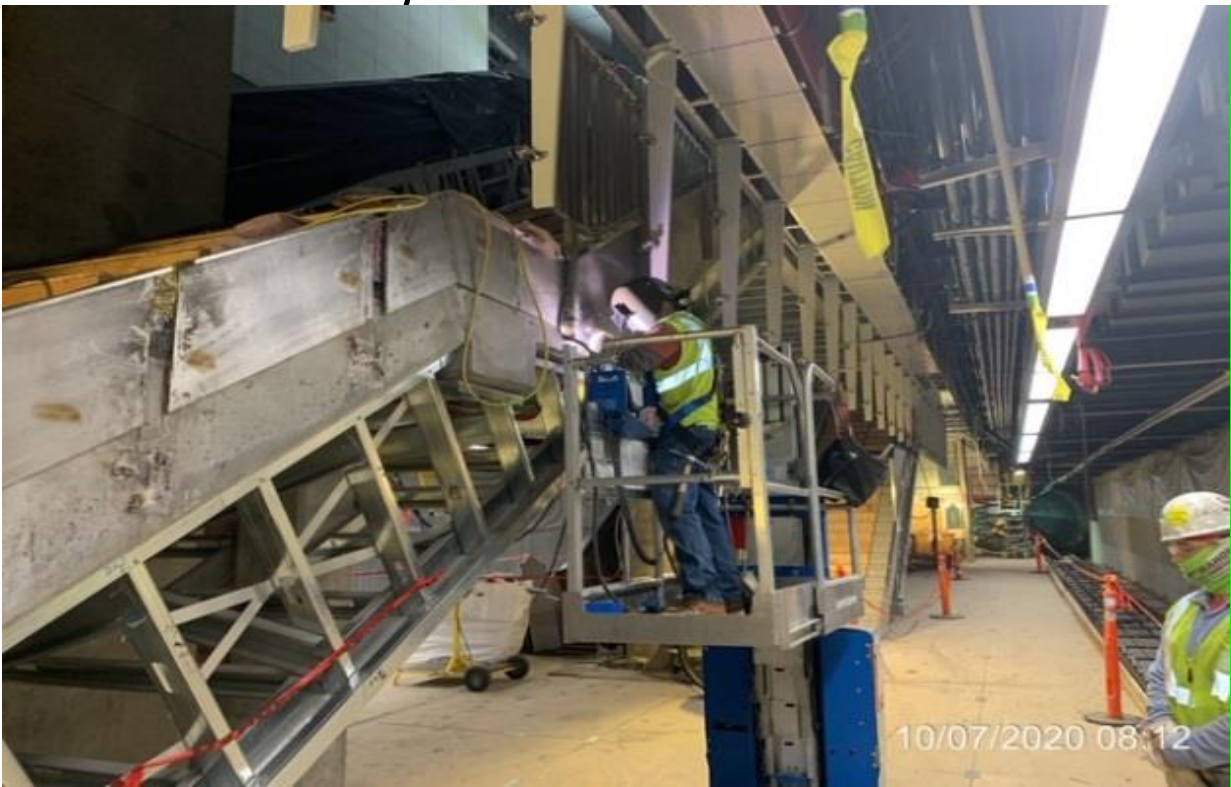
MLK STATION – McMahon cosmetic welding and grinding escalator #2.

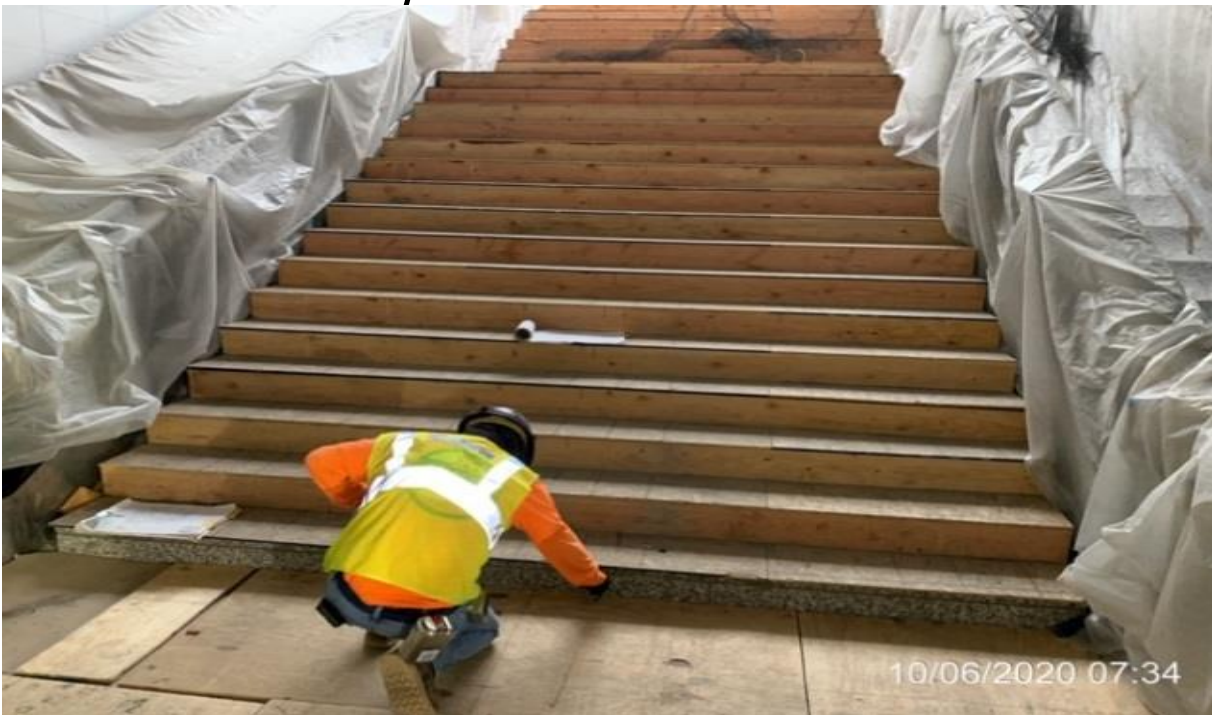
MLK STATION – Laying out for the center handrail of Staircase 1 from plaza to concourse level.

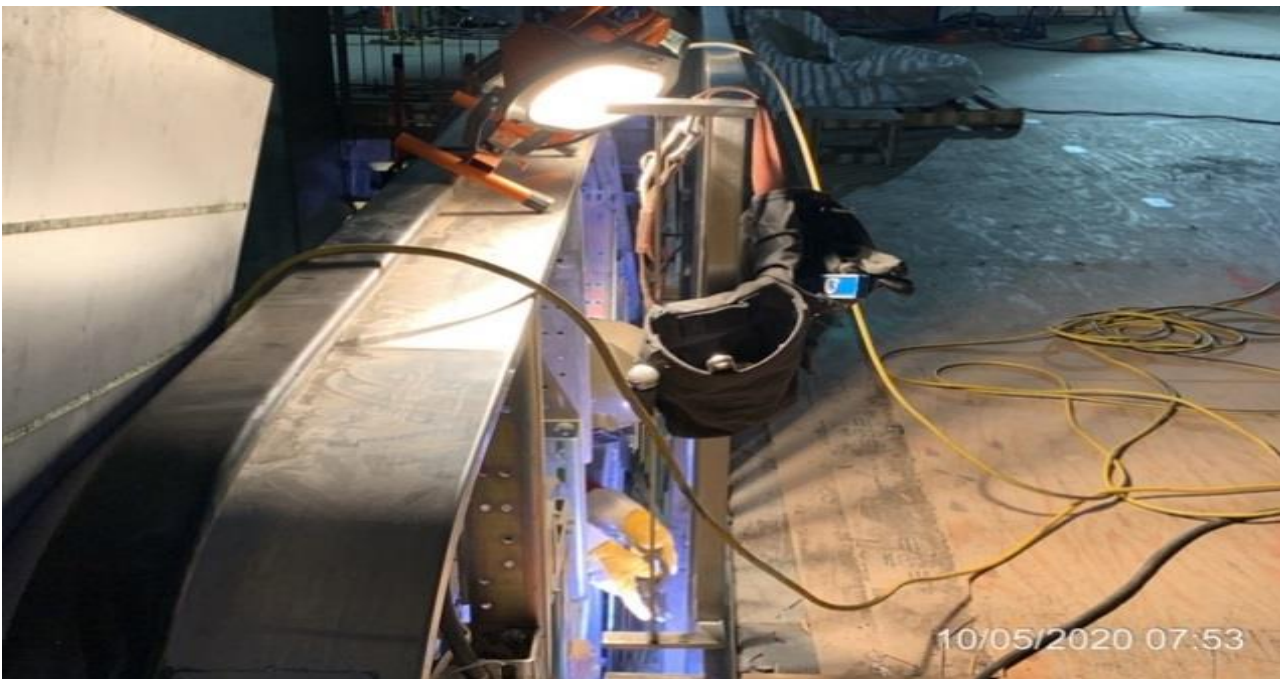
MLK STATION – Continue welding and finalizing guardrail finishes for Staircase #3 from concourse to platform level.

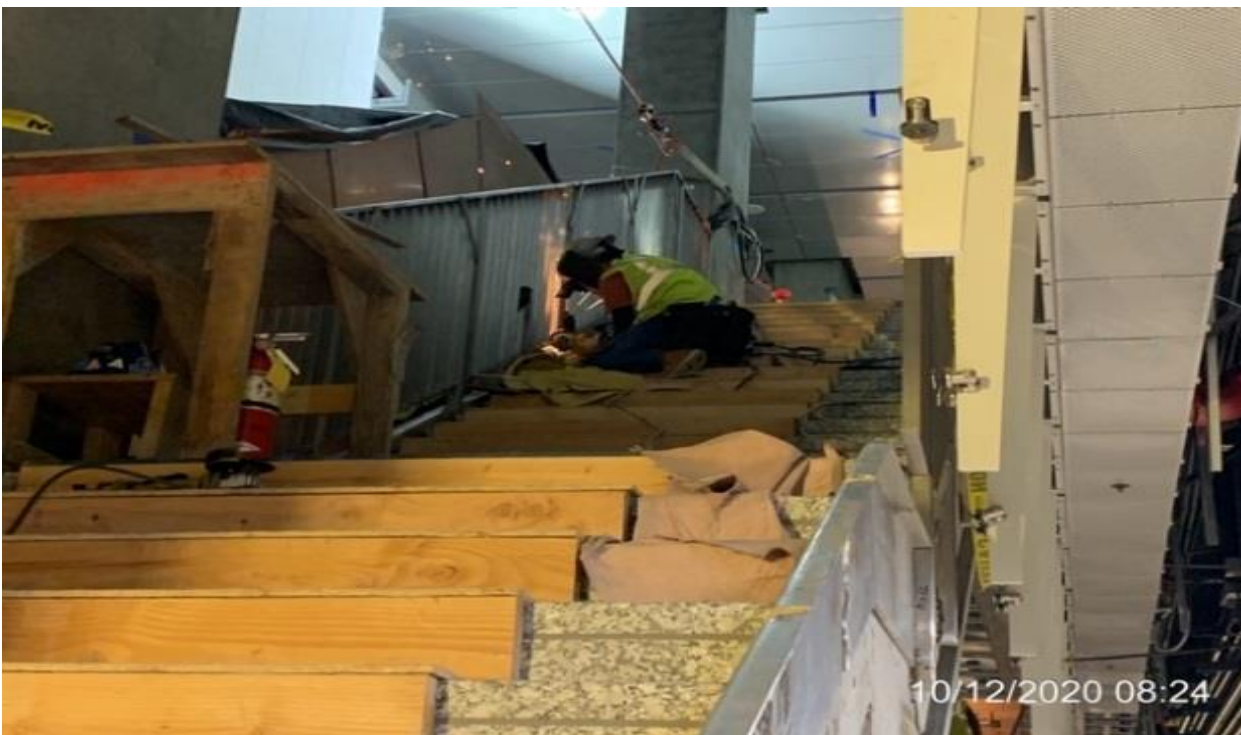
MLK STATION – Continue welding and installing guardrails to Staircase #2 from concourse to platform level.

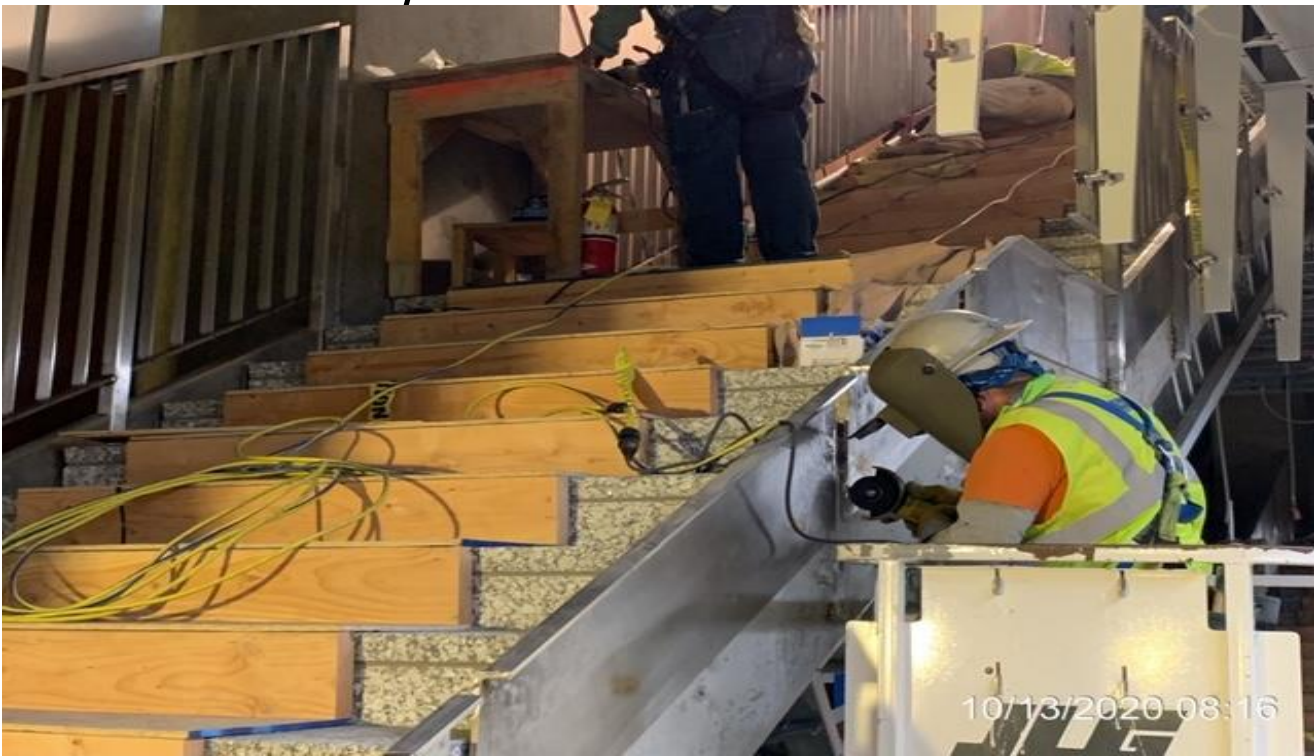
MLK STATION – Continue welding and installing guardrails to Staircase #2 from concourse to platform level.

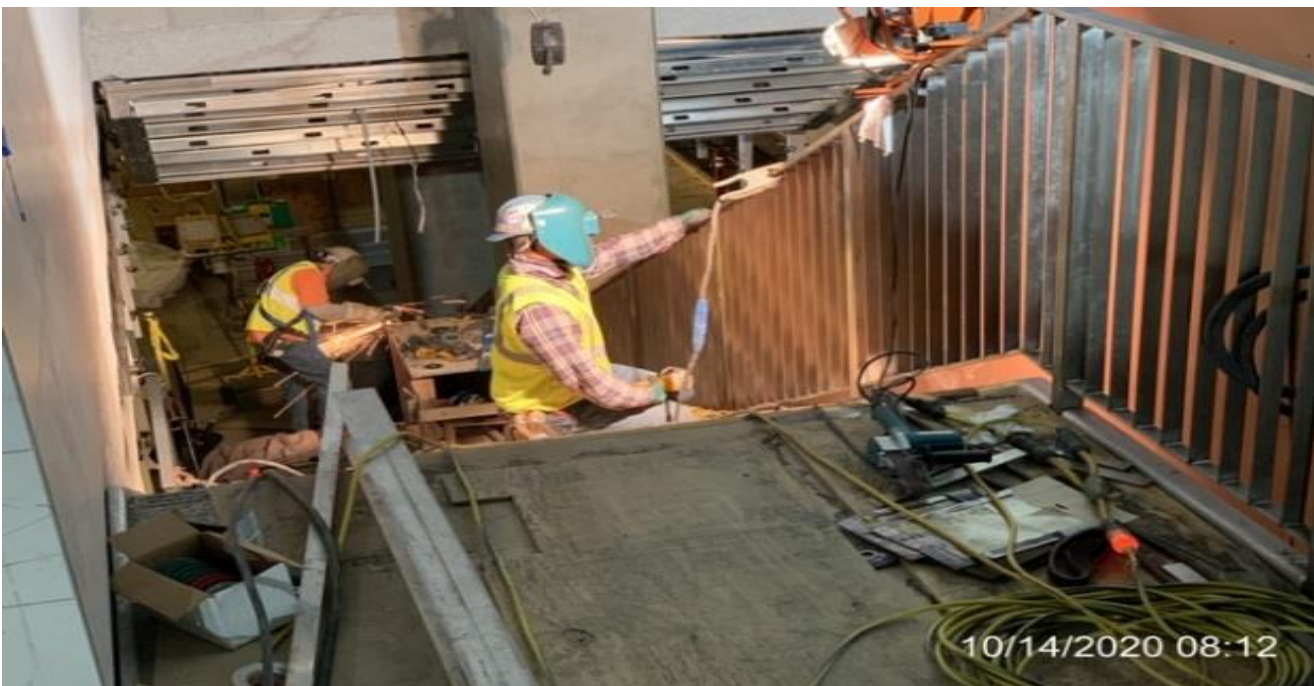
MLK STATION – Continue welding and installing guardrails to Staircase #2 from concourse to platform level.

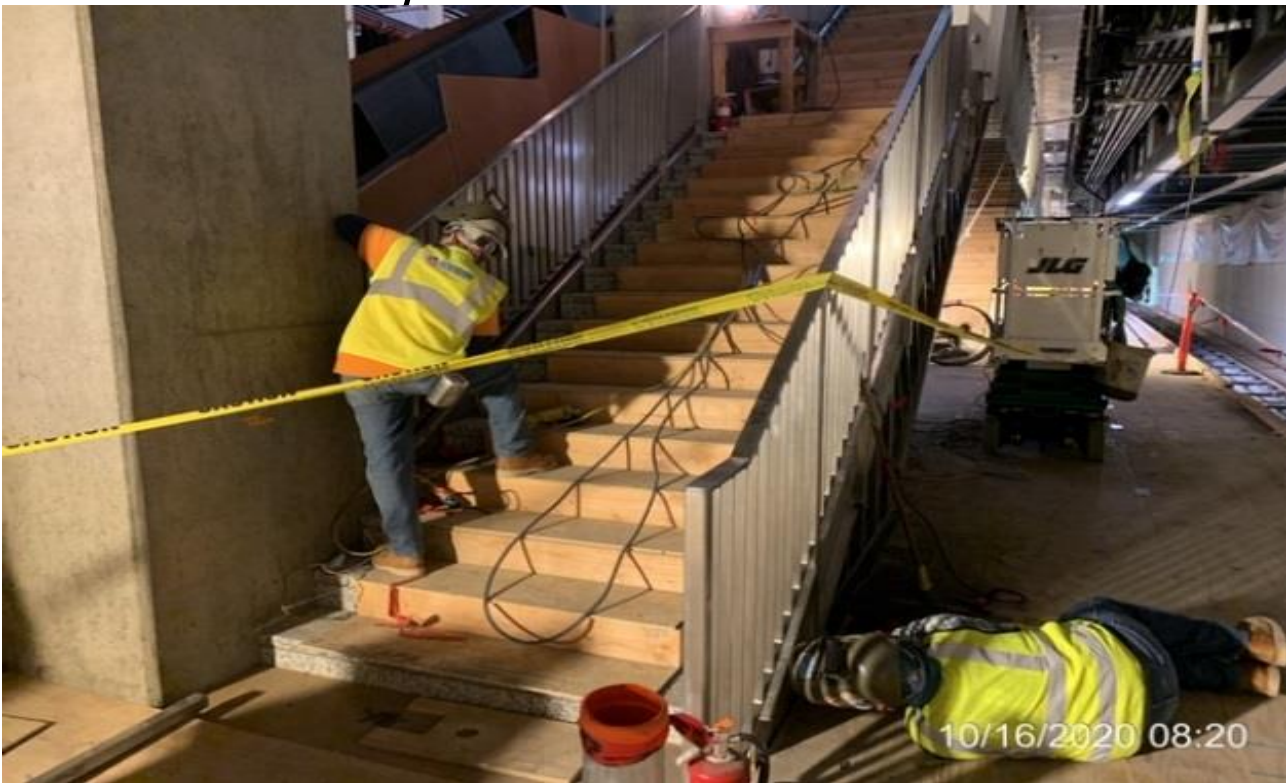
MLK STATION – Continue welding and installing guardrails to Staircase #2 from concourse to platform level.

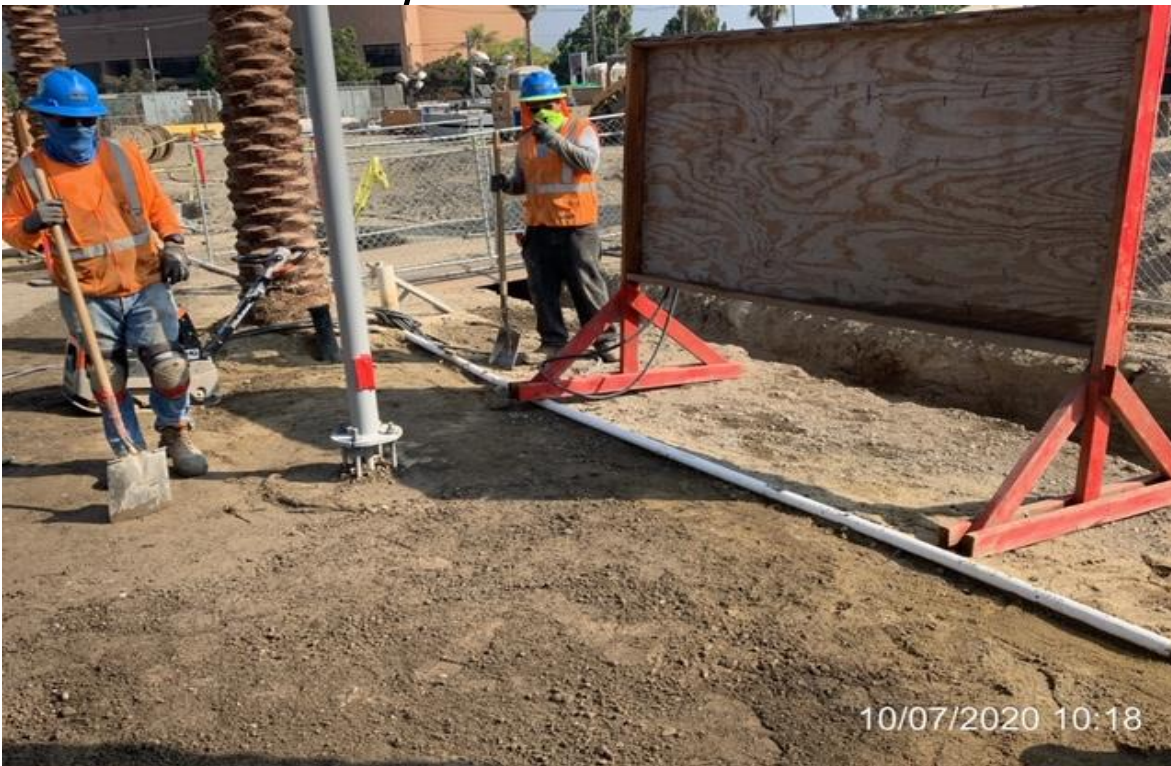
EXPO STATION– WSCC grading and compacting south end.

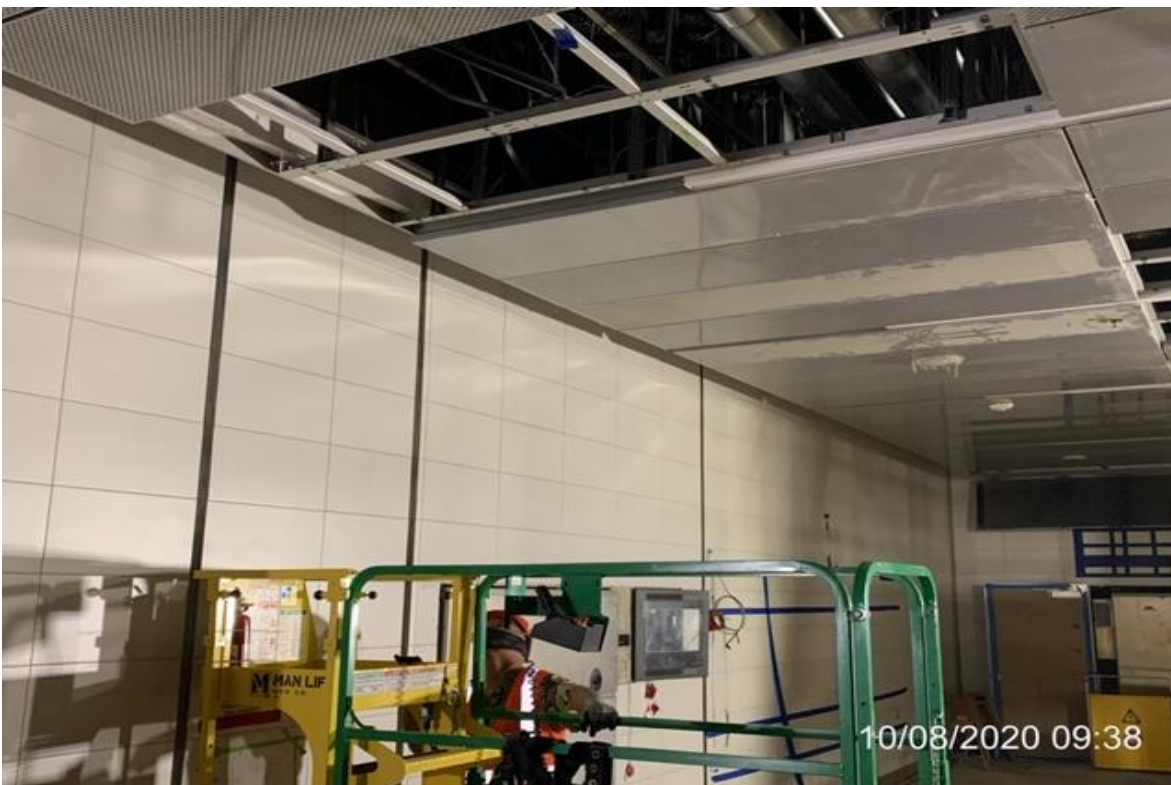
EXPO STATION – WSCC ironworkers installing ambient noise sensors.

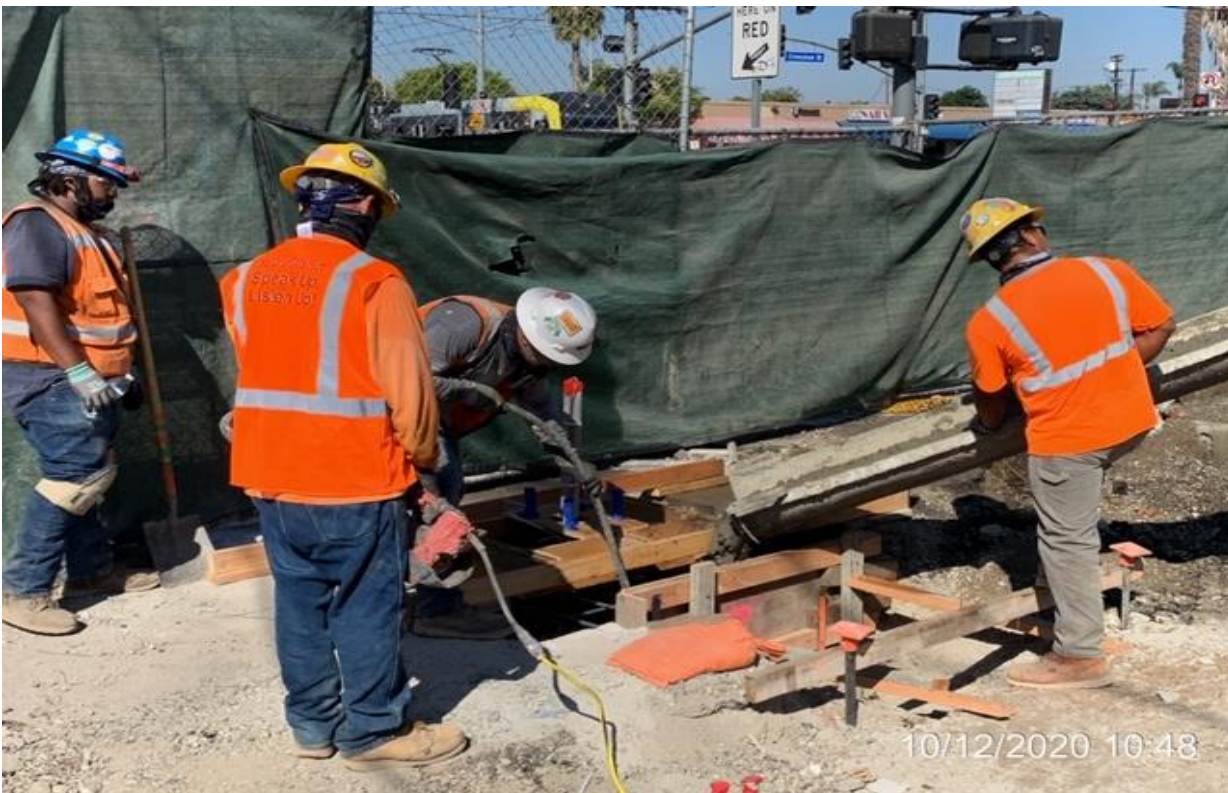
EXPO STATION – WSCC crew placing concrete footing for grand pylon signage

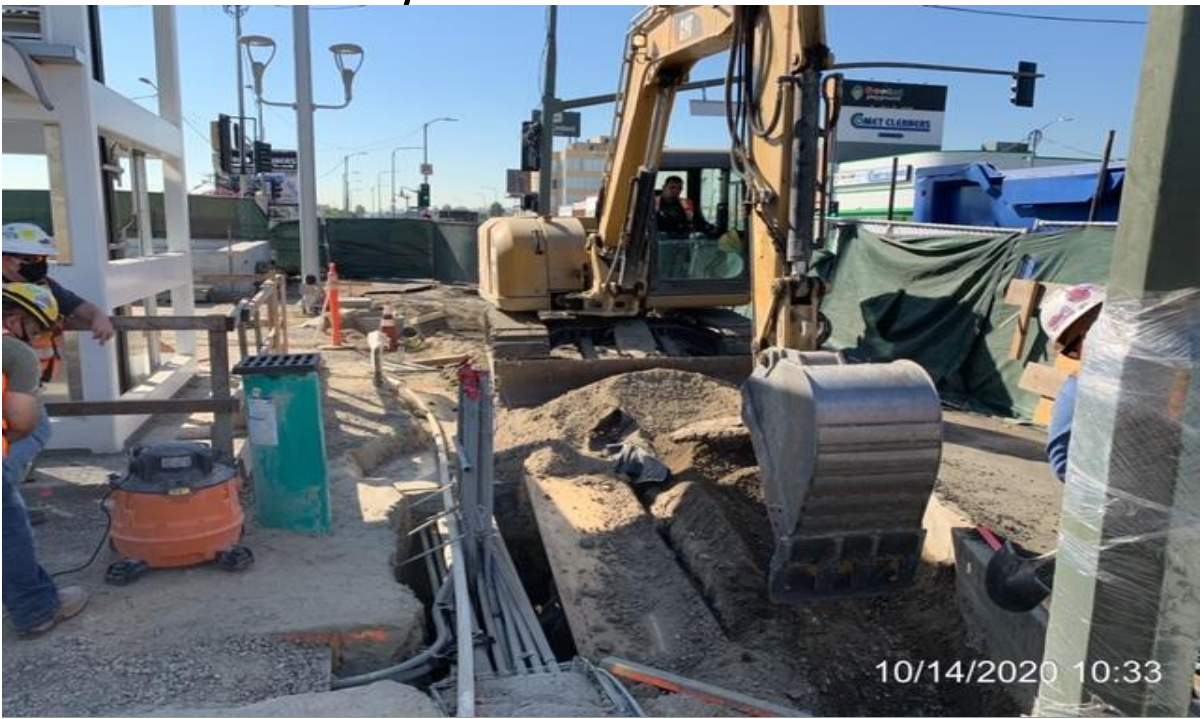
EXPO STATION– WSCC crew trenching for bollards on west side of station.

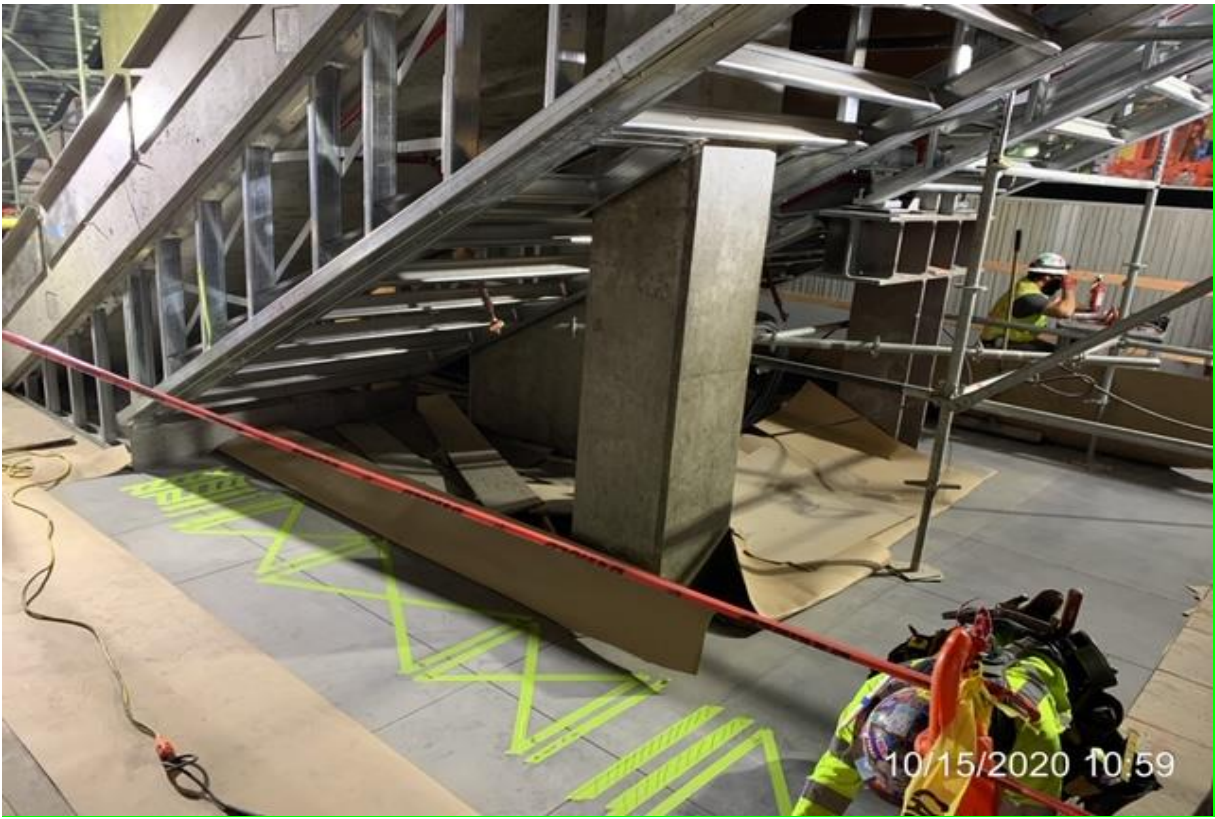
EXPO STATION– WSCC carpenter scanning platform slab for safety barrier install.

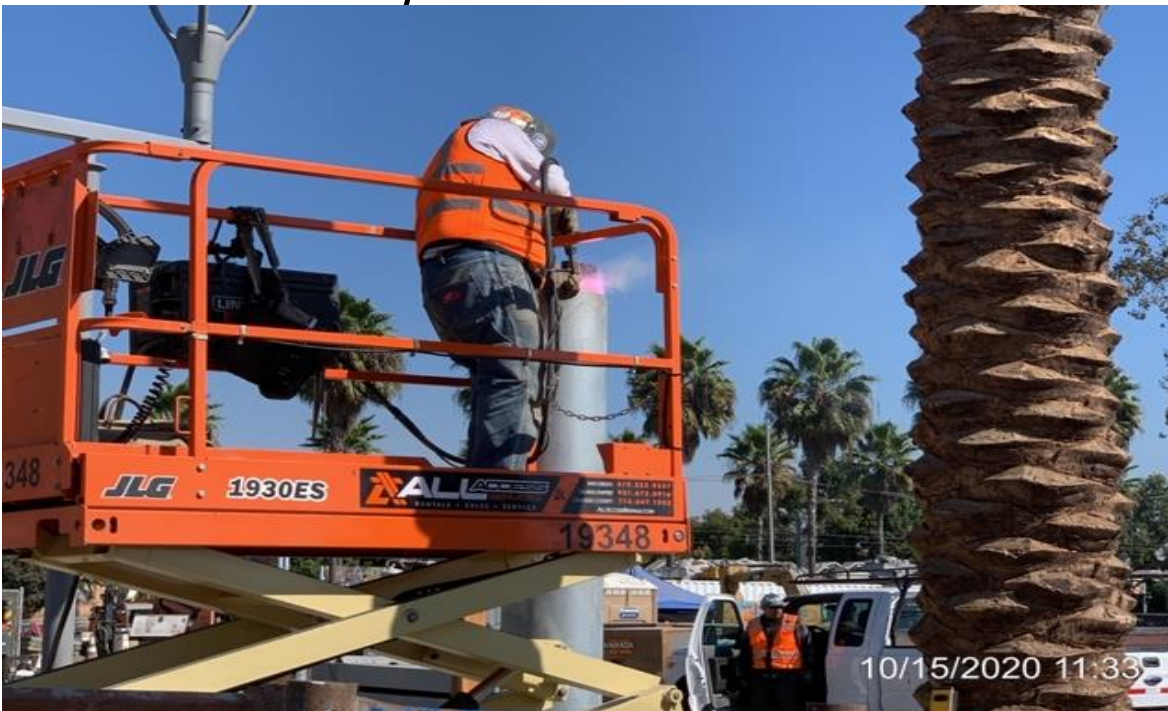
EXPO STATION – WSCC ironworkers welding pipe clamps at top of vent stack.

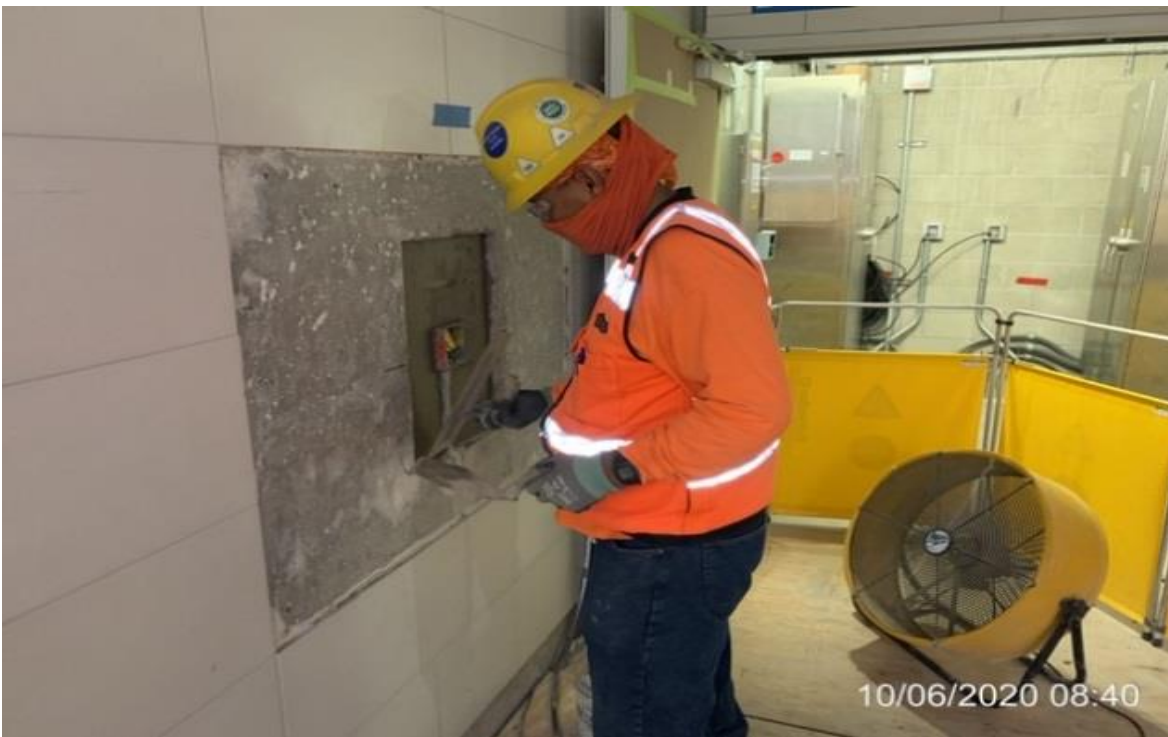
EXPO STATION SITE – WSCC finishers patching and prepping wall for E-tel mount installation.

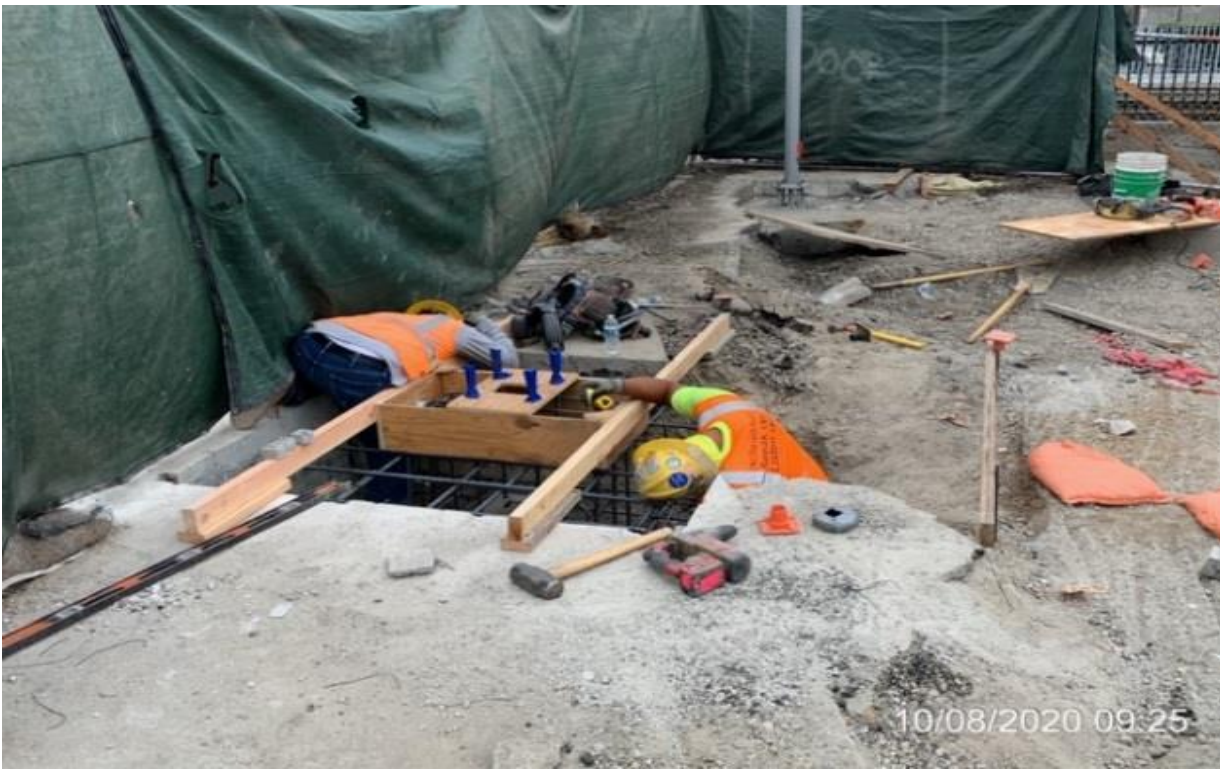
EXPO STATION – WSCC carpenters building formwork for grand pylon footing.

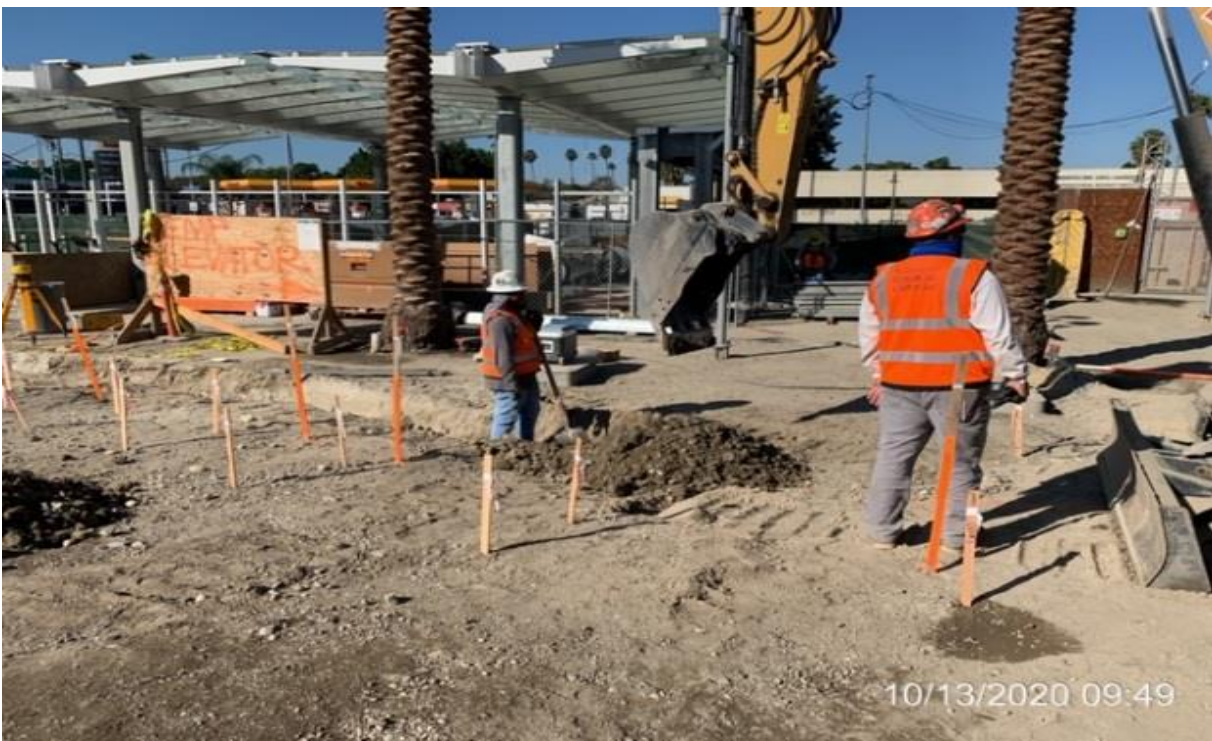
EXPO STATION – WSCC crew trenching for bollards on east side of station.

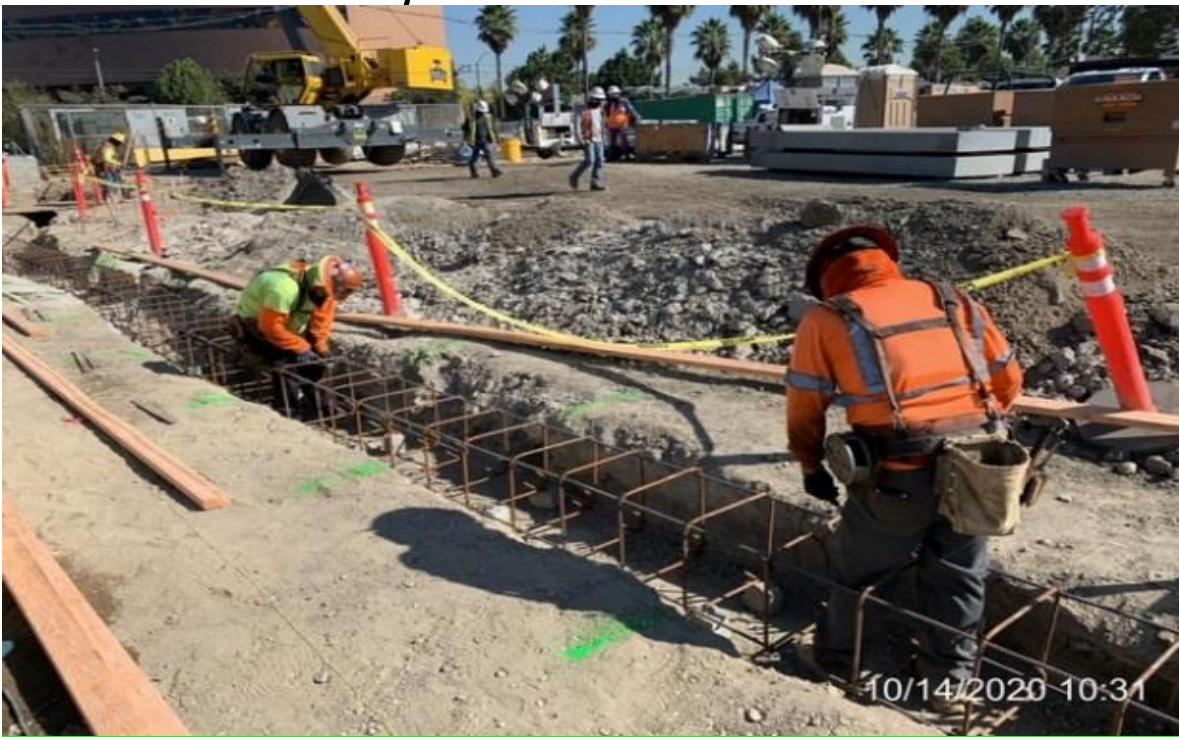
EXPO STATION – IRP installing rebar for bollard footing.

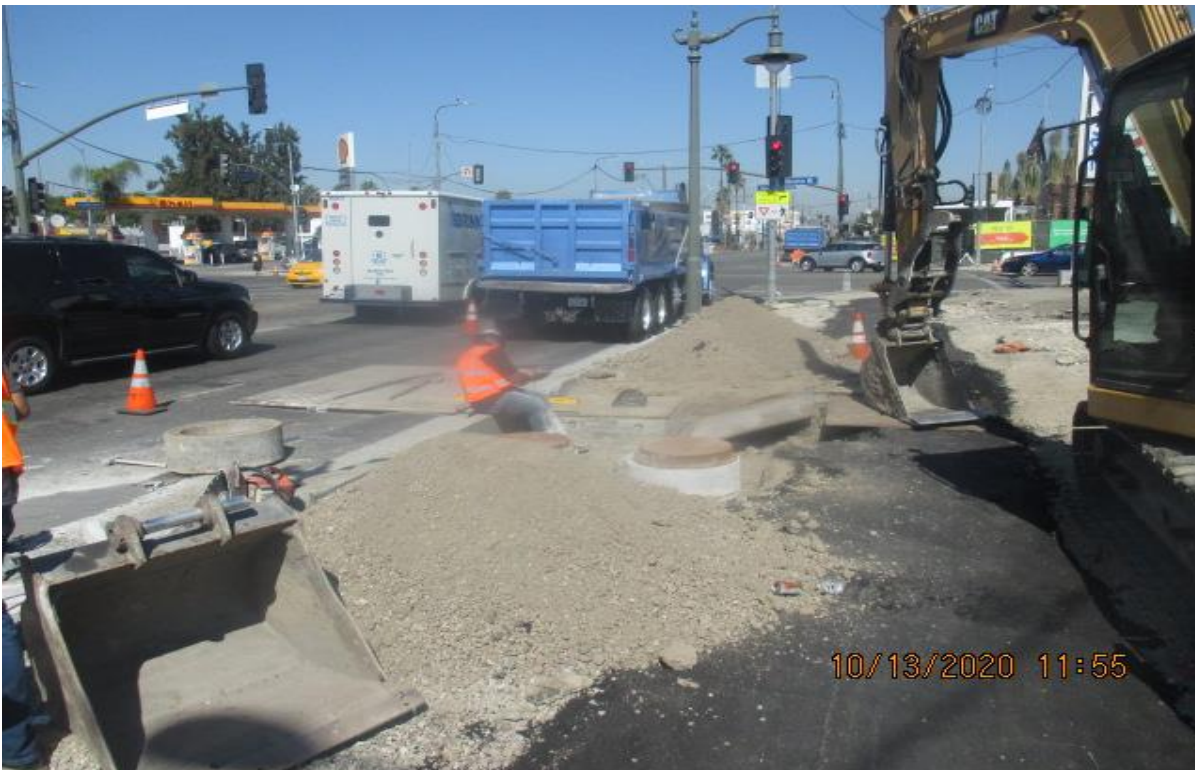
EXPO STATION – Setting final elevations for access covers along northbound Crenshaw Blvd south of Obama Blvd.
