CRENSHAW/LAX PHOTOGRAPHIC UPDATE

October 30, 2020

Crenshaw/LAX Transit Project

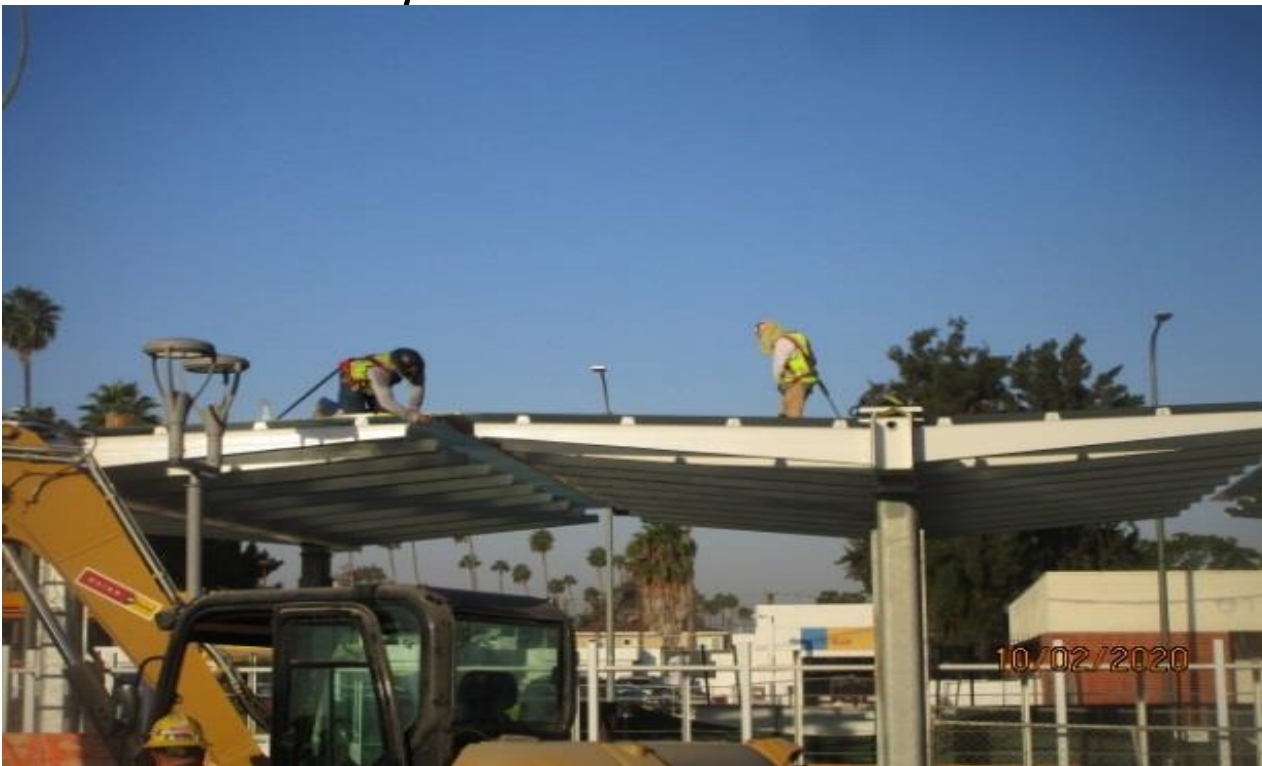
EXPO STATION – Caulking and sealing expansion joints for the glass roof of the main entrance canopy at the plaza level.

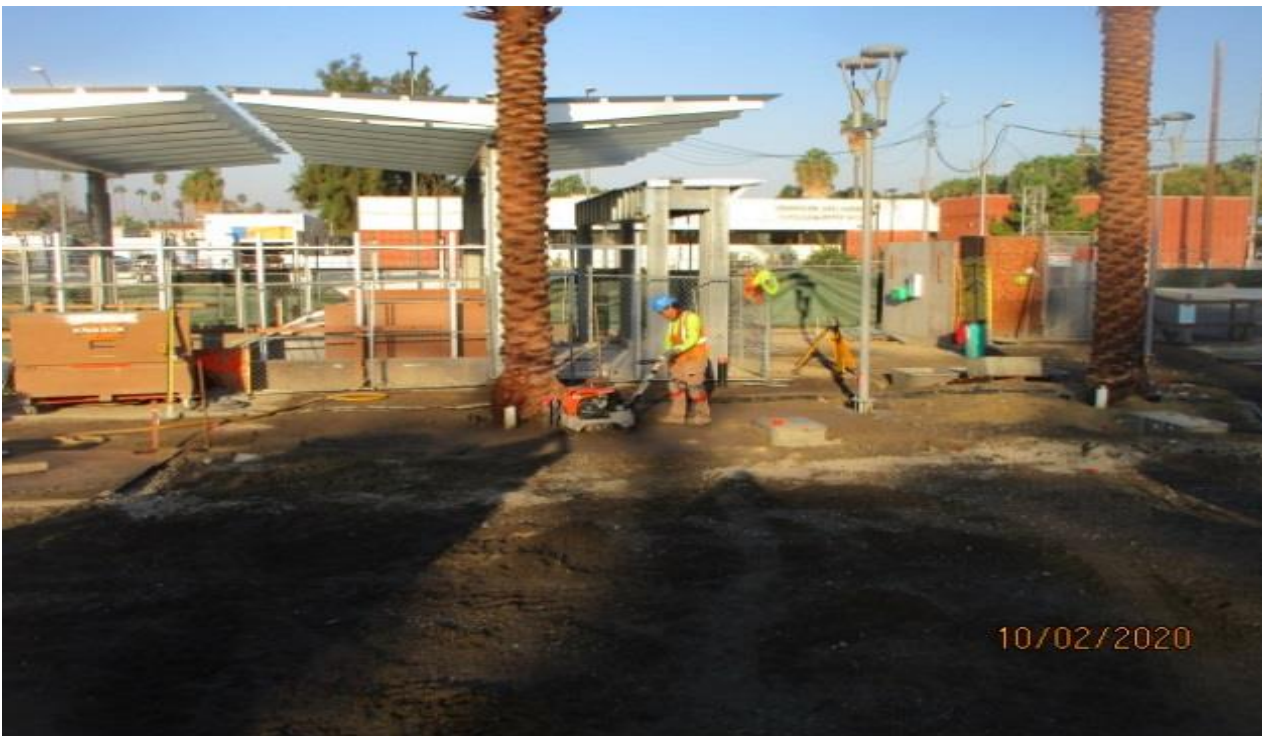
EXPO STATION SITE– Continue rough grading/compacting throughout the plaza.

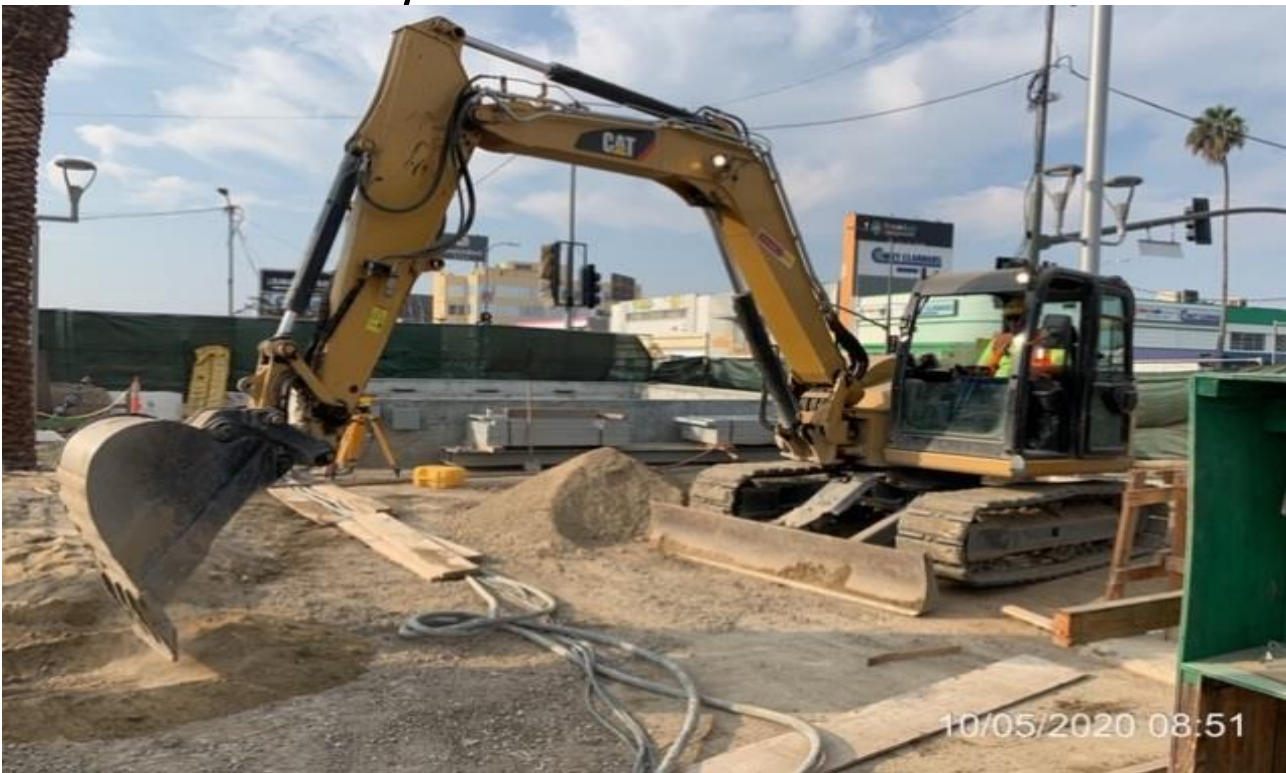
EXPO STATION – Continue rough grading/compacting throughout the plaza.

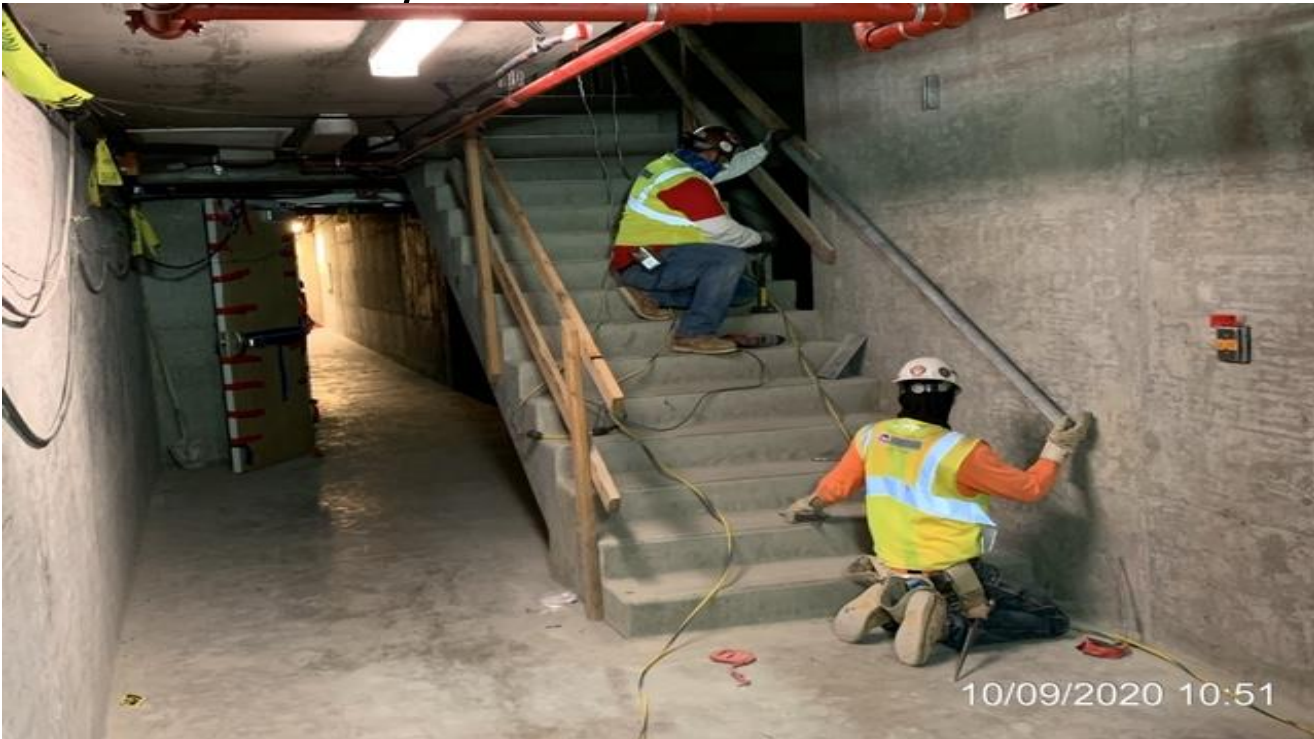
EXPO STATION – Continue installing galvanized handrails throughout Emergency Exit Stair South #2.

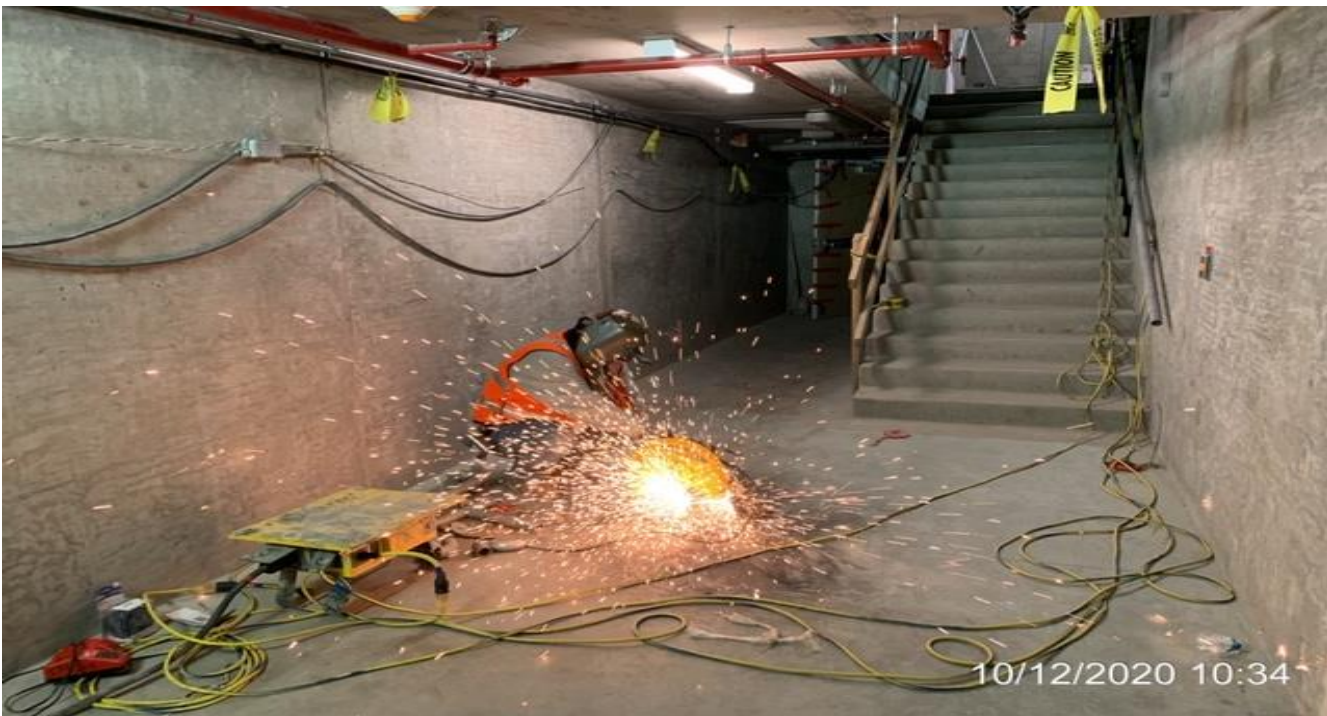
EXPO STATION – Continue installing grid support system and base plates for the mosaic art wall at the concourse level.

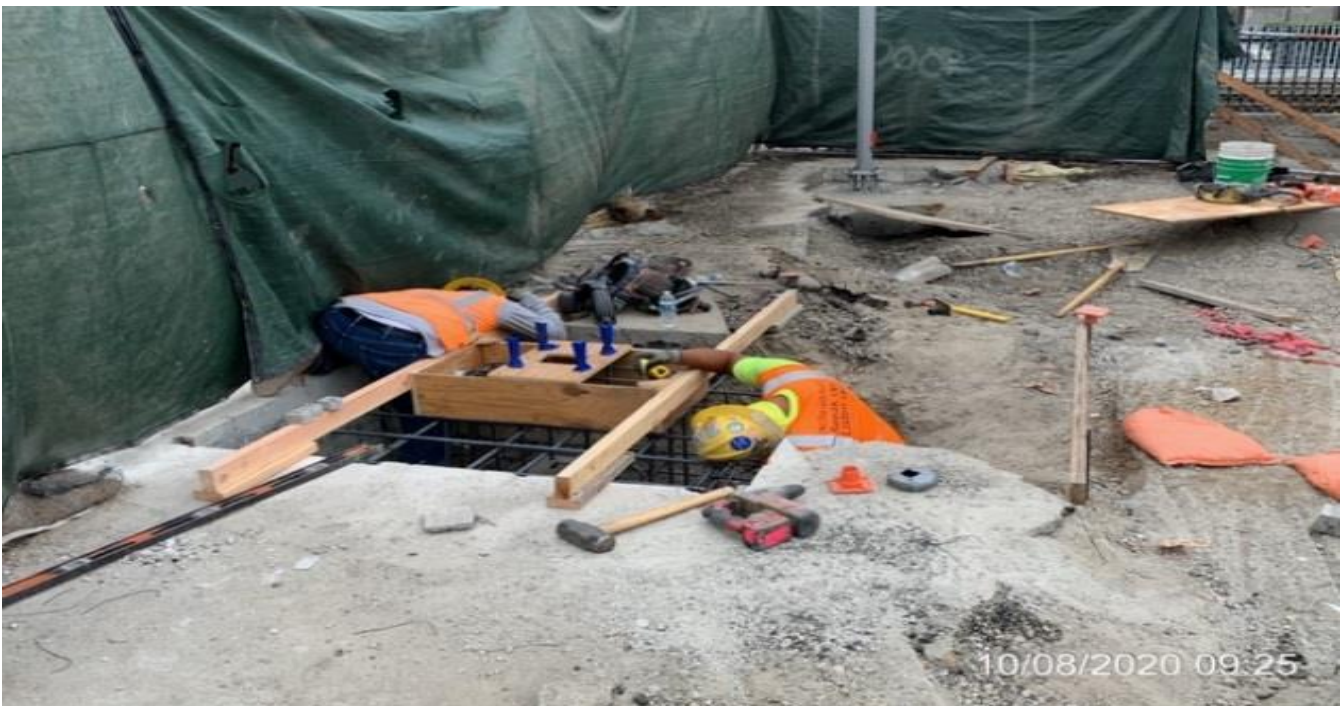
EXPO STATION – Building formwork for the grand pylon foundation footing at the plaza level.

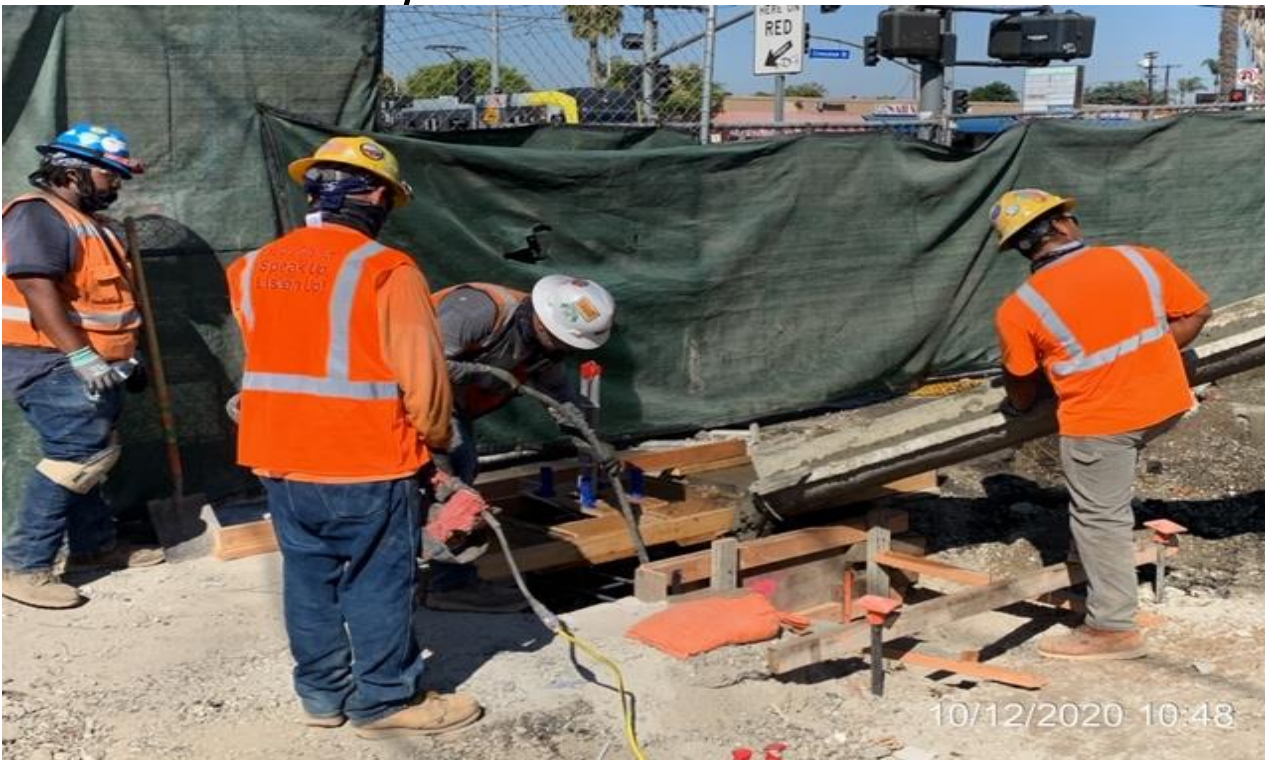
EXPO STATION – Placing concrete for the grand pylon foundation footing at the plaza level.

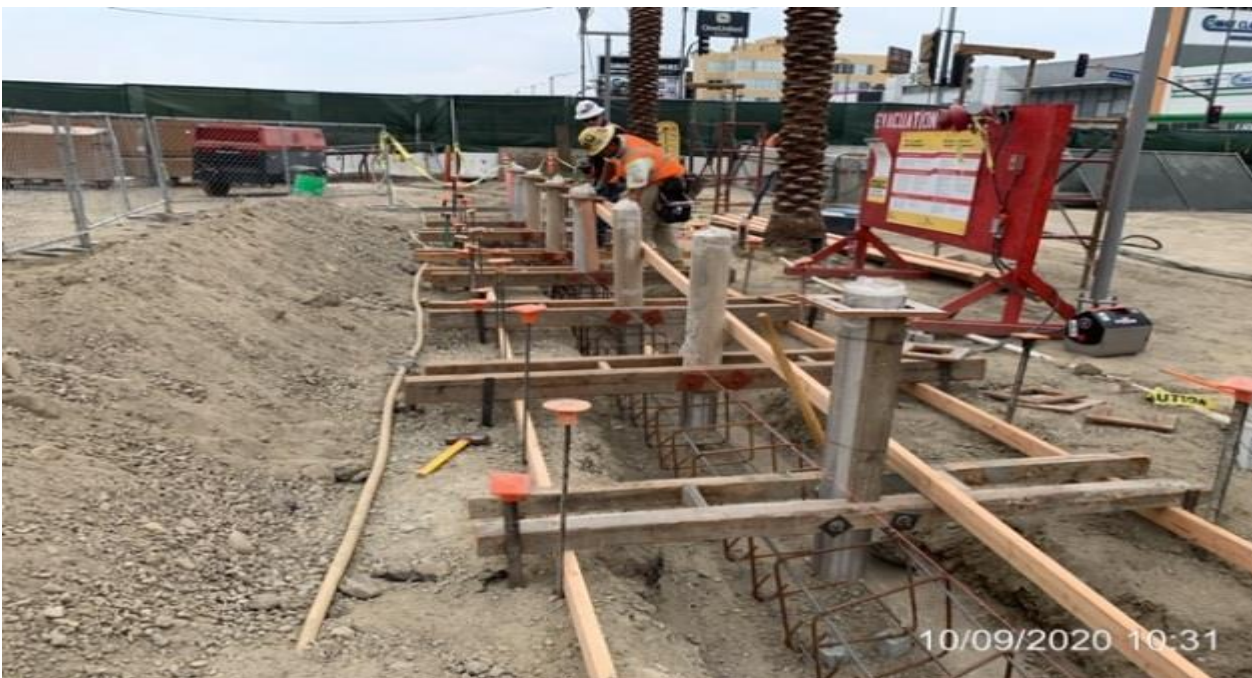
EXPO STATION - Building formwork and setting the east side bollard foundations at the plaza level.

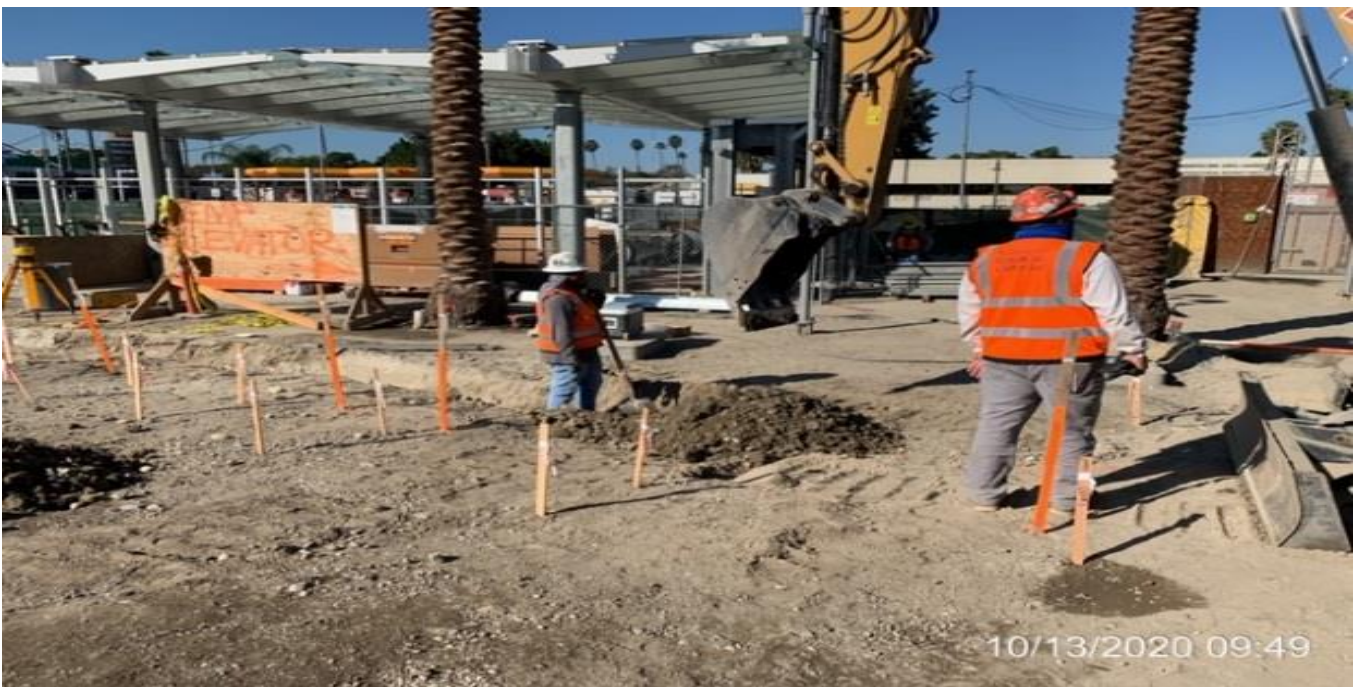
EXPO STATION – Continue building formwork, setting, and excavating for the east side bollard foundations at the plaza level.

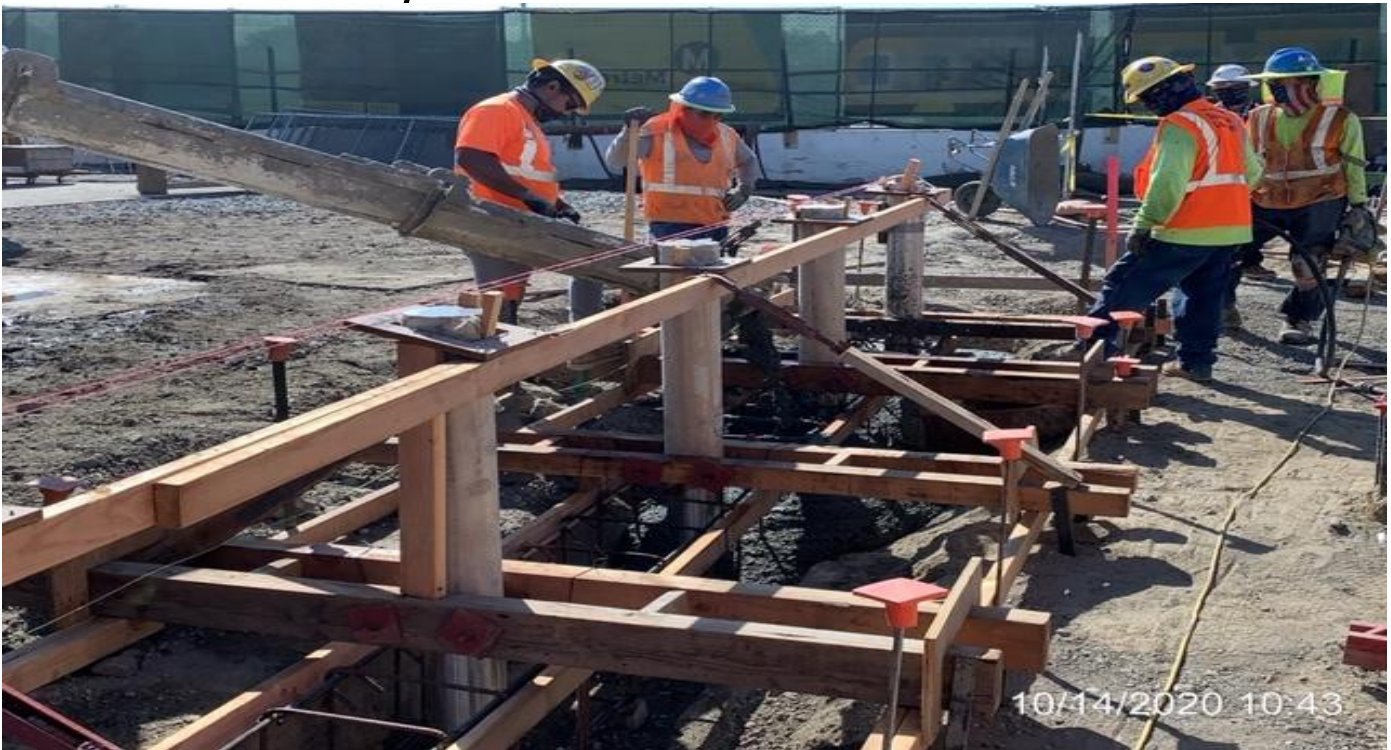
EXPO STATION – Setting rebar and placing concrete for the east side bollard foundations at the plaza level.

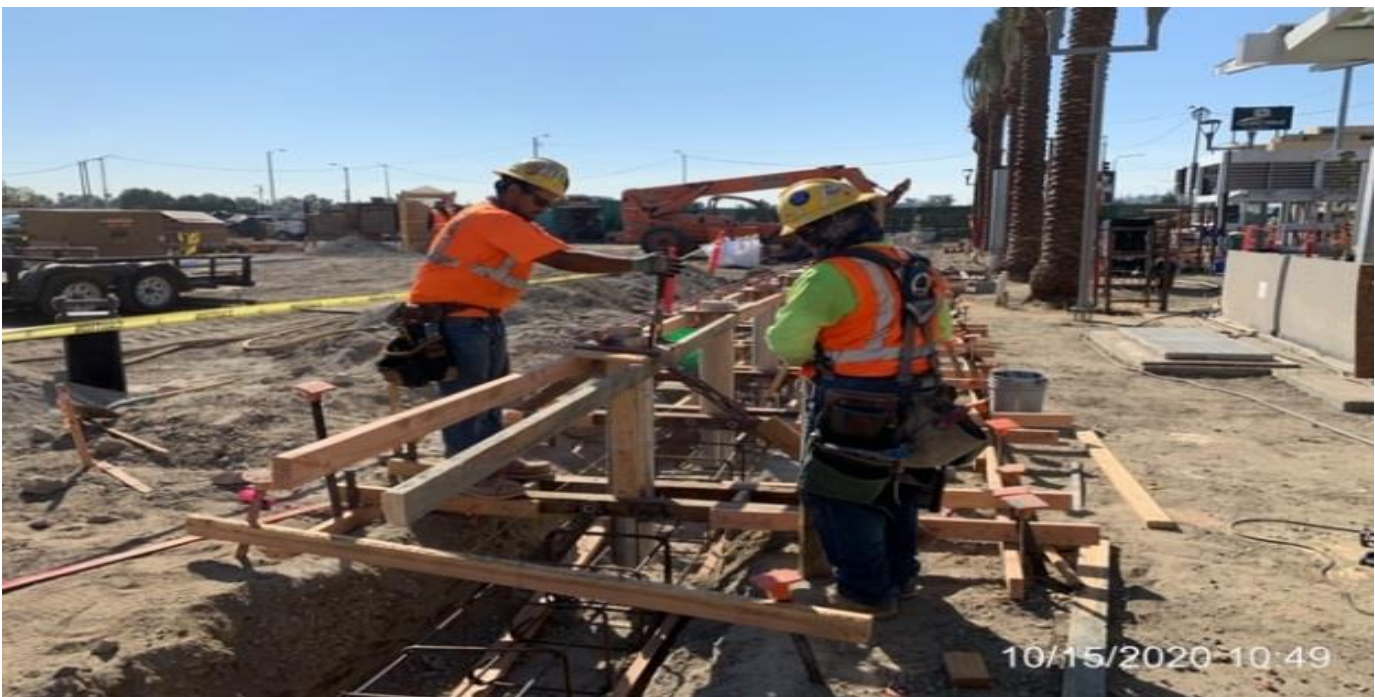
EXPO STATION – Continue building formwork and setting the east side bollard foundations at the plaza level.

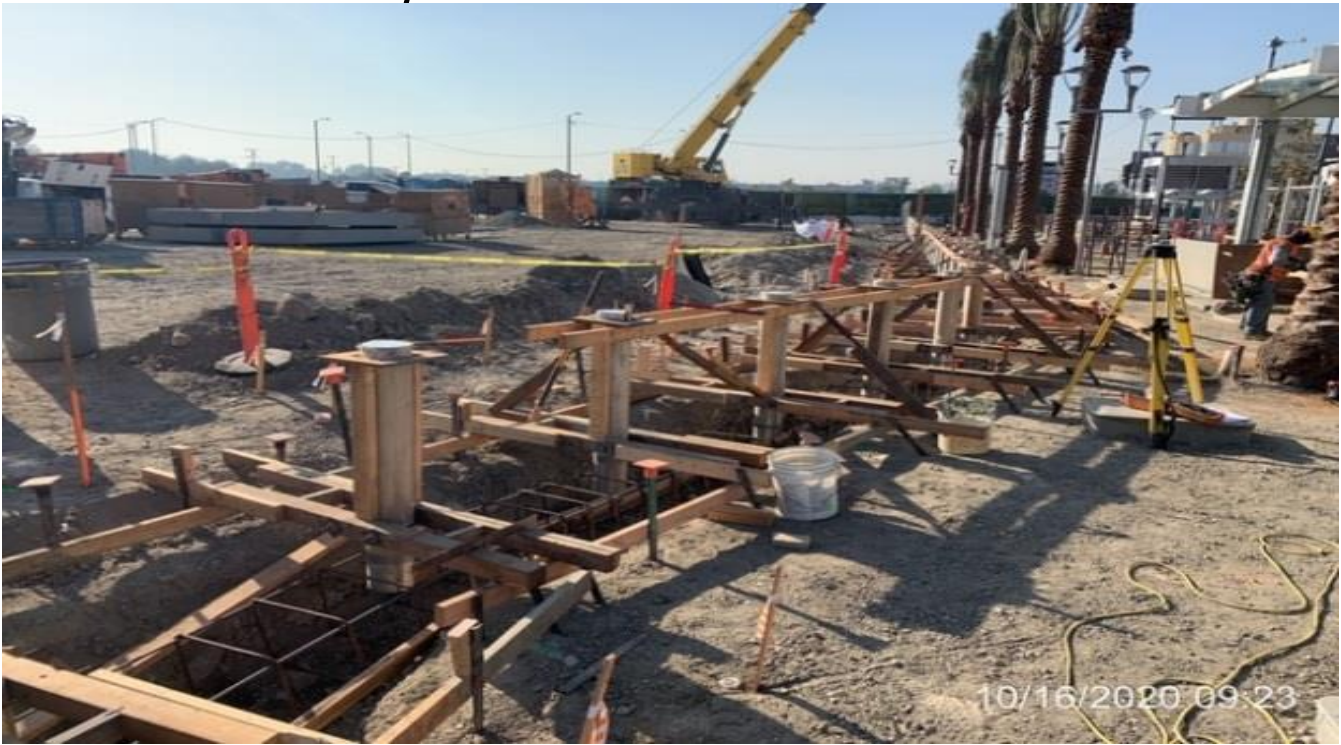
EXPO STATION – Continue building formwork and setting the east side bollard foundations at the plaza level.

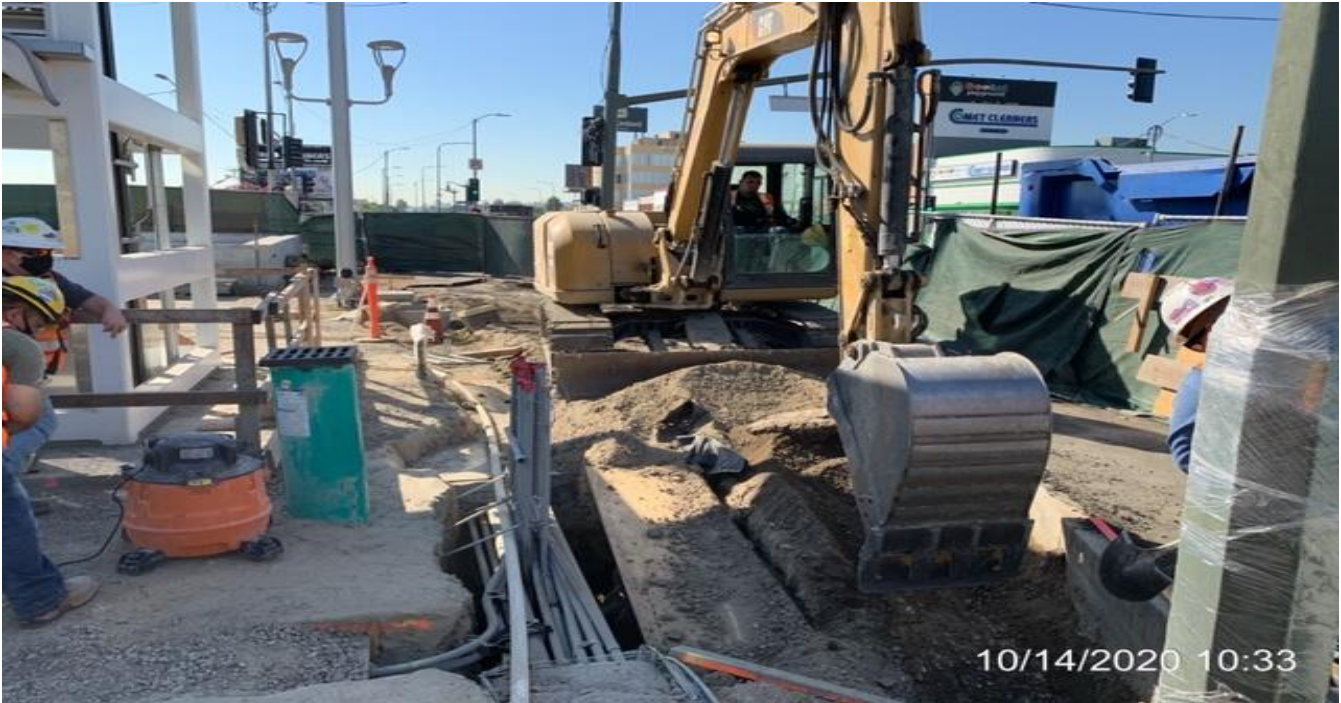
EXPO STATION – Excavating/trenching for the west side bollard foundations at the plaza level.

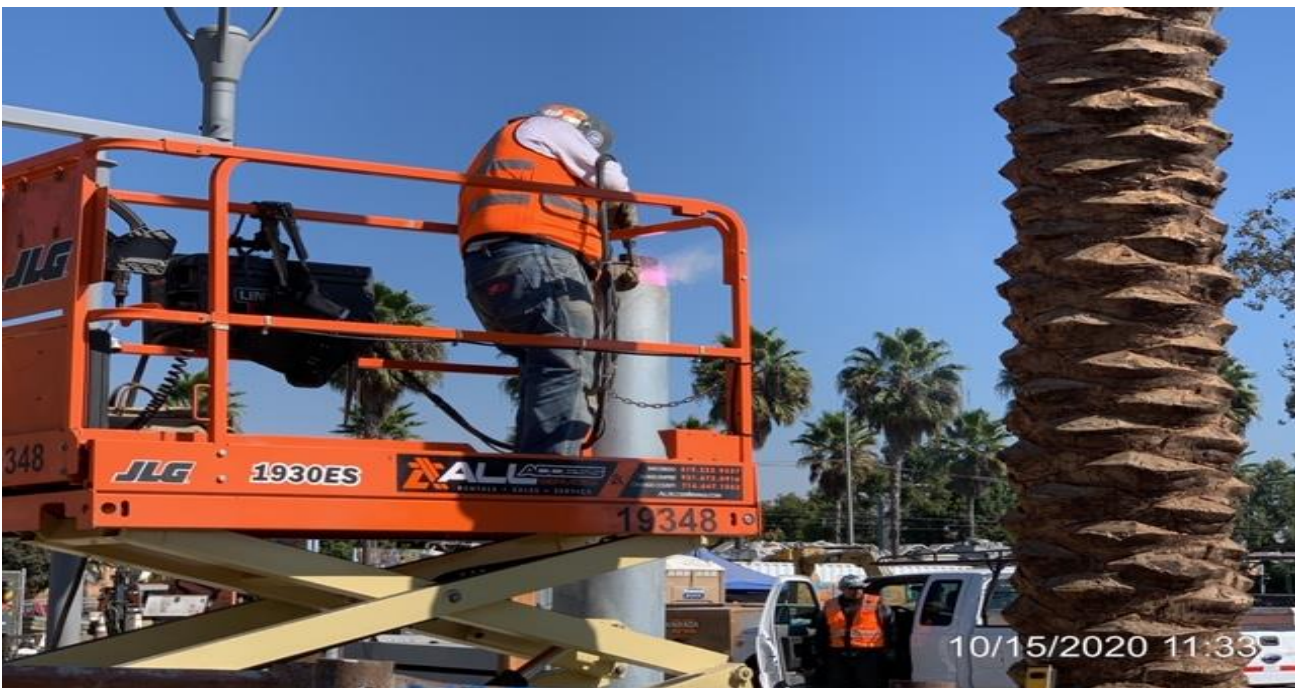
EXPO STATION – Welding pipe clamps to the east plumbing vent stack at the plaza level.

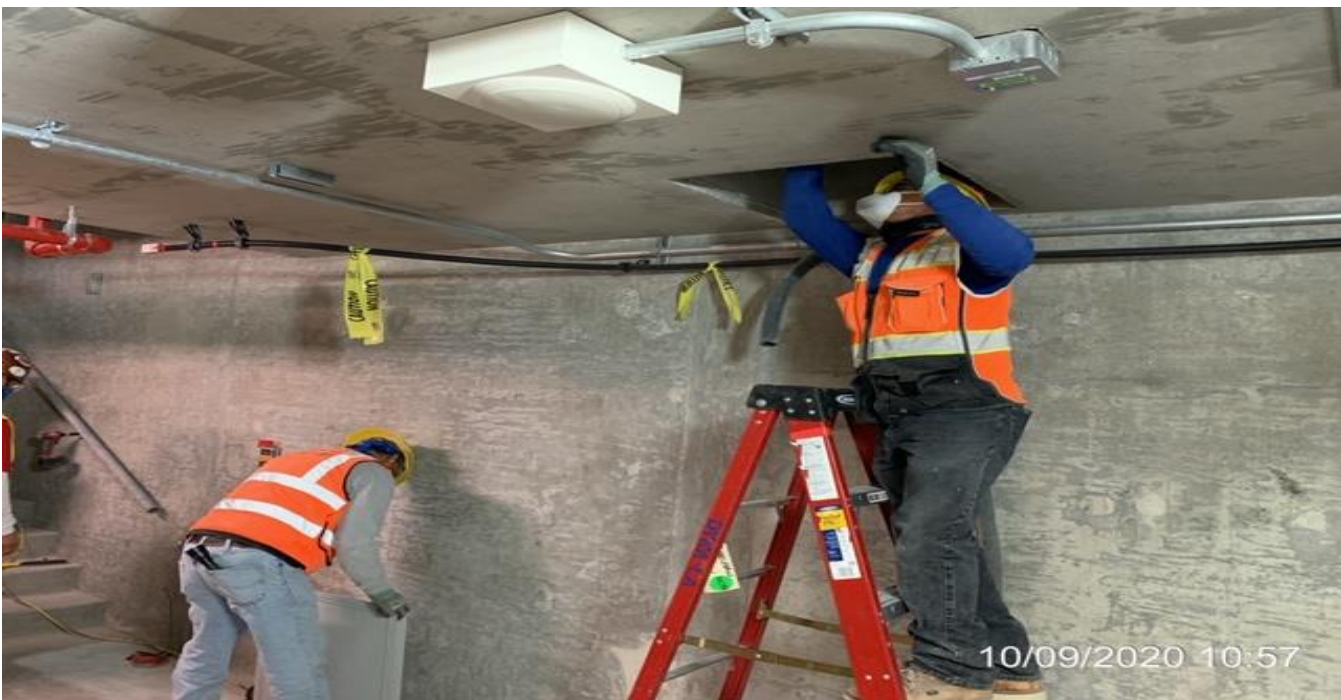
EXPO STATION – Installing ceiling access hatch panels at Emergency Exit Corridors 2&3 at the concourse level.
