# CRENSHAW/LAX PHOTOGRAPHIC UPDATE

Dec 30, 2020

## Crenshaw/LAX Transit Project

Overview of trackwork progress issues for 11/30/2020 – 12/15/2020  
(Please note the attached Trackwork Progress Tracking Report)

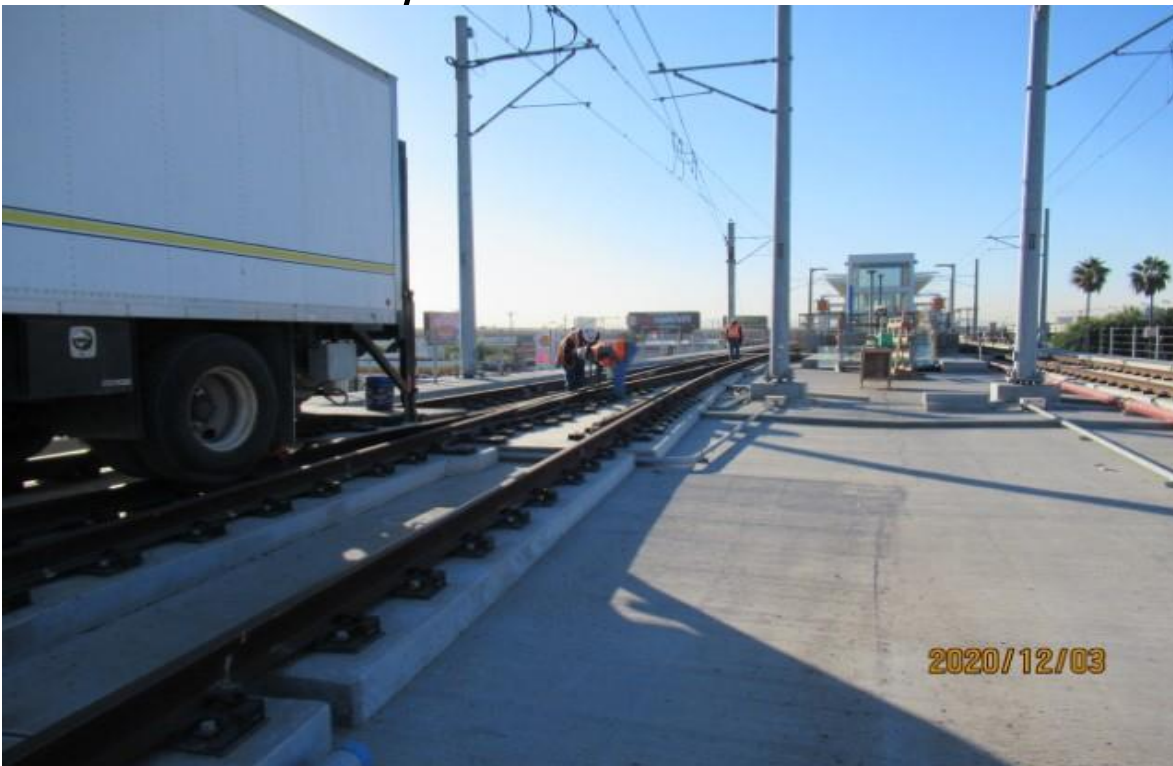
AVIATION/CENTURY- HCC working on open issues log at Century/Aviation bridge 10K1LHXO NB track (looking southeast) Rework

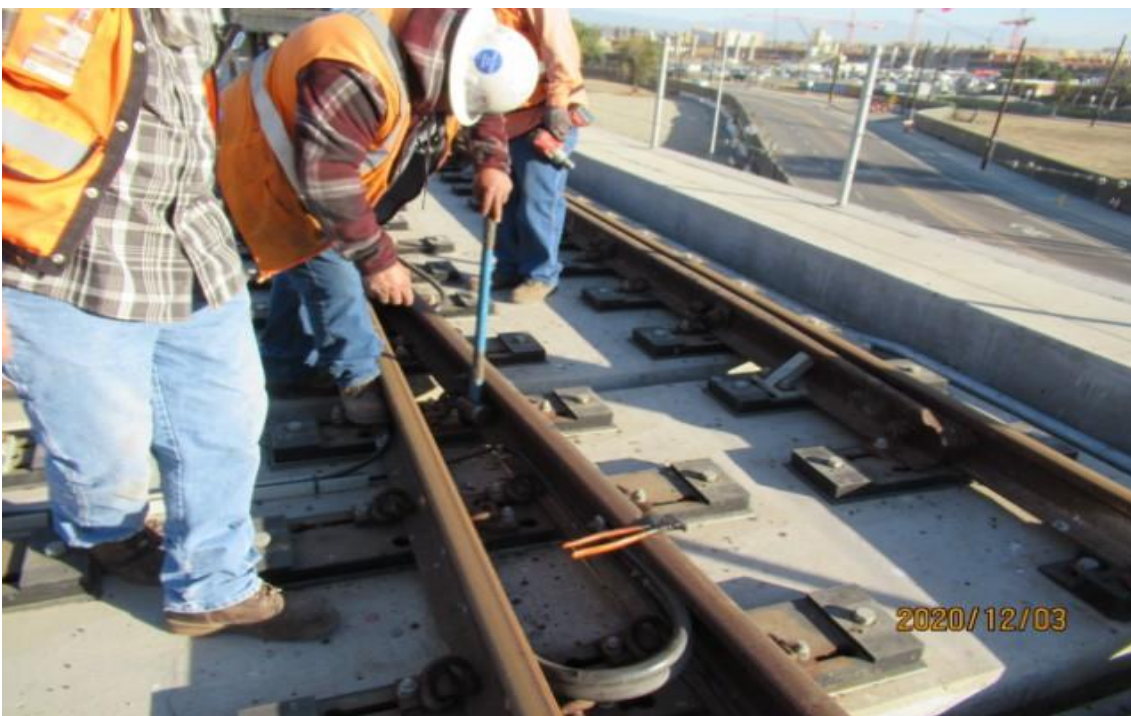
AVIATION/CENTURY- HCC working on 10K1LHXO open issues log for NB track Century/Aviation bridge (looking northeast) Rework

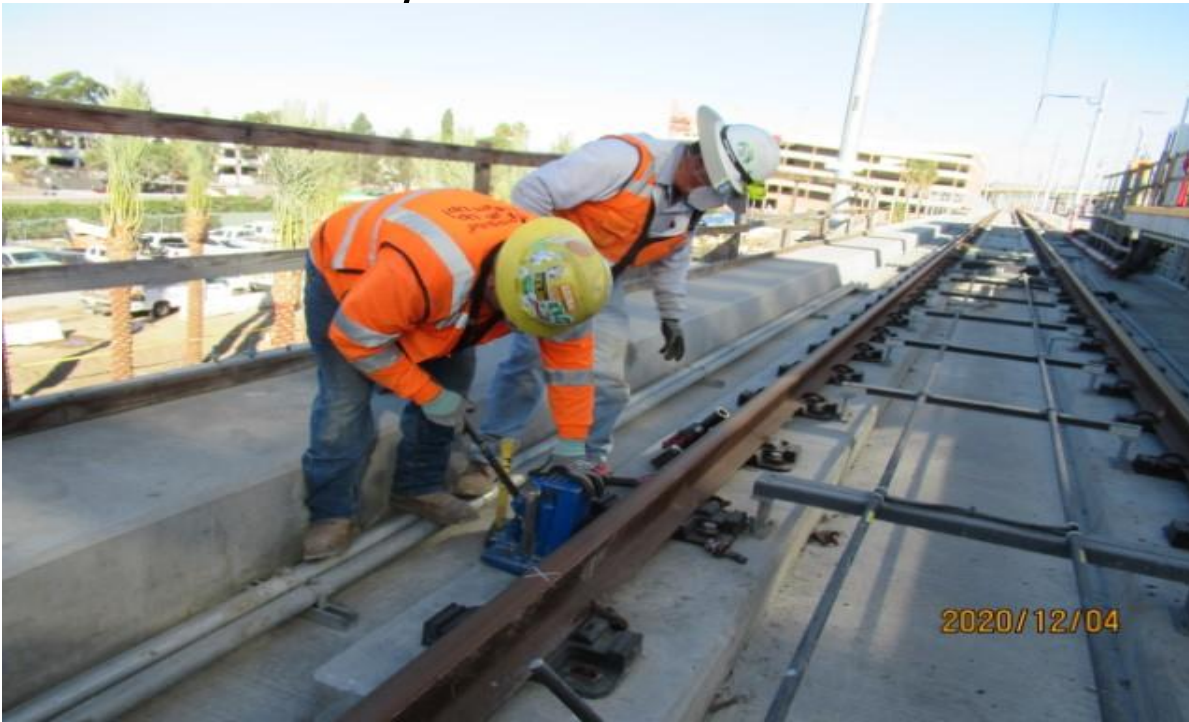
AVIATION/CENTURY- WSCC on Century/Aviation bridge SB track pull testing fastener 133 plinth 18 left side rail result was pass (looking northwest)

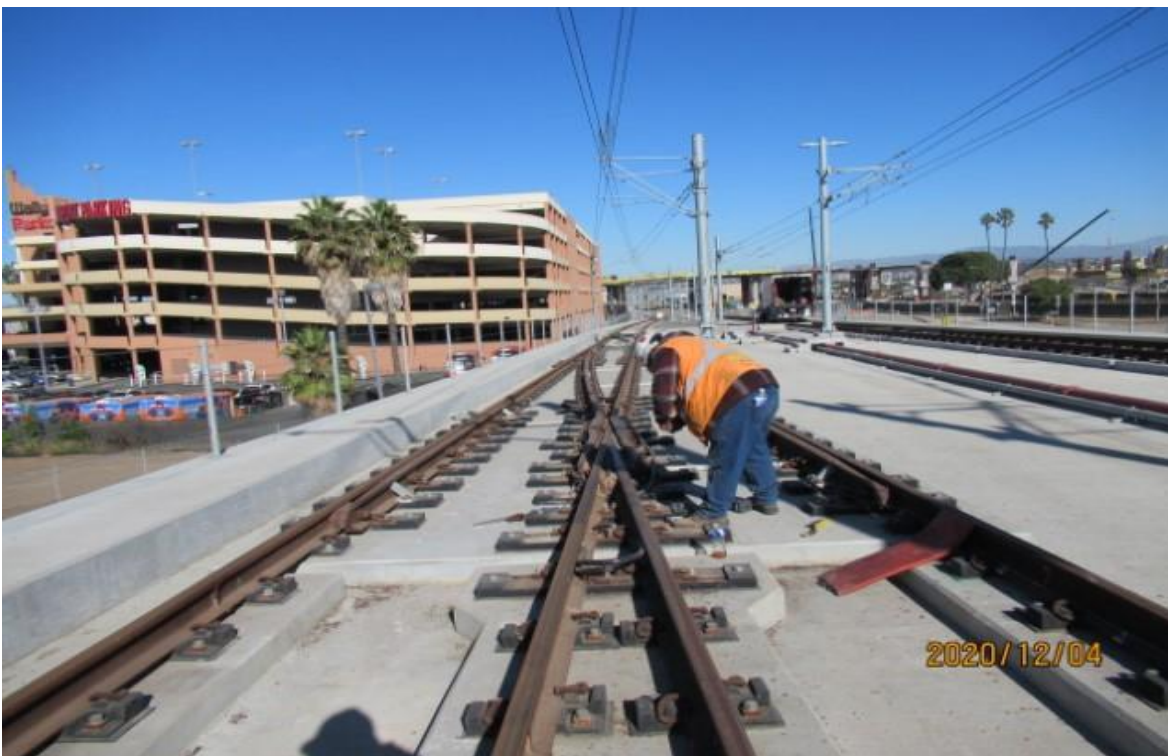
AVIATION/CENTURY- HCC working on open issues log Century/Aviation bridge 10K2LHXO SB track

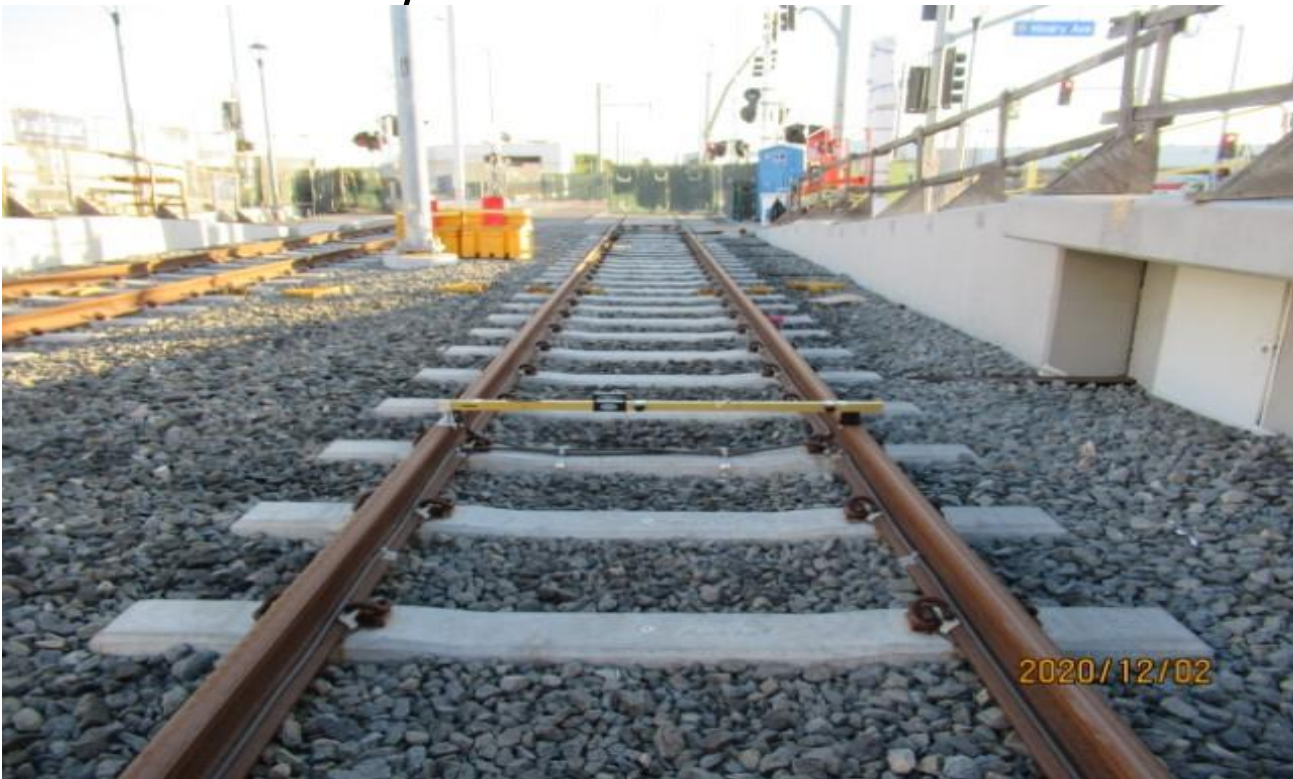
Hindry – Verifying cross levels at Hindry Station NB track STA 134+59 (looking north) Re-tamped by HCC

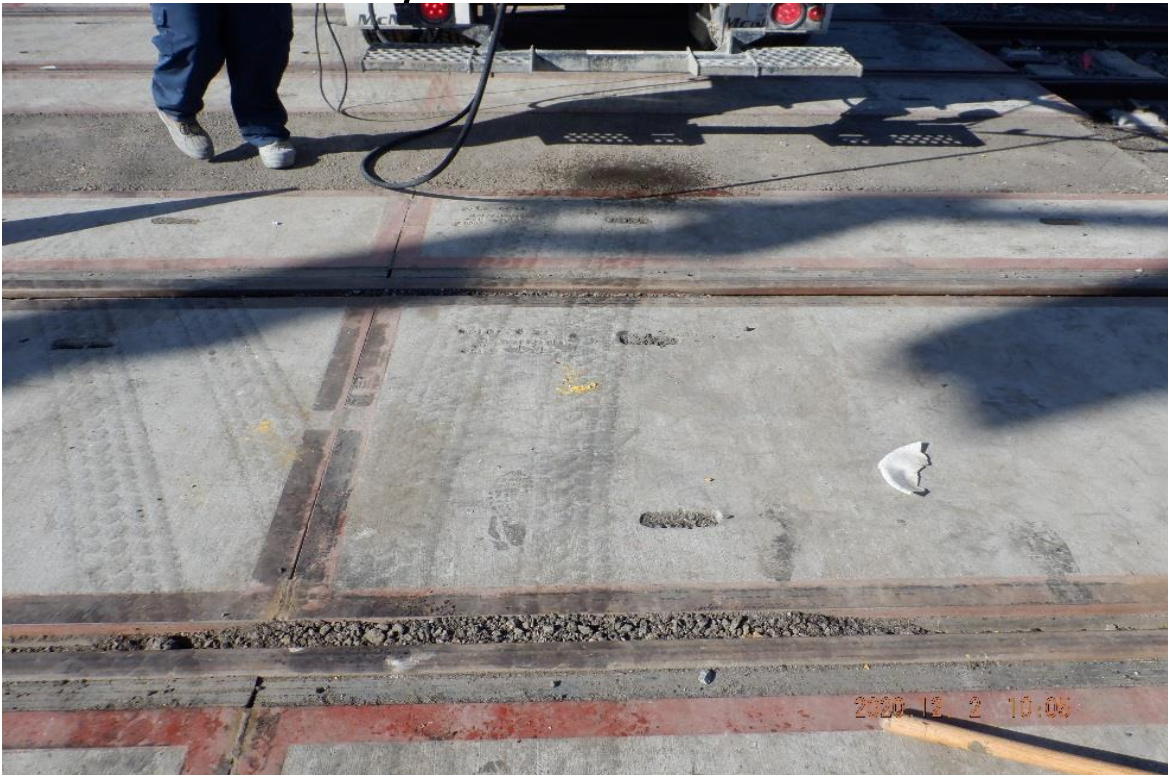
PARK MESA – STA 339+19 TK#4/NB looking west – AC in the crossing panel flangeway after road improvement work on Crenshaw Blvd with 54th St

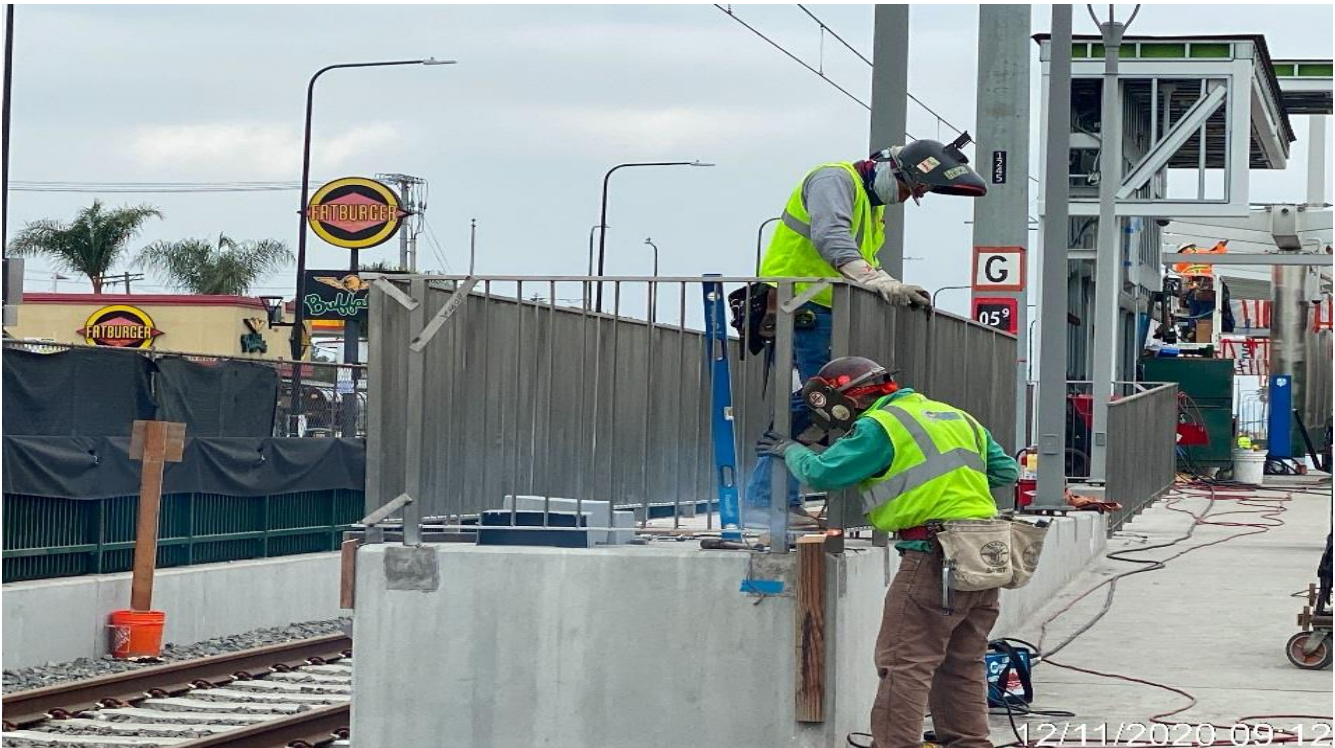
PARK MESA – Continue installing guardrails along the north and southbound side of the south end entrance ramp.

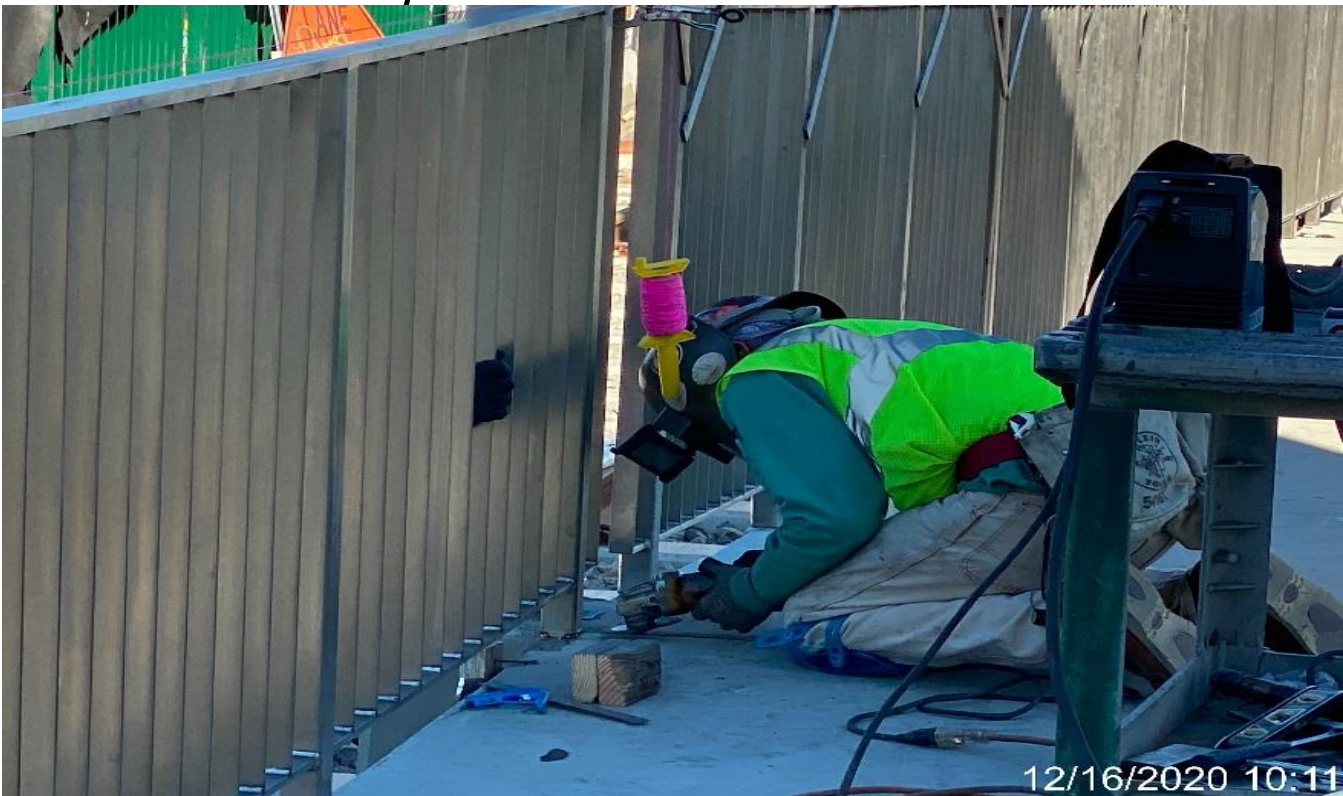
PARK MESA – Continue installing guardrails along the north and southbound side of the north end entrance ramp.

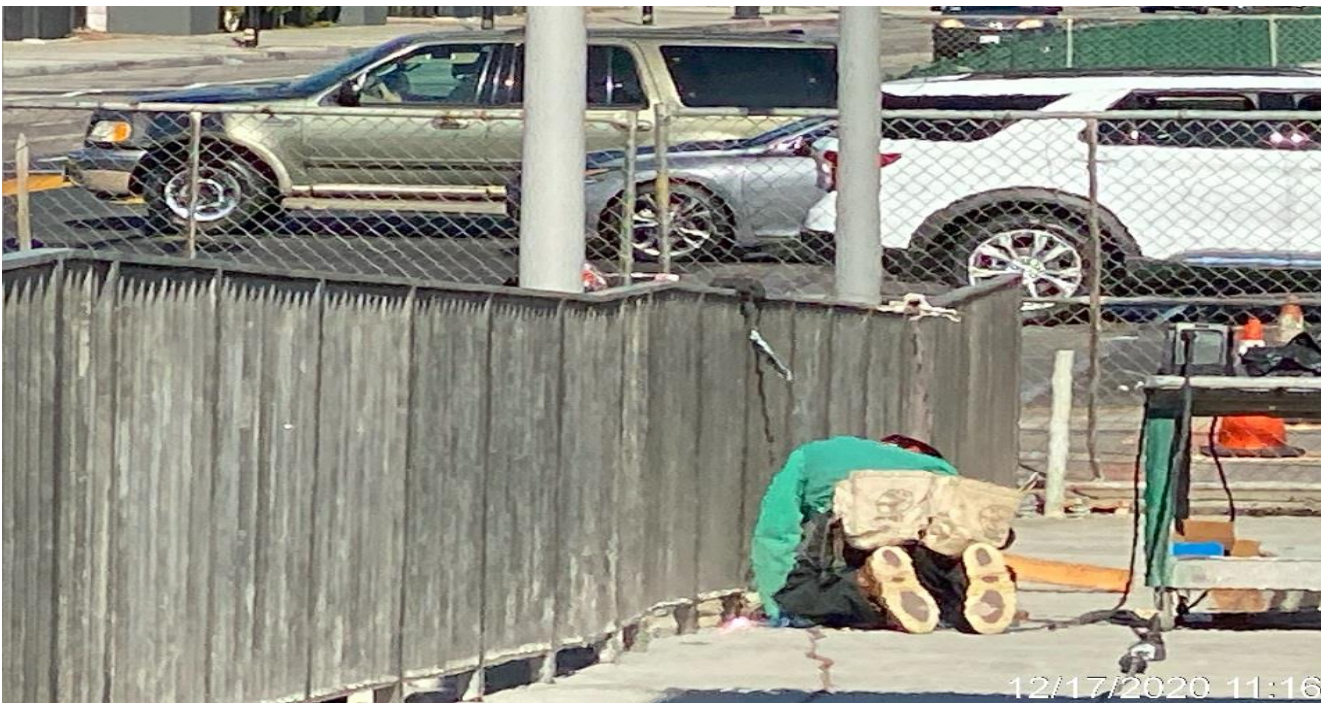
PARK MESA – Continue installing guardrails along the north and southbound side of the north end entrance ramp.

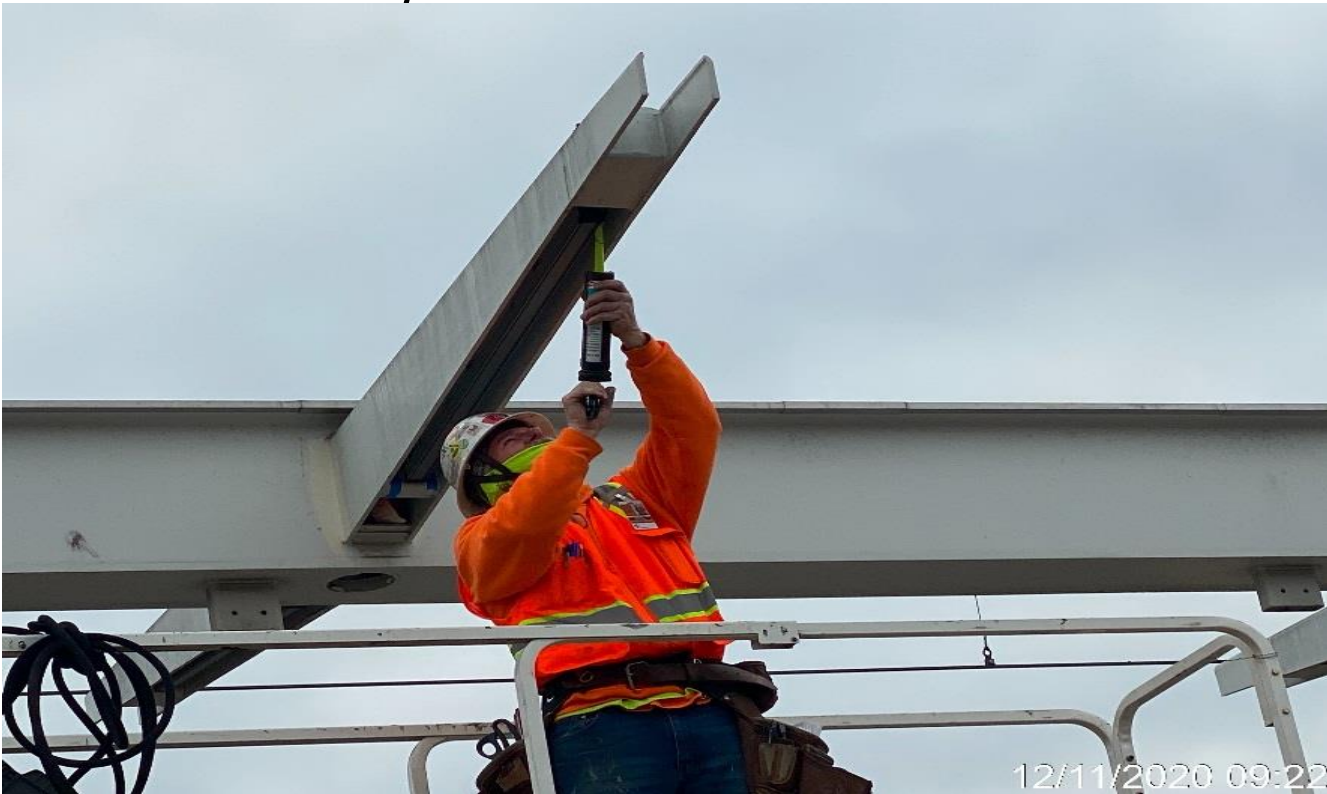
PARK MESA – Caulking and sealing BOCA light fixtures to the north end canopy outriggers at the platform.

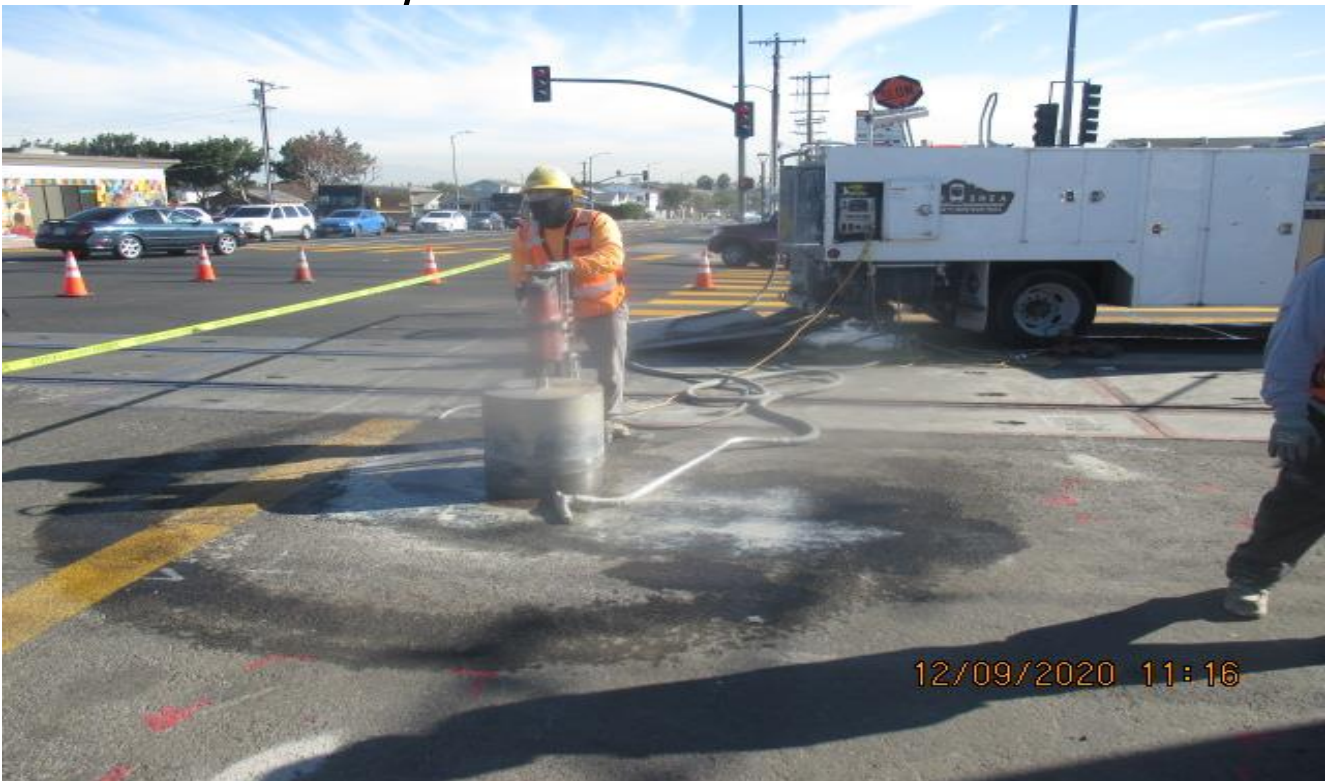
PARK MESA – Coring pavement in preparation of steel bollard installation on the crosswalk at Slauson Ave and Crenshaw Blvd.

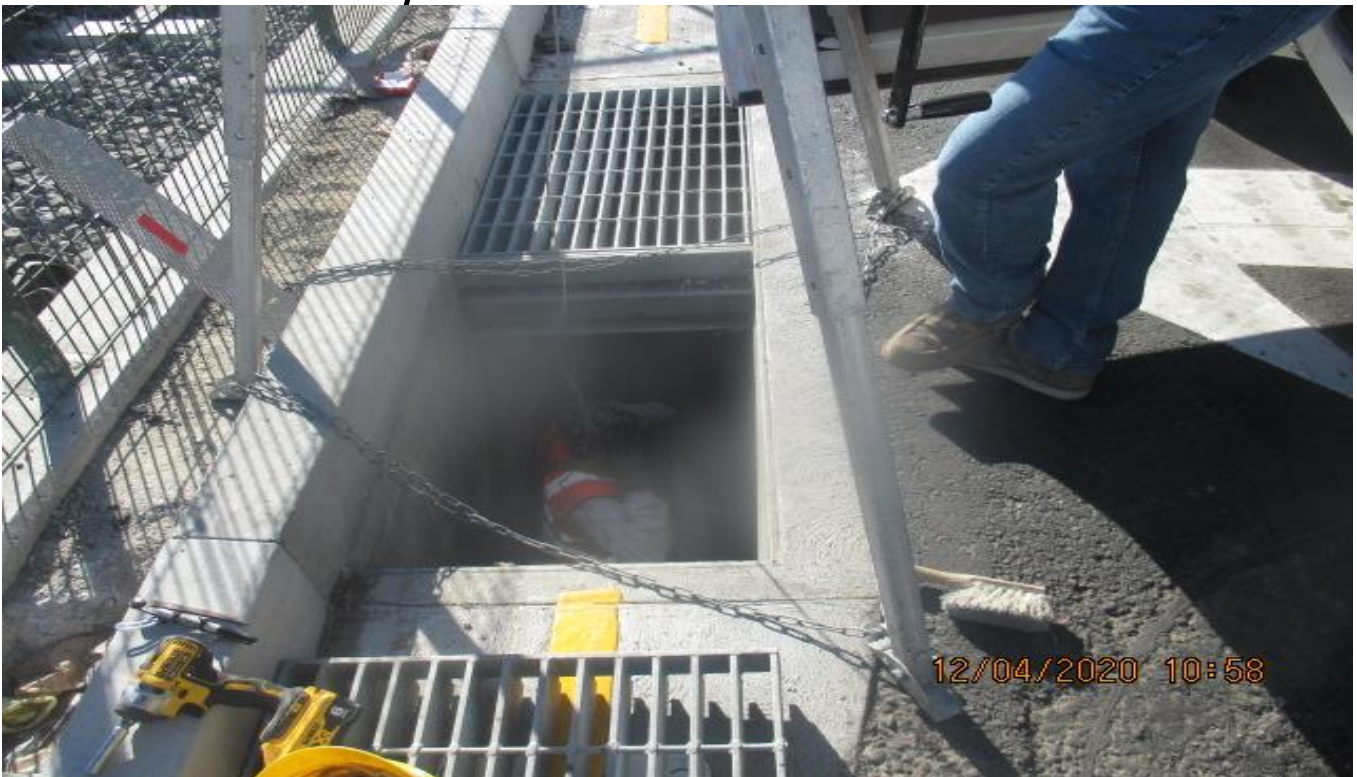
PARK MESA – Installing steel grates to Catch Basin #13 on southbound Crenshaw Blvd and Slauson Ave.

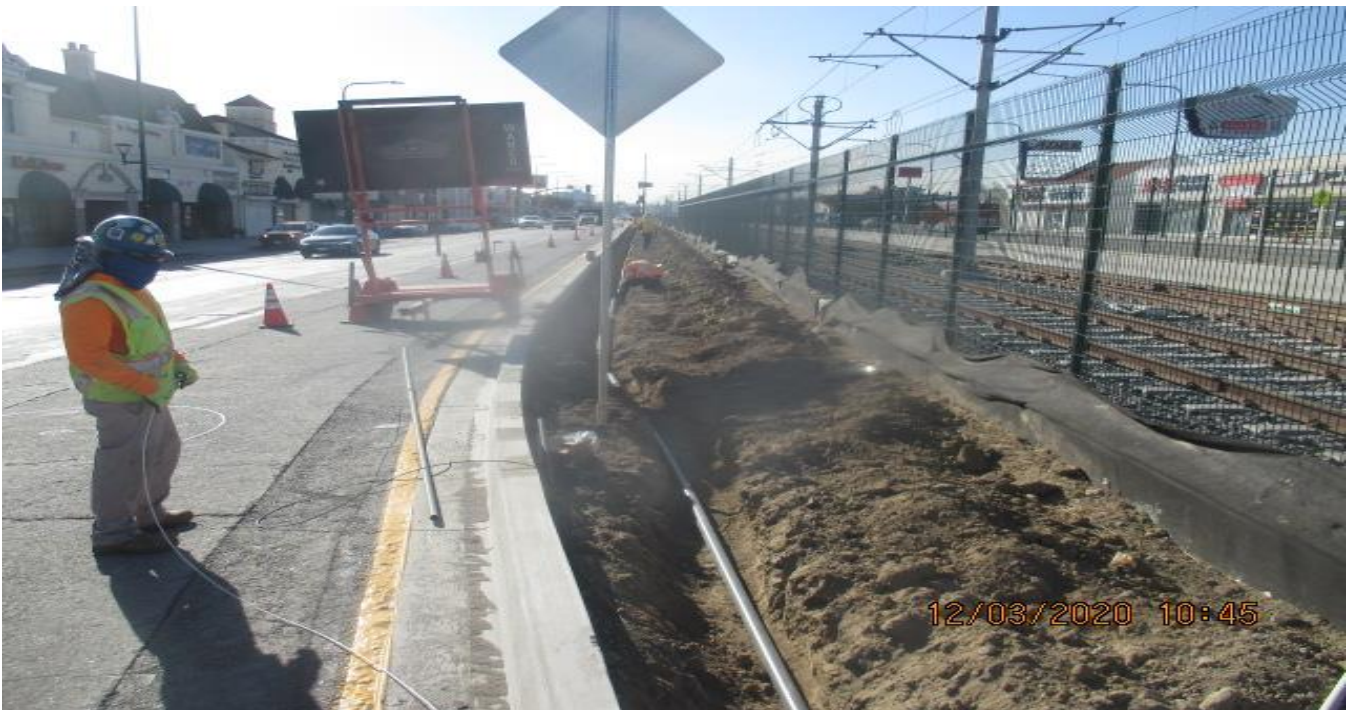
PARK MESA – Installing irrigation pipe line along the northbound median curb of Crenshaw Blvd on 57th St and moving toward 54th St.

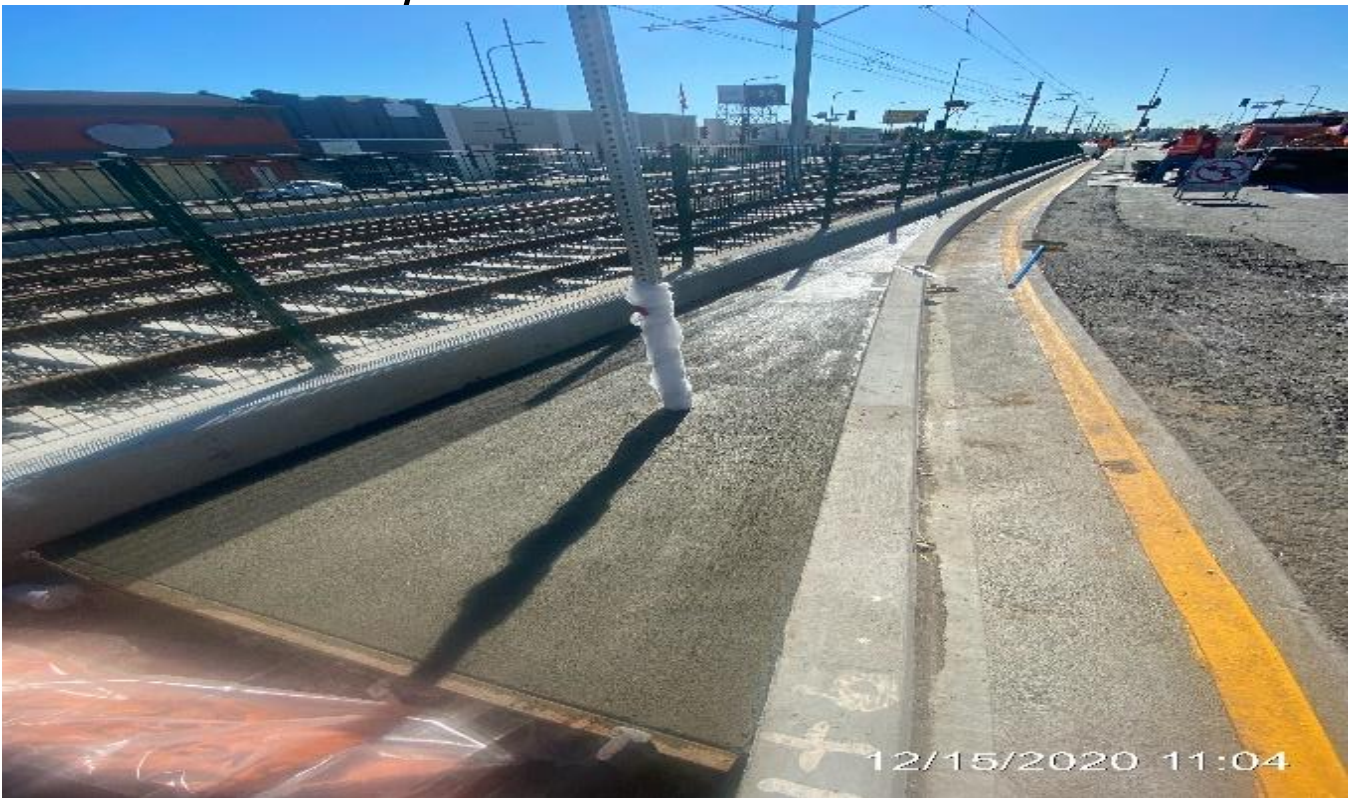
PARK MESA – Placing cobble mortar base to the southbound median curb of Crenshaw Blvd from 57th St to 54th St.

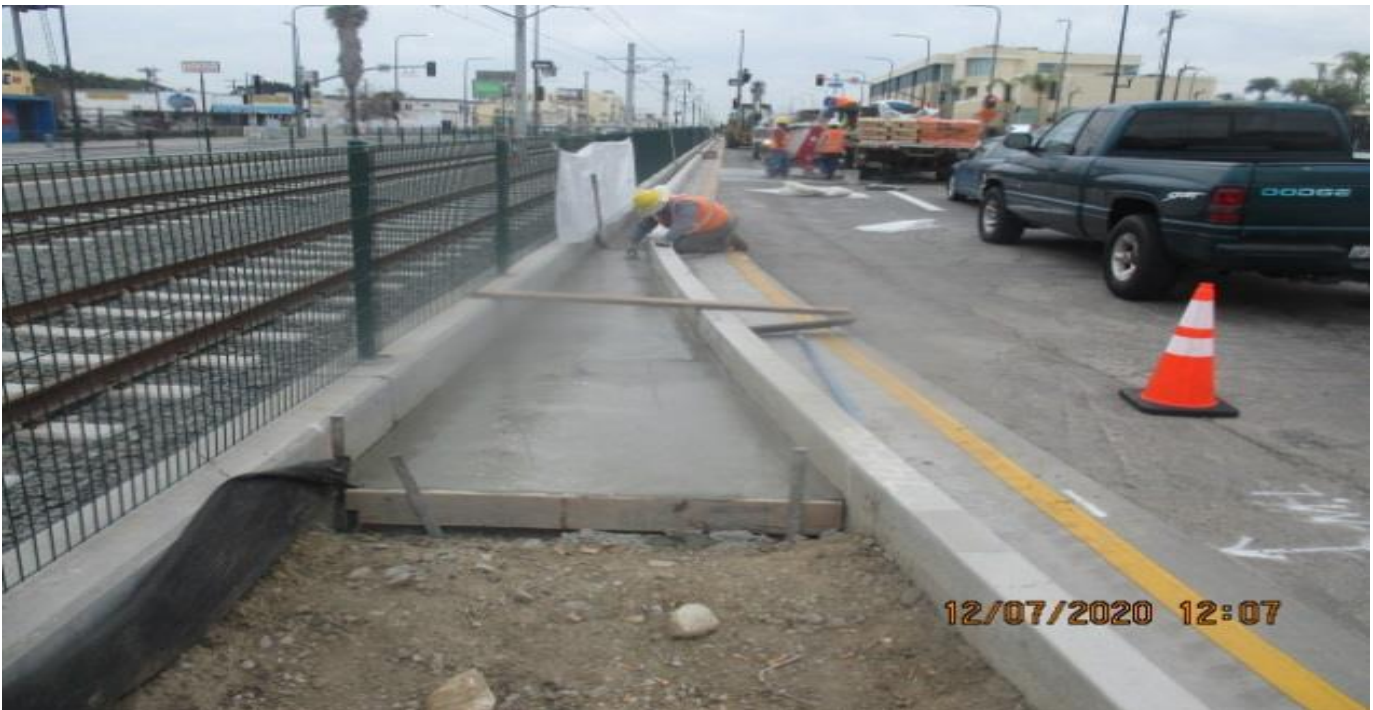
PARK MESA – Placing cobble mortar base to the southbound median curb of Crenshaw Blvd and 52nd St.

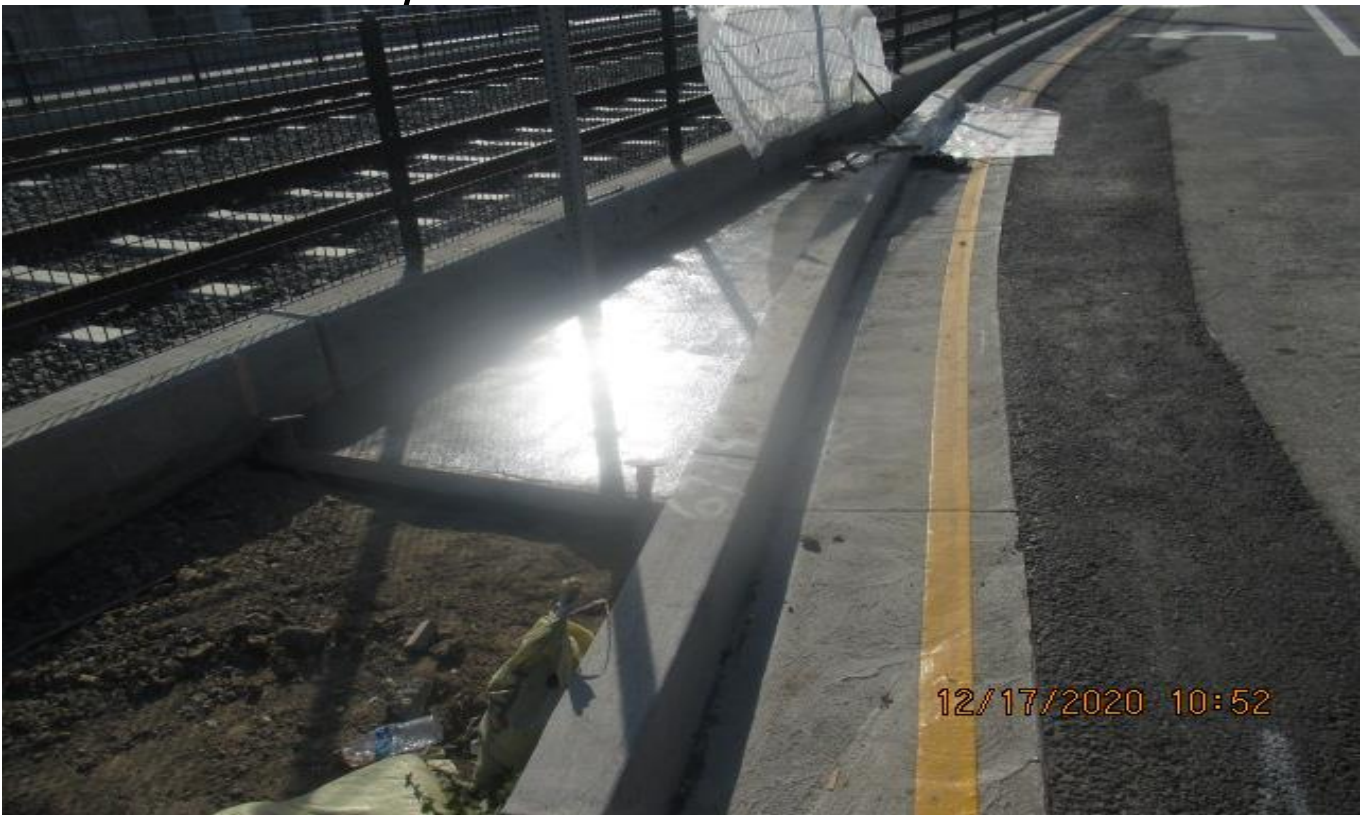
PARK MESA – Placing cobble mortar base to the southbound median curb of Crenshaw Blvd and 52nd St.

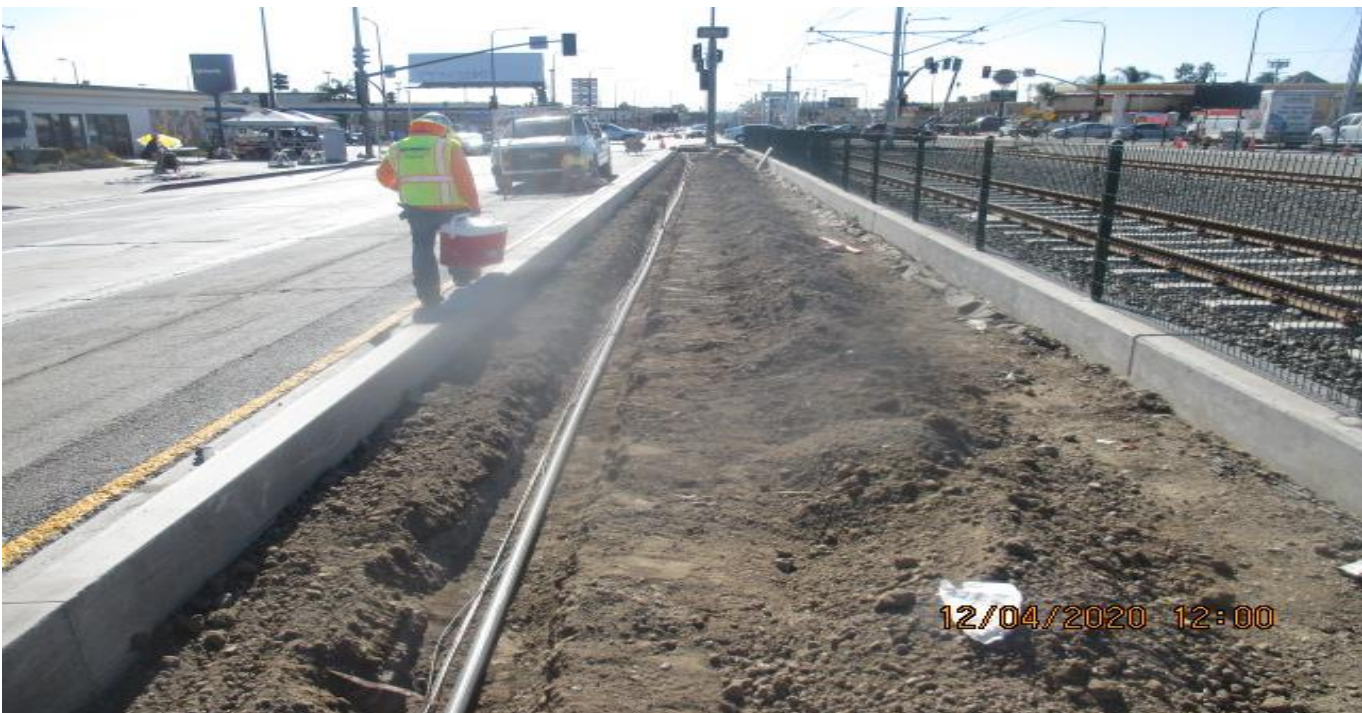
PARK MESA – Installing irrigation pipe line along the northbound median curb of Crenshaw Blvd and 48th St.

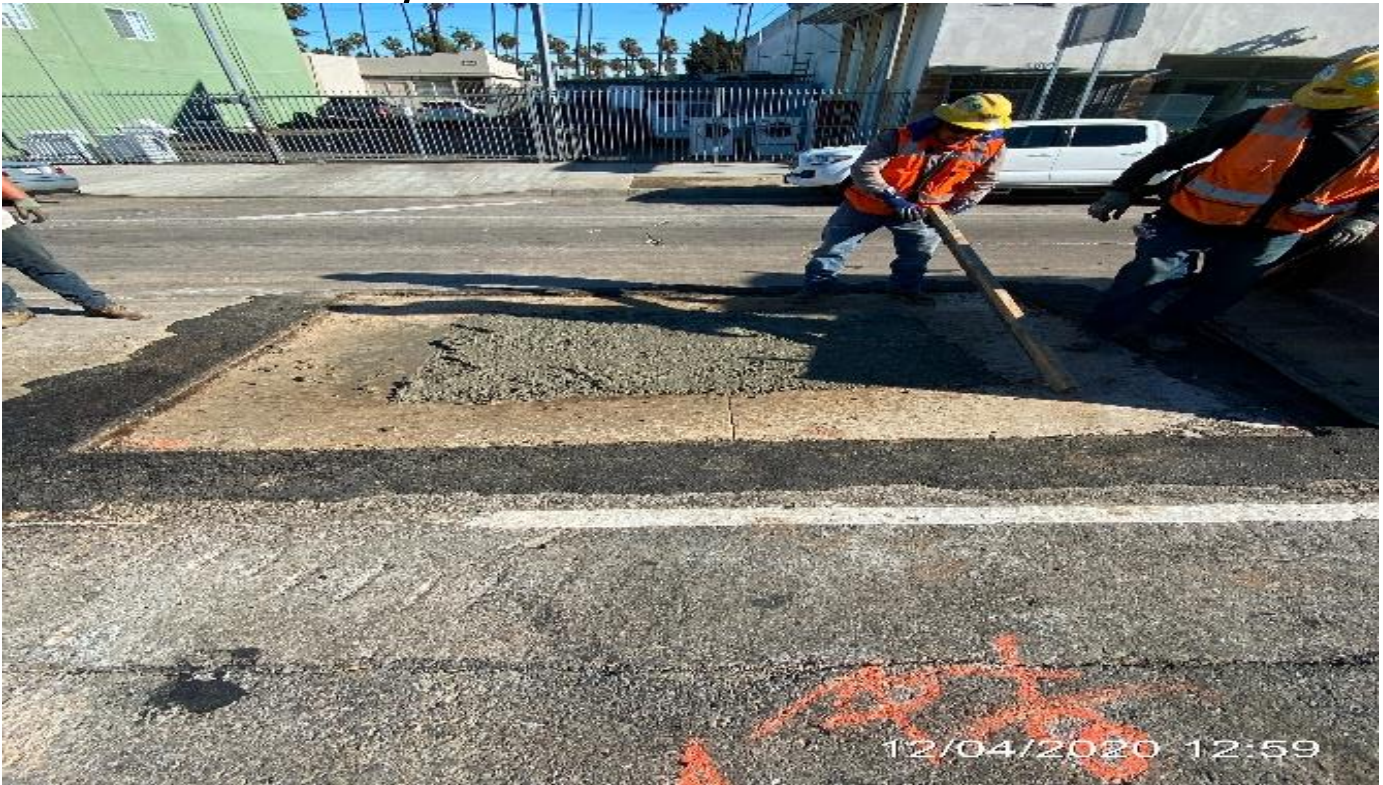
PARK MESA – Placing concrete over existing overhead sign foundation on northbound Crenshaw Blvd and 48th St.

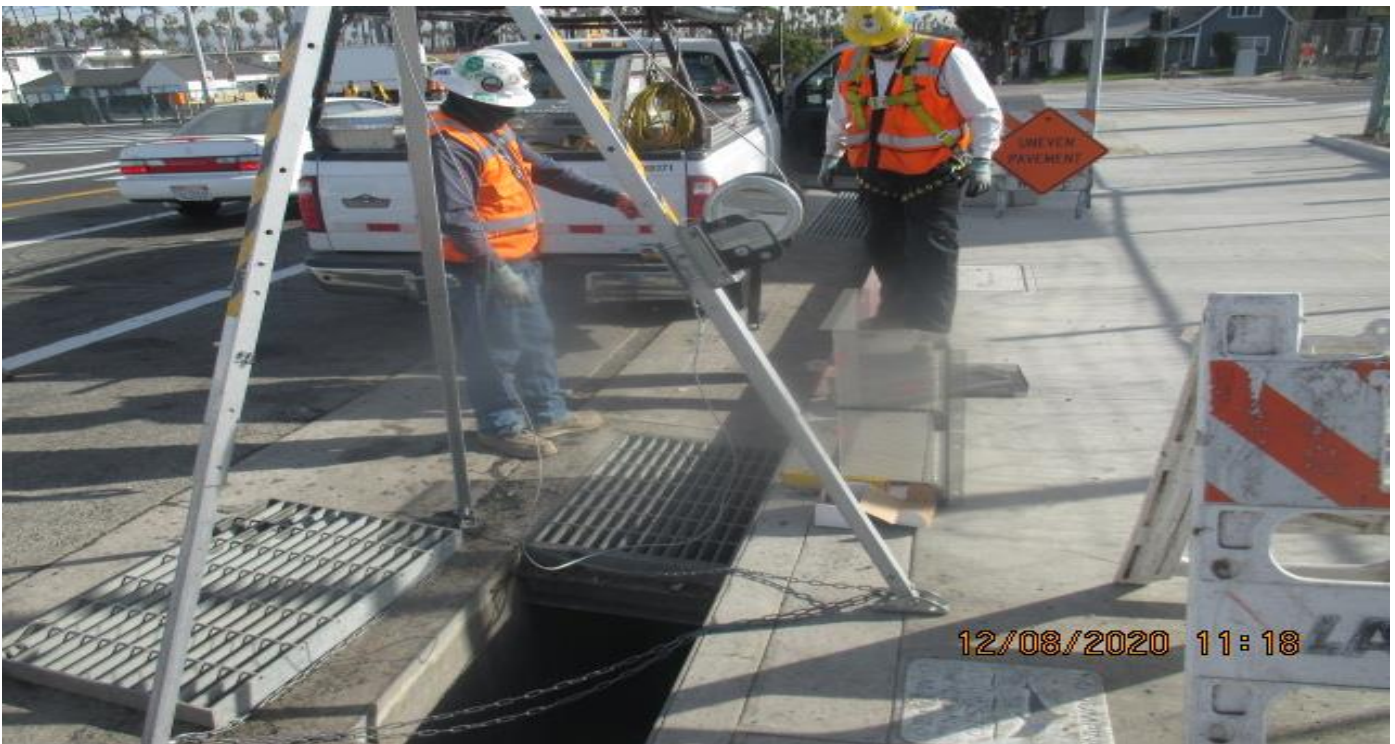
PARK MESA – Installing steel grates to Catch Basin #36 on the southwest corner of Crenshaw Blvd and 48th St.

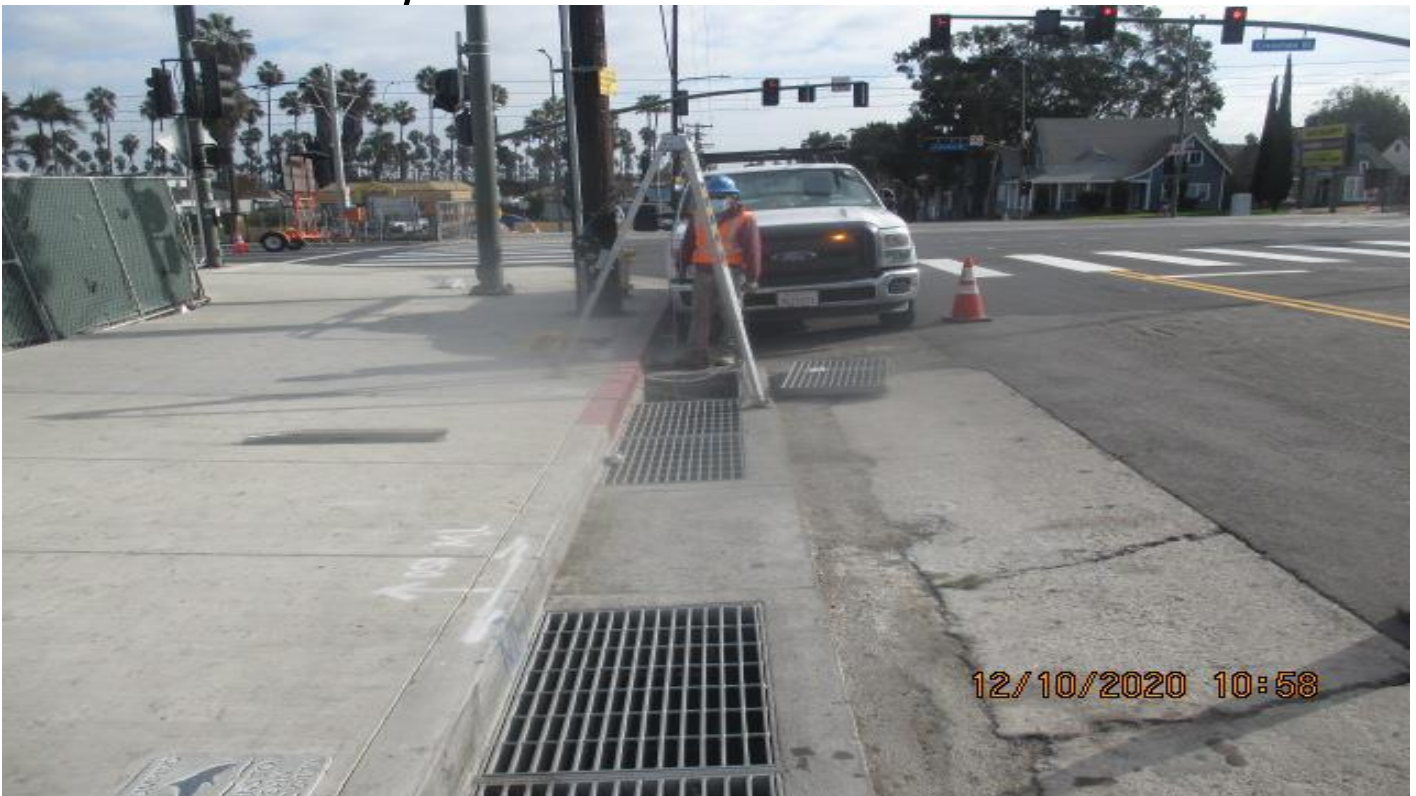
PARK MESA – Installing steel grates to Catch Basin #29 and #37 on eastbound 48th St and Crenshaw Blvd.

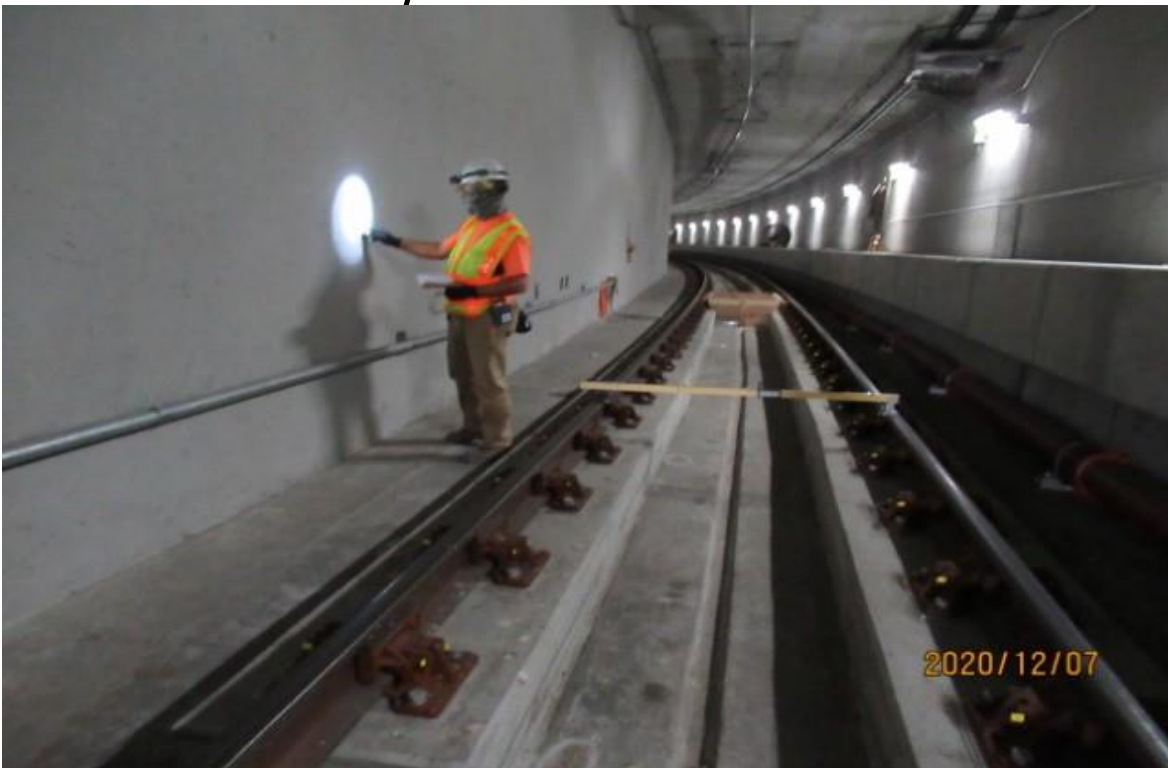
UG4 – Metro's QA Track Inspector on SB track in UG4 verifying correct survey spiral locations for SB-34 curve (looking north)

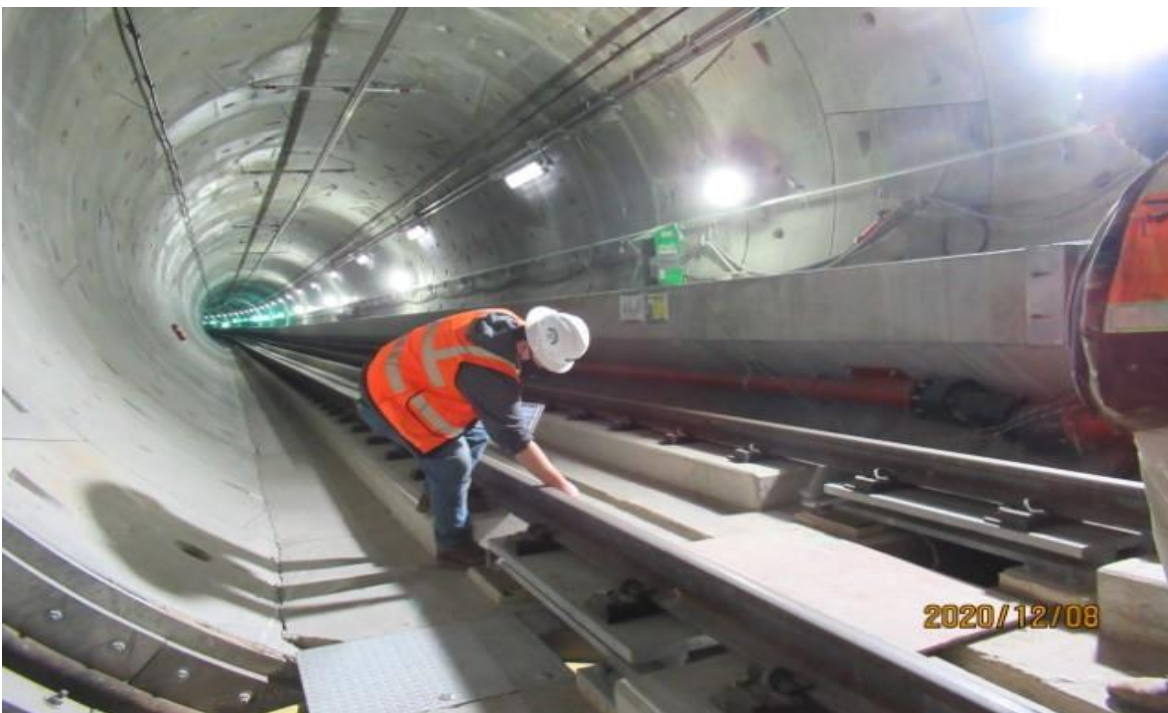
UG4 – WSCC field engineer logging non-conformance issues in UG4 NB track STA 401+55 (looking southwest).
