# CRENSHAW/LAX PHOTOGRAPHIC UPDATE

Dec 30, 2020

## Crenshaw/LAX Transit Project

Overview of trackwork progress issues for 11/30/2020 – 12/15/2020  
(Please note the attached Trackwork Progress Tracking Report)

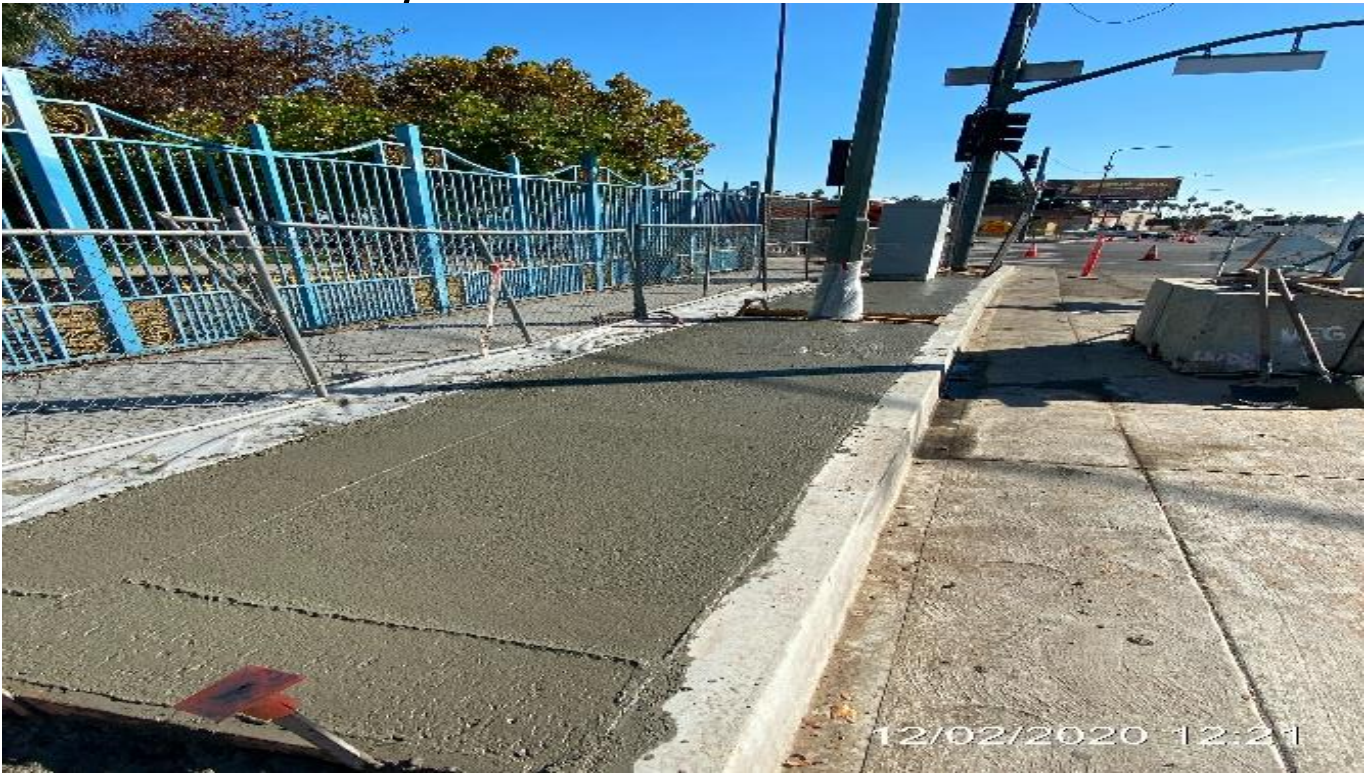
LEIMERT PARK STATION – Placed concrete over sidewalk on northbound Crenshaw Blvd between Vernon Ave and 43rd Pl.

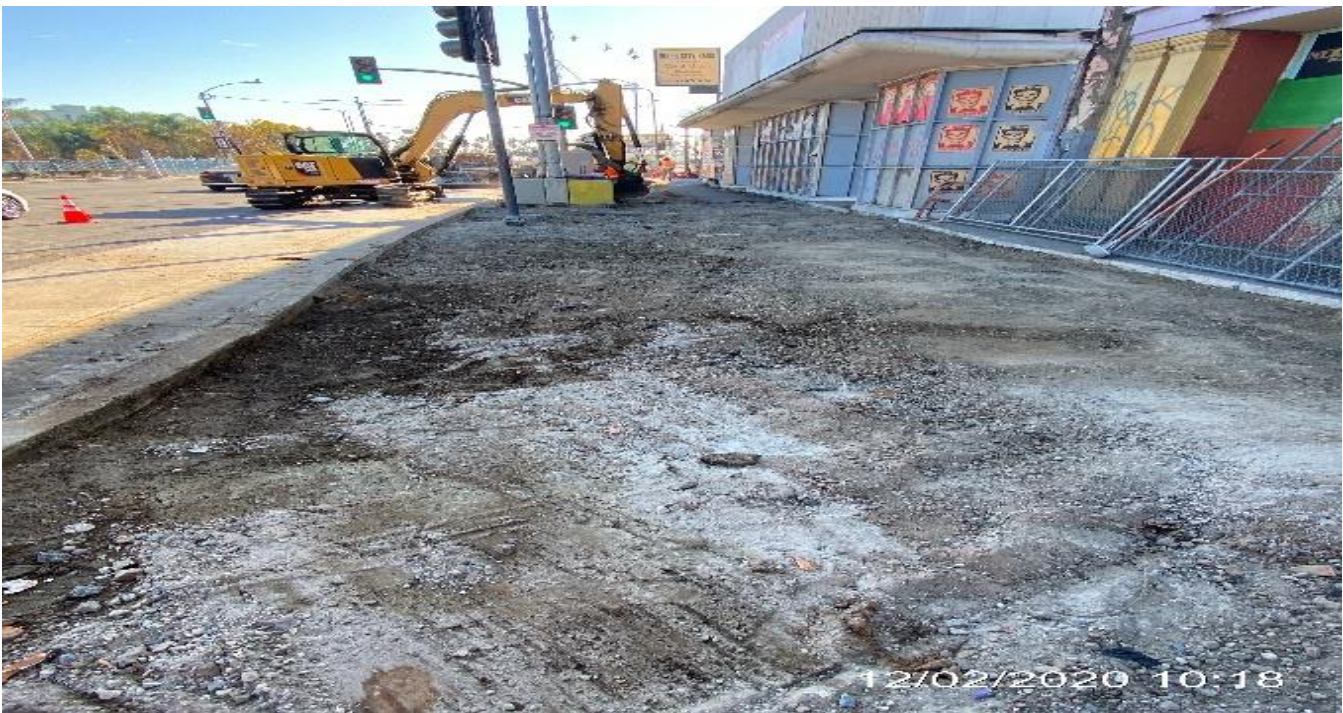
LEIMERT PARK STATION – Excavating/grading the entire sidewalk on southbound Crenshaw Blvd between Vernon Ave and Homeland Dr..

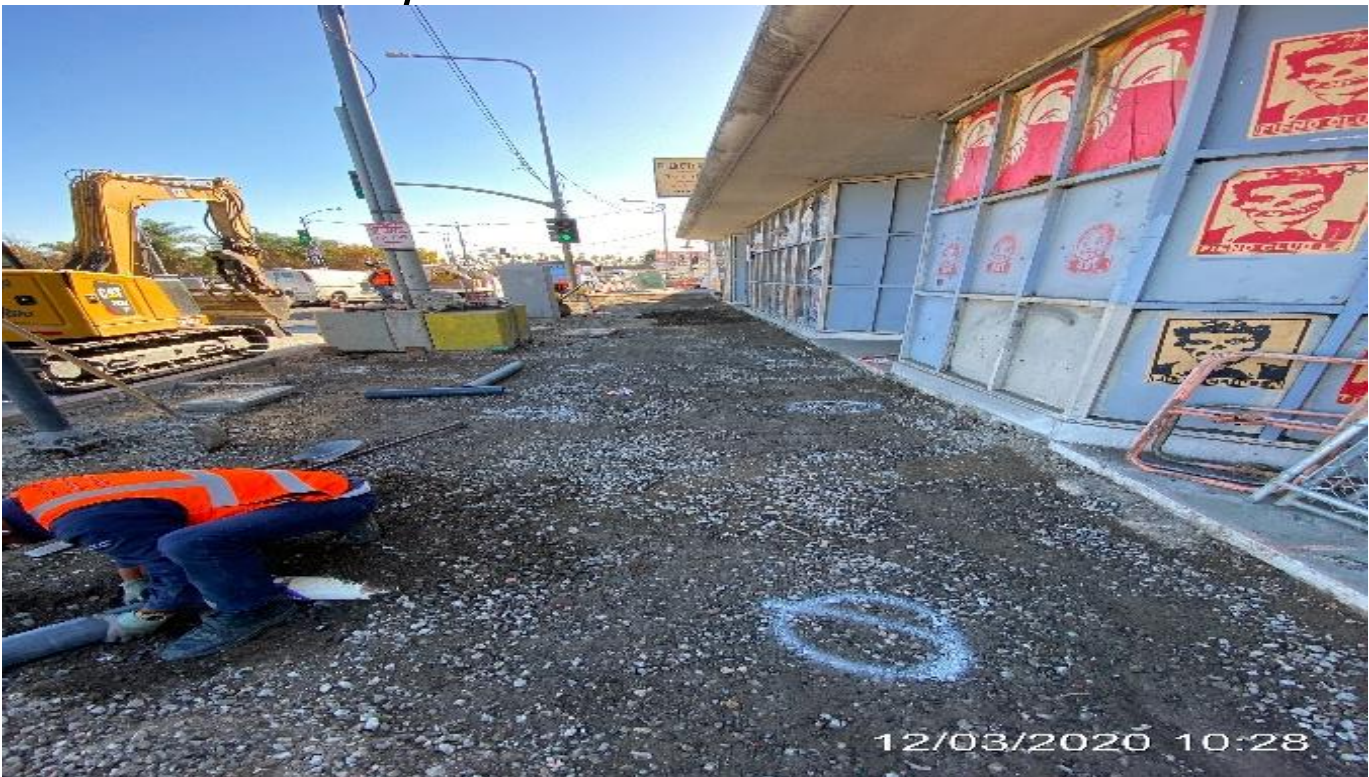
LEIMERT PARK STATION – Continue excavating/grading the entire sidewalk on southbound Crenshaw Blvd between Vernon Ave and Homeland Dr.

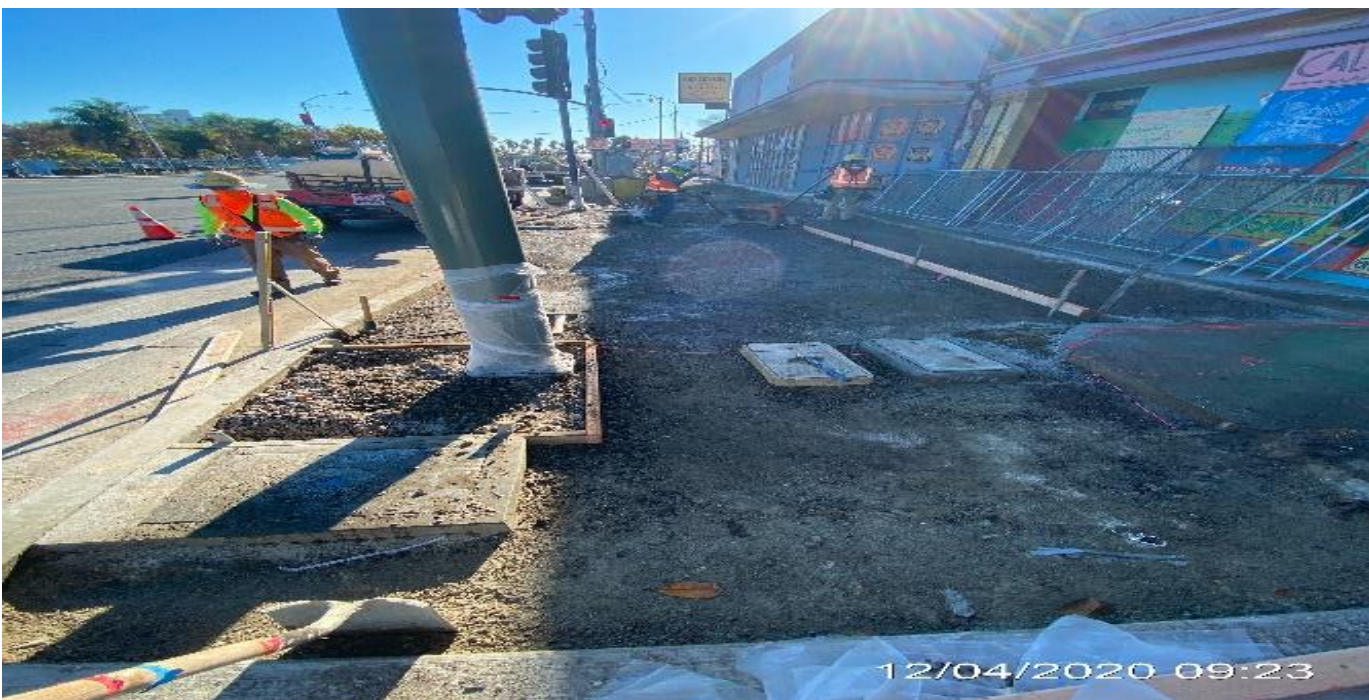
LEIMERT PARK STATION – Placing formwork for entire sidewalk on southbound Crenshaw Blvd between Vernon Ave and Homeland Dr.

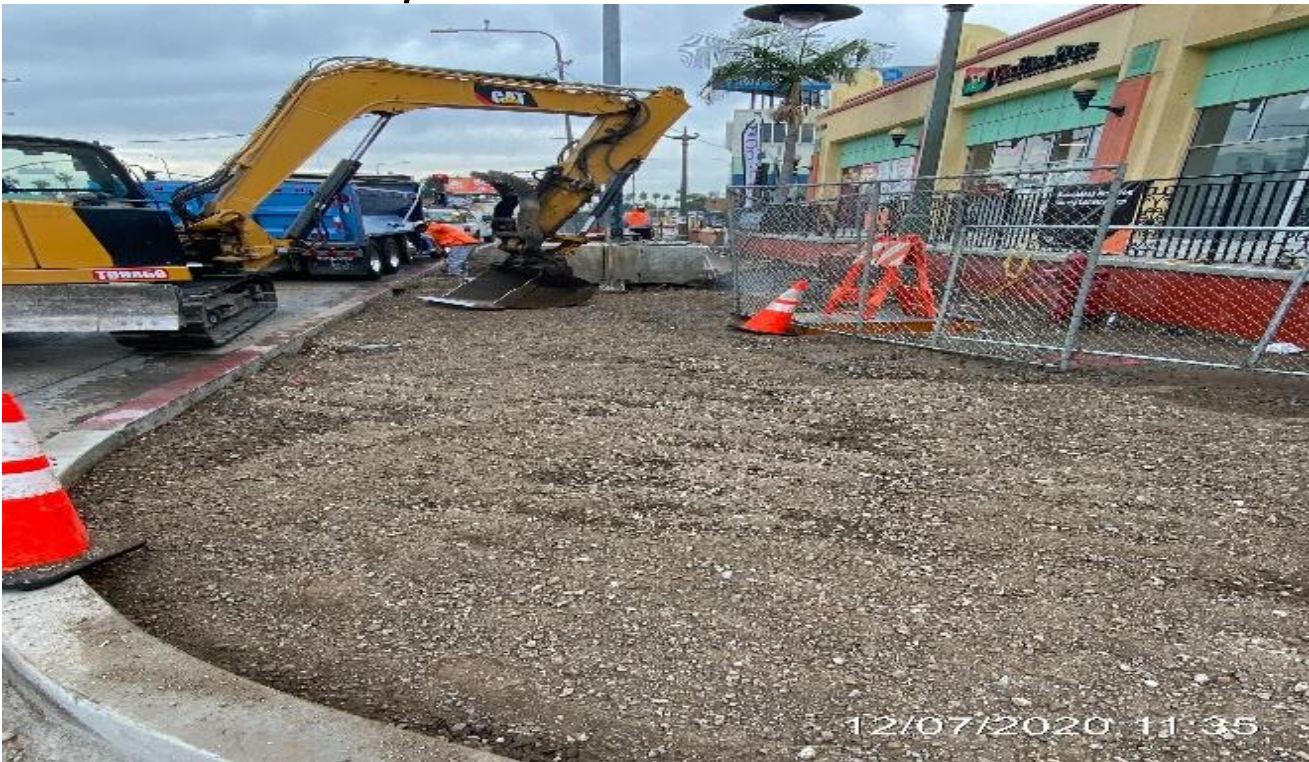
LEIMERT PARK STATION – Backfilling and compacting the entire sidewalk on southbound Crenshaw Blvd between Vernon Ave and Homeland Dr.

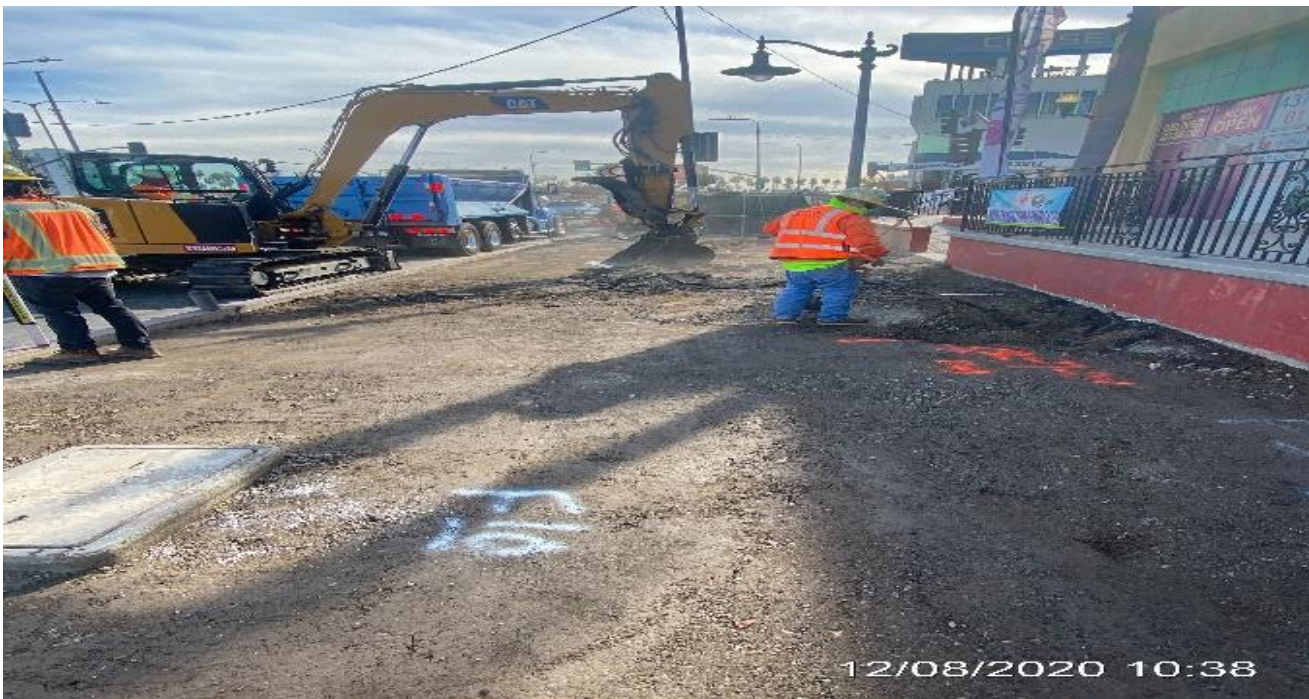
LEIMERT PARK STATION – Continue backfilling and compacting the entire sidewalk on southbound Crenshaw Blvd between Vernon Ave and Homeland Dr.

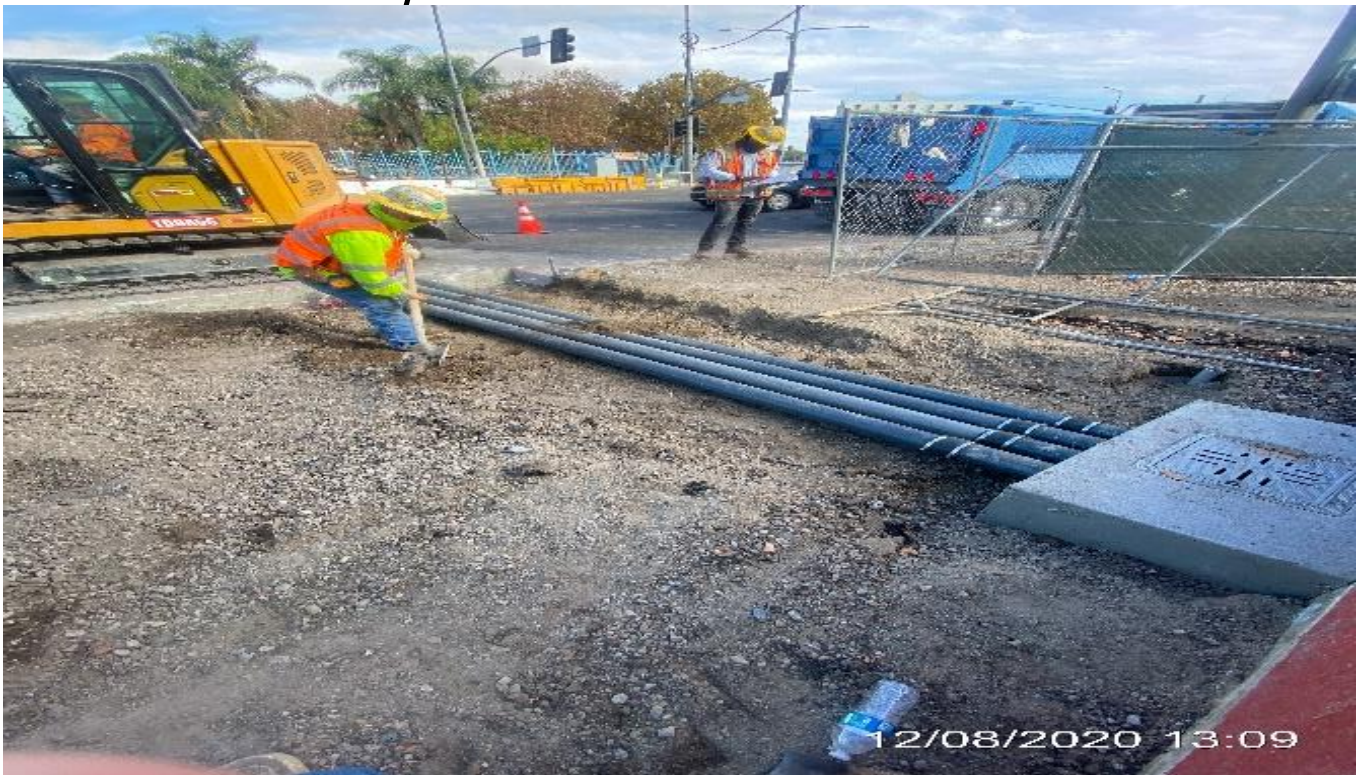
LEIMERT PARK STATION – Installing PVC pipes to the culvert drainage on the northwest corner of Crenshaw Blvd and Vernon Ave.

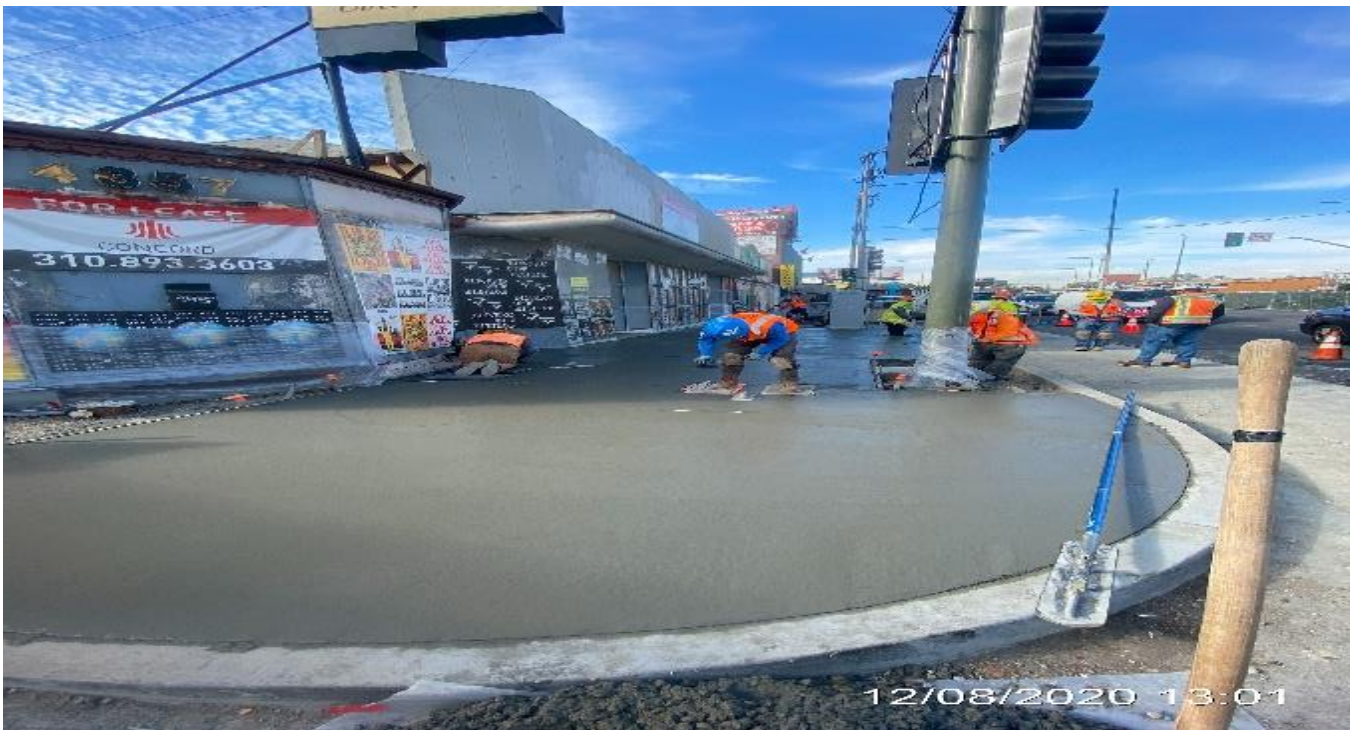
LEIMERT PARK STATION – Placing concrete for the entire sidewalk on southbound Crenshaw Blvd between 43rd Pl and Homeland Dr.

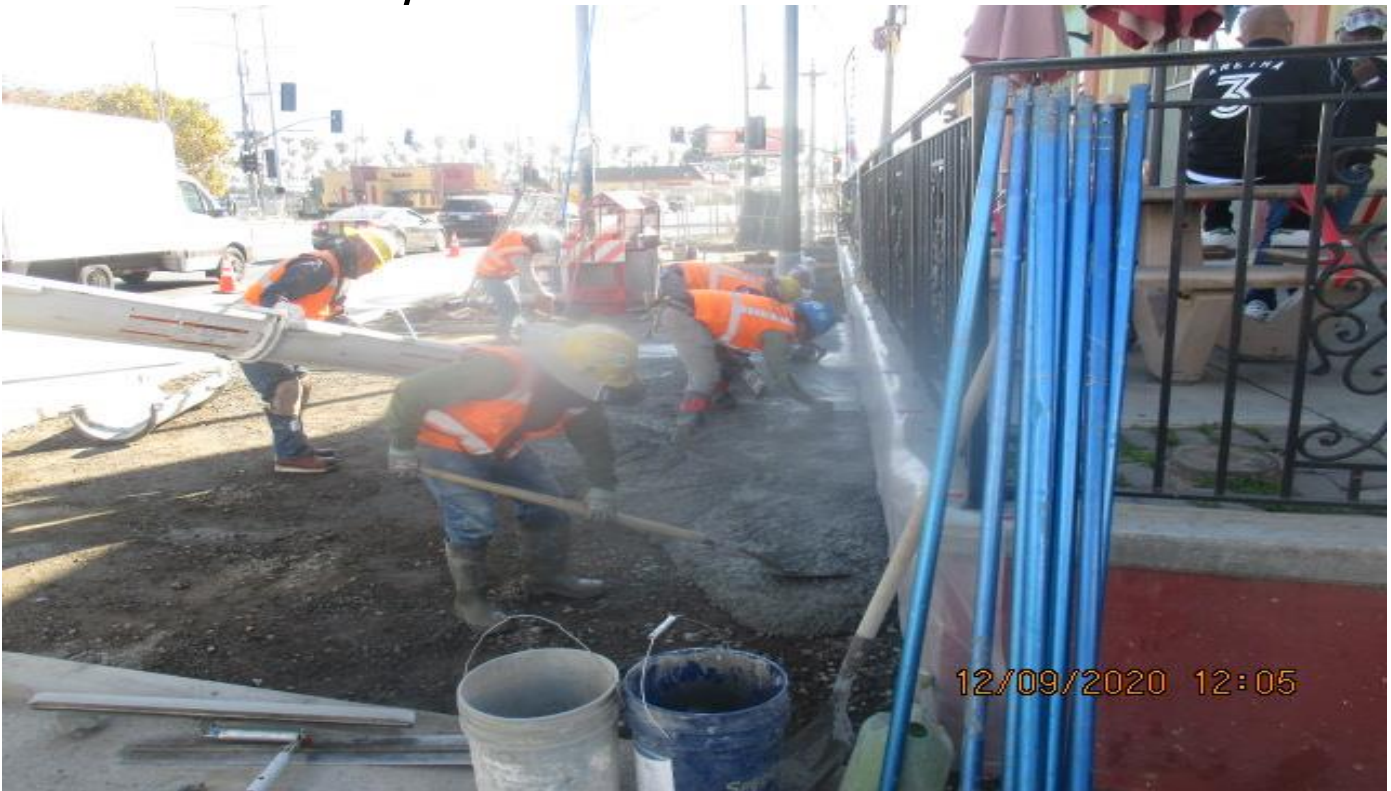
LEIMERT PARK STATION – Placing concrete for the entire sidewalk on southbound Crenshaw Blvd between 43rd Pl and Vernon Ave.

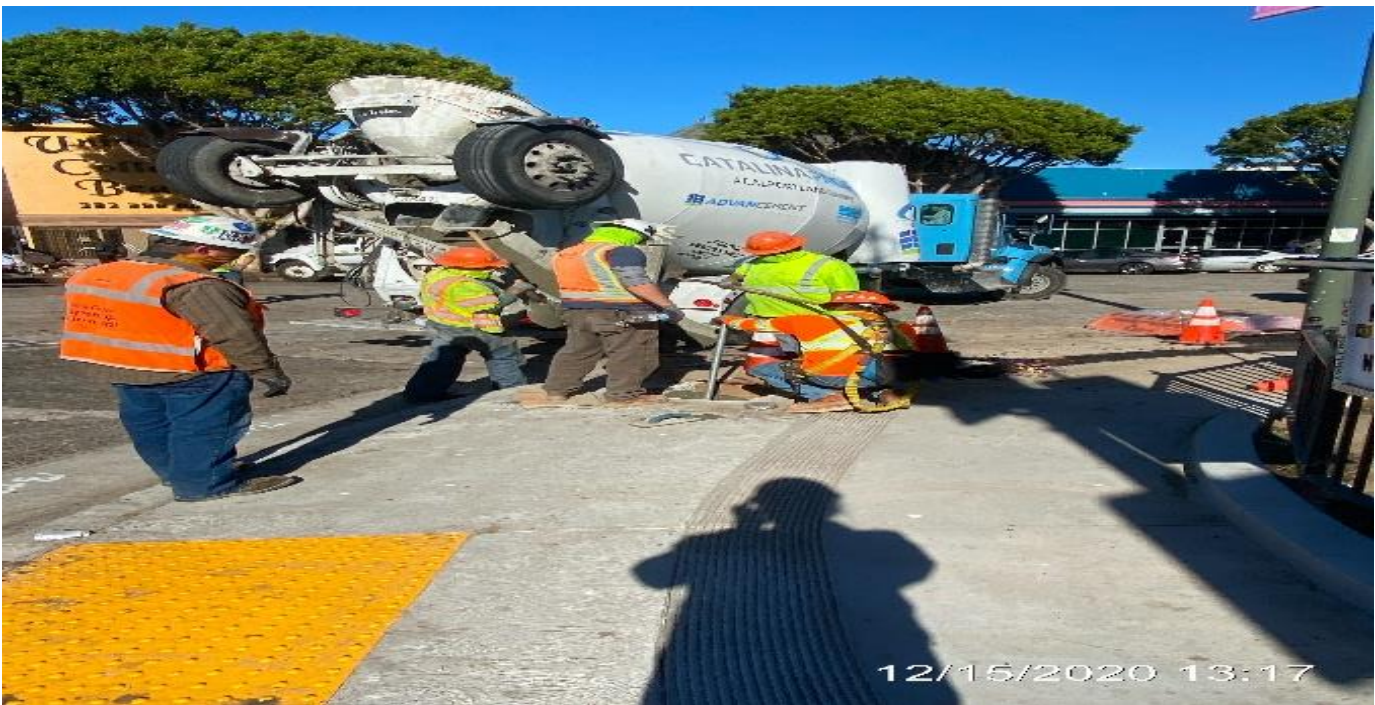
LEIMERT PARK STATION – Placing concrete for street light foundation on the southeast corner of Crenshaw Blvd and 43rd Pl.

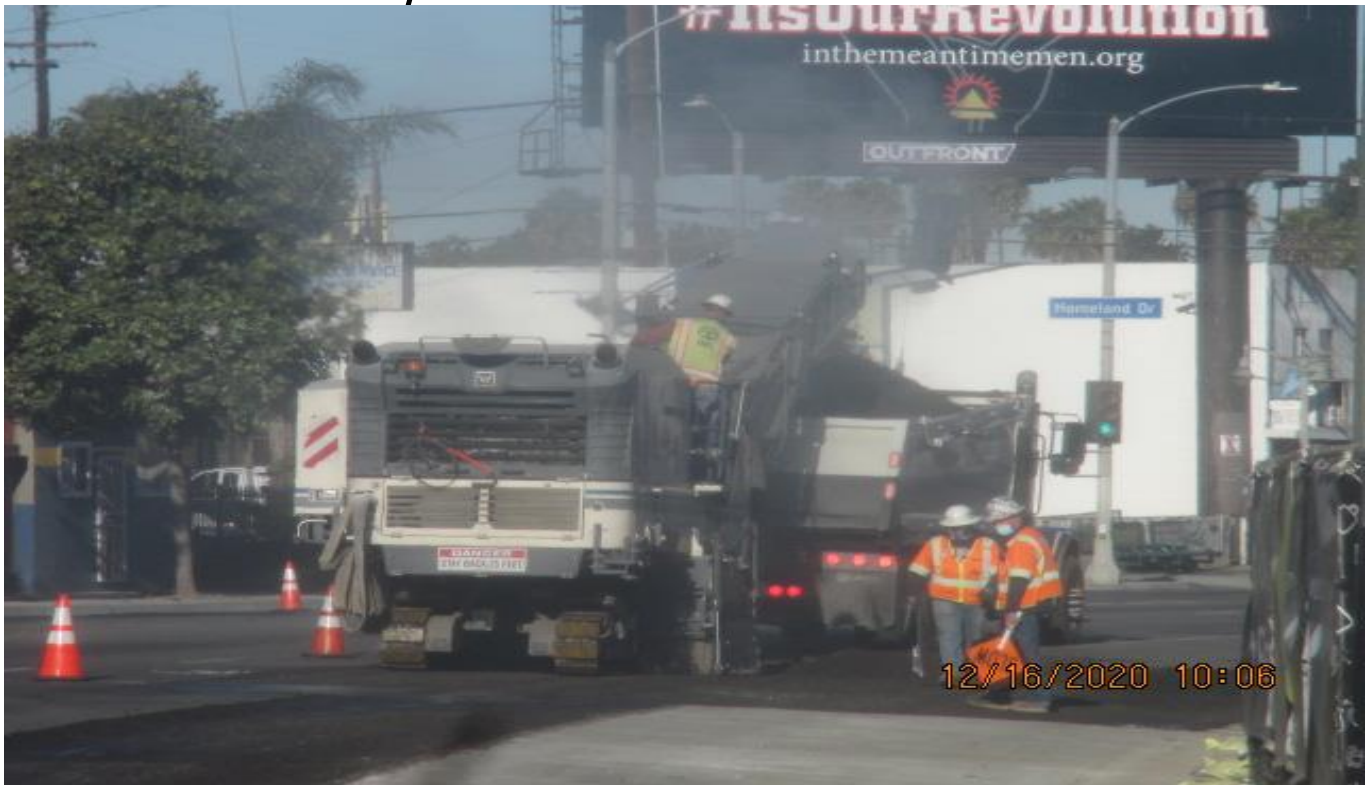
LEIMERT PARK STATION – Placing asphalt concrete along northbound Crenshaw Blvd starting from Vernon Ave and ending at Homeland Dr

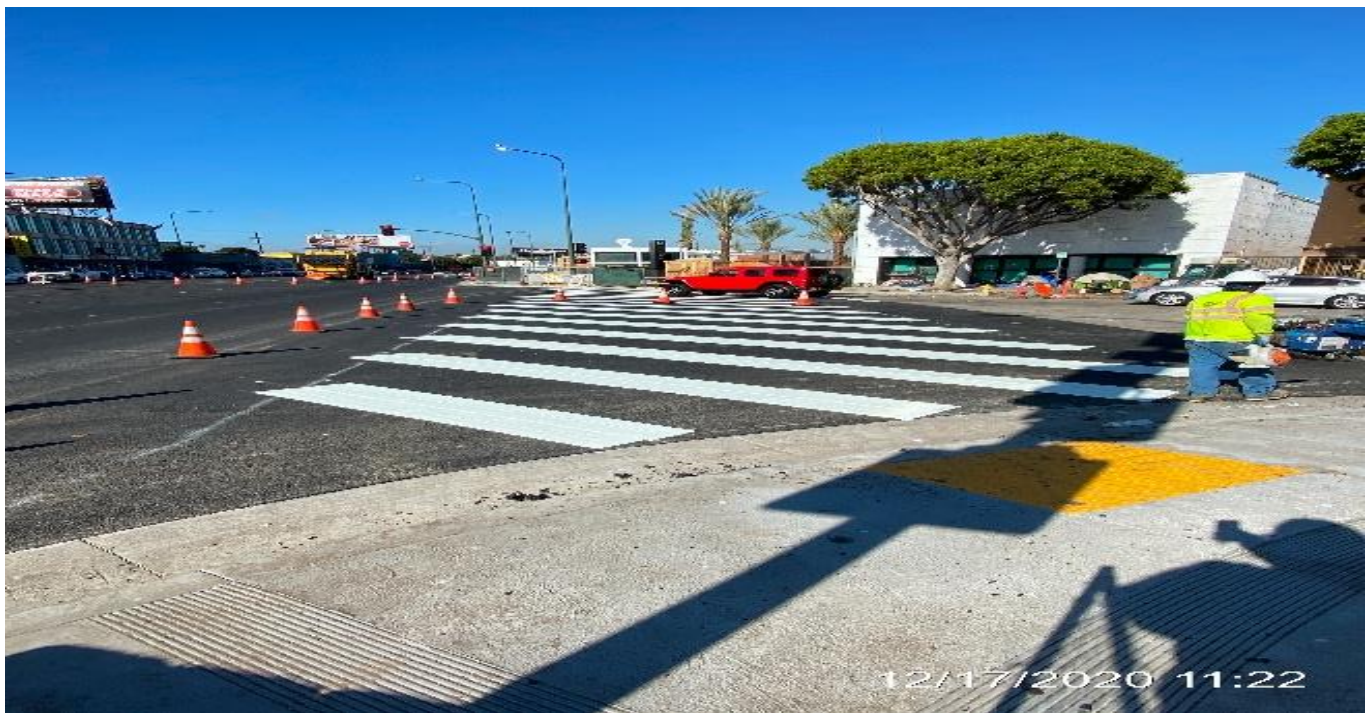
LEIMERT PARK STATION – Placing markings and lane striping along north and southbound Crenshaw Blvd from 48th St and ending at 43rd Pl.

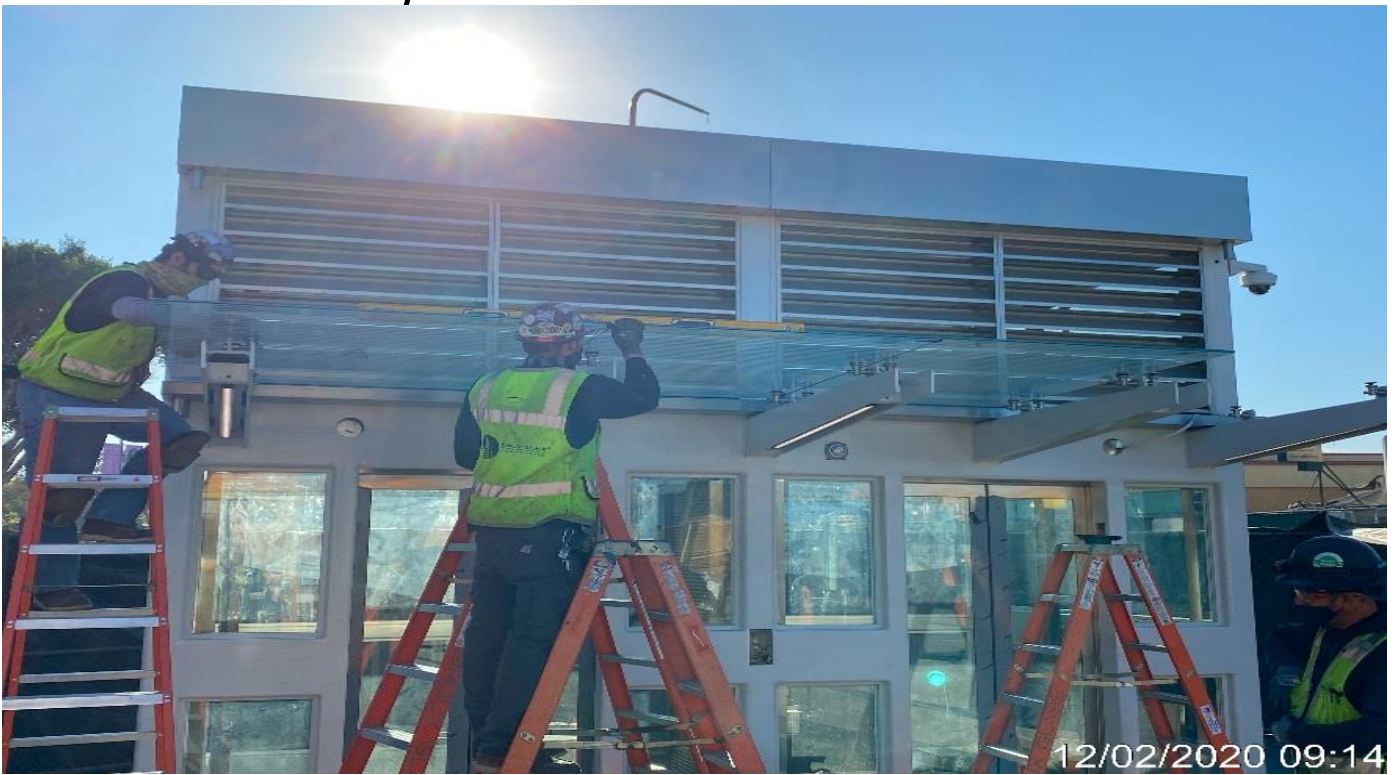
LEIMERT PARK STATION – Installing glass panels to the canopy outriggers of Elevators 1&2 at the plaza.

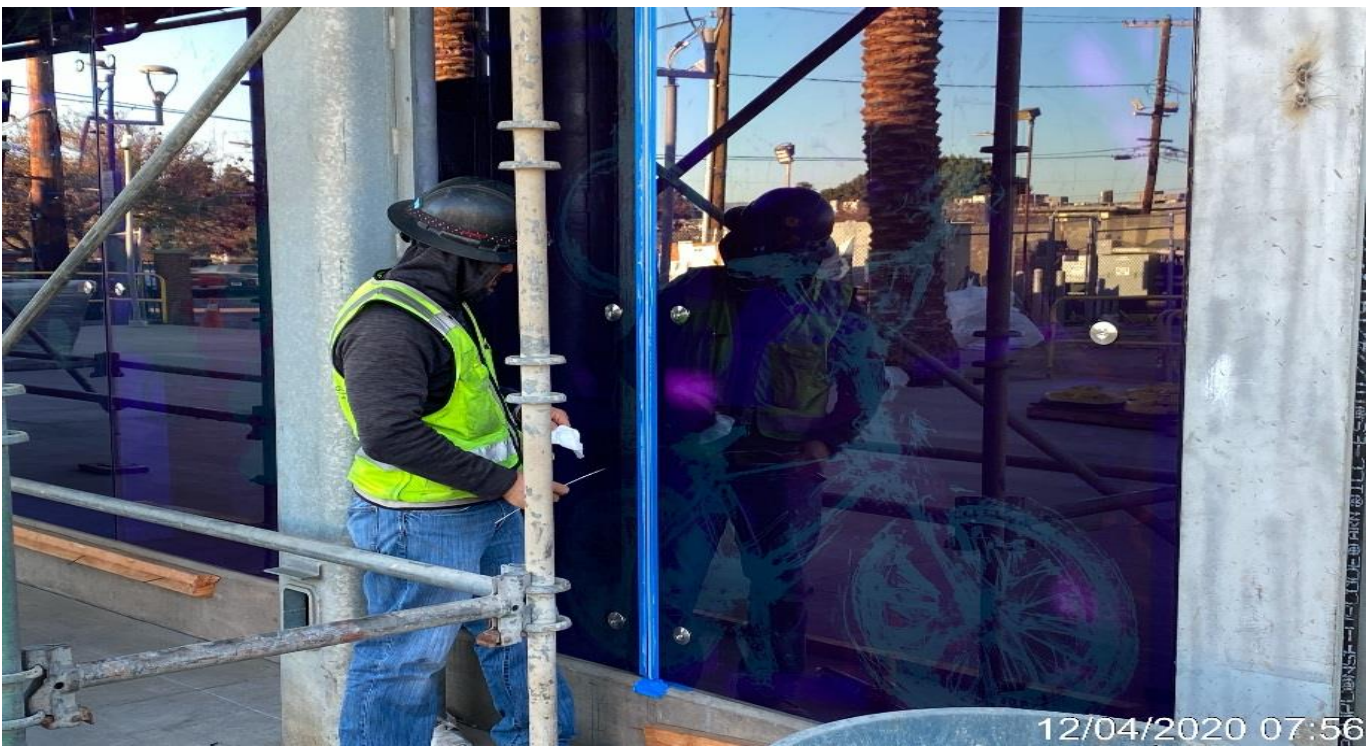
LEIMERT PARK STATION – Caulking and sealing the art glass around the main entrance canopy at the plaza.

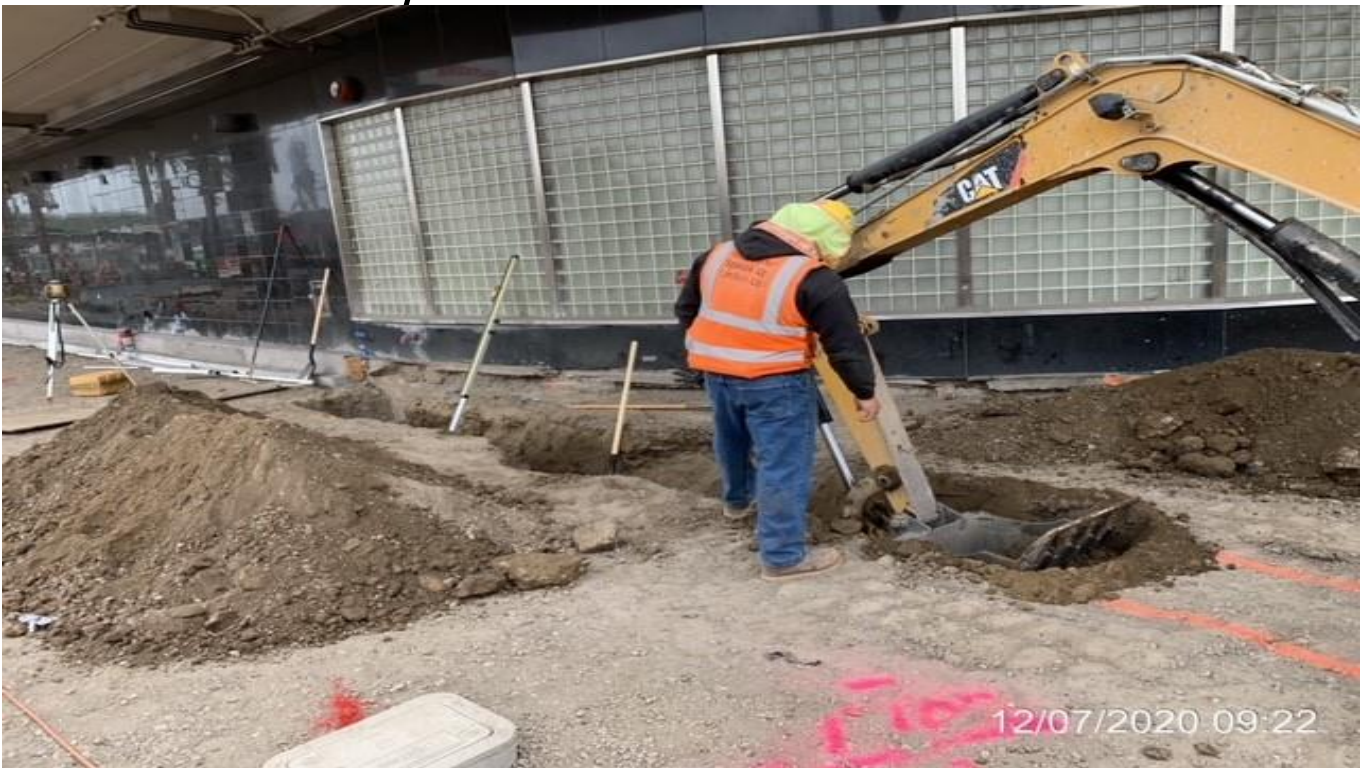
MLK STATION – Excavating/trenching for the Capri gas line installation at the north side of the plaza.

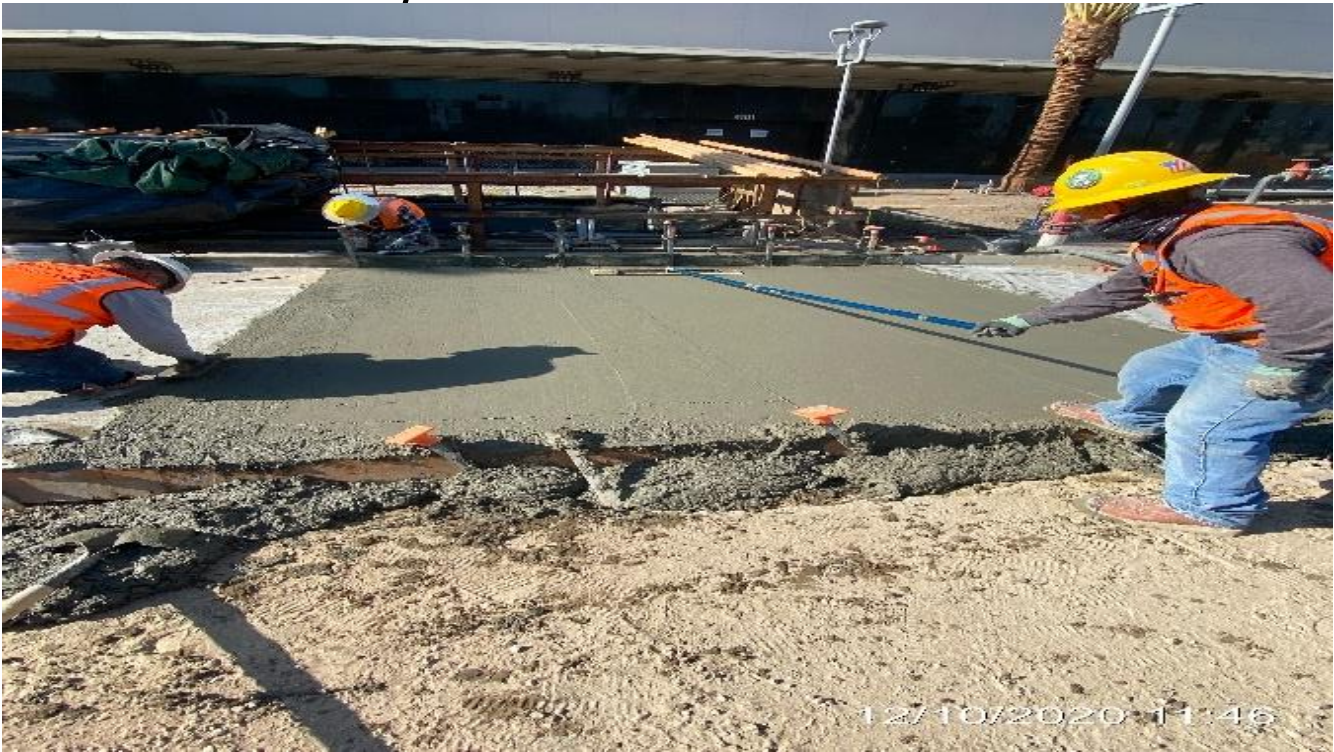
MLK STATION – Built formwork and placed concrete for bus pad along the east side of the plaza.

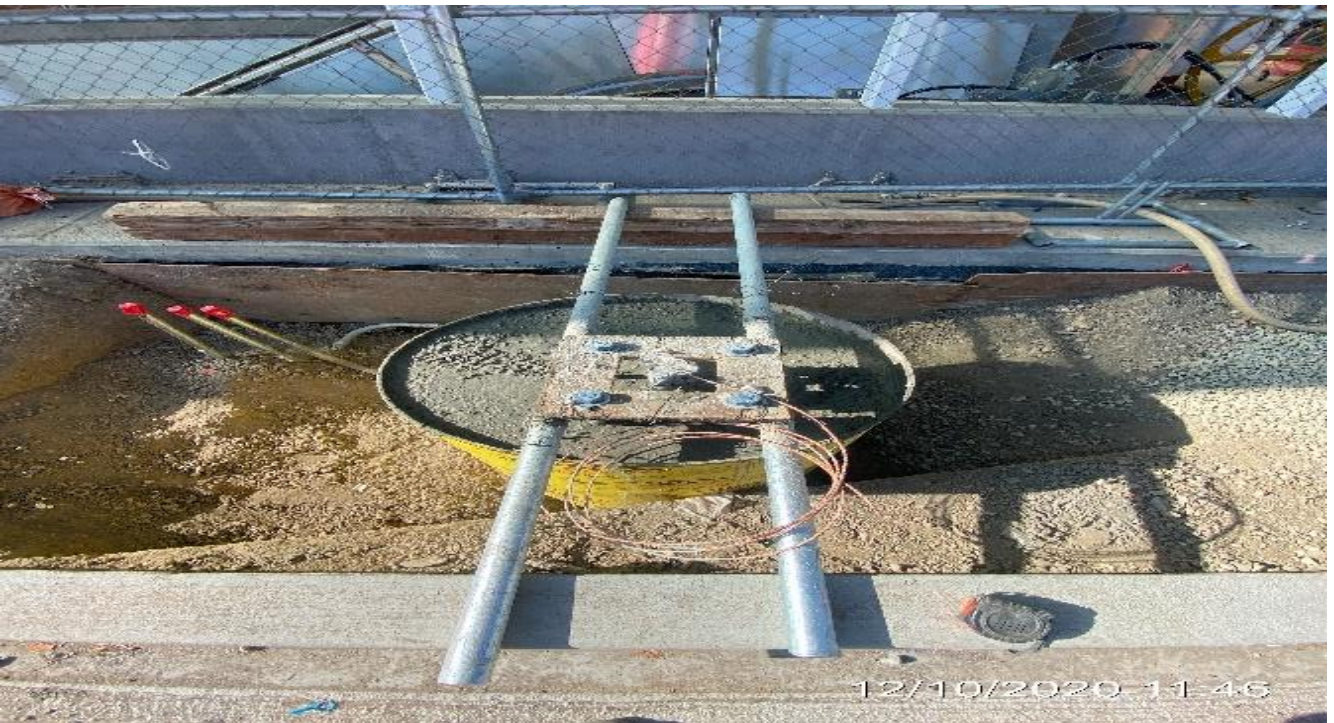
MLK STATION – Placed concrete for street light foundations along the east side of the plaza.

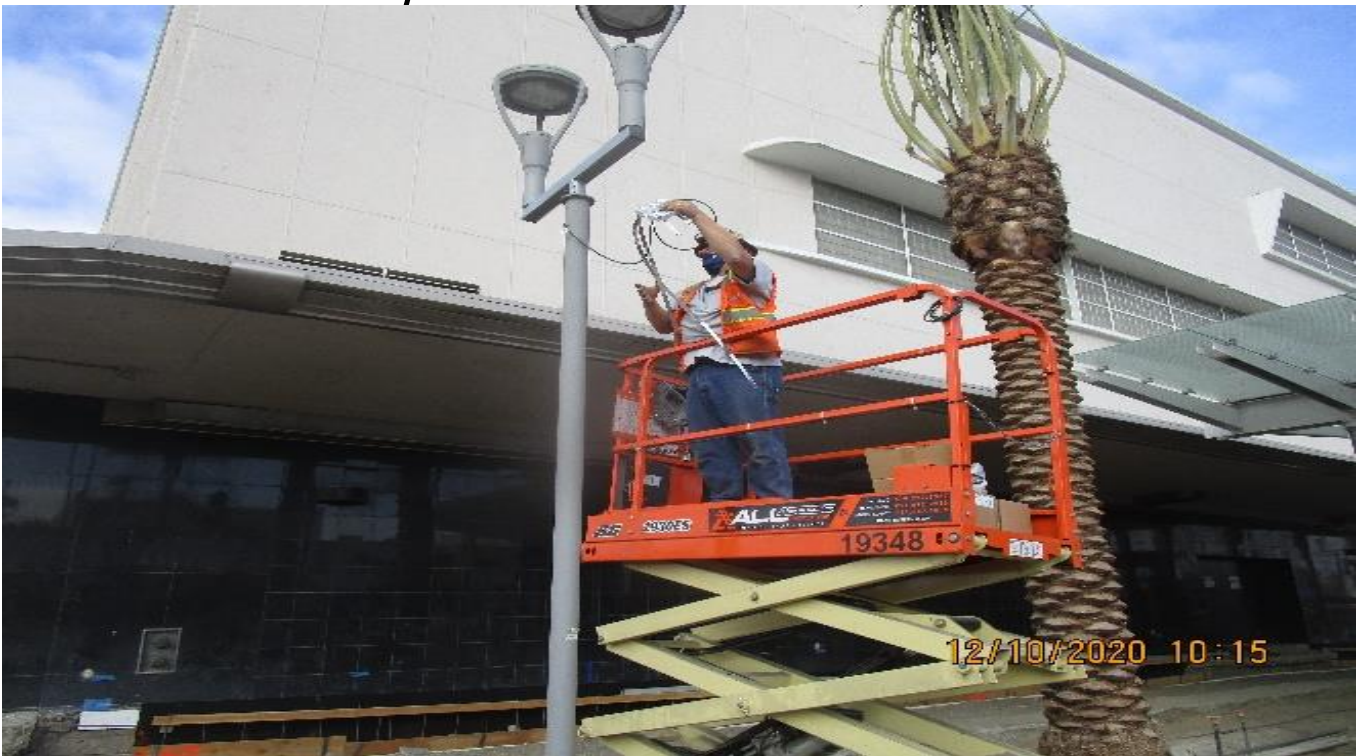
MLK STATION – Installing CCTV support brackets to the pedestrian light poles at the plaza.

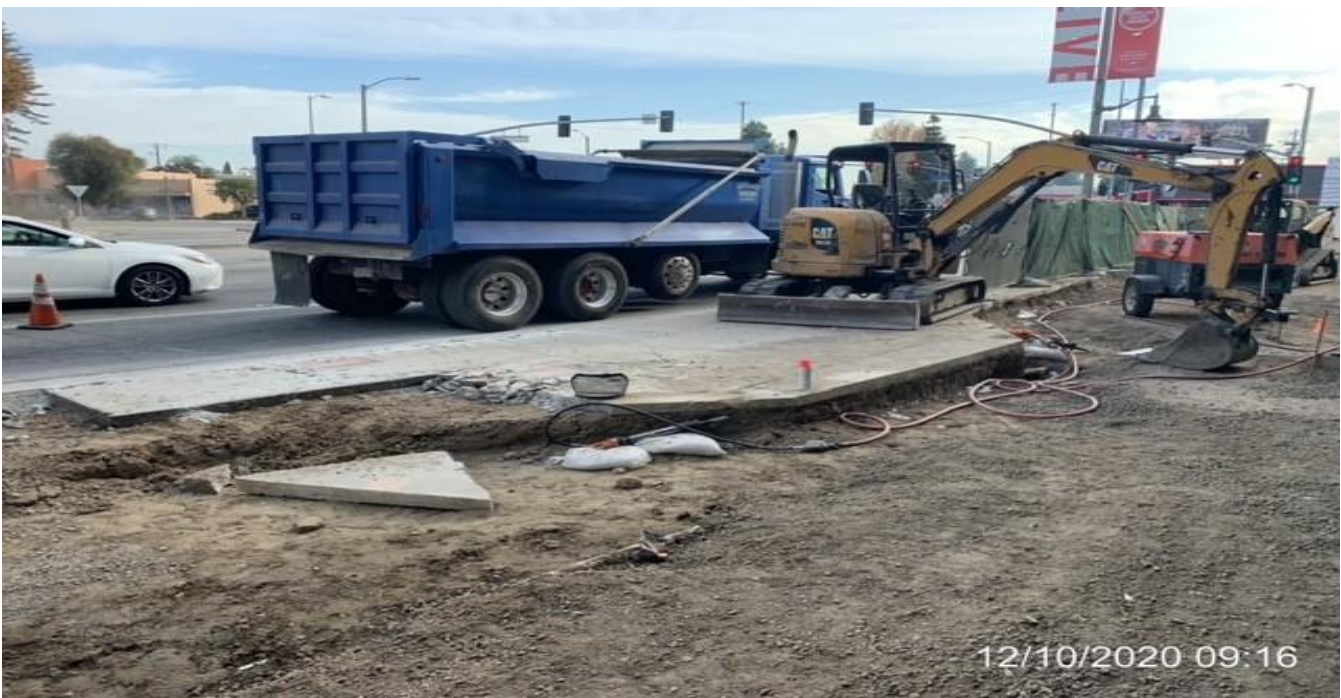
MLK STATION – Demolishing and removing remaining sidewalk sections at the far northwest area of the plaza.

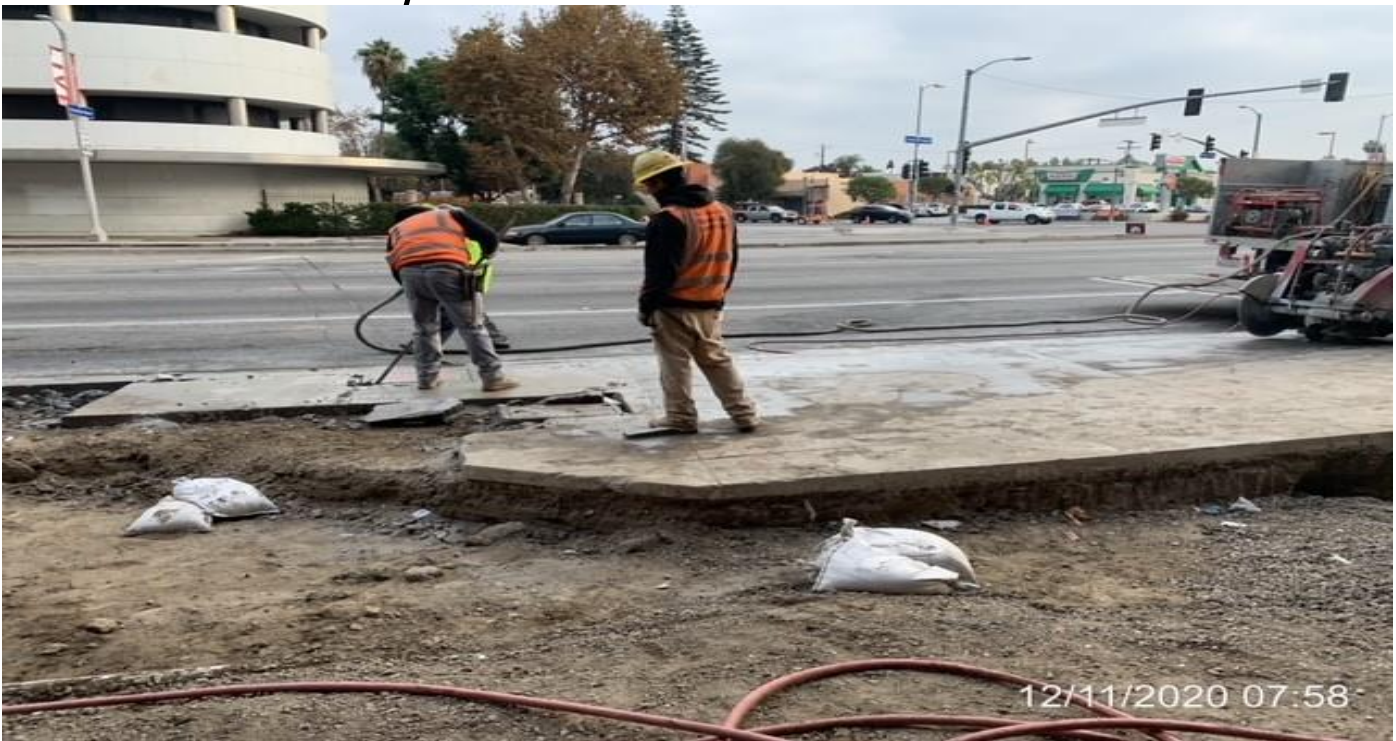
MLK STATION – Continue demolishing and removing remaining sidewalk sections at the far northwest area of the plaza.

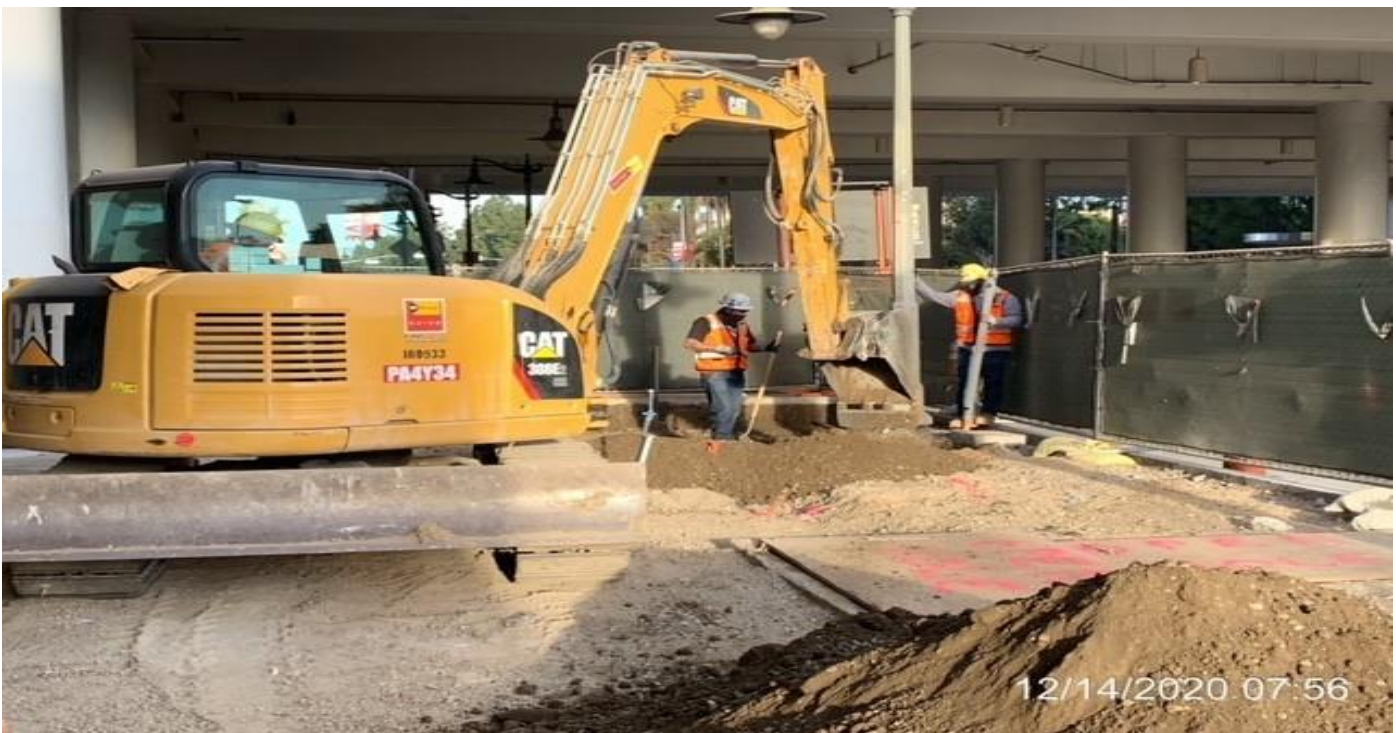
MLK STATION – Continue removing remaining sidewalk and grading the far northwest area of the plaza.

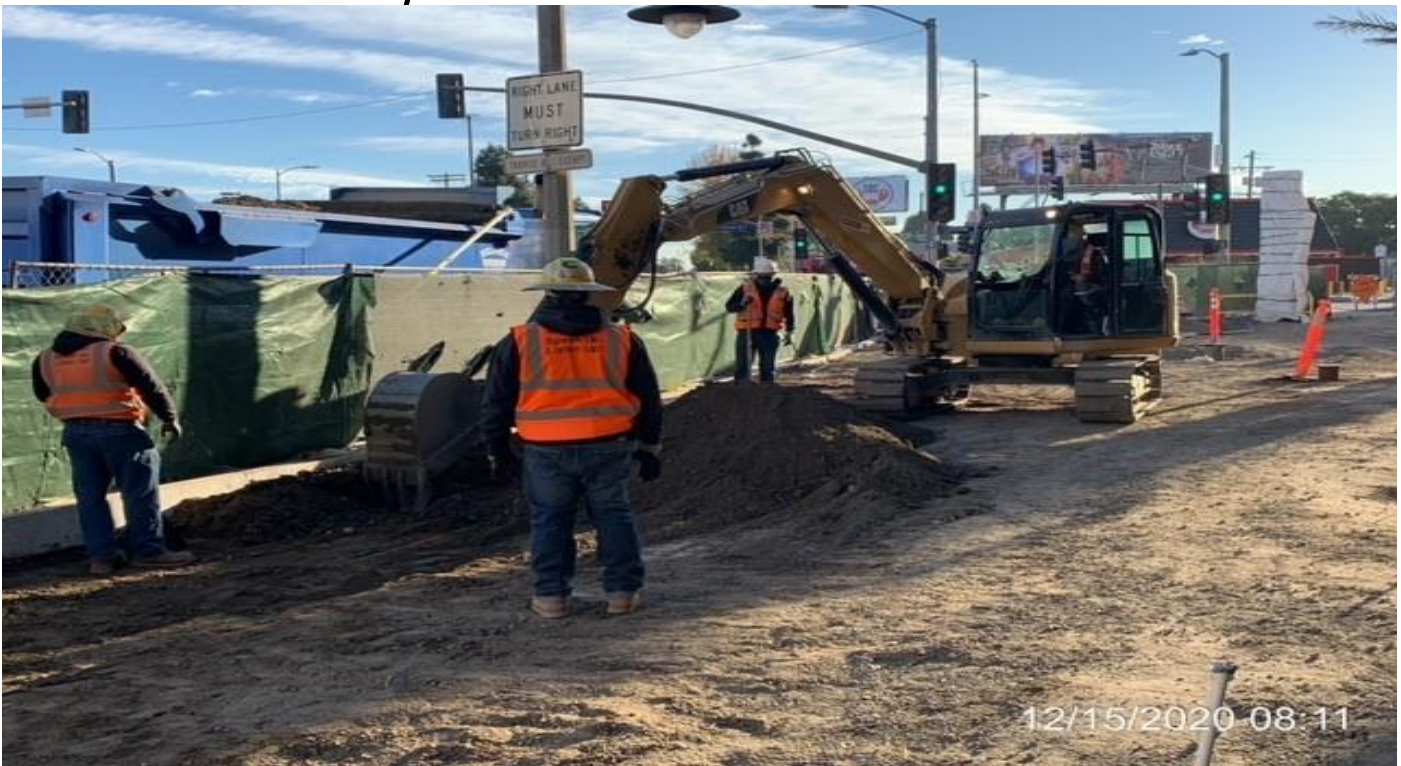
MLK STATION – Continue grading and compacting the far northwest area of the plaza.
