# CRENSHAW/LAX PHOTOGRAPHIC UPDATE

Dec 30, 2020

## Crenshaw/LAX Transit Project

Overview of trackwork progress issues for 11/30/2020 – 12/15/2020  
(Please note the attached Trackwork Progress Tracking Report)

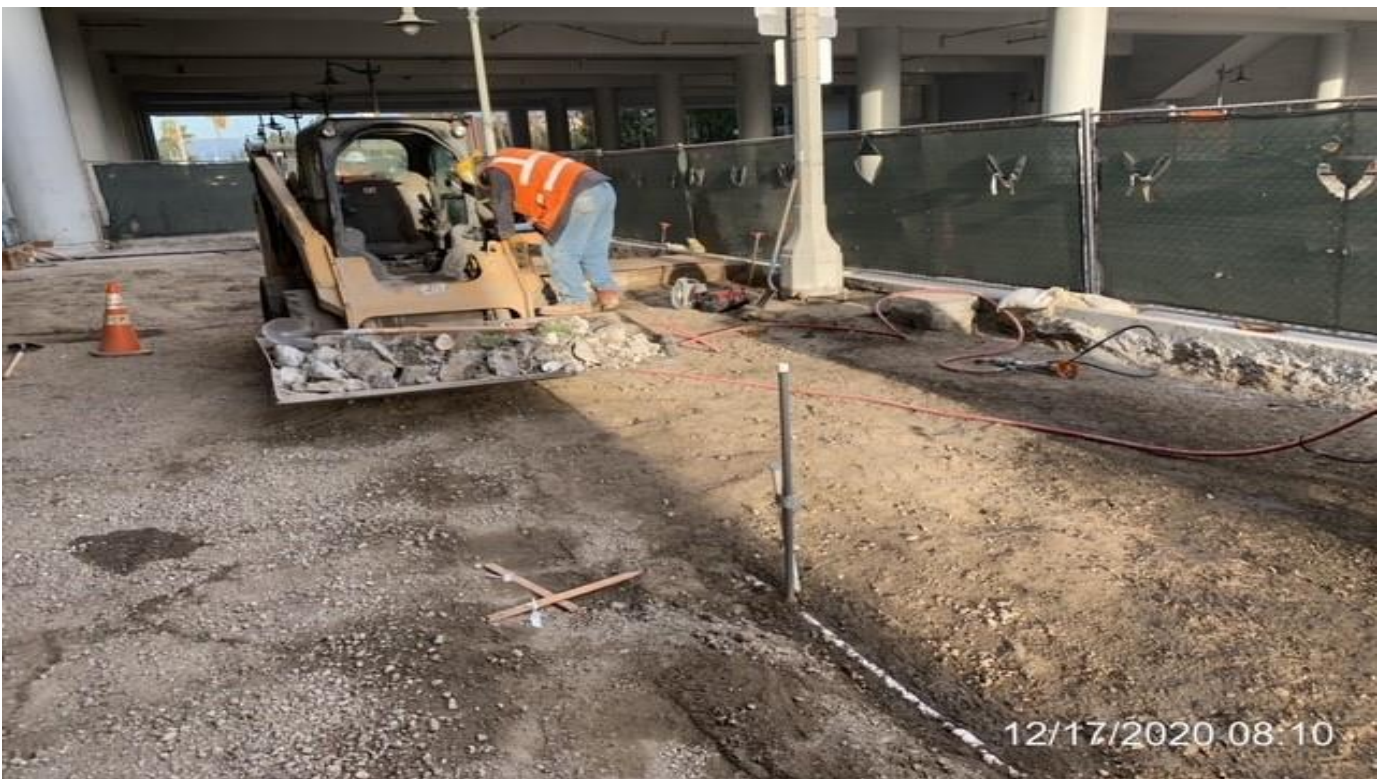
MLK STATION – Continue grading and compacting the far northwest area of the plaza.

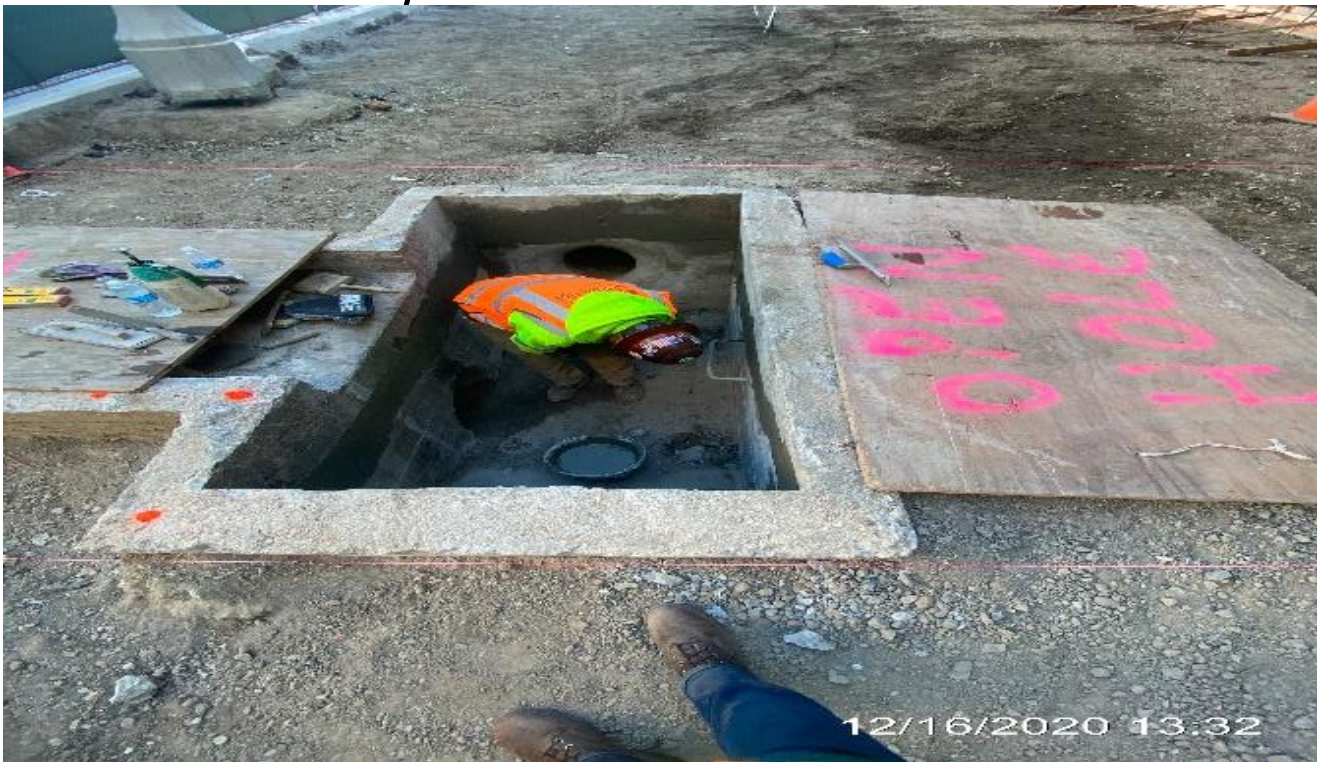
MLK STATION – Sacking and patching Catch Basin 3 on the northeast side of the plaza.

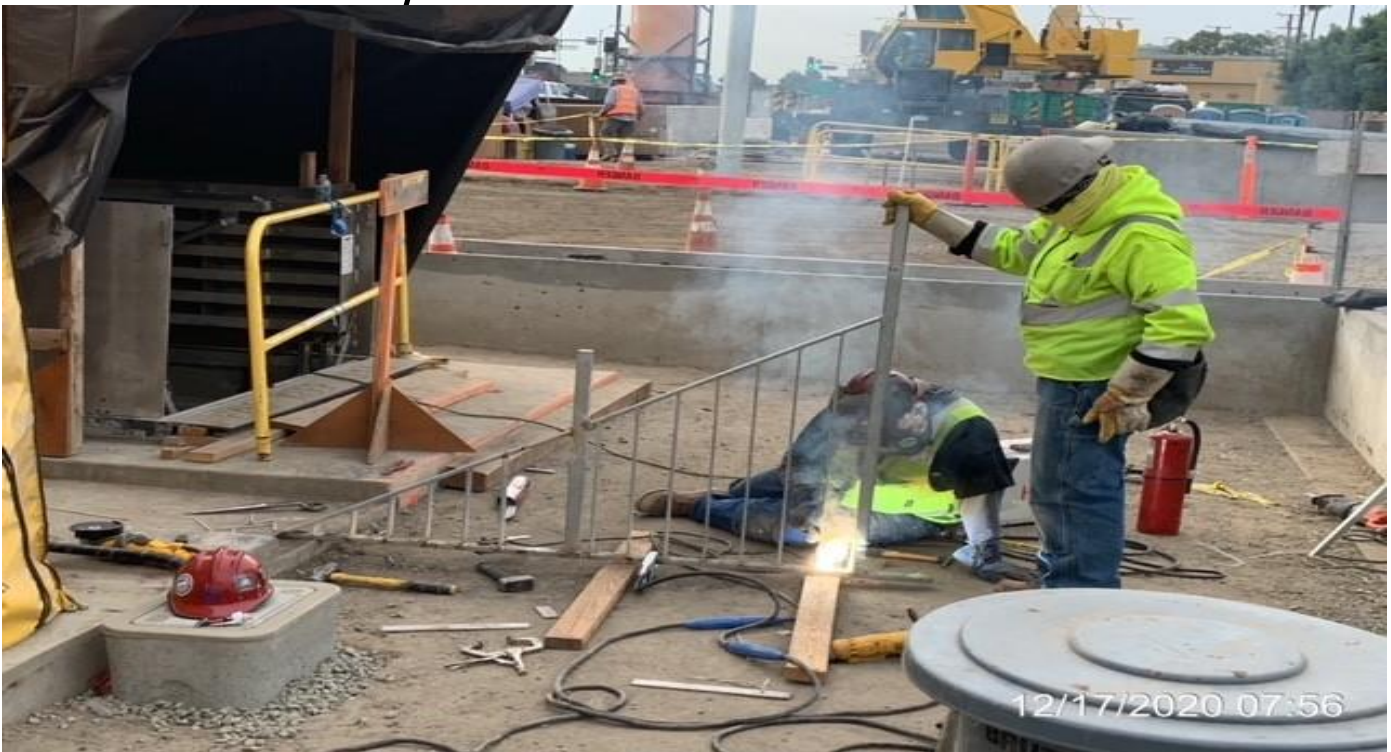
MLK STATION – Fabricating guardrails at the plaza to continue installation throughout Emergency Exit Stair South 2.

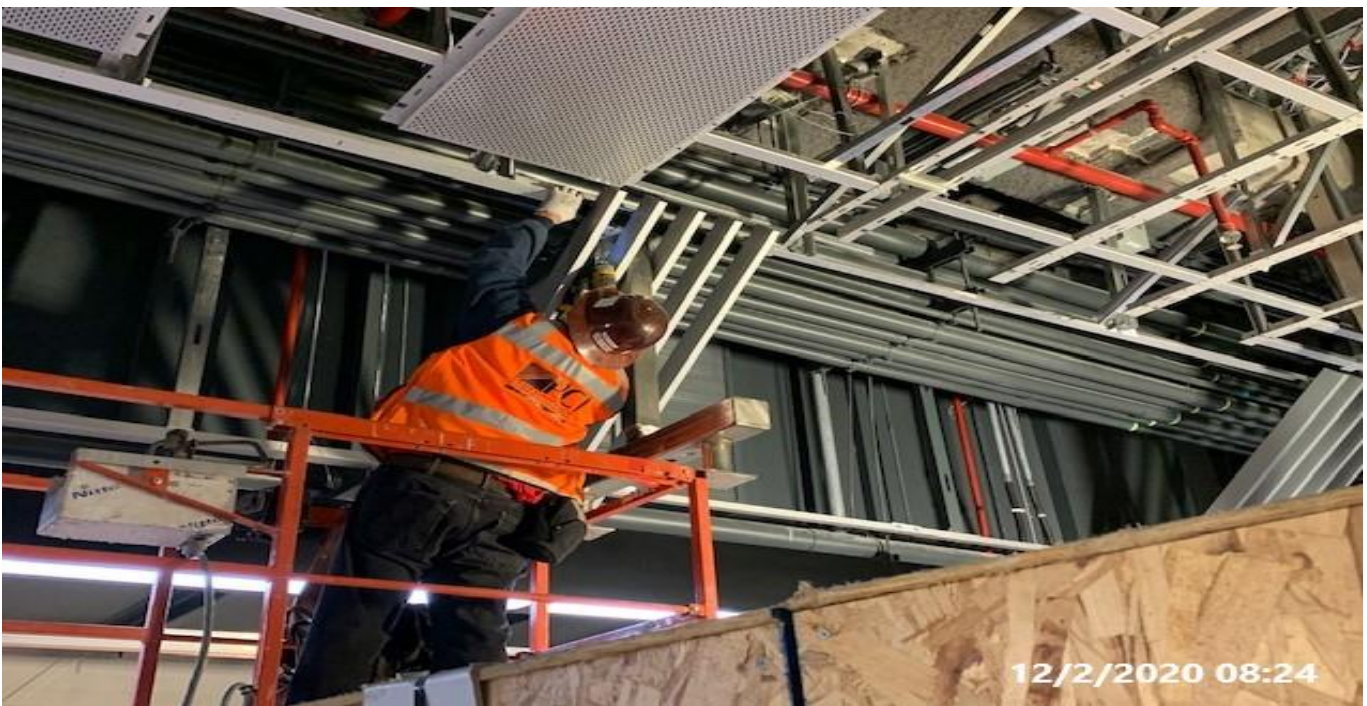
MLK STATION – Installing diagonal screen ceiling panels along the northbound side of the platform.

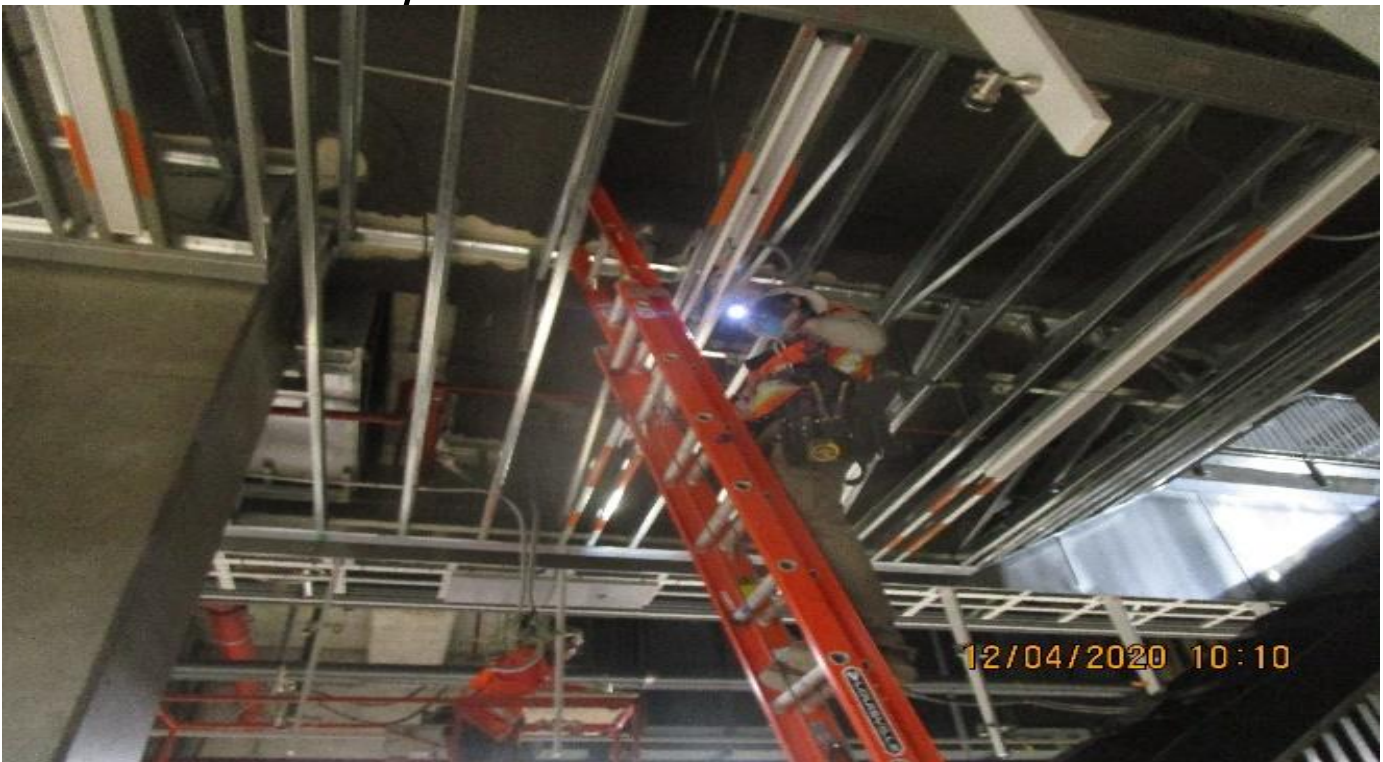
MLK STATION – Installing LED light fixtures above Escalator 3 and Staircase 2 at the platform.

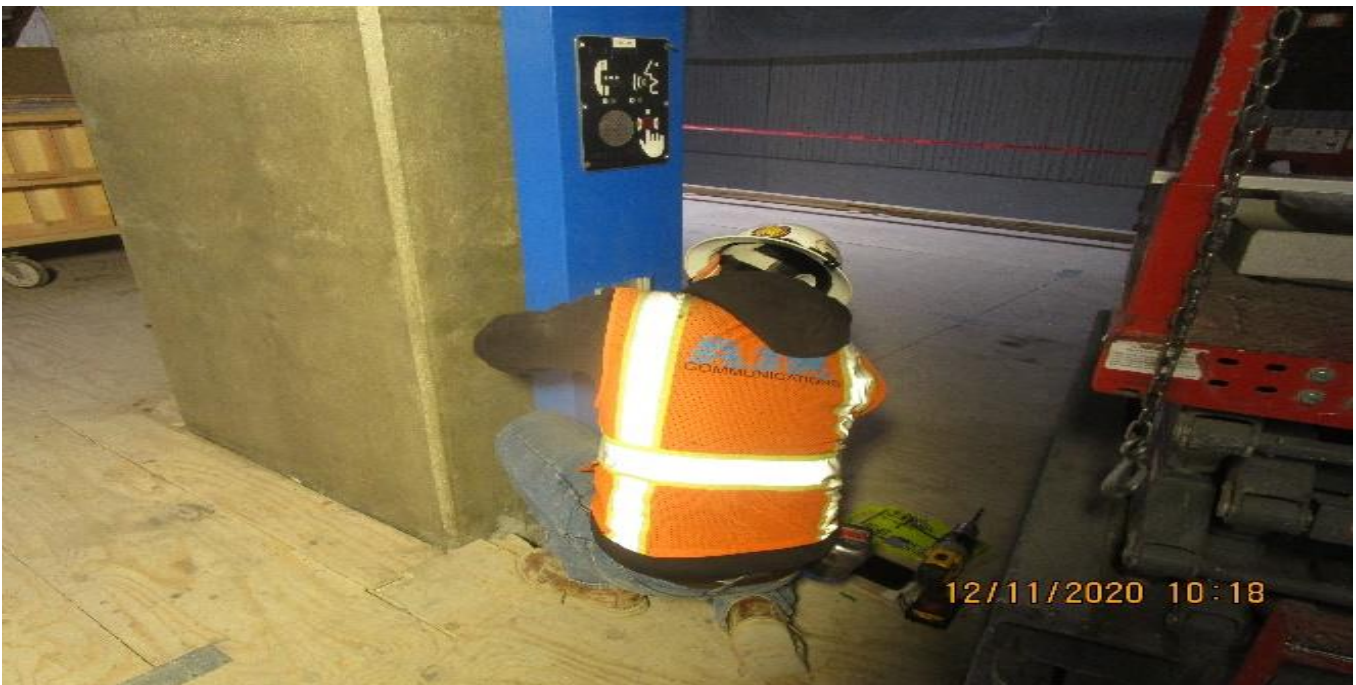
MLK STATION – Drilled and anchored passenger telephone pedestal at the north end of the platform.

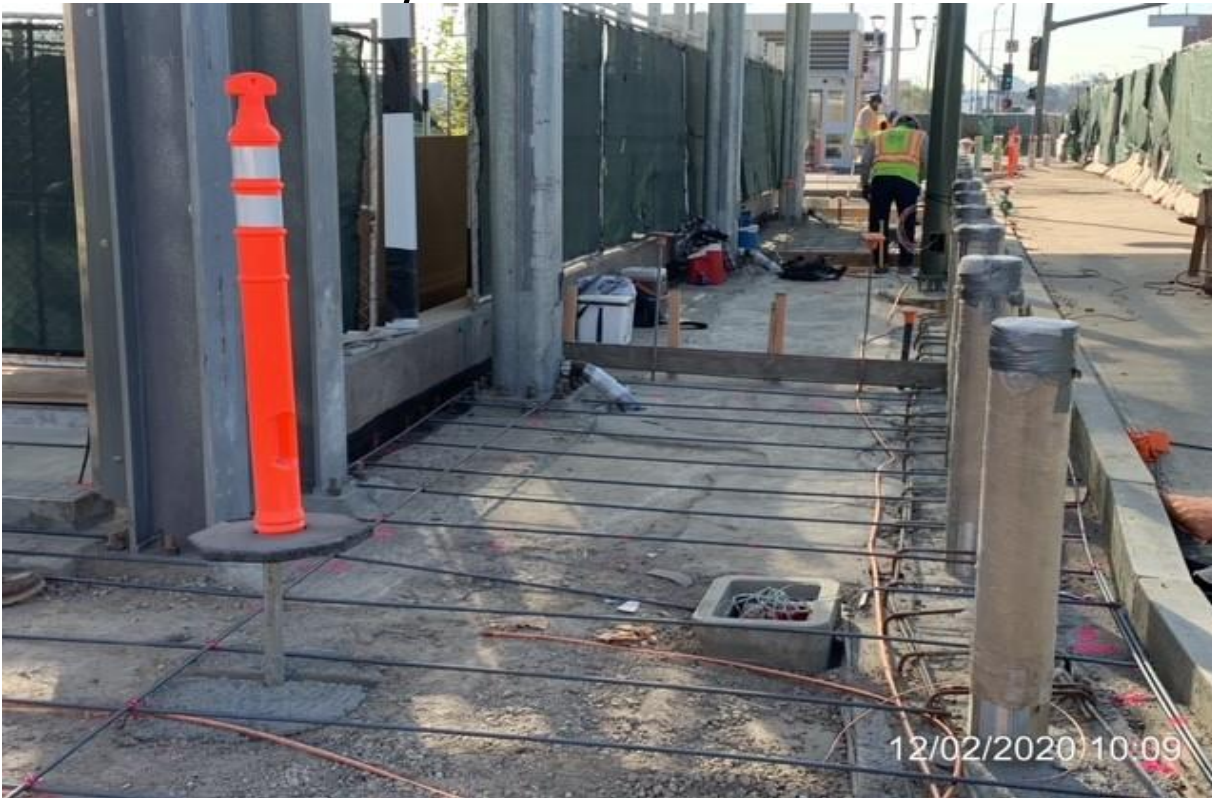
EXPO STATION– Dean Visosky setting rebar reinforcement for concrete slab.

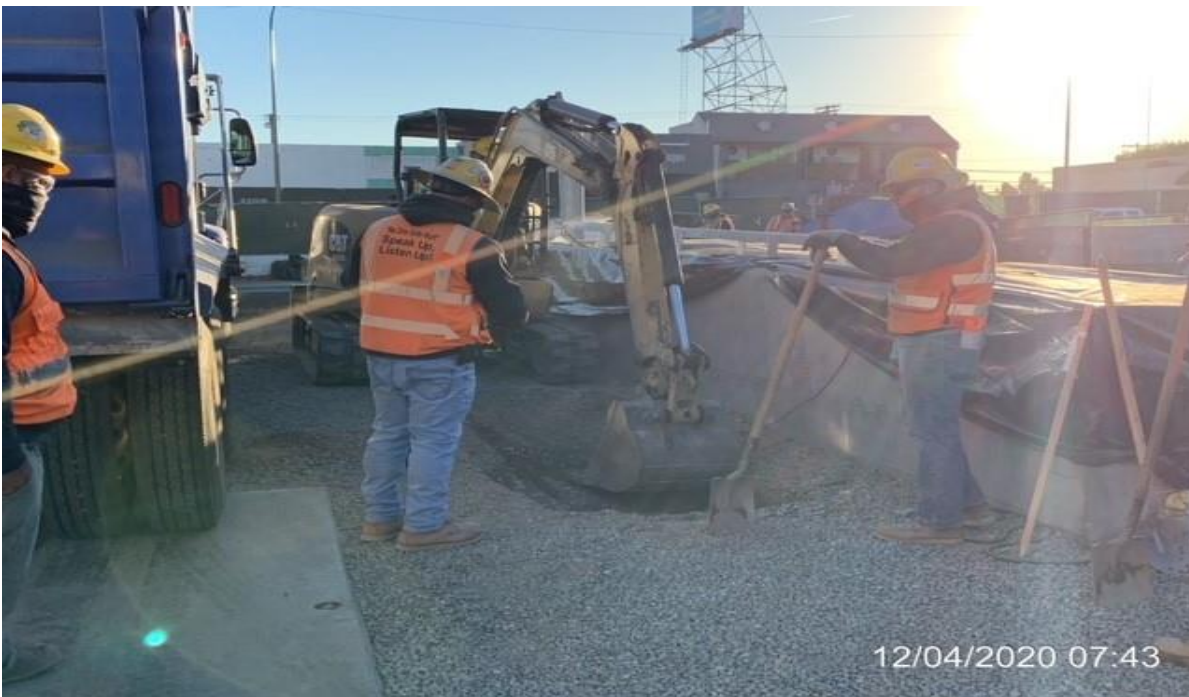
EXPO STATION– WSCC crew excavating for curb and gutter of service road.

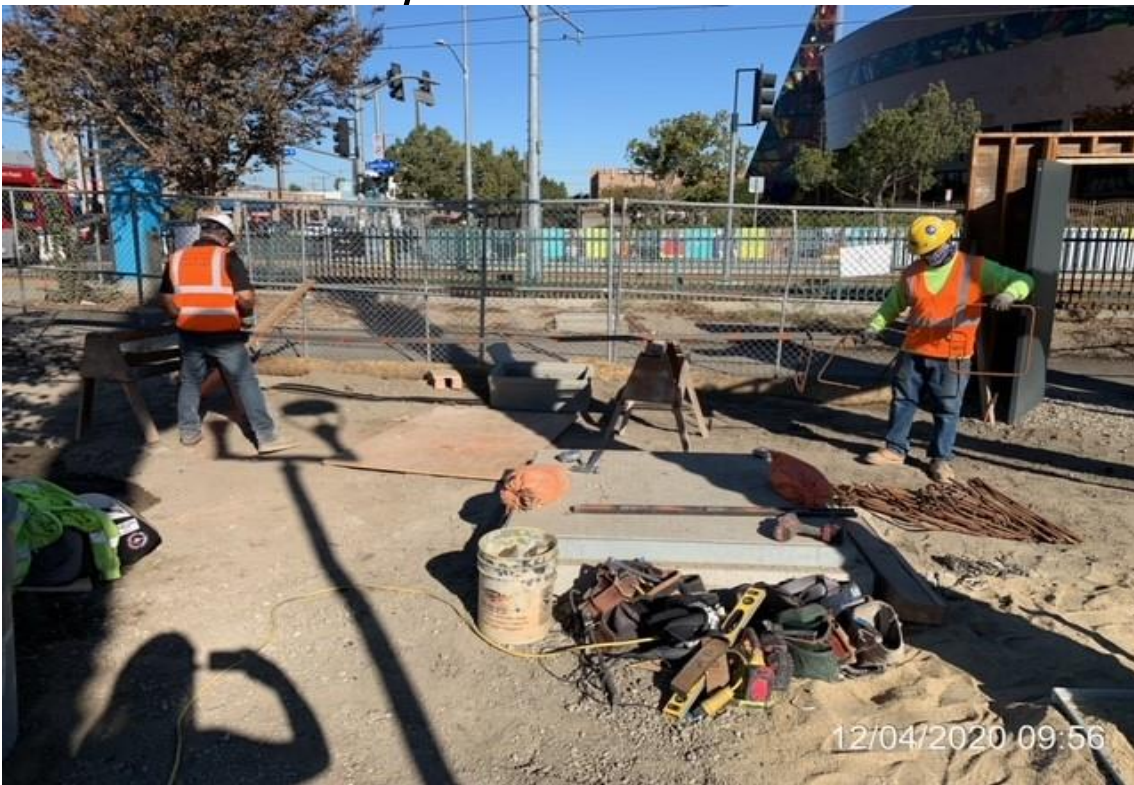
EXPO STATION – WSCC carpenters building formwork for bollards.

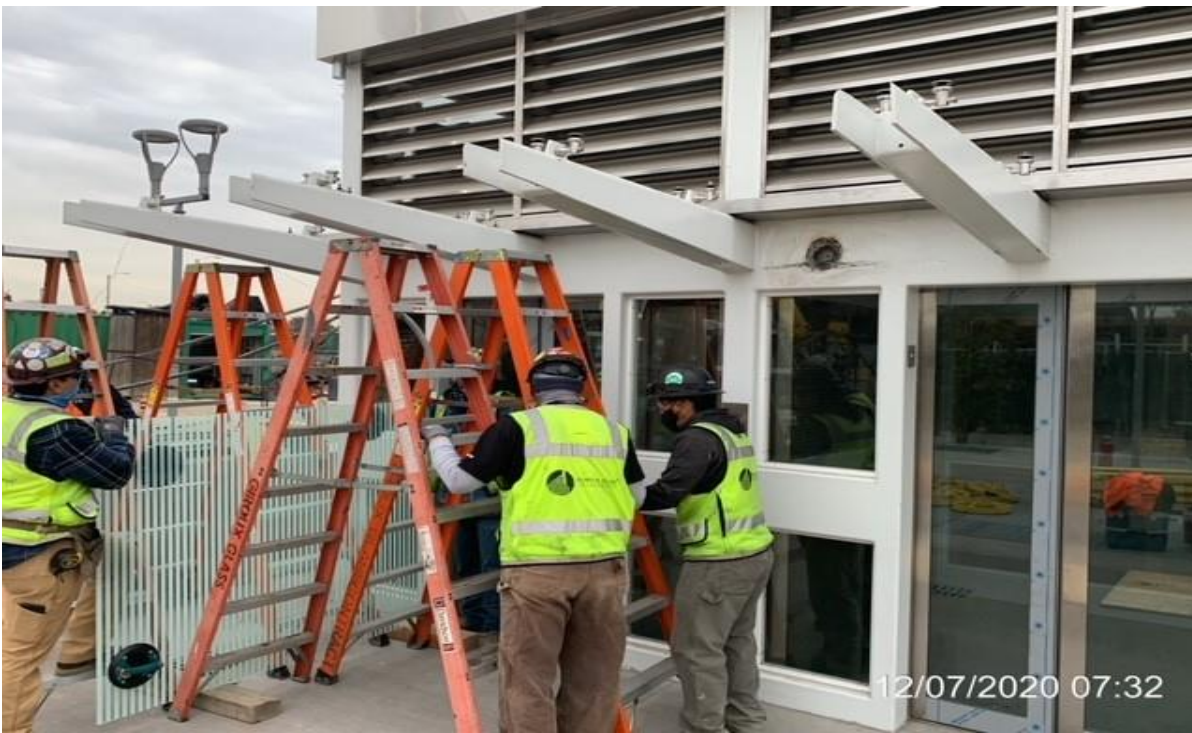
EXPO STATION – Giroux Glass installing glass for eyebrow on elevator structure #1 and #2

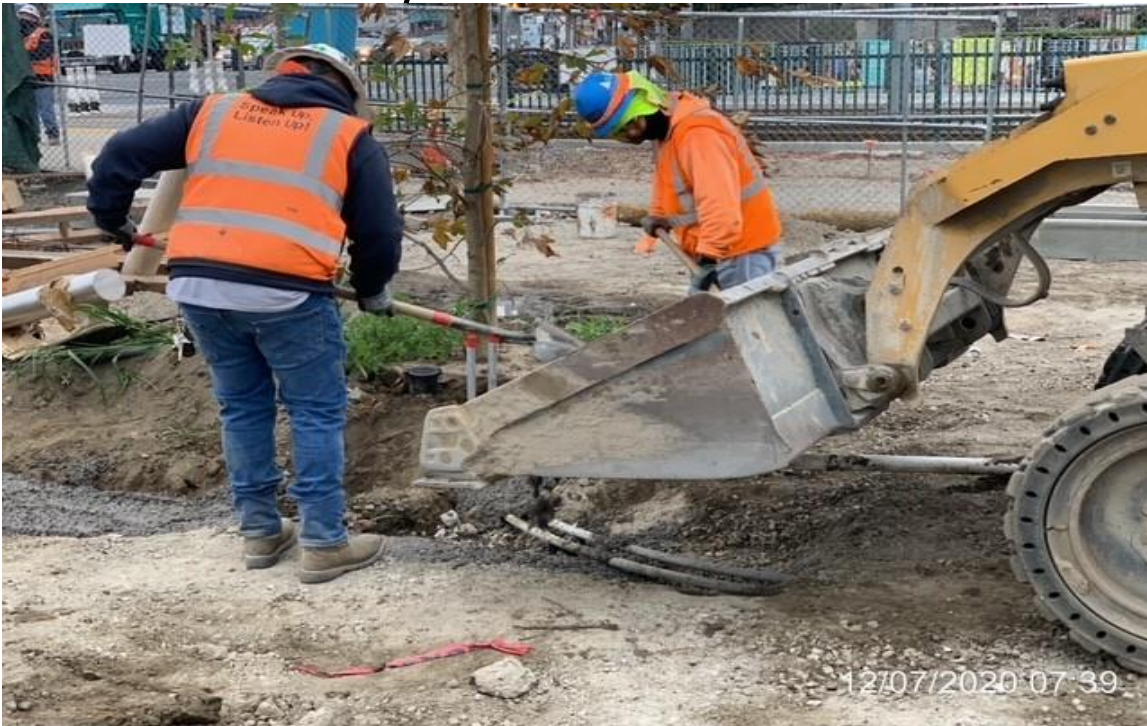
EXPO STATION – WSCC crew concrete encasing electrical conduit for palm tree lighting.

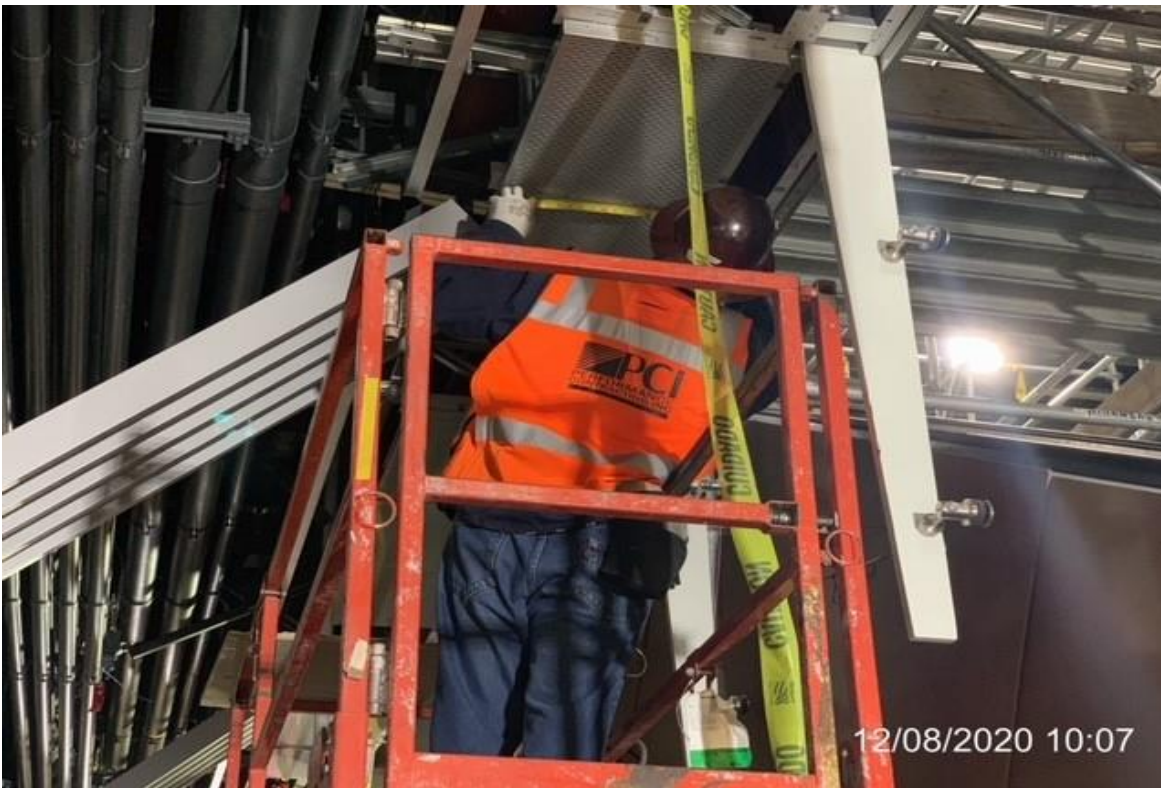
EXPO STATION– PCI taking field dimensions for custom ceiling panels.

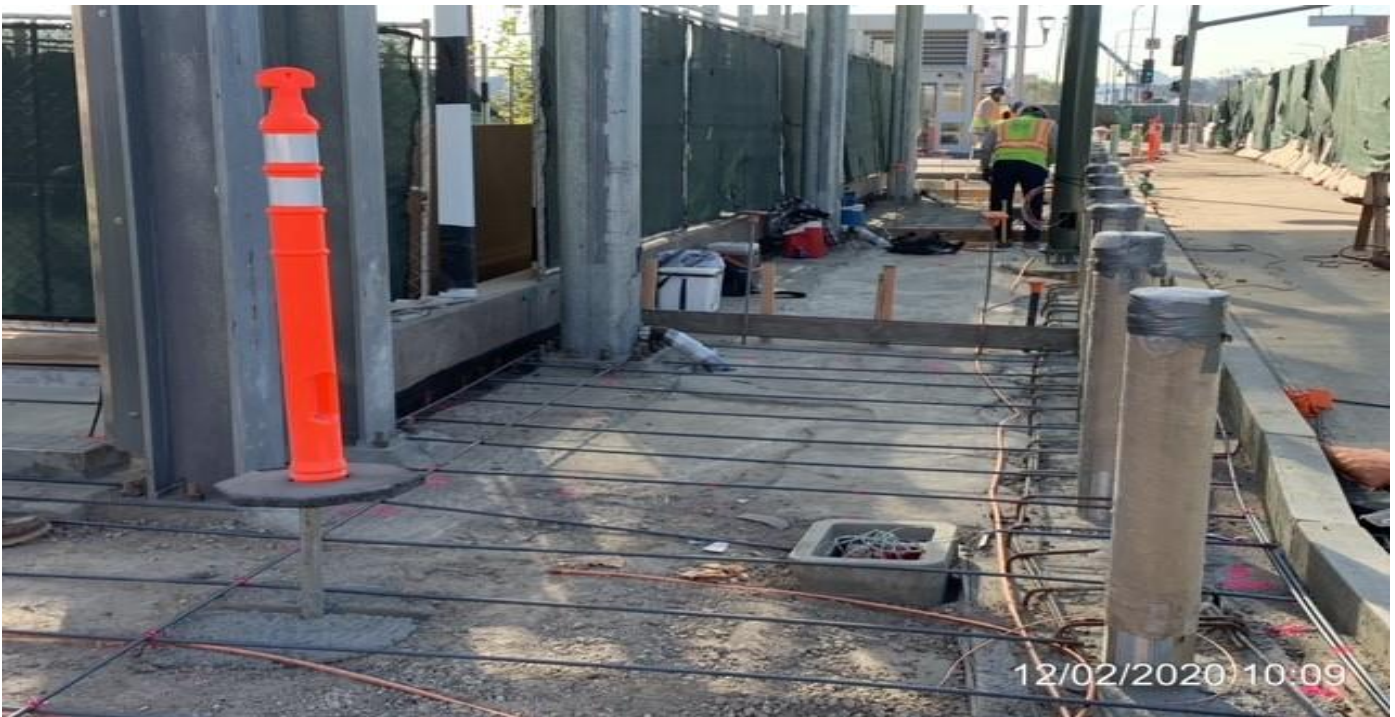
EXPO STATION – Building formwork and placing rebar for the architectural topping slab around the main entrance of the station.

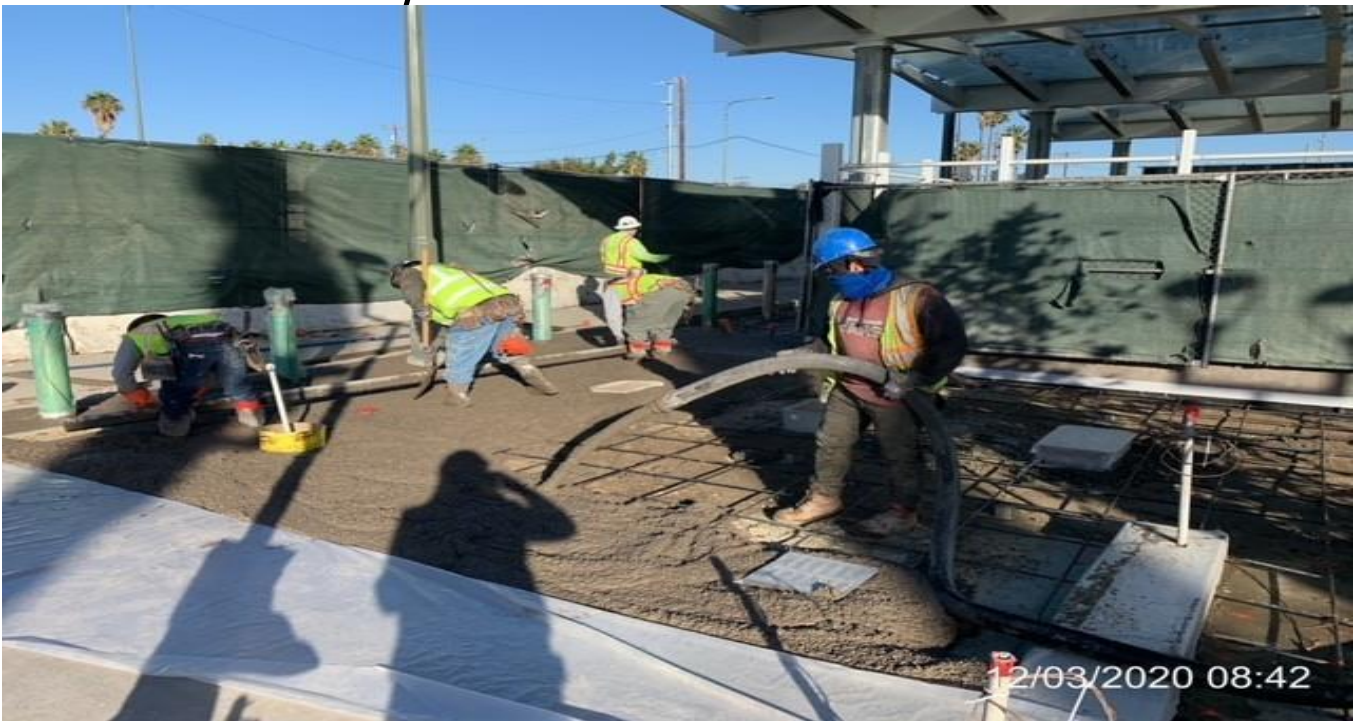
EXPO STATION SITE – Placing concrete for the architectural topping slab around the main entrance of the station.

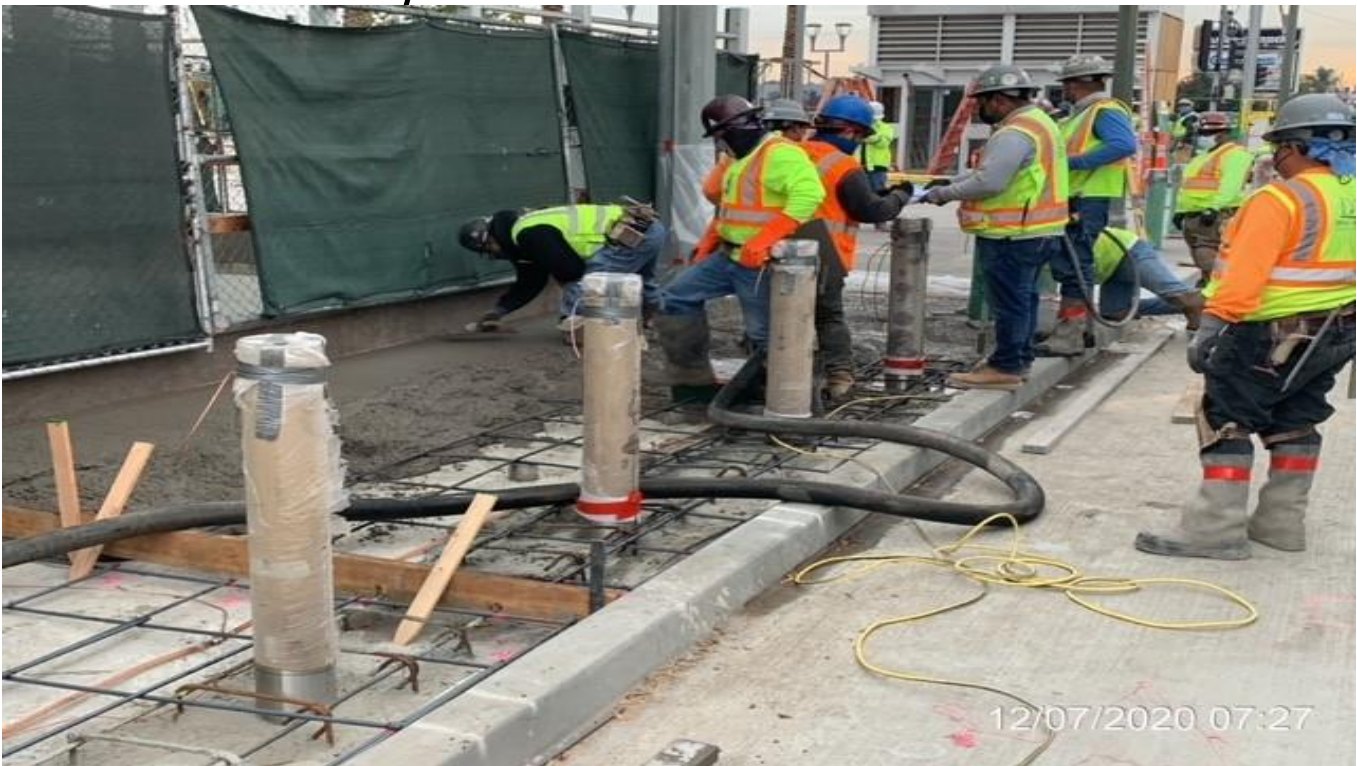
EXPO STATION – Placing concrete for the architectural topping slab at the north end of the plaza.

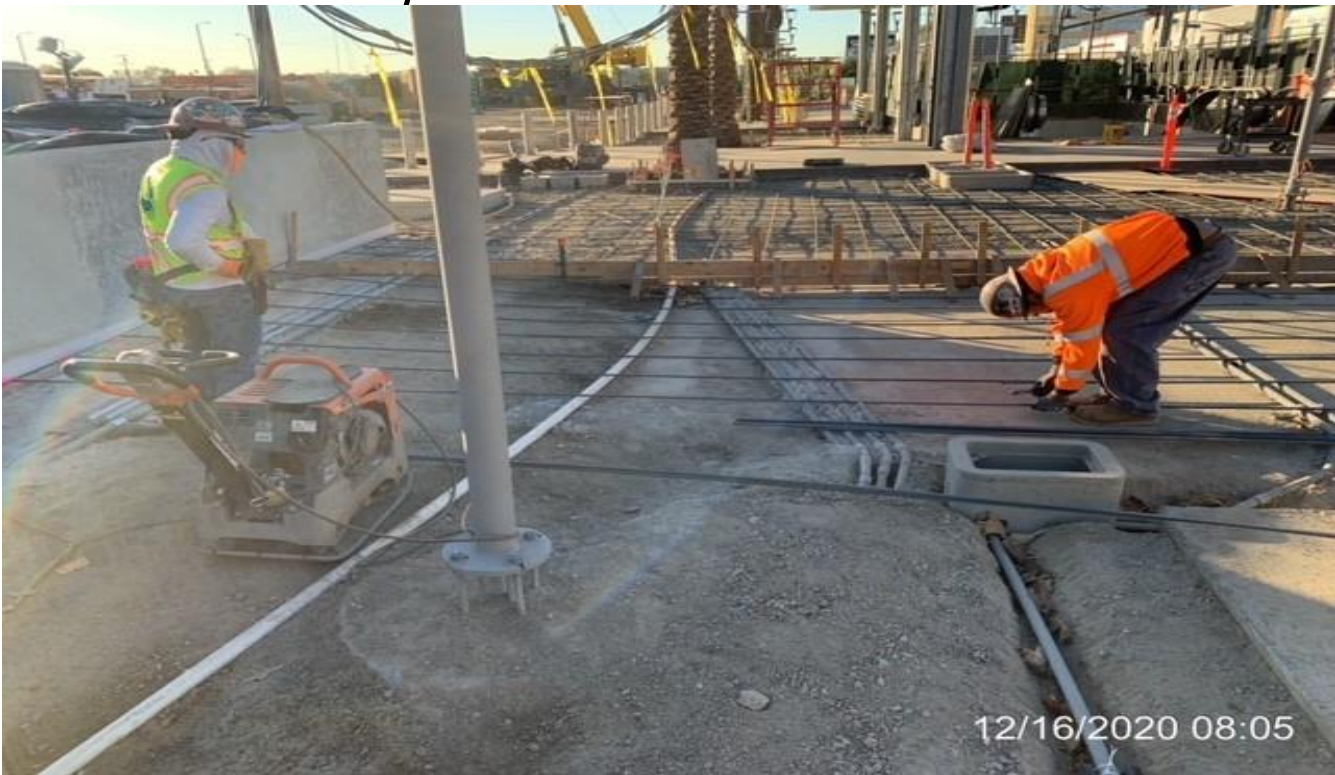
EXPO STATION – Resume building formwork and placing rebar for the architectural topping slab at the north end of the station.

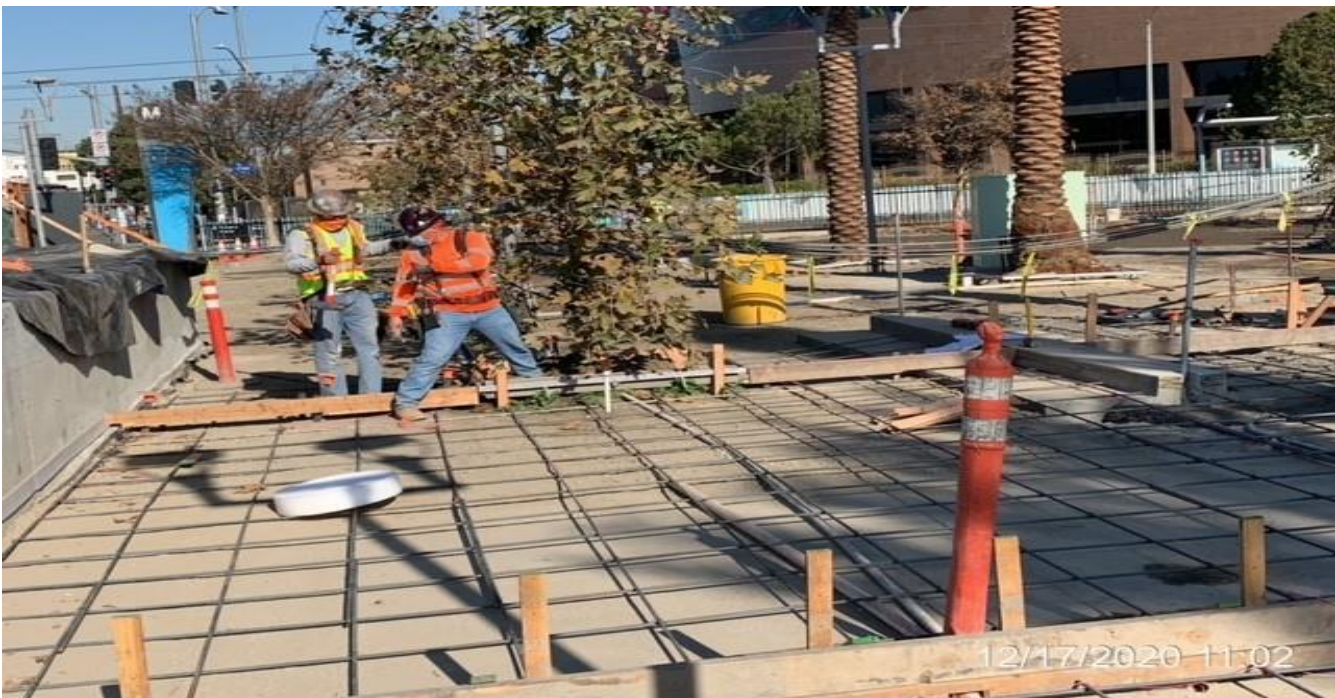
EXPO STATION – Continue building formwork and placing rebar for the architectural topping slab at the north end of the station.

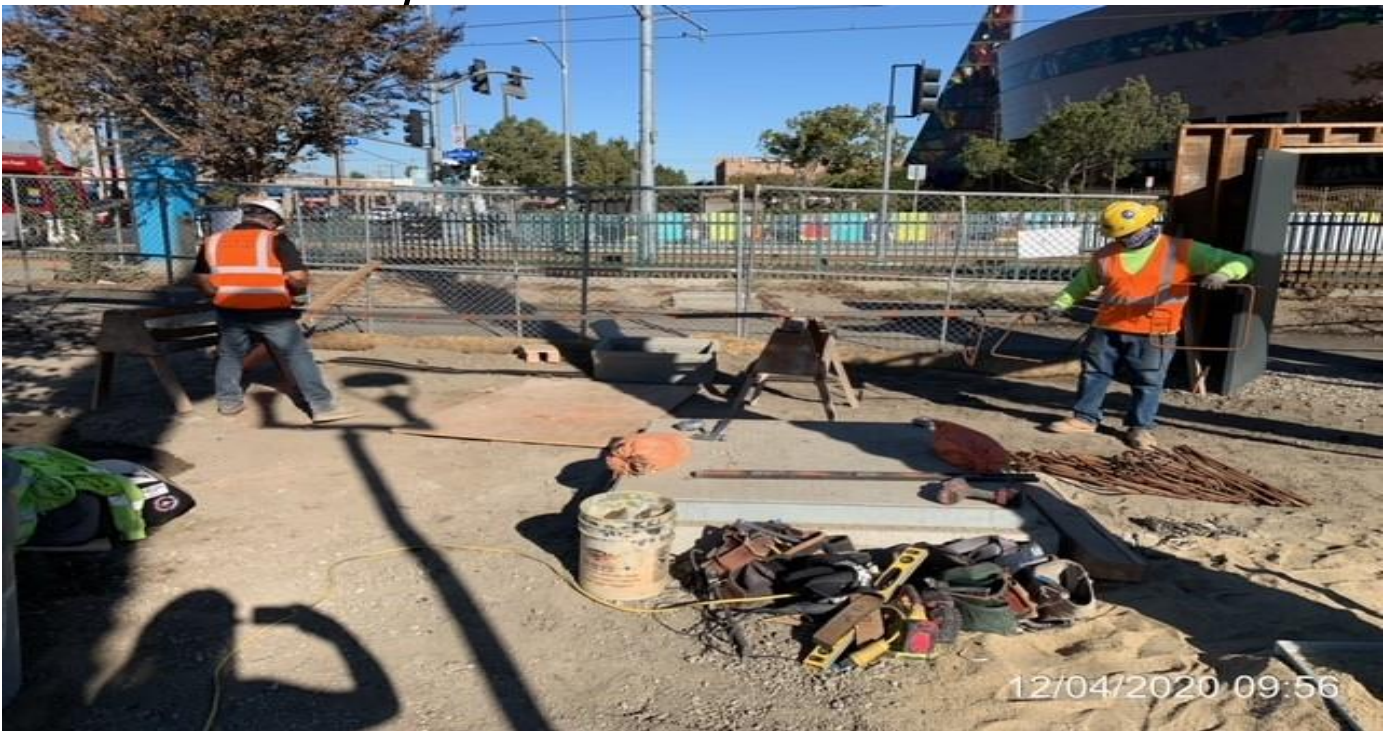
EXPO STATION SITE– Building formwork for the remaining steel bollard foundations at the north end of the plaza.

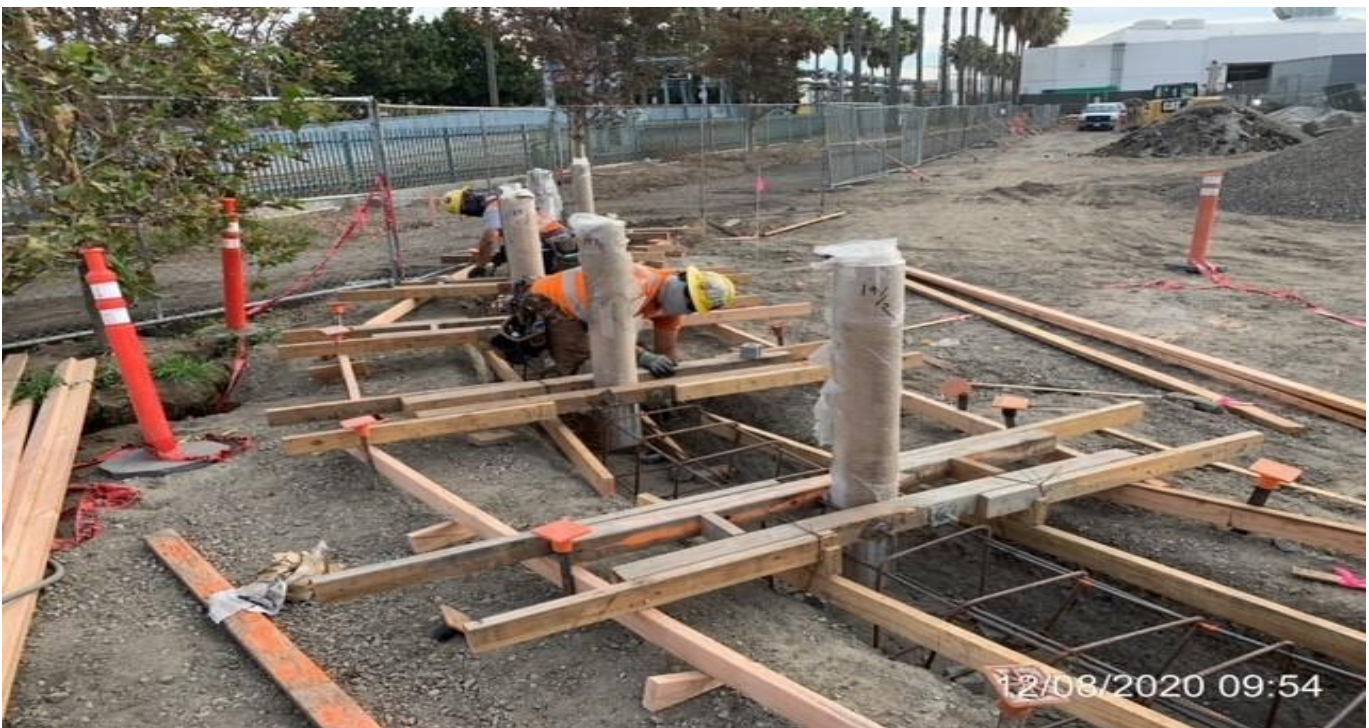
EXPO STATION – Continue setting formwork and installing the remaining steel bollards at the north end of the plaza.

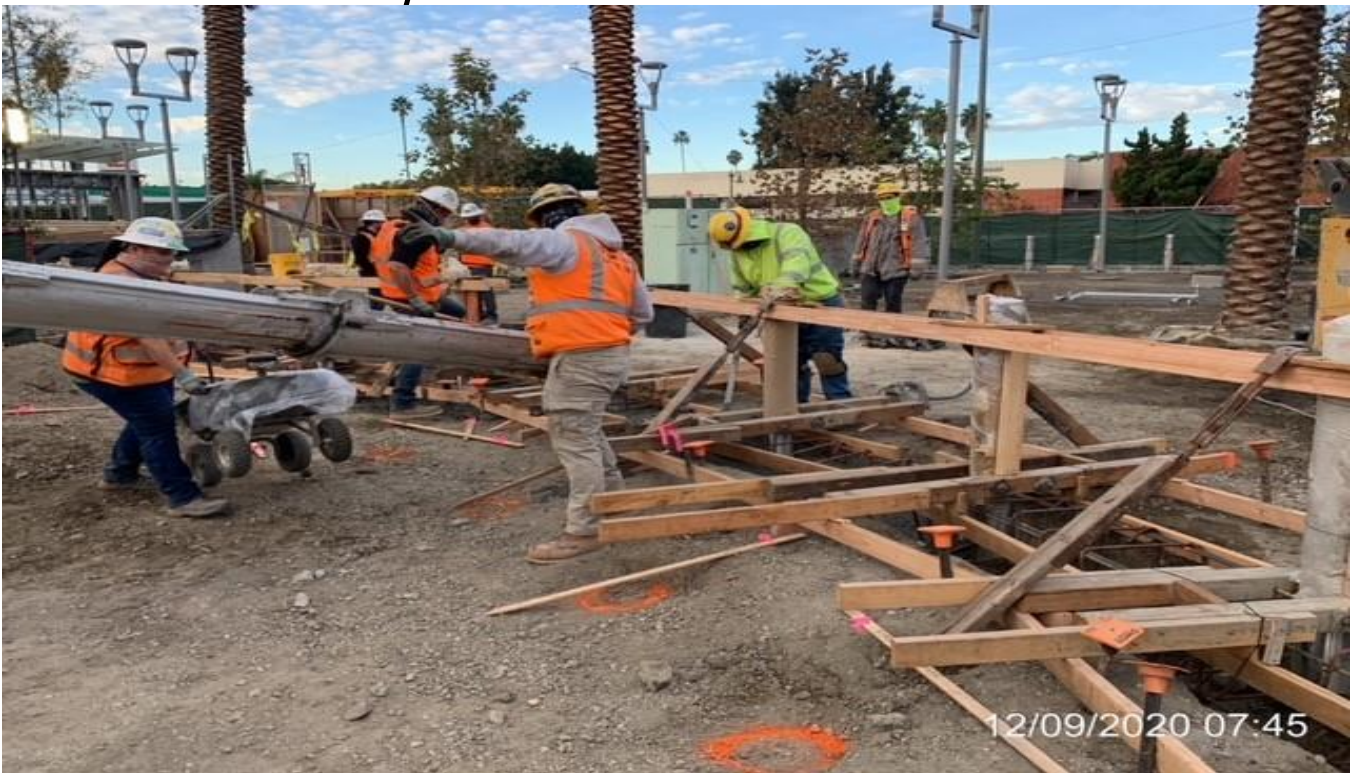
EXPO STATION – Placing concrete for the remaining steel bollards at the north end of the plaza.

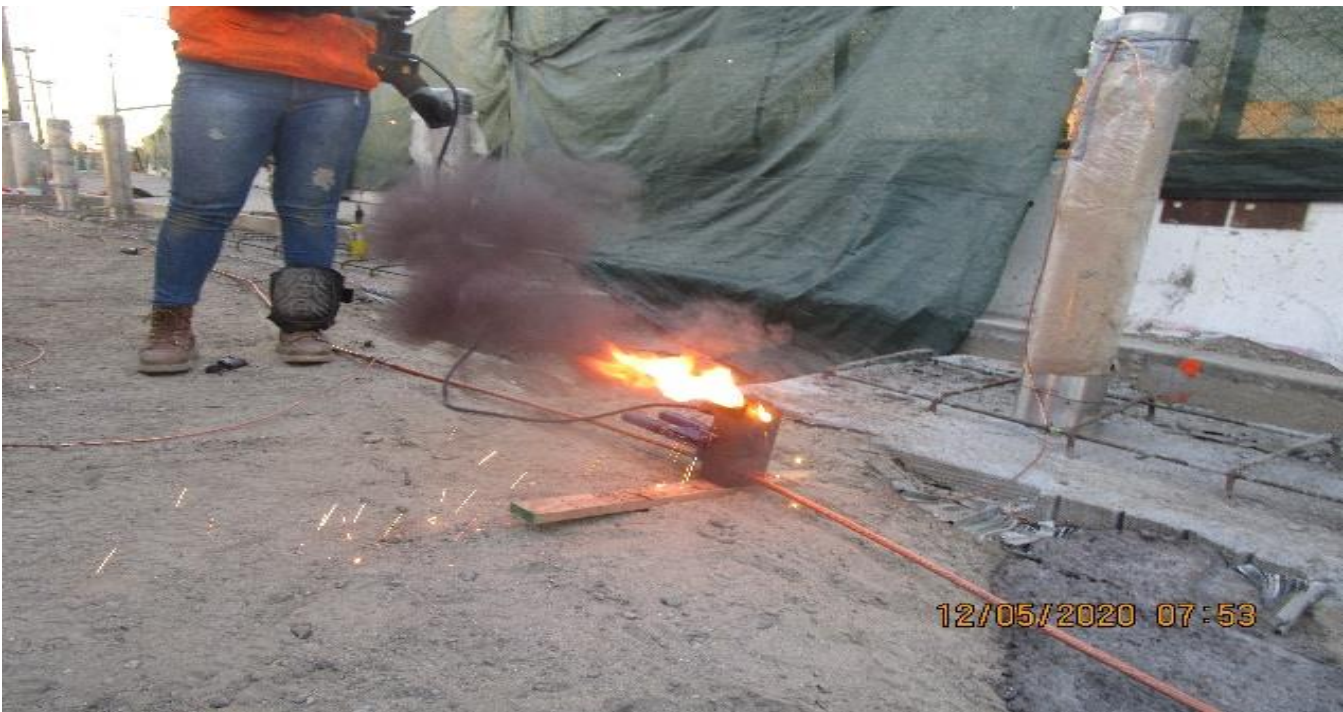
EXPO STATION – Continue ground grid system installation at the plaza.

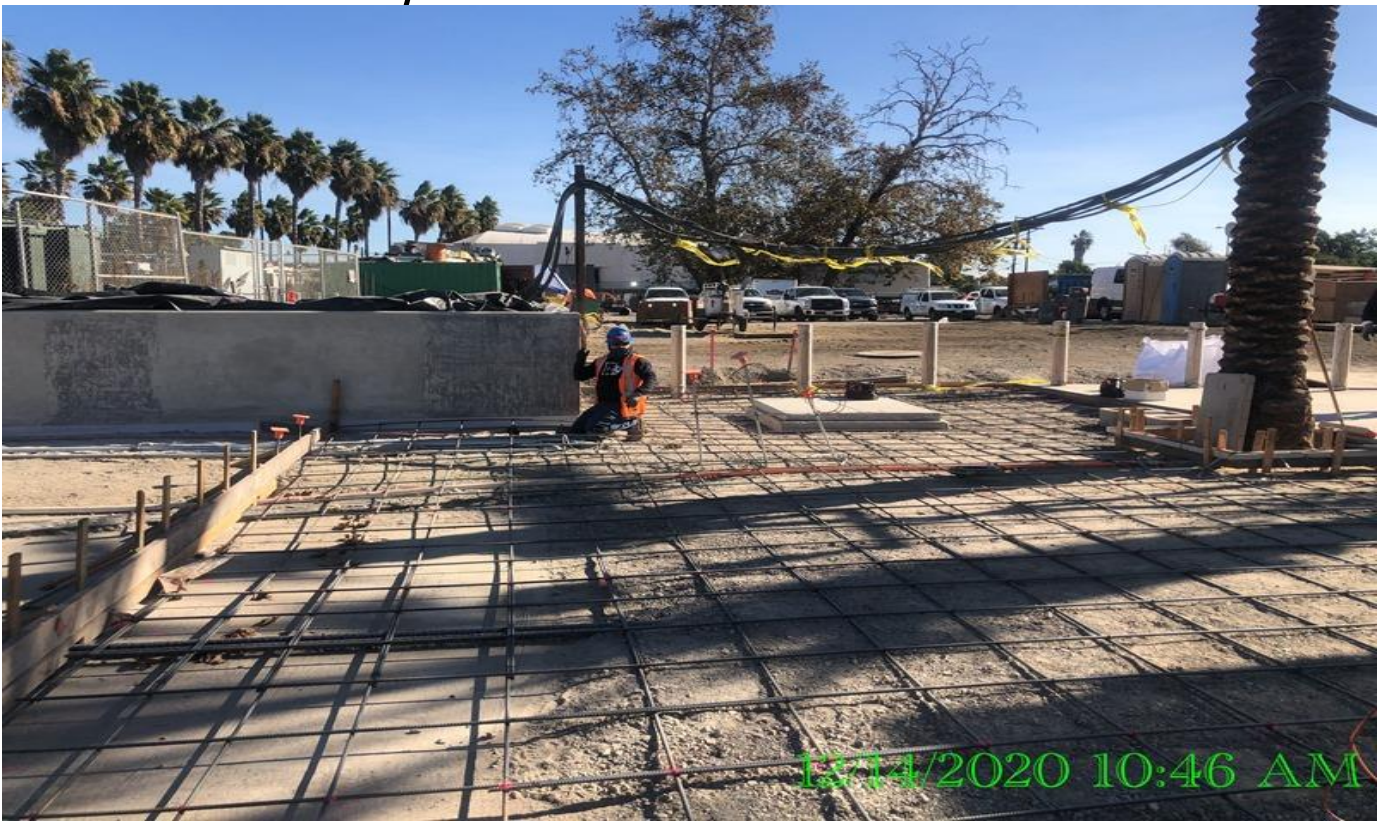
EXPO STATION – Continue ground grid system installation at the plaza.

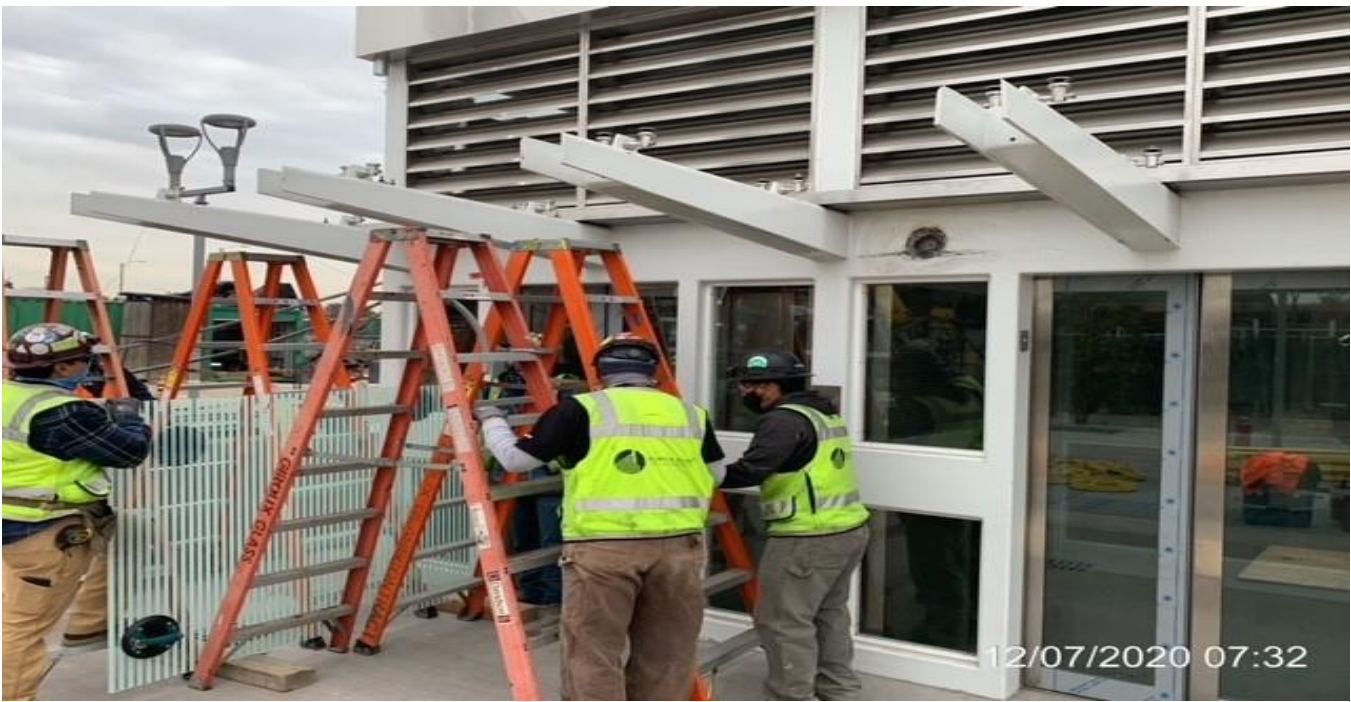
EXPO STATION – Installing glass panels to the top section of Elevators 1&2 at the plaza.
