# CRENSHAW/LAX PHOTOGRAPHIC UPDATE

Dec 30, 2020

## Crenshaw/LAX Transit Project

Overview of trackwork progress issues for 11/30/2020 – 12/15/2020  
(Please note the attached Trackwork Progress Tracking Report)

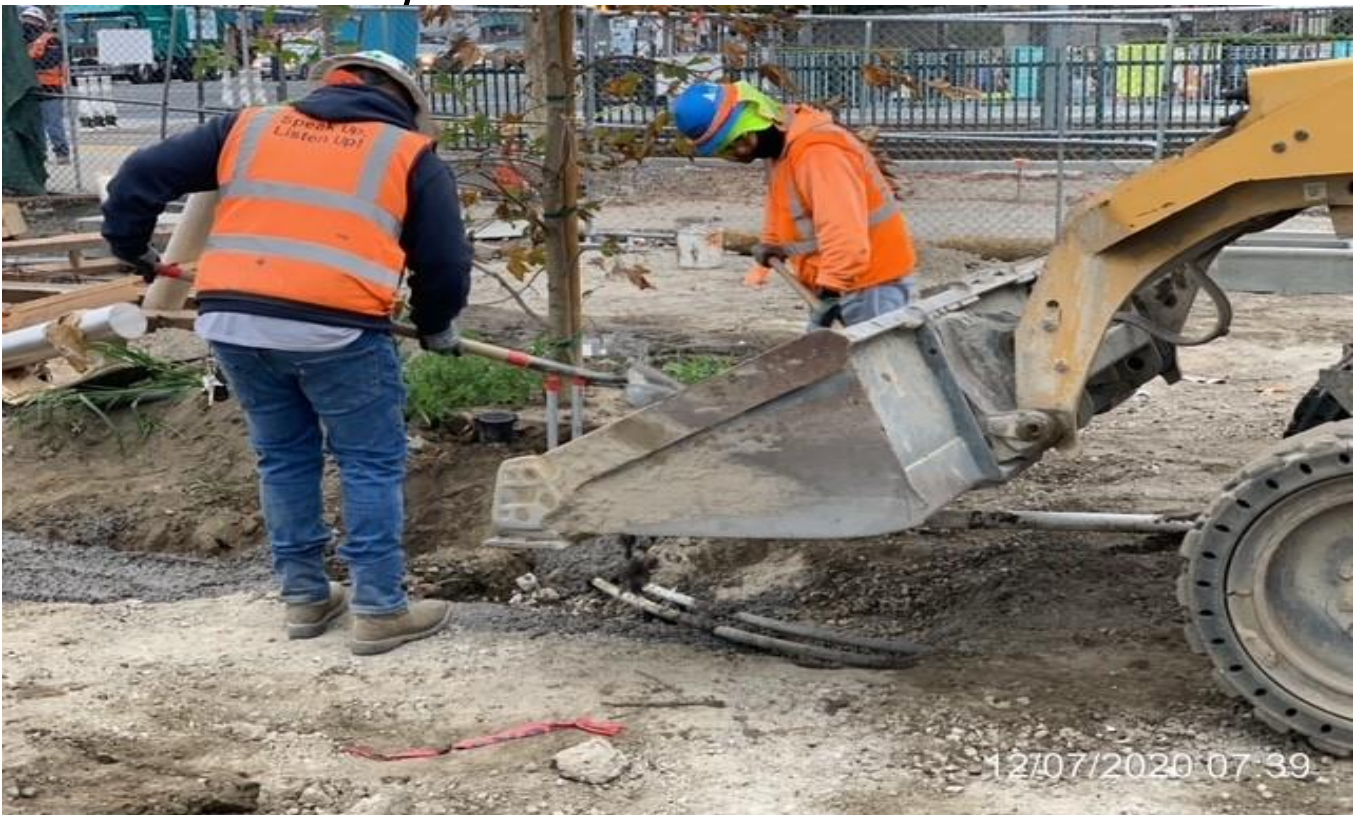
EXPO STATION – Concrete encasing landscape lighting conduit for trees at the plaza.

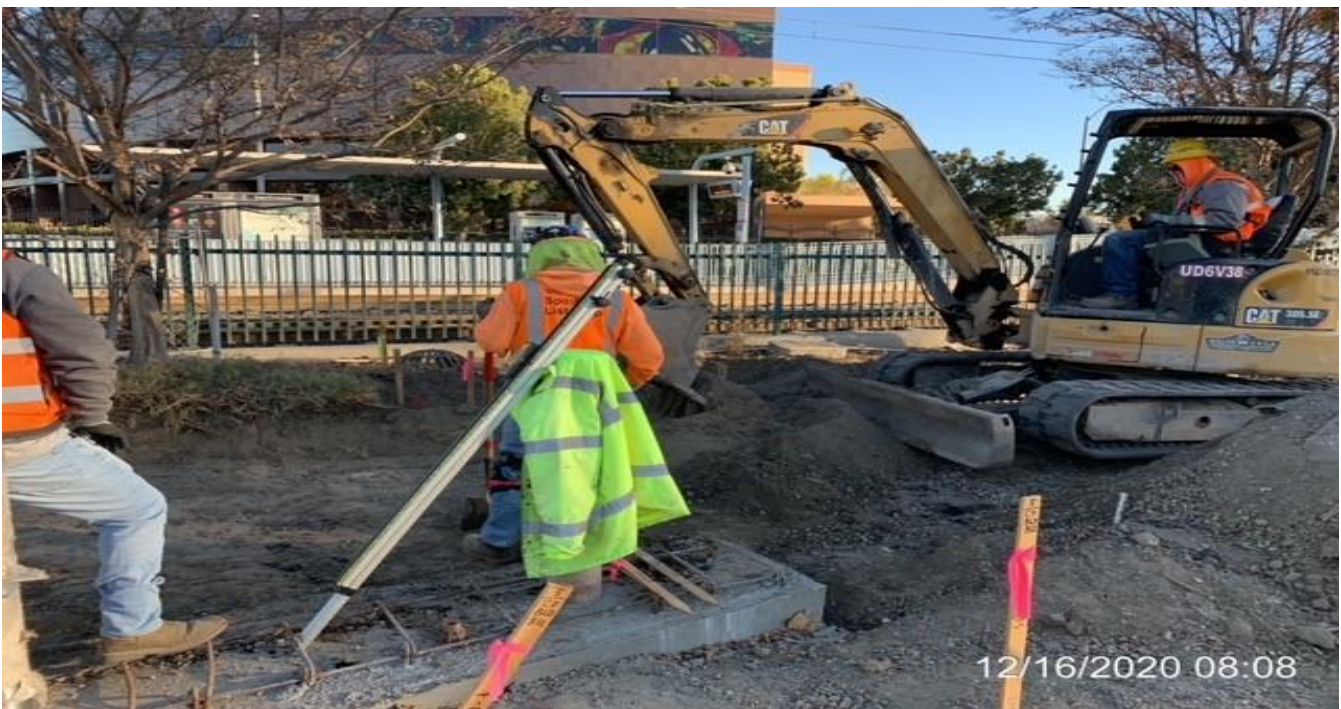
EXPO STATION - Continue grading/compacting and laying base at the northwest corner of the plaza.

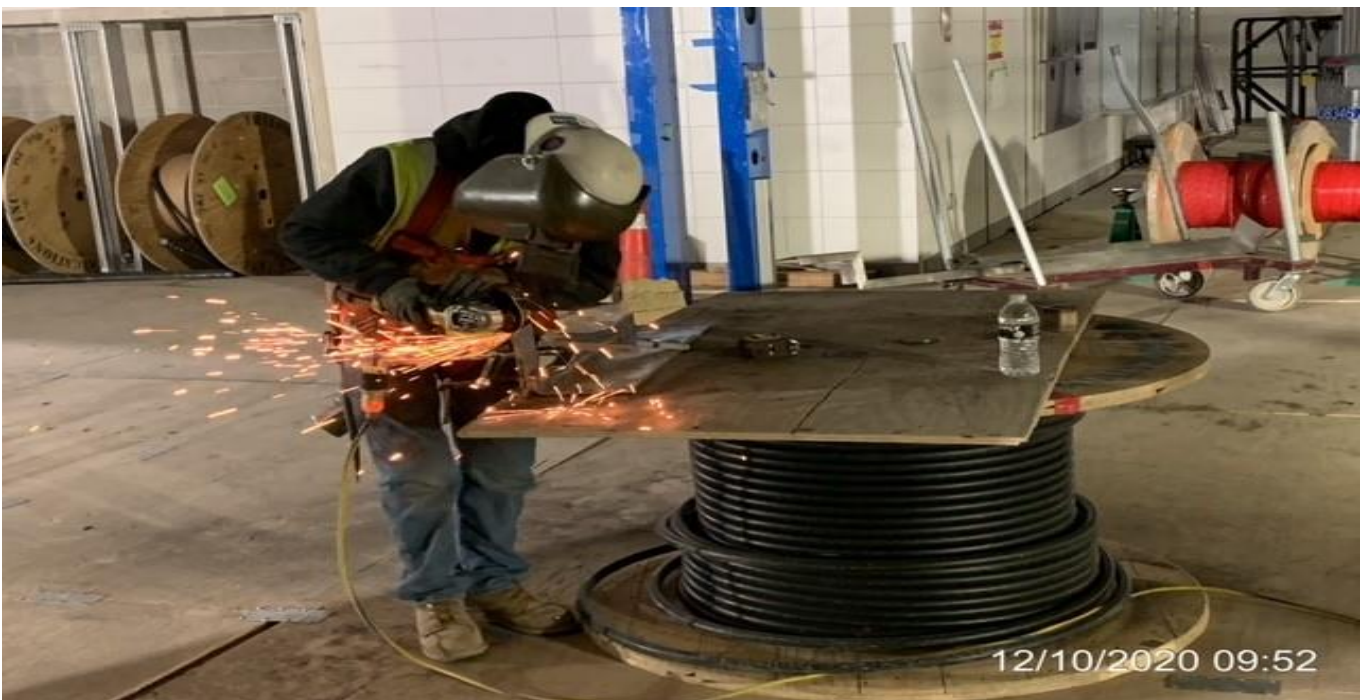
EXPO STATION – Fabricating for edge plate installation along the bottom guardrail perimeter of the escalator/staircase opening.

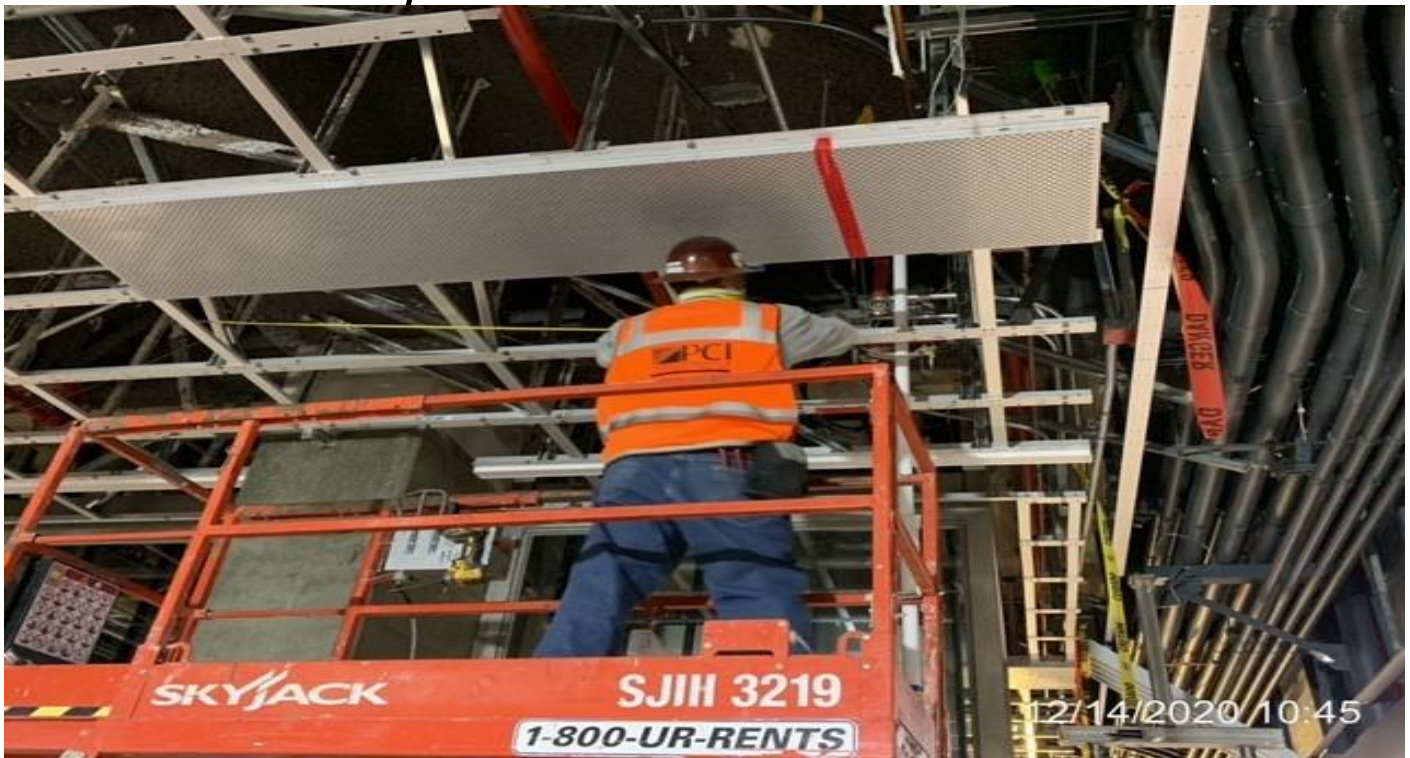
EXPO STATION – Resume perforated ceiling panel installation throughout the platform.

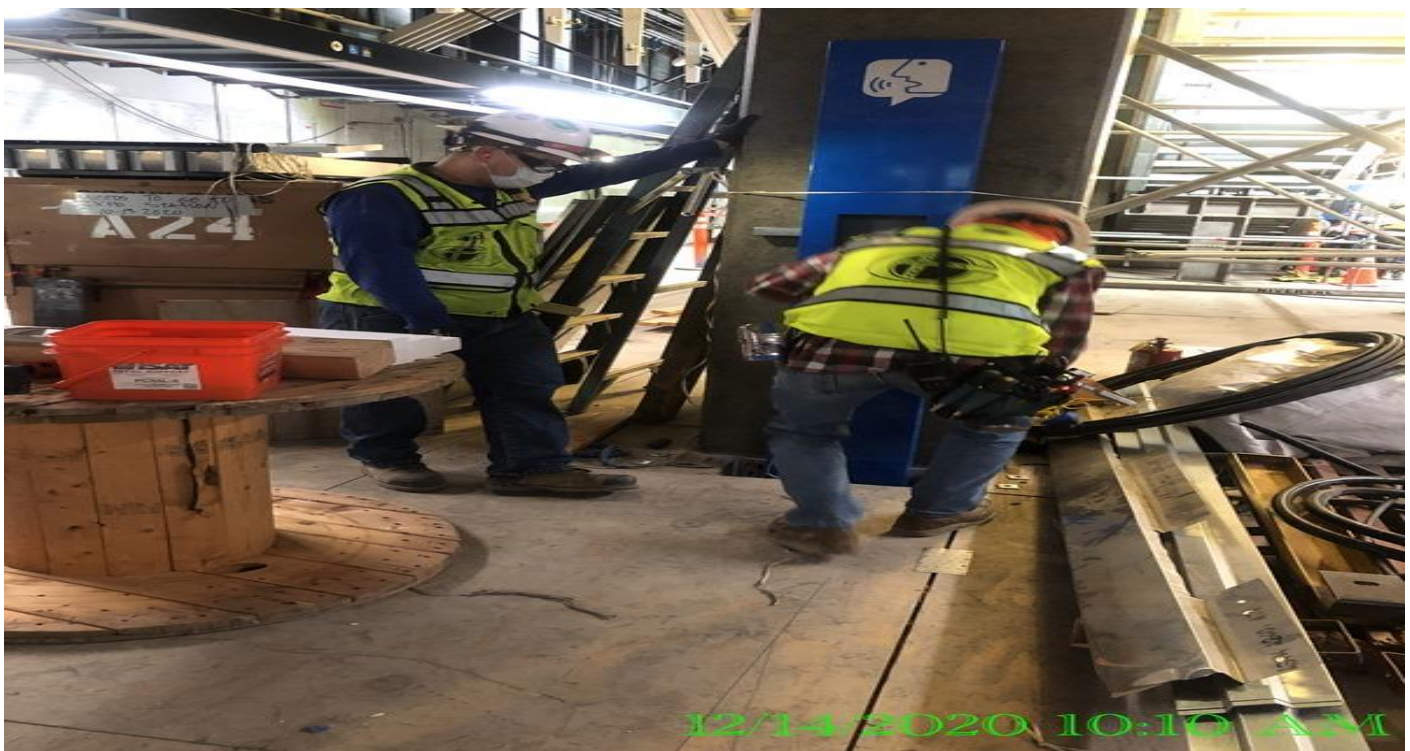
EXPO STATION – Drilled and anchored passenger telephone pedestal at the north end of the platform.
