CRENSHAW/LAX PHOTOGRAPHIC UPDATE

March 17, 2020

Crenshaw/LAX Transit Project

- 8.5 miles Light Rail
- 8 Stations
- \$2,058.0 Million
(Board approved revised LOP)

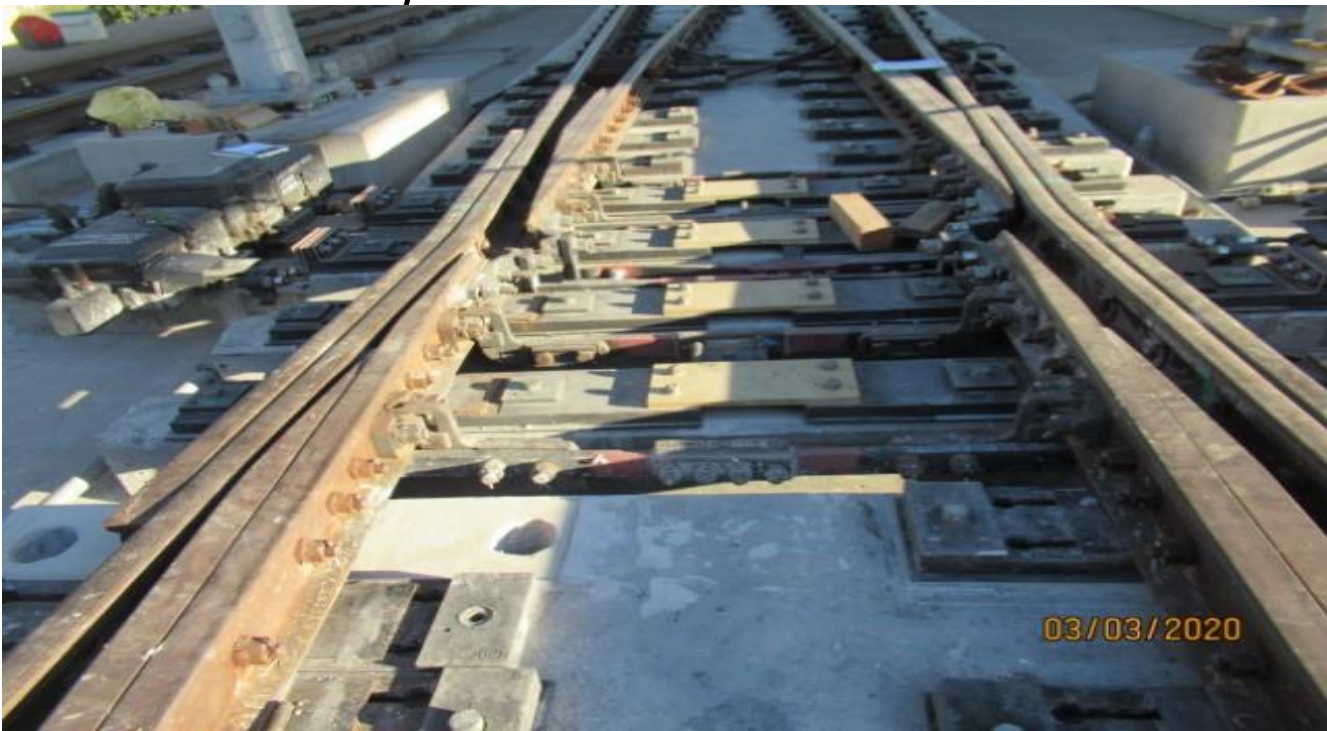
GUIDEWAY - MPF at GL Wye STA 13+90 incomplete work on concrete.

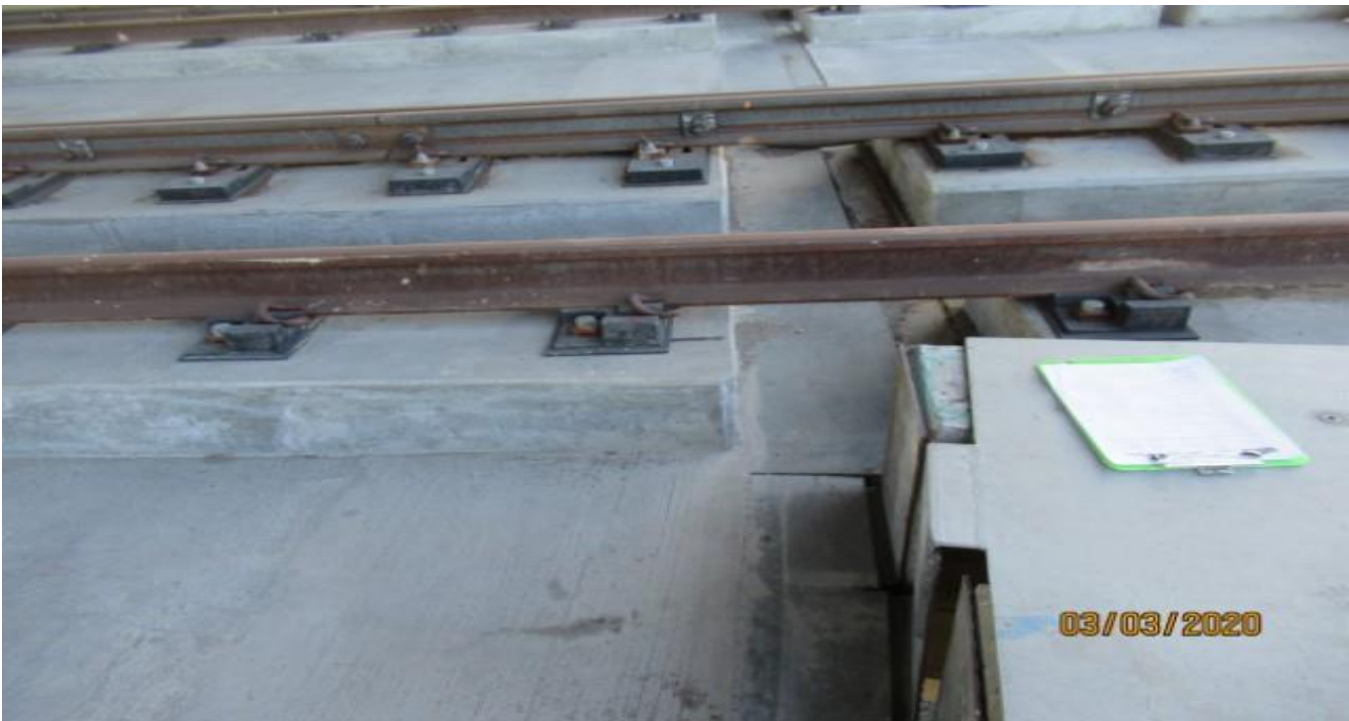
GUIDEWAY - Taper gauge under fastener plate east leg of wye.

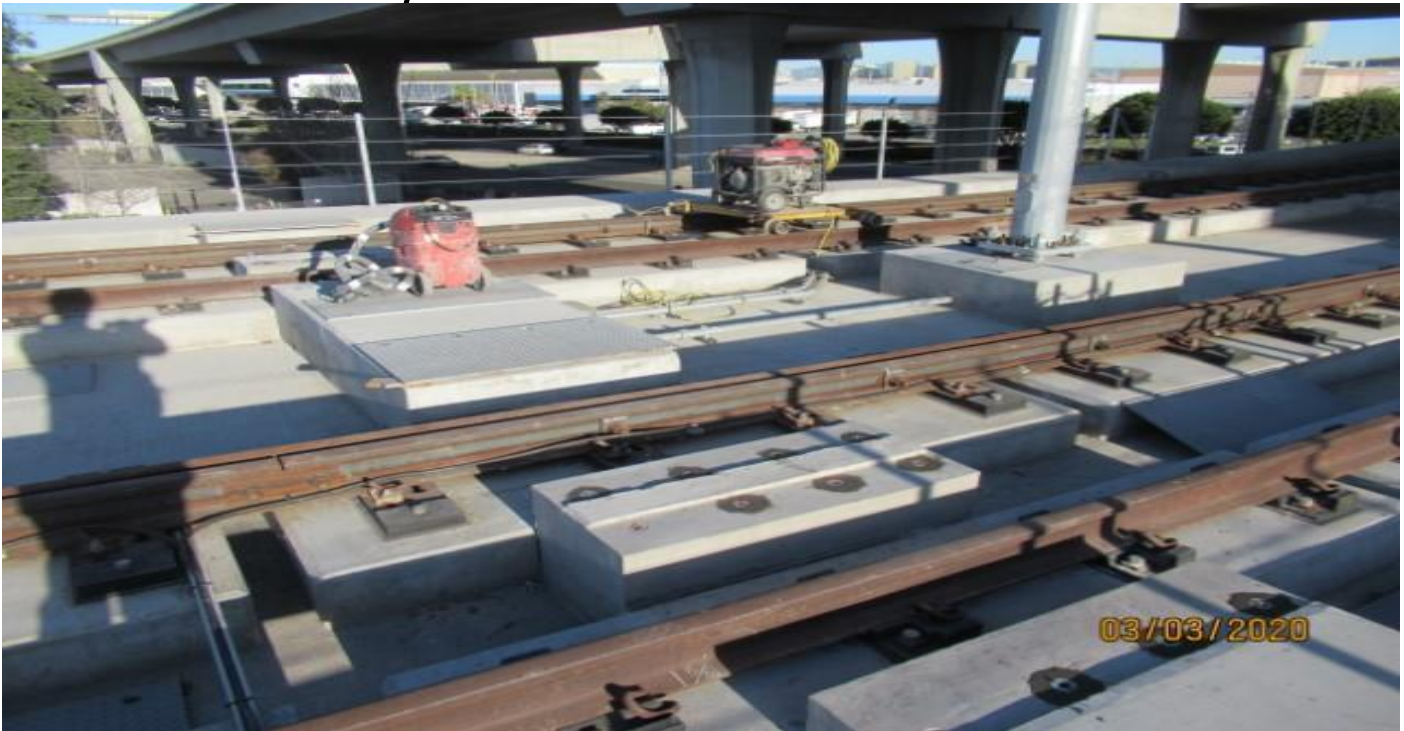
GUIDEWAY - WSCC setting up workstation for grinding insert epoxy on inserts for crossing on west leg of wye STA 13+01.

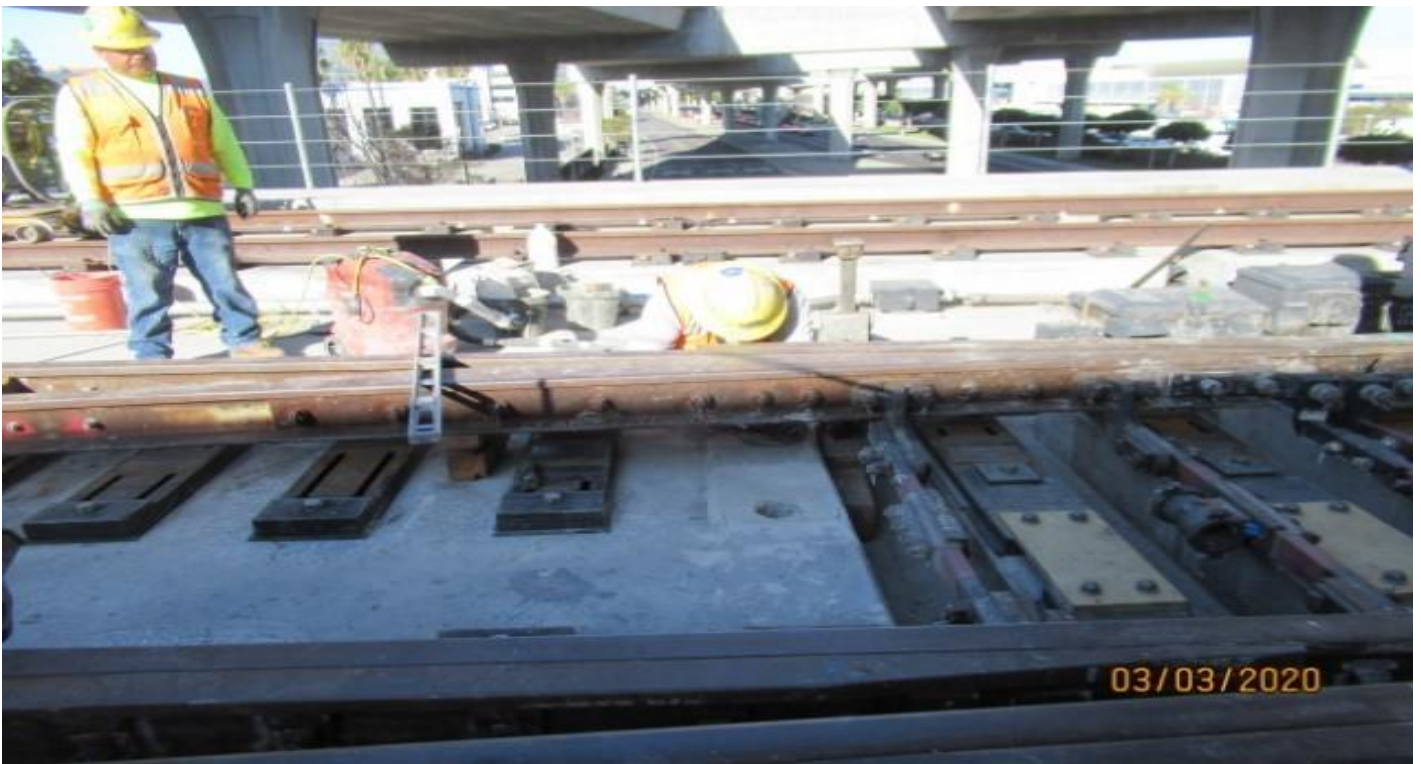
GUIDEWAY - WSCC Concrete foreman hand grinding concrete slab under rails for MPF at GL Wye STA 13+90.

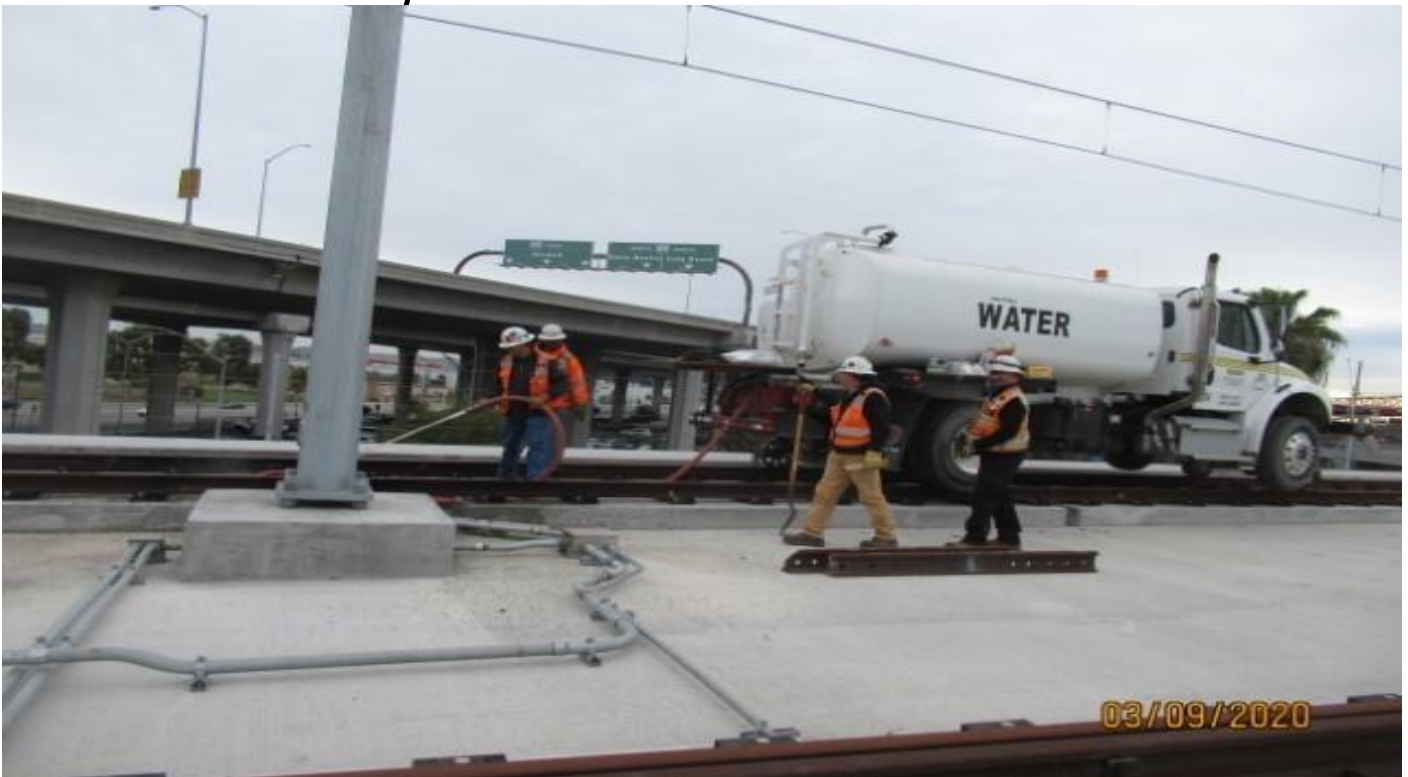
GUIDEWAY - HCC on NB1300 track east leg of Wye removing debris from bridge deck (looking east)

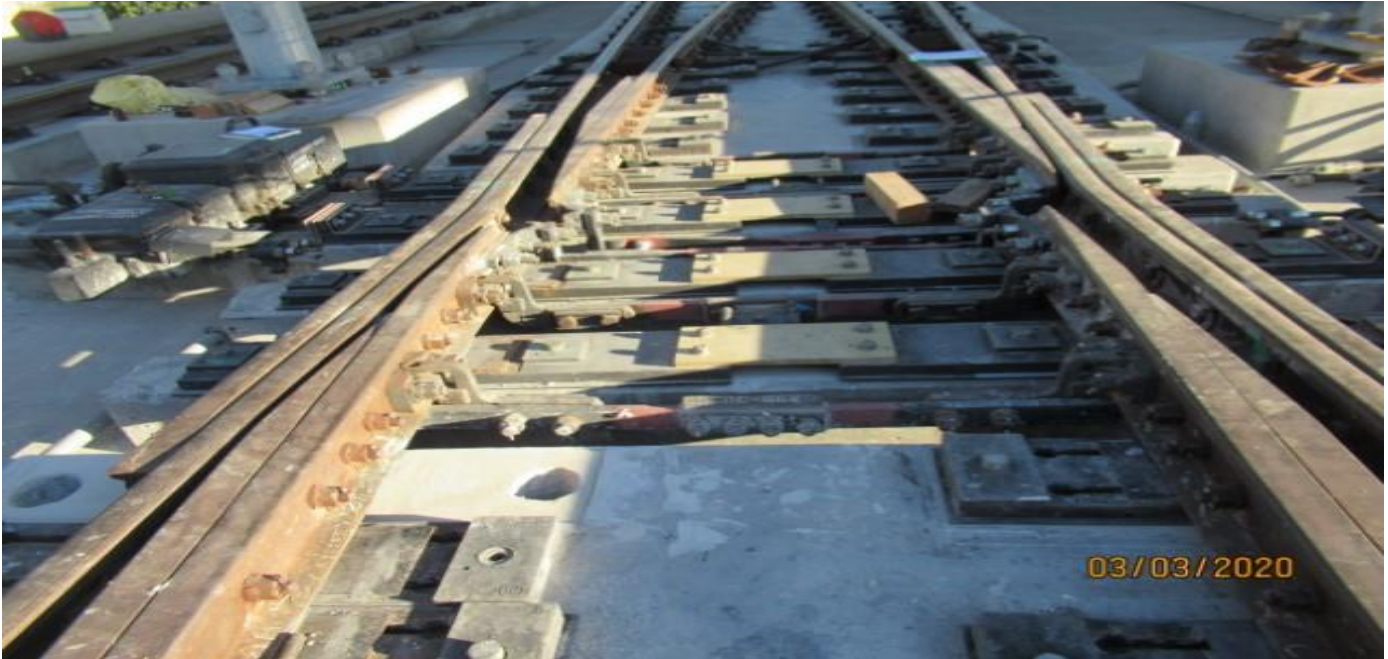
GUIDEWAY - MPF at GL Wye STA 13+90 incomplete work on concrete.

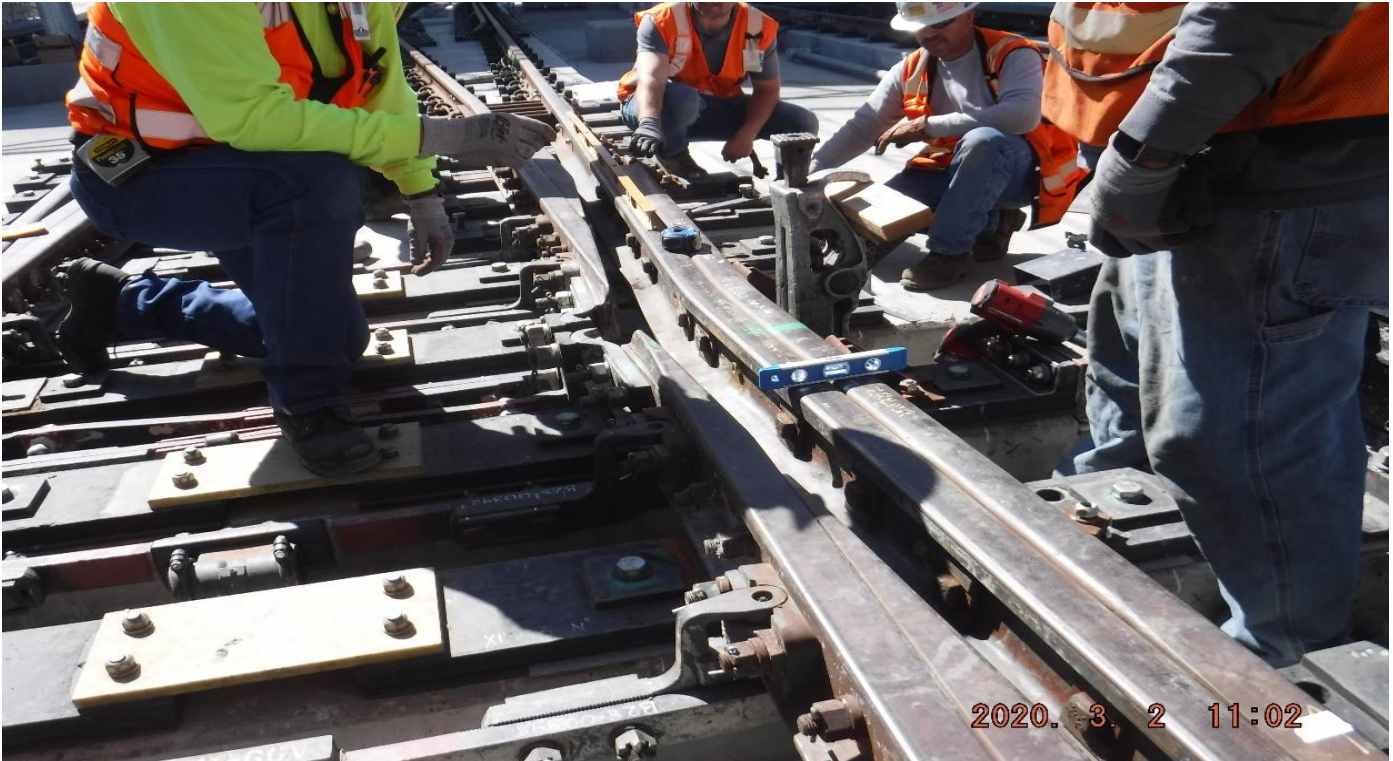
Imperial Hwy - STA14+00_ Looking South_ XING3_ Set components_ Imperial

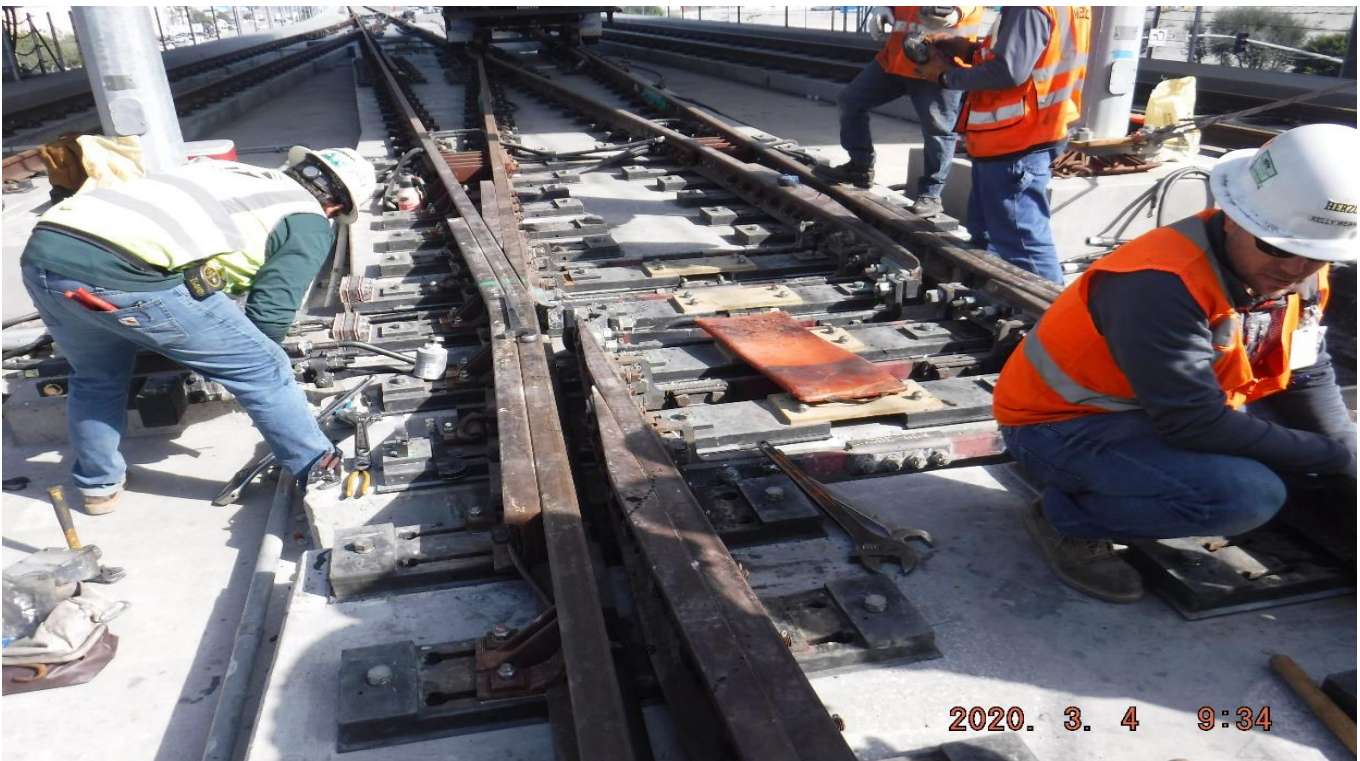
Imperial Hwy - STA14+00_ Looking North_ XING3_ Set-up switch rods_ Imperial.

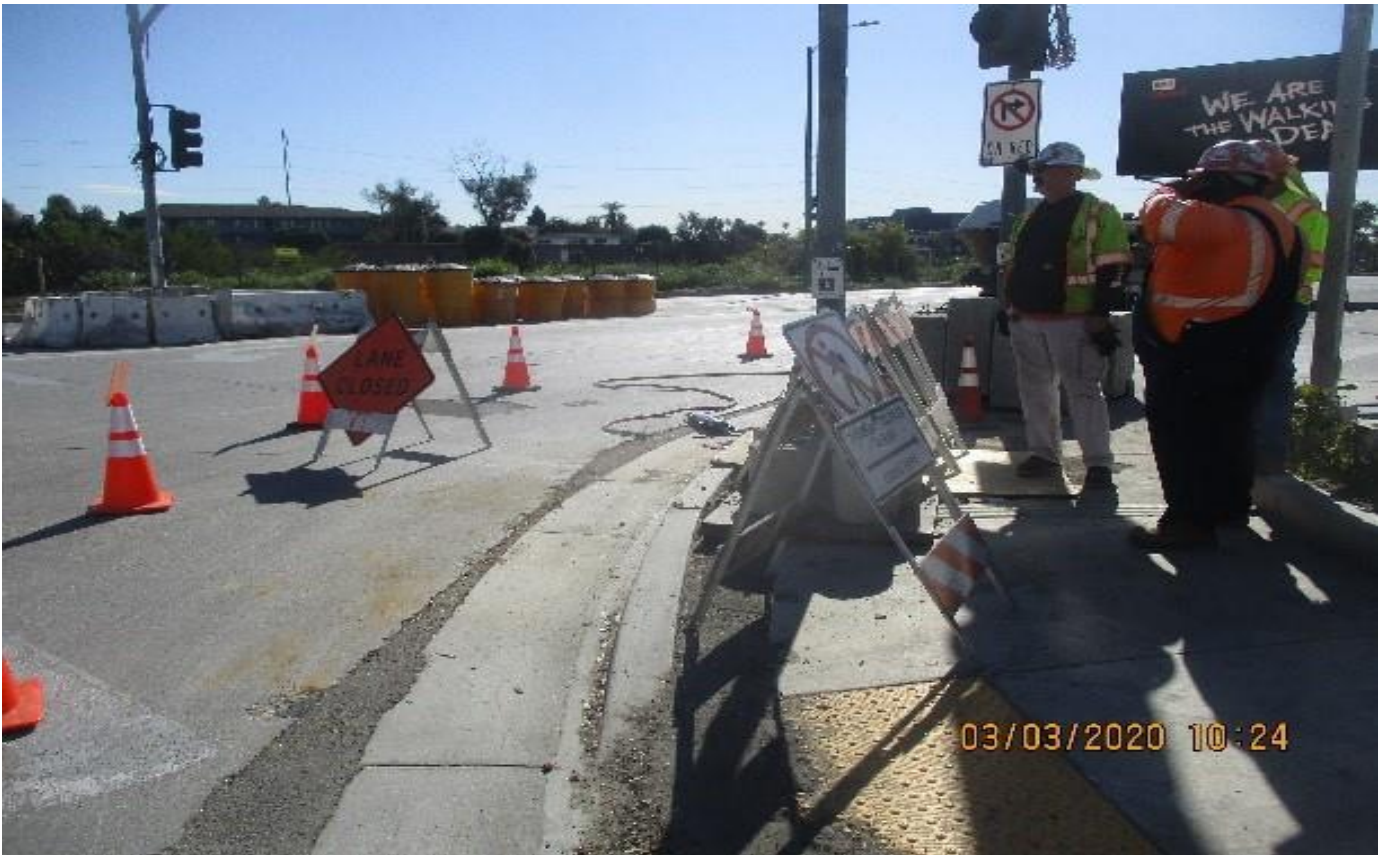
La Cienega/Florence - Select Electric Removing foundations at La Cienega and Florence.

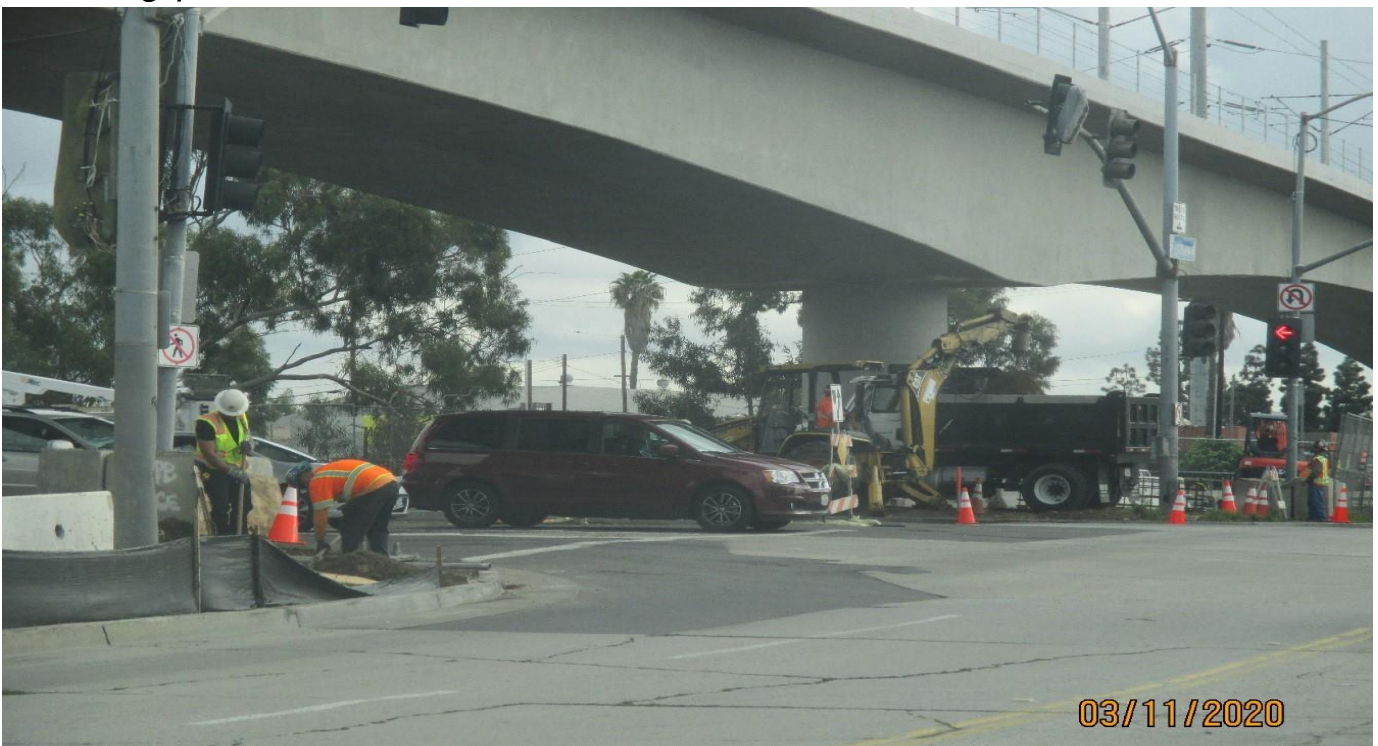
La Cienega/Florence - Excavating for the traffic signal foundations on La Cienega. Facing NE.

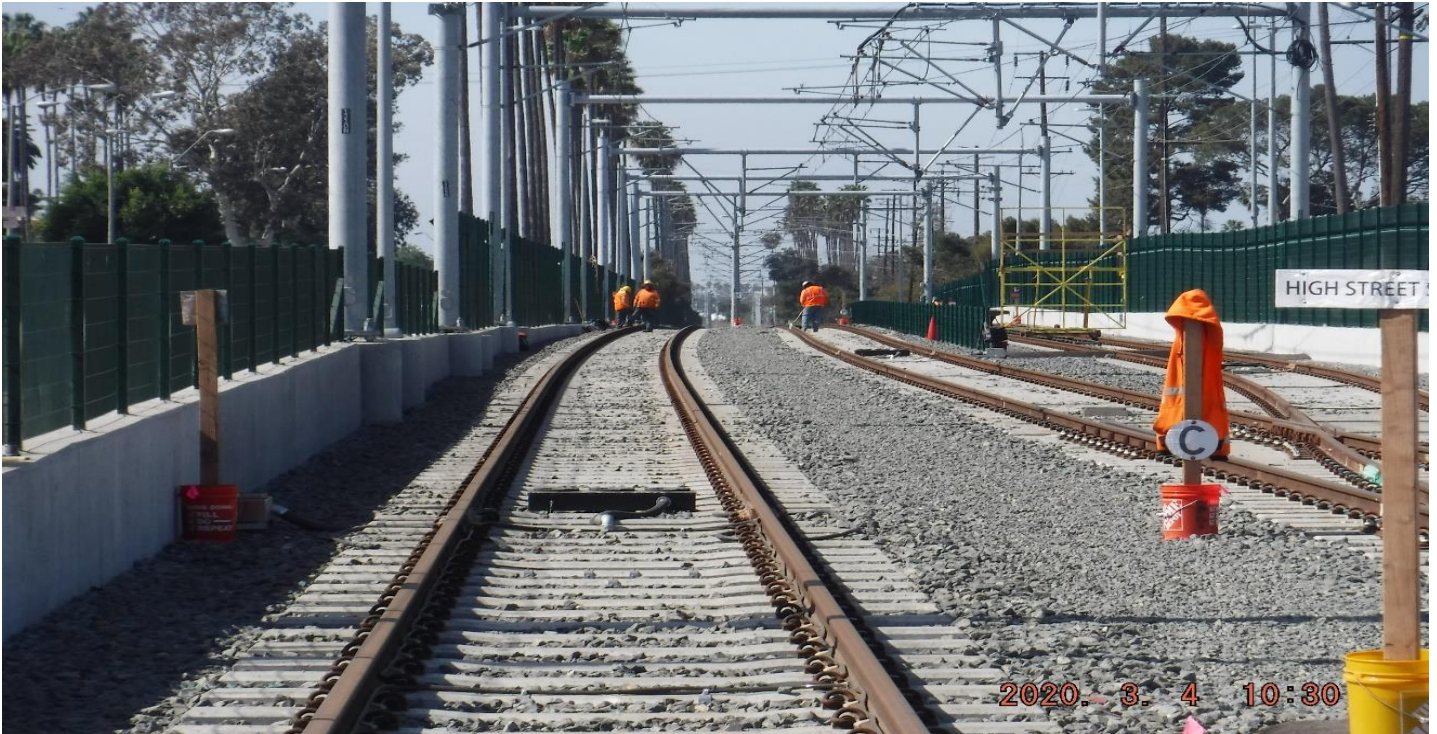
Florence/Ivy - STA256+10_ Looking North_ Disturbed track structure OCS#1212_ PUNCH LIST_ High.

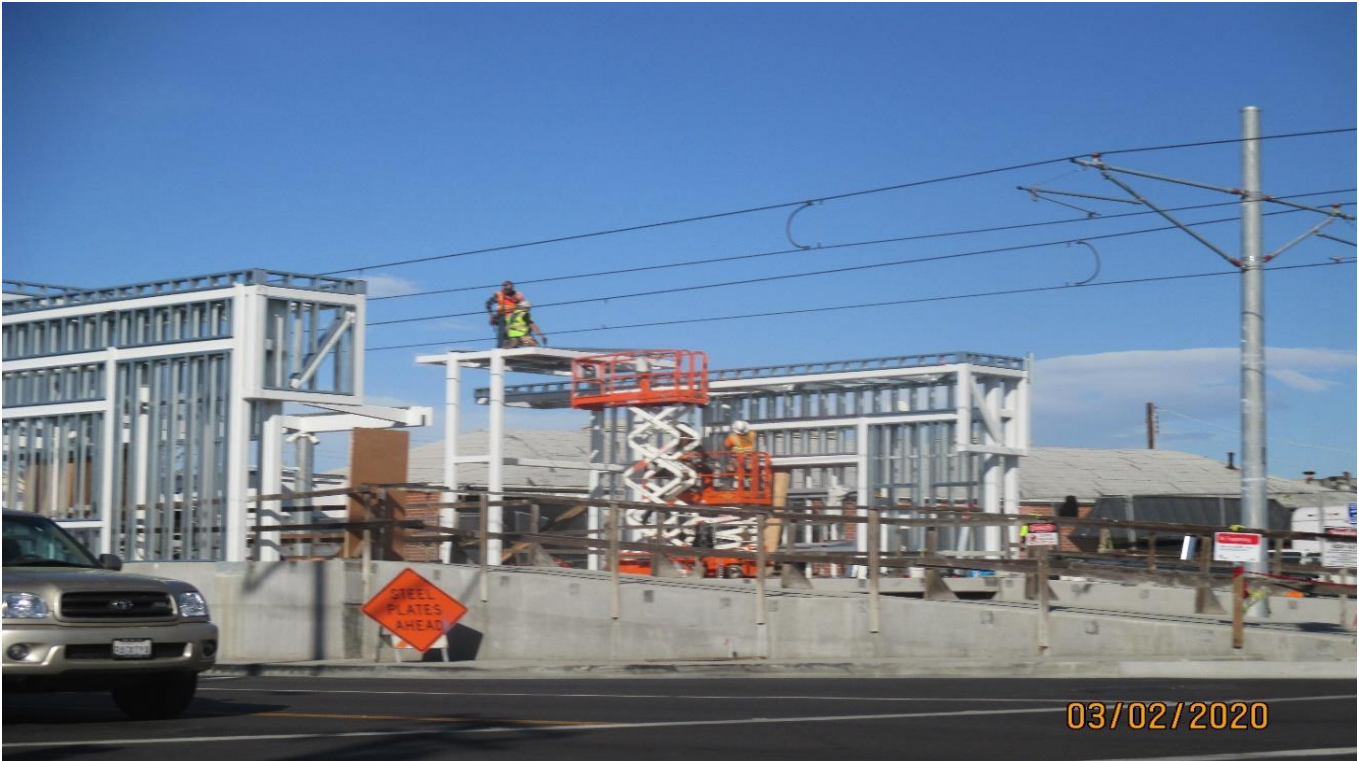
HINDRY AVE- Metal stud framing at the Hindry Station.

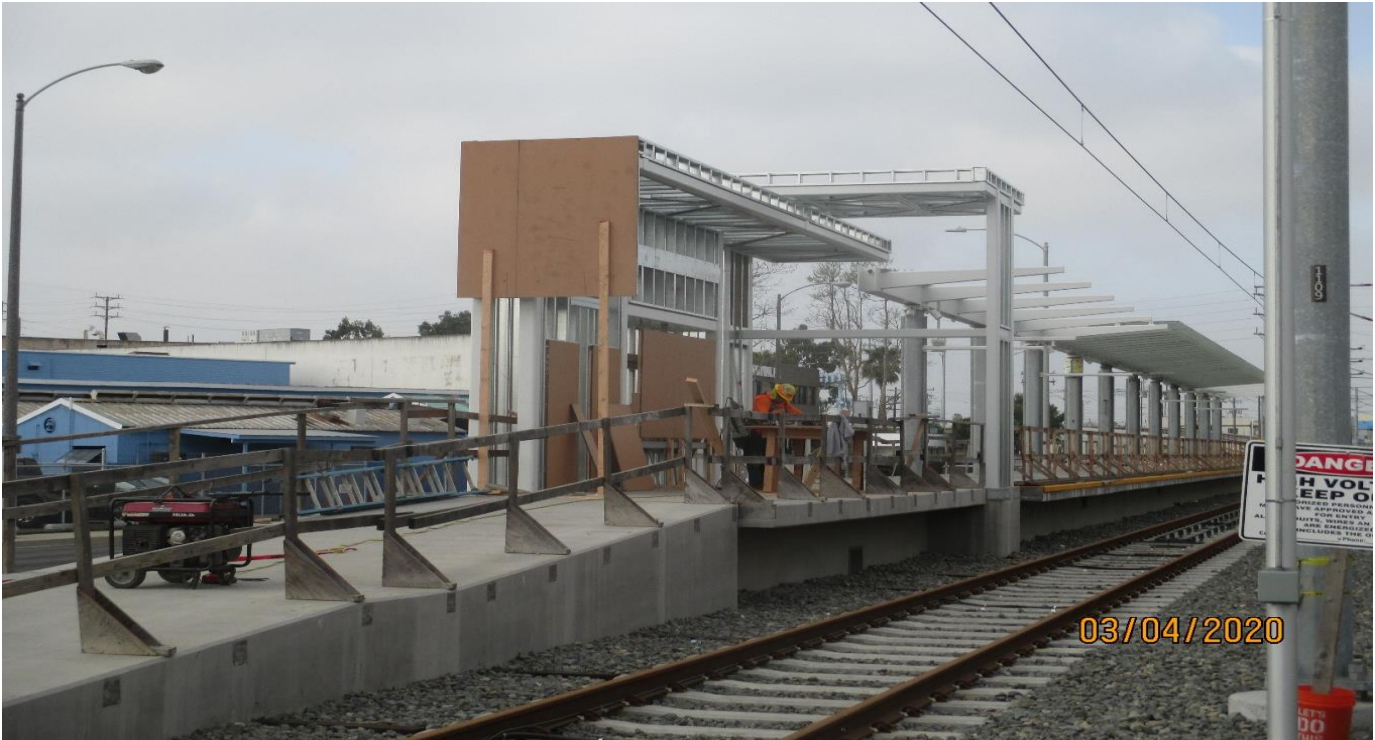
HINDRY AVE- Ticket vending machine mock-up construction at the Hindry Station NB platform.

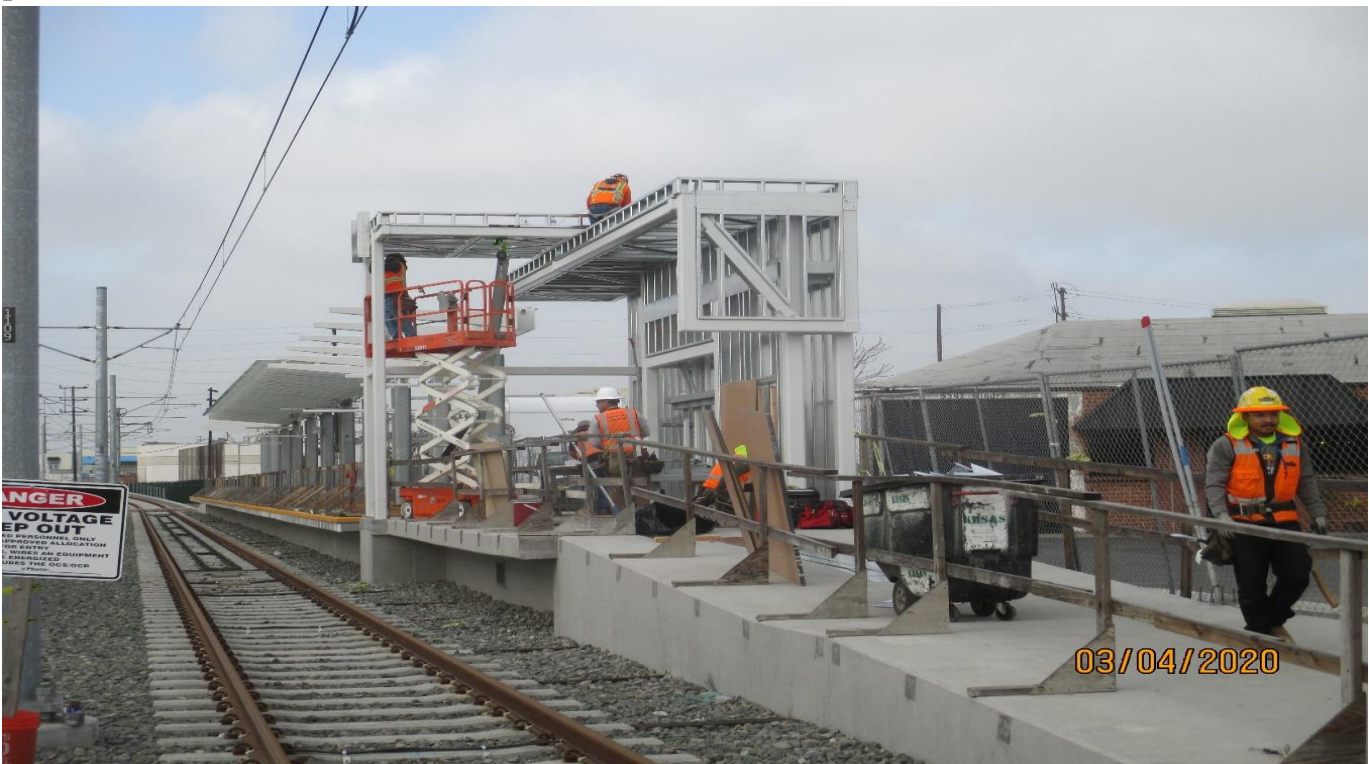
HINDRY AVE- Ticket vending machine mock-up construction and metal stud framing at the Hindry Station SB platform.

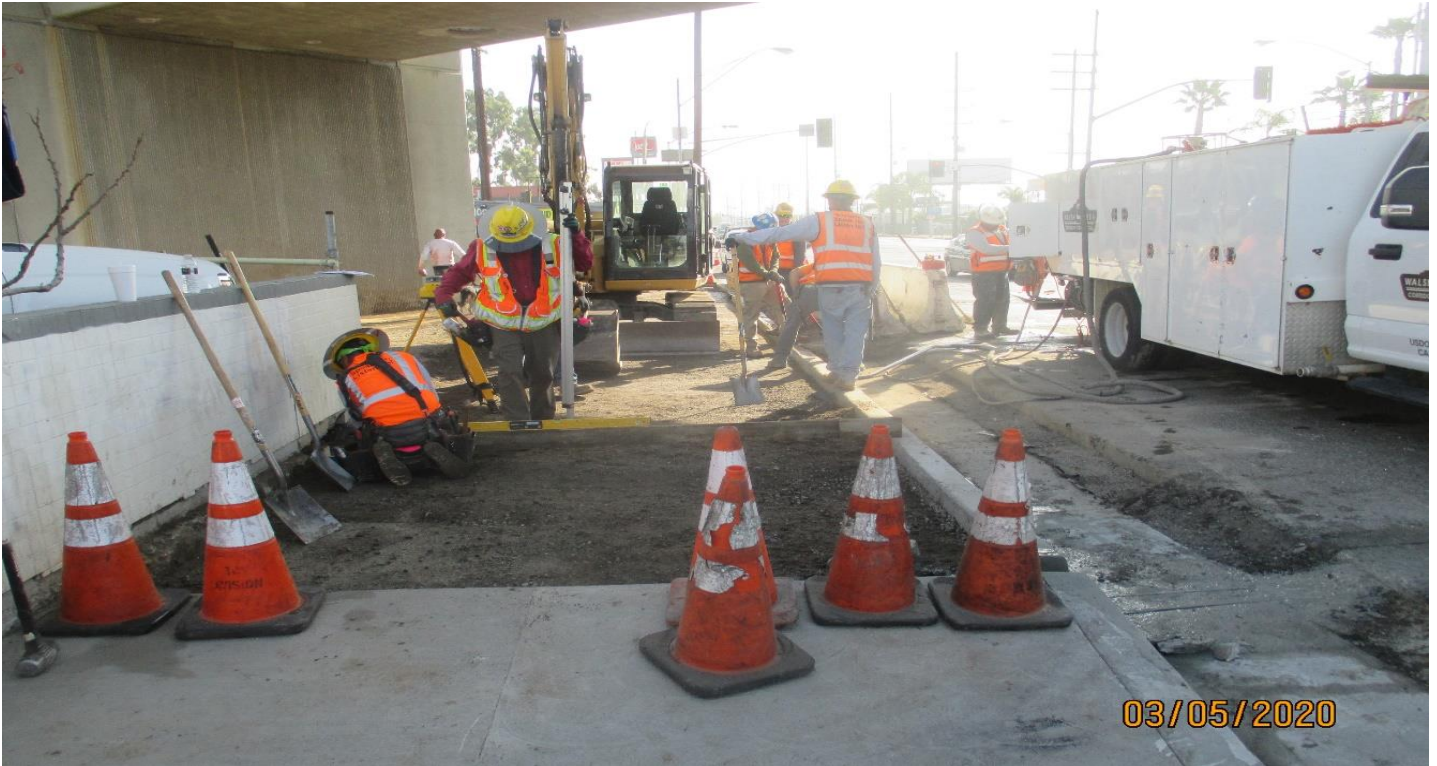
MANCHESTER AVE- Sidewalk grading at Manchester.

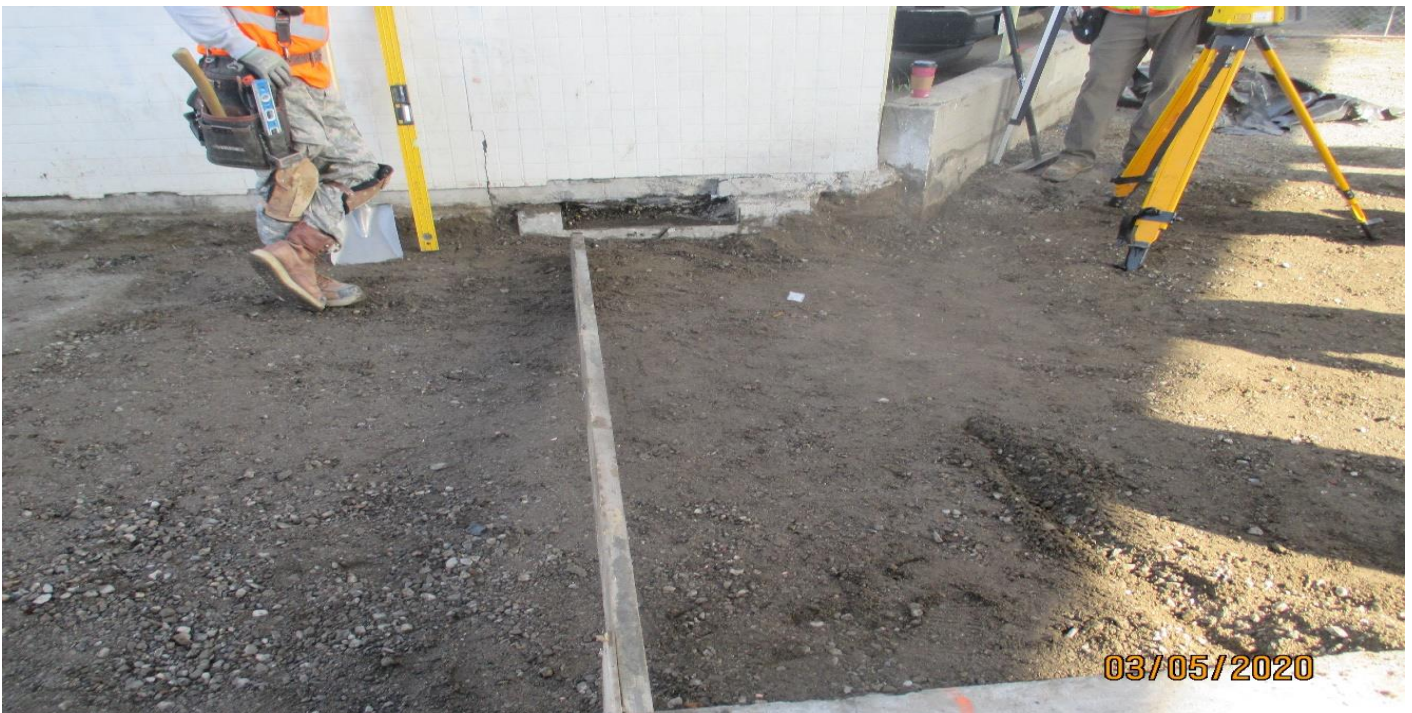
MANCHESTER AVE- Drain that was forgotten and need to be placed in the sidewalk on Manchester.

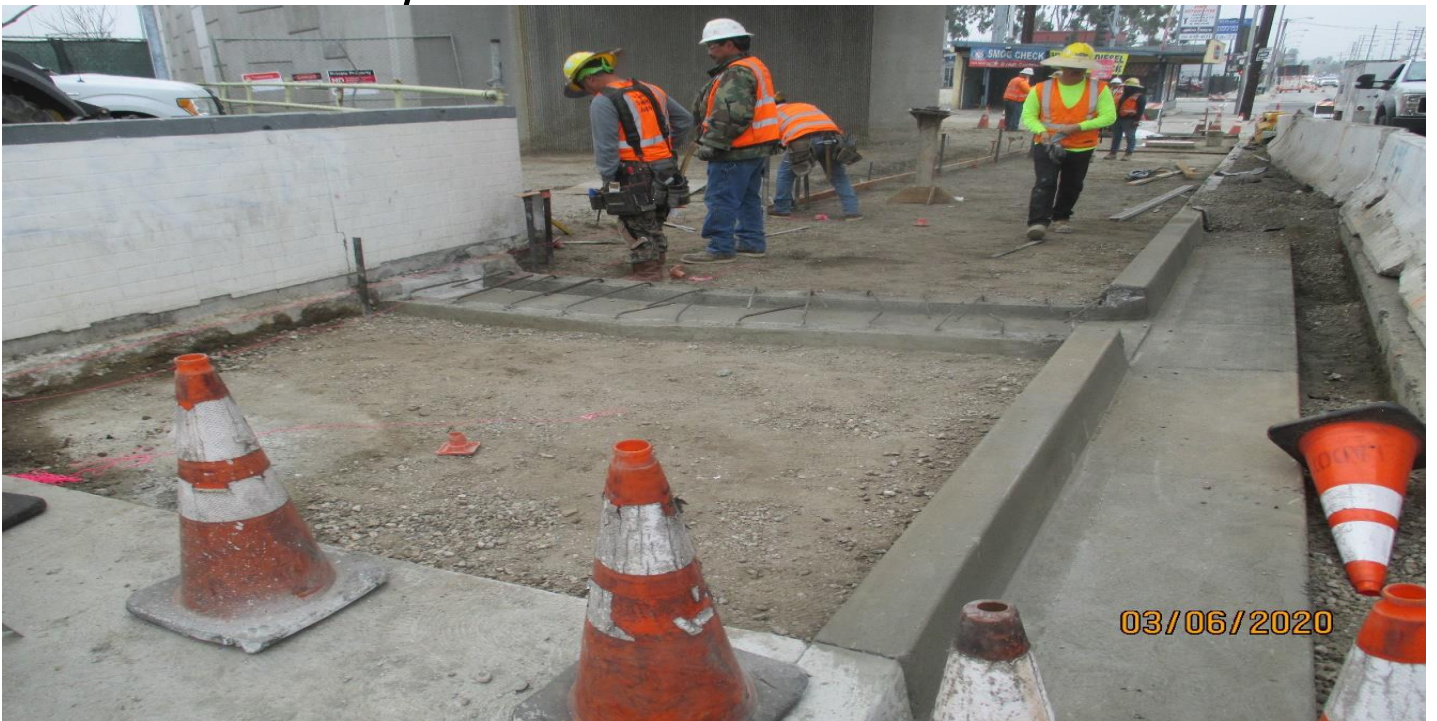
MANCHESTER AVE- Parking lot drain in the sidewalk on the north side of Manchester.

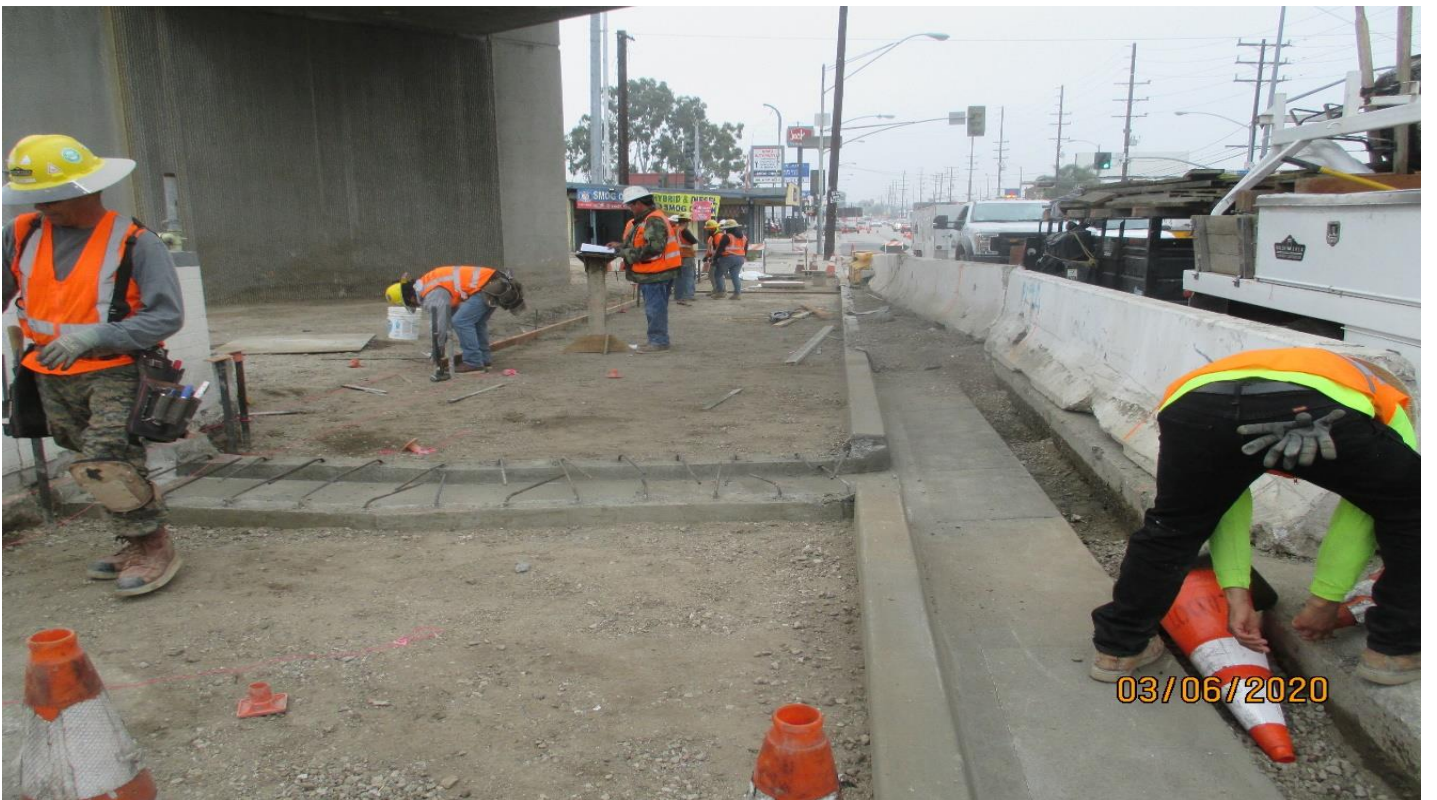
MANCHESTER AVE- Forming for concrete for the sidewalk on the north side of Manchester.

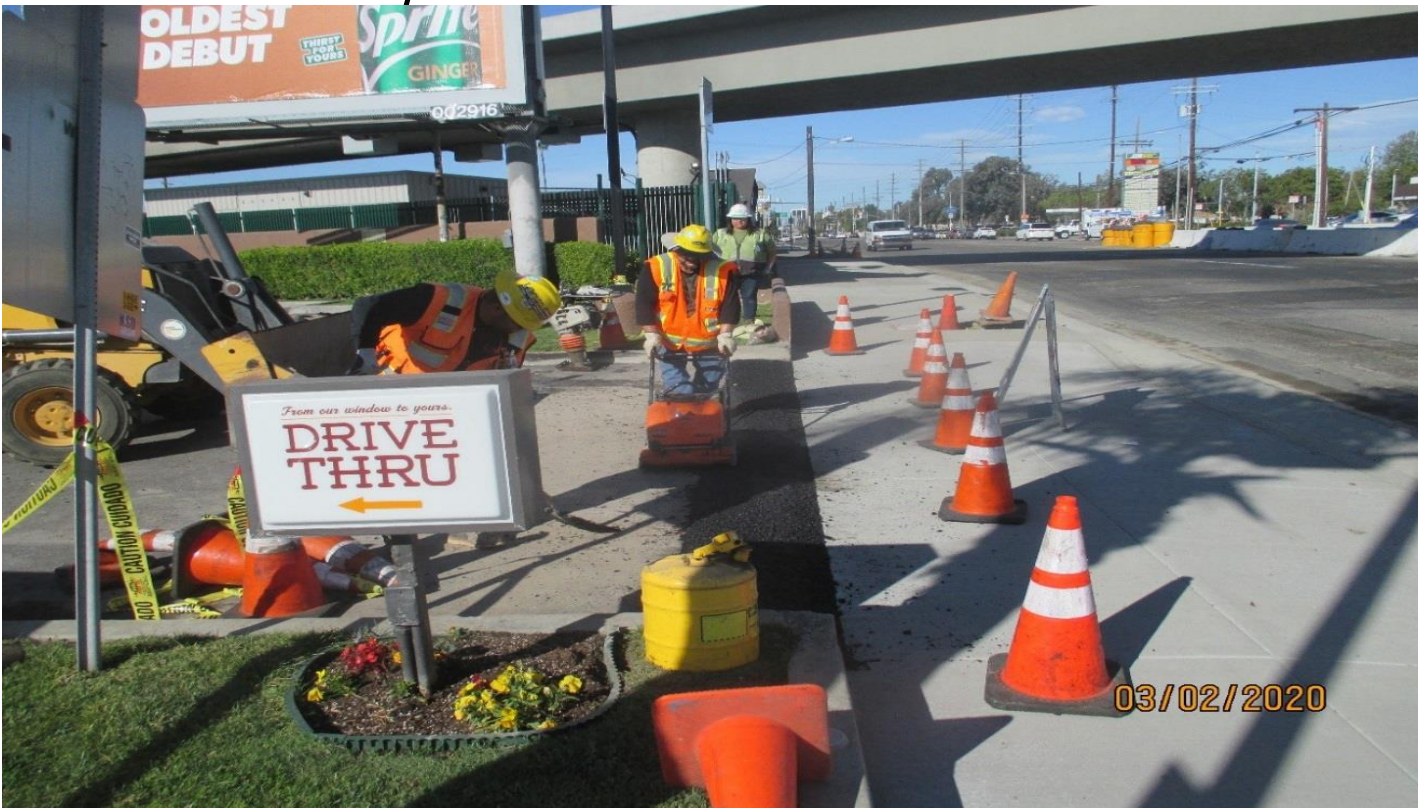
MANCHESTER AVE- Slot paving for the El Pollo Loco driveway on Manchester. Facing west.

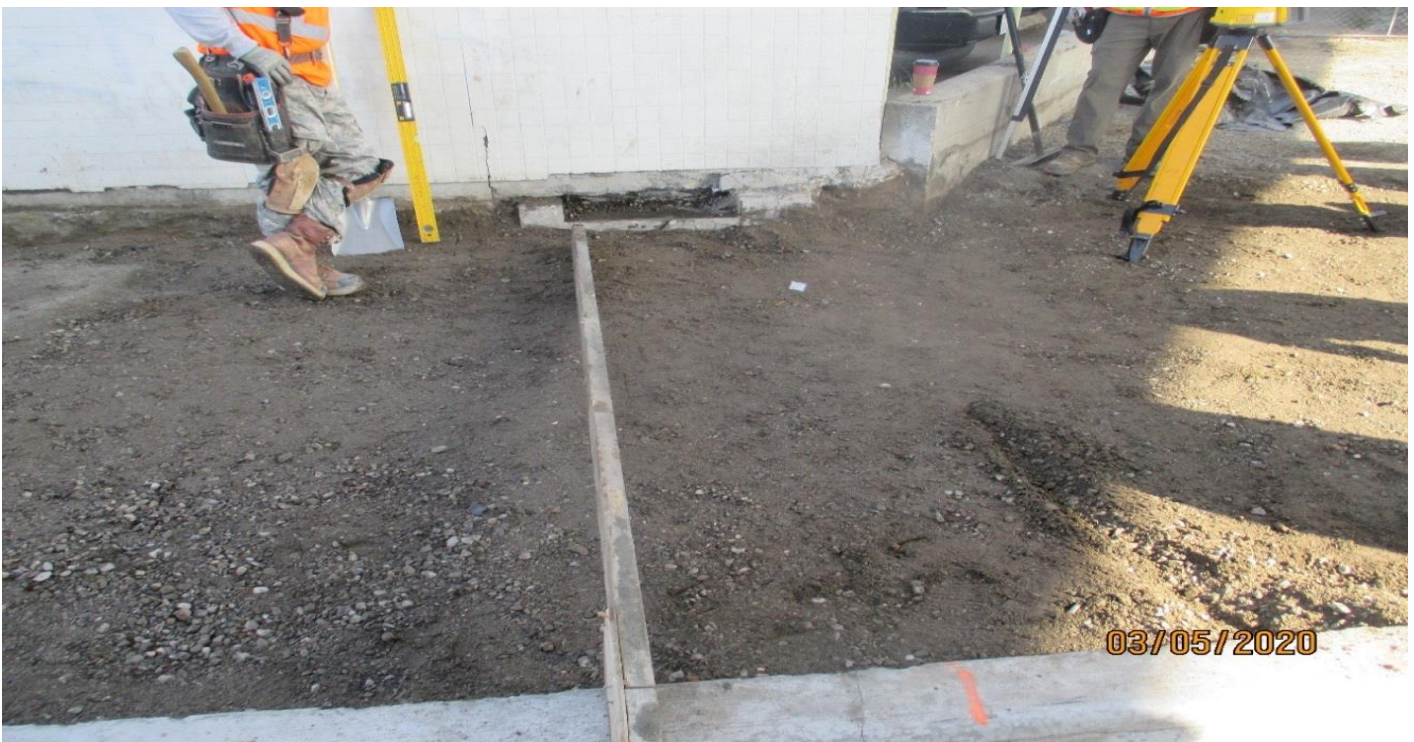
MANCHESTER AVE- Parking lot drain that was forgotten on Manchester. Facing north.

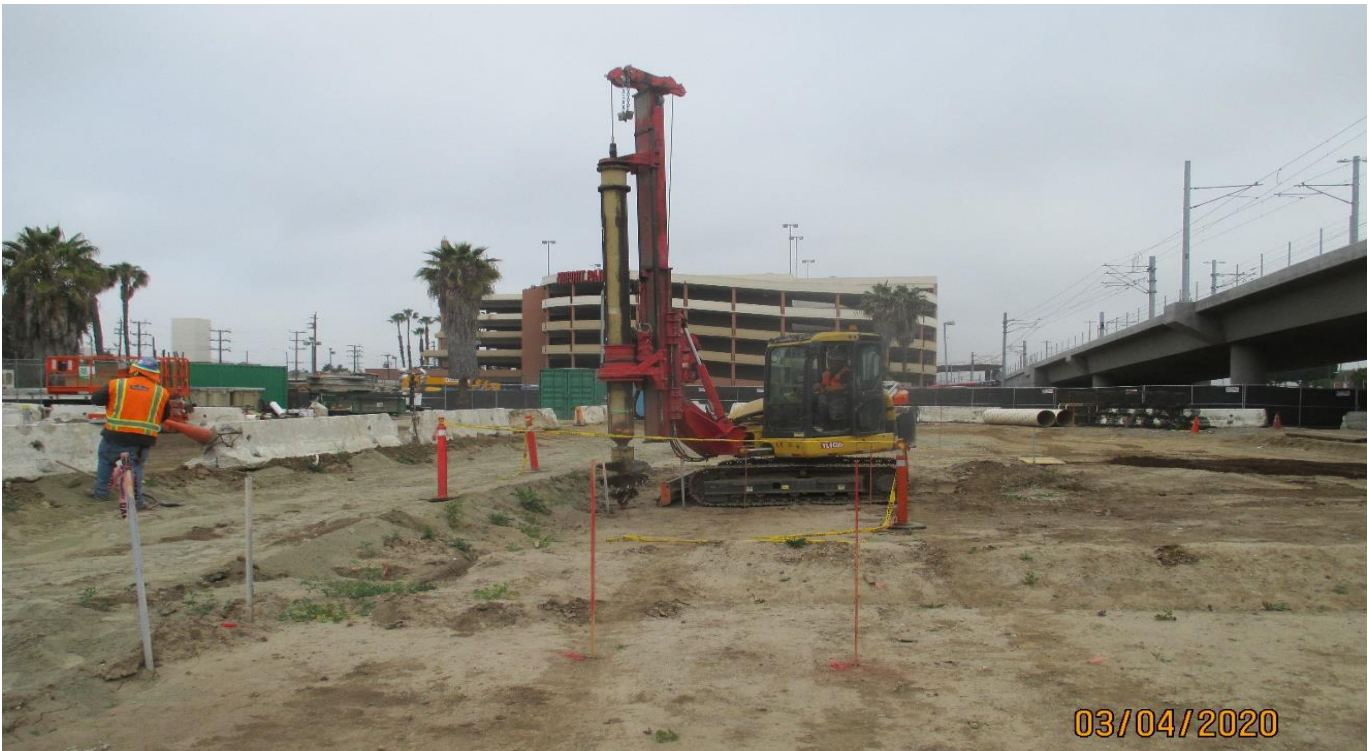
AVIATION/CENTURY- Drilling light pole foundations at the Aviation Station plaza area.
