CRENSHAW/LAX PHOTOGRAPHIC UPDATE

March 17, 2020

Crenshaw/LAX Transit Project

- 8.5 miles Light Rail
- 8 Stations
- \$2,058.0 Million
(Board approved revised LOP)

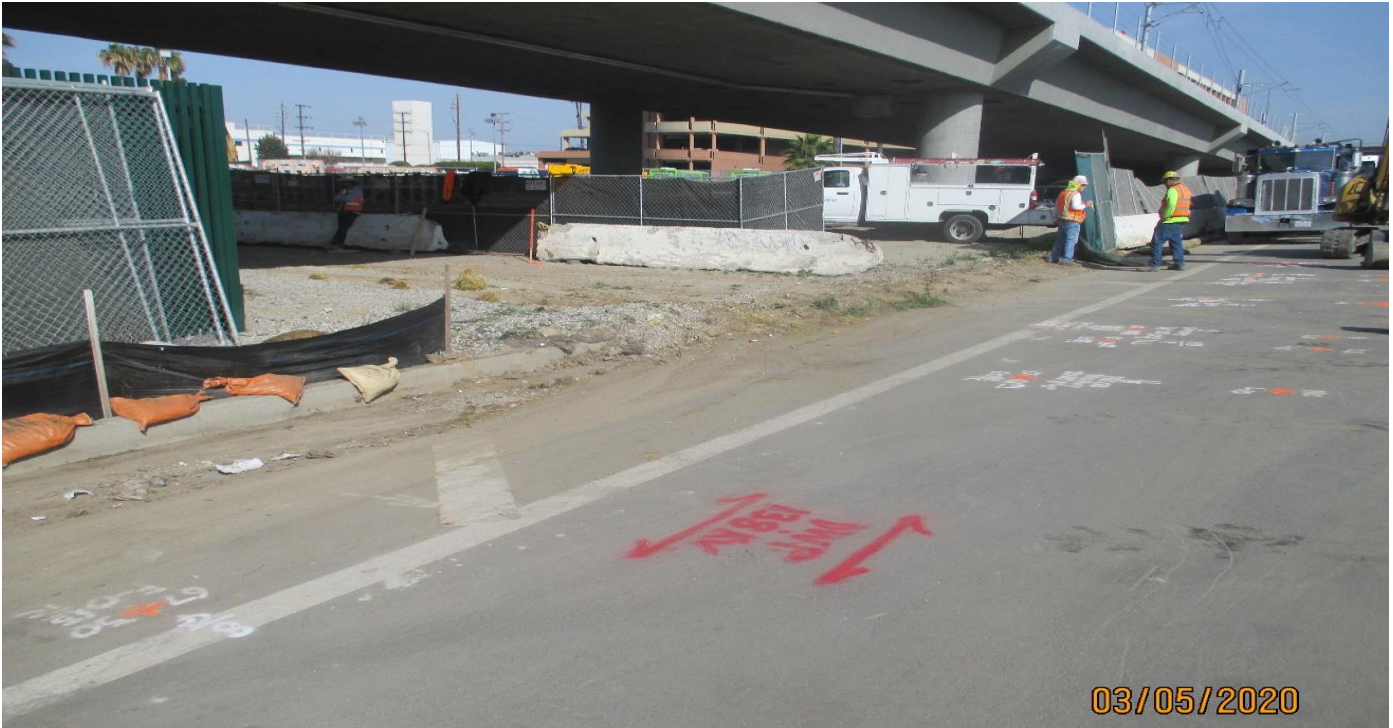
AVIATION/CENTURY- Grading for the Aviation Station plaza and parking lot.

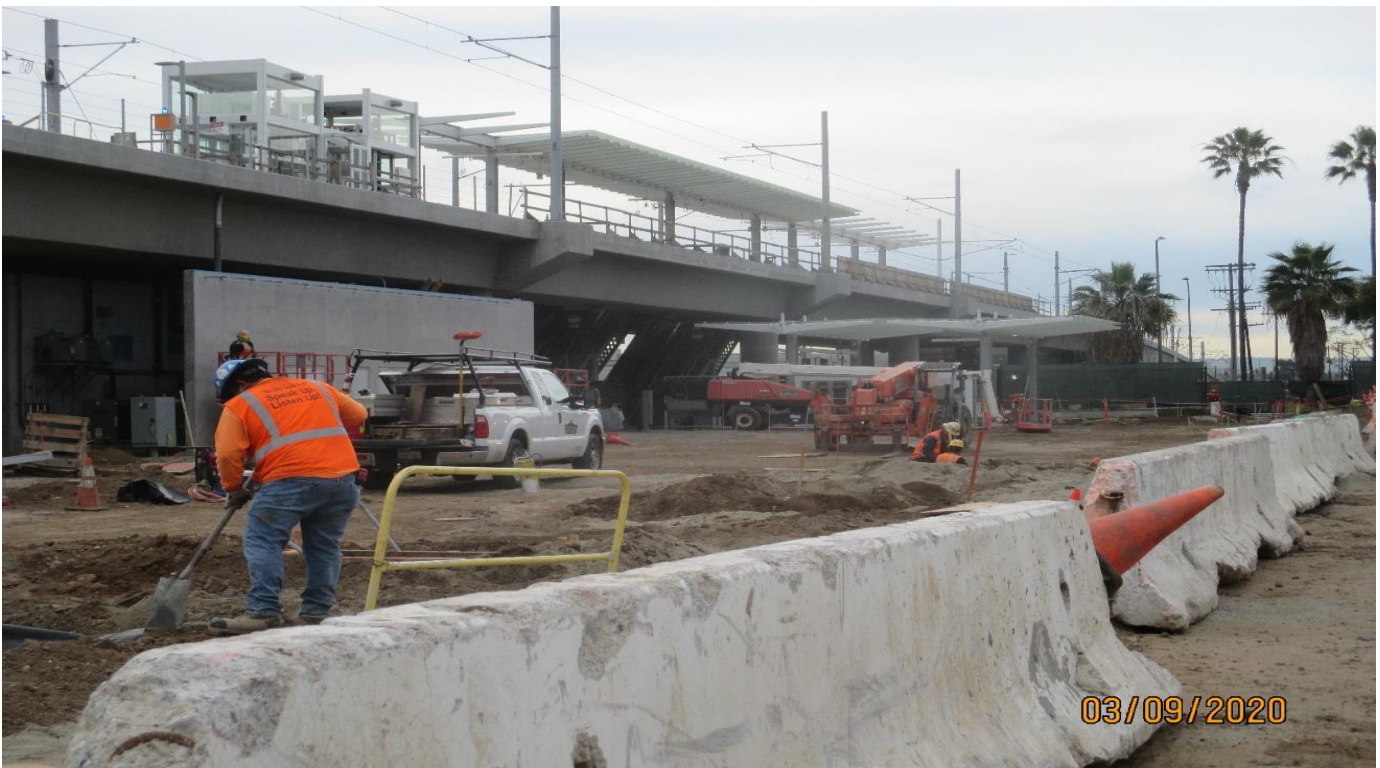
AVIATION/CENTURY- Setting forms and sonatubes for the Aviation Station light pole foundations.

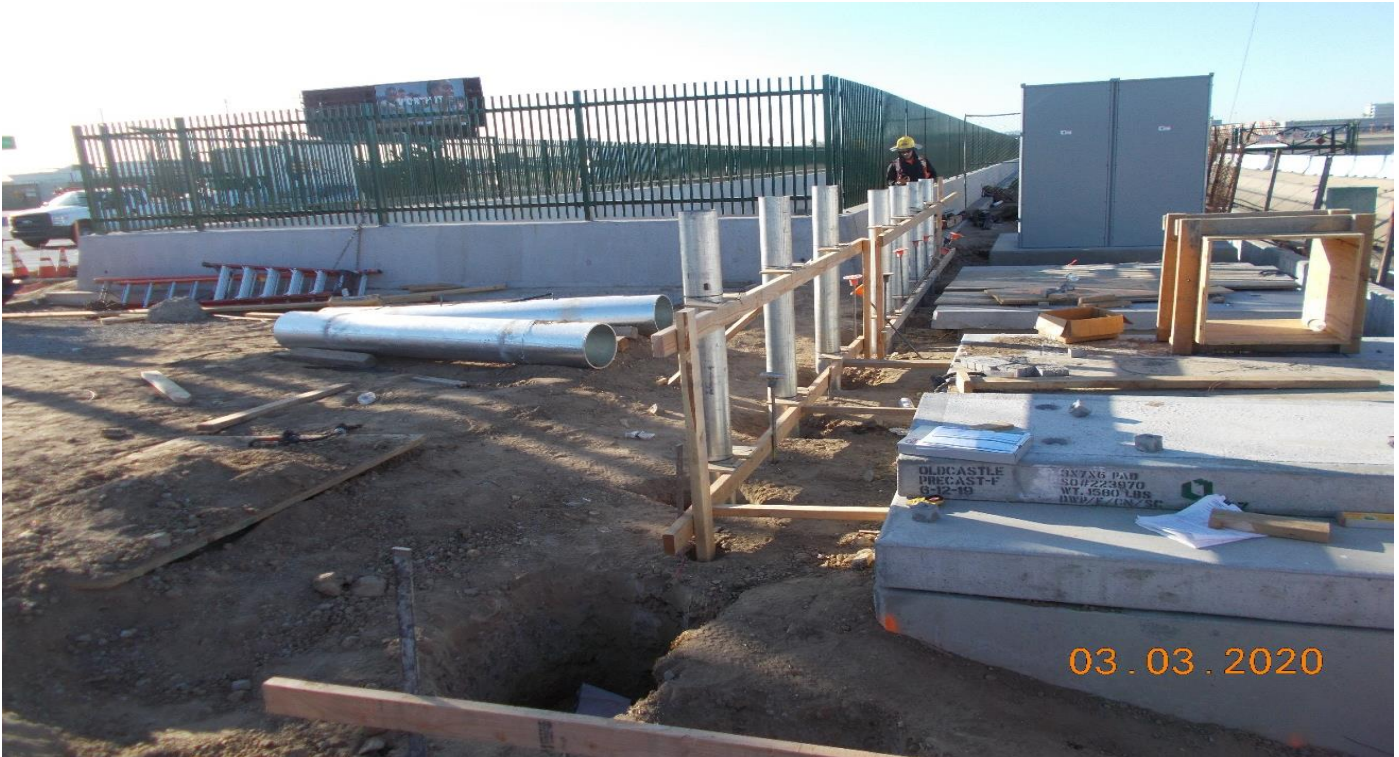
104th STREET – 104th St - WSCC was installing DWP bollards.

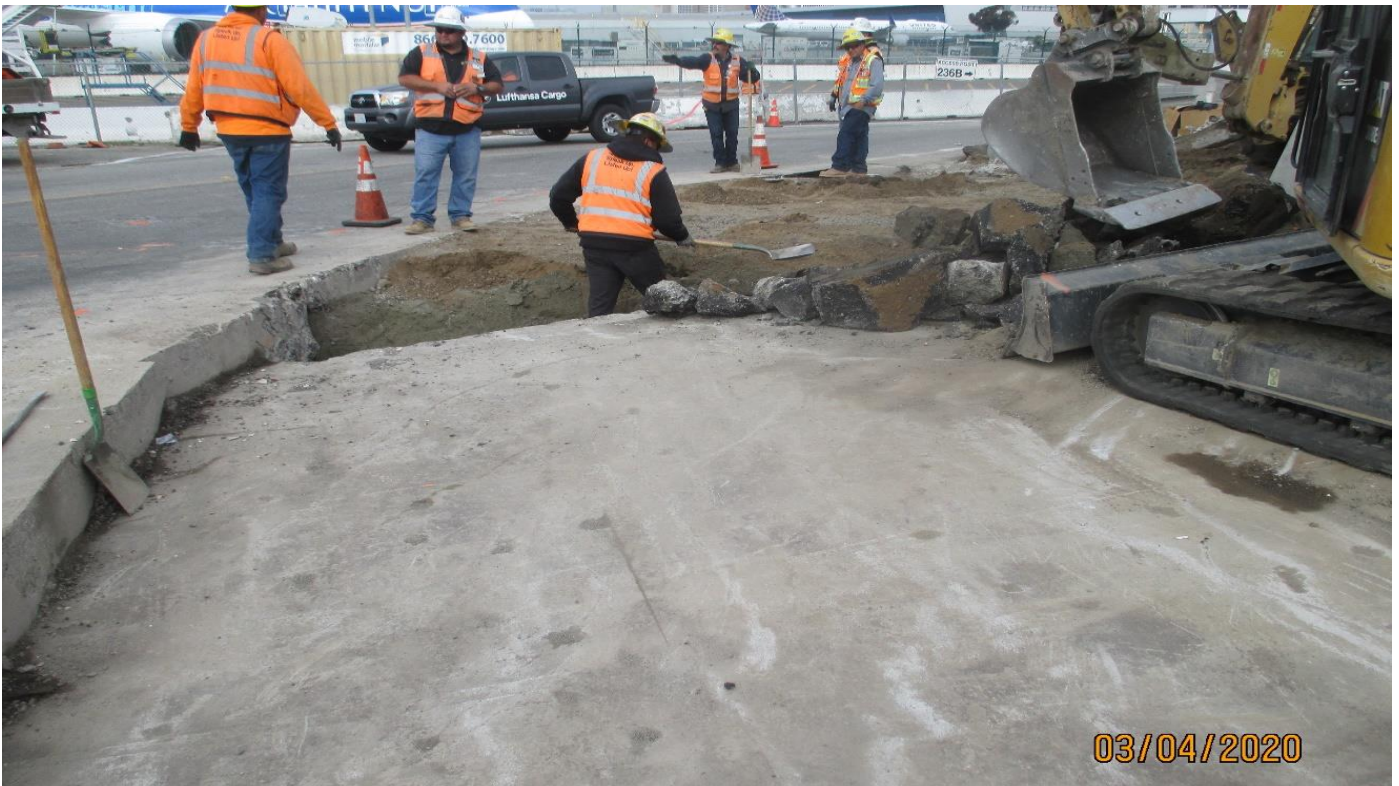
104th STREET – Curb & gutter removals at 104th street.

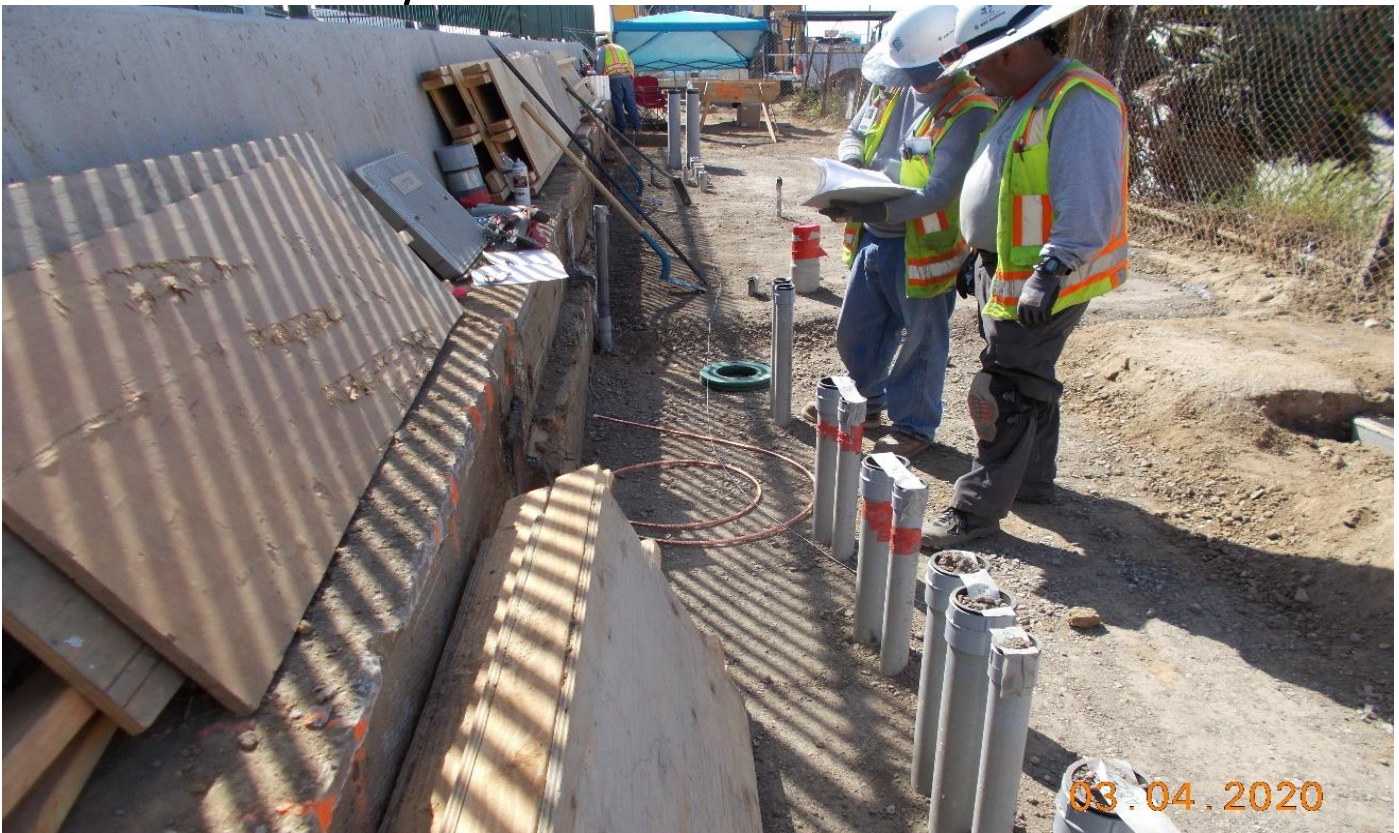
104th STREET – 104th St - Dyna Electric pulling string lines in MCC conduits.

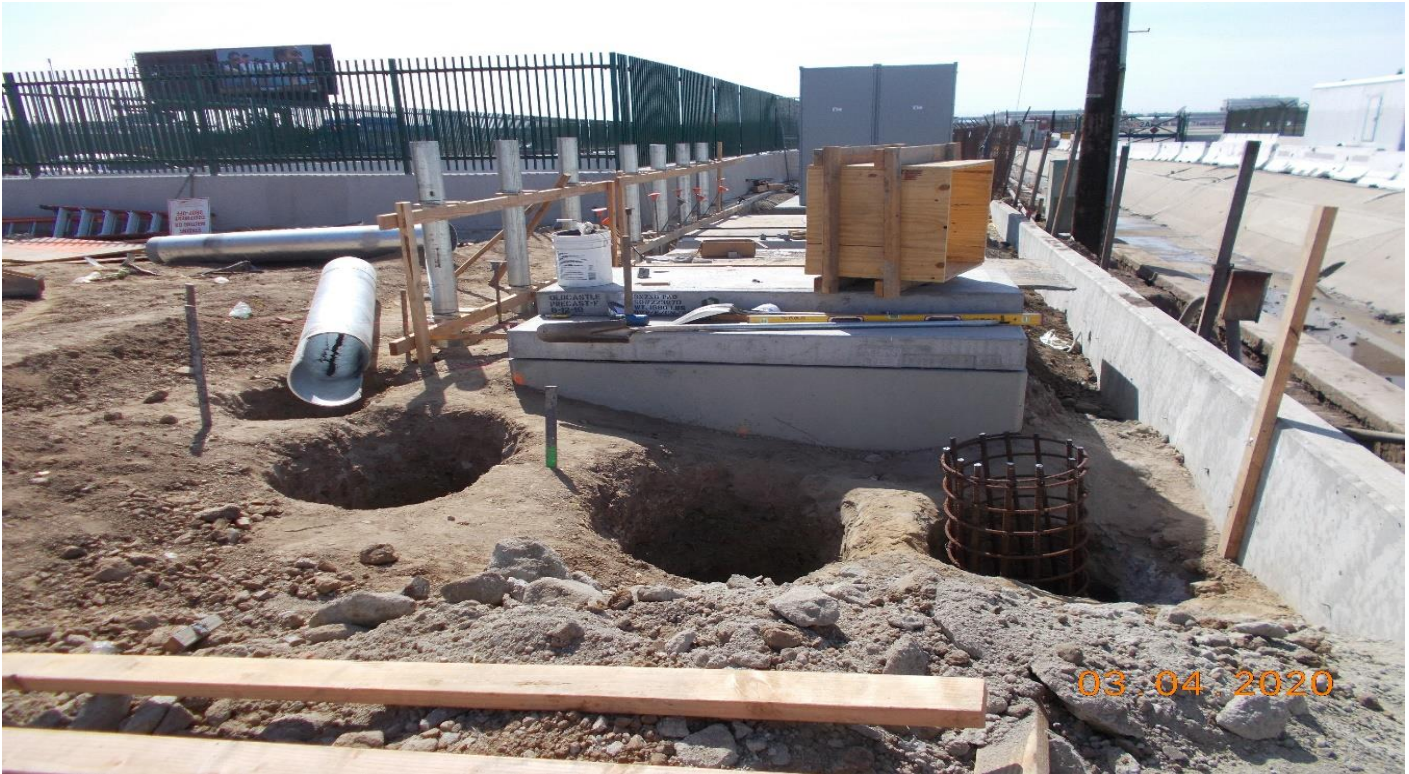
104th STREET – WSCC had dug large footings for large DWP bollards.

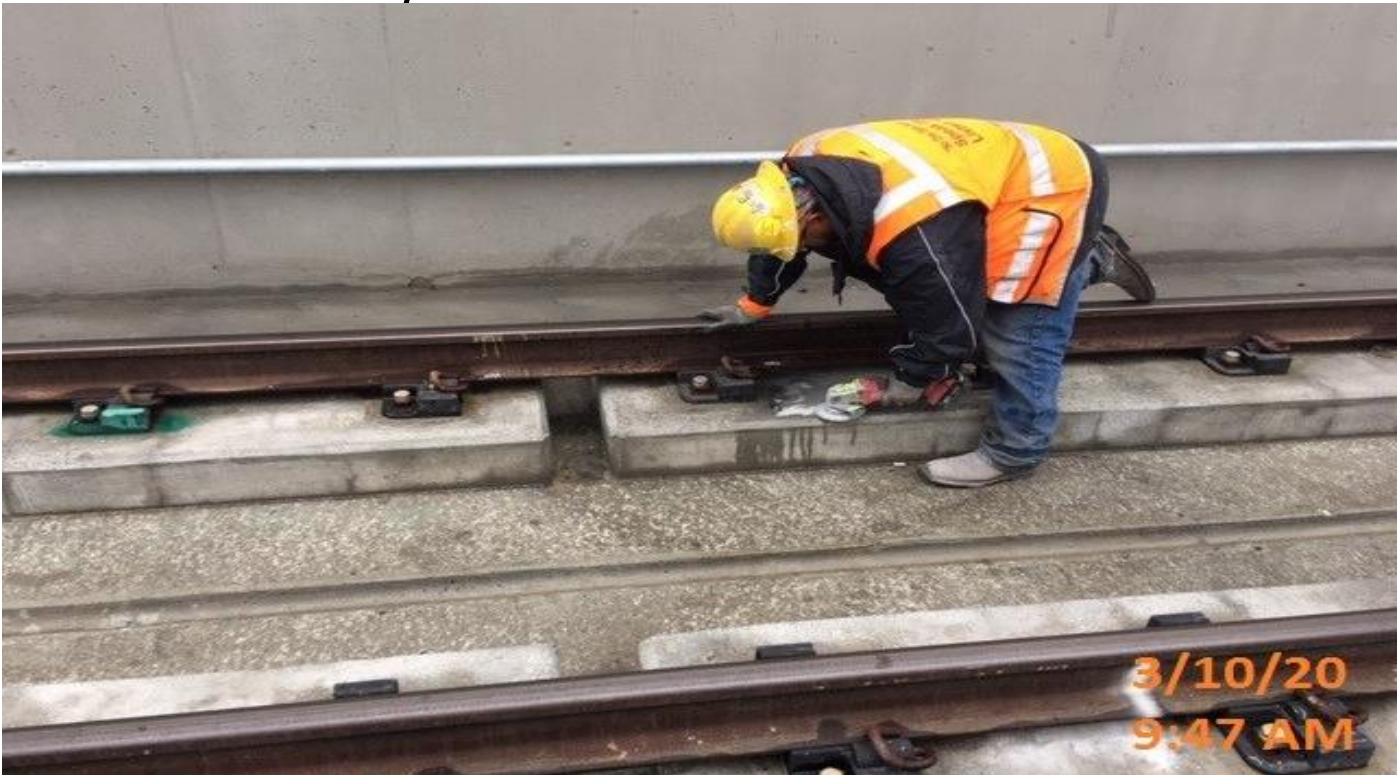
UG3 – UG3 – WSCC crew grinding numbers off of plinths along SB side.

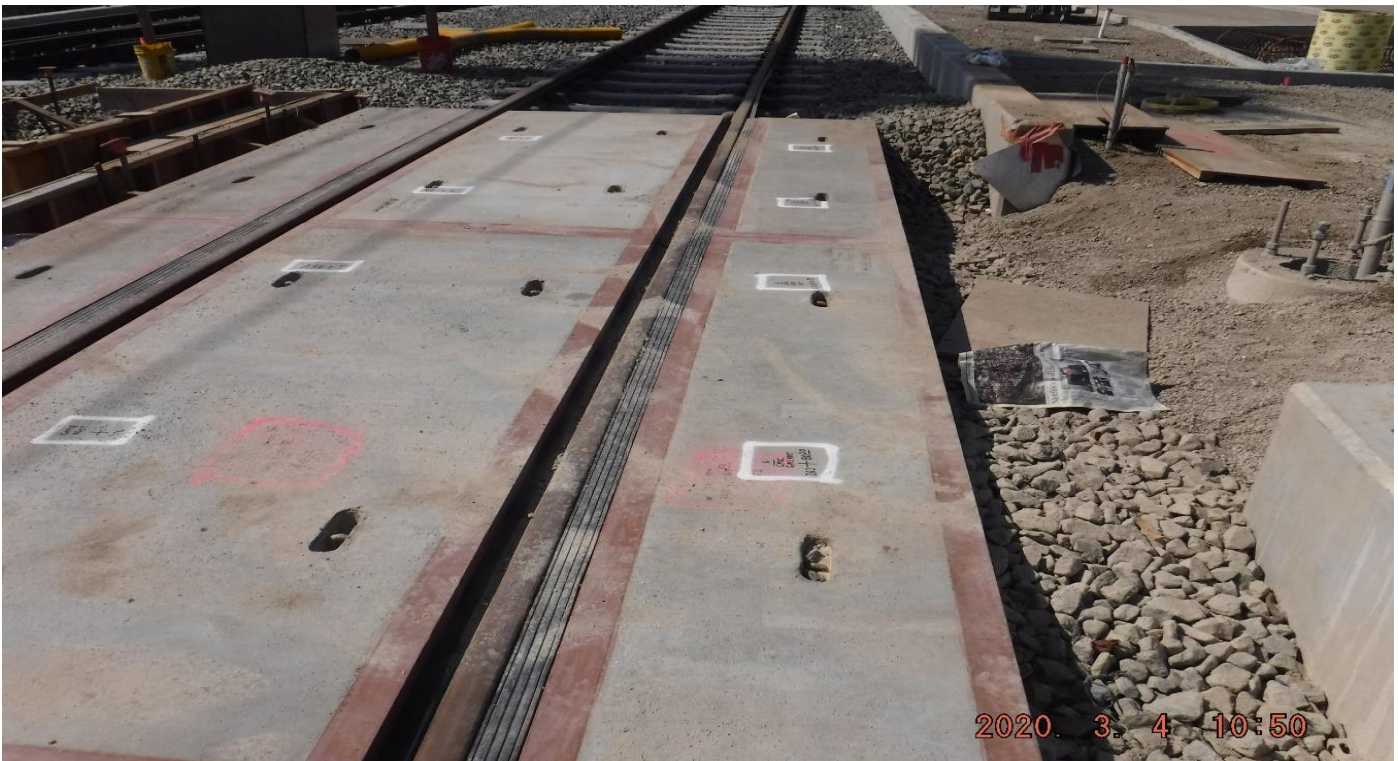
WEST Blvd - STA262+74_ Looking South_ Dirt spilled over TK ballast_ PUNCH LIST_ West.

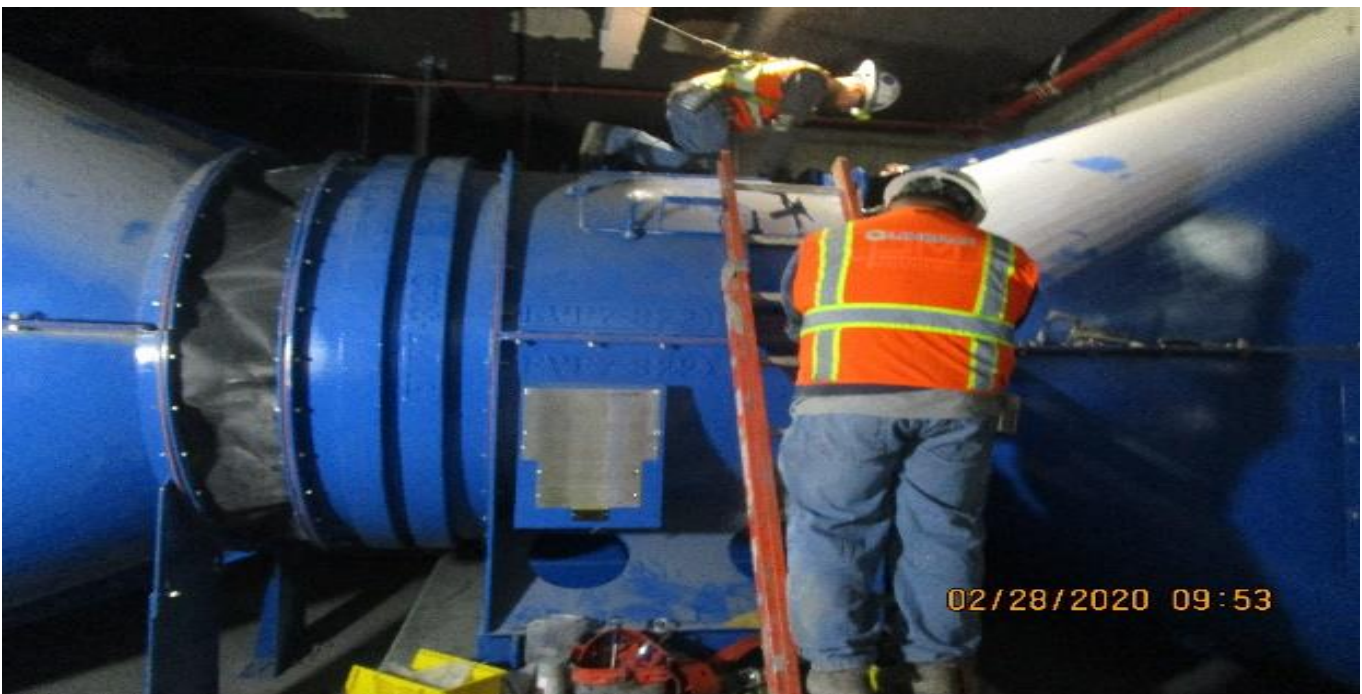
MLK STATION – Began flex connection installation for EVF-6-322 in the North Fan Room C – 142 of the concourse level.

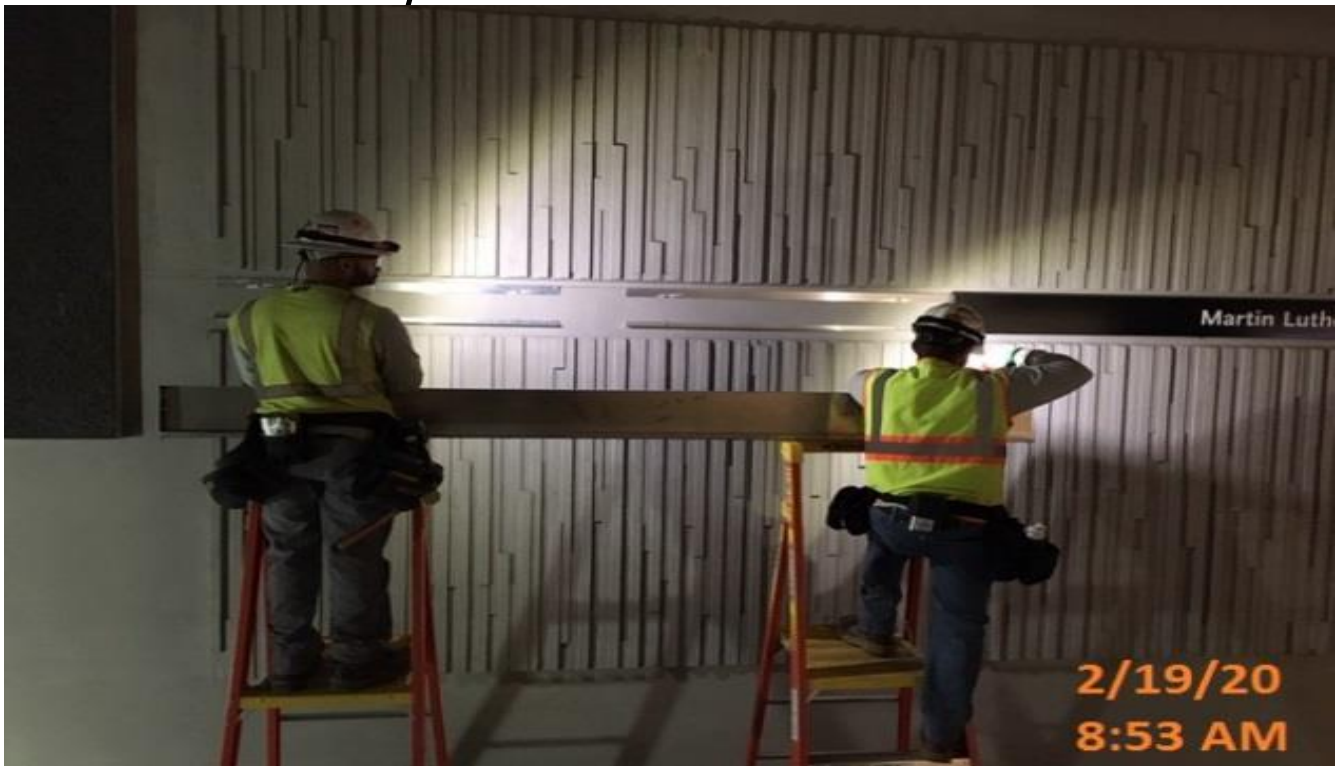
MLK STATION – Continue installing hardware and signage identification along the northbound track of the platform level.

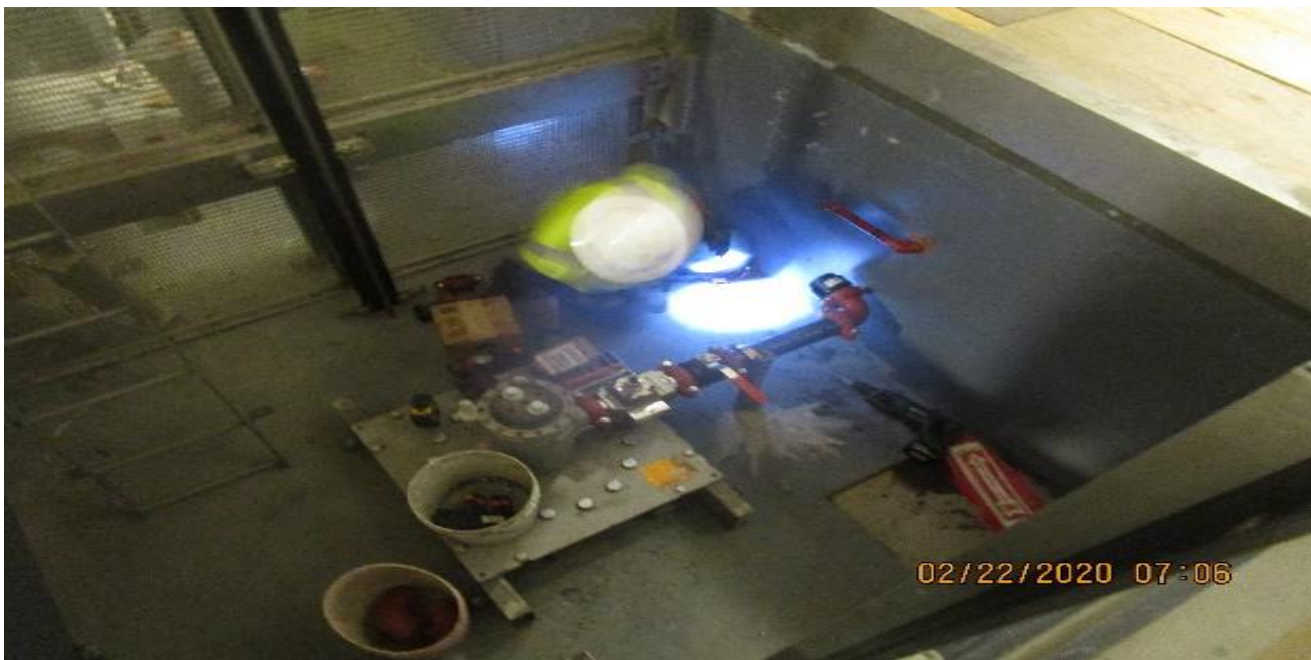
MLK STATION – Installation 3” hydraulic line to valve for Elevator hoist way/pit 3&4 at the platform level.

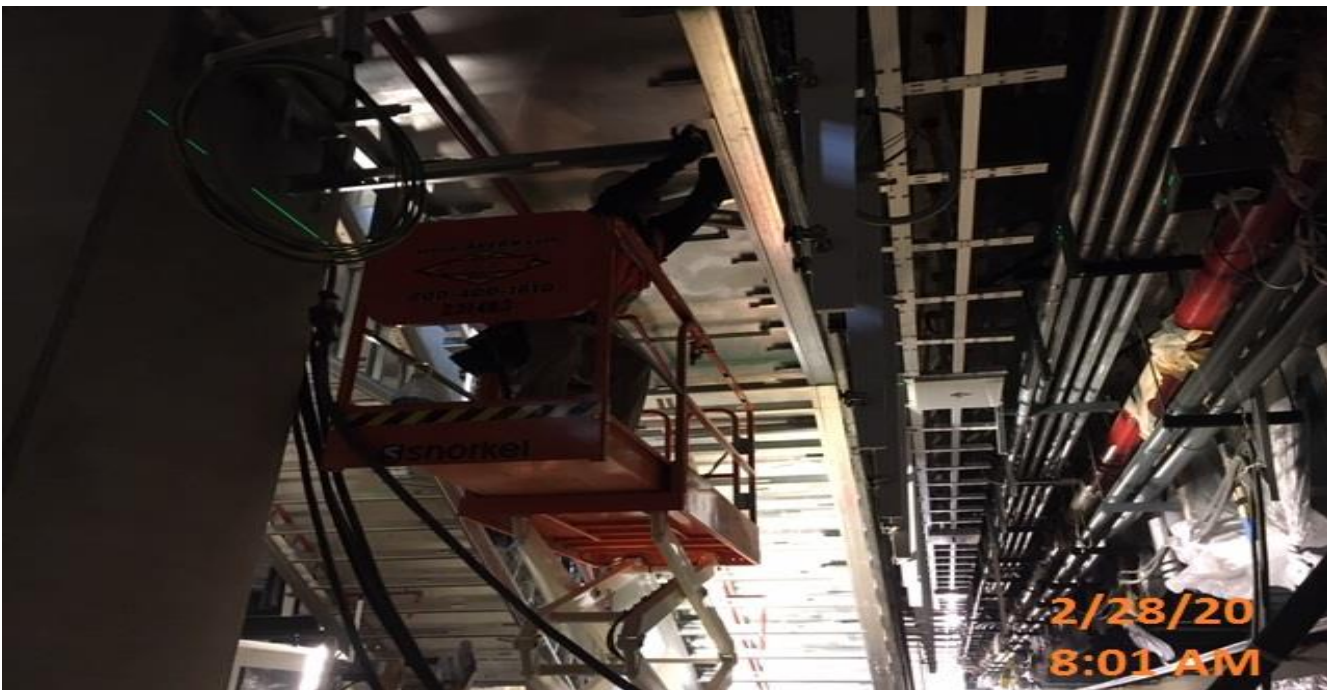
MLK STATION – Continue installation of laminated cladding frame for the metal panels beneath staircase 3 at the platform level.

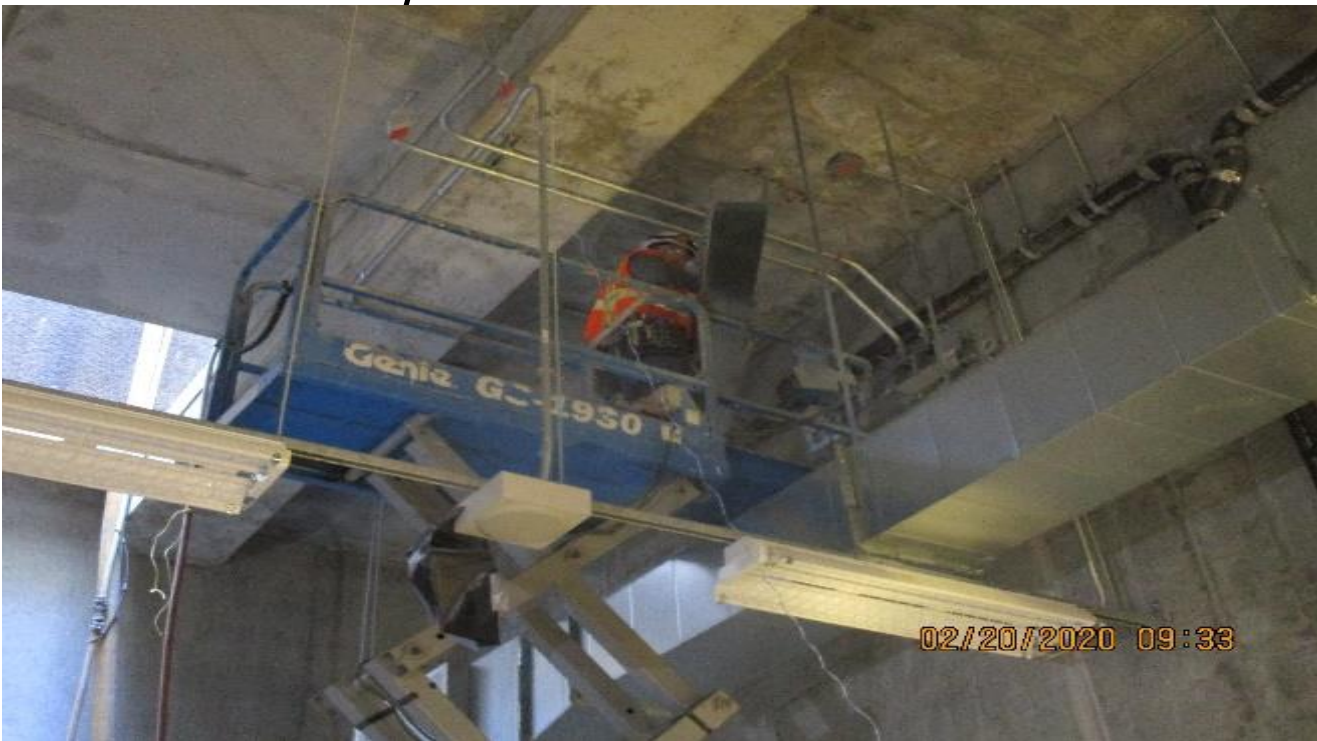
MLK STATION – Continue installing sheet metal drip pans for the overhead drainage in TPPS Room T109 of the invert level.

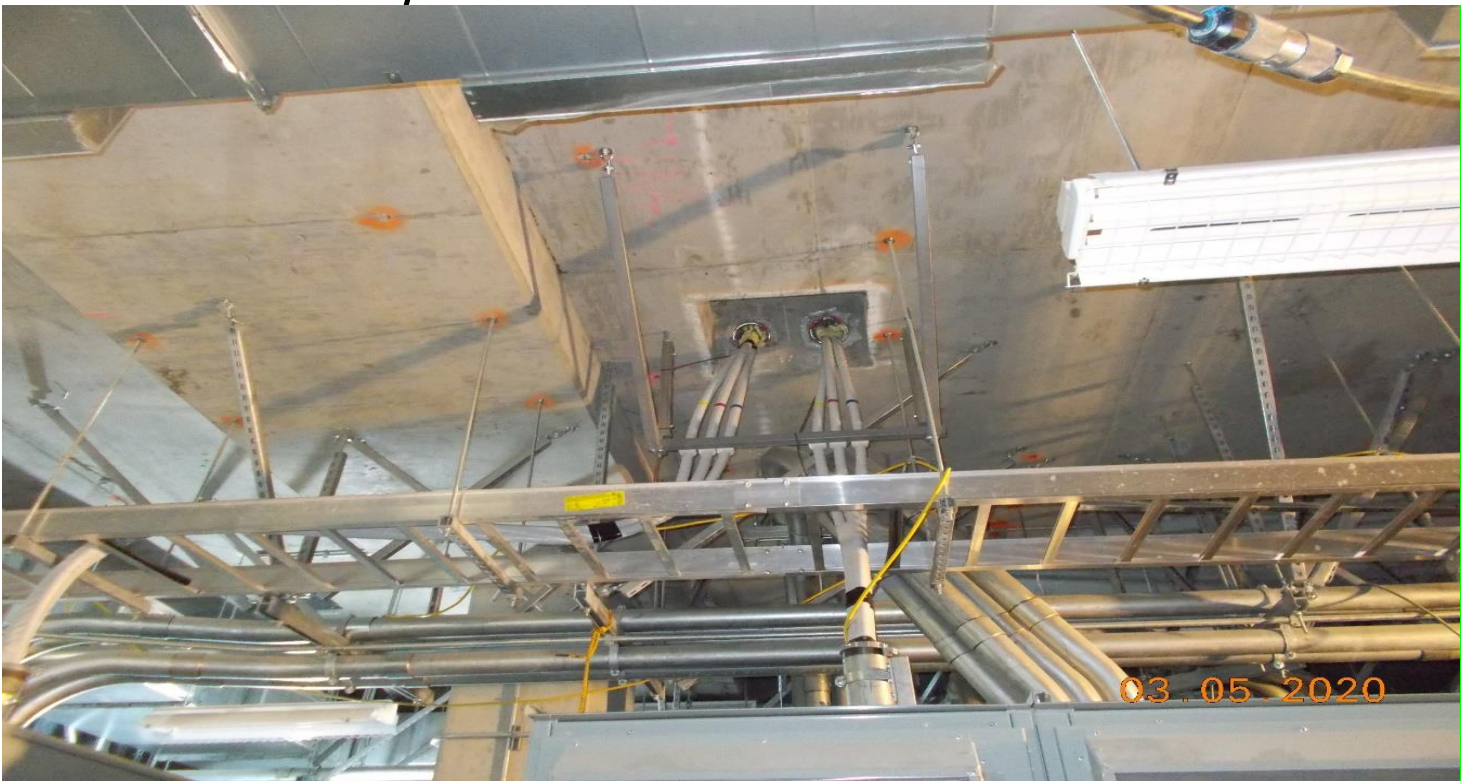
MLK STATION – In Aux Pwr room south Faith Electric had installed a support structure for the high voltage cables.

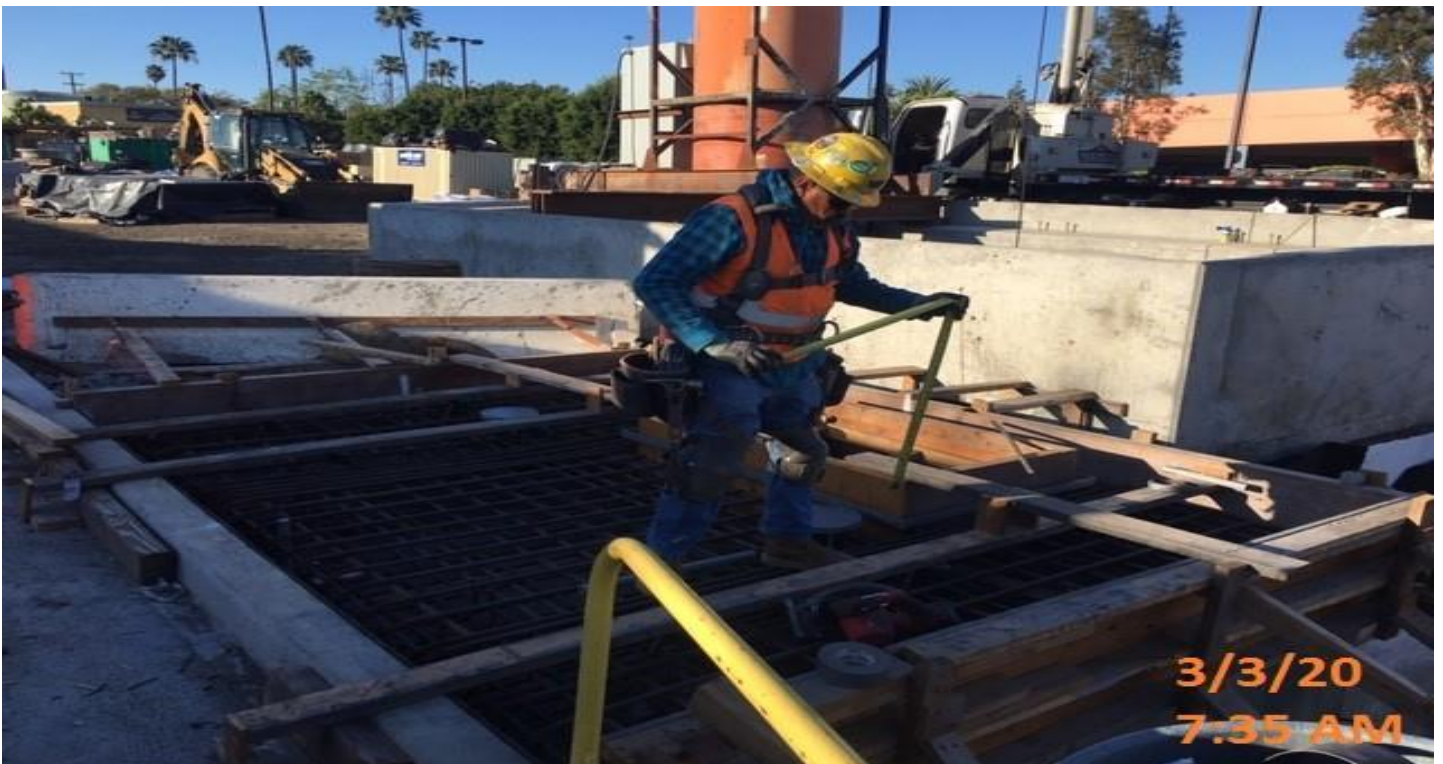
MLK STATION – WSCC crew setting rod embeds for concrete slab.

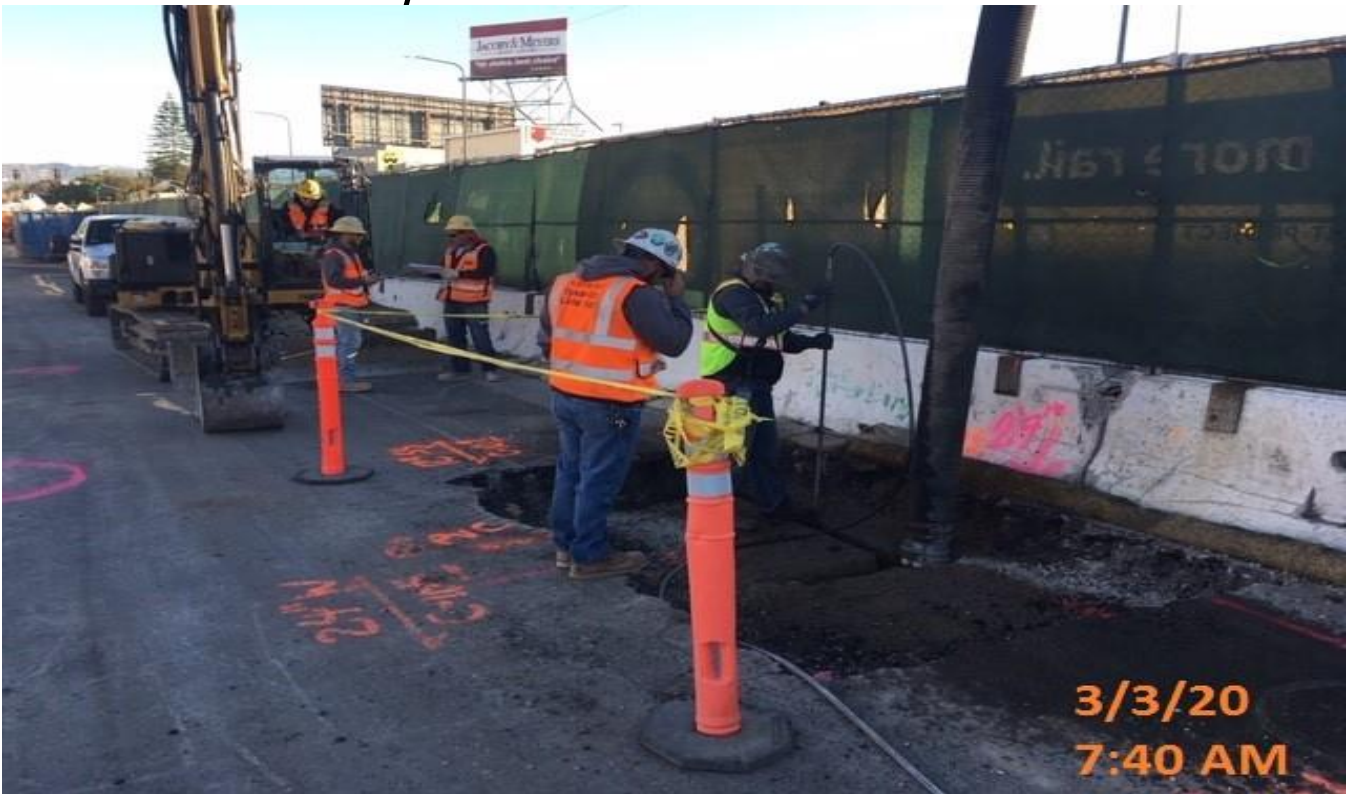
MLK STATION – WSCC crew and Norcal potholing in new area.

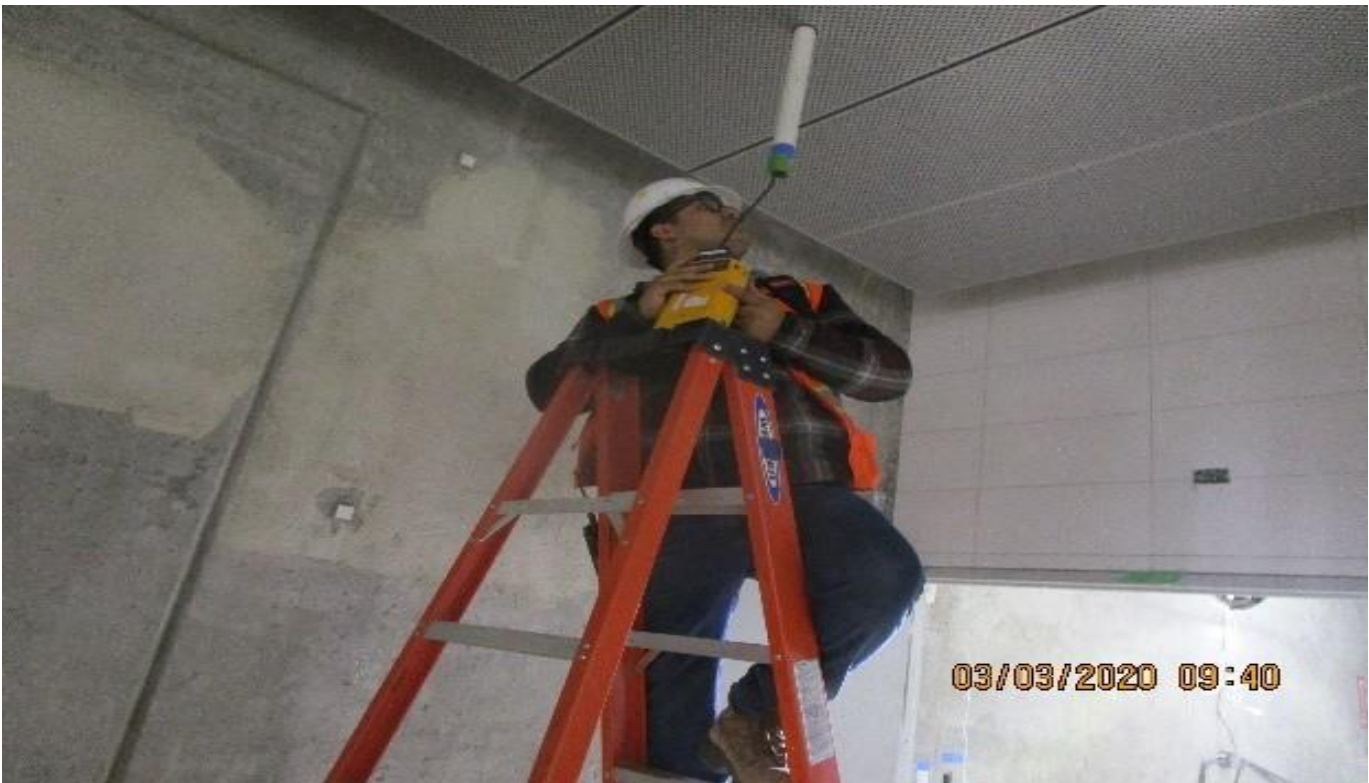
MLK STATION – Free Area C118 & Paid Area C119, Begin at device locations continuity testing CAT-6 cables for LCD-CCTV.

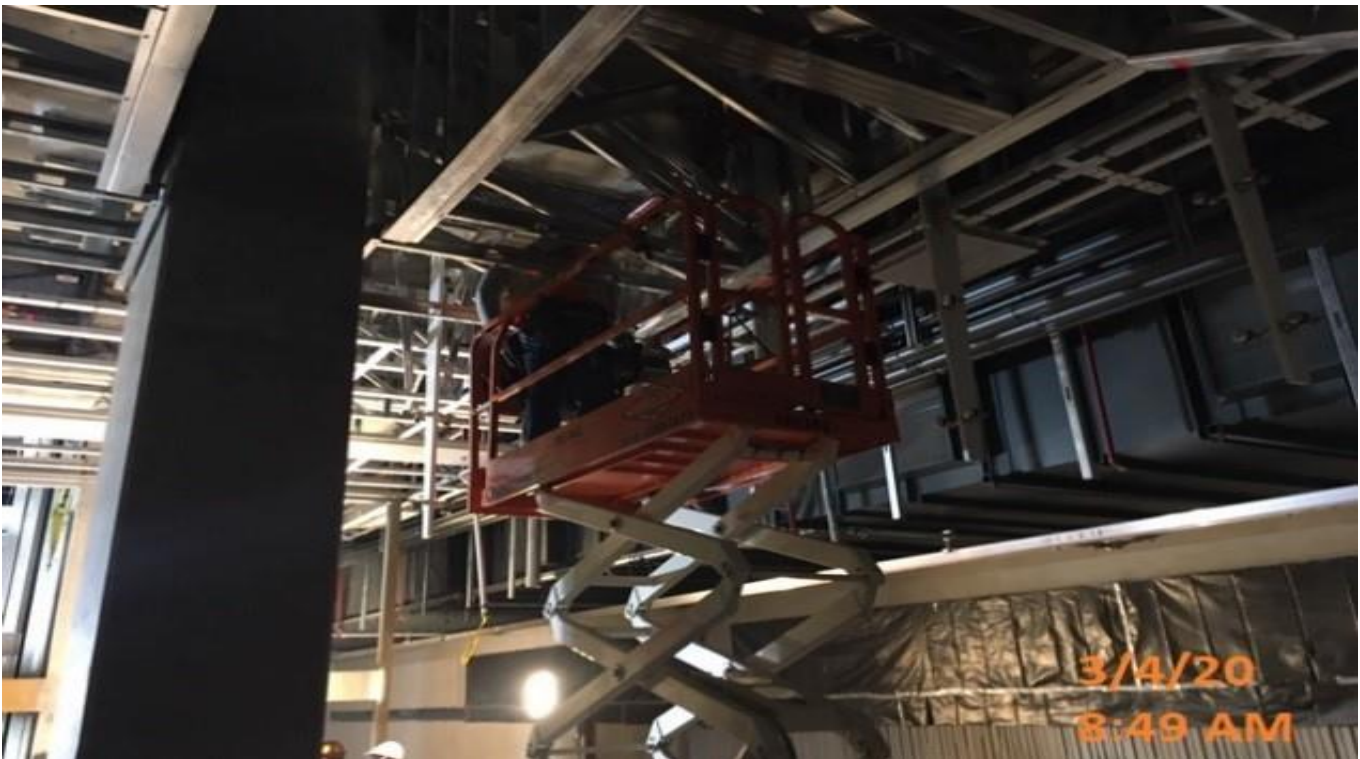
MLK STATION – KHS&S installing steel stud track beneath stairs.

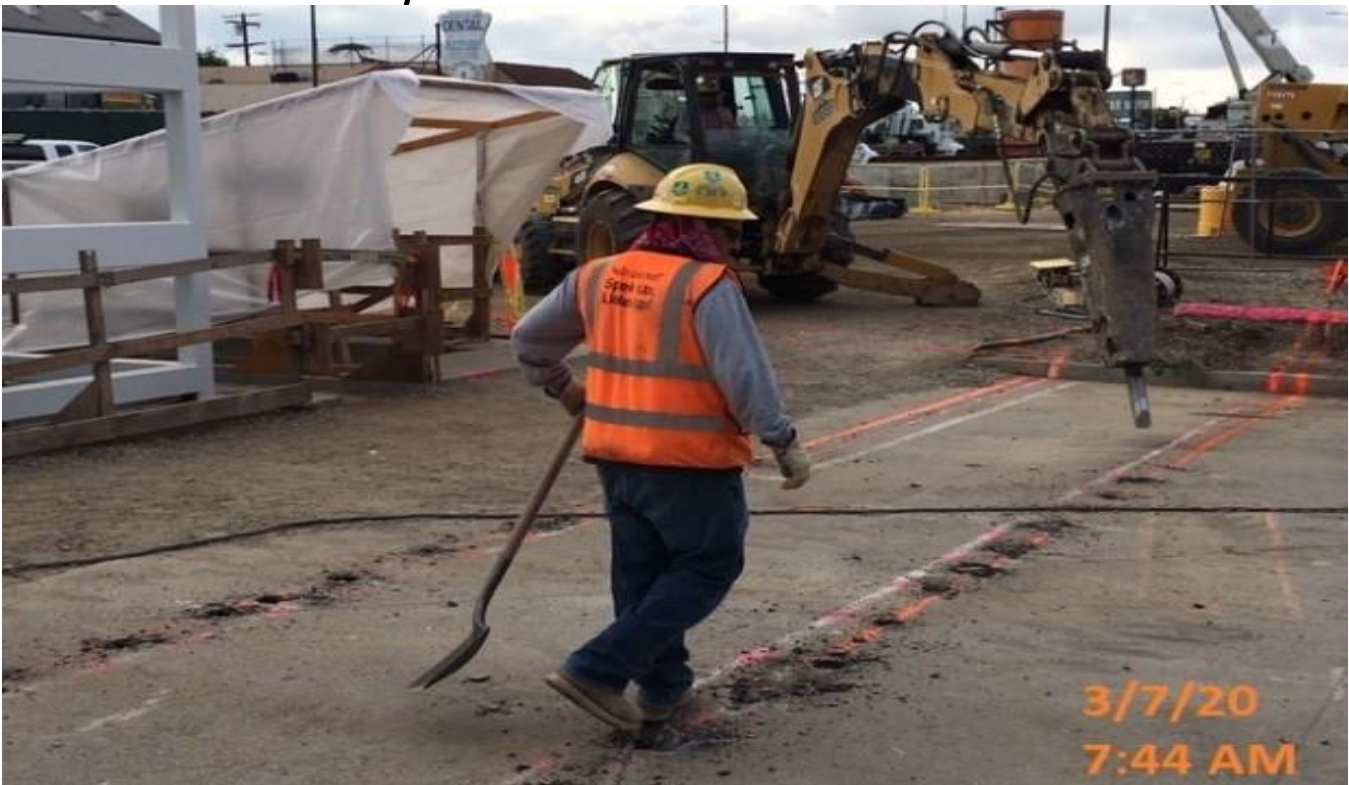
MLK STATION – WSCC crew demoing AC for planter.

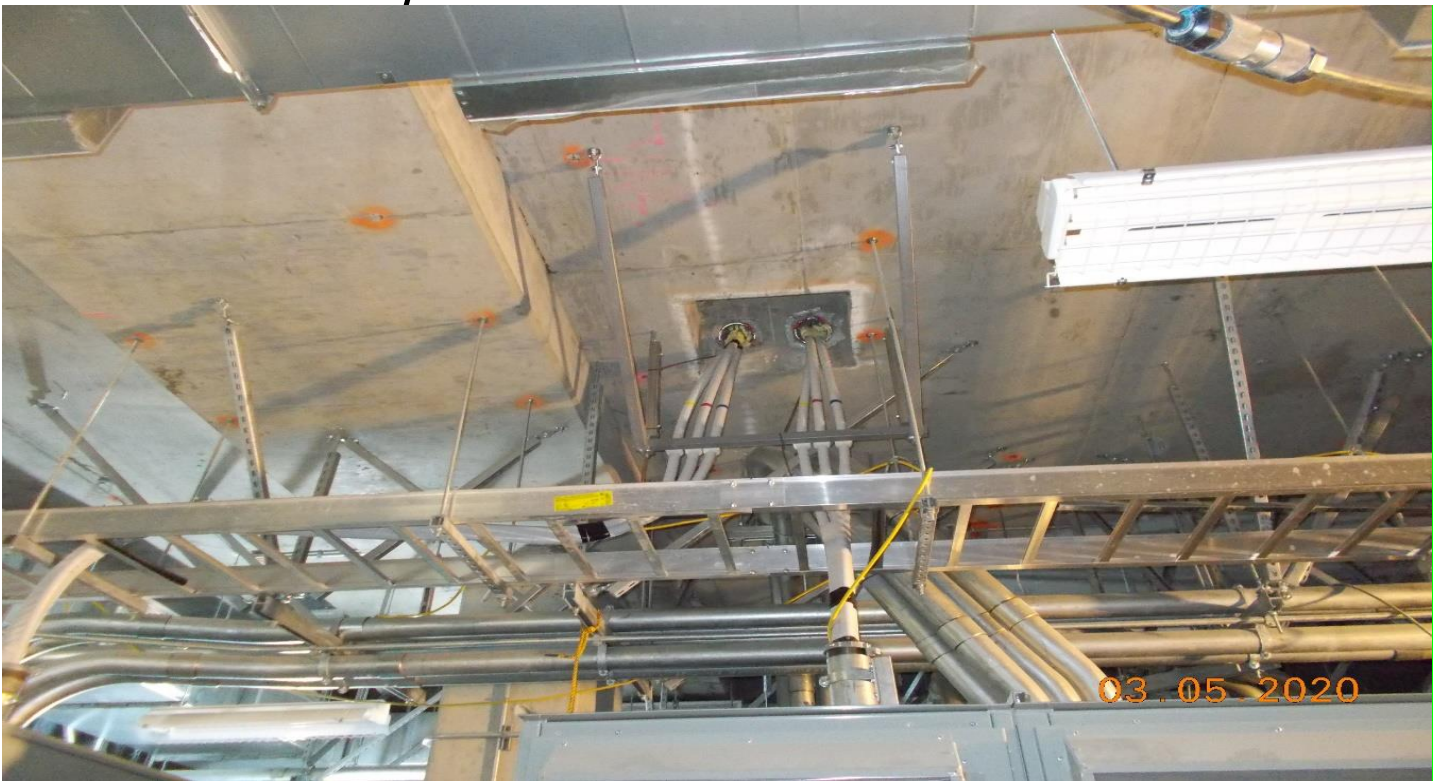
MLK STATION – In Aux Pwr room south Faith Electric had installed a support structure for the high voltage cables.

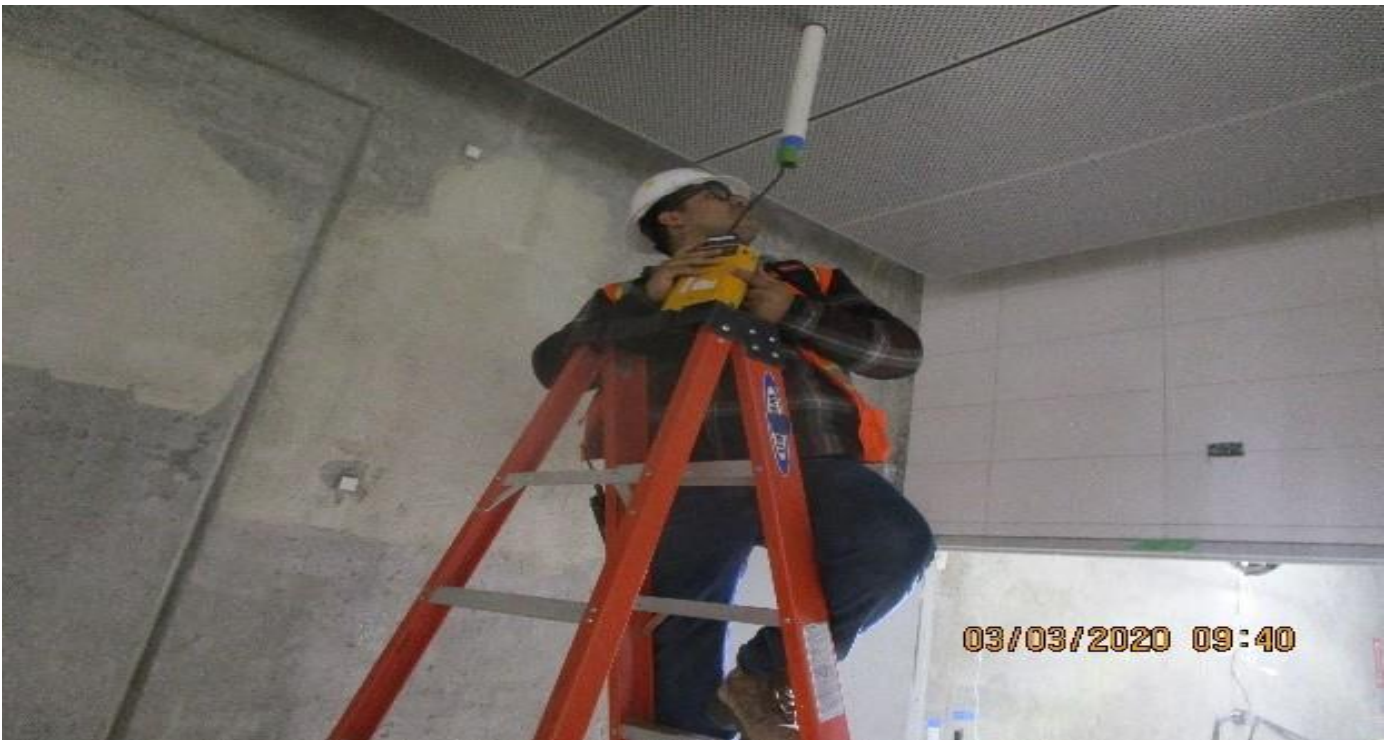
MLK STATION – Free Area C118 & Paid Area C119, Begin at device locations continuity testing CAT-6 cables for LCD-CCTV.
