CRENSHAW/LAX PHOTOGRAPHIC UPDATE

March 17, 2020

Crenshaw/LAX Transit Project

- 8.5 miles Light Rail
- 8 Stations
- \$2,058.0 Million
(Board approved revised LOP)

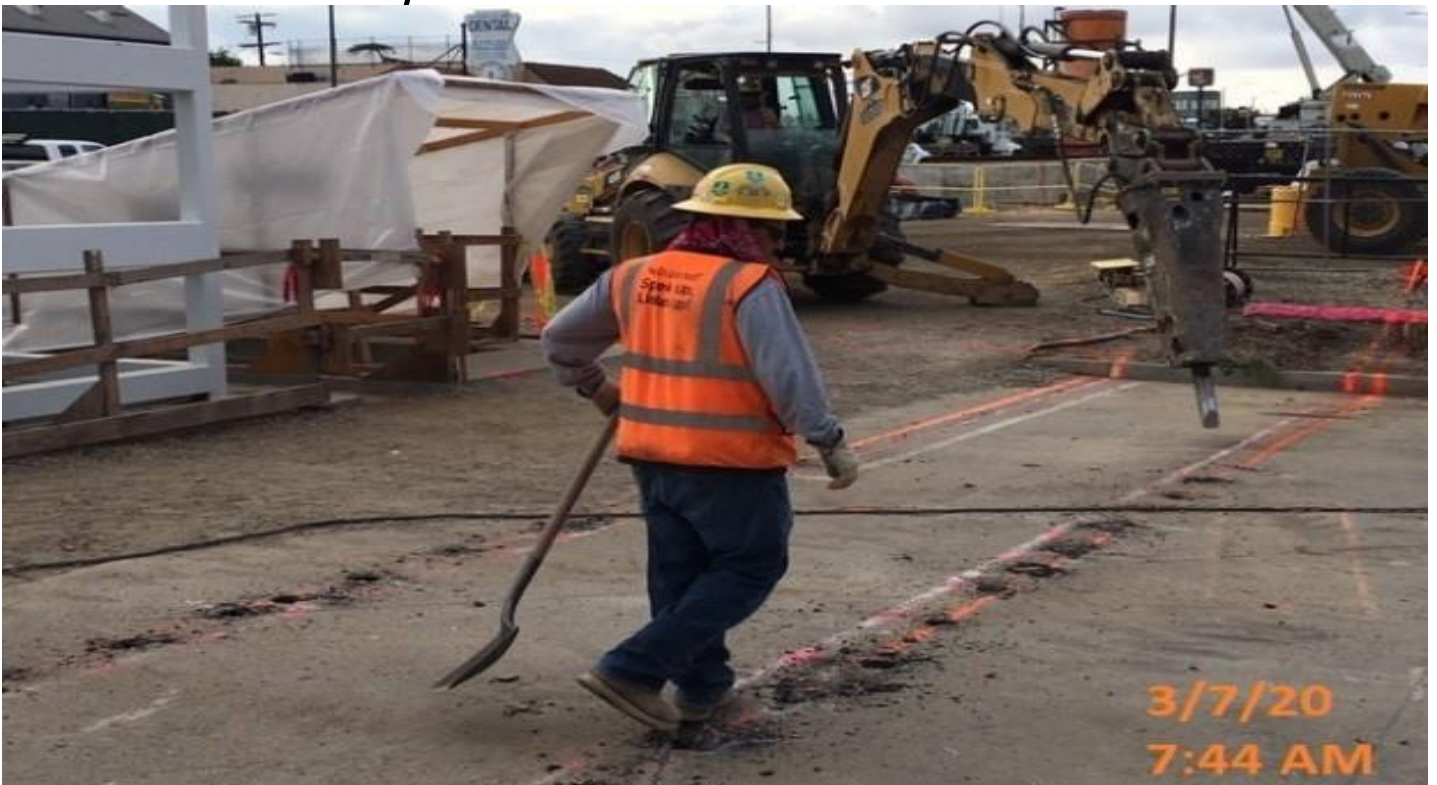
MLK STATION – WSCC crew demoing AC for planter.

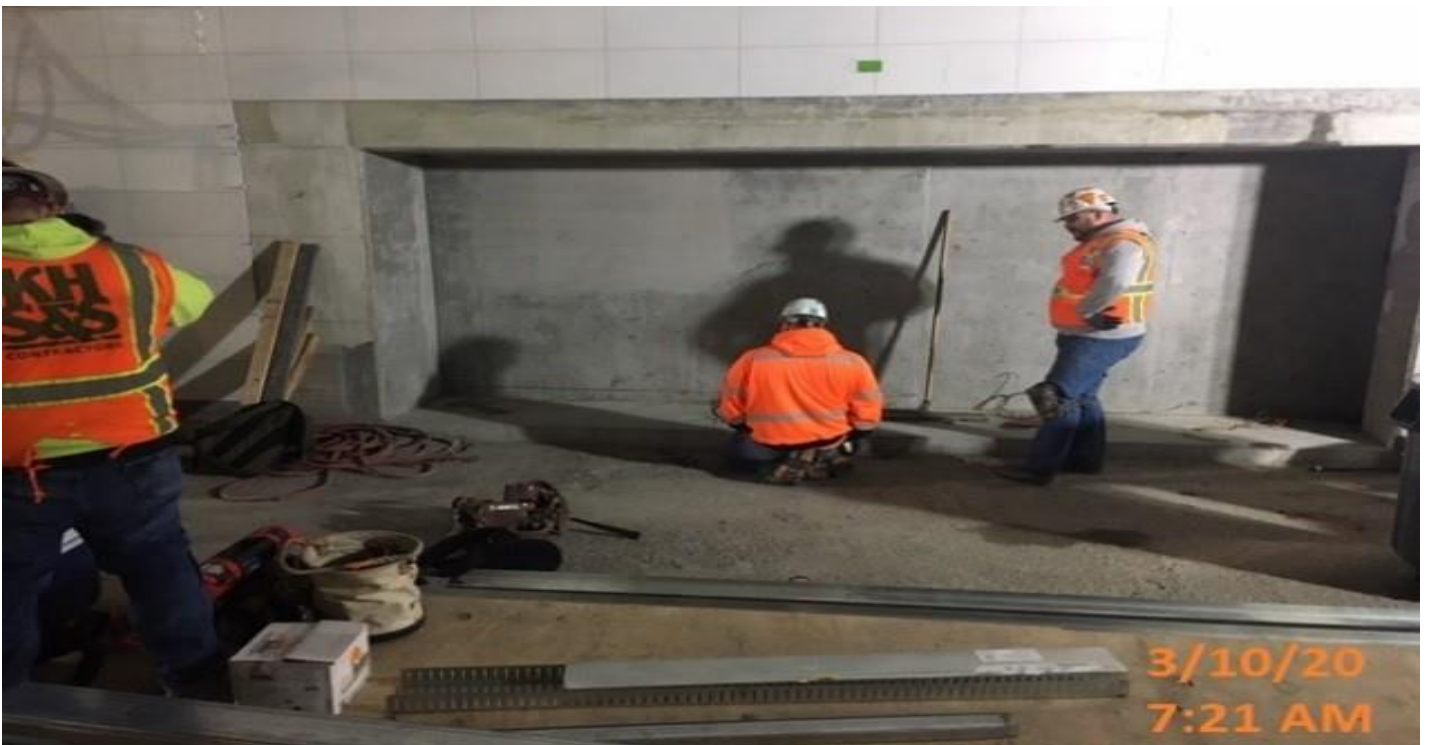
MLK STATION – KHS&S installing steel stud track for ticket vending machine at concourse level.

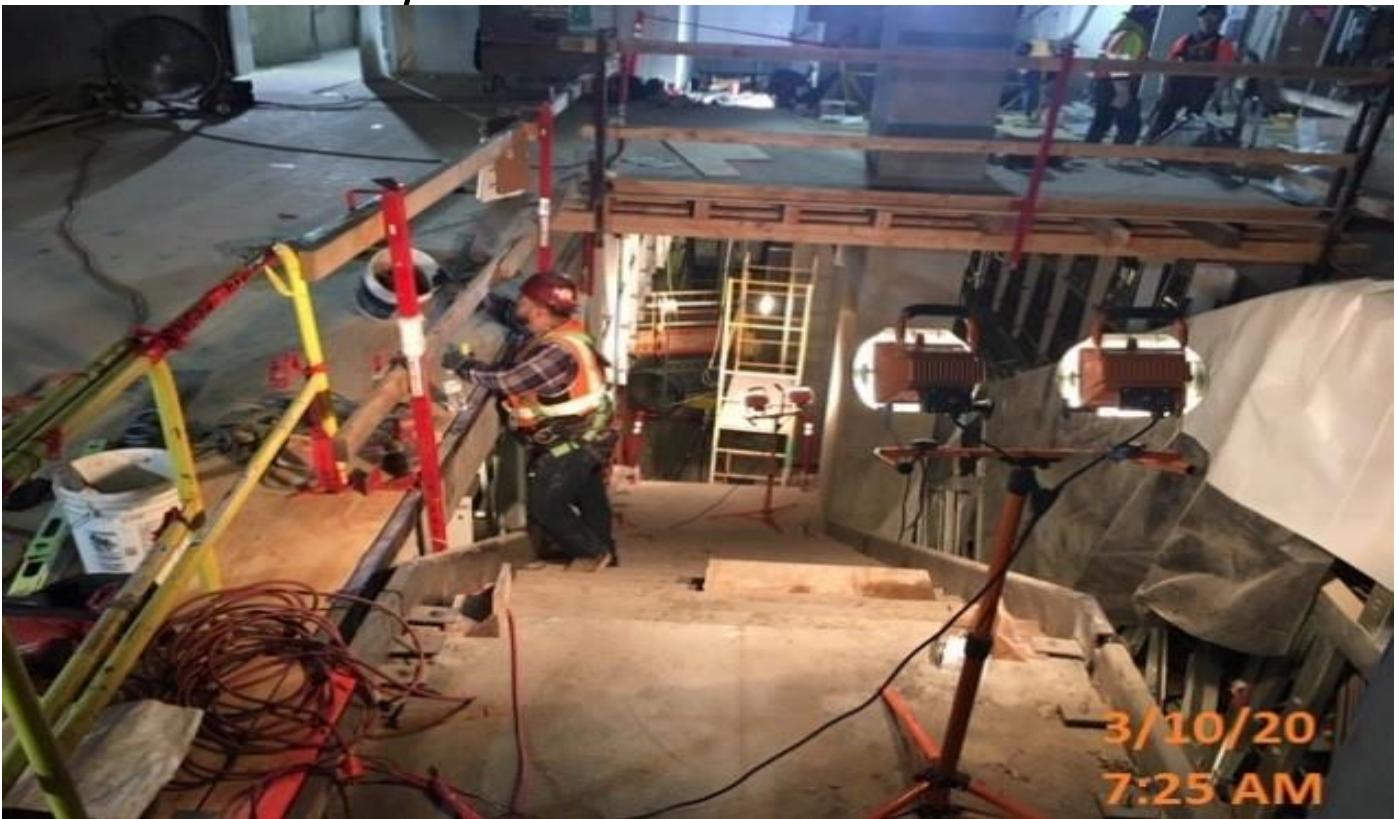
MLK STATION – Carrera Marble laying out granite risers for stair #3.

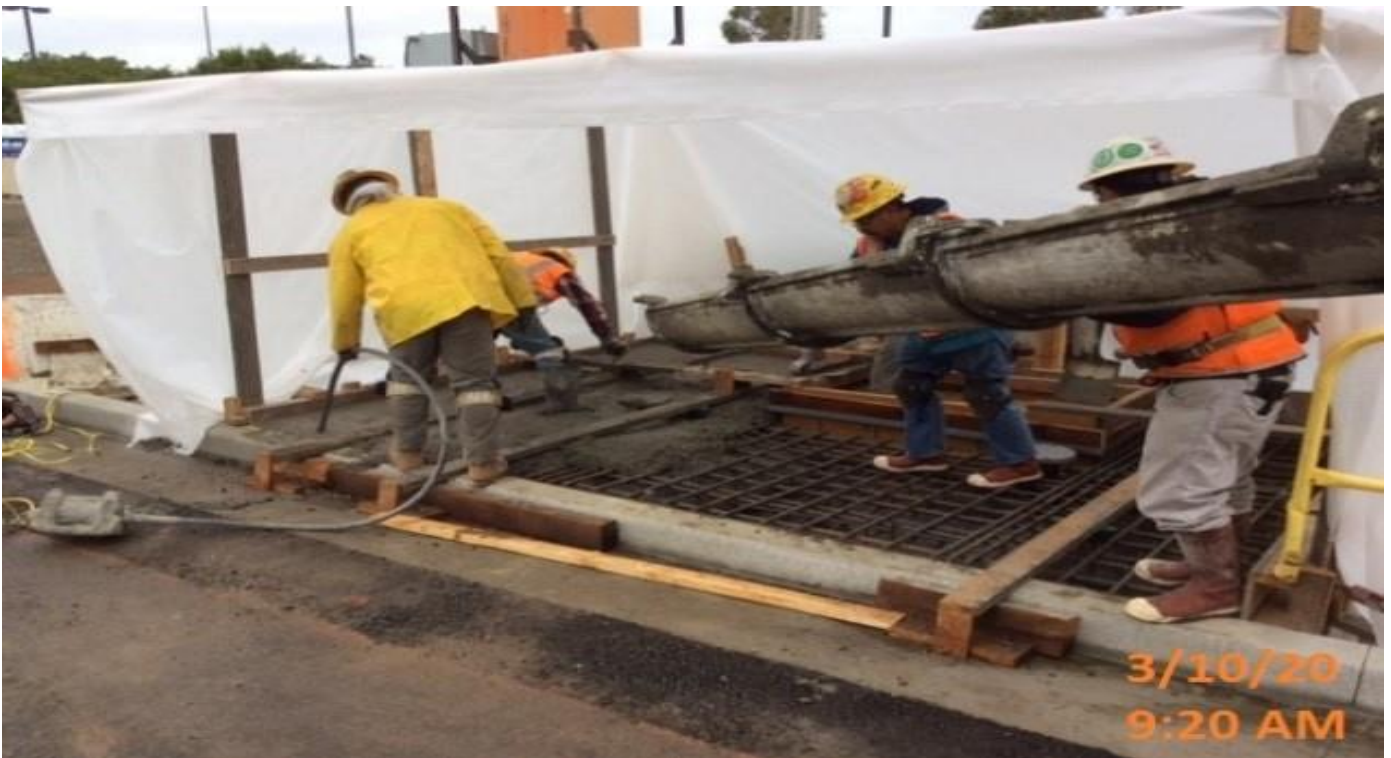
MLK STATION – WSCC crew placing concrete for fire protection valve pit top.

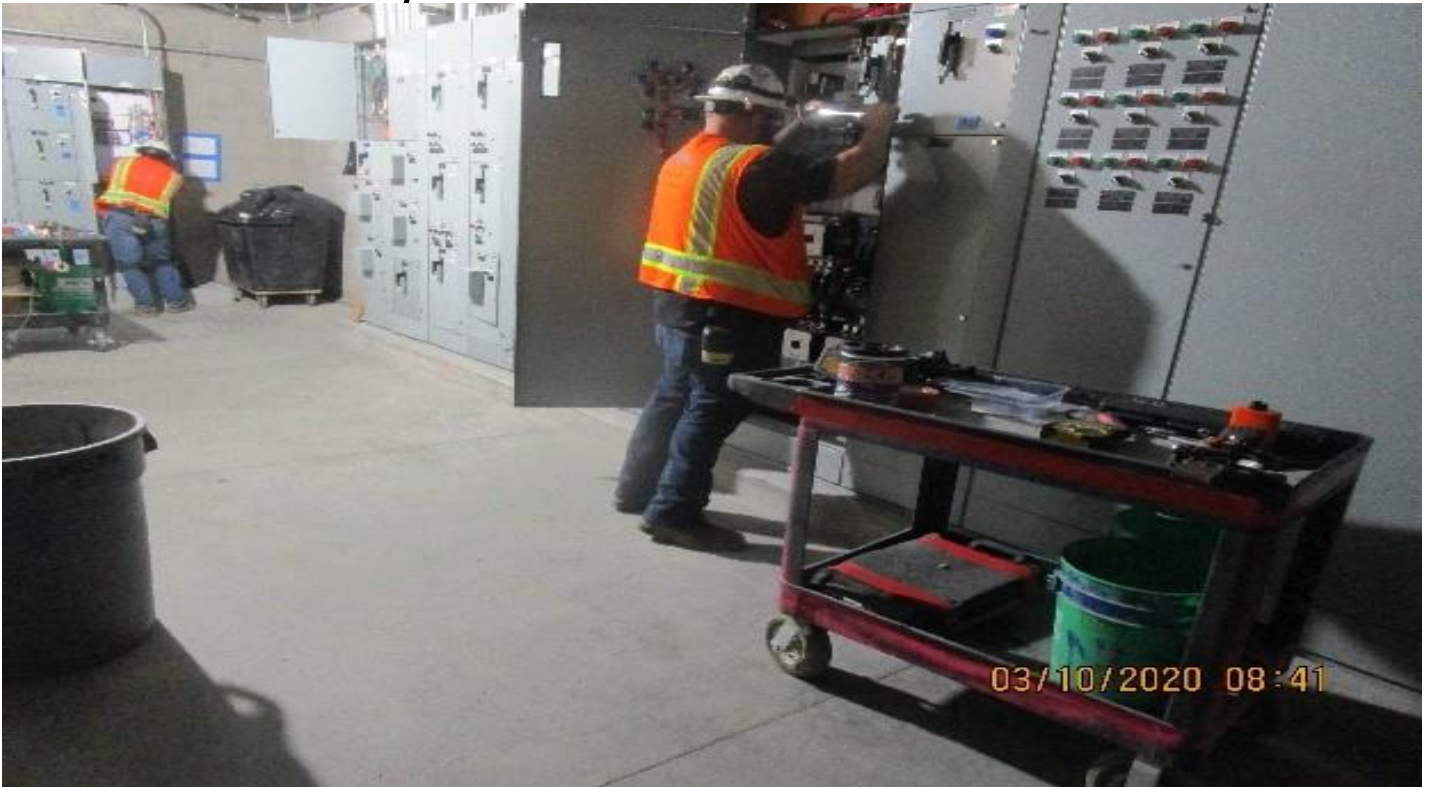
MLK STATION - MLK, Aux power (S) C109, Continued at MCC1,S & MCC2,S pre-energization Q,C check list items.

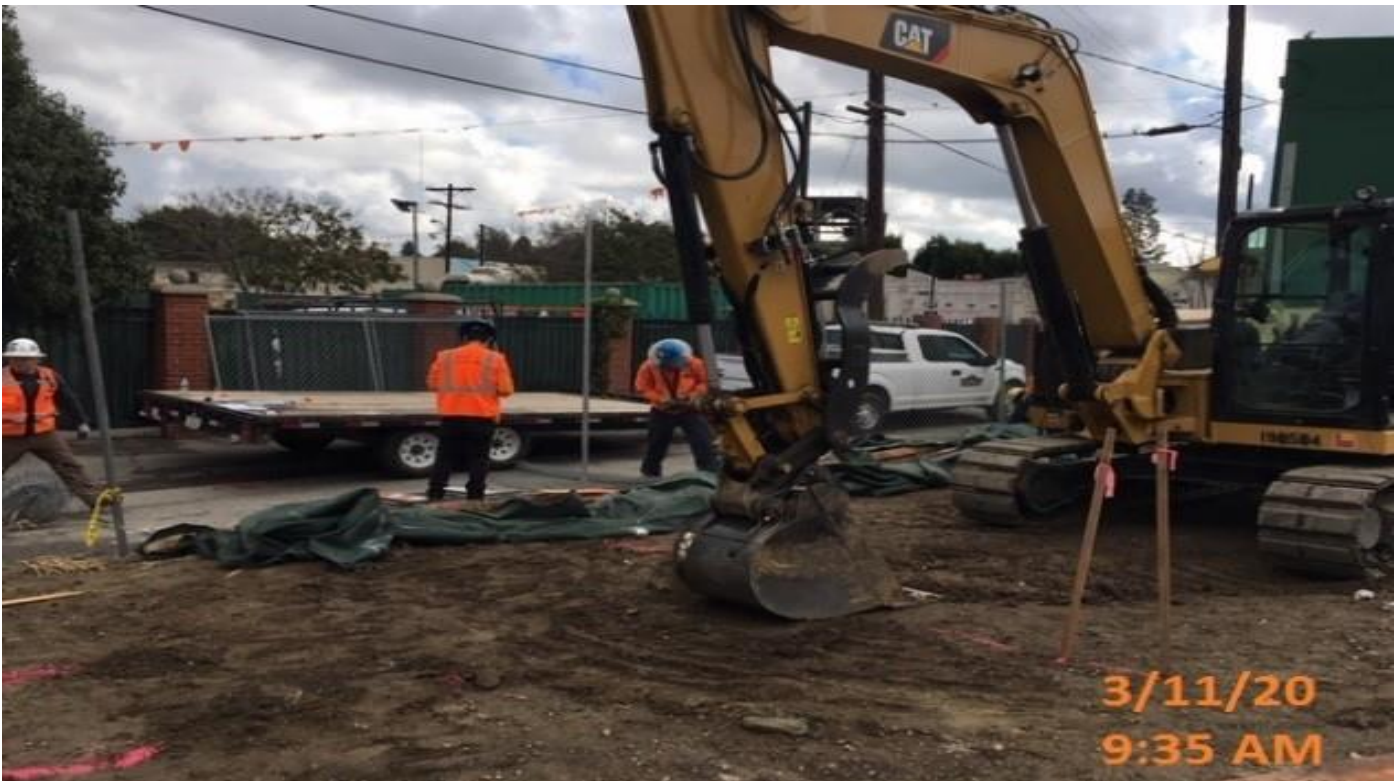
MLK STATION - WSCC removing fencing and placing temp fence prior to excavating for east entrance stairs.

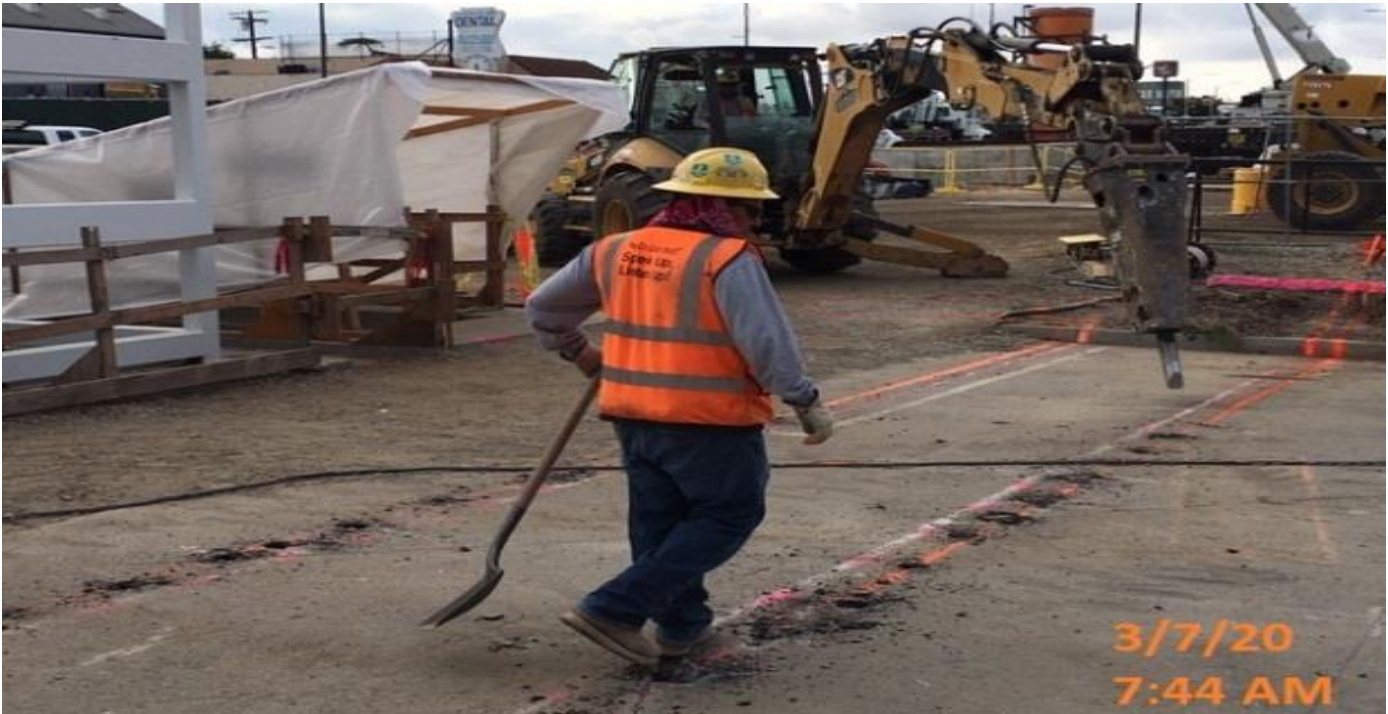
MLK STATION - Excavating/demolishing for planter wall footings at the plaza level.

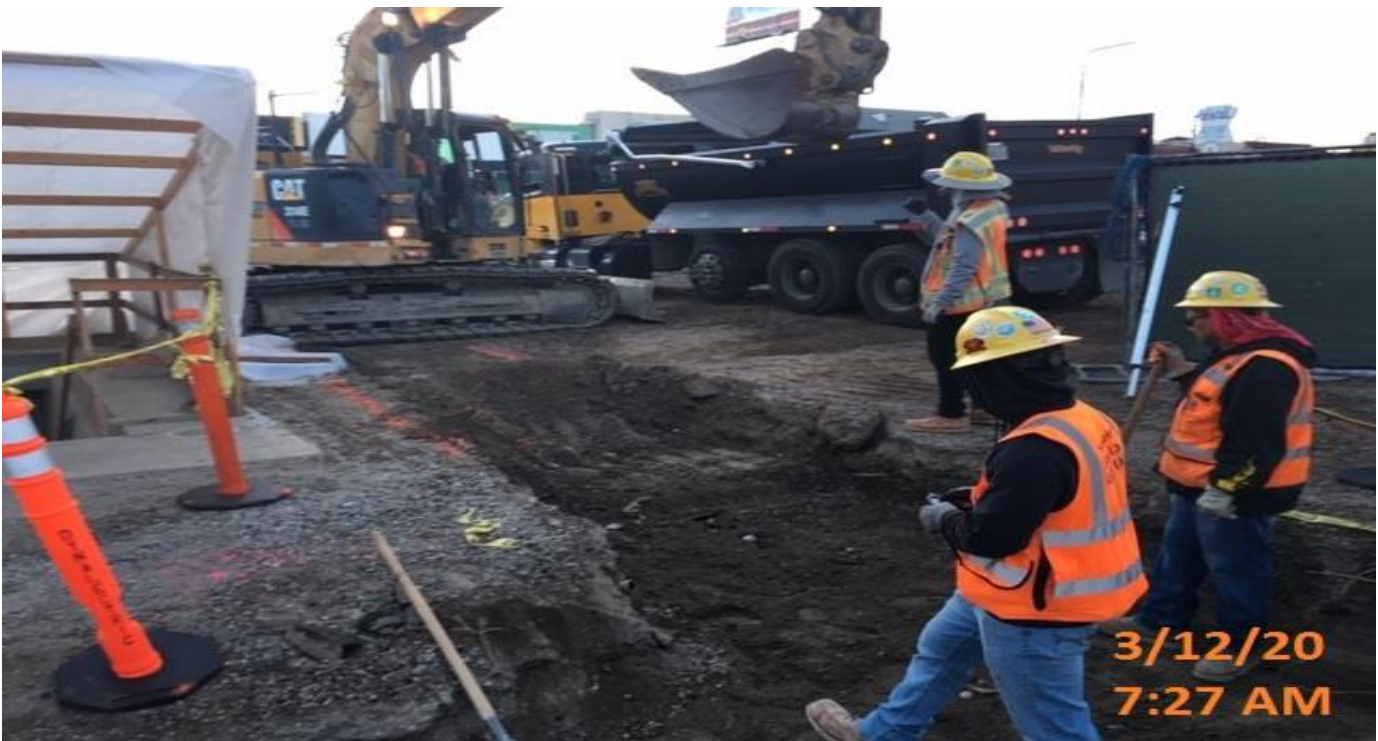
MLK STATION - Continue excavating/demolishing for planter wall footings at the plaza level.

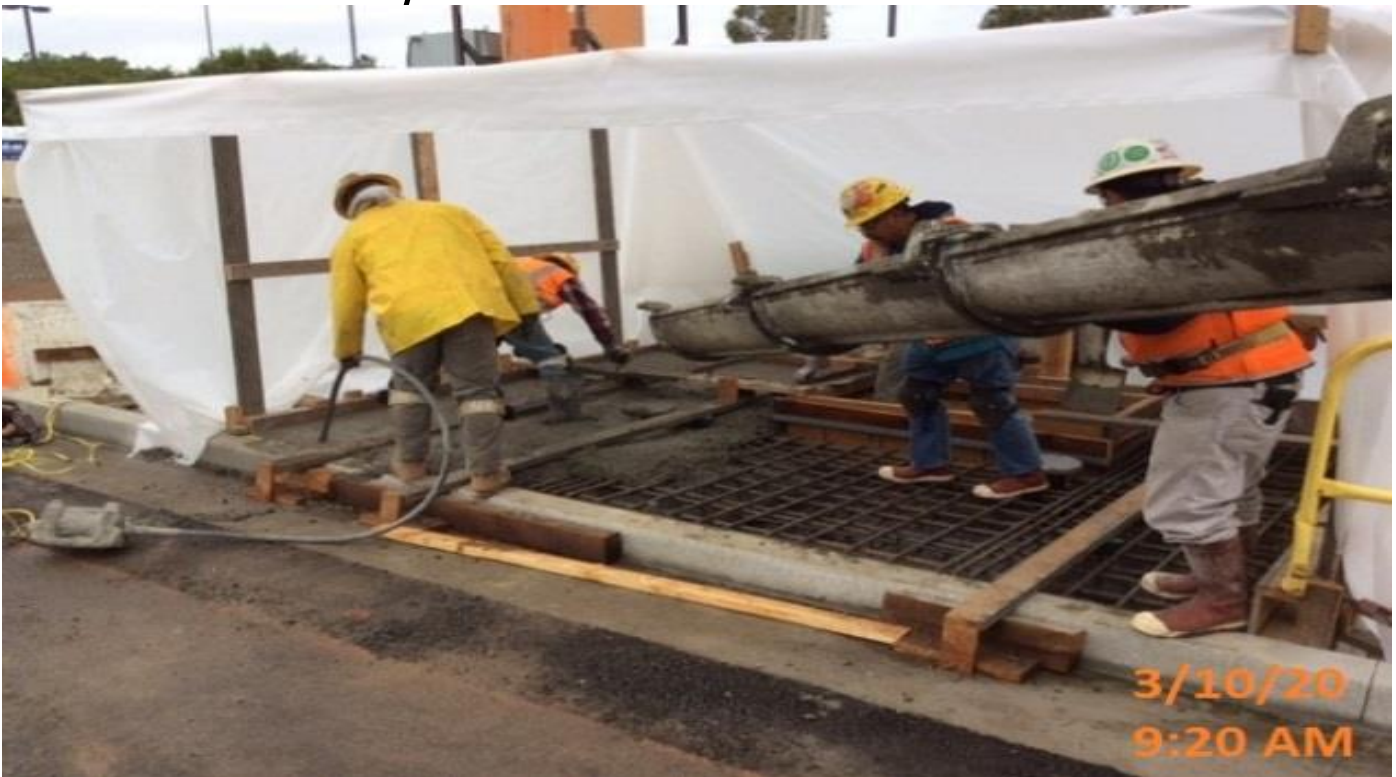
MLK STATION - Began placing concrete on top of the fire protection valve pit access hatch at the plaza level.

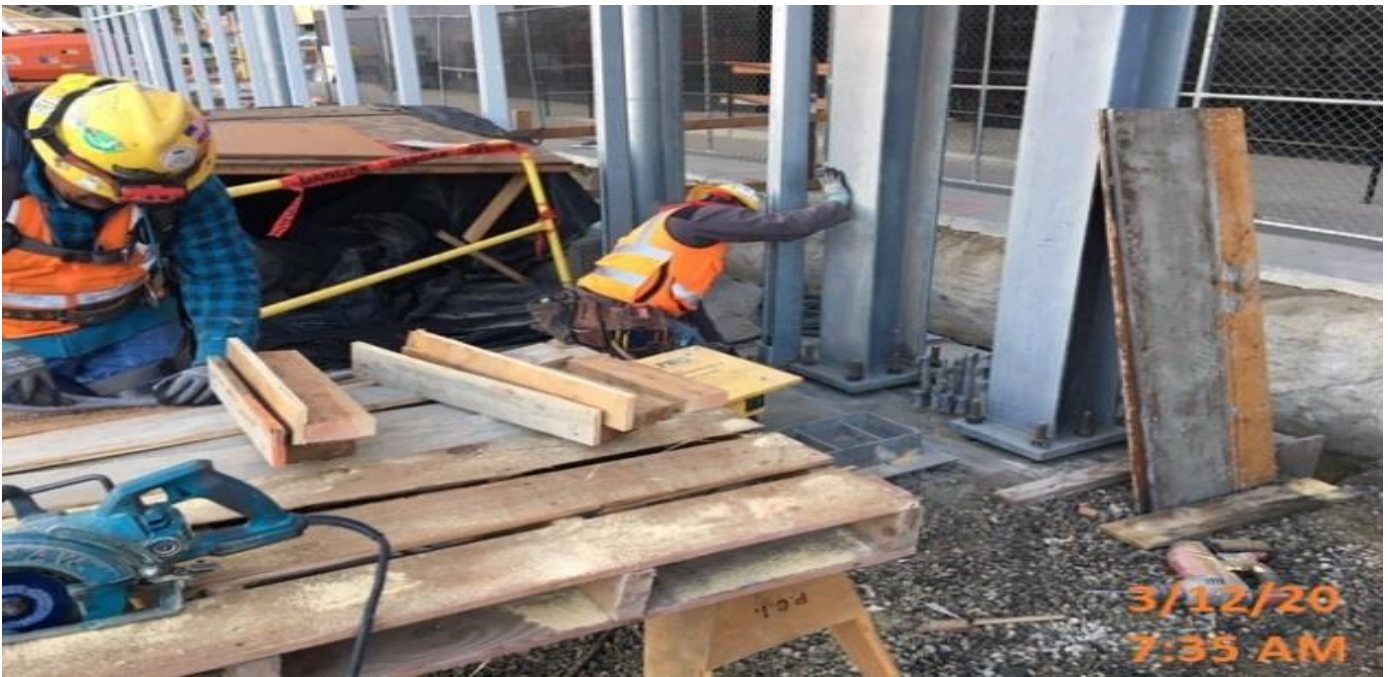
MLK STATION - Building forms for metal base plates for the main entrance canopy columns at the plaza level.

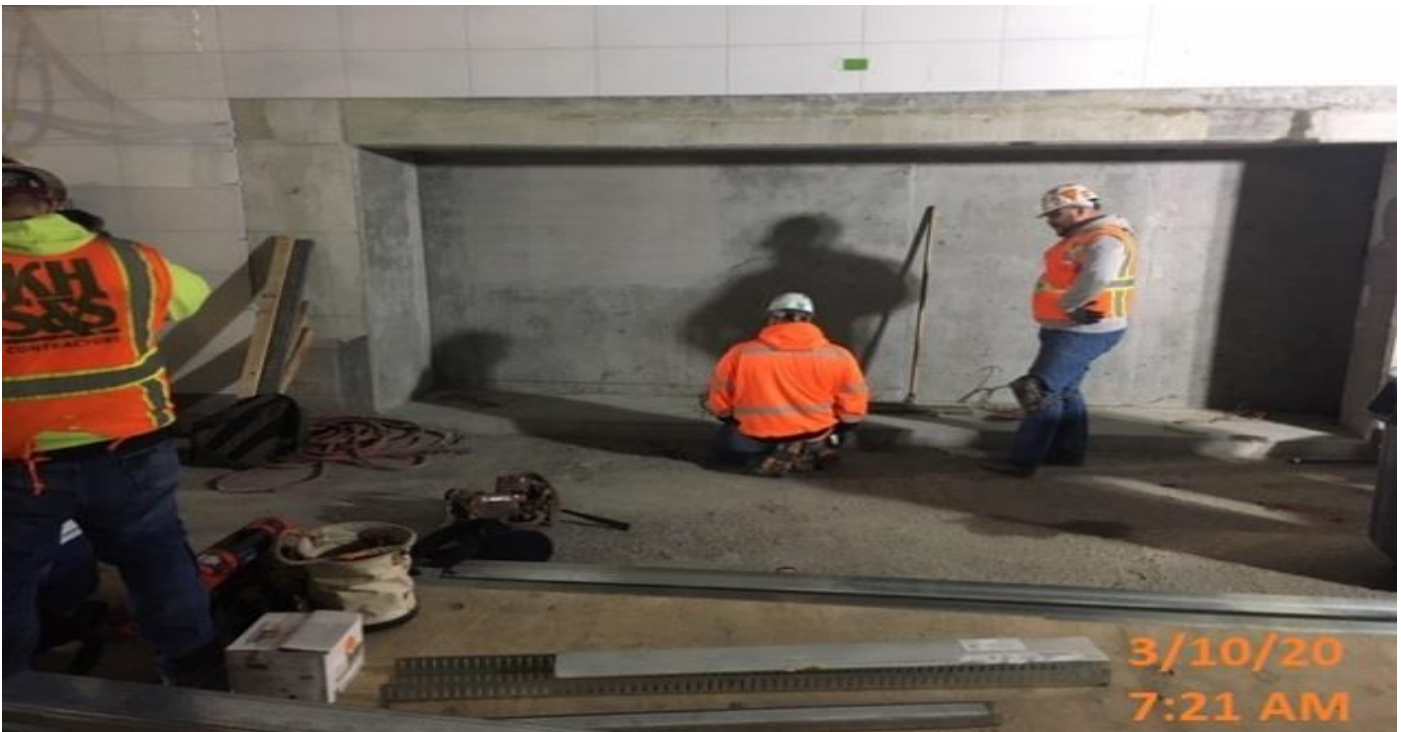
MLK STATION - Installing steel stud track for the ticket vending machine at the concourse level.

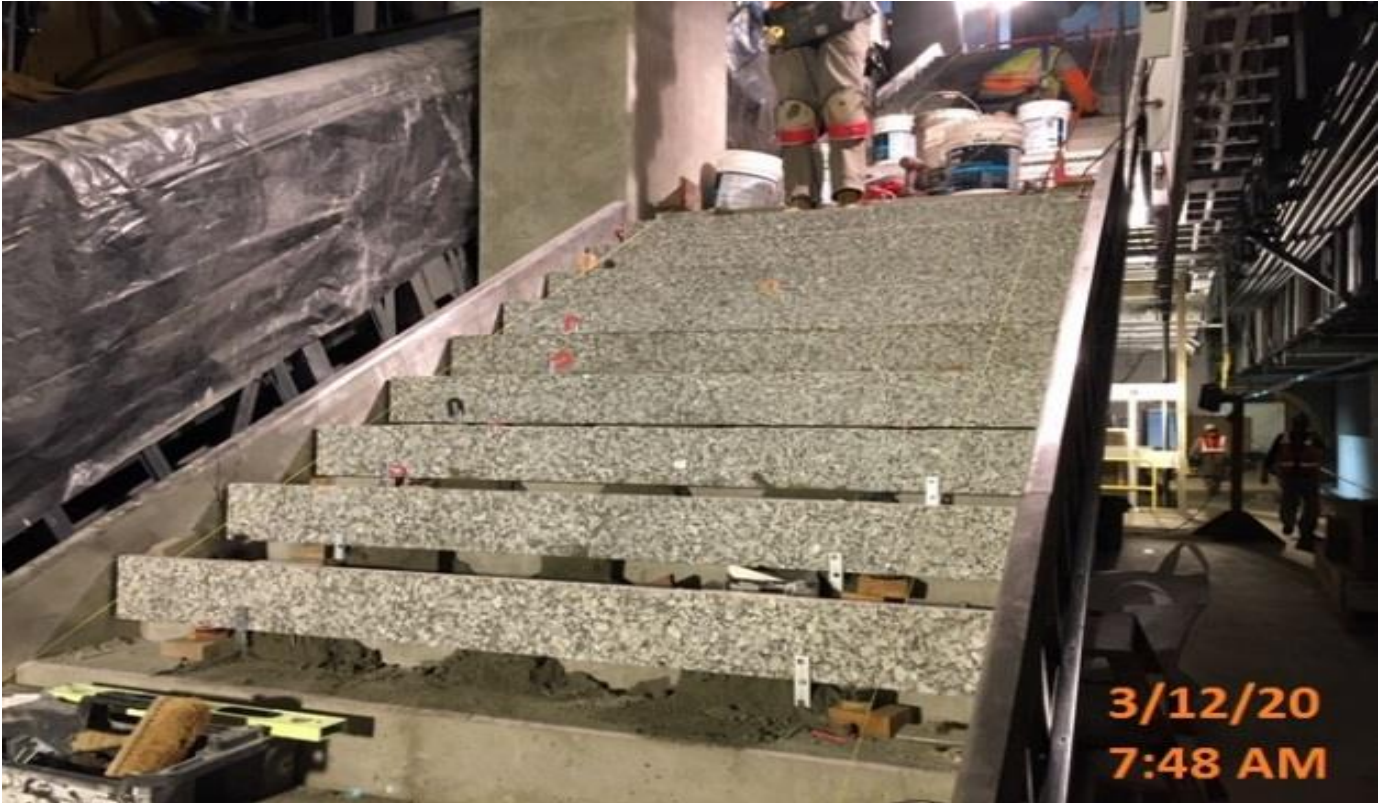
MLK STATION - Began granite riser installation for staircase#3 at the concourse level.

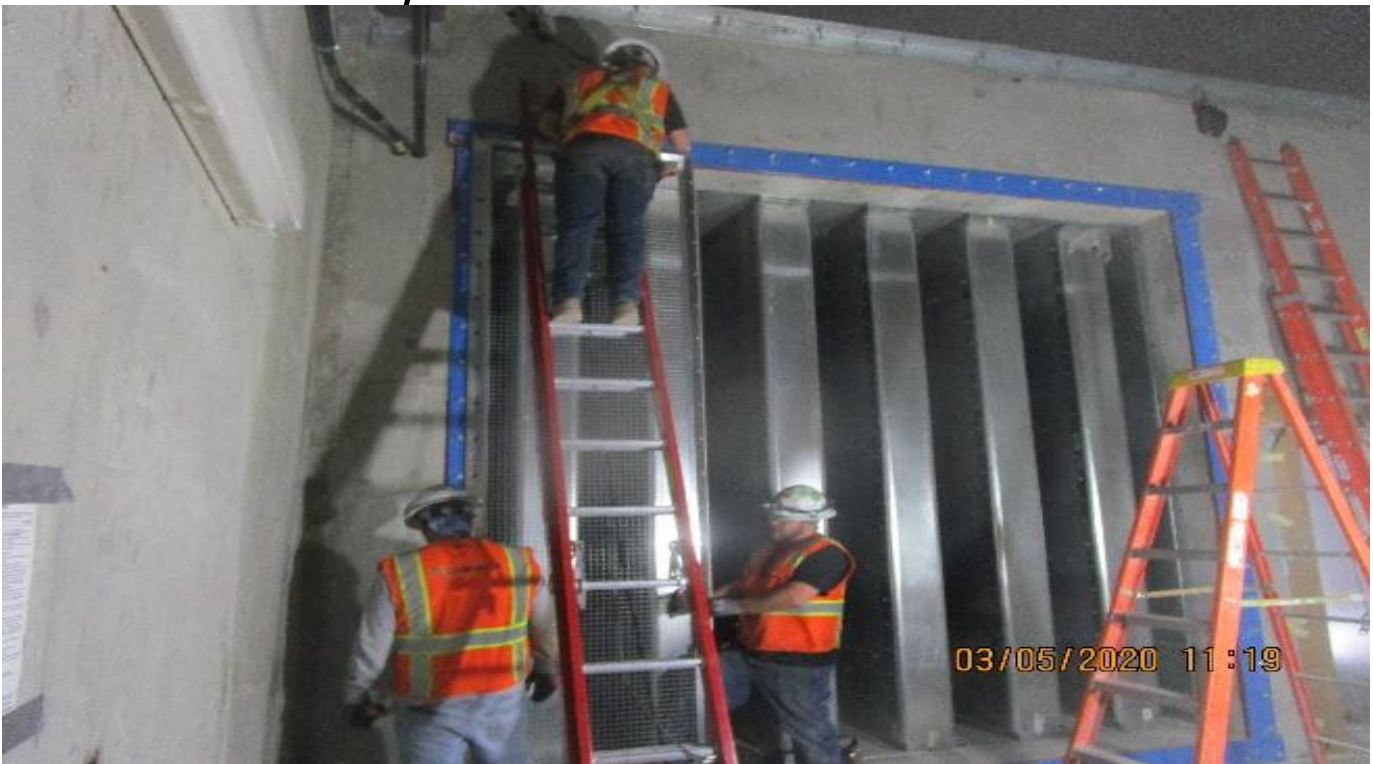
MLK STATION - Installing bird protection screens on the sound attenuators for EVF-7-322 in the North Fan Room C – 142 of the concourse level.

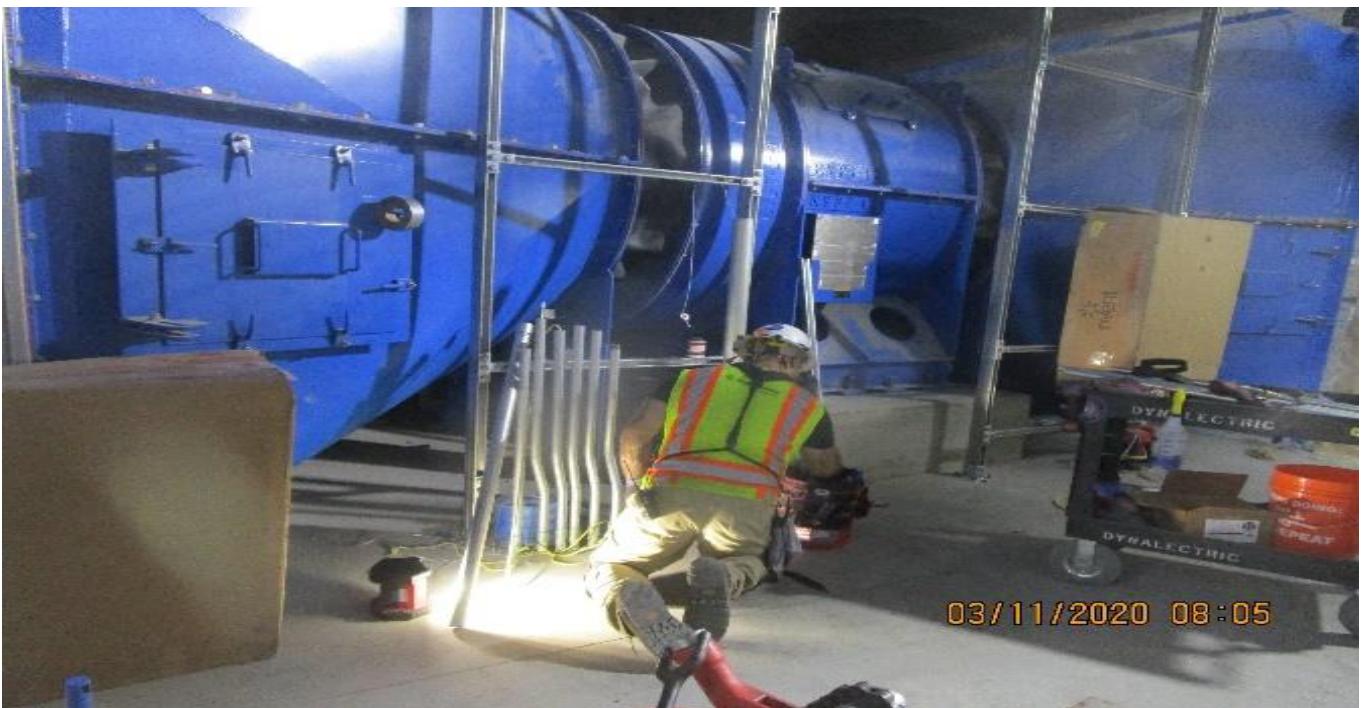
MLK STATION - Began rough in for fire rated conduit installation to the pull box for EVF-7-121 in the South Fan Room C – 102 of the concourse level.

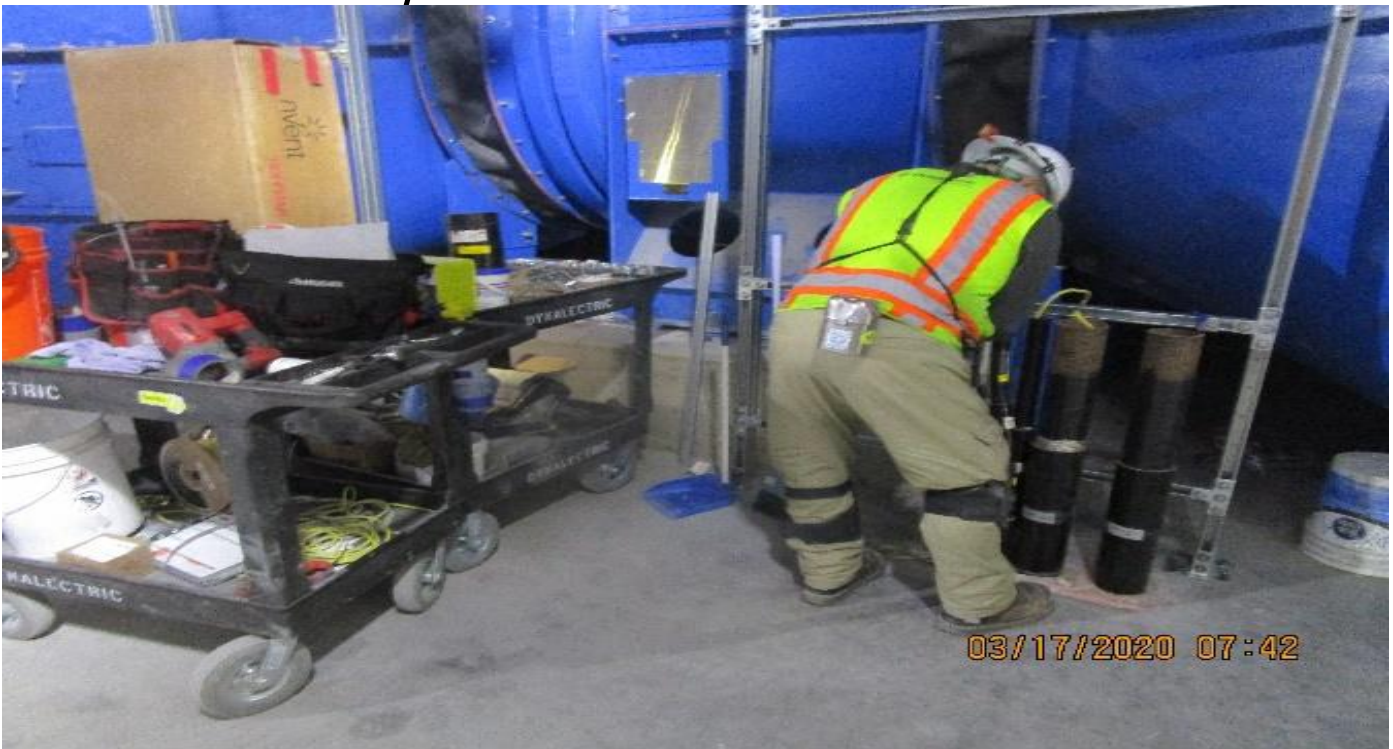
MLK STATION - Continue rough in for fire rated conduit installation to the pull box for EVF-7-121 in the South Fan Room C – 102 of the concourse level.

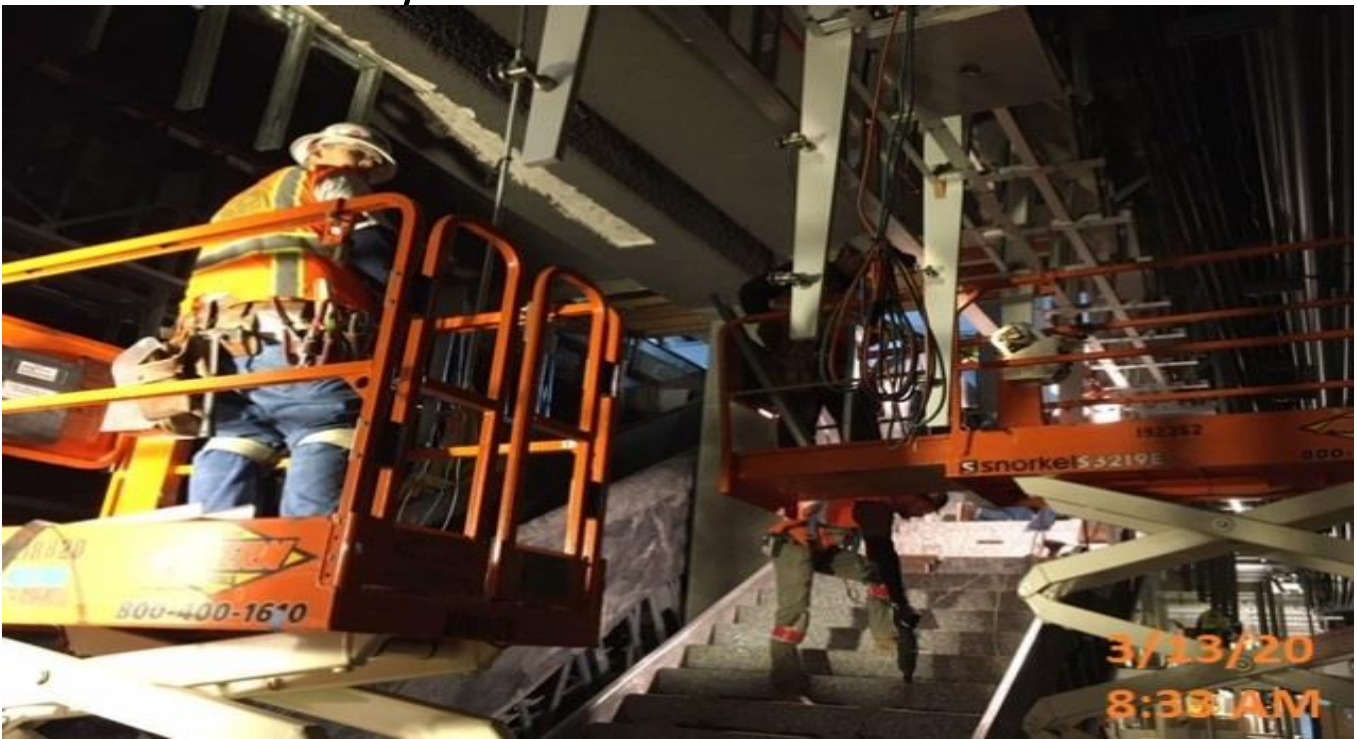
MLK STATION - Continue installing steel stud track and framing underneath escalator 3&4 at the platform level.

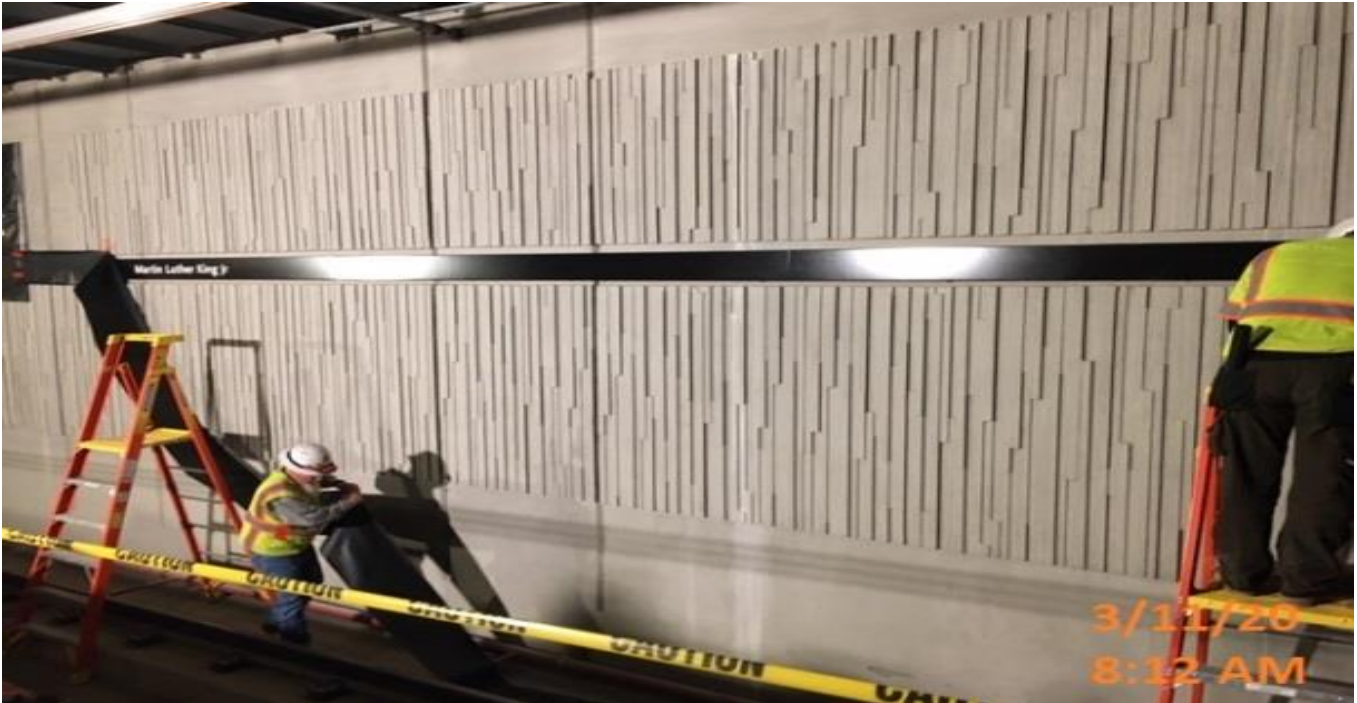
MLK STATION - Completing installation of the Metro signage at the platform level.

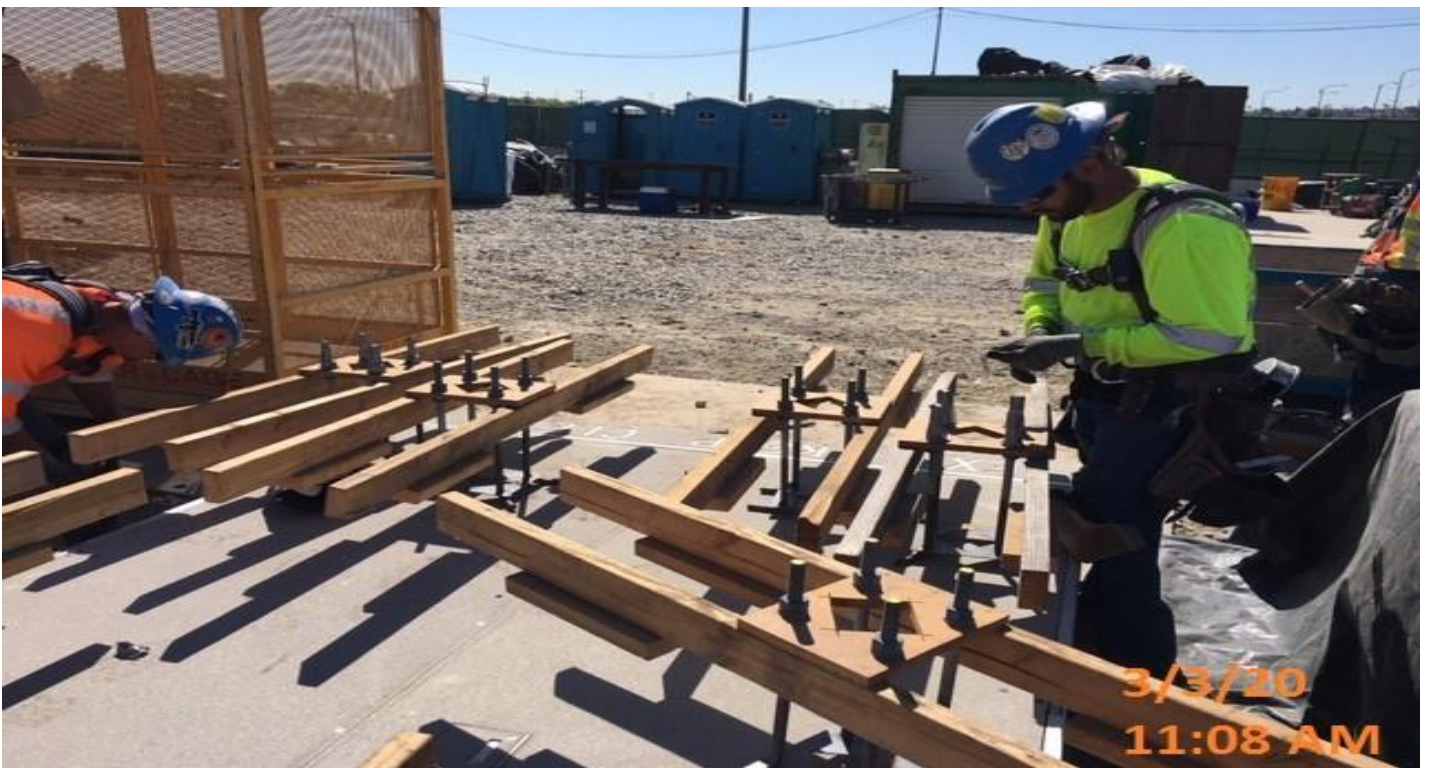
EXPO STATION- WSCC crew setting bolt templates for sono tubes.

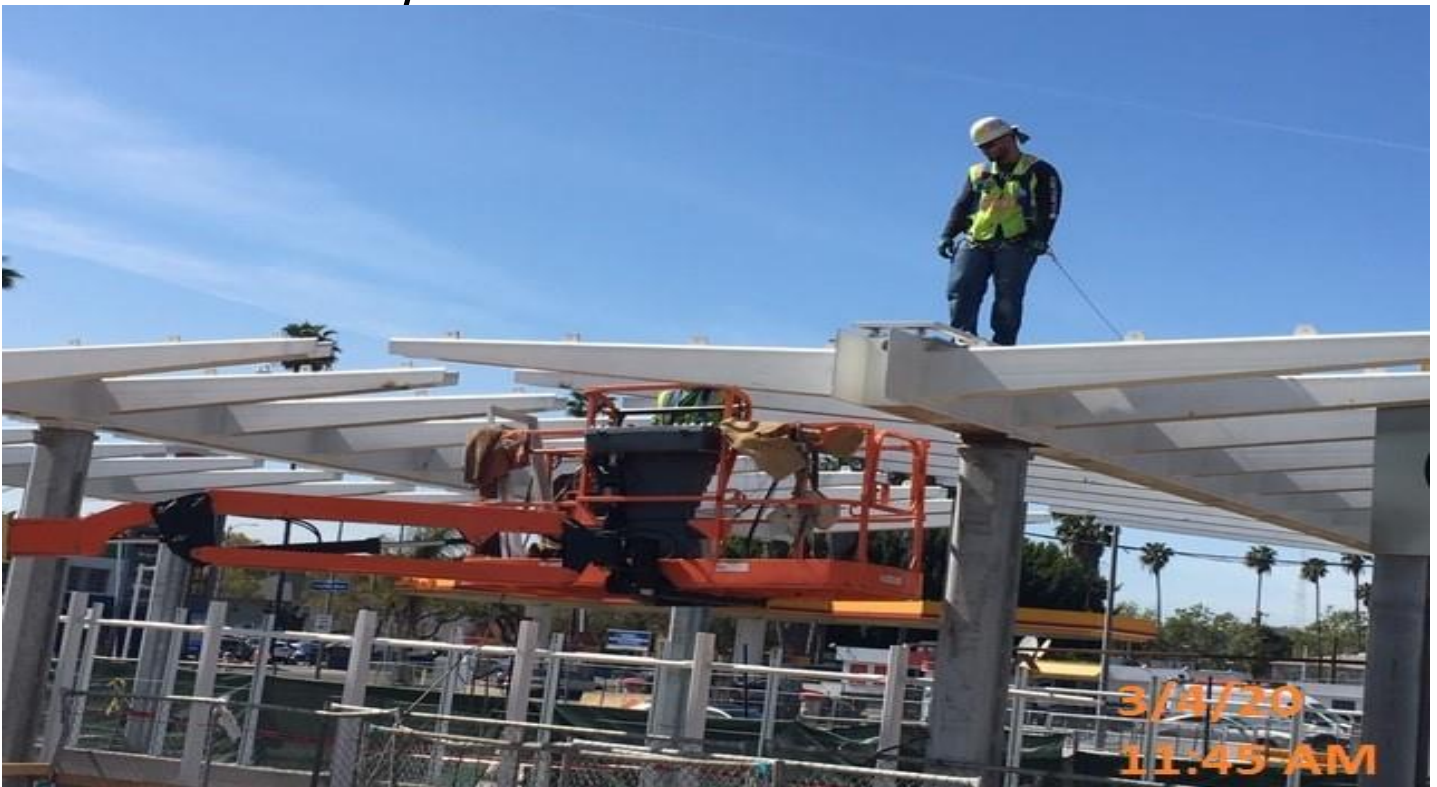
EXPO STATION- McMahon installing cat walk grating above main.

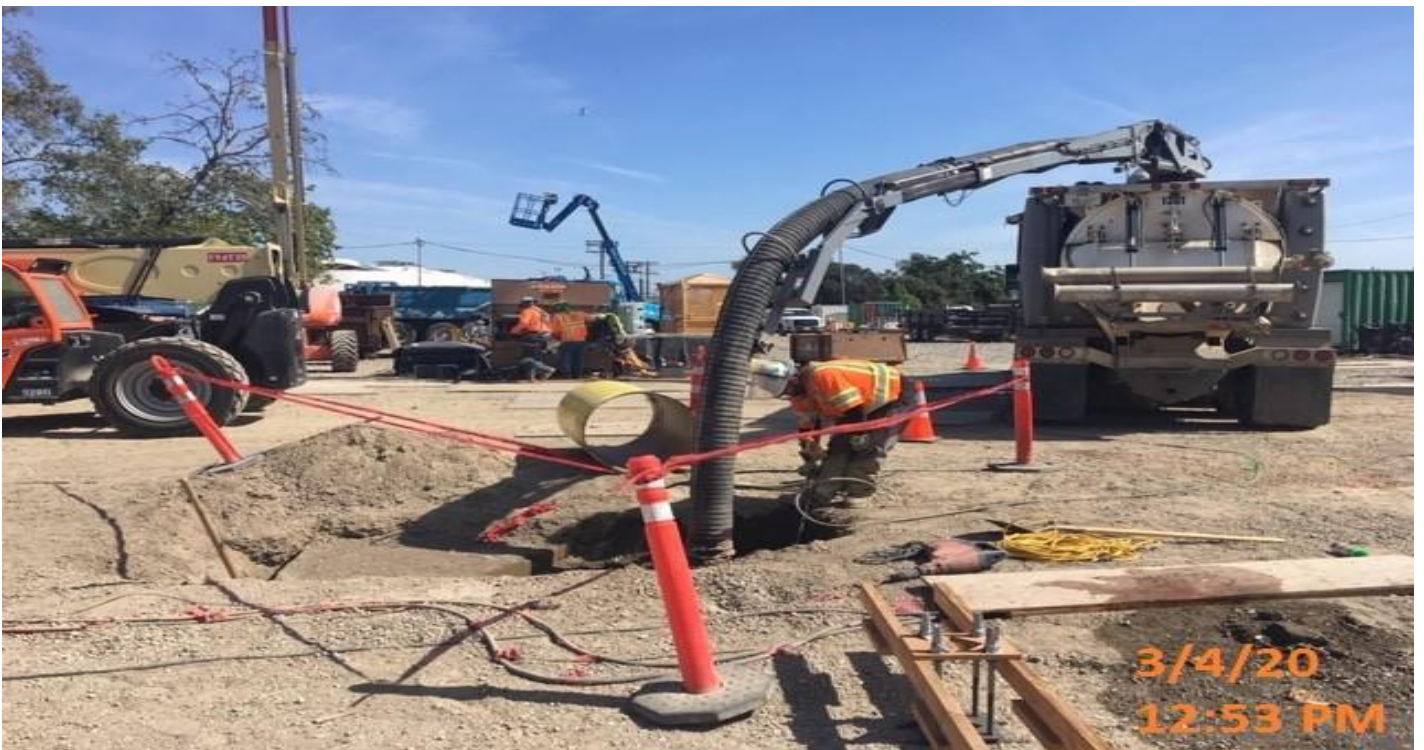
EXPO STATION- WSCC crew potholing and setting sono tubes for plaza lighting

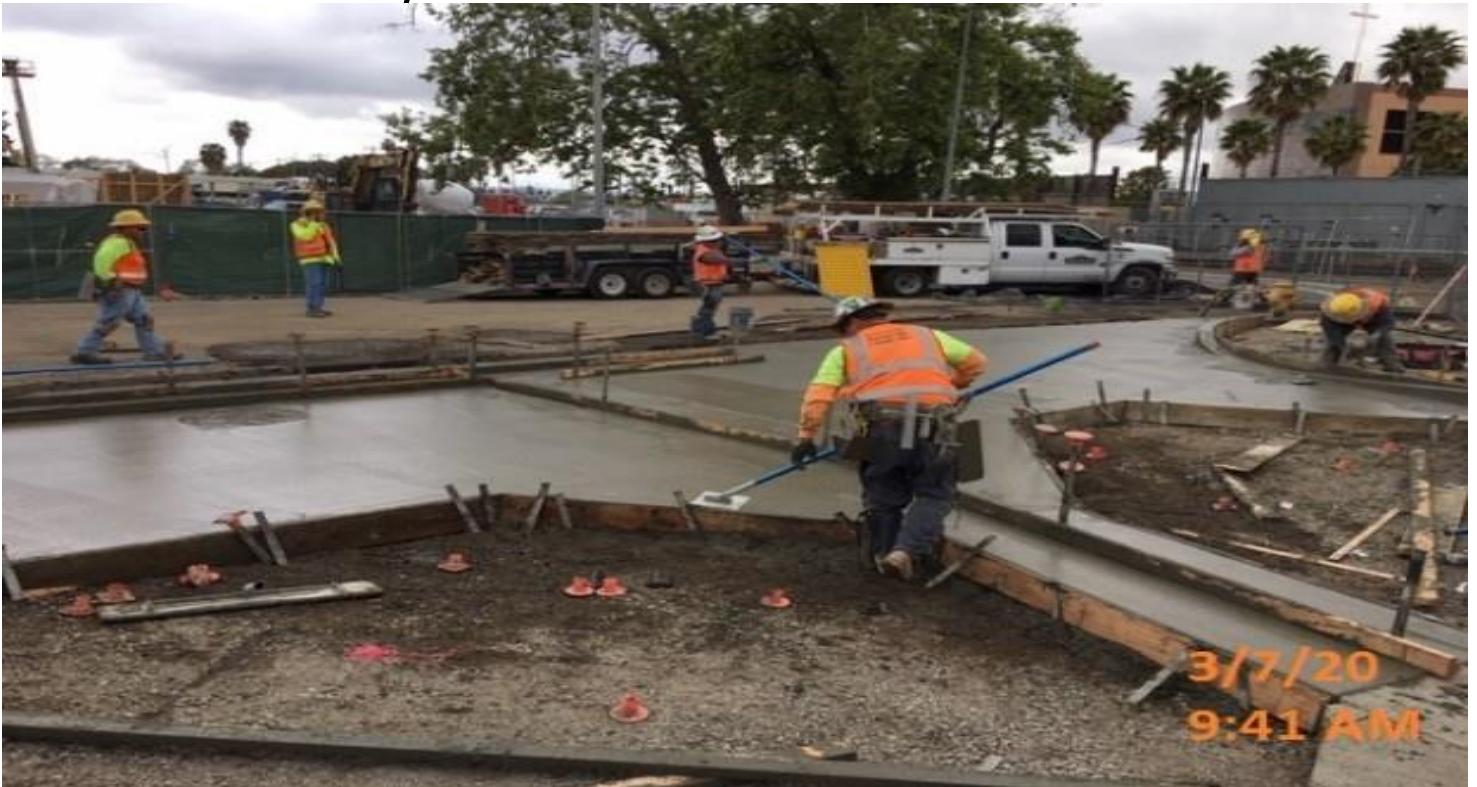
EXPO STATION- EXPO Civil- WSCC placing concrete for cross gutter.
