CRENSHAW/LAX PHOTOGRAPHIC UPDATE

March 17, 2020

Crenshaw/LAX Transit Project

- 8.5 miles Light Rail
- 8 Stations
- \$2,058.0 Million
(Board approved revised LOP)

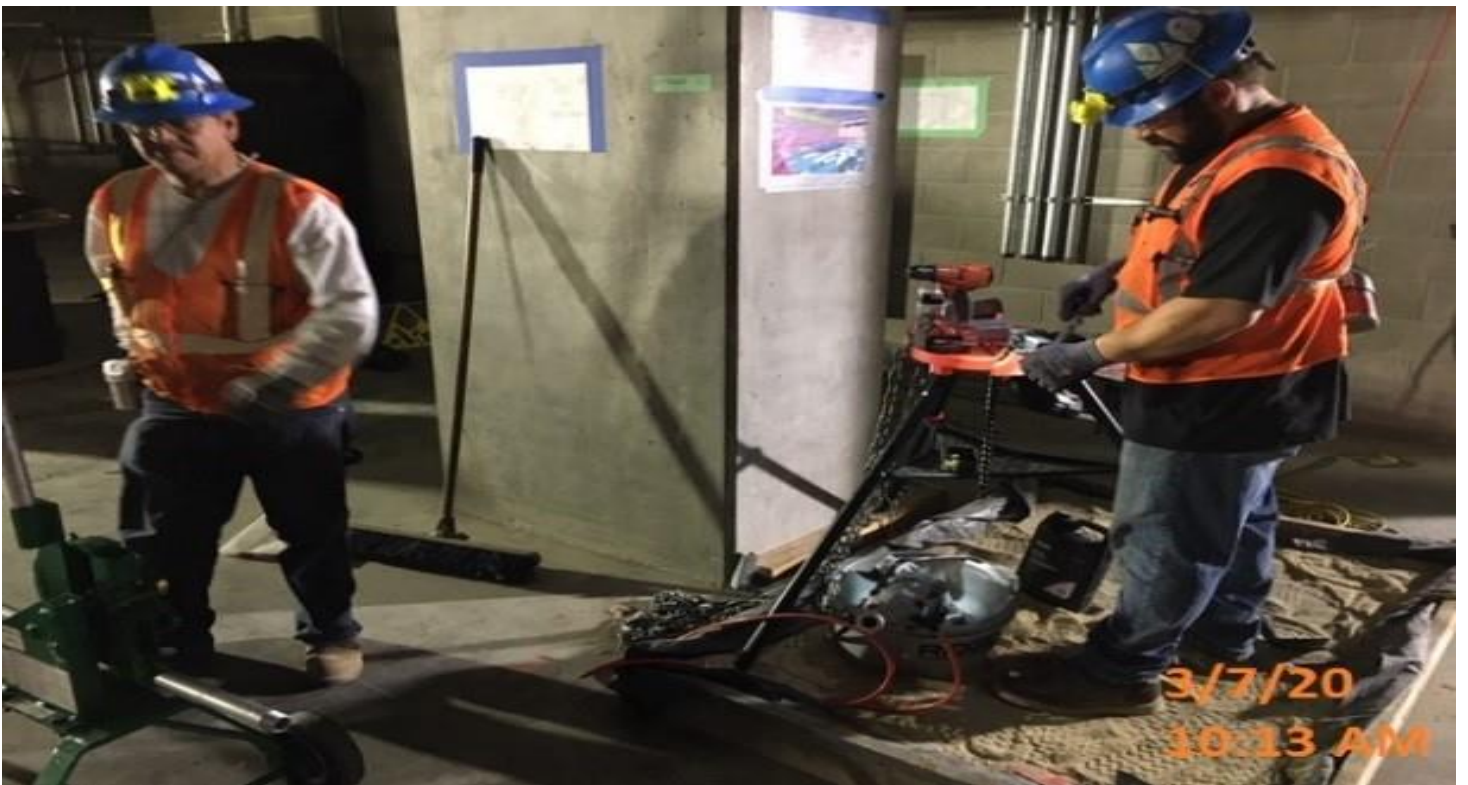
EXPO STATION- WSCC electricians installing FA conduit.

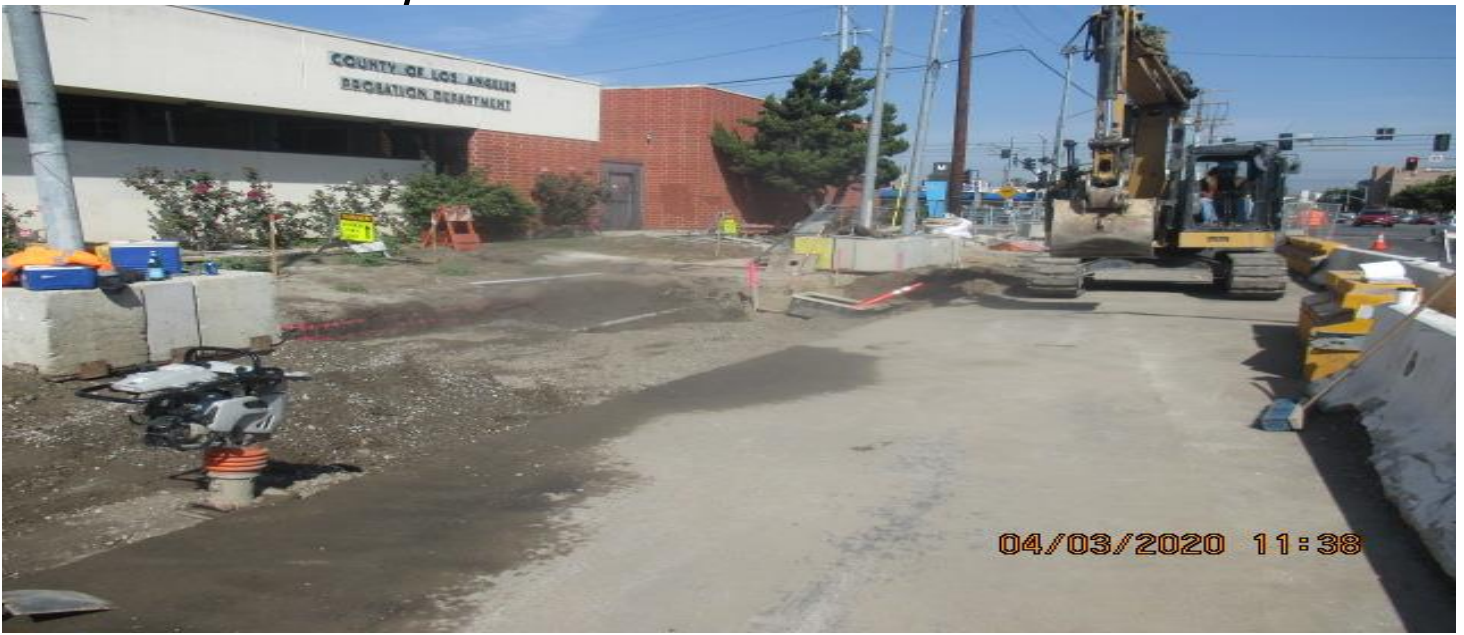
EXPO STATION- Excavating for new curb/gutter and sidewalk installation on Crenshaw Blvd between Exposition Blvd and Rodeo Blvd. 3/4/20

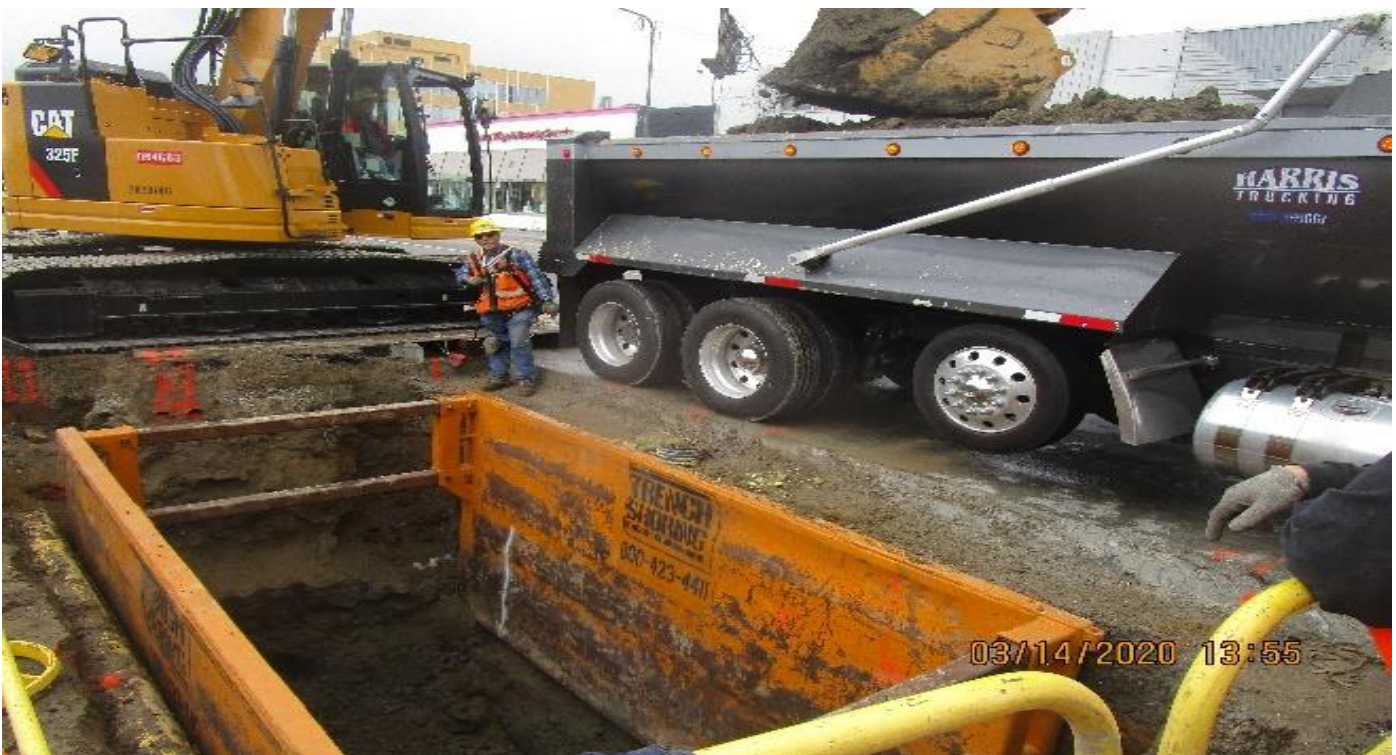
EXPO STATION- Excavated and completed the installation of shoring box #1 for the oil water separator on Rodeo Blvd and Crenshaw Blvd.

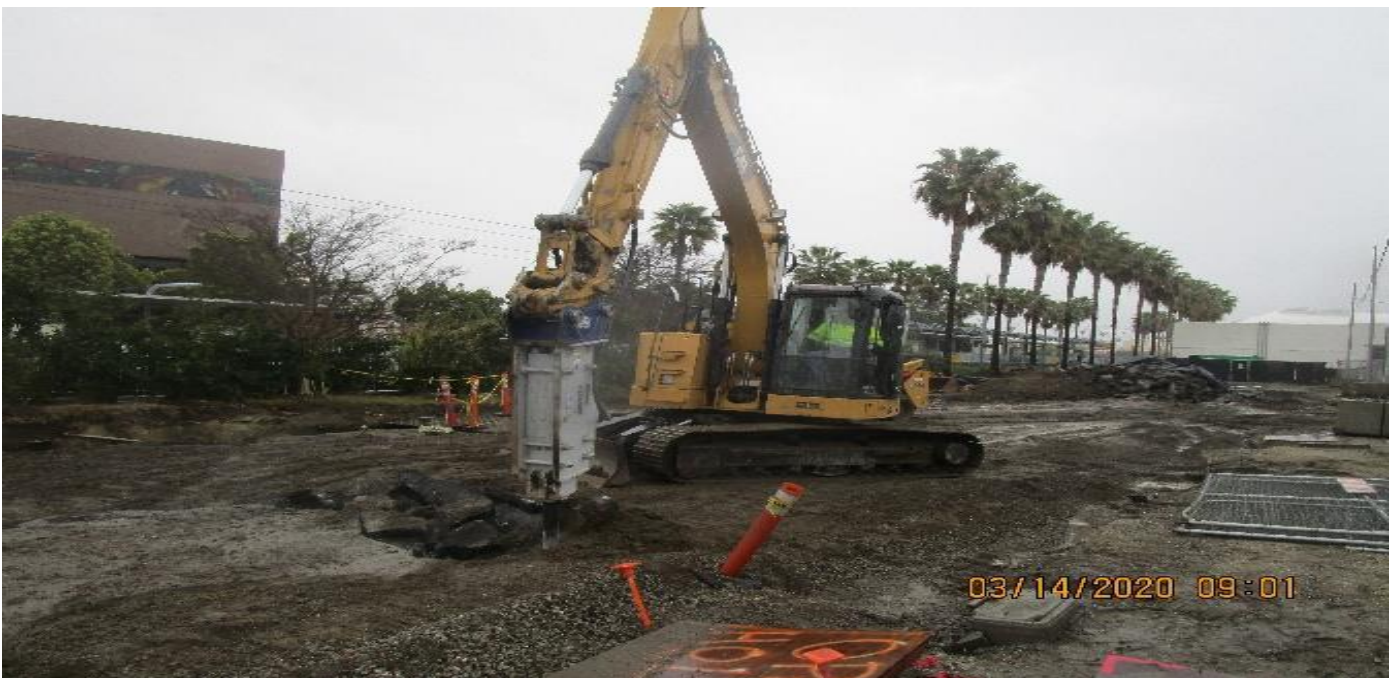
EXPO STATION- Continue demolition/excavation of the roadway east of the plaza in preparation for trenching and underground electrical fiber rough in. 3/14/20.

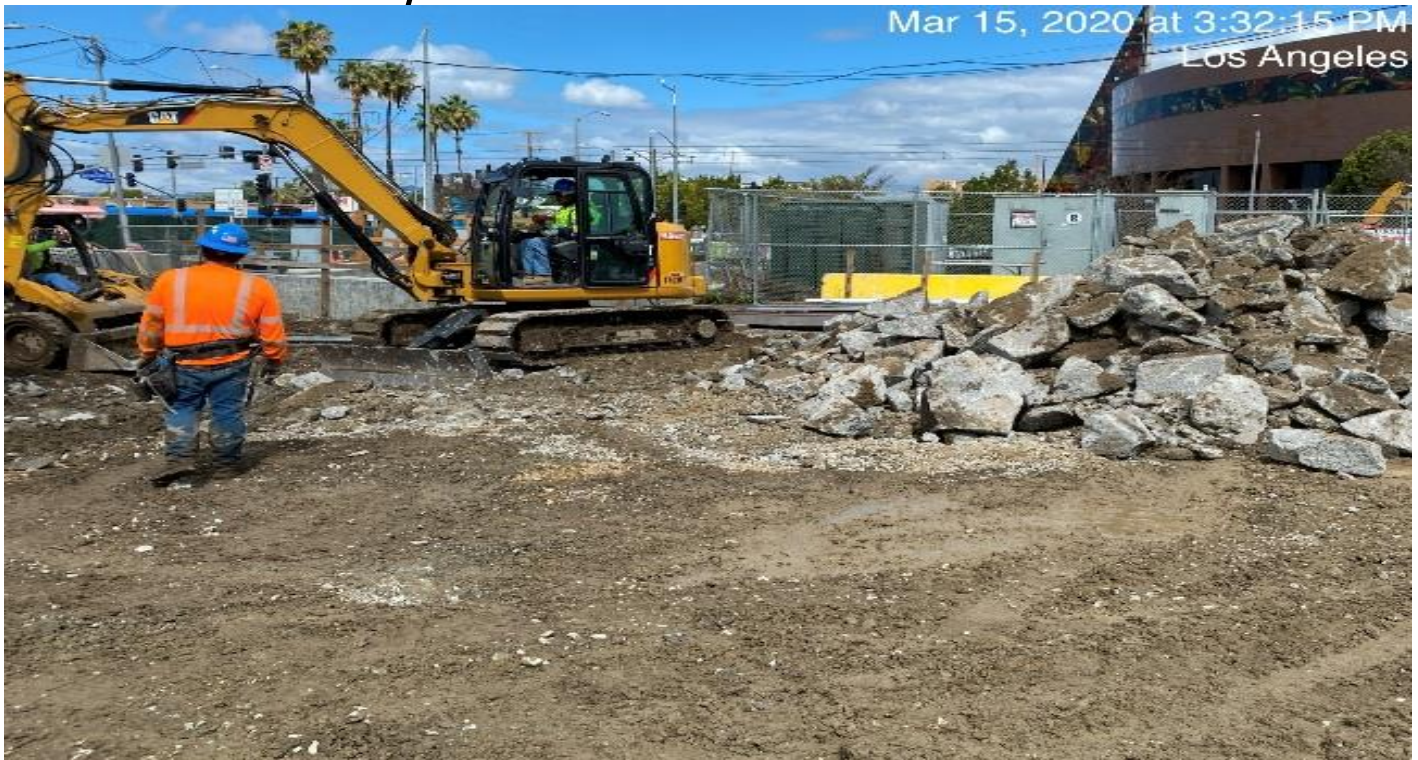
EXPO STATION- Continue demolition/excavation of concrete slabs east of the plaza in preparation for trenching and underground electrical fiber rough in.

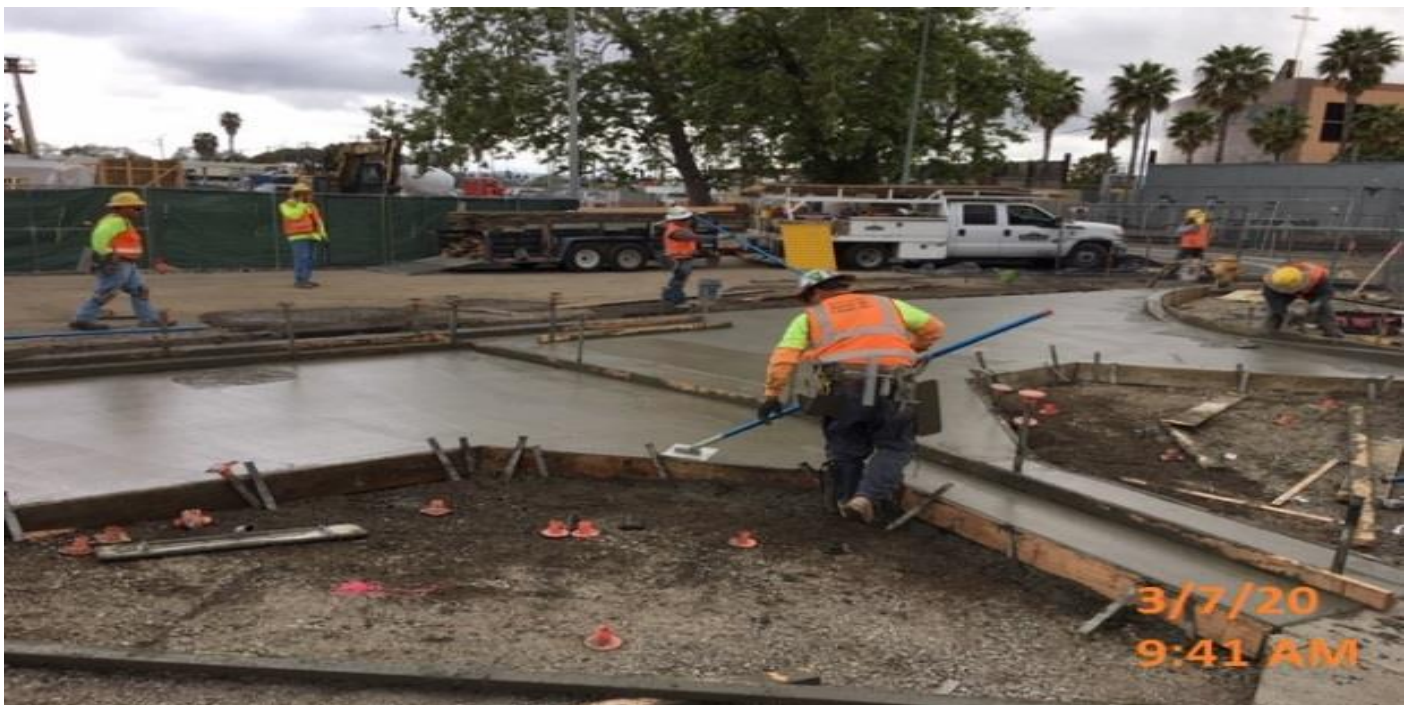
EXPO STATION- Placing concrete for cross gutter on Bronson St. east of the plaza.

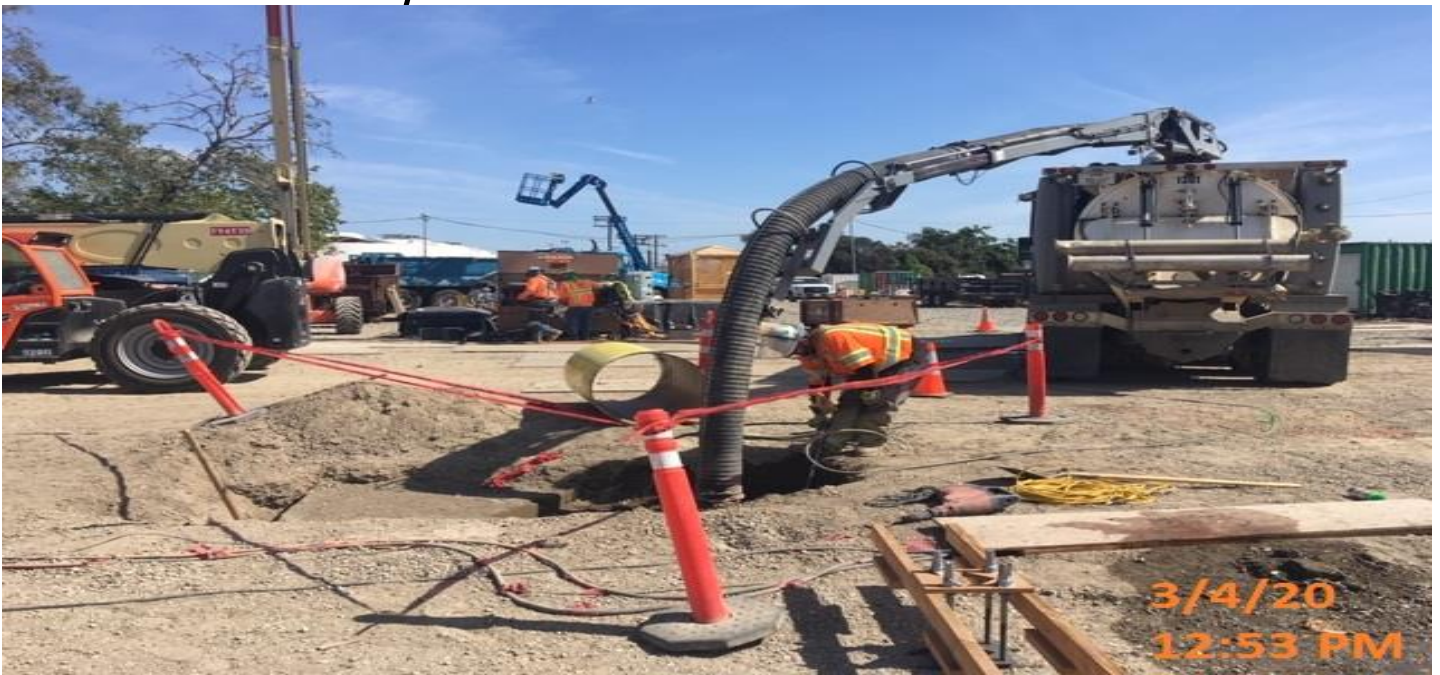
EXPO STATION- Continue setting sonotube foundation for the installation of the luminaire light posts at the plaza level.

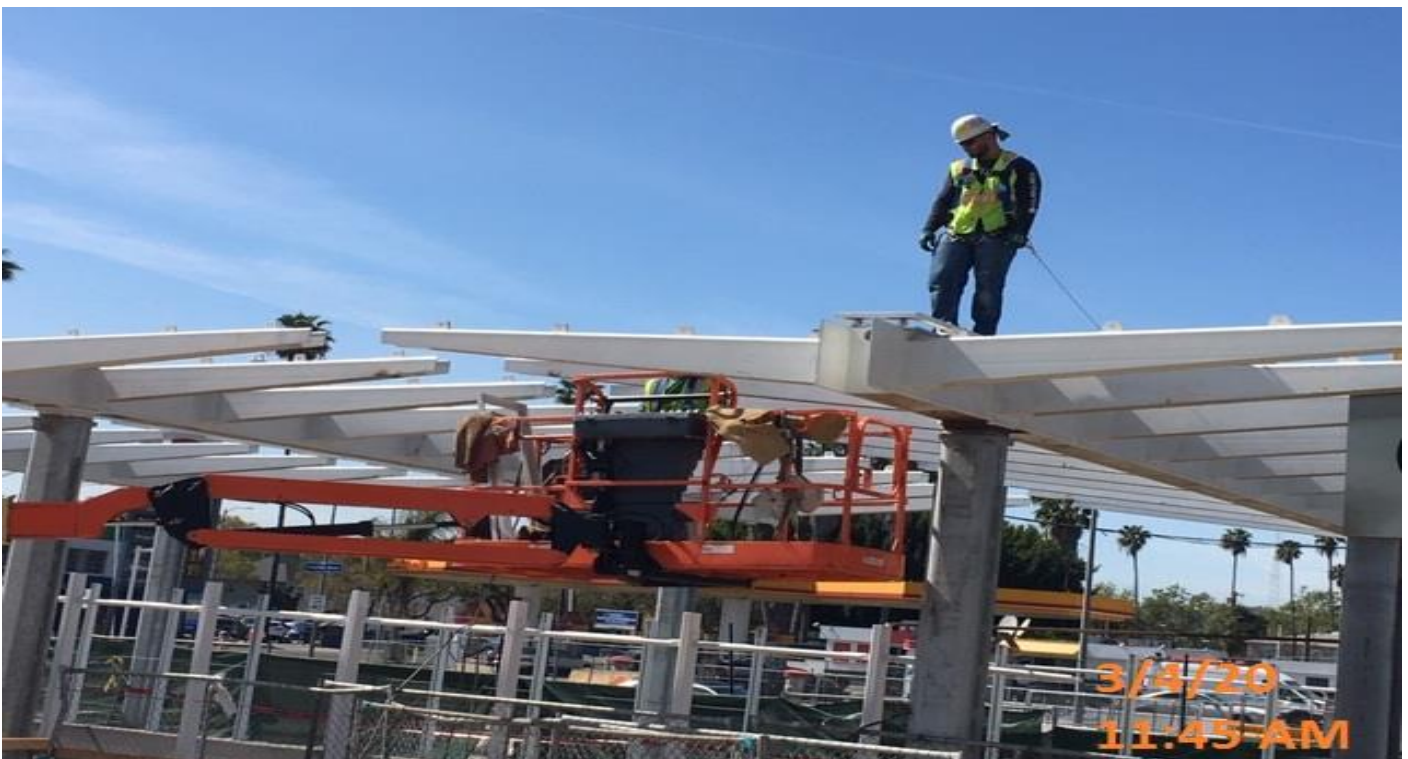
EXPO STATION- Installing cat walk grating above the main entrance canopy structure at the plaza level.

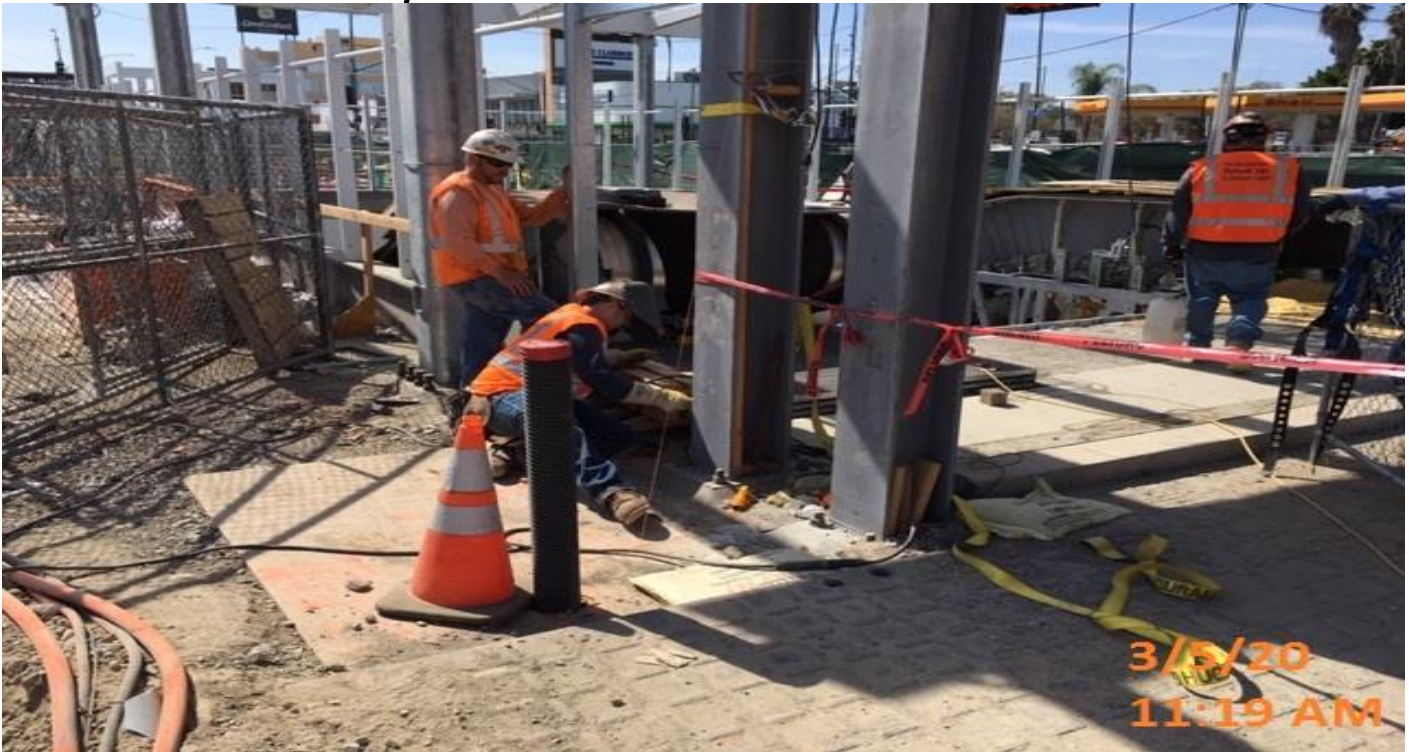
EXPO STATION- Welding frame for the emergency exit stairs at the main entrance of the plaza level.

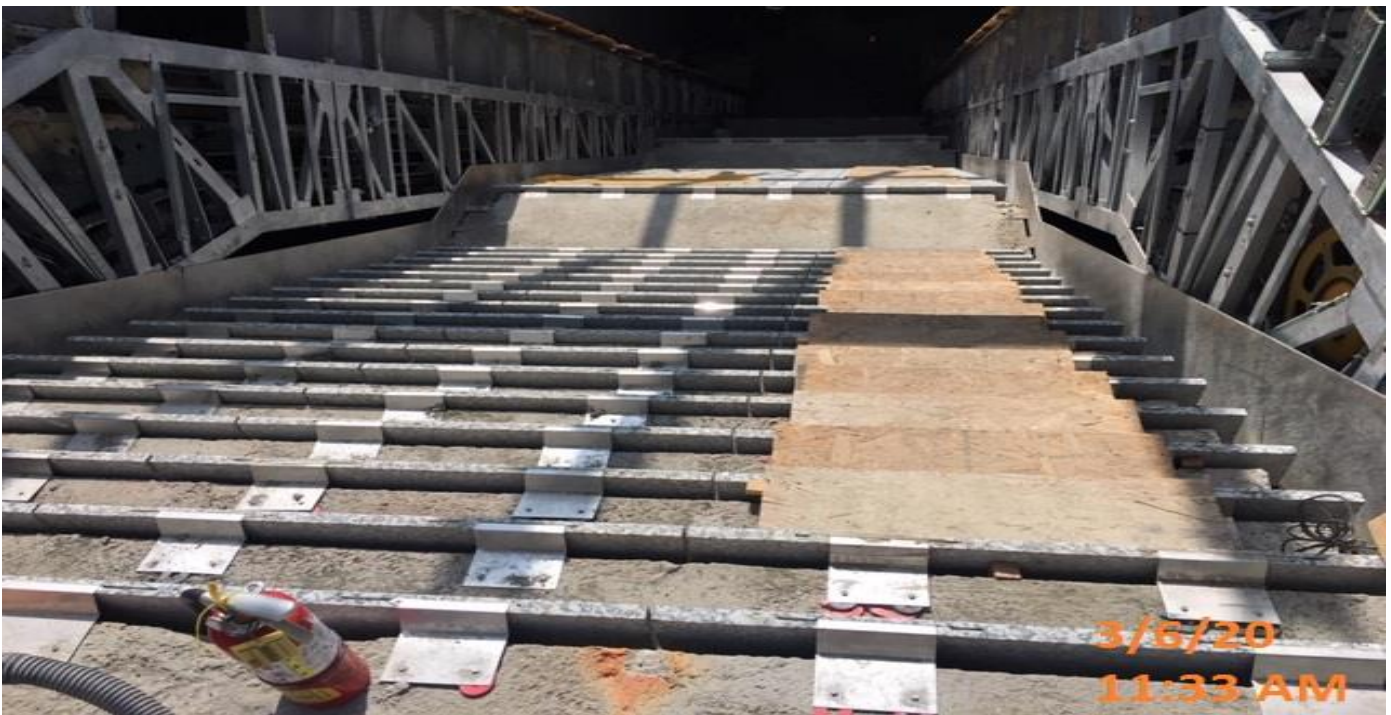
EXPO STATION- Installing granite risers at the main entrance staircase landing of the plaza level.

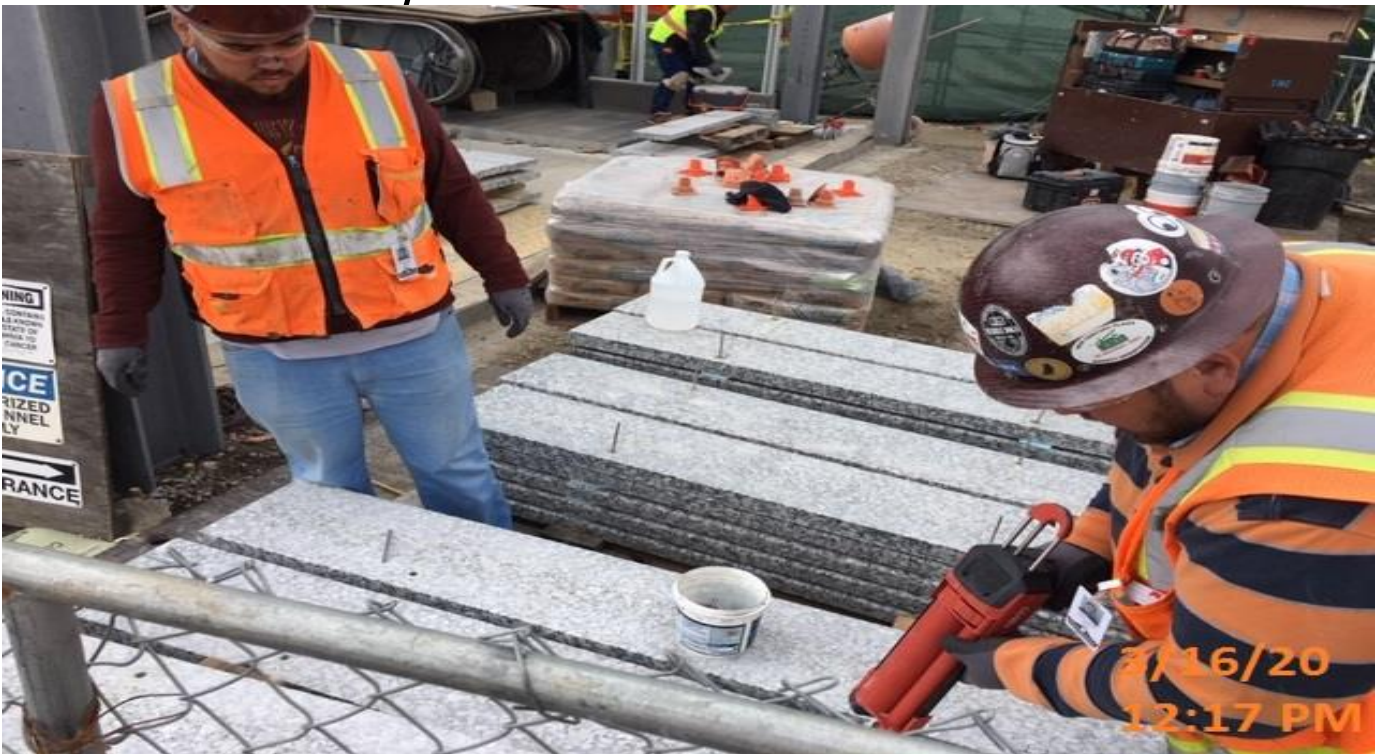
EXPO STATION- Continue installing granite risers at the main entrance staircase landing of the plaza level.

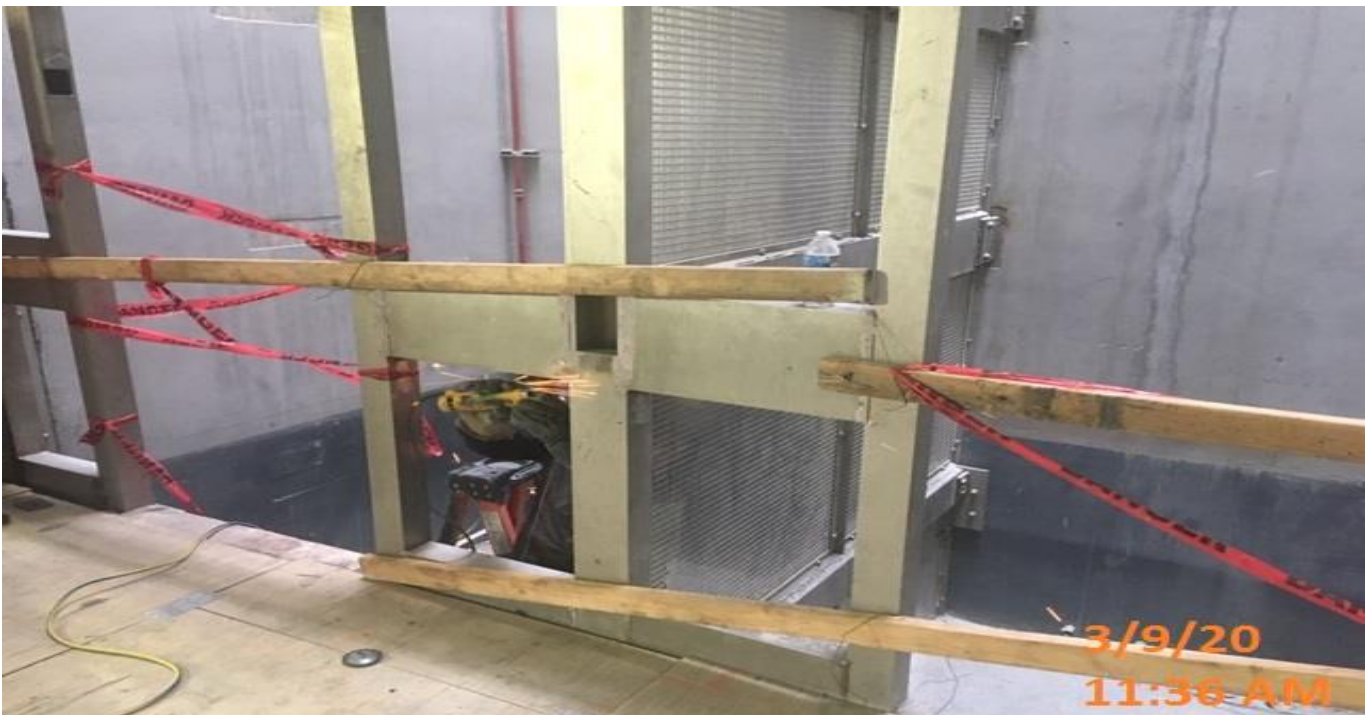
EXPO STATION- Grinding welds on fascia of Elevator Structures 1&2 at the concourse level.

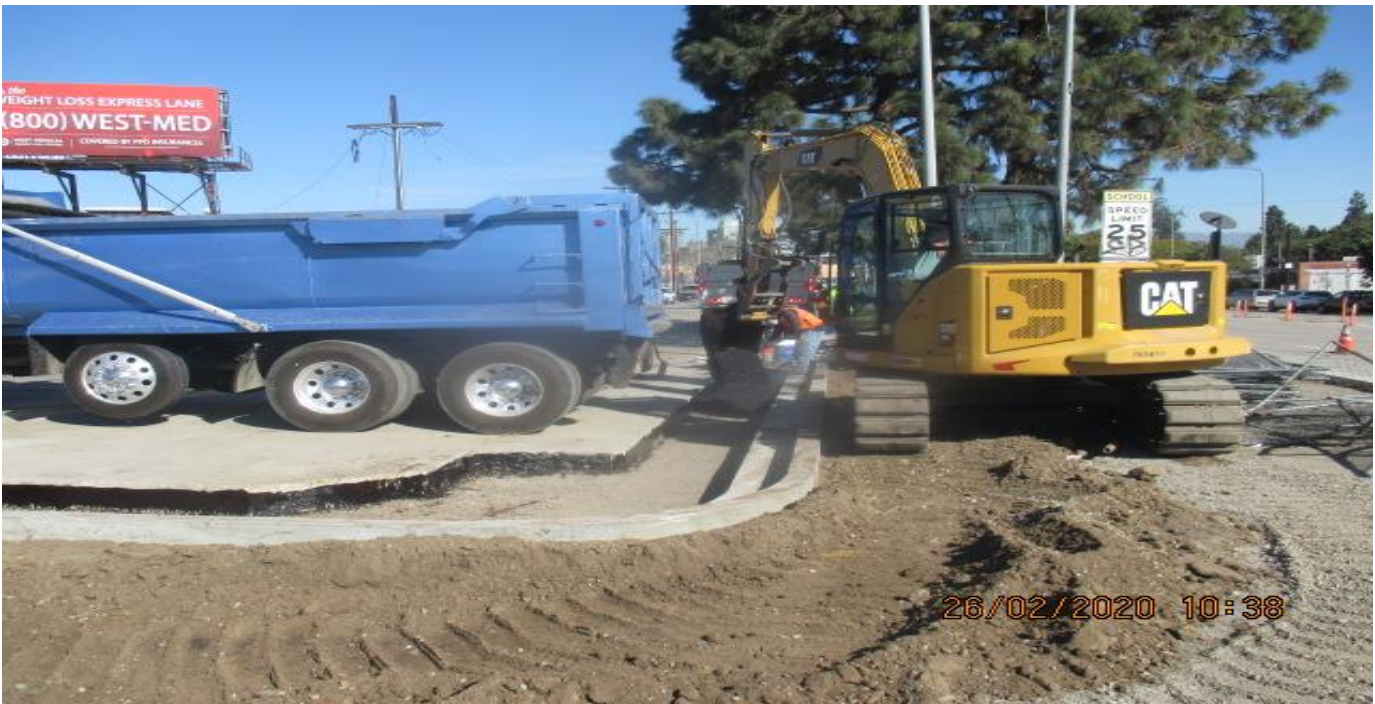
LEIMERT PARK STATION – Placing asphalt concrete and compacting sidewalk on northbound Leimert Blvd and Crenshaw Blvd. 2/26/20

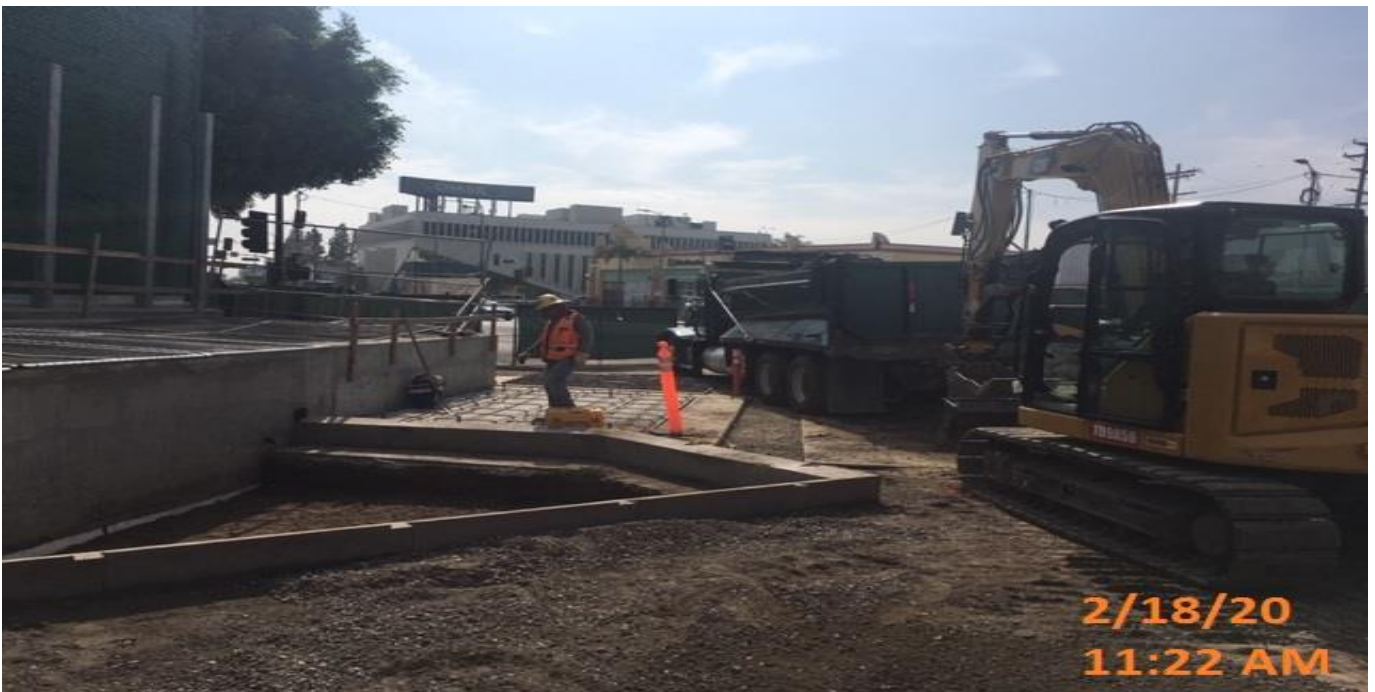
LEIMERT PARK STATION – Continue excavating for planar wall sections at the northeast end of the plaza level.

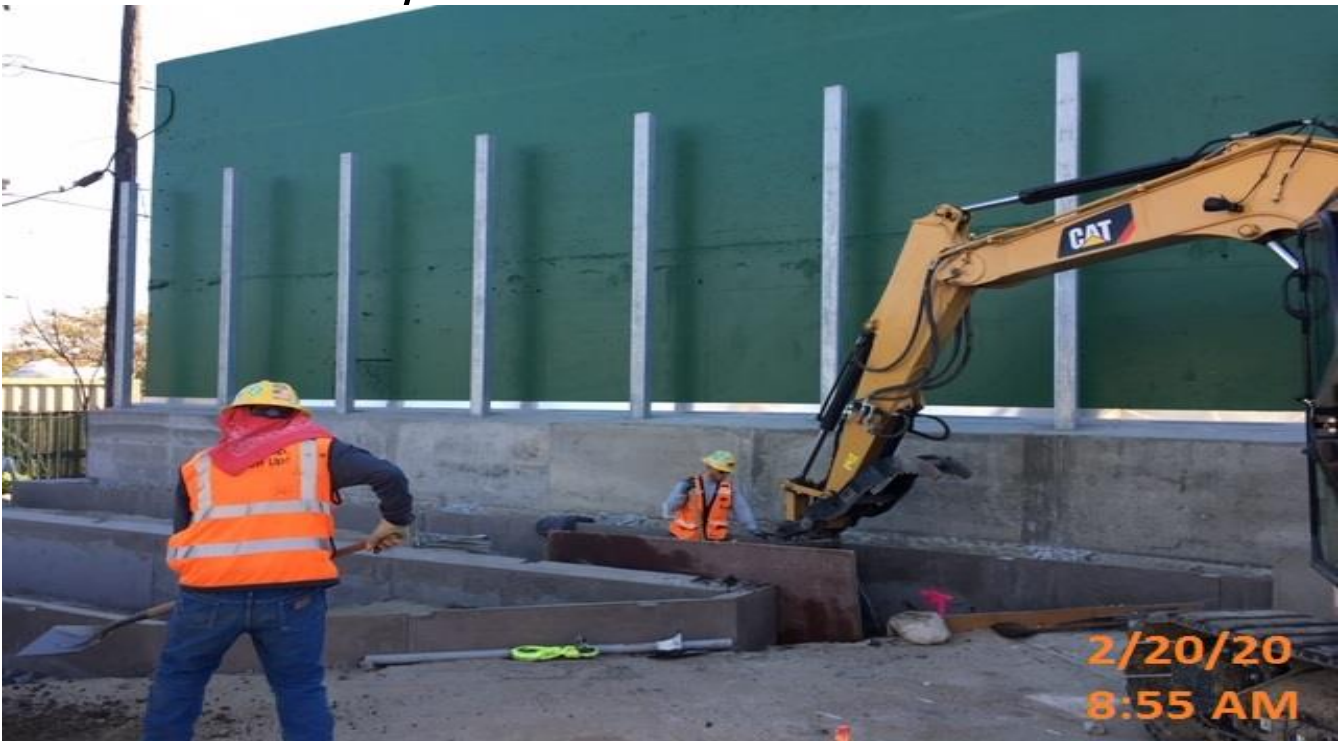
LEIMERT PARK STATION – Excavating for ADA ramp installation at the southeast end of the plaza level.

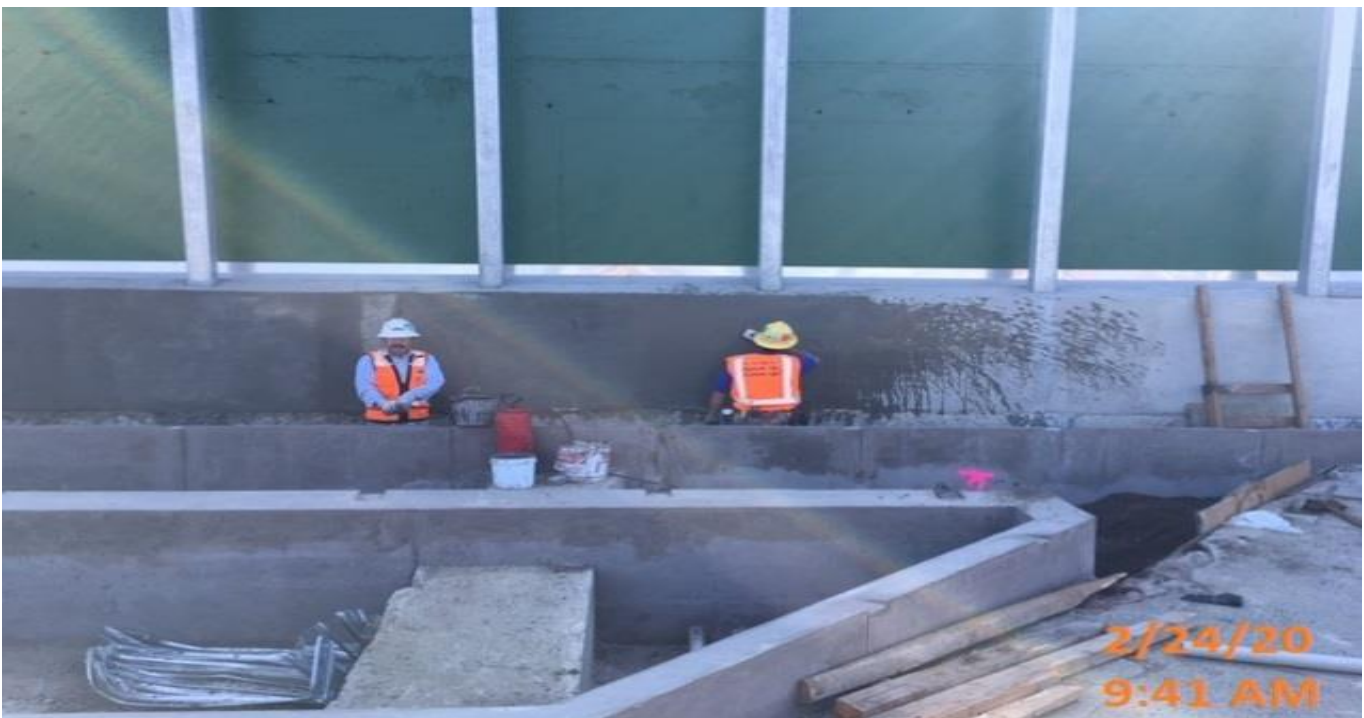
LEIMERT PARK STATION – Surfacing and patching the green screen wall at the south perimeter of the plaza level.

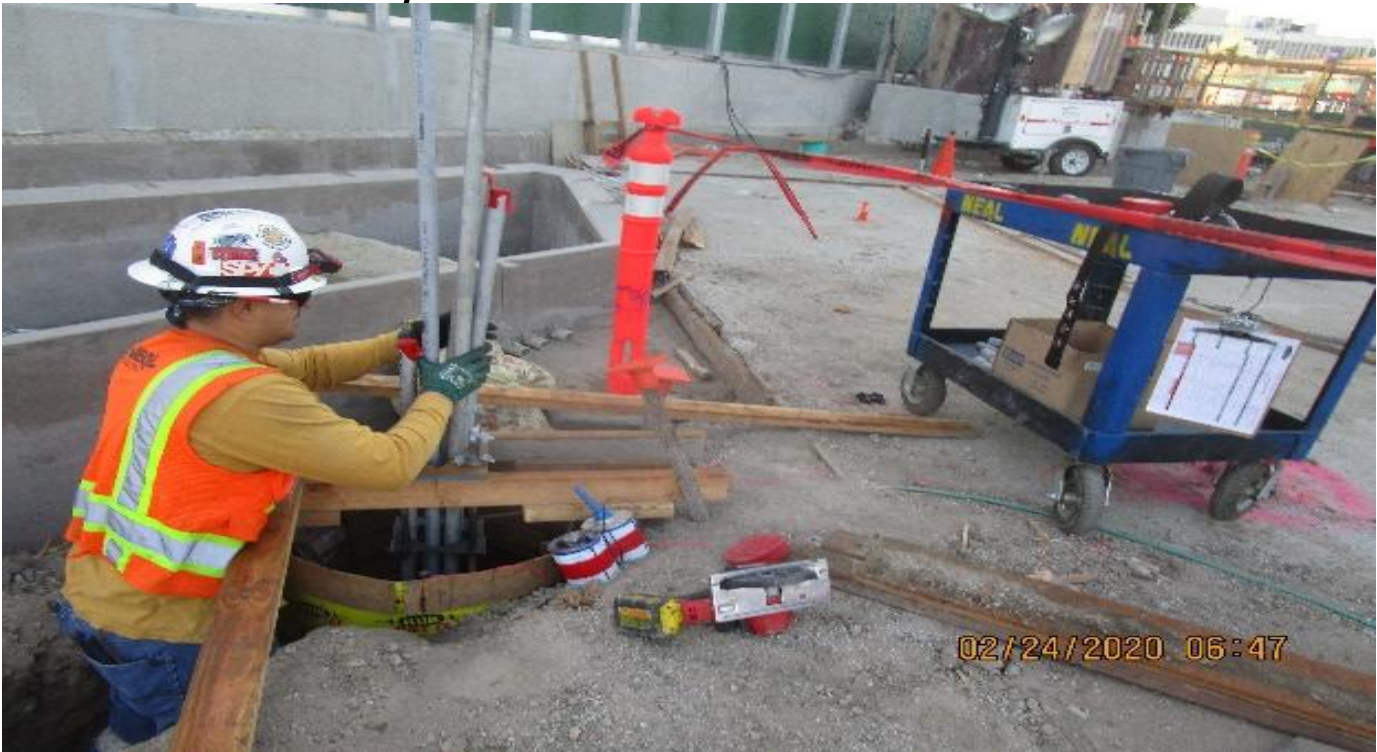
LEIMERT PARK STATION – Setting sonotube foundation forms and rough-in of PVC footings for the installation of the luminaire light posts at the plaza level.

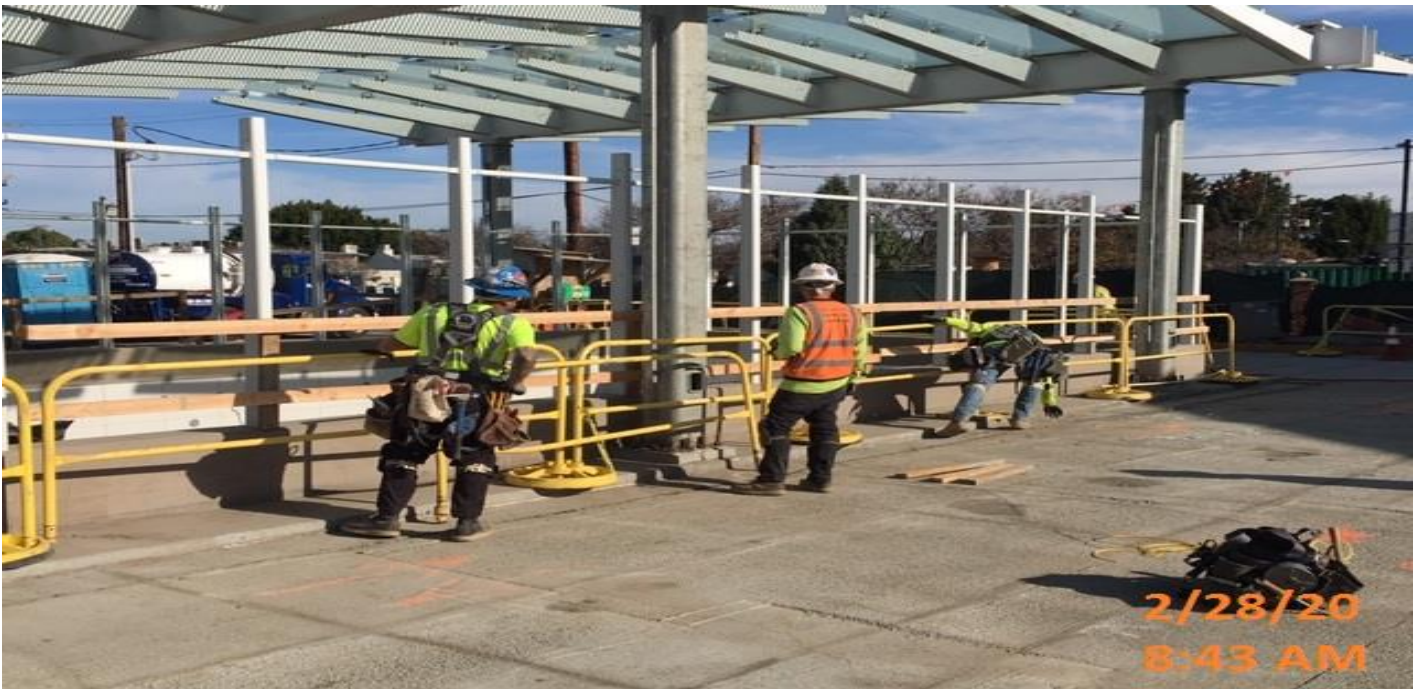
LEIMERT PARK STATION – Began perimeter formwork for slab encasement of irrigation lines for the main entrance canopy at the plaza level.

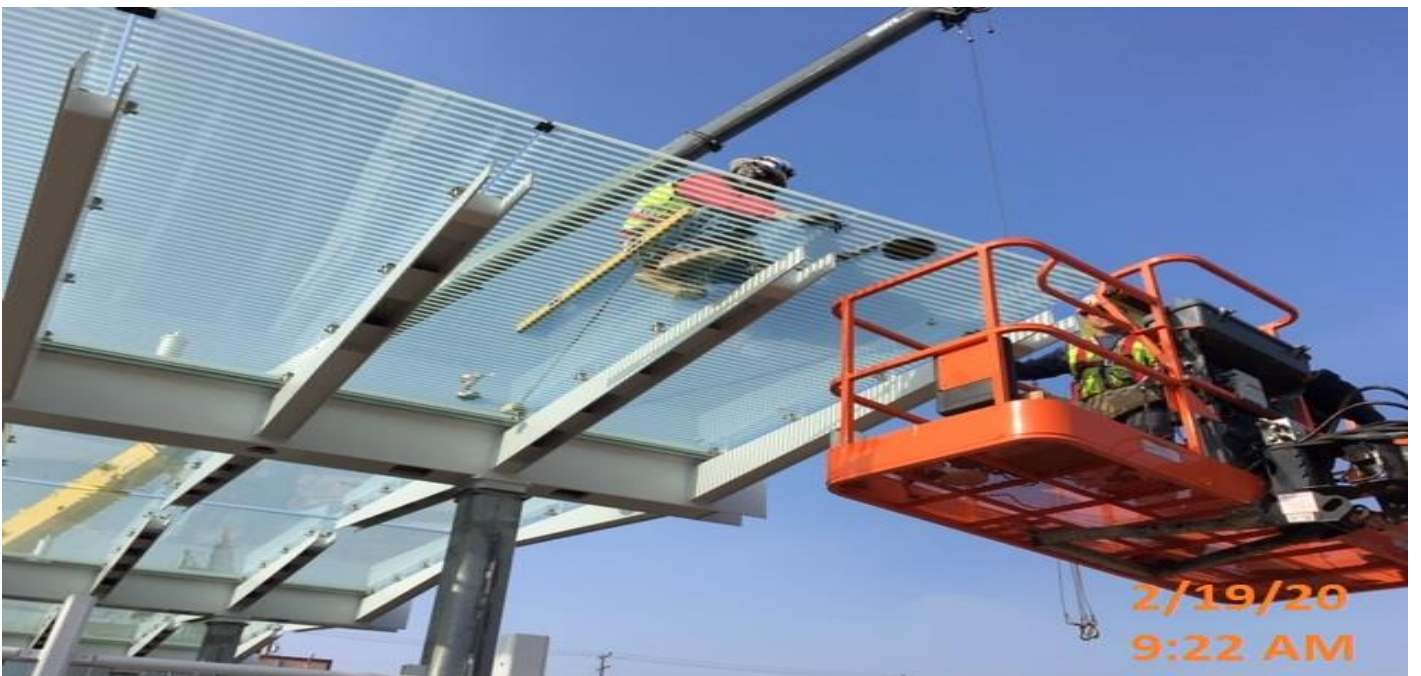
LEIMERT PARK STATION – Continue glass panel installation above the main entrance canopy structure at the plaza level.

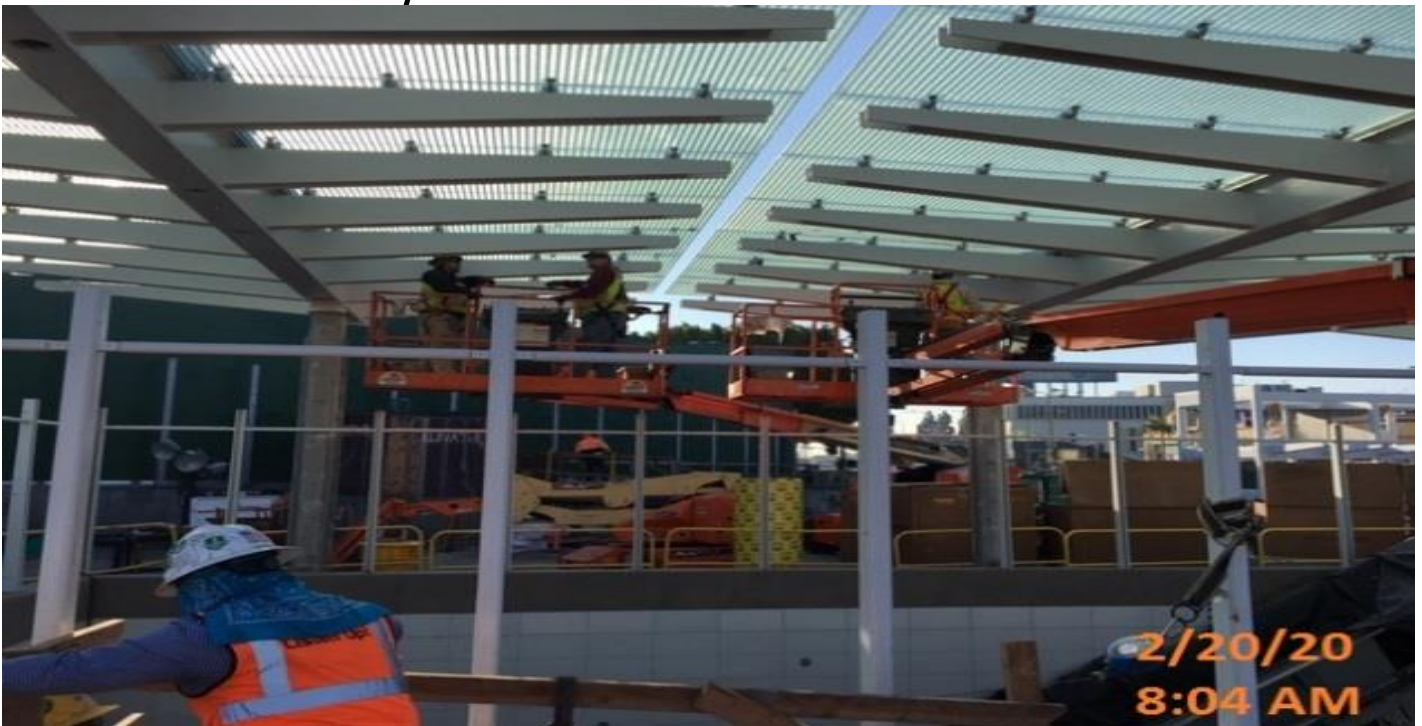
LEIMERT PARK STATION – Continue glass panel installation above the main entrance canopy structure at the plaza level.

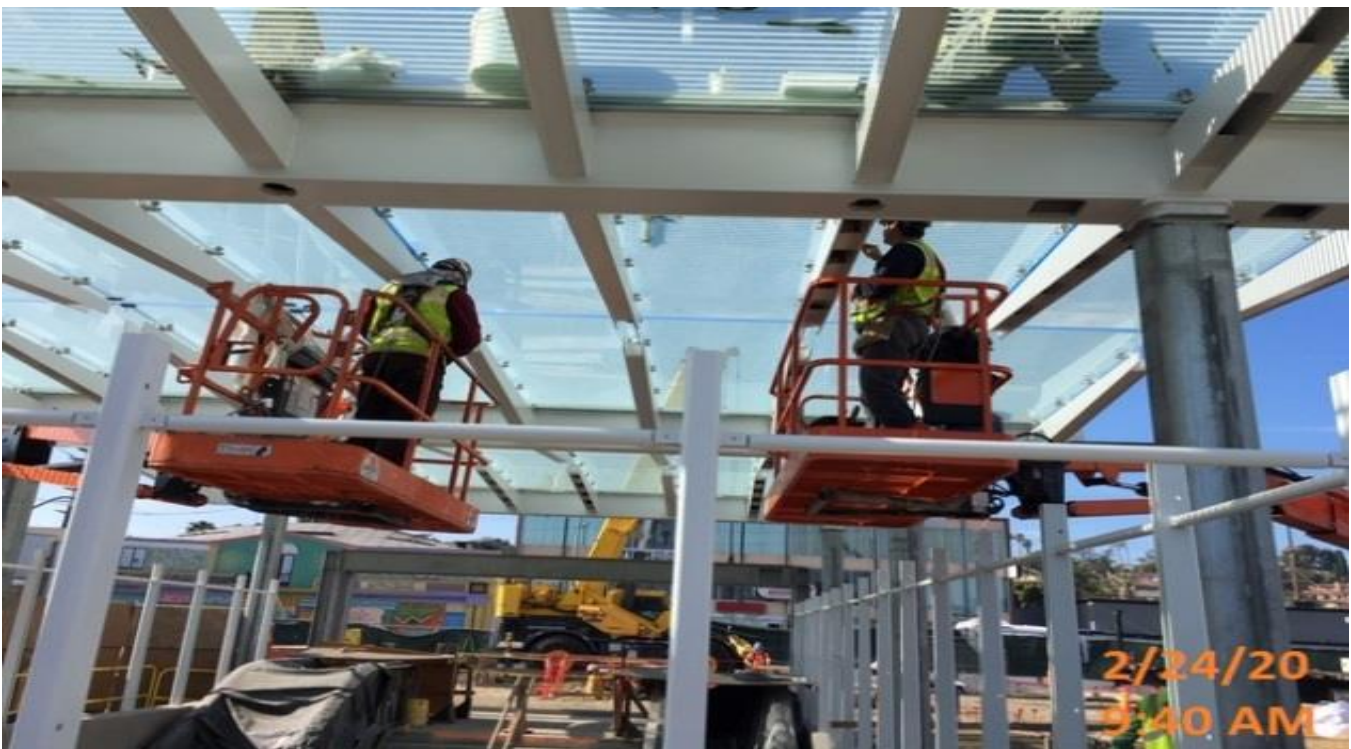
LEIMERT PARK STATION – Continue glass panel installation and sealing edges with silicone above the main entrance canopy structure at the plaza level.

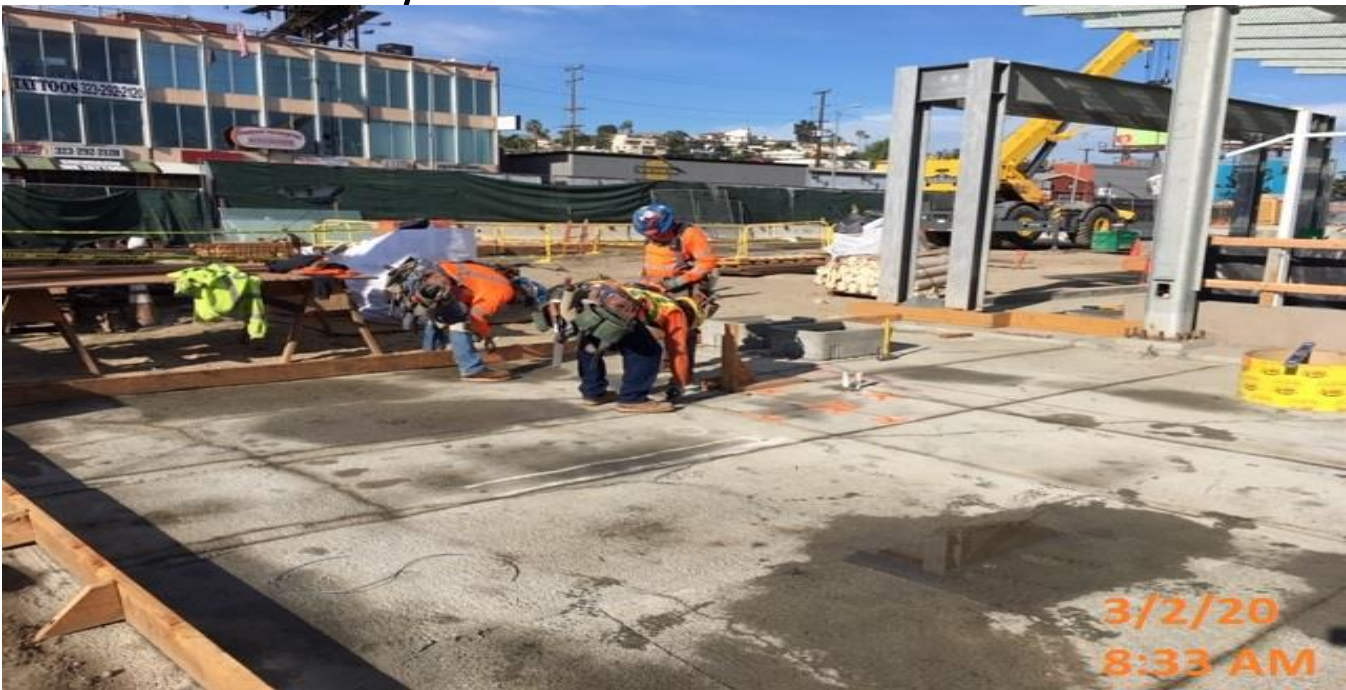
LEIMERT PARK STATION – Marking gridlines in preparation for the architectural topping slab at the plaza level.
