CRENSHAW/LAX PHOTOGRAPHIC UPDATE

March 17, 2020

Crenshaw/LAX Transit Project

- 8.5 miles Light Rail
- 8 Stations
- \$2,058.0 Million
(Board approved revised LOP)

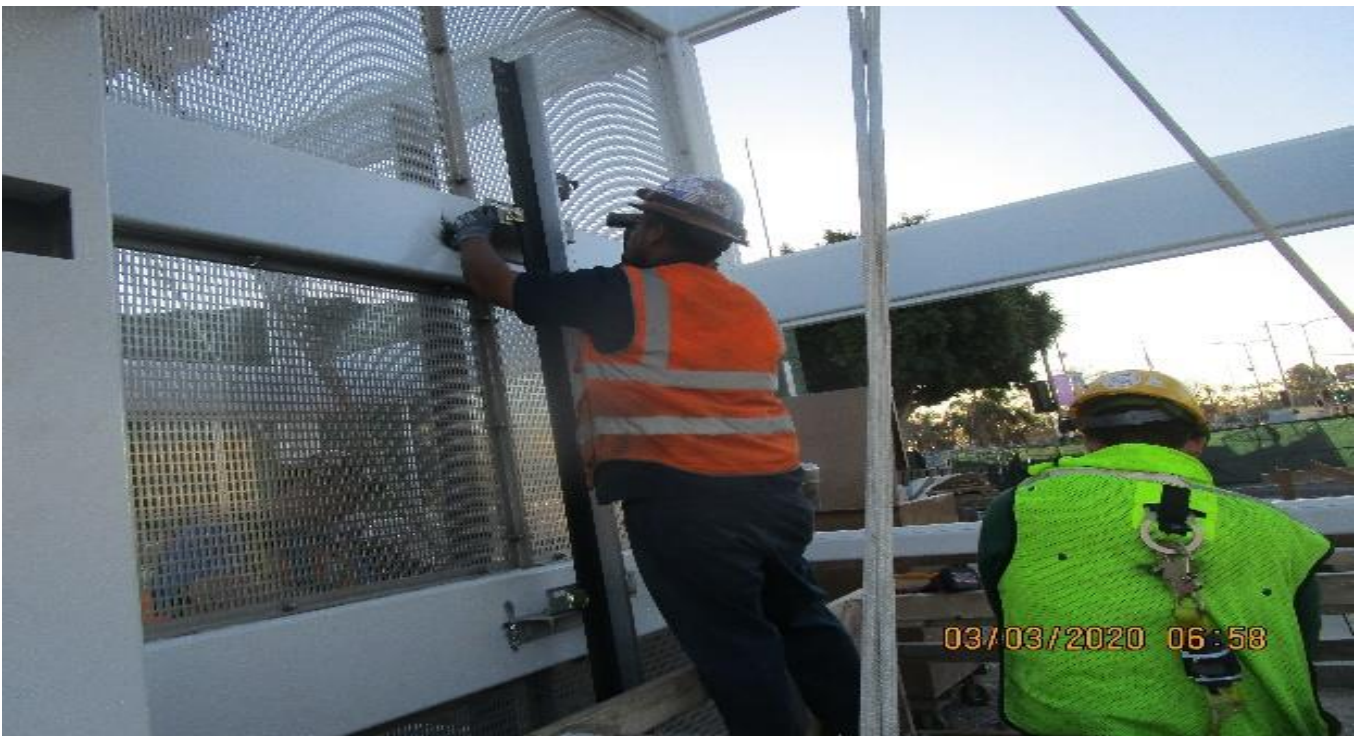
LEIMERT PARK STATION – Continue guide rail bracket support for Elevator hoist way/pit 1 at the plaza level.

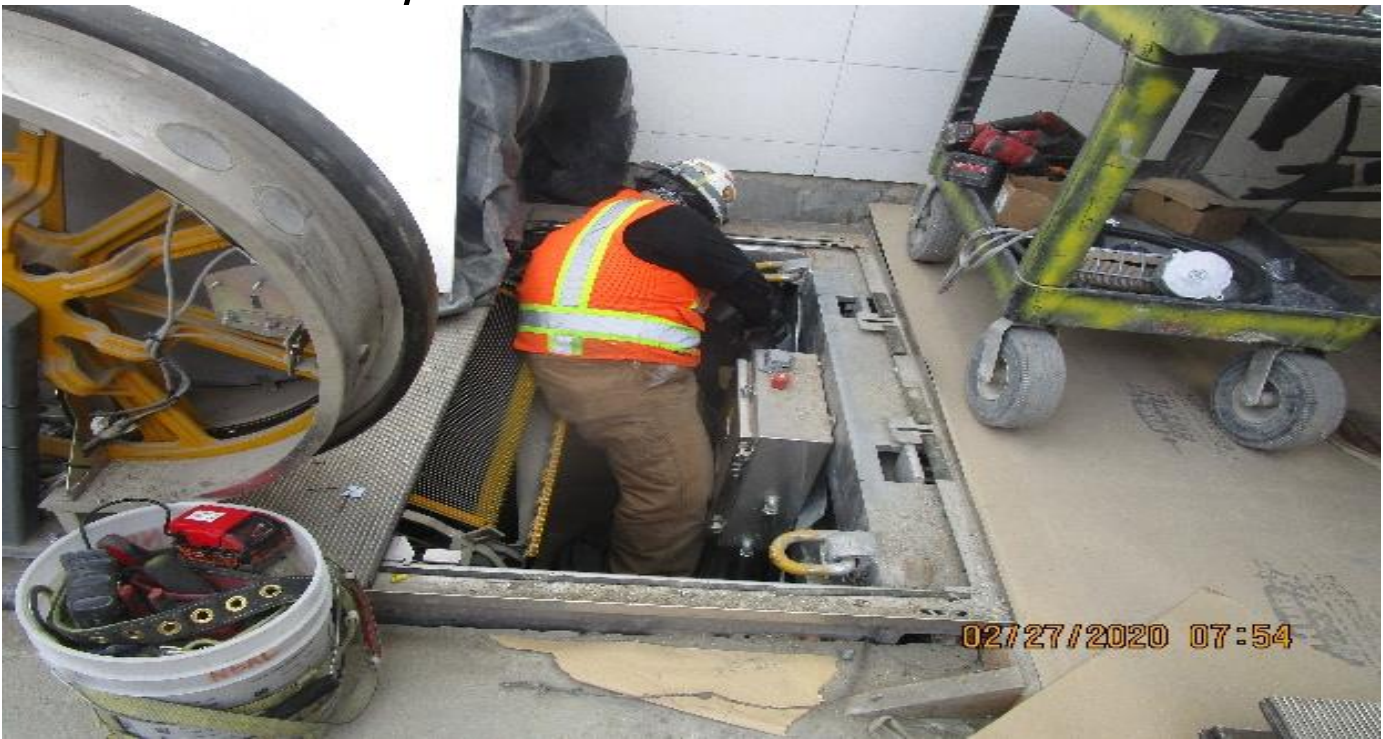
LEIMERT PARK STATION – Installing conduit to junction boxes for Escalators 1&2 at the intermediate level.

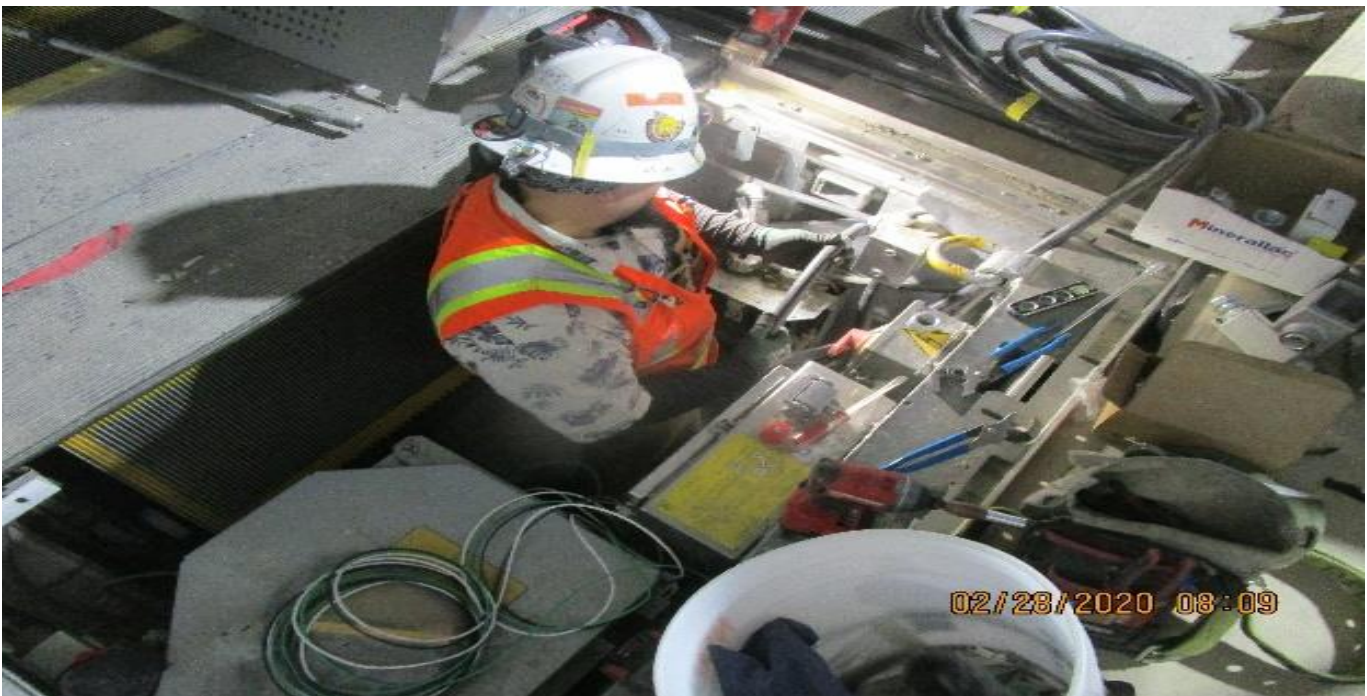
LEIMERT PARK STATION – Installing conduit to junction boxes for Escalators 3&4 at the intermediate level.

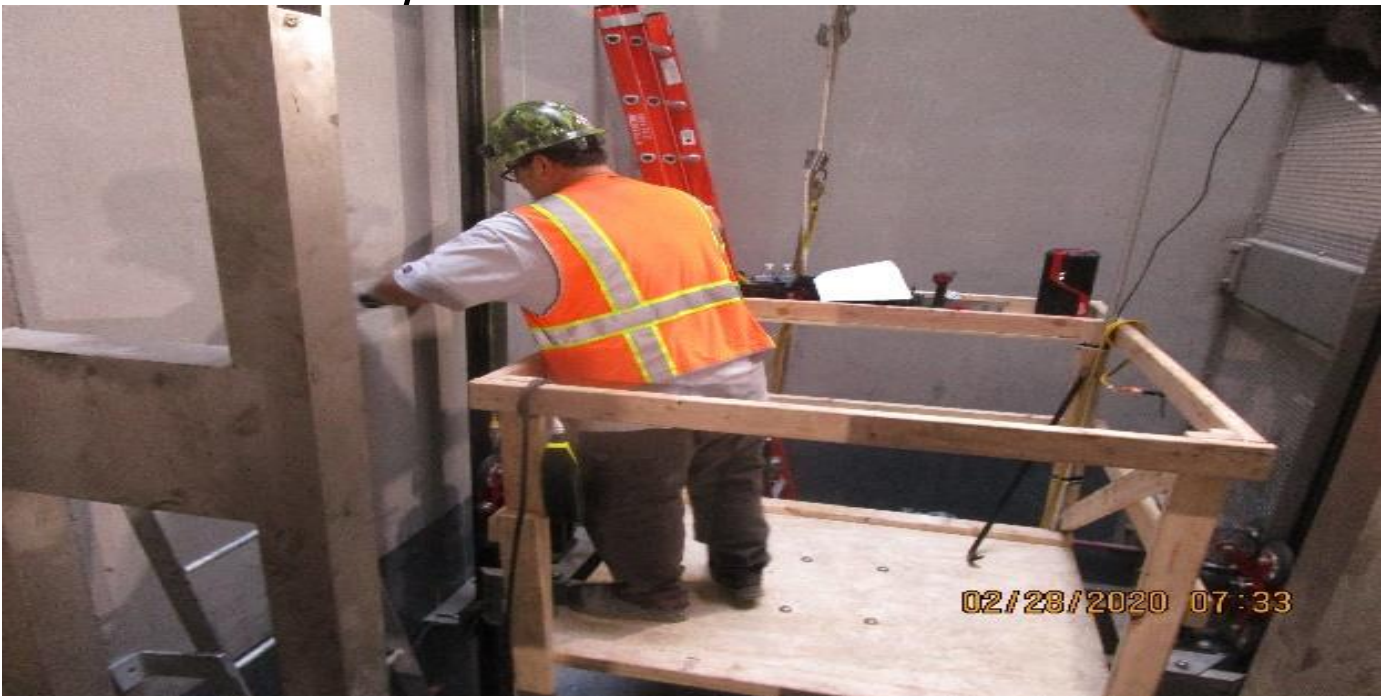
LEIMERT PARK STATION – Continue guide rail bracket support for Elevator hoist way/pit 2 at the concourse level.

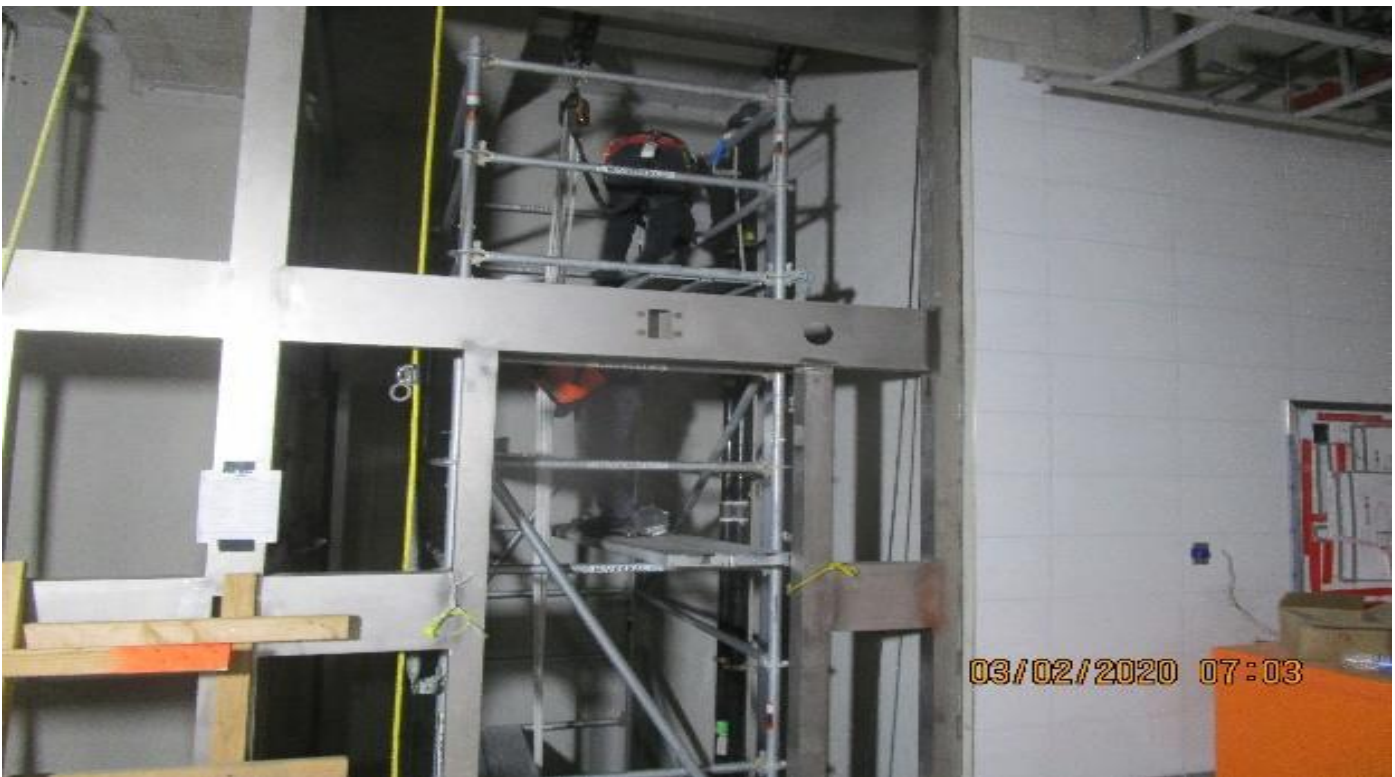
LEIMERT PARK STATION – Continue guide rail bracket support for Elevator hoist way/pit 3 at the concourse level. 3/2/20

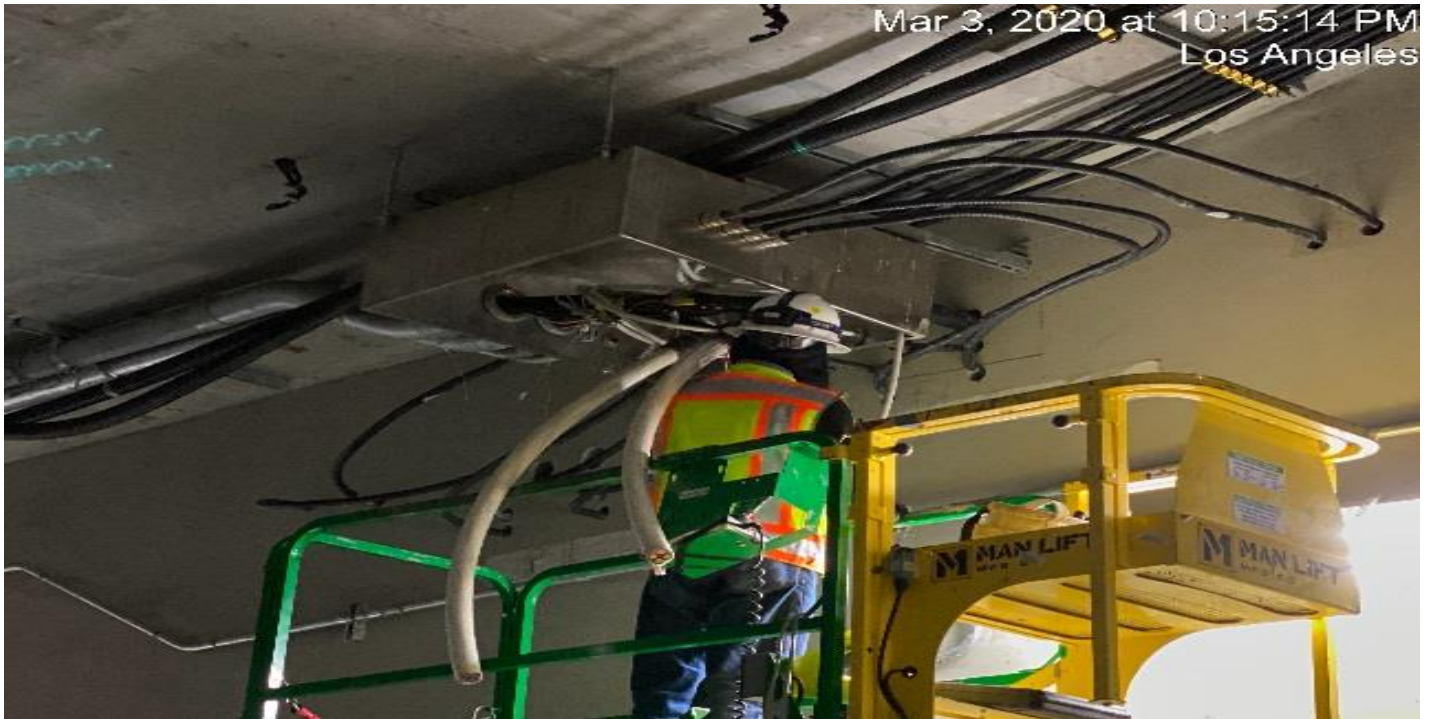
UG4 – Continue wiring and running cable for the booster fans on both north and southbound tunnels at Sta 378+75.

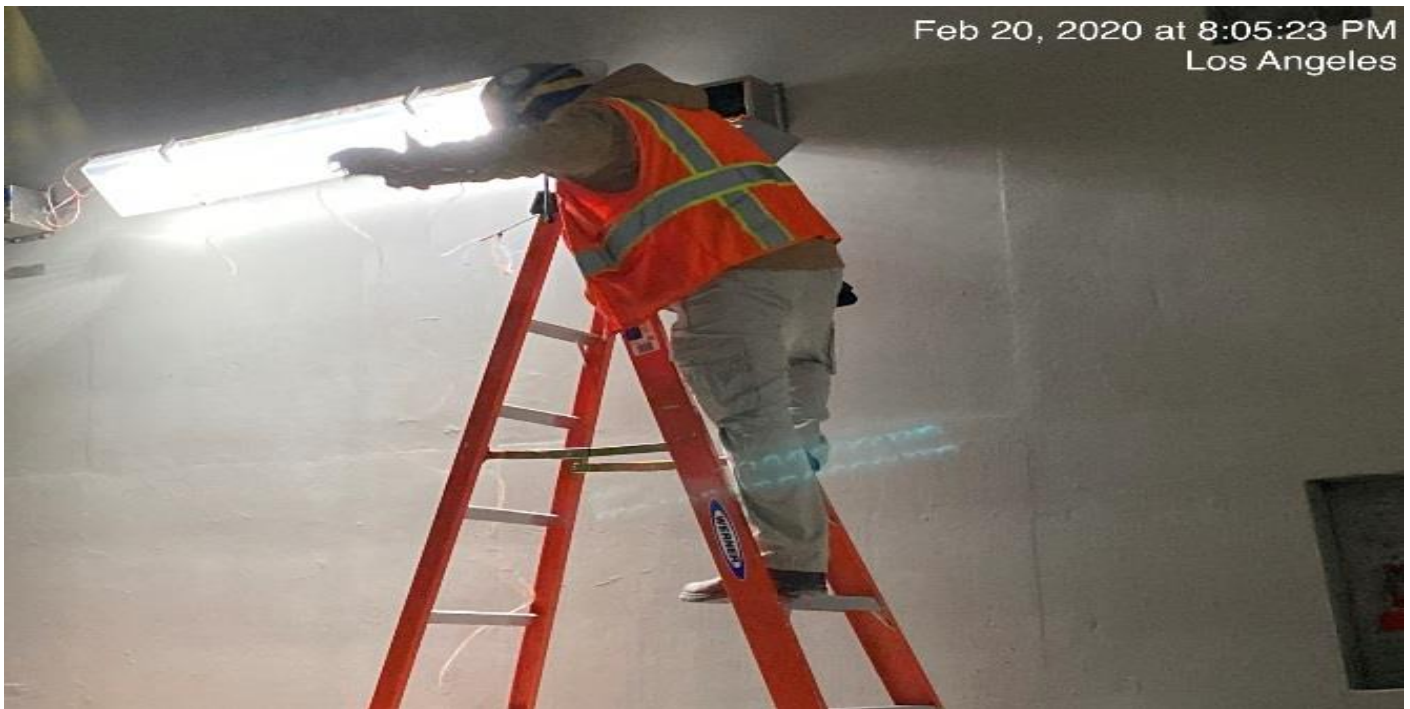
UG4 – Continue pulling wire for the emergency lighting along the northbound tunnel at Sta 374+85.

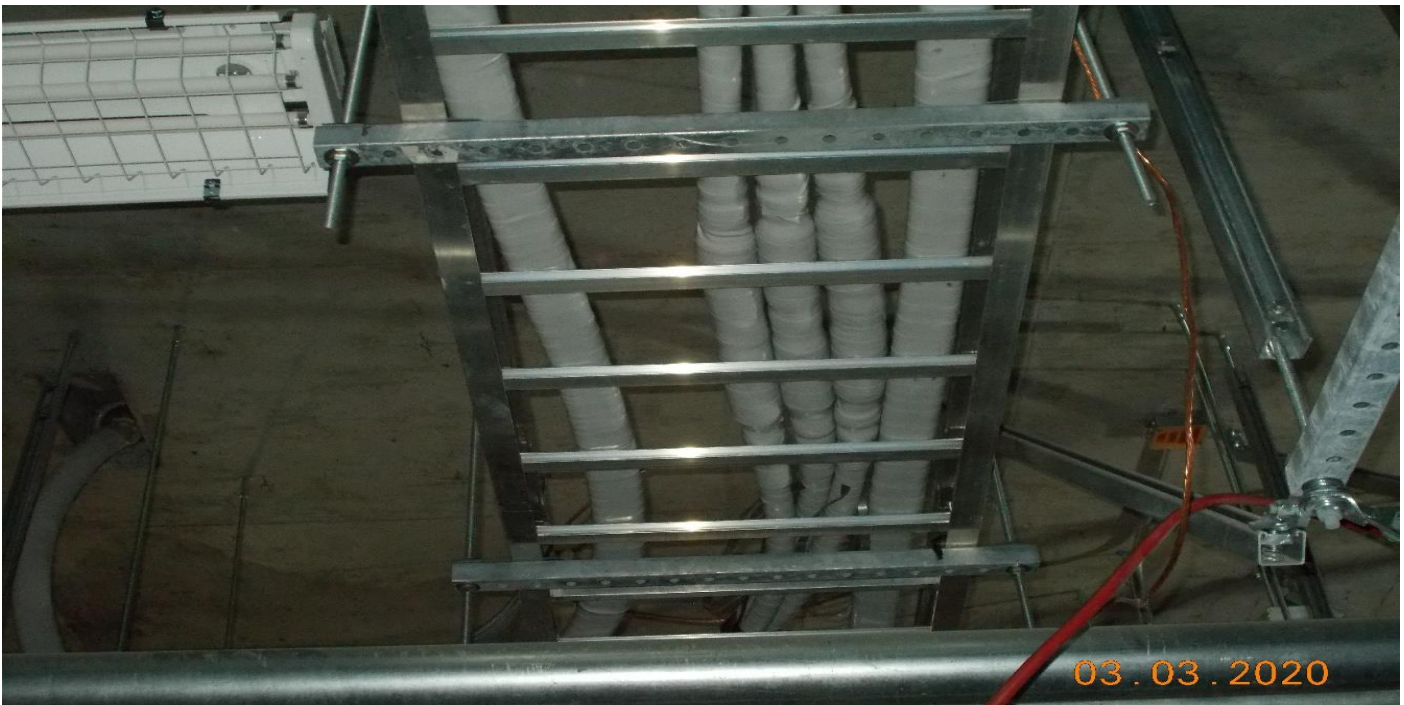
Crenshaw/Vernon – Aux Pwr room south has unterminated high voltage cable grounds in the cable tray.

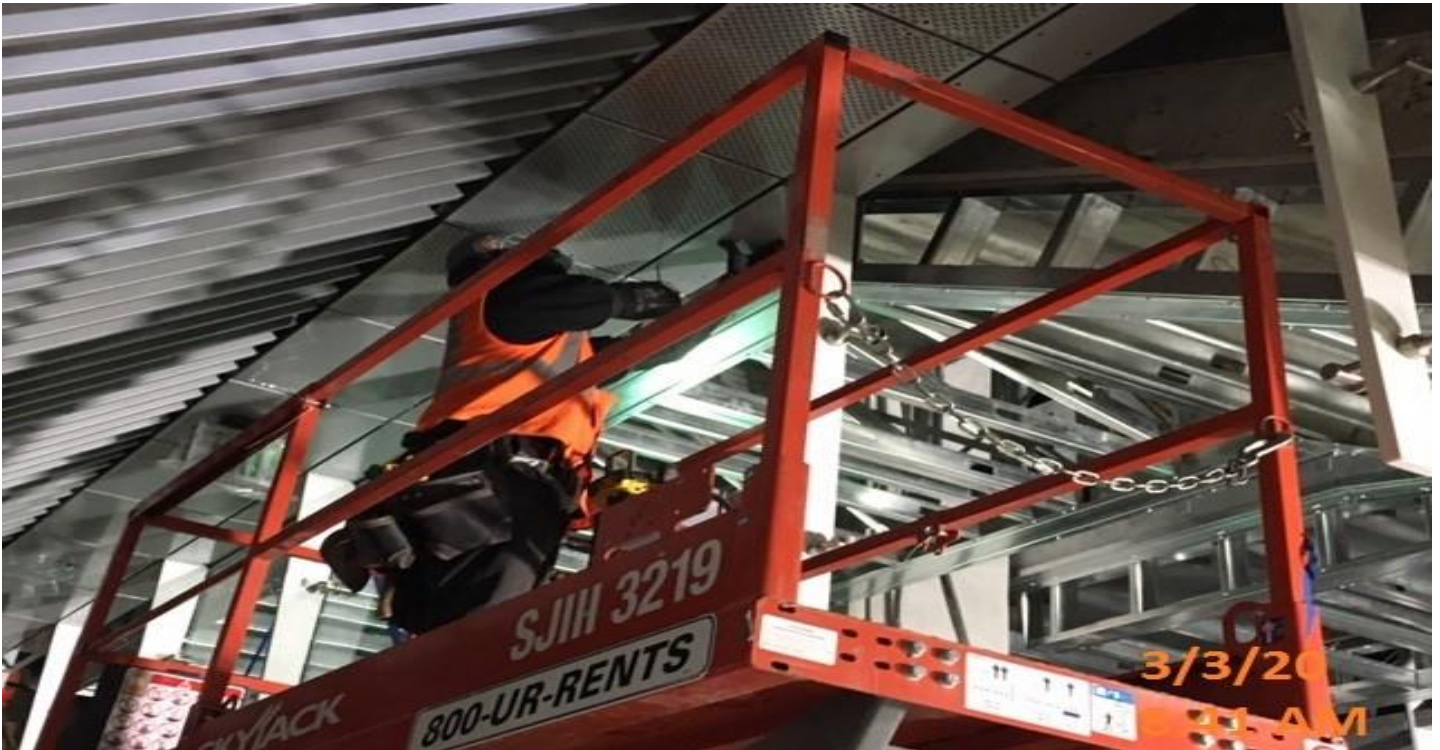
Crenshaw/Vernon – VERNON – PCI swapping out bolts on down stand.
