CRENSHAW/LAX PHOTOGRAPHIC UPDATE

June 12, 2020

Crenshaw/LAX Transit Project

Overview of trackwork progress issues for 05/15/2020 – 06/01/2020
(Please note the attached Trackwork Progress Tracking Report)

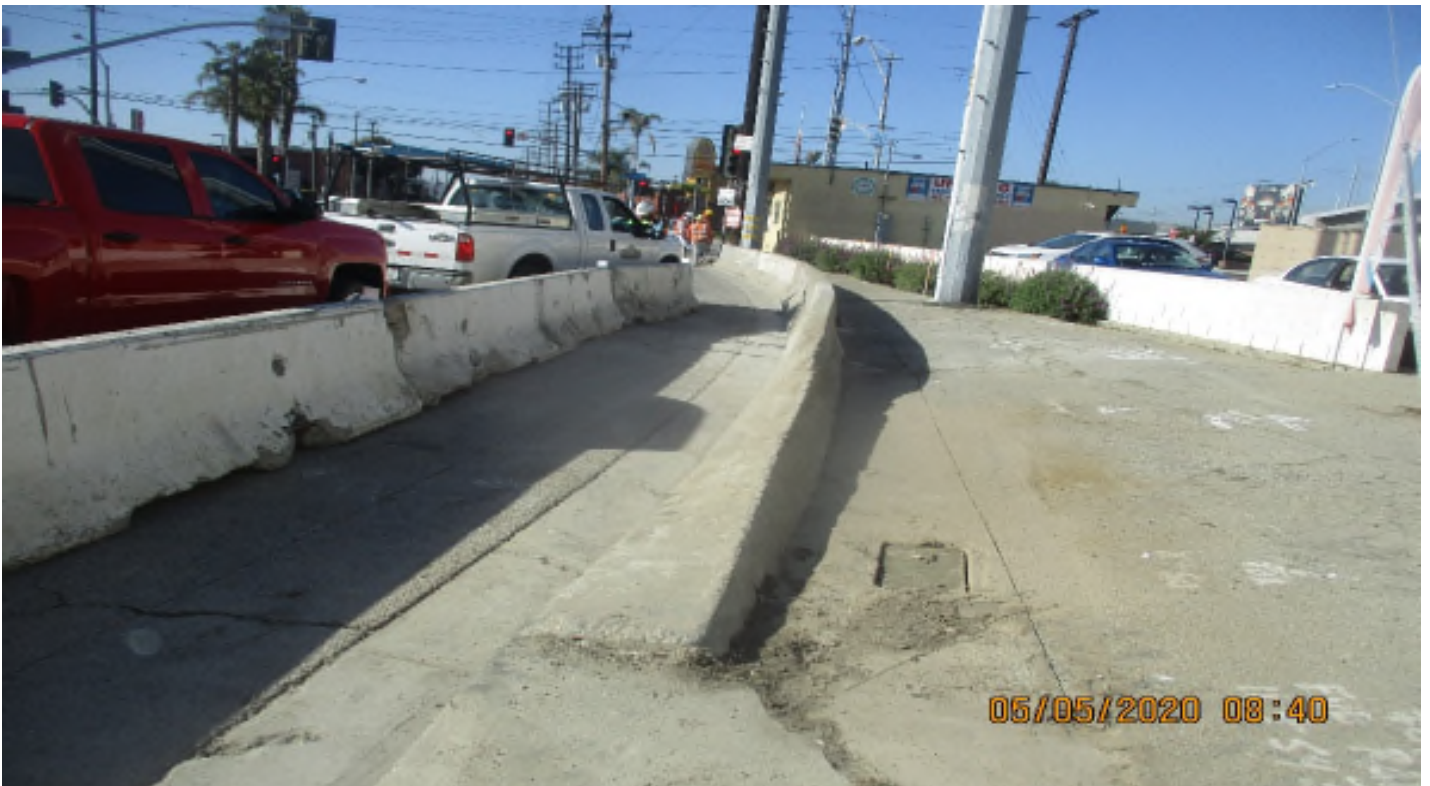
Manchester Bridge - Manchester Bridge NB #4 track STA 121+45 no condition changes for disturbed ballast . on Metro's Punch list, item #250 in Segment A.

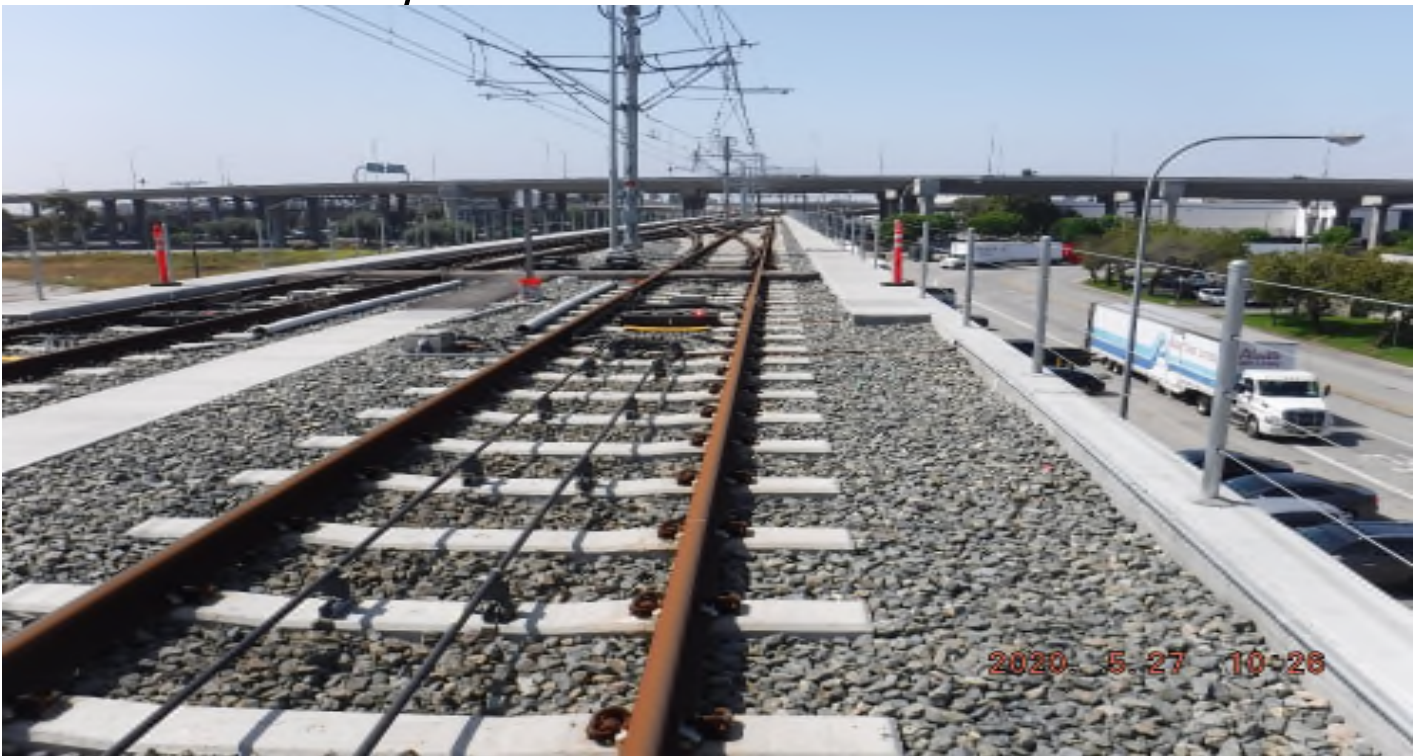
Aviation/Century – 1. STA 21+48 TK#3/SB looking south – rail grind validation in progress (Aviation - DXO area)

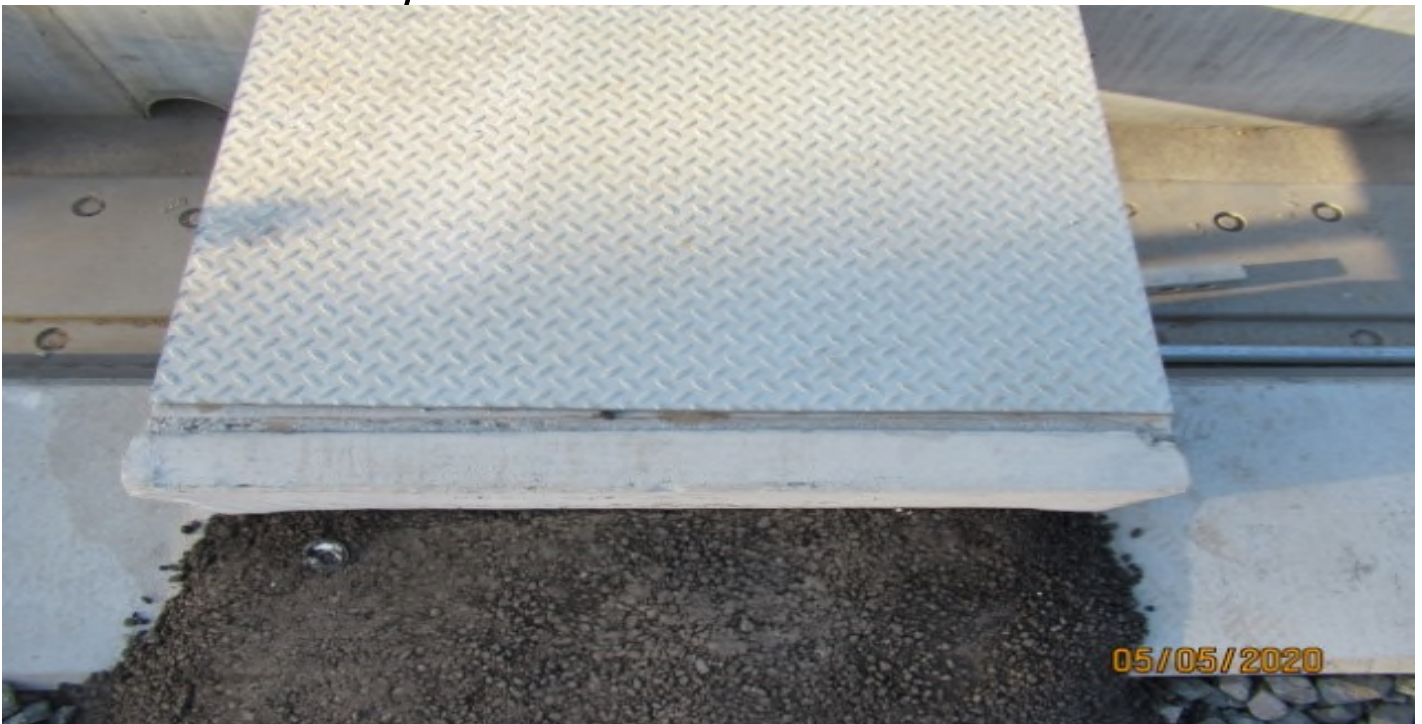
Aviation/Century – Emergency Walkway crossing at edge of DF track on Century/Aviation bridge STA 74+72.

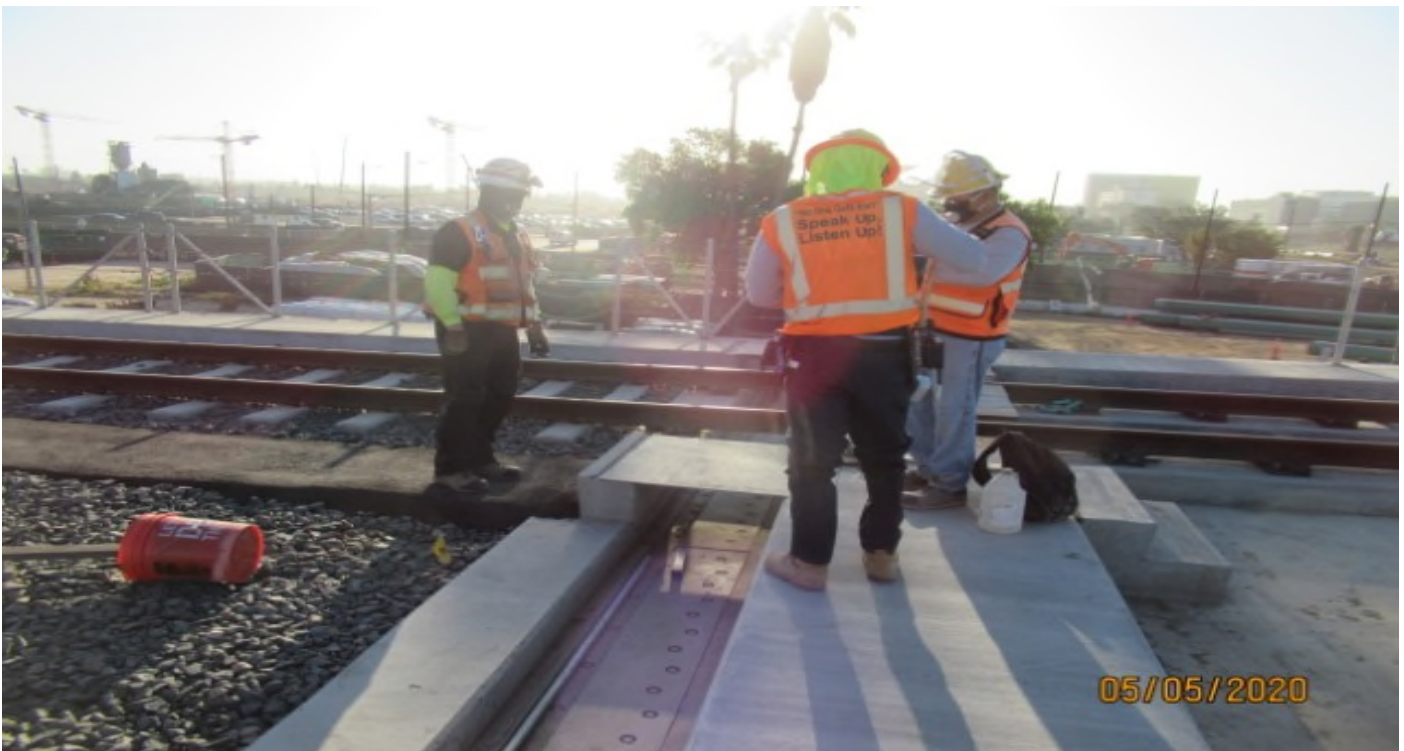
Aviation/Century – WSCC QC & concrete foreman going over open item punch list, Activity #1498 on Century/Aviation bridge (looking east) rework

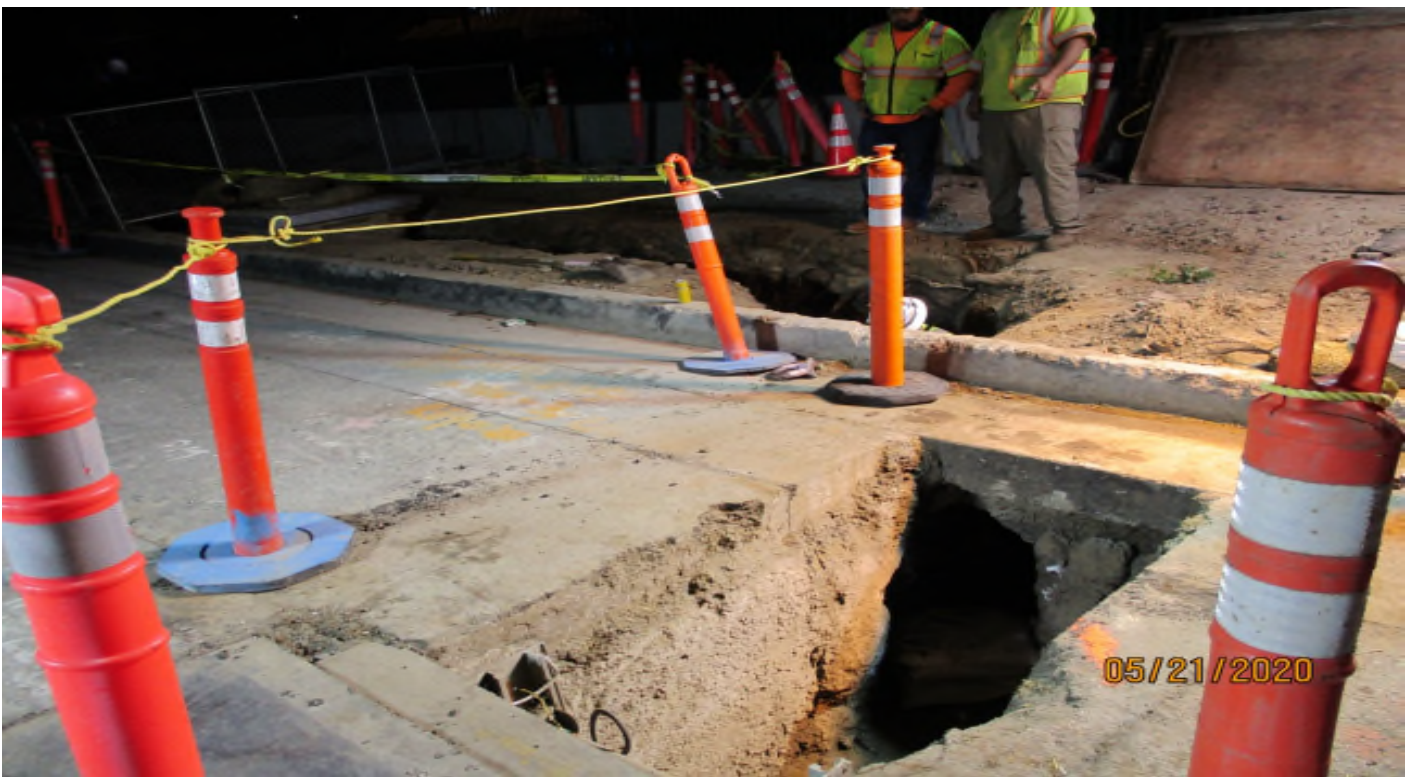
111th Street – Fire line trench turn at 111th street.

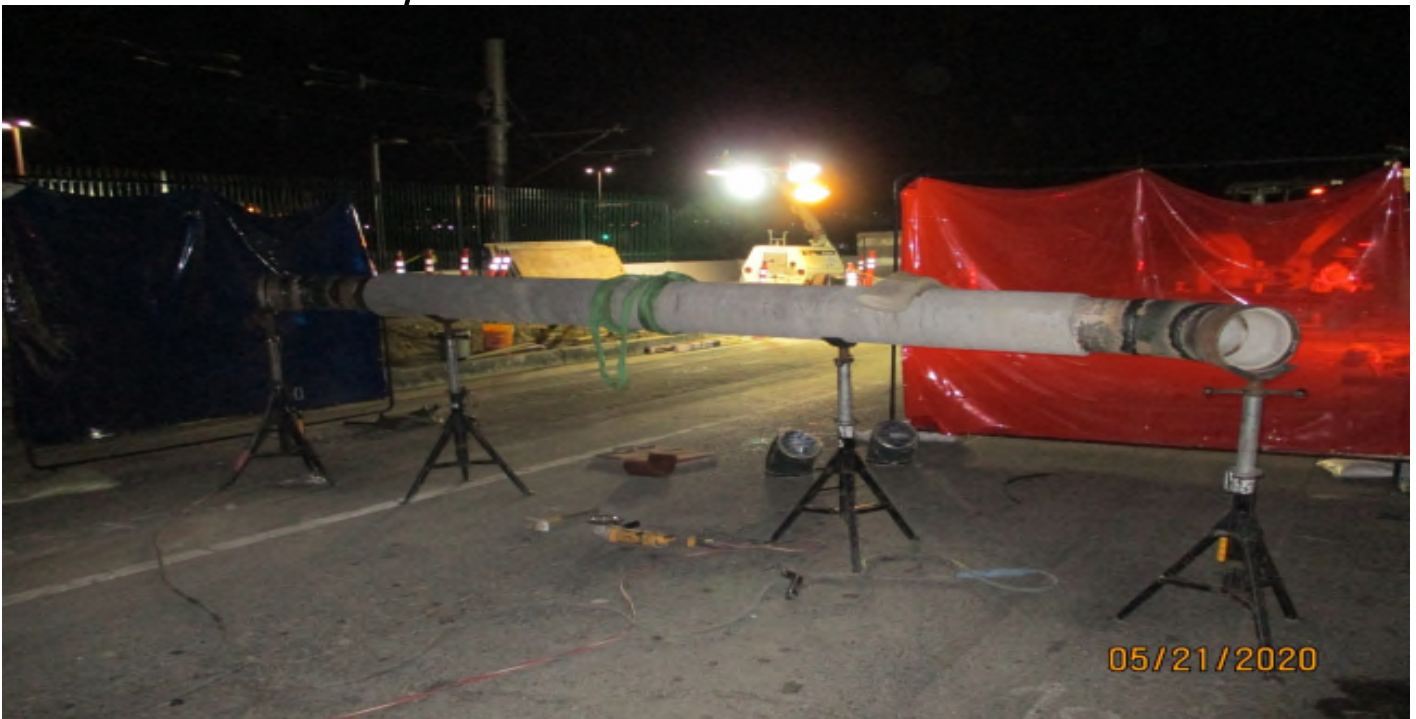
111th Street – Welding fire line pipe at 111th street.

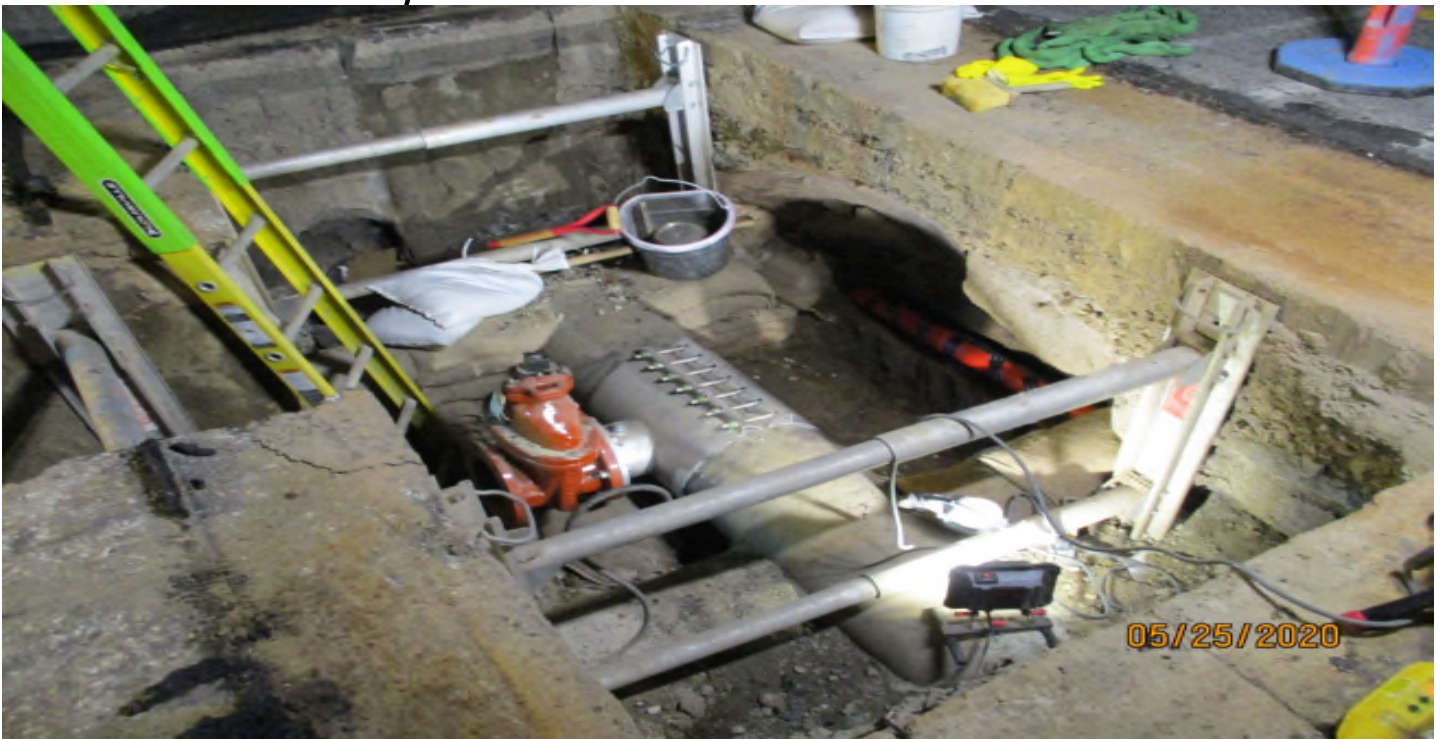
111th Street – Fire line saddle and valve prior to concrete placed for the thrust block at 111th street.

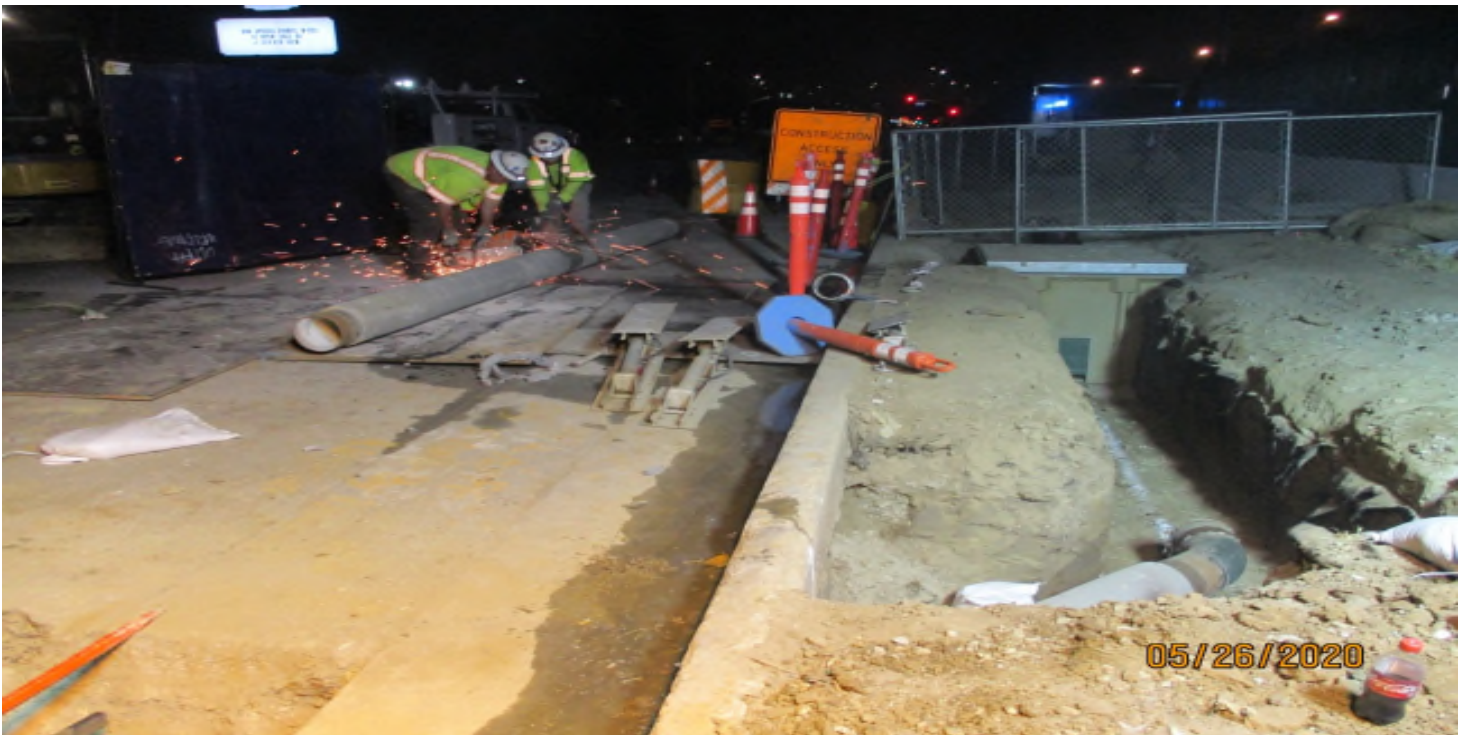
111th Street – Curb & gutter over-excavation and conduit installation at 111th street. Facing west.

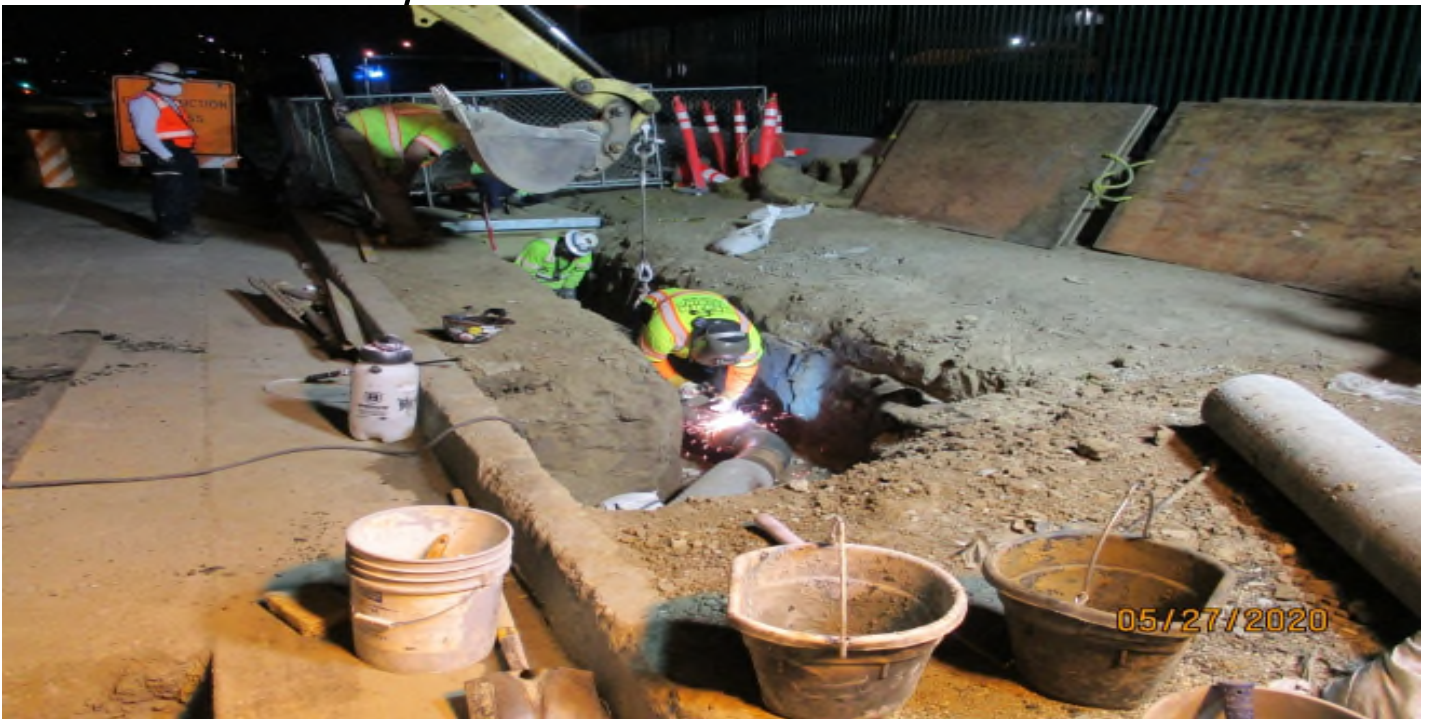
111th Street – Curb & gutter over-excitation and conduit installation at 111th street. Facing west.

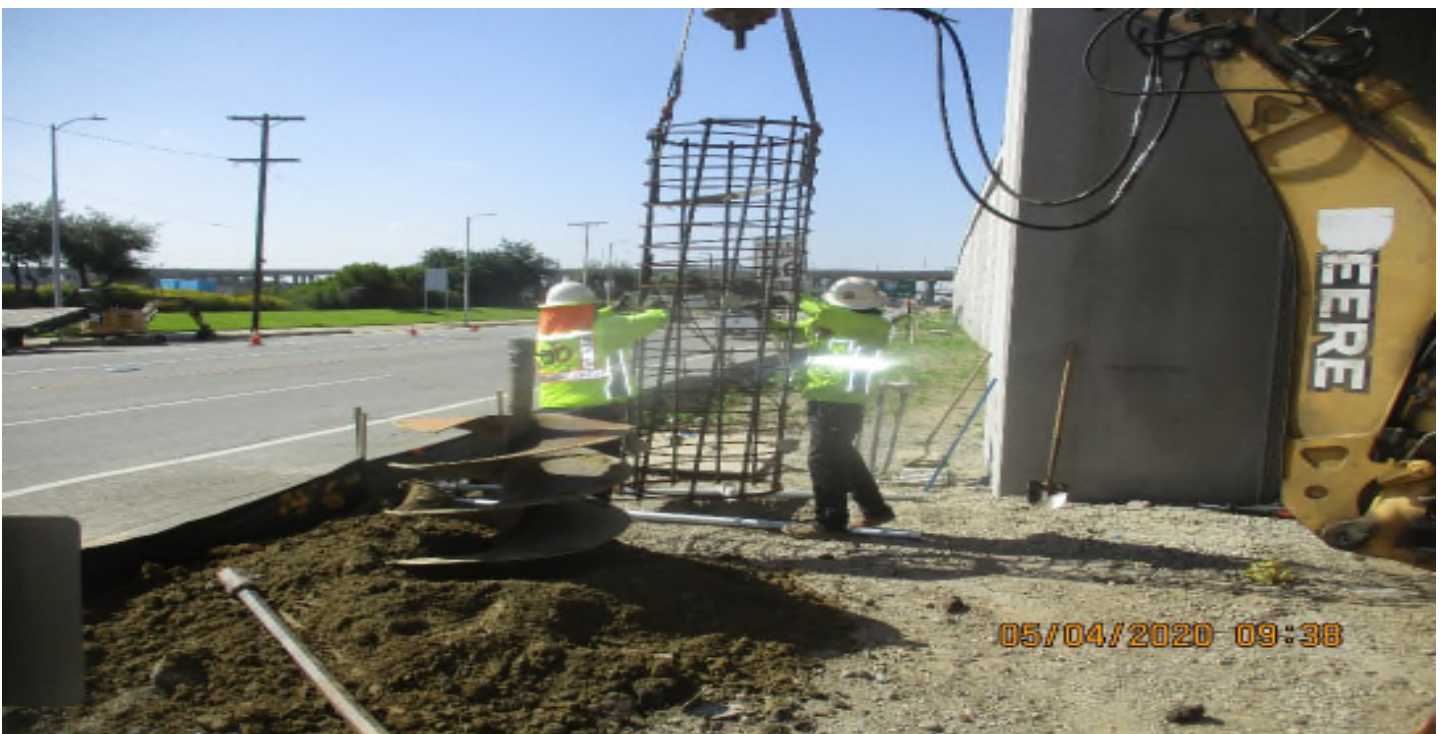
111th Street – DB Electrical Place cage for SL at S, WCOR of Aviation and 111th.

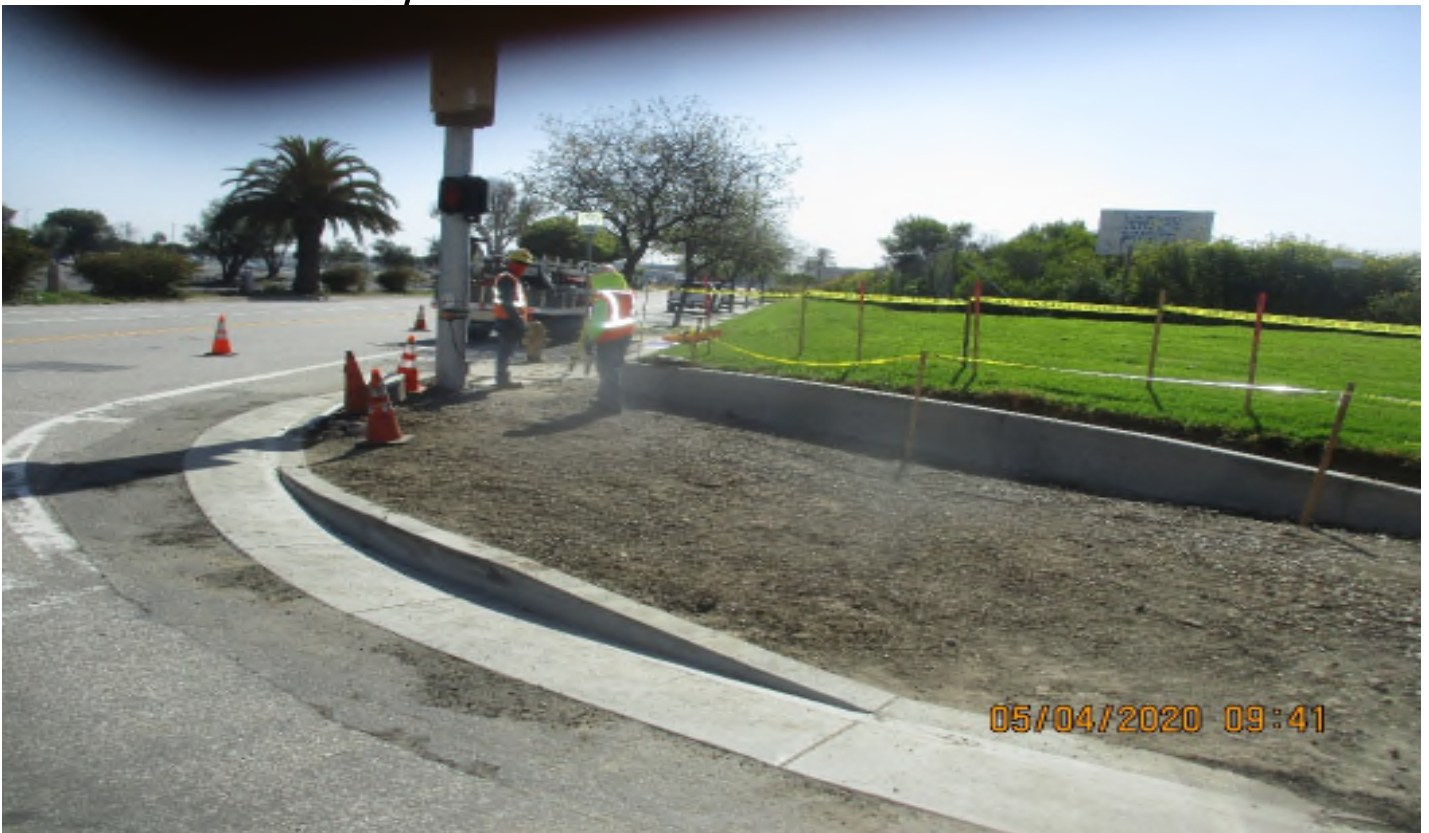
111th Street – WSCC Cut SWK grade at S,E COR of 111Th and Aviation.

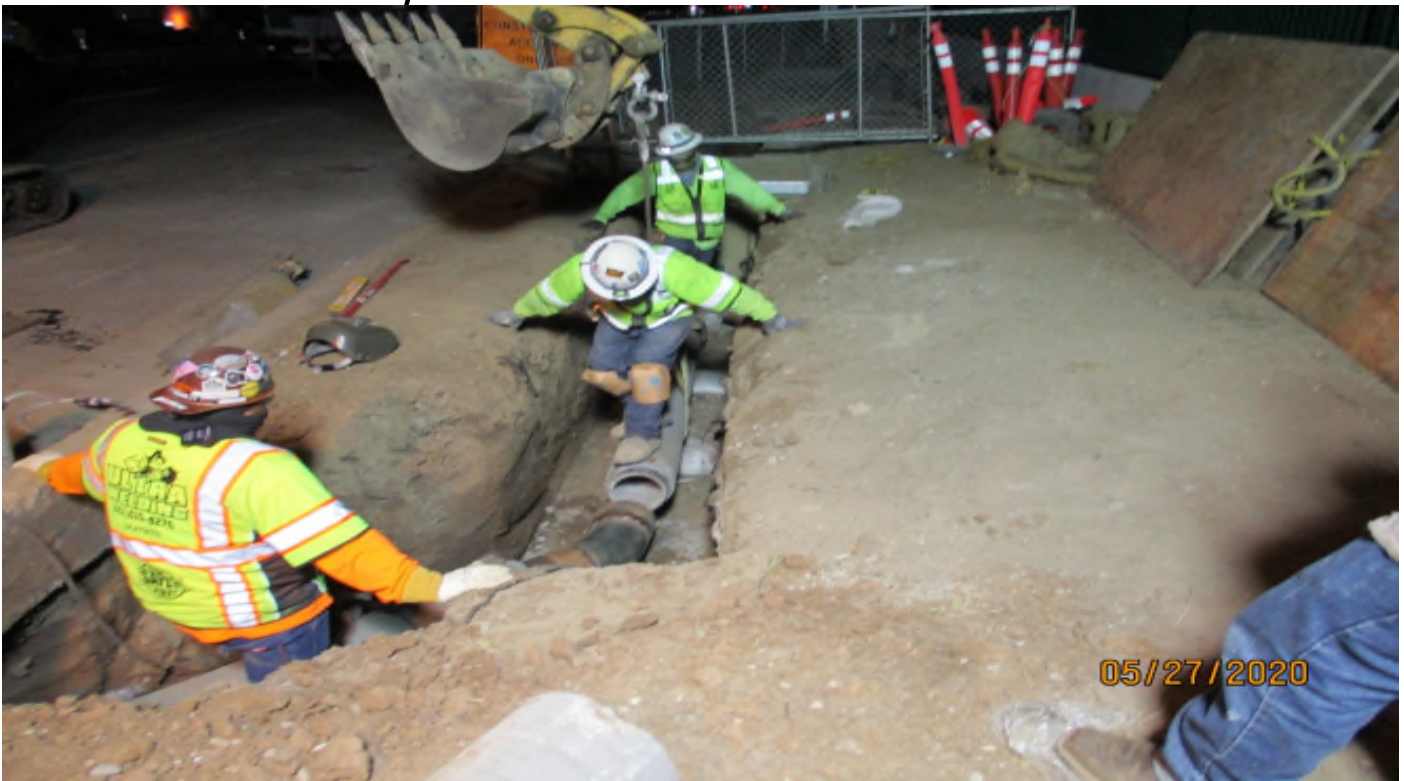
111th Street – Setting a section of fire line pipe at 111th street.

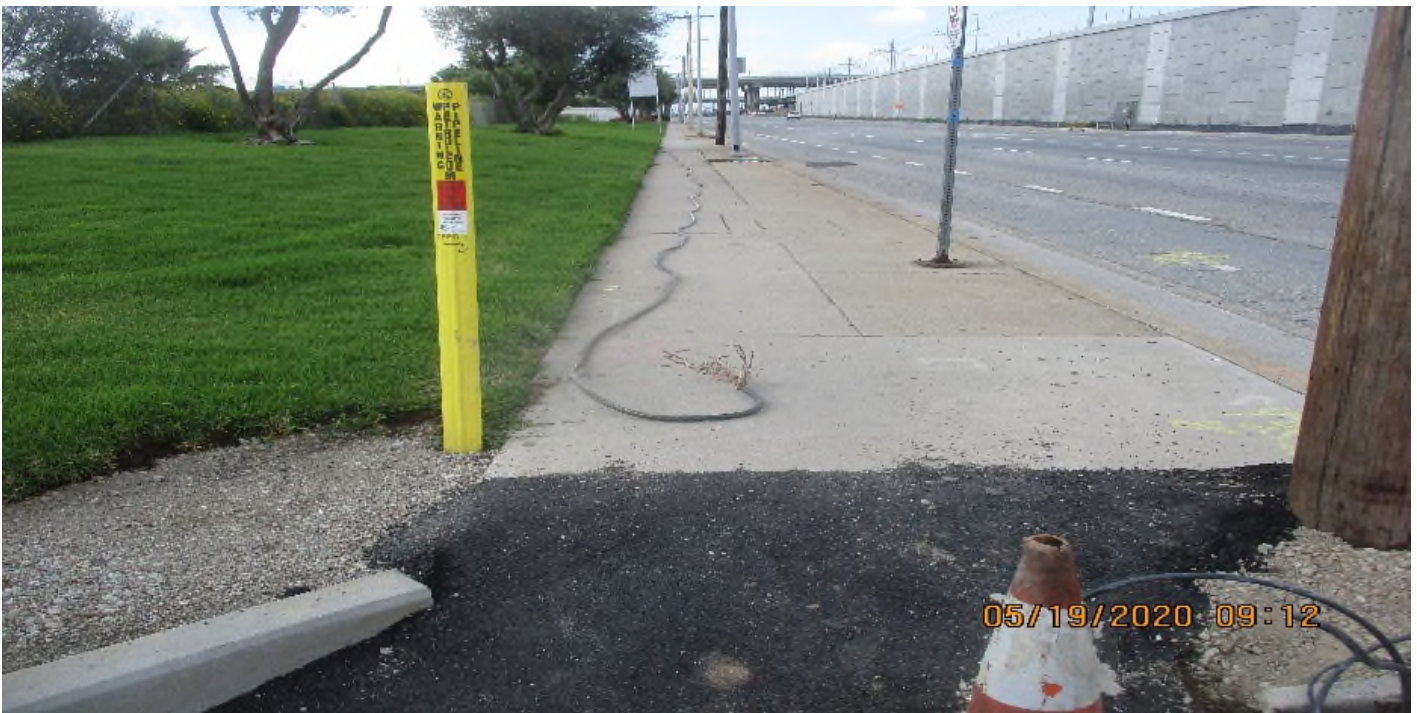
111th Street – DB Electric Removed loop cable at N,B Aviation at 111Th St.

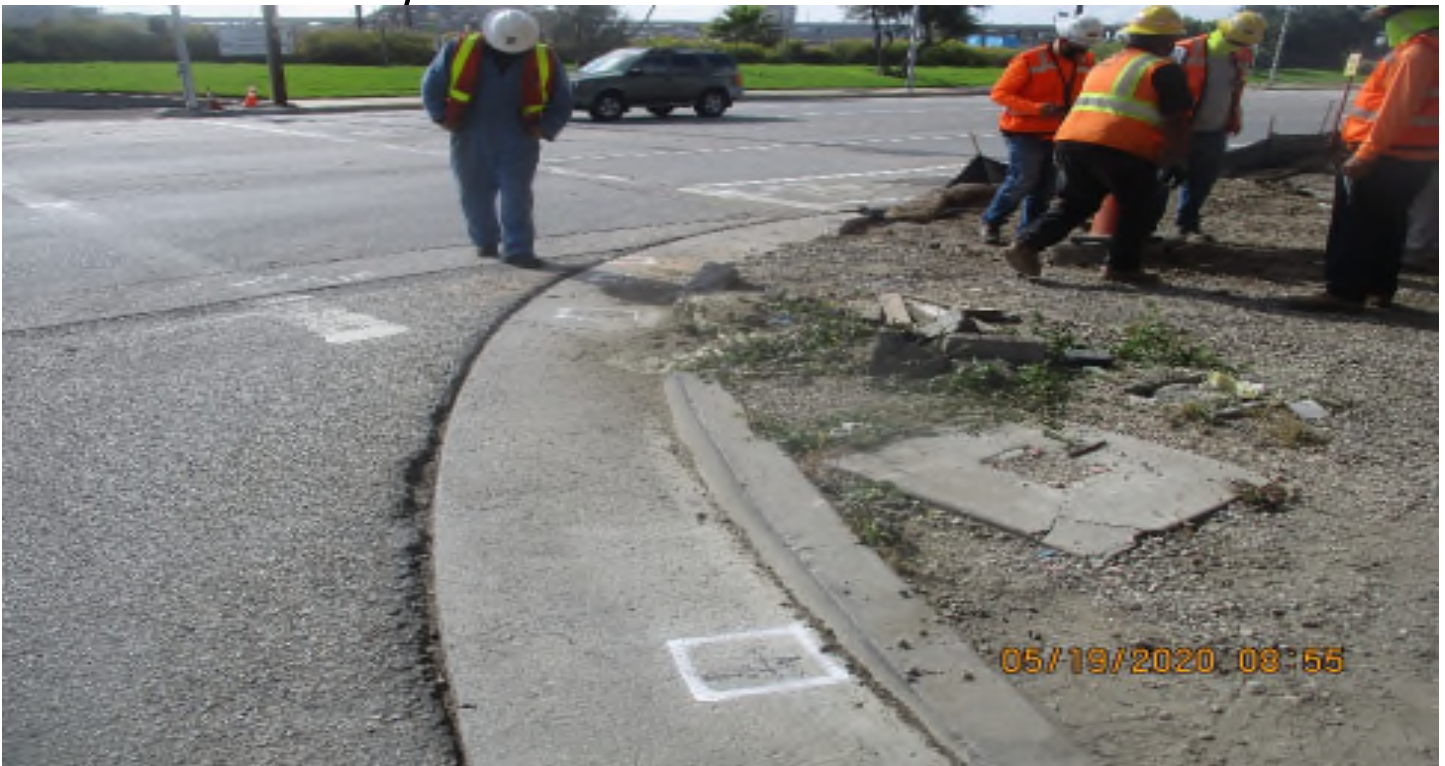
111th Street – WSCC Started removals of old C&G at 111Th and Aviation S/W CORNER

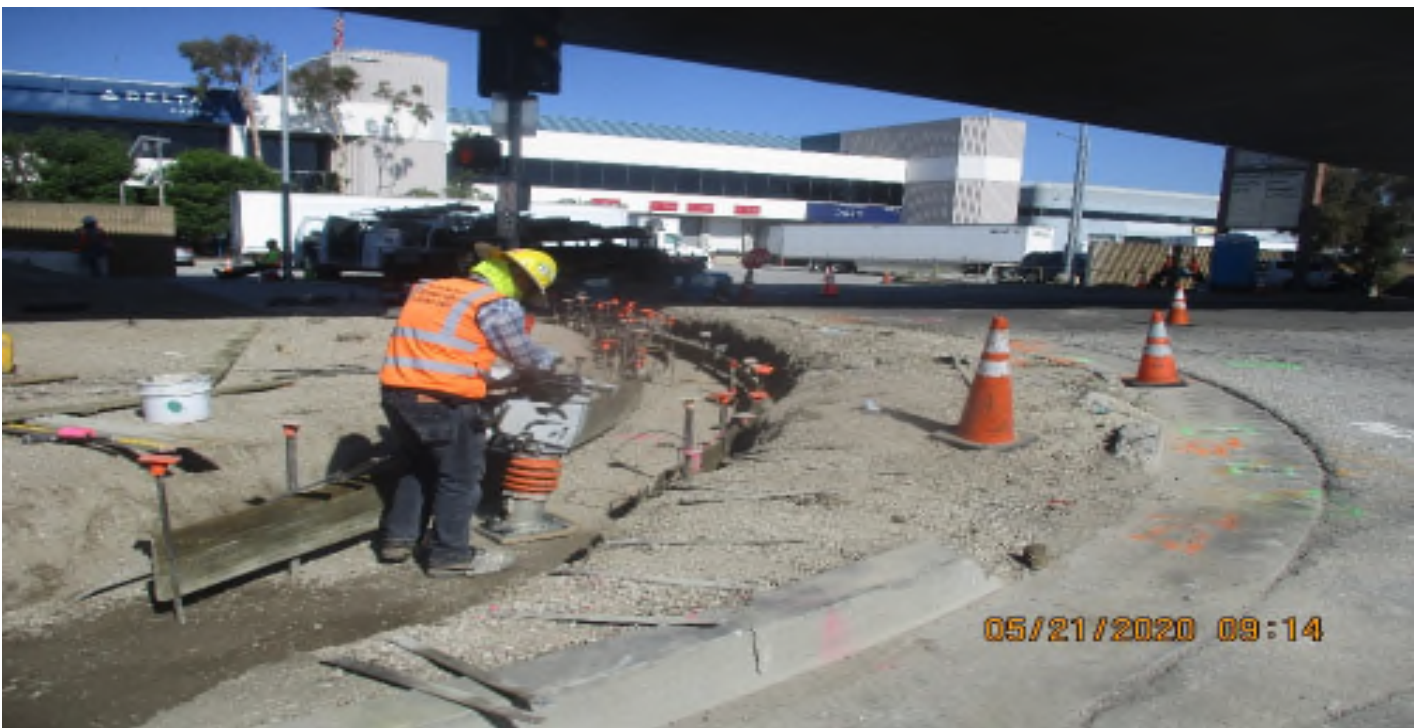
111th Street – Make grade for and place concrete C&G at SW COR of Aviation and 111th St.

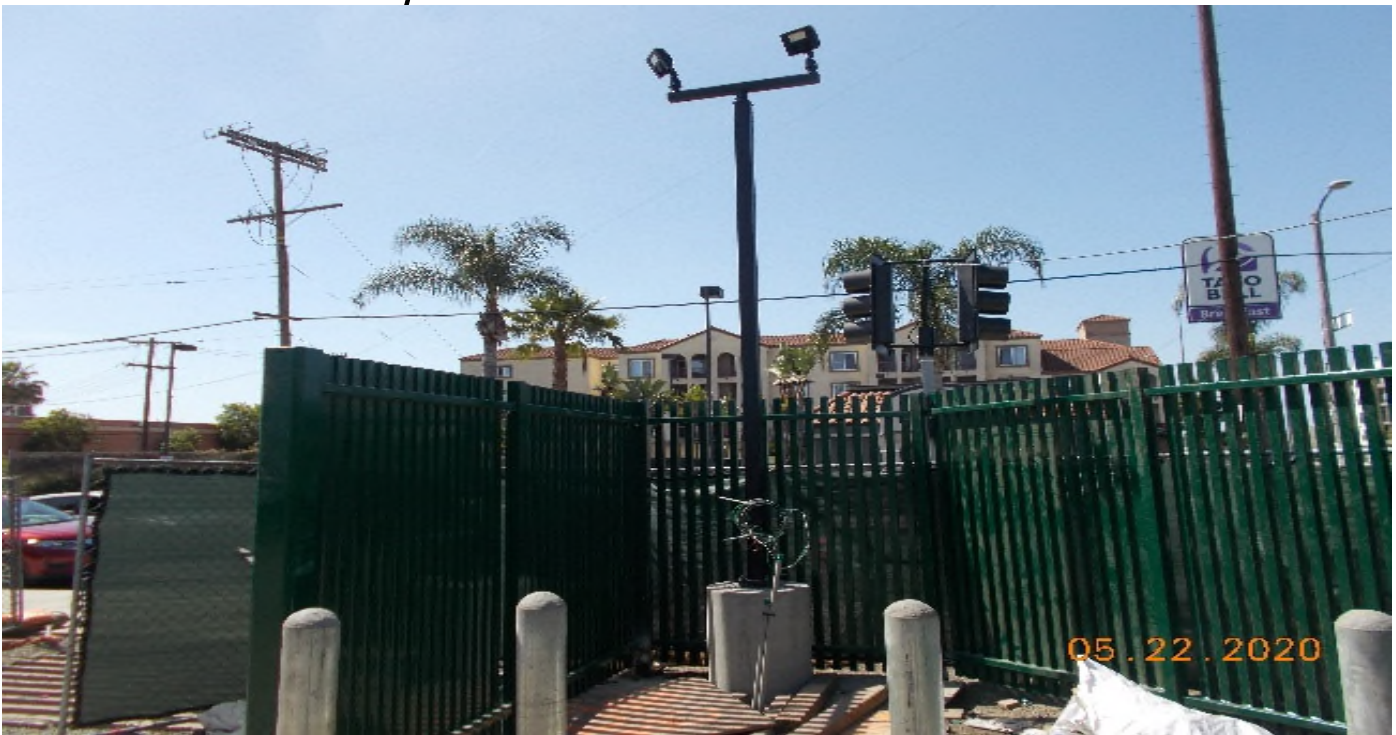
PARK MESA – Completed light pole foundation at the northeast corner of TPSS#7 on 60th St & Crenshaw Blvd.

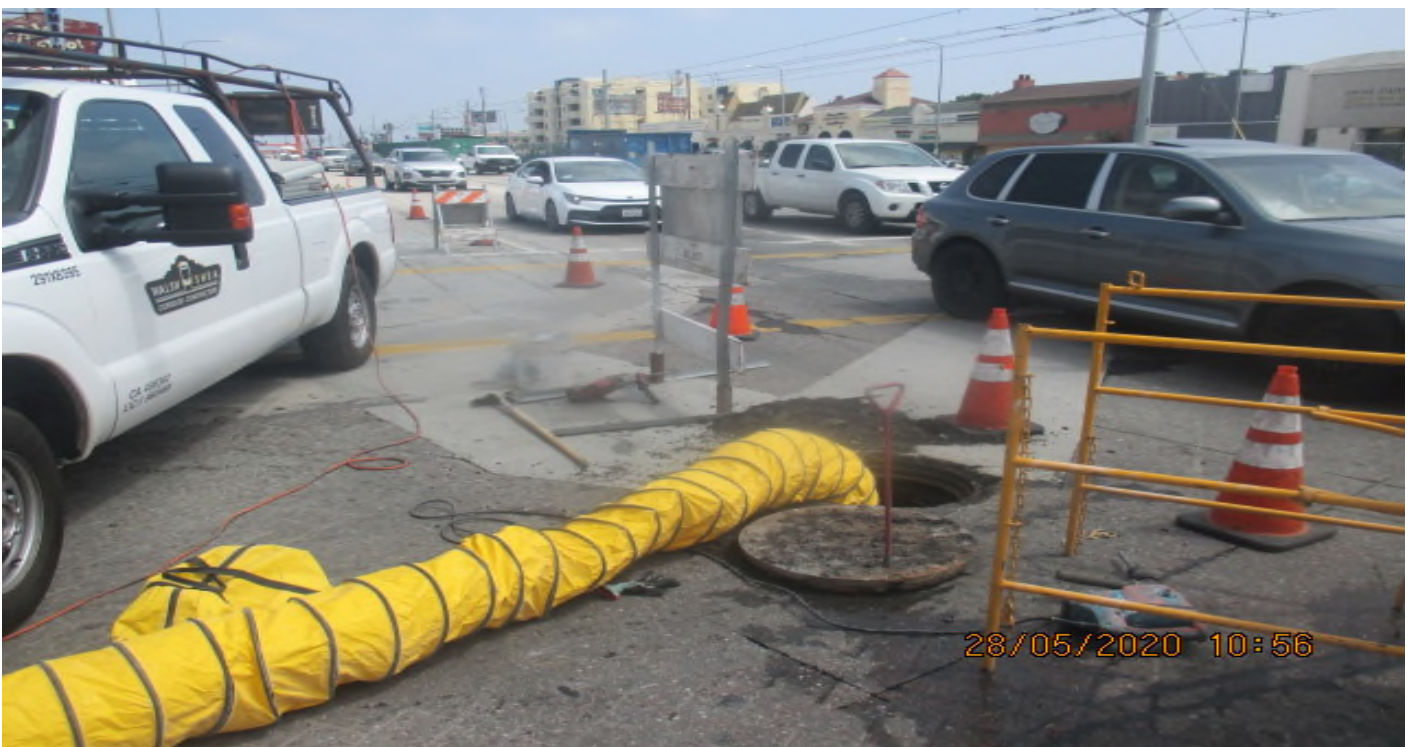
PARK MESA – Sack and patching storm drain line 335 – 2 on southbound Crenshaw Blvd and 57th St. 5/28/20

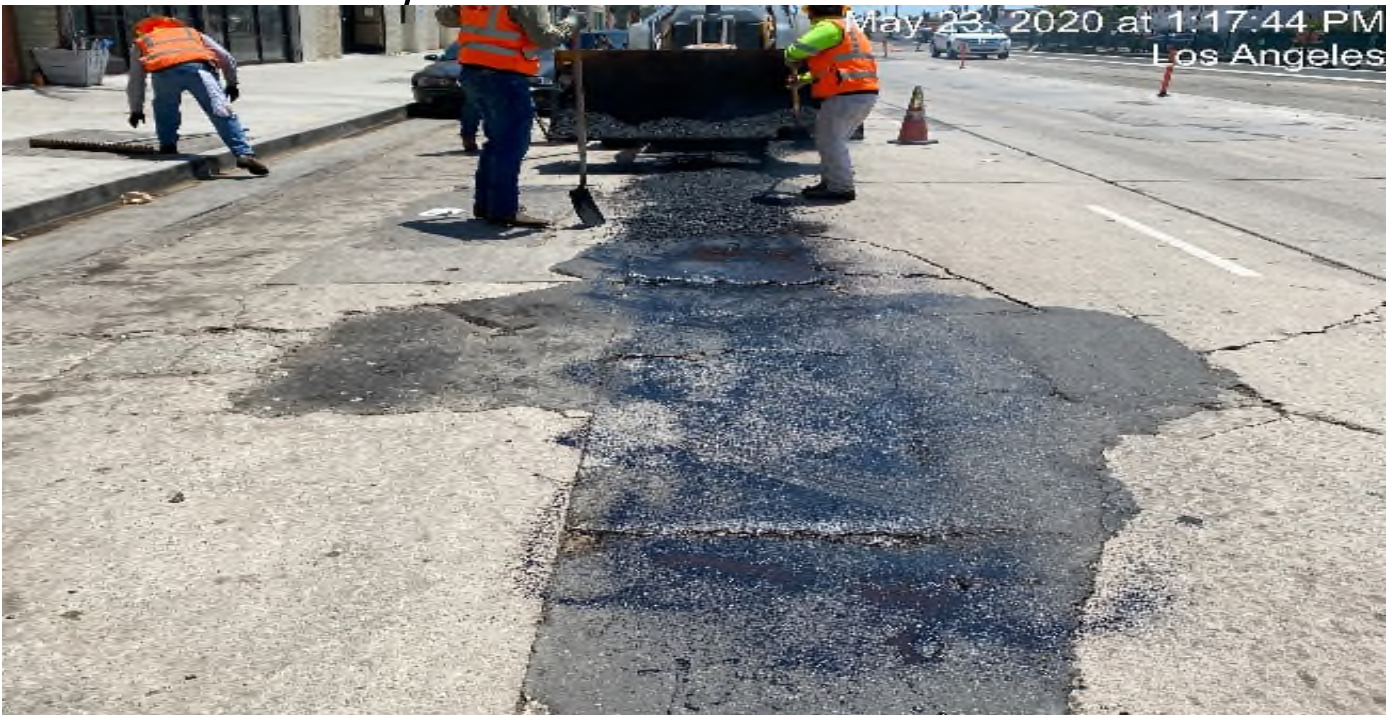
PARK MESA – Asphalt patching various potholes along northbound Crenshaw Blvd between Slauson Ave and 48th St.

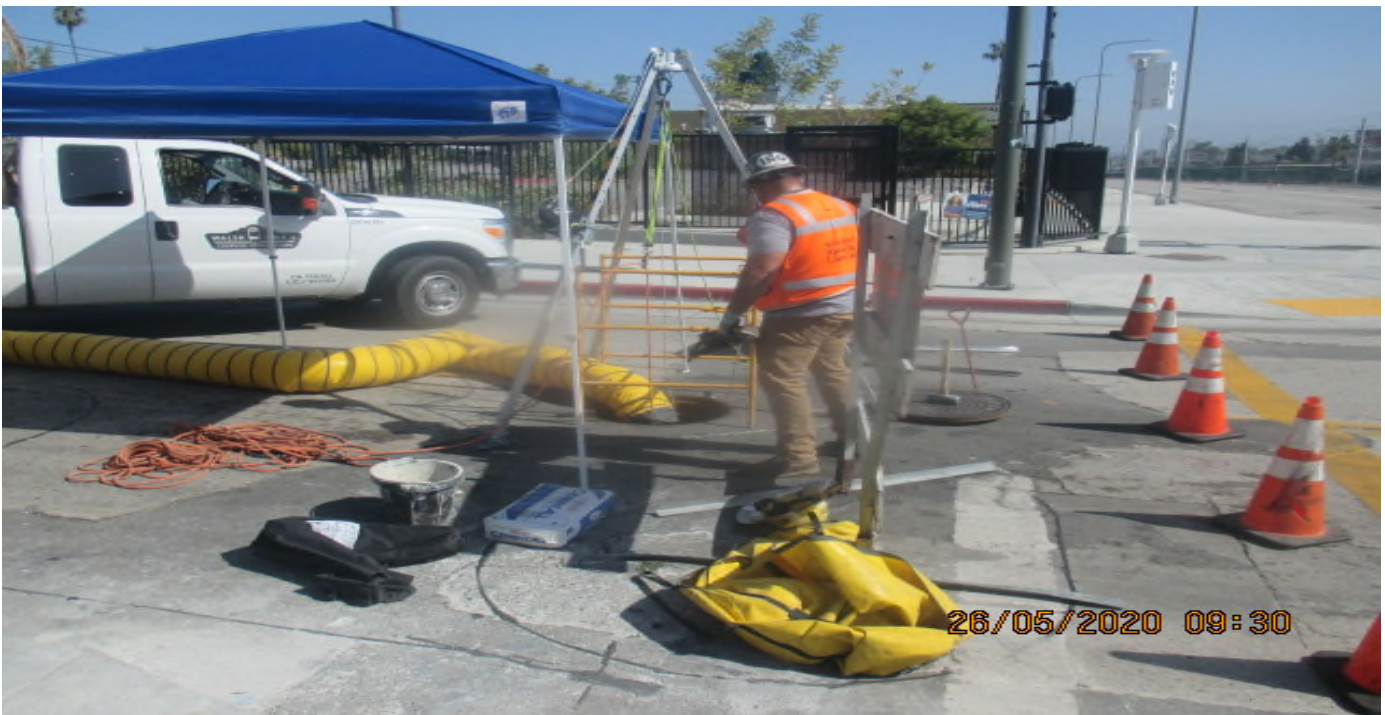
PARK MESA – Sack and patching storm drain line JS-2 on southbound Crenshaw Blvd and 52nd St. 5/26/20

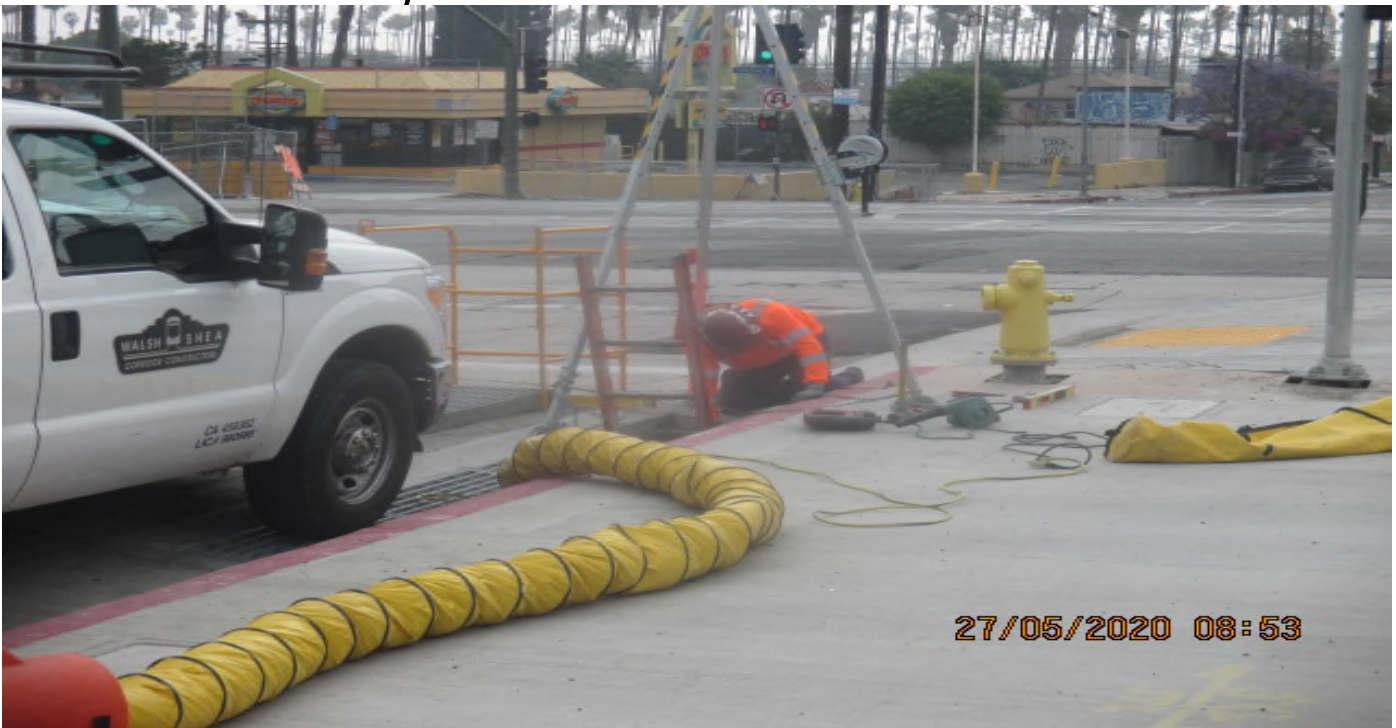
PARK MESA – Drilling and installing ladder rungs inside Catch Basin #27 on the southwest corner of Crenshaw Blvd and 48th St. 5/27/20

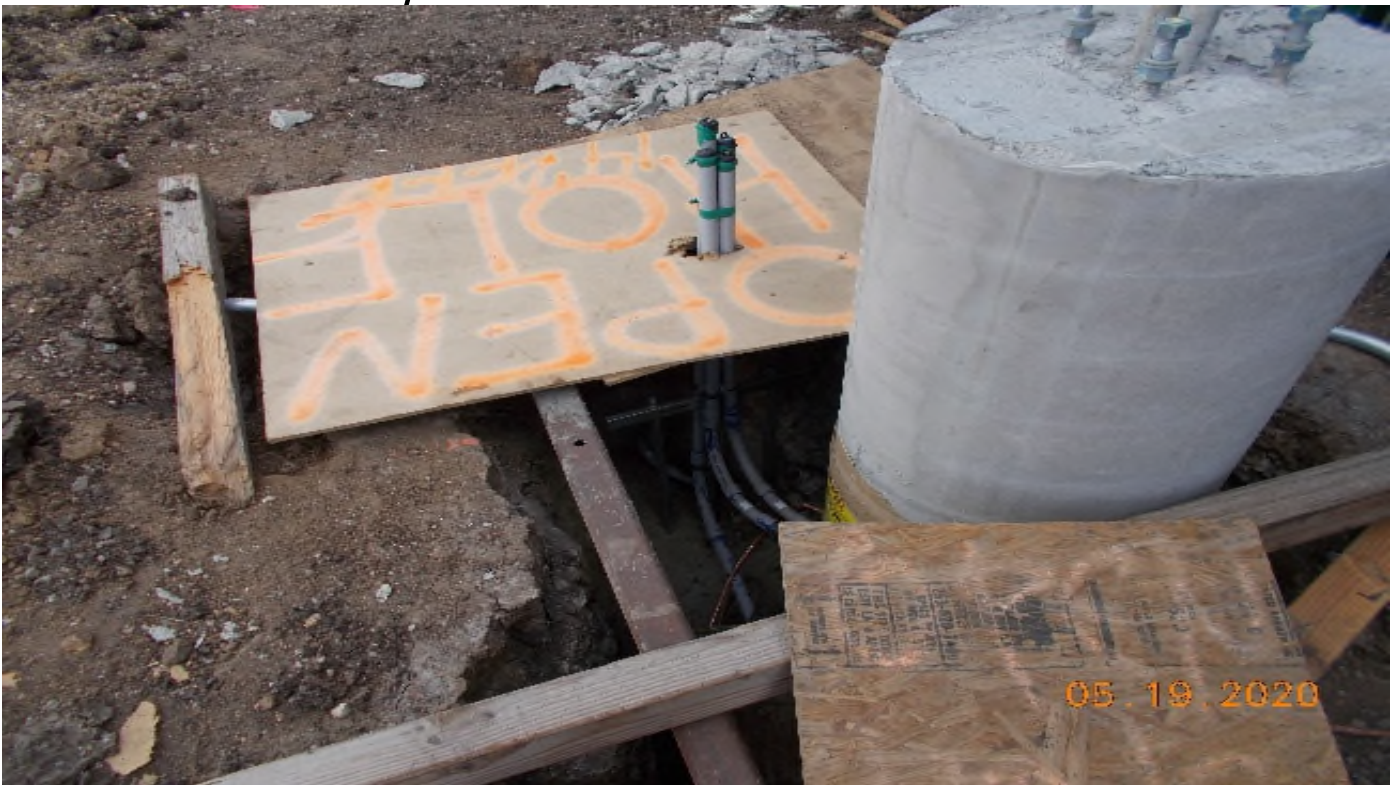
60th Street - View of light pole and conduits ready for vault. 60th street.
