CRENSHAW/LAX PHOTOGRAPHIC UPDATE

June 12, 2020

Crenshaw/LAX Transit Project

Overview of trackwork progress issues for 05/15/2020 – 06/01/2020
(Please note the attached Trackwork Progress Tracking Report)

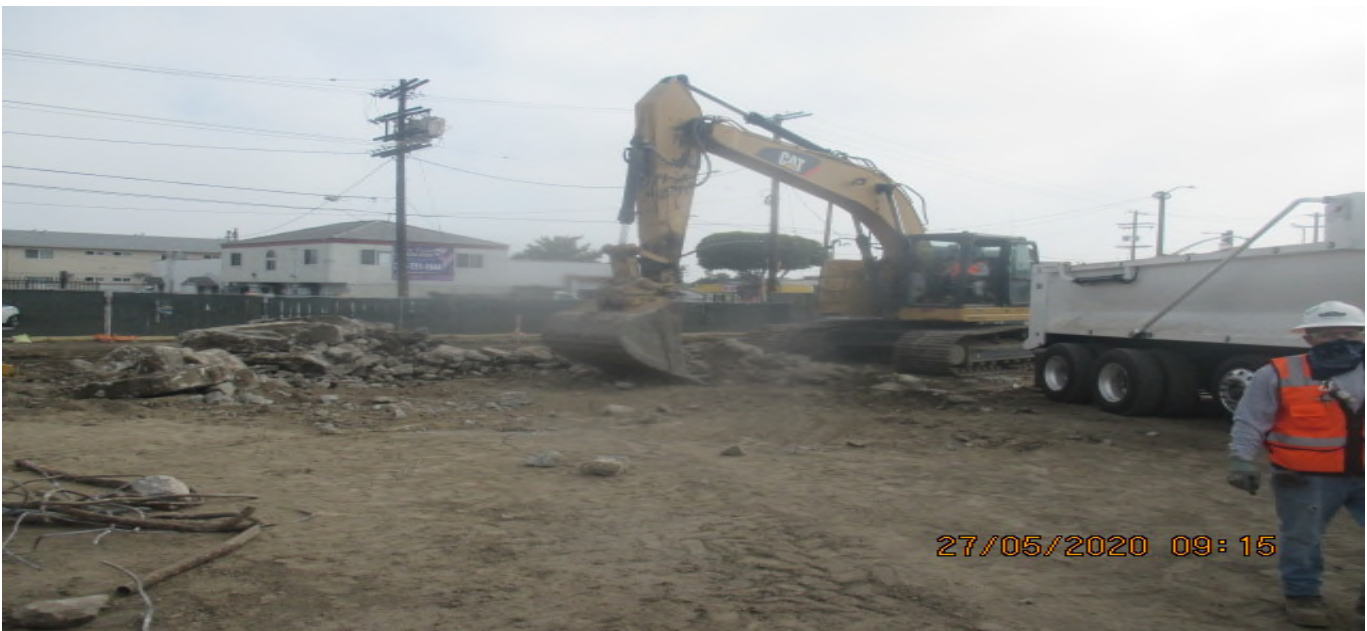
UG3 – Continue excavating the north east section of Victoria Yard for upcoming pavement installation. 5/27/20

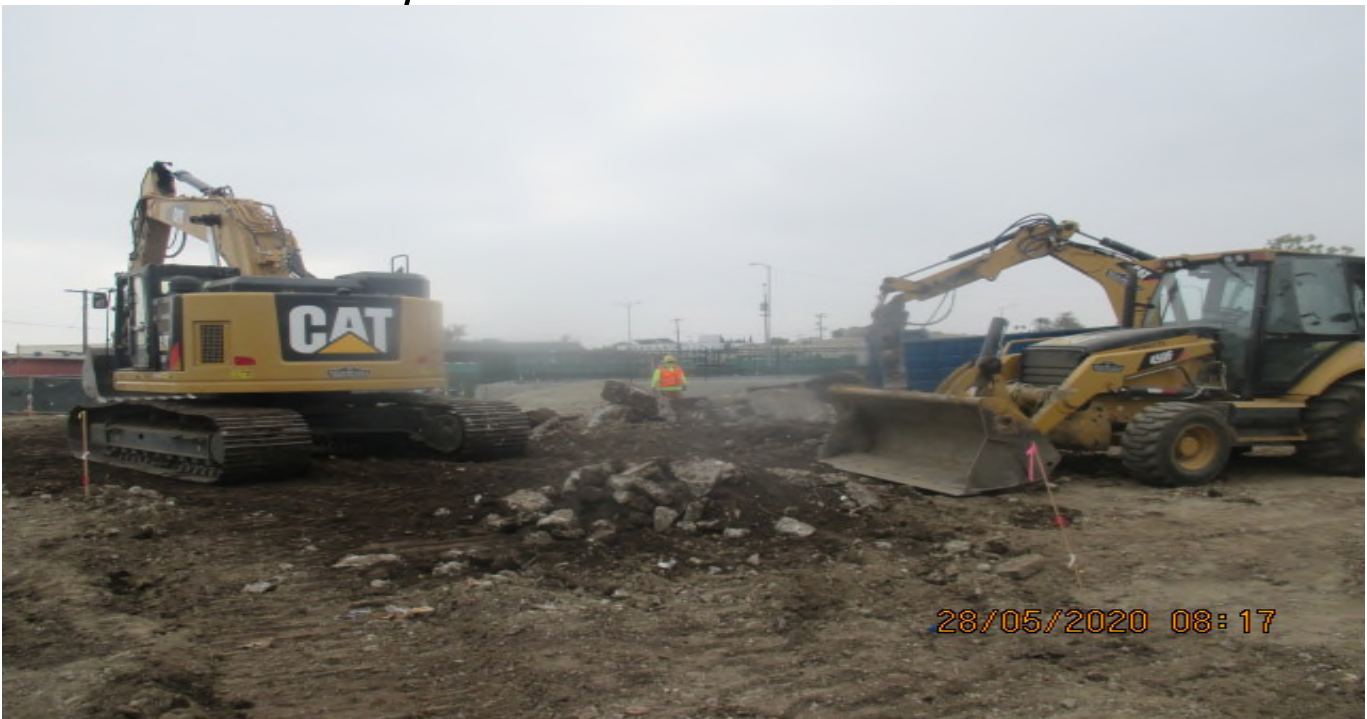
UG3 – Continue excavating the north east section of Victoria Yard for upcoming pavement installation. 5/28/20

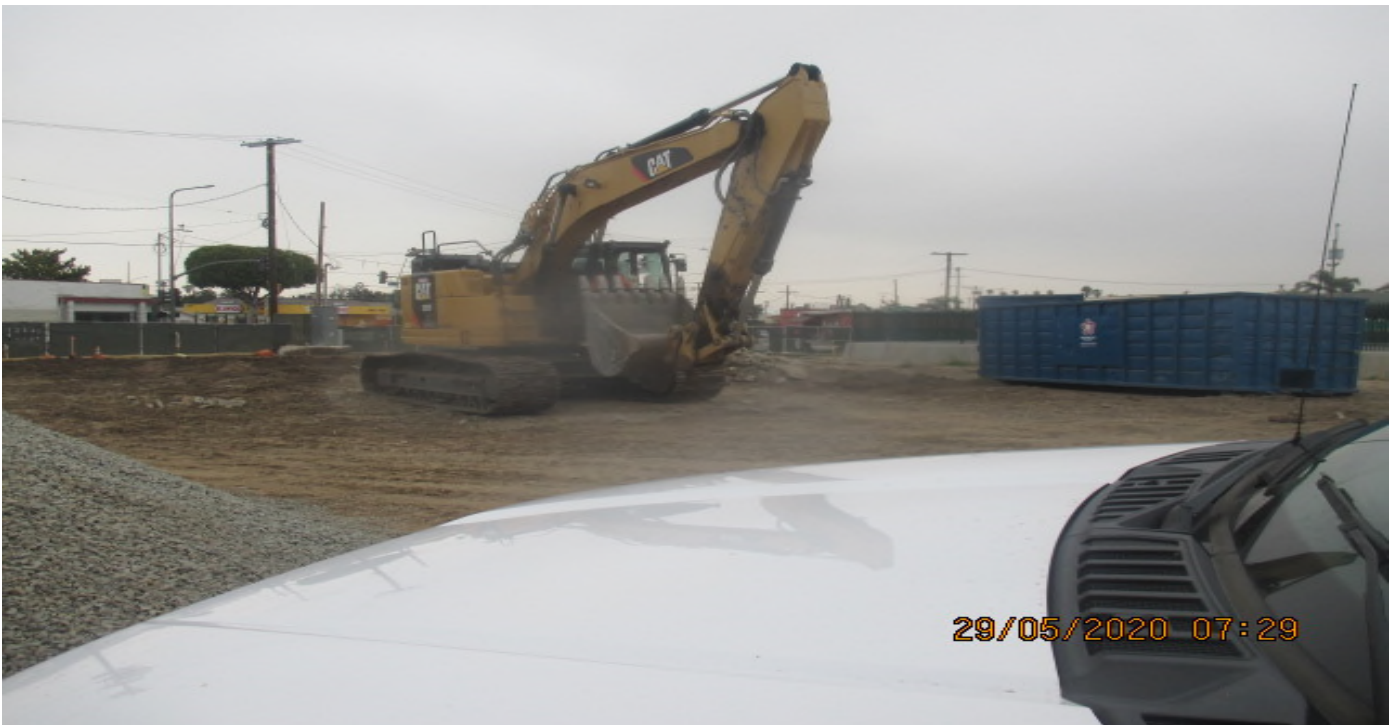
UG3 – Continue excavating the north east section of Victoria Yard for upcoming pavement installation. 5/29/20

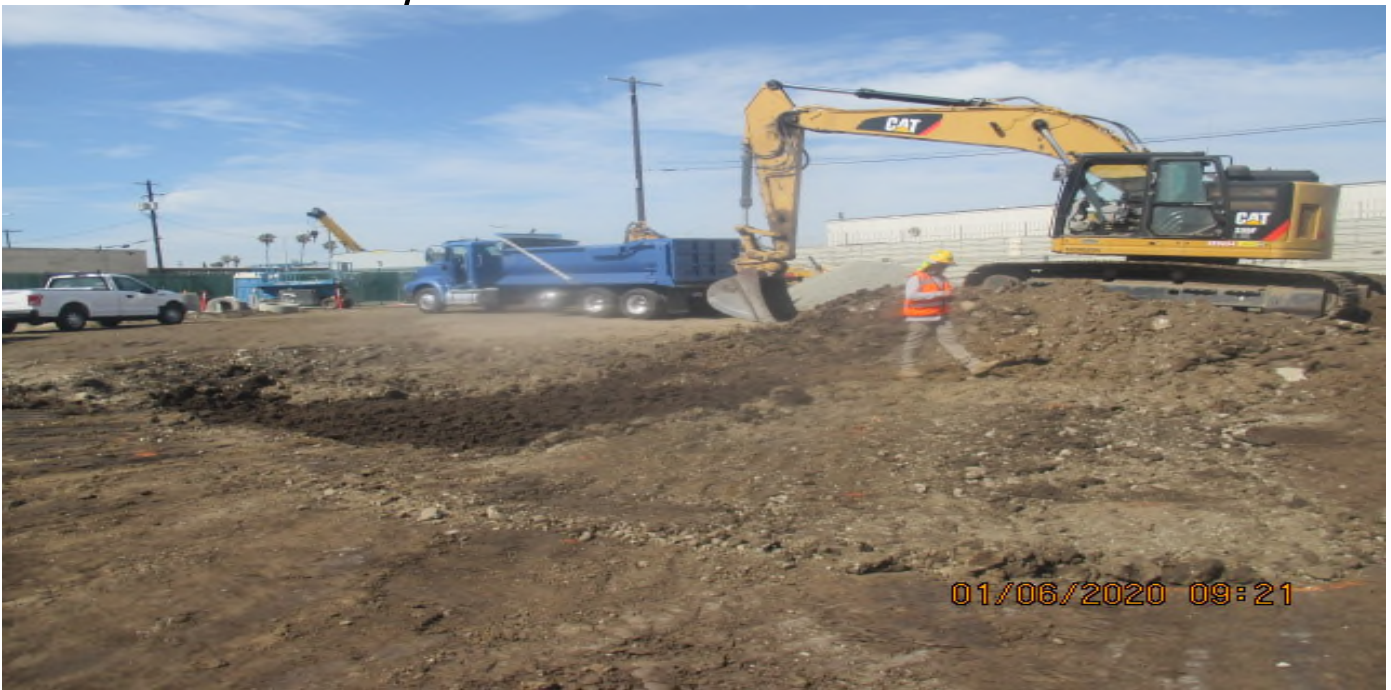
UG3 – Continue excavating the north east section of Victoria Yard for upcoming pavement installation. 6/1/20

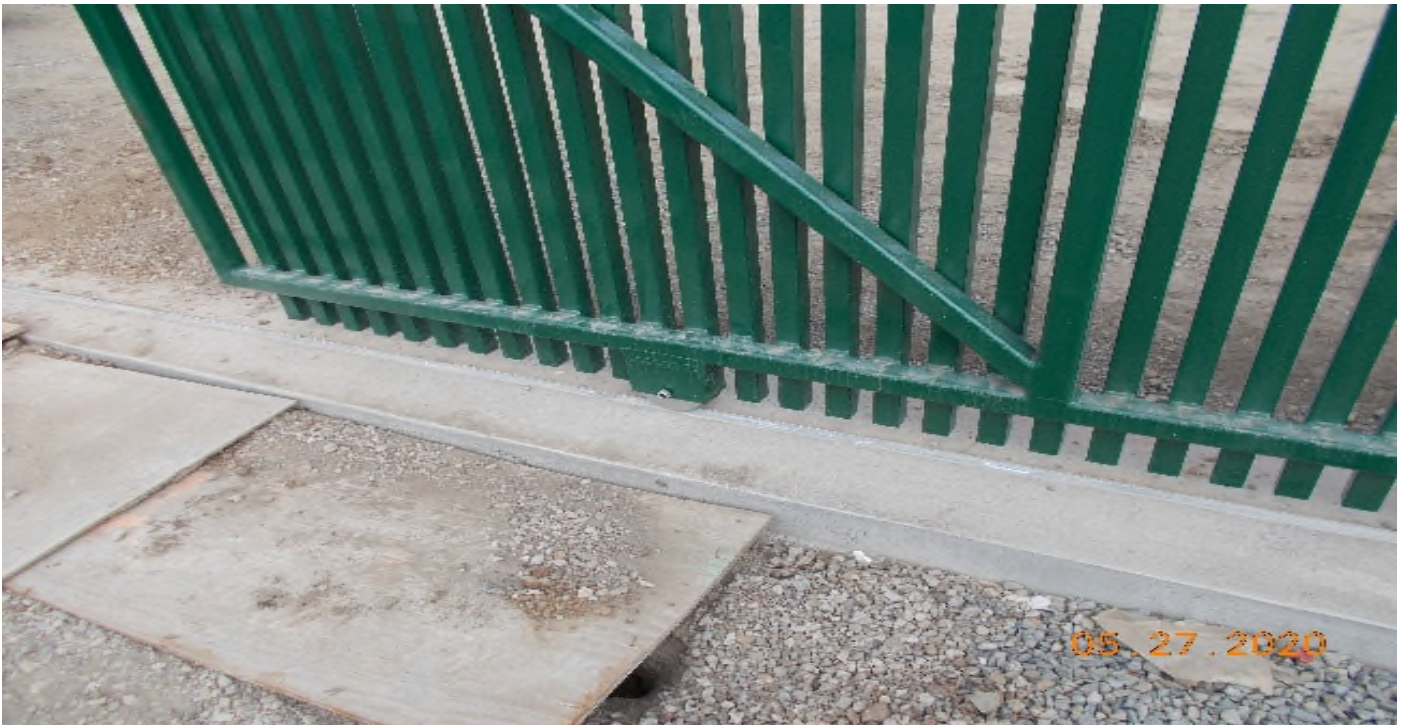
UG3 – Installed track wheels for the sliding gate at the entrance of the Auxiliary Power Bungalow at Victoria Yard.

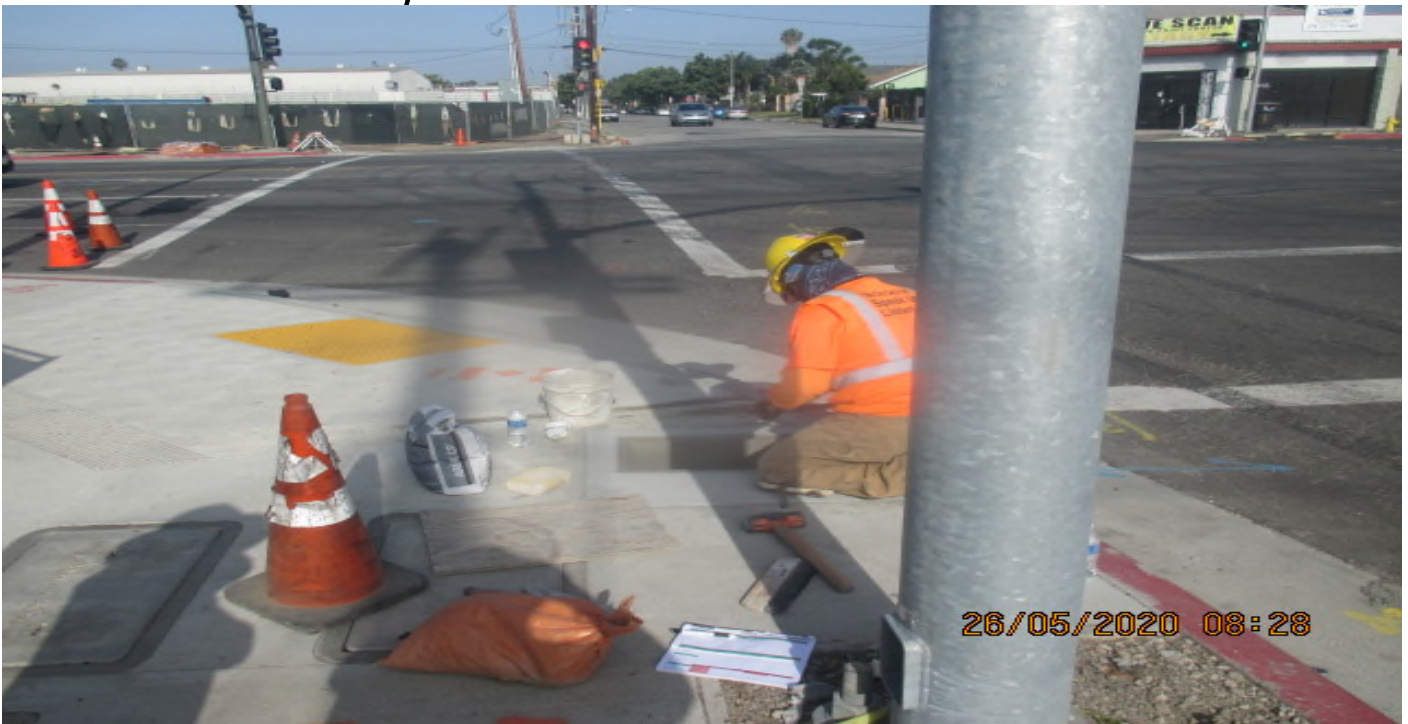
UG3 – Sack and patching DWP water meter box on the southeast corner of 67th St and Crenshaw Blvd. 5/26/20

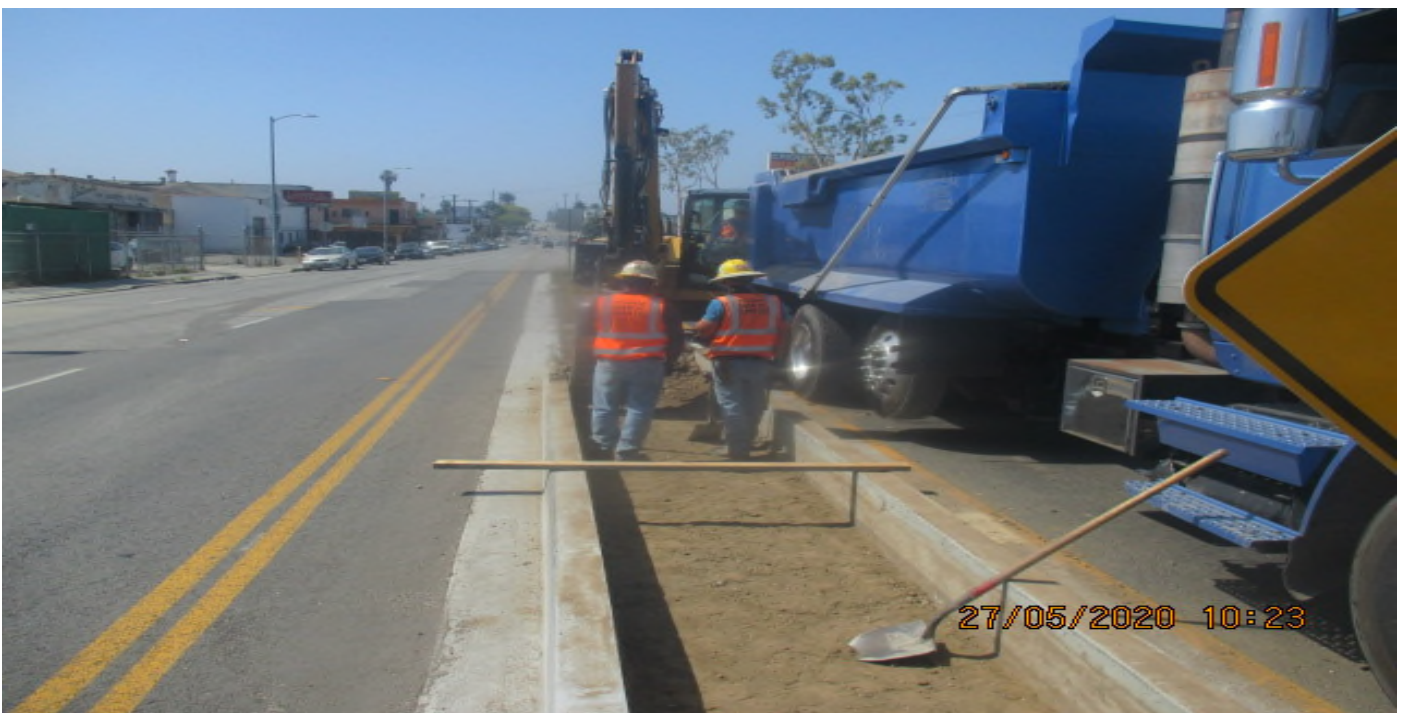
UG3 – Excavating for median cobble installation on the median island south of 67th St and Crenshaw Blvd. 5/27/20

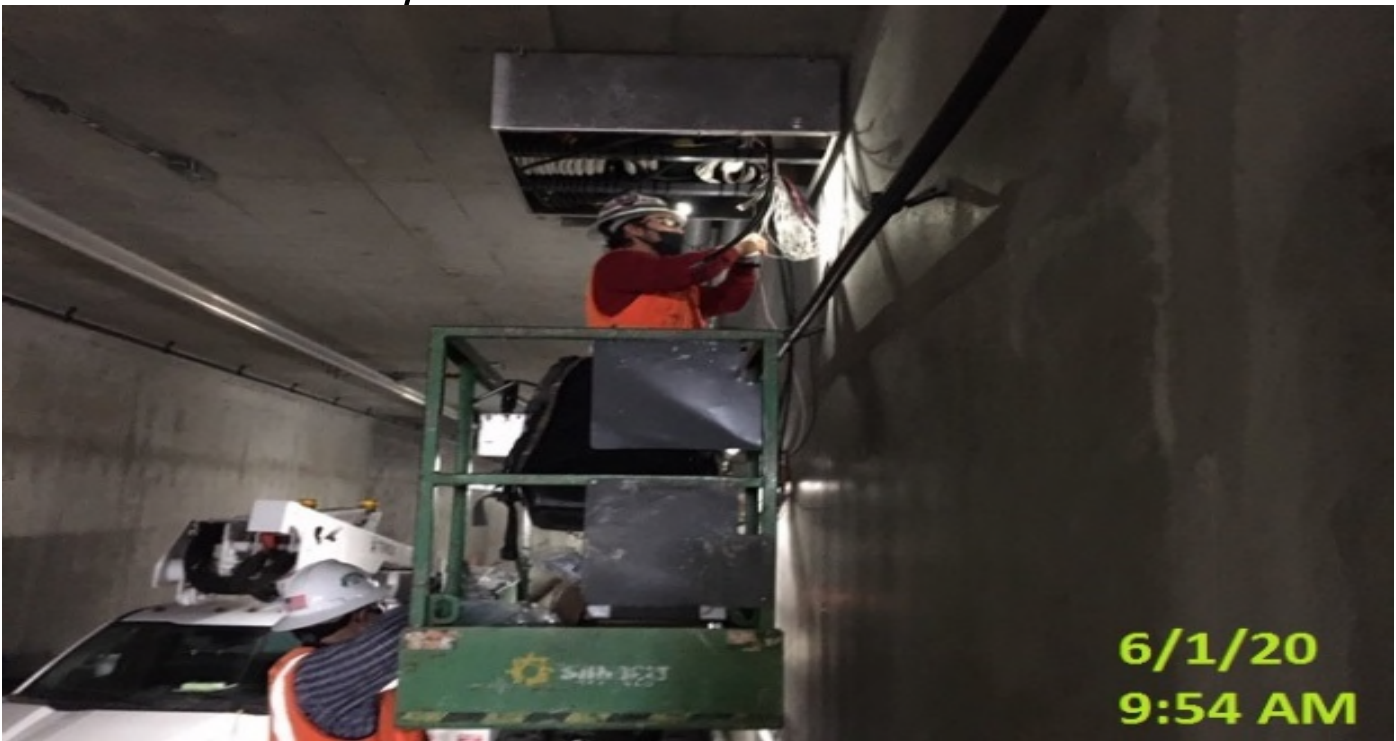
UG3 – Continue splicing permanent power cables along the northbound tunnel at Sta 311+34.

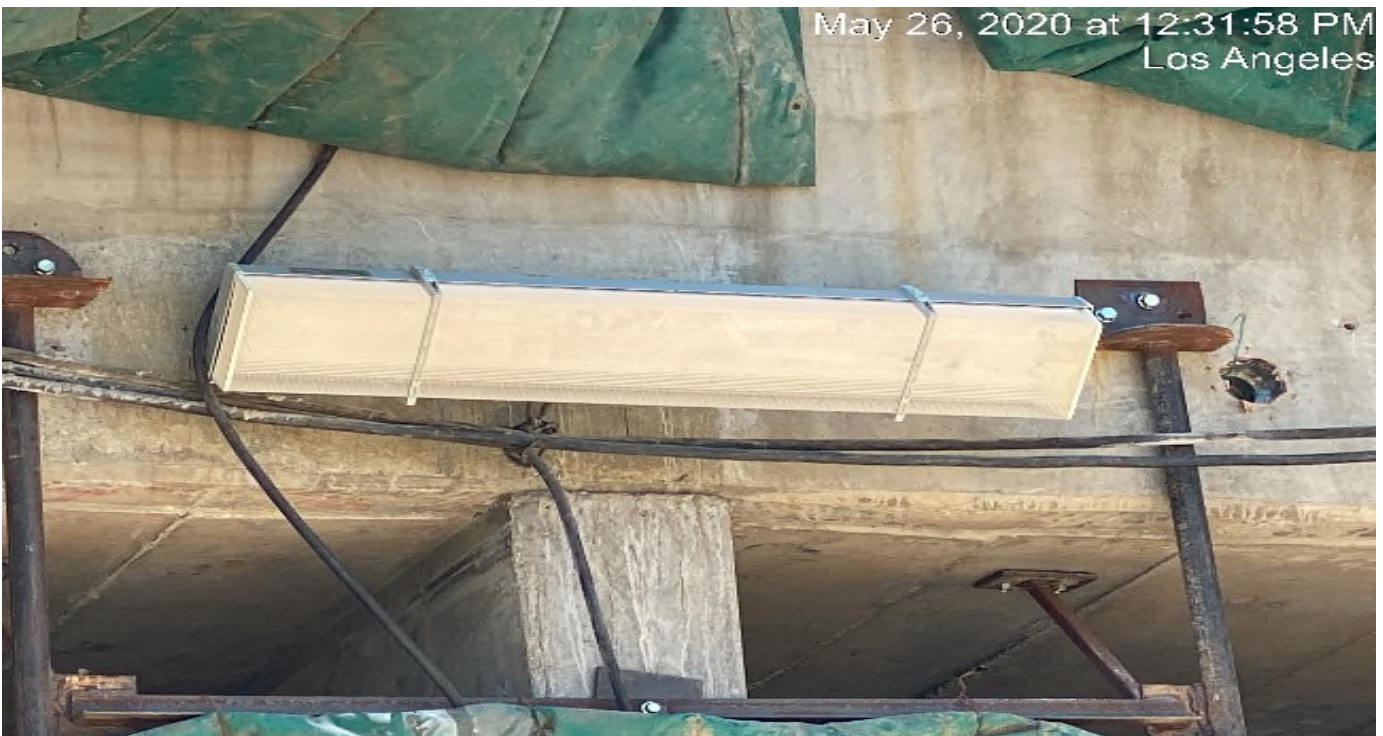
UG3 – Installing outdoor lighting at the south end portal entrance.

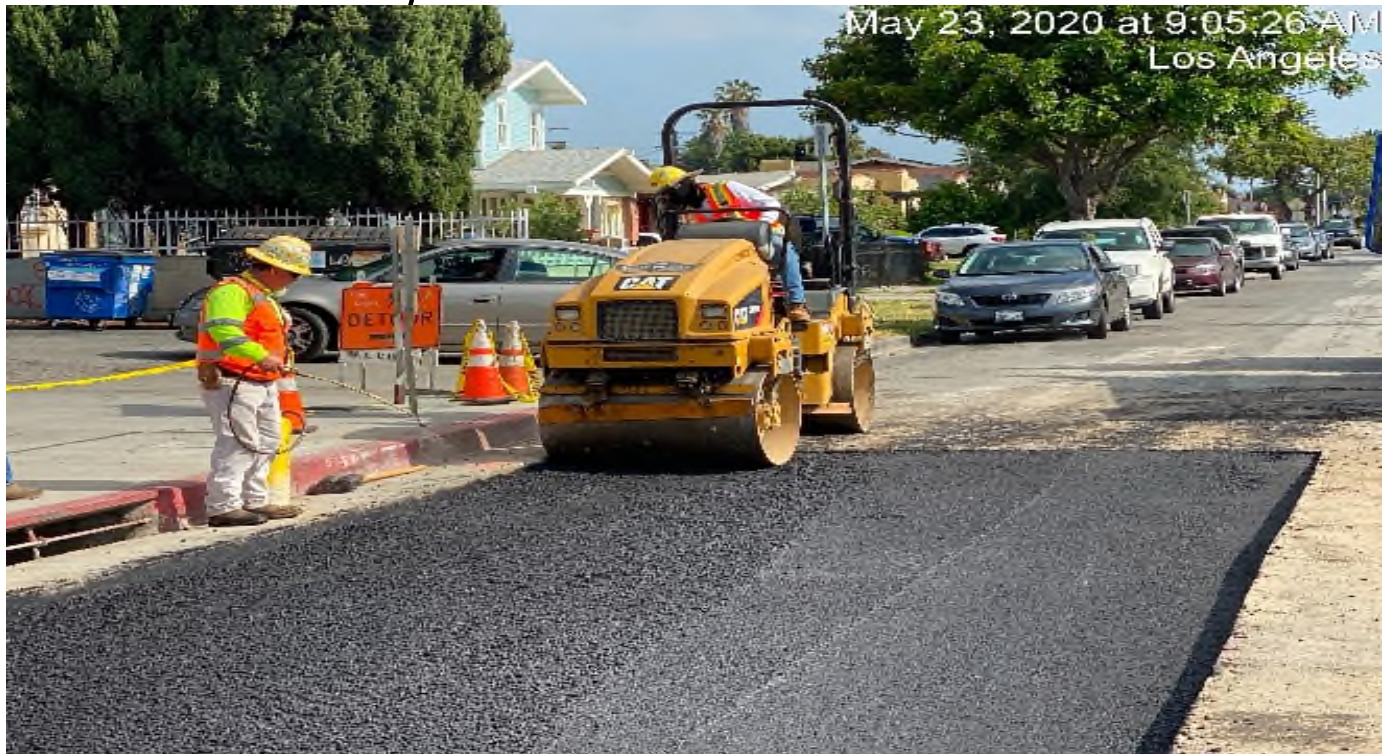
Crenshaw / Slauson – WSCC paving at Slauson and Victoria.

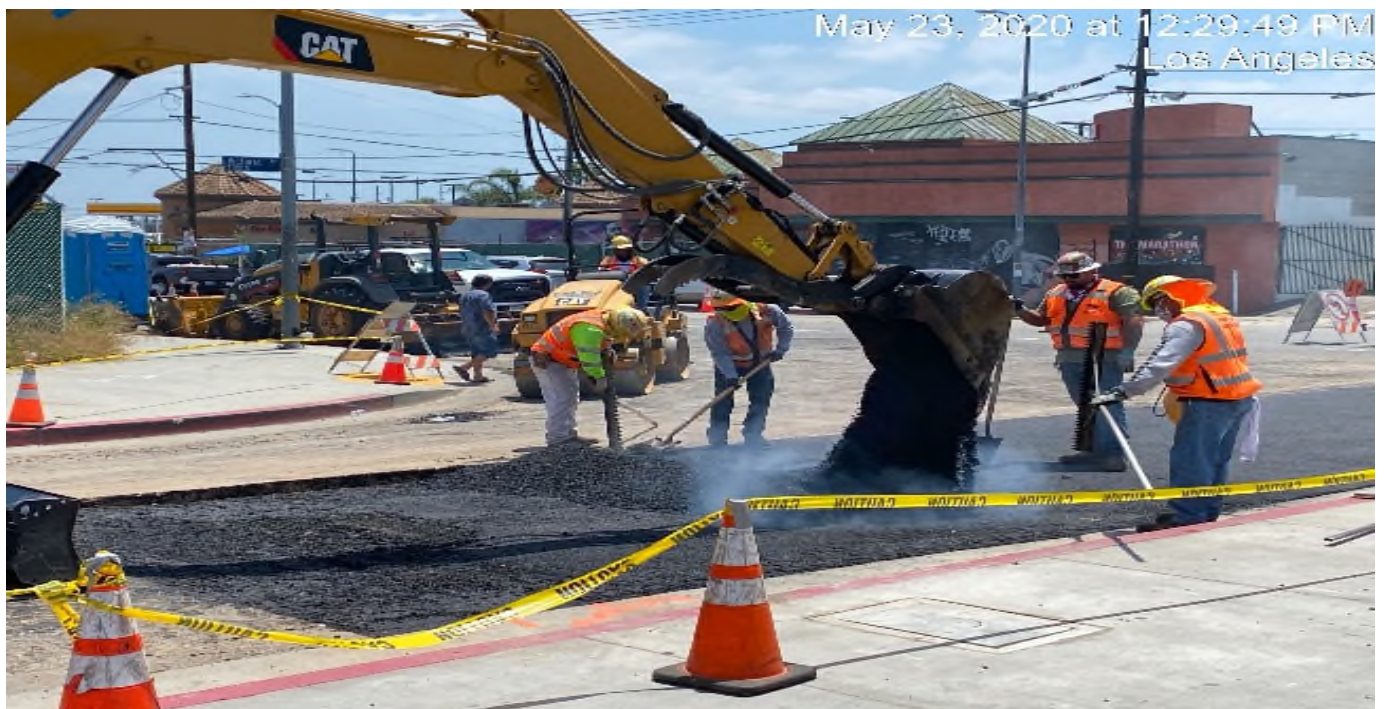
Crenshaw / Slauson – WSCC paving at Slauson and Victoria.

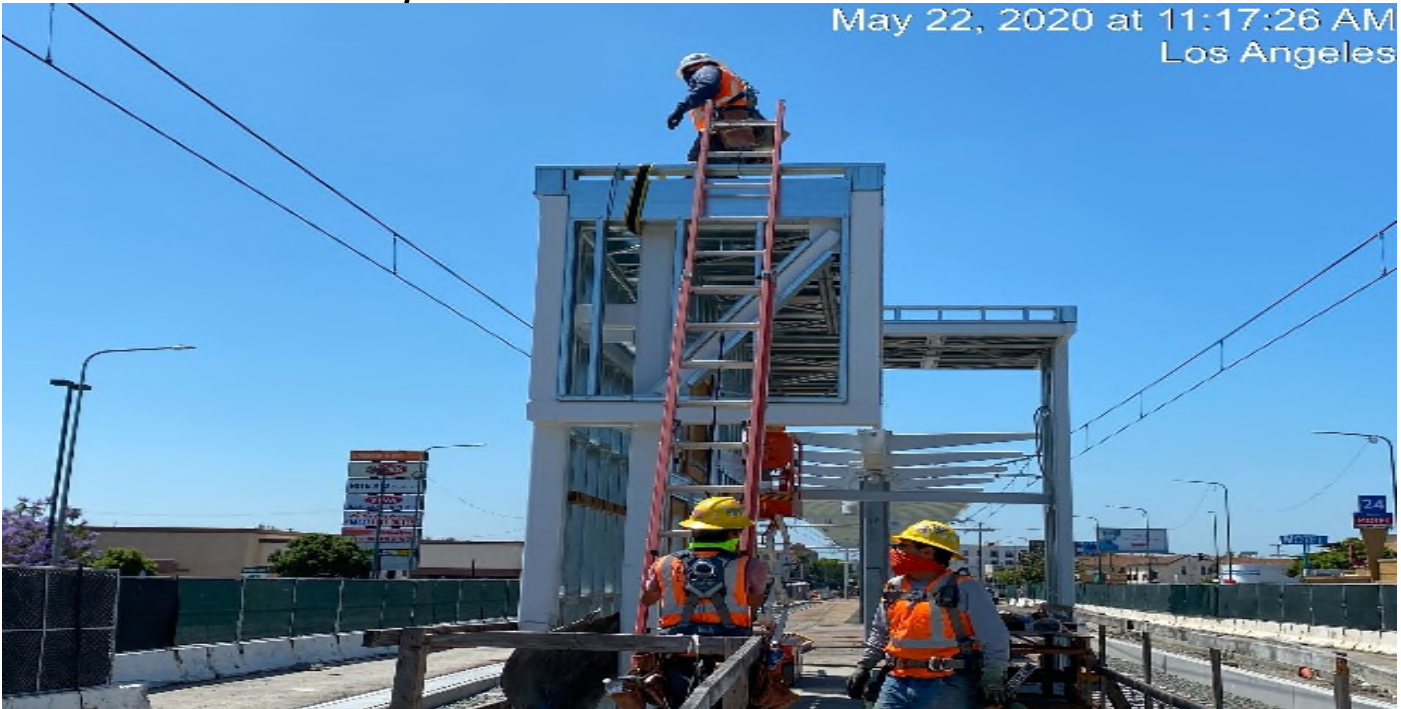
Hyde Park Station – Installing safety cables on top of the north end canopy at the platform level.

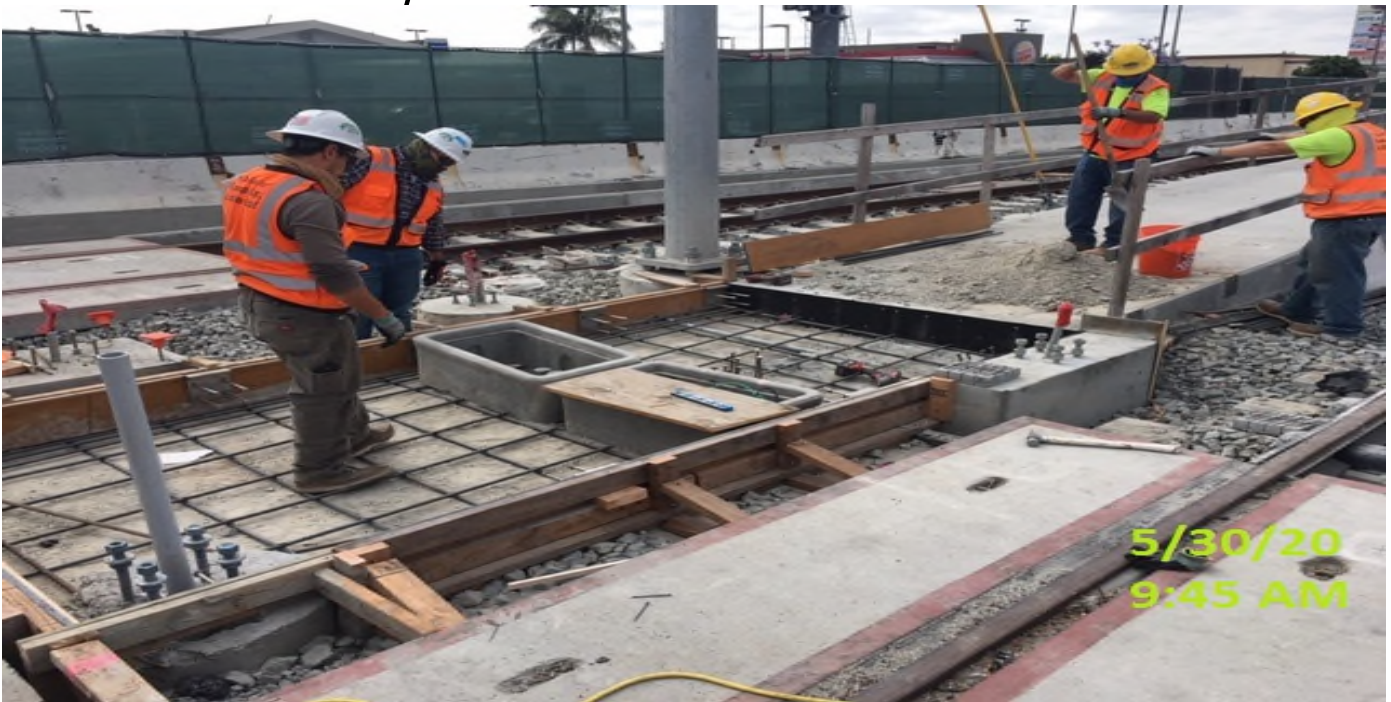
Hyde Park Station – Continue forming and installing rebar for the north end ramp leading to the platform level in preparation for concrete placement.

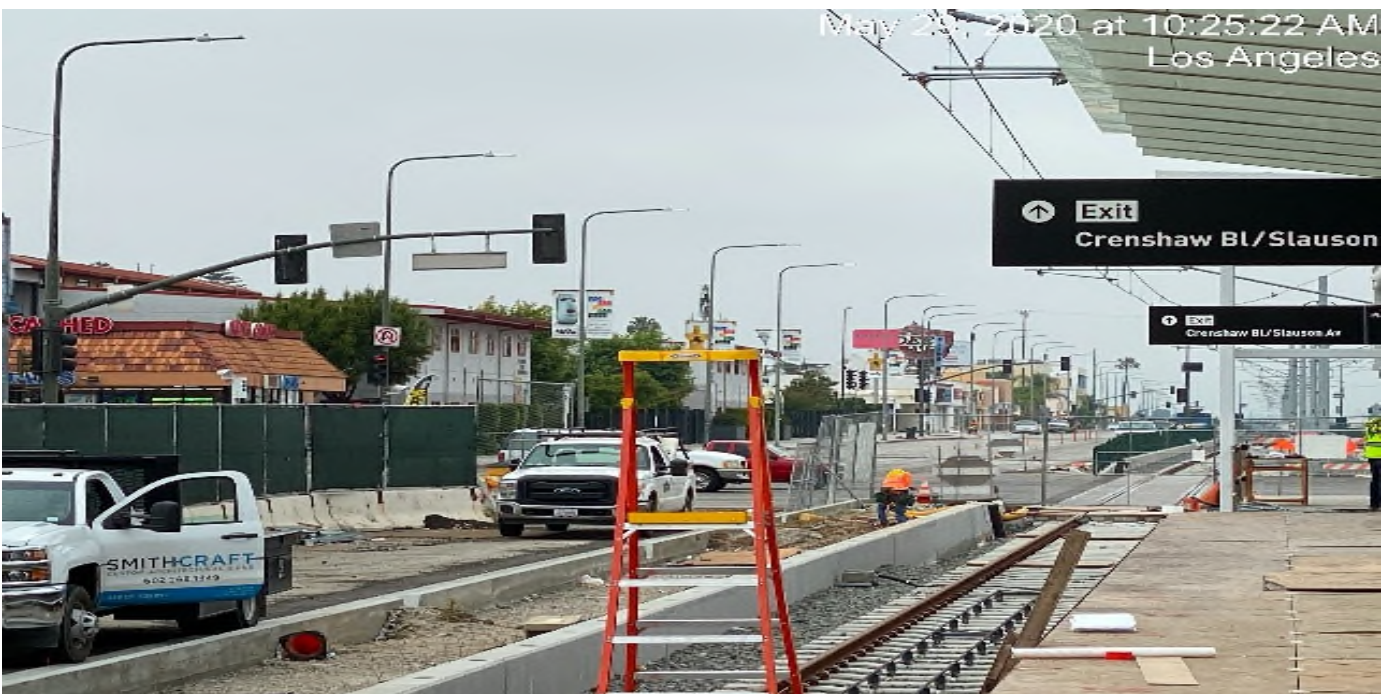
Hyde Park Station – Began signage installation at the platform level.

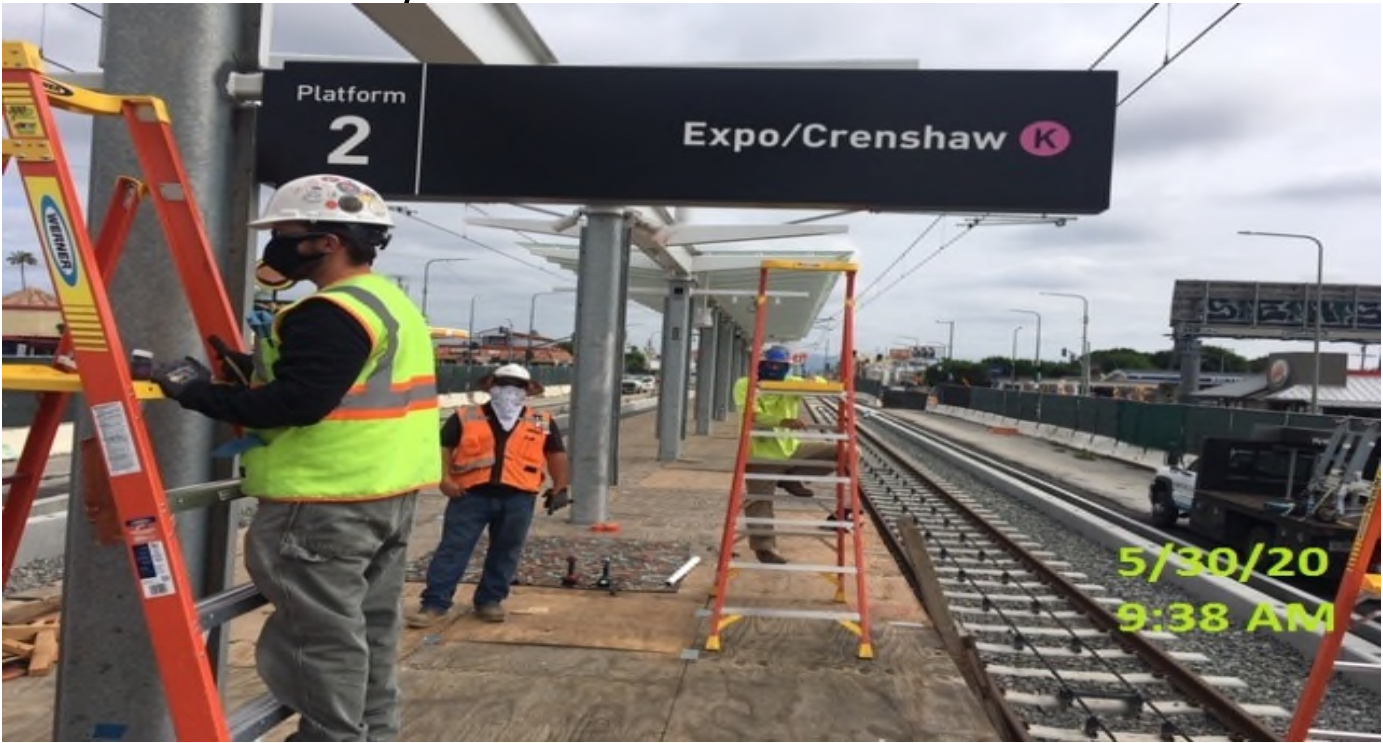
Hyde Park Station – Continue signage installation at the platform level.

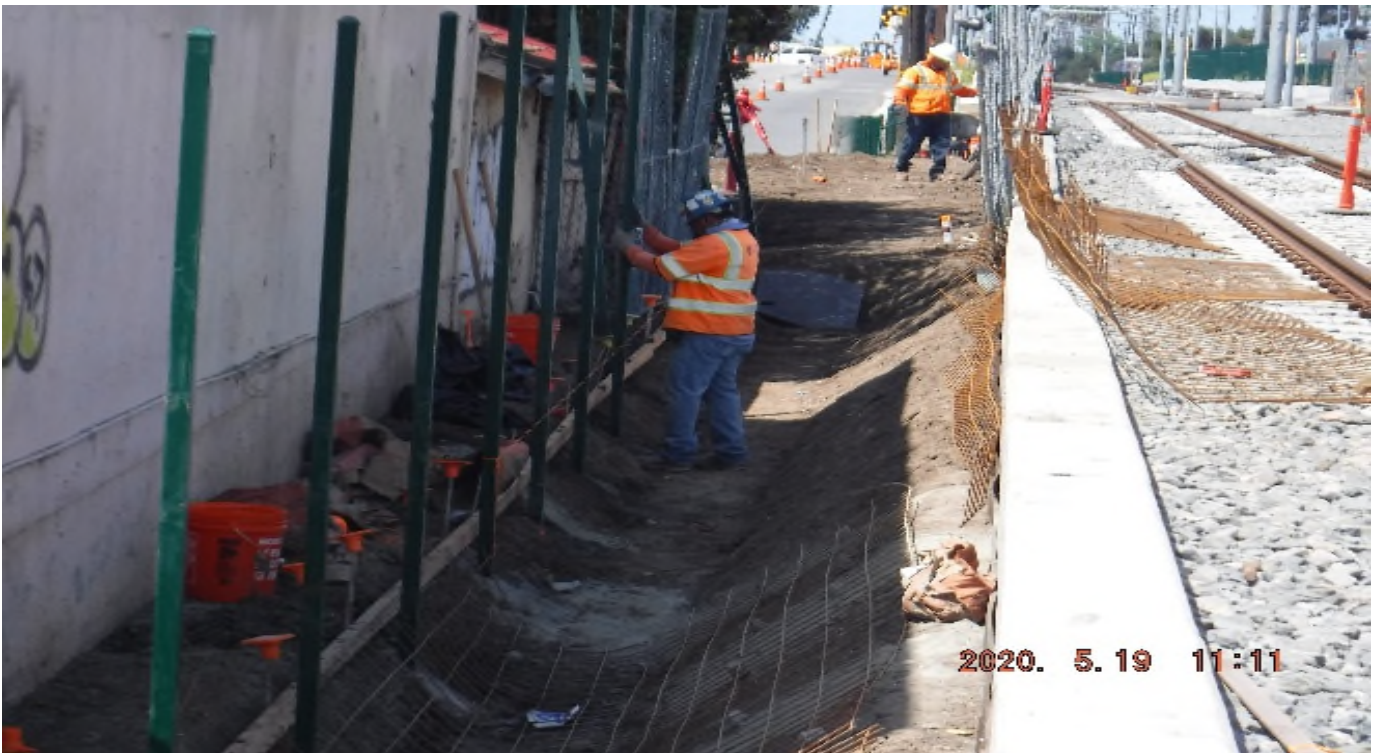
Florence/West – 13. STA 263+00 (TK#4/NB) looking south – fence work along R/W south of West Station.

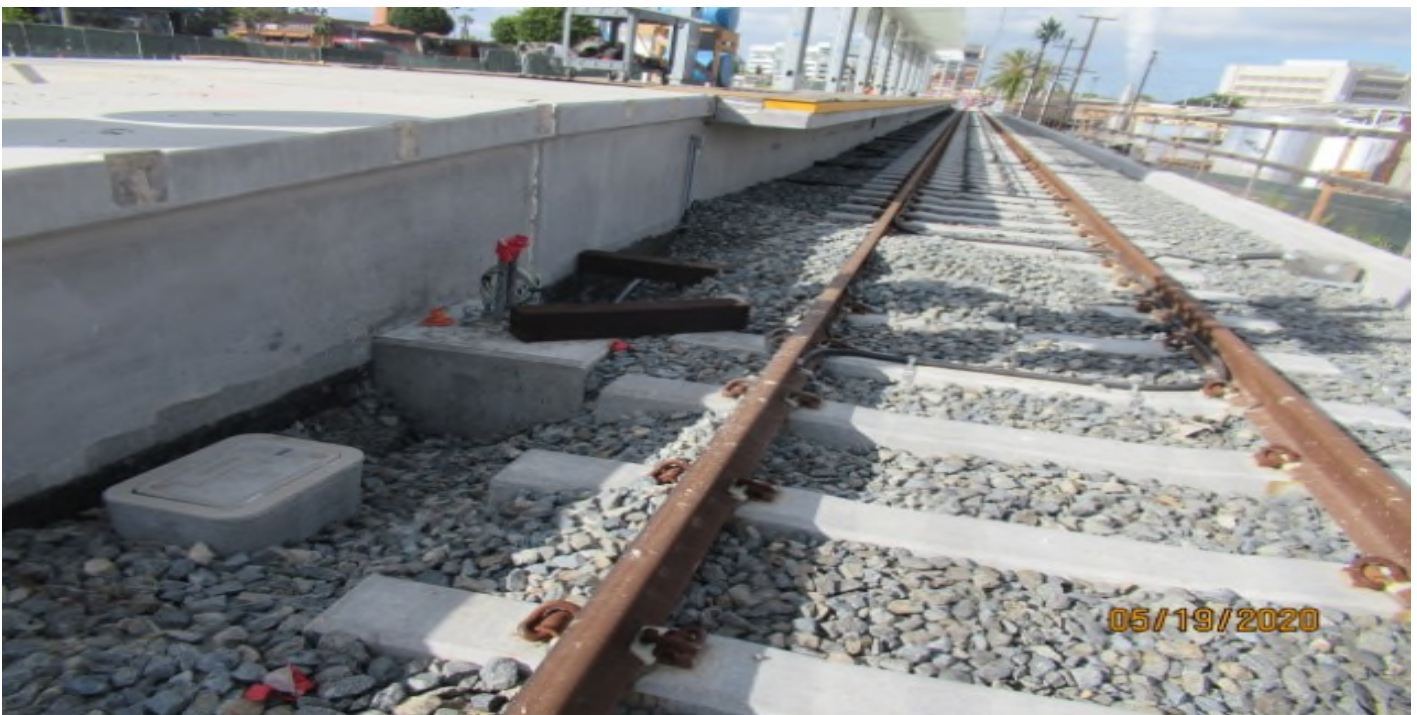
Florence/La Brea – SB #3 track STA 211+07 north side of La Brea station platform, disturbed track ballast, no changes

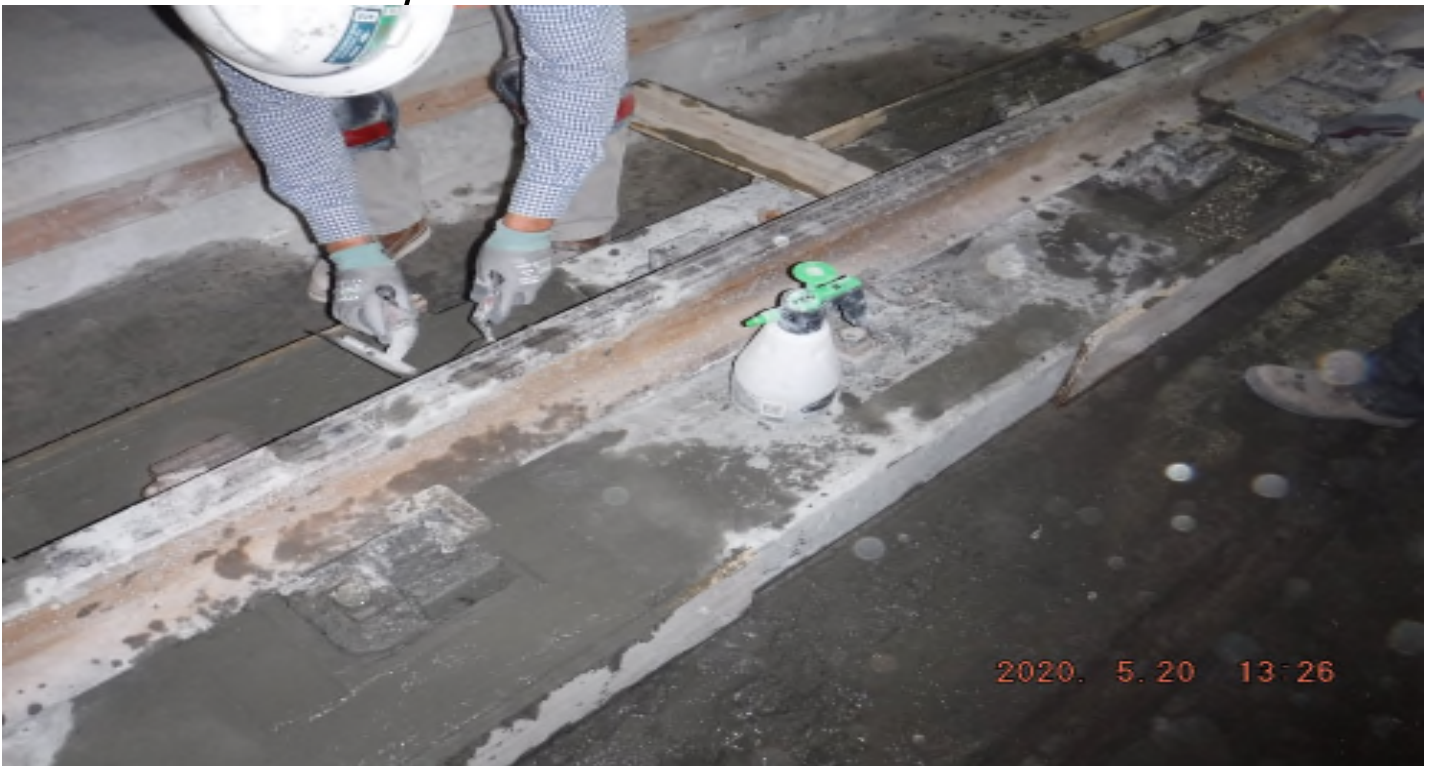
Crenshaw/Expo - STA 447+94 TK#4/NB looking north – left plinth new PCC under DF #3999 and DF #3401 – Exposition Station

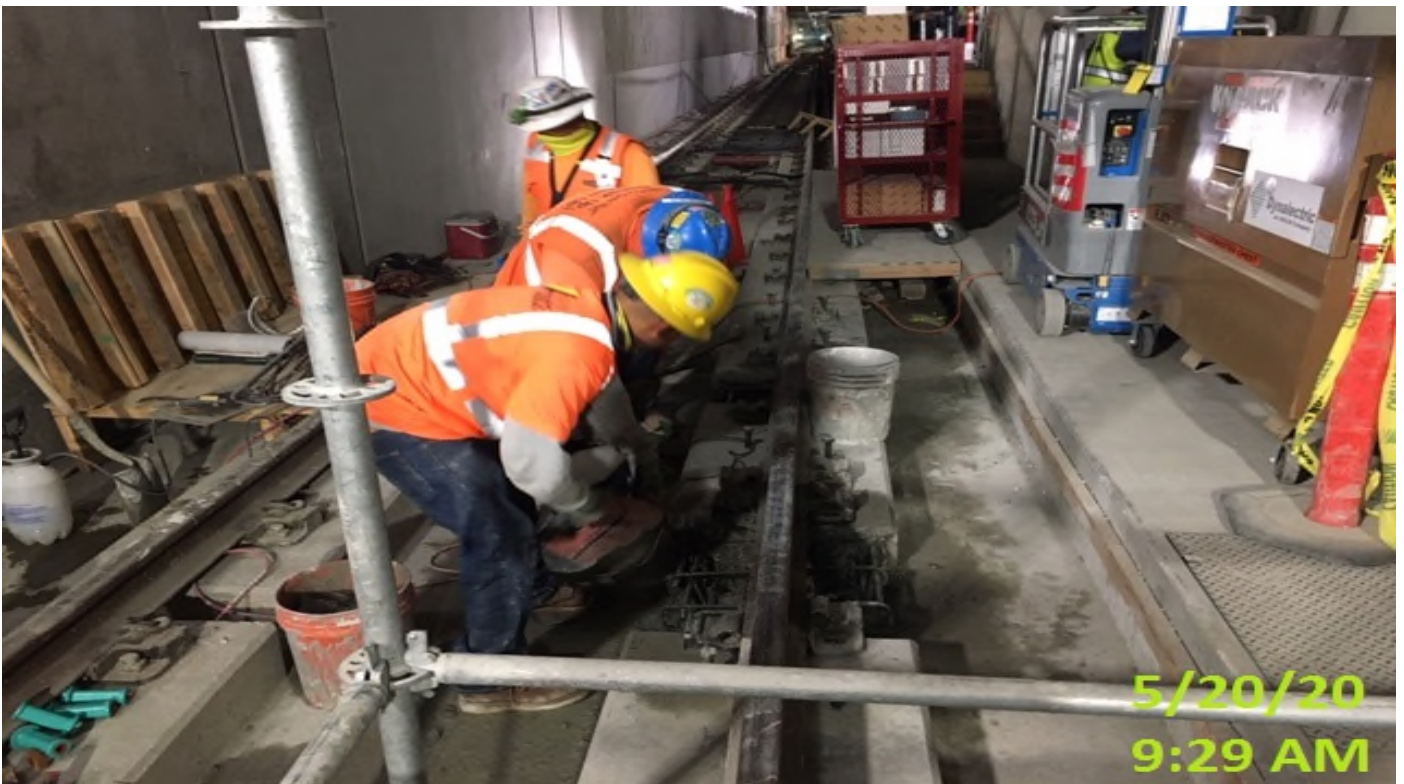
Crenshaw/Expo - EXPO – WSCC demoing plinth blocks at N. end platform.

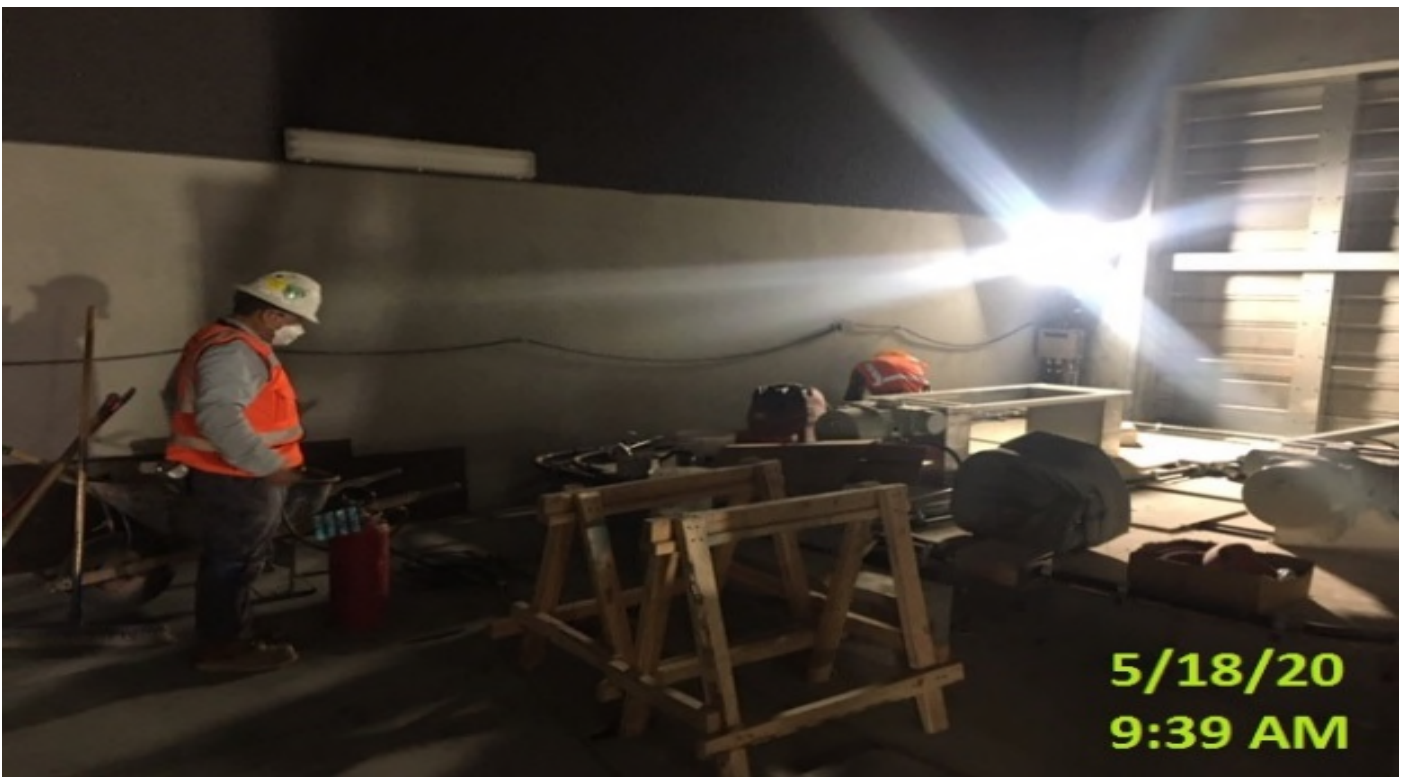
Crenshaw/Expo - WSCC finishers patching and resurfacing walls at north EVF room.

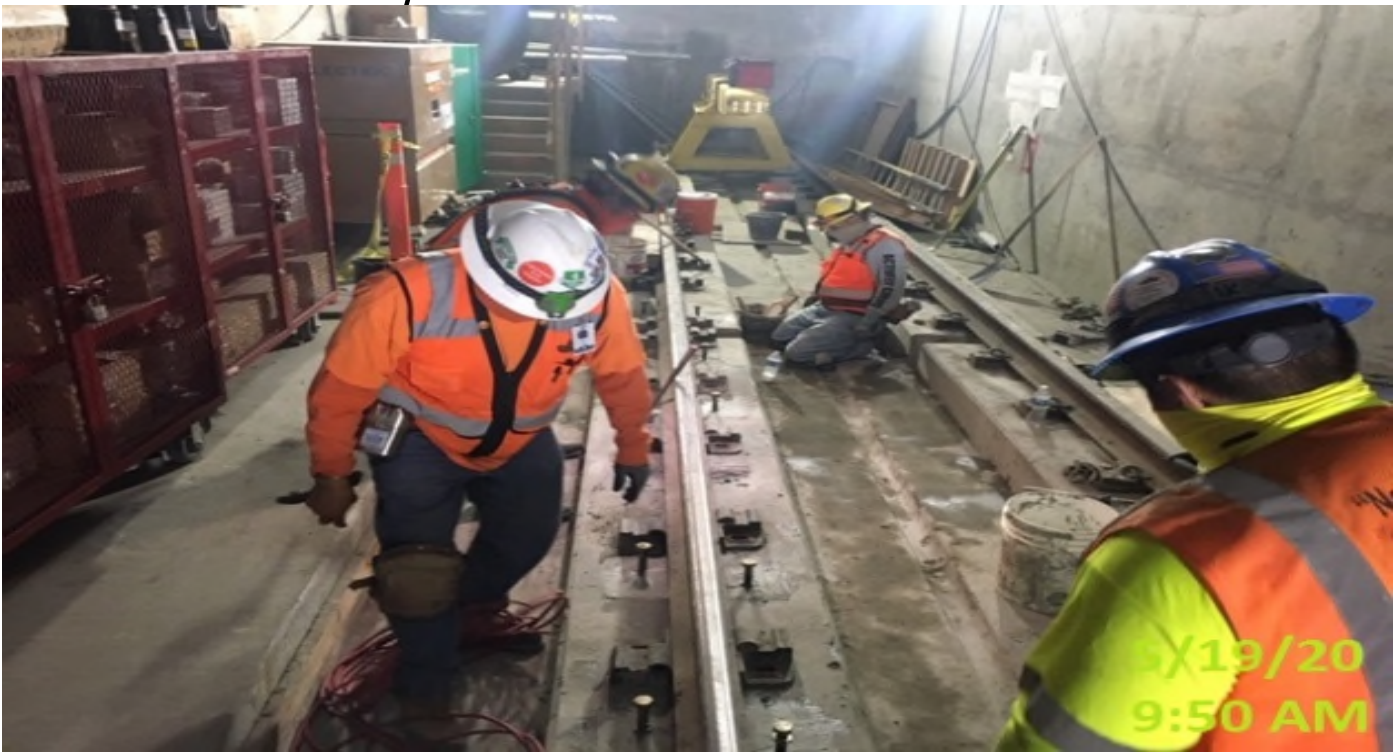
Crenshaw/Expo - WSCC installing rail fasteners and demoing plinth block.

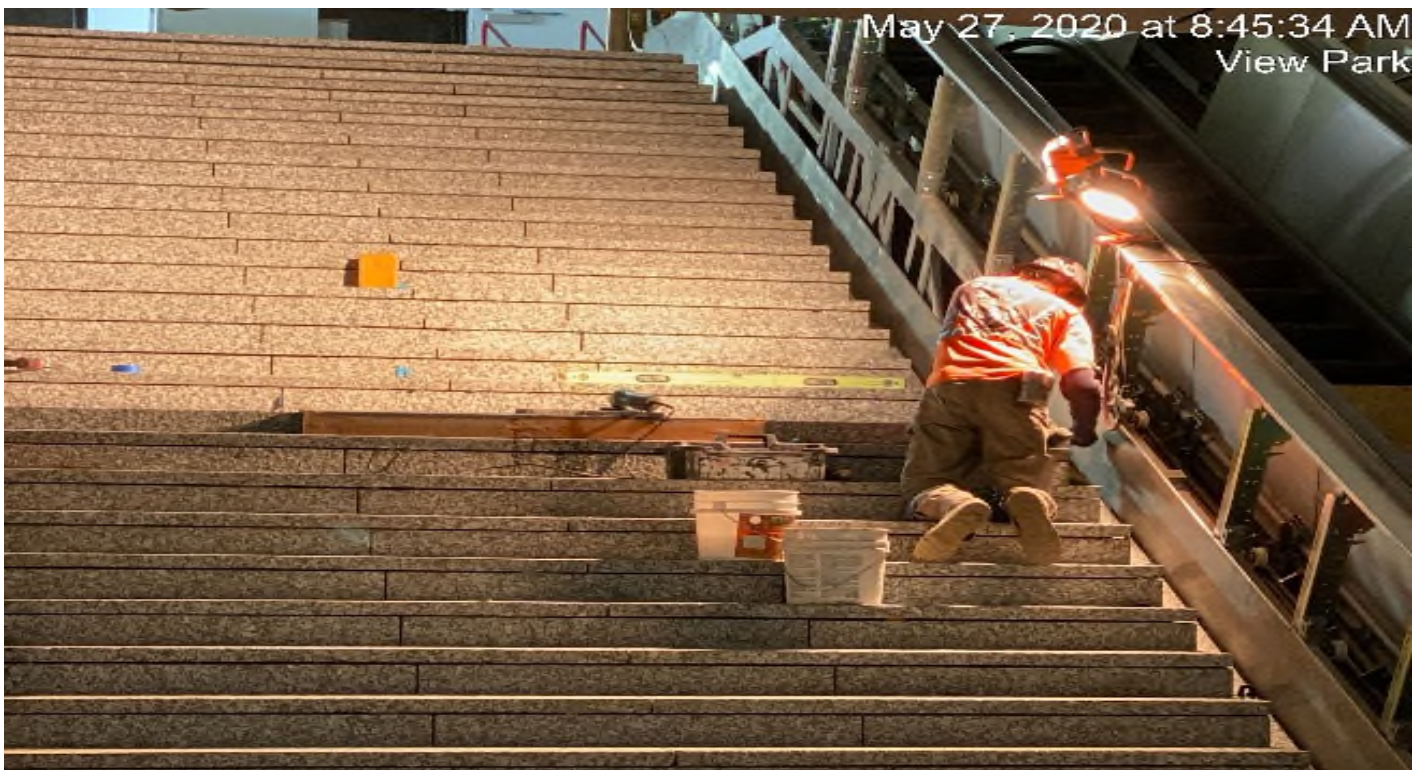
LEIMERT PARK STATION – Continue granite thread and riser installation from intermediate and concourse staircase landings.
