CRENSHAW/LAX PHOTOGRAPHIC UPDATE

June 12, 2020

Crenshaw/LAX Transit Project

Overview of trackwork progress issues for 05/15/2020 – 06/01/2020
(Please note the attached Trackwork Progress Tracking Report)

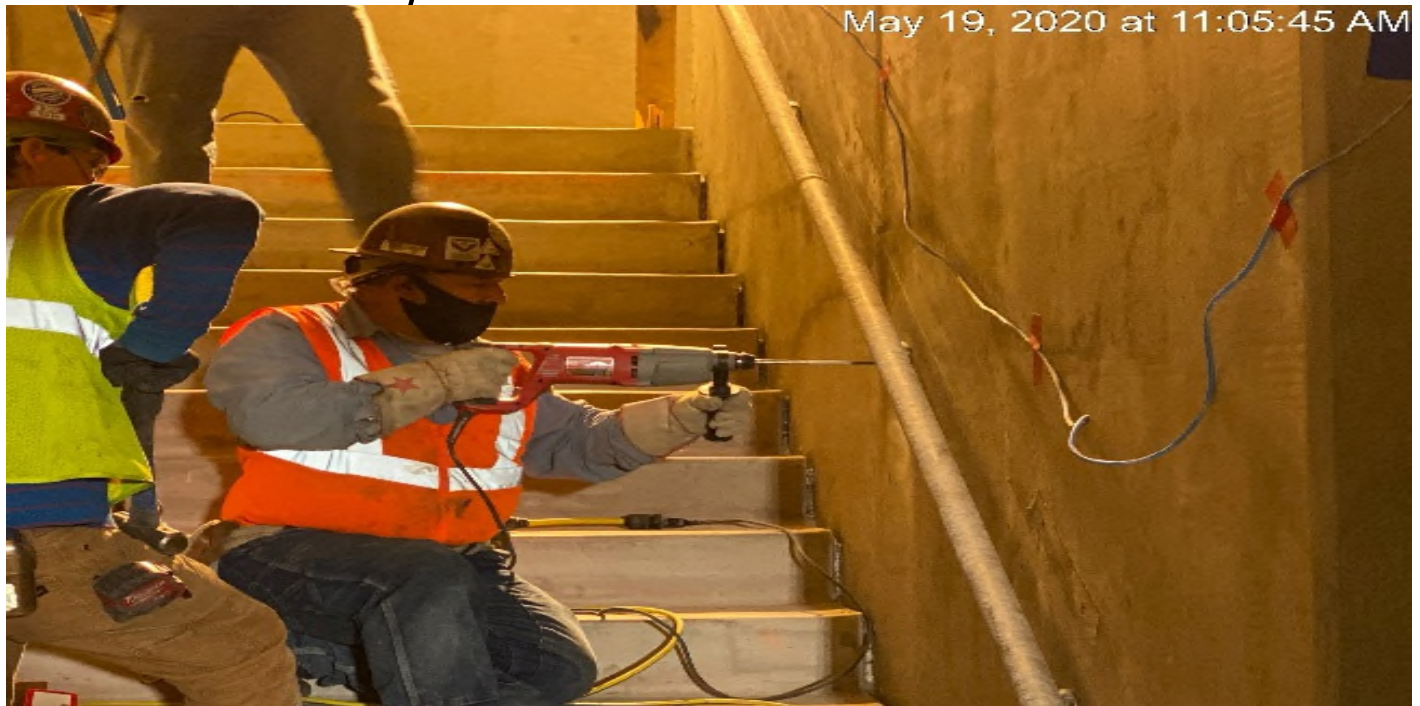
LEIMERT PARK STATION – Continue embedded and ramp lighting fixture installation for the planter stair risers on the northwest section of the plaza level.

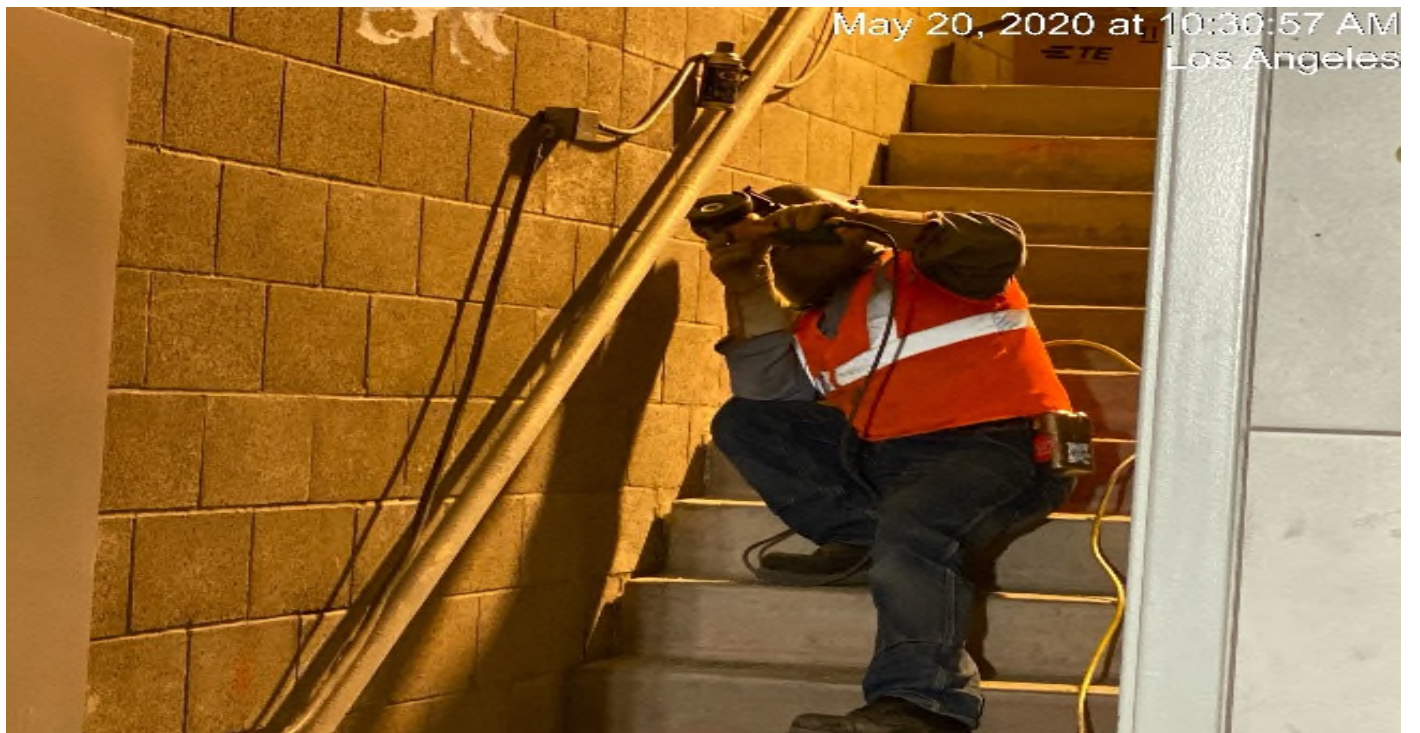
LEIMERT PARK STATION – Continue installing handrails in the south emergency exit stairwell leading into the concourse.

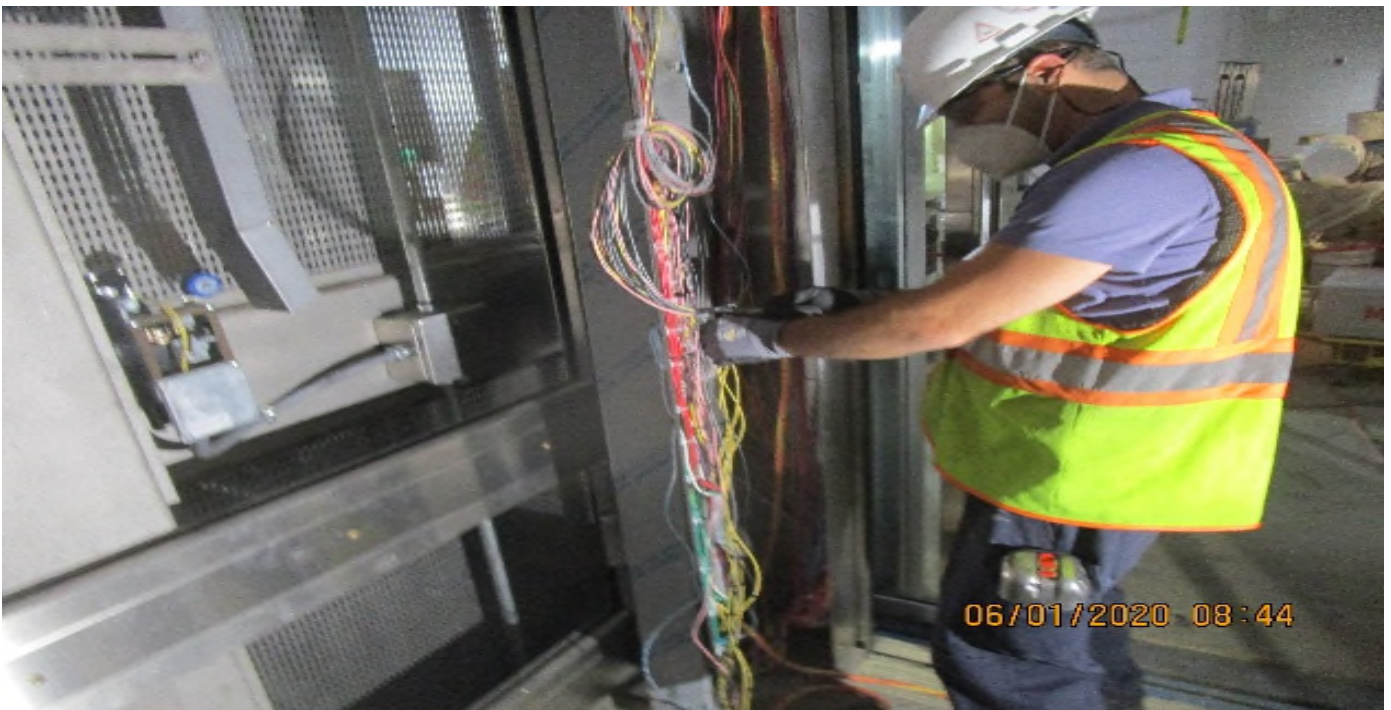
LEIMERT PARK STATION – Continue terminating wires for the cab operating panel for Elevator 2 at the concourse level.

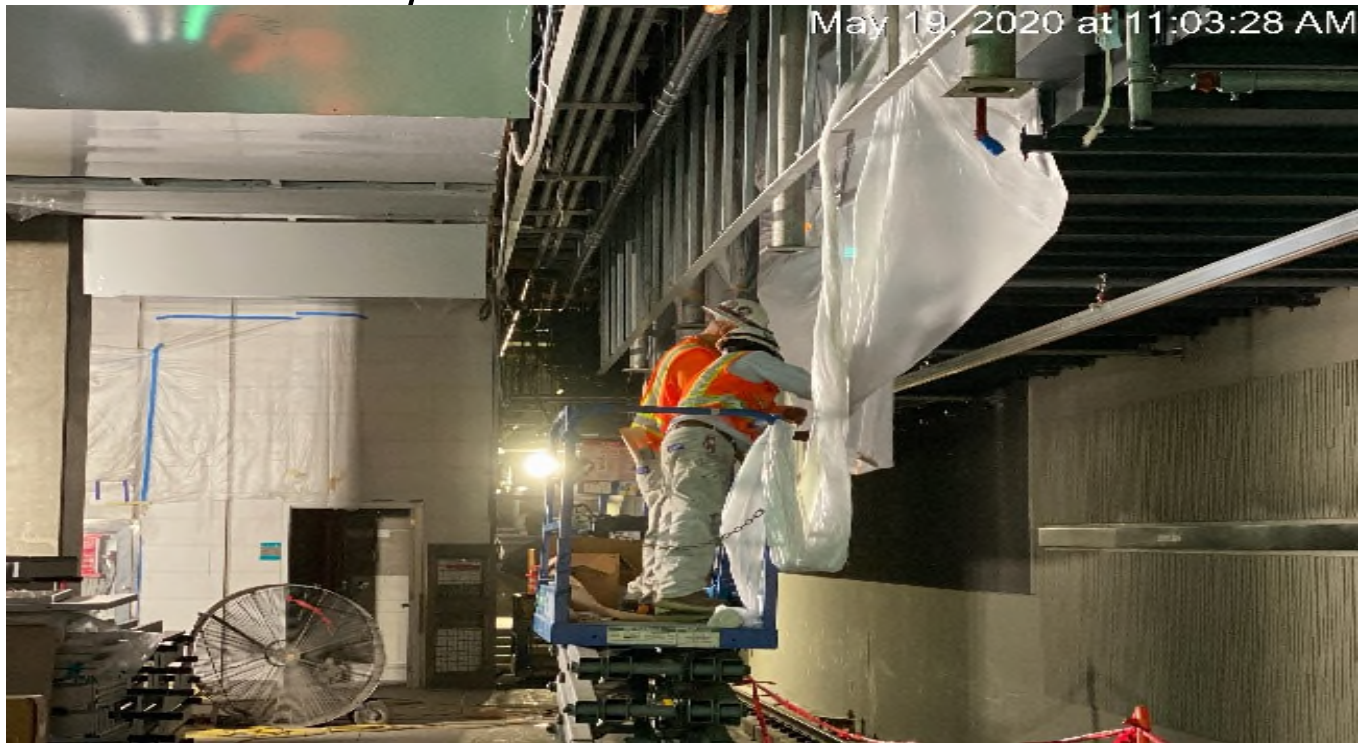
LEIMERT PARK STATION – Continue applying finish paint to the ceiling conduits at the platform level.

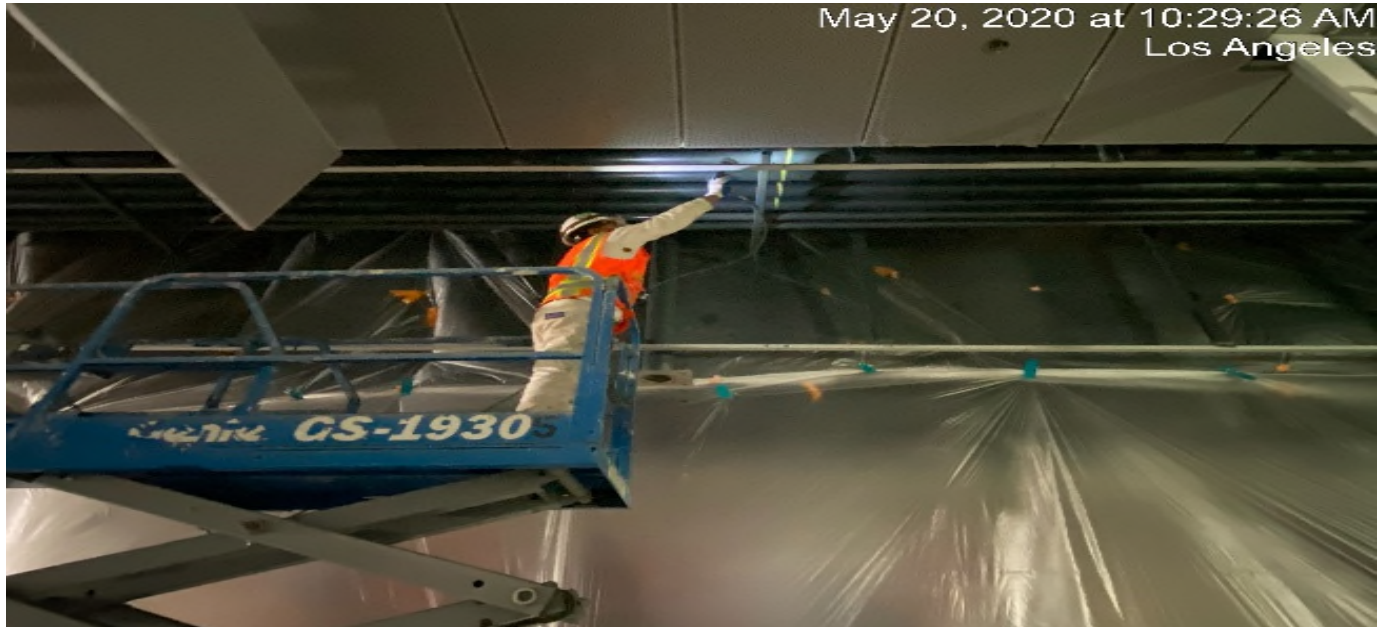
LEIMERT PARK STATION – Continue applying finish paint to the ceiling conduits at the platform level.

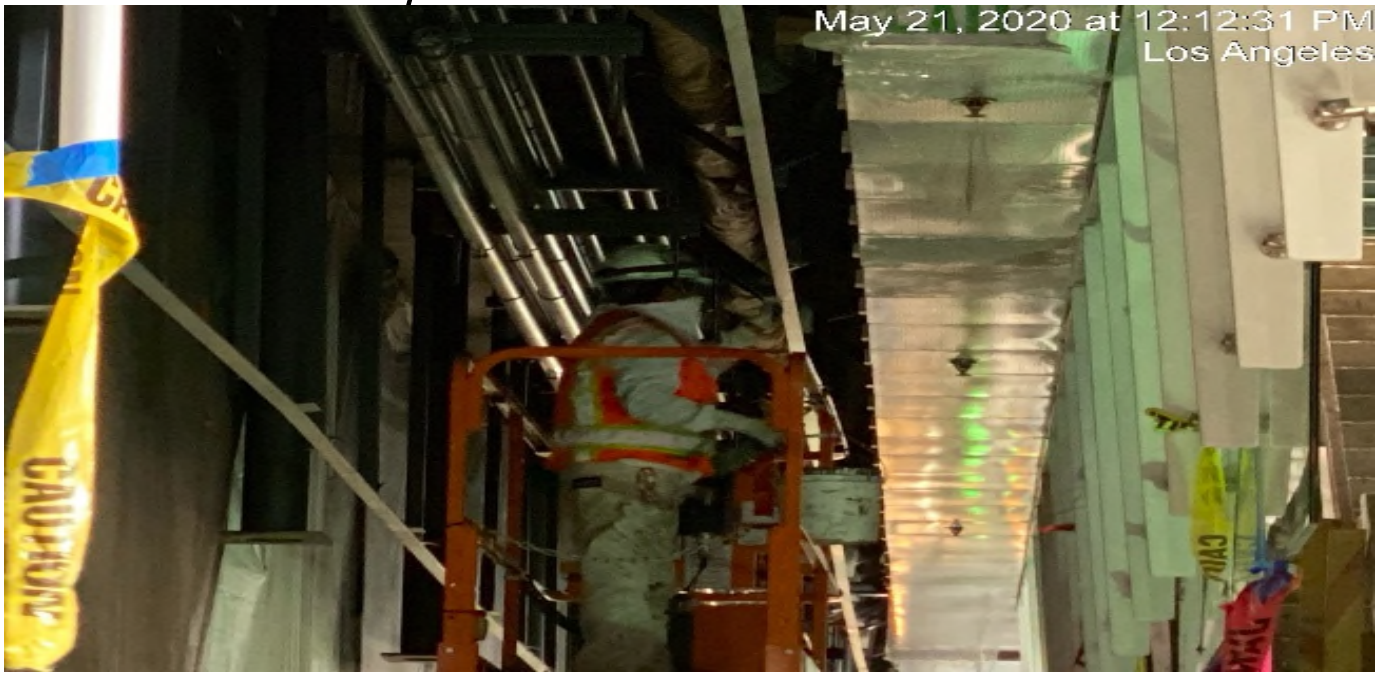
LEIMERT PARK STATION – Continue applying finish paint to the ceiling conduits at the platform level.

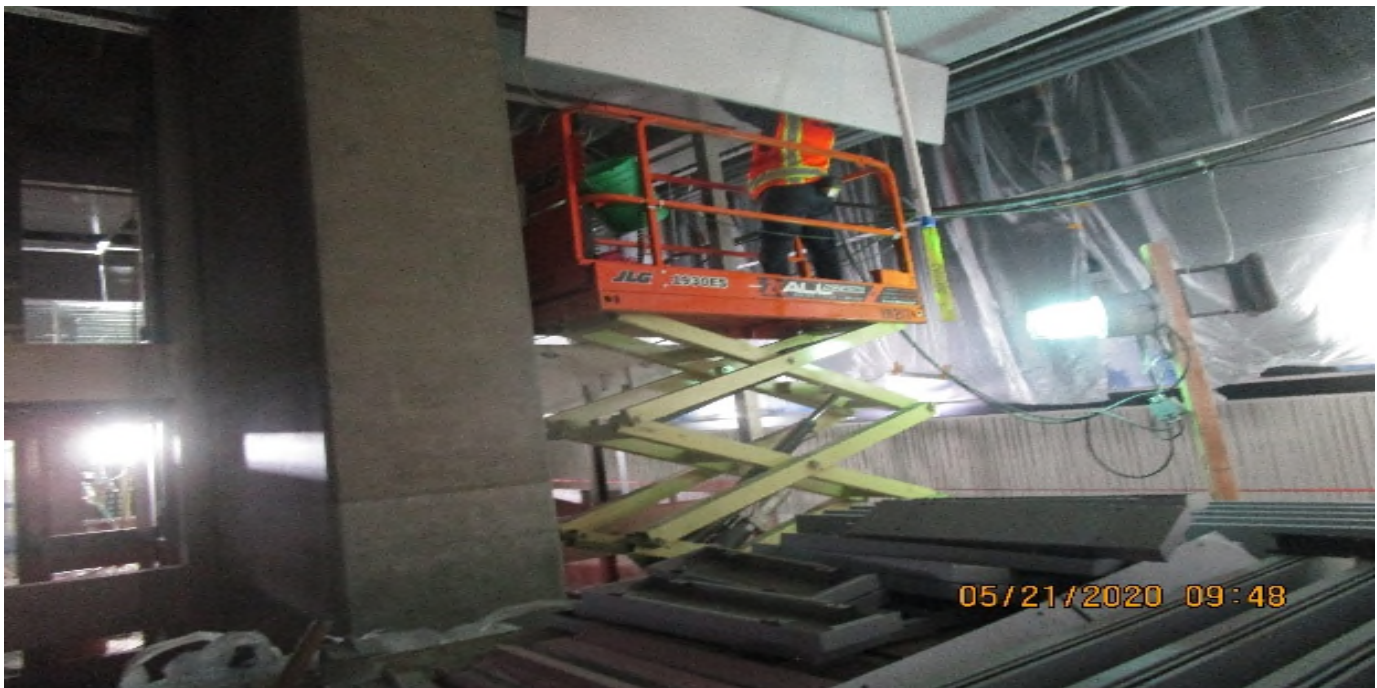
LEIMERT PARK STATION – Resume ceiling light fixture installation at the platform level.

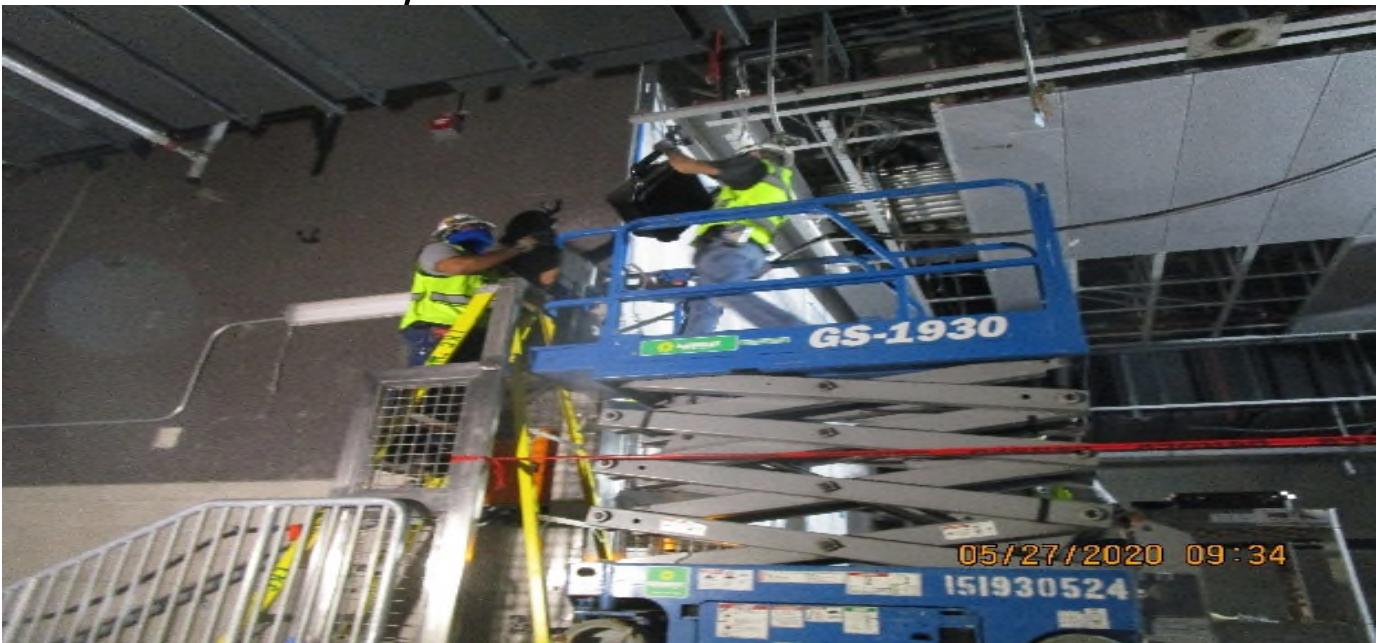
LEIMERT PARK STATION – Began installing flashing hand signal displays above the north and southbound end gates at the south end of the platform level.

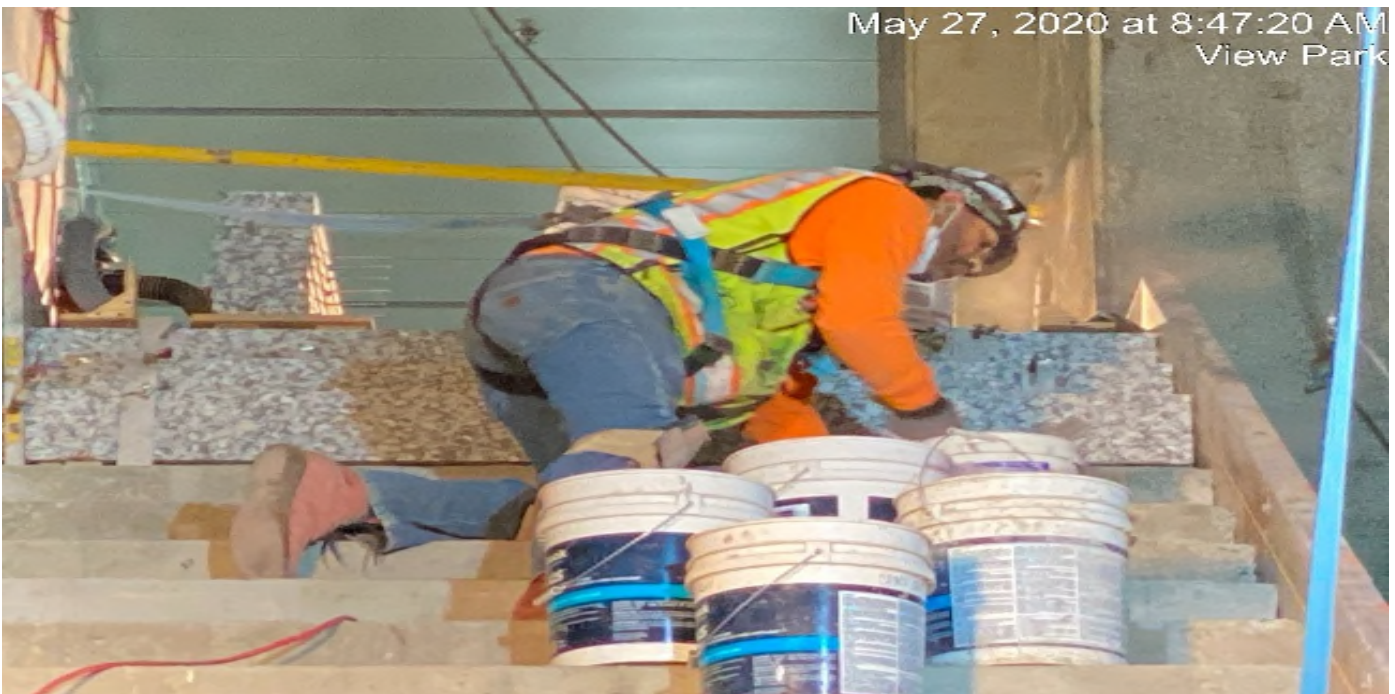
LEIMERT PARK STATION – Began installing granite tread and riser for staircase #4 from concourse to platform level.

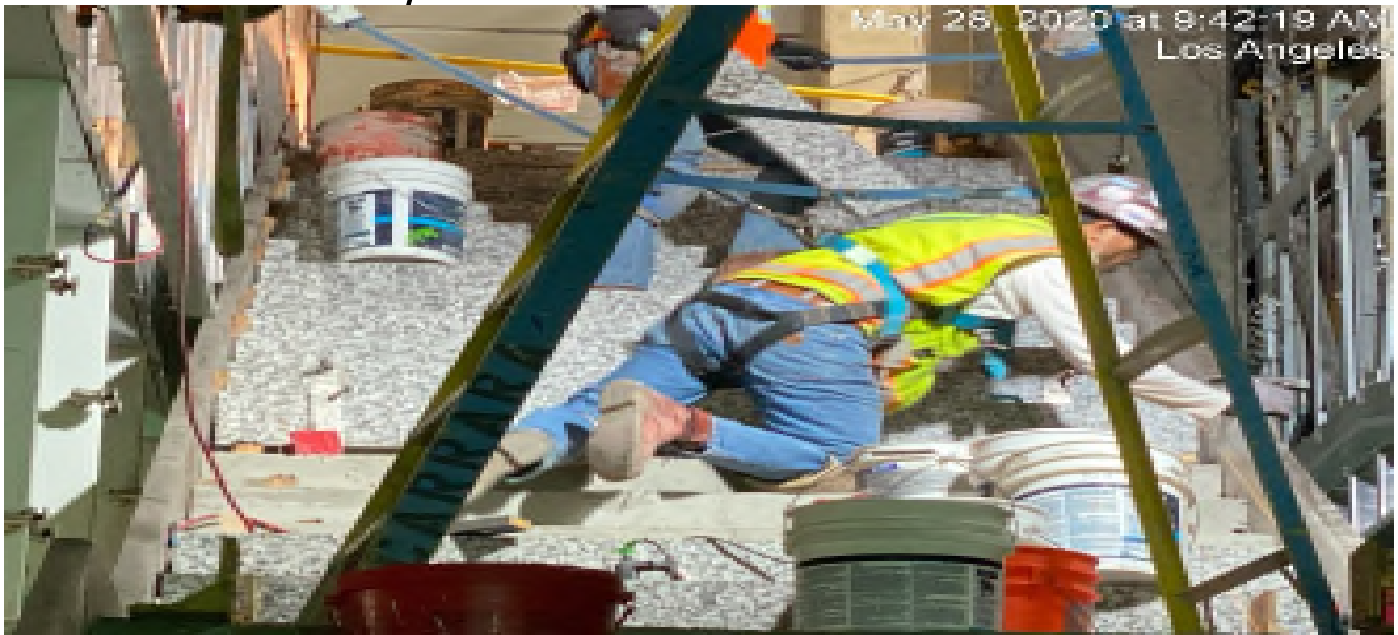
LEIMERT PARK STATION – Continue installing granite tread and riser for staircase #4 from concourse to platform level.

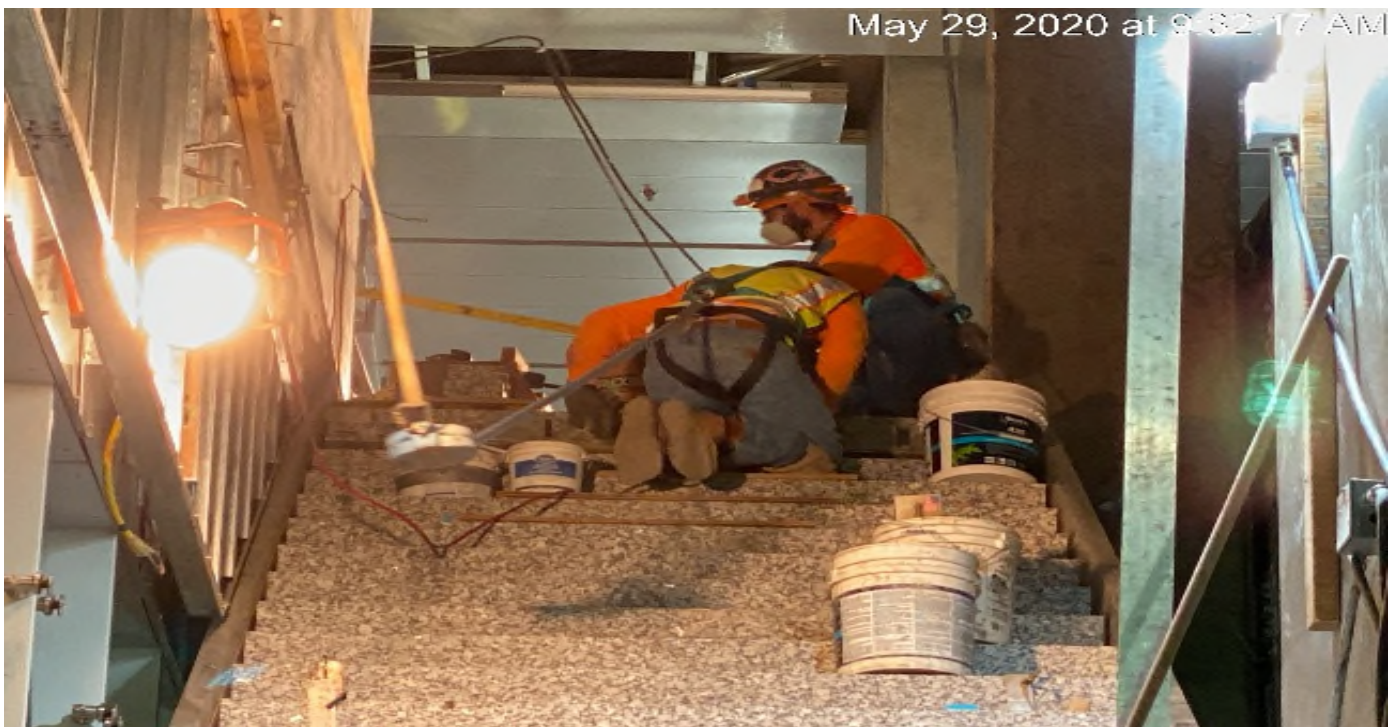
LEIMERT PARK STATION – Continue installing granite tread and riser for staircase #4 from concourse to platform level.
