CRENSHAW/LAX PHOTOGRAPHIC UPDATE

July 7, 2020

Crenshaw/LAX Transit Project

Overview of trackwork progress issues for 06-22-2020 – July 7, 2020
(Please note the attached Trackwork Progress Tracking Report)

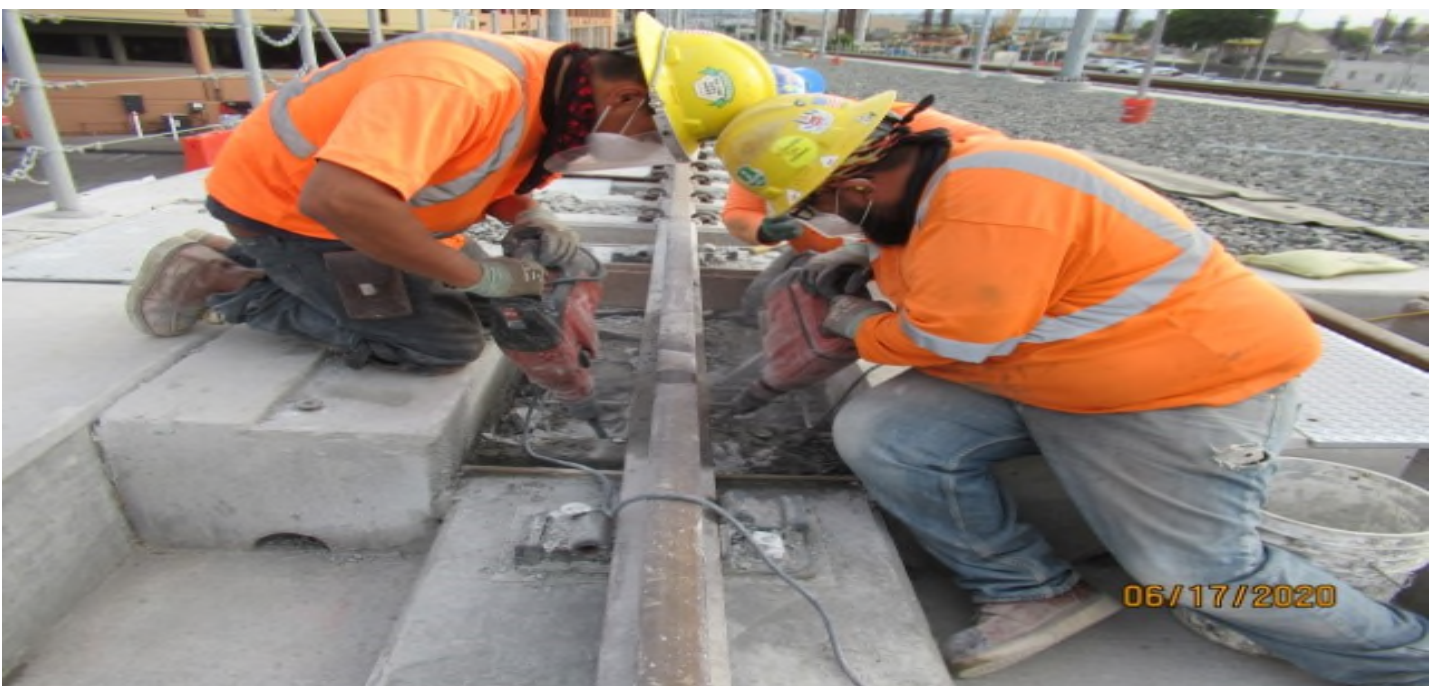
AVIATION/CENTURY- SB #3 track STA 74+60, WSCC concrete demolishing partial plinth left (high) side of curve 7A (looking north) Rework.

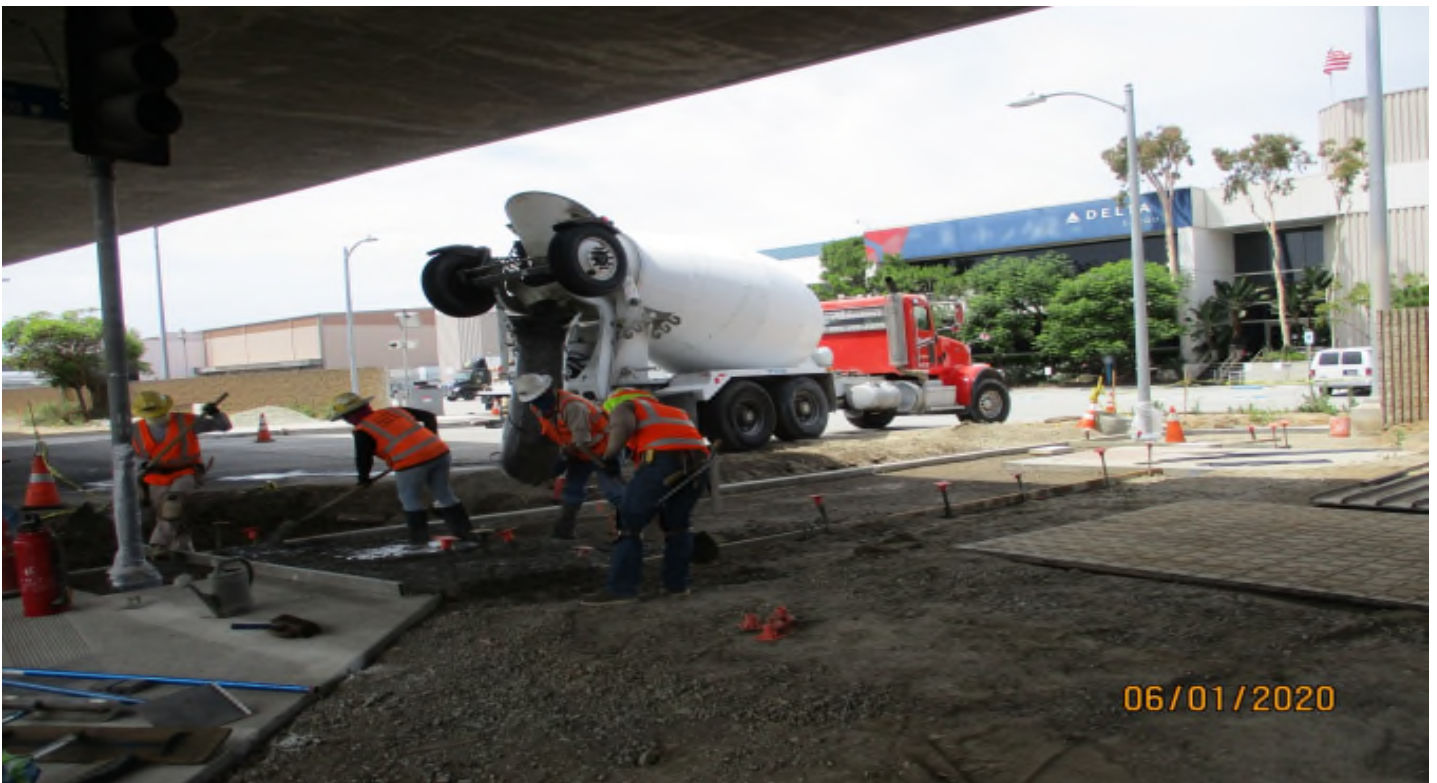
111th Street- Placing concrete for the sidewalk at 111th street.

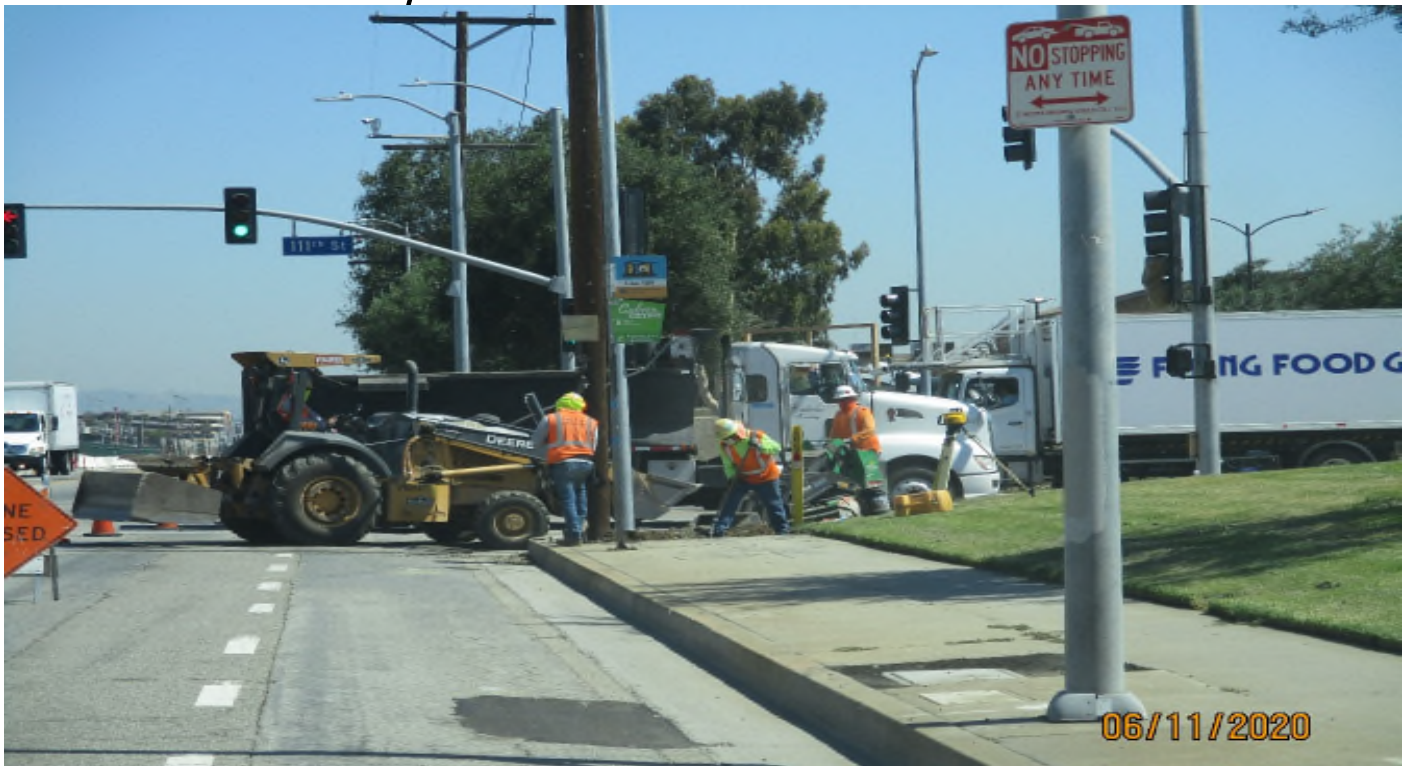
111th Street- Grading and base placement for the ADA ramps at 111th street. Facing north.

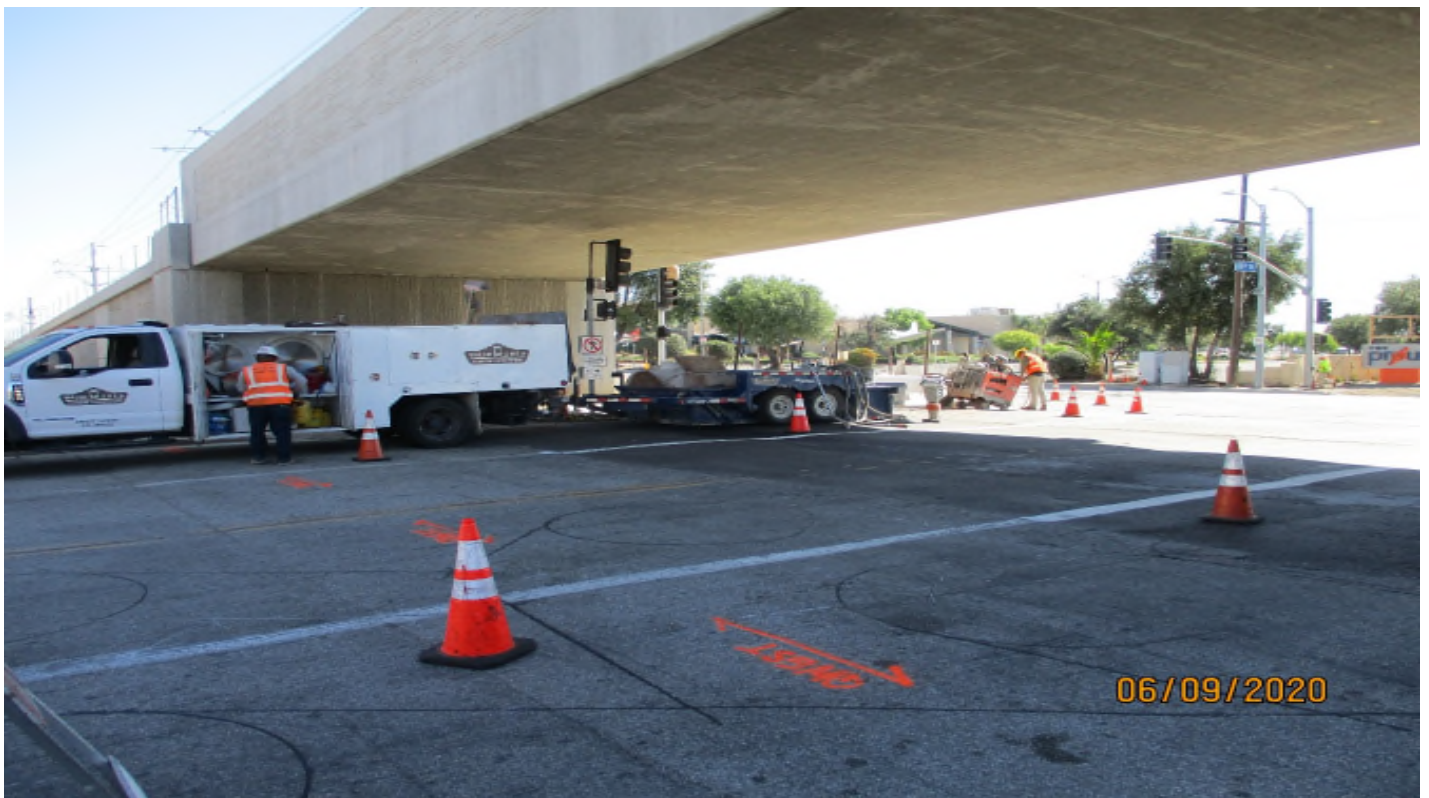
111th Street- Saw cutting the existing roadway Ac for potholing at 111th street. Facing NW.

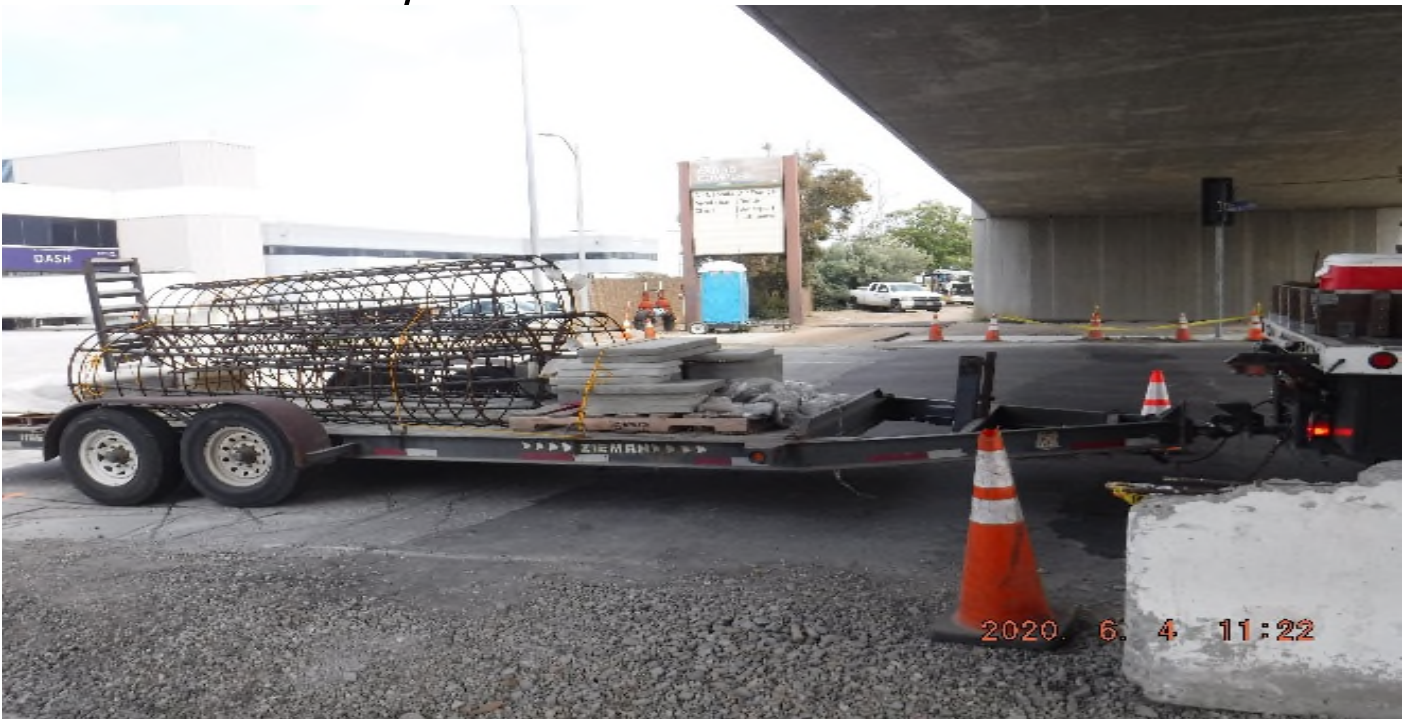
111th Street- STA 27+00 under 111th bridge looking north – DBE mobilization material & equipment.

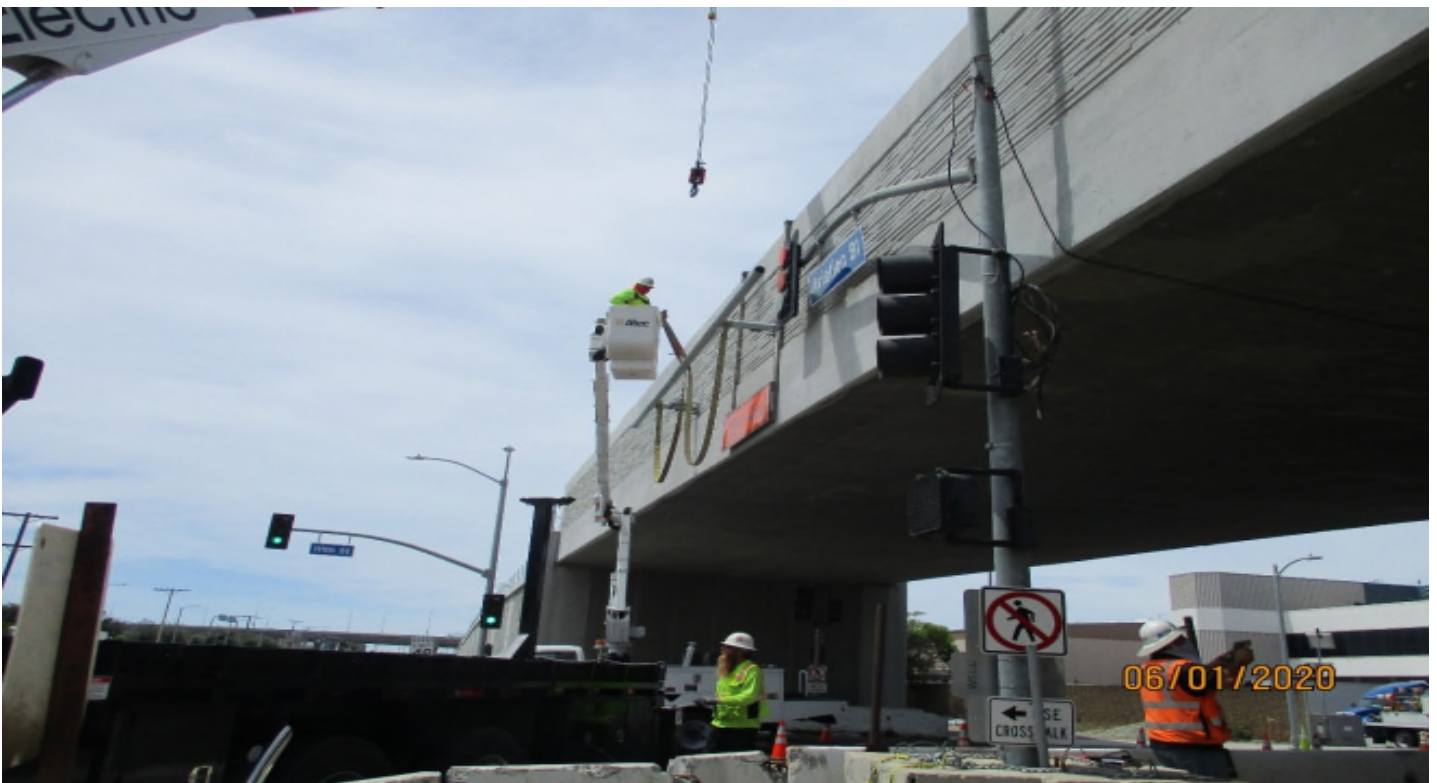
111th Street- Hanging the traffic signal mast arm at 111th street. Facing SW

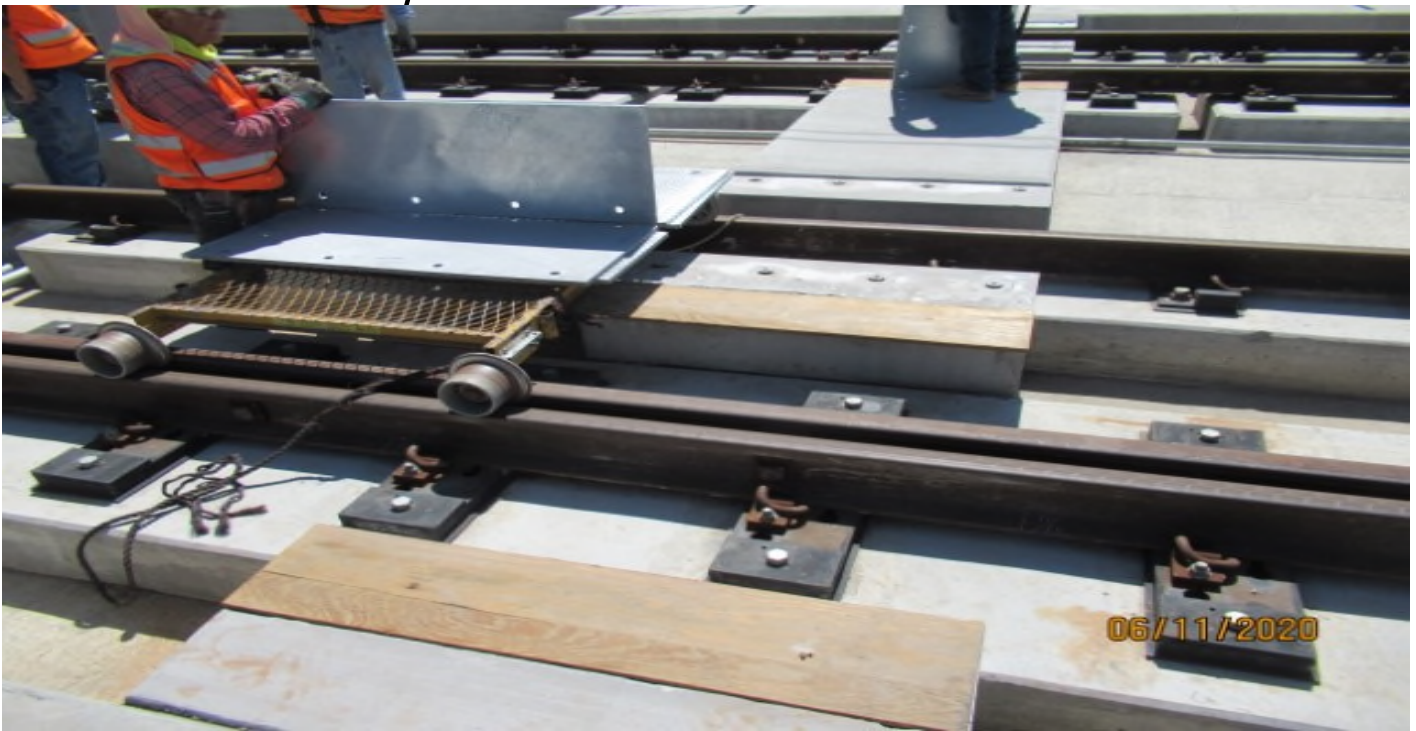
GREENLINE UNDERPASS- WSCC re-installing emergency walkway plates on west leg of GL Wye.

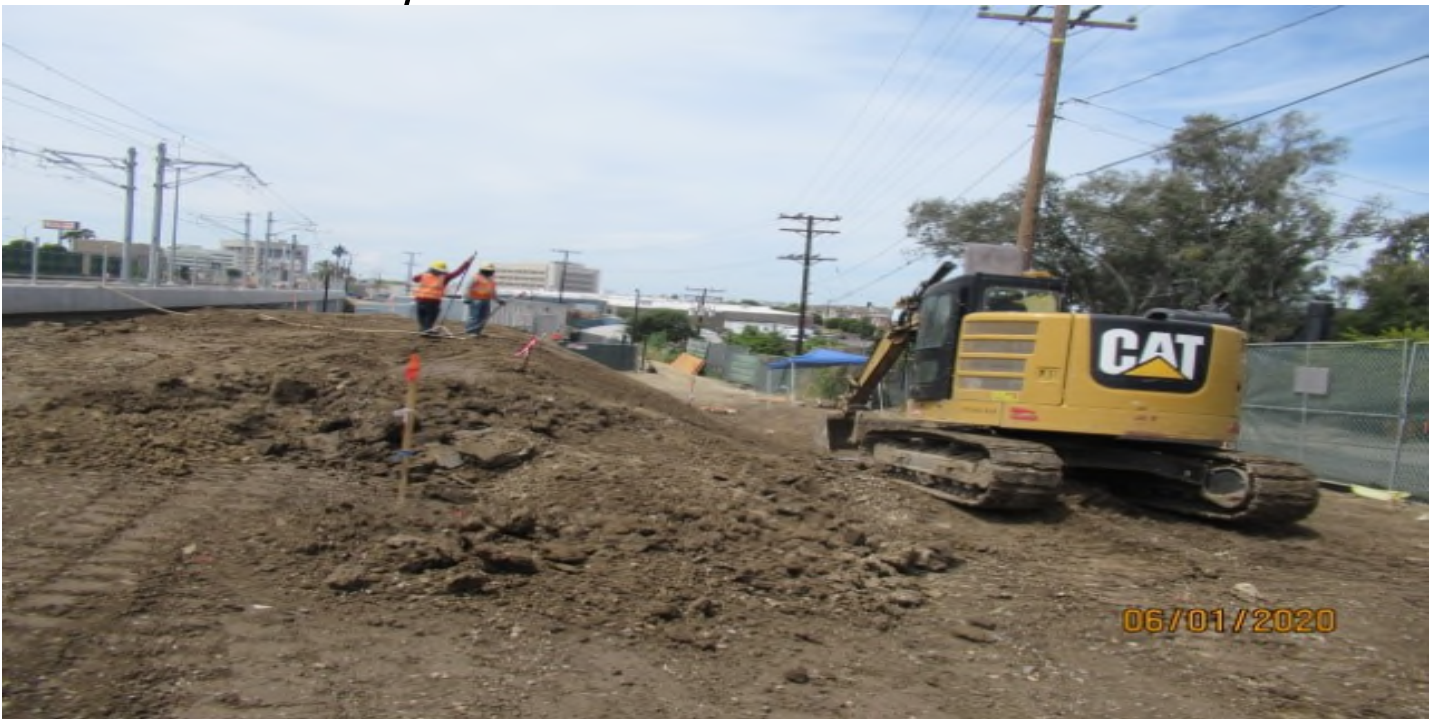
La Brea – WSCC civil dirt crew installing V-ditch, west side at La Brea (looking south)

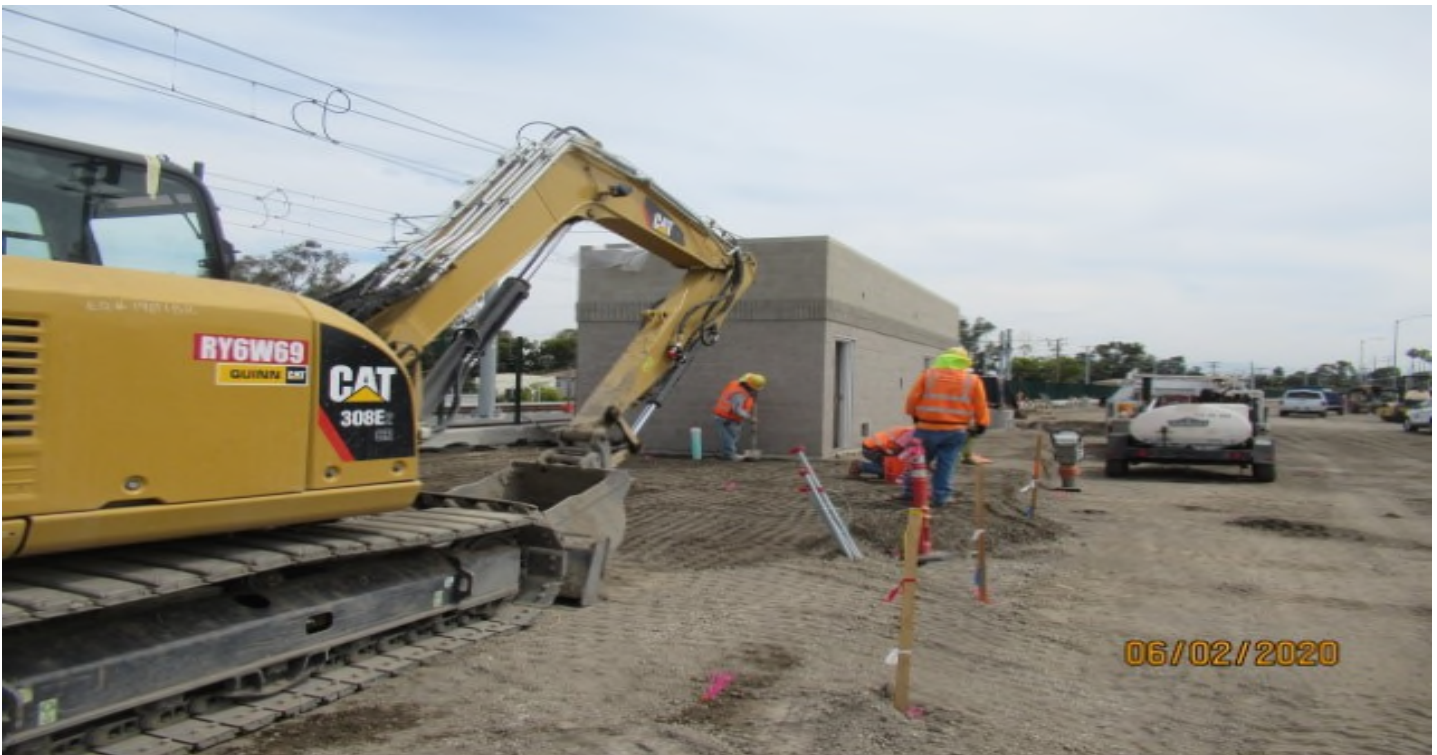
La Brea – WSCC dirt crew installing pad for future concrete at La Brea station (looking northwest)

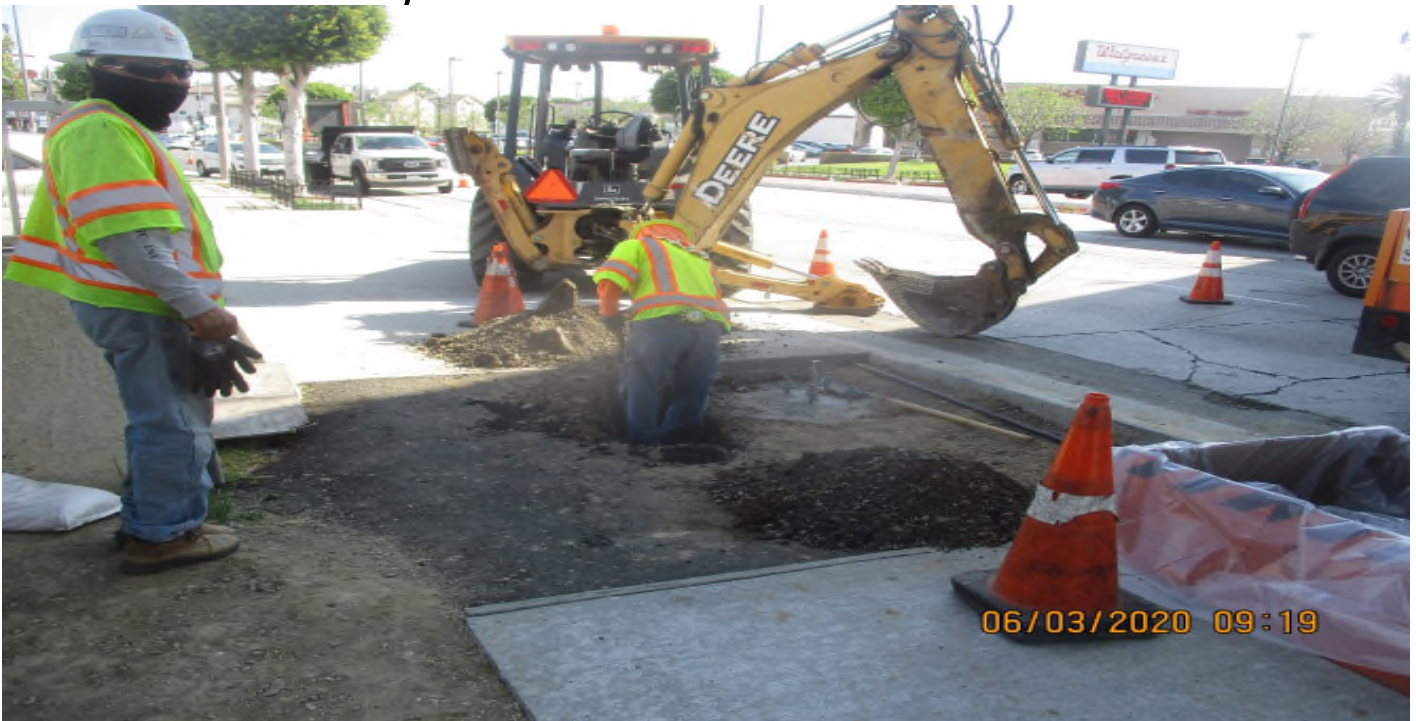
La Brea – Select Electric Excavated to place pull boxes at La Brea and Florence and under La Brea Bridge.

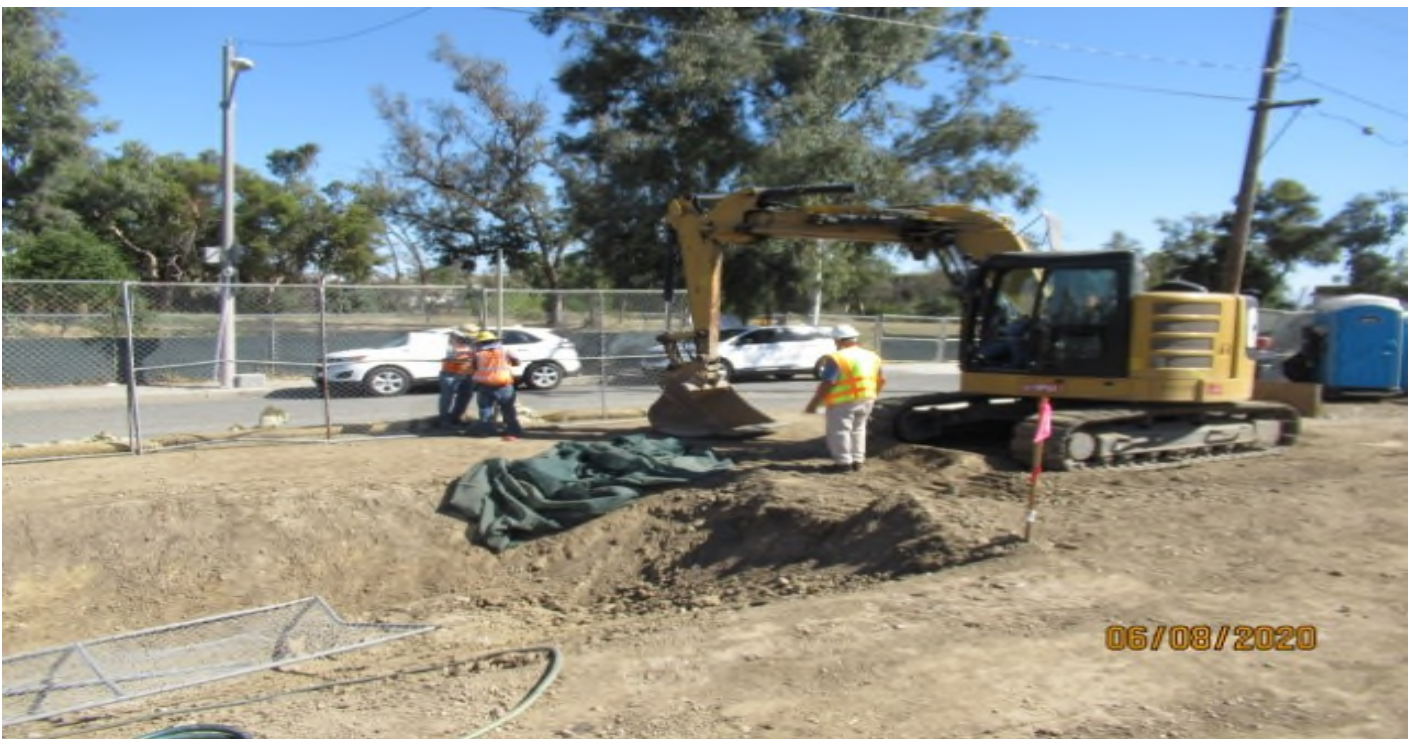
La Brea – WSCC dirt crew on west side of La Brea station, repairing temp. fence lines.

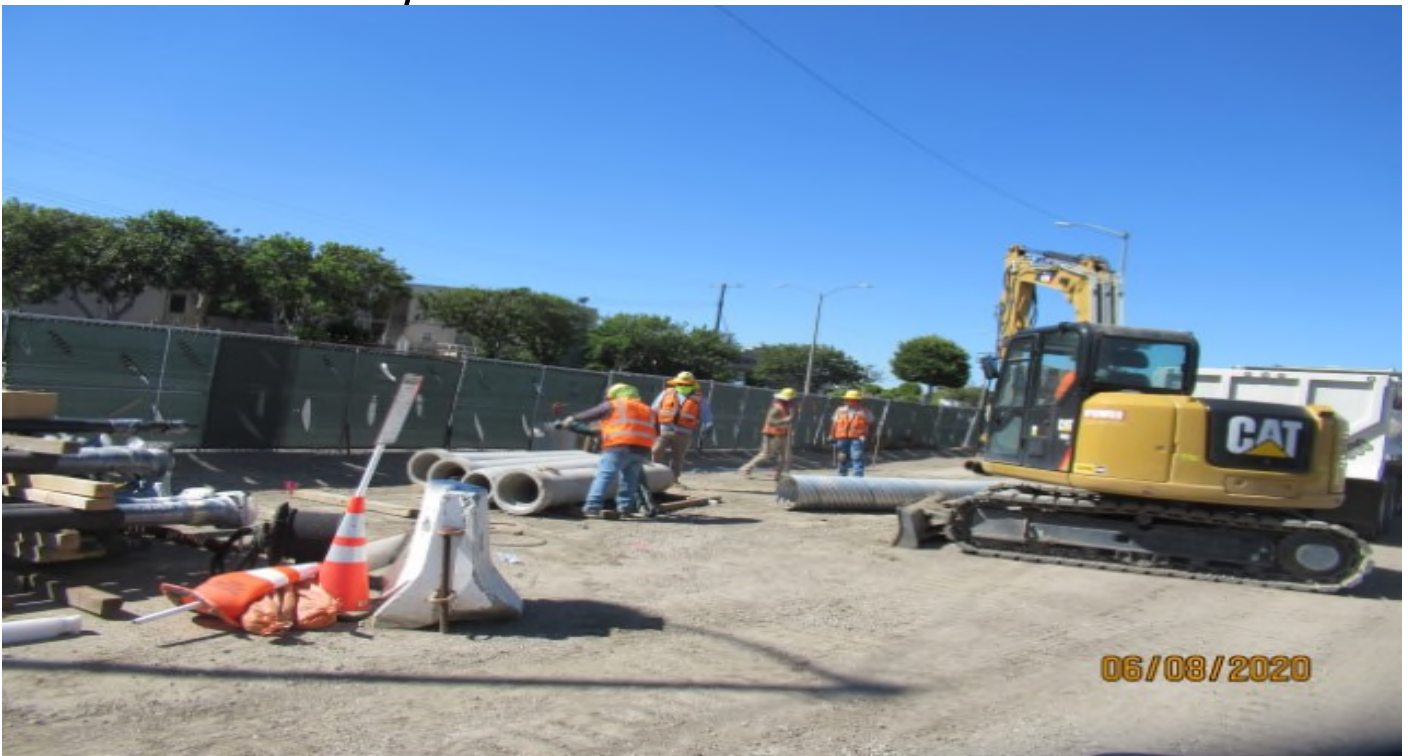
La Brea – WSCC at La Brea pavilion removing materials using excavator (looking southeast)

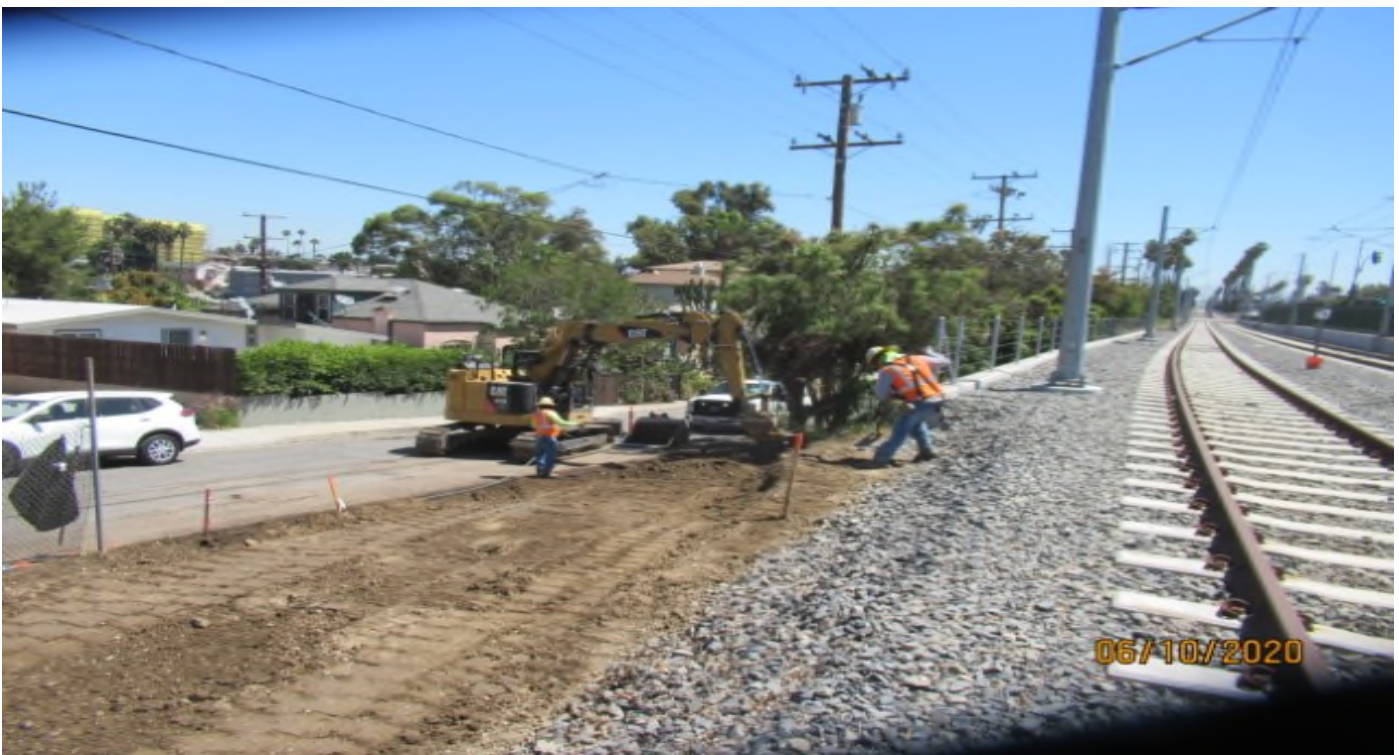
La Brea – WSCC on west side of La Brea, adding soils to slope & compacting using sheepfoot (looking north)

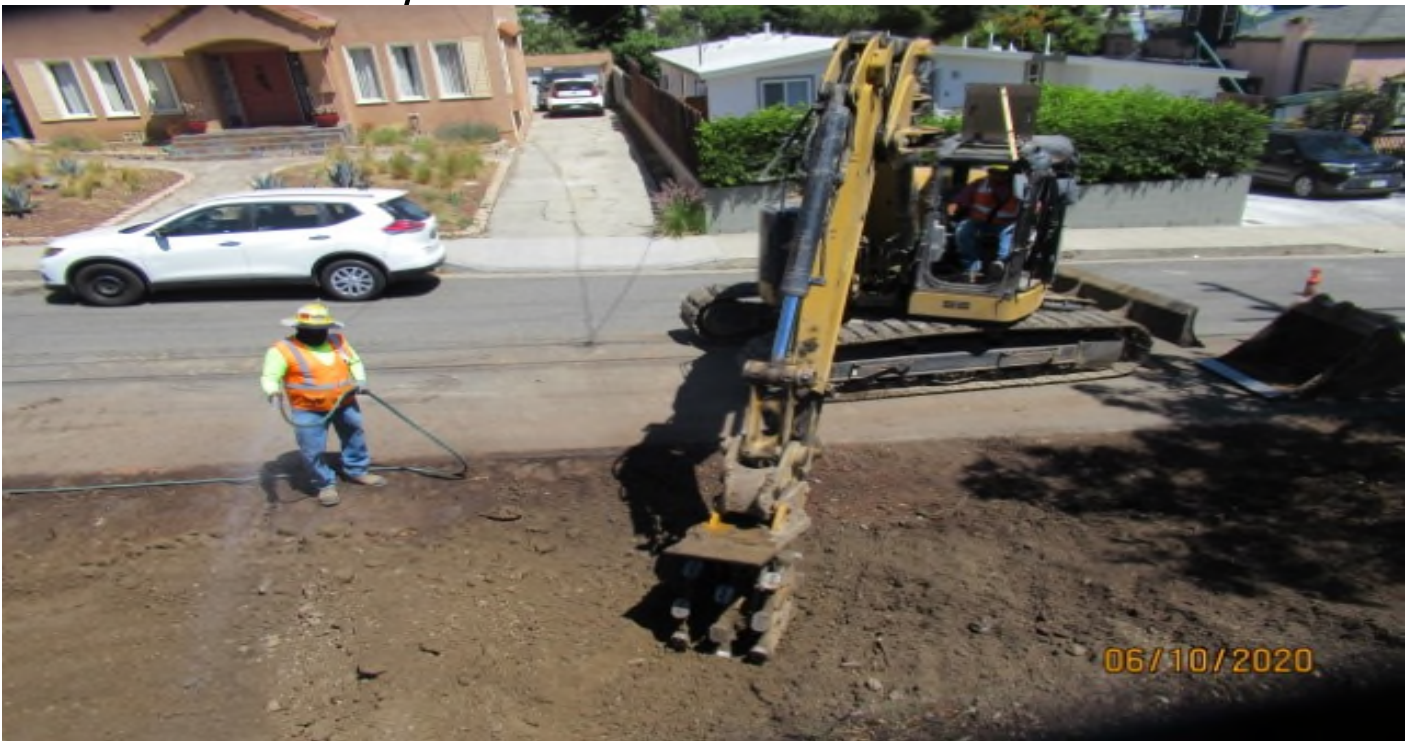
La Brea – WSCC dirt crew rolling slope & adjusting elevations at La Brea (looking west)

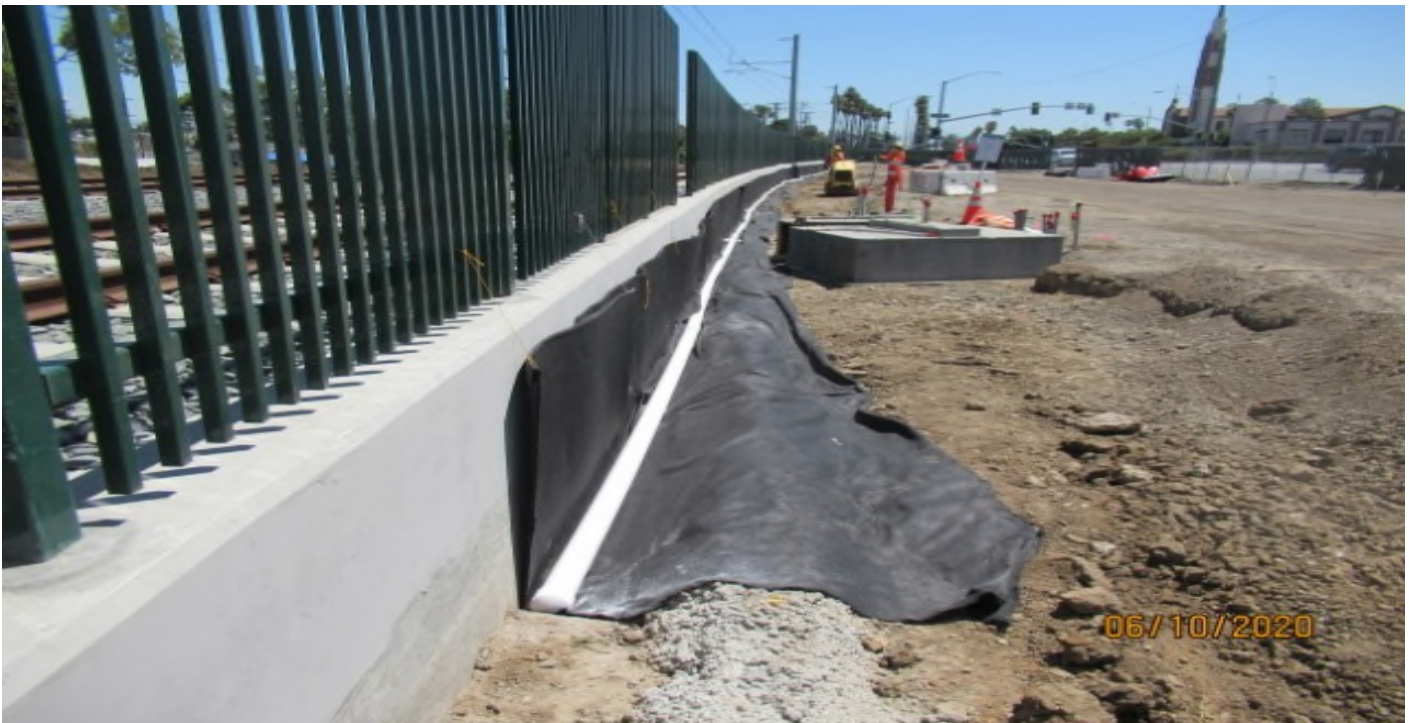
La Brea – La Brea Station WSCC preparing to Burreto rap storm drain pipe next to NB ballast retaining wall STA 156+00 (looking north)

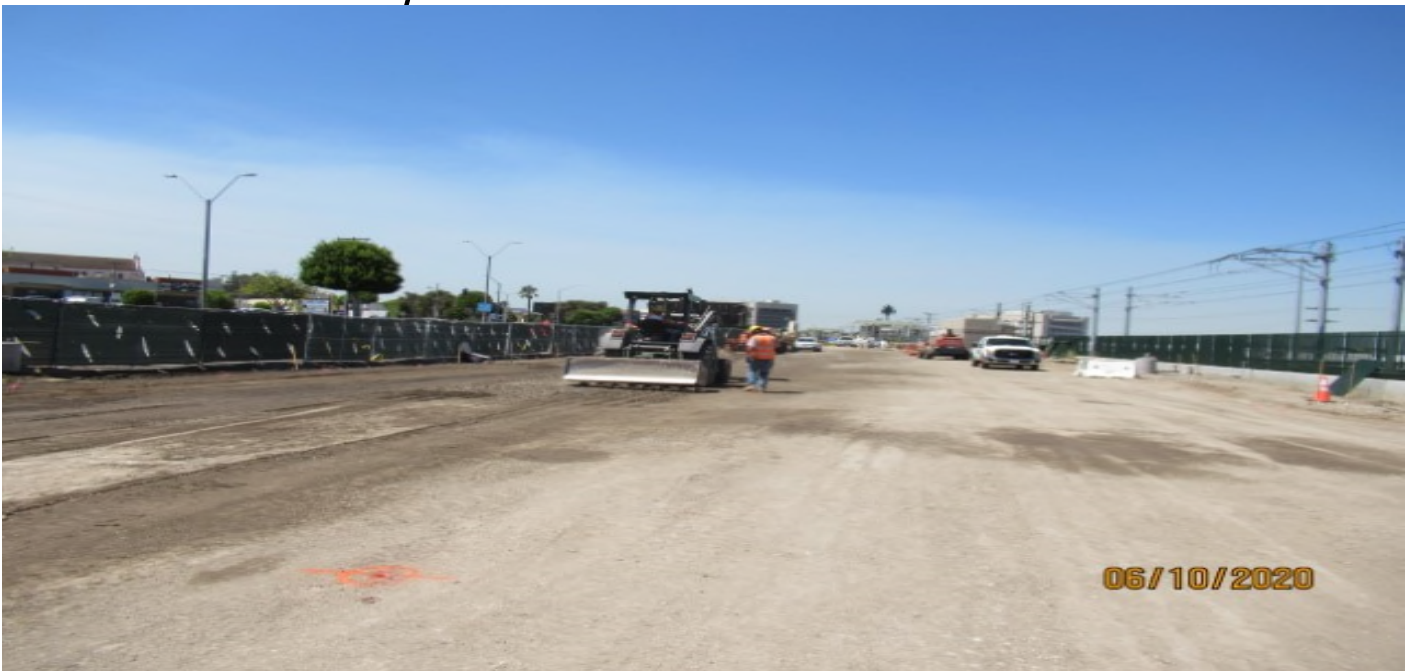
La Brea – WSCC adjusting elevations on CMB in La Brea parking lot, using front end skip loader (looking south)

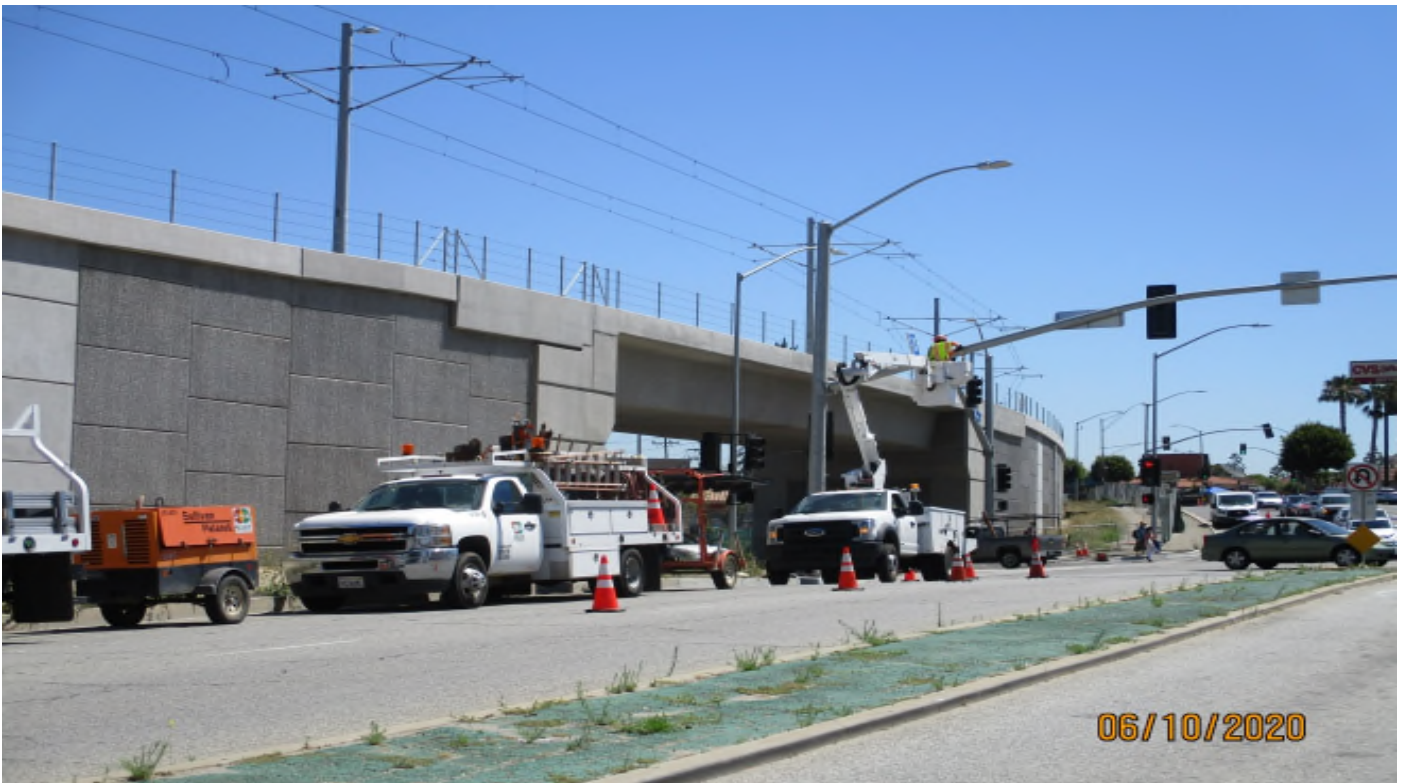
La Brea –Placing street signs on the traffic signal mast arm at La Brea.

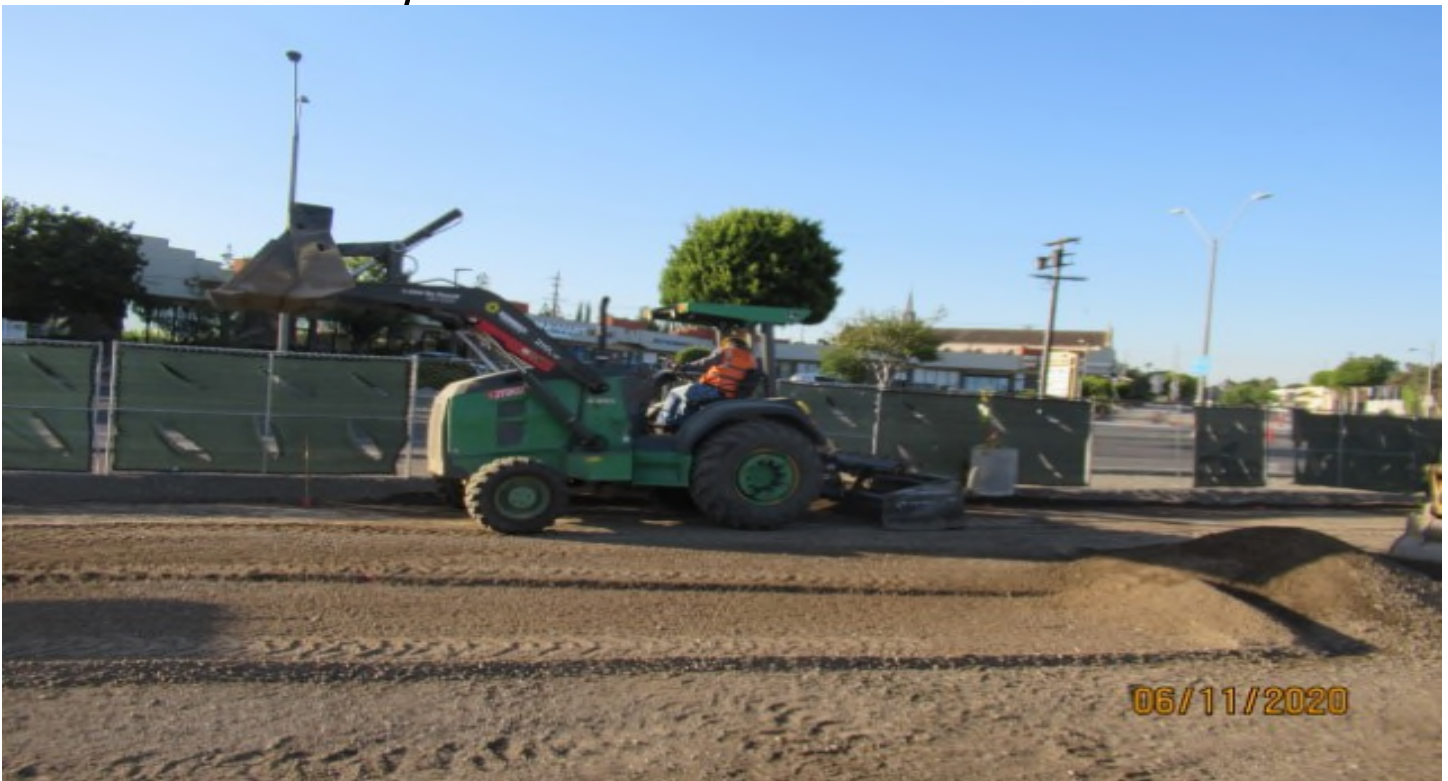
La Brea – WSCC final grading in La Brea parking lot (looking east)

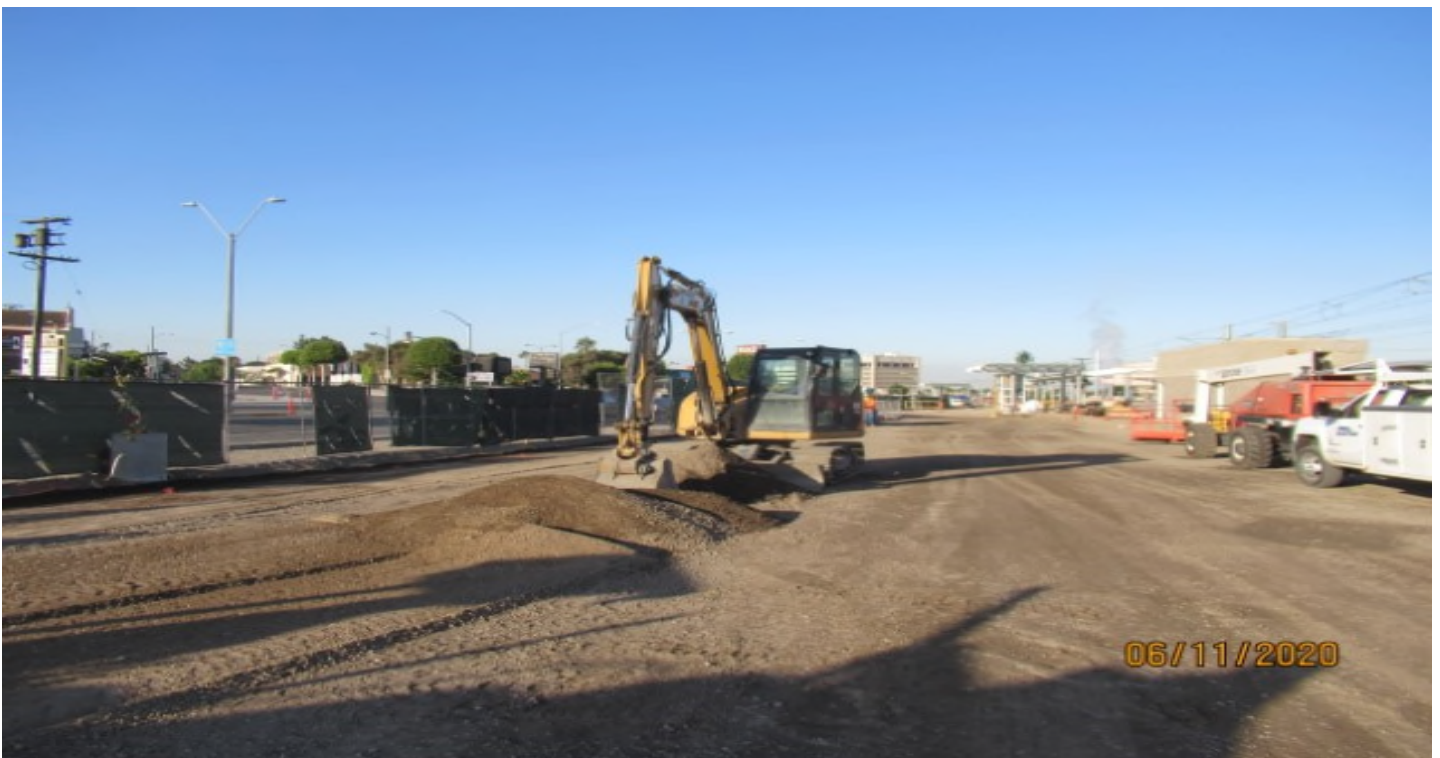
La Brea – La Brea parking lot WSCC final grading CMB (looking south)

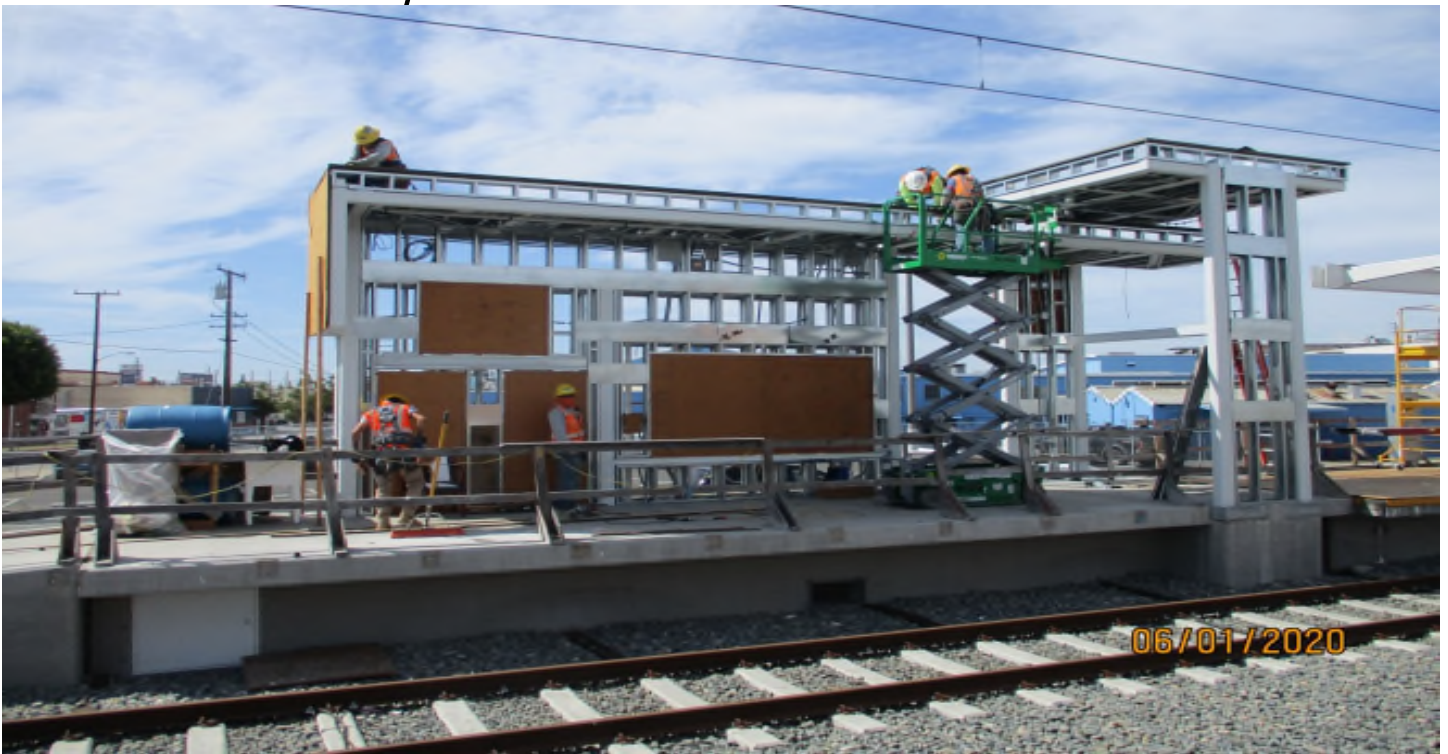
Hindry Station – Framing in the roof block outs at the Hindry Station.

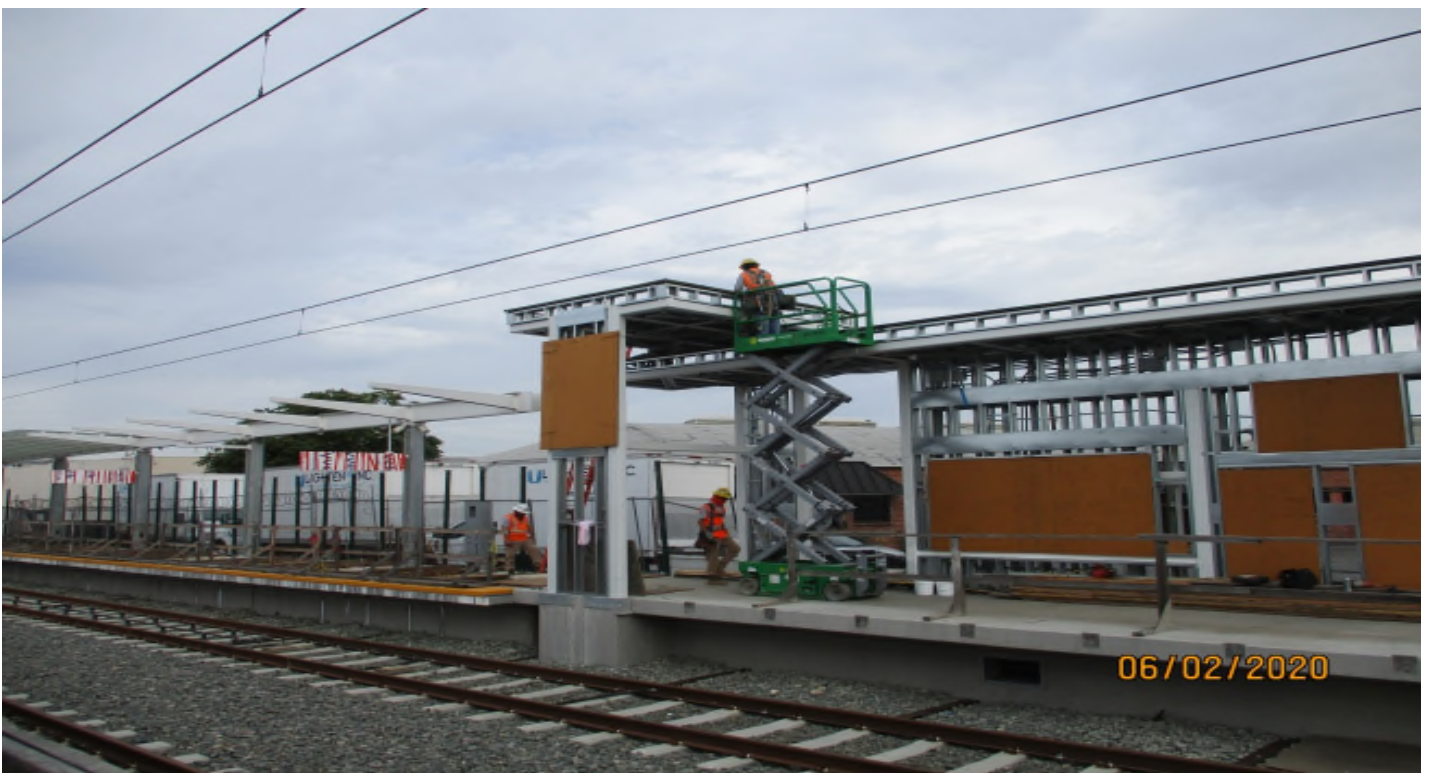
Hindry Station – Framing for the TVM roof deck at the Hindry Station SB platform.
