CRENSHAW/LAX PHOTOGRAPHIC UPDATE

July 7, 2020

Crenshaw/LAX Transit Project

Overview of trackwork progress issues for 06-22-2020 – July 7, 2020
(Please note the attached Trackwork Progress Tracking Report)

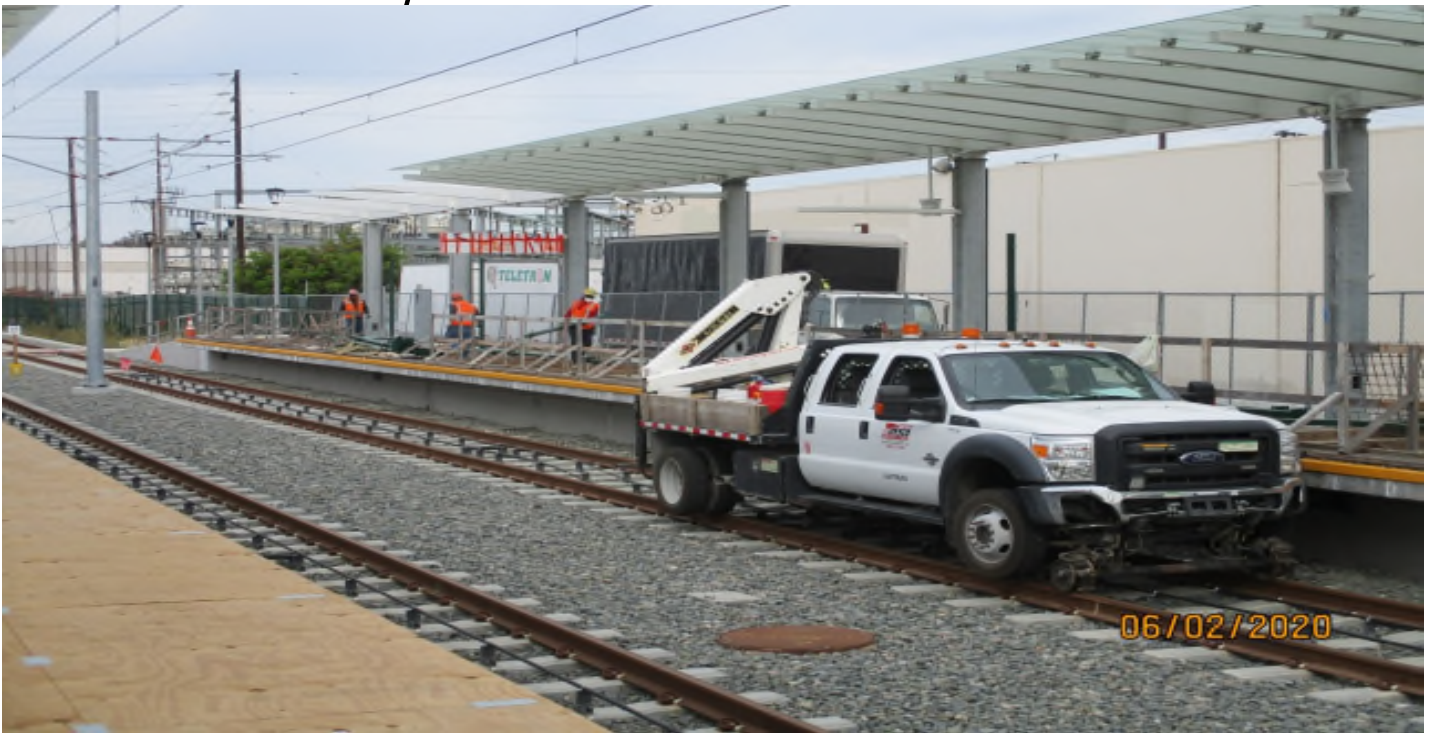
Hindry Station – Setting fence posts at the Hindry Station SB platform.

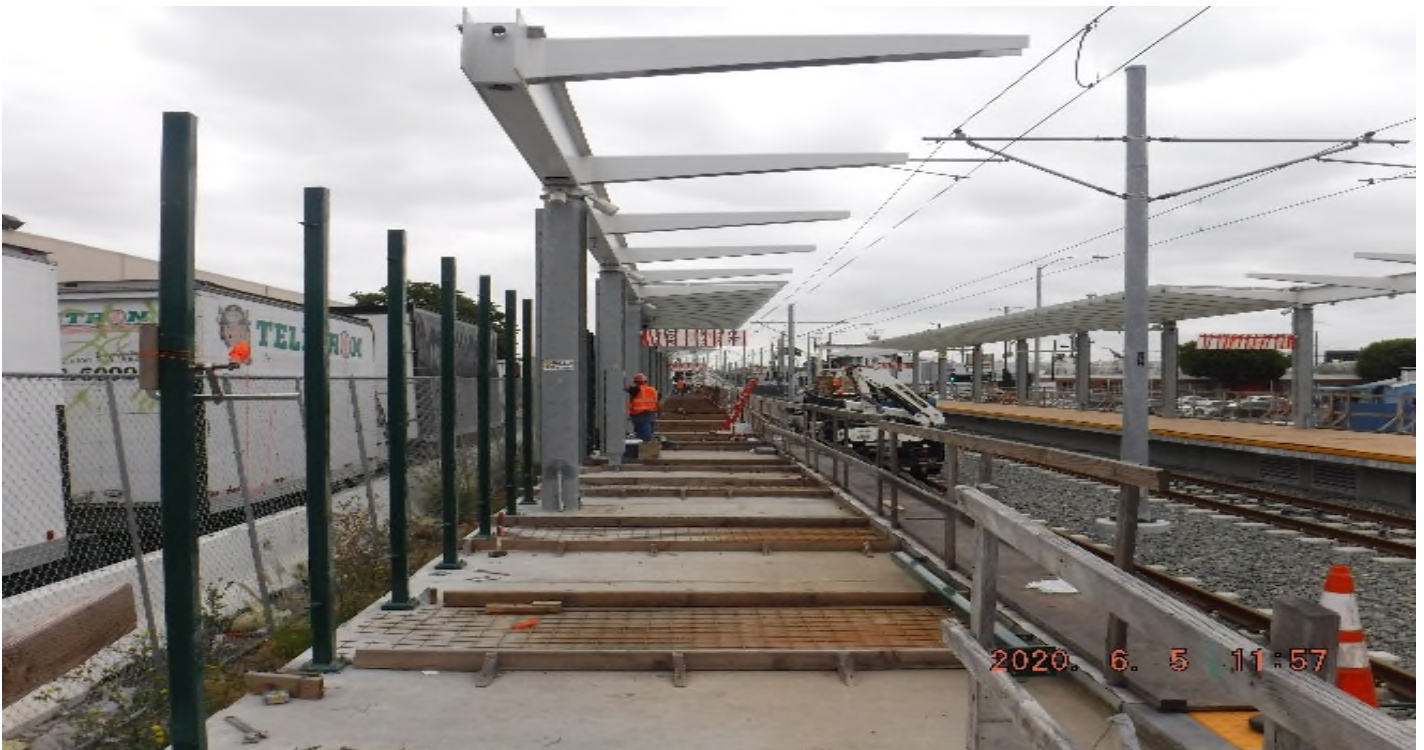
Hindry Station – STA 131+00 TK#3/SB looking north – Hindry Station install the 8' fence posts along the backside of the platform

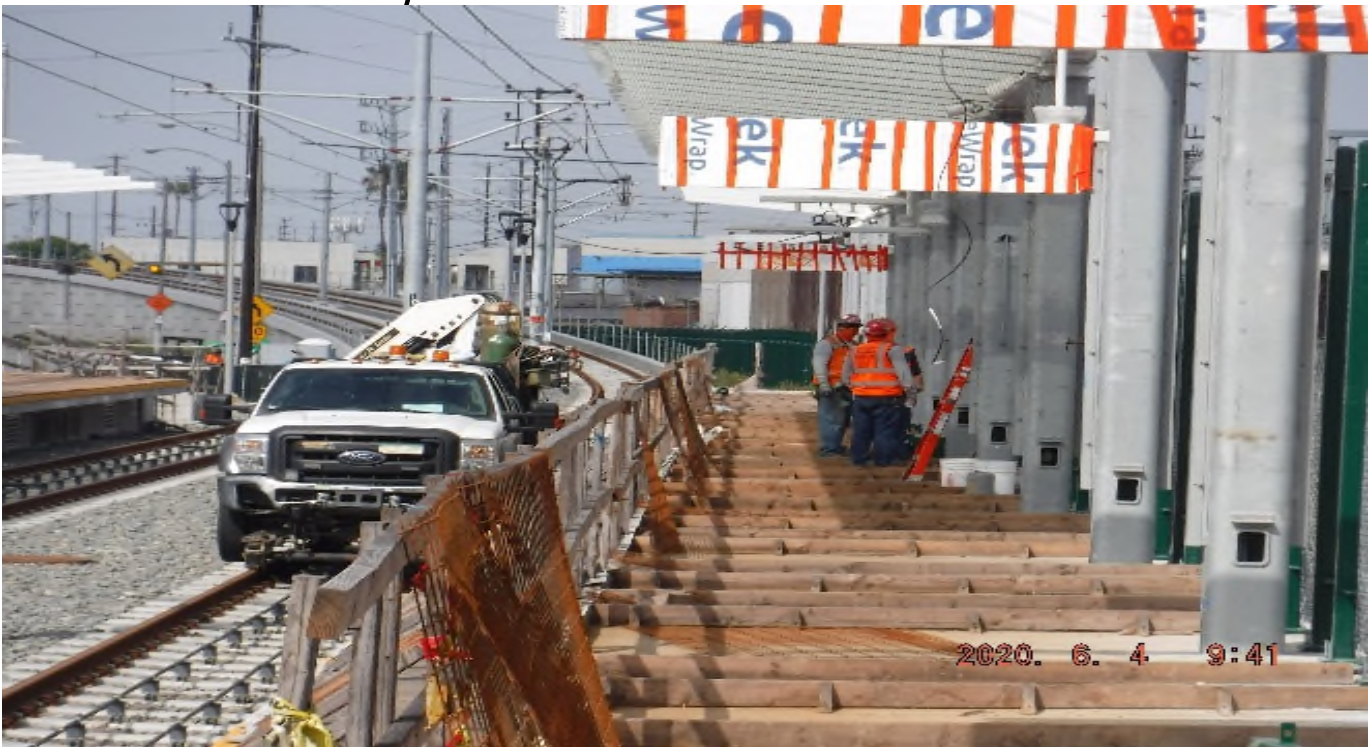
Hindry Station – STA 135+00 TK#3/SB looking south – Hindry Station install the 8' fence posts along the backside of the platform.

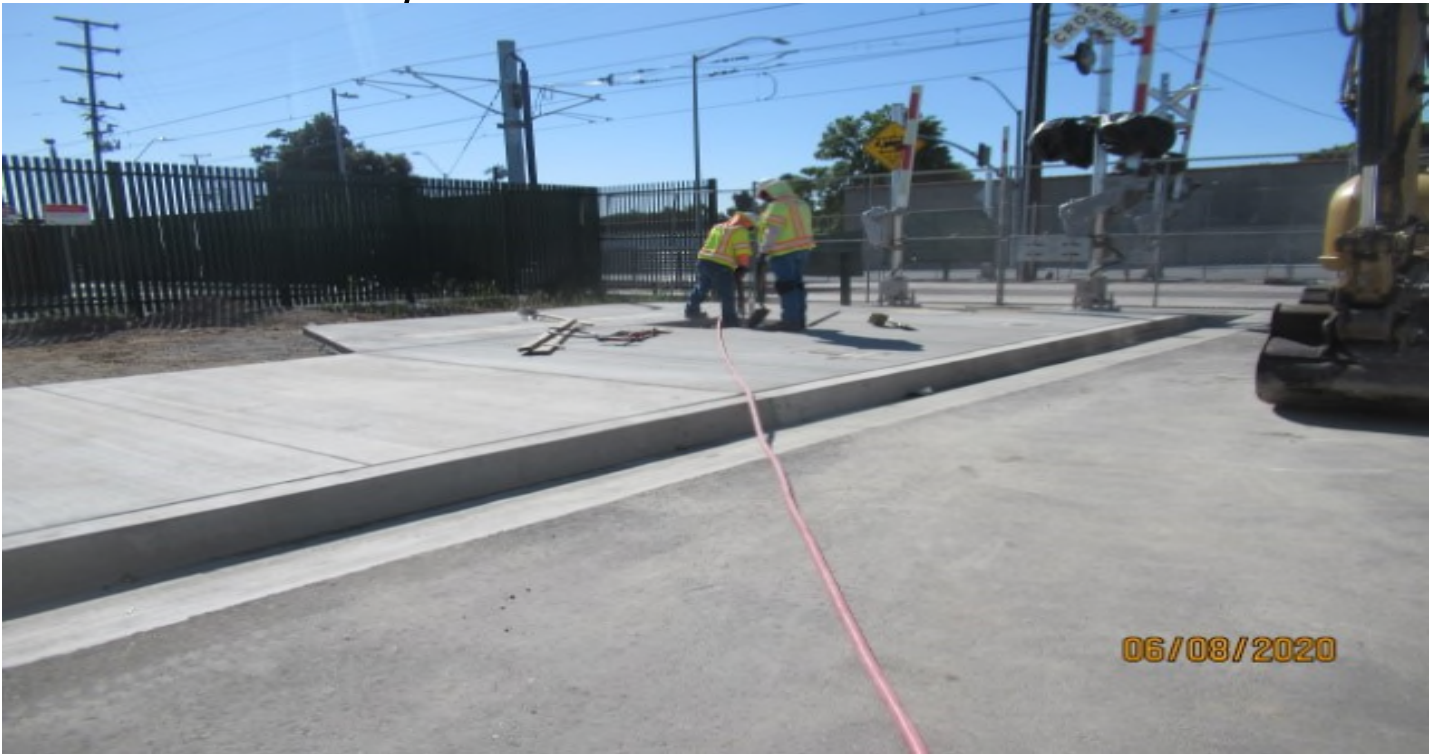
High Street – Select Electric at High St. preparing street light foundation controller box (looking northeast)

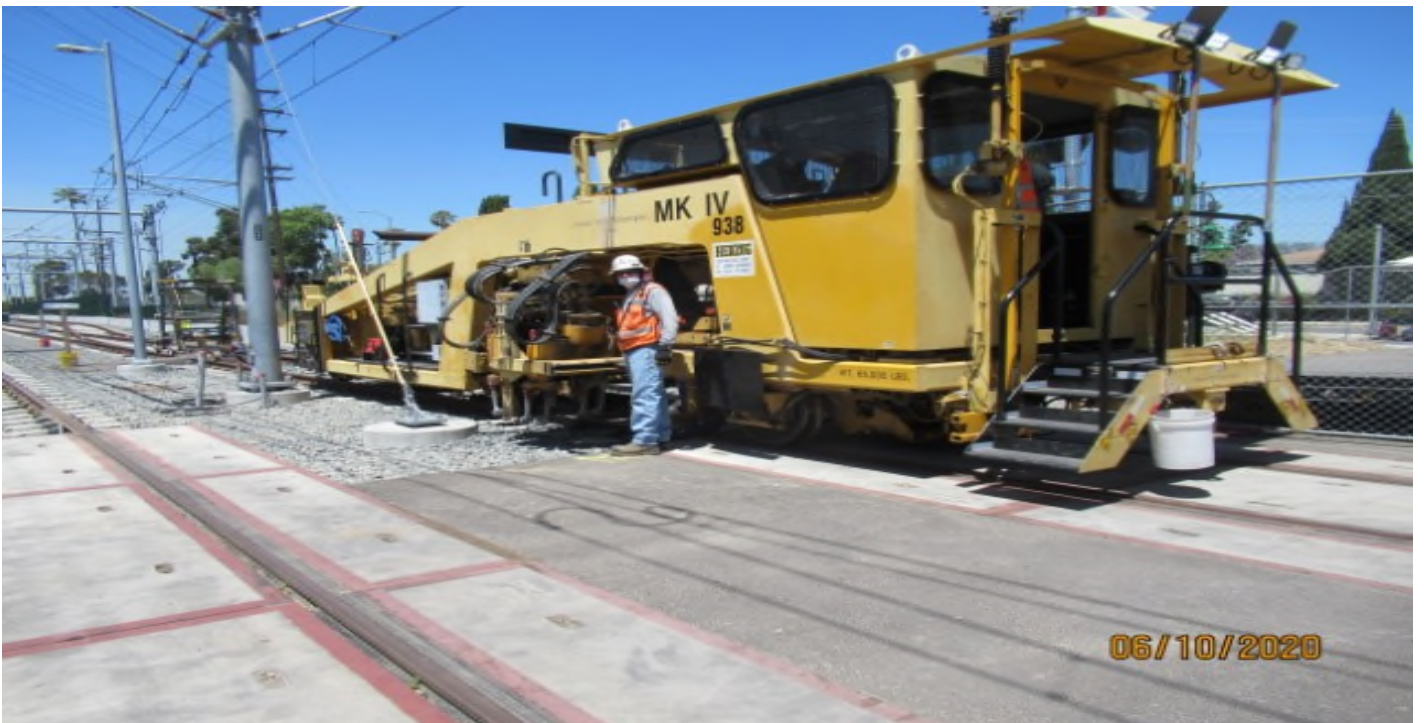
High Street – HCC’s Mark IV tamper at High St. on SB #3 (looking south west)

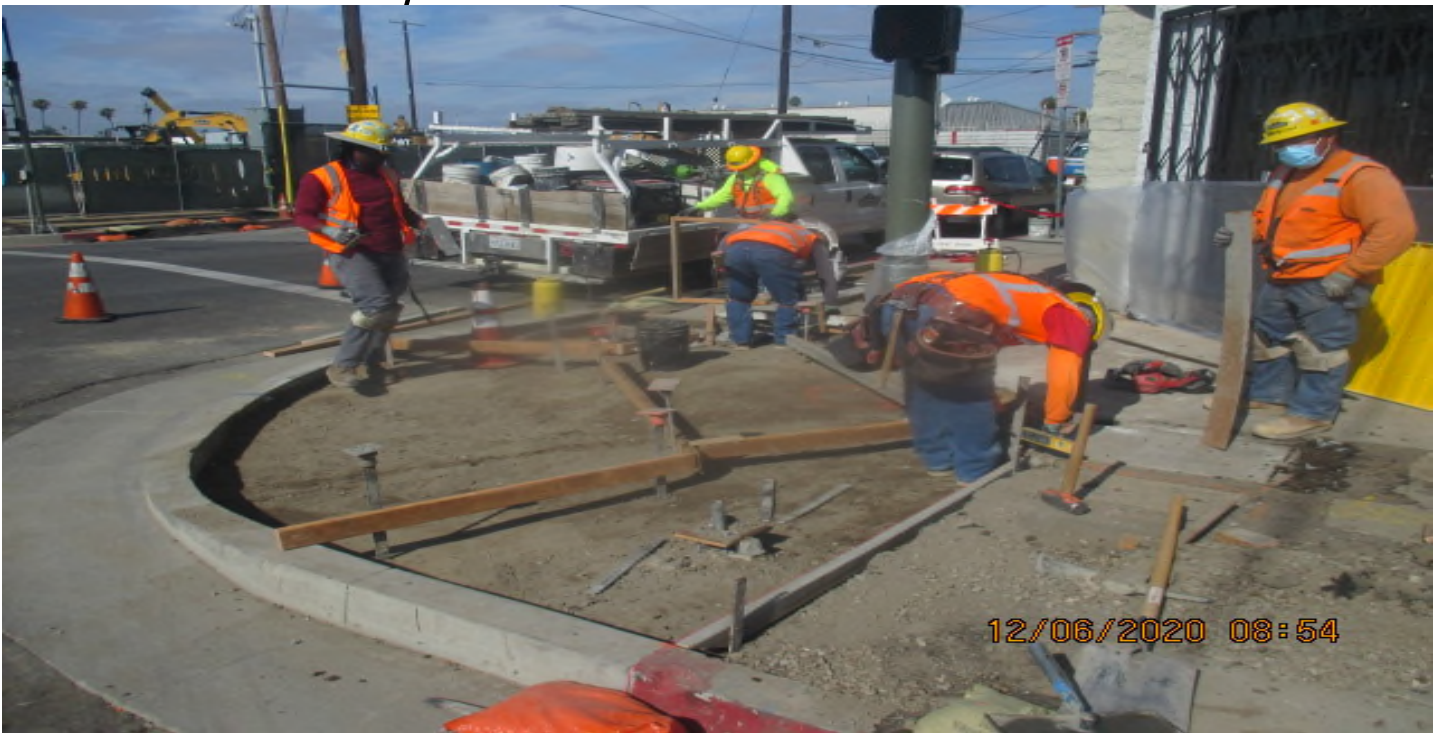
PARK MESA – Installing block-out forms for concrete placement of ADA ramp on the northwest corner of 67th St & Crenshaw Blvd. 6/12/20

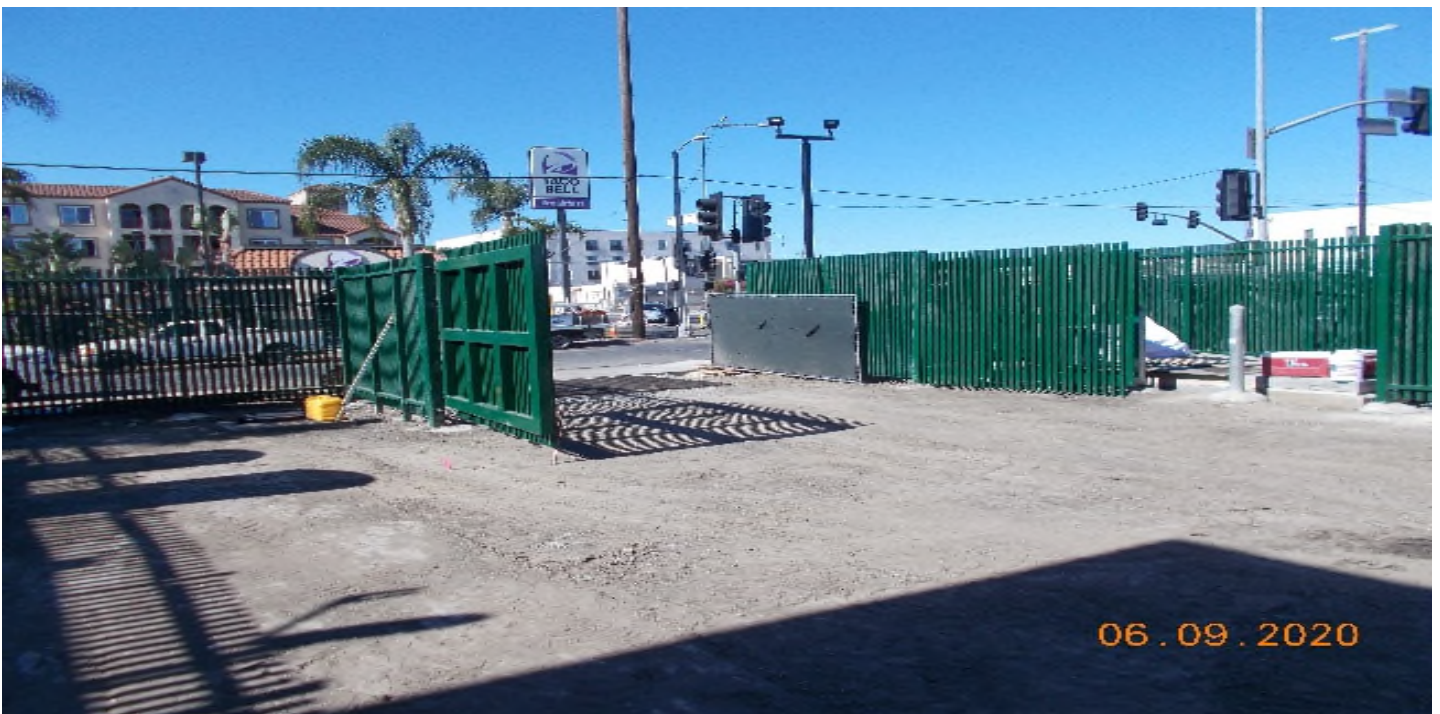
PARK MESA – Completed swing gate installation at the entrance of TPSS#7 on 60th St & Crenshaw Blvd.

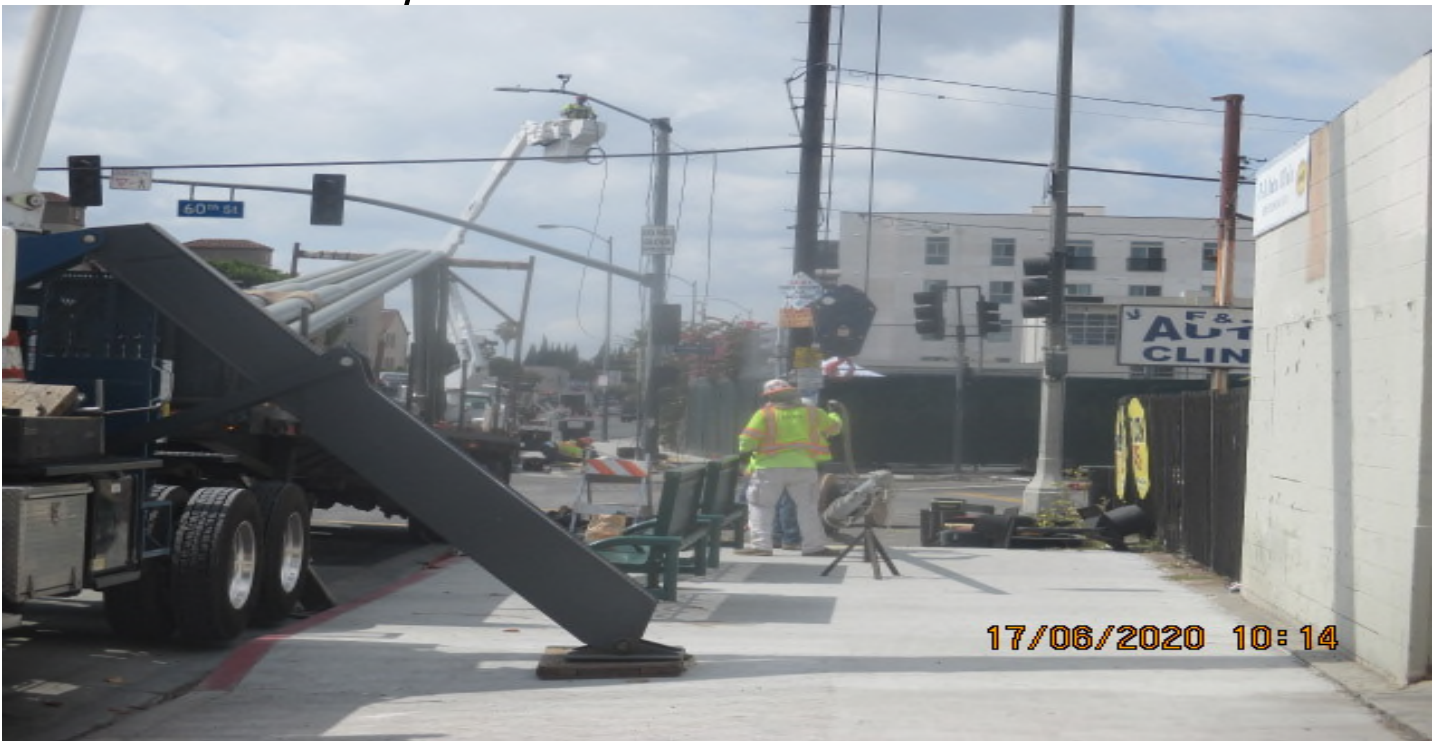
PARK MESA – Installing street light poles on both north and southwest corners of 60th St & Crenshaw Blvd. 6/17/20

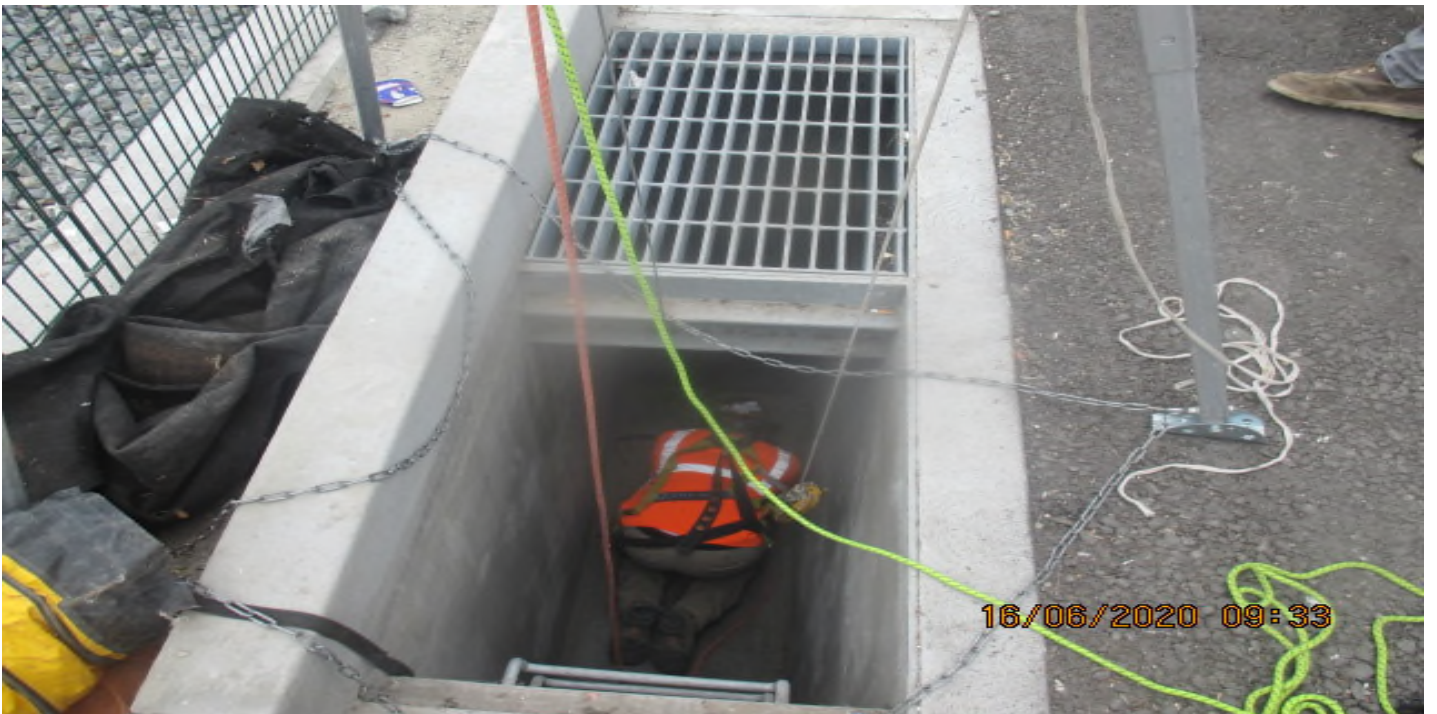
PARK MESA – Sack and patching Catch Basin #13 on southbound Crenshaw Blvd and Slauson Ave. 6/16/20

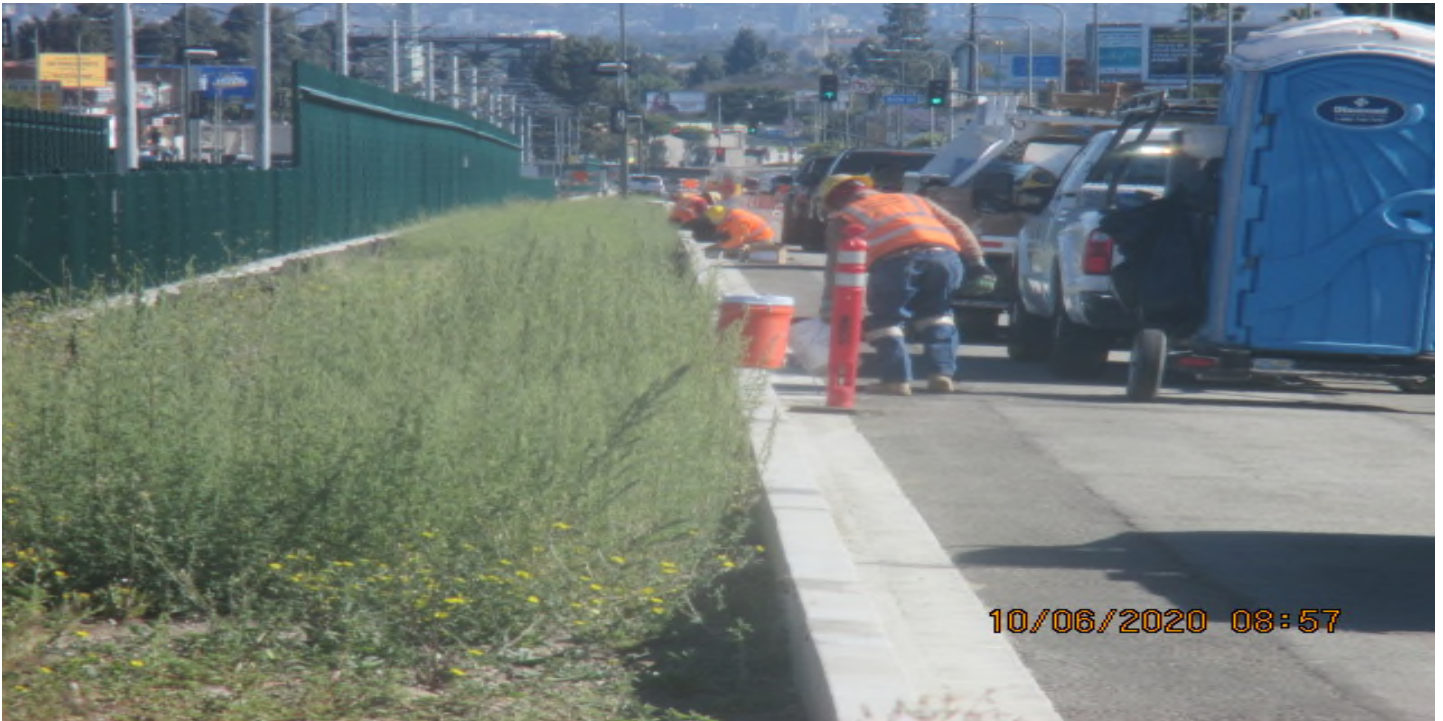
PARK MESA – Continue sack and patching center median on northbound Crenshaw Blvd between 50th St. and 52nd St. 6/10/20

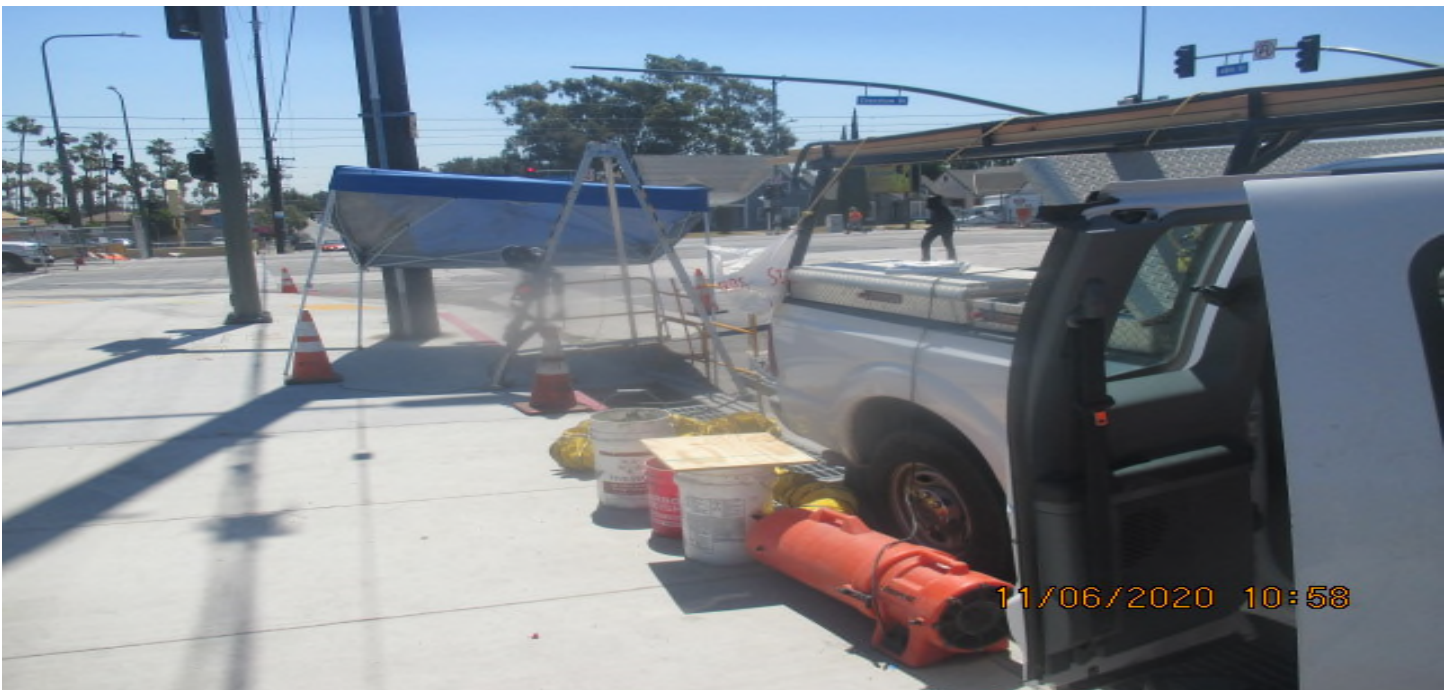
PARK MESA – Sack and patching Catch Basin #29 on southbound Crenshaw Blvd and 48th St. 6/11/20

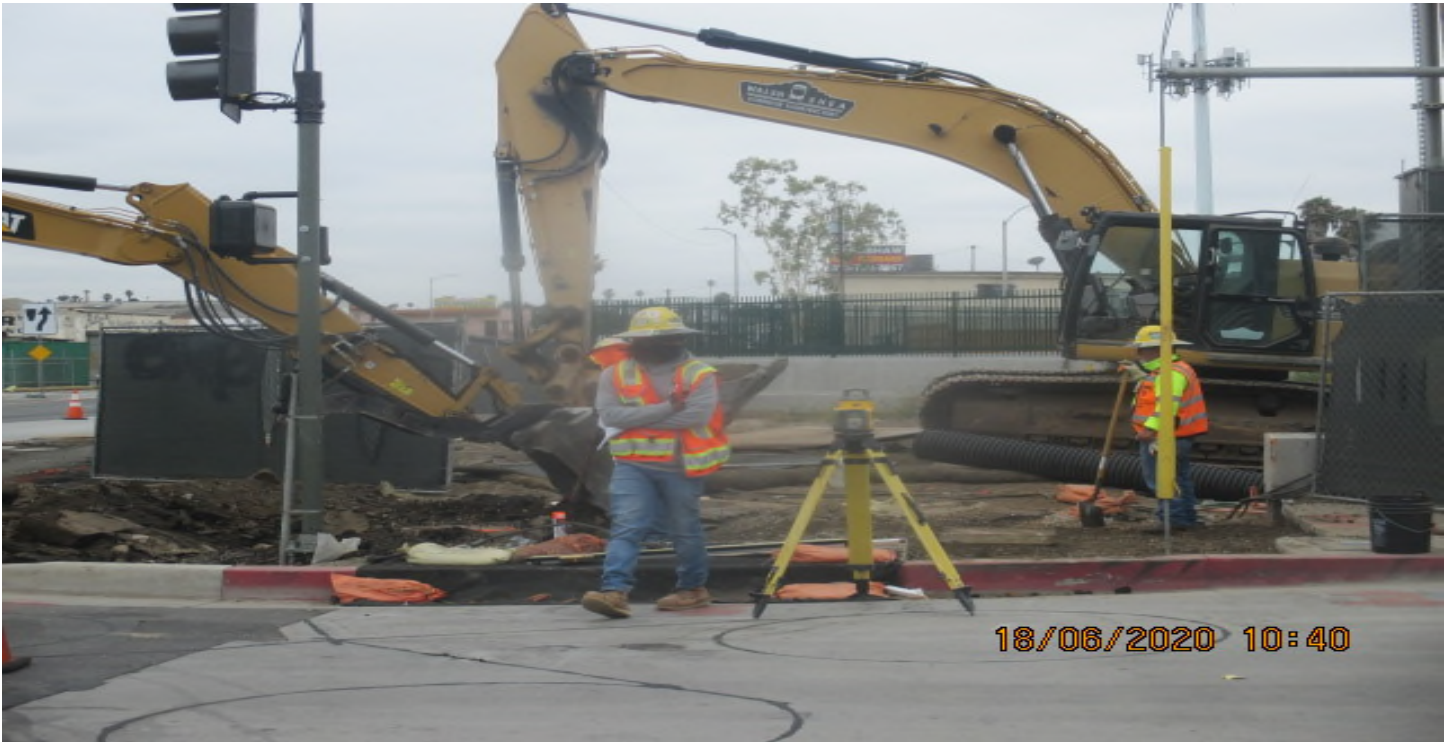
PARK MESA – Excavating/grading for new sidewalk installation on the southwest corner of 67th St & Crenshaw Blvd. 6/18/20

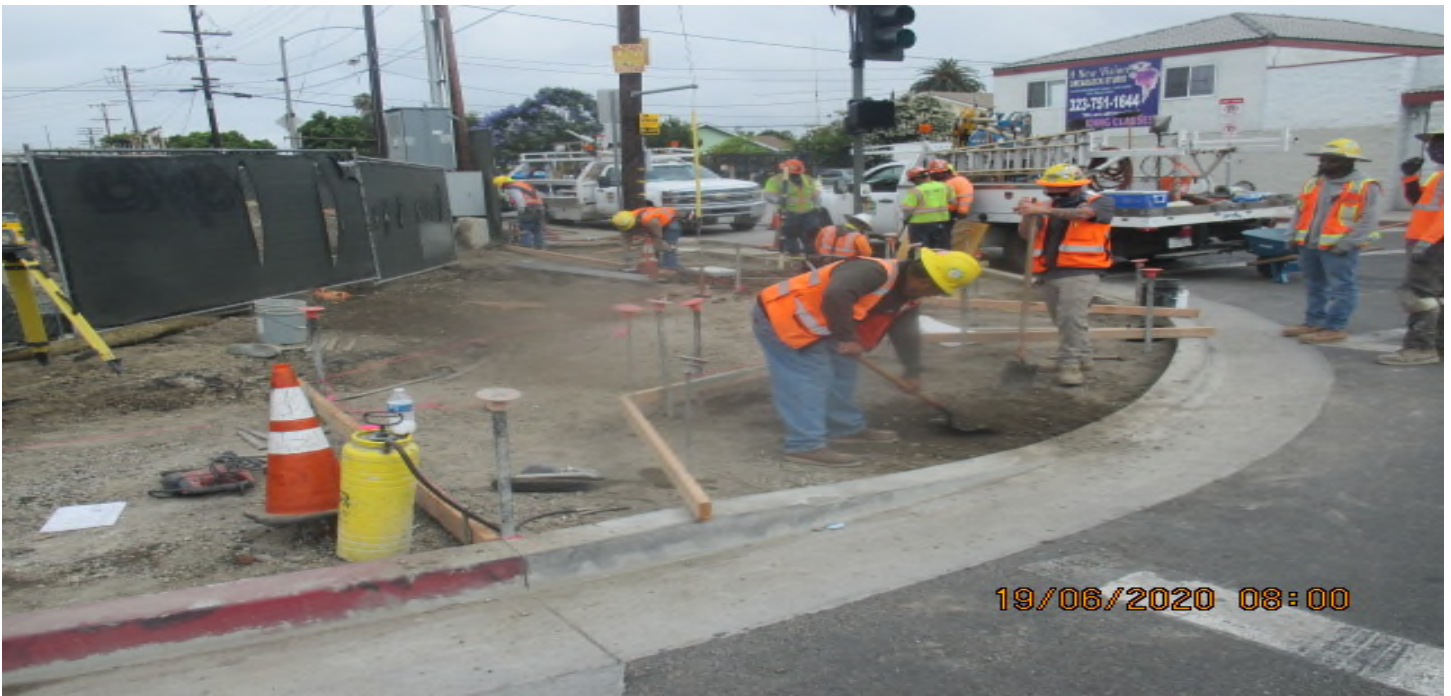
PARK MESA – Build block-out forms for ADA ramp installation and light pull boxes on the southwest corner of 67th St & Crenshaw Blvd. 6/19/20

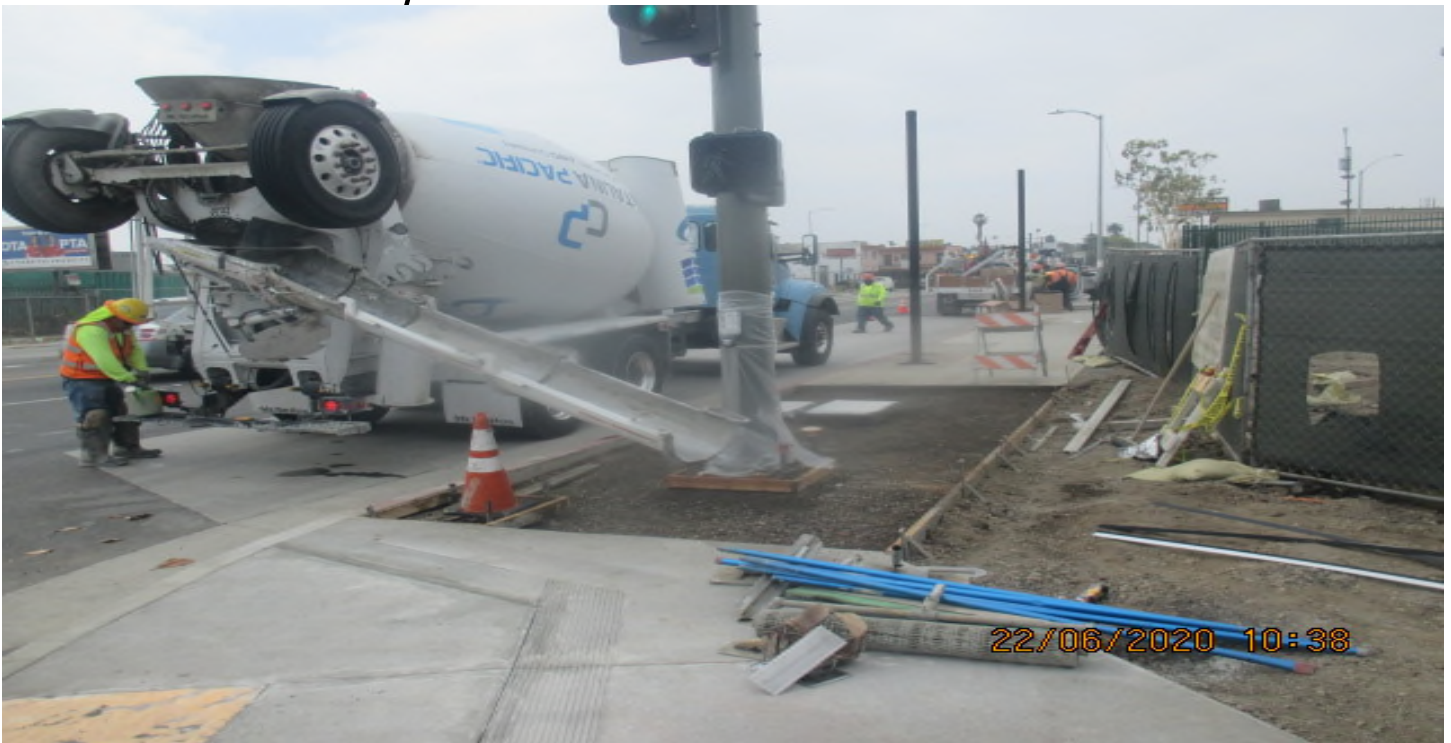
PARK MESA – Placing concrete for new sidewalk panel installation on the southwest corner of 67th St & Crenshaw Blvd. 6/22/20

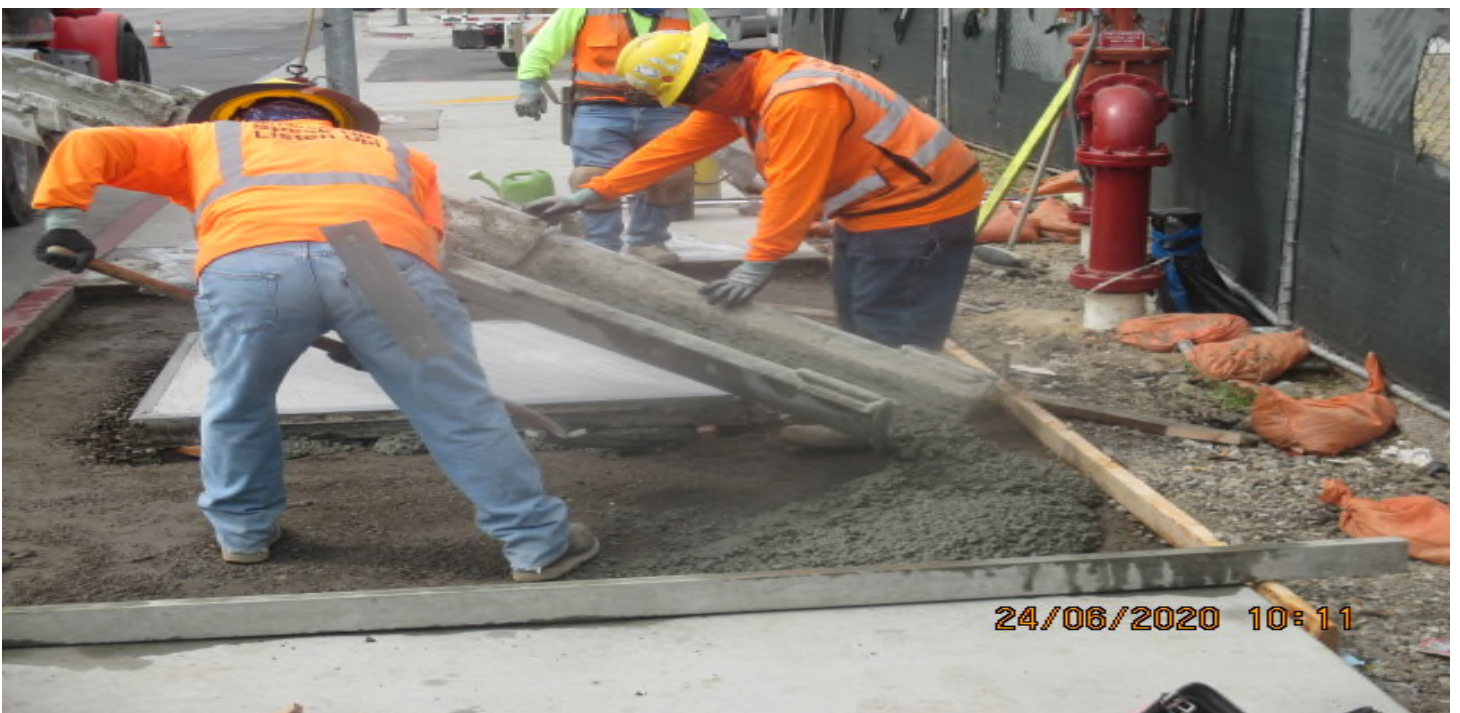
PARK MESA – Placing concrete for new bud pad installation on the southwest corner of 67th St & Crenshaw Blvd. 6/24/20

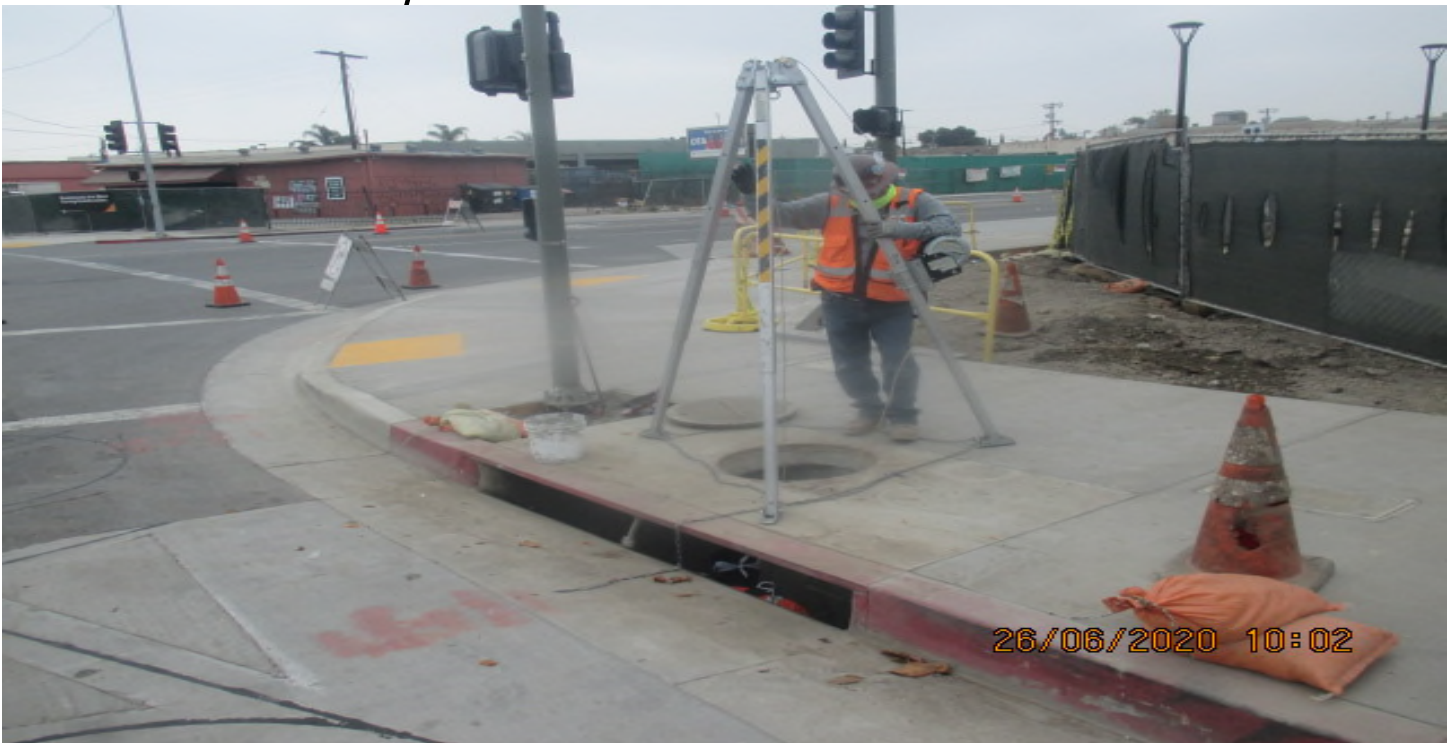
PARK MESA – Sack and patching Catch Basin #31 on the southwest corner of 67th St & Crenshaw Blvd. 6/26/20

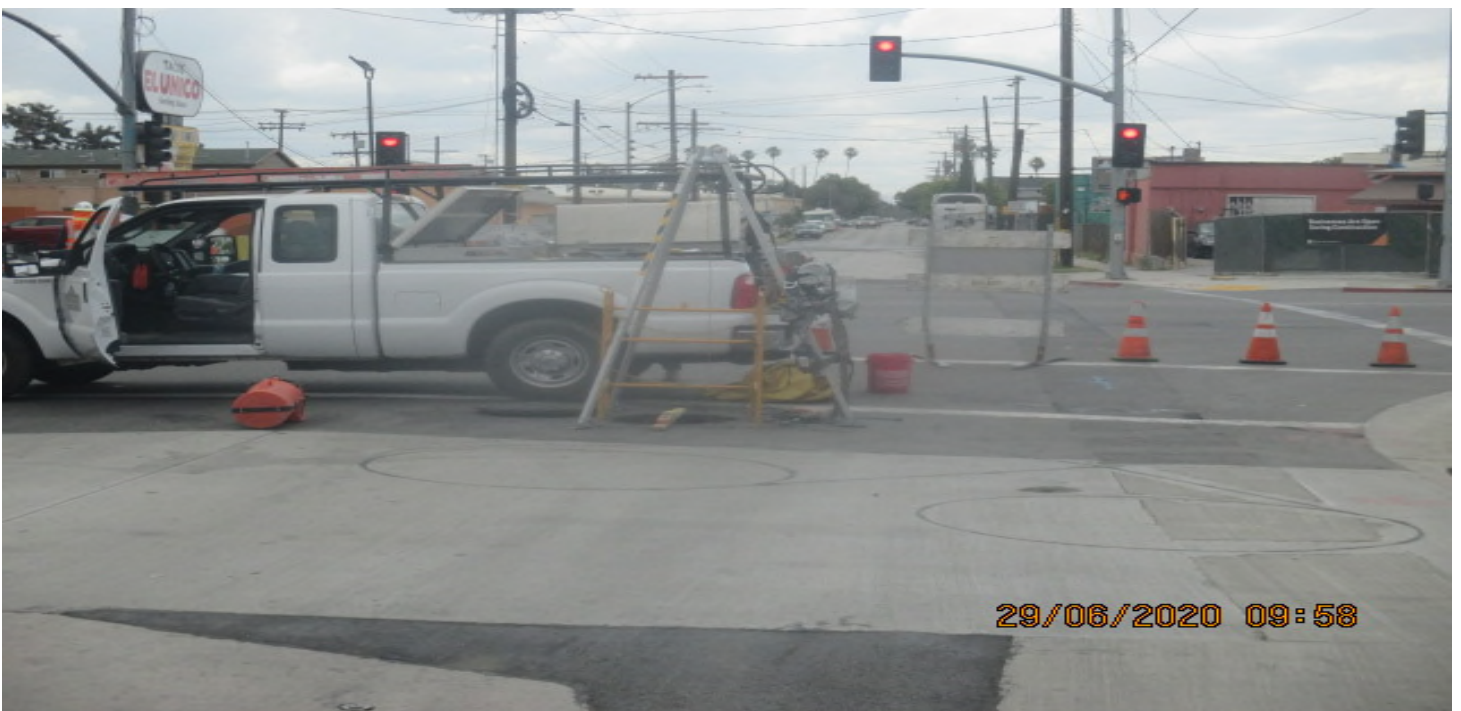
PARK MESA – Sack and patching Manhole #4 on the southwest corner of 67th St & Crenshaw Blvd. 6/29/20

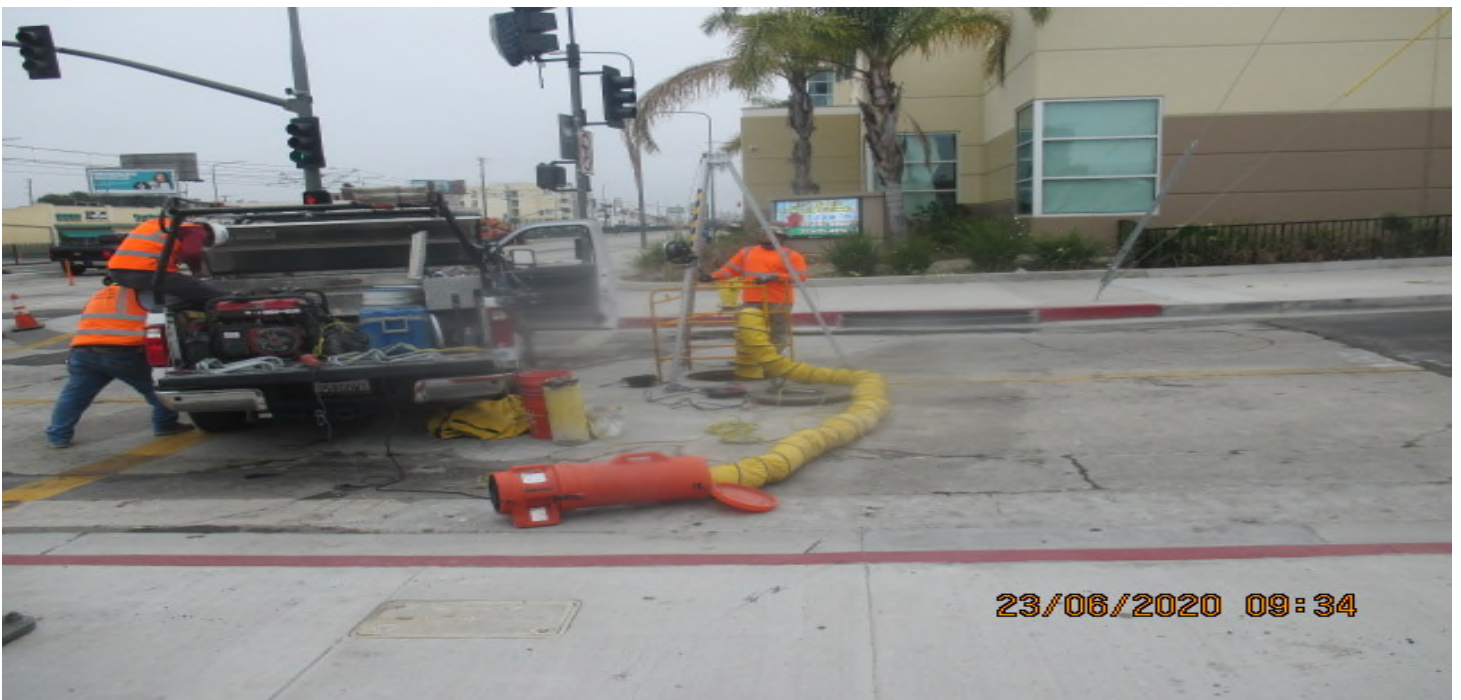
PARK MESA – Sack and patching Manhole #23 on southbound Crenshaw Blvd and 52nd St. 6/23/20

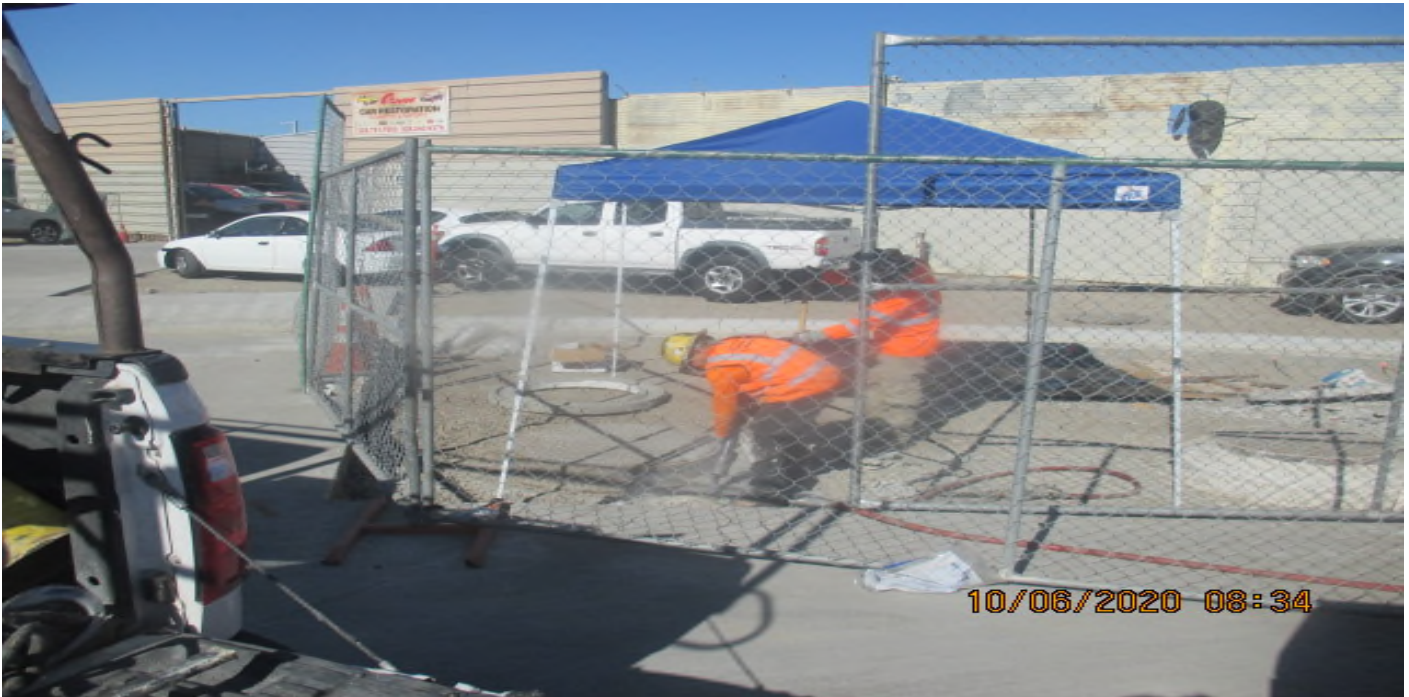
UG3 – Raising top elevation of existing manholes to road elevation at the Victoria Cul-de-sac. 6/10/20

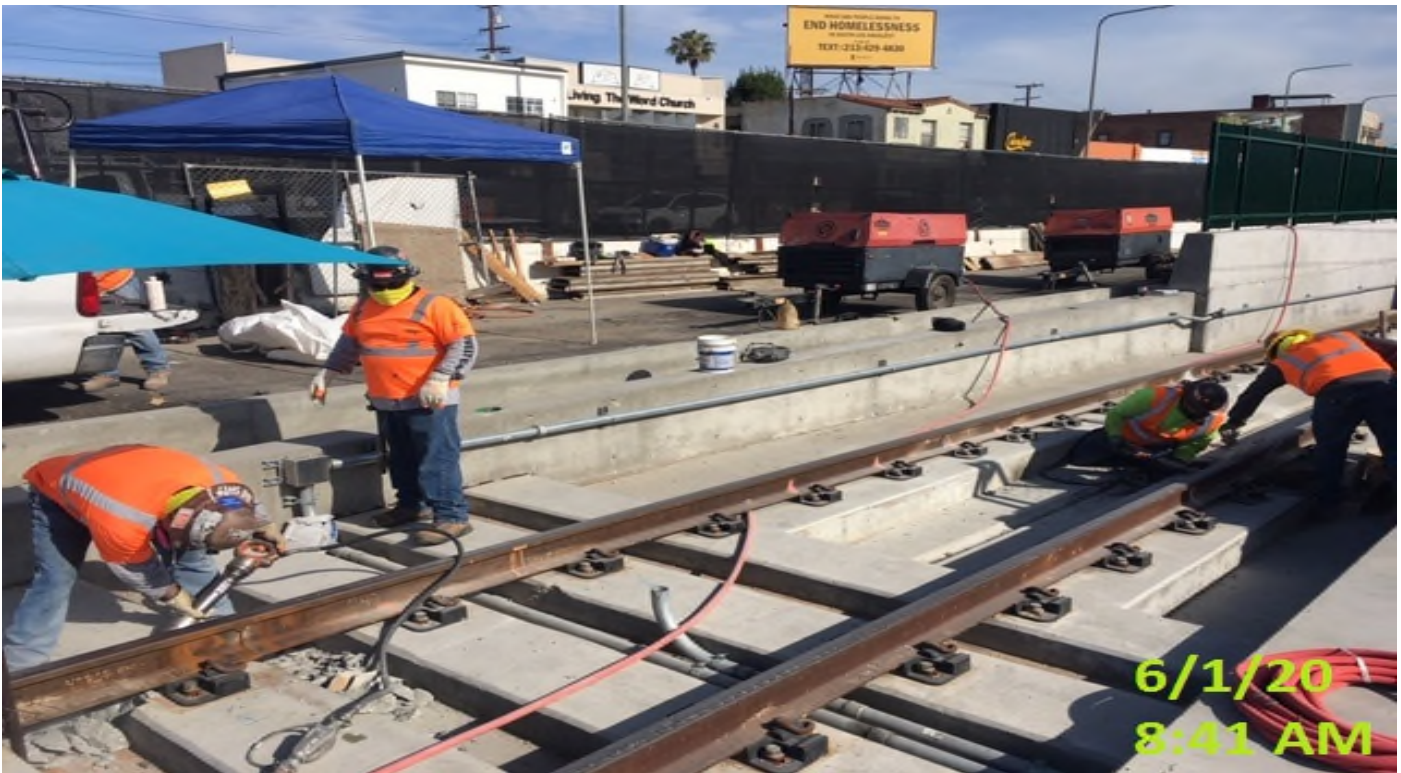
UG4 – Crew demoing sections of plinths blocks.

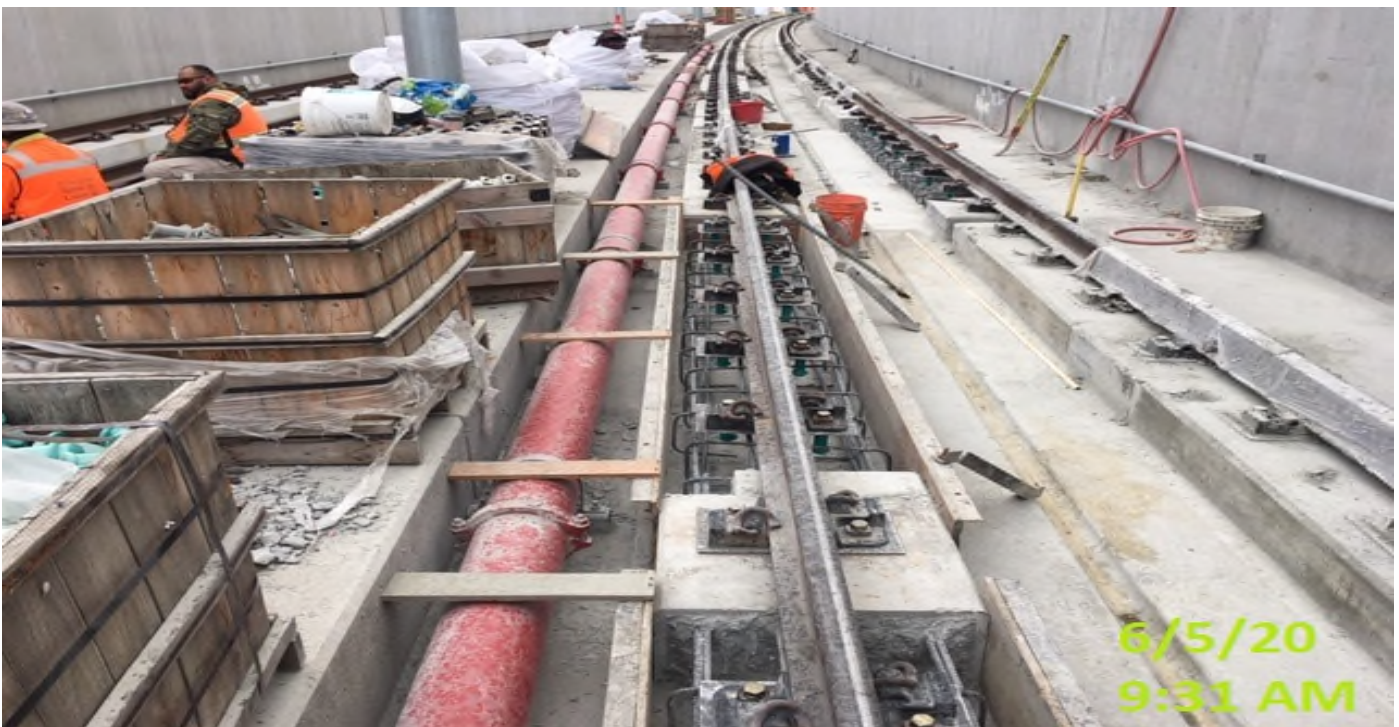
UG4 – WSCC crew continue demoing sections of plinths blocks.
