CRENSHAW/LAX PHOTOGRAPHIC UPDATE

July 7, 2020

Crenshaw/LAX Transit Project

Overview of trackwork progress issues for 06-22-2020 – July 7, 2020
(Please note the attached Trackwork Progress Tracking Report)

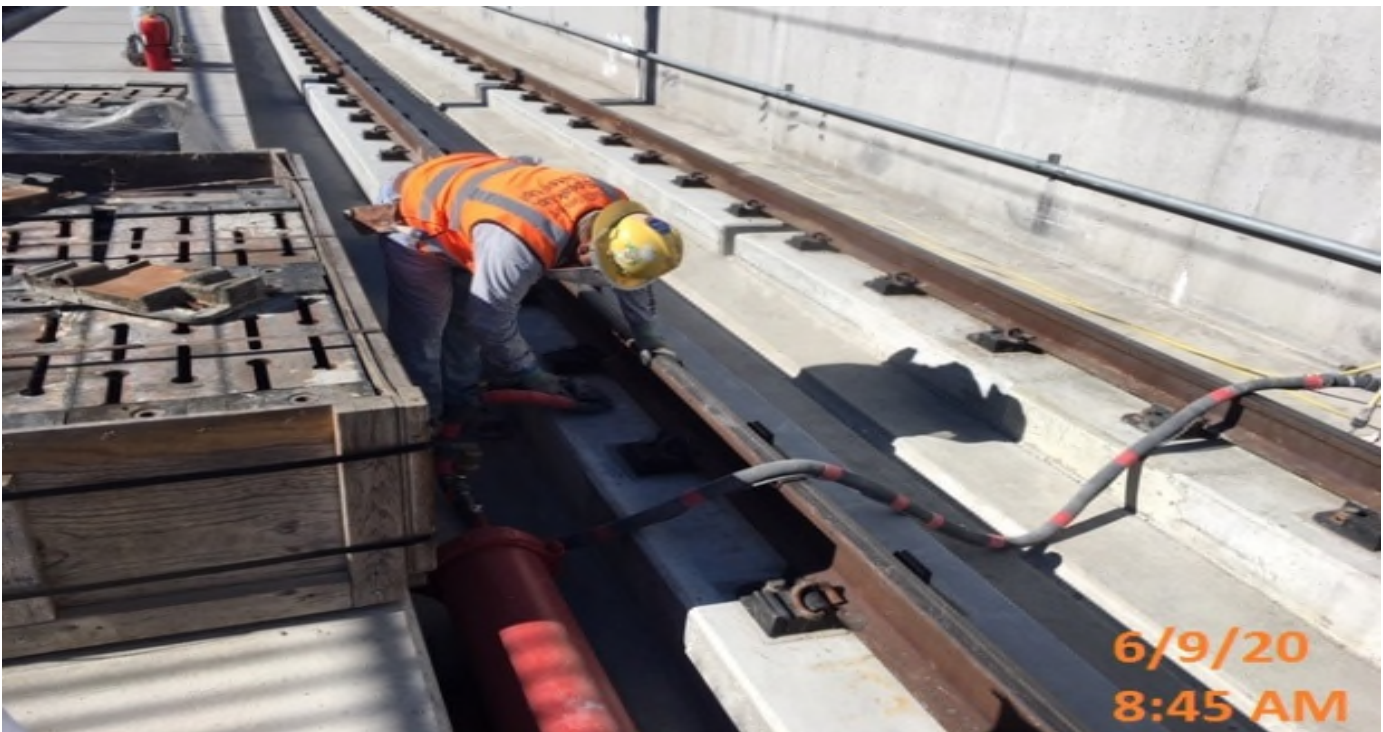
UG4 – WSCC crew resurfacing section of plinths.

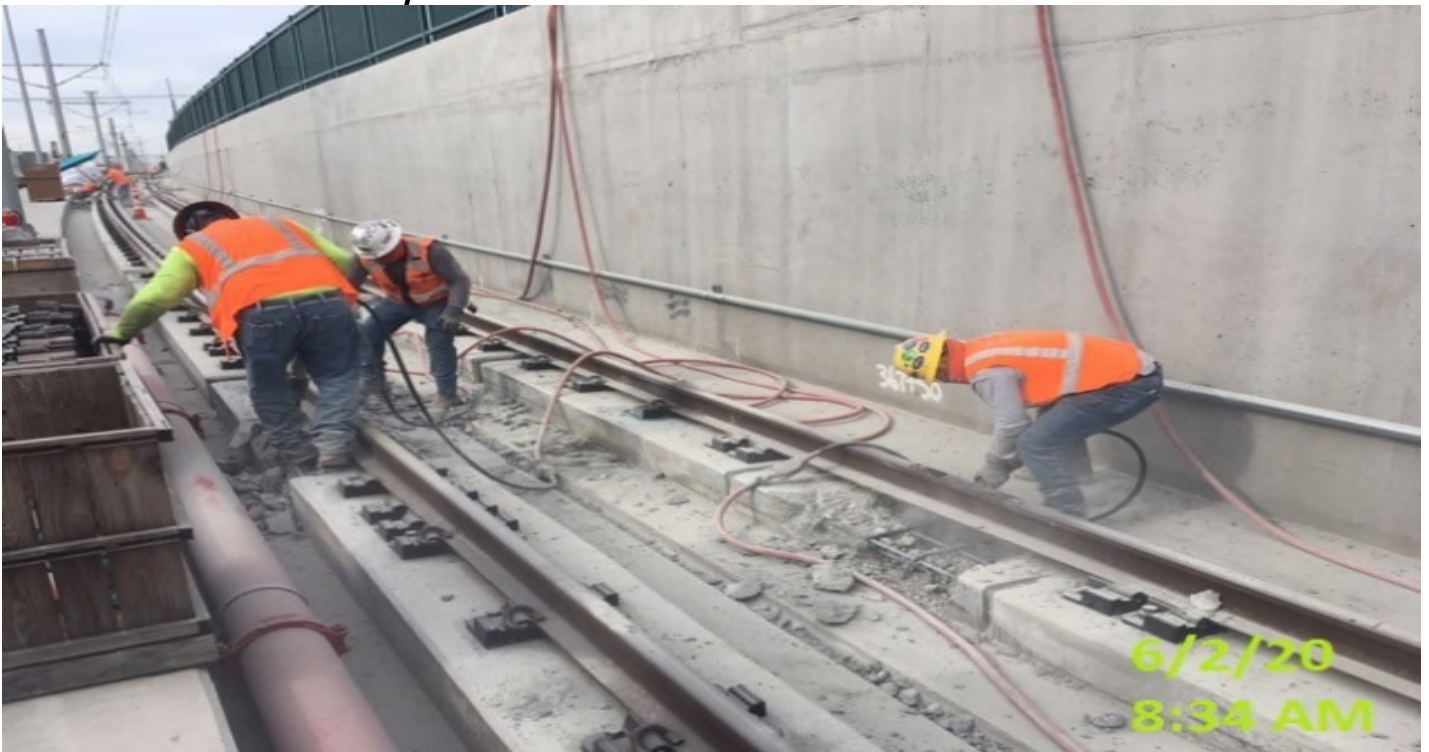
UG4 – Crew demoing sections of plinths blocks.

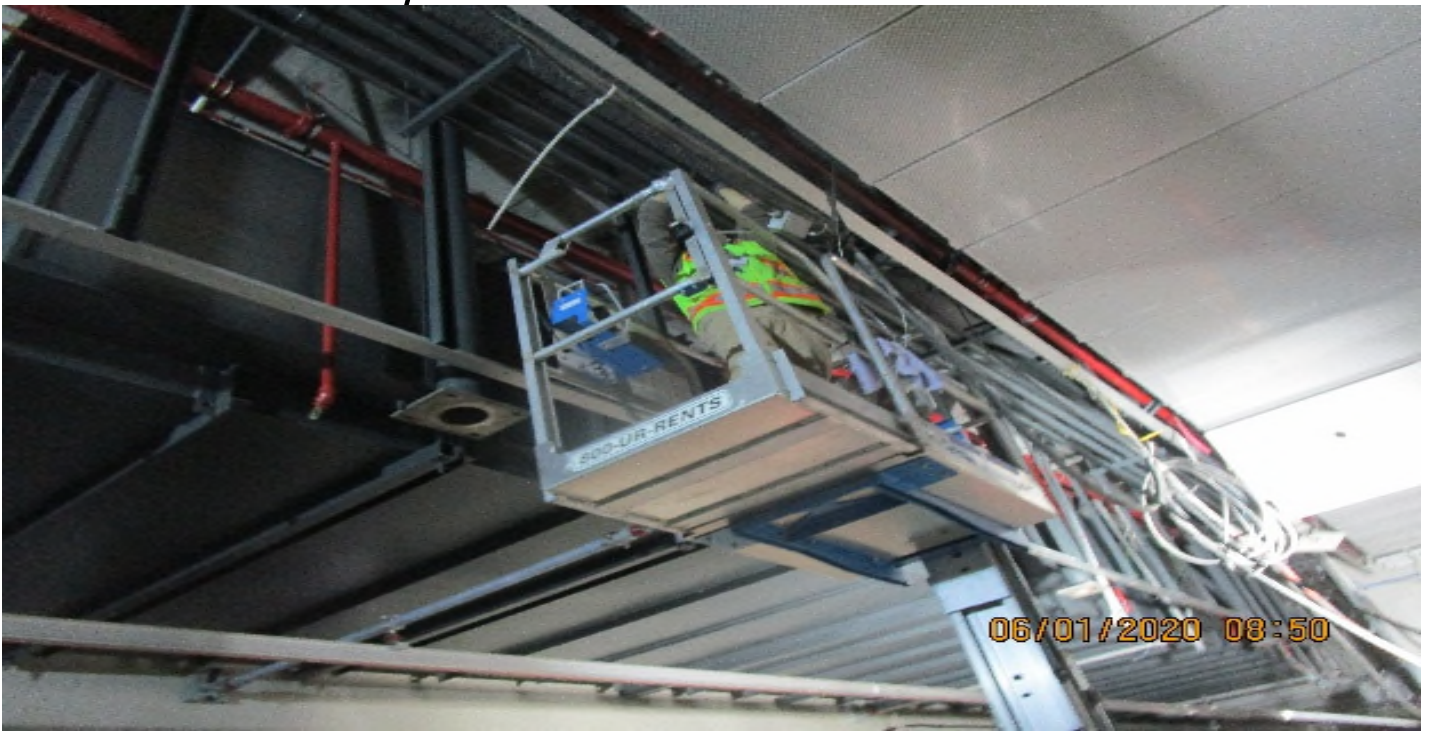
VERNON STATION- GL's 5.5,B.5, Continued piping 2" GRC fire alarm between pull boxes (punch list)

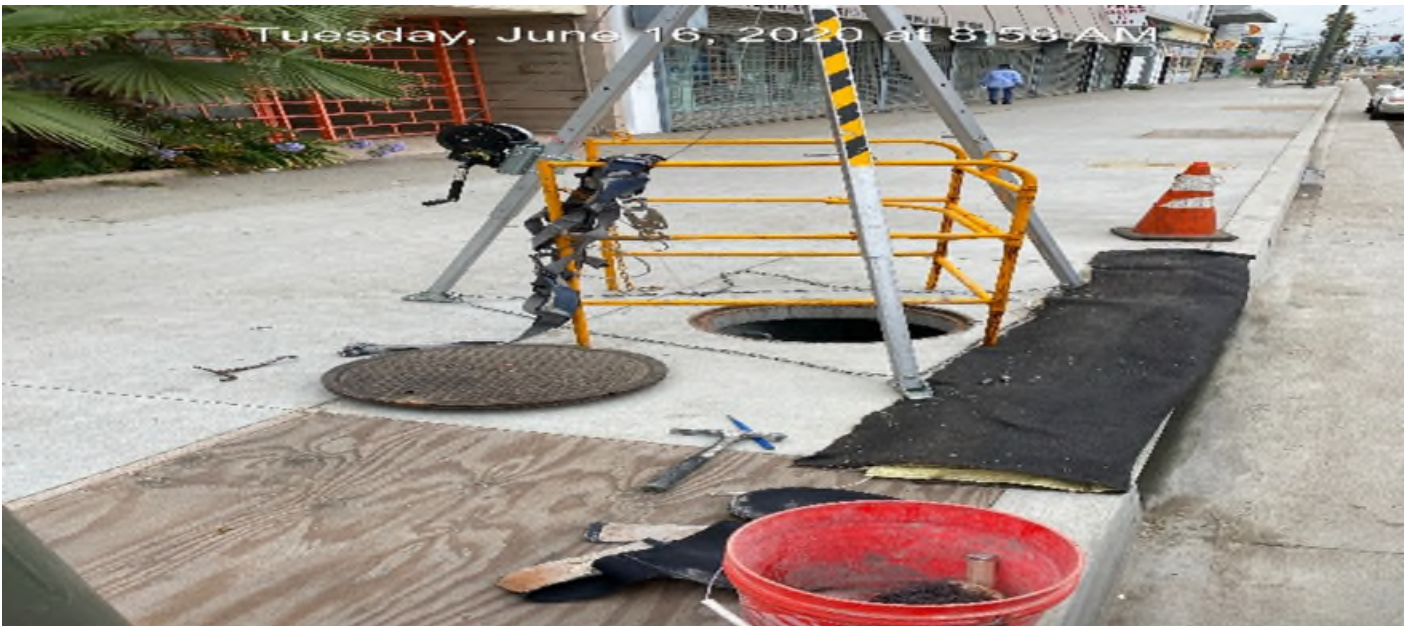
EXPO STATION – Sack and patching Catch Basin #8 on southbound Crenshaw Blvd between Rodeo Pl and Obama Blvd.

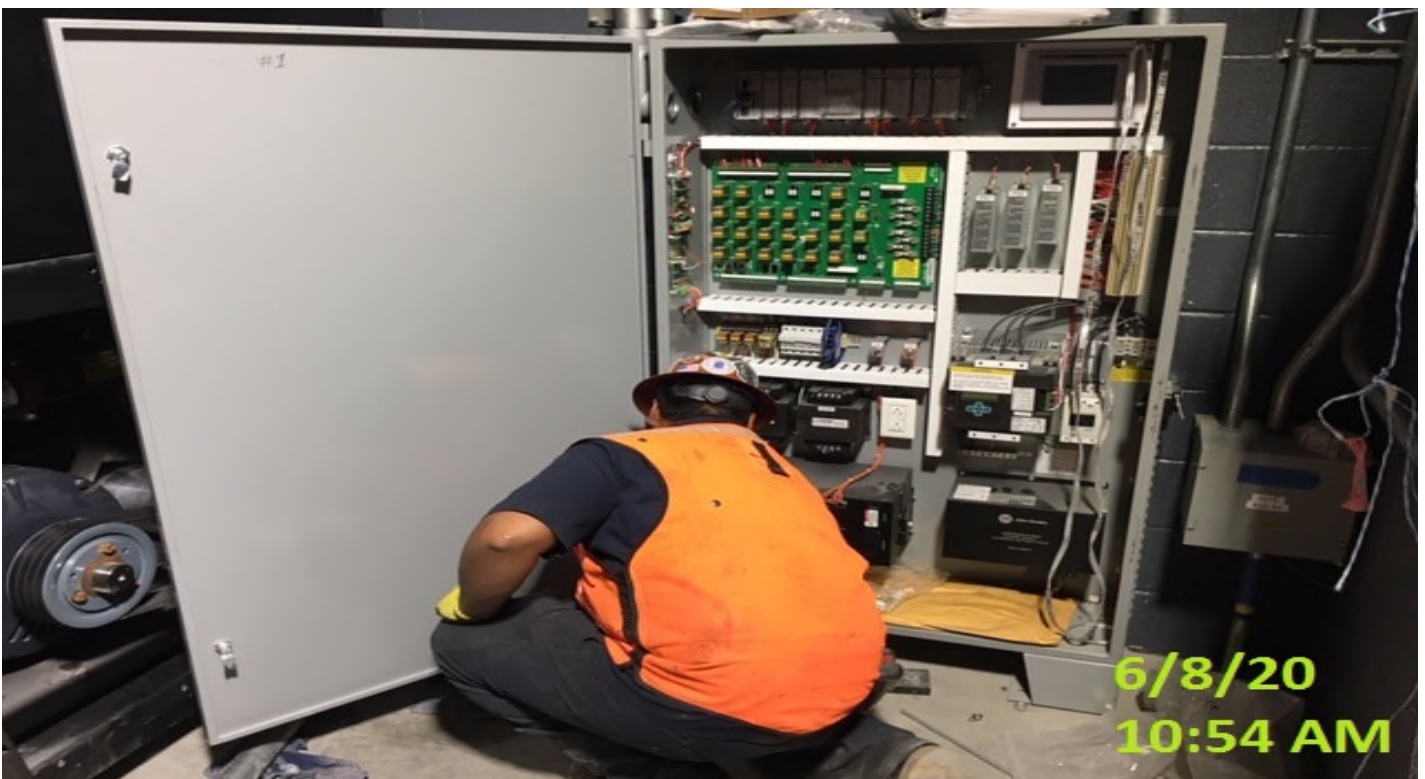
EXPO STATION- Excelsior running lines from motor leads to control panel.

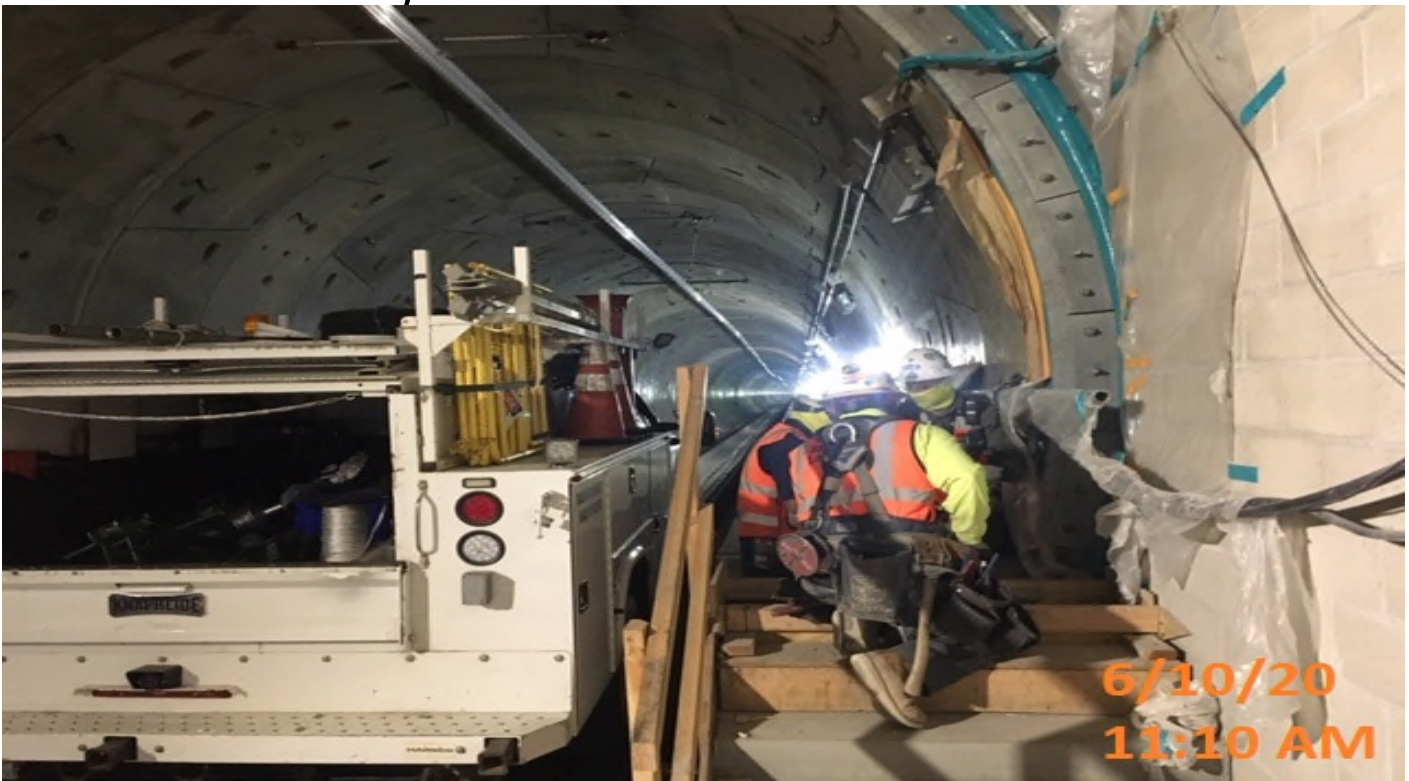
EXPO STATION- WSCC crew installing embed for stair landing at emergency walkway.

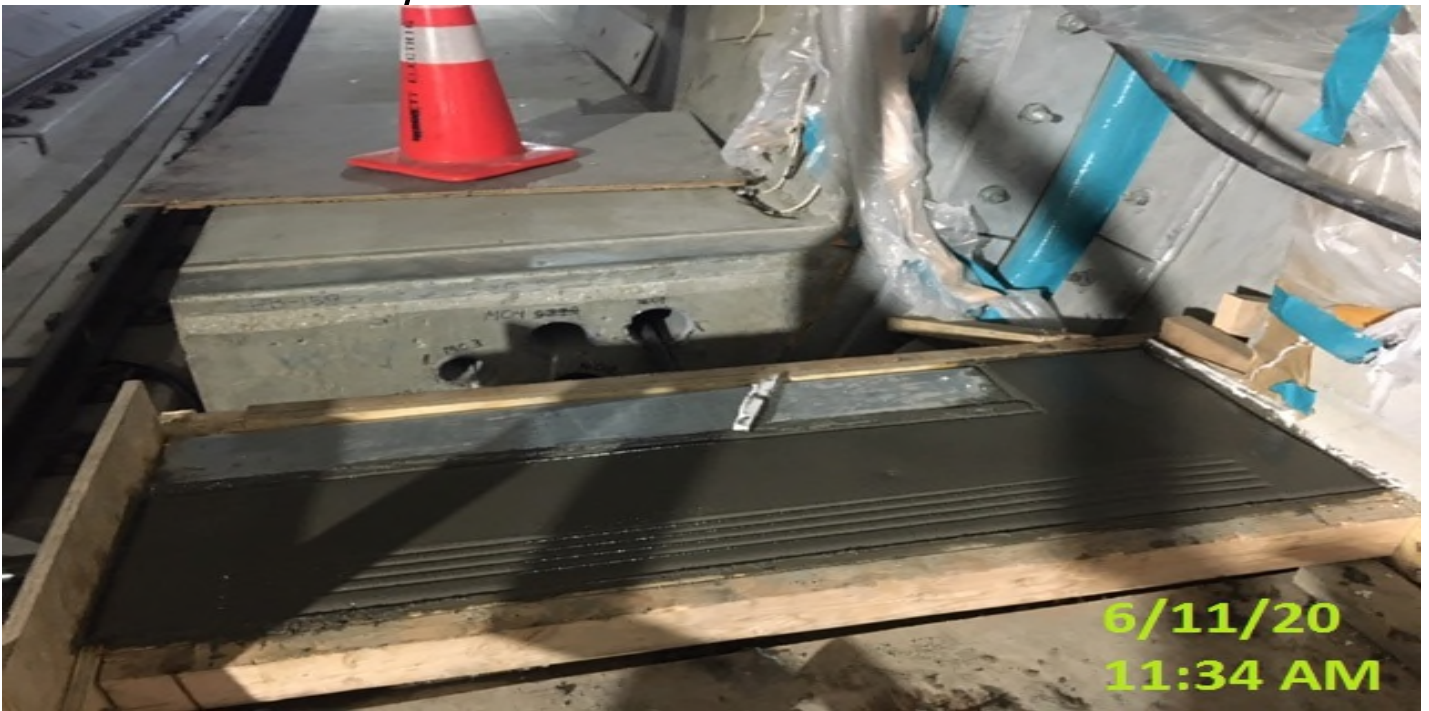
EXPO STATION- WSCC crew encasing embed in concrete for stair landing at emergency walkway.

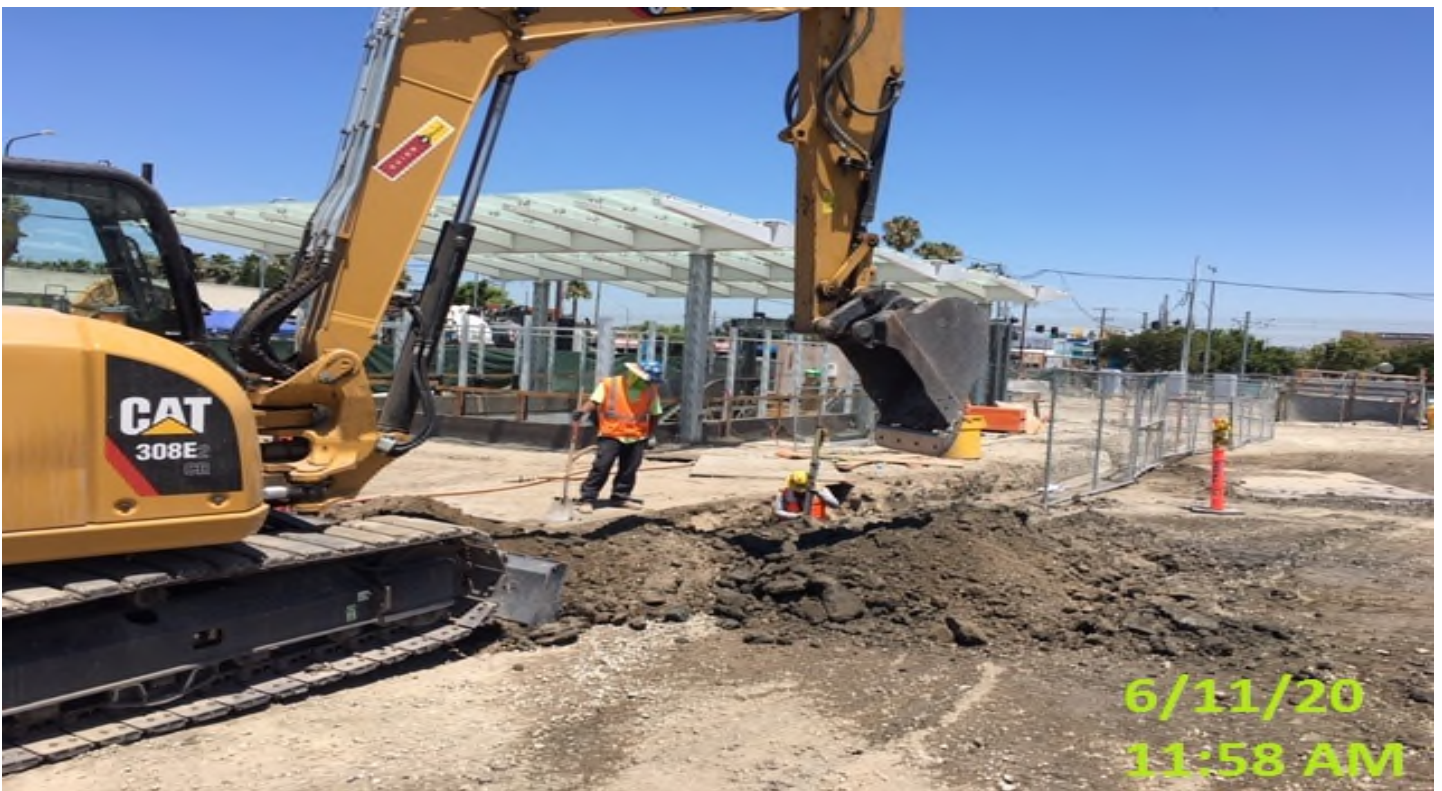
EXPO STATION- WSCC excavating trench for lighting conduit and irrigation.

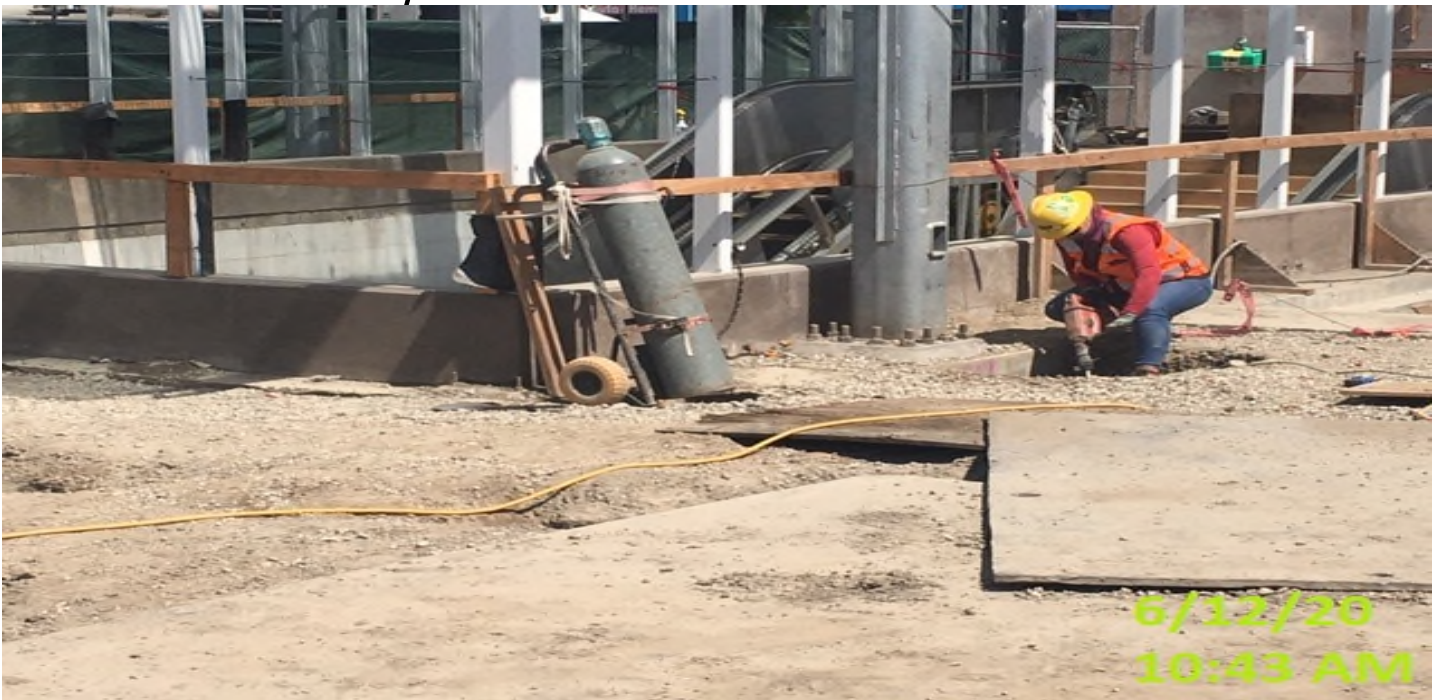
EXPO STATION- WSCC crew hand digging adjacent to canopy footings for plaza lighting stubbing.

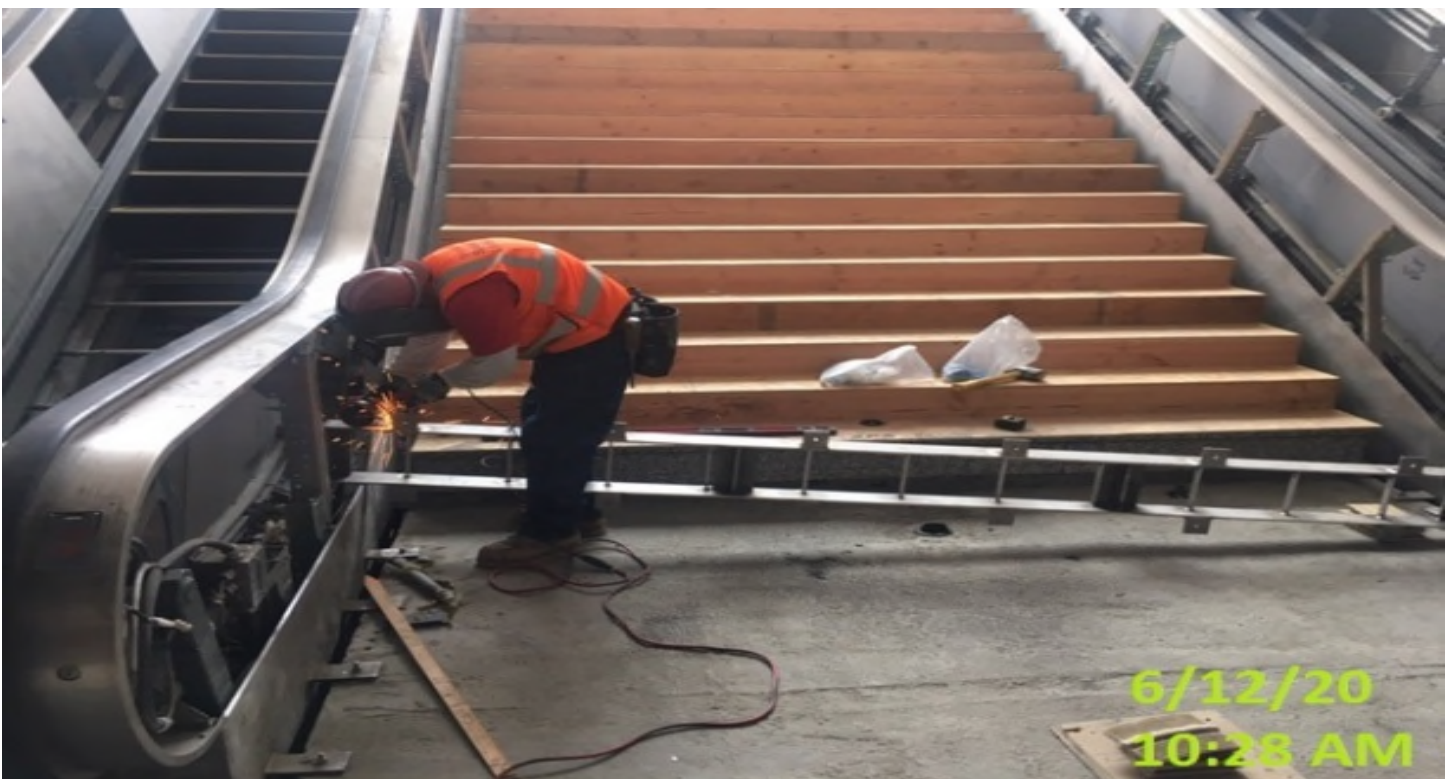
EXPO STATION- WSCC ironworkers installing trench drain at main staircase landing.

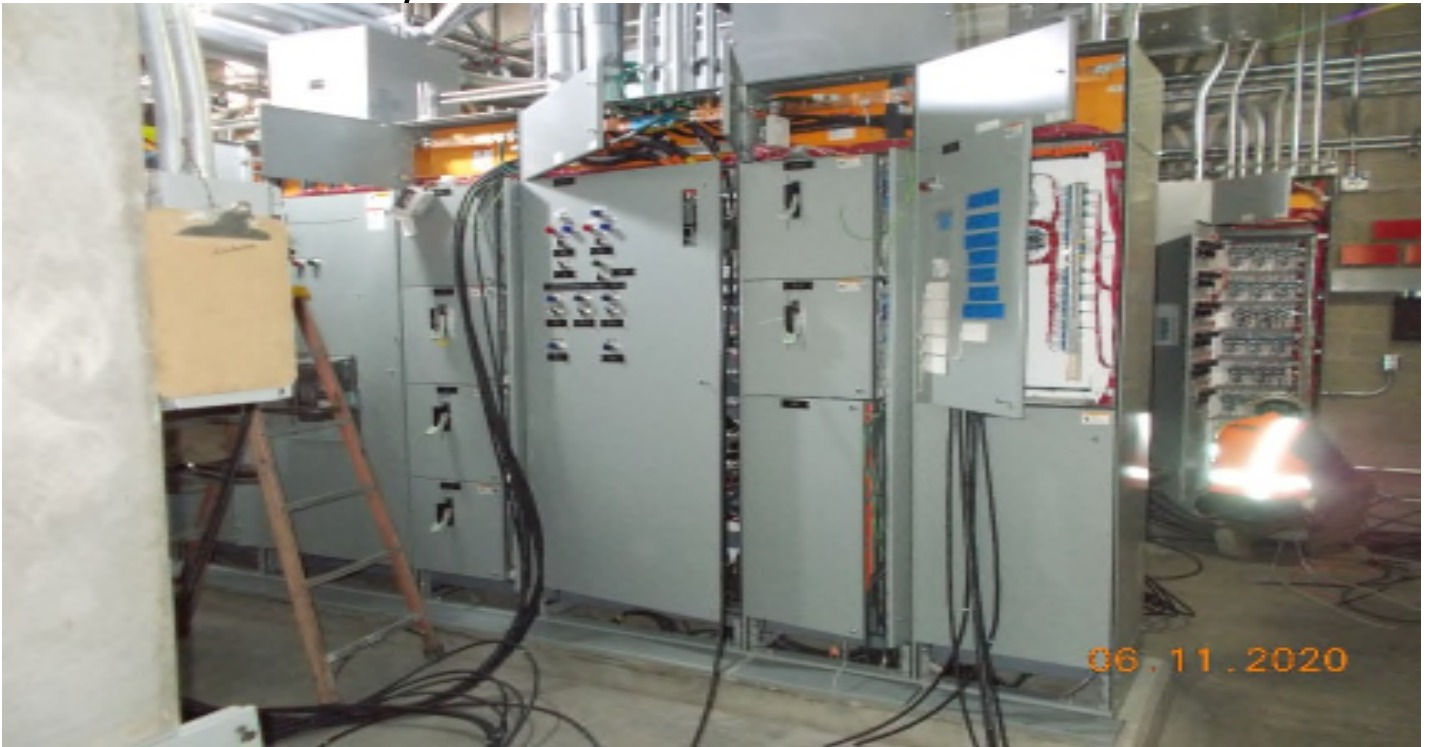
EXPO STATION- View of MCC1N and interconnects being routed.

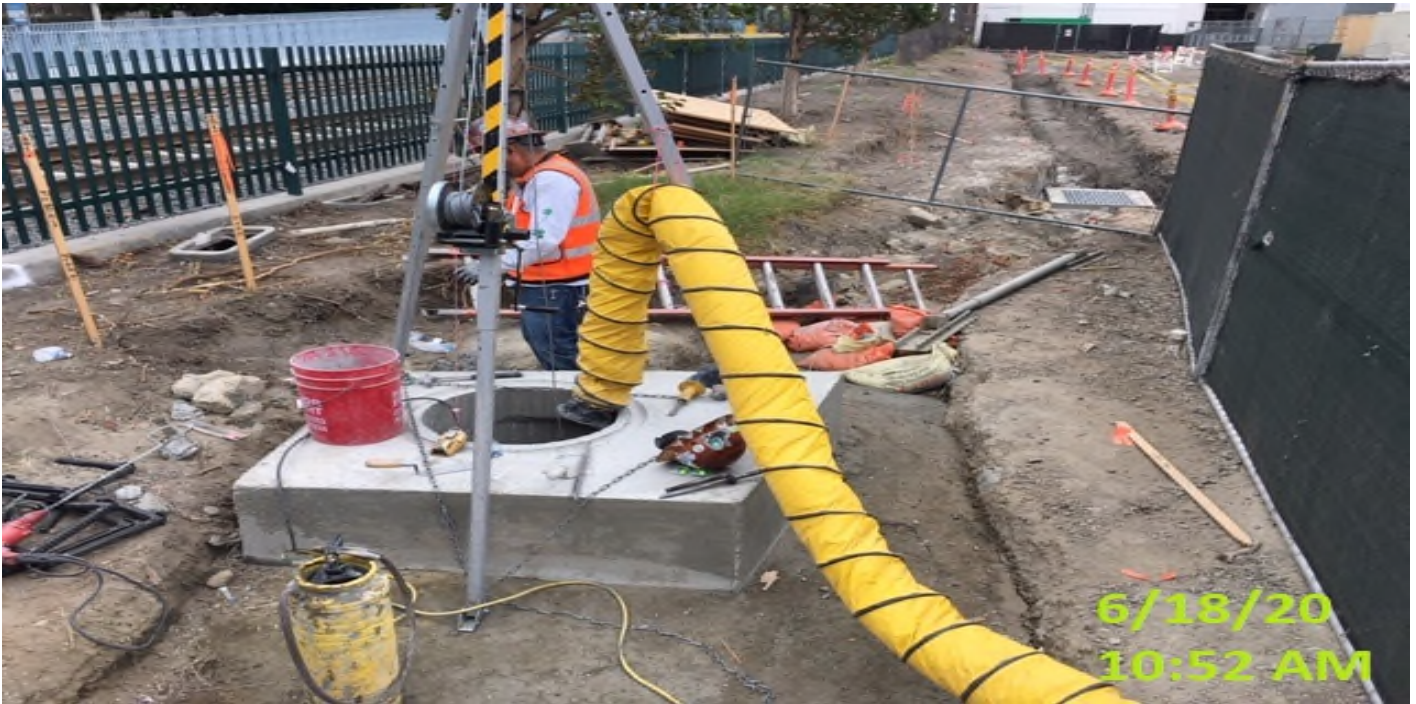
EXPO STATION- WSCC crew chipping and sack & patch inside of manhole #1.

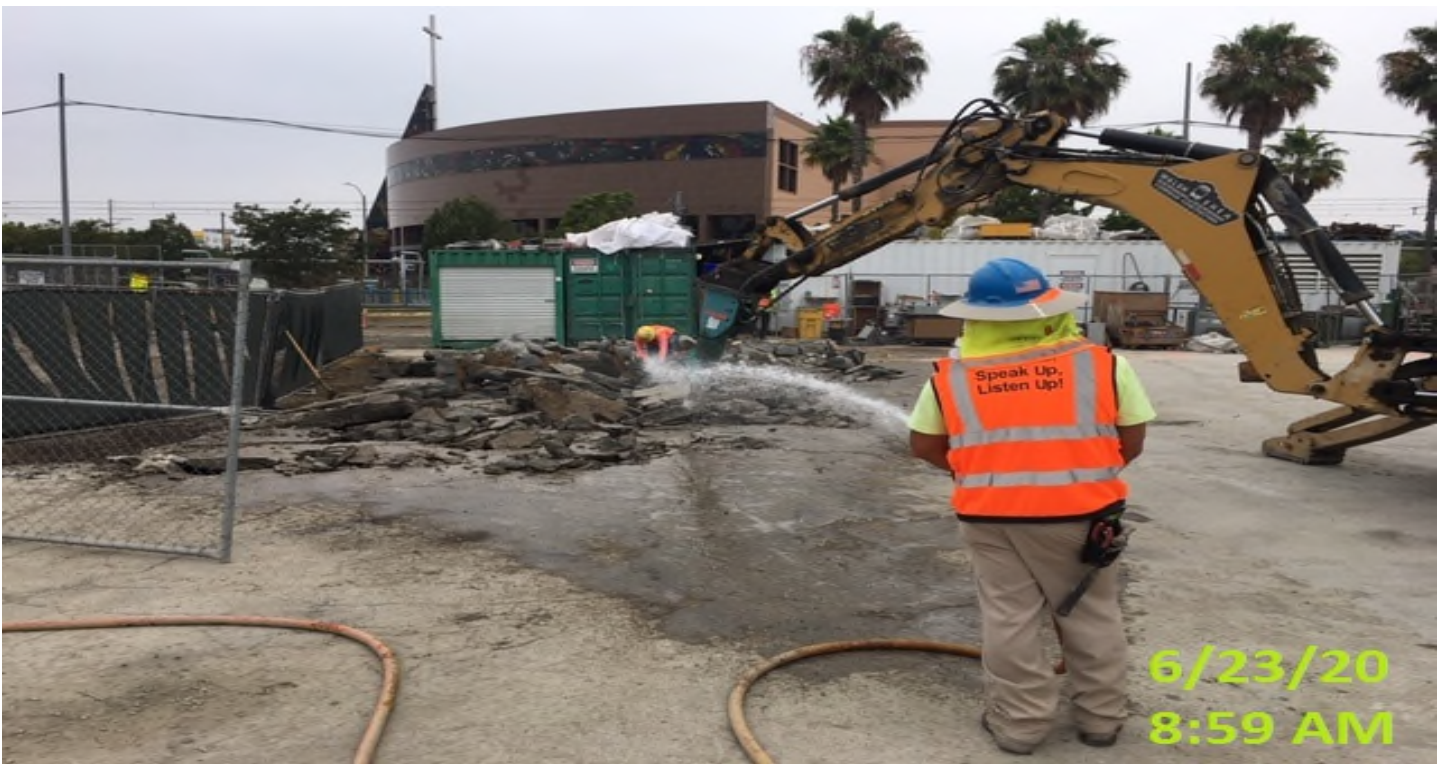
EXPO STATION- WSCC crew demoing and removing concrete slab for park and ride.

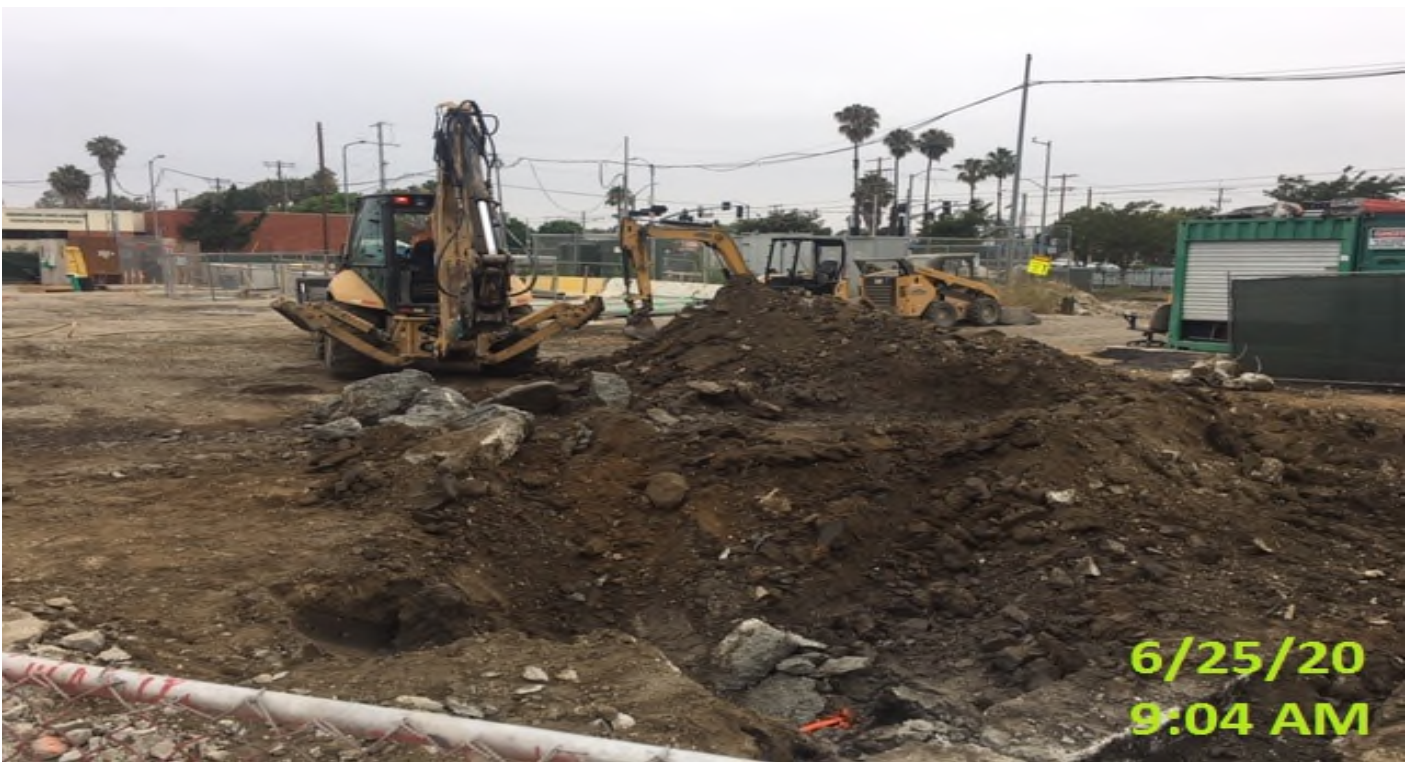
EXPO STATION- WSCC crew demoing slab at north end yard.

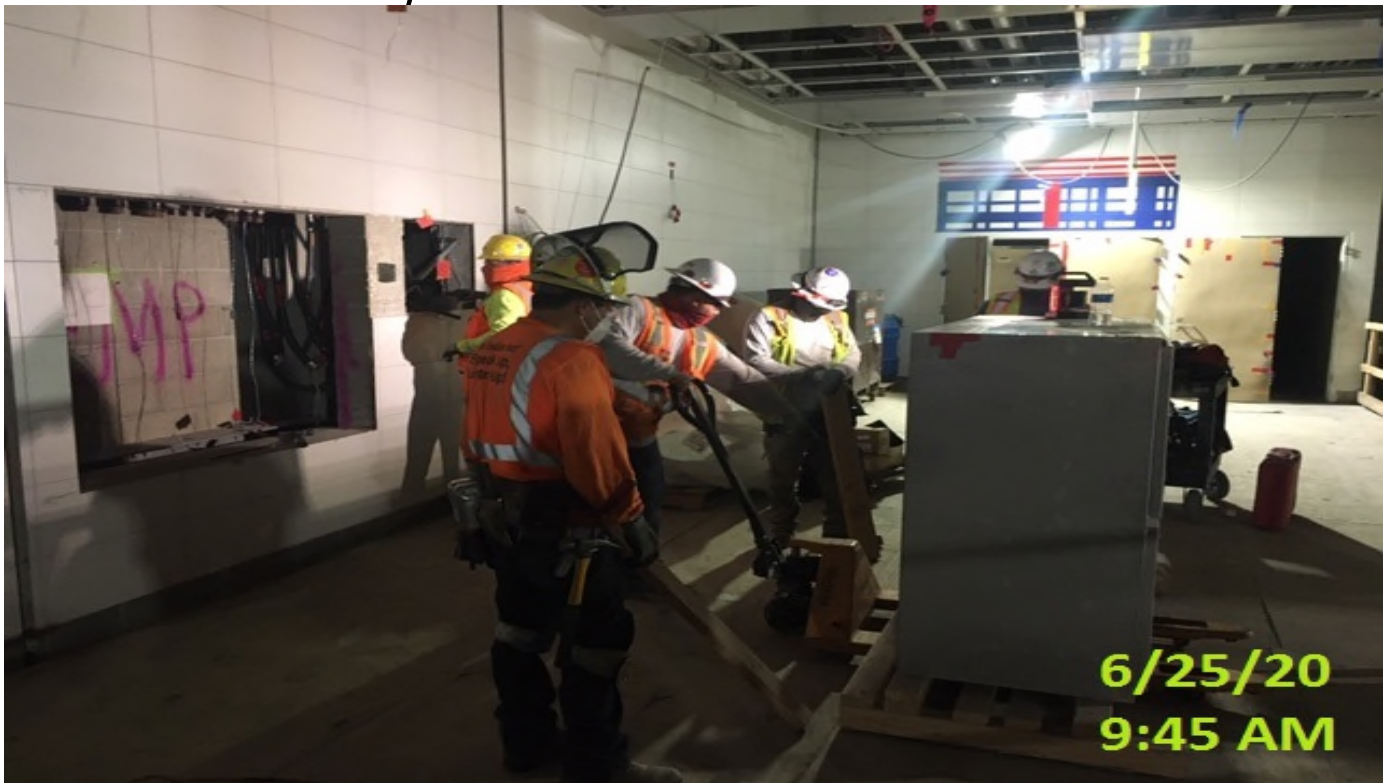
EXPO STATION- WSCC crew sub-support installing EMP unit.

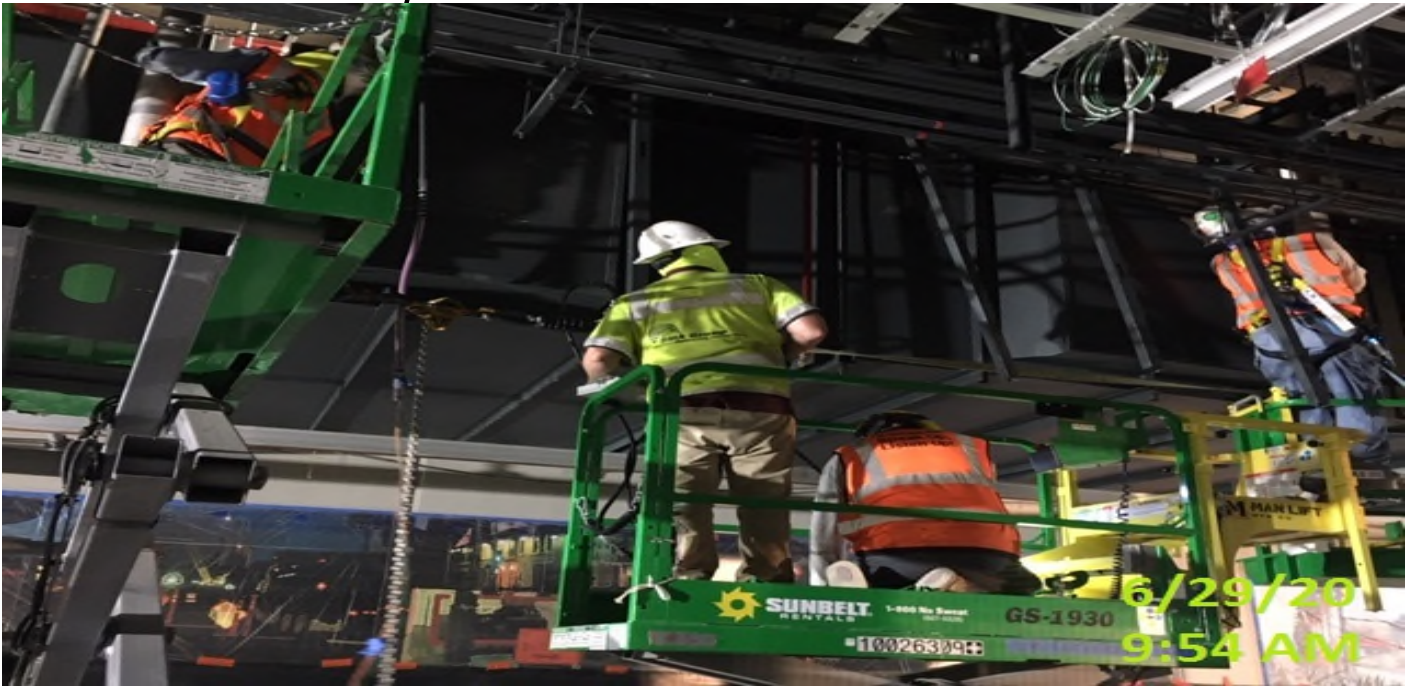
EXPO STATION- WSCC crew performing pull tests on edge lighting down stand embed plates.

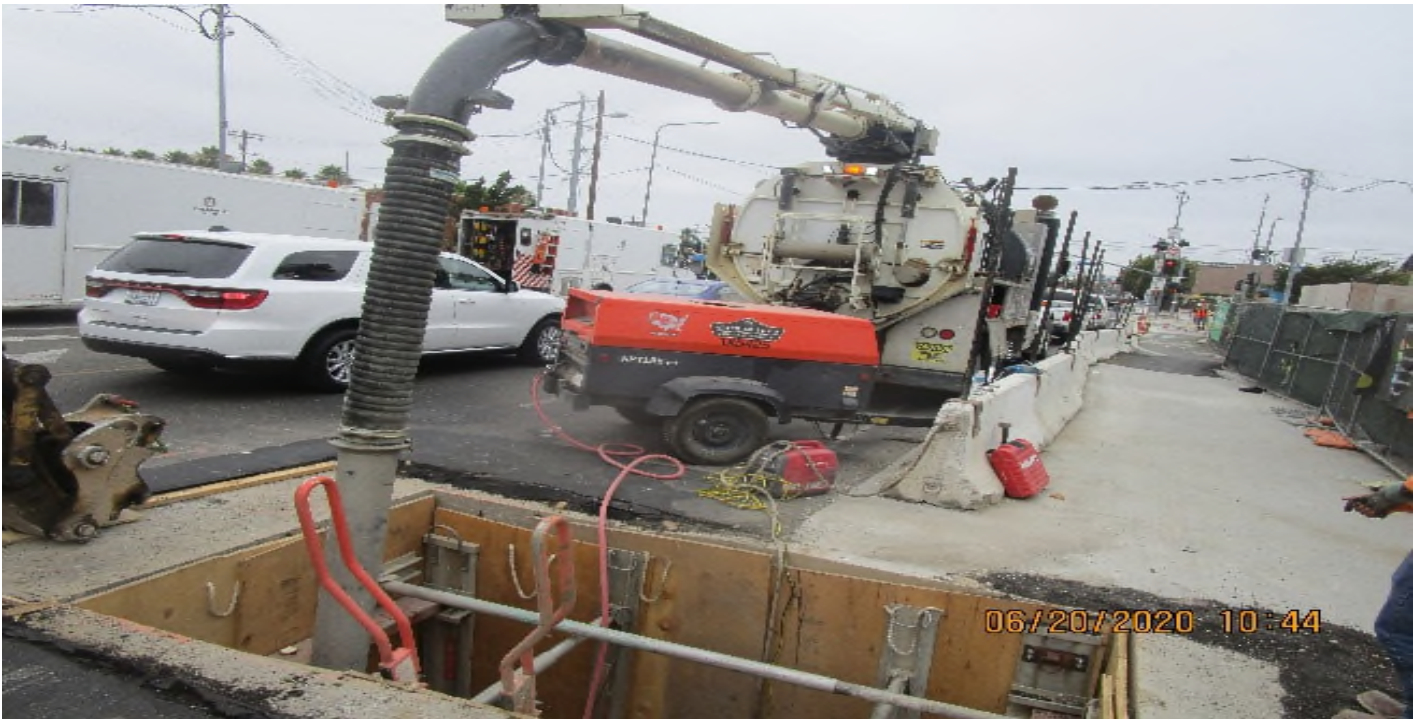
EXPO STATION- Crenshaw & (S) of Exposition Blvd, potholing for 6" ductile iron sewer vent (Pan) piping penetrations for Expo leaks.

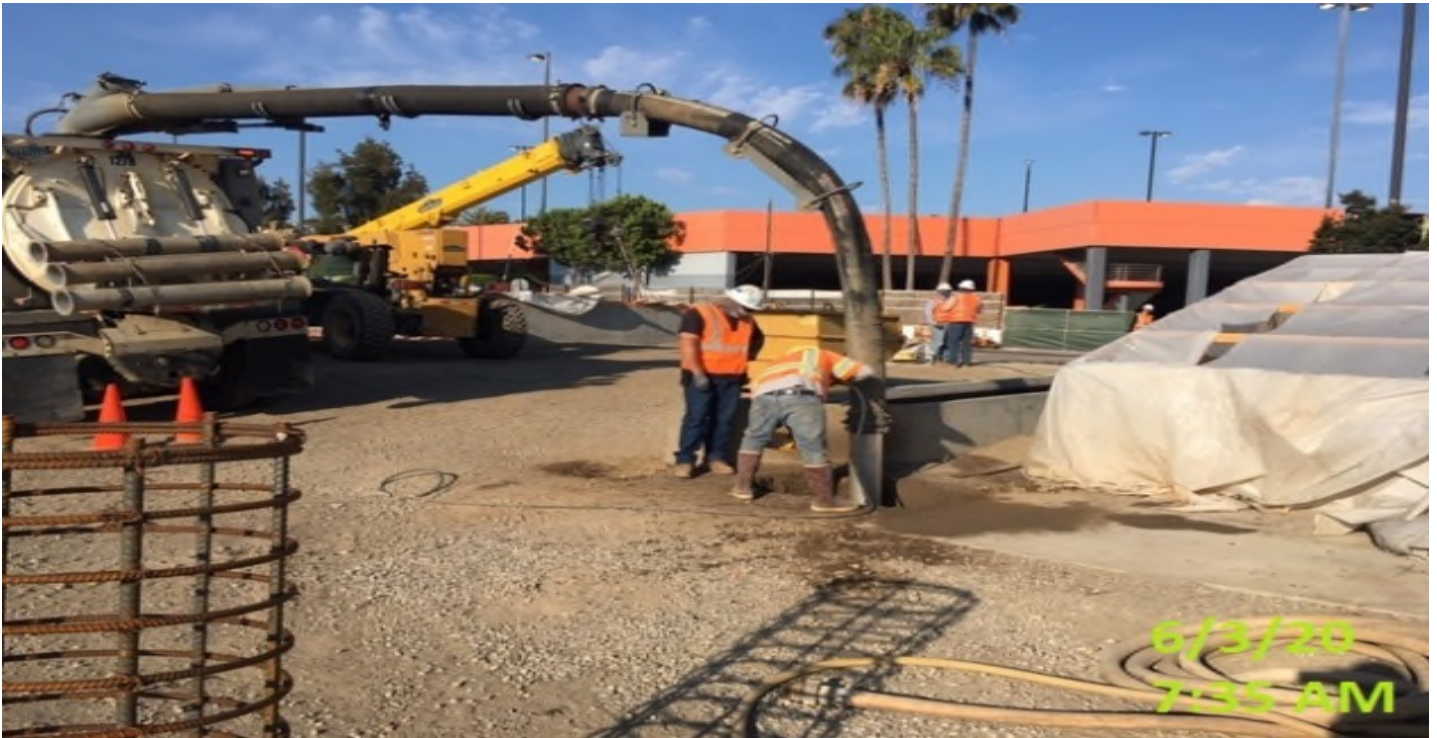
MLK Station - Potholing for the installation of light pole foundations at the plaza level.

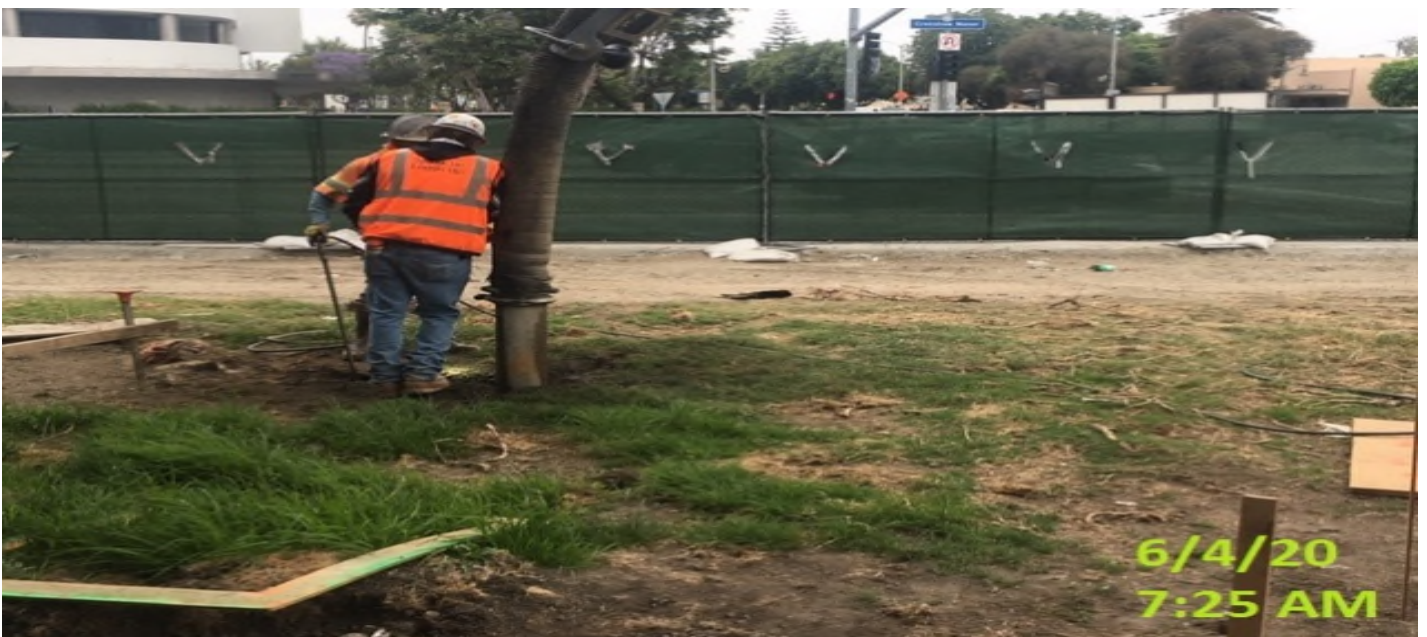
MLK Station - MLK – Continue potholing for the installation of light pole foundations and tree wells at the plaza level.

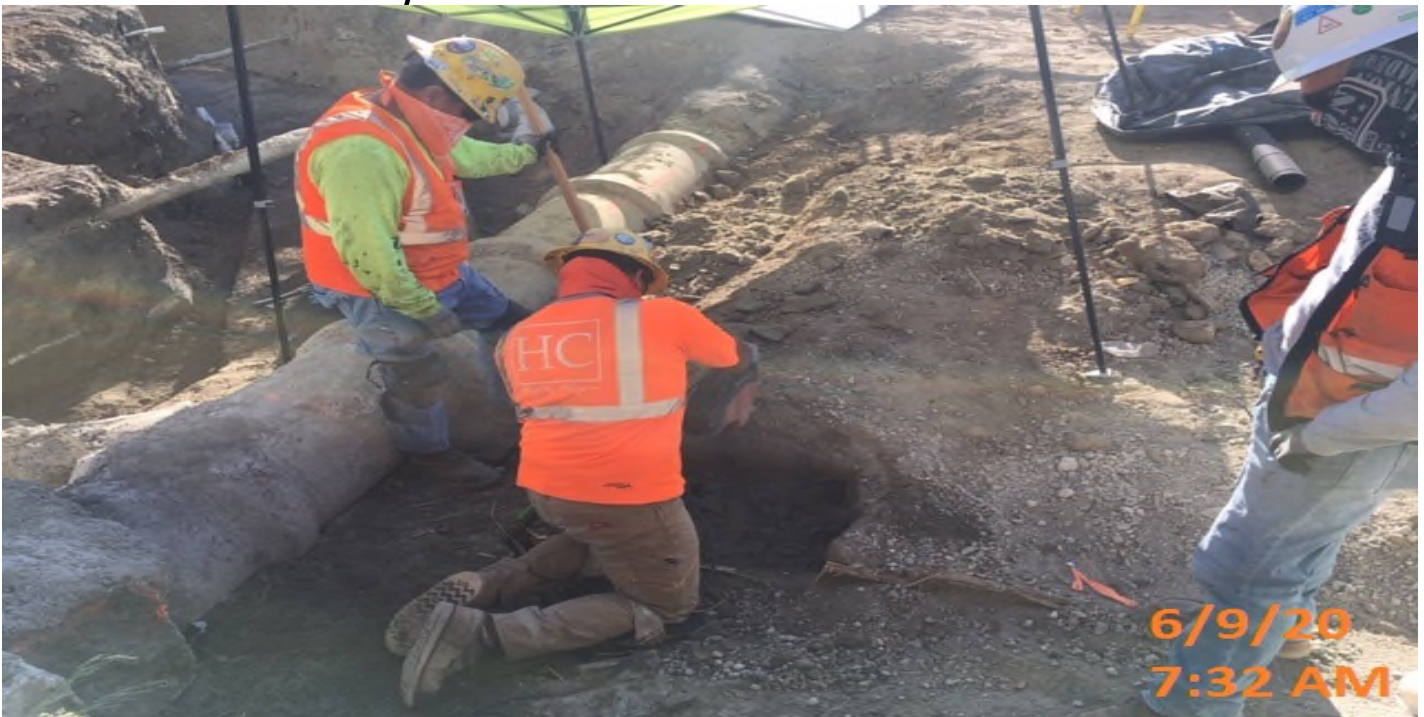
MLK Station - Excavating for pedestrian light pole foundations at the northwest side of the plaza level.

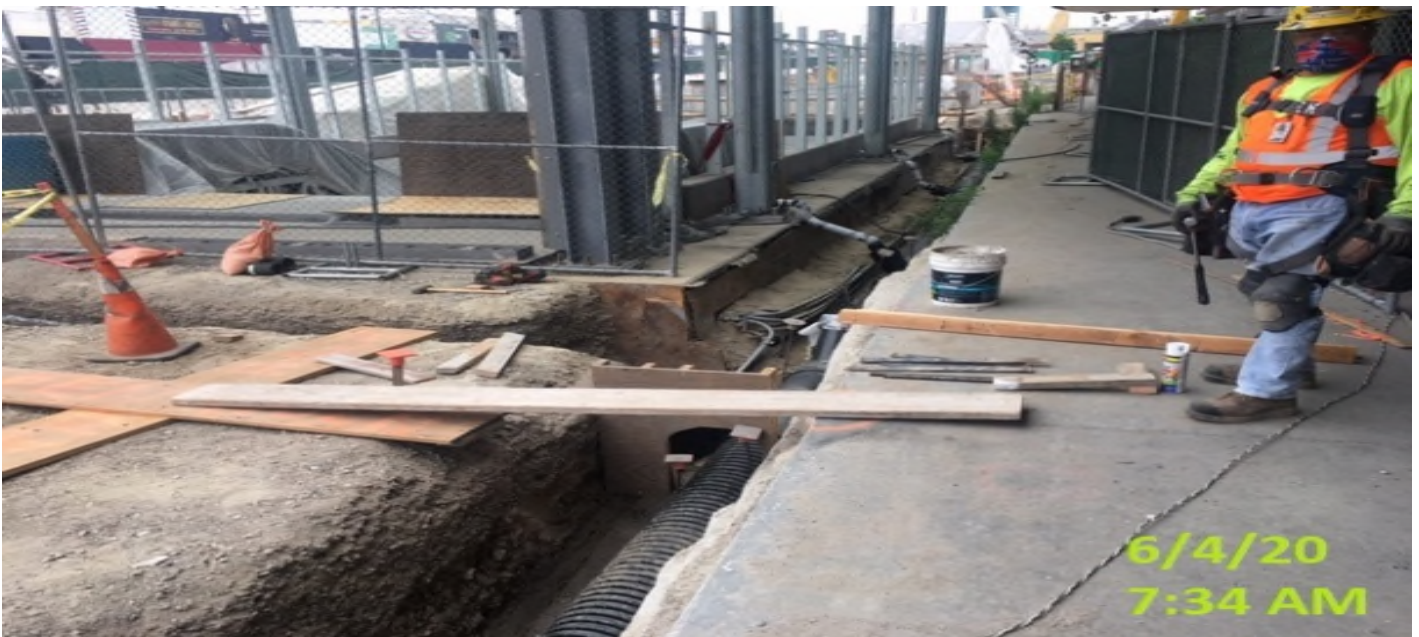
MLK Station - Building and installing bulkheads for slurry encasement of the 12" HDPE drainage pipe at the plaza level.

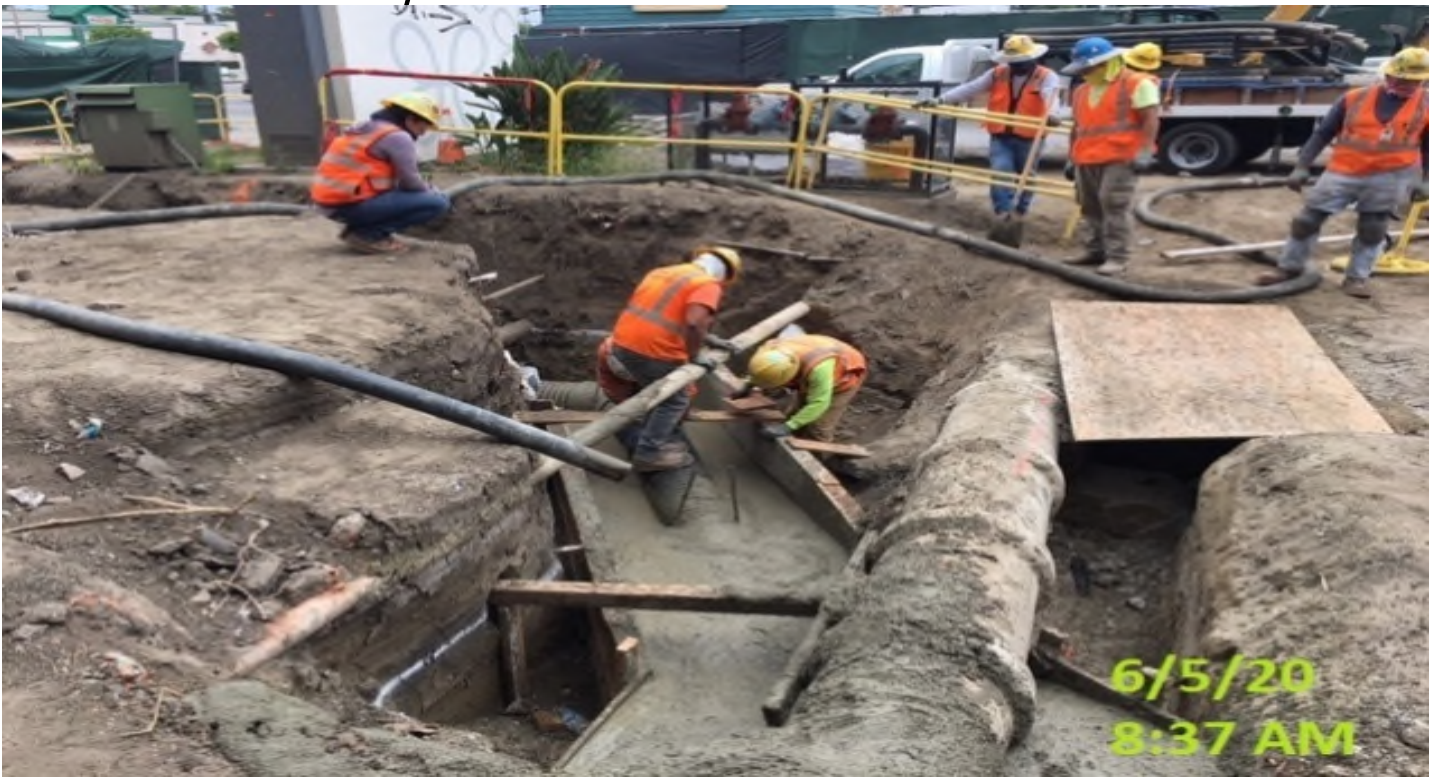
MLK – Placing slurry encasement for the 12” HDPE drainage pipe at the plaza level.
