CRENSHAW/LAX PHOTOGRAPHIC UPDATE

July 7, 2020

Crenshaw/LAX Transit Project

Overview of trackwork progress issues for 06-22-2020 – July 7, 2020
(Please note the attached Trackwork Progress Tracking Report)

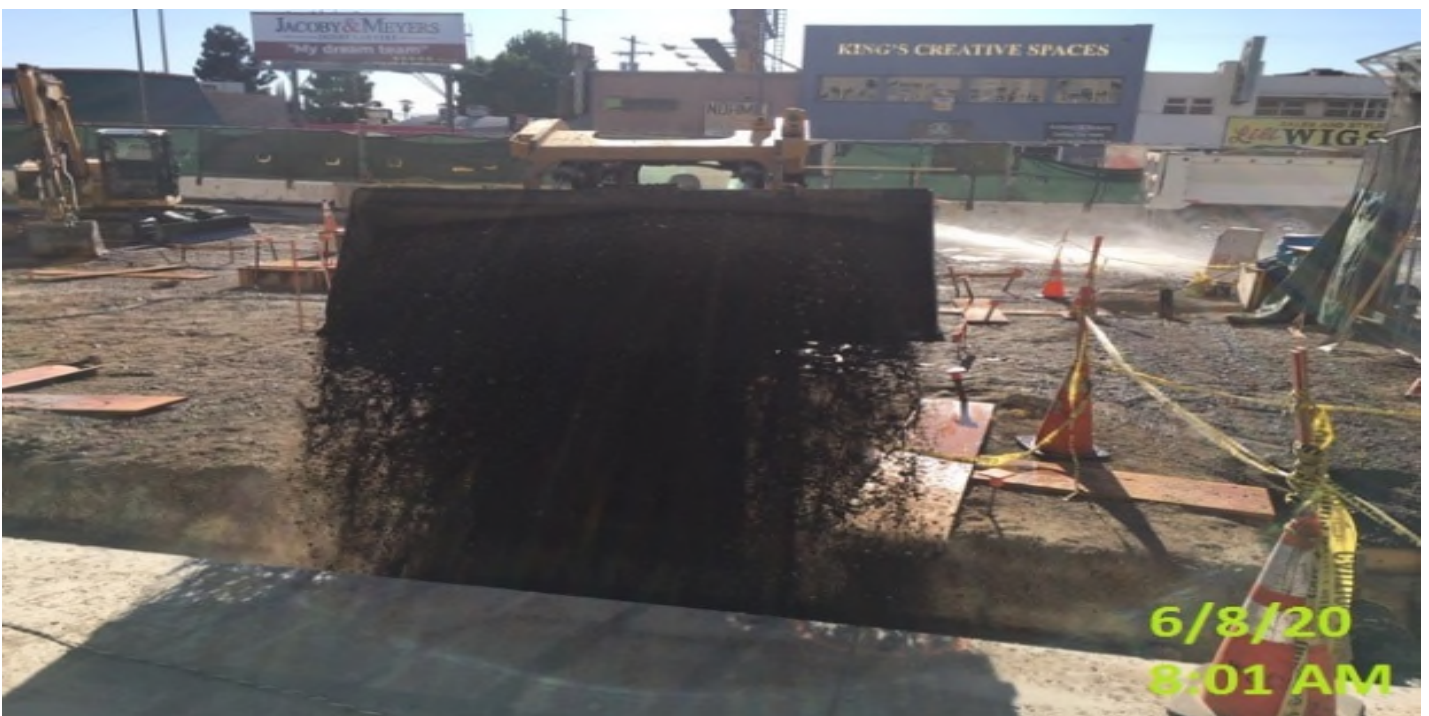
MLK - Backfilling the encased 12” HDPE drainage pipe line at the plaza level.

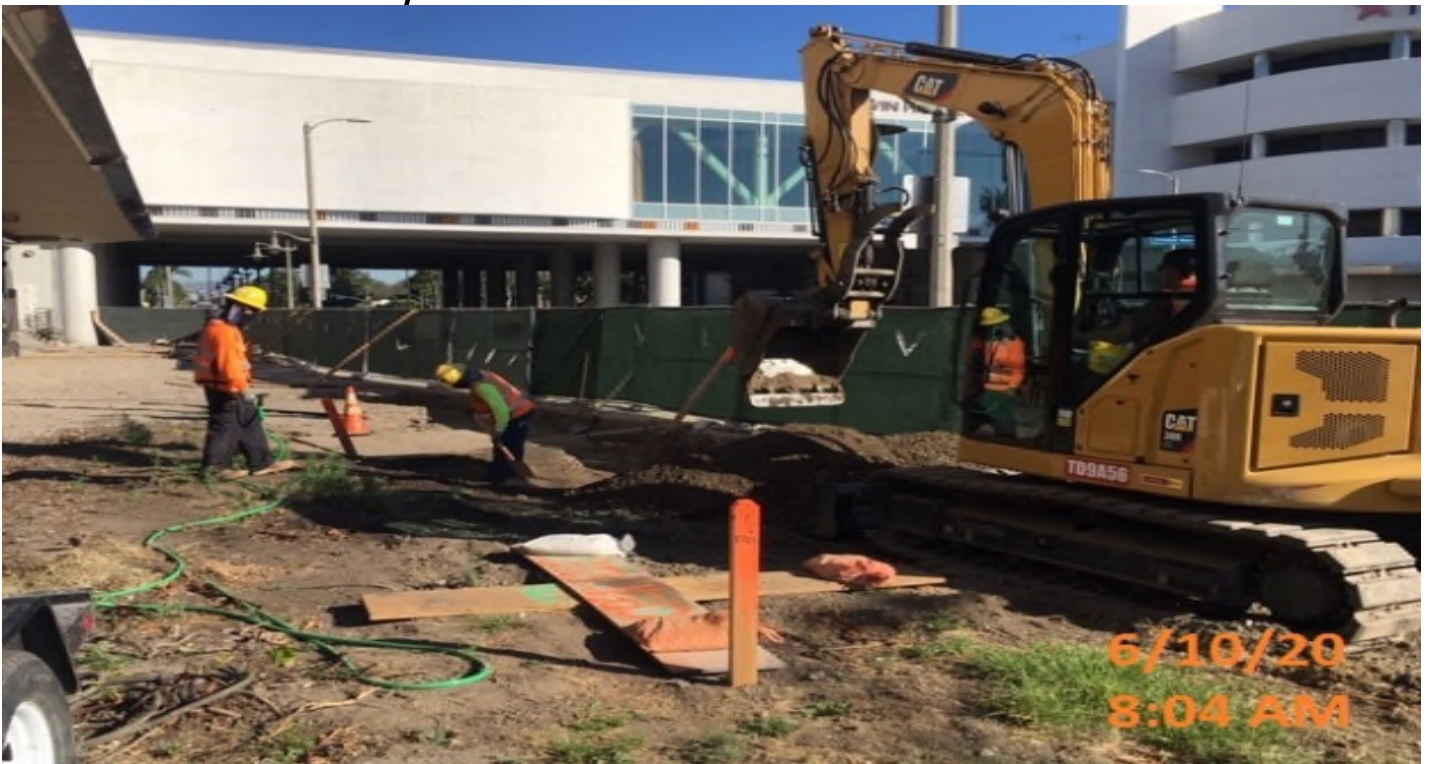
MLK - Excavating for upcoming paver and sidewalk installation at the north end of the plaza level.

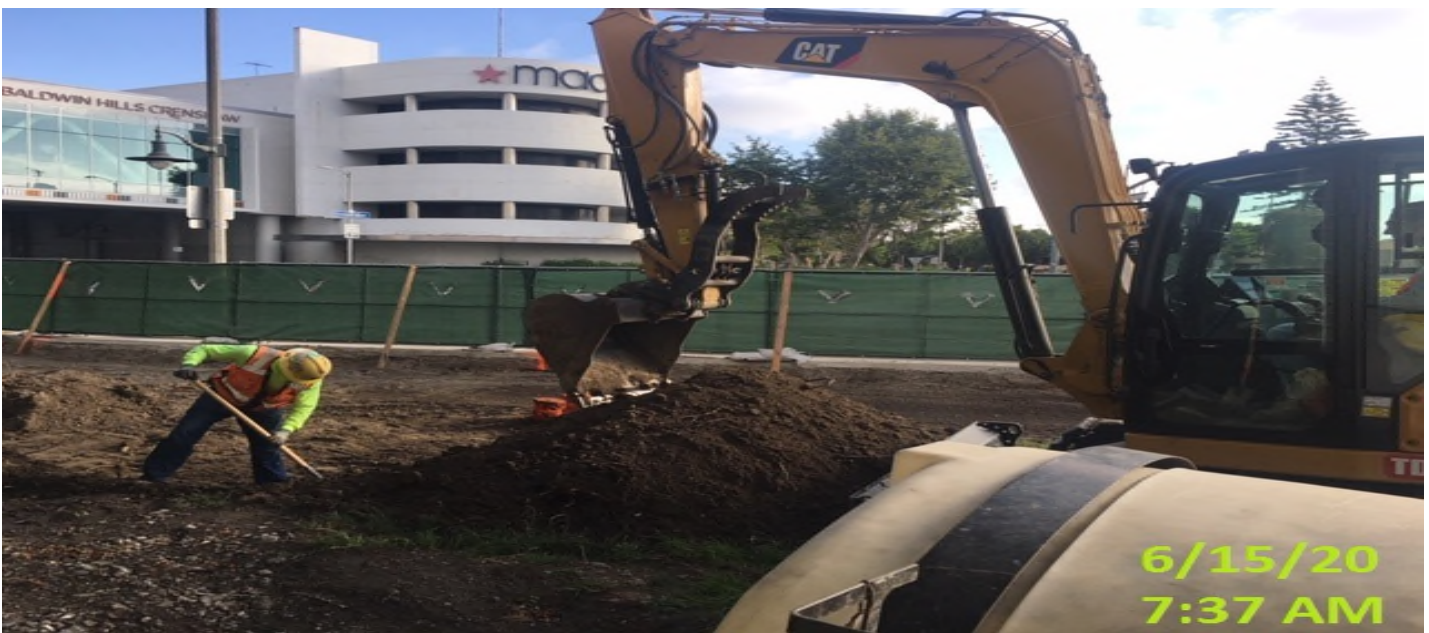
MLK - Continue excavating for upcoming paver and sidewalk installation at the north end of the plaza level.

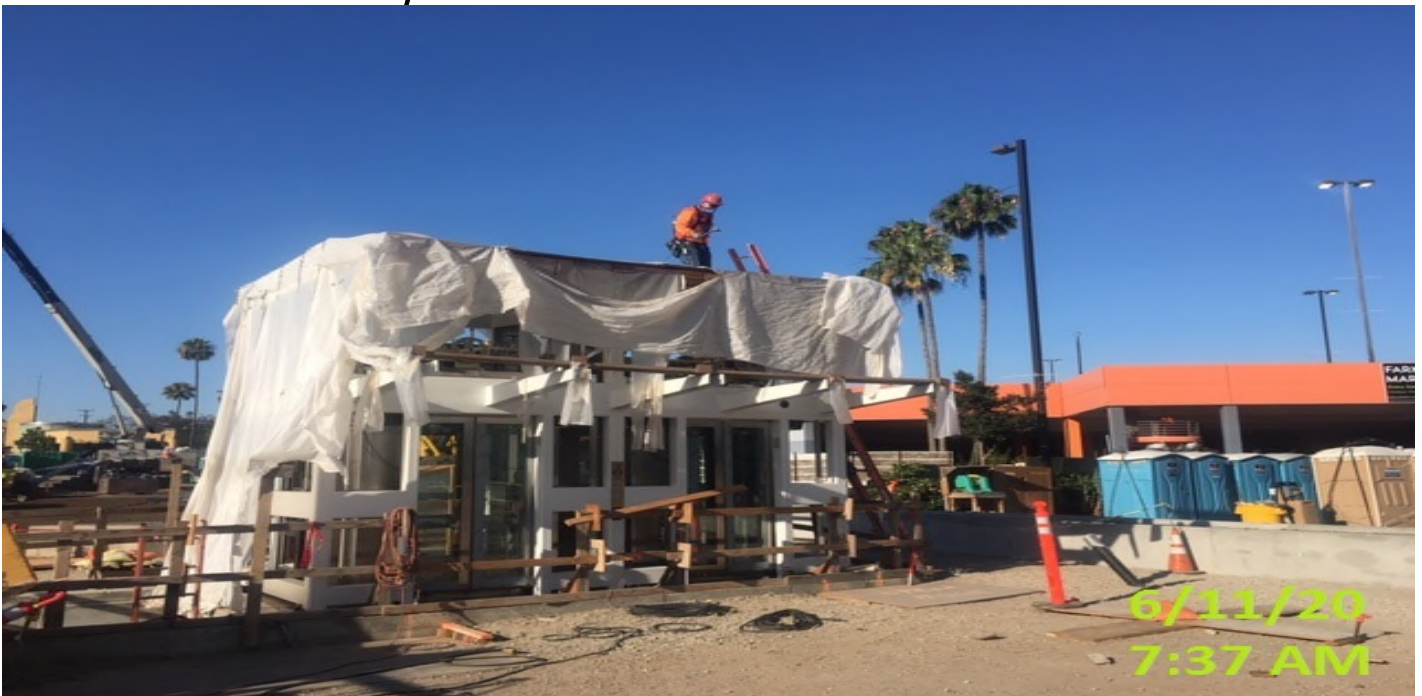
MLK, Installing roofing deck for Elevators 1&2 at the plaza level.

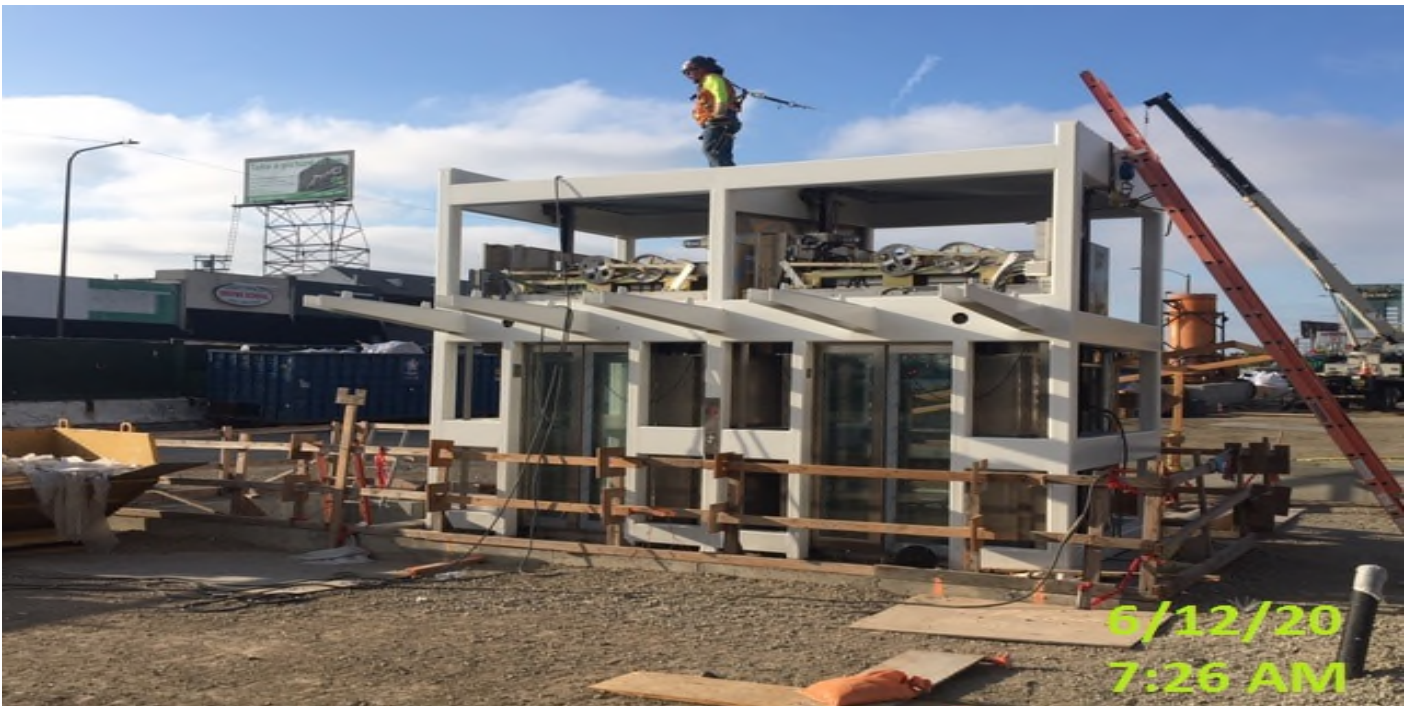
MLK - Continue installing roofing deck for Elevators 1&2 at the plaza level.

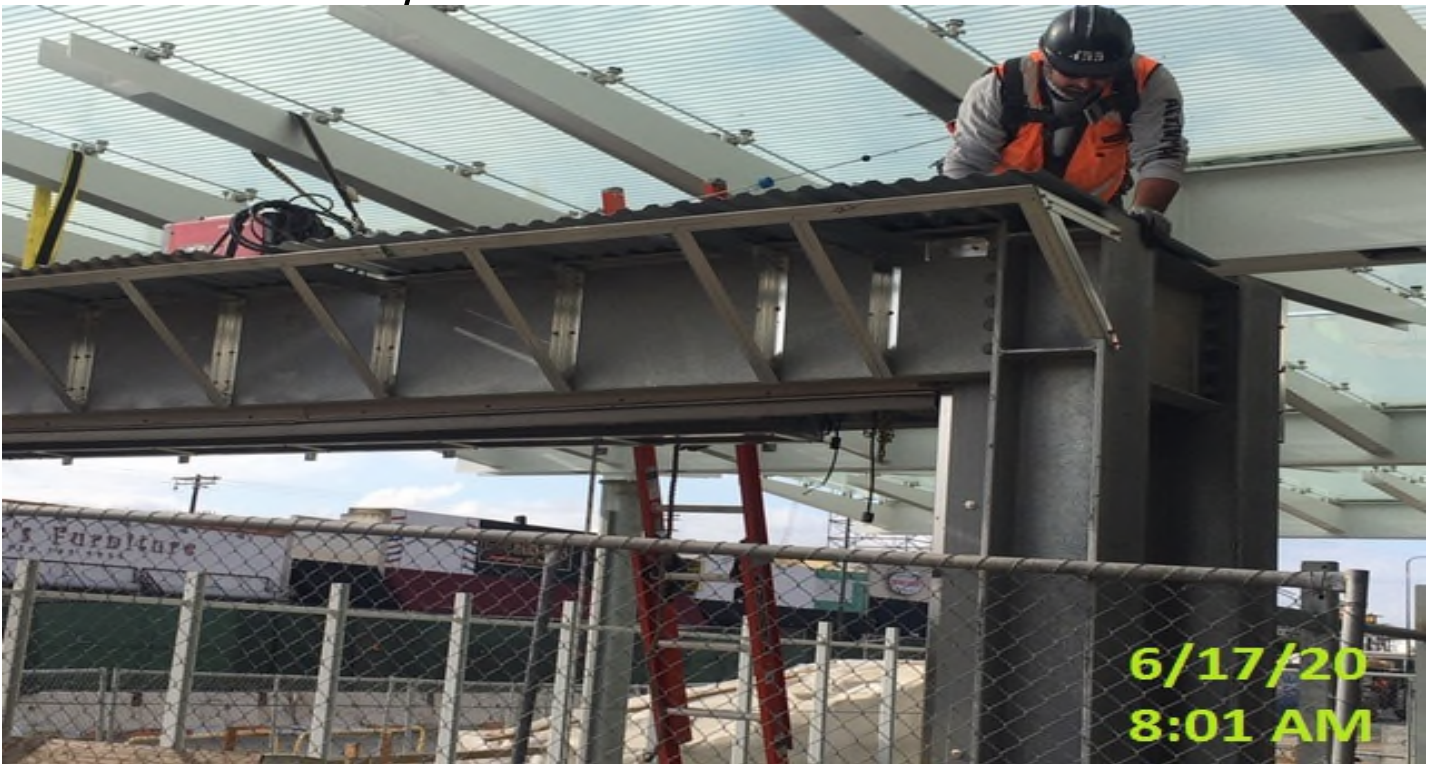
MLK - Installing roofing deck to the main entrance canopy structure at the plaza level.

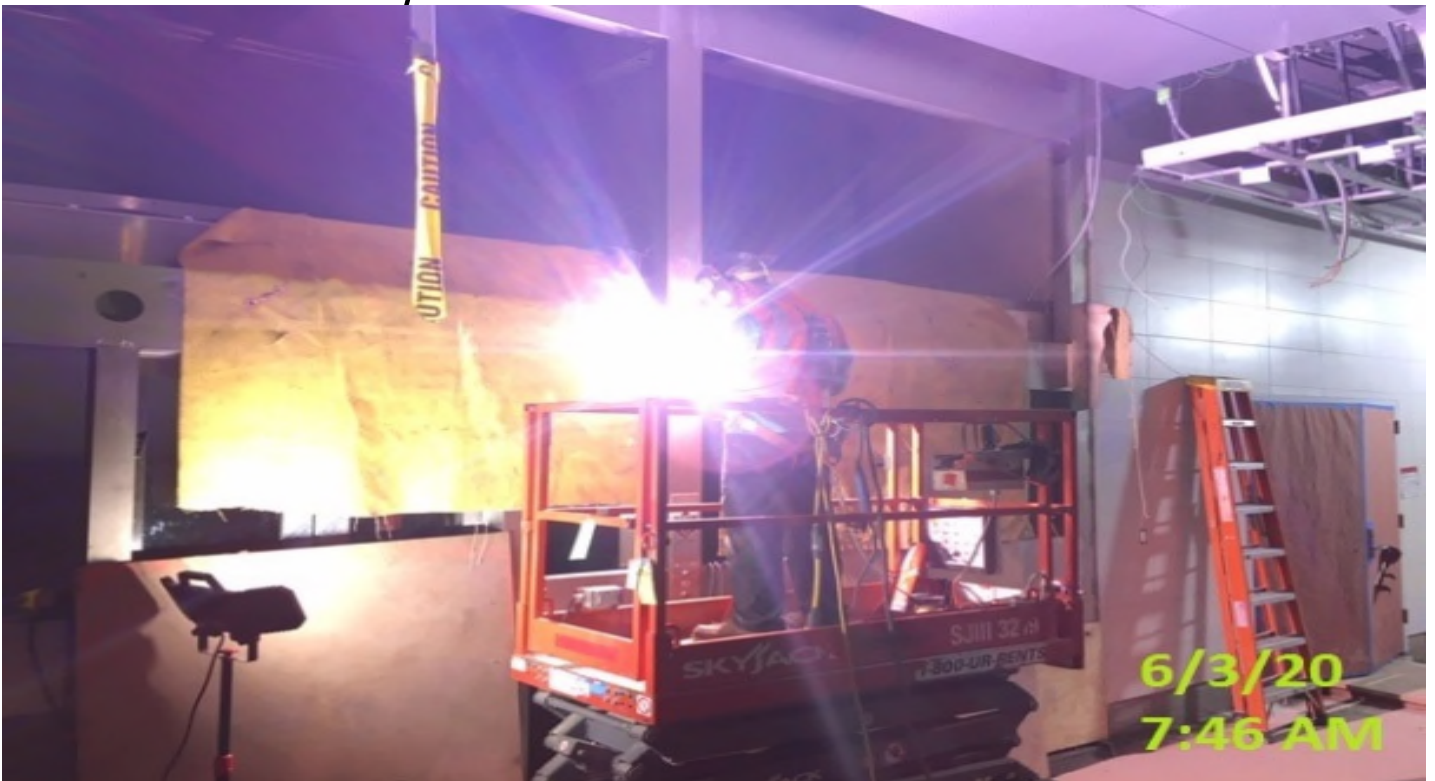
MLK – Began welding the fascia mesh screen panels to Elevators 3&4 at the concourse level.

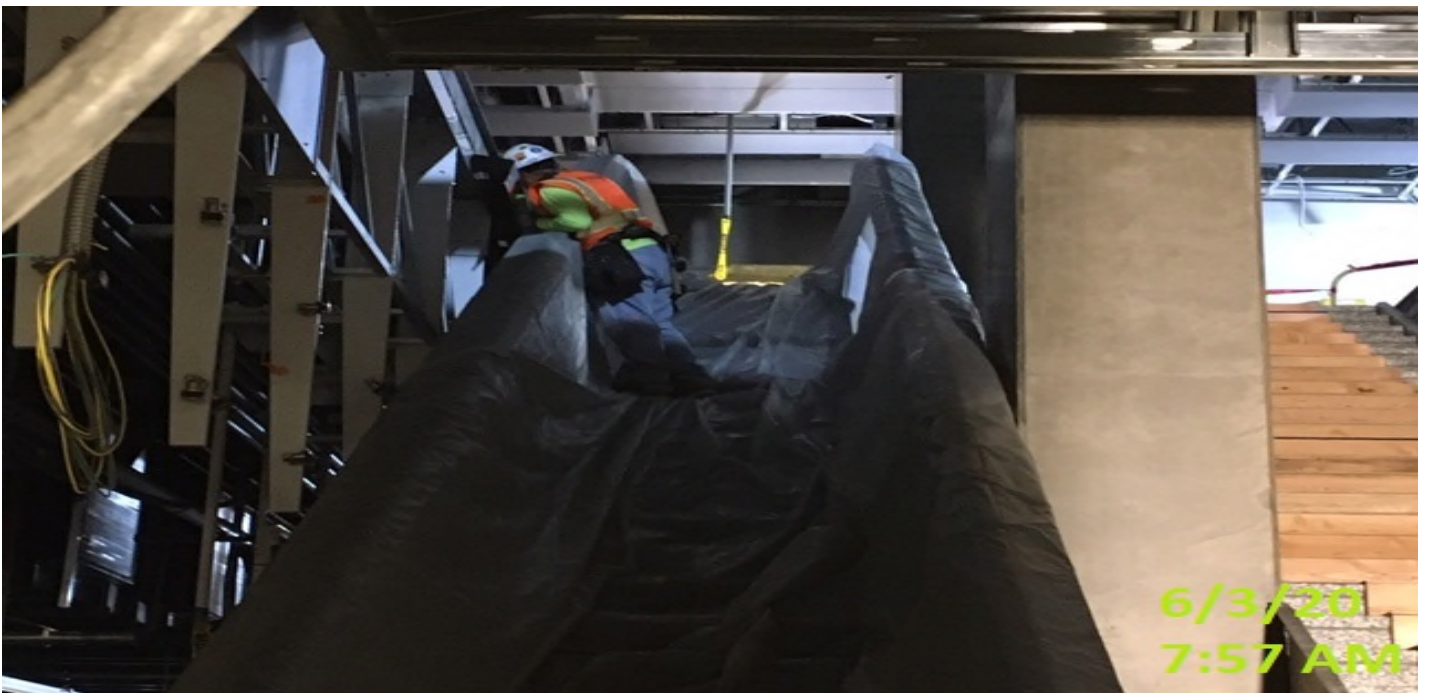
MLK – Continue installing stainless steel cladding panels on the smoke screen edges at the platform level.

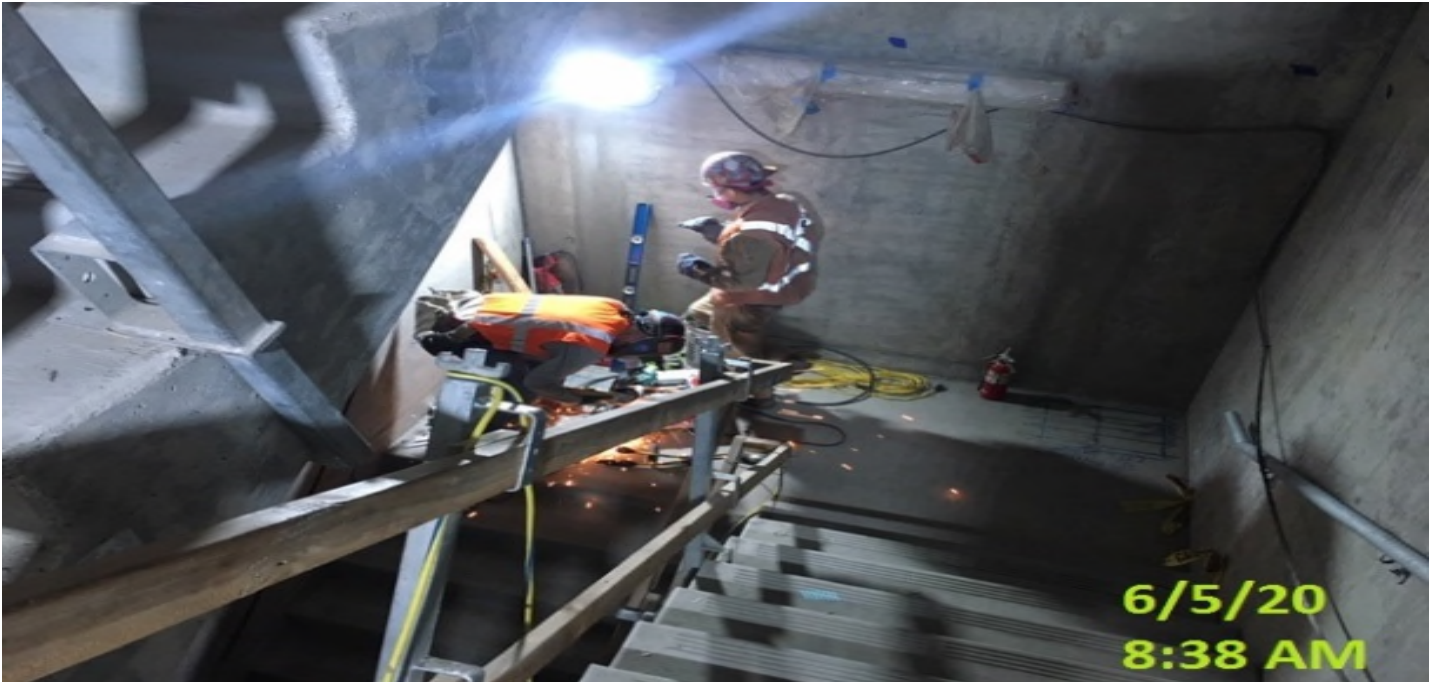
MLK STATION – Continue installing handrails at the emergency exit stairs south #2 from concourse to invert level.

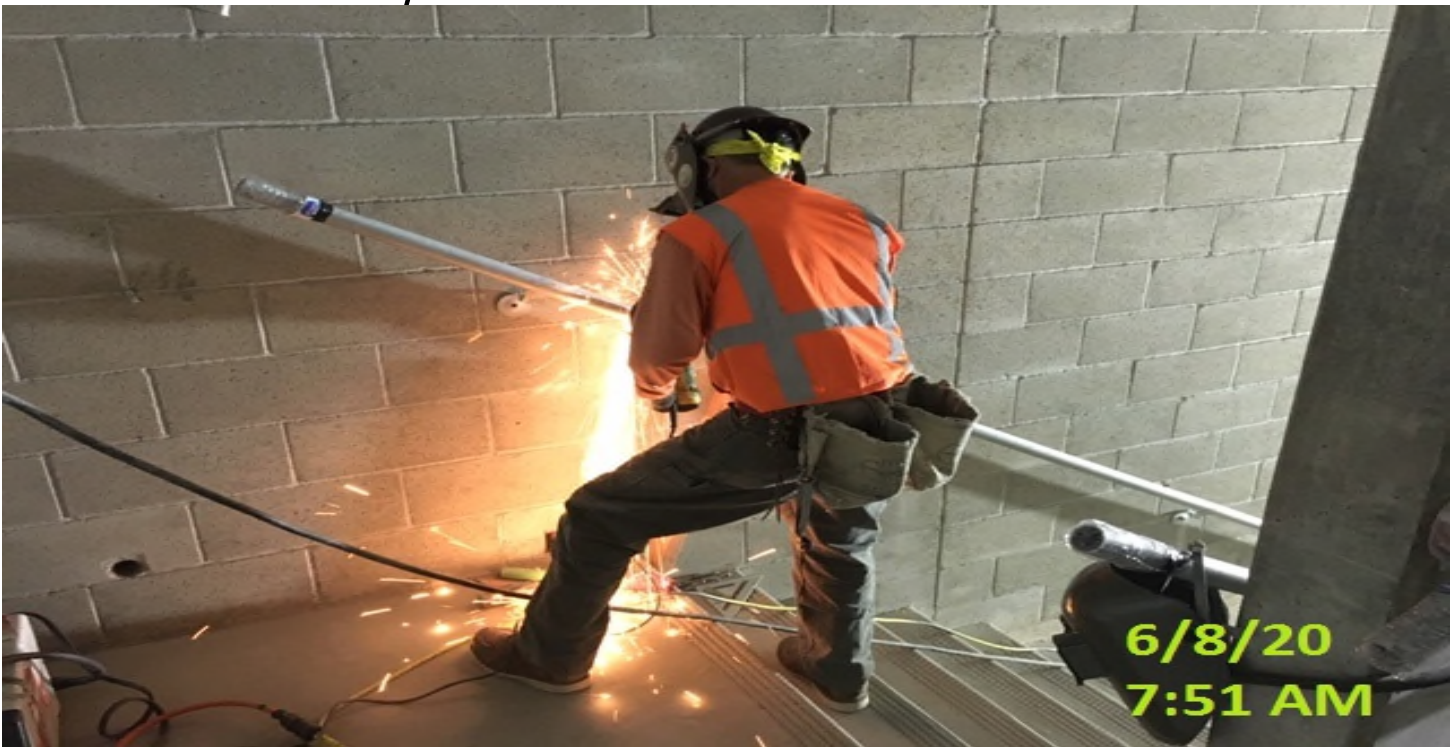
MLK STATION – Continue installing handrails at the emergency exit stairs south #2 from concourse to invert level.

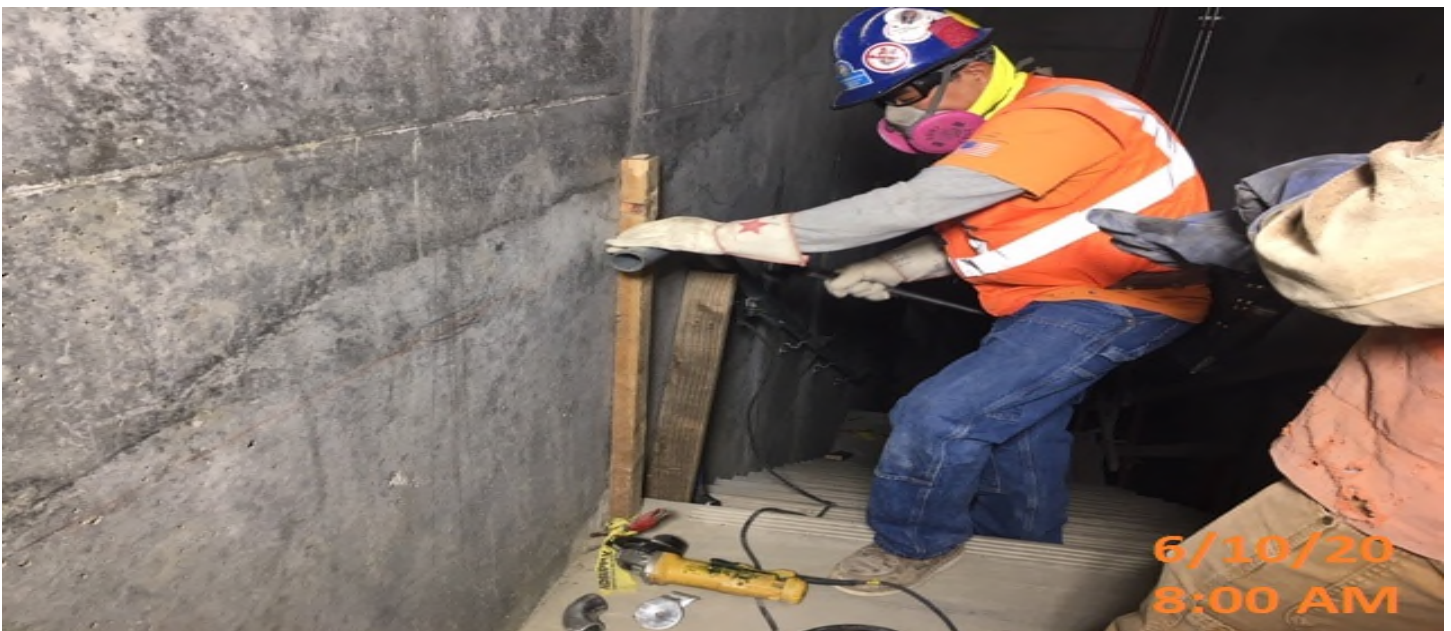
MLK STATION – Continue installing handrails at the emergency exit stairs south #2 from concourse to invert level.

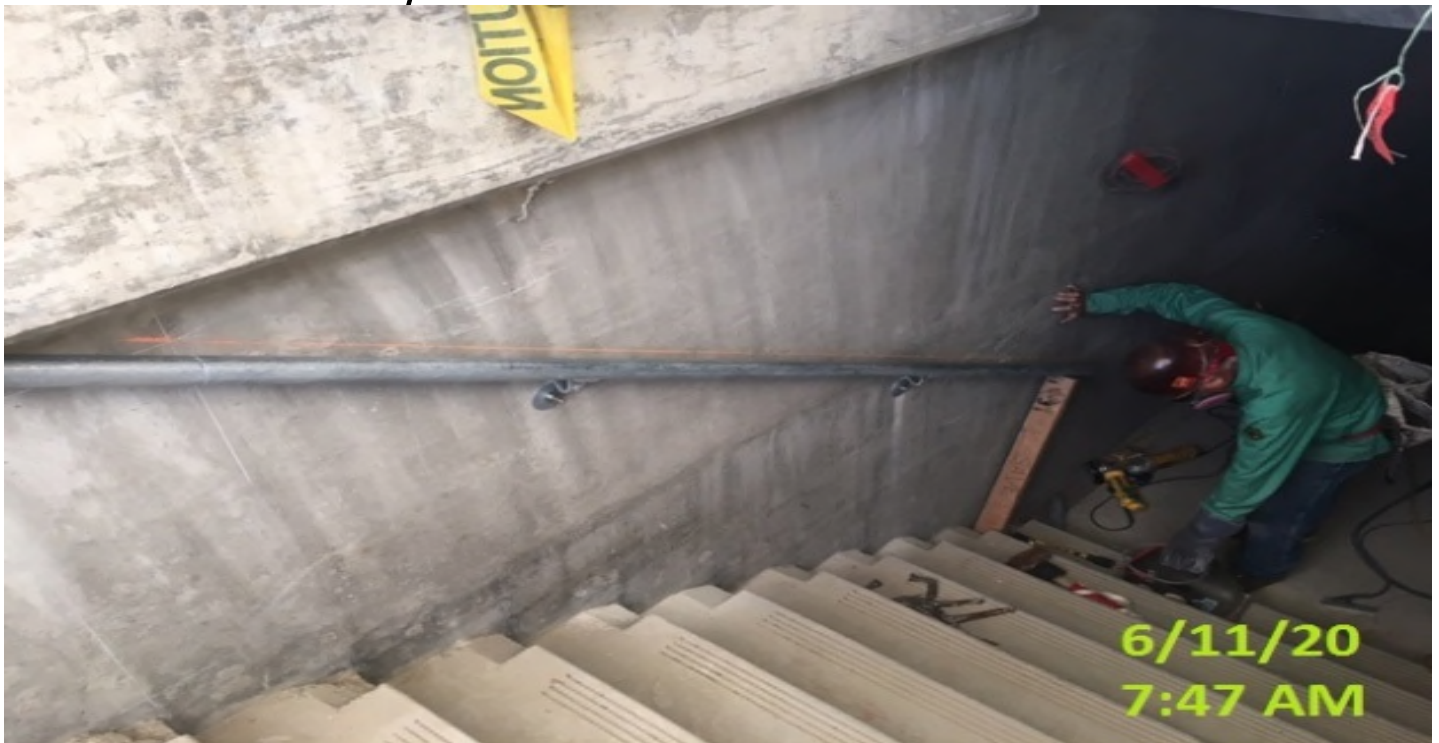
MLK STATION – Continue installing handrails at the emergency exit stairs south #2 from concourse to invert level.

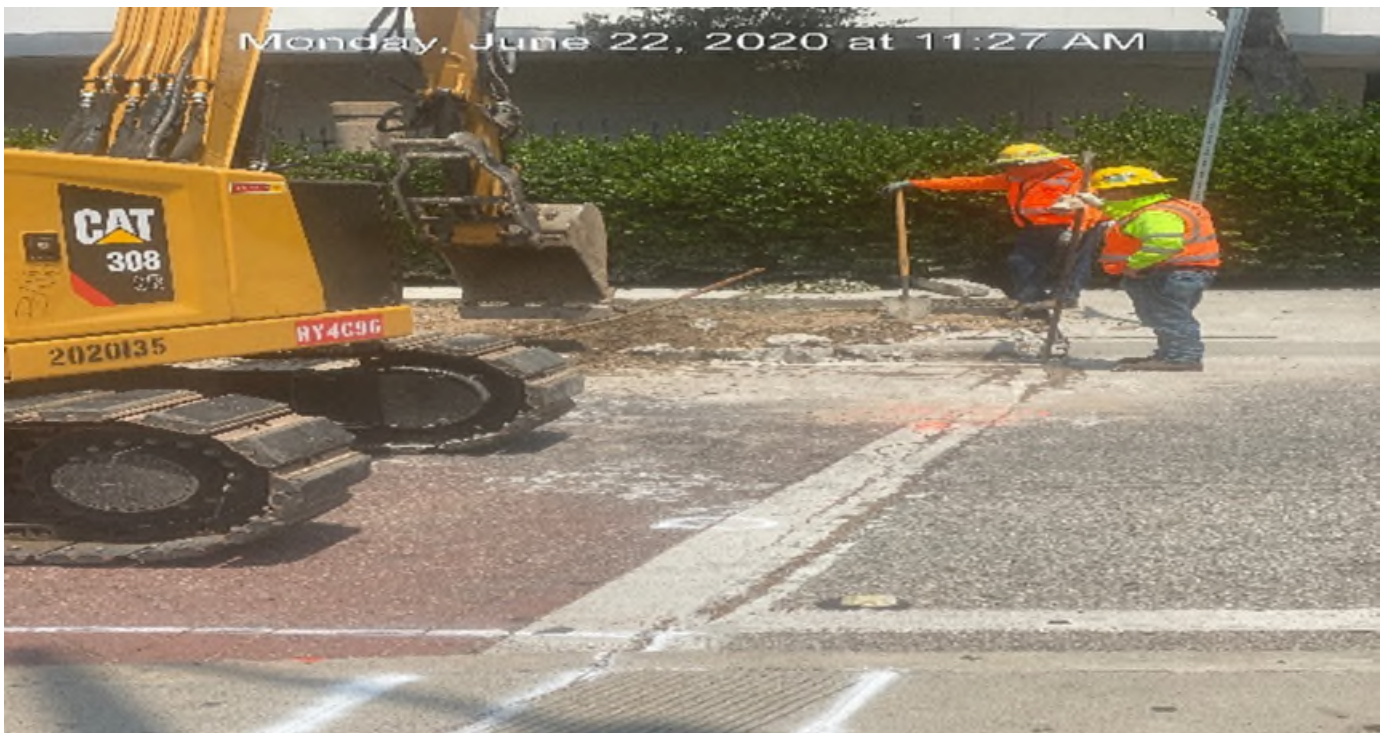
MLK STATION – Excavating/demolishing for new ADA ramp and sidewalk installation on the northwest corner of MLK Blvd and Crenshaw Blvd.

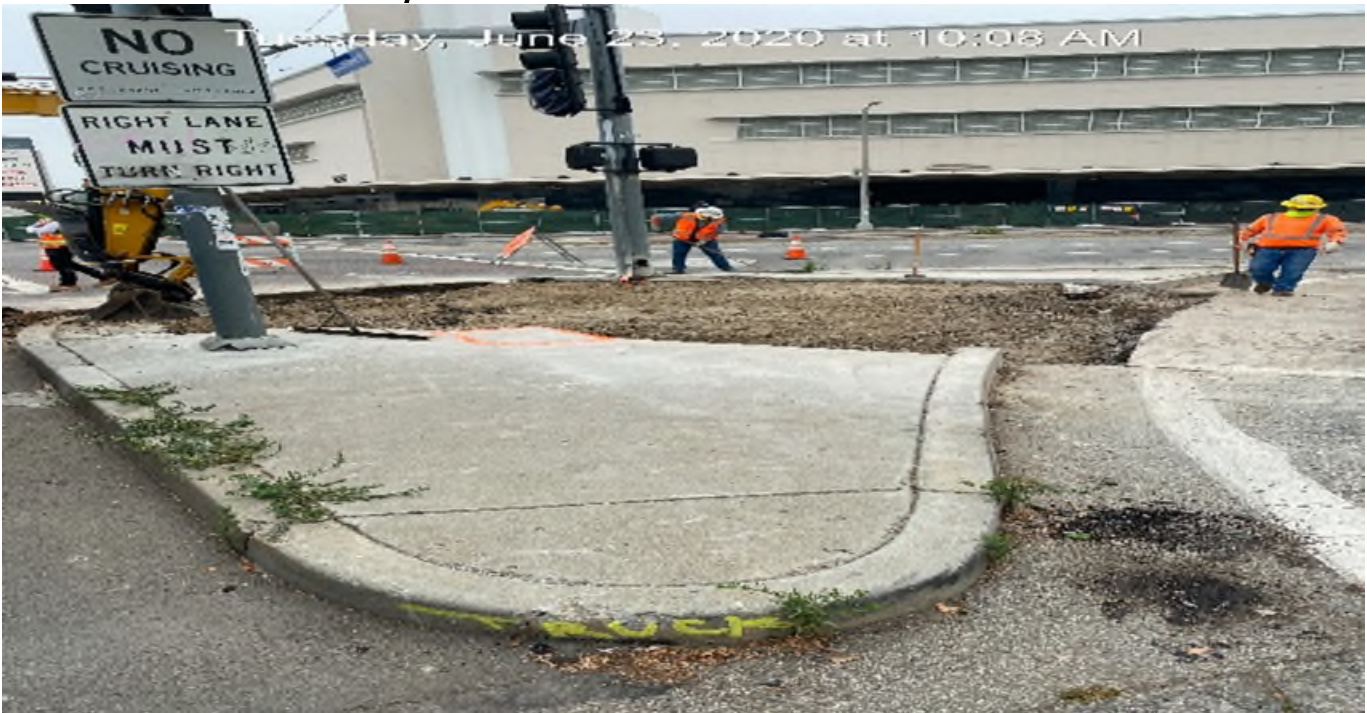
MLK STATION – Excavating/demolishing for new ADA ramp and sidewalk installation on the west median corner of MLK Blvd and Crenshaw Blvd.

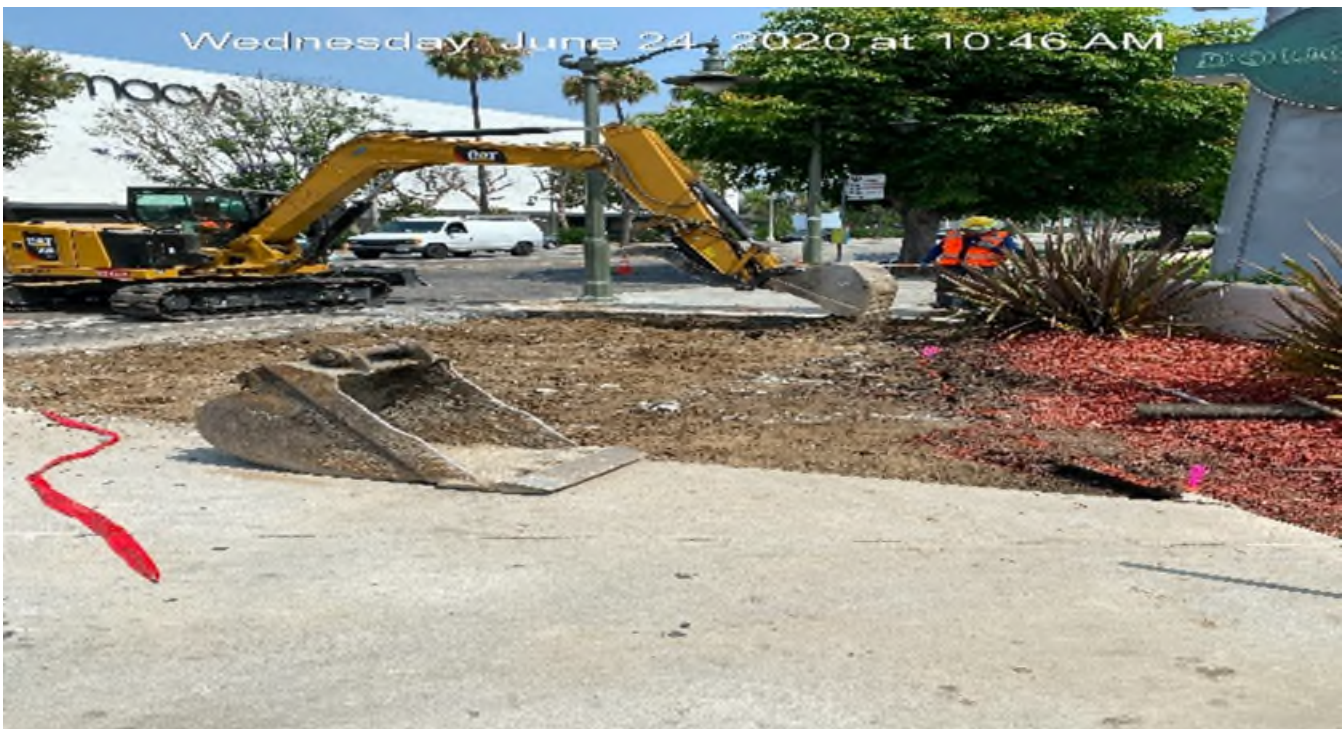
MLK STATION – Excavating/demolishing for new ADA ramp and sidewalk installation on the northeast corner of MLK Blvd and Crenshaw Blvd.

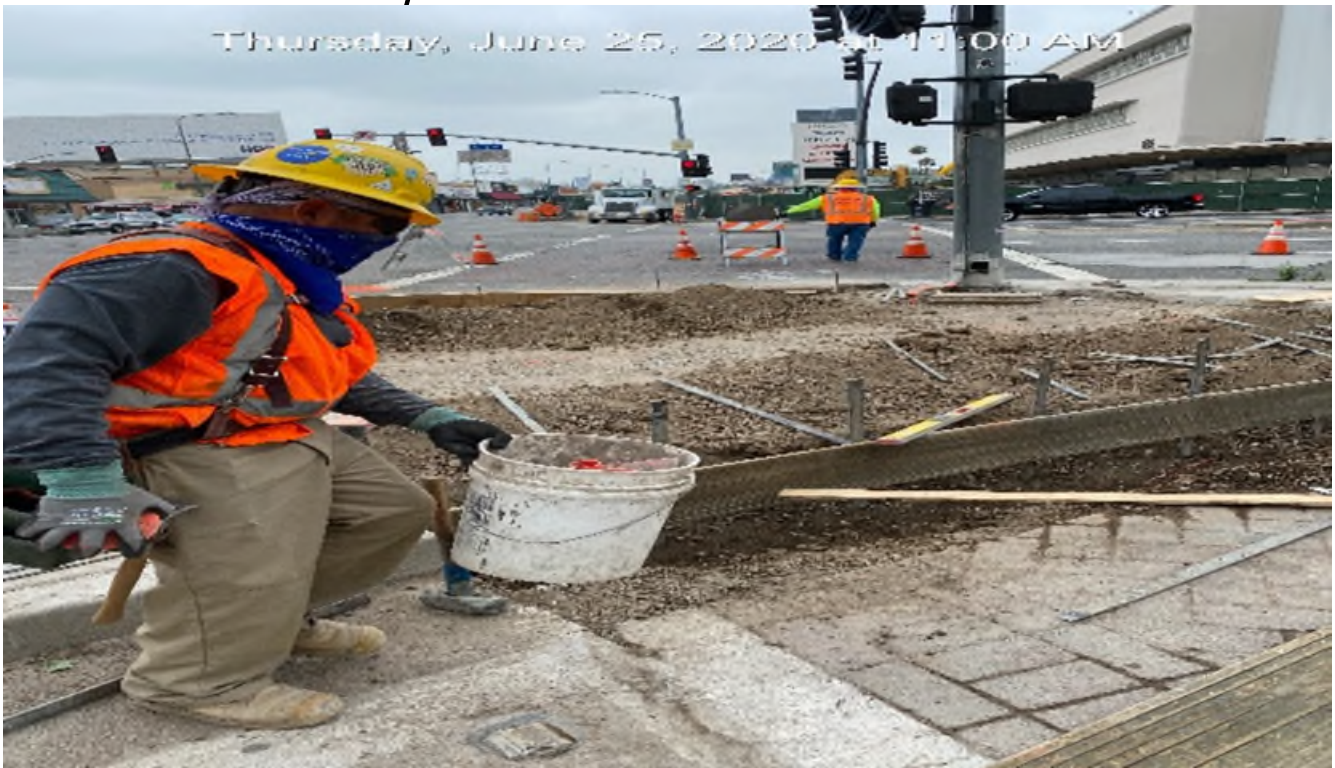
MLK STATION – Building formwork for new ADA ramp and curb/gutter installation on the west median corner of MLK Blvd and Crenshaw Blvd.

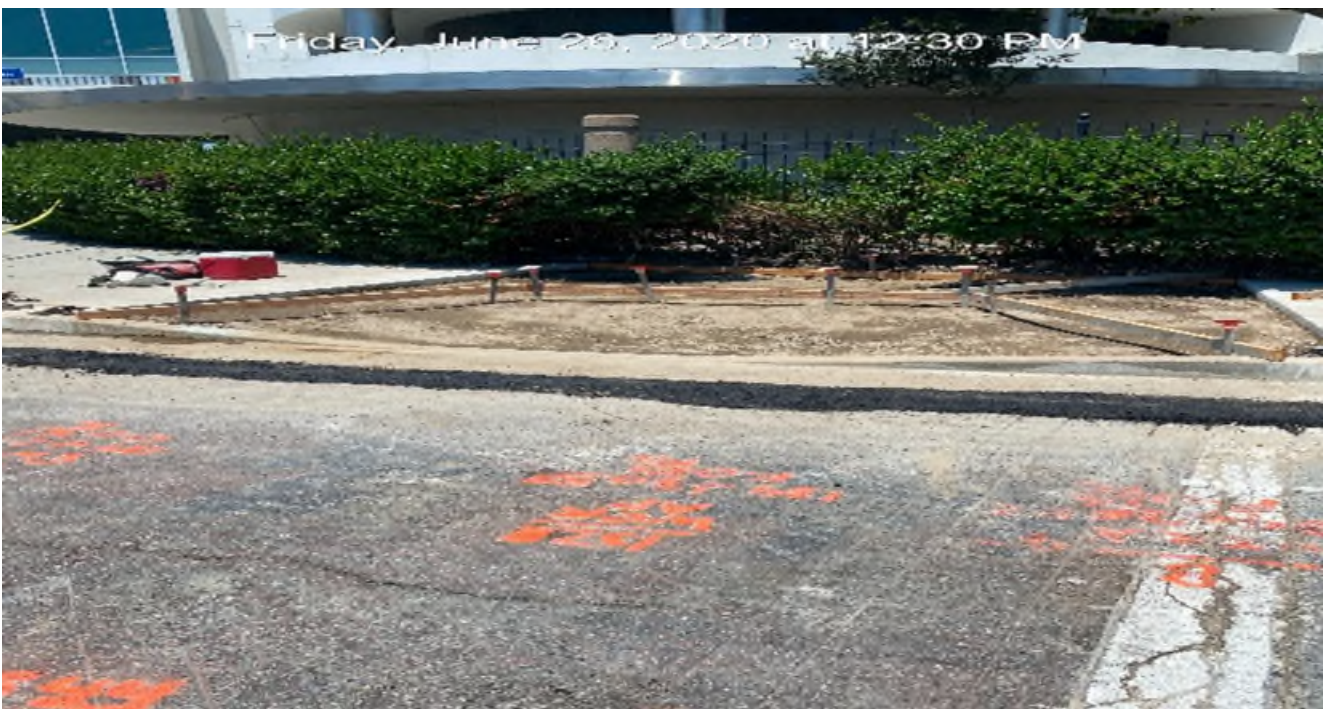
MLK STATION – Continue building formwork and placing concrete for new ADA ramp installation on the northwest corner of MLK Blvd and Crenshaw Blvd.

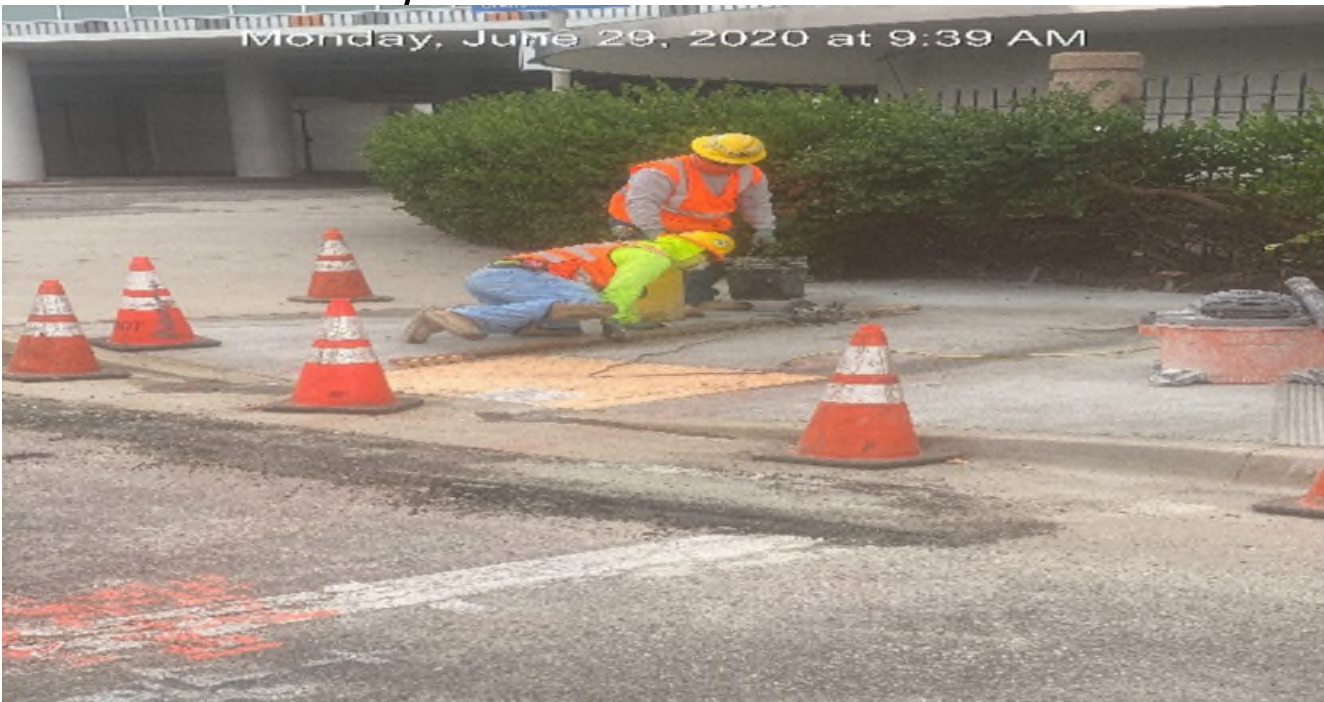
MLK STATION – Saw cutting new ADA ramp and curb/gutter on the northwest corner of MLK Blvd and Crenshaw Blvd.

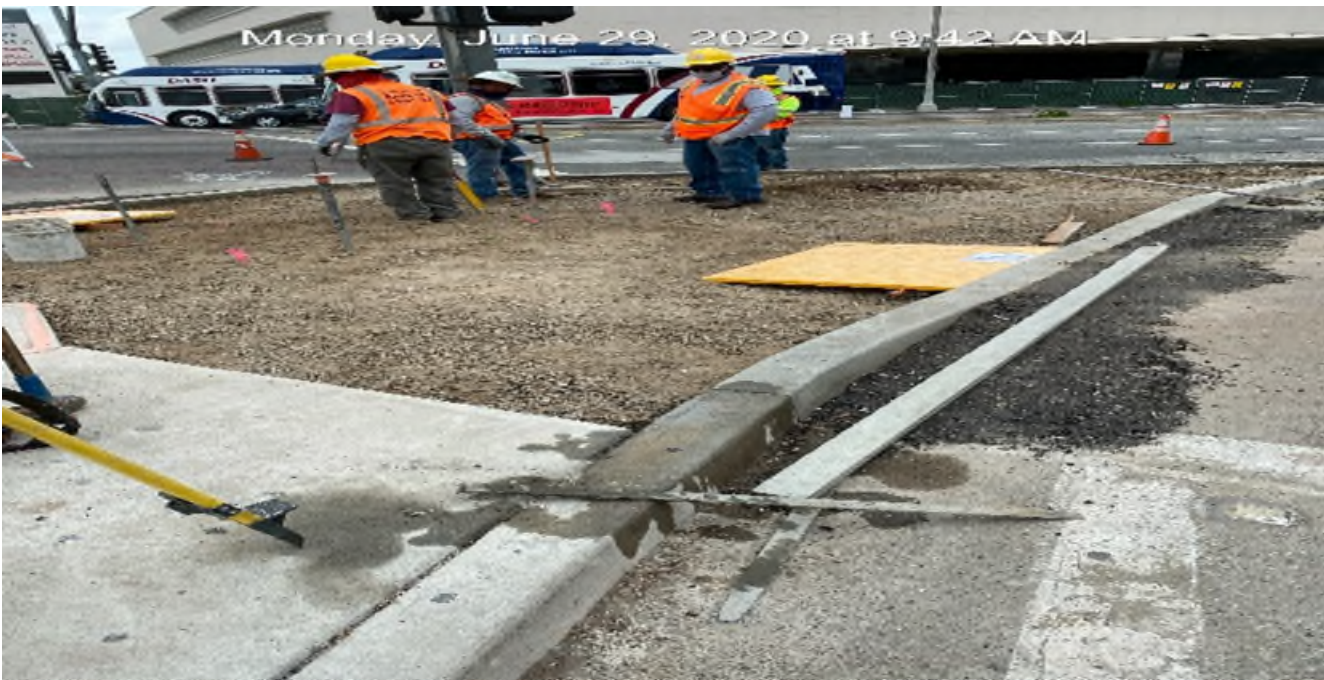
MLK STATION – Continue building formwork for new ADA ramp and curb/gutter installation on the west median corner of MLK Blvd and Crenshaw Blvd.

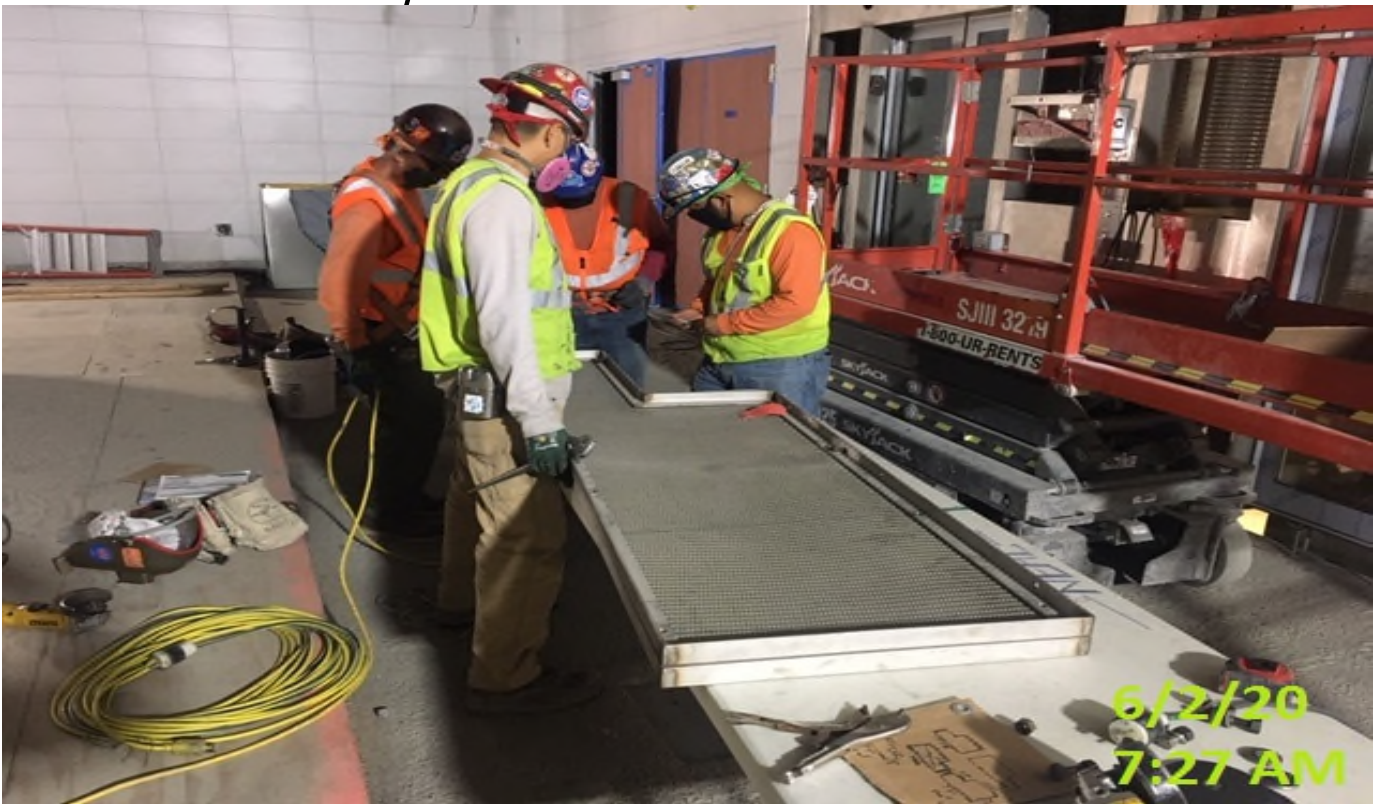
MLK STATION- McMahon installing mesh fascia screens for elevator #3 and #4.

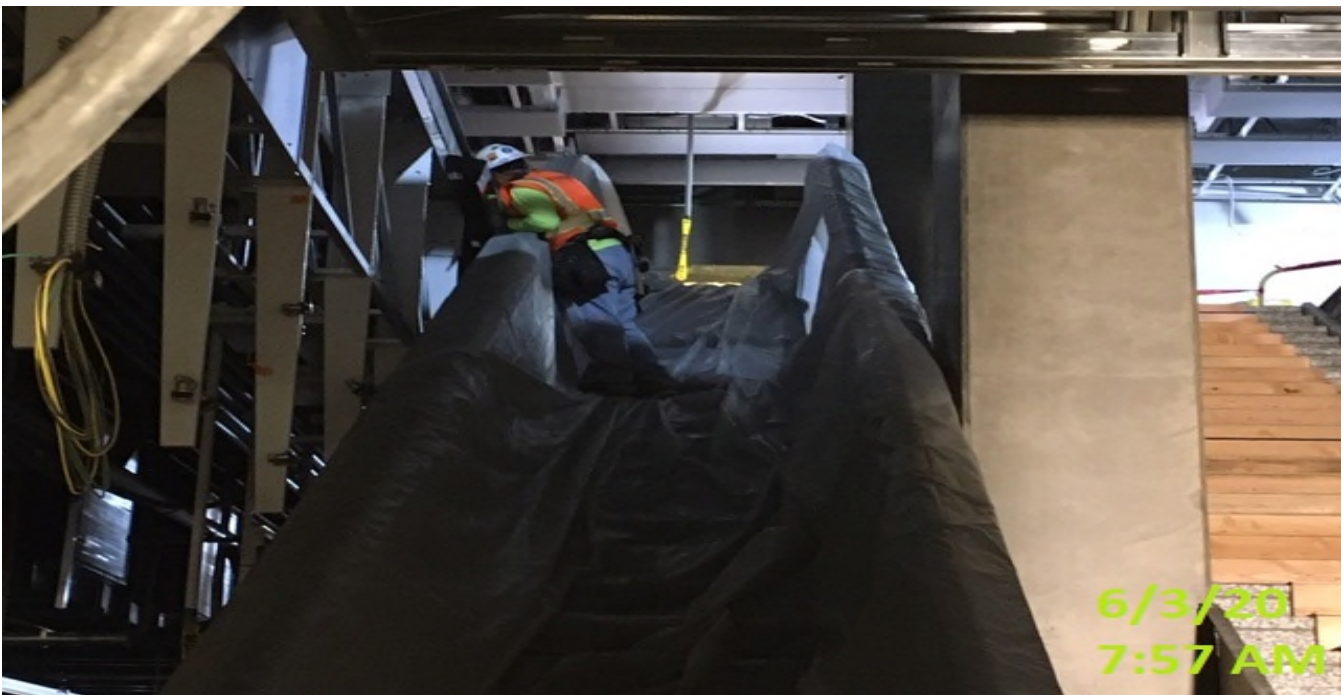
MLK STATION- VNSM crew installing stainless steel panels between escalator #4 and down stands.

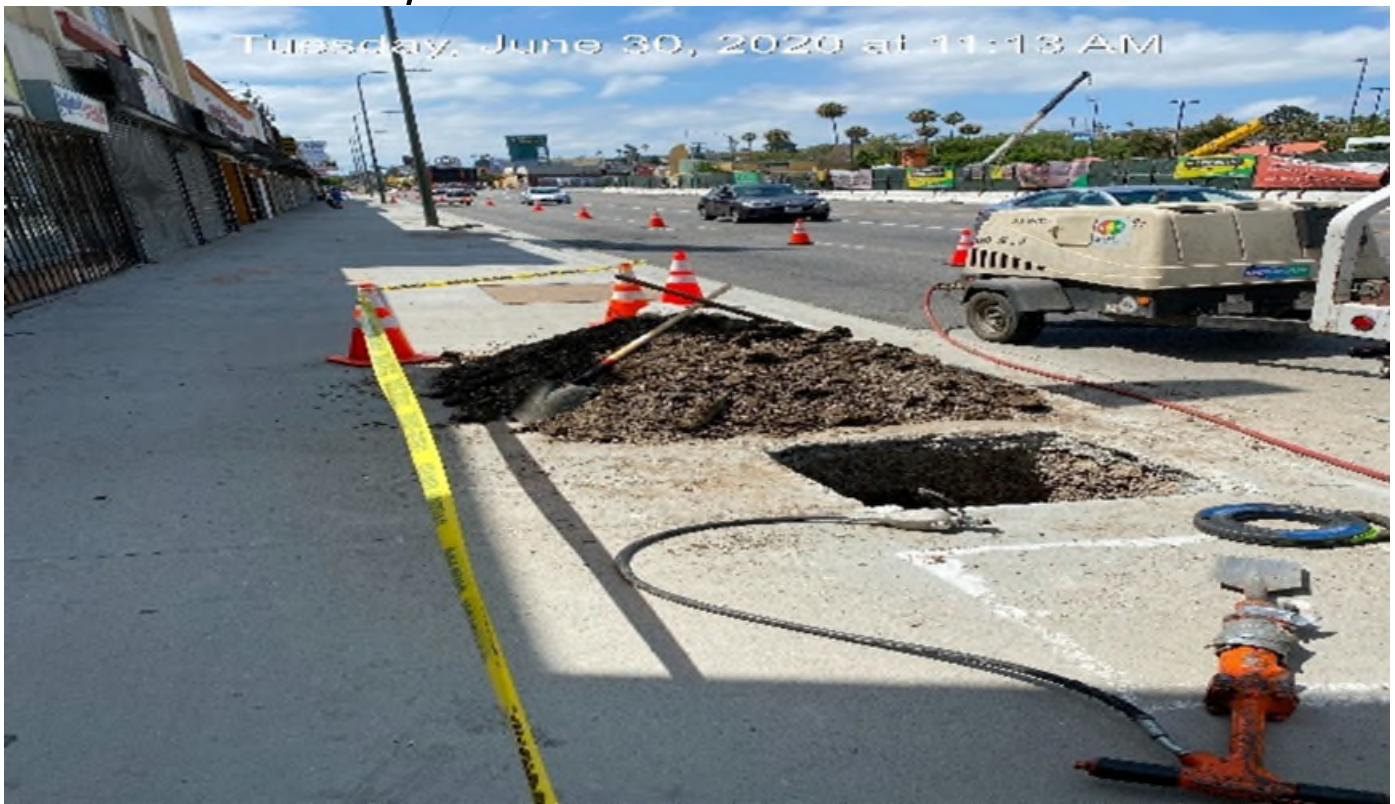
MLK STATION – Excavating for new pedestrian signal head foundations on Crenshaw Blvd between Stocker St and MLK Blvd.
