CRENSHAW/LAX PHOTOGRAPHIC UPDATE

July 7, 2020

Crenshaw/LAX Transit Project

Overview of trackwork progress issues for 06-22-2020 – July 7, 2020
(Please note the attached Trackwork Progress Tracking Report)

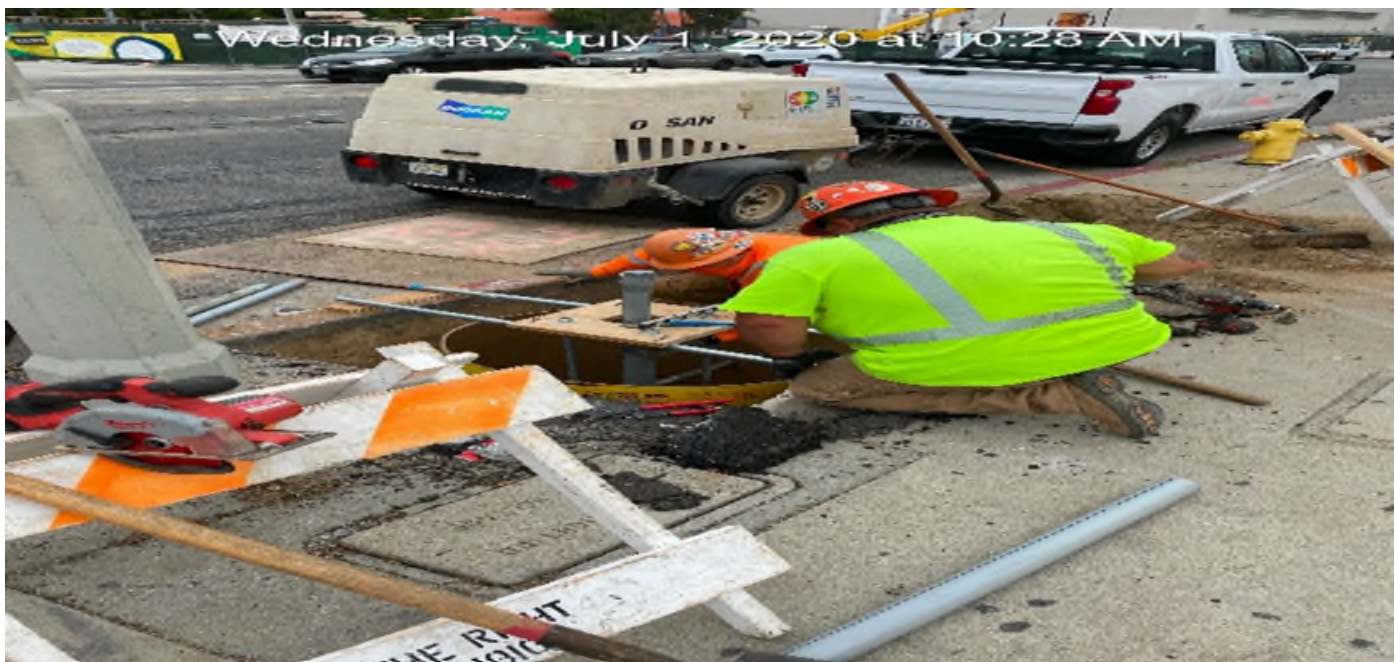
MLK STATION – Installing pedestrian signal head foundations on Crenshaw Blvd between Stocker St and MLK Blvd.

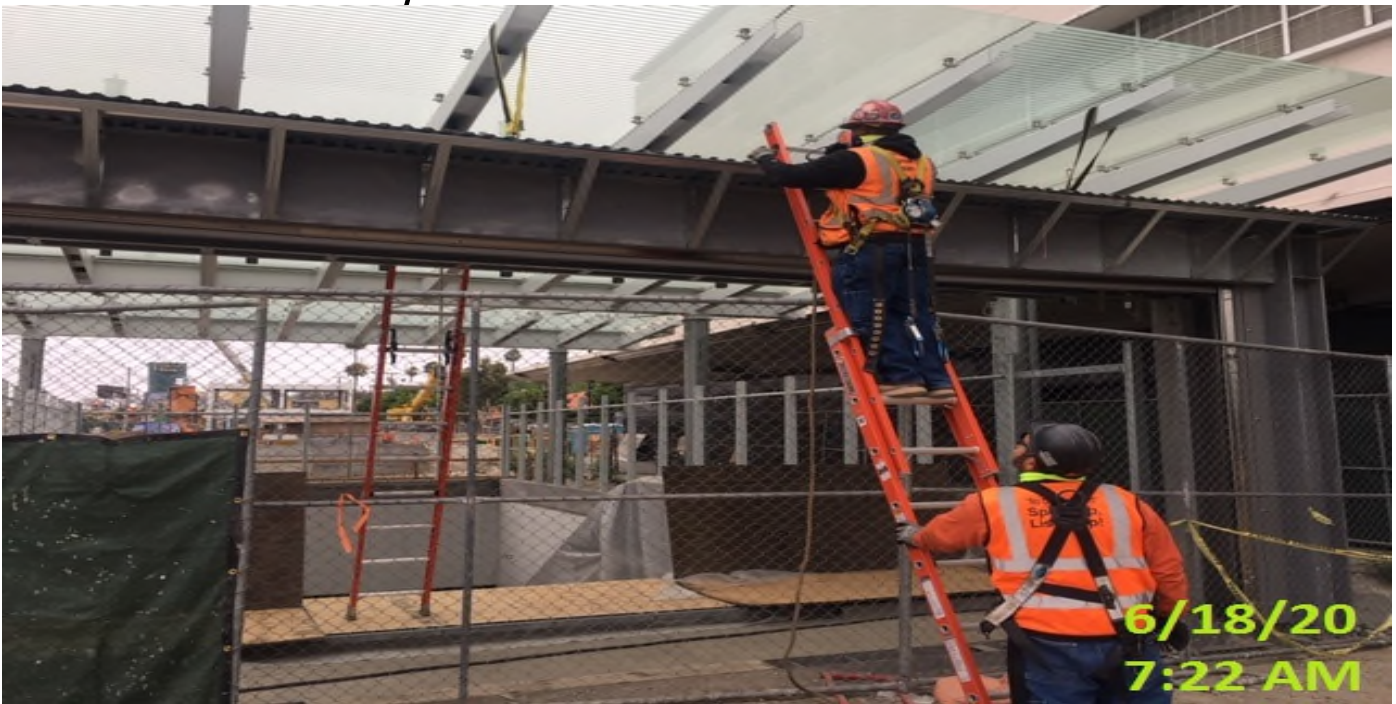
MLK STATION – Continue installing roofing deck to the main entrance canopy structure at the plaza level.

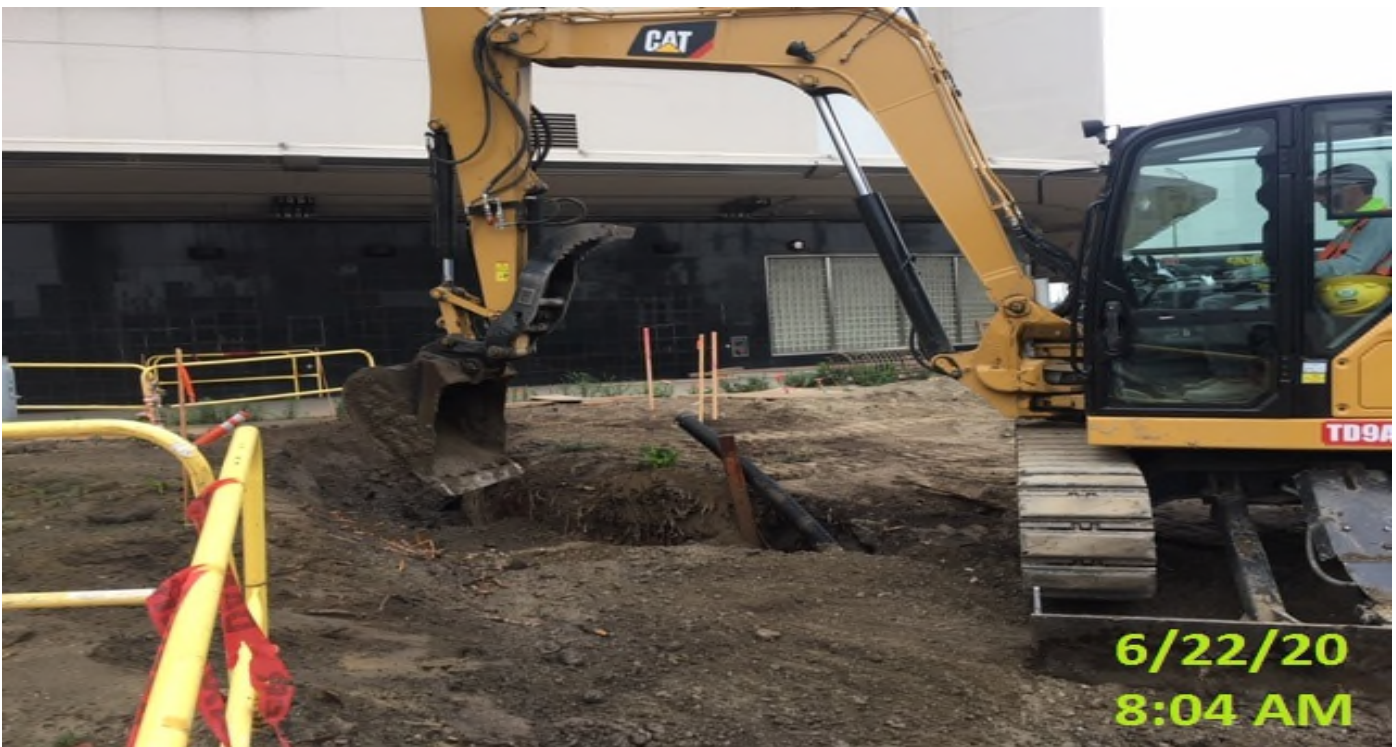
MLK STATION – Backfilling and compacting storm drain trench at the plaza level.

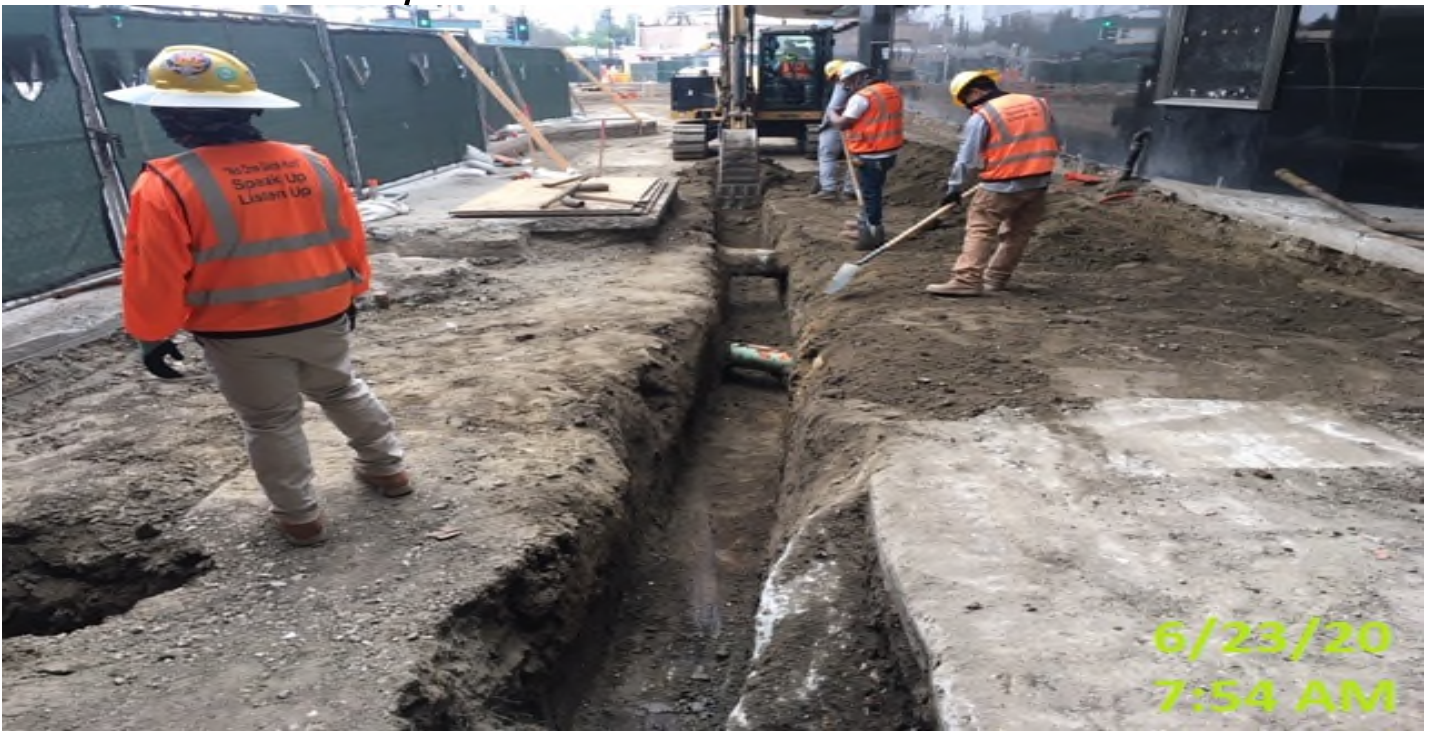
MLK STATION – Excavating/trenching for underground landscaping conduit installation at the west side of the plaza level.

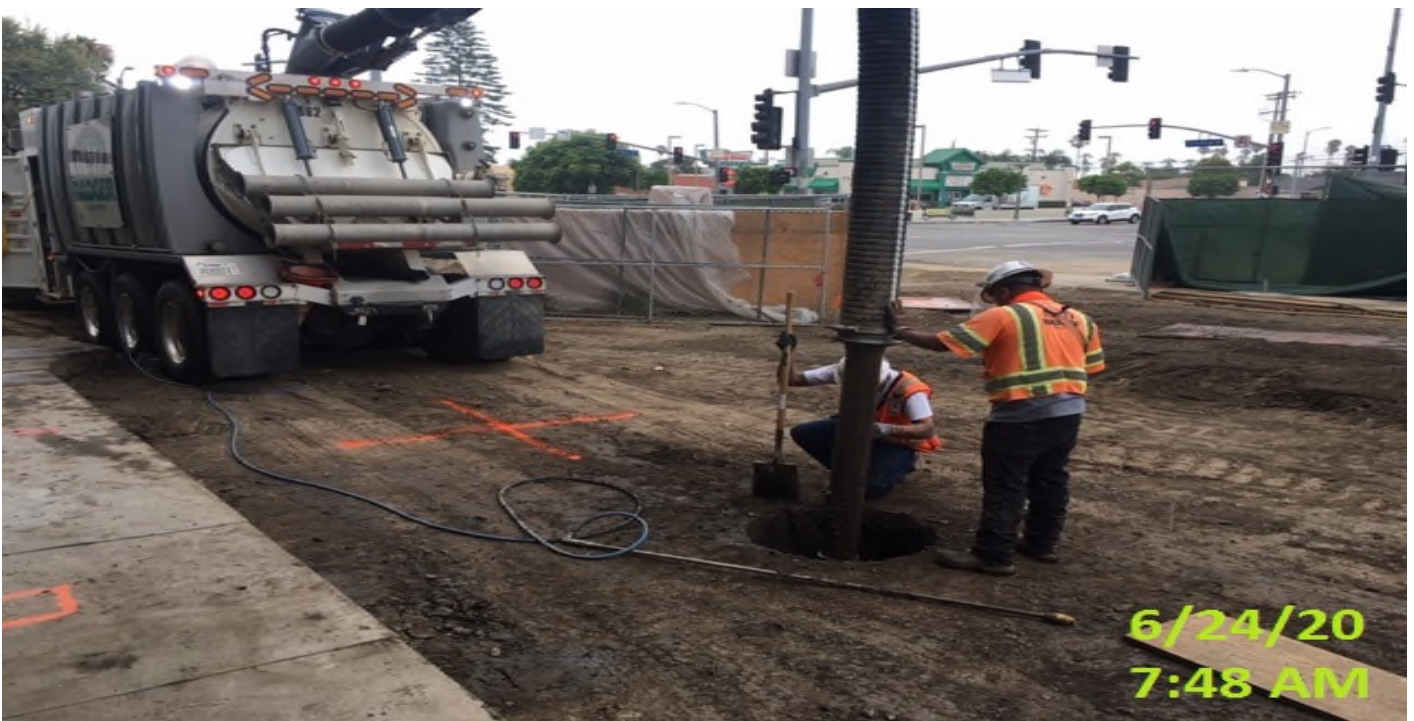
MLK STATION – Potholing for tree wells and underground landscaping conduit installation at the northwest corner of the plaza level.

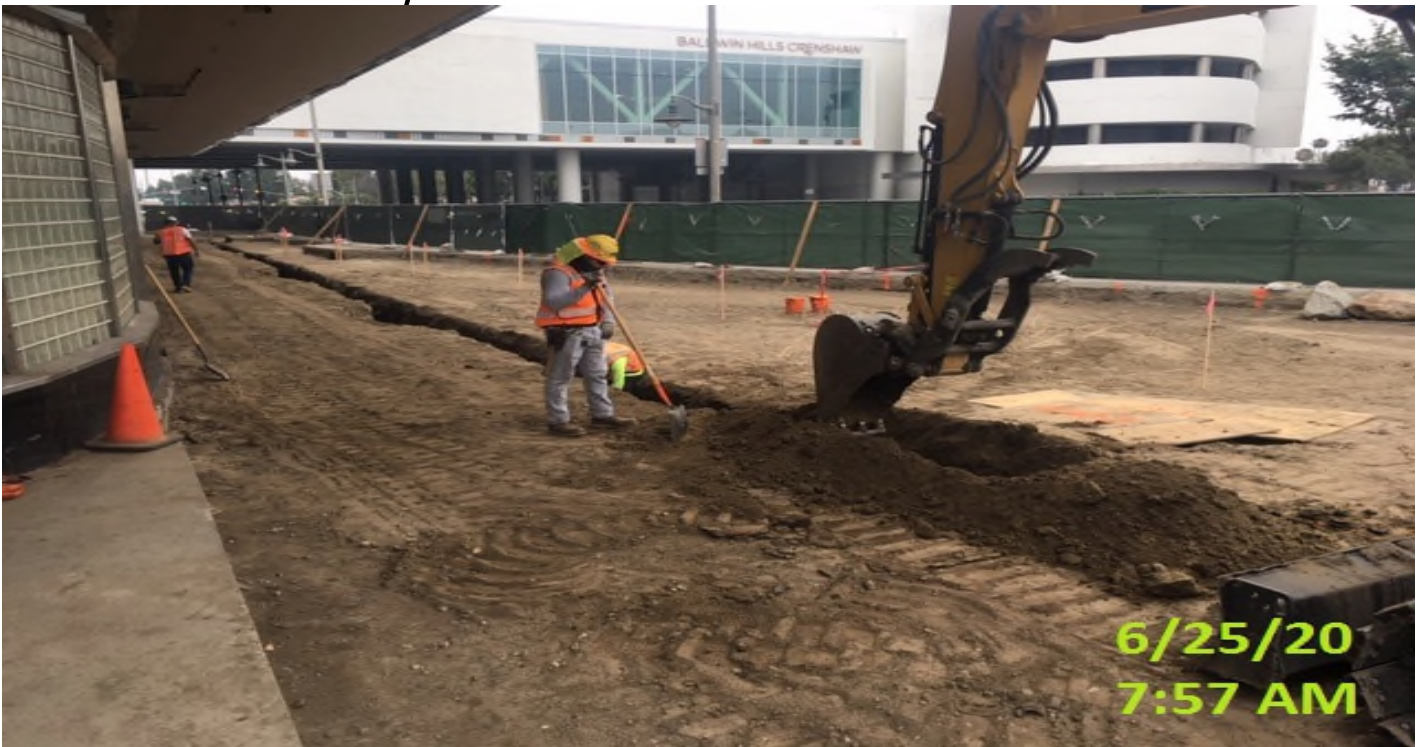
MLK STATION –Continue excavating/trenching for underground landscaping conduit installation at the west side of the plaza level.

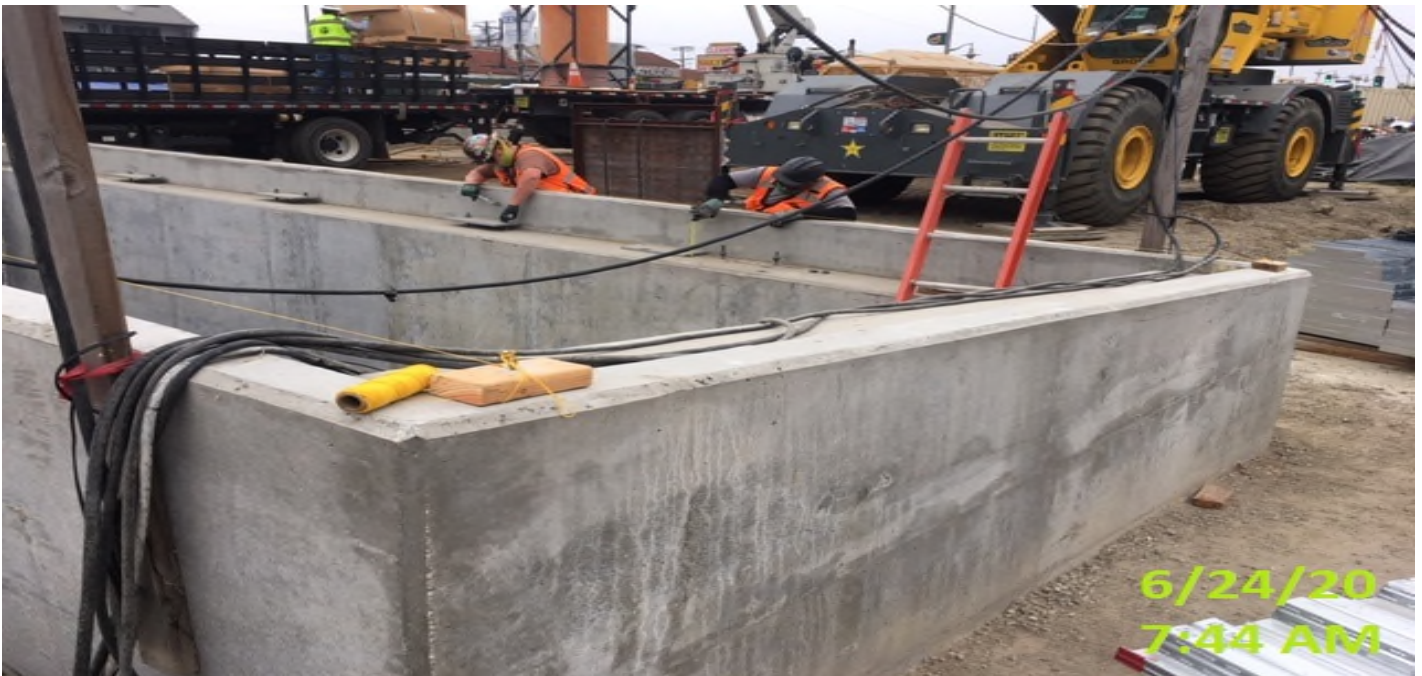
MLK STATION – Installing steel grating for the south air exhaust vent shaft at the plaza level.

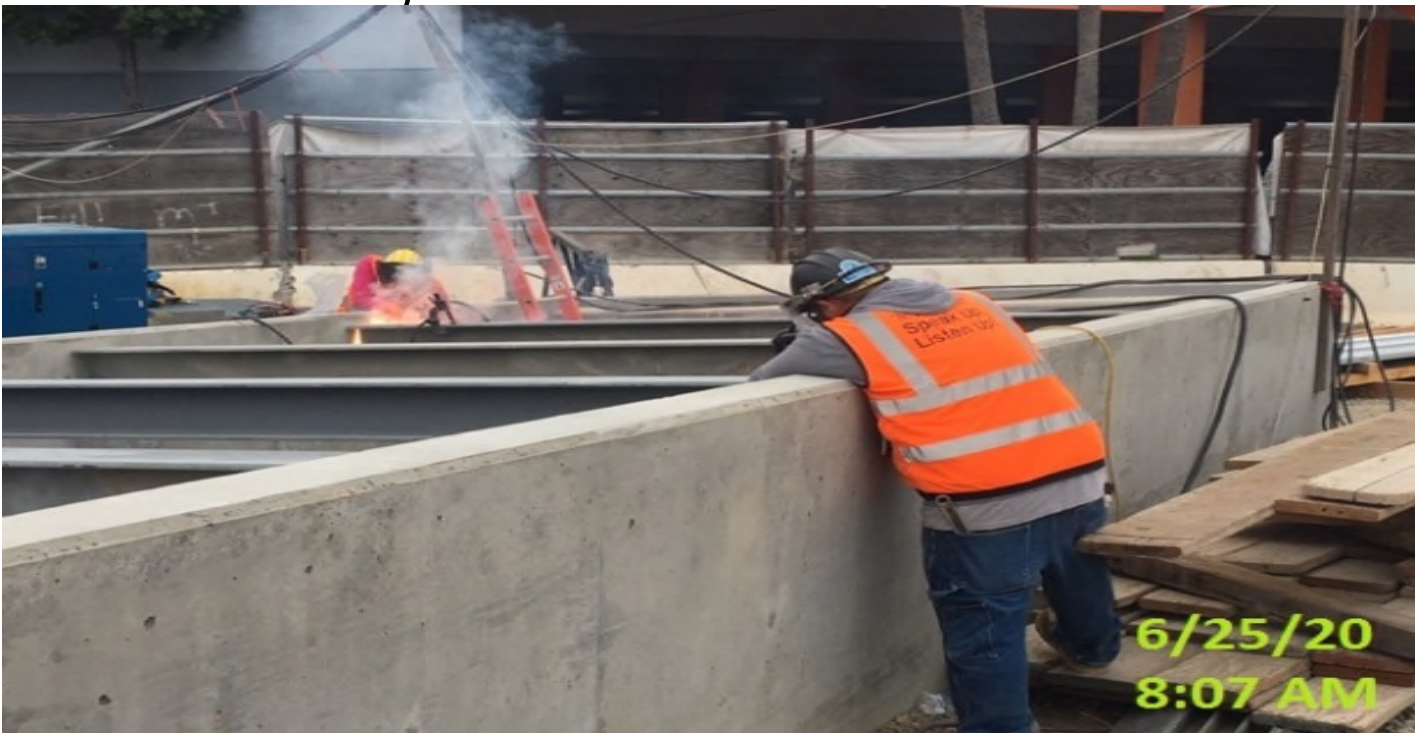
MLK STATION – Continue installing beams for steel grating for the south air exhaust vent shaft at the plaza level.

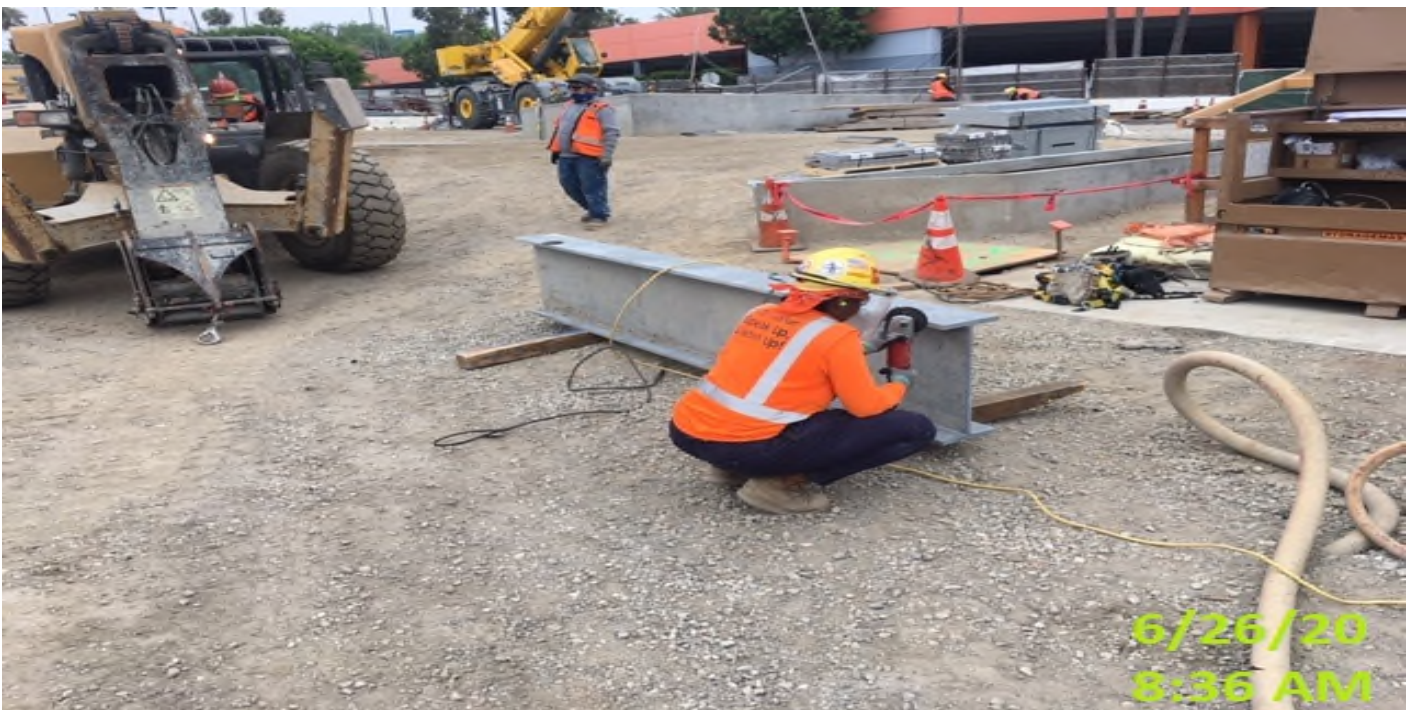
MLK STATION – Installing beams to the south air exhaust vent shaft and continue steel grating installation at the plaza level.

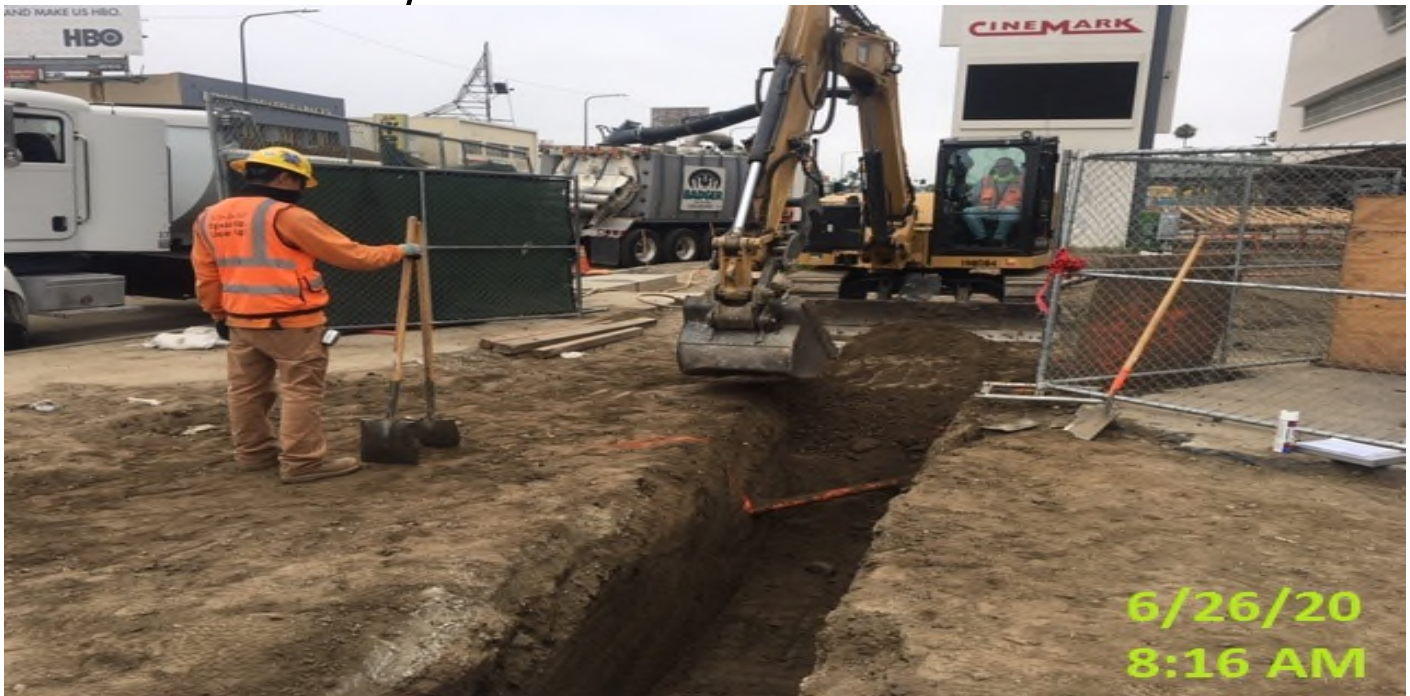
MLK STATION – Continue excavating/trenching for underground landscaping conduit installation at the west side of the plaza level.

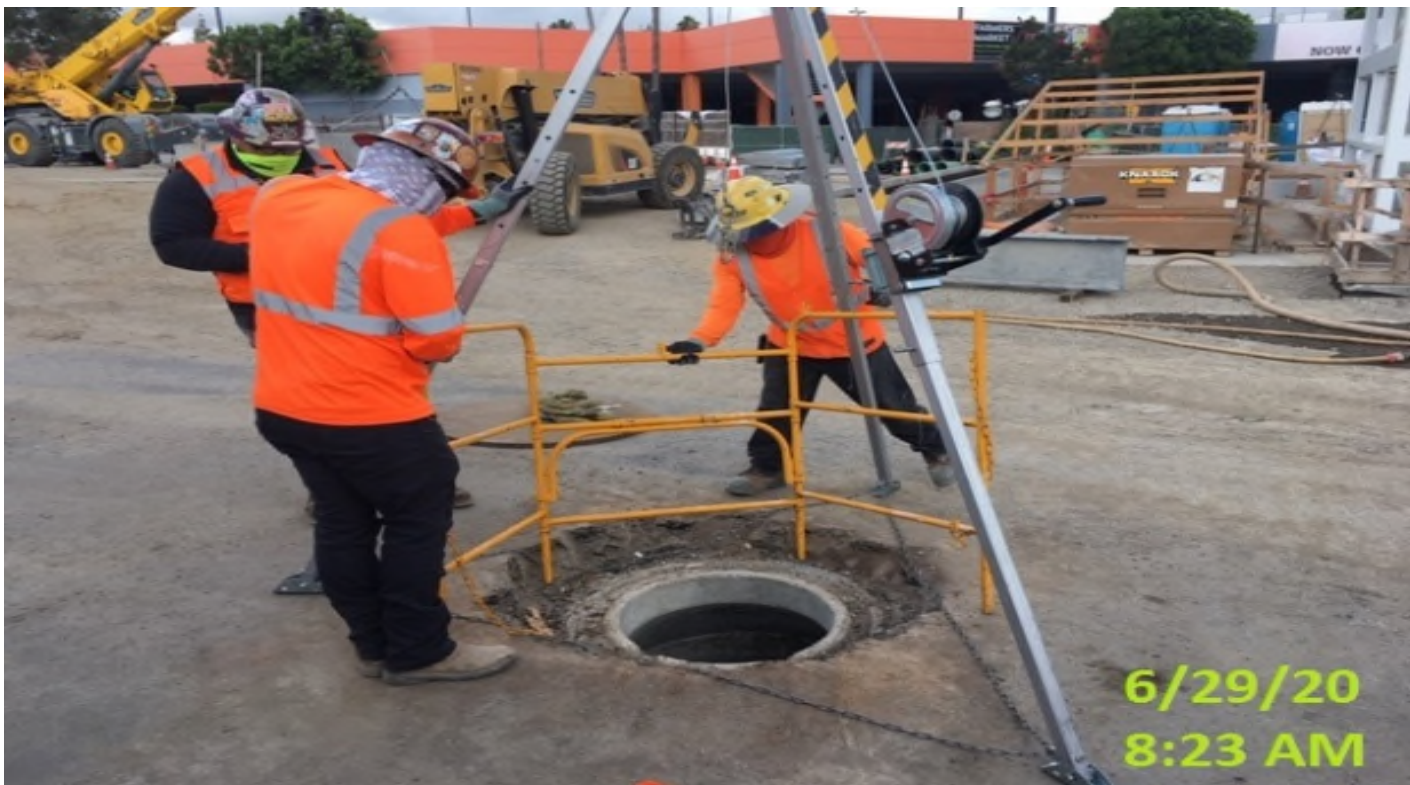
MLK STATION – Chipping and patching inside Man Hole #15 at the plaza level.

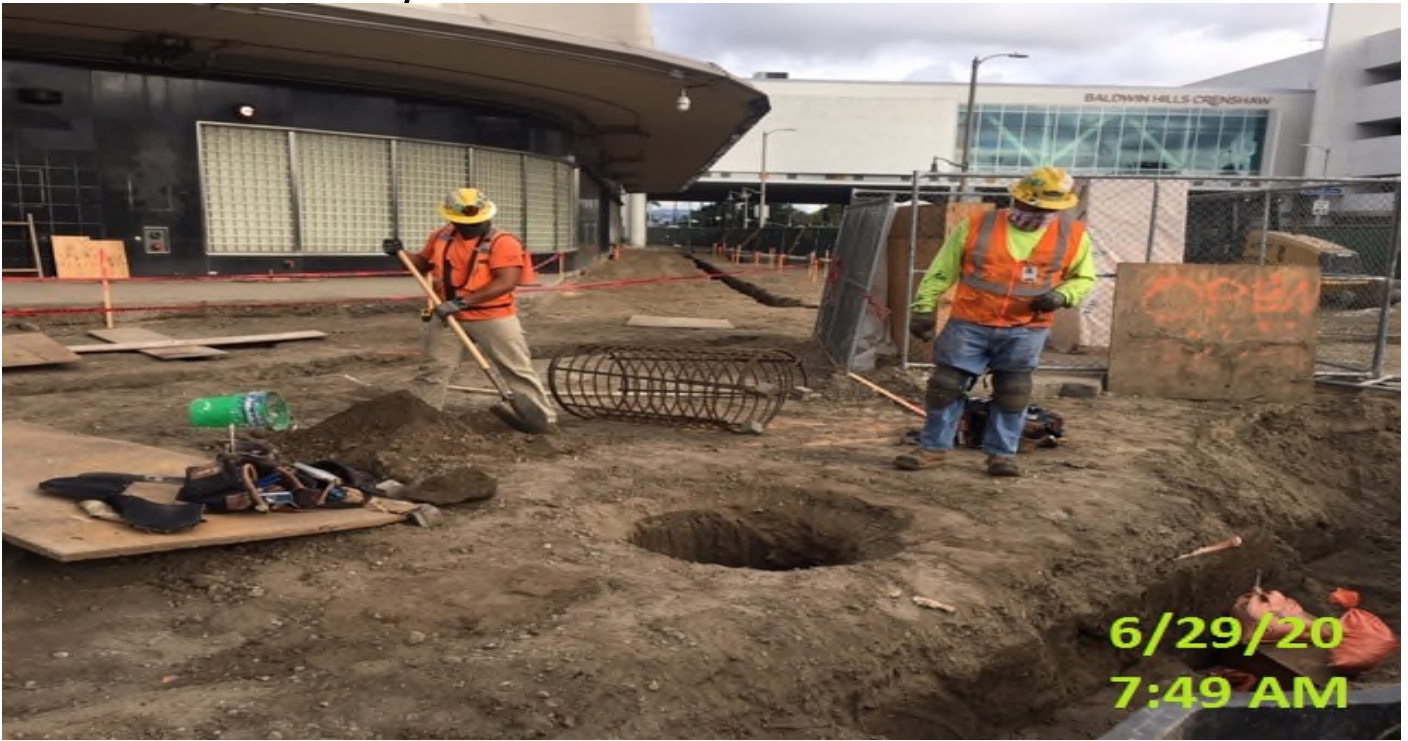
MLK STATION – Setting rebar cages for pedestrian light pole foundations throughout the plaza level.

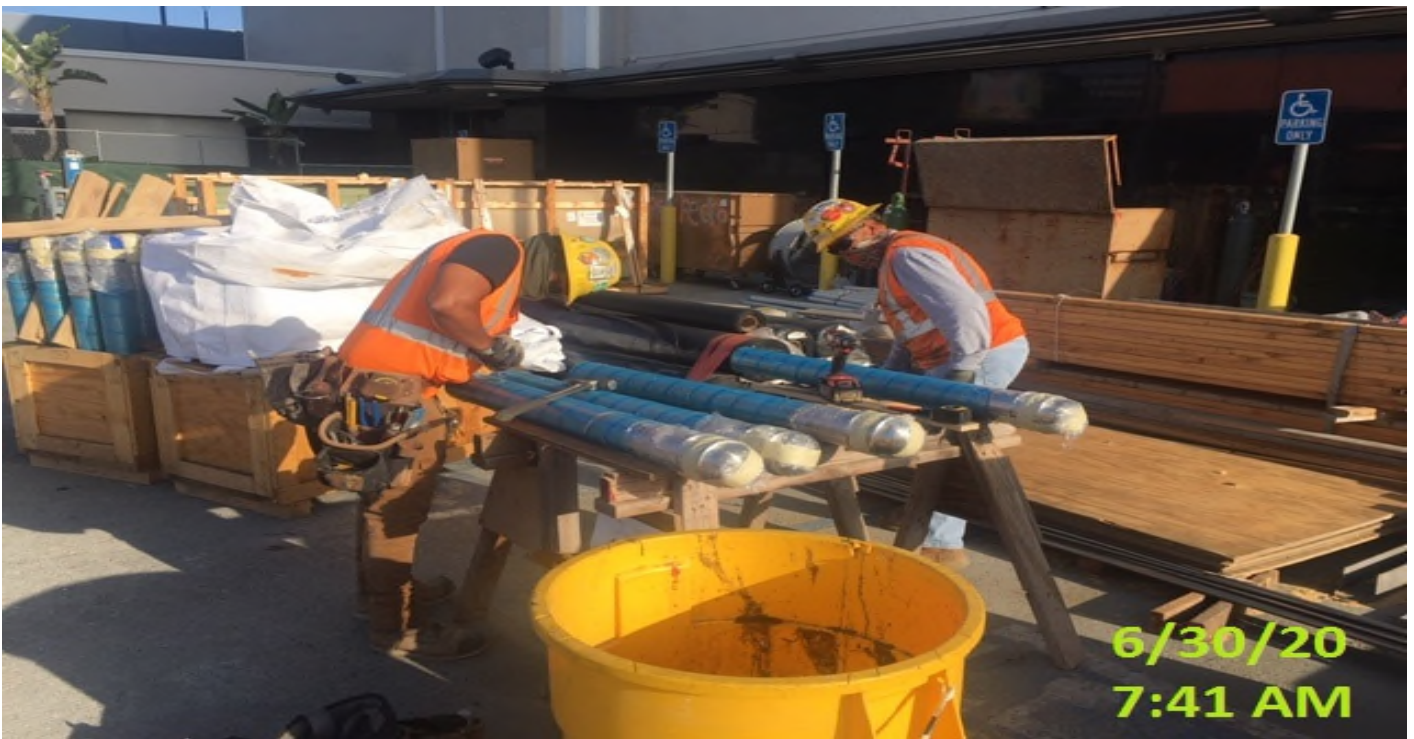
MLK STATION – Drilling and tapping the stainless steel bollards for ground wire prior to installation at the plaza level.

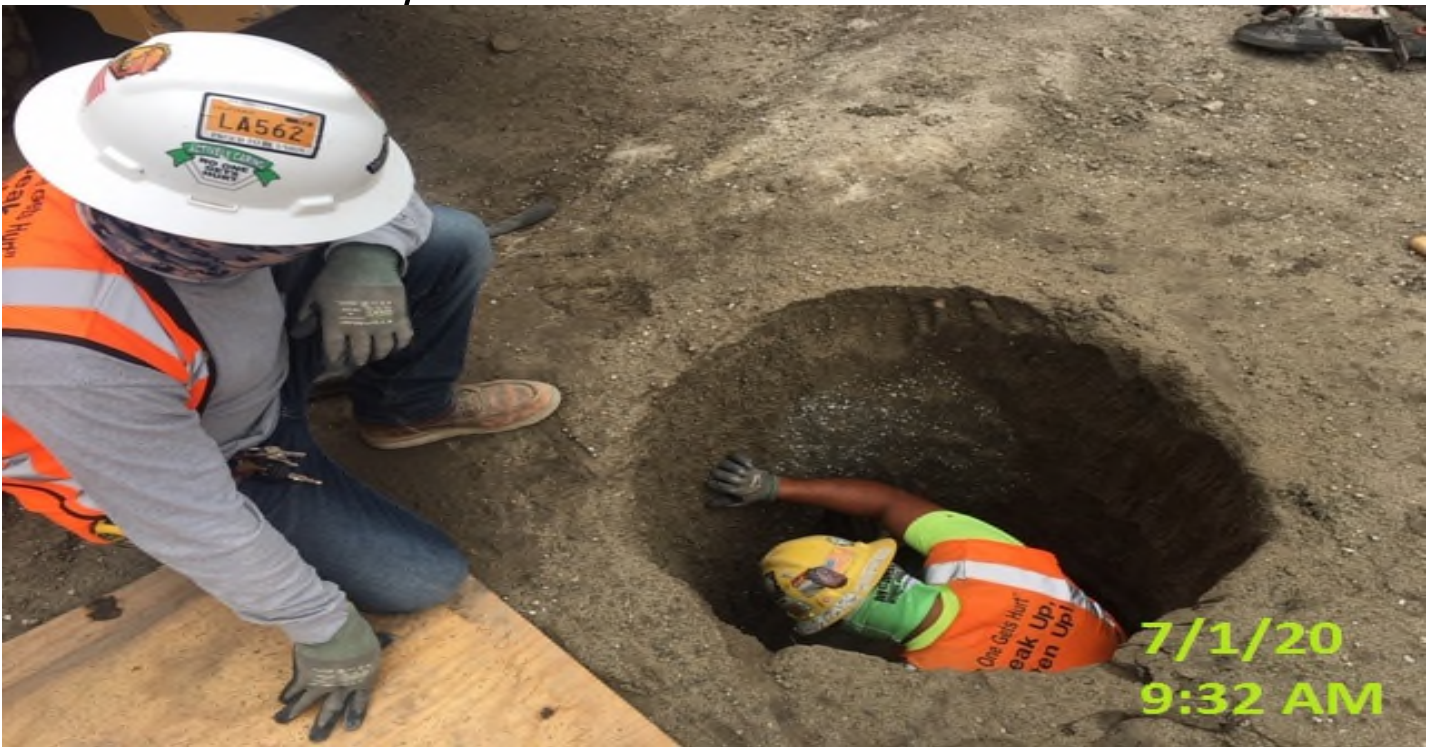
MLK STATION – Continue setting rebar cages for pedestrian light pole foundations throughout the plaza level.

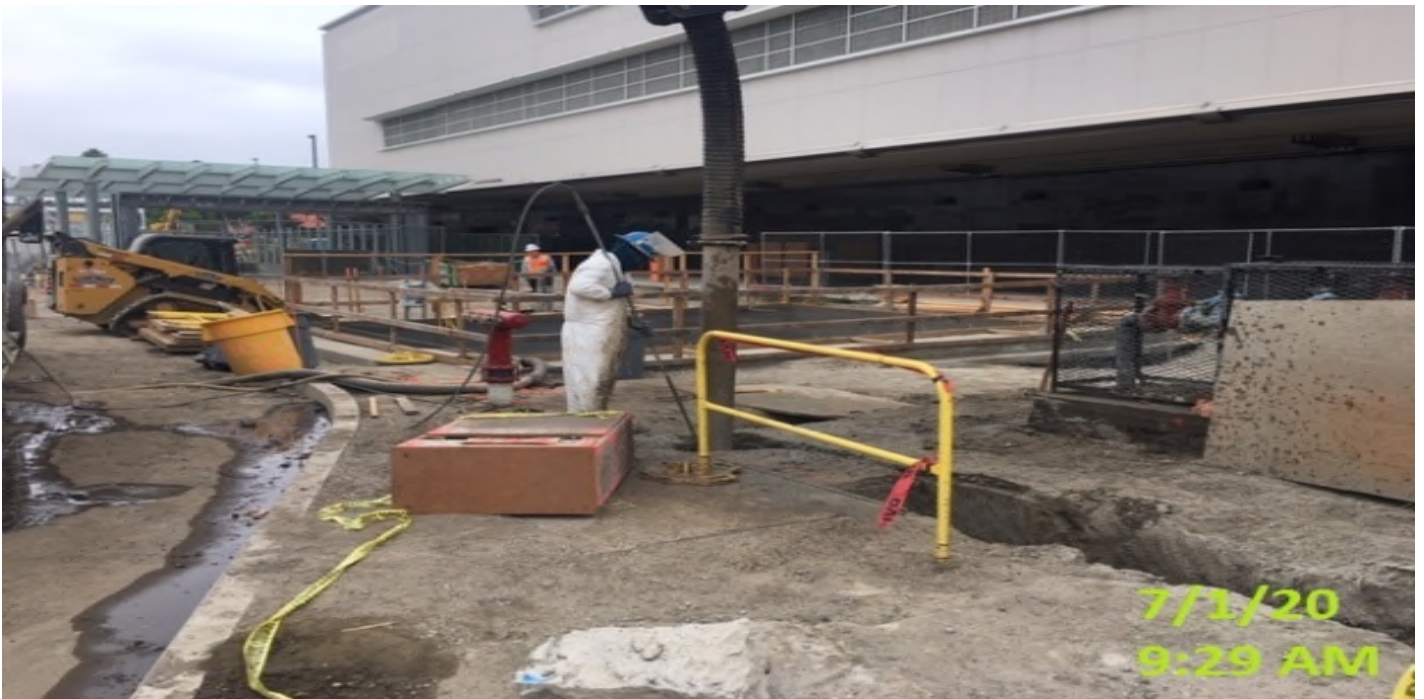
MLK STATION – Resume trenching/potholing for underground landscaping conduit installation at the northwest corner of the plaza level.

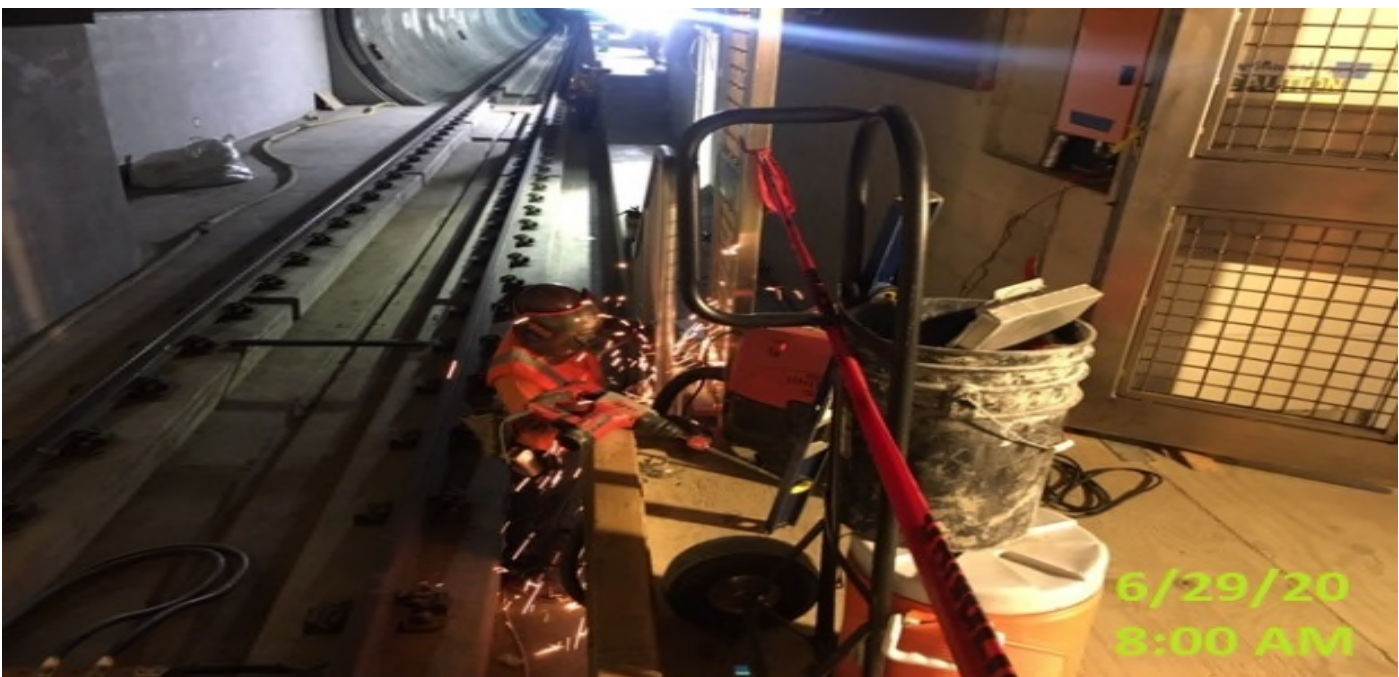
MLK STATION – Continue installing guardrails for both south and northbound tunnels at the south end invert level.

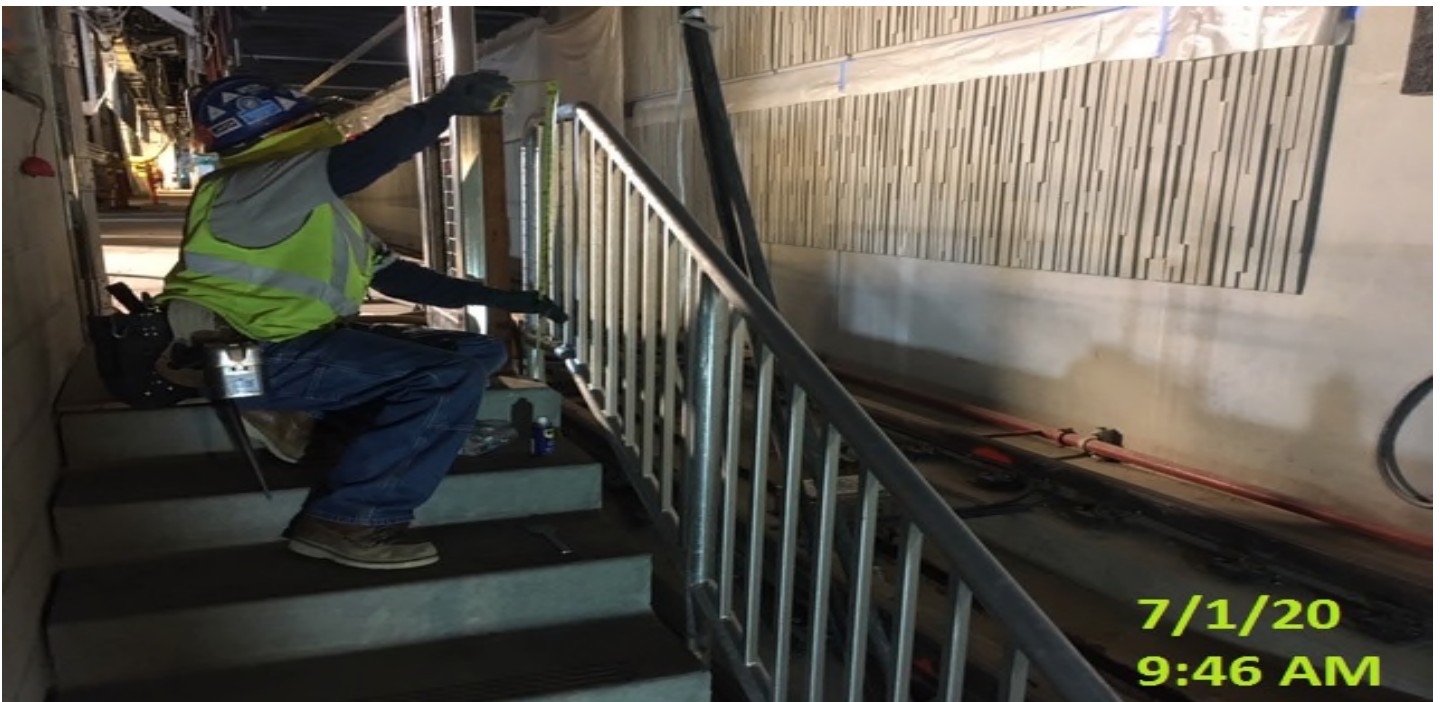
MLK STATION – Continue installing guardrails for both south and northbound tunnels at the north end invert level.

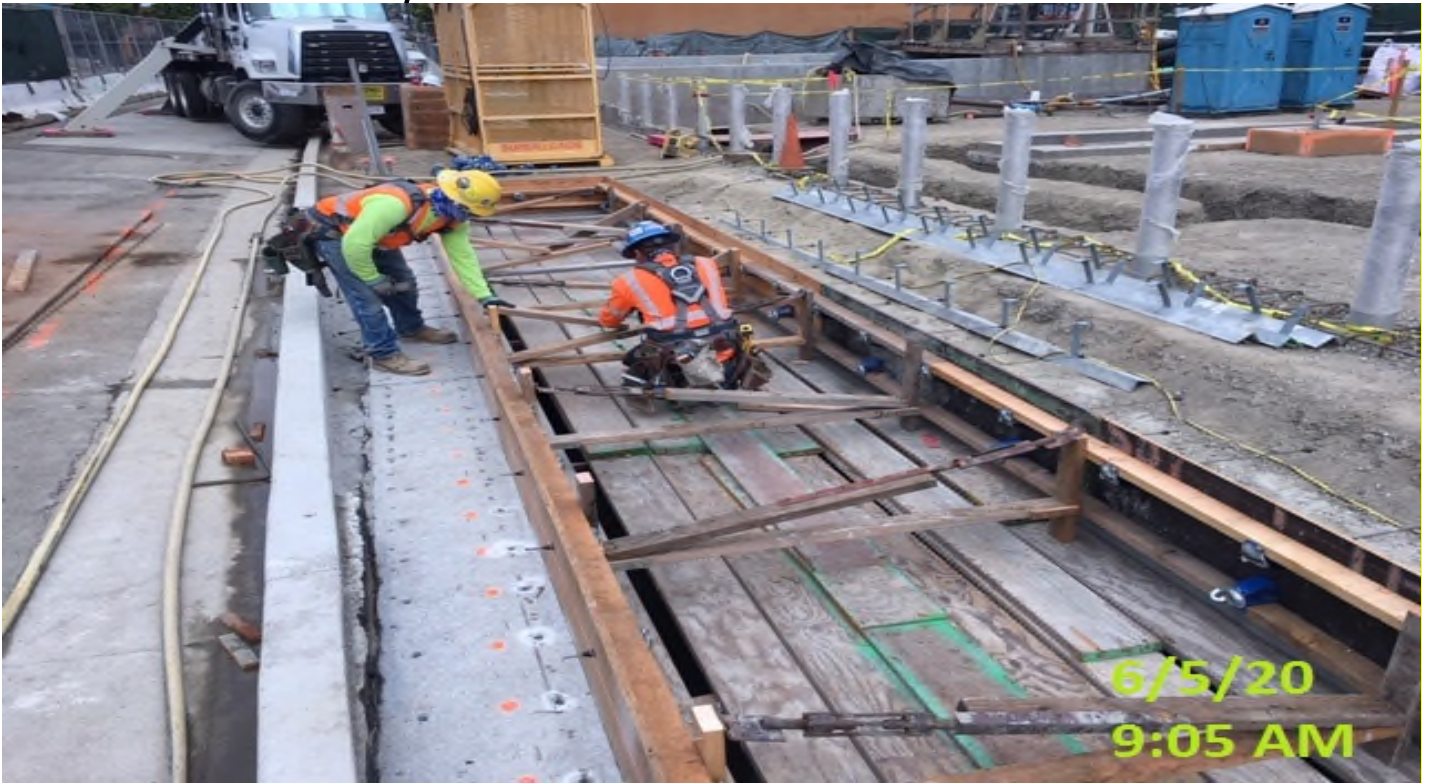
MLK STATION- WSCC crew building formwork for air exhaust shaft, per NCR.

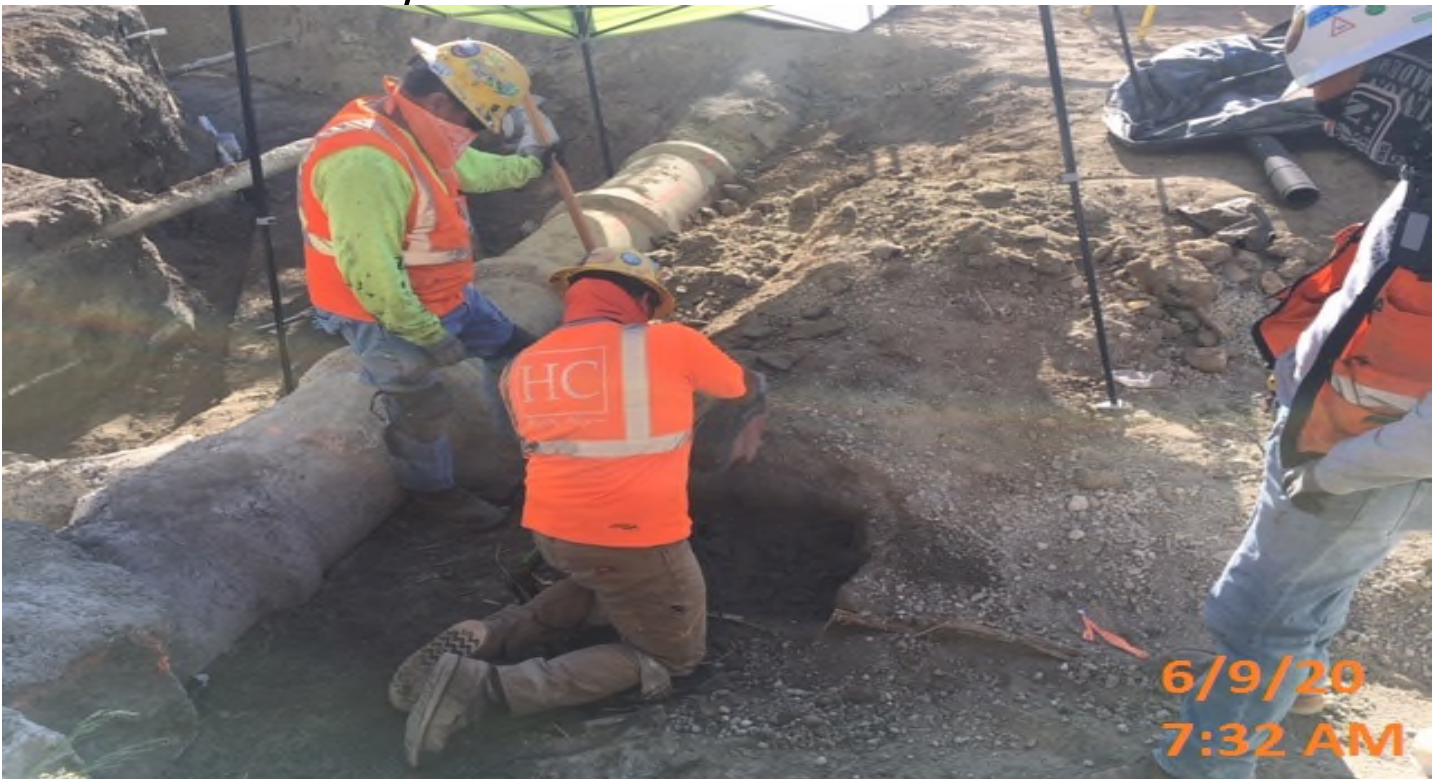
MLK STATION- WSCC crew hand digging for pedestrian light pole foundations.

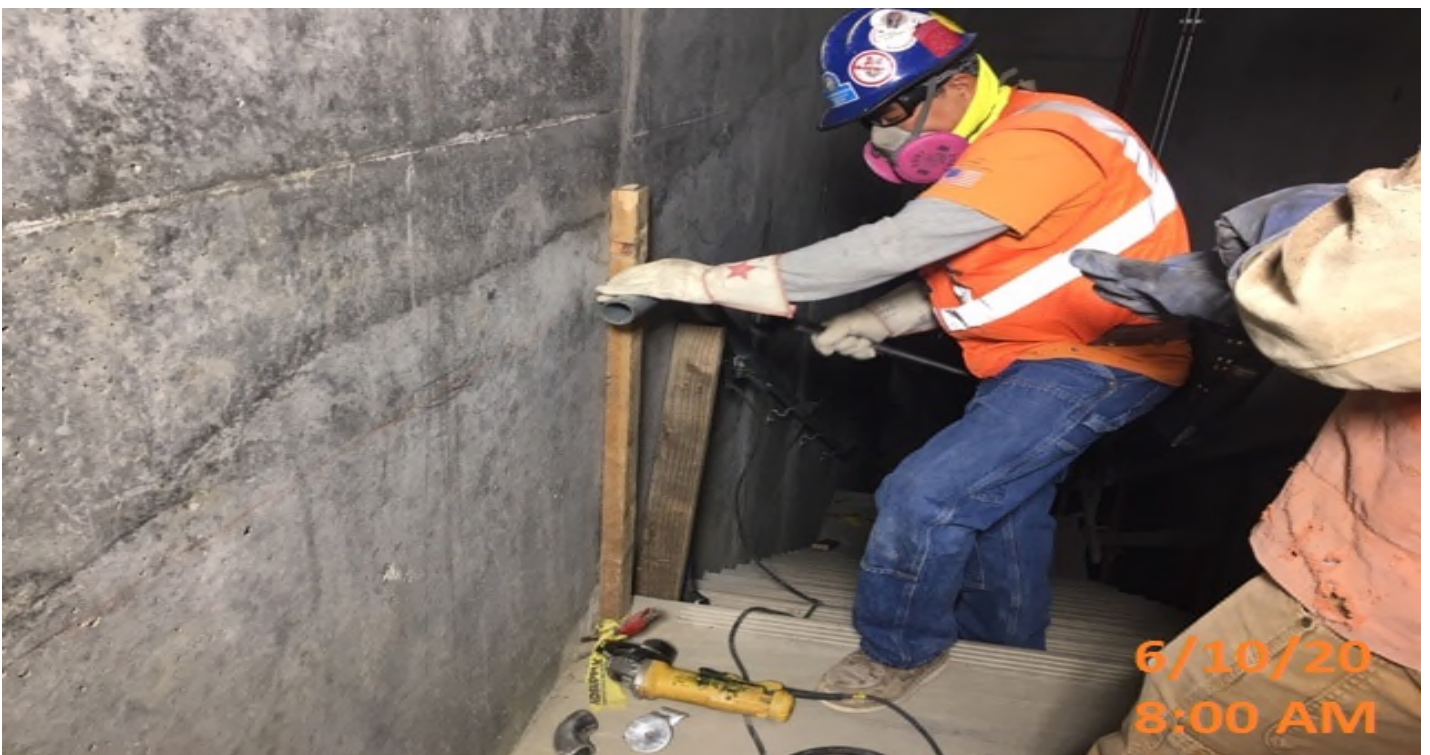
MLK STATION- McMahon Steel installing handrail at emergency exit north stair #2.

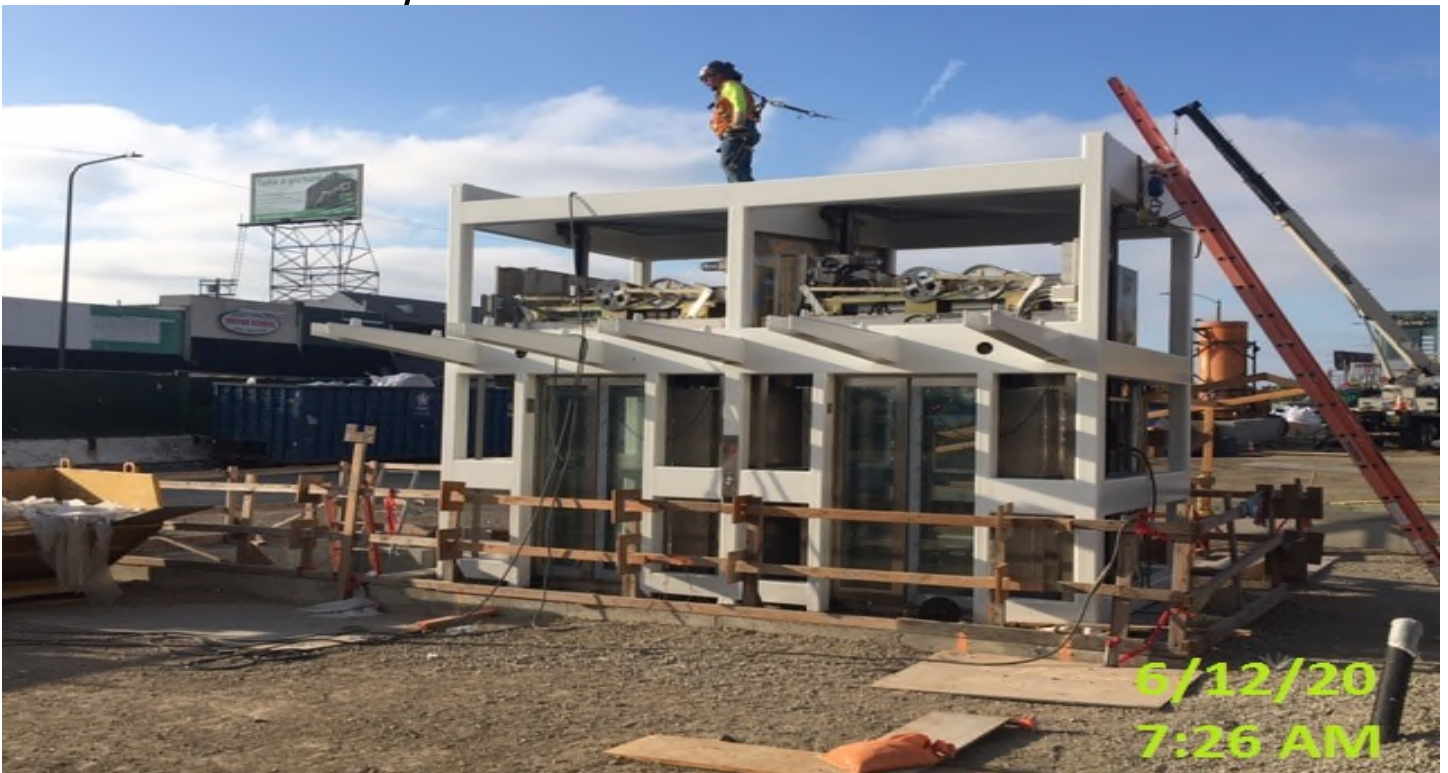
MLK STATION- WSCC Ironworkers installing metal roof deck at elevator structure #1 and #2.
