CRENSHAW/LAX PHOTOGRAPHIC UPDATE

July 7, 2020

Crenshaw/LAX Transit Project

Overview of trackwork progress issues for 06-22-2020 – July 7, 2020
(Please note the attached Trackwork Progress Tracking Report)

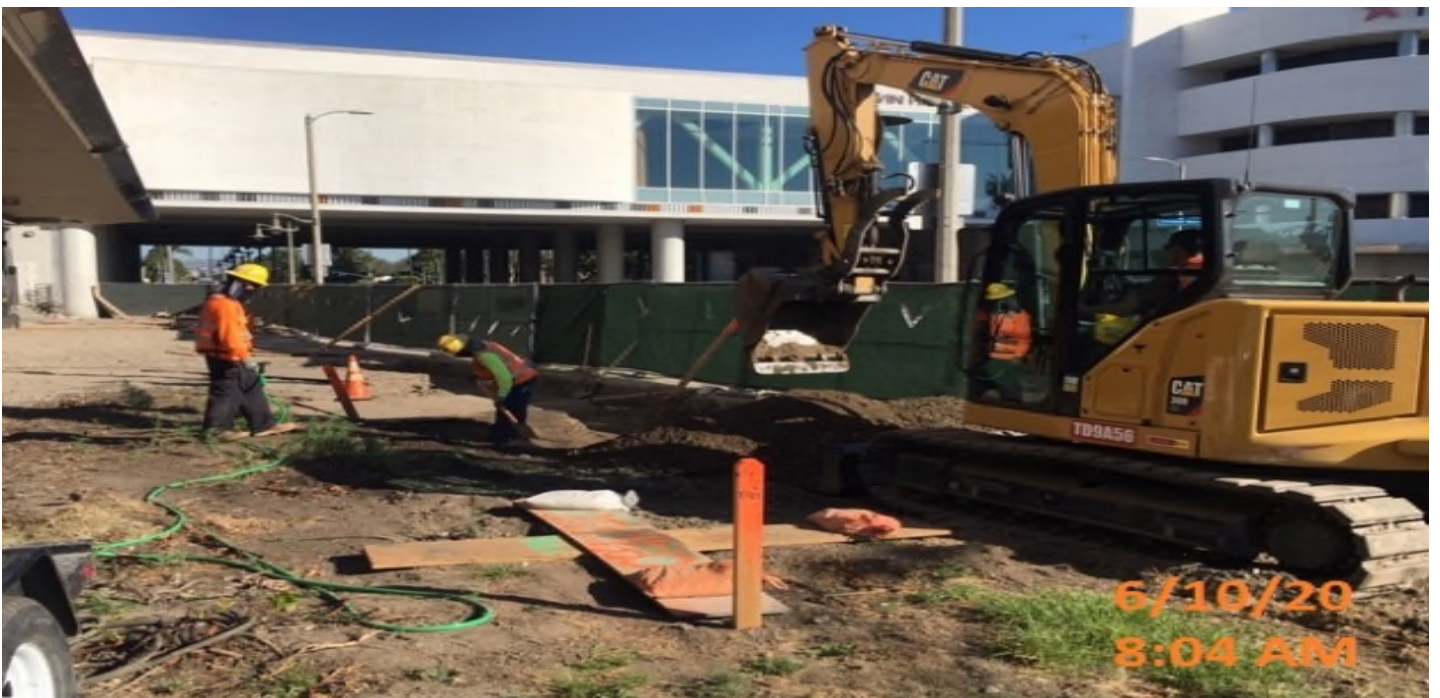
MLK STATION- WSCC crew excavating to subgrade for pavers and sidewalk.

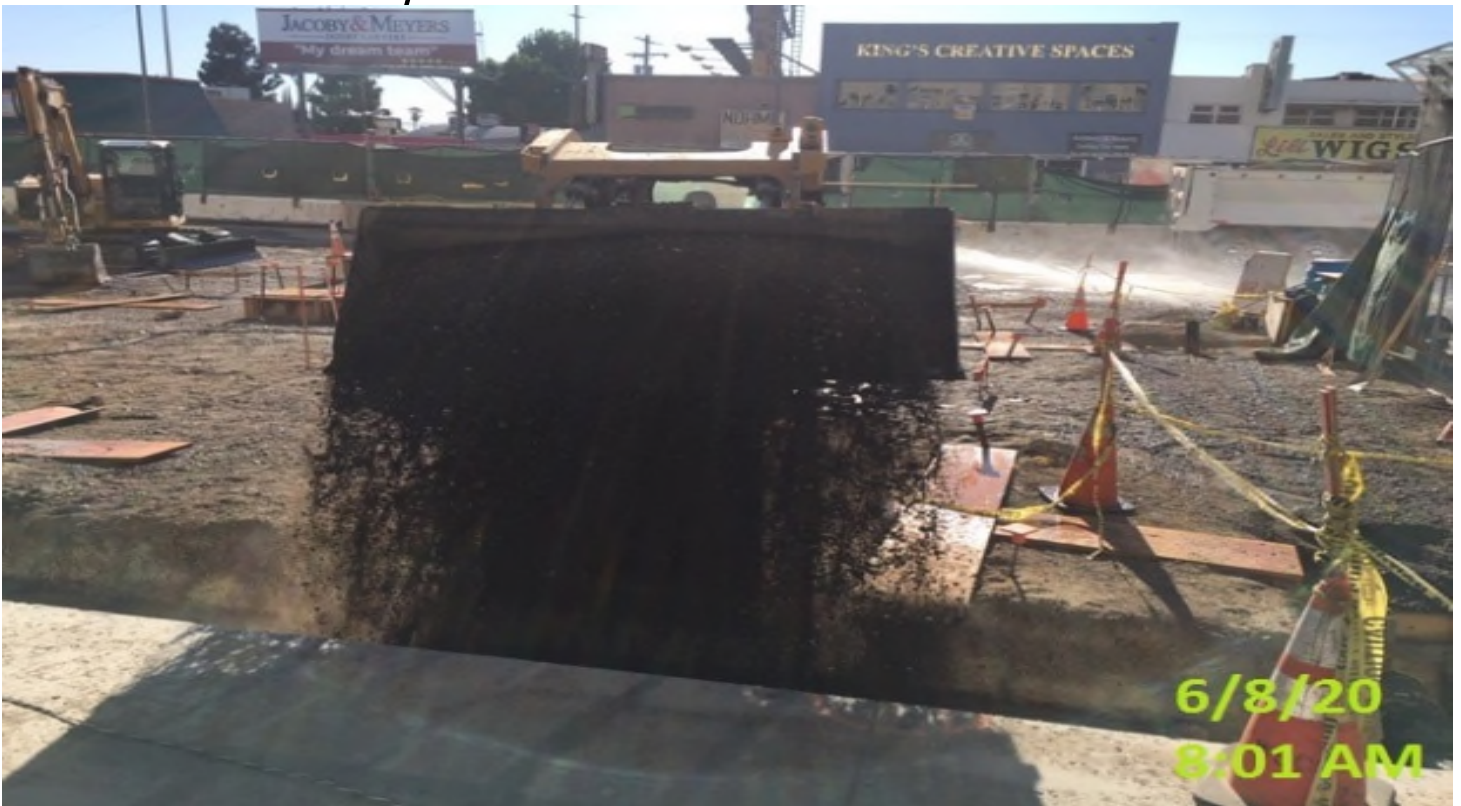
MLK STATION- WSCC crew backfilling encased 12" HDPE drain line with base grade.

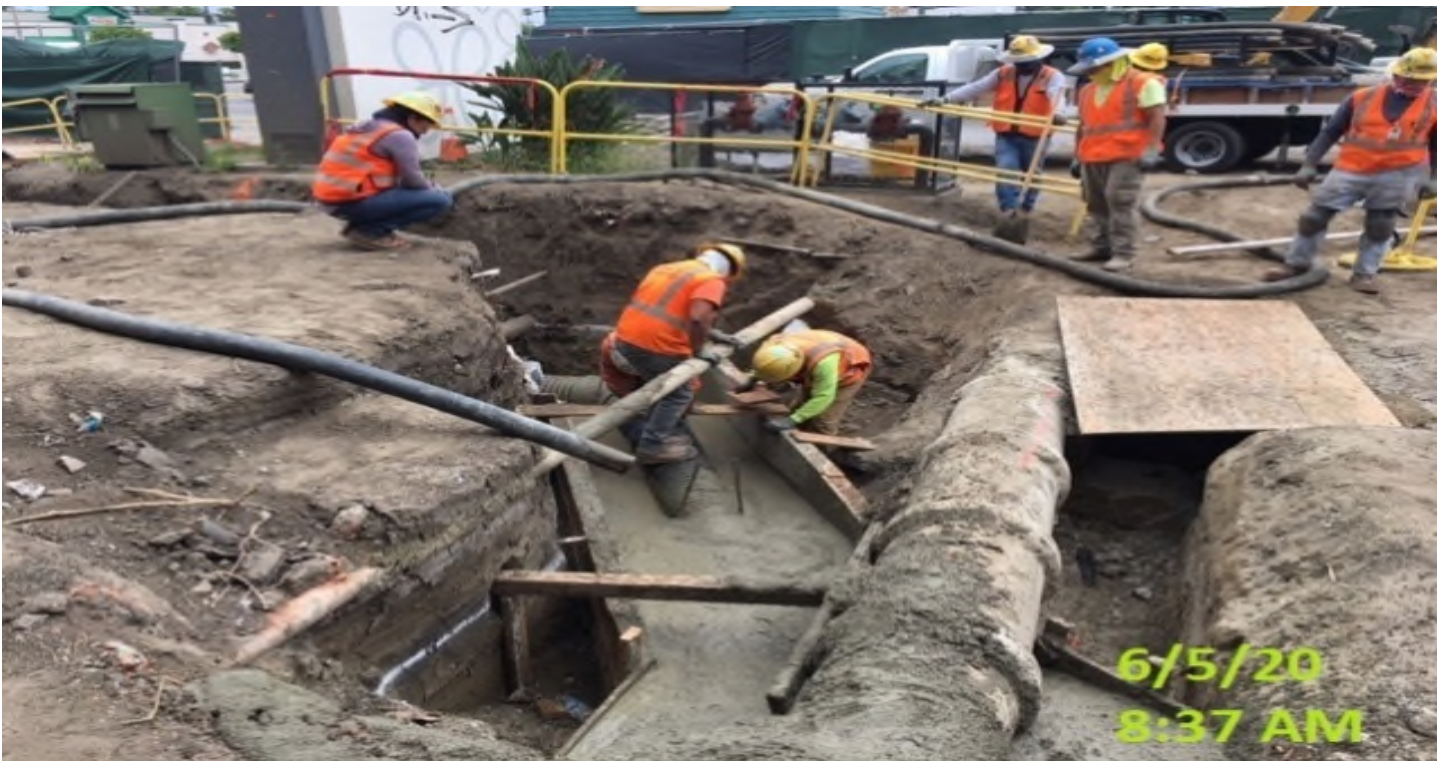
MLK STATION- WSCC crew encasing 12" HDPE drain line in slurry.

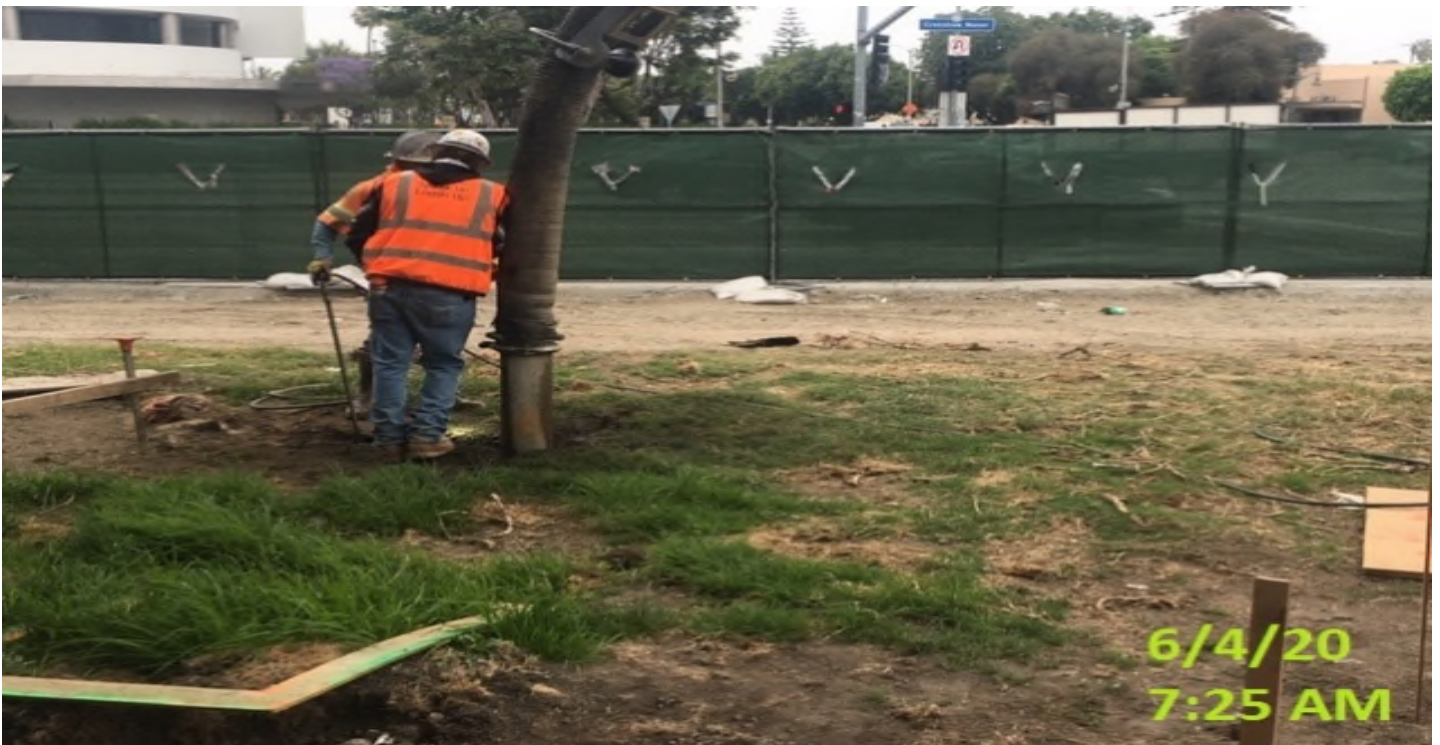
MLK STATION- WSCC crew potholing for tree wells and utility conflicts.

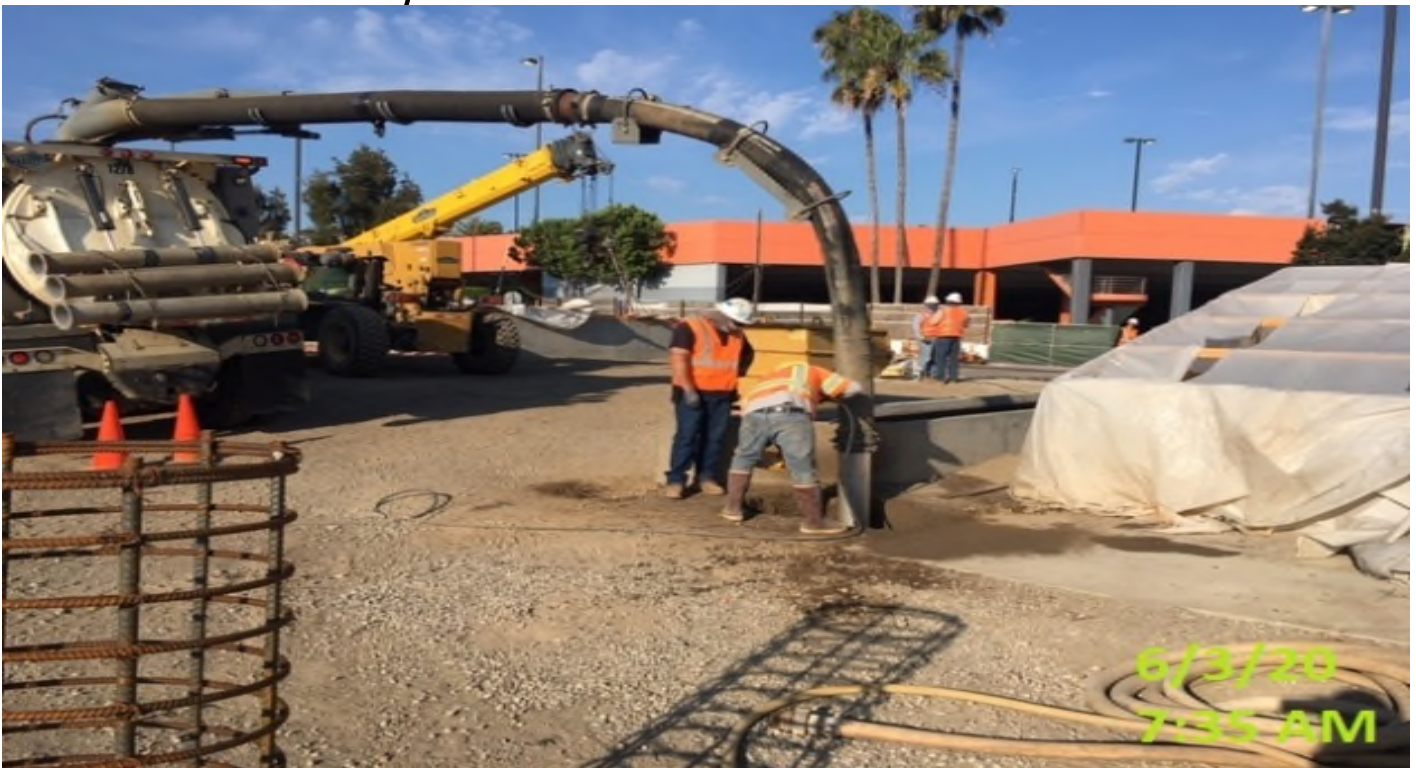
MLK STATION- WSCC crew potholing for light poles.

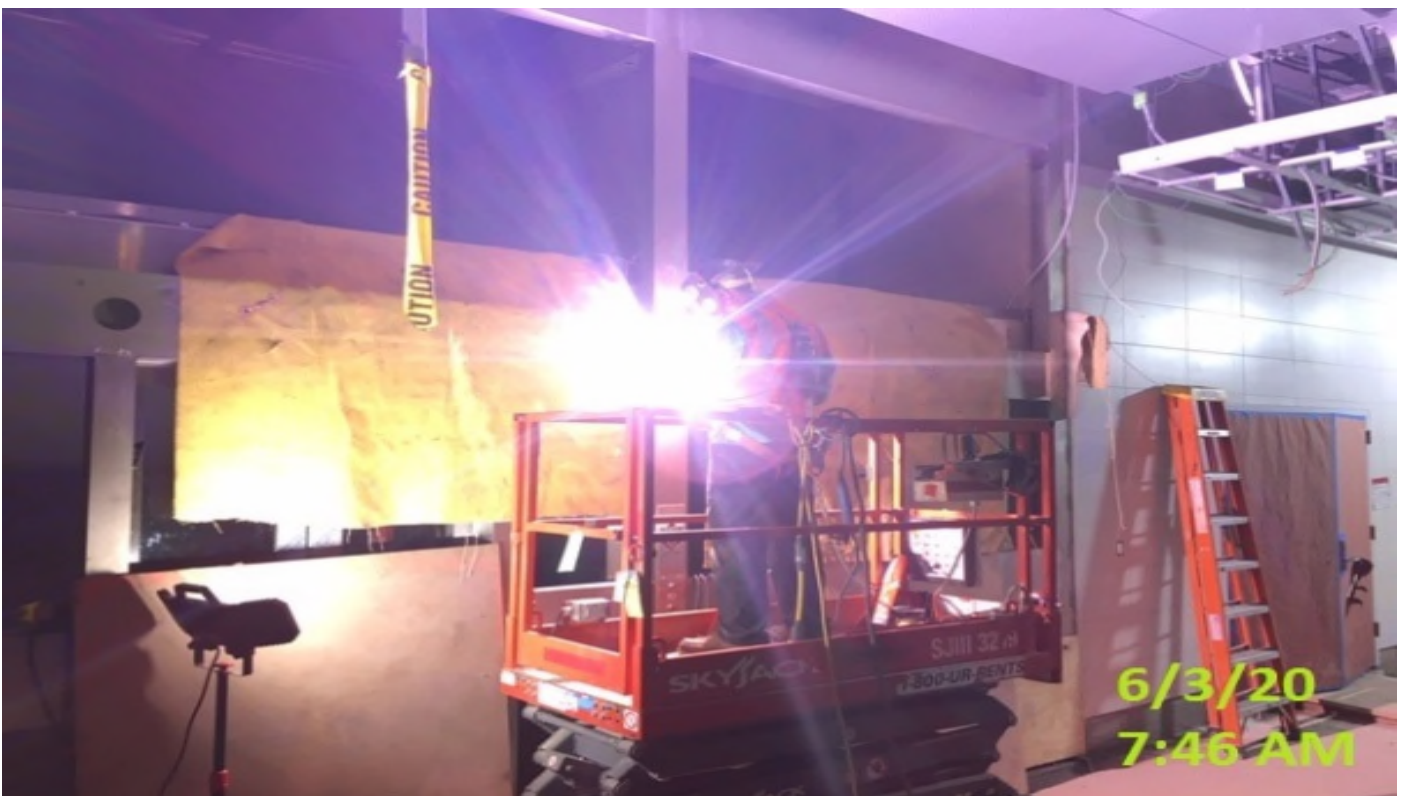
MLK STATION- McMahon Steel welding sections of fascia elevator #3 and #4.

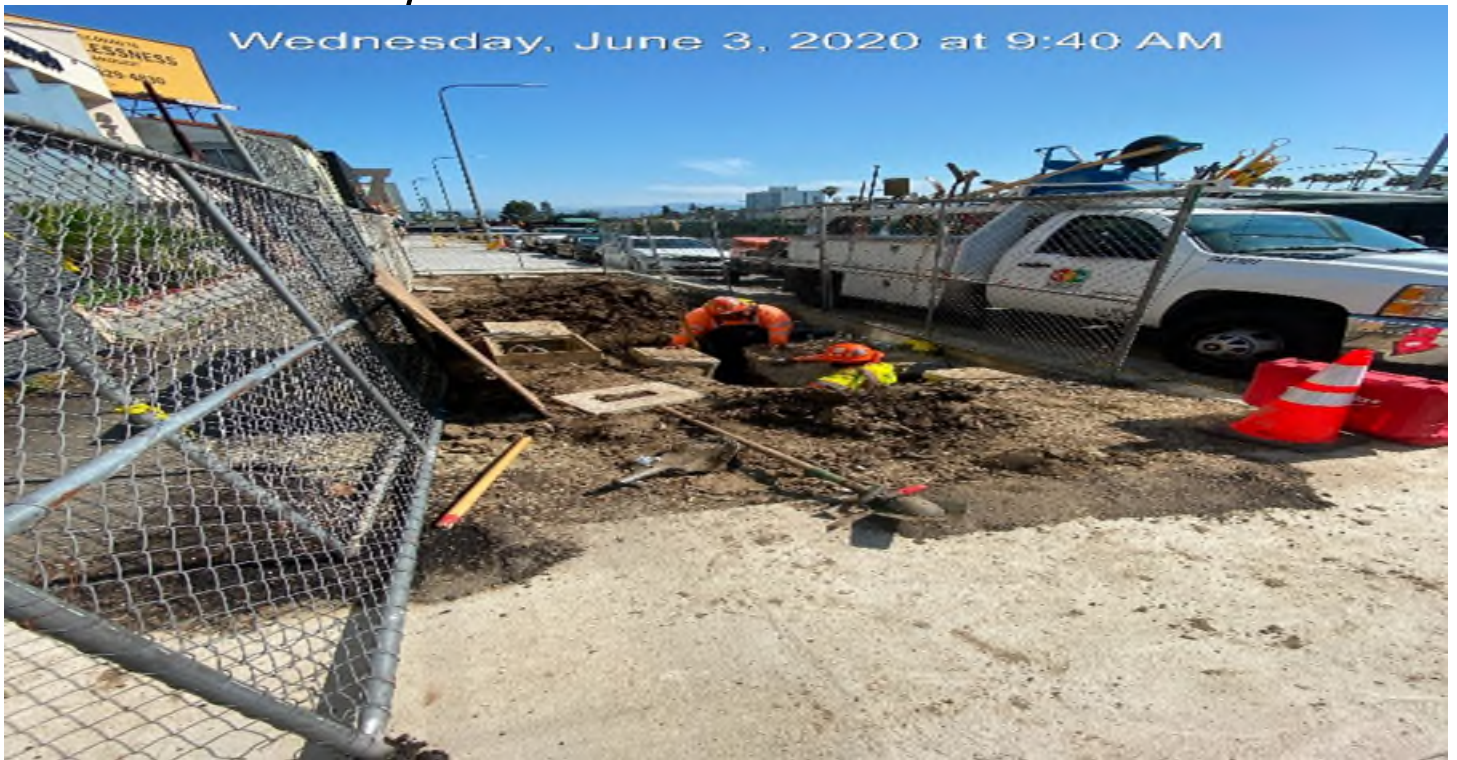
LEIMERT PARK STATION – Excavating for the installation of a street light foundation on southbound Crenshaw Blvd between 48th St and Brynhurst Ave.

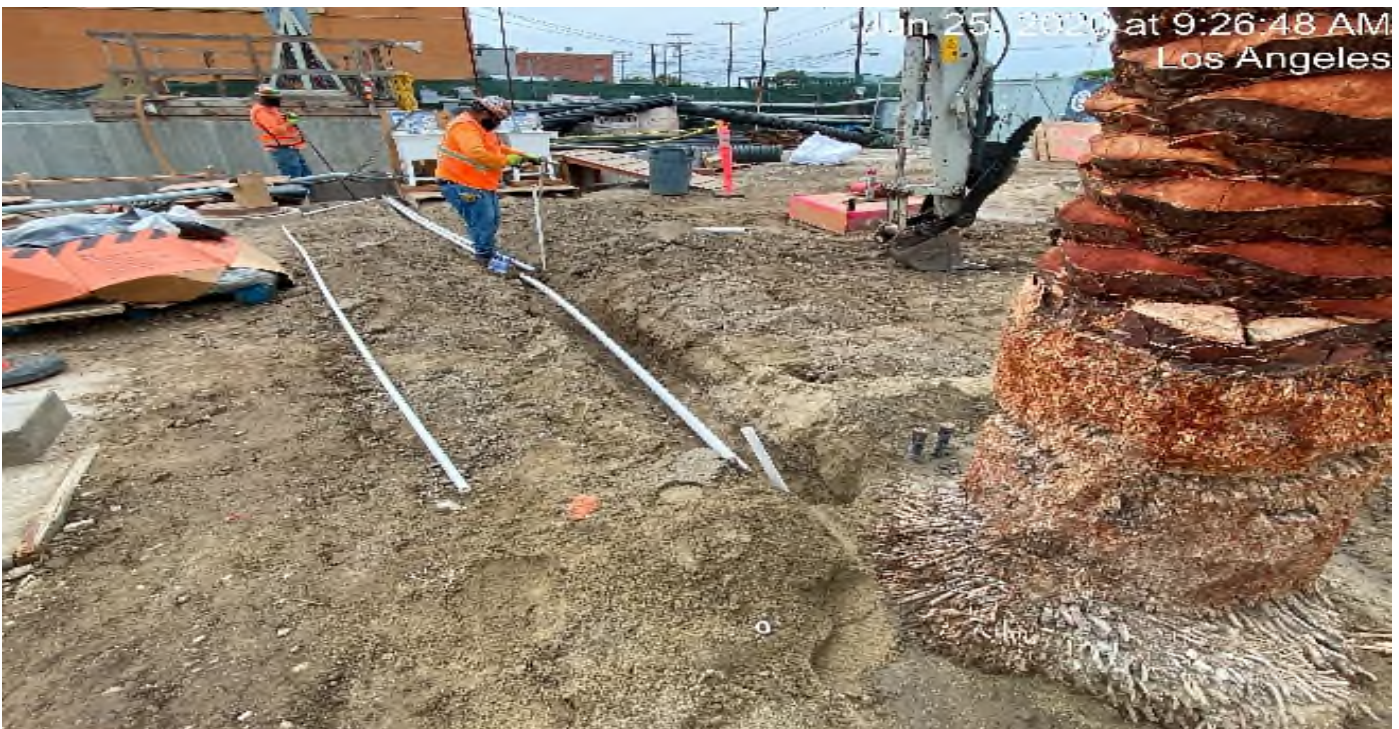
LEIMERT PARK STATION – Installing irrigation lines throughout the plaza level.

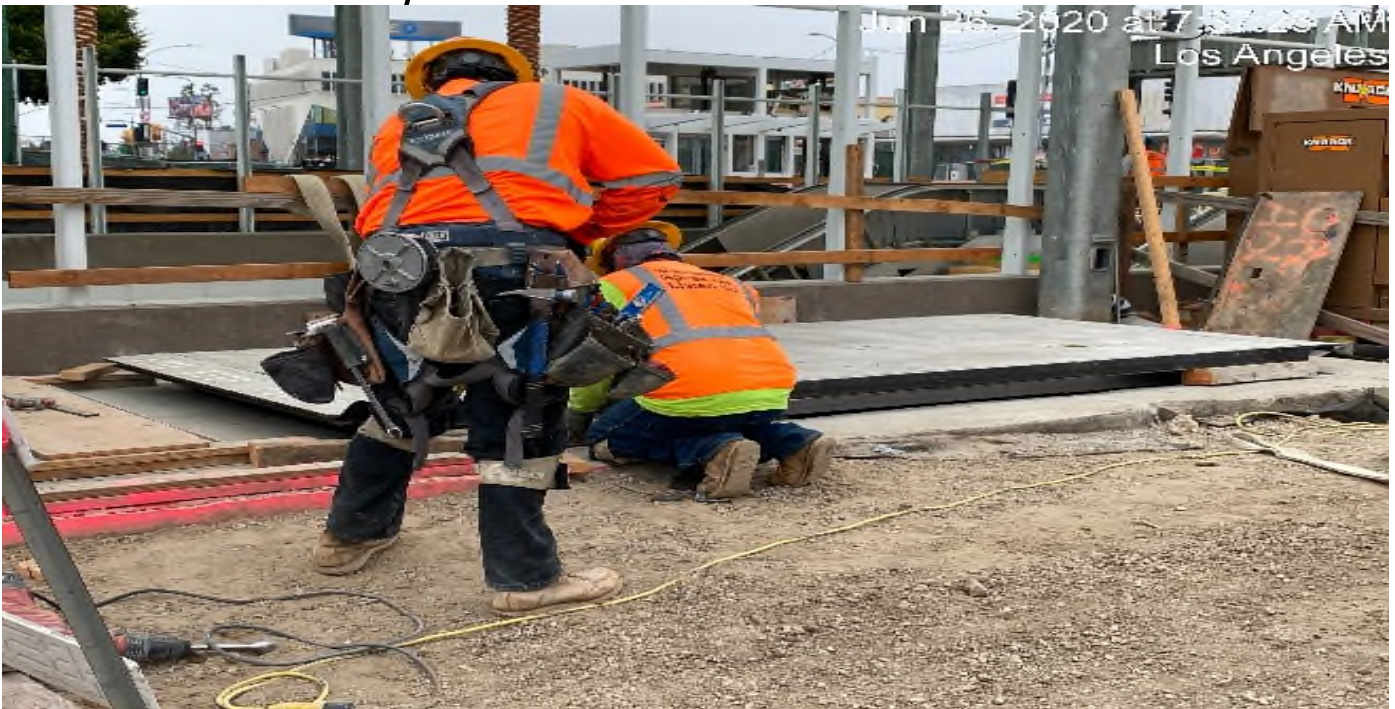
LEIMERT PARK STATION – Installing hatches to Emergency Exit Stair #2 at the plaza level.

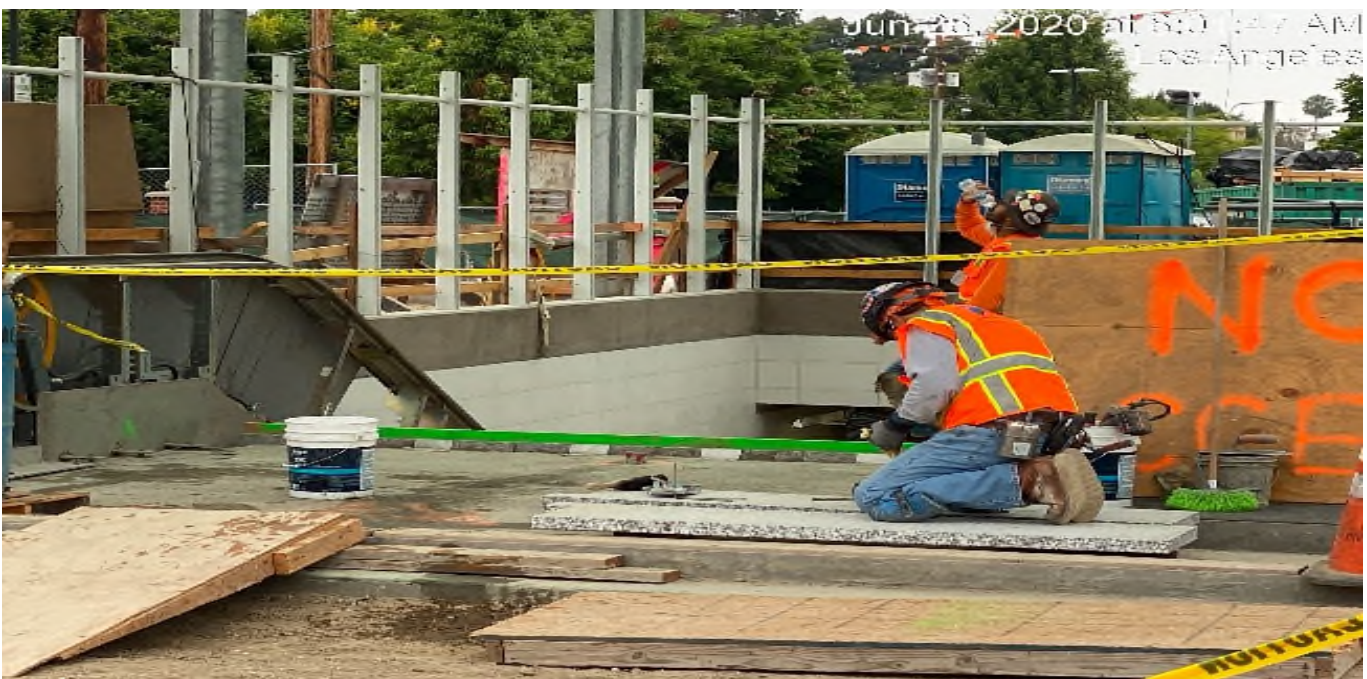
LEIMERT PARK STATION – Installing granite treads for the main entrance staircases at the plaza level.

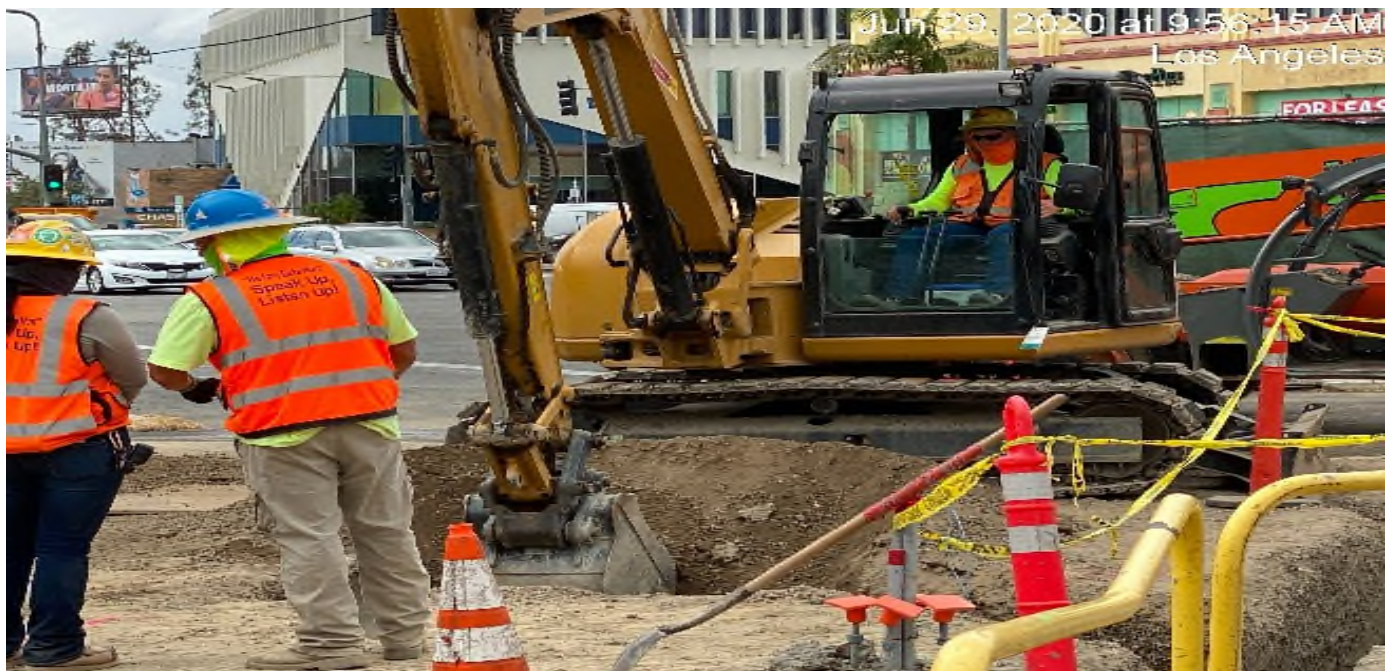
LEIMERT PARK STATION – Excavating for grand pylon foundation at the southeast corner of the plaza level.

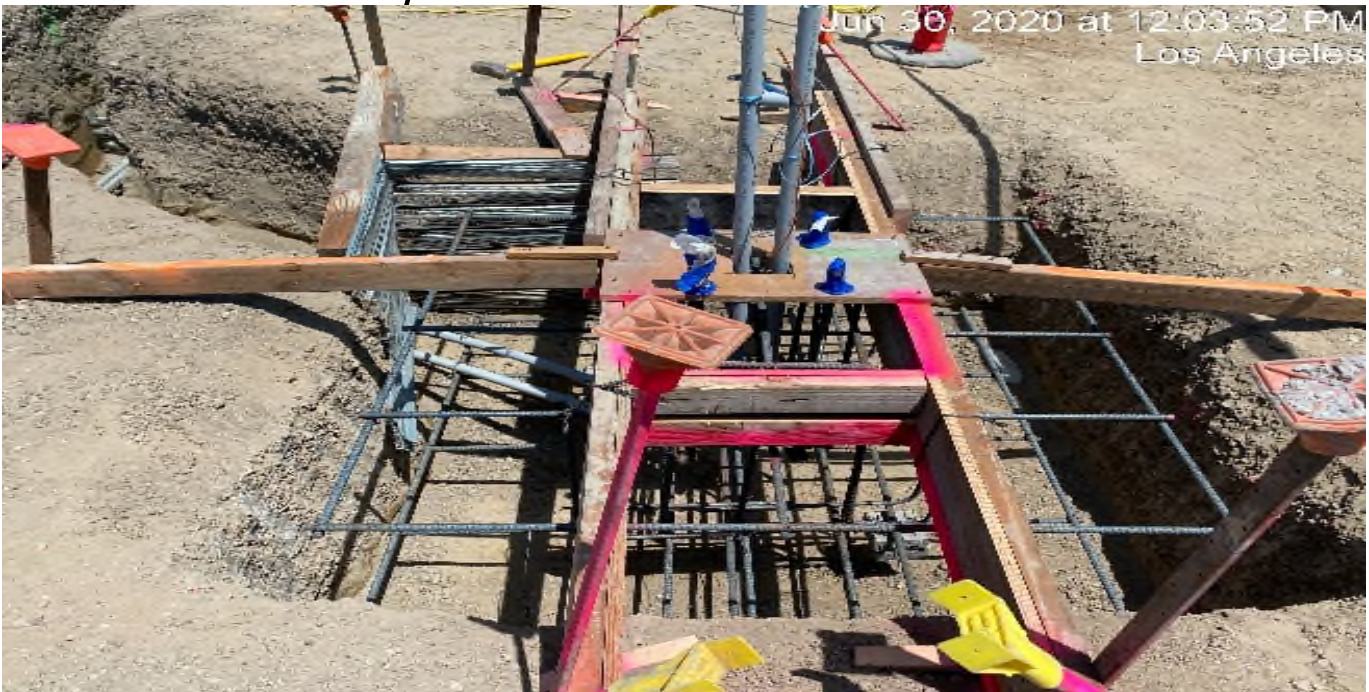
LEIMERT PARK STATION – Installing rebar for the grand pylon foundation at the southeast corner of the plaza level.

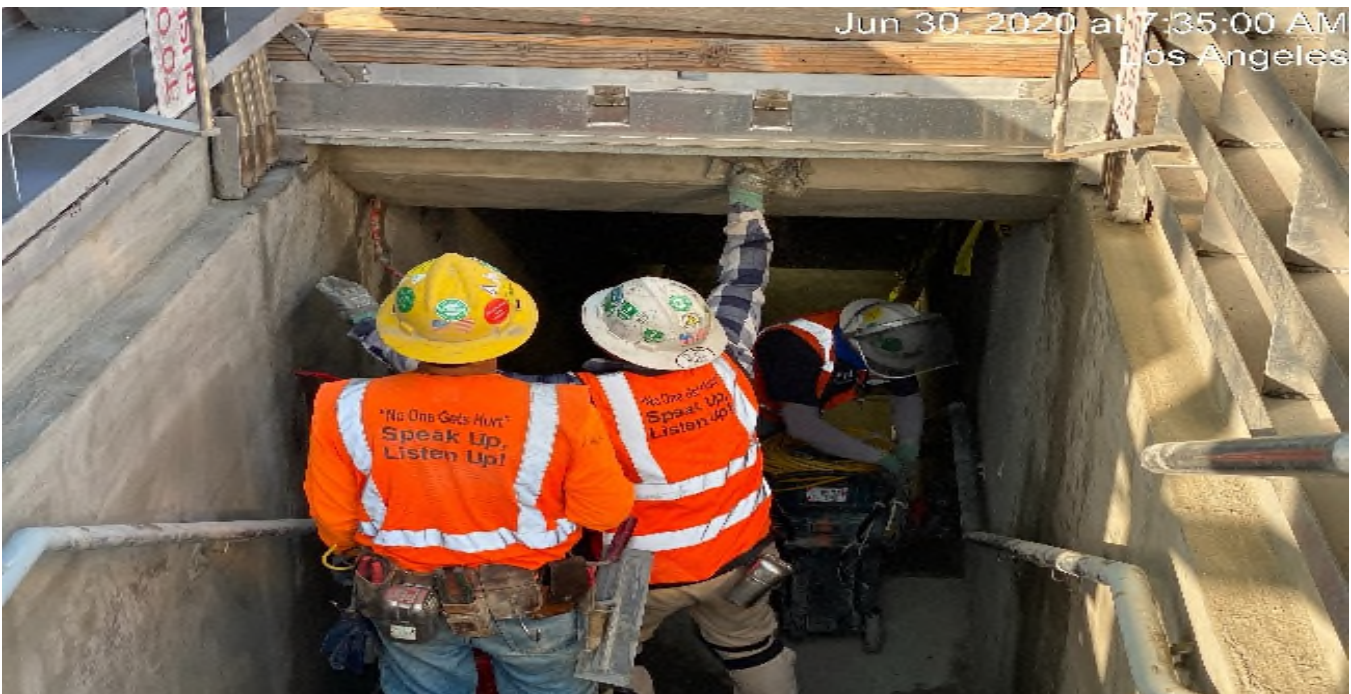
LEIMERT PARK STATION – Sack and patching the walls of Emergency Exit Stair 2 at the plaza level.

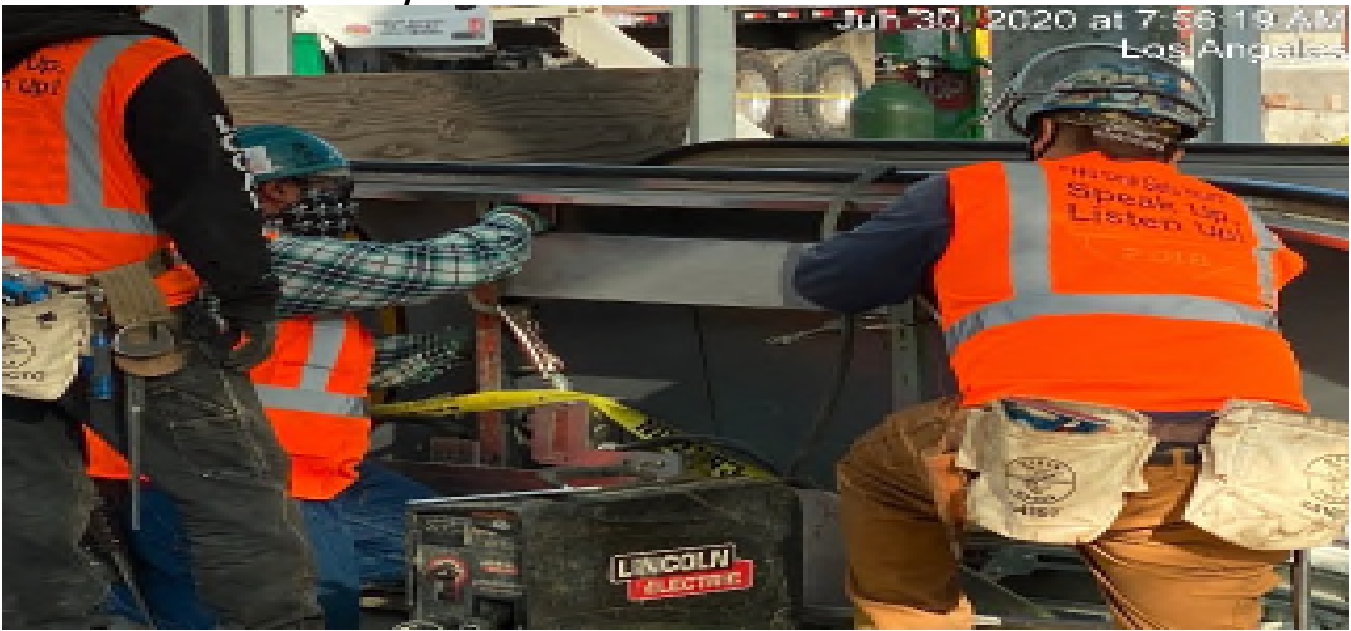
LEIMERT PARK STATION – Installing handrail backer for Escalator 1 at the main entrance landing.

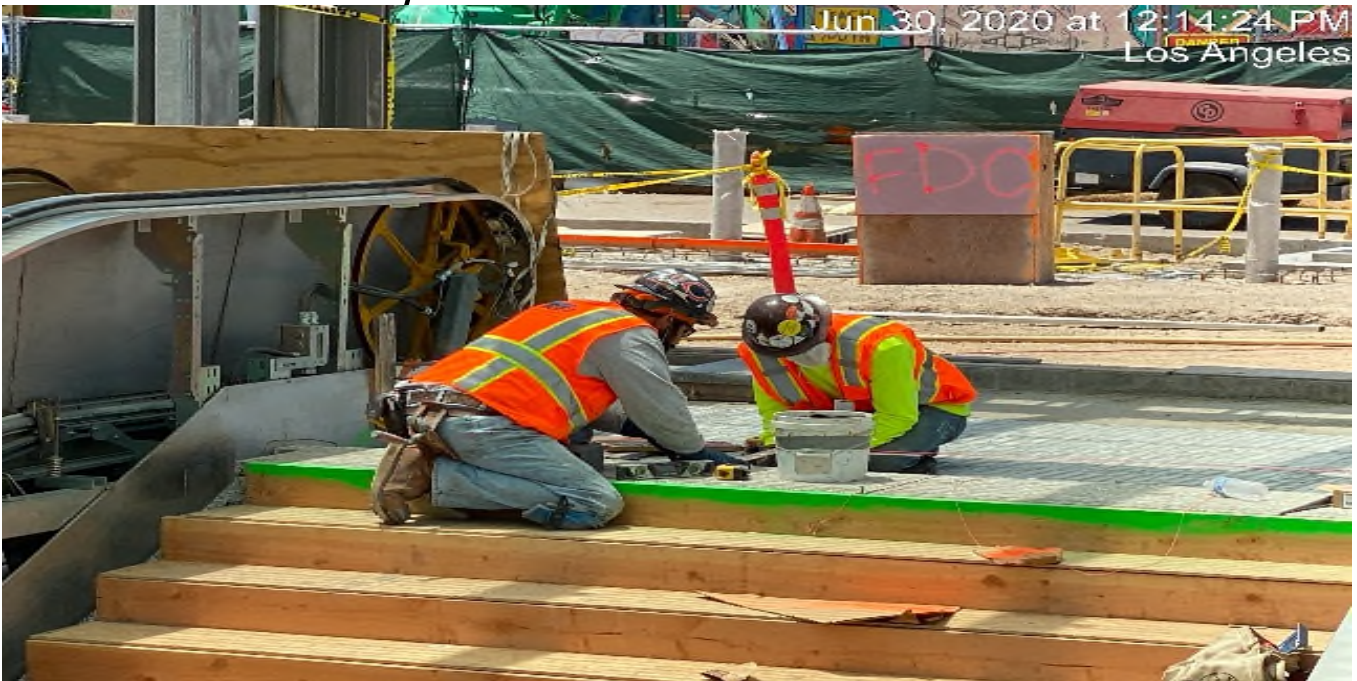
LEIMERT PARK STATION – Continue installing granite treads for the main entrance staircases at the plaza level.

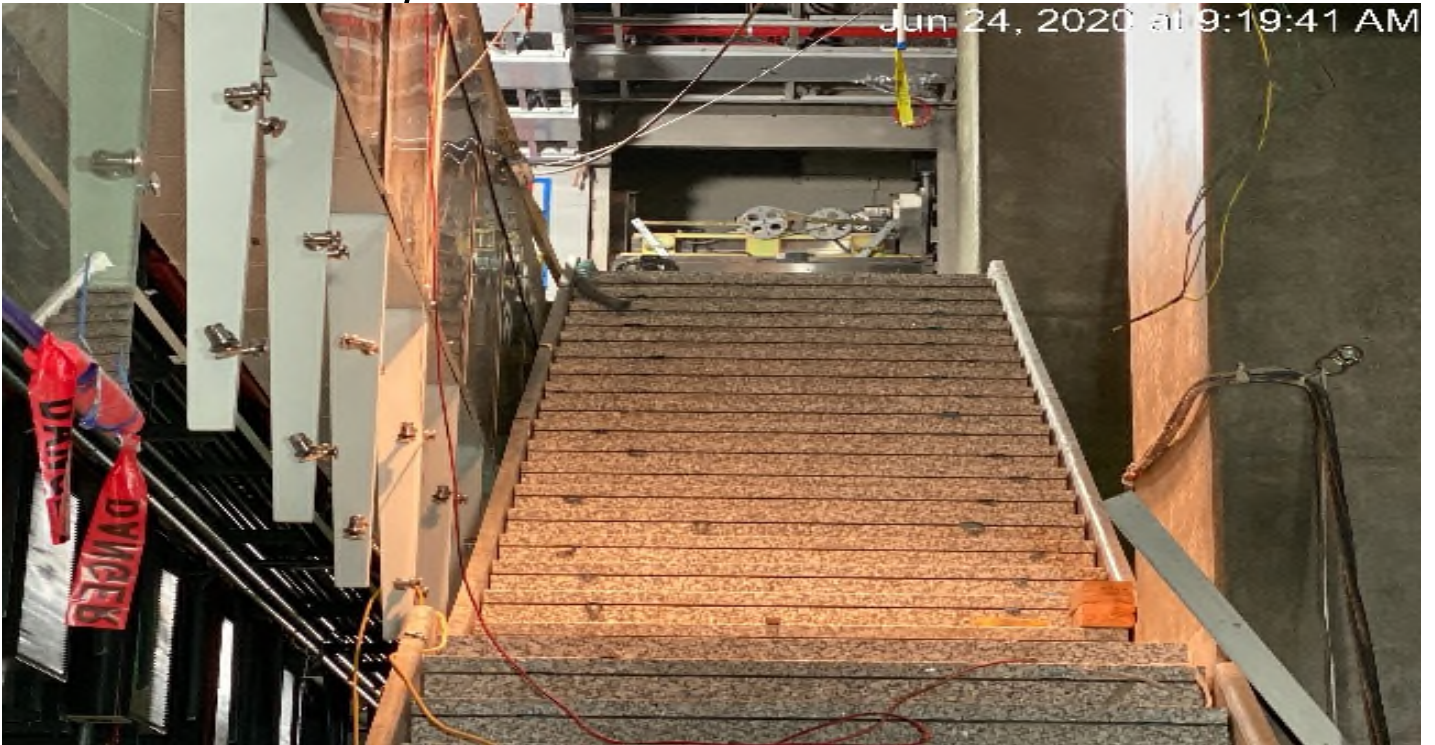
LEIMERT PARK STATION – Continue installing granite riser and threads for staircase #3 from concourse to platform level.

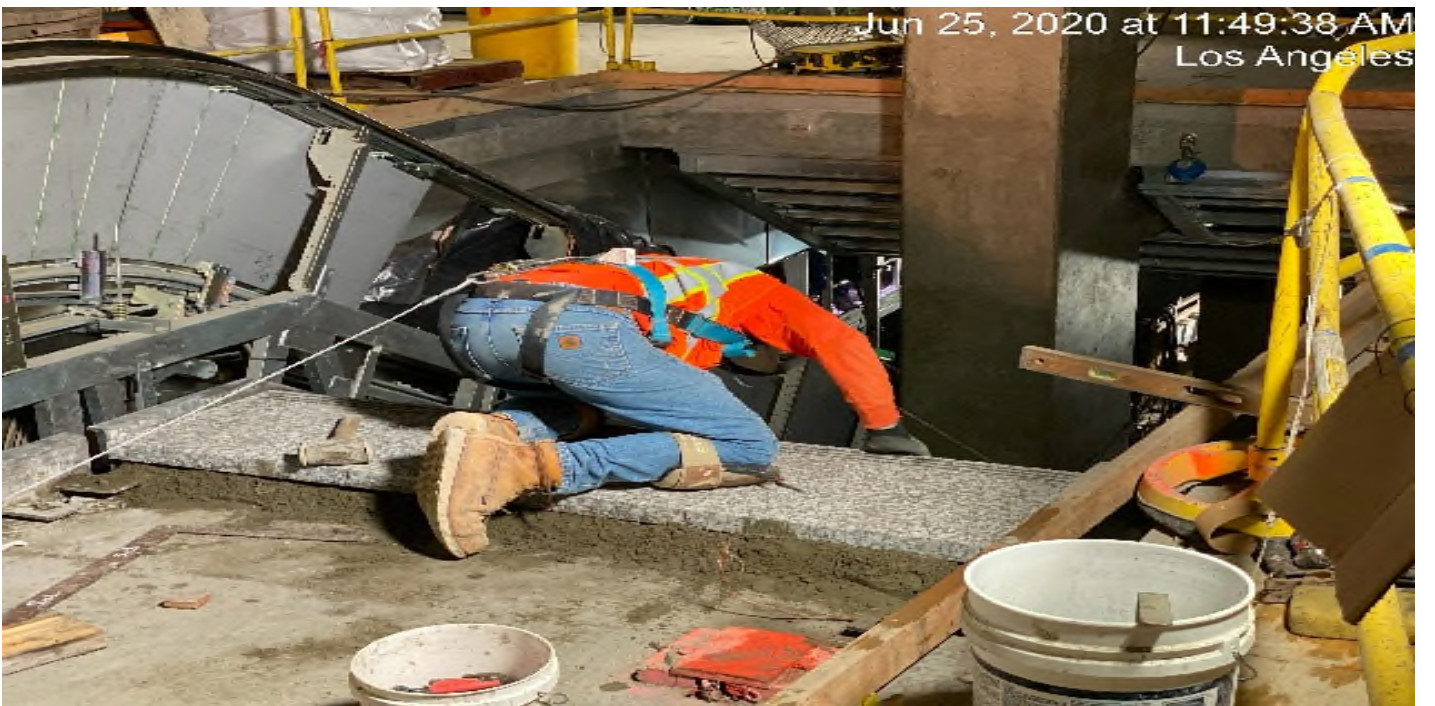
LEIMERT PARK STATION – Continue installing granite riser and threads for staircase #3 from concourse to platform level.

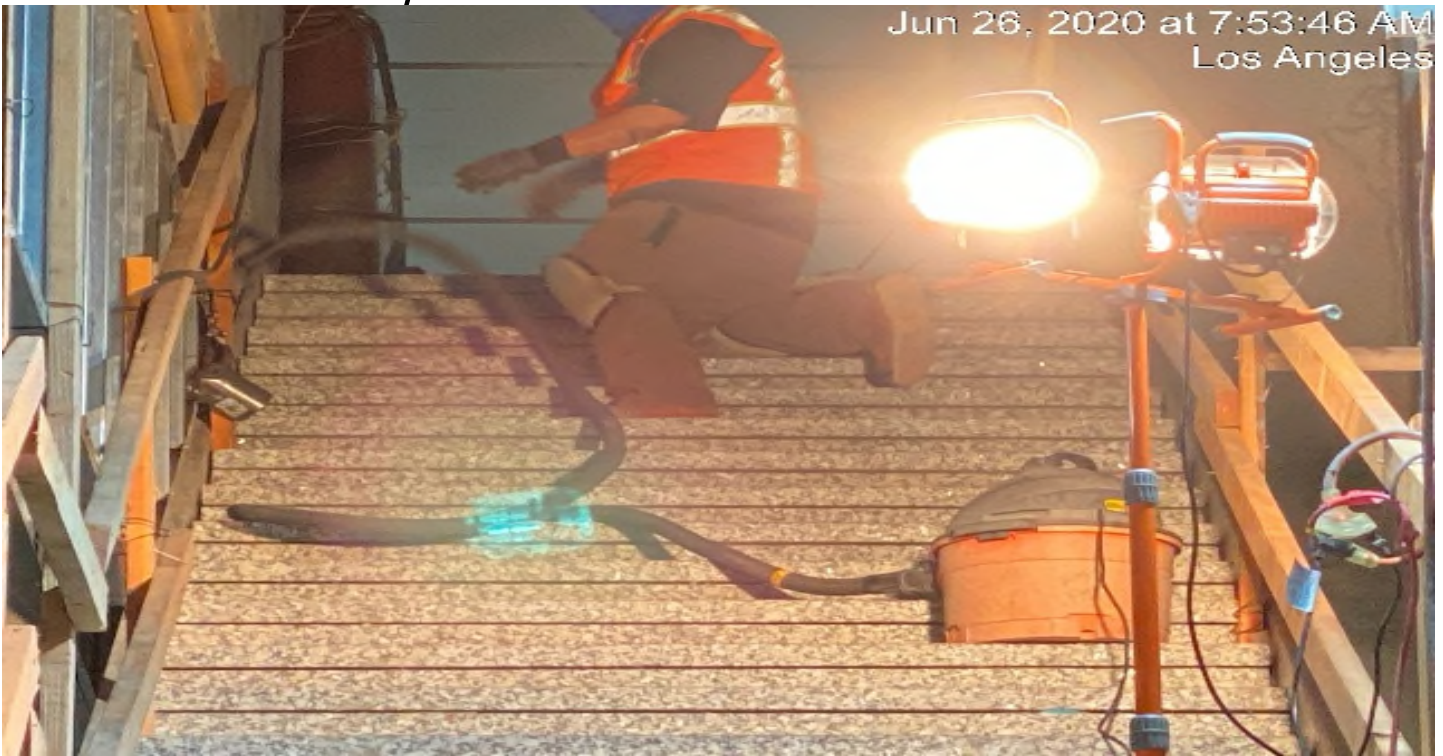
LEIMERT PARK STATION – Continue installing granite riser and threads for staircase #3 from concourse to platform level.

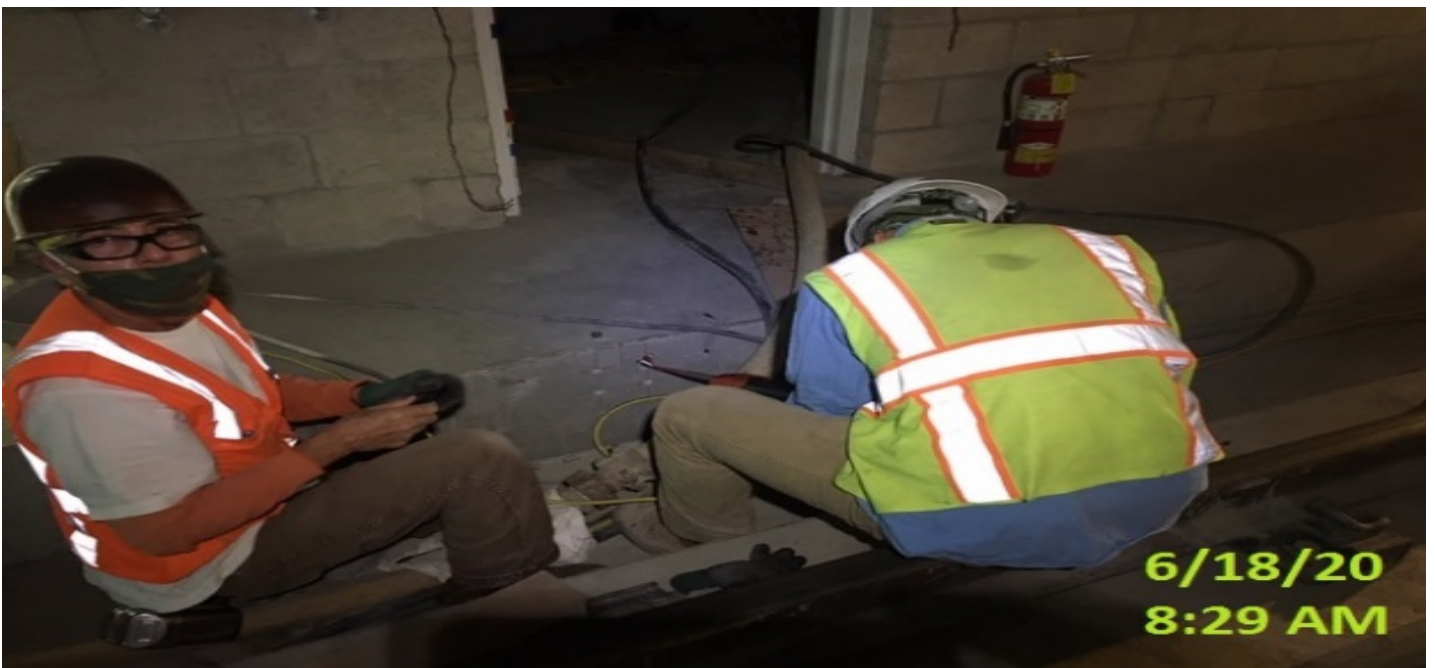
LEIMERT PARK STATION – Continue guardrail installation at the north and southbound walkways of the north end platform level.
