CRENSHAW/LAX PHOTOGRAPHIC UPDATE

Feb 12, 2021

Crenshaw/LAX Transit Project

Overview of trackwork progress issues for 1/30/2021- 2/15/2021
(Please note the attached Trackwork Progress Tracking Report)

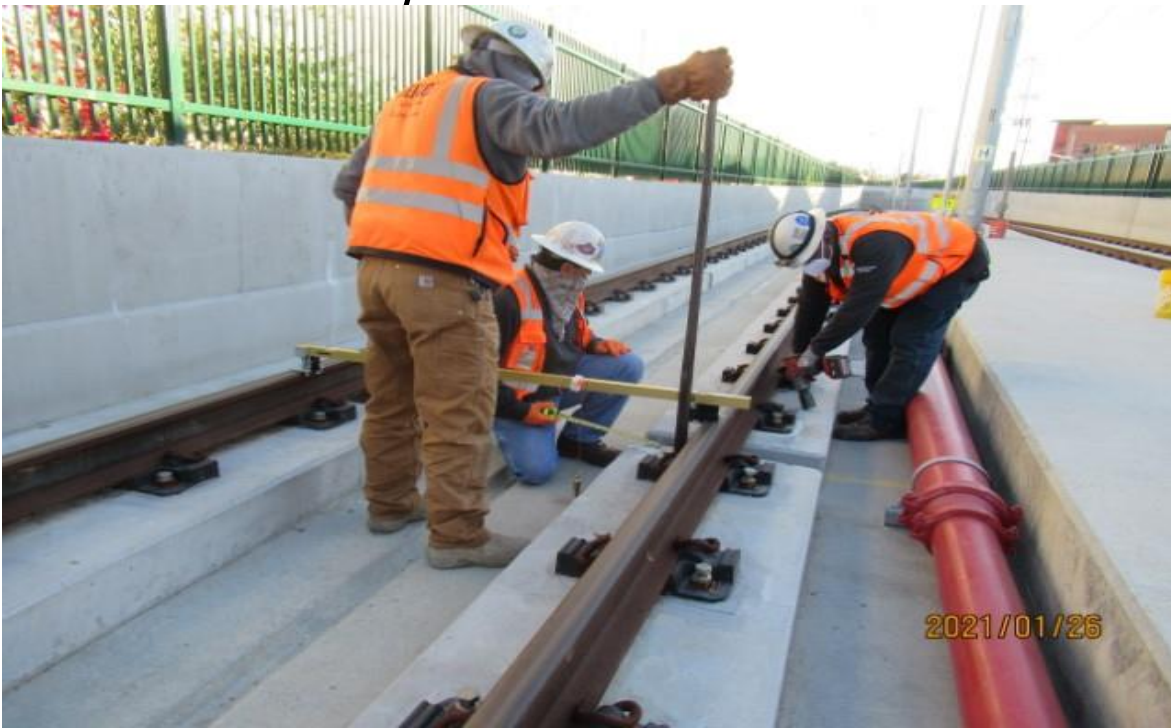
UG3 – HCC adjusting track alignment on survey scribe nail off sets SB track UG3 south portal (looking north) Rework

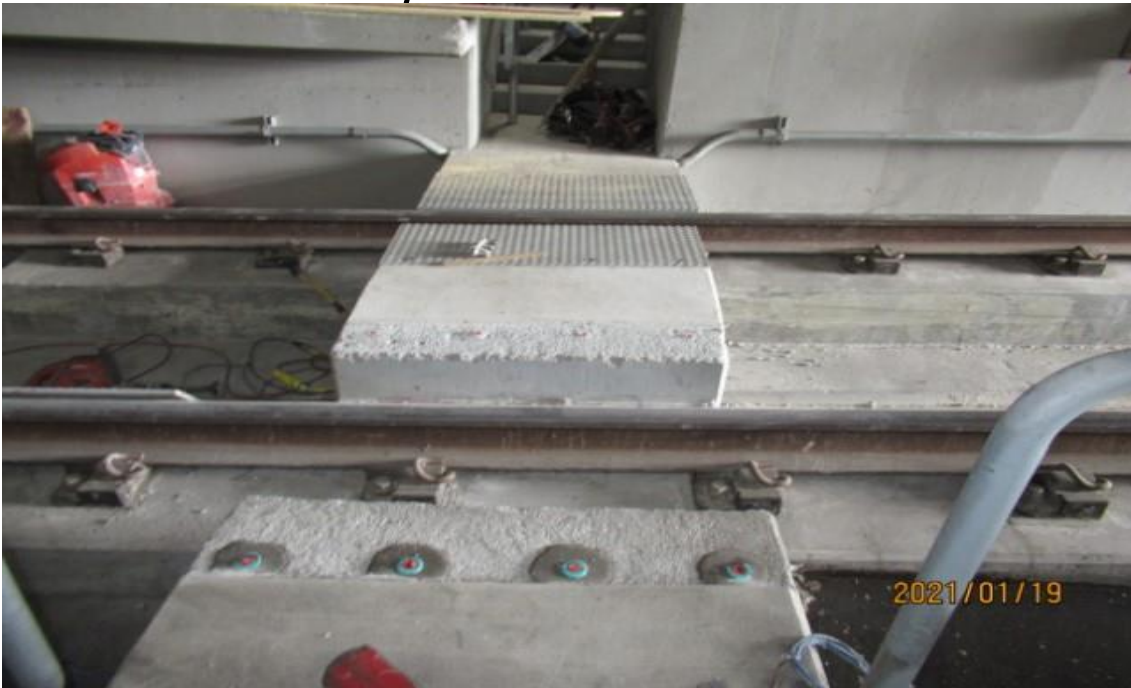
UG4 – UG4 NB track near portal STA 371+25 WSCC on-going work on emergency walkway plates for matching TOR elevations (looking east)

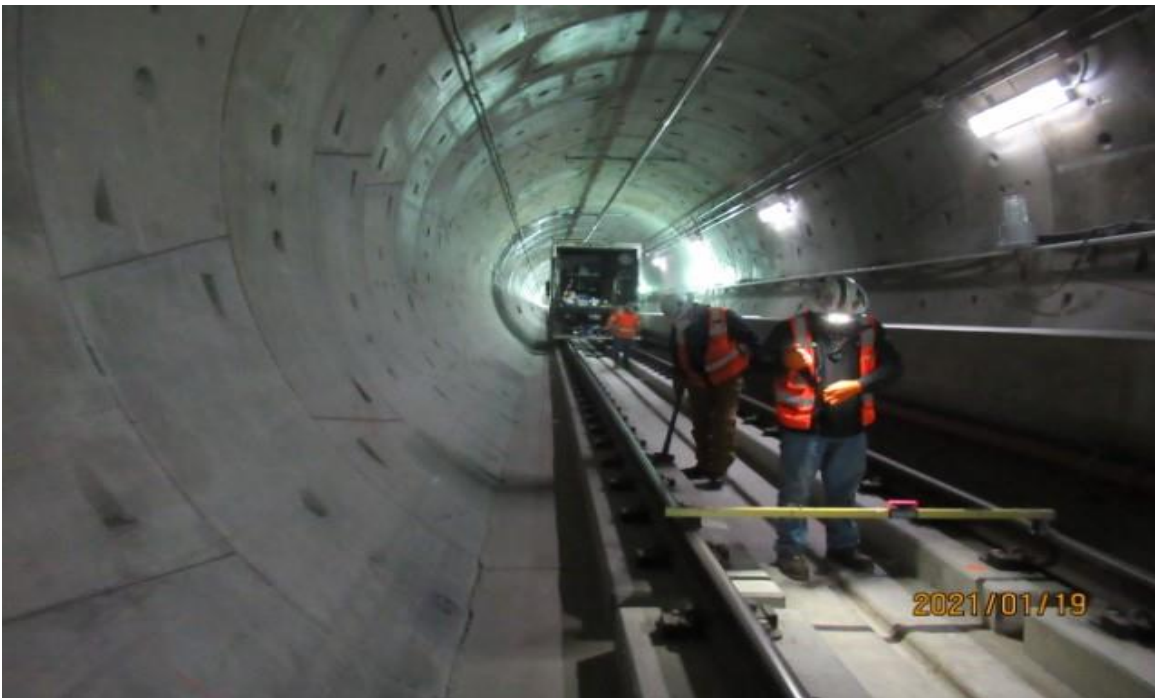
UG4 – HCC in UG4 NB track re-verifying cross level issue for open issues log 000340 after re-adjusting cross level between STA 431+72 & 432+00 (looking south) rework

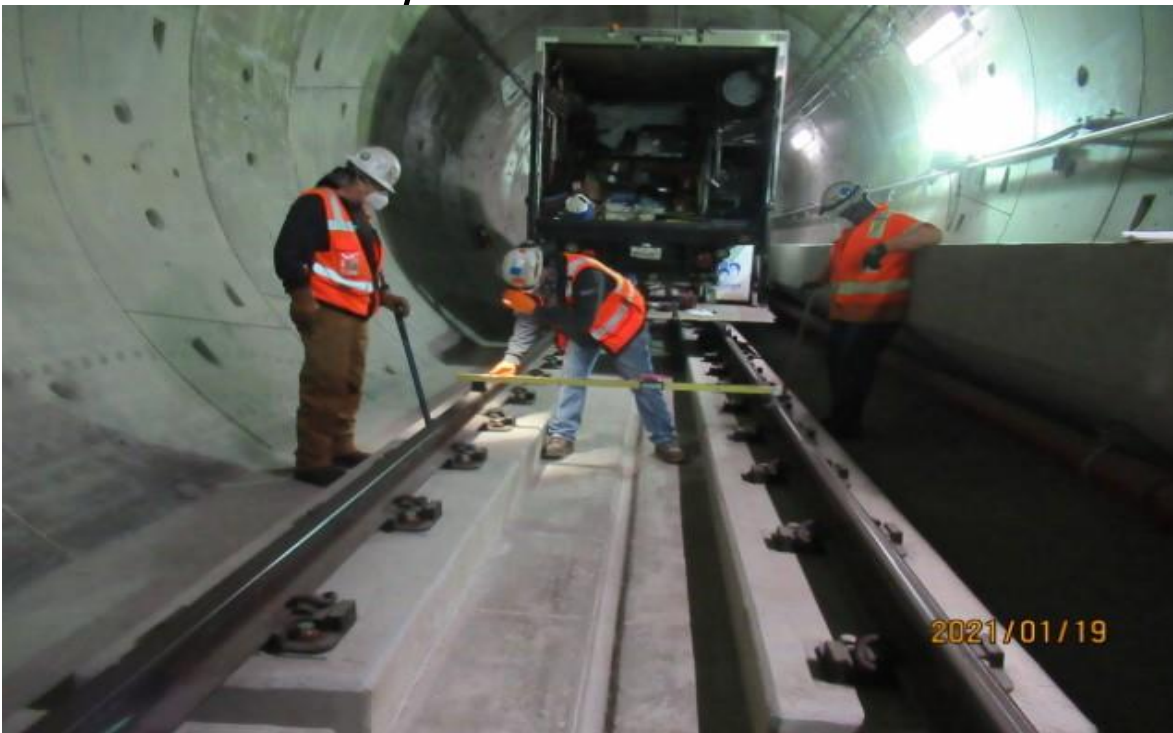
UG4 – HCC in UG4 NB track working on open issues log 000340 cross level out of tolerance between STA 431+72 & 432+00 (looking south) rework

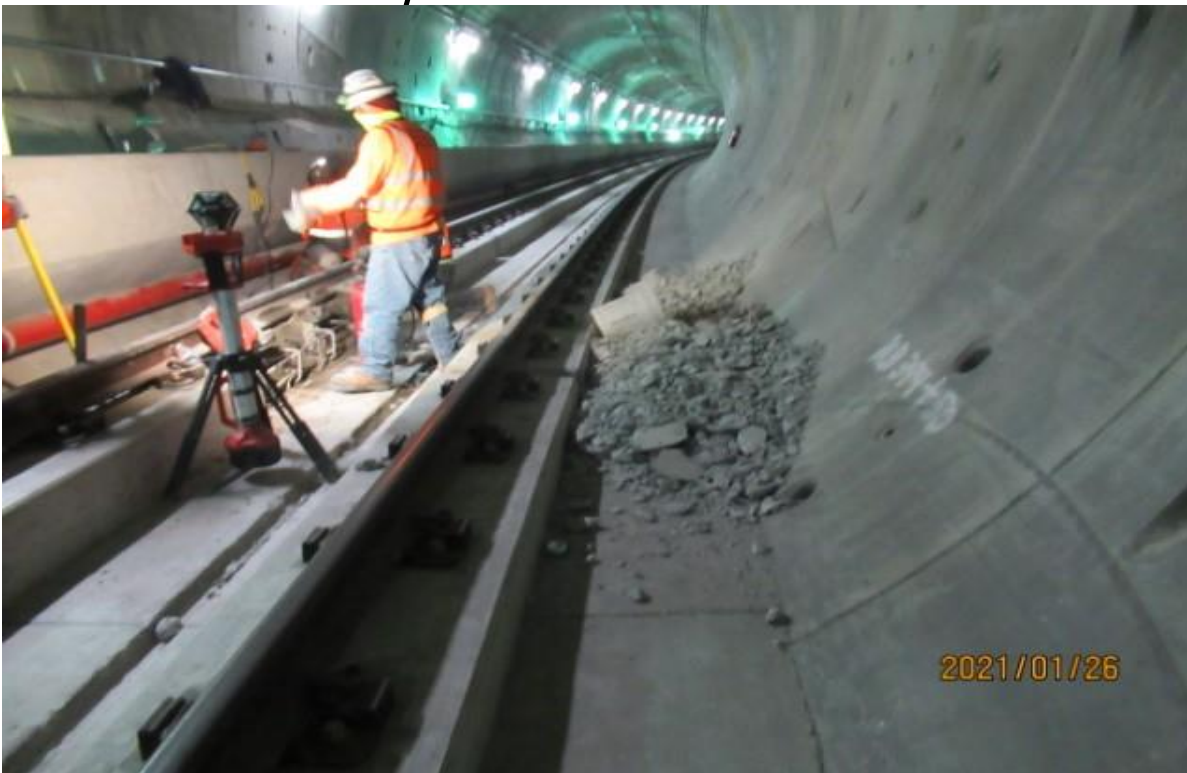
UG4 – UG4 NB track at STA 394+55 WSCC plinth 160 left side partial demo (looking north)
Rework

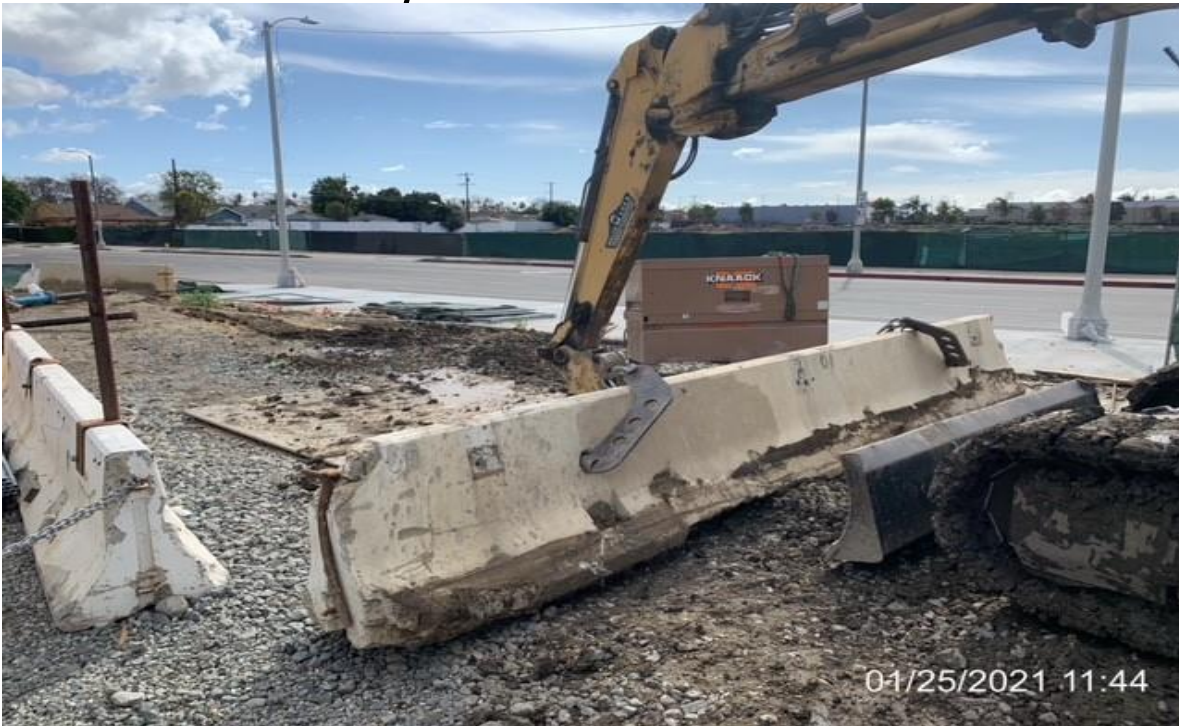
MLK STATION – WSCC crew replacing K rail with temporary fencing.

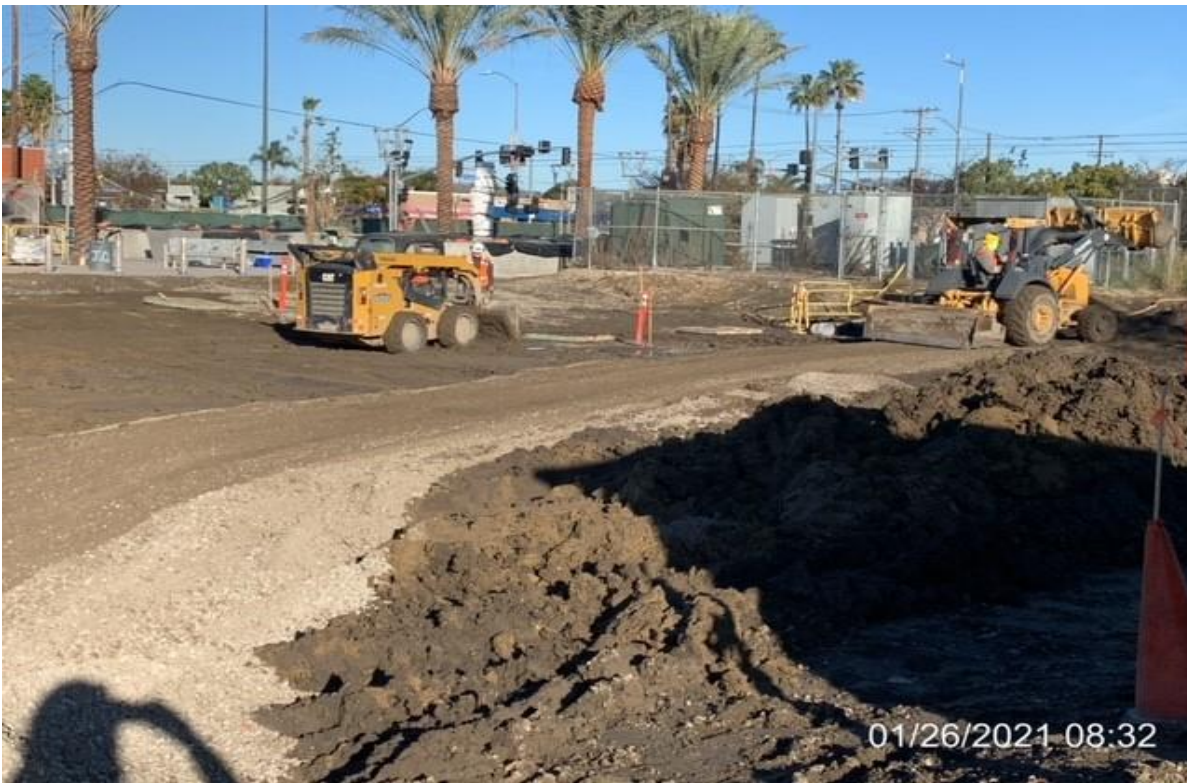
MLK STATION – WSCC crew distributing base and gravel in preparation for rainfall

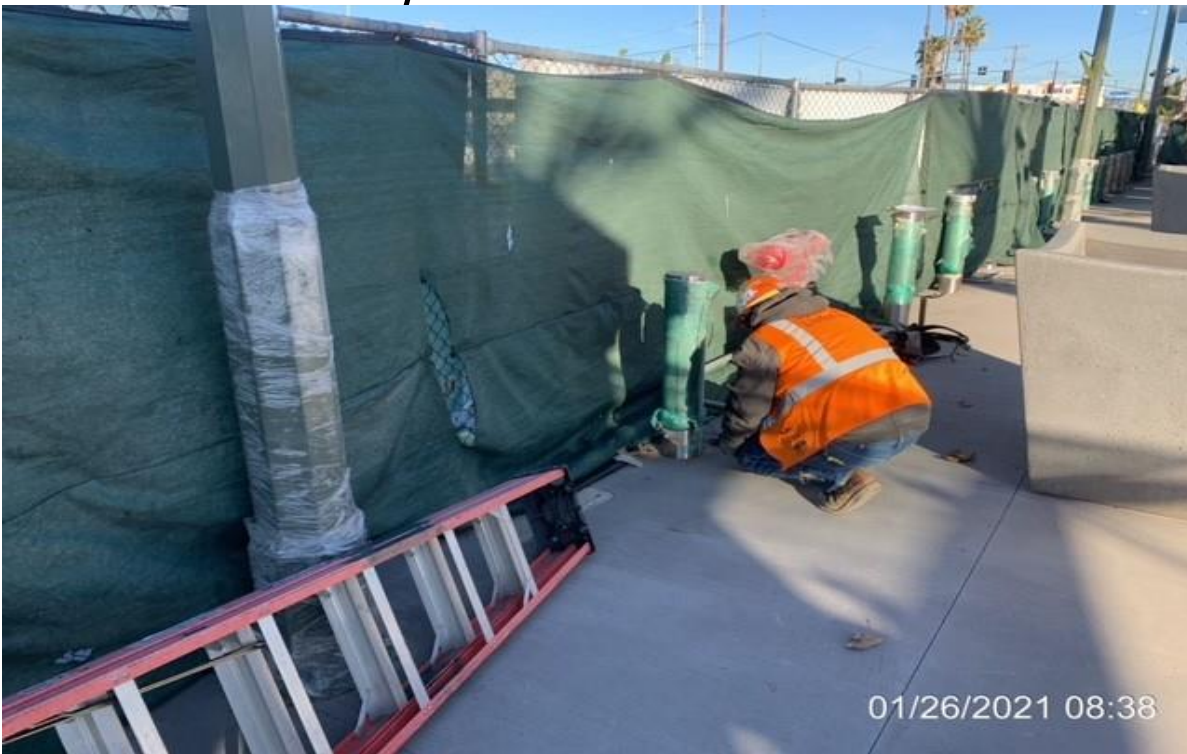
MLK STATION – WSCC ironworkers drilling holes into ballasts for ground wire.

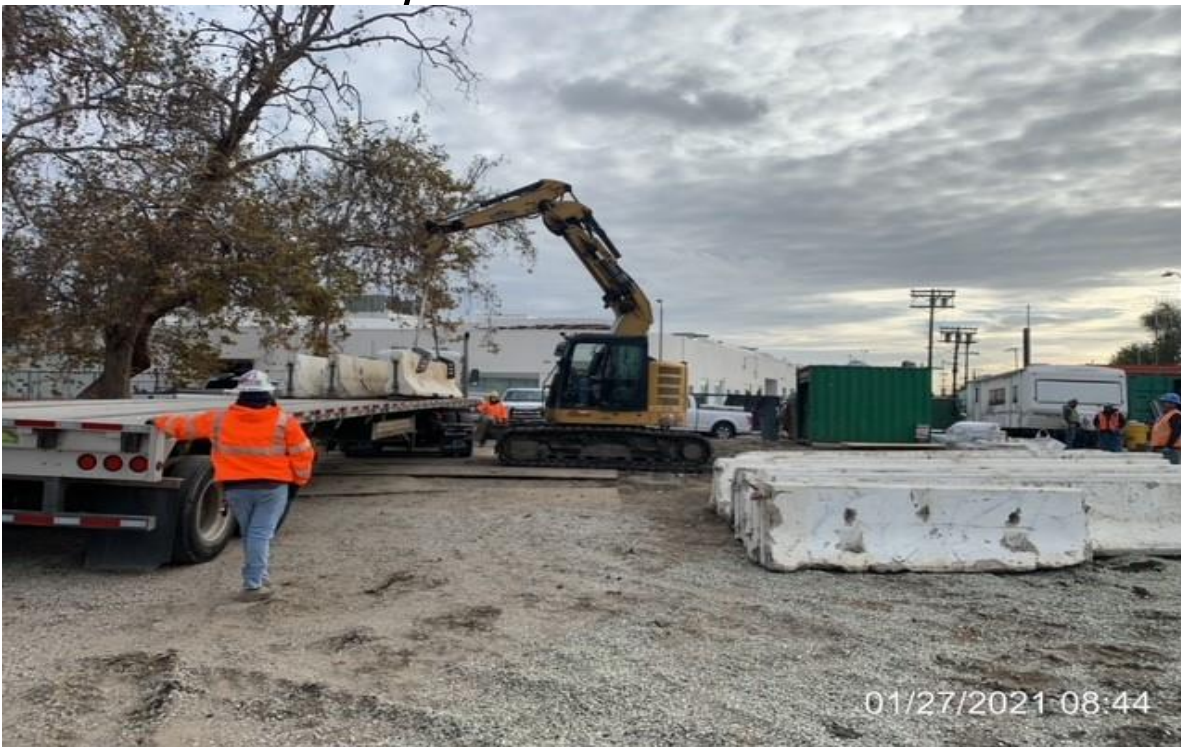
MLK STATION – WSCC crew removing K rail from park and ride yard.

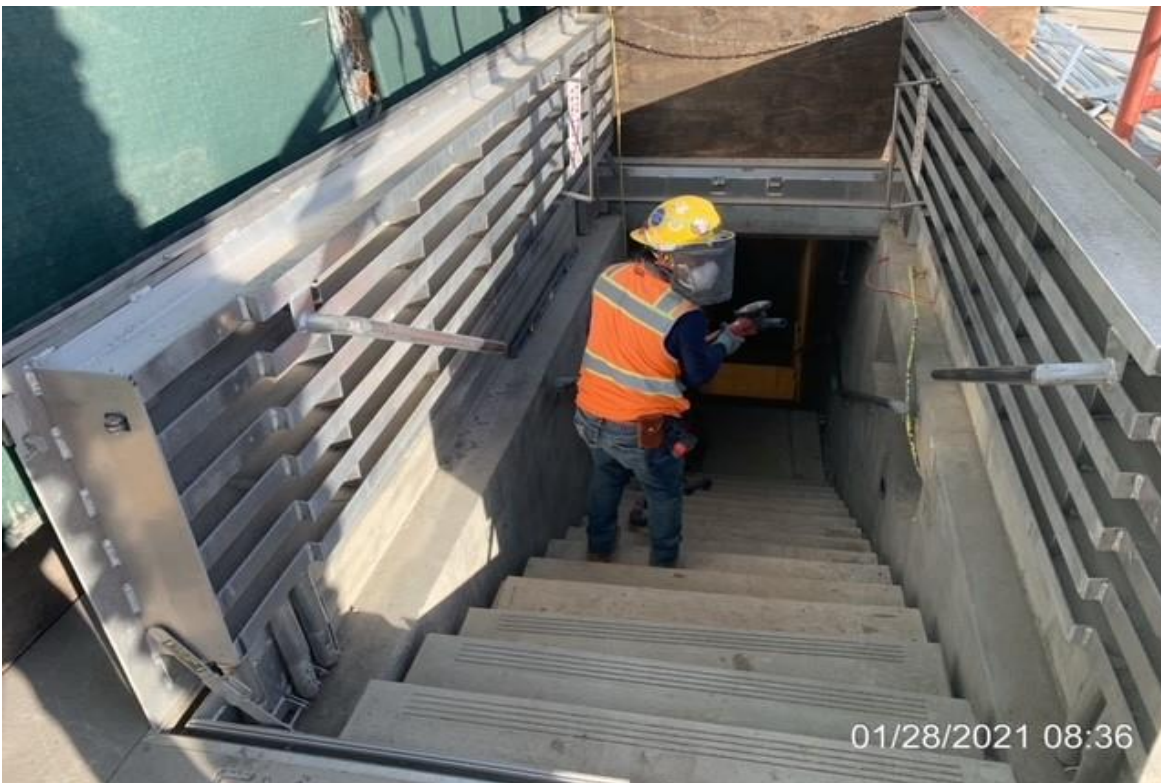
MLK STATION – WSCC finisher grinding and patching surface on ledge for exit hatch #3.

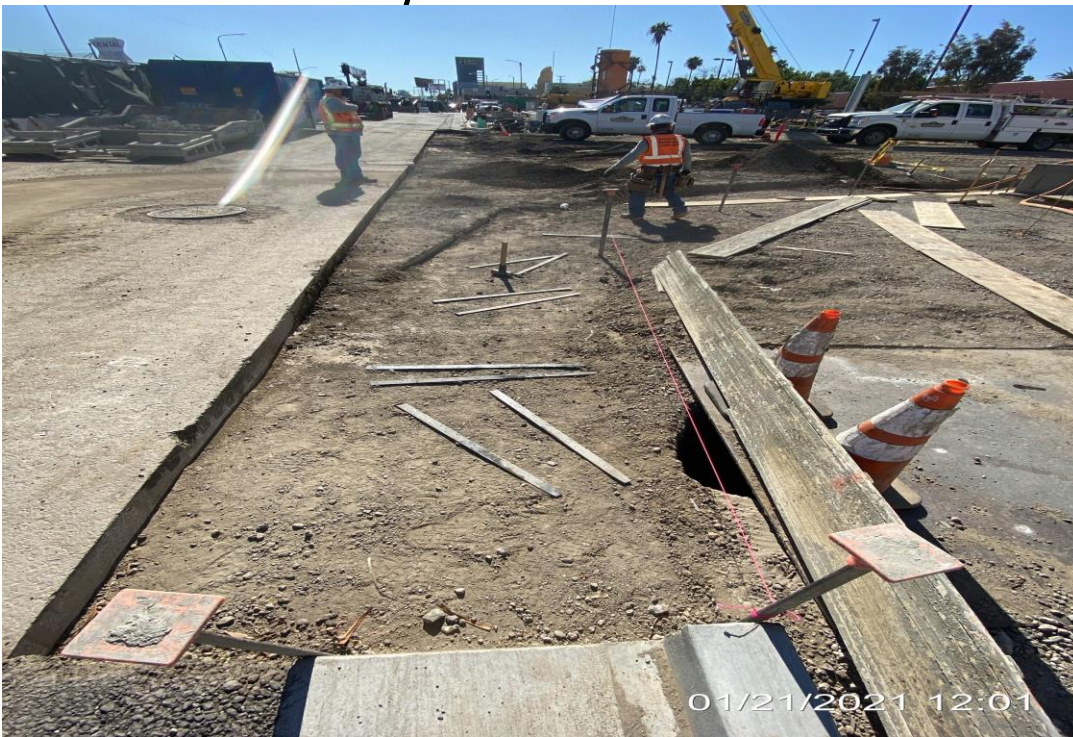
MLK STATION – Placing formwork for new curb and gutter installation along the access road south of the plaza.

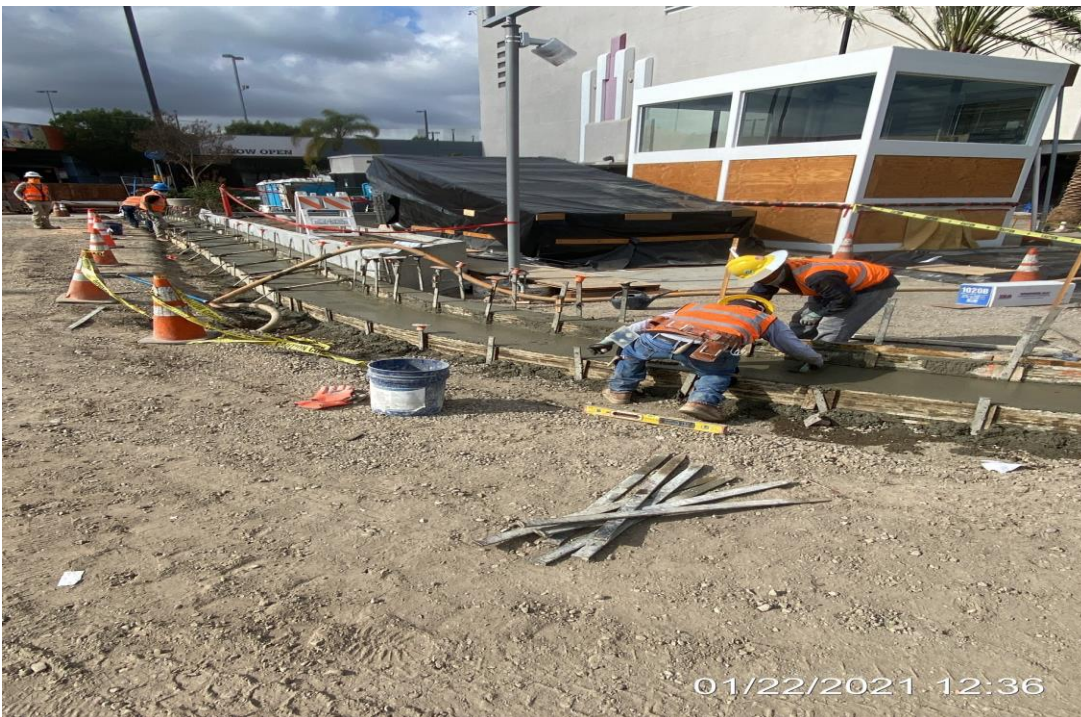
MLK STATION – Placing concrete for new curb and gutter installation along the access road south of the plaza.

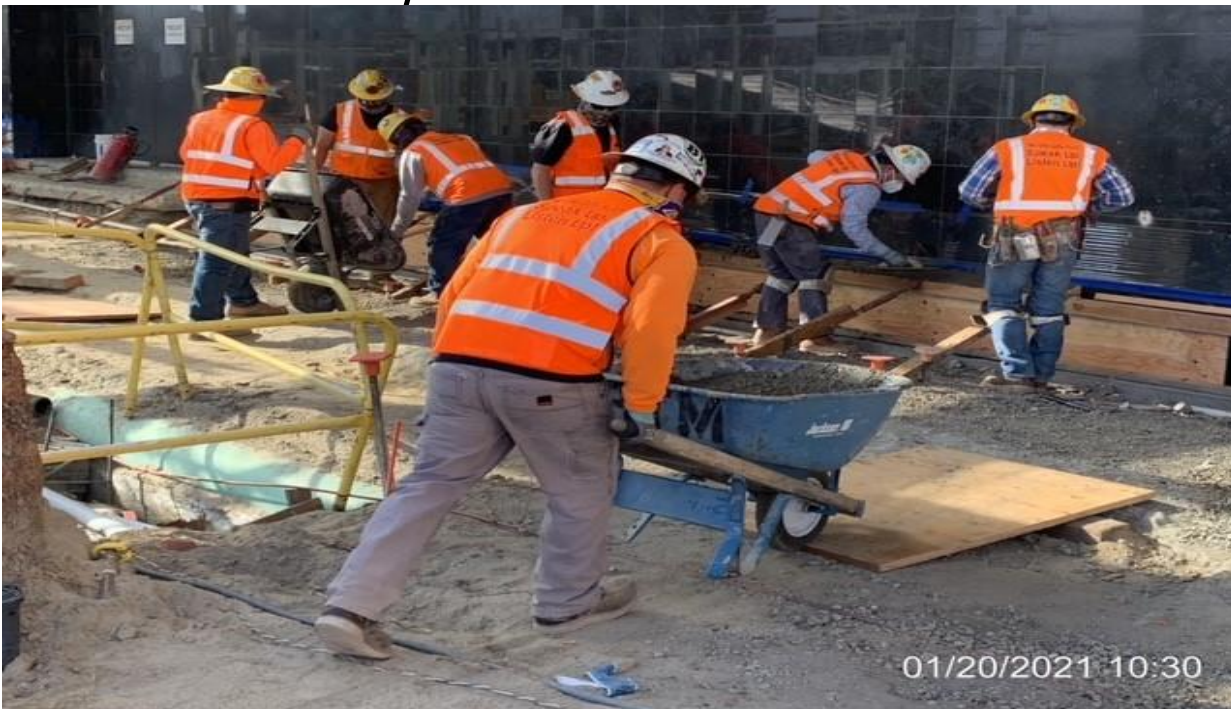
MLK STATION – Placing concrete for the short curb wall along the east side of the Mall at the plaza.

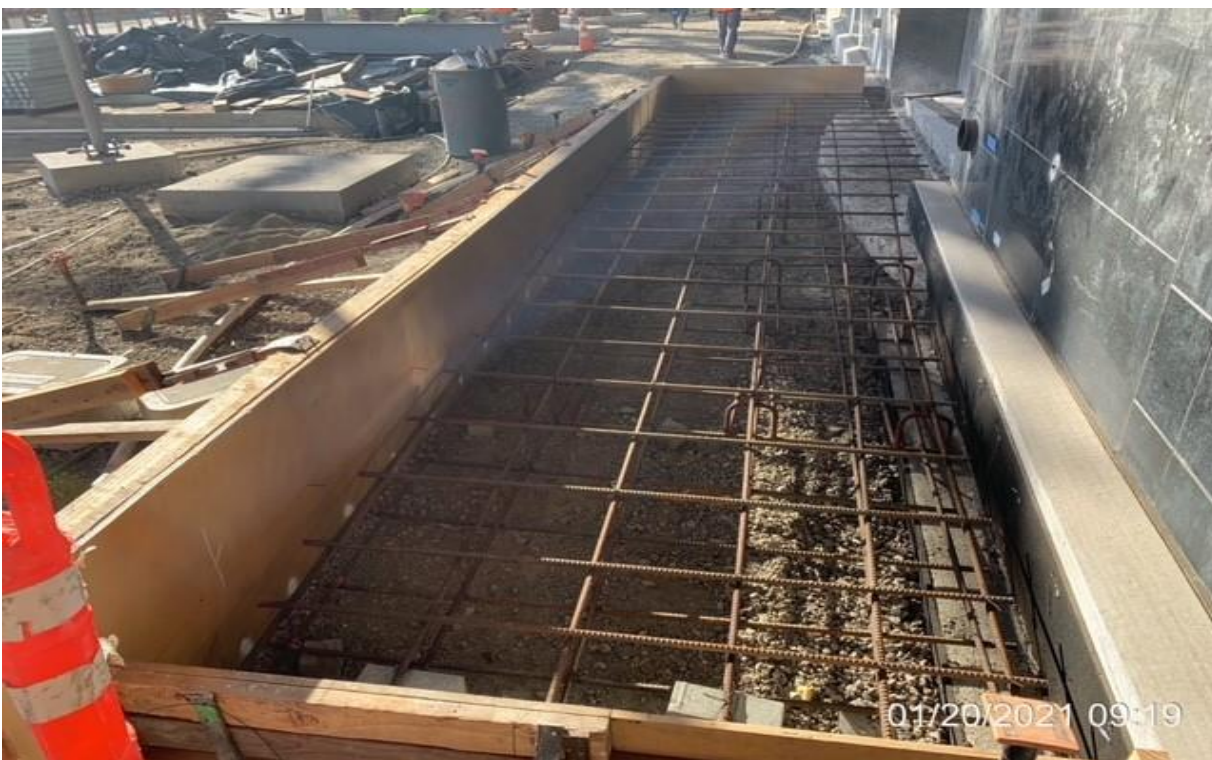
MLK STATION – Installed rebar for stair landing and ADA ramp adjacent to the west side of main entrance at the plaza.

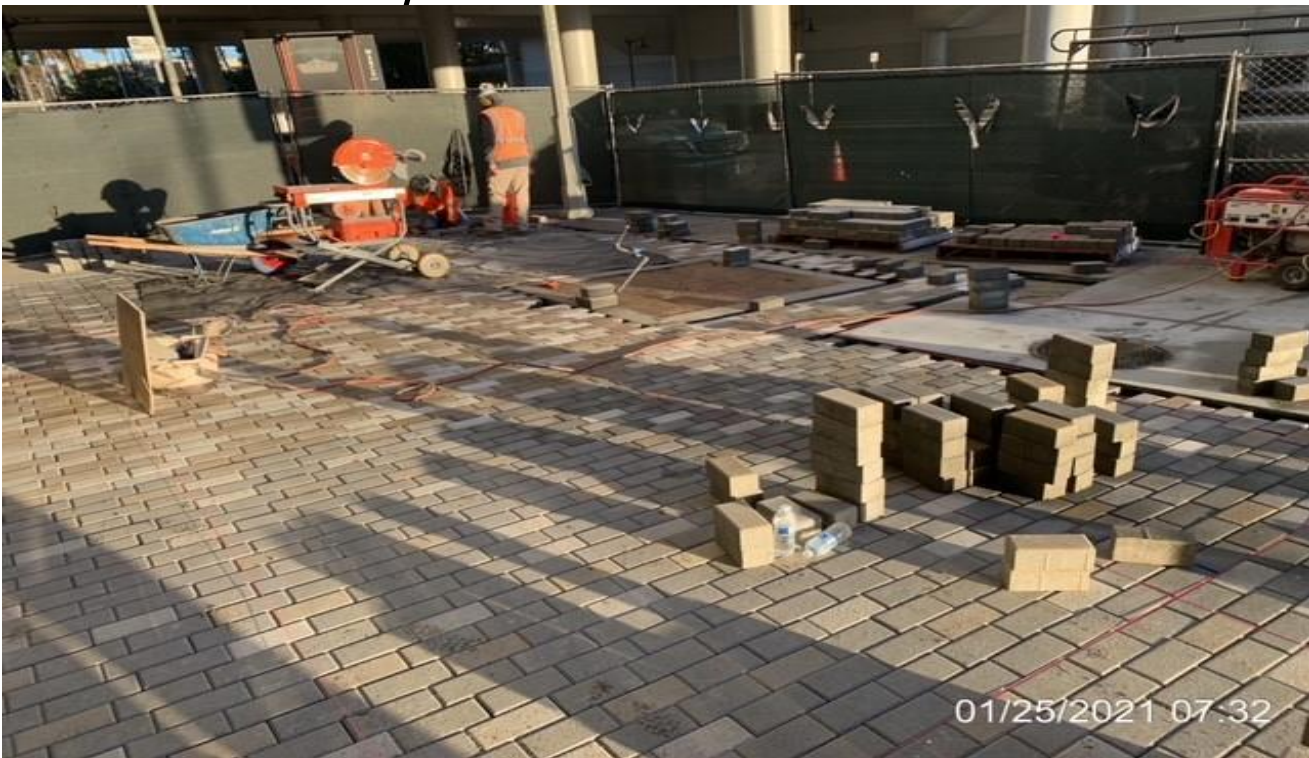
MLK STATION – Continue laying bedding sand and installing brick pavers at the far northwest plaza area.

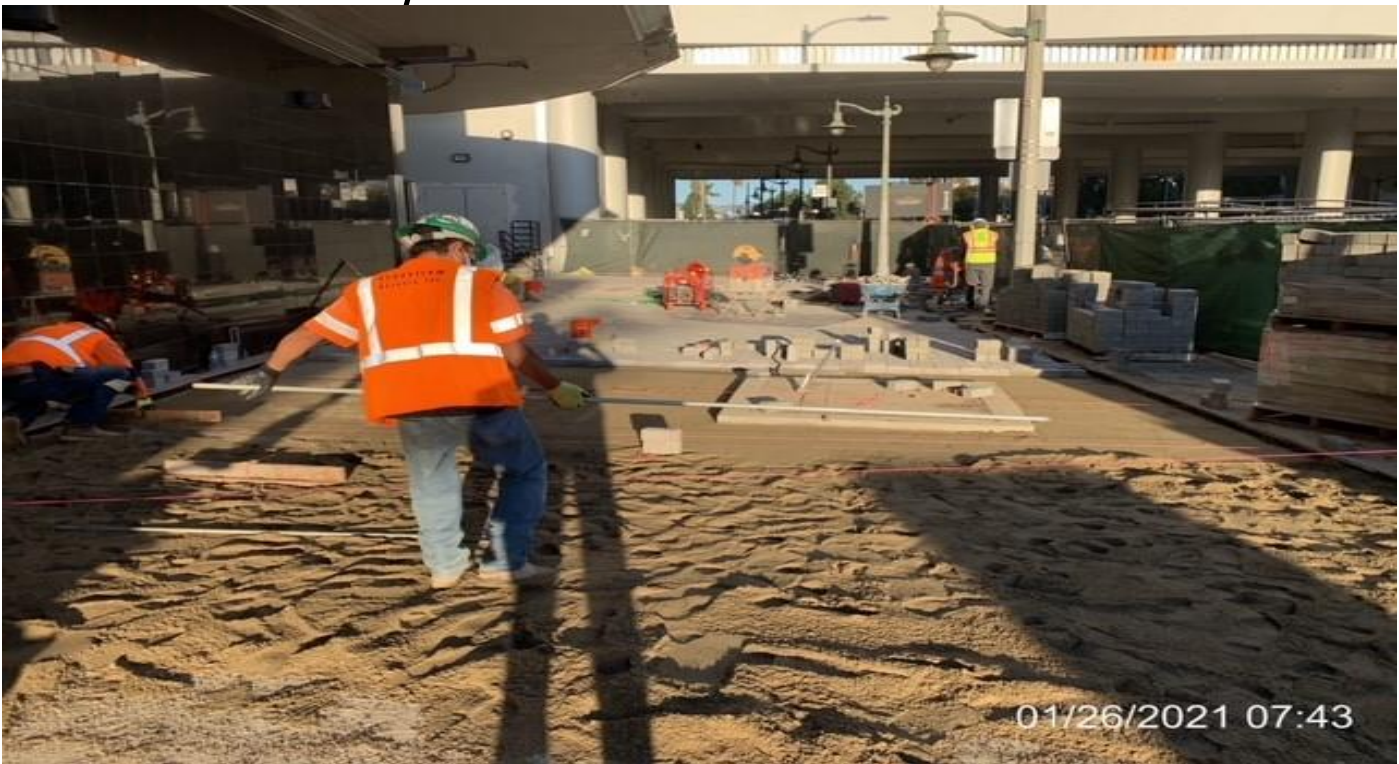
MLK STATION – Continue laying bedding sand and installing brick pavers at the far northwest plaza area.

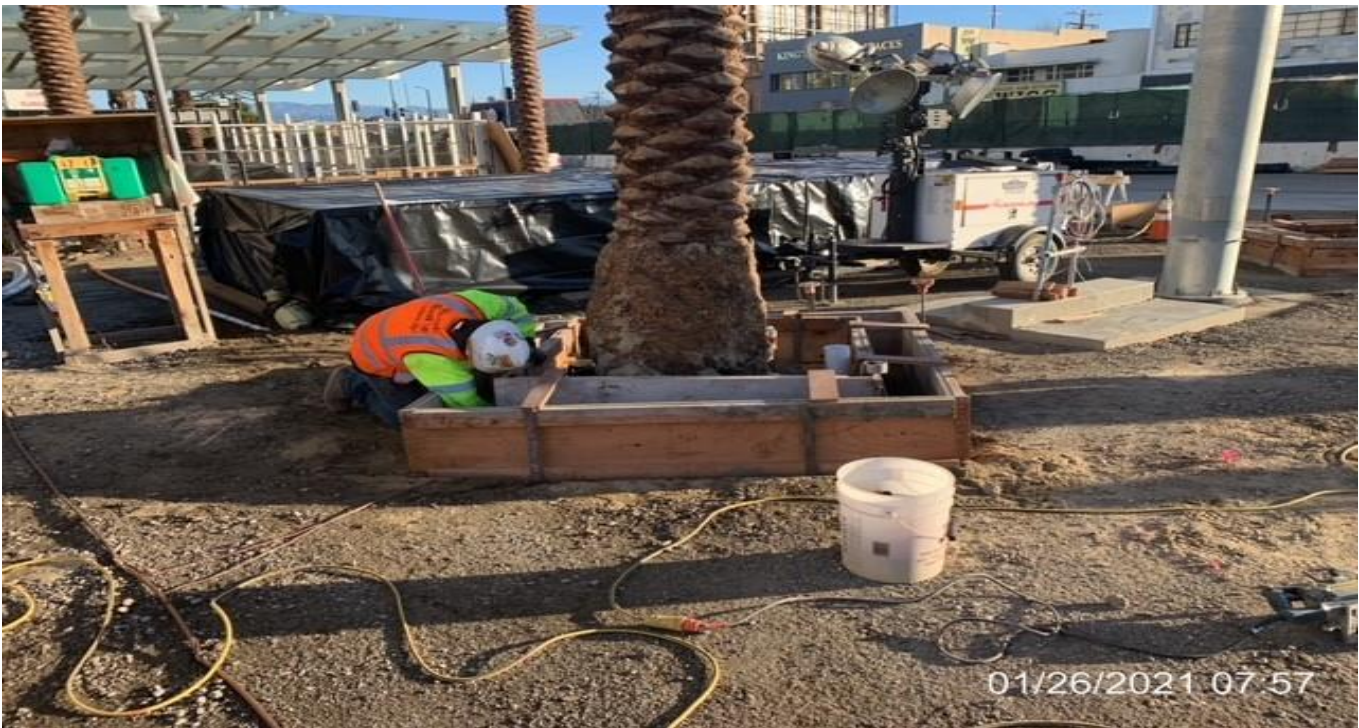
MLK STATION – Building formwork for tree wells bases at the south end of the plaza.

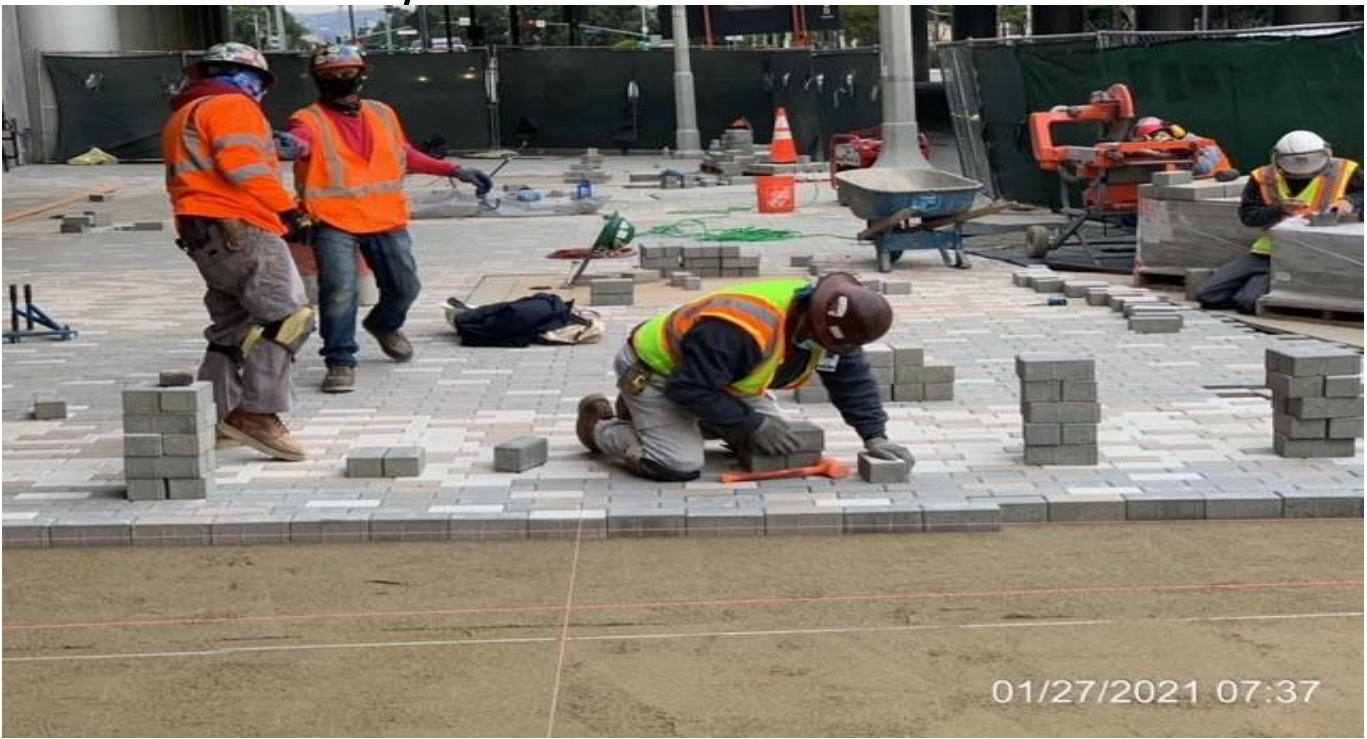
MLK STATION – Continue laying bedding sand and installing brick pavers at the far northwest plaza area.

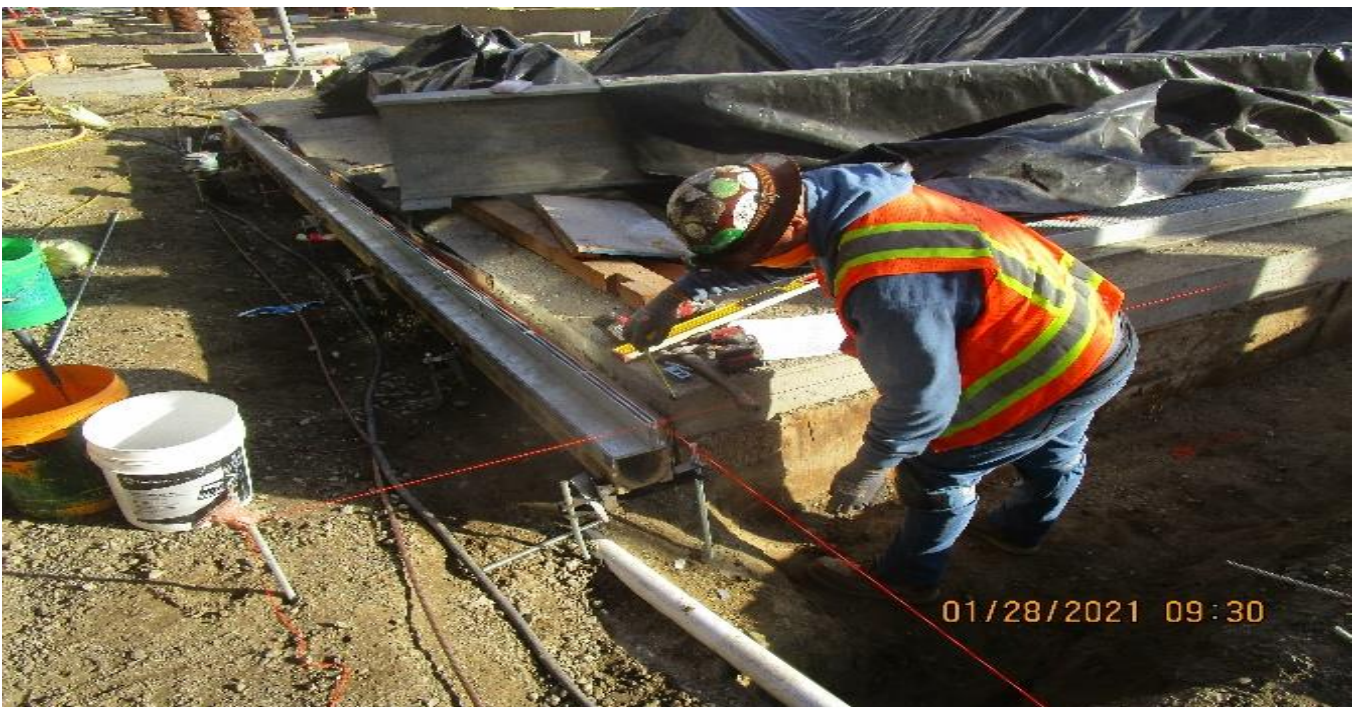
MLK STATION – Installing precast channel drains and HDPE pipe for storm drain tie-in along the west side of the plaza.

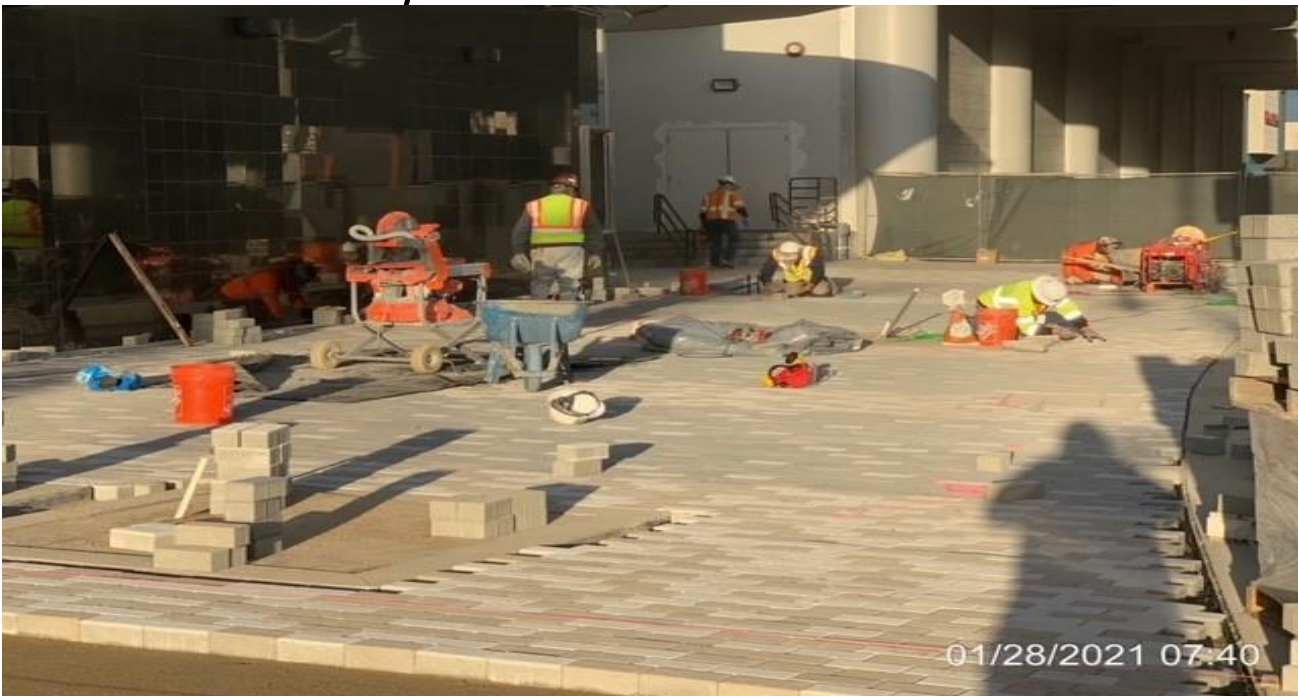
MLK STATION – Continue laying bedding sand and installing brick pavers at the far northwest plaza area.

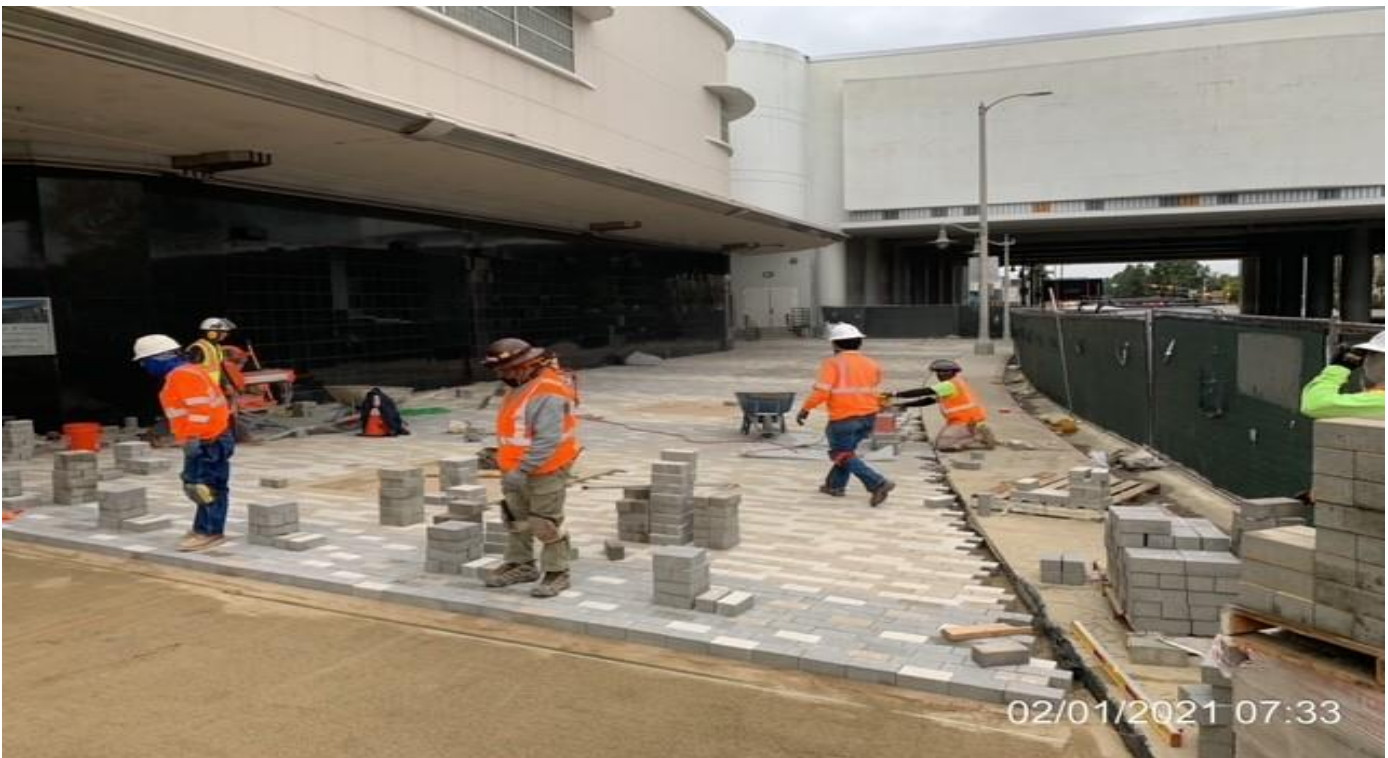
MLK STATION – Continue laying bedding sand and installing brick pavers at the far northwest plaza area.

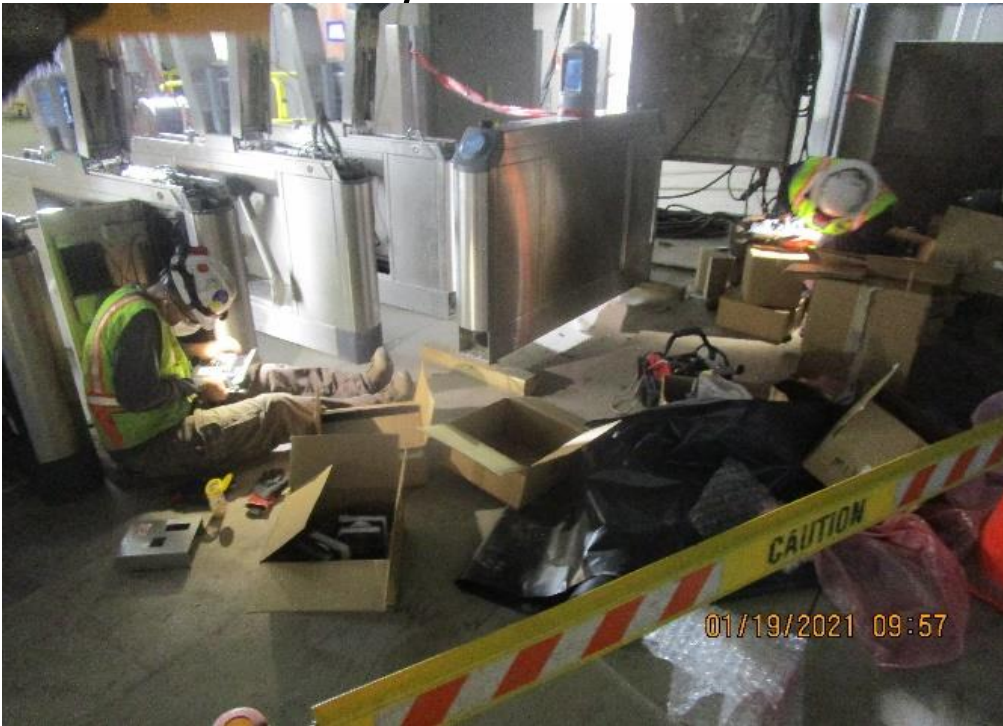
MLK STATION – Performing electrical work to the fare gate turnstiles at the Paid & Free Area.

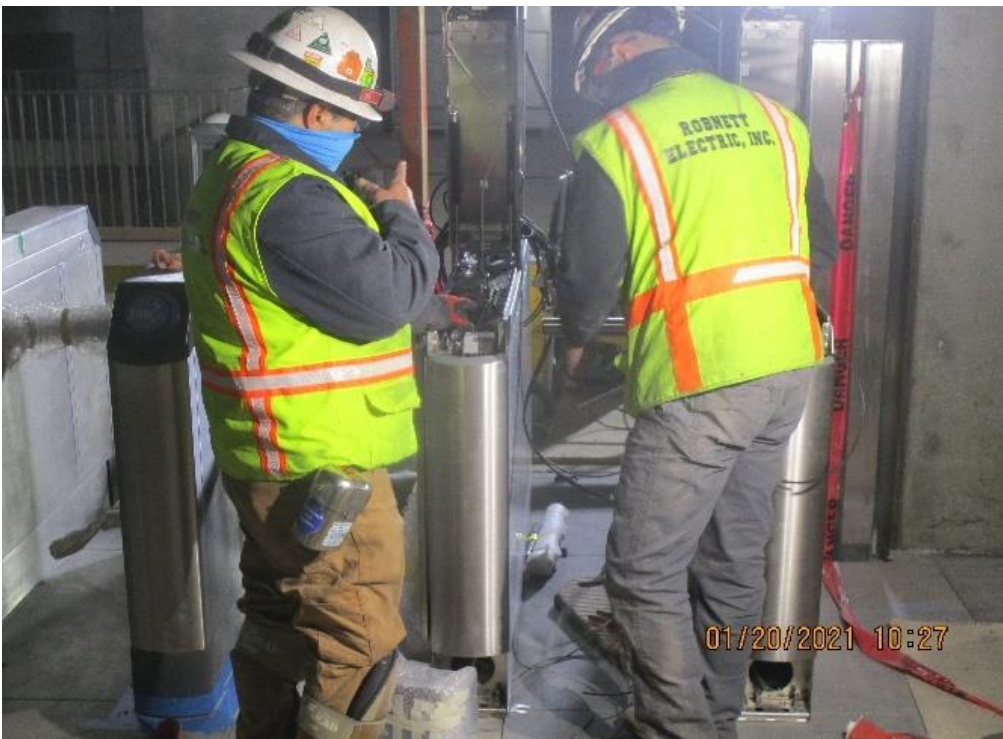
MLK STATION – Continue performing electrical work to the fare gate turnstiles at the Paid & Free Area.

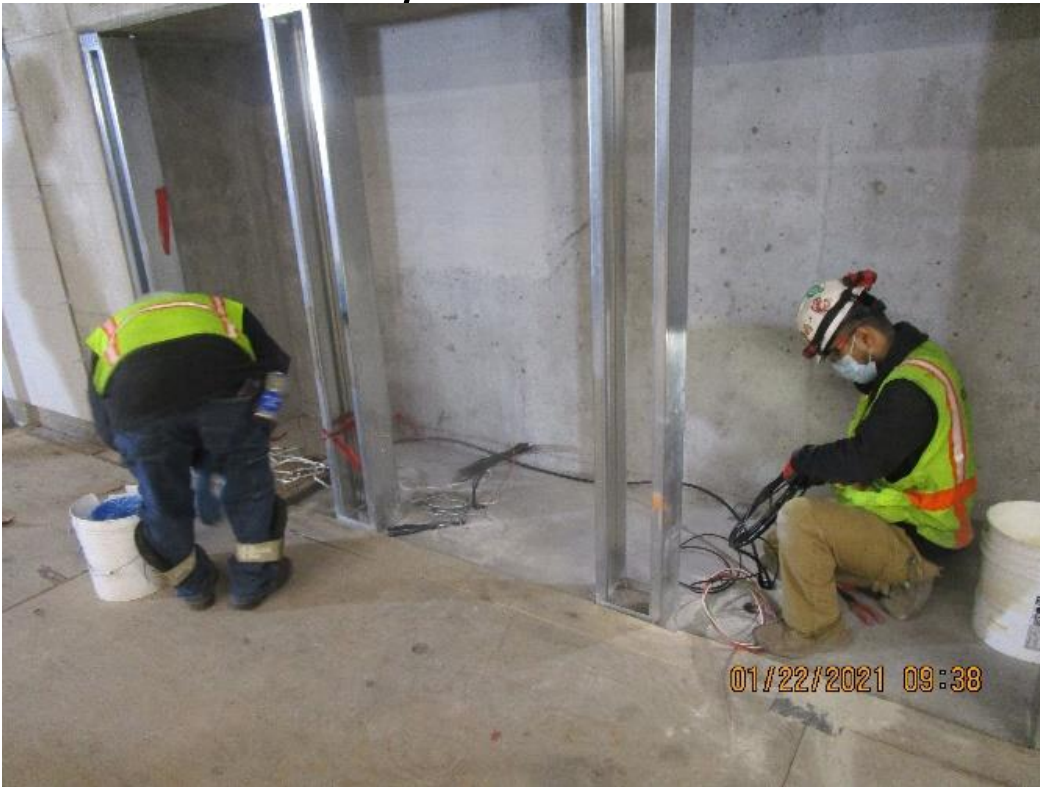
MLK STATION – Preparing for ticket vending machine installation at the Free Area.

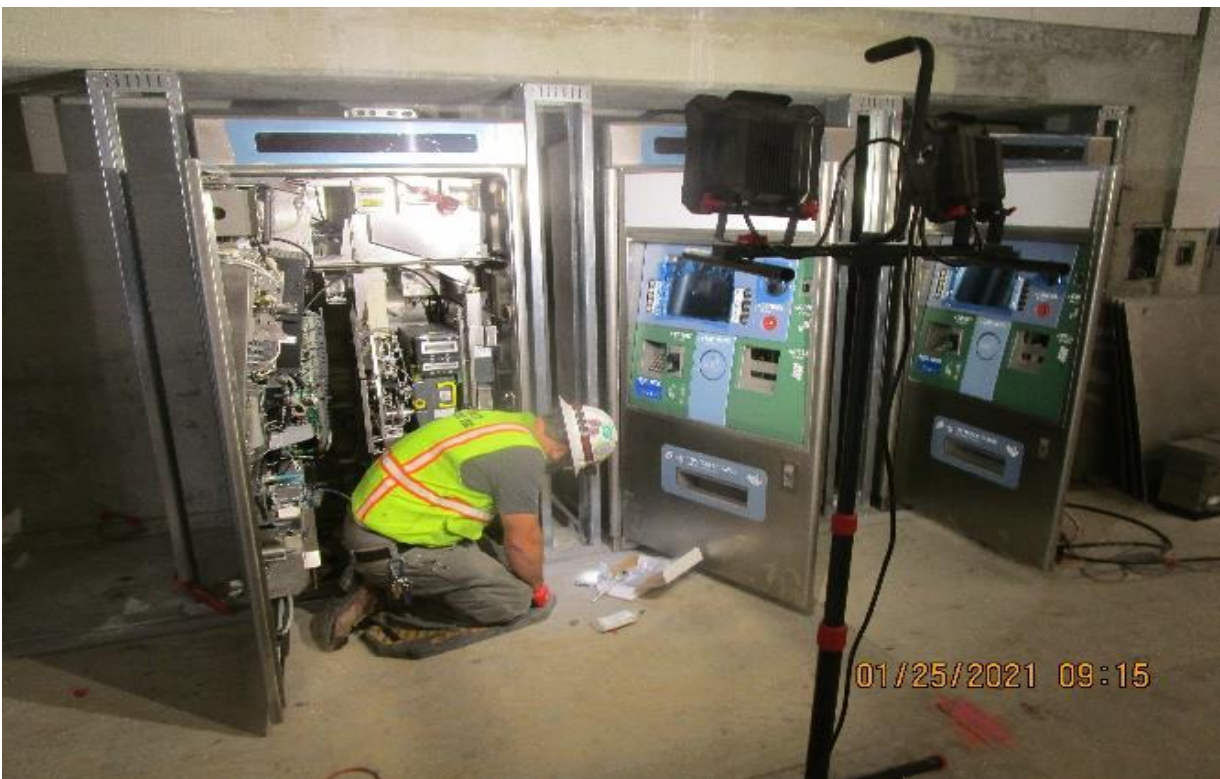
MLK STATION – Anchoring and installing ticket vending machines at the Free Area.
