CRENSHAW/LAX PHOTOGRAPHIC UPDATE

Feb 12, 2021

Crenshaw/LAX Transit Project

Overview of trackwork progress issues for 1/30/2021- 2/15/2021
(Please note the attached Trackwork Progress Tracking Report)

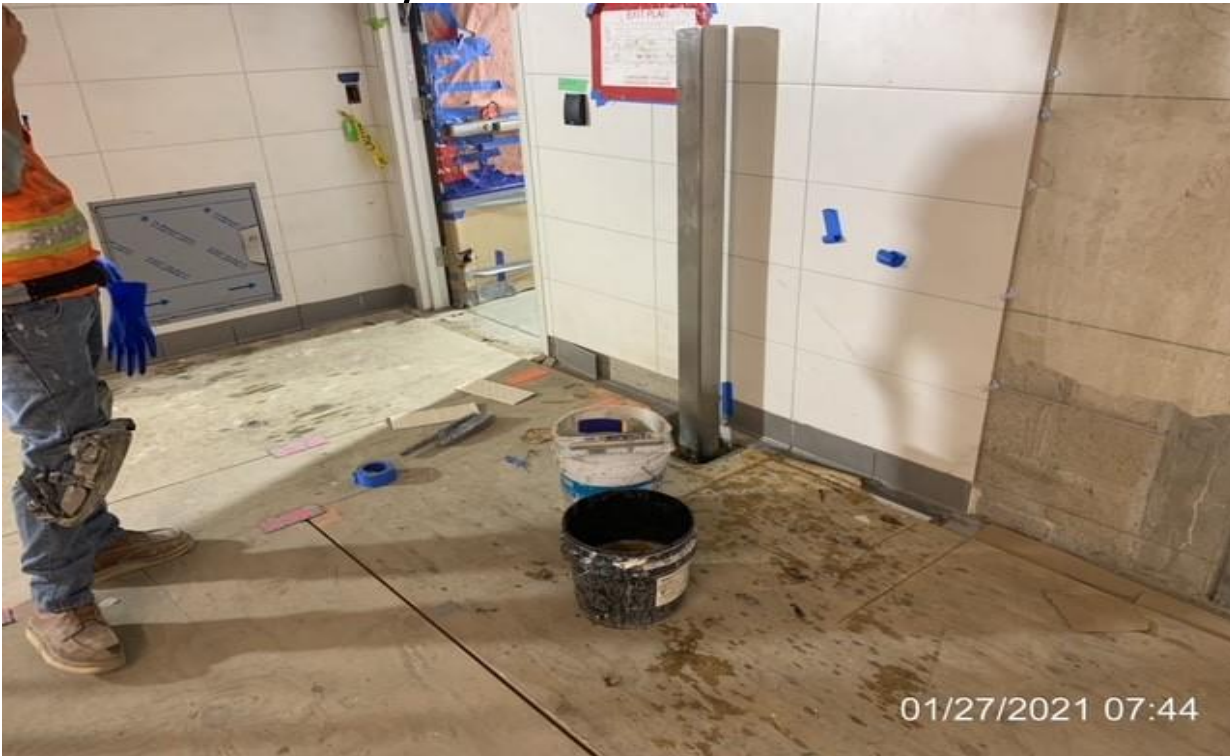
MLK STATION – Installing remaining tile at base cove locations throughout the Free Area.

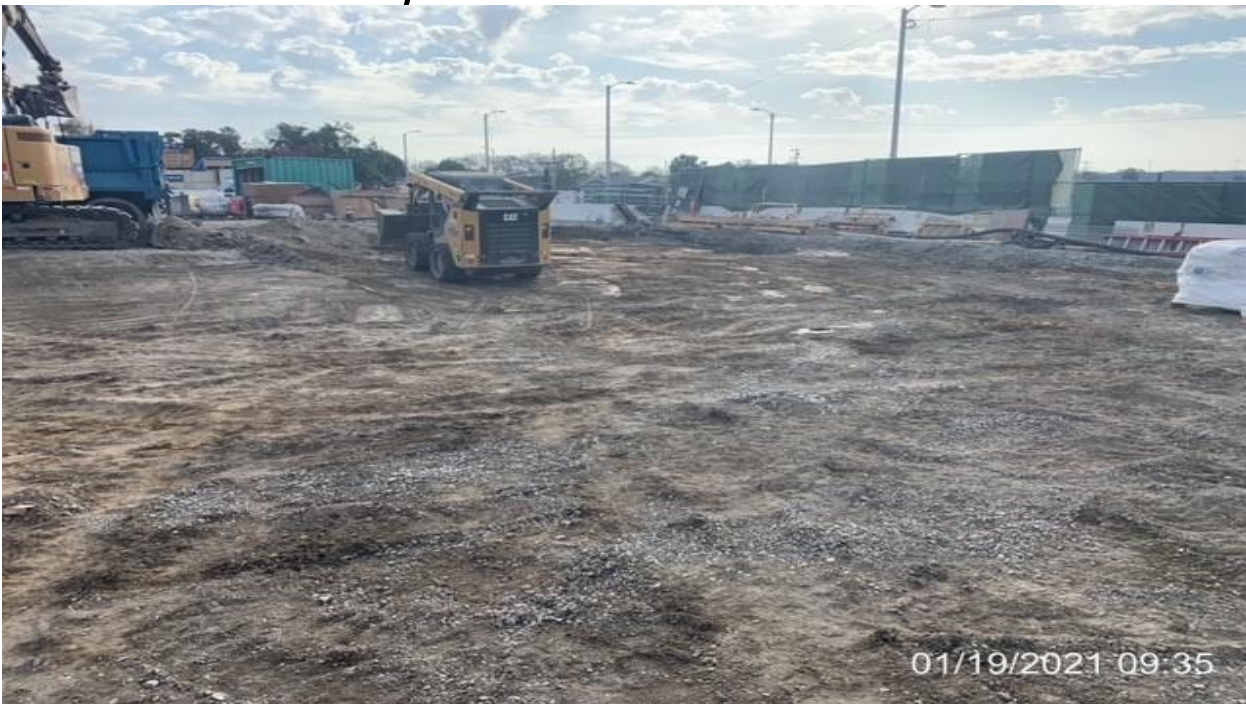
EXPO STATION - Continue excavating/grading and removing existing concrete throughout the entire Park & Ride lot area.

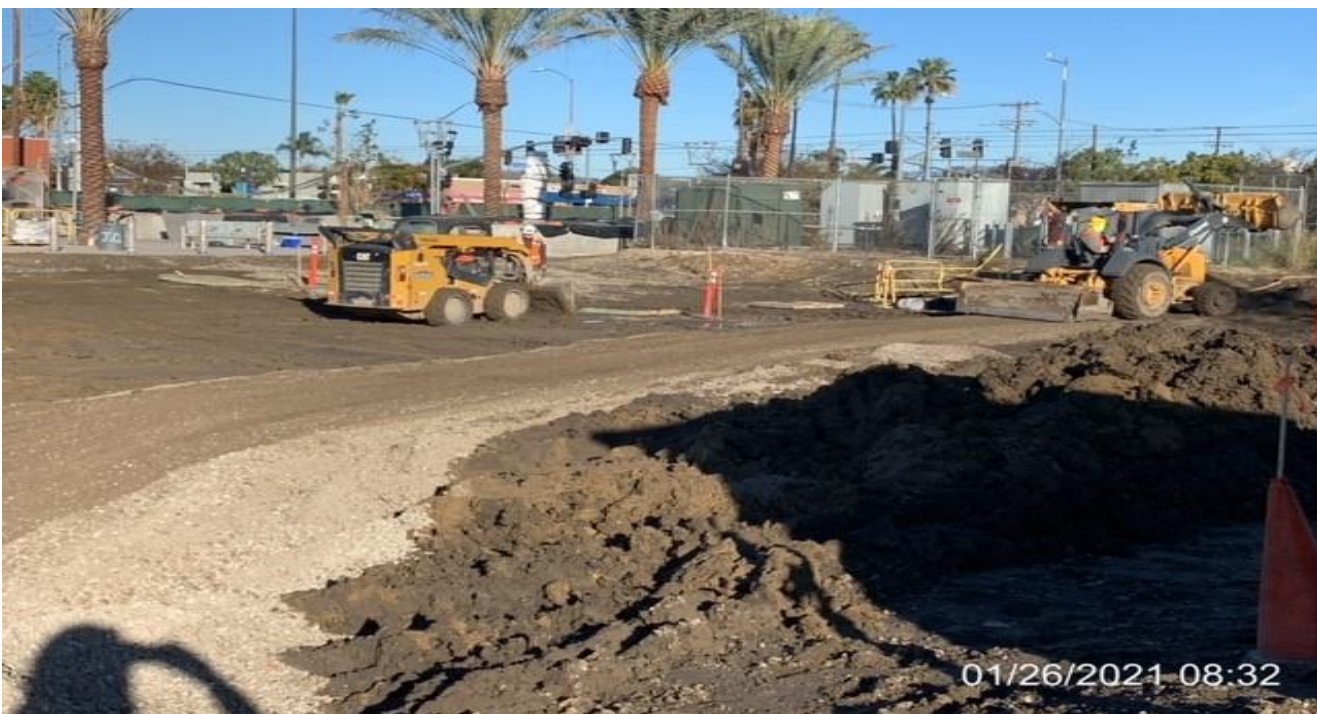
EXPO STATION– Placing base and grading throughout the entire Park & Ride lot area.

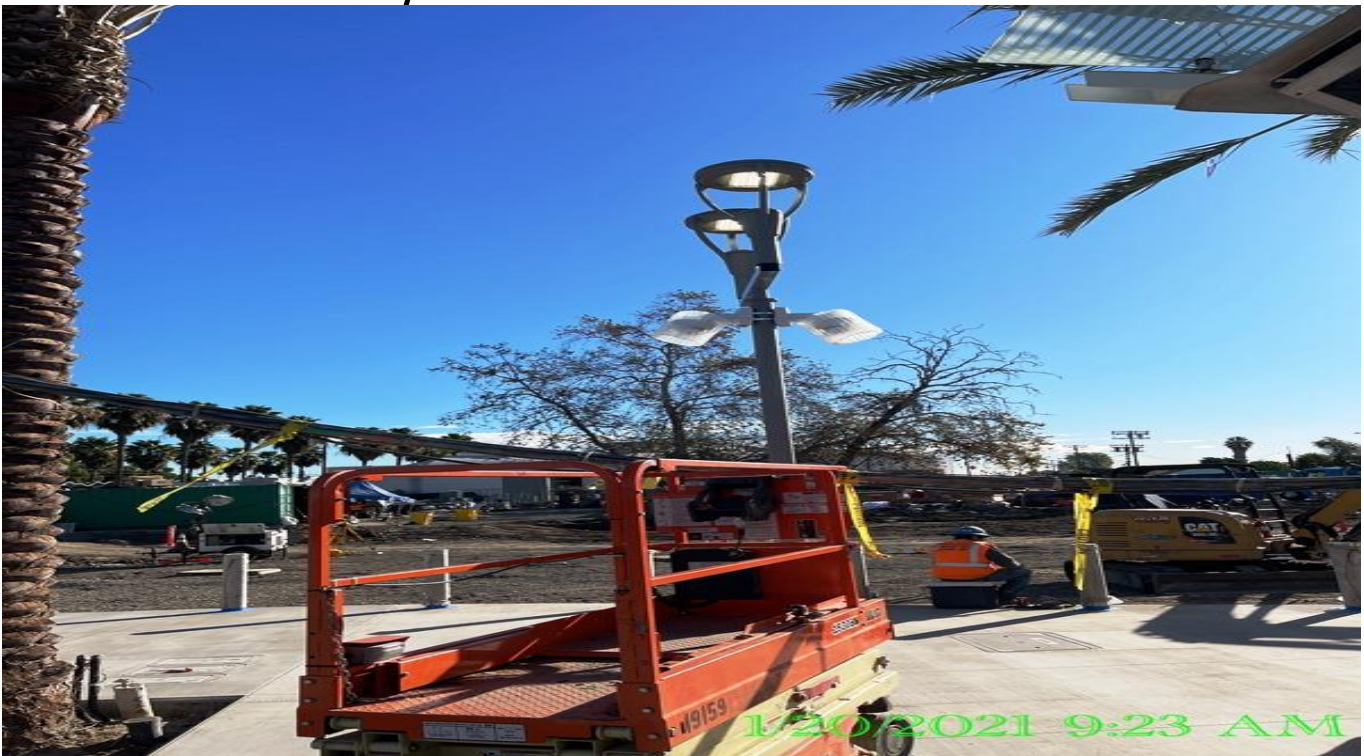
EXPO STATION– Installed domes to all the CCTV cameras mounted on pedestrian light poles throughout the plaza.

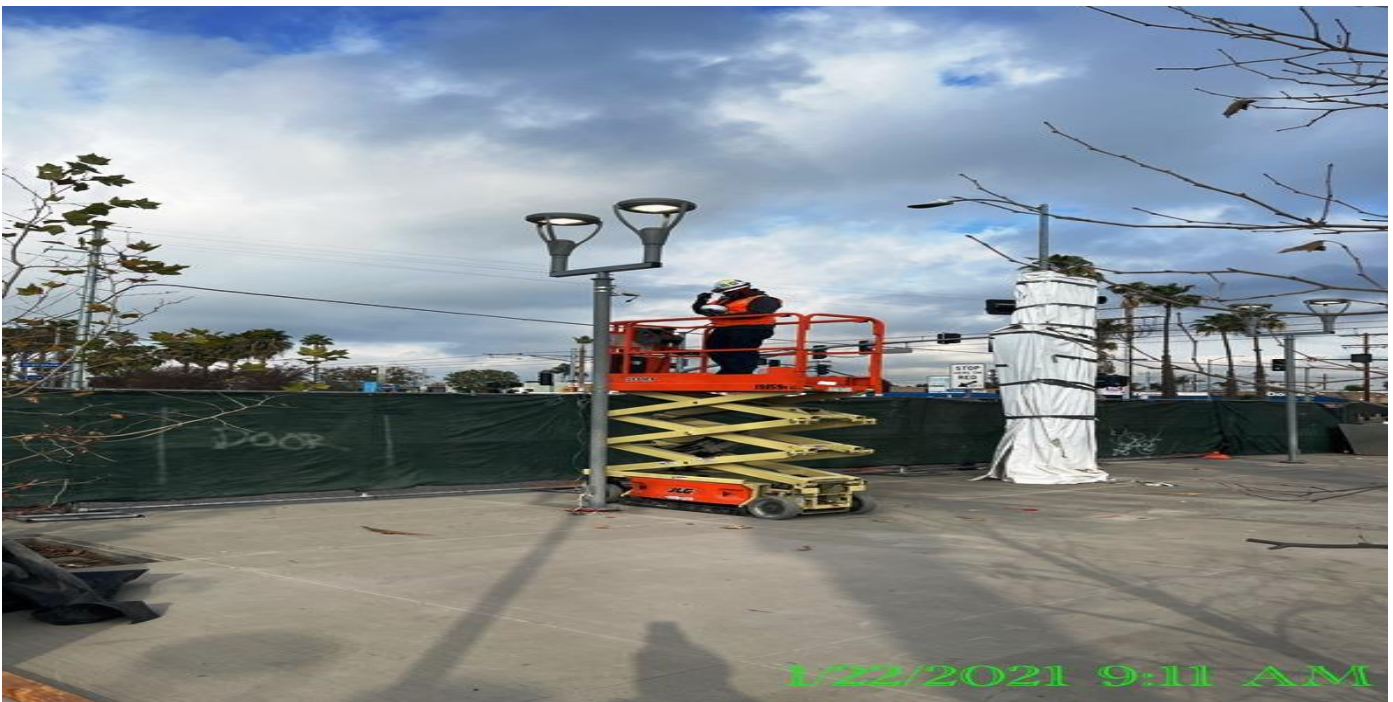
EXPO STATION – Continue dome installation to all the CCTV cameras mounted on pedestrian light poles throughout the plaza.

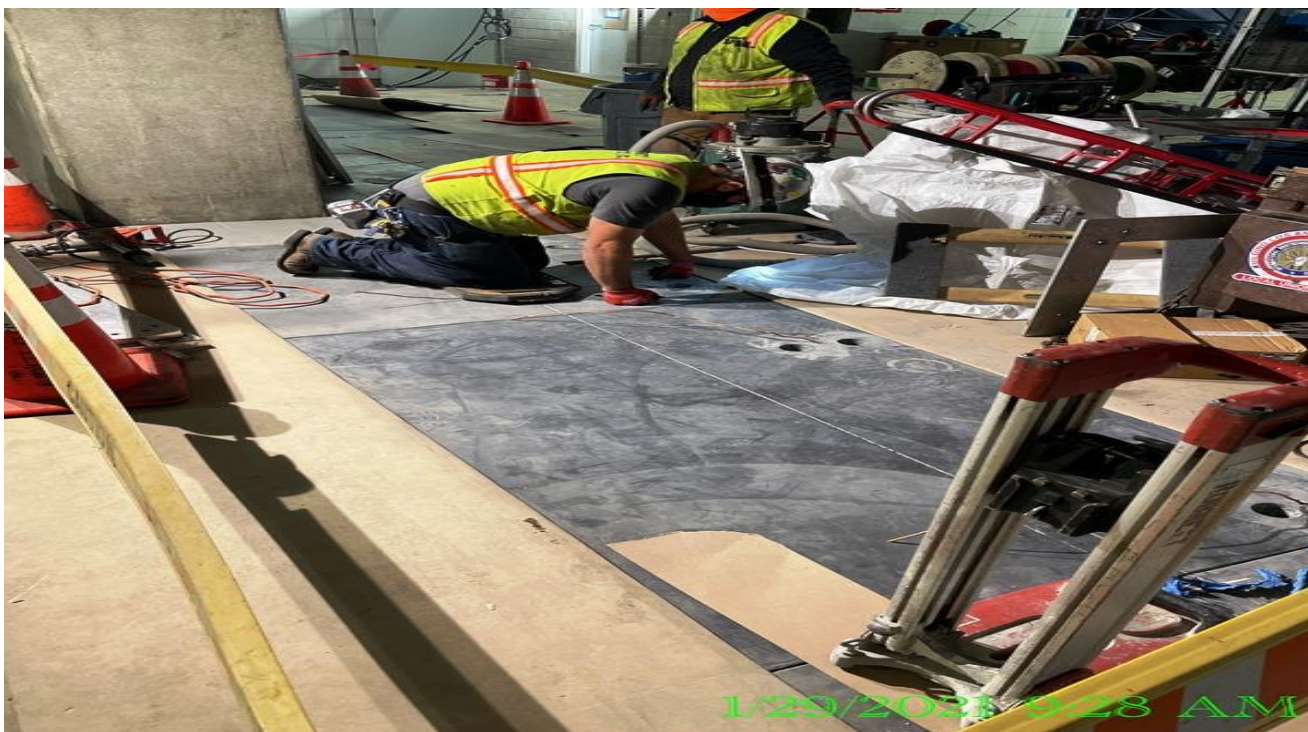
EXPO STATION– Continue performing layout in preparation for fare gate turnstile installation at the Paid & Free Area.

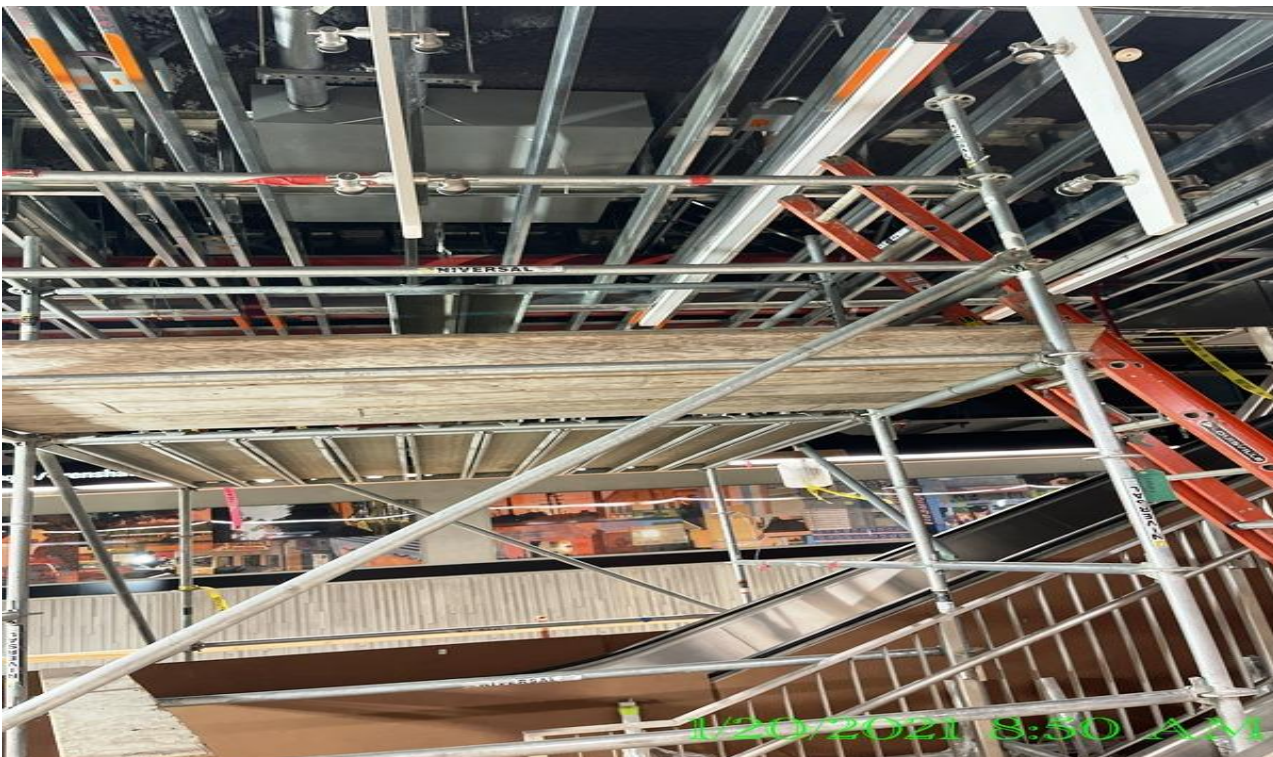
EXPO STATION – Continue LED light fixture installation at the platform ceiling grid.

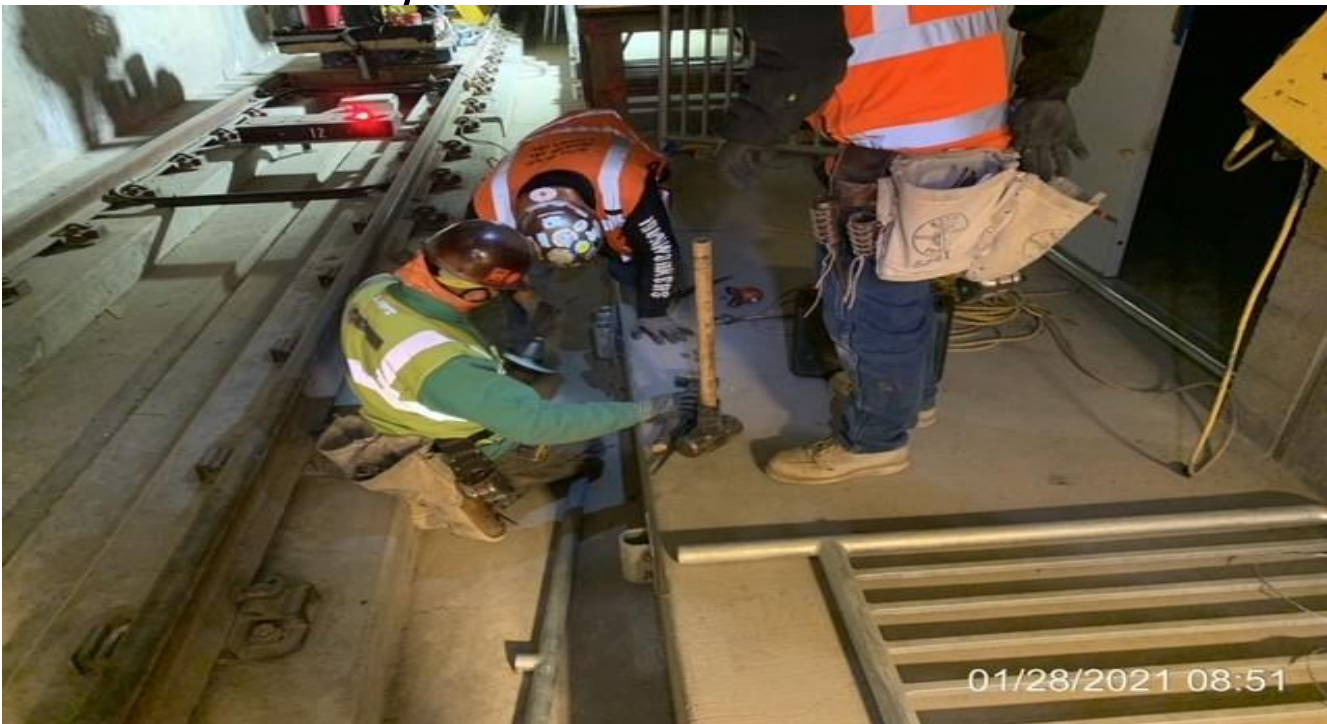
EXPO STATION – Continue installing guardrails along the northbound emergency walkway of the North back of House at the invert level.
