The Northridge Earthquake

Post Earthquake Investigation Report

California Department of Transportation - Division of Structures

17 January 1994

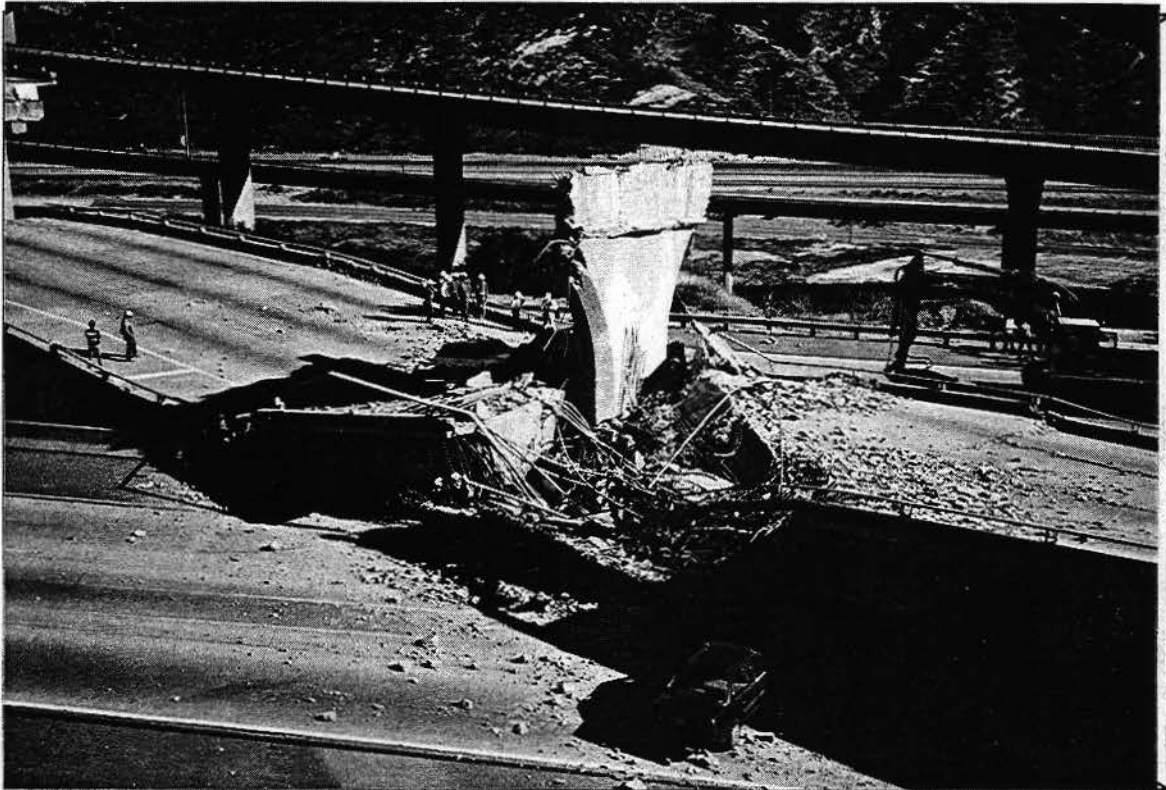
Pier 3 remained standing. Pier 3 did not have cracking on the transverse face, while some vertical cracking ($\approx 3/8$ " wide) was evident on the longitudinal face (looking in elevation). The superstructure on both sides of the pier was on the ground. The main bent cap reinforcement at pier 3 was also on the ground. The #18 bars appeared undamaged and all the concrete was cleaned from the bars. The #5 stirrups in the bent cap had been ripped from the bent cap. Furthermore, there was no longitudinal, mild steel through the bent cap. When the prestressing was over-stressed and failed, the superstructure had almost no negative moment capacity.

14/5 Conn. Sep. & OH 53-1960F 7-LA-14/5-R14.73/R45.62 3-36-JSM
Pier #3 from above, looking East

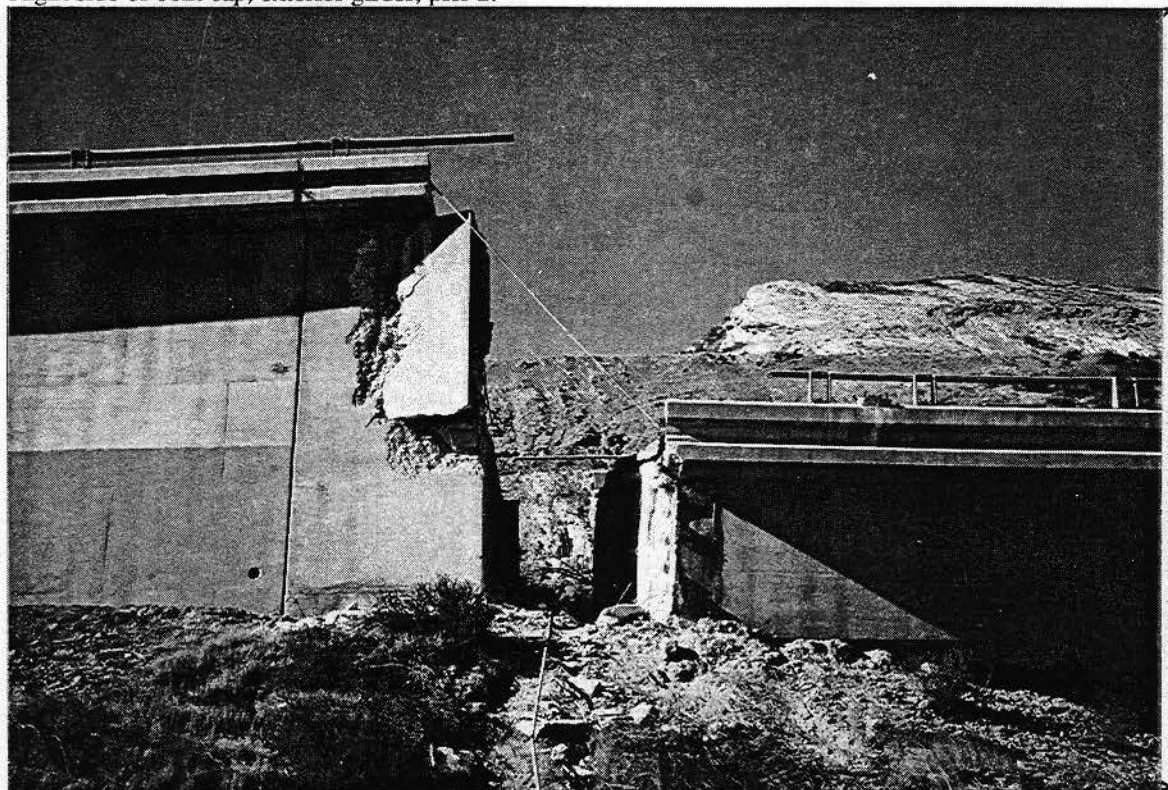
14/5 Conn. Sep. & OH
Abutment #1.

The first frame of the structure collapsed. At the abutment, the diaphragm was found unseated and lying on the ground approximately 5 feet from the face of the abutment seat. The right exterior shear key failed completely, and the left exterior shear key appeared undamaged. The abutment seat had no internal shear keys. There was no evidence of any significant longitudinal movement in the backwall. The backwall remained intact, with no signs of cracking.

The outward motion of frame 2 introduced a counter-clockwise rotation in frame 1. This can be seen by the failed shear key at the right exterior shear key at the abutment.

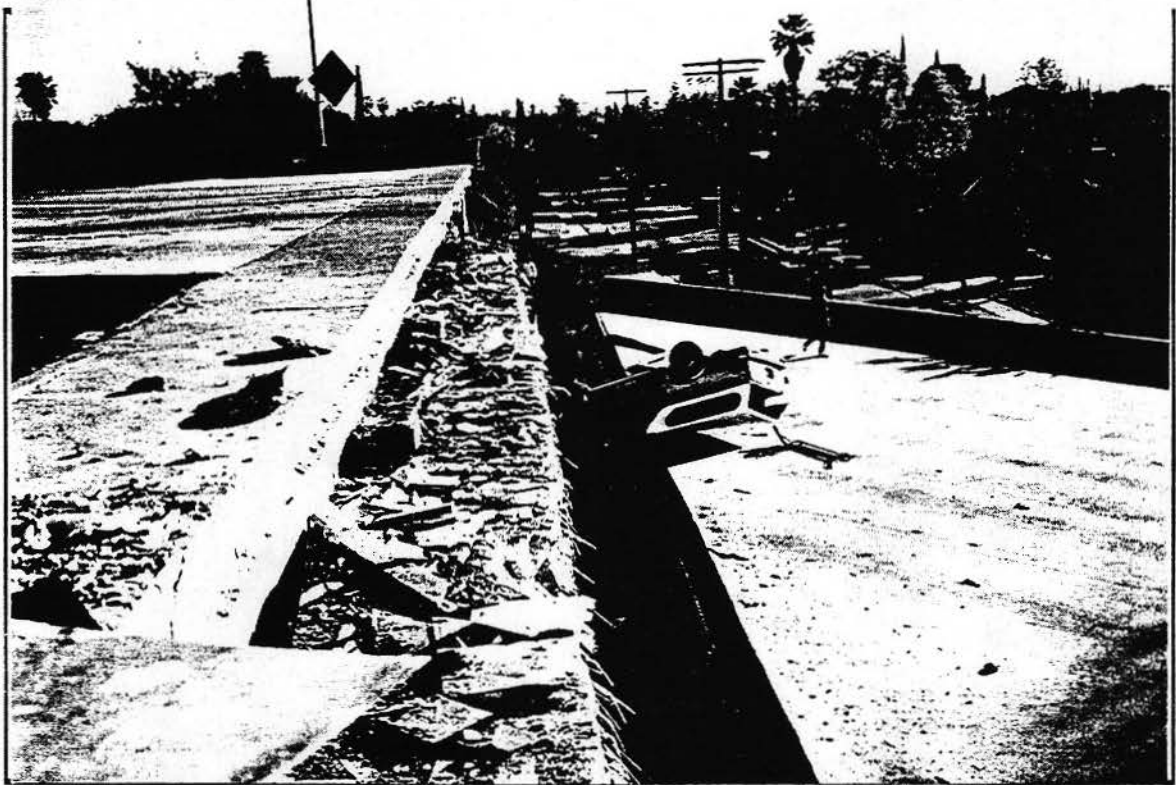
Mission Gothic
Abutment 5R. looking south.

As these columns were completely sheared or severely damaged, abutment 5 of the right bridge dropped. The columns of bents 2R, 3R, and 2L may or may not have been damaged before the failures at bents 4R and 3L occurred. Certainly secondary effects from the large deformations that occurred after bents 4R and 3L failed generated various types and levels of damage and displacements at other columns and abutments.

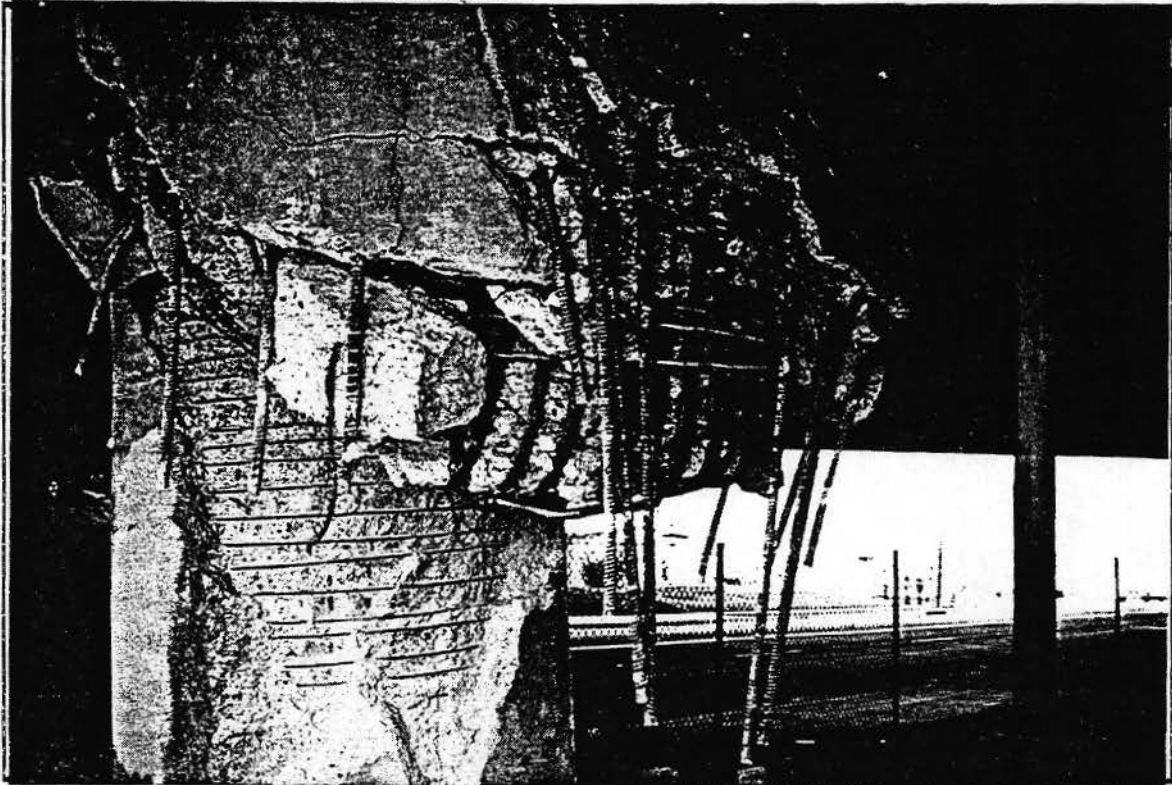
Mission Gothic 53-2205 7-LA-118-R8.63 9-3-TES
Bent 2R, left column, looking north.

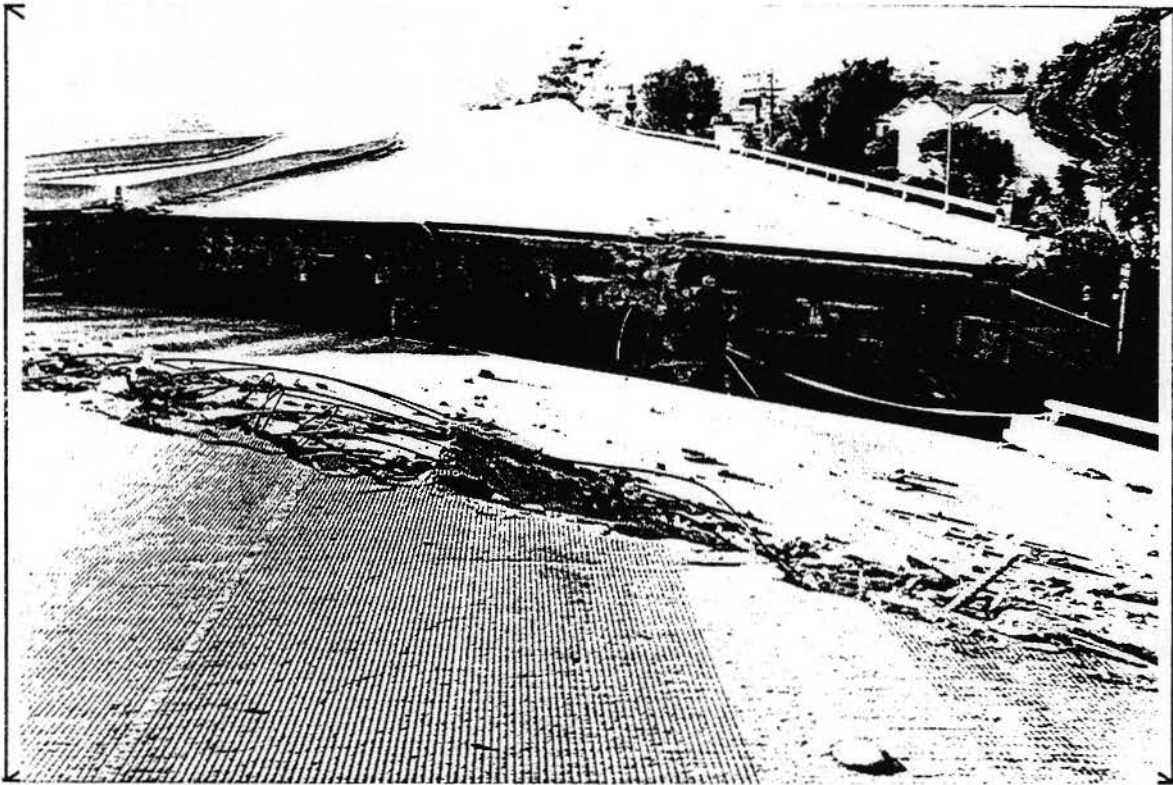
La Cienega-Venice U.C. 53-1609 7-LA-10-R8.83 C-31-BKT
Span 6 Collapse at Hinge. WB Struc., Looking West.

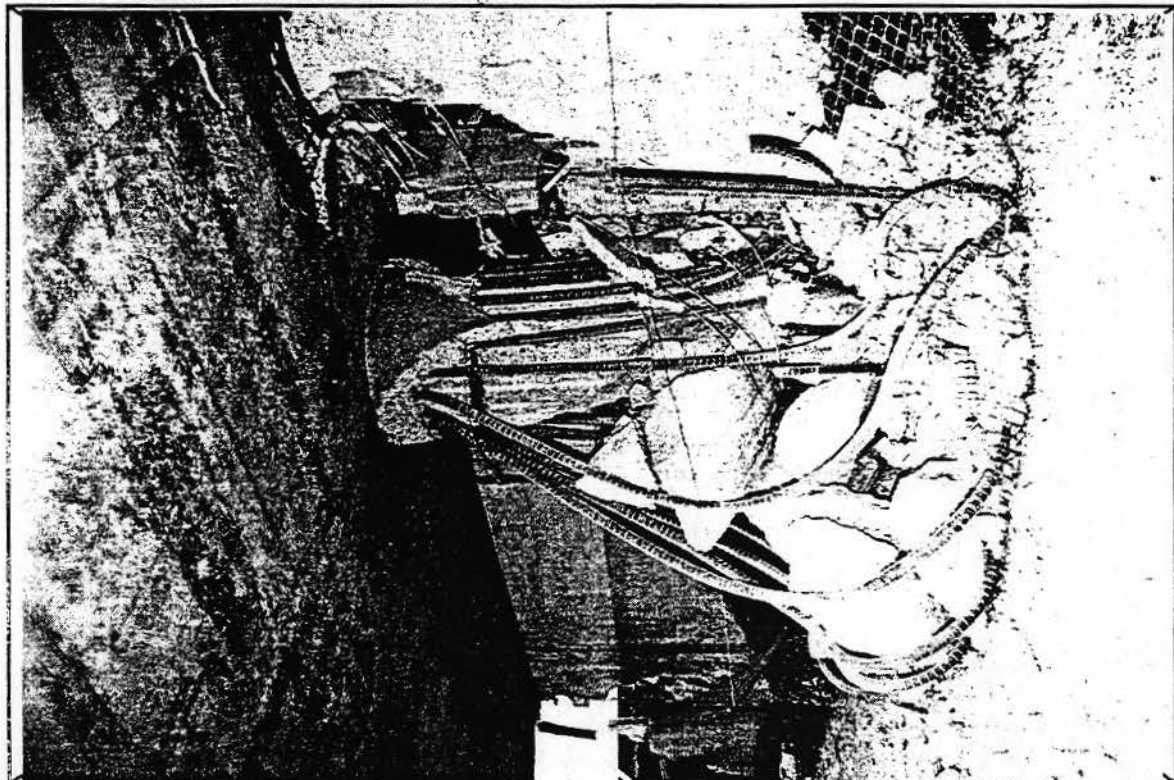
La Cienega-Venice U.C. 53-1609
Column 1. Bent 6 of WB Struc., Looking Southeast.

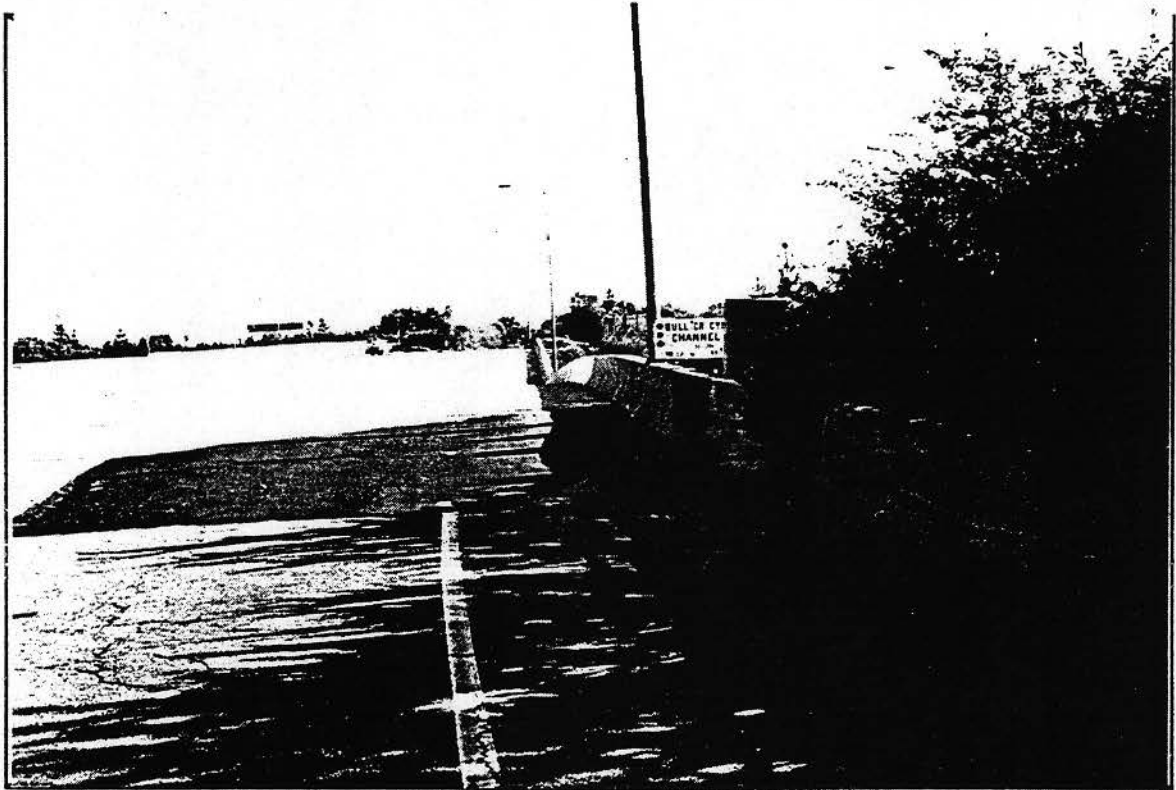
This structure suffered major damage. There was no evidence of cracking or spalling at the abutments with the exception of minor shear cracks near the shear keys. The structure appeared to have rotated clockwise. At abutment 4, there was some soil heaving at the right bridge.

Bull Creek Canyon Channel 53-2206 7-LA-118-R8.84 14-1-TES
Abutment 1, southside, looking east.

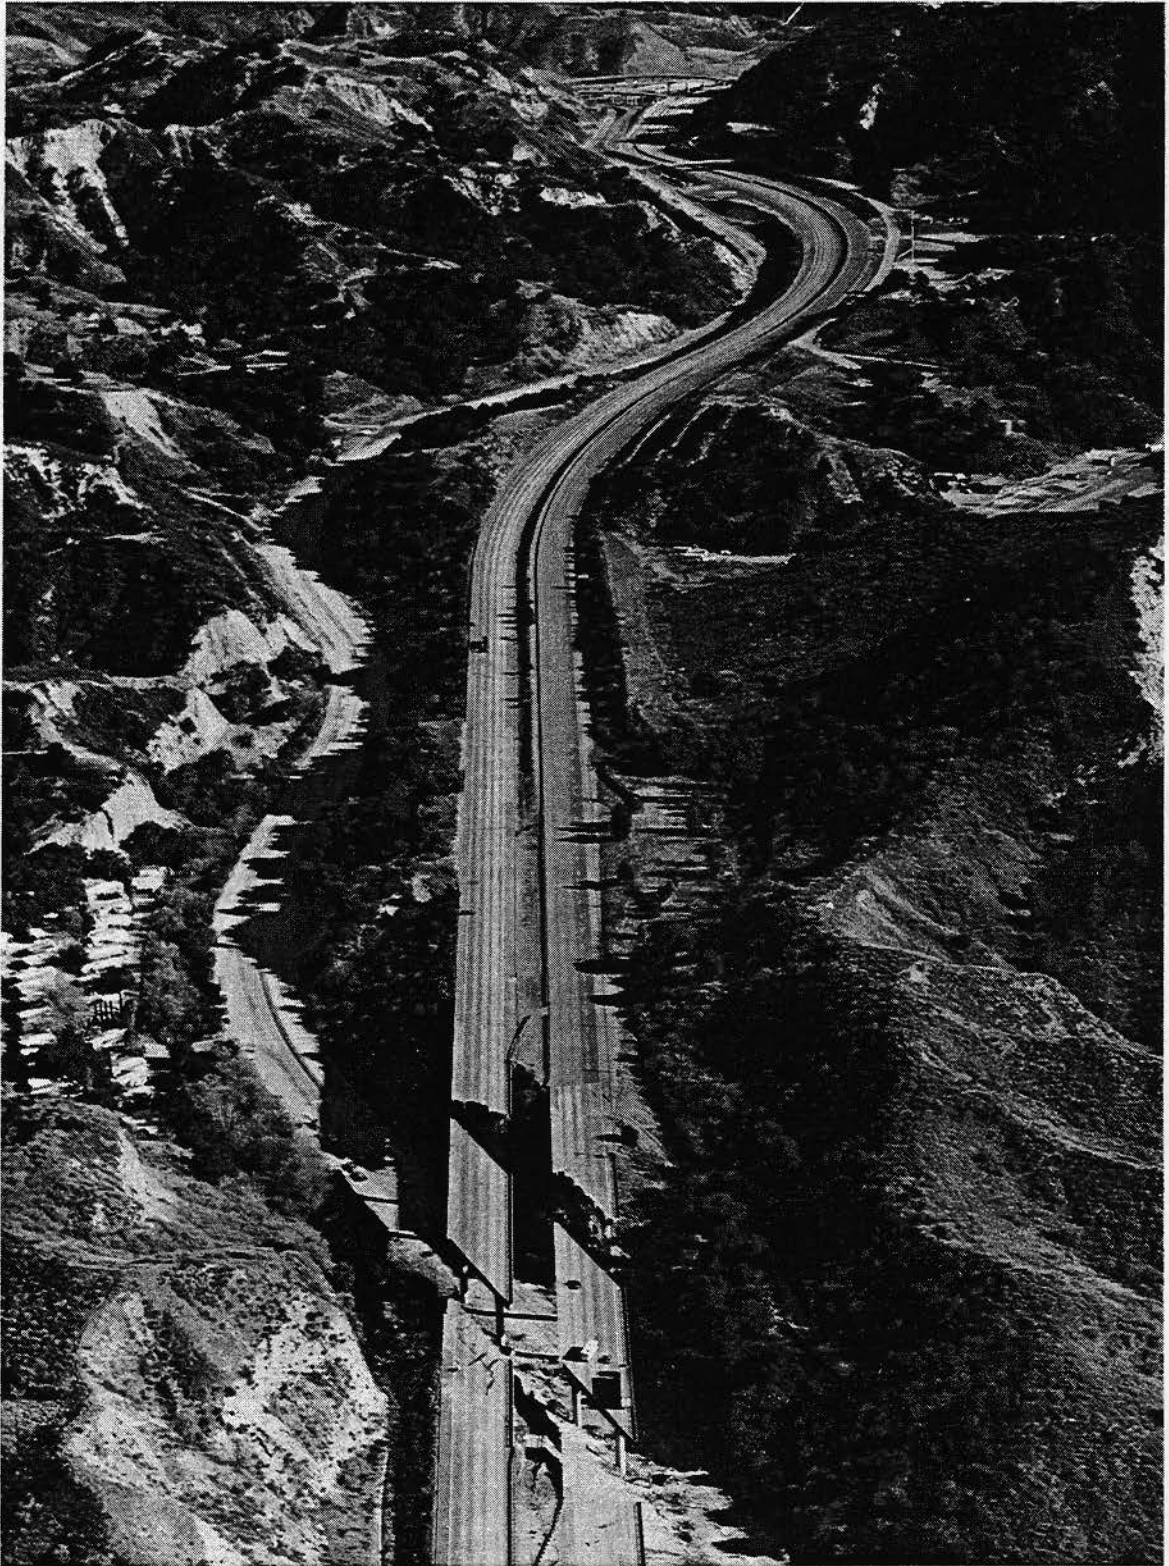
Overview of Gavin Canyon Road (53-1797R/L),
with Route 14/Interstate 5 Interchange in distance.

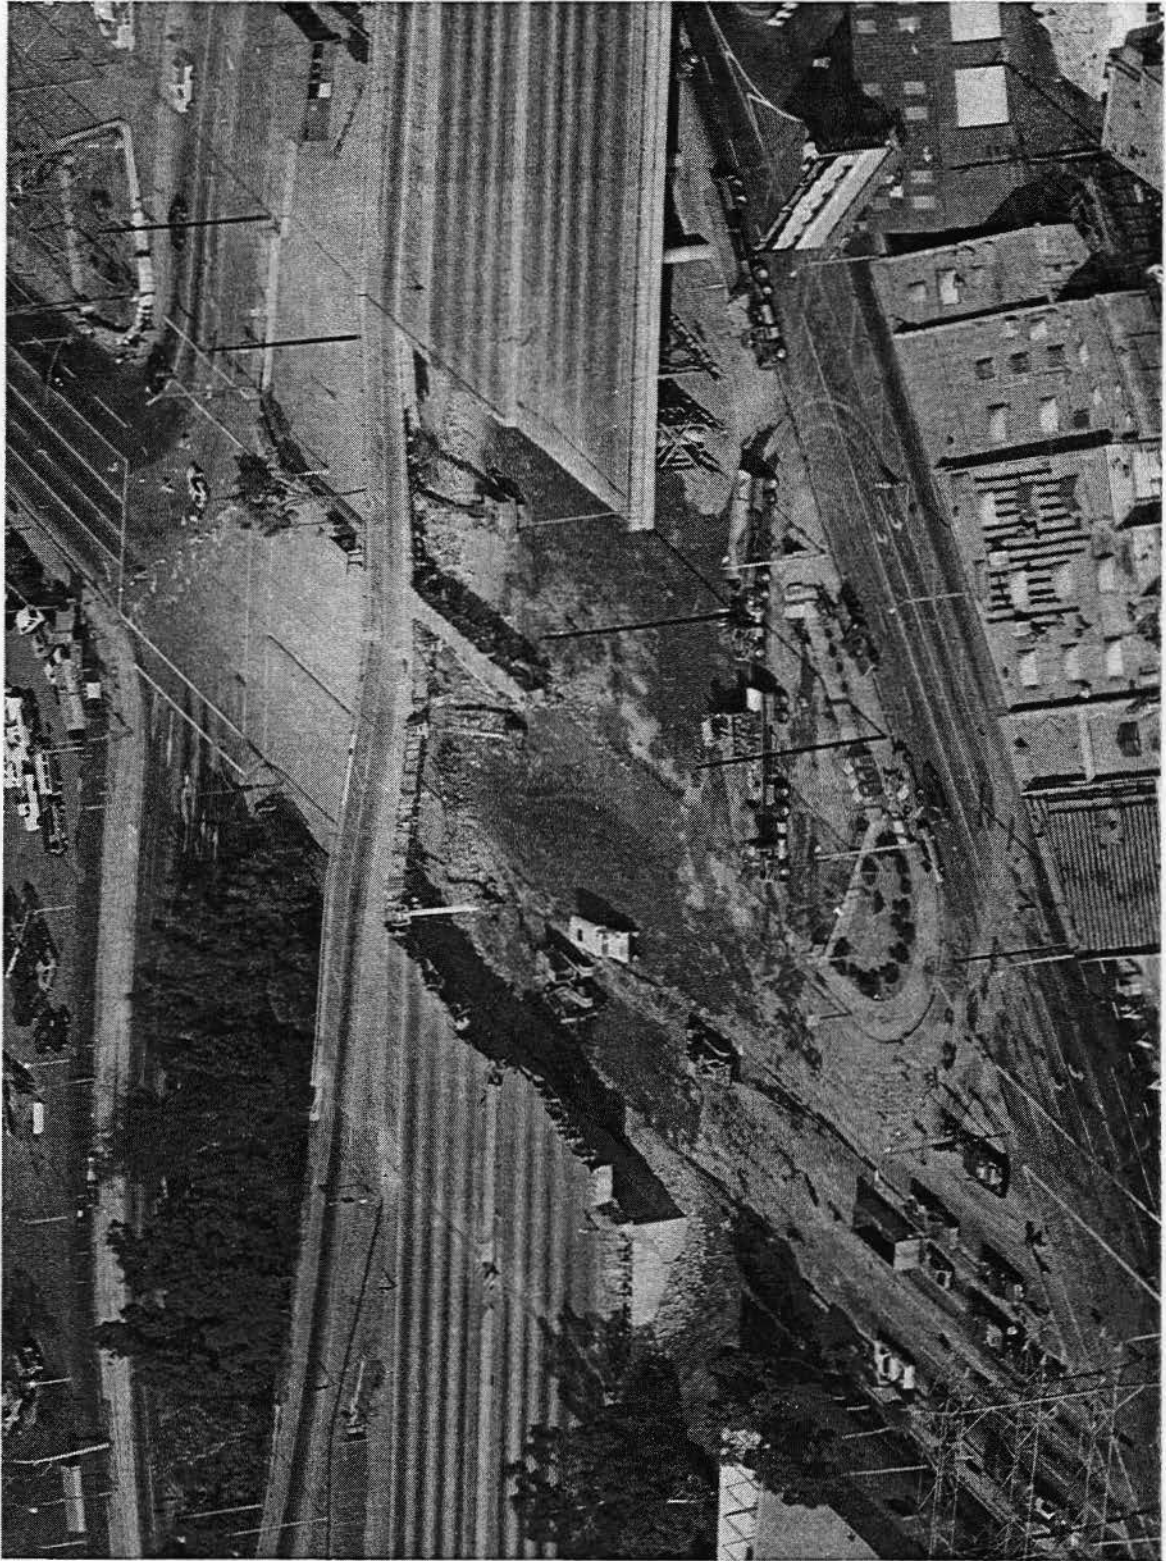
Overview of Fairfax - Washington Undercrossing (53-1580)

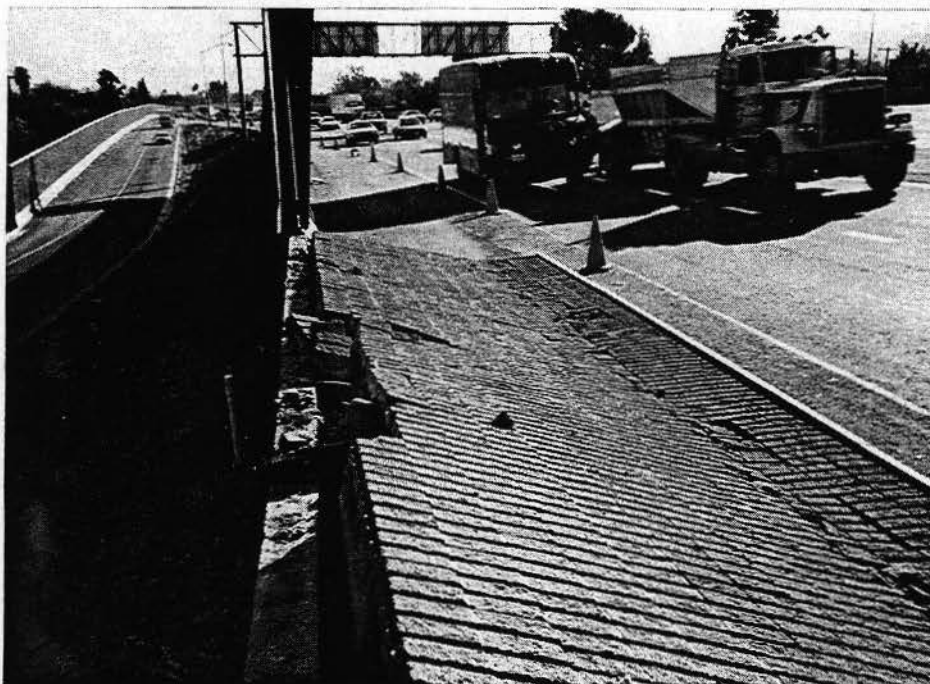
Collapsed Soundwall on WB Route 101 near Interstate 405

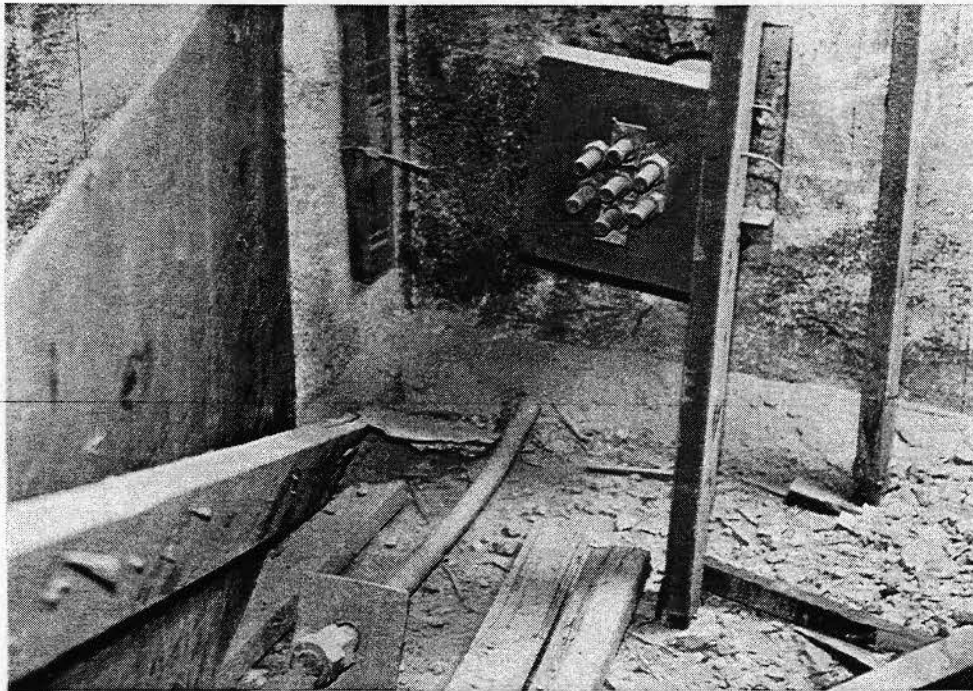
Inside cell opposite of previous pictures, equalizing bolt in fore ground.
