ATSP CASE STUDIES

Volume II
February 2016

Metro

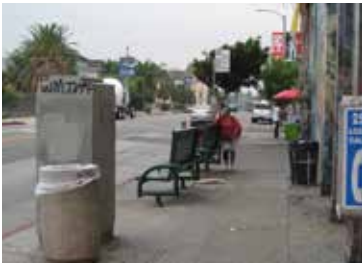
Bus waiting area

Most of the bus waiting areas within the site lack protection from natural elements such as the sun and rain.

Enhancing the bus waiting areas along the Pathway Arterials and Collectors can improve the safety and comfort of a bus rider's journey. Potential enhancements could include benches, shelters, lighting, signage, a wi-fi hotspot, mobile device chargers, etc.

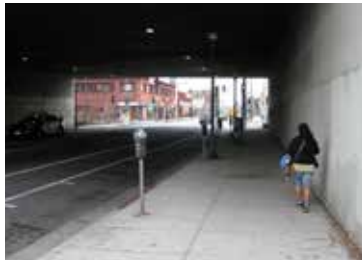
Freeway underpass

The freeway is a major barrier that disconnects the station from the residents to the west. Two underpasses in the study area can feel unsafe at night, and an overpass can be unpleasant to walk across.

Residents might be more likely to travel to the station if the underpasses and overpass were safer, cleaner, better illuminated and visually engaging.

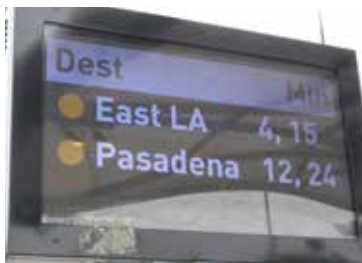
Wayfinding and informational signage

Transit-supportive signage is limited to the immediate station area. Outside the station plaza, however, there is no directional signage informing pedestrians, bicyclists and transit users of station proximity or location.

Medallion signage is an affordable type of wayfinding, or directional tool, that can be installed on utility poles and streetlights. The addition of medallion signage can help to increase awareness of station proximity, especially along Arterials and Collectors that connect to the schools, parks and commercial areas.

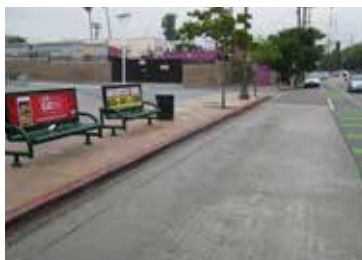
No park-and-ride lot or dedicated passenger drop-off zone

There is no existing parking or drop-off facility for those arriving to or departing from the station via automobile.

Park & Ride lots provide easy vehicular parking and encourage transit ridership for motorists using their vehicles for first last mile trips. The addition of a dedicated kiss & ride zone immediately adjacent to the station would help to improve accessibility, safety and convenience at the station.

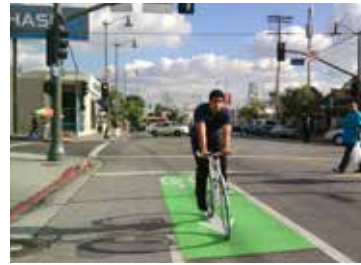
Enhanced bicycle lane

Bicycle lanes provide a safe route for bicyclists traveling along the primary east-west corridor. Approaching and after intersections, the lanes are painted with green paint and conflict zone markings to help make the "mixing zone" safer for bicyclists and motorists.

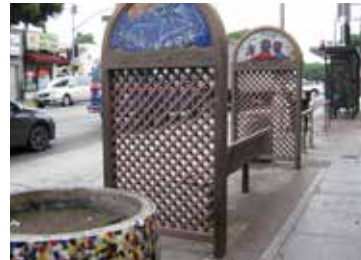
Street furniture

In general, the station area lacks well-maintained street furniture such as seating, waste receptacles, and landscape planters.

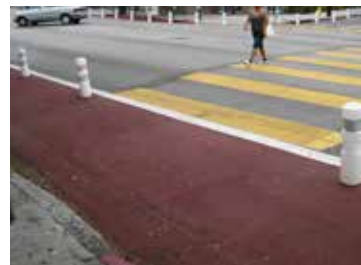
Curb Bulbouts and Extensions

Temporary curb extensions on one commercial street improve safety and enhances the overall pedestrian experience.

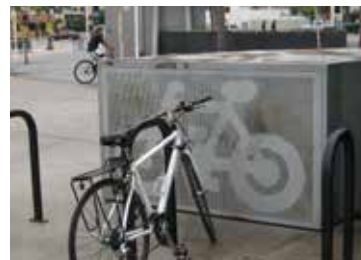
Bicycle Parking

Bicycle racks and lockers are located on the station plaza in view of the station portal. Safe, secure and convenient bicycle parking encourages transit riders to choose bicycling as a means to get to/from transit stations.

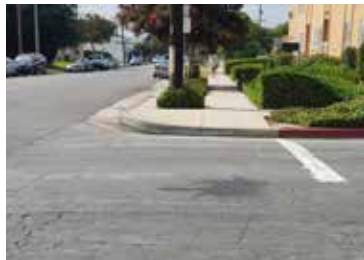
Lack of curb ramps and long blocks

Several intersections lack curb ramps, especially in residential areas. This limits accessibility for mobility-impaired individuals and people transporting goods on wheels. Also, many of the street blocks are very long with no crosswalks.

Enhancing existing crossings can help protect station users by increasing their visibility to motorists. Crossing times can be made longer and to occur more often. In addition to enhancing existing crosswalks, adding well-marked crosswalks at unsignalized intersections and at midblock locations can improve convenience and safety.

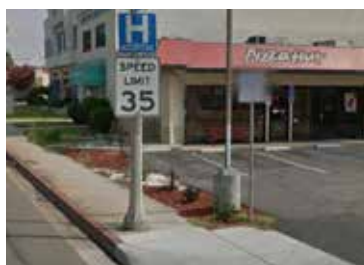
Fast-moving traffic on major arterials

There is fast-moving traffic on the major north-south and east-west corridors, with some segments of the street with posted speeds of over 35 mph. As a result, many motorists speed and do not abide by traffic rules and manners.

Traffic calming decreases speeds along streets with heavy, fast-moving traffic in order to increase safety and comfort for all users of the street. Traffic calming treatments include physical measures such as curb extensions to narrow the roadway, narrowed travel lanes to promote slower driving speeds, and diverters to limit vehicle cut-through traffic on neighborhood streets.

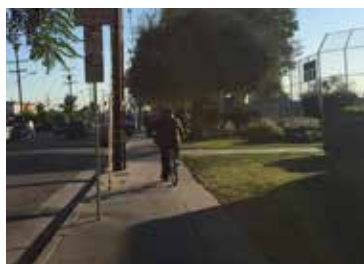
No bicycle facilities

There are currently no bicycle facilities to buffer people bicycling from fast-moving traffic. This encourages many people to bicycle on the sidewalk, which can result in collisions with people walking.

A variety of roadway and signalization improvements can improve safety and increase comfort for people bicycling. These include bicycle lanes physically separated from vehicular traffic, such as buffered lanes, cycle tracks, painted bicycle lanes, conflict zone markings at/approaching intersections, bicycle boxes, and bicycle-prioritized signalization.

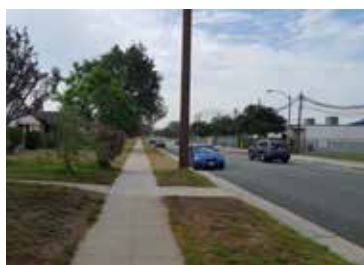
Lack of adequately-scaled lighting

Although there is an abundance of street lighting that illuminates the roadway, there is a lack of adequately-scaled lighting to help guide people walking, especially at night.

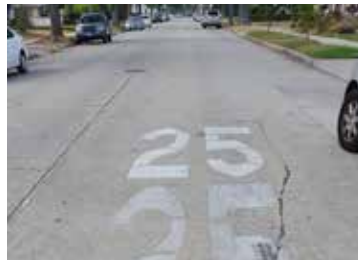
Traffic calming nearby schools

There are some locations where markings are the roadway signify drivers to slow down and watch for people crossing the street.

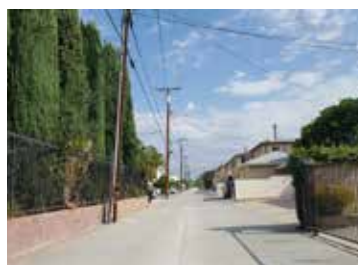
Alley network

The study area has a large alley network that is primarily used by vehicles to enter residences. Some people do use these alleys as a shortcut, but several alleys are not well lit and lack "eyes-on-the-street".

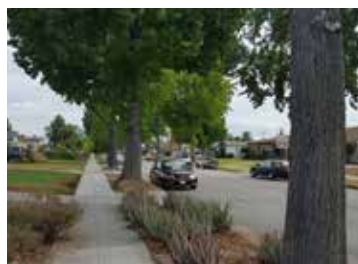
Well-maintained trees in most residential areas

Most of the residential streets have well-maintained landscaping that is aesthetically pleasing and provides shade.

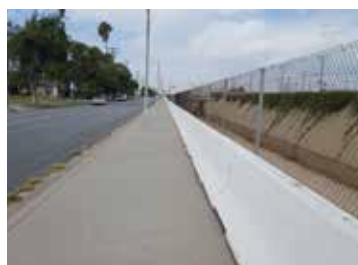
Railway to the north and freeway to the south

The railway to the north and the freeway to the south limit accessibility just outside of the study area where centers of industry are located. There are a few connections, but most accommodate motorists rather than people walking or bicycling.

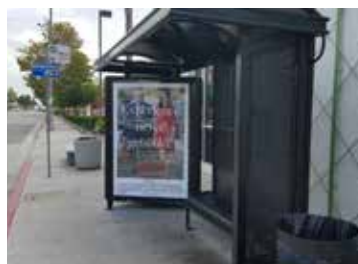
Bus waiting areas with bus shelters

Many of the bus waiting areas, especially along the main commercial corridor have bus shelters that provide shade. These bus shelters also have benches and sometimes waste receptacles.

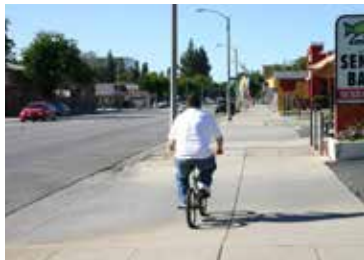
Lack of bicycle facilities

There are no bicycle facilities in the study area. As a result, people bicycling choose to ride on the sidewalk rather than the roadway.

A variety of roadway and signalization improvements can improve safety and increase comfort for people bicycling. These include bicycle lanes physically separated from vehicular traffic, such as buffered lanes, cycle tracks, painted bicycle lanes, conflict zone markings at/approaching intersections, bicycle boxes, and bicycle-prioritized signalization.

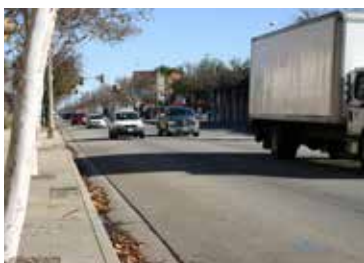
Fast-moving traffic

Traffic on the commercial streets moves at high speeds, often above the speed limit, which detracts from the comfort and safety of people walking and bicycling. In addition, a couple of residential streets have fast-moving cut-through traffic.

Traffic calming decreases speeds along streets with heavy, fast-moving traffic in order to increase safety and comfort for all users of the street. Traffic calming treatments include physical measures such as curb extensions to narrow the roadway, narrowed travel lanes to promote slower driving speeds, and diverters to limit vehicle cut-through traffic on neighborhood streets.

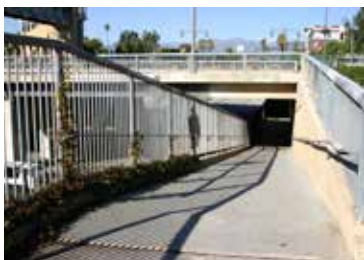
Unpleasant pedestrian underpass

The underpass under the rail line is long, dark, and lacks decorative treatments. A positive feature is its separation from the roadway by a grade difference and metal fence.

Transit riders might be more likely to travel to the station if the pedestrian overpass across the rail line and the underpass adjacent to the station were safer, cleaner, better illuminated, and visually engaging.

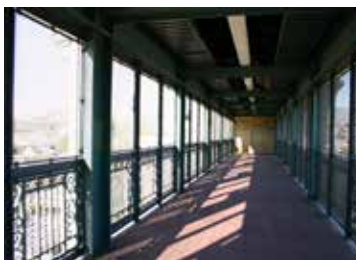
Pedestrian bridge

The architecturally-attractive pedestrian bridge provides a direct connection from the transit station to the downtown commercial district. It is somewhat unpleasant due to poor upkeep. In addition, a user's sense of safety is compromised by the low level of activity during much of the day.

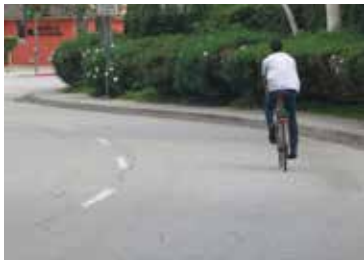
Lack of bicycle facilities

There are few bicycle facilities in the study area. As a result, people bicycling often choose to ride on the sidewalk rather than the roadway.

A variety of roadway and signalization improvements can improve safety and increase comfort for people bicycling. These include bicycle lanes physically separated from vehicular traffic, such as buffered lanes, cycle tracks, painted bicycle lanes, conflict zone markings at/approaching intersections, bicycle boxes, and bicycle-prioritized signalization.

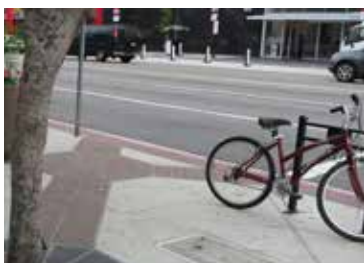
Lack of further bicycle amenities

Although bicycle parking is abundant in the study area, the area can greatly benefit from a bike share system that allows people to conveniently bicycle to and from the bus stop.

Bike share provides numerous strategic locations where users can rent bicycles for short-term use. Bike share stations located at transit stations and stops make bicycling a convenient option for first last mile trips. Other stations are typically placed at strategic locations close to destinations. Corporate sponsorships and other public-private coordination can help make bike share a relatively inexpensive intervention.

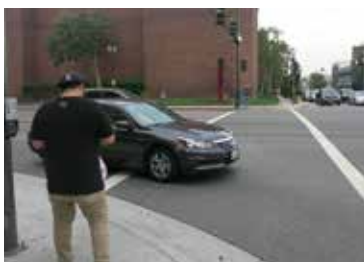
Fast-moving traffic

With relatively wide streets and wide travel lanes, some commercial streets have high traffic speeds, often above the speed limit, which detracts from the comfort and safety of people walking and bicycling. Some smaller streets have significant cut-through traffic with high speeds.

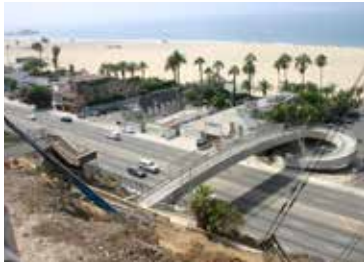
Difficult access to the oceanfront

The beach can be accessed via one of three pedestrian bridges in the study area. However, each requires navigating steep terrain and steps. The upcoming completion of a large roadway project will provide a more accessible route to and from the beach for bicyclists and individuals with mobility impairments.

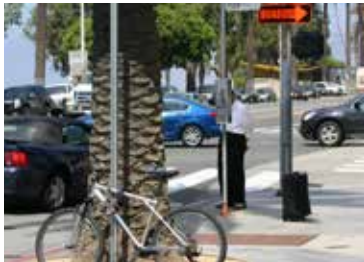
Lack of amenities at some bus stops

While the quality of bus stop amenities is generally good, there are some locations without shelters or shade-providing elements. The bus stop at the center of this study does not have any sheltering elements, seating, or bicycle parking.

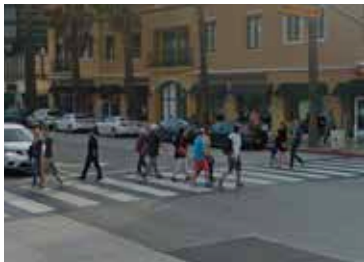
Long crossing distances on a commercial street

A primary street in the study area is about 80 feet wide, resulting in long crossing distances for people walking. There are no median refuge islands.

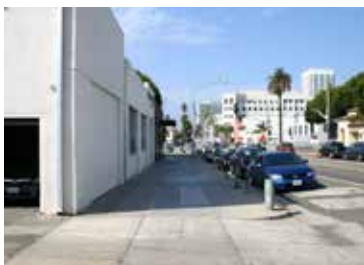
Lack of shade on some streets

While much of the study area is well shaded with mature trees, sections of commercial streets lack tree cover. In addition, some residential streets are lined with palm trees, which do not provide shade.

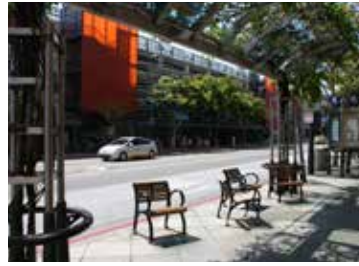
Enhanced Bus Shelters

Where bus shelters exist, they generally provide adequate shade and seating. Some have pleasant landscaping elements and seating options that are far different from the typical bus bench.

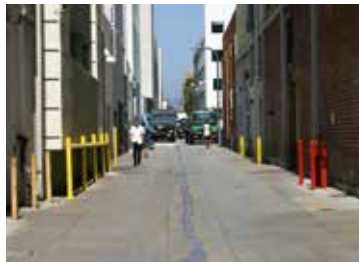
Alley cut-through paths

Alleys that run parallel to some commercial streets provide additional routes of travel for people walking and bicycling, in addition to their utilitarian use for commercial loading. They are relatively popular routes today, sometimes as quiet alternatives to the hustle and bustle of the surrounding streets.

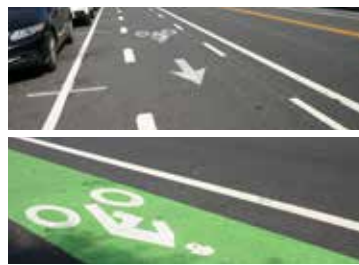
Buffered/Colored Bicycle Lanes

Enhanced bicycle facilities provide safer and more comfortable routes for people bicycling. Additional striped markings (top) guide people to bicycle outside of the dangerous “door zone” and provide a spatial buffer from traffic. A colored lane (bottom) provides enhanced visual cues.

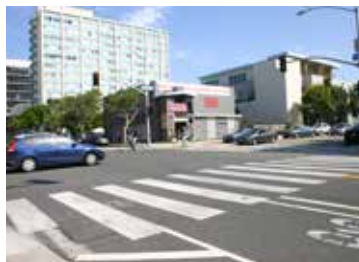
Enhanced crosswalks

Almost all intersections in the commercial area have enhanced crosswalks with continental striping and advanced stop lines.

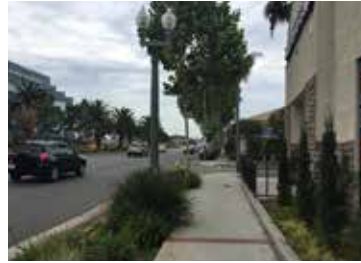
Well-maintained sidewalks

The sidewalk conditions on the primary east-west street are well-maintained, landscaped, shaded, illuminated, branded, and well-monitored. This offers a pleasant experience for people traveling along the corridor.

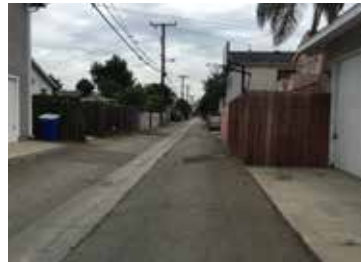
Alley network

There are several alleys in the residential parts of the study area that are not well-lit or maintained, creating an unpleasant environment for people to walk or bicycle, especially at night.

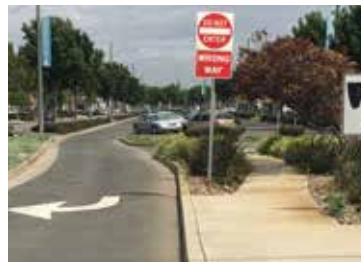
Parking at commercial corridors

There is an abundance of parking along the commercial corridors that make driving to the commercial area convenient. In addition to short-term curbside parking, there is parking in the roadway median.

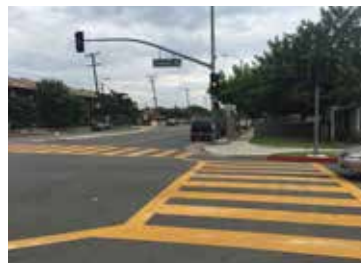
Safe crosswalks and new paving

Throughout the study area, crosswalks are generally well designed and highly visible. Curbs have ramps with either scoring or truncated domes, accommodating for the safety of all users. Several streets have also been recently repaved.

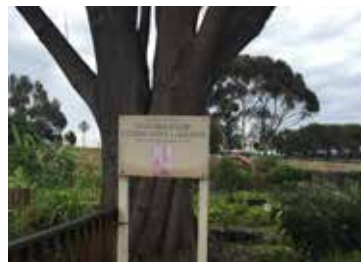
Local community garden

A community garden provides the opportunity for residents without gardening space to maintain an individual plot in a community space.

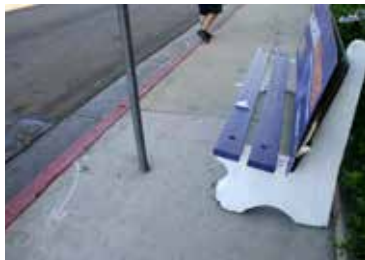
Narrow sidewalks

Some streets have narrow sidewalks with no buffer from the roadway. In many locations, the pedestrian pathway is further obstructed by bus benches, signage poles, and/or public utilities, making some areas inaccessible for mobility-impaired individuals.

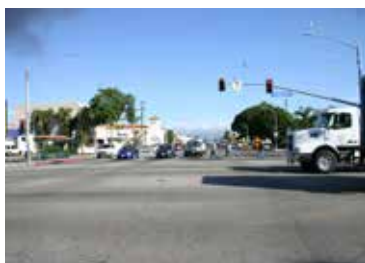
Long pedestrian crossing distances

Crossing distances on the primary north-south street are as long as 90 feet. At some intersections, corner bulbouts slightly reduce crossing distances, yet crossing distances at these locations are still long. A successful approach is seen at midblock locations where wide curb extensions reduce crossing distances to approximately 60 feet.

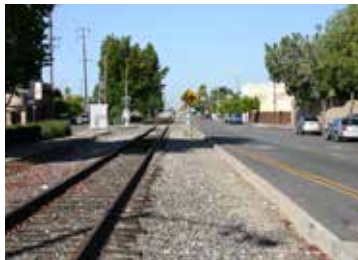
Railroad right-of-way

The railroad crossings are signalized or have stop signs. Some residential streets lack a dedicated crossing although there is no fencing to prohibit people from crossing over the tracks. Metro is currently exploring options for east-west mobility for people who walk and bicycle within this corridor to connect rail stations to the Los Angeles River.

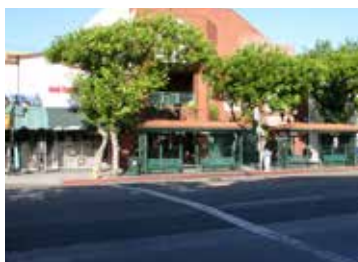
Midblock bus shelters and enhanced crossings

Midblock curb extensions contain bus shelters, bus benches, shade-providing trees, and additional seating. A four-block segment of the primary north-south street contains signalized midblock crossings, although most do not have enhanced crosswalk markings such as continental striping.

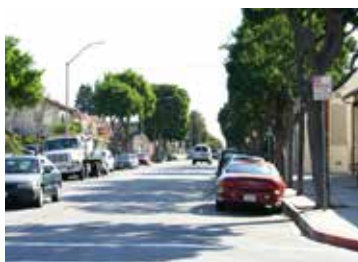
Shaded residential streets

The street environment in residential areas is generally pleasant, with mature shade-providing street trees and well-maintained landscaping. In some locations, however, the parkway width is too narrow to plant trees.

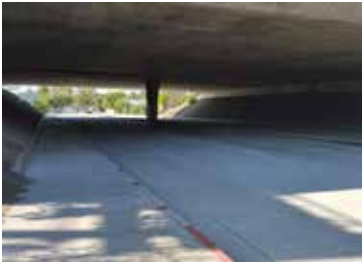
The freeway serves as a barrier that separates the north and south residential neighborhoods. Freeway undercrossings on several streets are not lit, and do not provide ample separation from fast-moving cars.

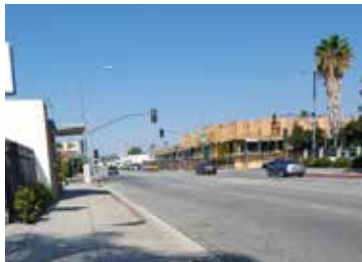
Industrial blocks with limited landscaping

The street arterials are made up of a mix of residential and commercial/industrial uses. High speeds, along with limited landscaping and shade, create an unpleasant pathway to and from the station.

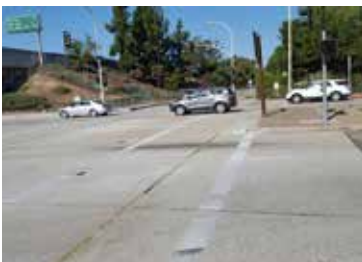
Long crossings

Crossings just outside of the station are long and do not provide a median refuge island for people walking.

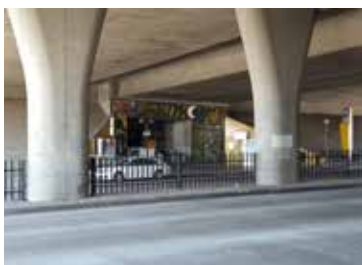
Lack of signage and amenities at transit station

The Metro portals not signed or visible from perpendicular streets. The entry portal itself is not porous, and the bus station in front does not include seating or amenities for mode transfers.

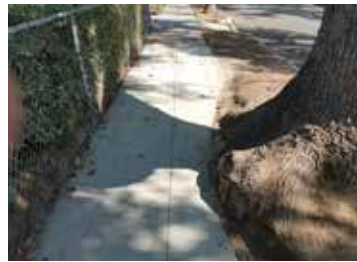
Sidewalk maintenance

In general, some areas may benefit from enhanced maintenance. This image shows a mature tree that is jutting out into the sidewalk, making it more difficult for people with mobility impairments to maneuver.

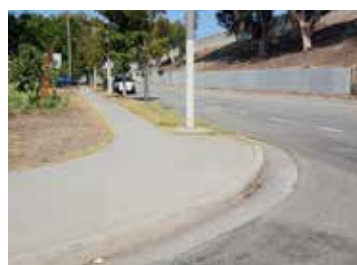
Narrow sidewalks and freeway barrier

Narrow sidewalks occur along the streets that front the freeway. Additionally, there are only roadway lights, with no pedestrian-oriented lighting along these routes.

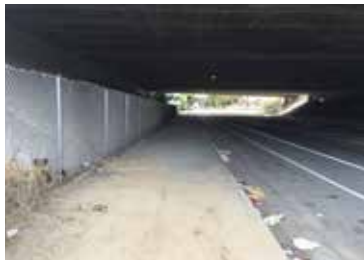
Lack of lighting throughout the entire study area

Although there are some street lights, there are no lights at a scale that is adequate for people traveling on the sidewalk. The lack of lighting decreases the sense of safety, especially at night.

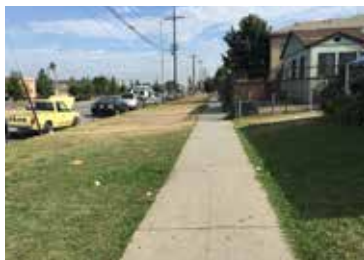
Lack of shade and amenities for people walking

There is a general lack of shade-providing trees in the study area. The parkway strip between the sidewalk and the roadway is generally unmaintained. In terms of other amenities, there are some bus benches, but there are no other seating options.

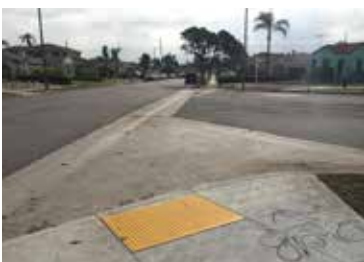
Several unenhanced crosswalks, especially near schools

Throughout the study area, several crossings are not sufficiently painted. Many of the curbs have ramps, but they can be further enhanced. Crossings over the railroad are also difficult to use.

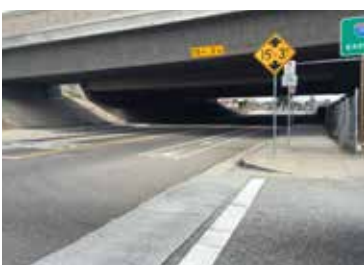
Unattractive and trashed underpasses and overpasses

Overpasses are unattractive to travel across and do not provide a good buffer from fast-moving automobiles. The underpass in the study area is dark and filled with trash.

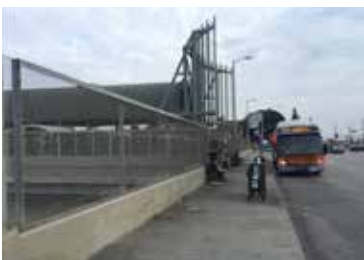
Lack of station identity and difficulty navigating

The station acts as a landmark for people immediately within view of the station. However, navigating to the station can be difficult as there is no Metro signage except at the park-and-ride area.

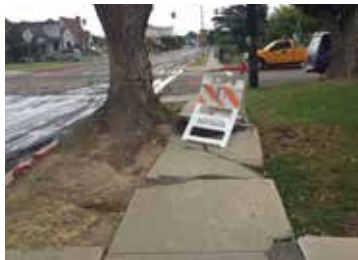
Broken or no sidewalks

Throughout the study area, there are several sidewalks that are broken. There are also a few sidewalks missing near the freeway and across the railroad.

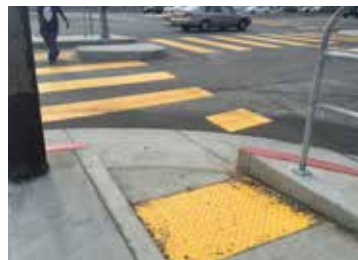
Enhanced school crossings

This crosswalk is newly painted and highly enhanced. This serves as a great example for how other crosswalks in the study area, especially near schools, should be designed.

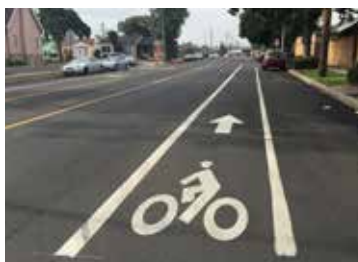
Major gaps in the bicycle network

There are several gaps in the bicycle network, particularly south of the station, that can discourage people to ride their bicycle to and from the station. Also, there is a lack of safe facilities to park your bicycle at the station.

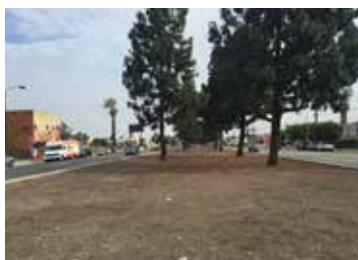
Underutilized median

The roadway median on the study area's main arterial is very wide and underutilized. Currently there are a few trees, but there are opportunities to transform this space into a green open space, which the study area lacks.

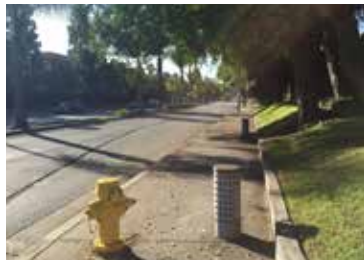
Sidewalk widths are narrow throughout the study area

Although most of the sidewalks are well maintained and of high quality, there is often little room to maneuver given the placement utilities and trees.

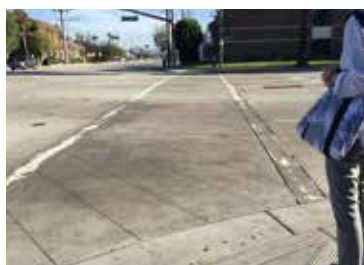
Unenhanced crossings at important intersections

Many of the intersections lack highly visible striping to signify drivers of approaching stops. Some curbs do not have ramps, especially around the industrial areas. Also, because many street blocks are long, people often jaywalk at midblock locations.

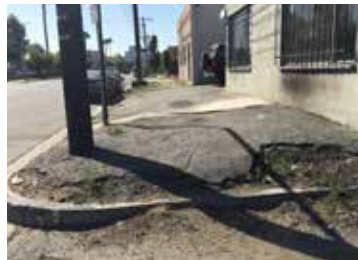
Broken or no sidewalks

Throughout the study area, some sidewalks are broken. There are also a few sidewalks missing near the freeway and the industrial areas.

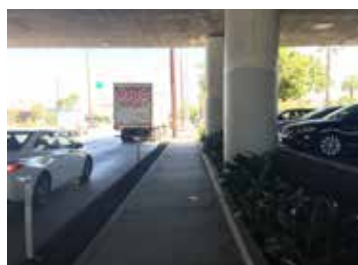
Some underpass improvements

Some of the freeway underpasses, especially near the shopping mall, have improvements such as a sidewalk buffer and planting. The addition of adjacent parking also provides a sense of safety knowing that people are nearby.

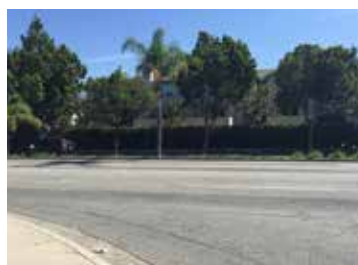
Lack of "eyes-on-the-street"

Currently, there is a low level of pedestrian activity on the street, which is partially due to the orientation of the commercial, industrial, and residential buildings facing away or set back far from the street.

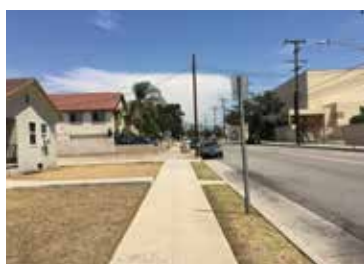
Lack of shade

Several streets lack sufficient shading from the sun. Many of these streets are common routes to schools.

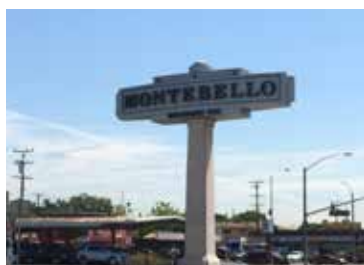
Lack of station identity and difficulty navigating

Currently, there is a large sign in the median of the primary east-west street welcoming people as they drive. Other than this landmark, there is no signage that signifies that the transit stop is nearby.

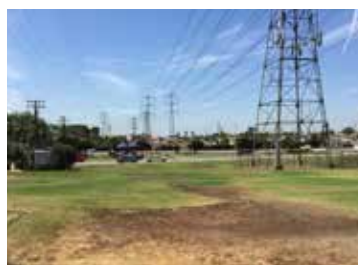
Transmission tower right-of way

West of the transit stop, there is a transmission tower right-of-way that is underutilized. Some parcels use this area as a public park or a plant nursery.

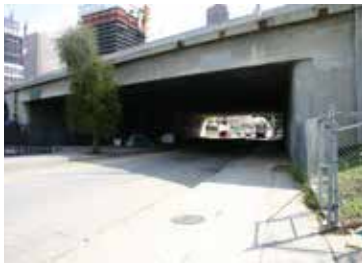
Underpasses and overpasses over the freeway

The freeway divides the study area, but most of the streets connect via an overpass or an underpass. However, overpasses and underpasses are often dark, unattractive, or not well-shaded. This can lower the perception of safety and discourage people from traveling to and from the station.

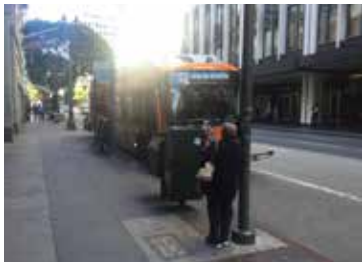
Unenhanced bus waiting areas

Almost at every intersection, there are bus stops that host several local and regional bus lines. However, most of these bus stops are unenhanced, lacking seating, lighting, shade protection, and other amenities.

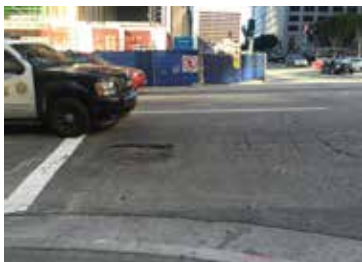
Unenhanced crosswalks

Several crosswalks lack high-visibility striping, curb ramps, and/or lighting. Given the high volume of people crossing at these intersections, there is a need for better crosswalks in the study area.

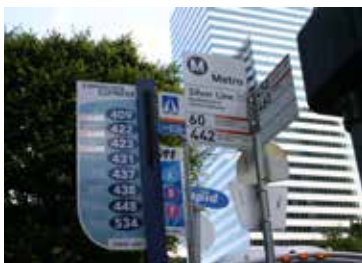
Inconsistent and lack of wayfinding

There are many signs that help direct people to destinations in the study area. However, there lacks consistent signage to guide people to the station, and the station entrance itself is hard to locate.

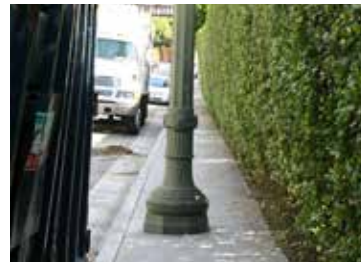
Utilities on the sidewalk

Some portions of the sidewalk are obstructed by utility poles or other public utilities. This makes maneuvering on the sidewalk difficult, especially for people with mobility impairments.

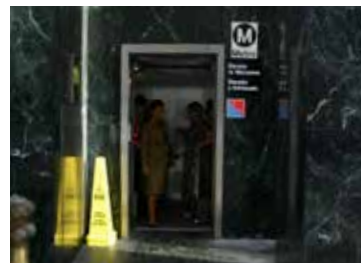
Lack of signage at the station

The entrance to the station is not highly visible and lacks sufficient signage to orient people to its location. The elevator entrance to the station is set back from the street and is hard to find.

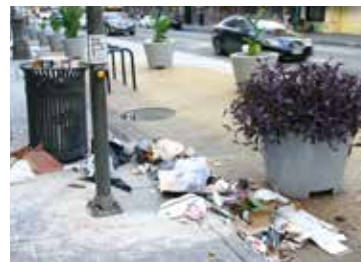
Lack of clean and well-maintained public realm

The high volume of activity and the lack of maintenance create an unpleasant experience walking or bicycling to and from the station.

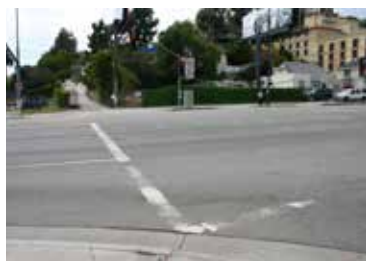
Pedestrian crossings

Many crossings across busy commercial streets do not have effective markings such as continental crosswalks and advance stop lines. In addition, curb ramps are generally bidirectional (leading people walking toward the center of the intersection) rather than unidirectional (leading to the direction of the crosswalk path).

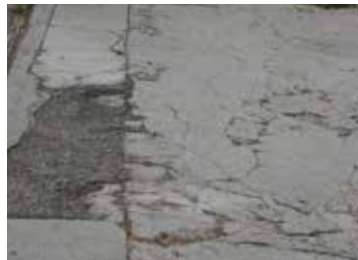
Sidewalk conditions are generally good in the study area, but some residential streets have uneven and/or broken sidewalks.

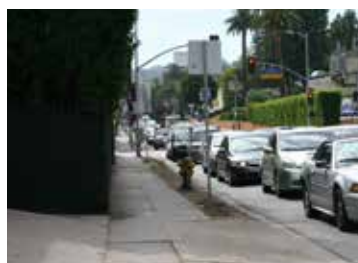
High traffic levels and backups

Roadway congestion and traffic backups result in increased car exhaust and can encourage aggressive motorist behavior. In addition, heavy traffic makes bicycling more difficult and reduces safety for people walking.

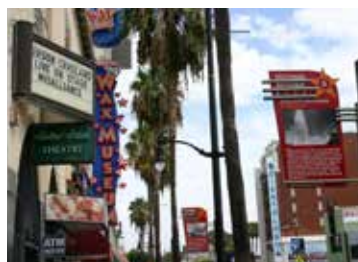
Pedestrian-oriented signage

Tourist areas have some pedestrian-oriented signage that provides historical information on local attractions, but there is a general lack of signage directing road users to destinations (including the Metro station).

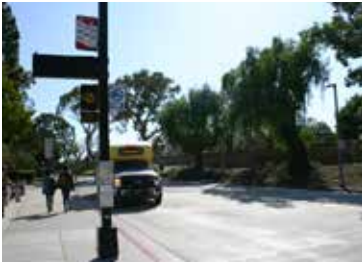
Connectivity Barrier

The Medical Center is located adjacent to the University campus, but it is not accessible from the campus. A tall, continuous brick wall separates the two areas.

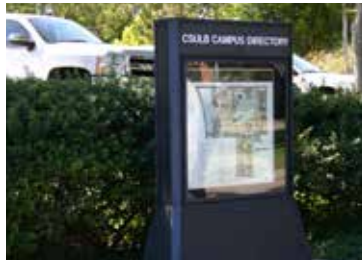
Wayfinding and informational Signage

Wayfinding signage is placed inconsistently along walking and bicycling routes throughout the campus, and is sometimes located away from primary routes of travel.

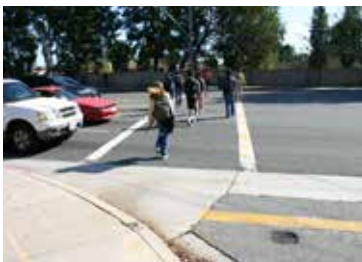
Unenhanced crossing and long crossing distance

The crossing in this image is located at the southern entrance to the campus. Crossing distance is long, the pedestrian crossing interval is short, and crosswalk striping is unenhanced. In addition, a single curb cut (slightly visible in the foreground) is oriented away from the crosswalk.

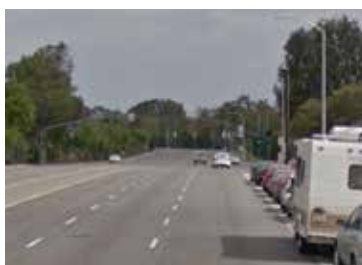
Unenhanced bicycle routes

Although it is a designated bicycle route, this roadway segment (near the west campus entrance) has no dedicated space for bicyclists. On streets south of campus, bicycle lanes are standard curbside bicycle lanes with inconsistent striping at intersections.

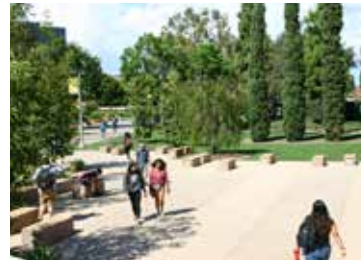
Lack of shade in some areas

Although much of the campus is well shaded, some open plaza areas could benefit from the addition of shade.

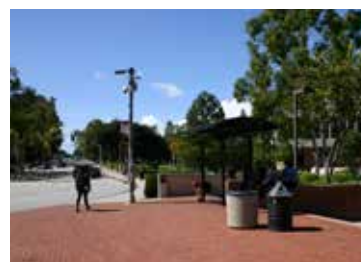
Lack of seating at main bus stop

The main bus stop at the center of the study area is located on a plaza with few seating opportunities. An expanded bus shelter and/or other seating would provide a desired amenity for transit riders.

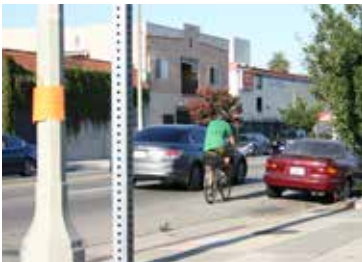
Few enhanced bicycle facilities

There is only one bicycle lane in the study area. In many cases, people bicycling on the roadway are required to navigate between parked vehicles and narrow travel lanes. Many people choose to bicycle on the sidewalk.

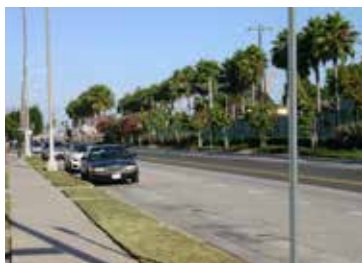
Lack of shade

While some residential areas are abundantly shaded, the majority of the study area has insufficient tree cover to provide protection from the sun.

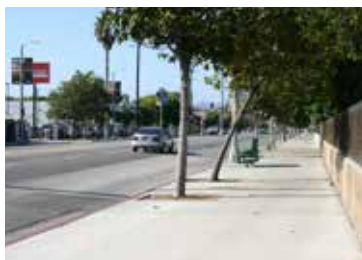
Lack of street furniture

There are few comfortable seating opportunities in the study area, and waste receptacles are placed sparingly. Seating opportunities are limited to bus benches at bus stops.

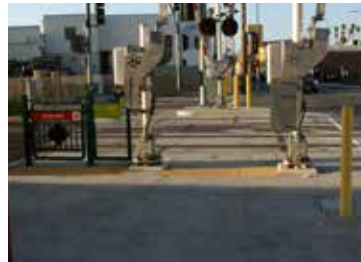
Inefficient, confusing transition

Navigation from the transit platforms to adjacent streets is complicated by a jumble of physical structures, pavement patterns, and small areas to wait for walk signals.

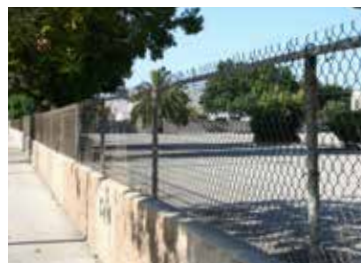
Fencing and blank walls

On main streets, some vacant parcels and parking lots impair the aesthetic experience and comfort of people walking.

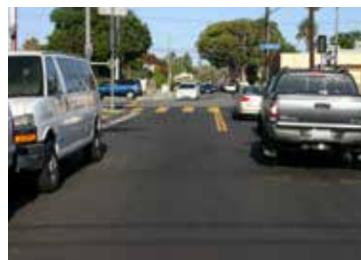
Narrow right-of-ways

Many collector streets do not have sufficient right-of-way width to accommodate bicycle lanes or curb extensions.

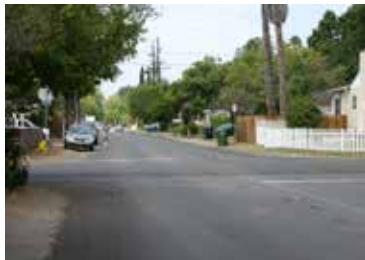
Lack of sidewalks / narrow sidewalks

Several residential streets do not have sidewalks. Some commercial corridors have narrow sidewalks with no landscape buffer from the roadway. Sidewalks are sometimes obstructed by infrastructural elements such as utility poles, utility boxes and fire hydrants.

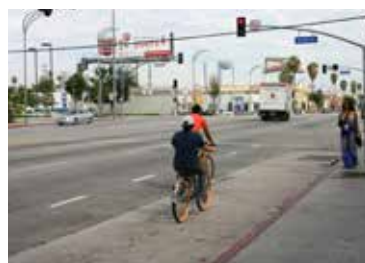
Unenhanced bicycle lane

The existing bicycle lanes are not buffered from vehicular traffic. As shown above, they drop off at intersection approaches and lack pavement markings in conflict zones.

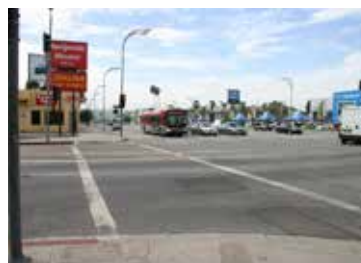
Long crossing distances

Crossing distances along the commercial corridors are generally long. The primary north-south corridor south of the station is especially wide, resulting in crossing distances as long as 120 feet.

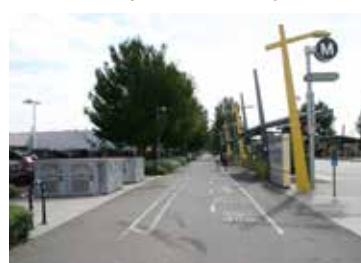
Multi-use path and bicycle facilities

This well-lit and shaded multi-use path provides a dedicated right-of-way for people walking and bicycling. The 18 mile-long path runs parallel to the BRT corridor, providing a convenient east-west regional connection. Bicycle racks and lockers at the station support multimodal transfers.

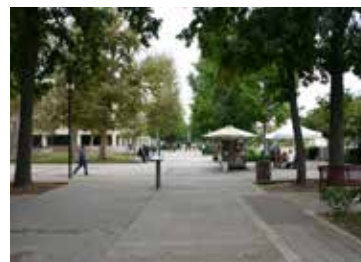
Attractive Civic Center Area

The Civic Center is an important regional destination. This area has well-maintained landscaping, pleasant walking paths, and comfortable seating areas.

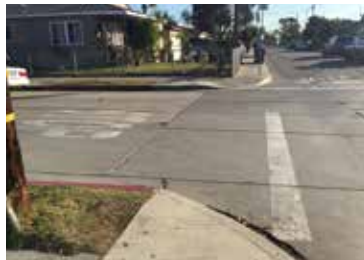
Unenhanced crossings at some intersections

At some intersections, there is a lack of sufficient crosswalk striping, creating unsafe crossing conditions. At certain locations, the stop limit line leaves no room for people to safely walk across when a vehicle is present.

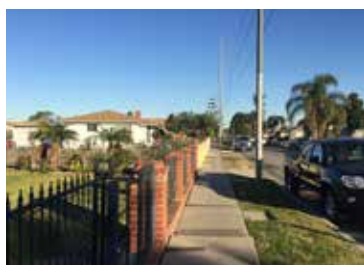
Lack of shade in some residential areas

Although most of the study area has well-maintained trees and bus shelters that offer shade, some residential areas lack this protection from the sun.

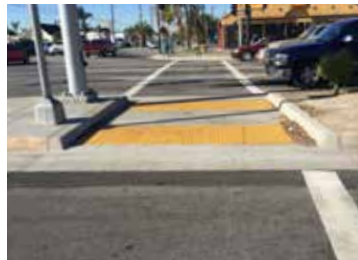
Enhanced crossings at most intersections

Most of the intersections within the study area have crosswalks that have been recently enhanced to be safe and accessible for all users of the sidewalk. This is especially true for large arterial streets that have highly-enhanced crosswalk ramps, long crossing times, and highly-visible striping.

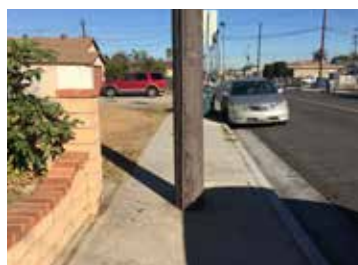
Utility poles on the sidewalk

At several locations throughout the study area, there are utility poles misplaced in the center of the sidewalk, leaving little space for people to travel, especially by wheelchair.

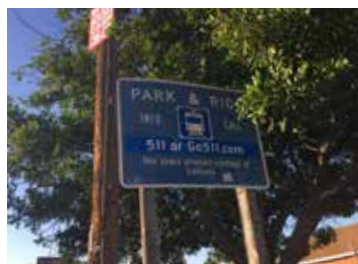
Park-and-ride lots near the station

There are park-and-ride lots just to the north of the station on both sides of the street that have hundreds of parking spaces. These lots are well-maintained and patrolled, which can encourage drivers to use transit.

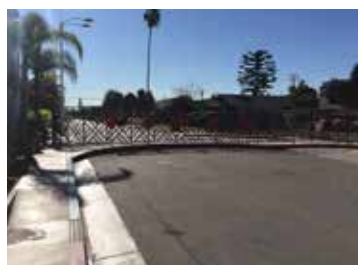
Fence with no doors limits connectivity

There is a gate that restricts access for vehicles as well as people walking and bicycling. This makes it difficult for people traveling to and from the station to get to their destination.

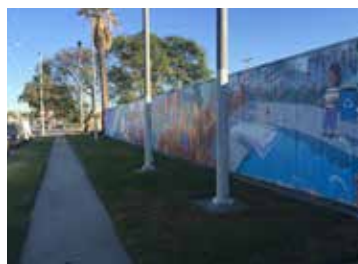
Public art facing the public realm

Located at the northwest corner of the study area, a community-designed mural fronts the sidewalk. The mural is well-maintained and is aesthetically pleasing for people traveling on the sidewalk.

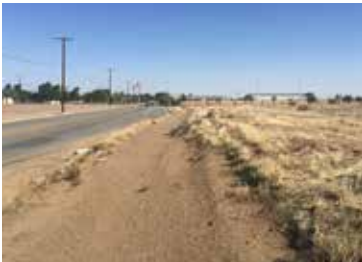
Lack of sidewalks throughout

Many of the parcels in the study area are undeveloped and lack sidewalks. As a result, there is no buffer from fast-moving vehicles. This is especially unsafe for mobility-impaired individuals.

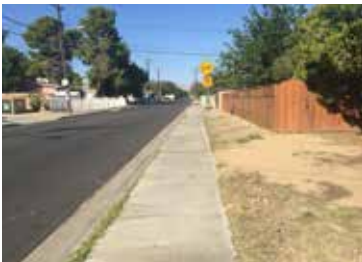
Lack of protection against the weather

The study area experiences extreme weather conditions, including temperatures over 100°F during the summer. There is a general lack of trees and landscaping in the public realm, which makes walking to and from the station feel uncomfortable.

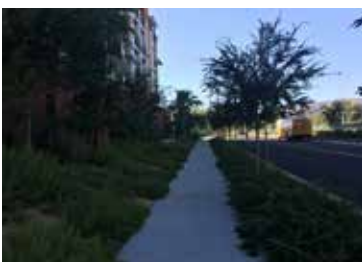
Lack of lighting

Many of the streets lack adequate street lighting for people walking and bicycling. This reduces visibility making it feel unsafe for all users of the road.

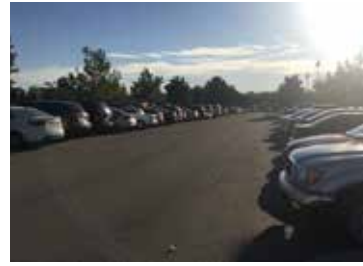
Abundant park-and-ride spaces

There are over 500 park-and-ride spaces at the station, including accessible and motorcycle spaces. There is security that monitors the lot during the day.

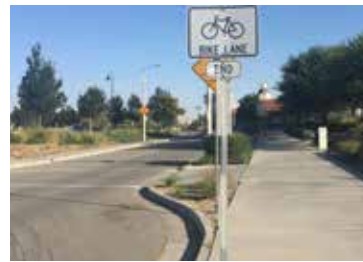
Gaps in the bicycle network

Although there are well-landscaped bicycle paths, there are some gaps in the bicycle network that limit accessibility. There also is greater need for more bicycle parking at the station.

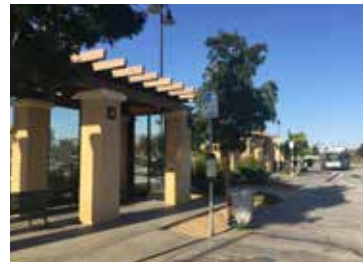
Abundance of station amenities

Overall, the transportation center has several desirable amenities such as bus shelters, wayfinding signage, kiss-and-ride zone, drought-tolerant landscaping, seating, real-time arrival information, bicycle parking, etc.

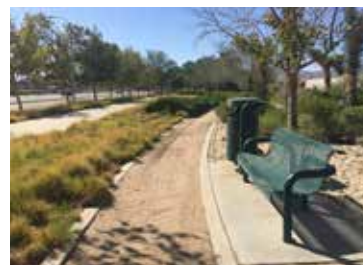
Walking and bicycle paths

There are well-maintained walking and bicycle paths running parallel to the main highway. A nearby park has pleasant walking paths and is a popular regional destination.

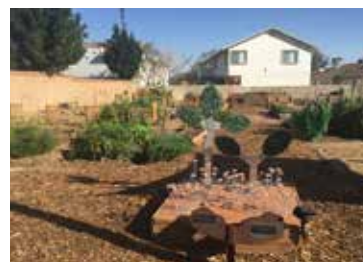
Local community garden

A community garden provides an opportunity for residents without gardening space to maintain an individual plot in a community space.

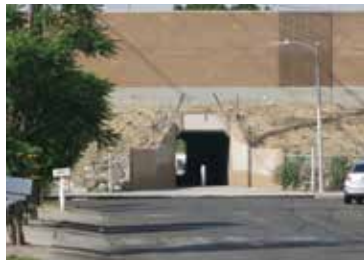
Unpleasant pedestrian undercrossings

Two pedestrian-only undercrossings provide valuable east-west connections for people walking and bicycling. Unfortunately, they are long, narrow, and dark, and they feel particularly unsafe at night. The freeway underpass on the main commercial corridor is also unpleasant (see description to the right).

Freeway Underpass & Overpass Enhancements

Residents might be more likely to travel to the station if the underpasses were safer, cleaner, better illuminated and visually engaging.

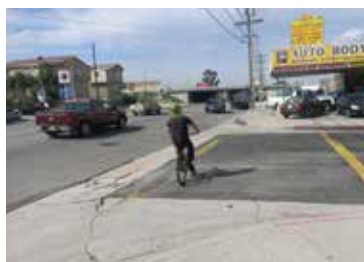
Lack of bicycle facilities

There are few bicycle facilities in the study area. As a result, people bicycling often choose to ride on the sidewalk rather than the roadway.

Enhanced Bicycle Facilities

A variety of roadway and signalization improvements can improve safety and increase comfort for people bicycling. These include bicycle lanes physically separated from vehicular traffic, such as buffered lanes, cycle tracks, painted bicycle lanes, conflict zone markings at/approaching intersections, bicycle boxes, and bicycle-prioritized signalization.

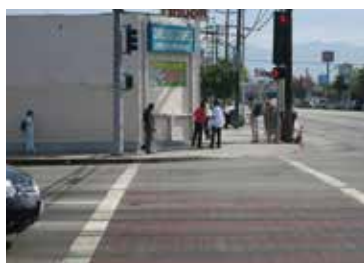
Unenhanced crossings

Many crosswalks lack enhanced features such as continental striping and advance stop lines. Some crosswalks along the primary commercial corridor have decorative pavements that have faded and provide no enhanced visibility.

Enhanced Pedestrian Crossings

Enhancing existing crossings can help protect station users by increasing their visibility to motorists. Crossing times can be made longer and to occur more often. In addition to enhancing existing crosswalks, adding well-marked crosswalks at unsignalized intersections and at midblock locations can improve convenience and safety.

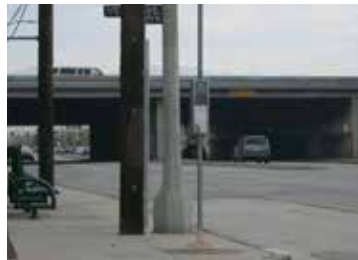
Freeway underpass

The underpass along the primary commercial corridor is dark, lacks aesthetic improvements, and lacks a buffer between the sidewalk and the roadway.

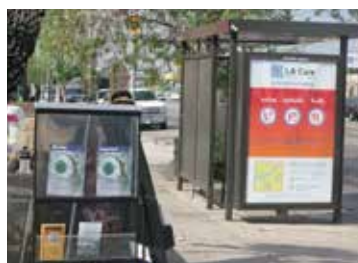
Pedestrian amenities and street activity

The primary commercial corridor has some pedestrian-oriented amenities such as bus shelters and waste receptacles. Some informal vending and informational booths provide activity in the pedestrian realm.

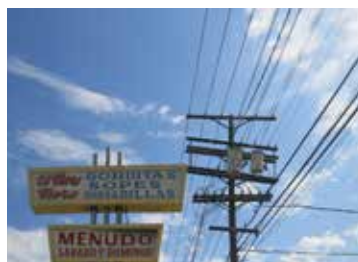
Visual clutter from utility poles and power lines

In some locations, utility poles and power lines have a negative effect on the aesthetics of the streetscape.

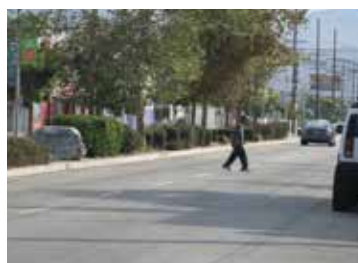
Long street segments without crosswalks

Long street segments without crosswalks invite jay walking. In addition, several intersections across arterial streets are without crosswalks.

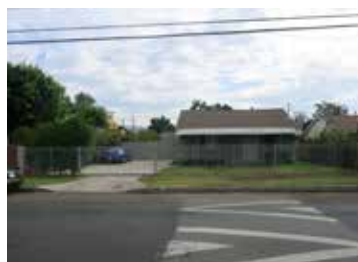
Traffic calming treatments

A few speed humps are located in the residential neighborhoods, but, overall, there are not a significant number of traffic calming treatments such as speed humps, curb extensions, speed feedback signs, etc.

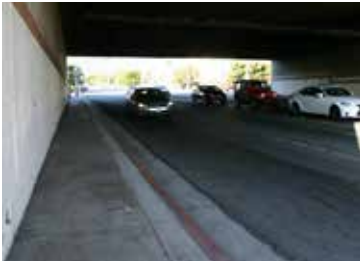
Unpleasant freeway underpasses

Freeway underpasses are dark, lack aesthetic improvements, and lack buffers between the sidewalk and the roadway.

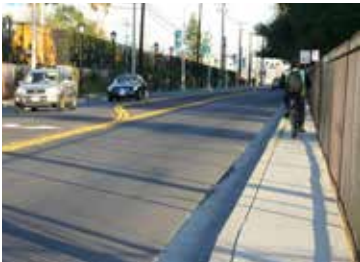
Limited bicycle facilities

There are very few bicycle facilities in the study area. As a result, people bicycling often choose to ride on the sidewalk rather than the roadway.

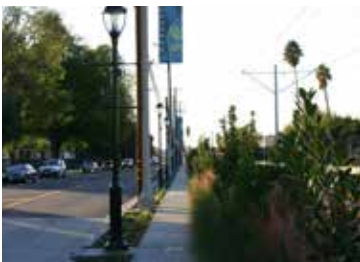
Narrow sidewalks (and no sidewalks in some locations)

Sidewalks in the study area are generally narrow (on both commercial and residential streets). This image shows a very attractive streetscape environment, but the narrow right-of-way limits sidewalk width. Many street segments in the residential neighborhoods lack paved sidewalks.

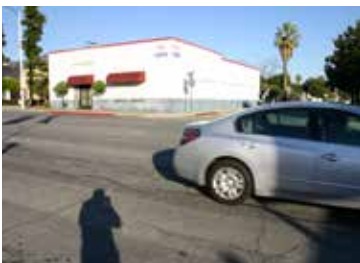
Fast-moving traffic

Traffic speeds are high on some sections of commercial streets and there is fast-moving cut-through traffic on a couple residential streets.

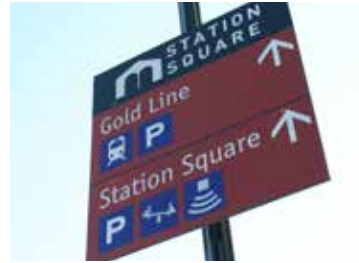
Wayfinding signage near station

Wayfinding signage is placed in strategic locations around the station area. However, no pedestrian-oriented signage is located elsewhere in the study area.

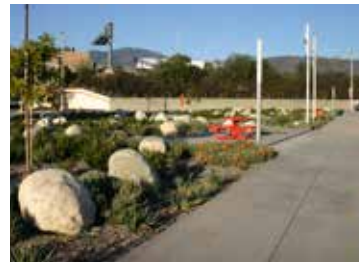
Pleasant, well-shaded residential neighborhoods

As part of the recent renovations to the transit station area, Metro has developed a small park that provides valuable open space and attractive places to sit.

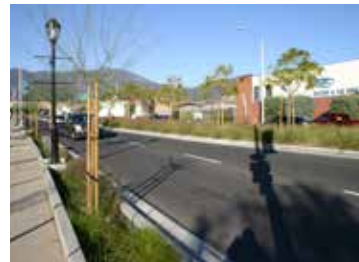
Attractive pedestrian environment near the station

Near the station, attractively-planted bioswales and medians contribute to a pleasant street environment. In addition to landscaping, the area around the station includes pedestrian amenities such as seating, wayfinding signage, and pedestrian lighting.

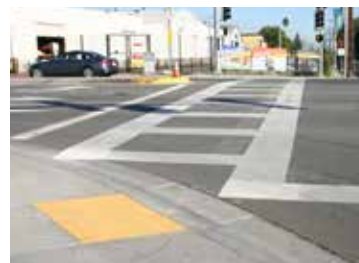
Enhanced crossings

New crosswalks and curb ramps near the station improve accessibility and visibility.

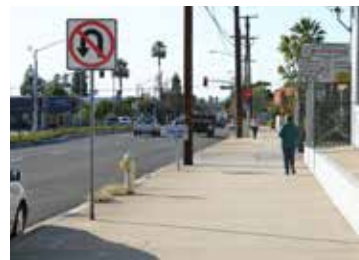
Some lack of landscaping and shade

Although the study area is generally well landscaped, some segments of the two primary commercial streets are lacking in landscaping and shade-providing trees.
