BEST PRACTICES FOR BICYCLE TRAIL PAVEMENT CONSTRUCTION AND MAINTENANCE IN ILLINOIS

Research Report FHWA-ICT-12-009

**Developing Best Practices for Bicycle Trail
Pavement Construction and Maintenance in Illinois**

June 2012

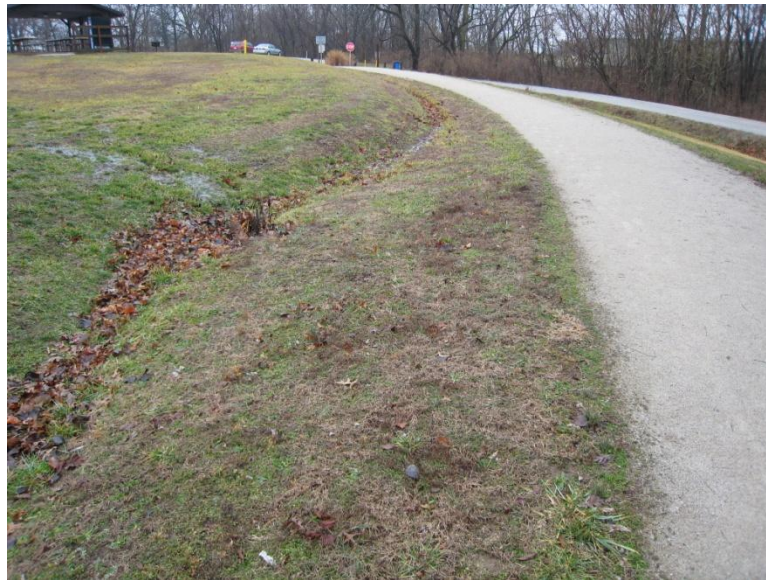
Figure D.9. Adequate shoulders prevent humping, and separation of the trail from drainage components prevents surface degradation.

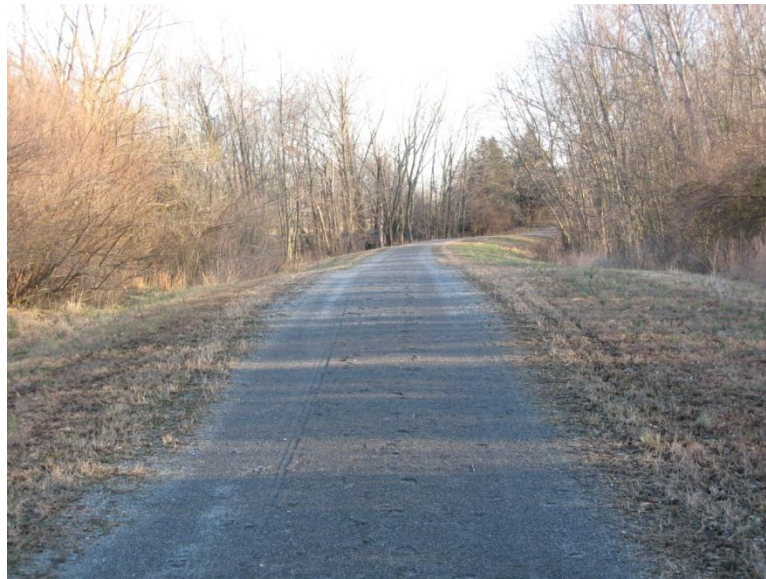
Portions of the trail over the former county road base were performing well. The old road base provided both good support and well-planned drainage facilities, as shown in Figures D.17 and D.18. However, regardless of drainage and base material, some displacement of the surface material due to heavy precipitation and small flooding events is expected, and occurred, as shown in Figure D.19.

Figure D.17. Road bed offers support across trail width.

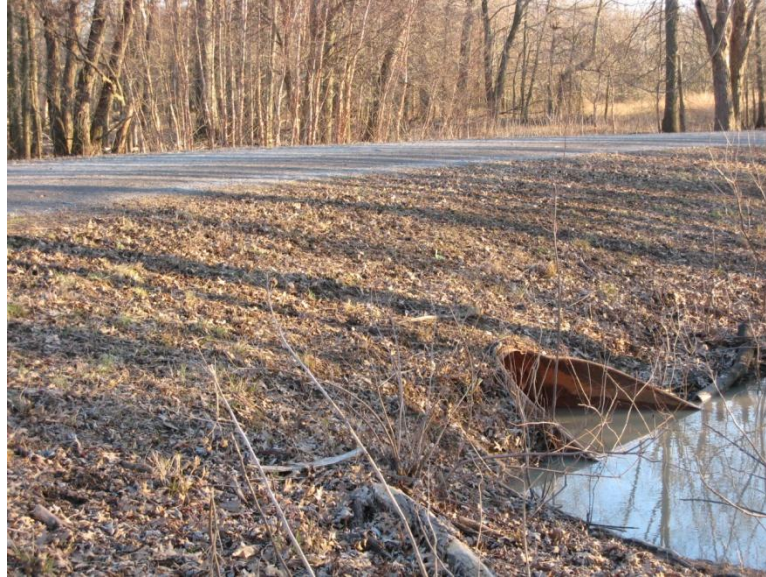
Figure D.18. Good separation between trail surface and culvert.

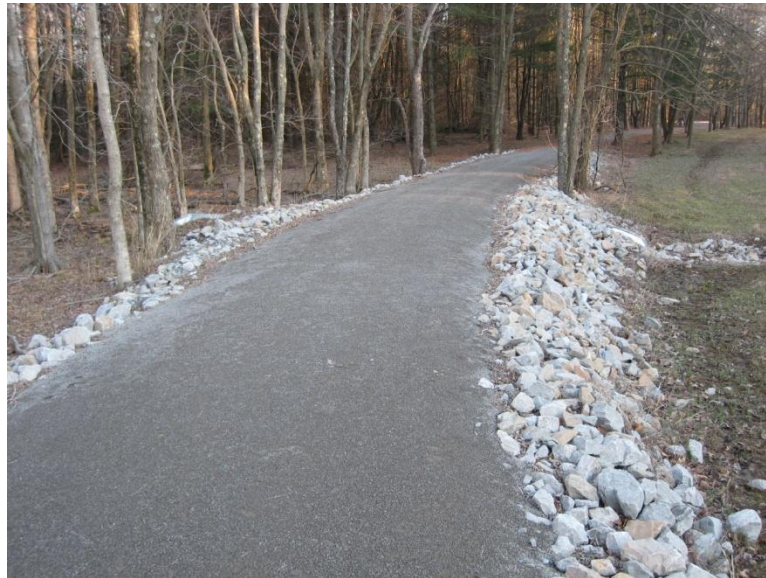
Figure D.21. Fortification of drainage components after installation.

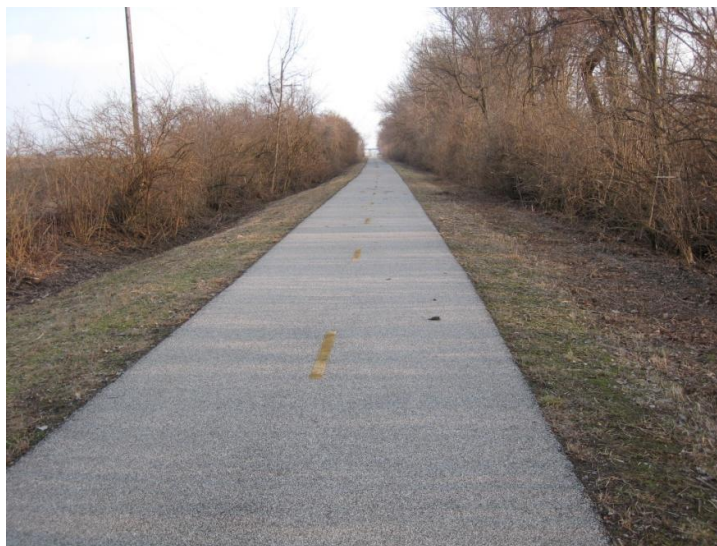
This trail was in outstanding condition. Like the Nature Trail, there were no thermal cracks present. As shown in Figure D.38, there was good vegetation clearance and pavement edge support. Some areas had low-severity longitudinal cracking, as shown in Figure D.39. One localized area of binder bleeding was observed, as shown in Figure D.40.

Figure D.38. Good edge support and vegetation clearance.

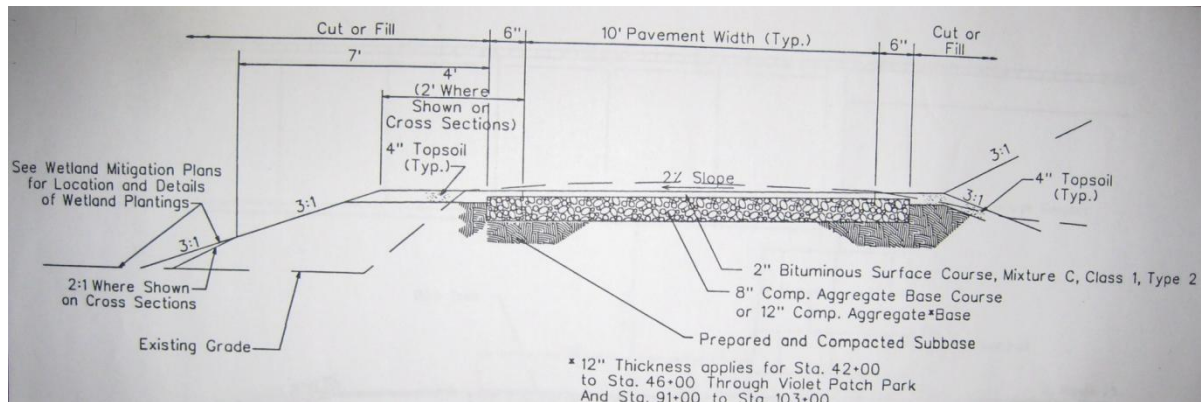
Figure D.43 shows a cross-sectional view of the HMA trail design for the portion of the Fox River Trail passing through Violet Patch Park.

Figure D.43. Asphalt trail pavement cross section through Violet Patch Park.

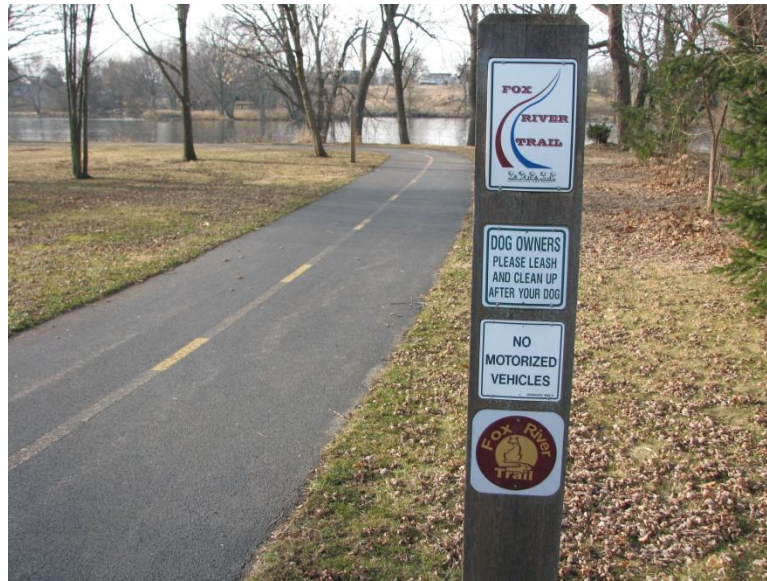
Figure D.44. Typical seal-coated path appearance.

The regular seal coat applications seem to be providing a good level of pavement preservation. A seal-coated trail can be seen in Figure D.44, with a close-up of the trail’s surface shown in Figure D.45. As evident in the figures, seal coats generally do not adhere well to pavement paint or thermoplastic marking products; therefore, traffic control markings applied before the seal coat may start to ghost the surface as the seal coat weathers and ages.

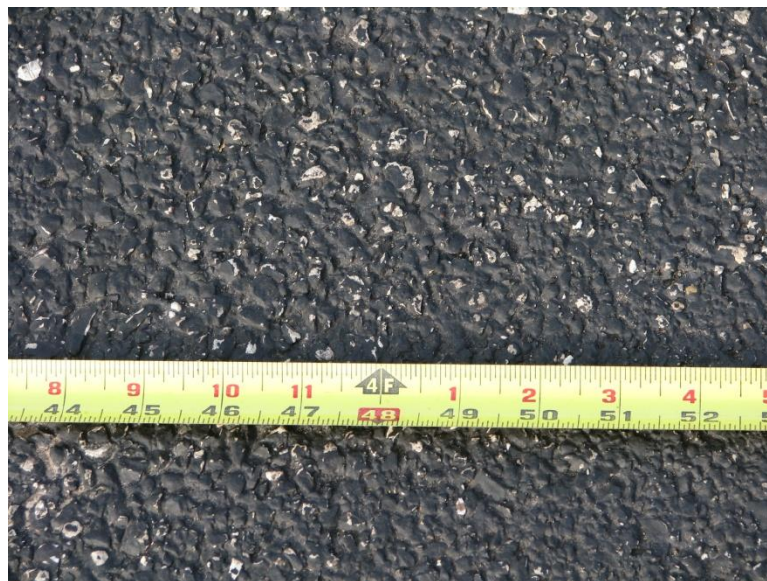
Figure D.45. Seal-coated asphalt trail surface.
