METRO RED LINE, SEGMENT 2, CONTRACT B251

Investigation of Tunnel Collapse and Sinkhole

Wiss, Janney, Elstner Associates, Inc.

FINAL REPORT

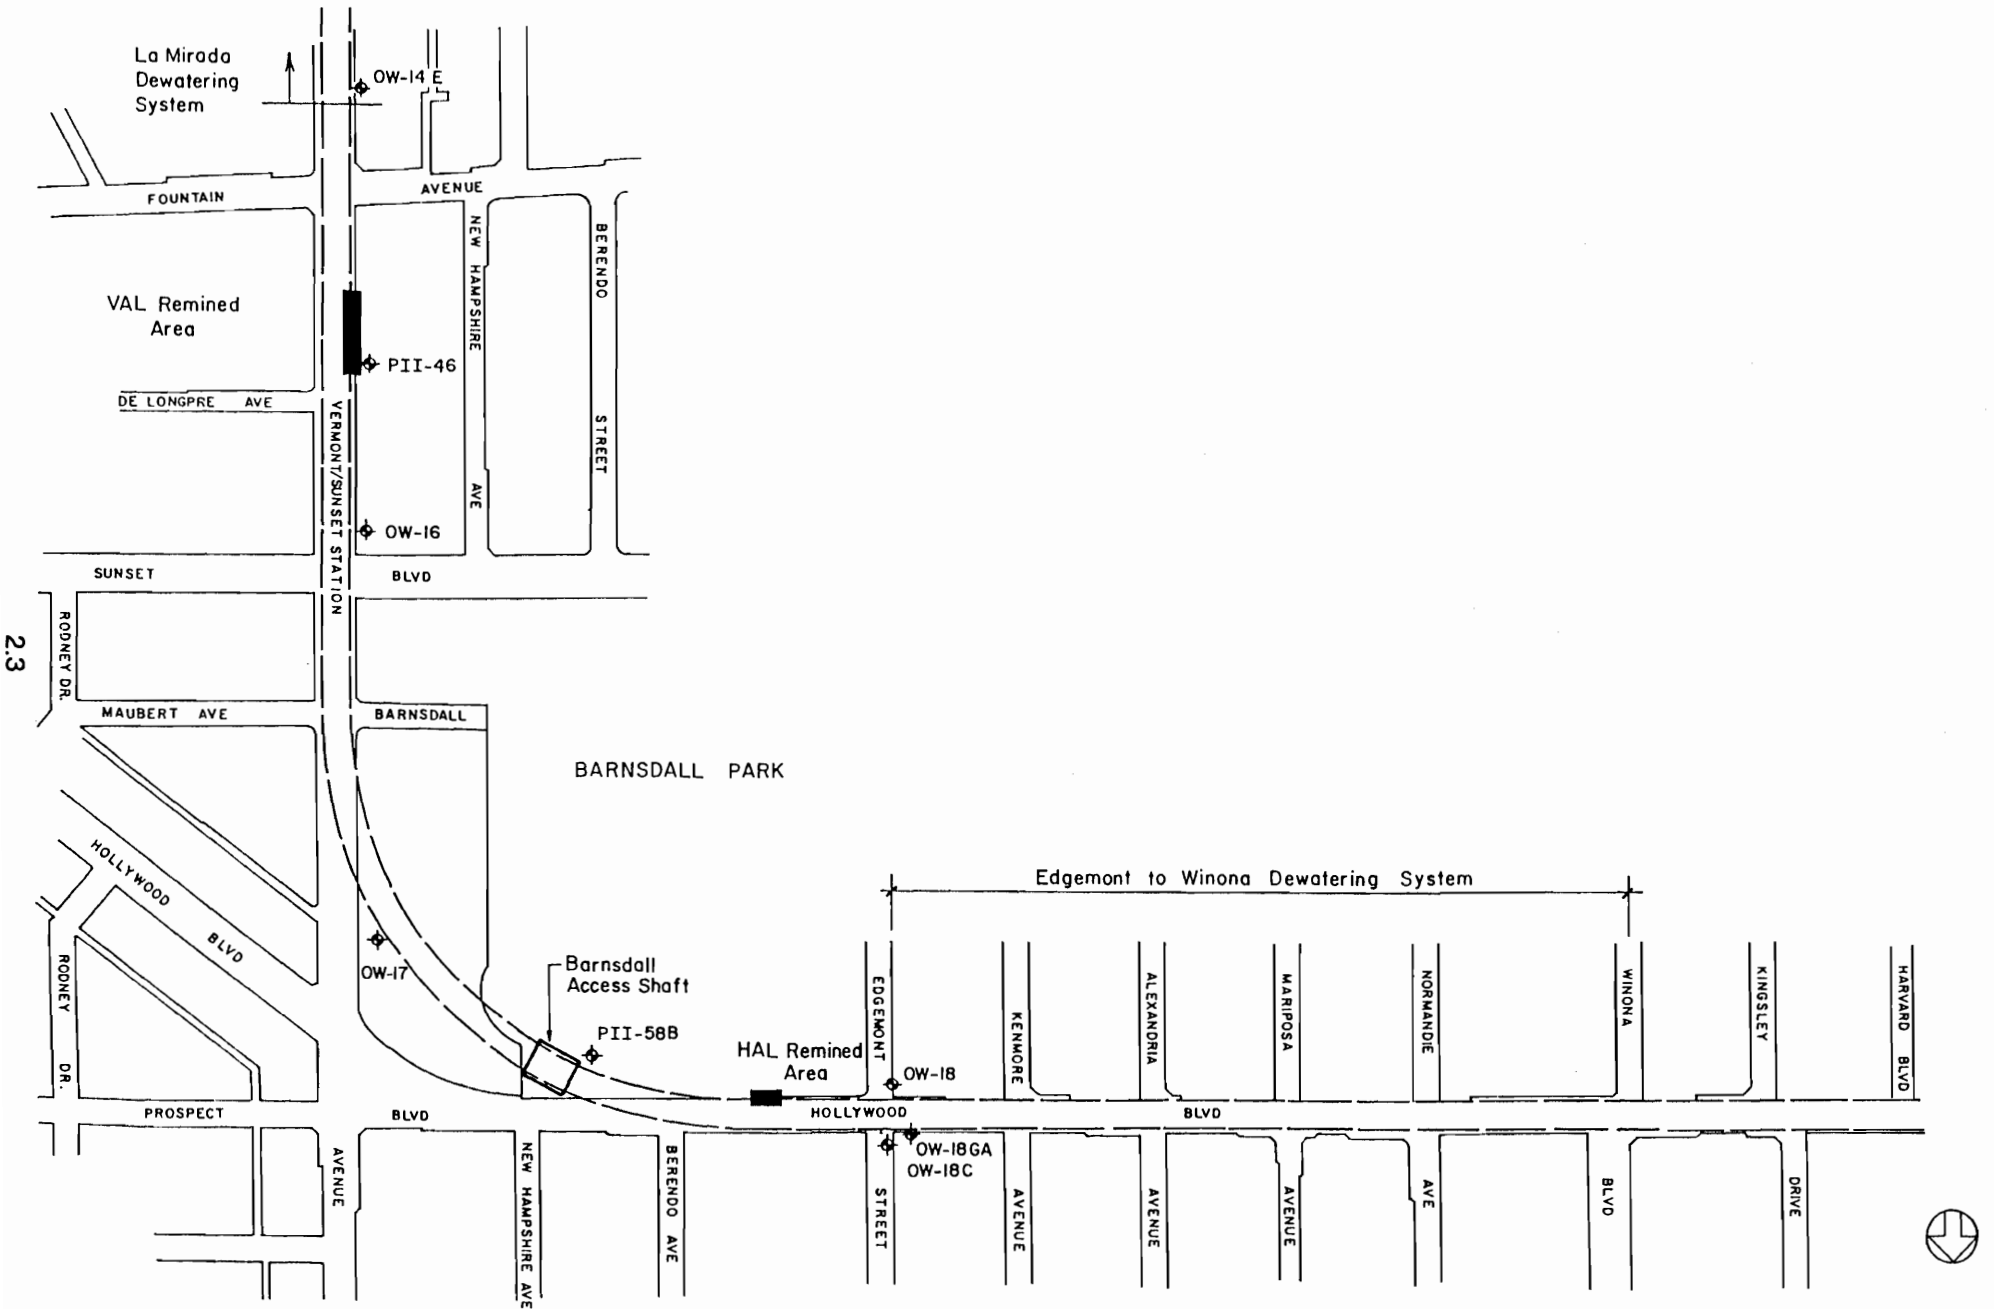
Fig. 2.1 Plan View of Portions of The Vermont and Hollywood Tunnels

One hundred and sixty-four ft of the VAL segment between stations 441+05 and 439+41 were successfully remined and resupported during September 1994. Remining the HAL tunnel between station 464+34 and 465+14 (AL stationing) began on June 15, 1995. During the early morning hours of June 22, large ground movements and seepage occurred near station 465 as the heading was nearing completion. A portion of the HAL tunnel collapsed at approximately 6:10 a.m. (Fig. 2.2). A sinkhole, approximately 15 ft deep, developed at the ground surface as earth and water ran westward through the HAL tunnel from the collapse site. After the collapse, water from a broken 10 in. diameter water main poured into the sinkhole until the water main was shut off (Fig. 2.4). At approximately 11:35 a.m. the same day, the ponded water caused an additional collapse, resulting in earth, debris and water to be pushed eastward through the Barnsdall Shaft and into the Vermont Tunnels.

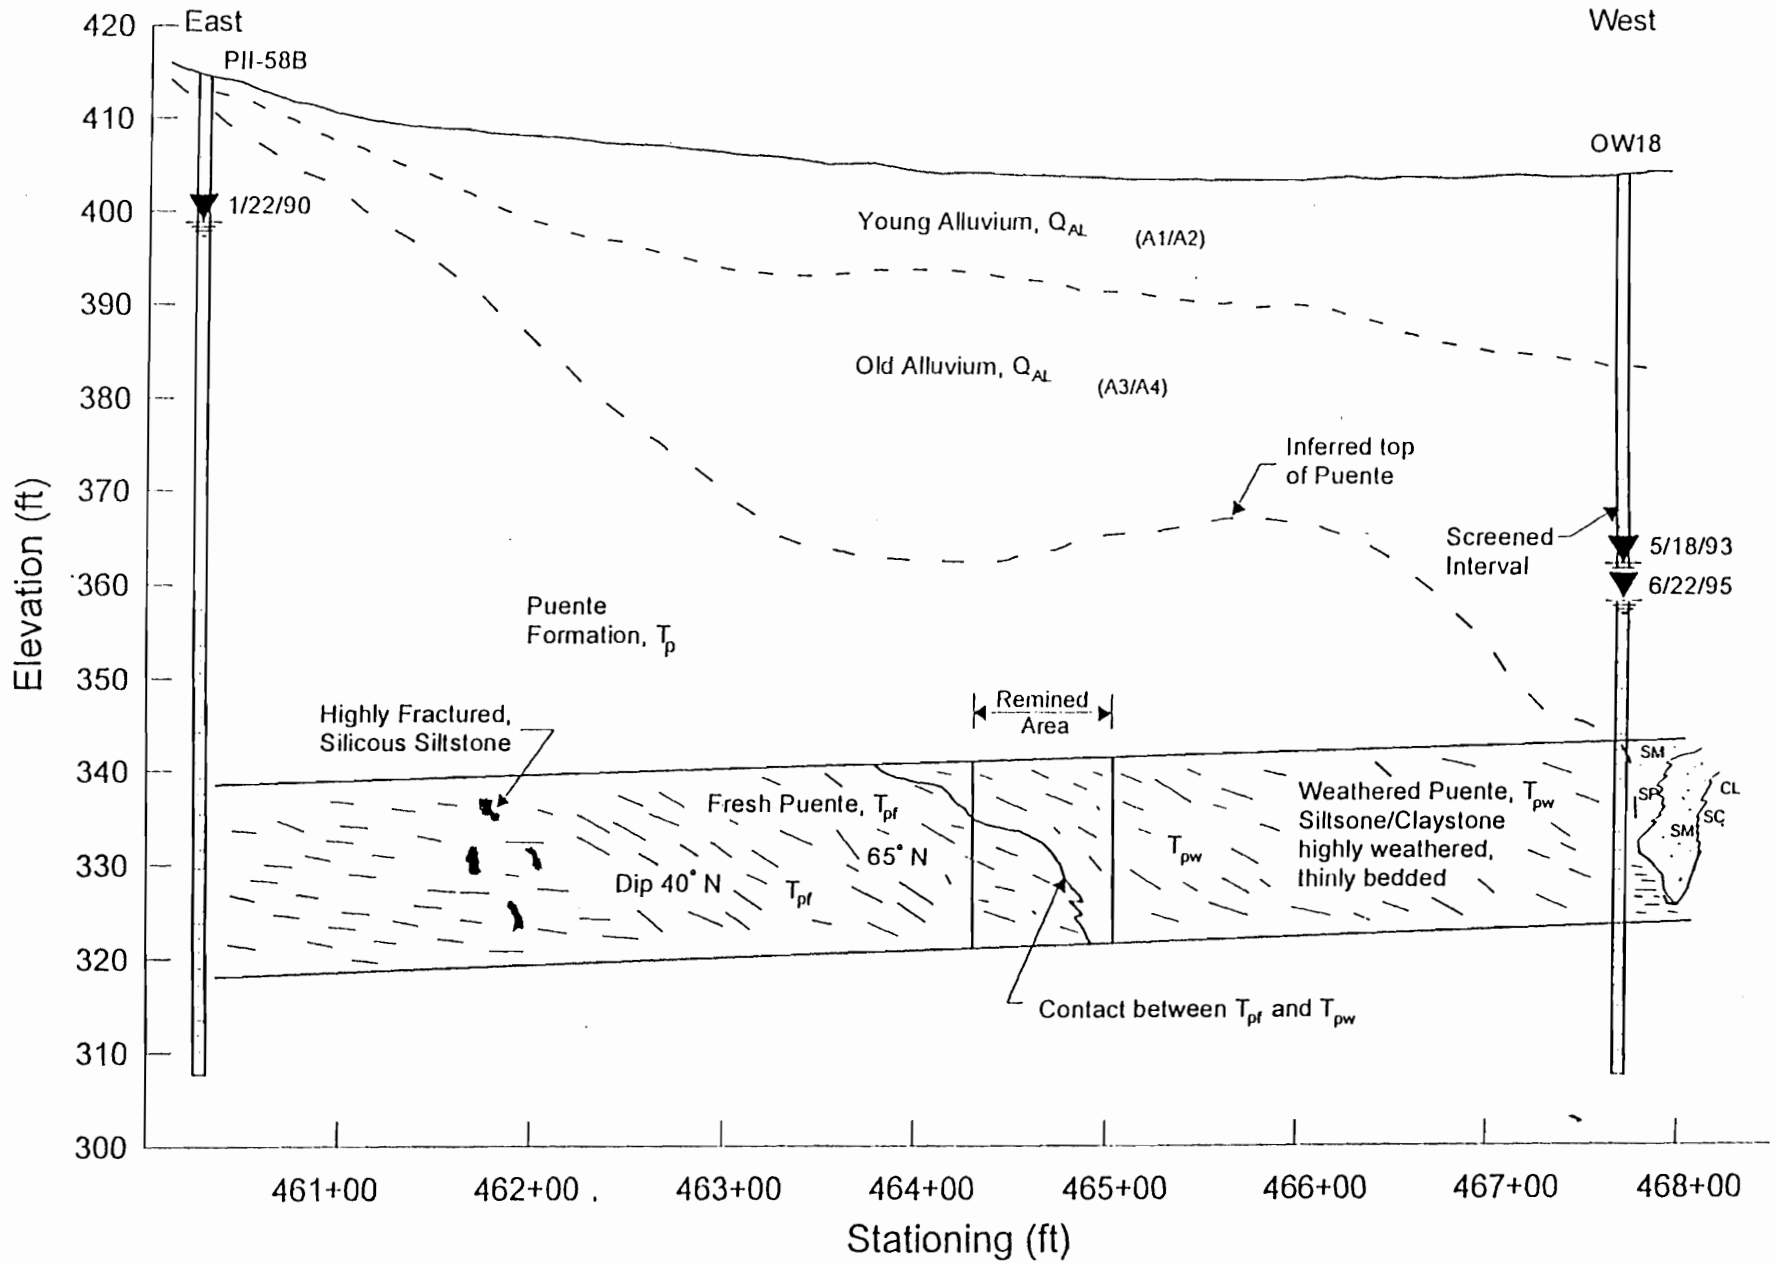
Fig 3.2 Subsurface Conditions Near HAL Remined Area

5.2.1 HAL remining - This remined area is located between the recharge area at Barnsdall Park and the closest observation well to the site, OW-18 (Fig. 3.2). Therefore it is up gradient from OW-18 and the water levels at the remined area would be higher than those measured at OW-18. In June 1995 when remining took place, the water level in OW-18 was at elevation 360 ft. Assuming a gradient of 0.022, based on water levels given in the GDSR between the Barnsdall shaft and OW-18, the water level above the remined area would be computed to be elevation 366 ft, or 24 ft above the crown of the tunnel.

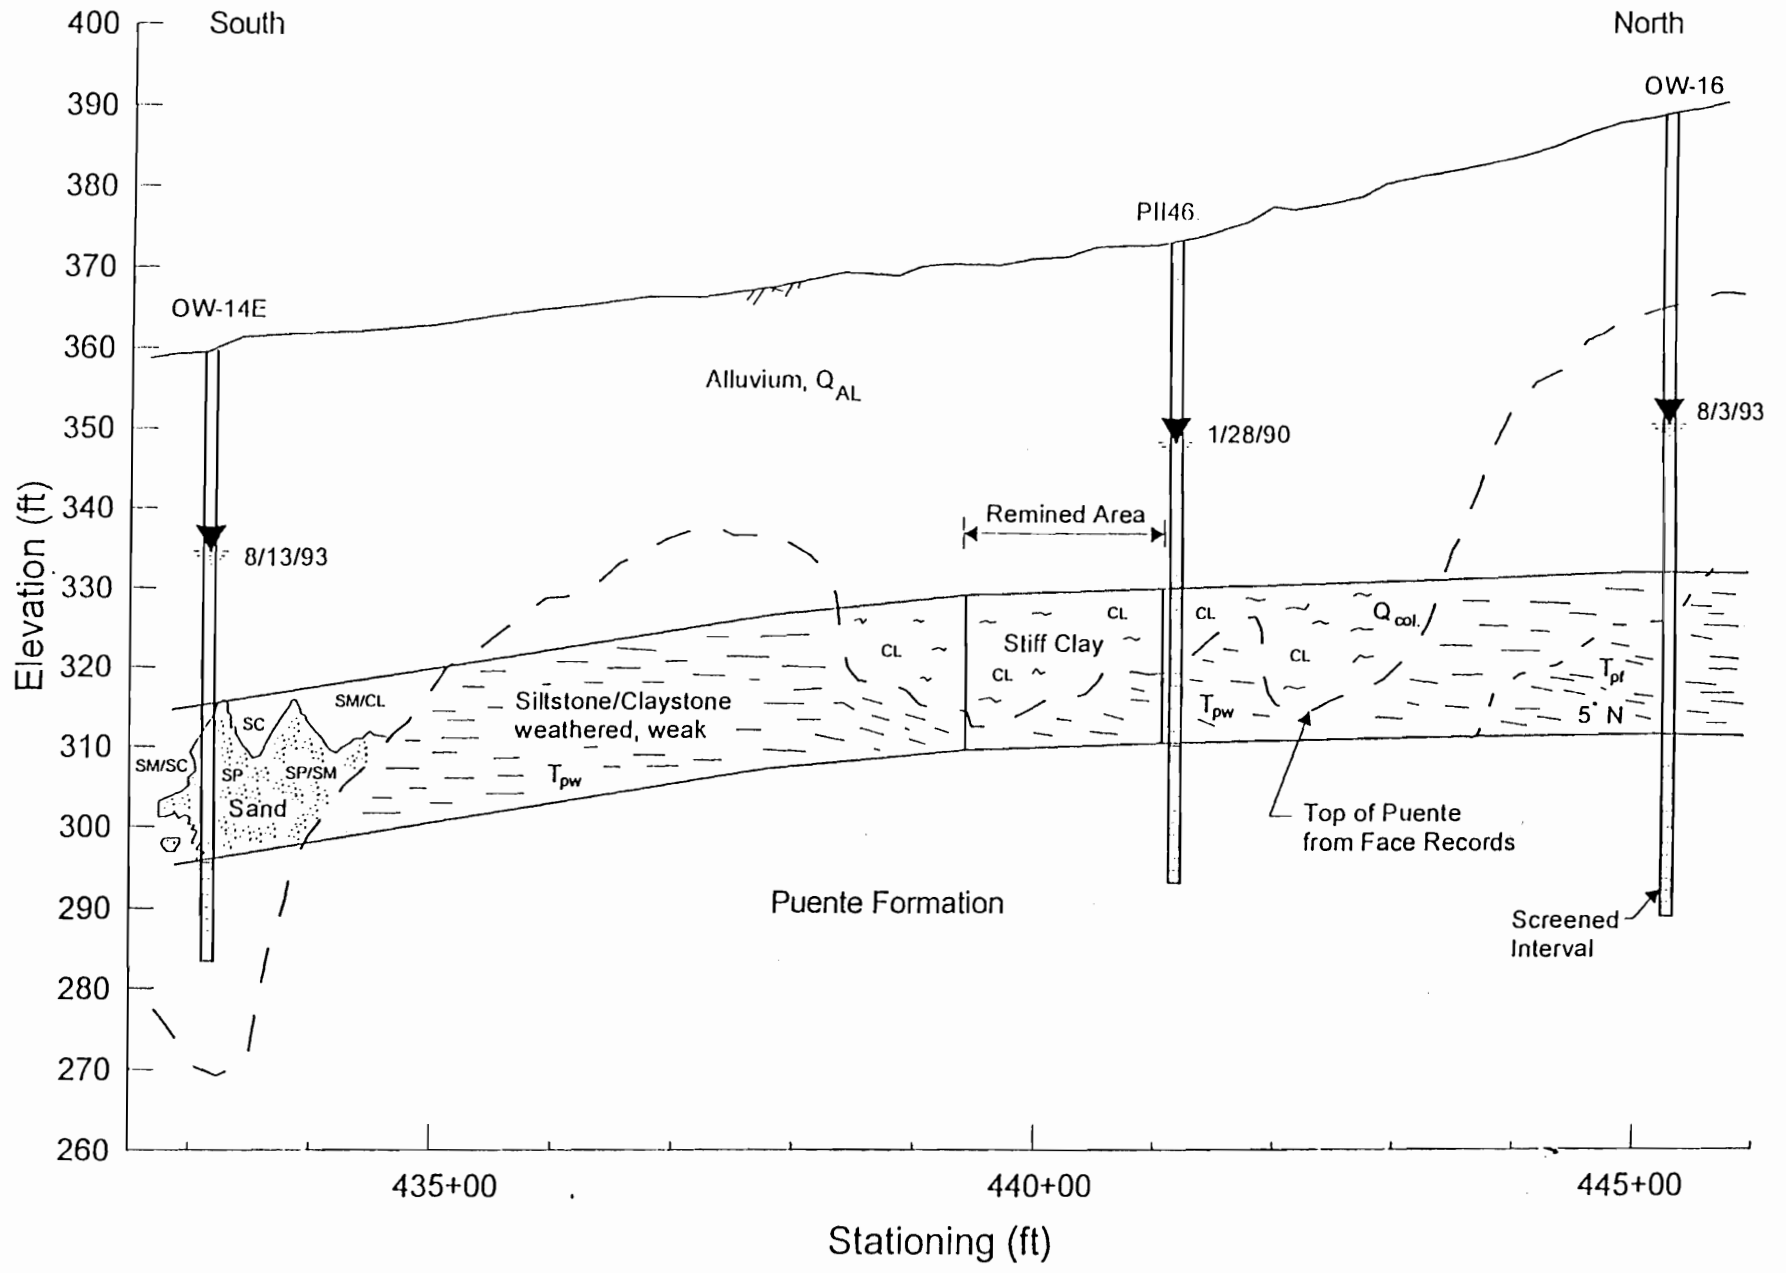
Fig. 3.4 Subsurface Conditions Near VAL Remined Area

The closest well was located 260 ft from the HAL site and 430 ft from the VAL site. Piezometer PII-46 was very near the VAL site (Fig. 3.4), but no data was collected after the initial site investigation, which occurred well before the tunneling began. Therefore the water conditions at both sites must be interpreted from wells located at some distance from each.

5.2.2 VAL remining - This remined area is located between OW-16 and OW-14E (Fig. 3.4), with the water levels decreasing from OW-16 southward. Therefore it is down gradient from OW-16 and the water levels at the remined area would be lower than those measured at OW-16. In September 1994 when remining took place, the water level in OW-16 was at elevation 358 ft. Assuming a gradient of 0.013, based on water levels between OW-16 and OW-14 before the dewatering system near OW-14E was pumped, the water level above the remined area would be computed to be elevation 351 ft, or 20 ft above the crown of the tunnel. This calculation assumes that the dewatering near OW-14E had no effect on the water levels at the remined area.

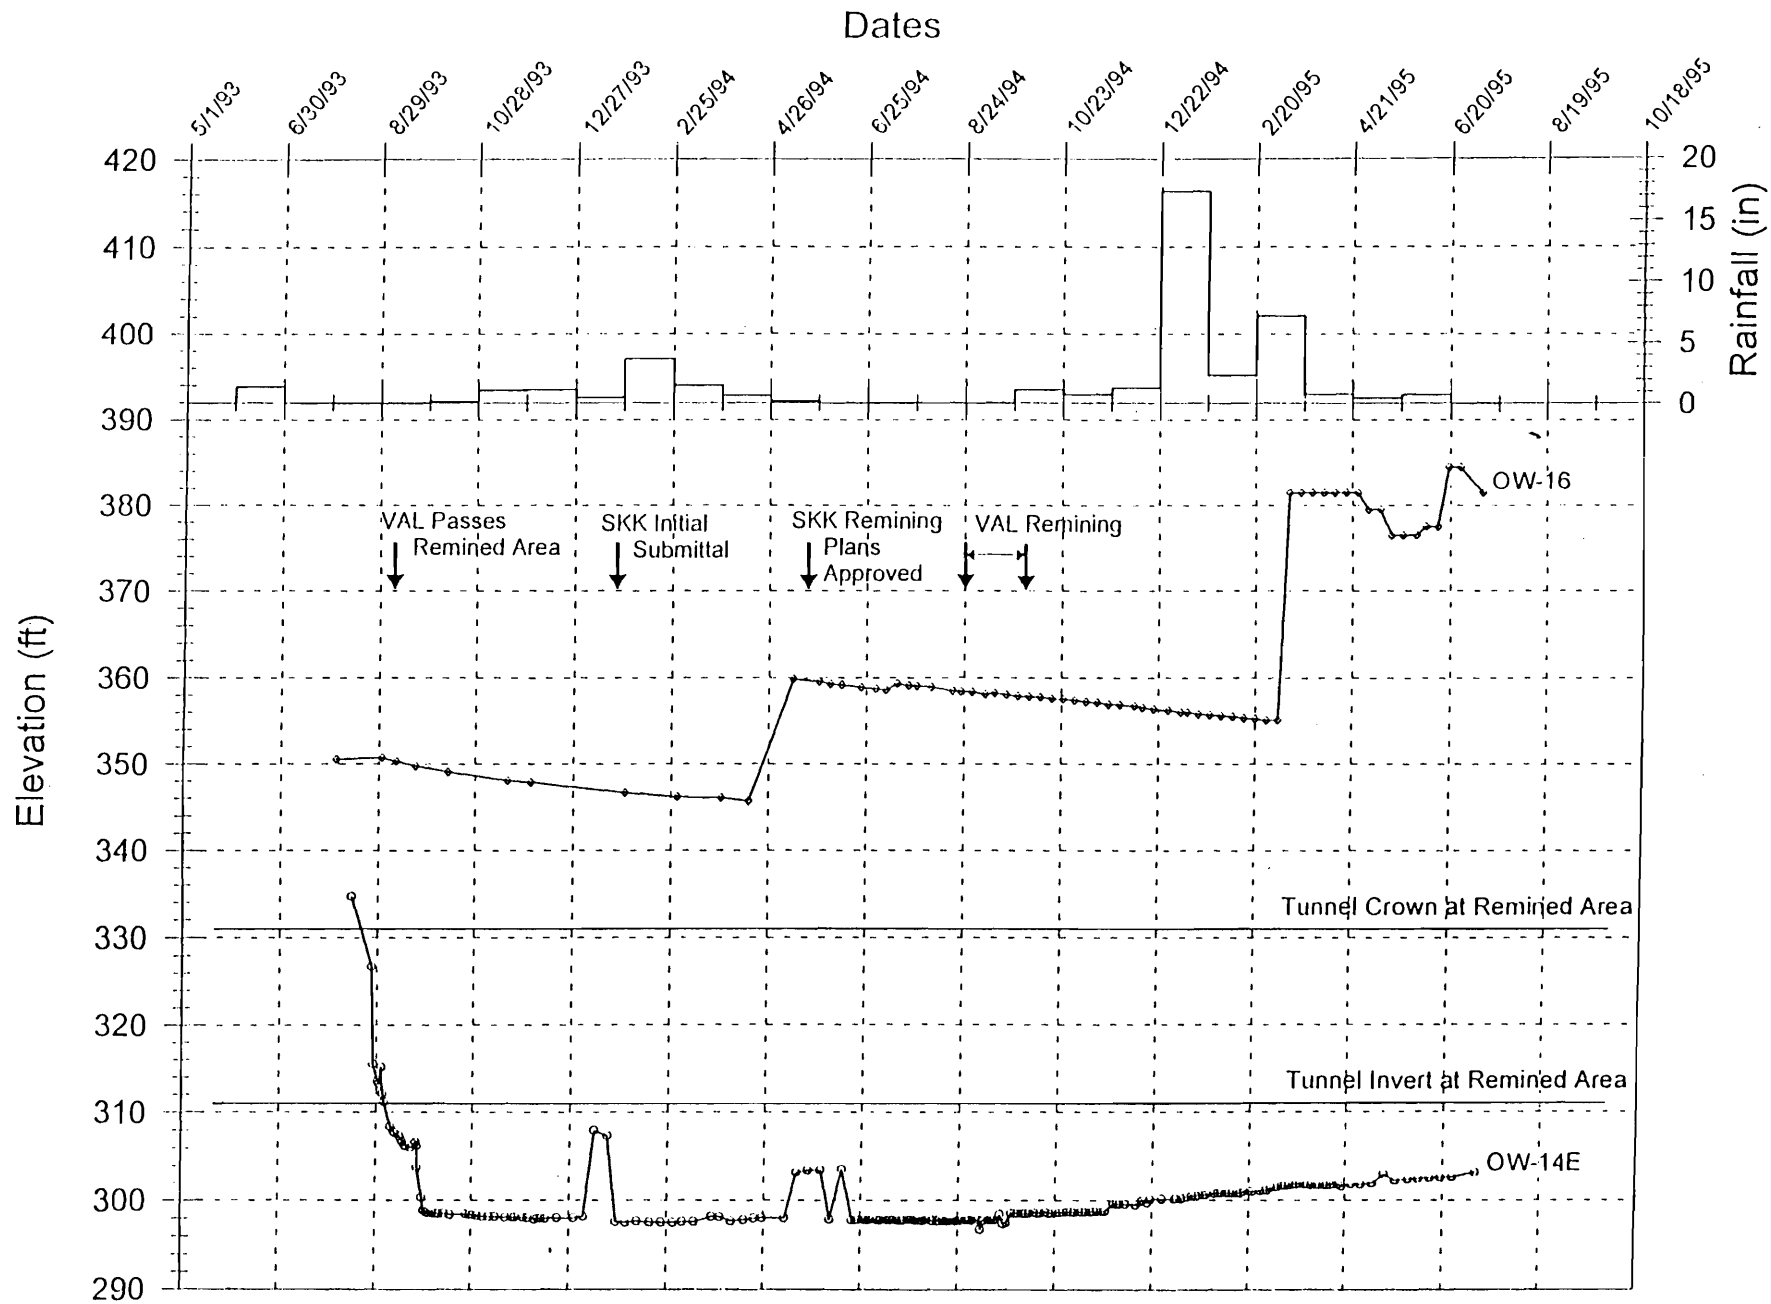
Fig. 3.5 Ground Water Levels Near VAL Remined Area

The temporal variations of groundwater levels in wells near the VAL remined area are shown in Fig. 3.5. Data from observation wells OW-14E and 16 are presented. The data from OW-14E is typical

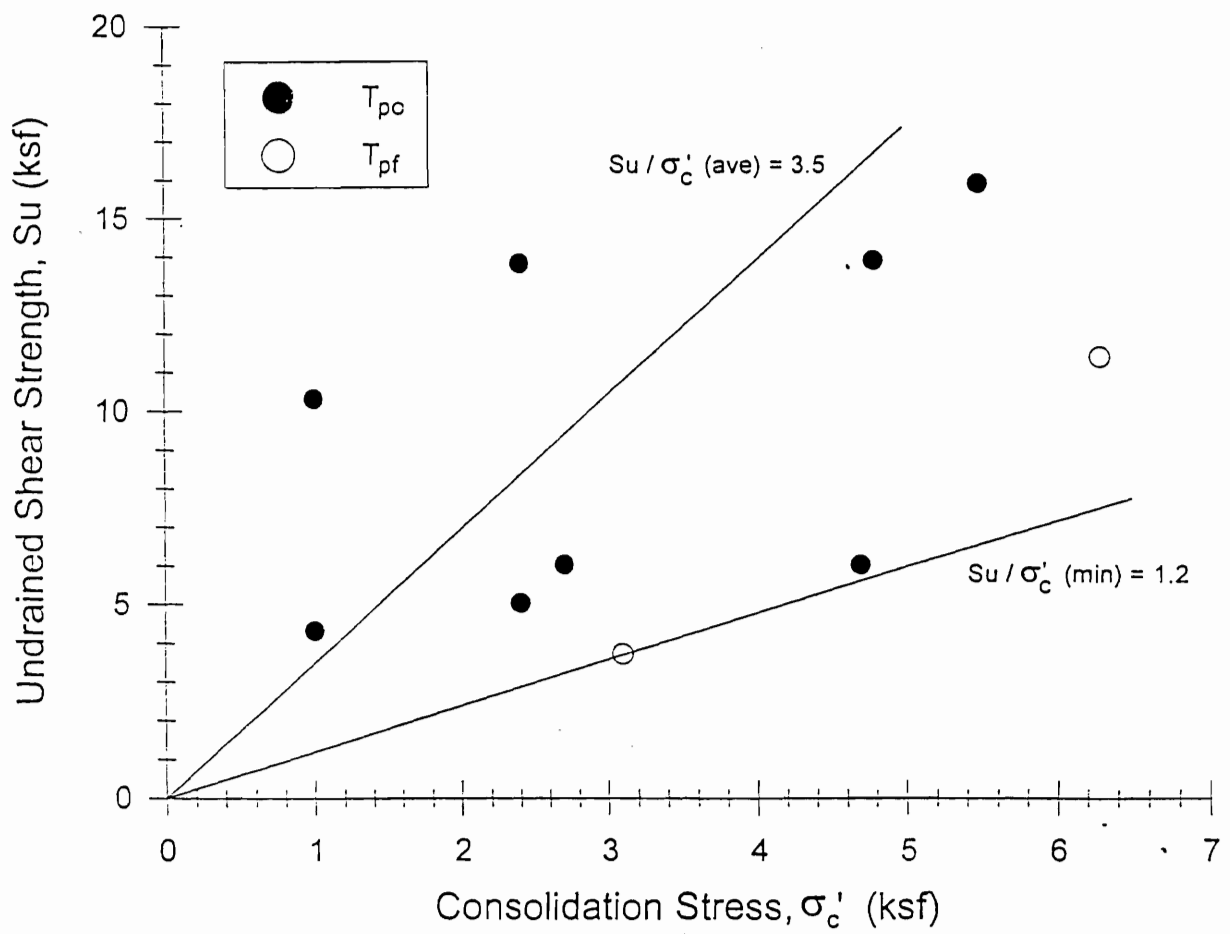
Fig. 3.6 Summary of Triaxial Test Data on Puente Specimens

The results of 10 isotropically consolidated, undrained triaxial compression tests on specimens obtained from the Puente formation are summarized on Figure 3.6. No tests were conducted on T_{pw} specimens. The data indicates that the laboratory values of S_u increase slightly with effective consolidation pressure, σ'_c , and are generally larger than those found in the U tests (Table 3.1), most likely as a consequence of the increased confinement in the triaxial tests. Again, no real distinction can be made between the strengths of the T_{po} and the T_{pf} specimens. To obtain a value of S_u for a given depth of cover, a value of S_u/σ'_c can be found, based on a slope through the data, and that ratio is multiplied by the corresponding vertical effective stress. Using the minimum value of S_u/σ'_c of 1.2, the corresponding value of S_u for the conditions at the HAL remining area is 7.4 ksf.

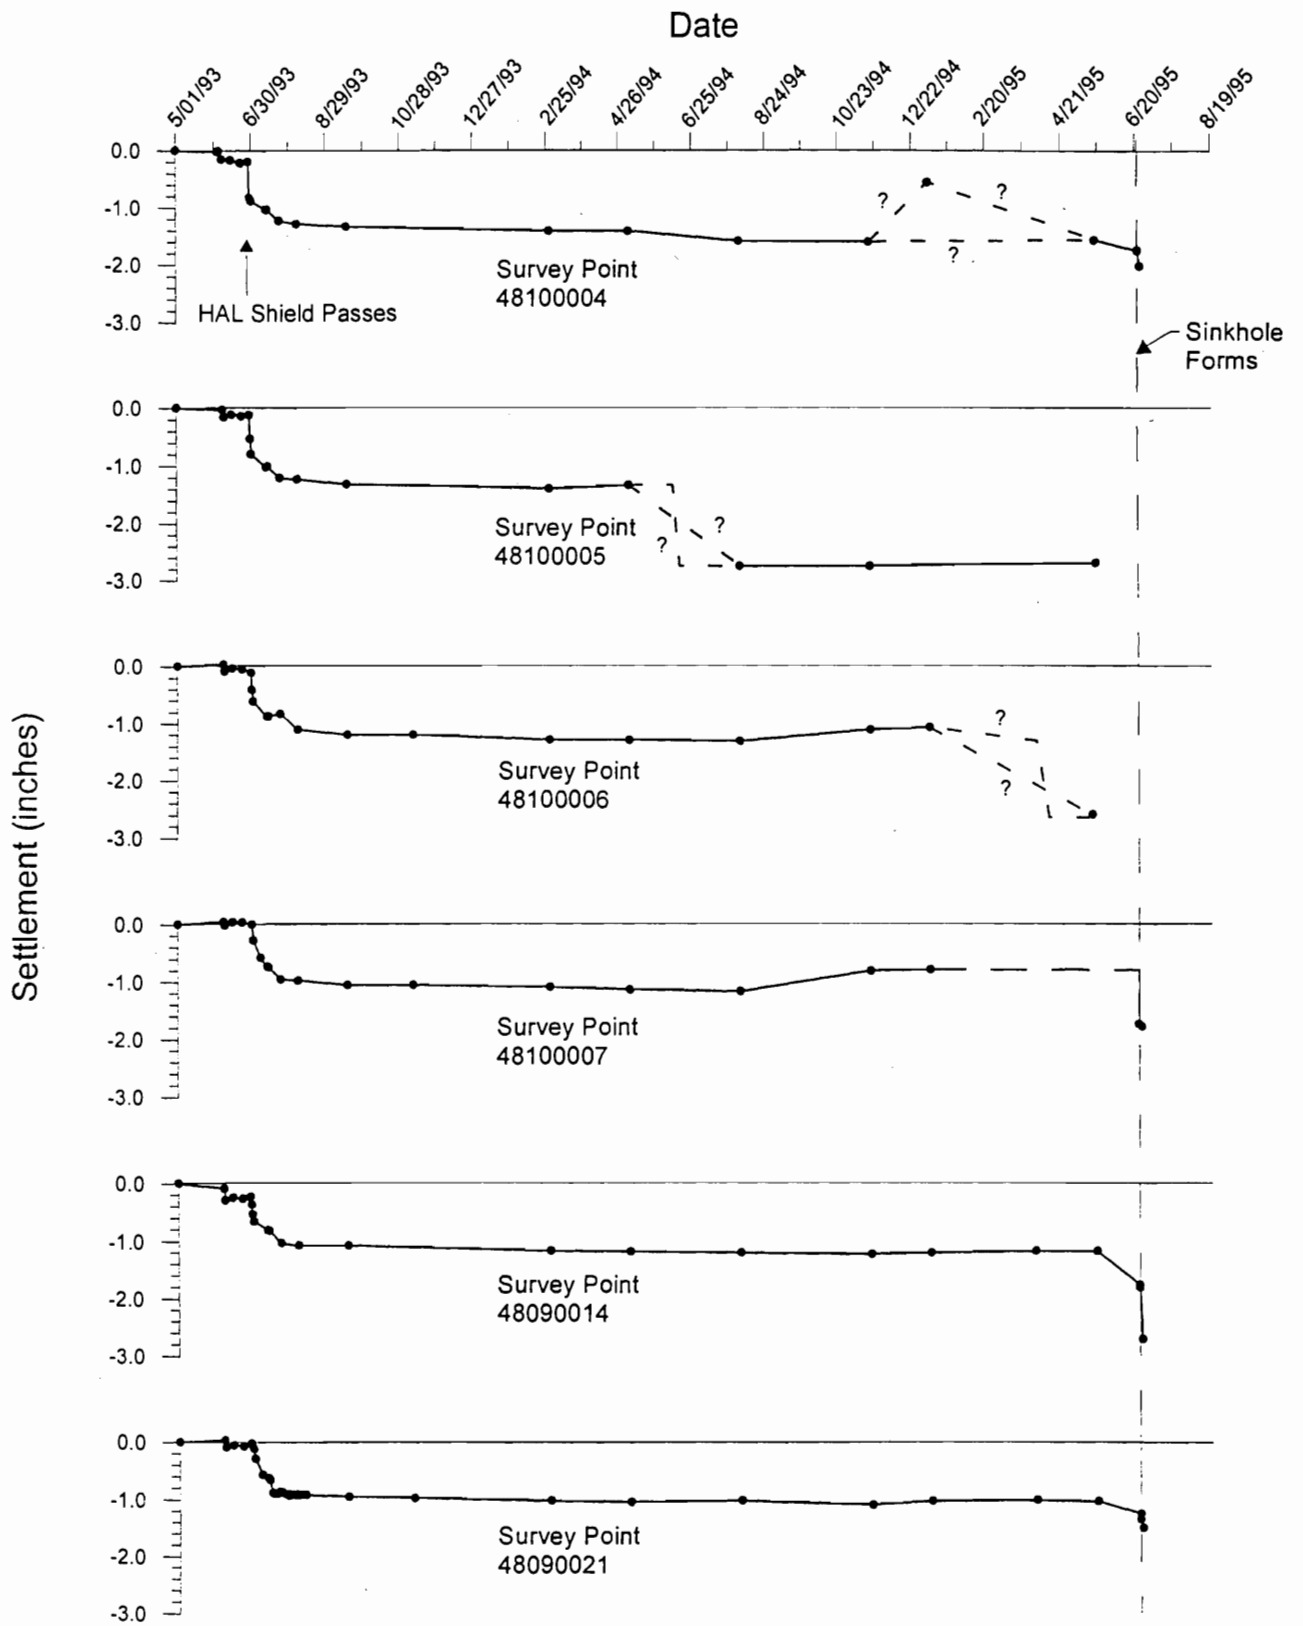
Fig 3.7 Ground Surface Settlements Near HAR Remined Area

Two exceptions were observed at ground point 48100005 and 48100006, points B and C in Fig. 2.2, located above the HAL tunnel at the location of the sinkhole. As indicated in Fig. 3.7, surface settlements were similar to the typical settlements immediately after shield passage, but subsequent incremental drops of about 1.5 in. were observed prior to the sinkhole collapse. These movements did not occur at the same time, but developed at least 5, and as many as 10, months apart. More accurate definition is precluded by the paucity of readings taken at these points. Total settlements prior to the start of the remaining operations were 2.7 and 2.6 in., respectively. These two anomalies may have been the result of very localized effects of water infiltration resulting in hydrocompression settlements, or

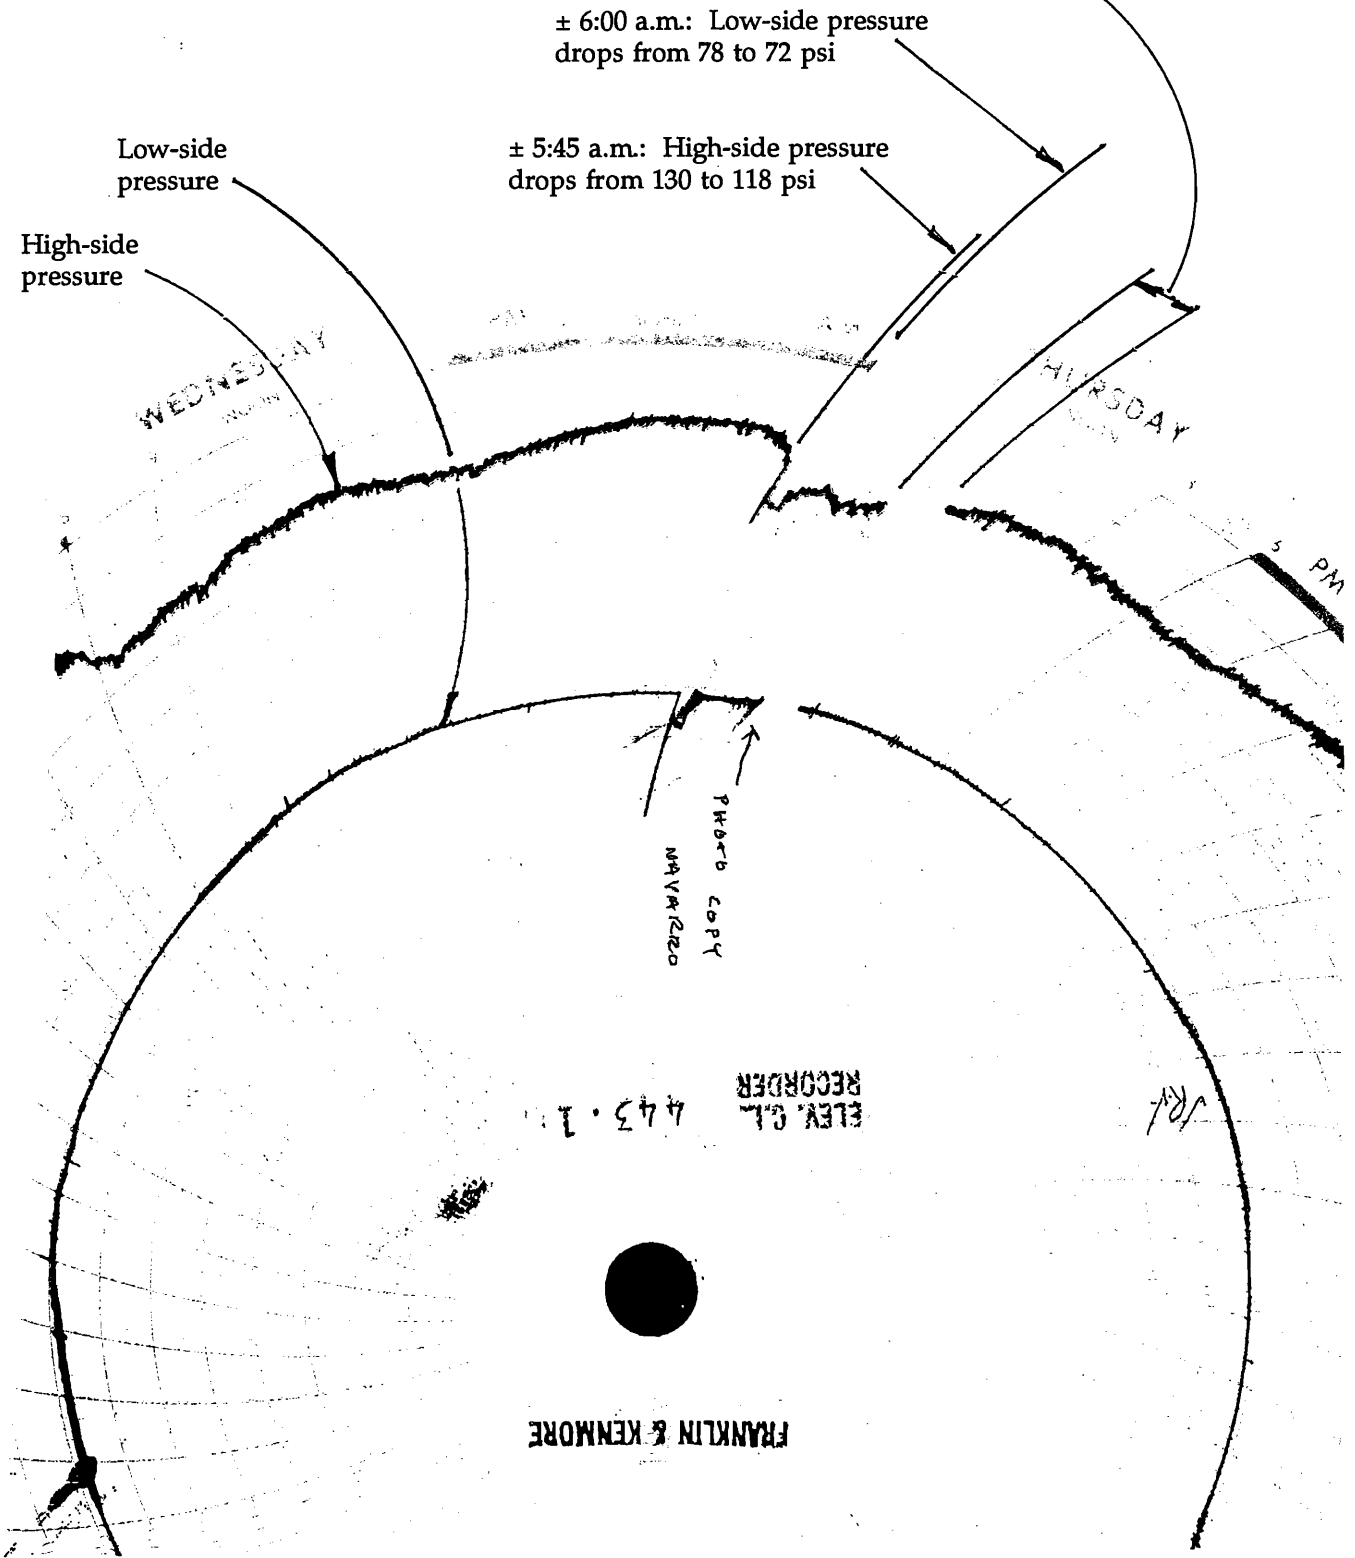
Fig. 3.8 - Franklin/Kenmore pressure record

The tunnel collapse and water main break were detected at the Franklin/Kenmore monitoring station. Pressure and flow chart records are provided in Figs. 3.8 and 3.9, respectively. At approximately 6:00 a.m. on June 22, flow increased from 10 to 24 cfs, a 14 cfs increase. The exact time is difficult to determine from the photocopy of the flow record. As can be seen in Fig. 3.8, low-side pressure dropped from 78 to 72 psi at 6:00 a.m. A sudden drop in the high-side pressure was recorded at about 5:45 a.m.

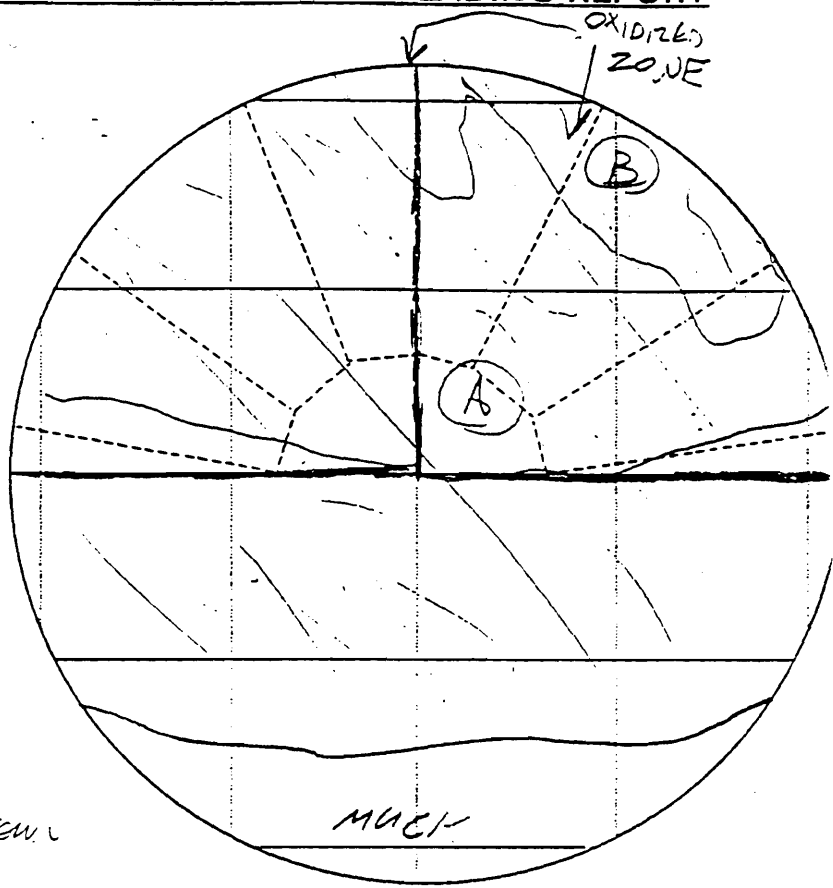
COMMENTS: PURE FINE OLIVE
GREEN OXIDIZED TO REDDISH BROWN
MOIST, MODERATELY SHEARED
APPARENT DIP - 65° TRUE DIP NORTH WEST
SPLITTING IS DOWN THE LINE
PARALLEL TO FACE WITH WELL DEVELOPED SPLIT SIDES, OXIDIZED
ZONES NEAR CROWN DIP ALONG BEDDING, EAST MINING
THESE ARE FRAGILE AND HARD ROCK

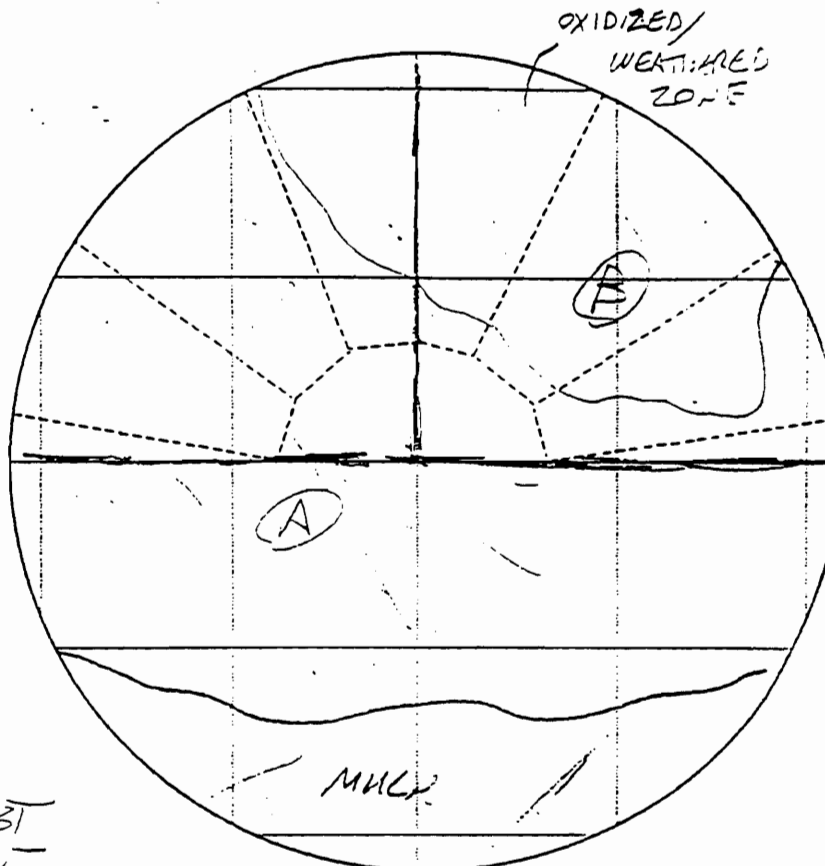
COMMENTS: PUEBLO FM, OLIVE
GRAY-YELLOW ROCK, MOST
MODERATELY SHEARED. APPARENT
DIP ~65° OXIDIZED/WEATHERED
ZONE EXTENDS DOWN ALMOST
TO SPRING LINE ALONG BEDDING PLANES & JOINTS, NO
HARD ROCK EASILY MML (FRIABLE)

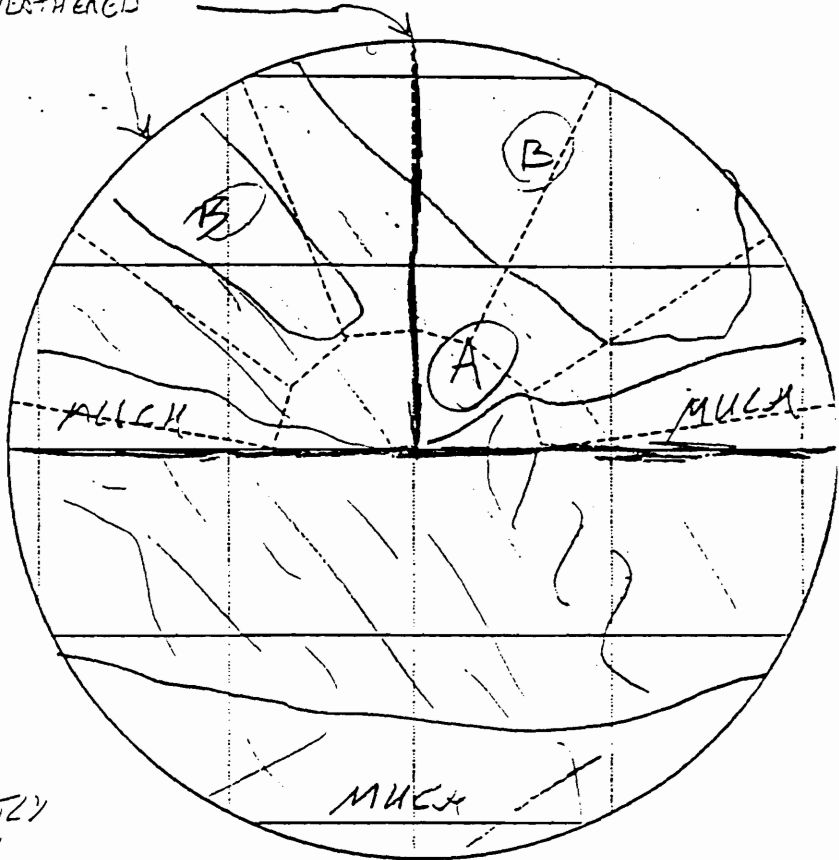
COMMENTS: PUEBTE Fm OLIVE
GRAY - ORANGE BROWN. MODERATELY
SHEARED BEDDING DIPS NW
@ ~ 45° (VARIABLE) WEATHERED
ZONES ALONG BEDDING AND

SHOWS DOWN FROM CROWN TO SPRING LINE, OXIDIZED OVER
MOST OF THE FACE, NO HARD ROCK, EASILY MINED B1
SM (FRAGILE)

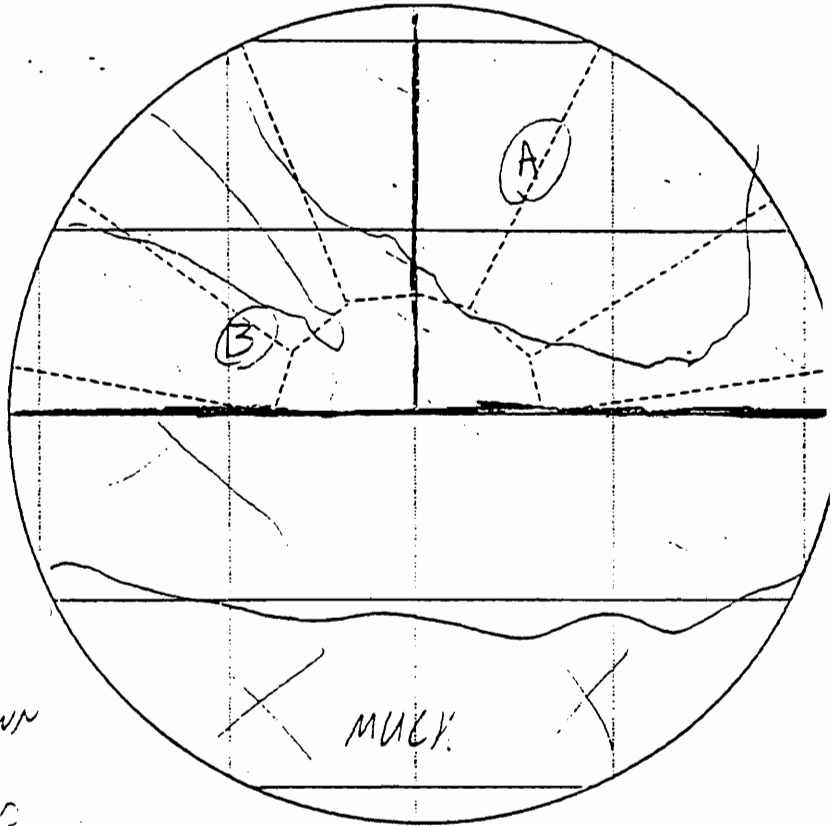
SPONS NEAR DEVELOPED SLIP SURFACE. NO HARD ROCK EVIDENT

MINED BY TSM

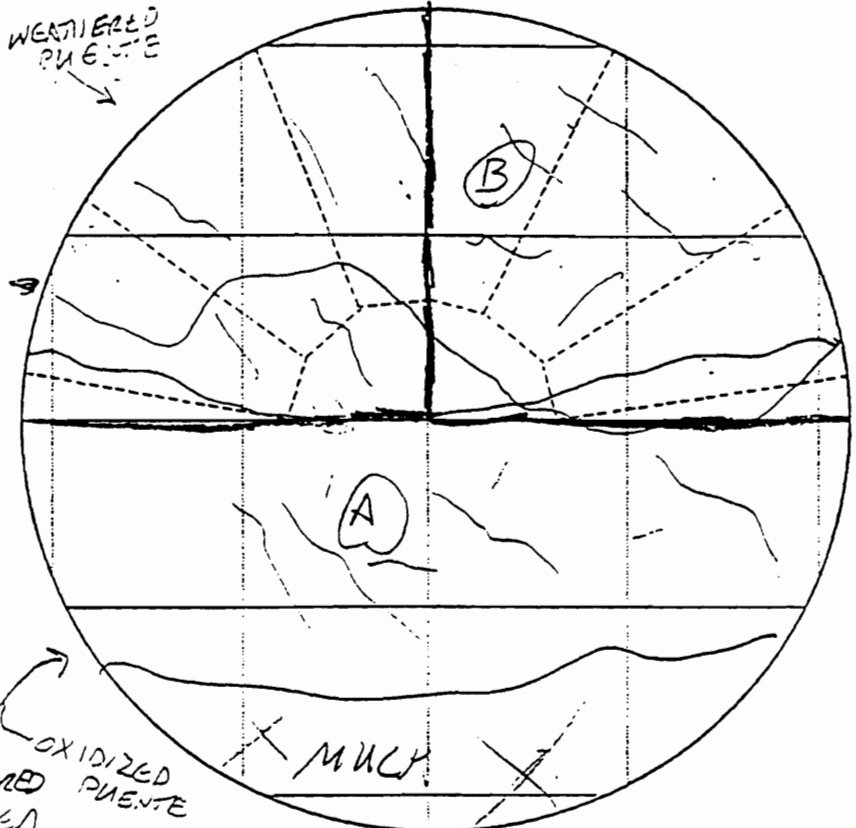
COMMENTS: PUENTE Fm ORANGE
BROWN - GRAY GREEN, WEATHERED
ABOVE SPRING LINE OXIDIZED
BELOW MODERATELY SHEARED
WITH WELL DEVELOPED SLIP SURFACES
BEDDING IS NOT DISTINCT, NO HARD ROCK, MATERIAL IS
FRIABLE AND EASILY MINED BY TSM

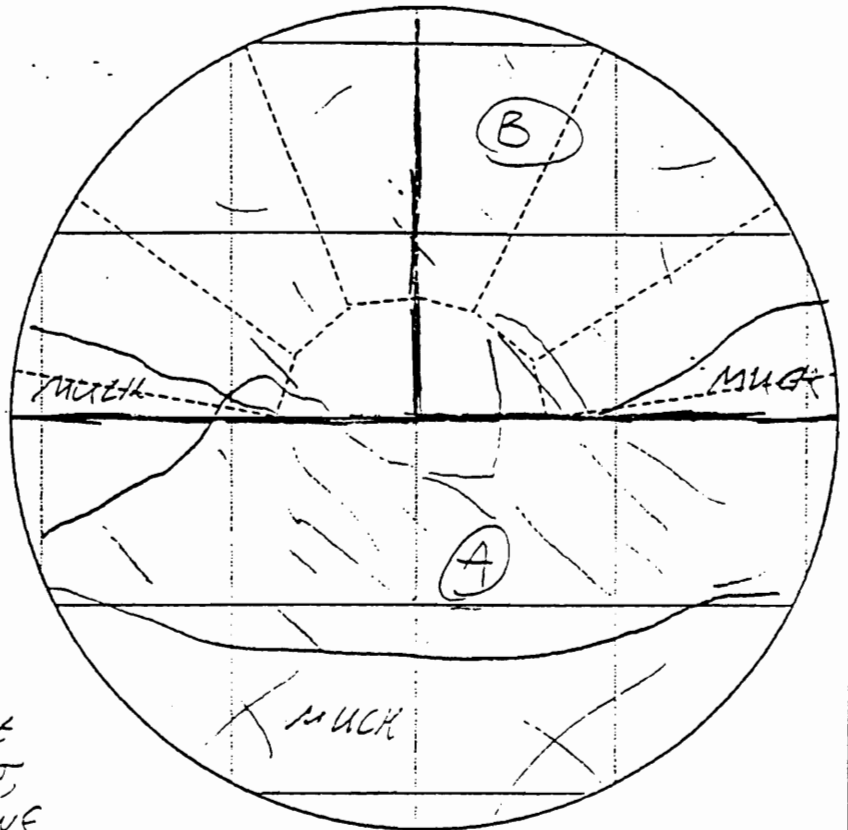
COMMENTS: PUEBLO Fm. ORANGE
BROWN - GRAY GREEN, MOIST,
WEATHERED ABOVE SPRING LINE
OXIDIZED ALONG JOINTS & BEDDING

BELOW, MODERATELY SHEARED WITH TOTAL CRACKED ... WEATHERED ...
WELL DEVELOPED SLIVER BEDS, BEDDING DIPS NORTH-NORTHEAST
~65° NO HARD ROCK, FRAGILE. EASILY ... BY ...

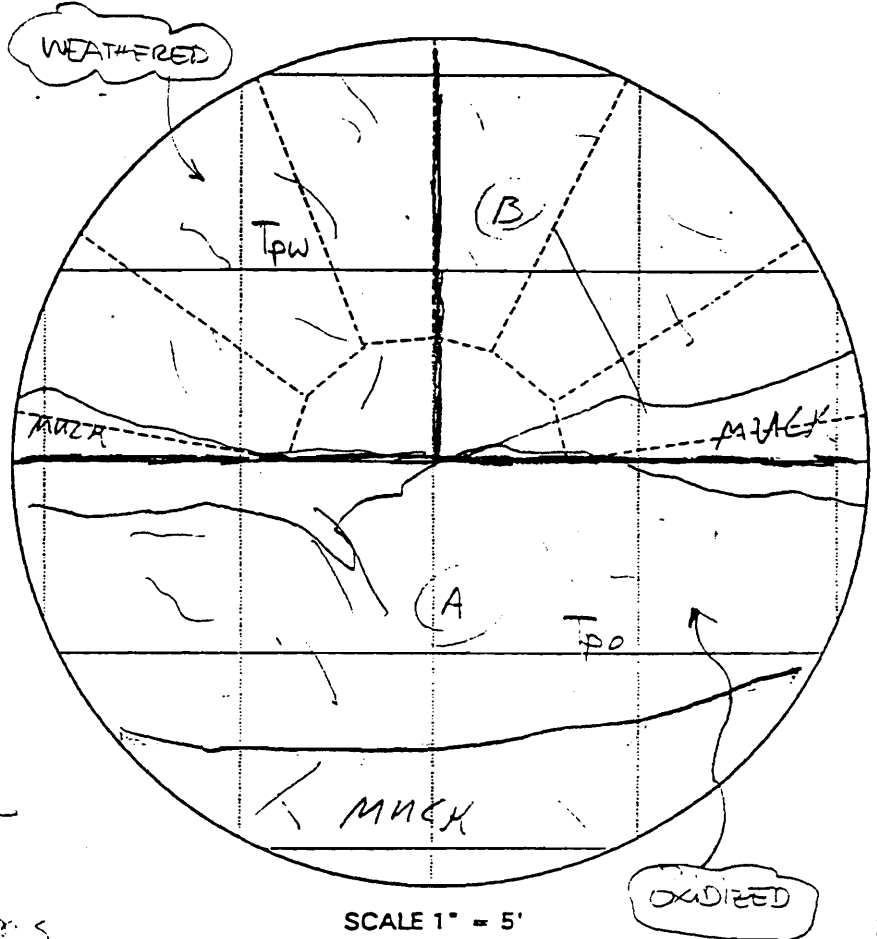
COMMENTS: PARQUETE Fm ORANGE
BROWN - GRAY-GREEN, MOIST
MODERATELY SHEARED WITH
WELL DEVELOPED SLICKENSIDES
BEDDING IS ABSENT

NEAR CROWN & POORLY DEFINED NEAR INVERT, WEATHERED
ZONE (B) EXTENDS FROM CROWN TO JUST BELOW SPRING LINE
PARTIALLY OXIDIZED ZONE (A) IS DARK GRAY AND OXIDIZED ALONG D.O.N. &
BEDDING PLANES. NO HARD ROCK EASILY MARKED BY TBM

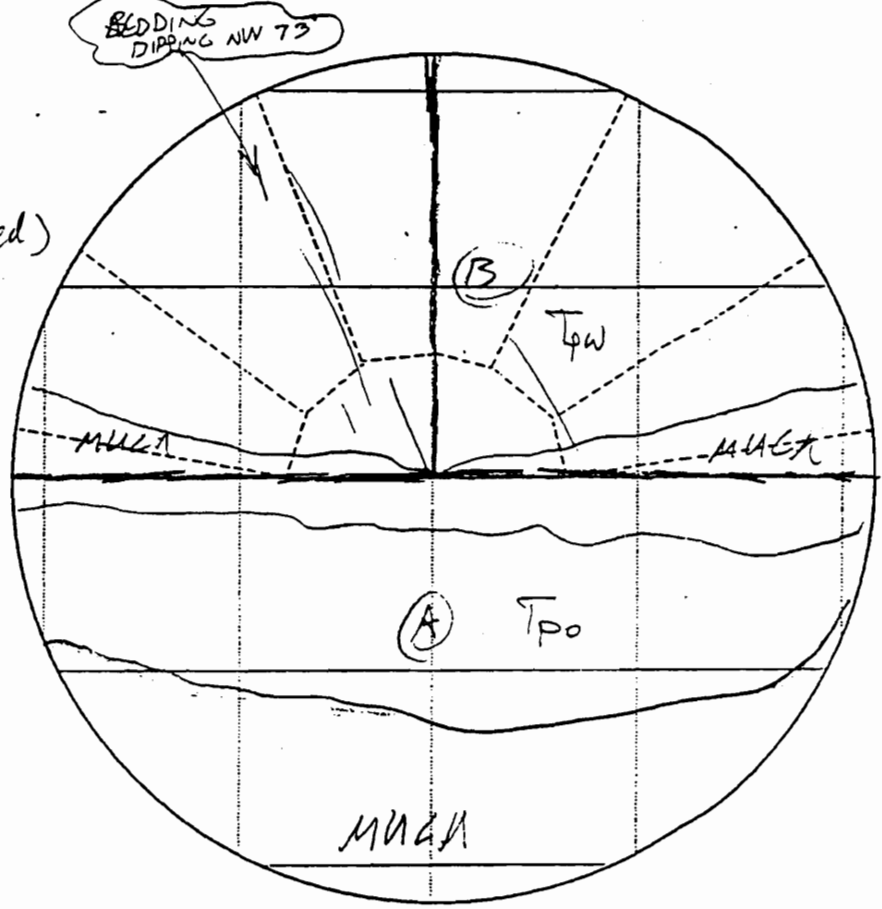
GRAY GREEN - ORANGE BROWN
MOIST, MODERATELY SHEARED
BEDDING DIPS NW @ 73°
STRIKE ~ 3° SOUTH OF HEADING
SHEARING SHOWS WELL DEVELOPED SLICENSIDES, NO HARD ROCK
EASILY M.M.D BY TSM, WEATHERED ZONE EXTENDS BELOW
SPRING LING
