METRO RED LINE, SEGMENT 2, CONTRACT B251

Investigation of Tunnel Collapse and Sinkhole

Wiss, Janney, Elstner Associates, Inc.

FINAL REPORT

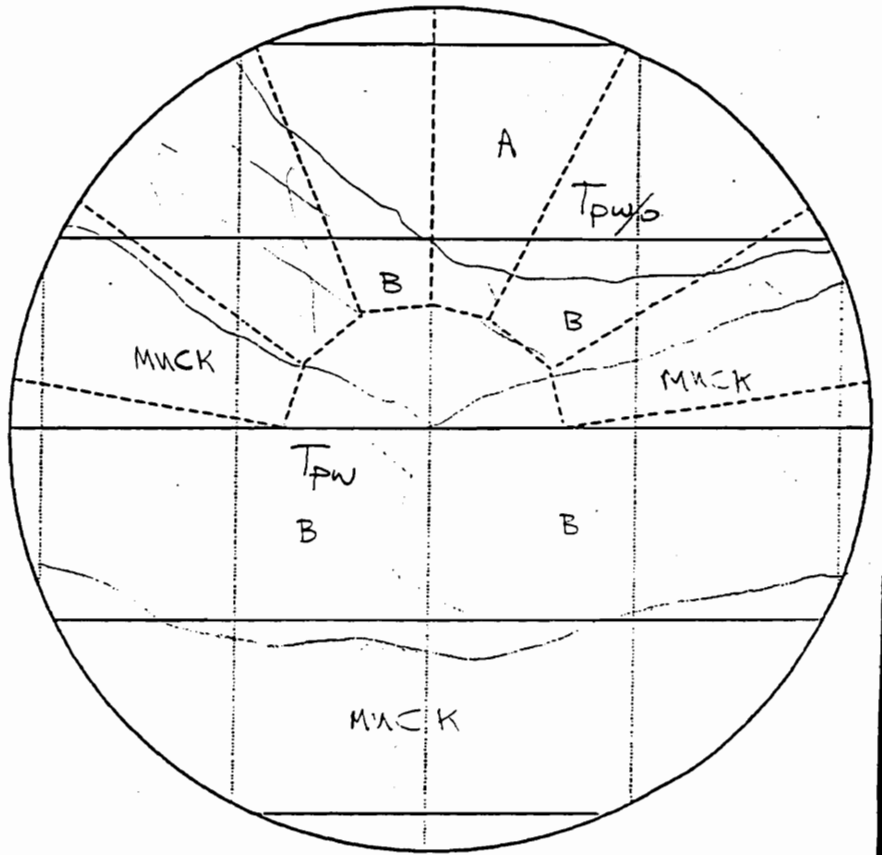
A. Brownish yellow oxidized Puzos.

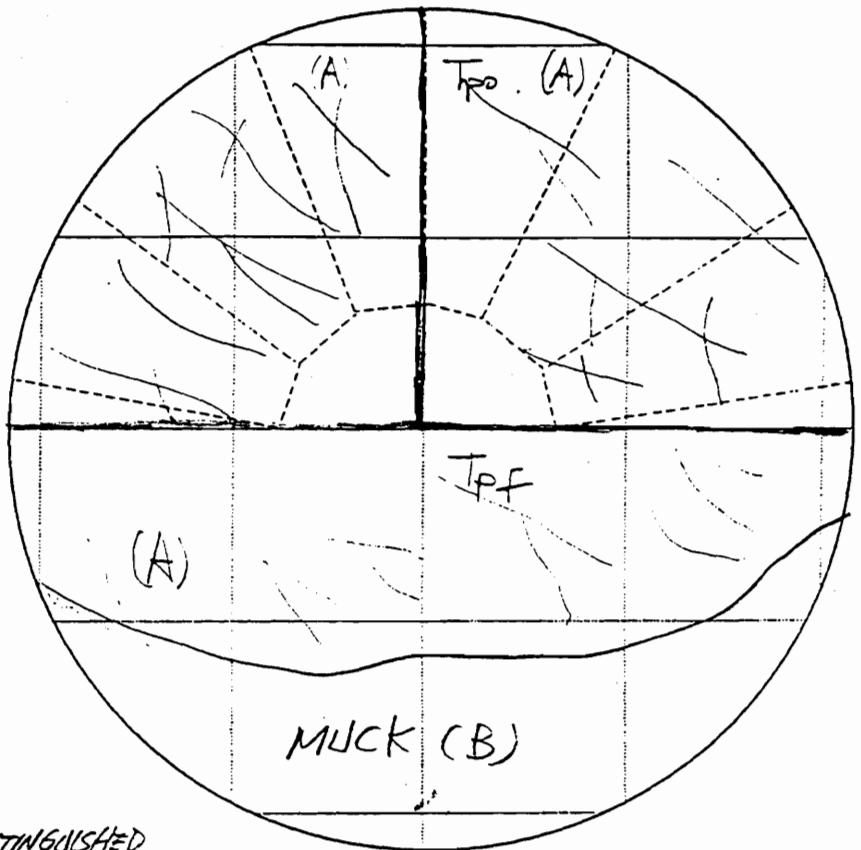
(A) - HIGHLY SHEARED AND JOINTED
 PUENTE FM. BEDDING IS UNDISTINGUISHED.
 OXIDIZED PUENTE IS PRESENT AT
 THE CROWN AREA. EASY TO
 EXCAVATE. NO WATER SEEPING OUT OF FACE.
 (B) - MUCK EXCAVATED FROM FACE

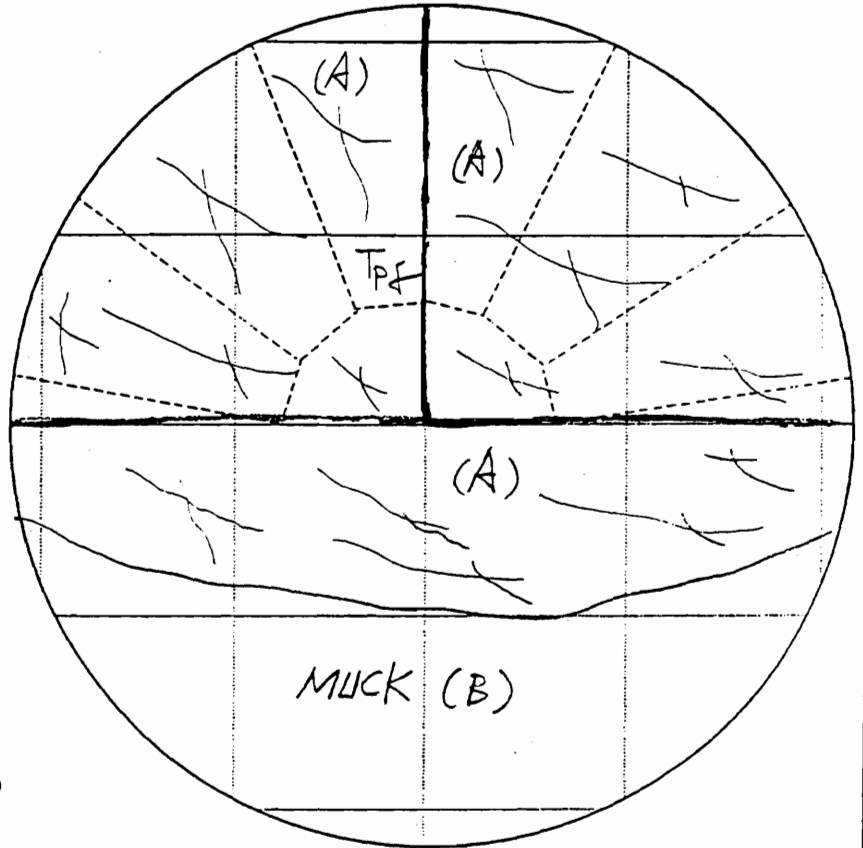
(A) - HIGHLY SHEARED AND JOINTED
 PUENTE FM. SOME OXIDIZED
 PUENTE IS PRESENT AT THE
 CROWN AREA (YELLOWISH BROWN
 IN COLOR). FACE IS EASY TO EXCAVATE.
 NO WATER SEEPING OUT OF FACE
 (B) - MUCK EXCAVATED FROM FACE

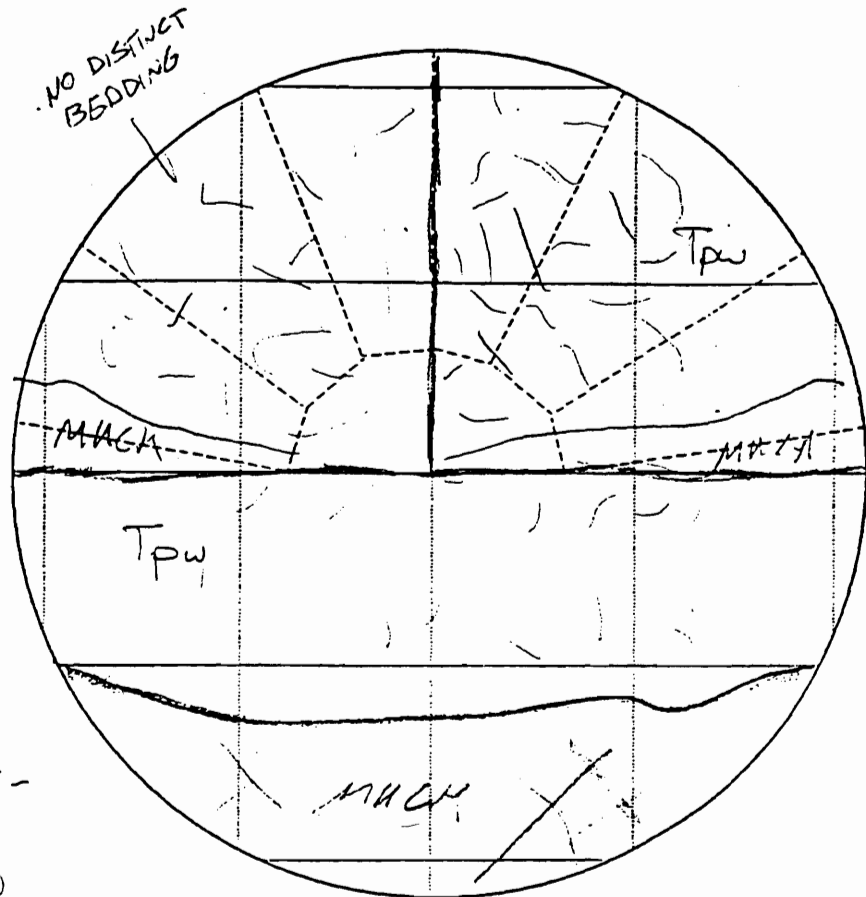
COMMENTS: PUENTE Fm, ORANGE -
BROWN, MOIST MODERATELY
SHEARED WITH WELL DEVELOPED
SUBSIDES, WEATHERED

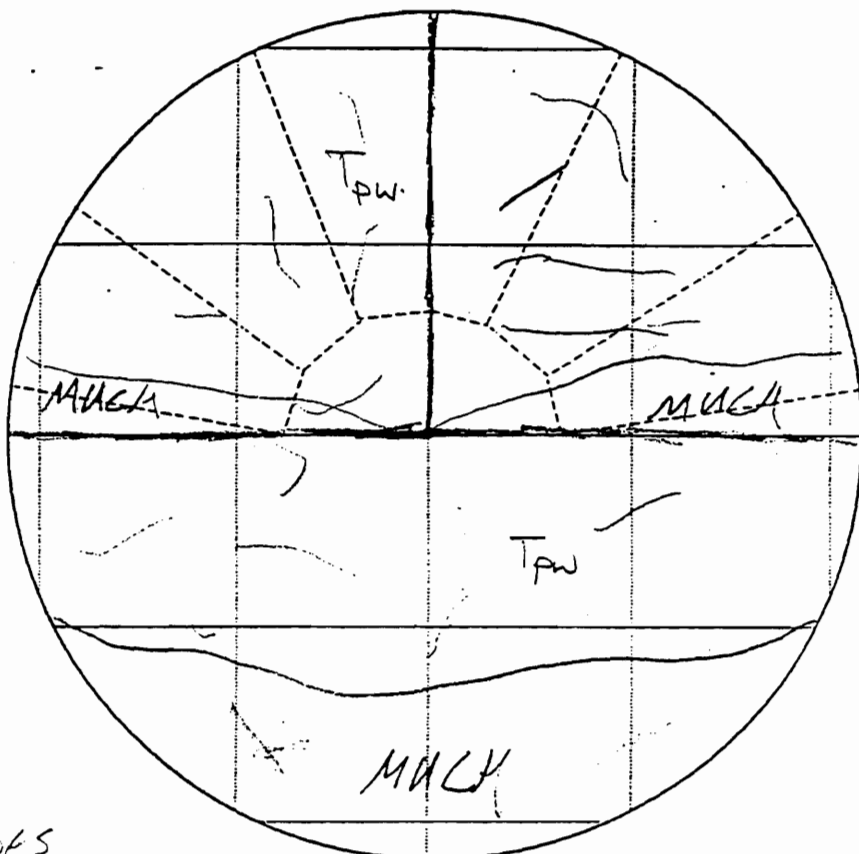
COMMENTS: PUEBLO Fm, ORANGE
BROWN, MODERATELY SHEARED
WITH CLOSELY SPACED SLICKEN SIDES
HIGHLY WEATHERED, NO BEDDING
APPARENT, PUEBLO IS
FRIABLE AND EASILY MOVED BY T.S.M

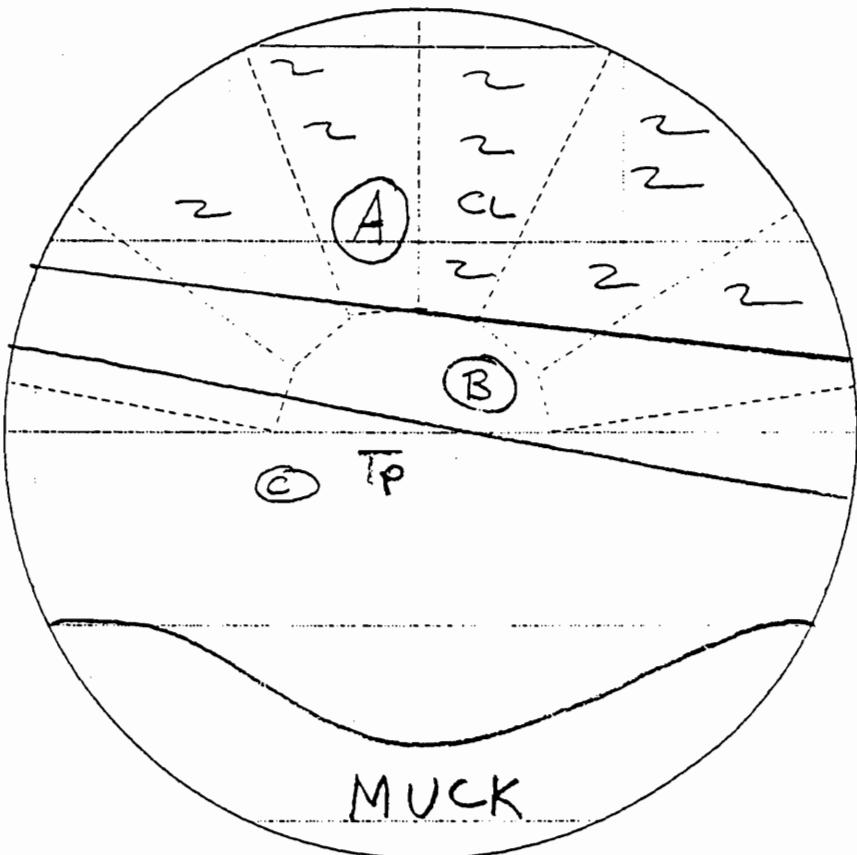
COMMENTS: A. Reddish-Brown
CLAY, Low Plasticity
medium stiff, moist
ravels during mining
B. Colluvium - same as
A with 20% chunks of weathered Puente

C. Puente formation (Tp) HIGHLY WEATHERED - crumbles to touch
Grayish green. Bedding not very well defined but mostly horizontal,
Very Very weak
mining - Operator using ripper tooth & spade over inner 60% of face.
Shield shoving caves rest.

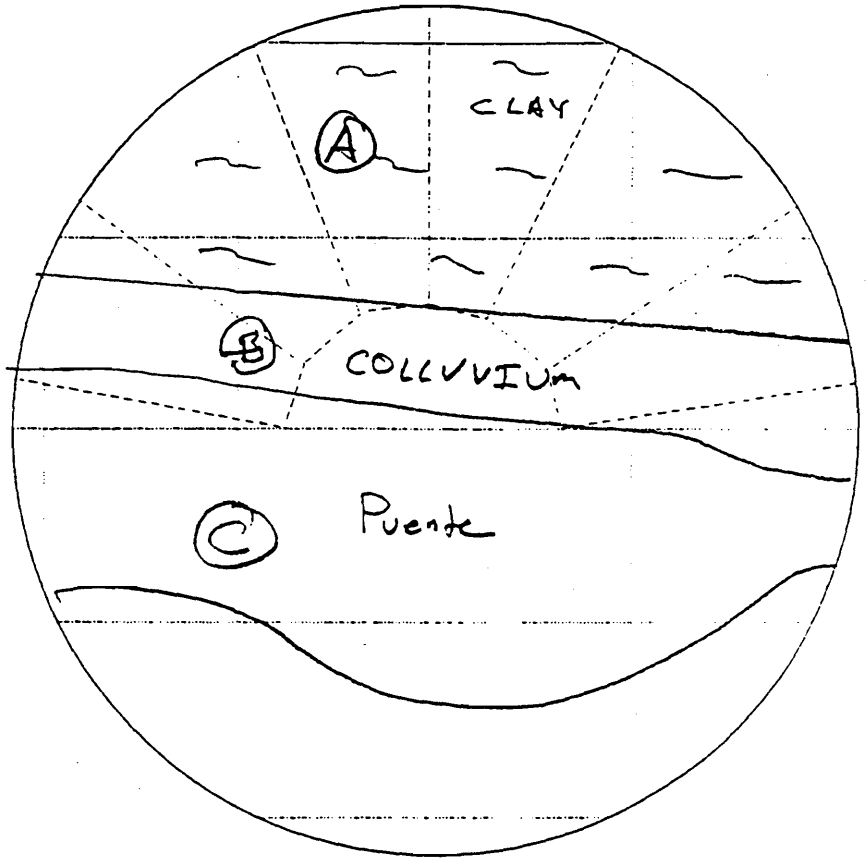
A. Reddish Brown CLAY
 Medium stiff, moist low Plasticity

B. Colluvium - Reddish brown
 CLAY with 10% chunks of weathered Puente, moist medium stiff

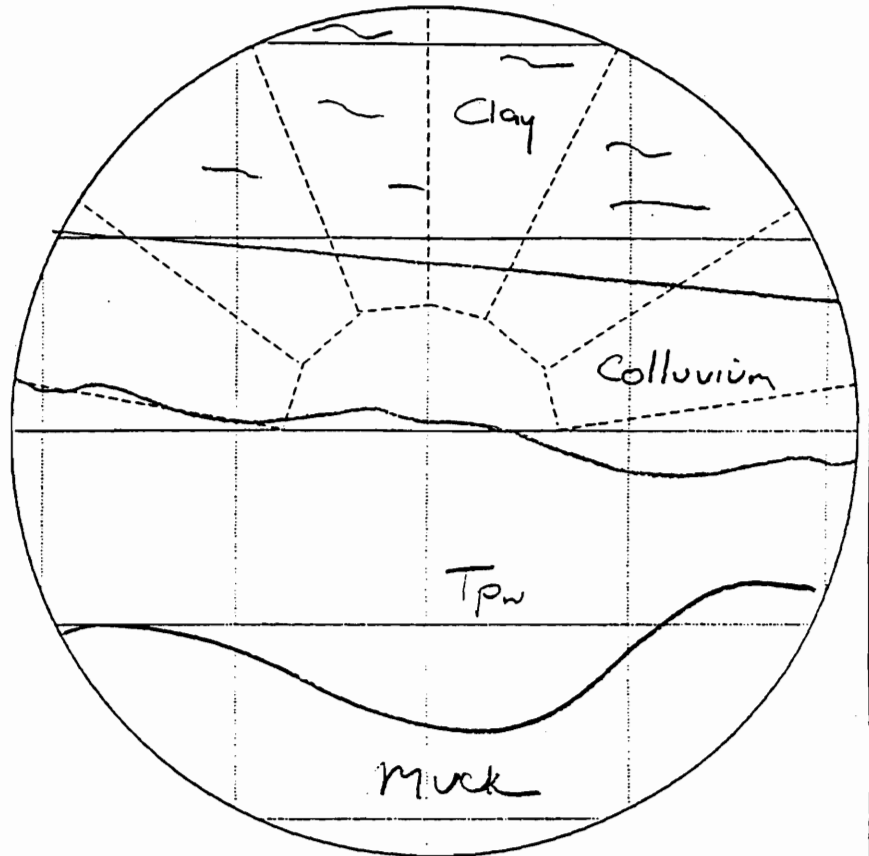
A. Reddish Brown CLAY
 moist, medium stiff low
 plasticity.

B. Colluvium - Reddish brown CLAY moist, medium stiff contains
 10-20% pieces of weathered puerco

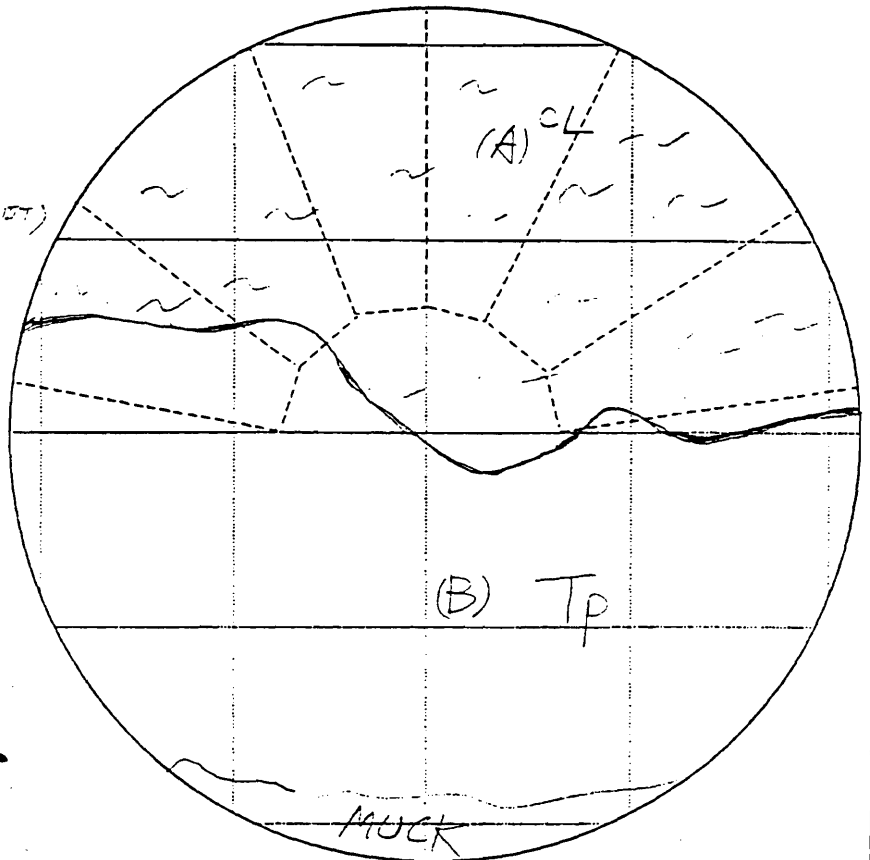
(A) ALLUVIUM - CLAY (CL). OLIVE GRAY
 IN COLOR. MEDIUM STIFF.
 MOIST.

(B) DIAPYCNITE FM. HIGHLY WEATHERED. BEDDING IS NOT WELL DEFINED BUT
 MOSTLY HORIZONTAL. MOIST. WEAK. ORANGE BROWN IN COLOR.

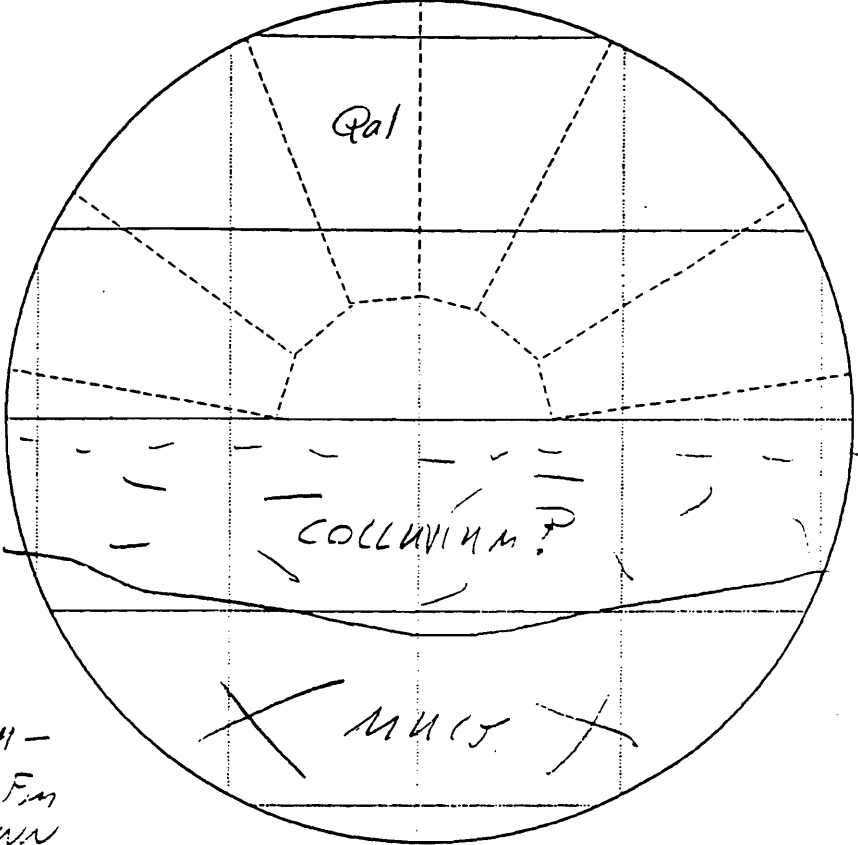
COMMENTS: ALLUVIUM / COLLUVIUM -
- HIGHLY WEATHERED PUENTE F.M
ALLUVIUM IS REDDISH-BROWN
MOTTLED, CLAY (CL) MOIST,
STIFF, NO WATER SEEPAGE
COLLUVIUM IS HIGHLY WEATHERED PUENTE CLAY, GREEN-
BROWN, MOTTLED BEDDING IS IRREGULAR

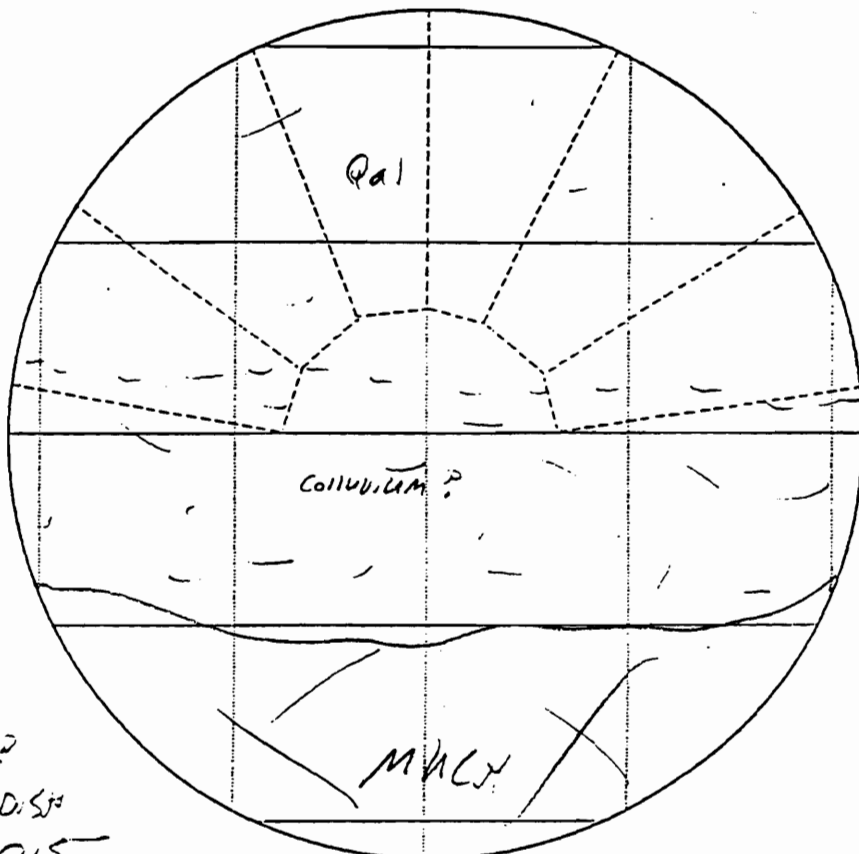
BROWN/GREEN MOTTLED WITH

IRREGULAR BEDDING - CLAY (CL)

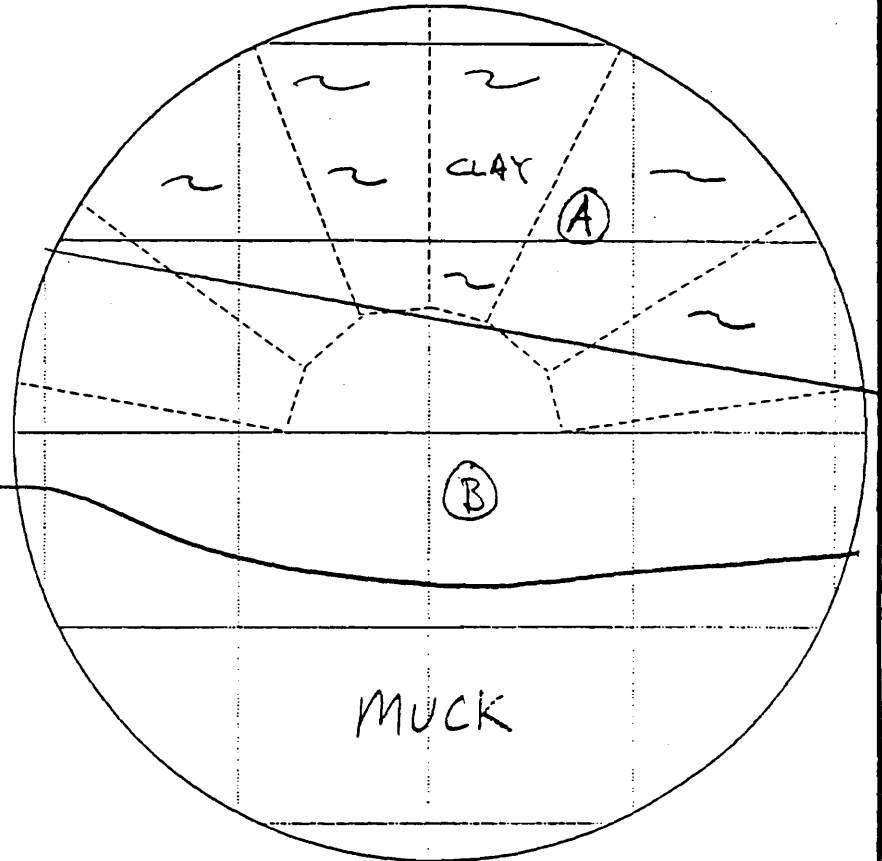
(165)

DATE: 9-10-93 TIME: 818
 HEADING: VERMONT - AL
 STATION: 439+84 ← 21 foot correction
 RING NO: 471
 PHOTOGRAPH NO: _____
 SOIL / ROCK SAMPLE NO: _____
 INSPECTOR: ELLIS
 HARD ROCK IN - RING #: _____
 HARD ROCK OUT - RING #: _____
 GPR SURVEY RING #: _____
 ROCK SPLITTER USED: _____
 SLOWER PROGRESS: _____
 GROUNDWATER INFLOW GPM: _____
 GAS TESTING: _____
 COMMENTS: _____

A. Reddish Brown CLAY
Low Plasticity, Medium stiff
raveling, moist. Trace of
wet areas on face

NO	MATERIAL	USCS	COLOR	DENSITY	CONSISTENCY	STRENGTH	WEATHERING	MOISTURE
A	CLAY	CL	Red/bn		medium stiff	—		
B	CoAlluvium	CL	Lt Brown		medium stiff	—

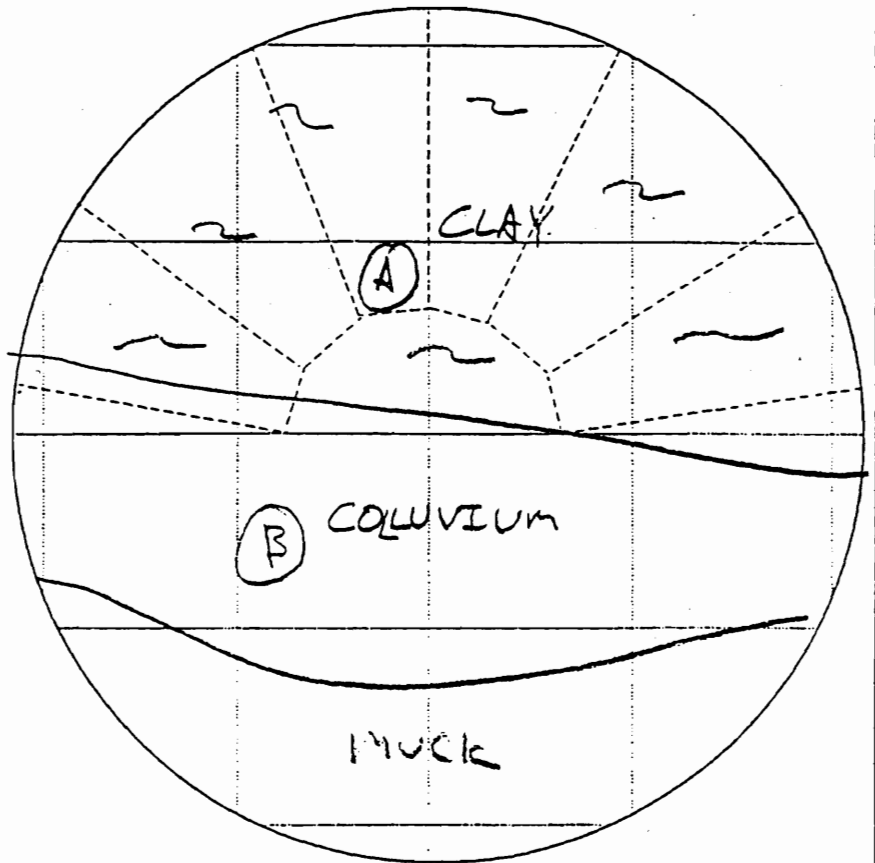
(166)

DATE: 9-10-93 TIME: 1223
 HEADING: VERMONT - AL
 STATION: 439+52
 RING NO: 479
 PHOTOGRAPH NO: _____
 SOIL / ROCK SAMPLE NO: _____
 INSPECTOR: Ellis
 HARD ROCK IN - RING #: _____
 HARD ROCK OUT - RING #: _____
 GPR SURVEY RING #: _____
 ROCK SPLITTER USED: _____
 SLOWER PROGRESS: _____
 GROUNDWATER INFLOW GPM: _____
 GAS TESTING: _____
 COMMENTS: _____

(A) - Reddish Brown CLAY medium stiff, raveling during excavation
moist

NO	MATERIAL	USCS	COLOR	DENSITY	CONSISTENCY	STRENGTH	WEATHERING	MOISTURE
A	CLAY		Red brown		medium stiff			moist
B	CLAY		Red Lt Brn		medium stiff			moist

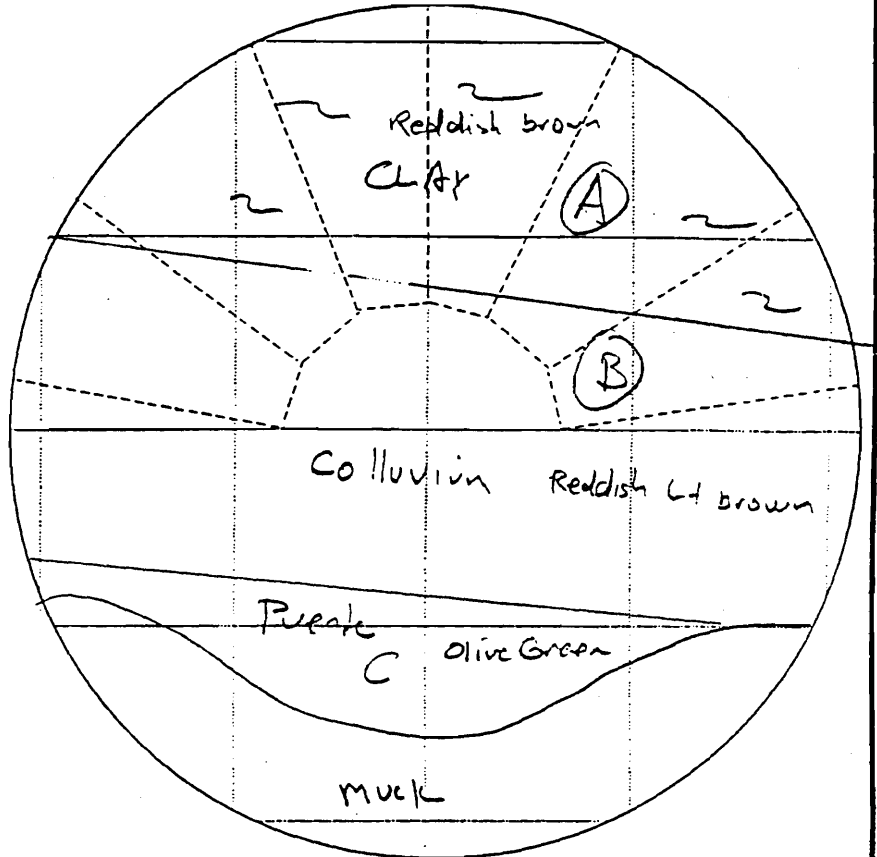
mining - operator using
Spade over 60% of
face

NO	MATERIAL	USCS	COLOR	DENSITY	CONSISTENCY	STRENGTH	WEATHERING	MOISTURE
A	CLAY	CL	RB		mod stiff			moist
B	Colluvium	CL	RLB		mod stiff			↓
C	Puede	TP	OG			Very Weak	Very Weak	↓
