Supportive Transit Parking Program

A key first step of the STPP Master Plan effort was the collection of quantitative data regarding how Metro’s parking spaces and qualitative information related to their condition and access. The purpose of the Facility Assessment effort was to understand current system operation and performance, which served as baseline information required to recommend future policy and operational changes, and to recommend and quantify the cost of improving the parking facilities.

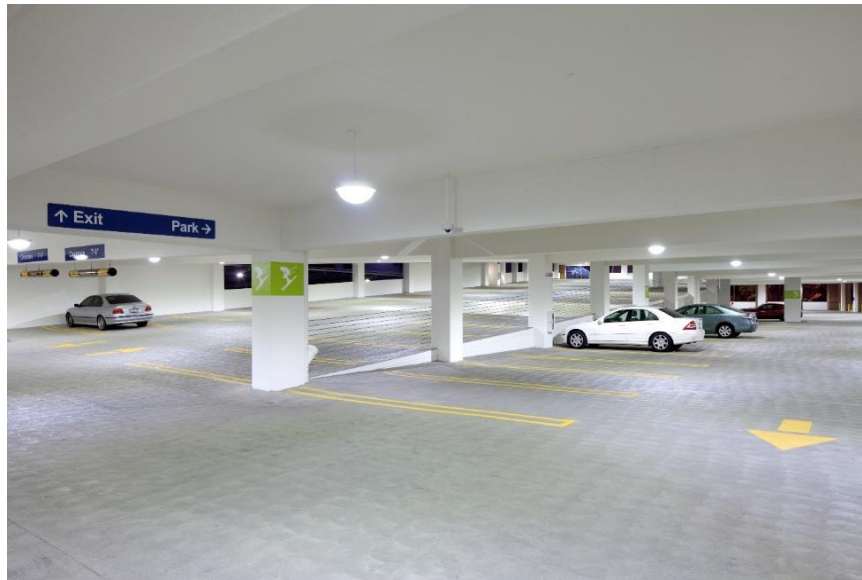
Figure 1: Examples of Minimum Lighting with Level of Service A

Level of service C is the recommended minimum threshold of acceptable lighting. For example, under level of service C, covered levels would have foot-candle levels between 2.0 and 3.0 while top levels and surface parking lots would have foot-candle levels between 0.5 and 1.5. Minimum foot-candle values that fall below level of service D (less than 1.0 for covered levels and less than 0.2 for top levels and surface parking lots) would be considered level of service E. Lighting levels continue to degrade over time. Therefore, lighting at levels D or E will only continue to decline in light output. Figure 1 illustrates examples of minimum lighting with level of service A.

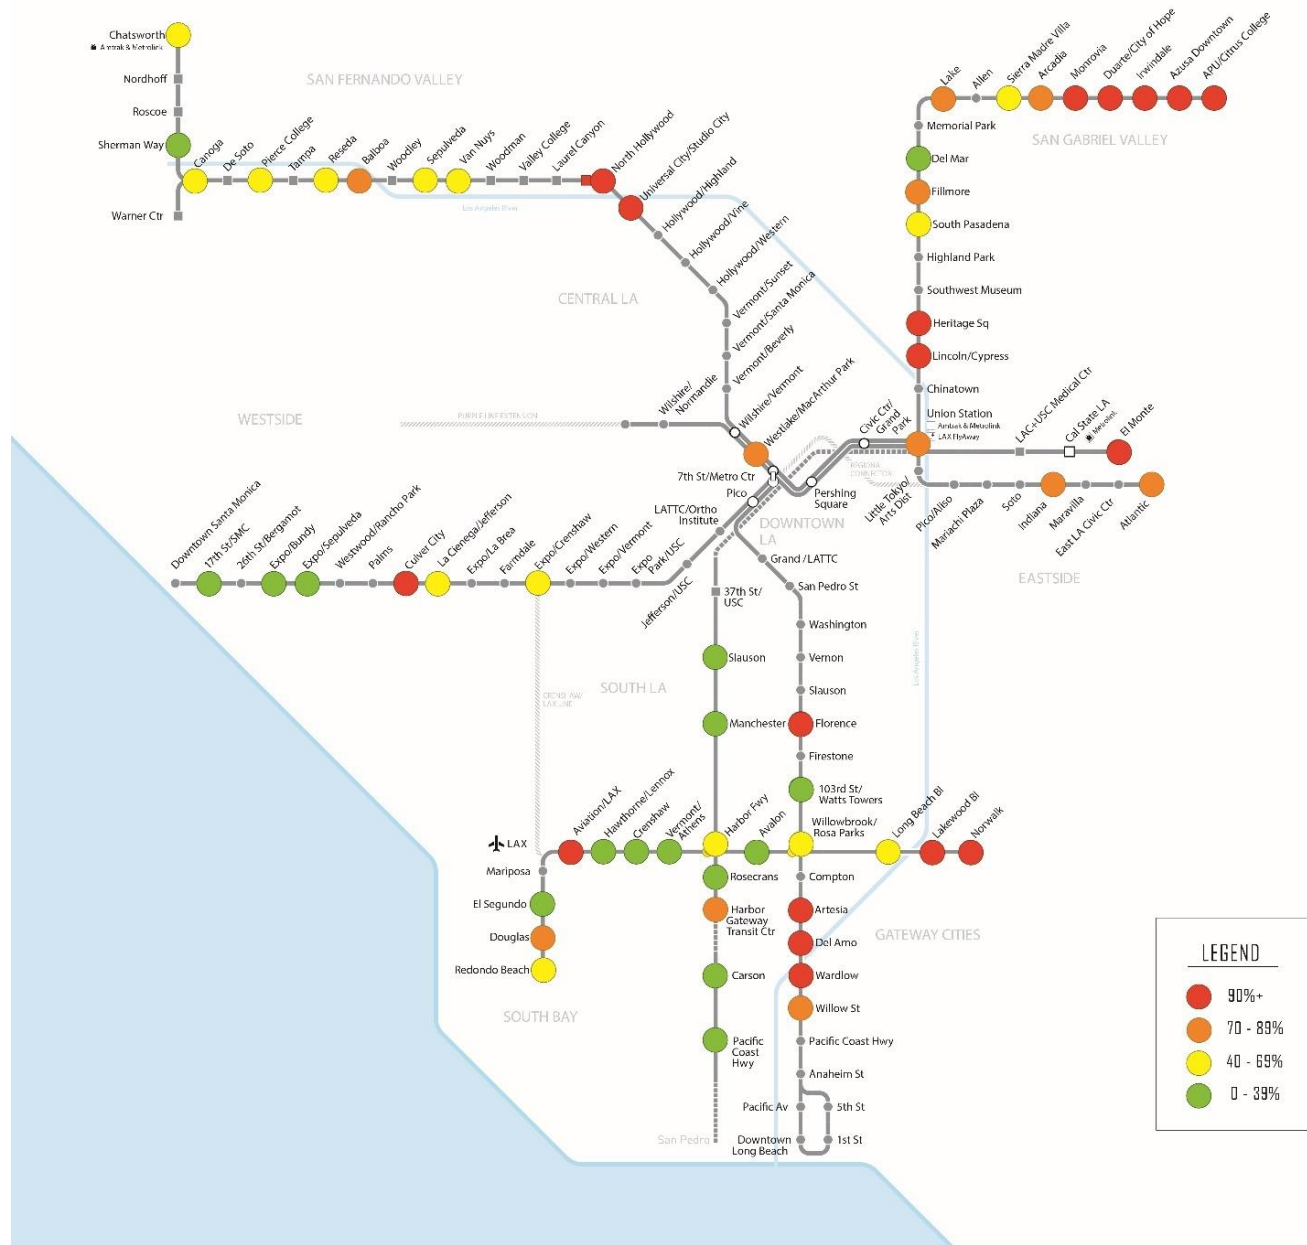
Figure 2: Metro Parking System Weekday Morning Occupancy Map

Figure 2 illustrates weekday morning occupancy throughout the Metro parking system. Occupancy levels are highest at terminus locations (and former ones in the case of Culver City) and stations that are the next closest to Downtown Los Angeles as demand at terminus locations will spill over to these. Gold Line stations along the Foothill extension experience high occupancy as do southern stations along the Blue Line.

Weekday evening and weekend (Saturday afternoon) occupancy levels were almost always lower than weekday morning occupancy levels. Aviation/LAX station had consistently high occupancy levels, likely due to LAX employees using the lot. APU/Citrus College also experienced high occupancy during the weekday morning and weekend.

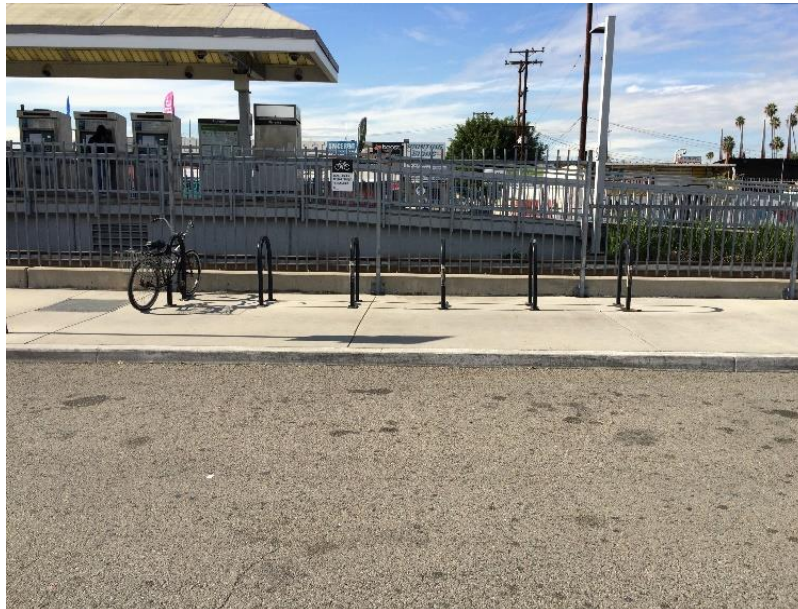
There are no bicycle facilities on or off-street in the vicinity of the station. The station itself provides a few bicycle racks but no bike lockers.

Photo 1: Bicycle Racks Adjacent to Station Platform

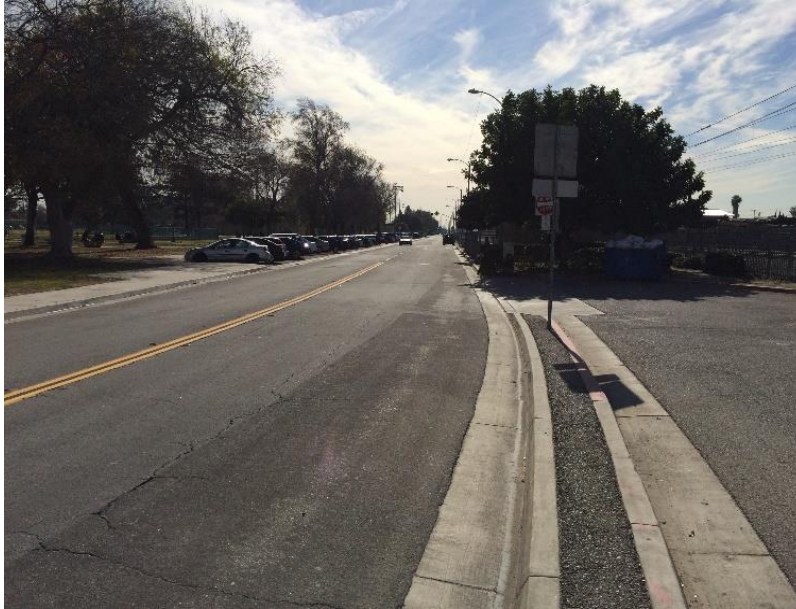
Photo 2: No Sidewalks on the West Side of Graham Ave. South of the Station

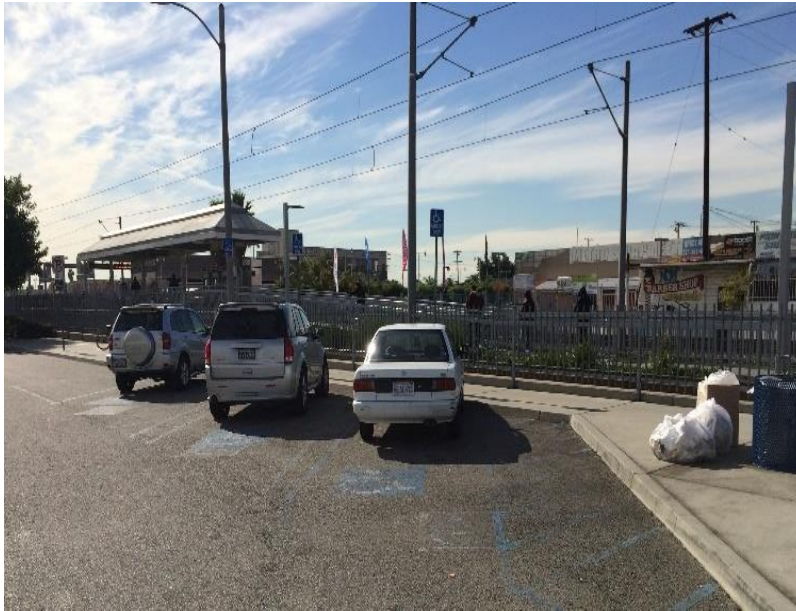
Photo 3: Bagged Trash Adjacent to Trash Can

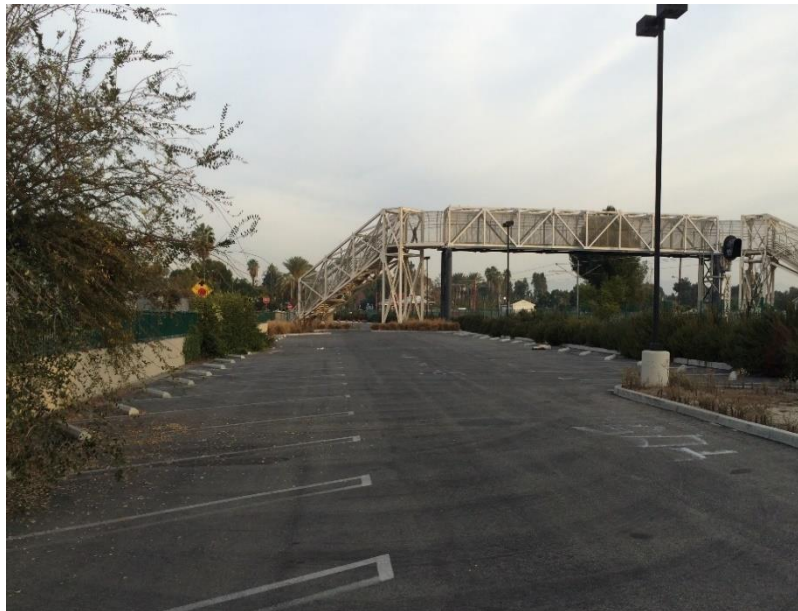
There is good pedestrian connectivity between the station and surrounding areas. Once parked, it is not apparent where the station platform is located.

Photo 4: No Signage in Lot to Direct Riders to the Platform

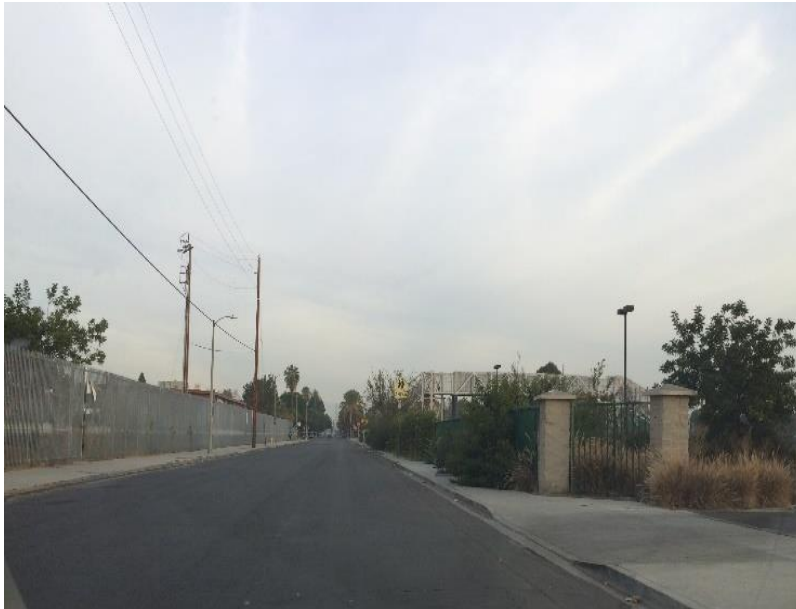
Photo 5: No Wayfinding Signage on Grandee Ave.

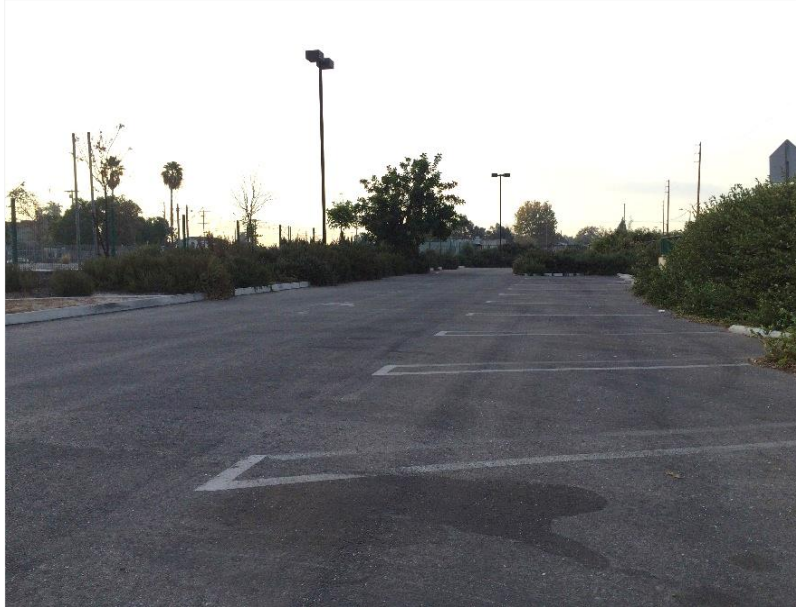
Photo 6: Faded Parking Space Striping

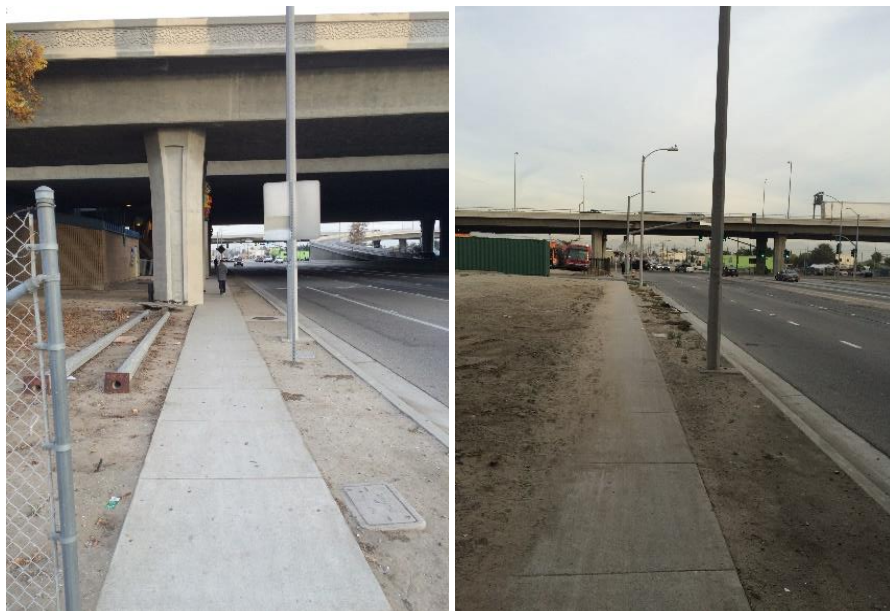
Sidewalks are in good shape. It is a long walk from the South Lot to the bus area, since the only option is to cross Wilmington at Imperial highway. The other option would be to walk up the platform to the Blue Line, across the freeway, and back down to access the buses.

Photo 8: Sidewalks along Wilmington Ave.

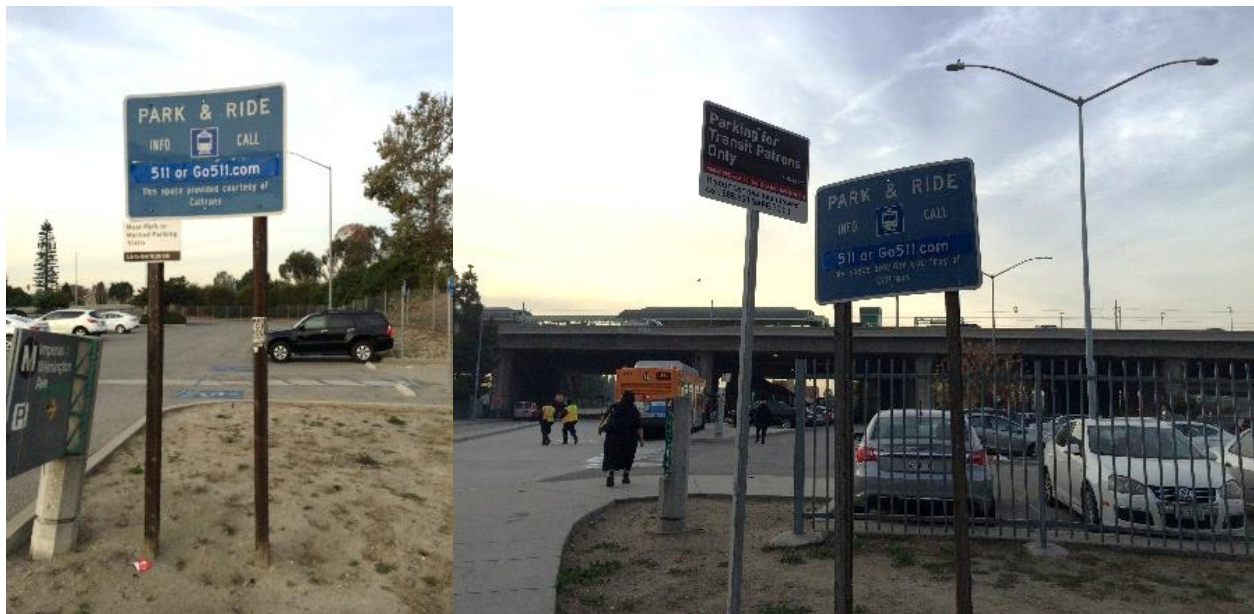
No visible monument signs on Wilmington or Imperial and no signage at parking entrances. No parking wayfinding signs, aside from Caltrans Park-and-Ride signs outside the parking lots. Due to heavy traffic on Wilmington, it is difficult to get from the North Lot to the South Lot when the North Lot is full. No signs directing motorists to the South Lot from the North Lot, which would be especially beneficial when the North Lot is full.

Photo 9: Signage at Entrance to South Lot (L); Signage at Entrance to North Lot (R)

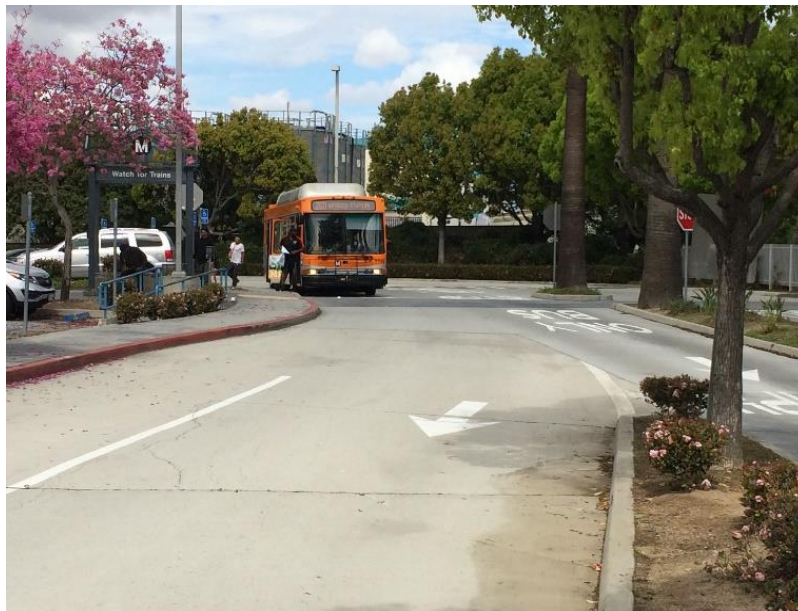
Sidewalks are in good shape on Acacia Court and Artesia Blvd. However pedestrians have no direct access to Artesia Blvd. and there is no pedestrian connection to the casino next door. Pedestrians must walk out to Acacia Court, south to Artesia Blvd. and then to the casino. There is a gated pedestrian access present between the station and the casino, but it is currently locked.

Photo 10: Entrance Lane and Sidewalk off of Acacia Ave.

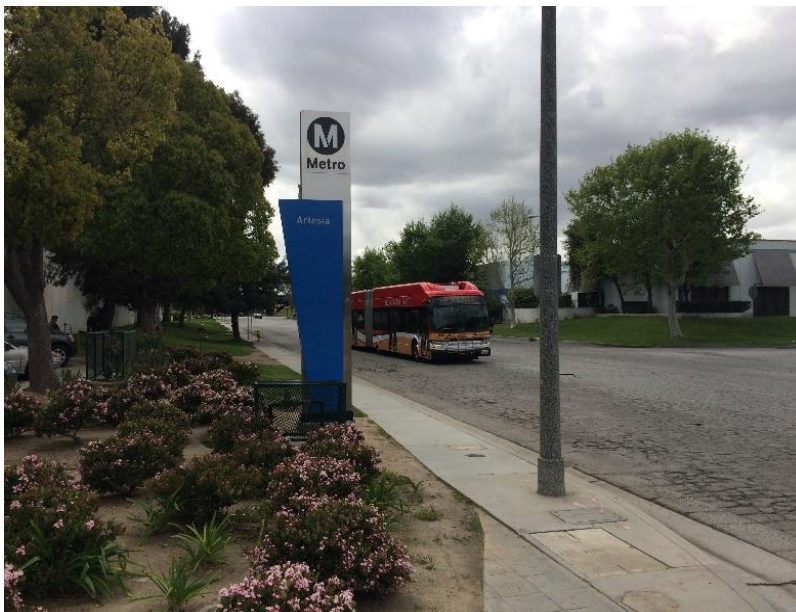
The station monument sign is on Acacia Court, but there is no signage on the main arterial, Artesia Blvd., when passing the station. There is no parking signage at the Acacia Court/Artesia Blvd. intersection that would indicate a train station with parking facilities is nearby.

Photo 12: Station Monument Sign

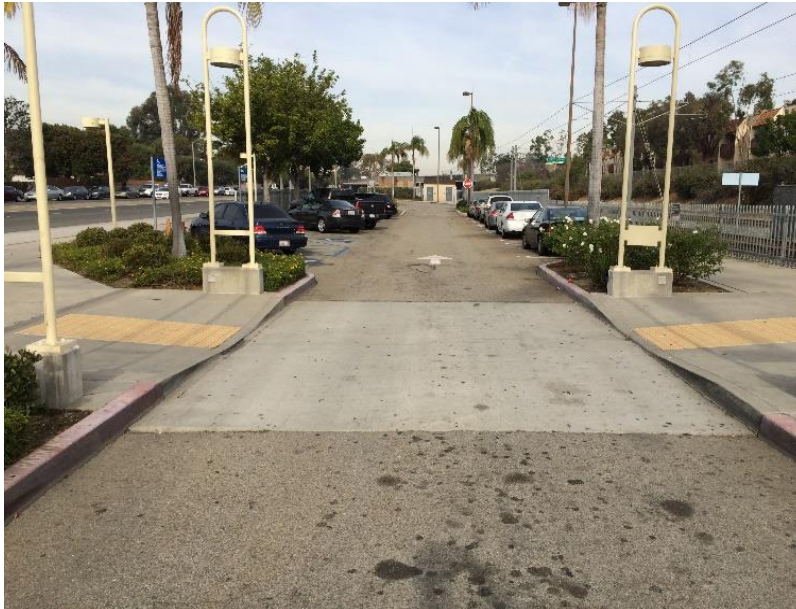
Photo 22: Non-Optimal Placement of ADA Parking

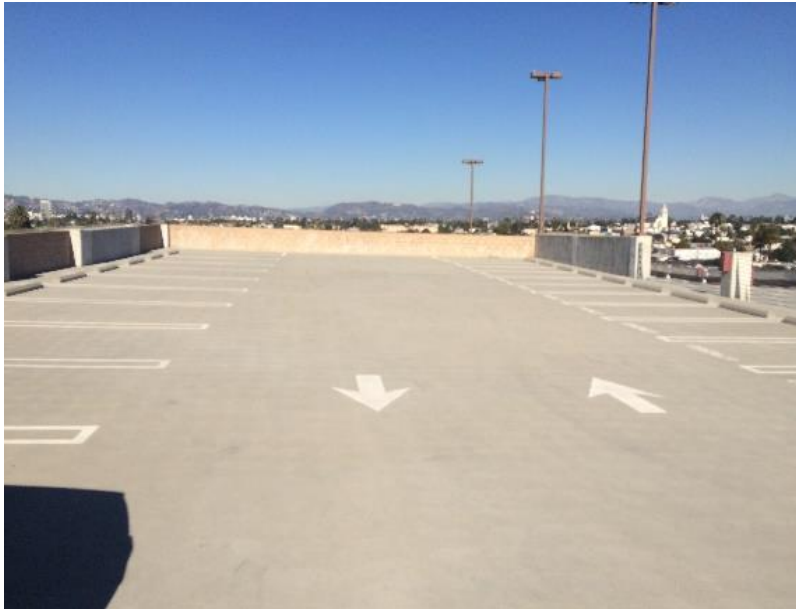
Photo 30: Roof of Parking Garage

No evening lighting measurements were taken at this location, however low lighting levels inside the parking structure were observed during the daytime.

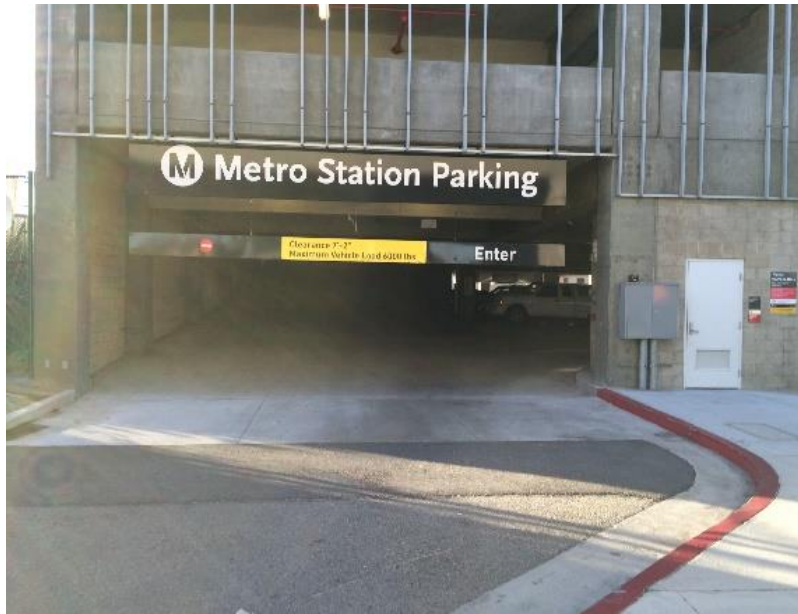
There are some parking wayfinding signs on the adjacent roadways such as a sign on westbound Jefferson Blvd. at the entrance to the parking structure, and signs pointing to the parking structure on northbound La Cienega. There are no wayfinding signs on eastbound Jefferson Blvd. or southbound La Cienega Blvd. No signage on southbound La Cienega Blvd. is a critical gap because drivers from the north must turn left onto Jefferson to be able to enter the parking structure.

Photo 34: Parking Entrance Signage

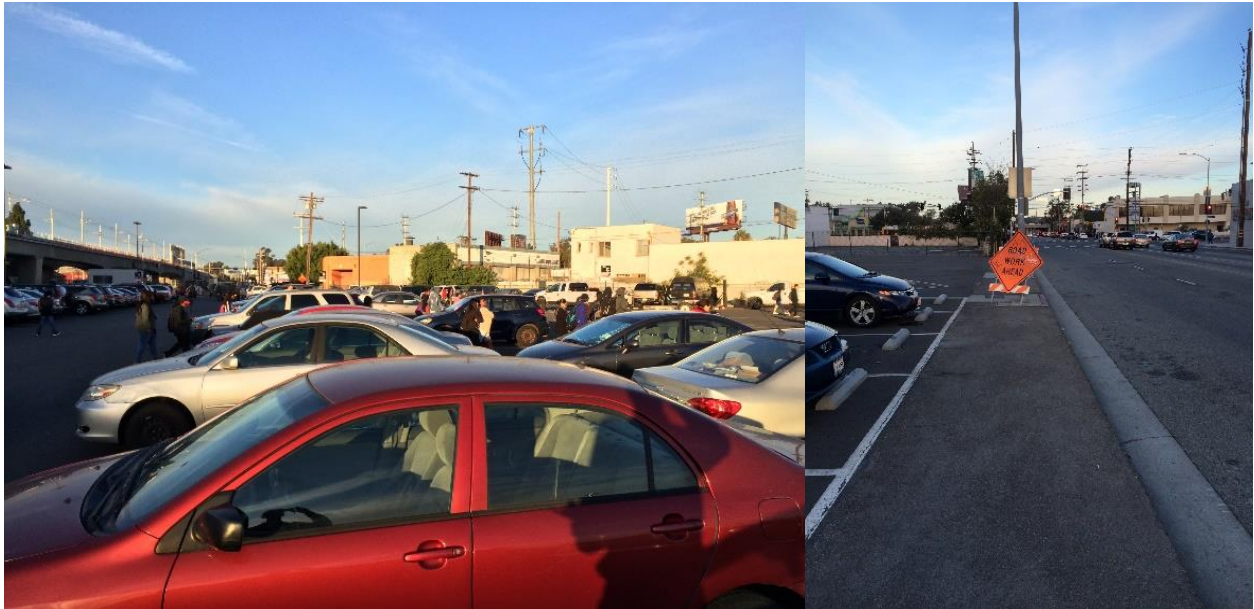
Sidewalks are present on Venice Blvd., Washington Blvd. and National Blvd., and are generally in good condition. The sidewalk on National Blvd. adjacent to the parking lot has some obstructions and uneven pavement. There is a lot of pedestrian activity within the lot, as students from Alexander Hamilton High School take the train to the Culver City station and walk through the parking lot on their path to school.

Photo 37: Students from Hamilton High School Crossing Through the Lot (L); Sidewalk along National Blvd. (R)

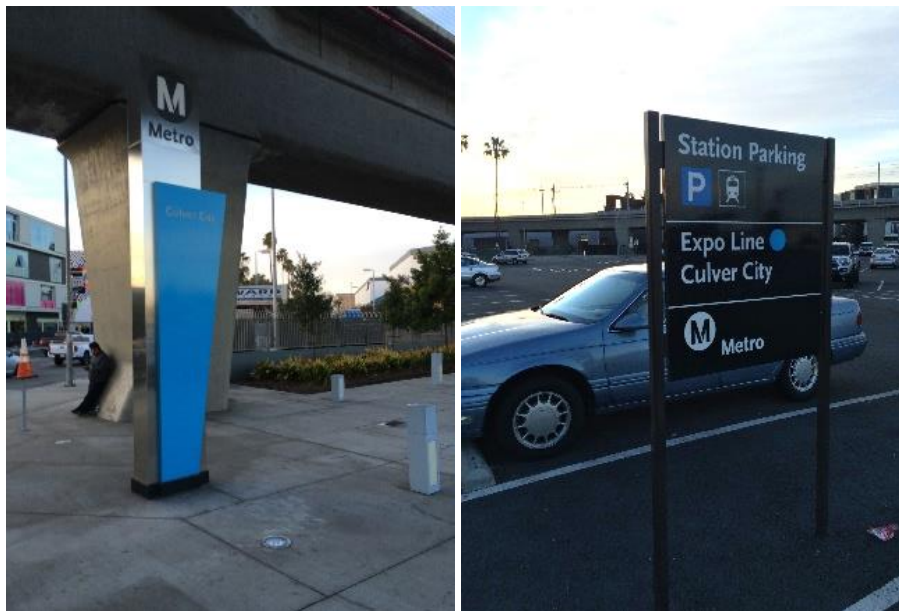
There is no wayfinding signage on Venice Blvd. directing patrons to the station, whether on foot or driving. There are only small signs at the entrances to the parking lot, which are easy to miss for motorists passing by. The directional signage within the parking is confusing and appears to be ignored; entering the lot at the Washington Blvd. driveway, motorists are immediately greeted with a no right-turn sign.

Photo 38: Station Monument Sign (L); Signage at Entry to Parking Lot (R)

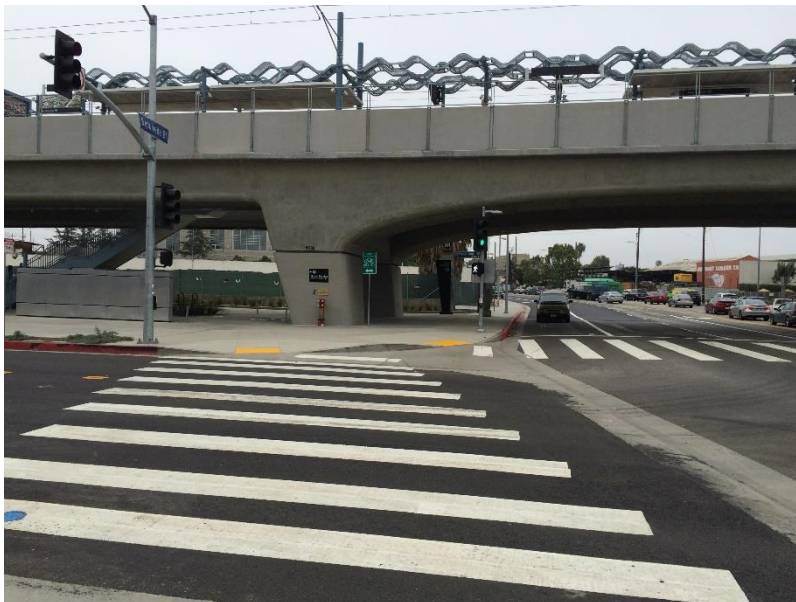
There are parking wayfinding signs on Exposition Blvd., attached to the support pillars of the train tracks. These signs are not highly visible to motorists traveling along Sepulveda Blvd.

Photo 43: Small Sign Directing Motorists to Parking

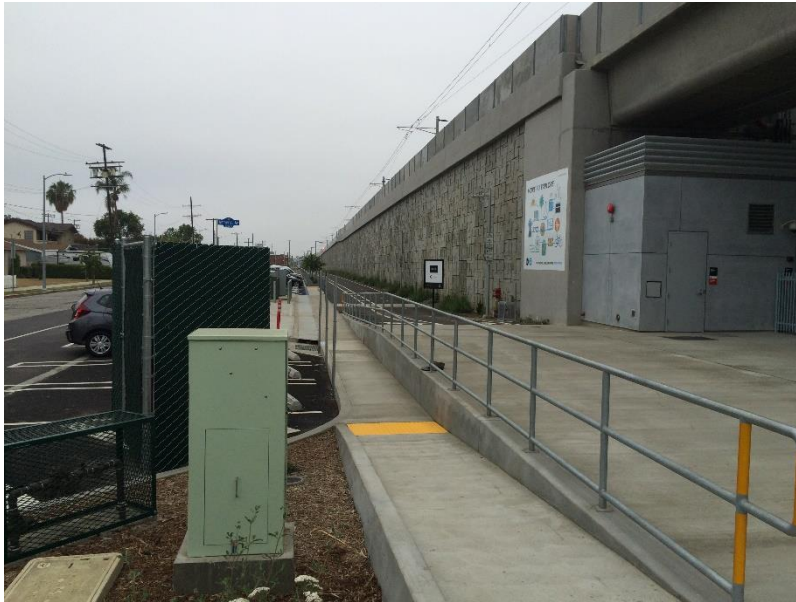
There is a small sign for an Uber waiting area; however, it is unclear where exactly this area is located.

Photo 47: Small Sign Directing to Unclear Uber Waiting Area

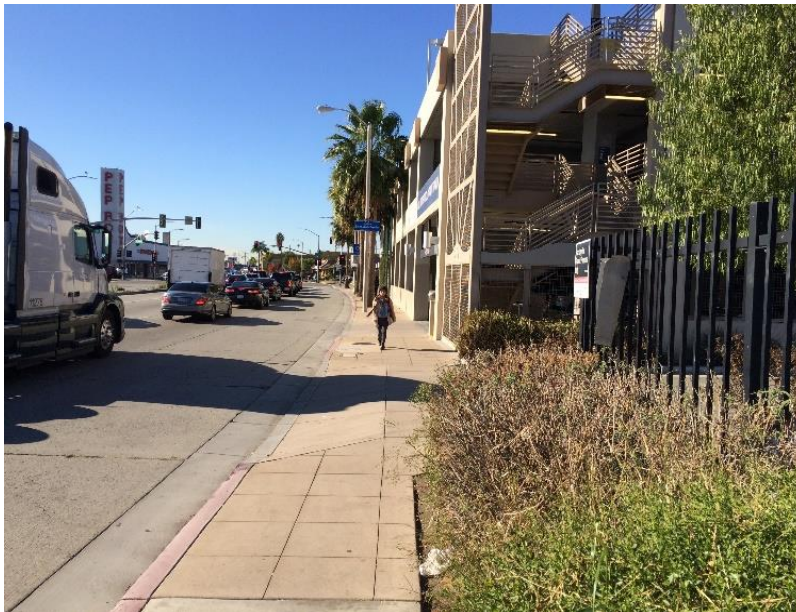
There is no parking wayfinding signage directing drivers to either the parking structure or surface lot. A driver not familiar with the parking must pay attention for signage mounted on the parking structure and surface lot fence which can be difficult to see when approaching. Since access to the parking is only along southbound Atlantic Blvd., a driver may easily miss the surface lot. Also, the entrance to the parking structure is south of the exit lane along Atlantic Blvd., which may result in drivers entering the exit lane.

Photo 57: No Visible Signage While Driving on Atlantic Blvd.

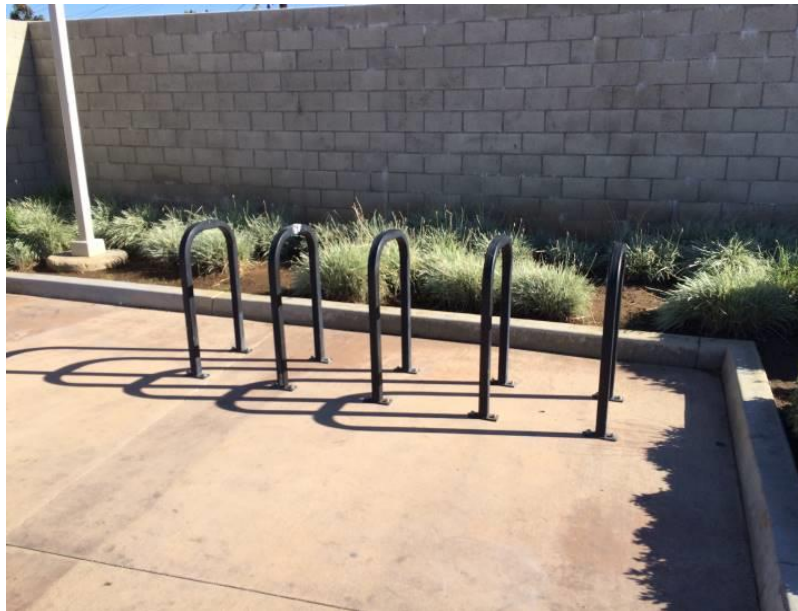
No Class I or Class II bicycle facilities in the vicinity of the station. On-site bike racks are located adjacent to the surface lot but are difficult to find.

Photo 59: Bike Racks

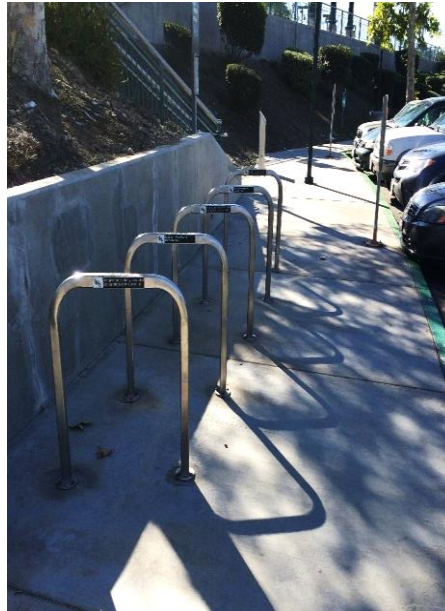
There are no Class I or Class II bicycle facilities providing station access. On-site bike racks are located adjacent to Platform 2 (towards East Los Angeles).

Photo 63: Bike Racks Adjacent to Platform 2

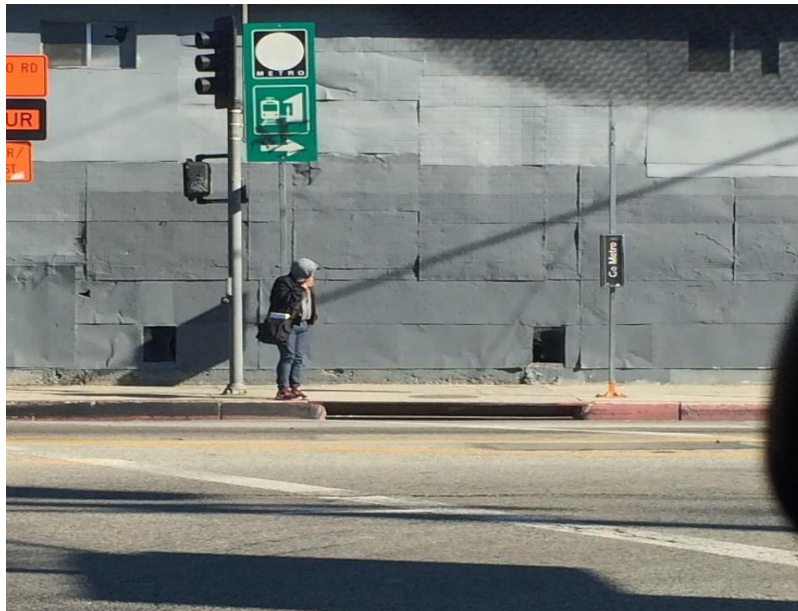
Photo 64: Crosswalk at Lacy St.

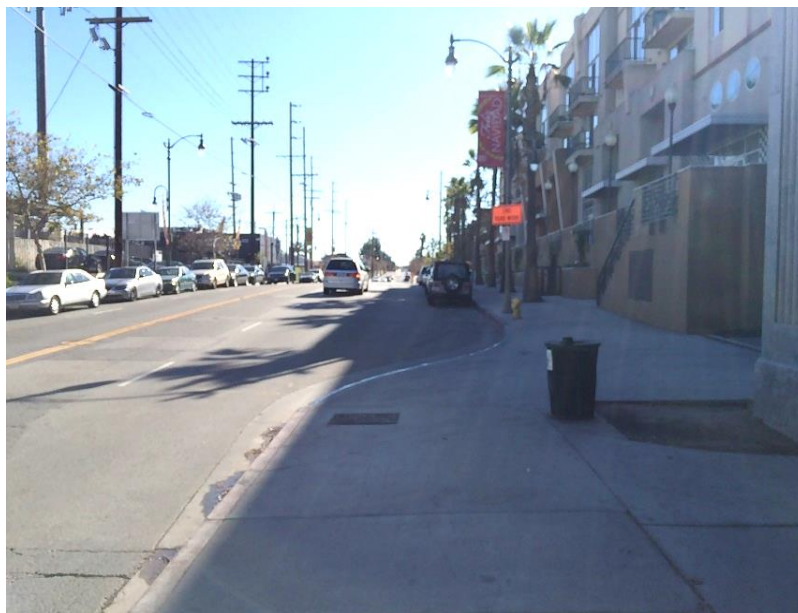
Photo 65: Sidewalk along Ave. 26

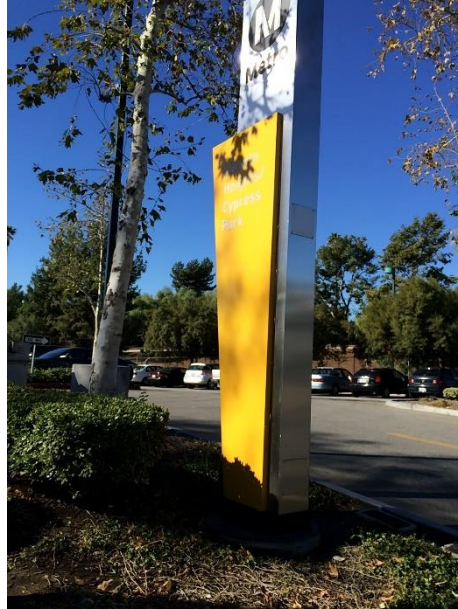
Photo 66: Station Monument Sign next to Parking Lot Entrance

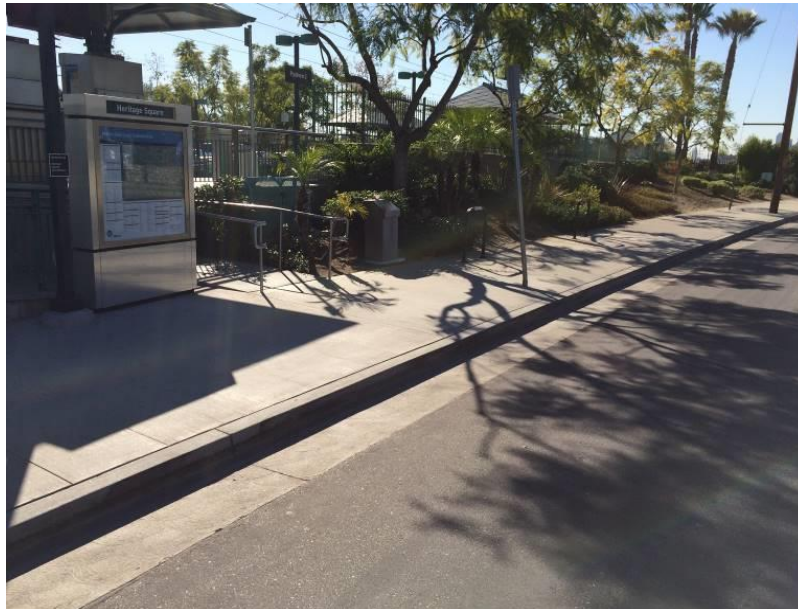
No Class I or Class II bicycle facilities in the vicinity of the station. On-site bike racks are located adjacent to the platform along Marmion Way and can be difficult to find if a bicyclist is expecting them to be adjacent to the parking lot.

Photo 67: Bike Racks Adjacent to Platform along Marmion Way

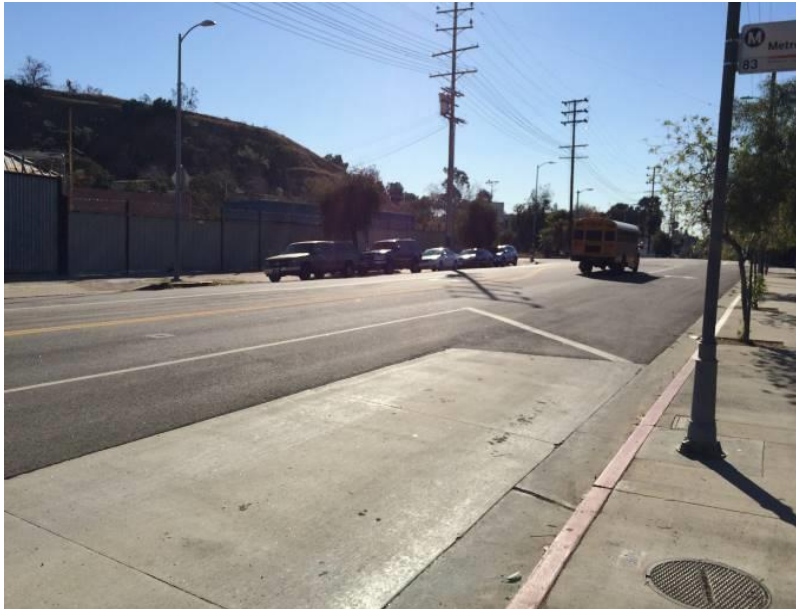
Photo 68: Sidewalk along Pasadena Ave.

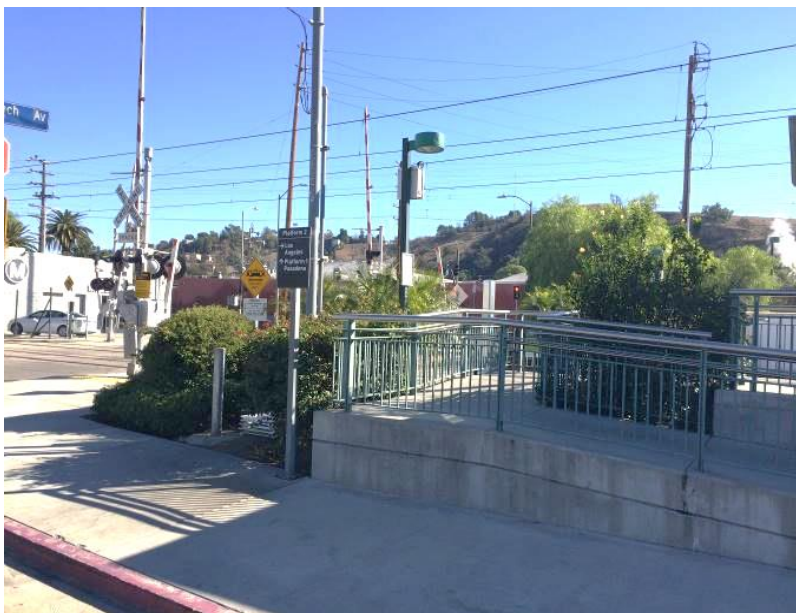
Photo 69: Sidewalk along Marmion Way

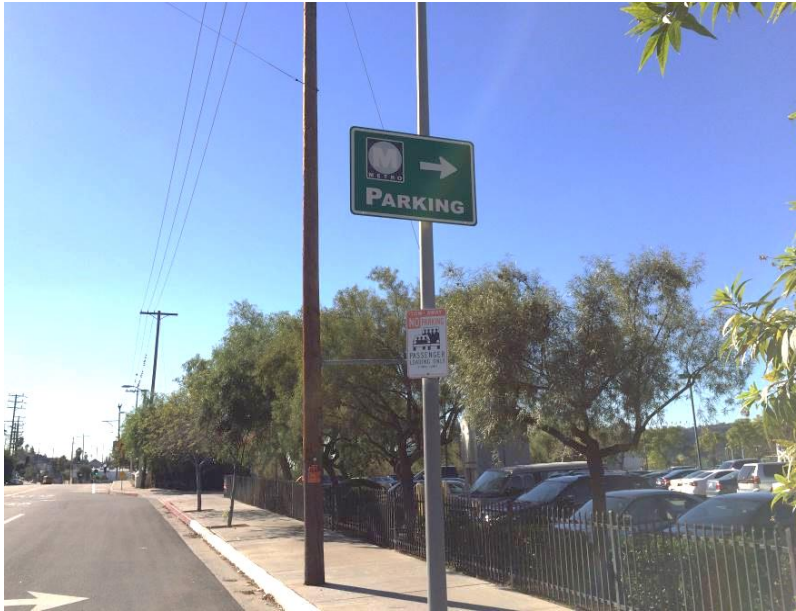
Photo 70: Wayfinding Signage along Pasadena Ave.

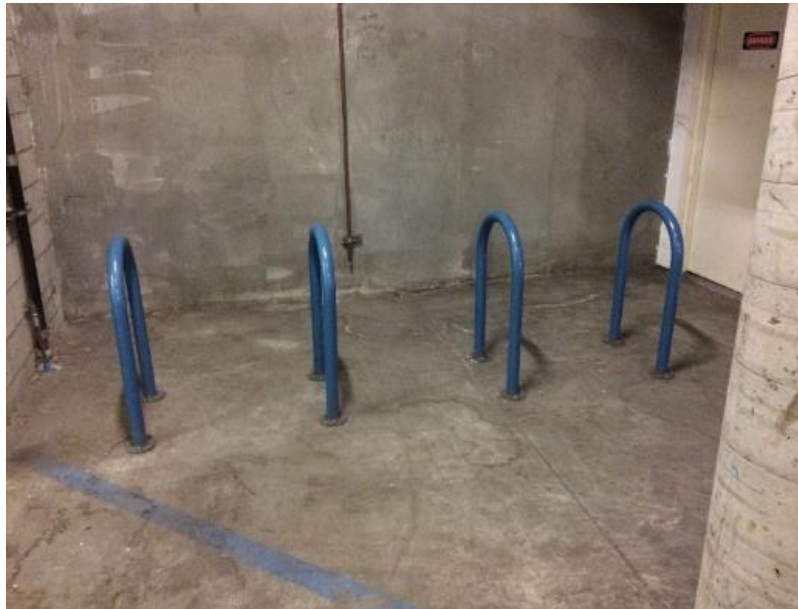
There are no Class I or Class II bicycle facilities providing station access. On-site bike racks are located in the parking structure and also near the platform bound towards Sierra Madre Villa station. There is no signage directing bicyclists to bike parking in the parking structure

Photo 71: Bike Racks in Parking Structure

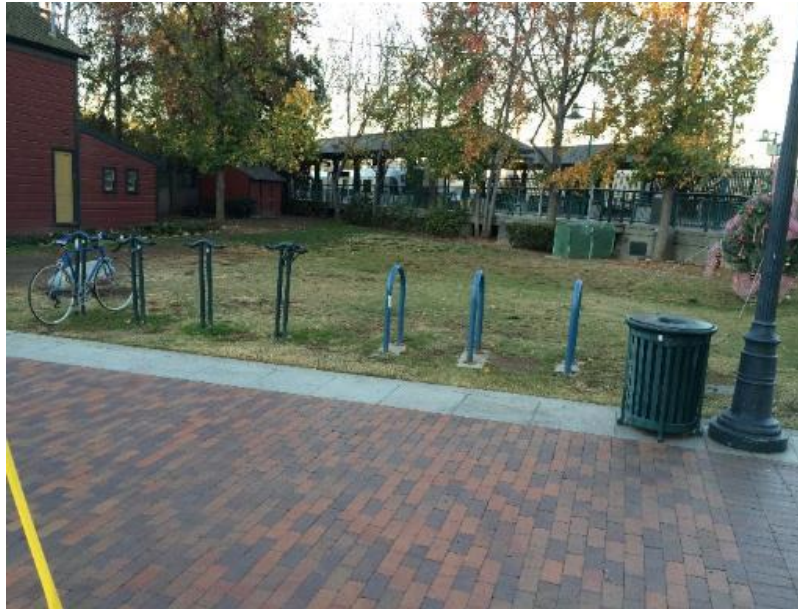
Photo 72: Bike Racks near Station Platform

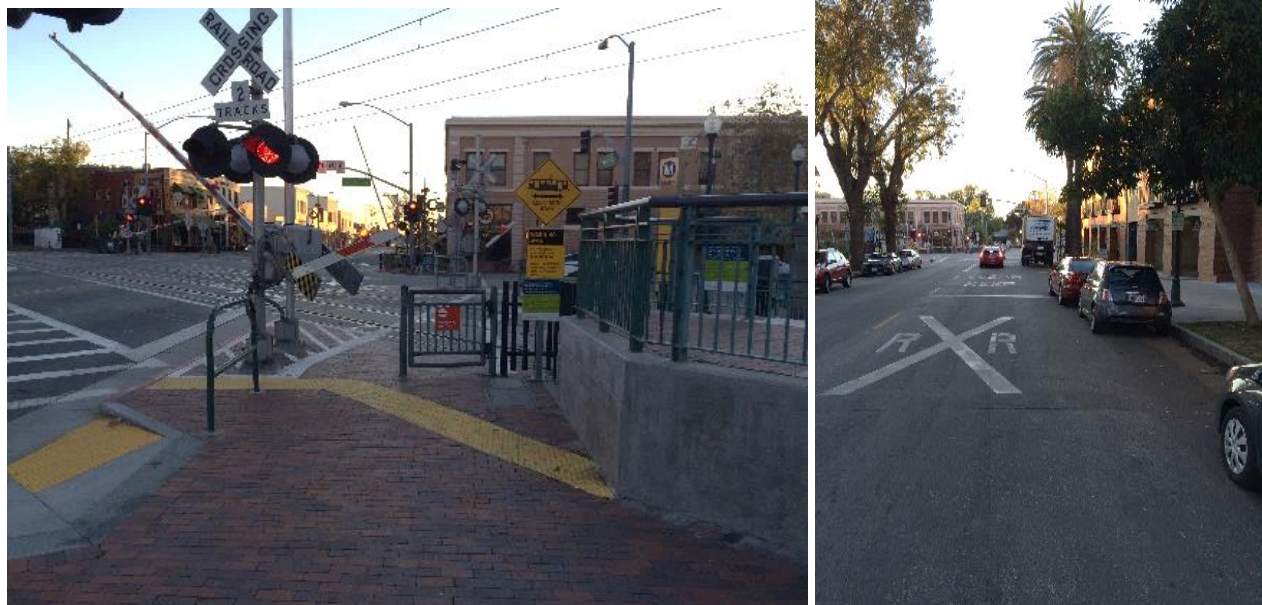
There is good sidewalk connectivity to the station area. Sidewalks are wide and in good condition. There is limited signage in the parking structure directing Metro riders to the station platform area.

Photo 73: Sidewalks near Station Platform (L); Sidewalk along Meridian Ave. (R)

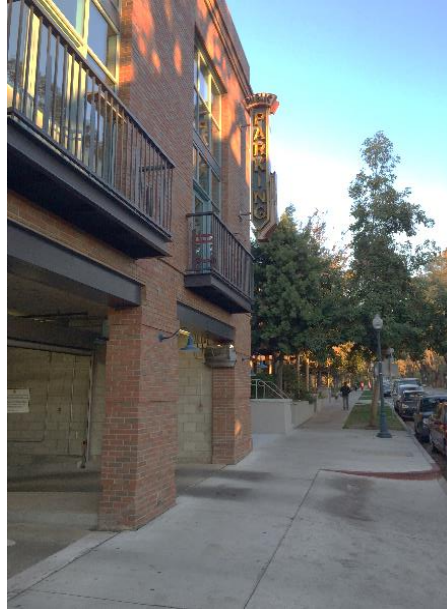
Photo 74: Parking Structure Entrance

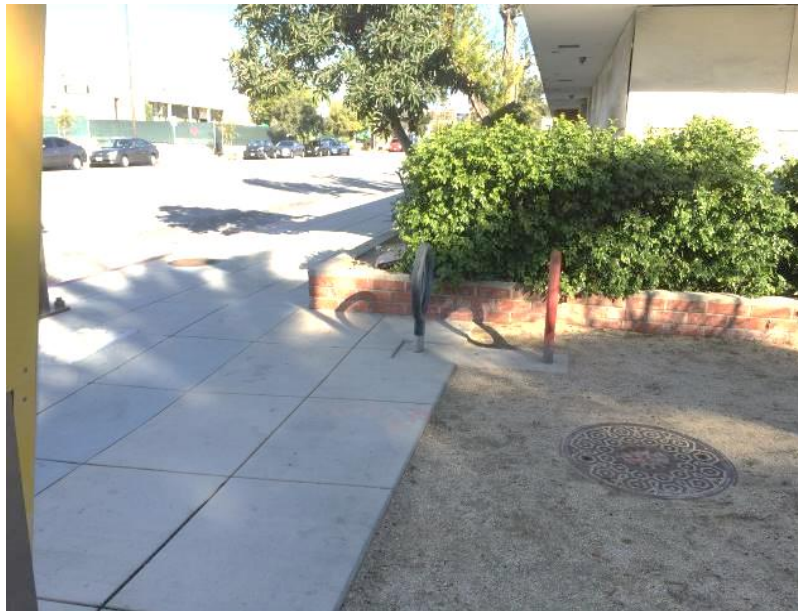
Photo 75: Bike Racks next to Sidewalk

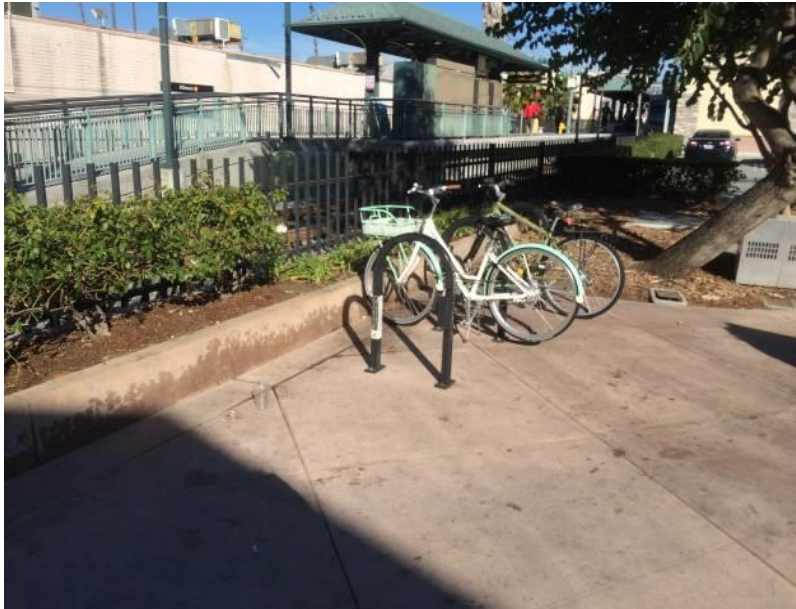
Photo 76: Bike Racks Closer to Station Platform

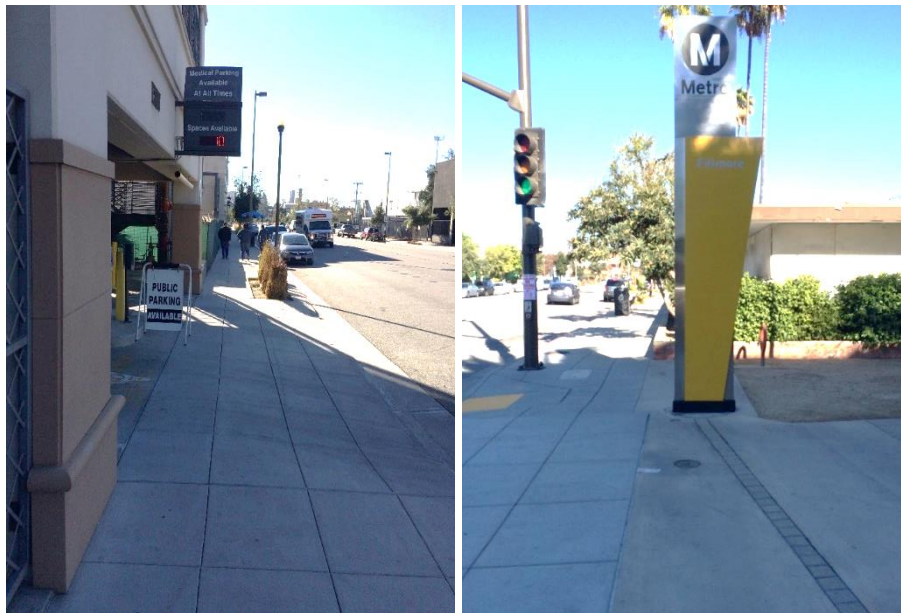
Photo 77: Sidewalk along Raymond Ave. Looking South (L); Sidewalk along Raymond Ave. Looking North (R)

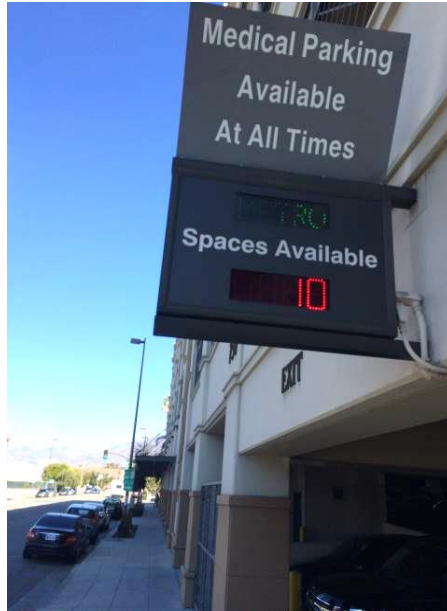
Photo 78: Signage at Entrance to Parking Garage

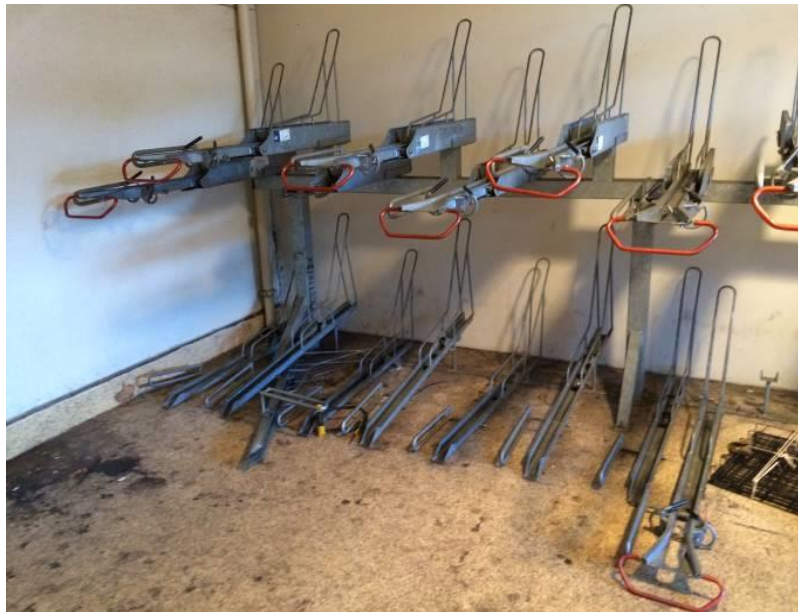
No Class I or Class II bicycle facilities in the vicinity of the station. On-site bike racks are located in a bike storage room that is not well-maintained.

Photo 79: Poorly Maintained Bicycle Storage Room

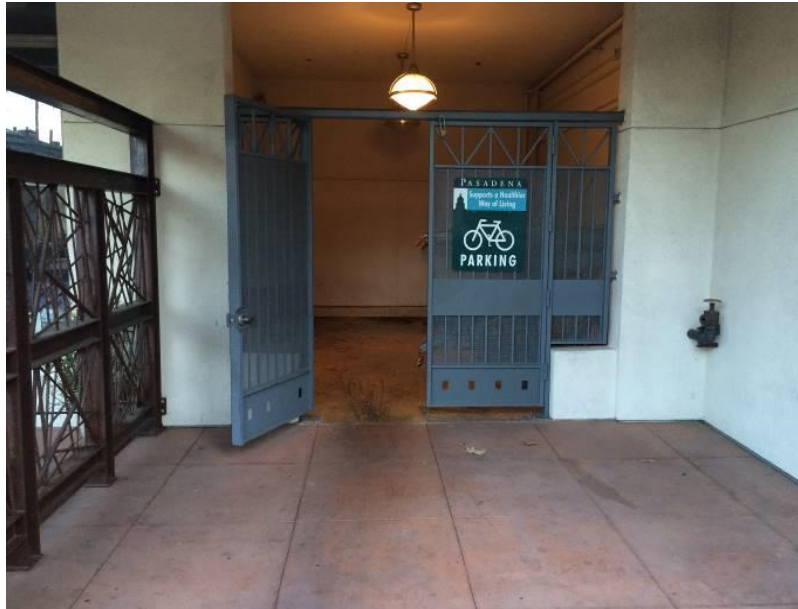
Photo 80: Entrance to Bicycle Room
