Supportive Transit Parking Program

A key first step of the STPP Master Plan effort was the collection of quantitative data regarding how Metro’s parking spaces and qualitative information related to their condition and access. The purpose of the Facility Assessment effort was to understand current system operation and performance, which served as baseline information required to recommend future policy and operational changes, and to recommend and quantify the cost of improving the parking facilities.

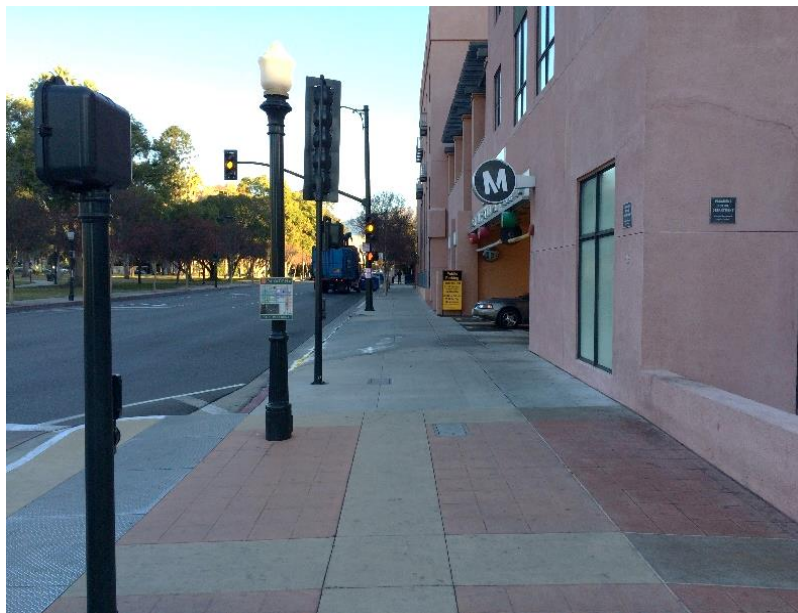
Photo 81: Sidewalk along Raymond Ave. Looking North

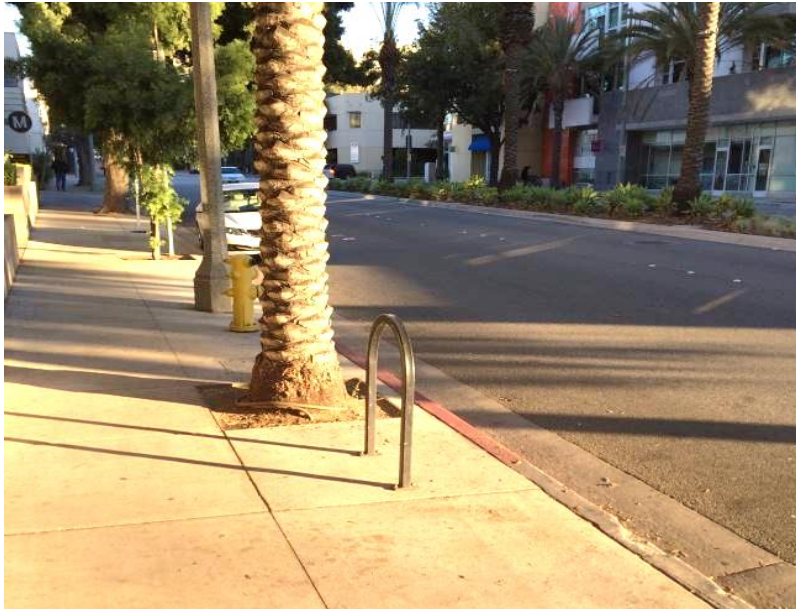
Photo 82: Sidewalk along Raymond Ave. Looking South

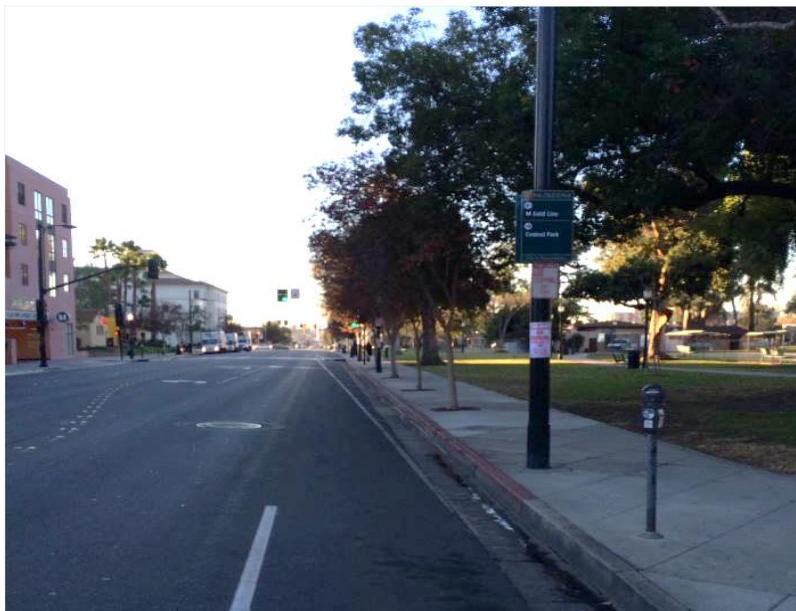
There is some parking wayfinding signage along Raymond Ave. but none along Arroyo Parkway. There are Metro logos mounted perpendicular to the façade that can be seen from a distance while driving on Raymond Ave. and Arroyo Parkway.

Photo 83: Wayfinding Signage along Raymond Ave.

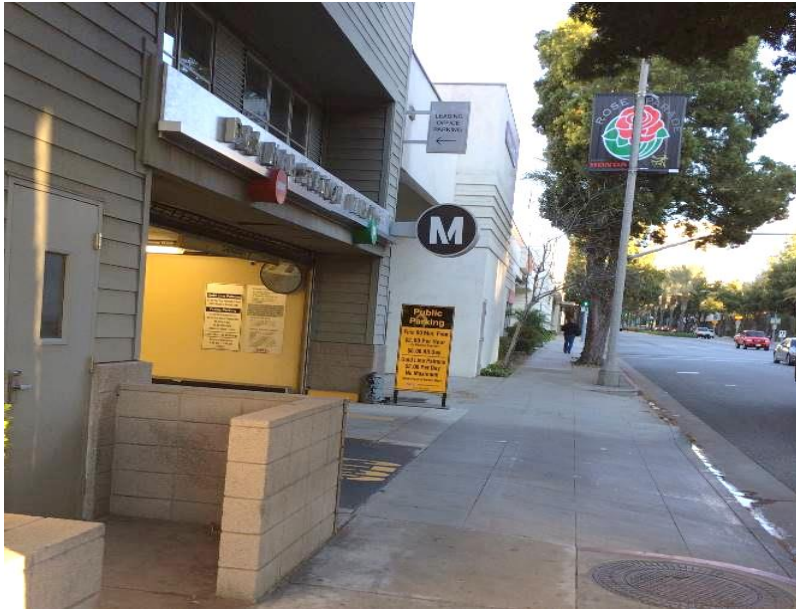
Photo 84: Metro Signage at Entrance to Parking Garage

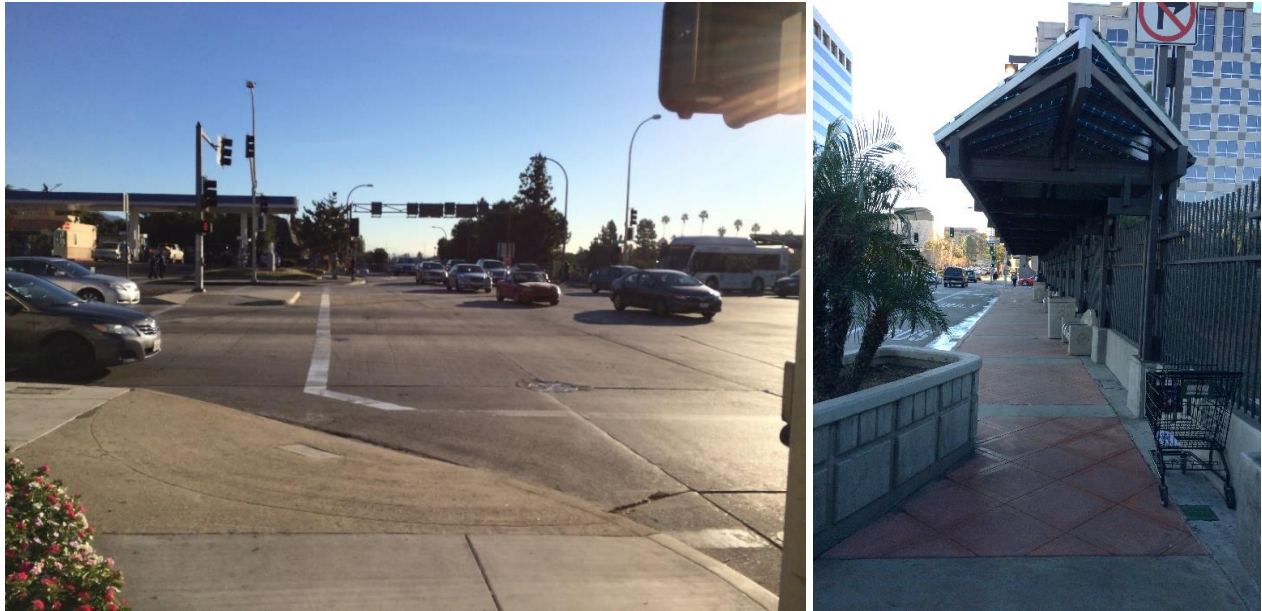
There is only one east/west crossing at Maple St. and Lake Ave. as well as at Corson St. and Lake Ave. Sidewalks in the area are wide and in good condition. Limited signage directs those who park to the station.

Photo 85: Pedestrian Crosswalks at Intersection of Maple St. and Lake Ave. (L); Sidewalk along Lake Ave. (R)

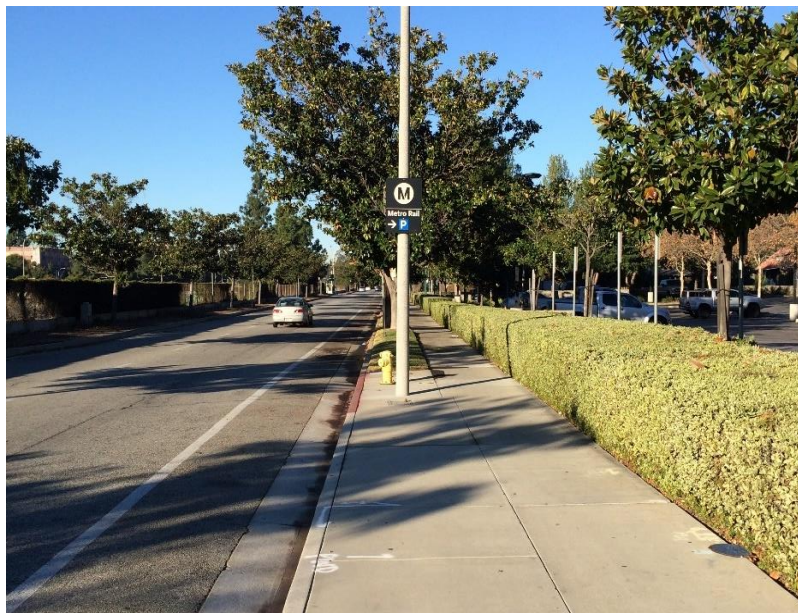
There are parking wayfinding signs on Lake Ave. directing drivers to Maple St. and then a sign on Maple St. directing them to the parking lot. However, there are no signs in the lot directing drivers to the Metro parking spaces. There are no visible signs on other streets.

Photo 86: Wayfinding Signage on Lake Ave.

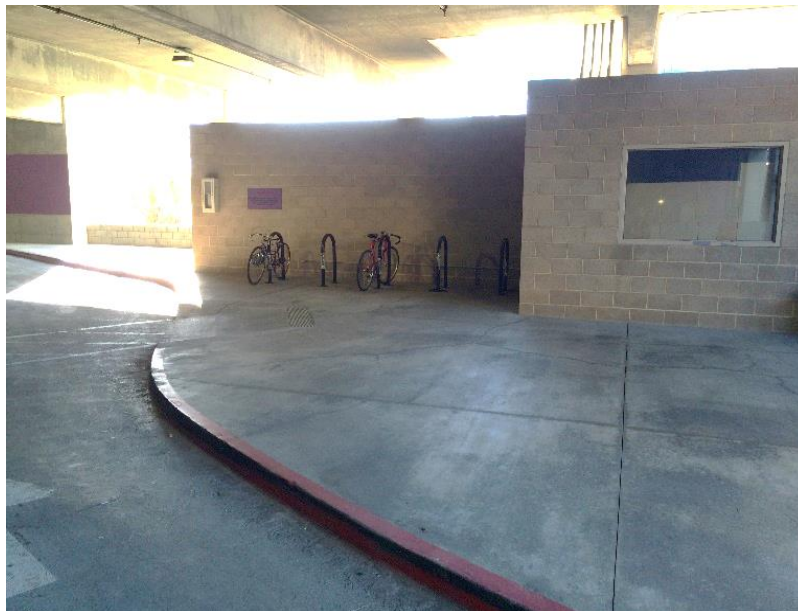
There are no Class I or Class II bicycle facilities providing station access. On-site bike racks and bike lockers are located on the ground level near the entrance from Sierra Madre Villa Ave. There are no signs directing bicyclists to the bike parking.

Photo 88: Difficult to Find Bike Racks

Given that the platform is on the fourth floor, it may be easier to direct bicyclists to park near the bridge to the platform on the fourth floor. It also serves to deter theft as there will be more eyes on the bike parking areas.

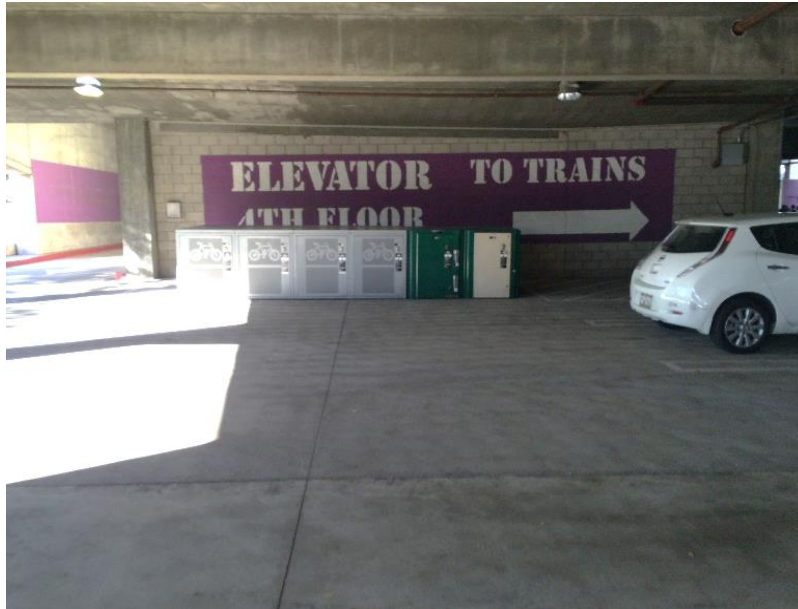
Photo 89: Difficult to Find Bike Lockers

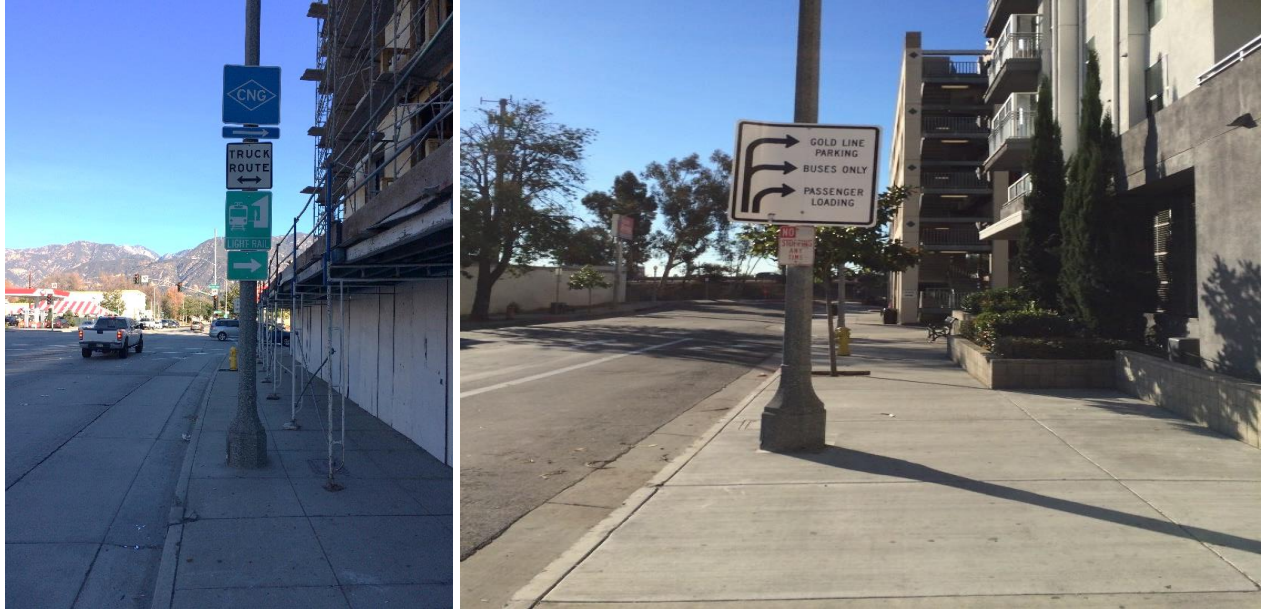
There is parking wayfinding signage along Foothill Blvd. directing Metro riders who park to the rear entrance to the parking structure off of Halstead St. Also there is signage on Sierra Madre Villa Ave. directing Metro riders who park to the entrance on Sierra Madre Villa Ave.

Photo 91: Wayfinding Signage along Foothill Blvd. (L); Signage when Approaching Halstead St. Entrance (R)

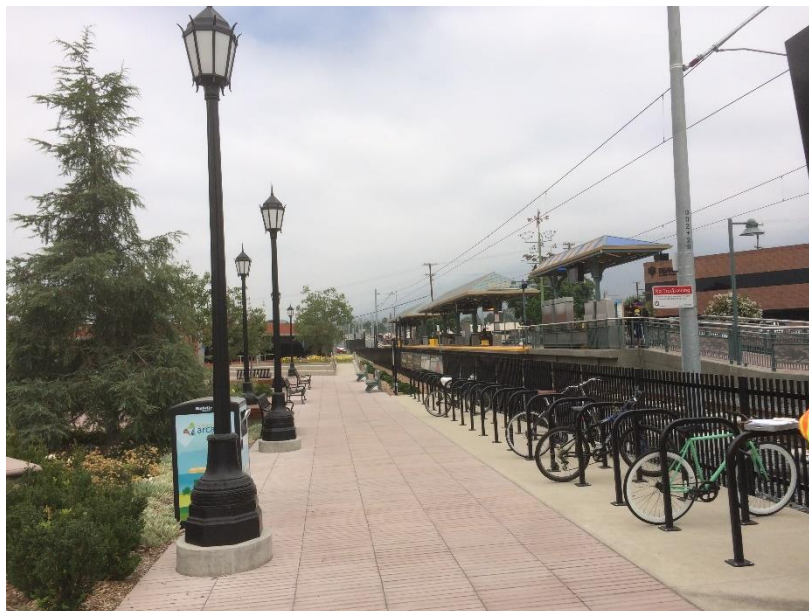
A Class II bicycle facility provides access to the station. Bike racks are located adjacent to the platform in the plaza area. Bike lockers are located on the first level of the parking structure adjacent to the elevators.

Photo 92: Bicycle Racks Adjacent to Platform

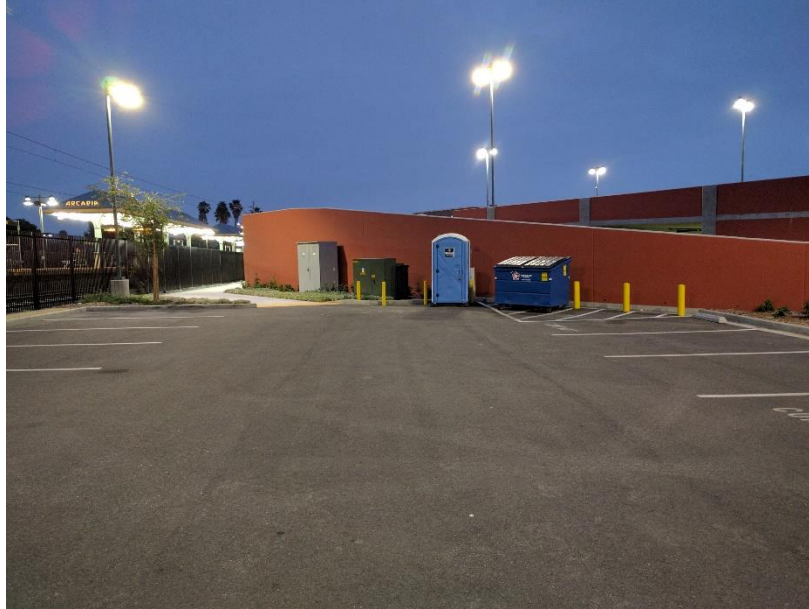
A small sign adjacent to the elevator on the second level of the parking structure directs riders to the first level in order to access the platform. There is no sign from the parking lot, although it is adjacent to the tracks.

Photo 93: No Signage in Parking Lot Directing to Platform Entrance

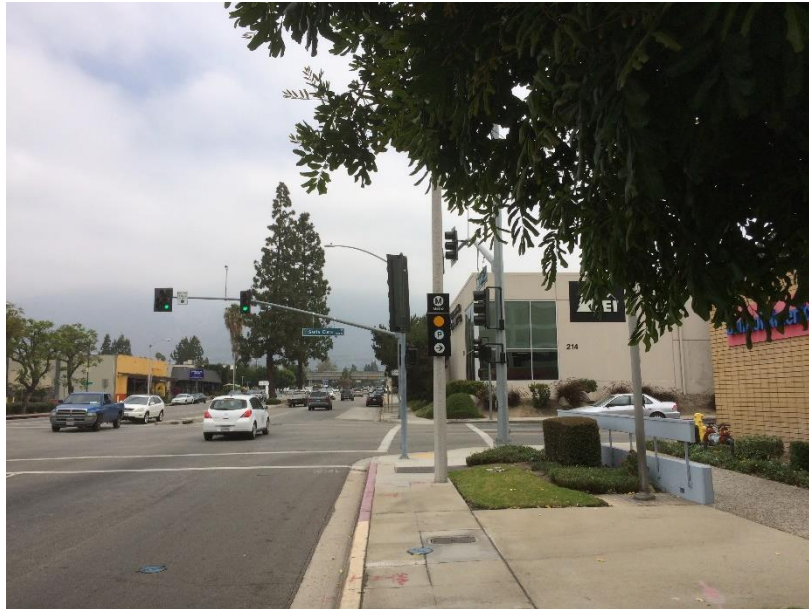
Photo 94: Signage along Santa Anita Ave. Directing to Station and Parking

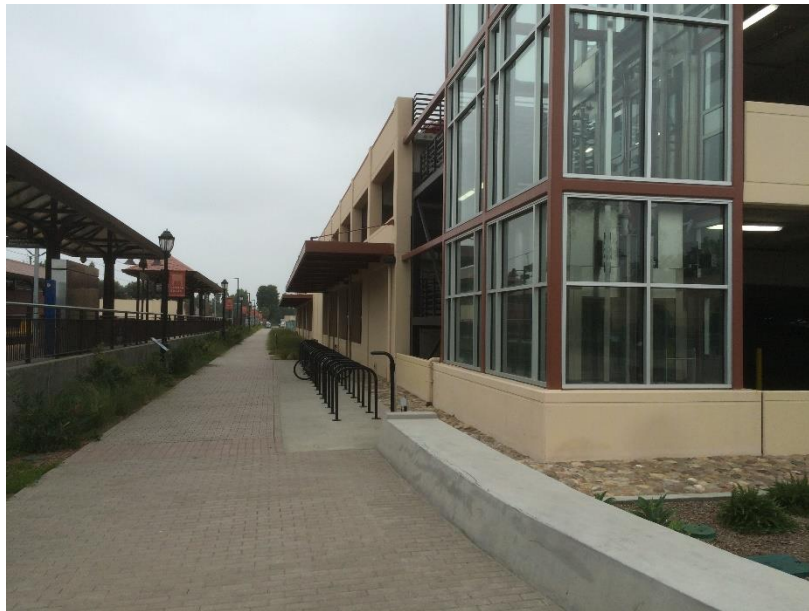
There are no Class I or Class II bicycle facilities providing station access. Bike lockers are located inside the parking garage adjacent to the plaza area. Bike racks are located between the garage and the platform. There is a small sign on the garage exterior directing bicyclists to the bike lockers.

Photo 96: Bicycle Racks between Structure and Platform

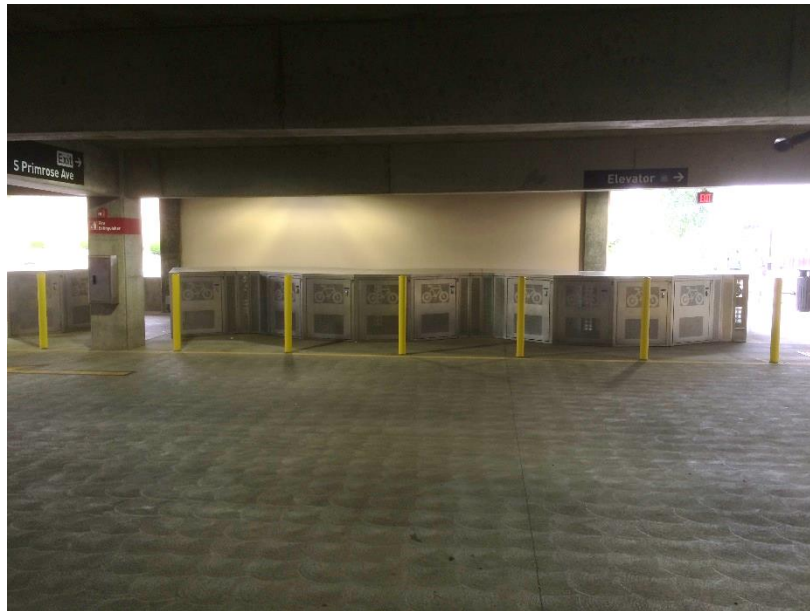
Photo 97: Bicycle Lockers inside Structure

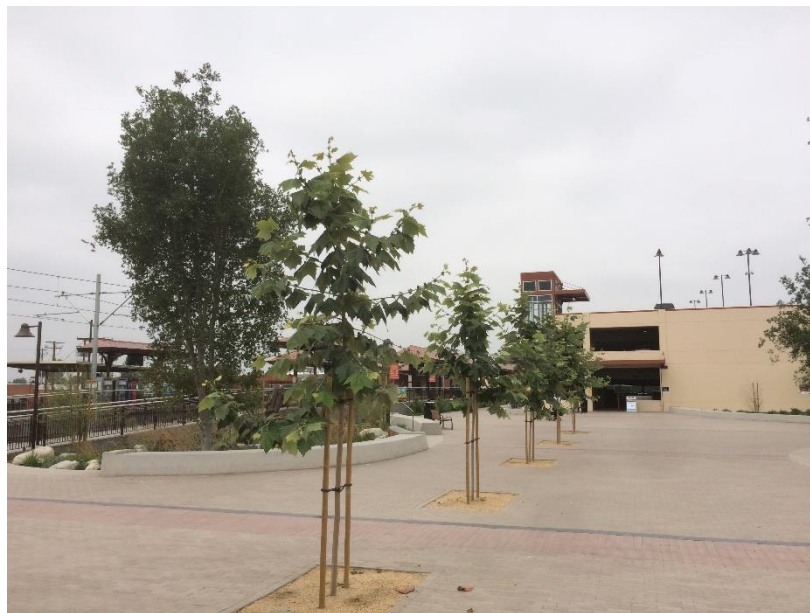
Photo 98: Plaza Area Connecting to Station Platform

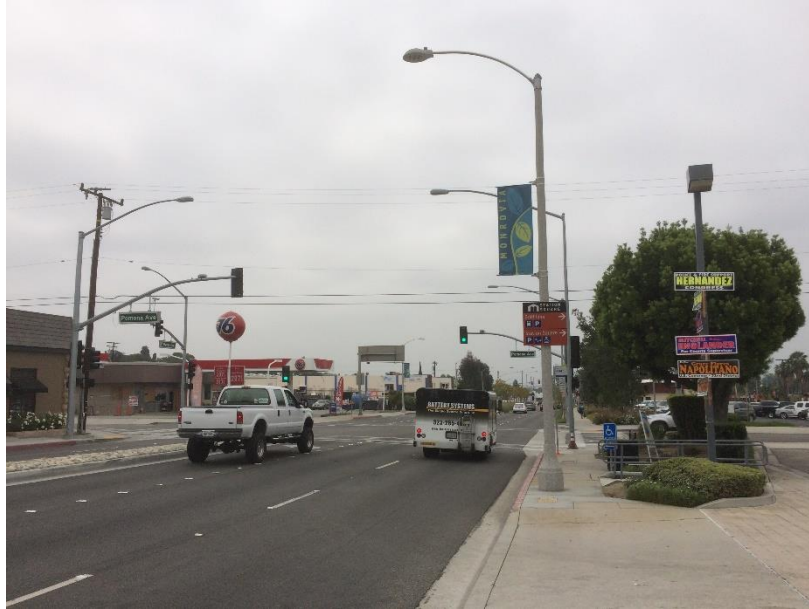
Photo 99: Signage along South Myrtle Ave. Directing to Station Platform and Parking

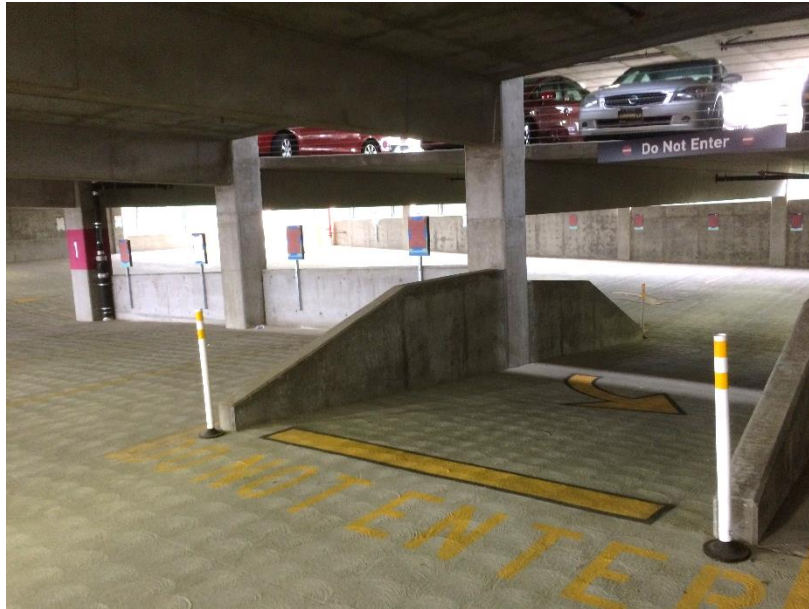
Photo 100: One-way Ramp Up from Lowest Level

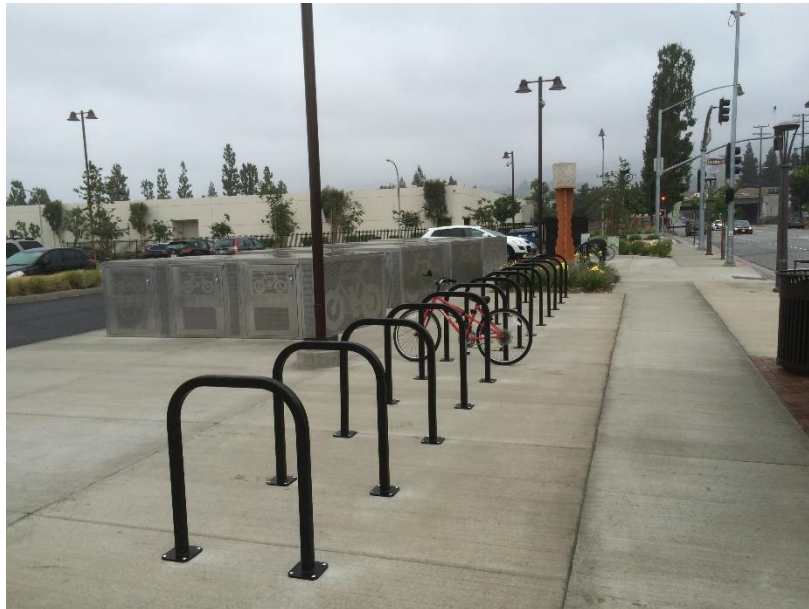
There are no Class I or Class II bicycle facilities providing station access. Bike lockers and bike racks are located along Highland Ave. adjacent to the parking lot. Those who approach the station by bike along East Duarte Road may not easily find the bike parking area.

Photo 101: Bicycle Parking along Highland Ave. Adjacent to Parking Lot

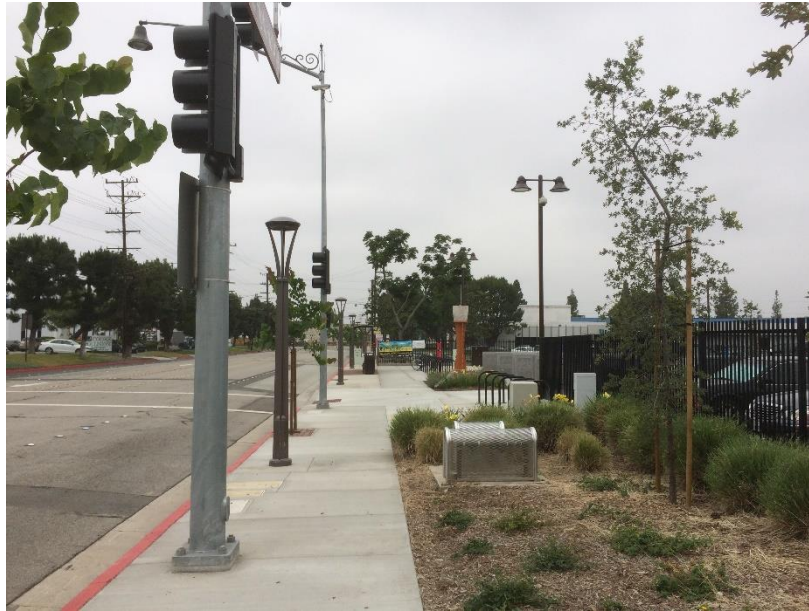
Photo 102: Sidewalk along Highland Ave. Connecting Parking to Station Platform

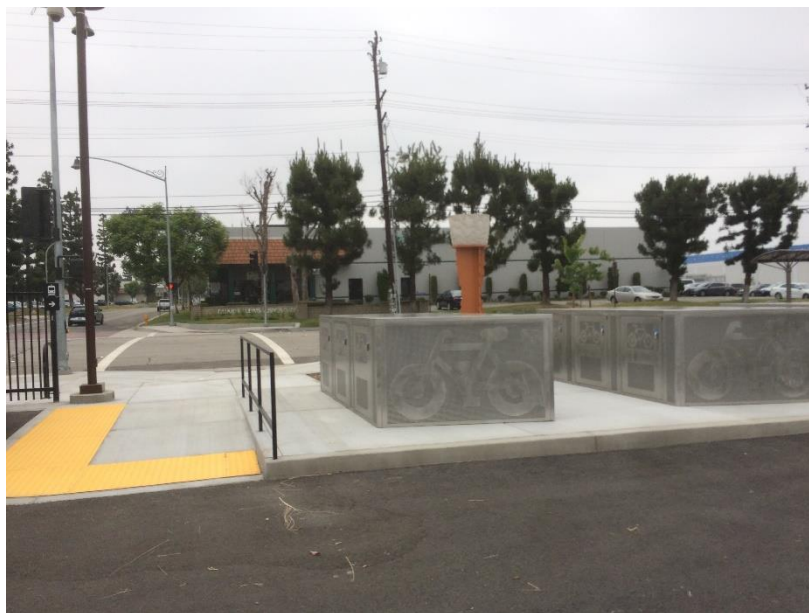
Photo 103: Small Sign Directing to Platform is Posted to Fence on Left Side

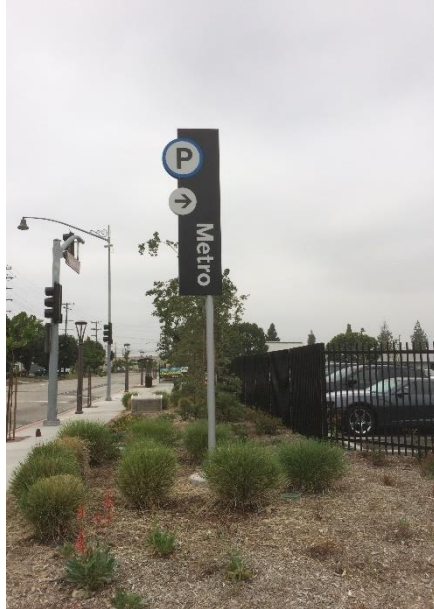
Photo 104: Sign Directing Drivers to Metro Parking Lot Entrance

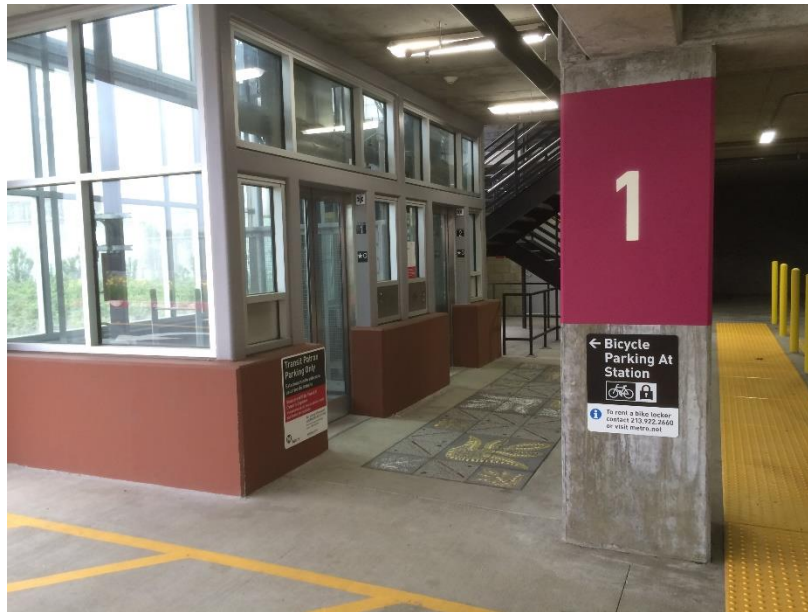
Photo 105: Sign in Garage Directing to Bicycle Parking

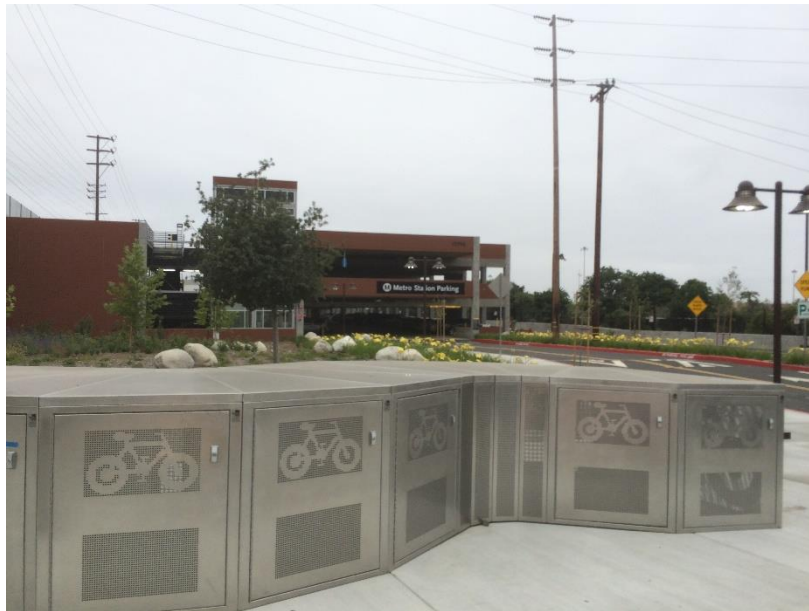
Photo 106: Bike Lockers at Irwindale Station

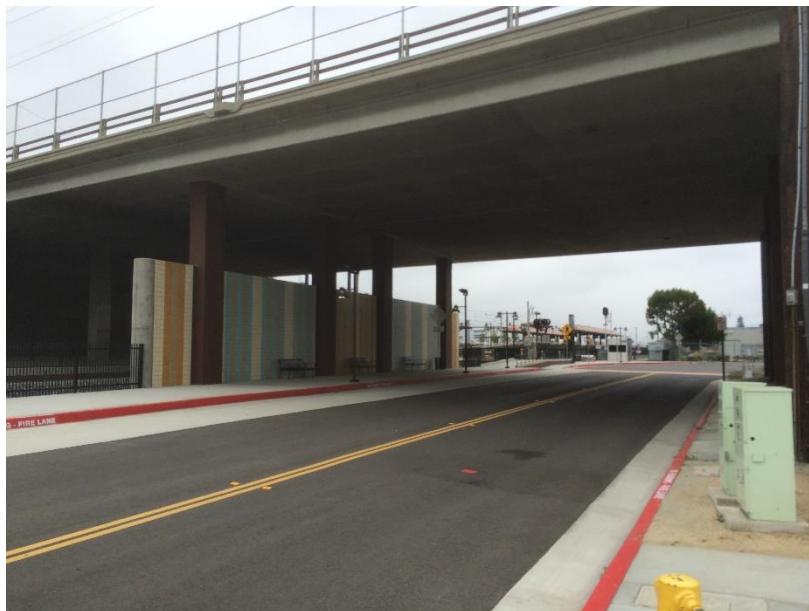
The station is challenging to reach on foot. Pedestrians must walk along busy North Irwindale Ave. and either walk through the parking structure or walk down Irwindale Ave. to reach Avenida Padilla where the station platform is located. There are only sidewalks on one side of Irwindale Ave. There is a sidewalk along the north side of Avenida Padilla for those walking from the garage to the platform.

Photo 107: Sidewalk on North Side of Avenida Padilla

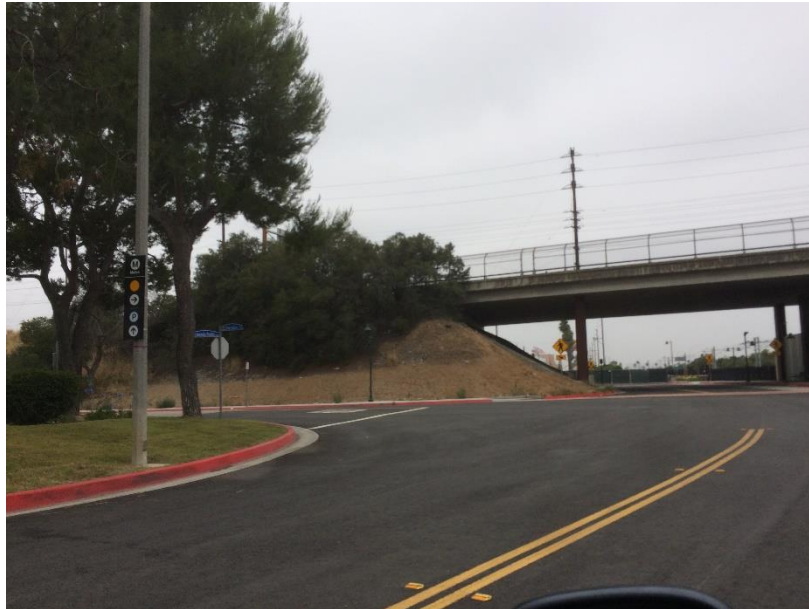
Photo 108: Signage along Avenida Padilla Directing to Platform and Parking

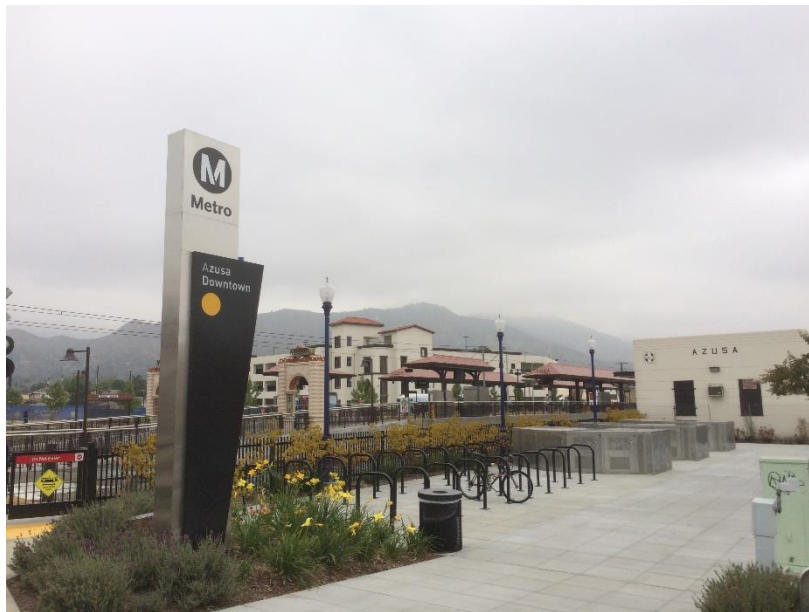
There are no Class I or Class II bicycle facilities providing station access. Bike lockers and racks are located south of the Gold Line tracks adjacent to Alameda Ave. There is no signage indicating where bicycle parking is located. However if bicyclists proceed in the direction of travel (northbound) on Azusa Ave., then they will see the bike lockers and racks on their right. A bicyclist who arrives from Alameda Ave. may have difficulty finding the bike parking area.

Photo 109: Bicycle Parking Area

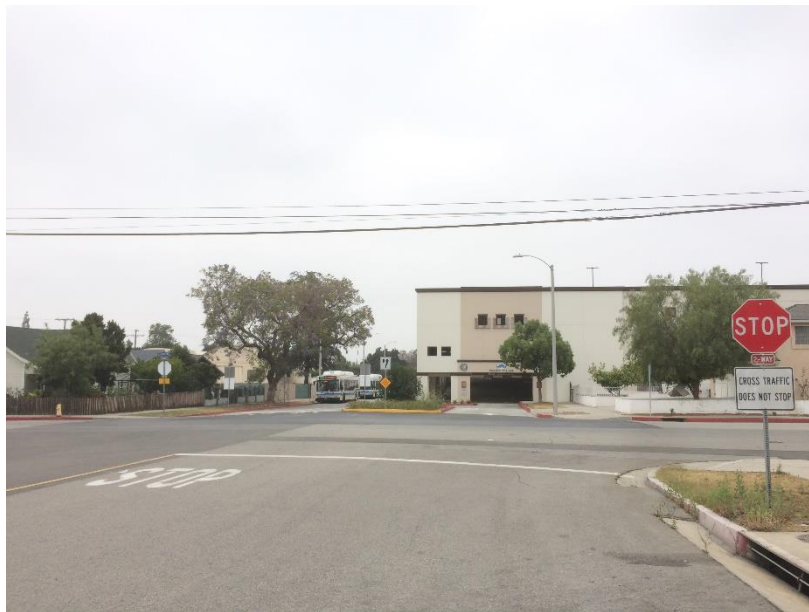
There are small parking wayfinding signs that direct drivers heading westbound on East 9th St. and northbound on Azusa Ave. to the parking structure. There were no signs observed on Foothill Blvd. or on North San Gabriel Ave. Drivers on northbound Azusa Ave. should identify the parking structure after seeing the station monument sign. However, it is less apparent to drivers who arrive from East 9th St. There are no signs on the structure that indicate Metro parking.

Photo 111: Parking Garage Entrance and Exit with Minimal Signage

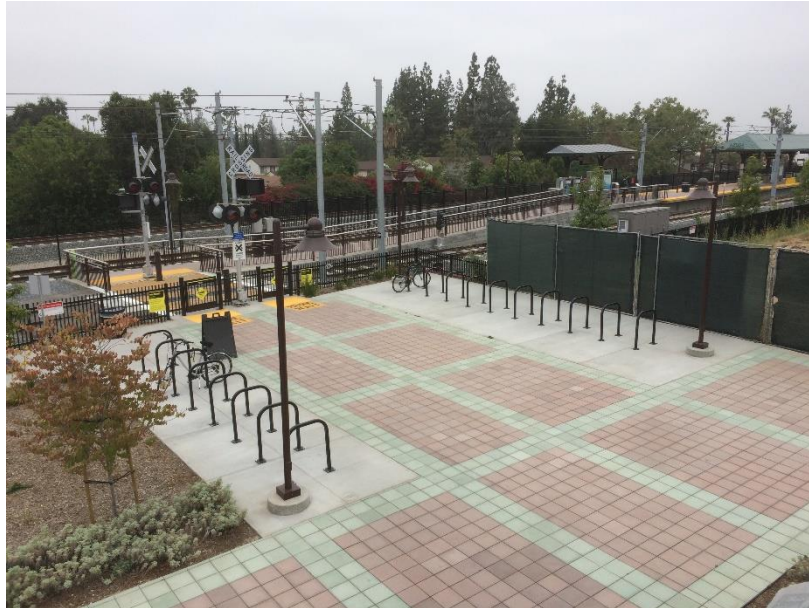
Photo 113: Bicycle Racks Adjacent to the Platform

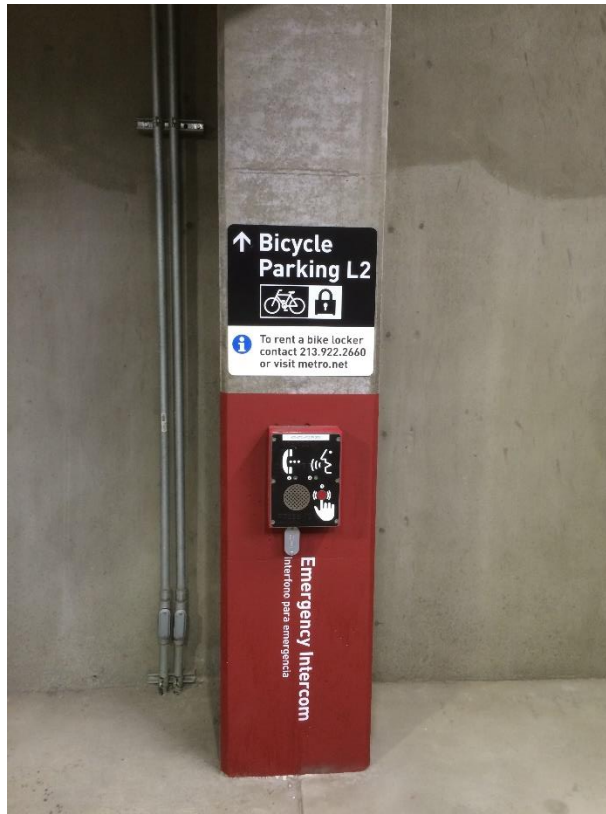
Photo 114: Signage in Garage Directing to Bicycle Parking

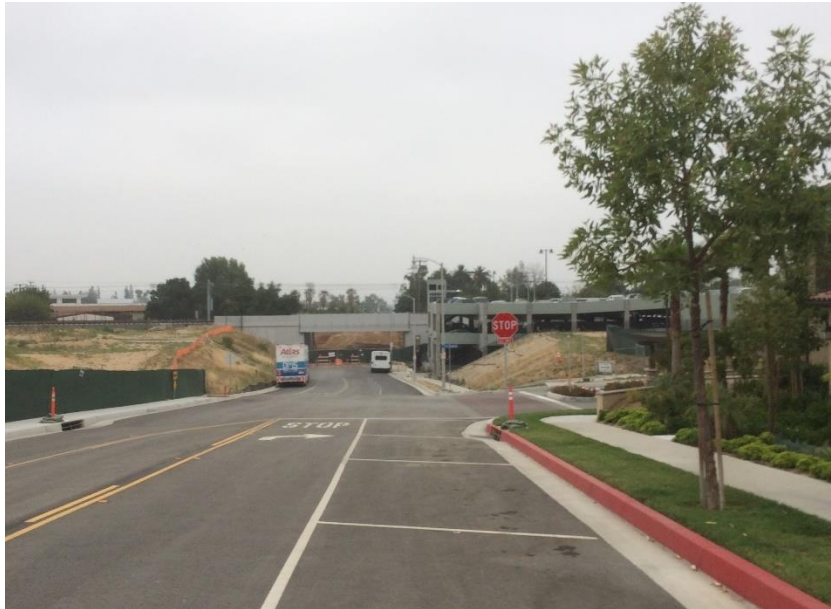
Photo 115: View along Citrus Ave. of Parking Garage

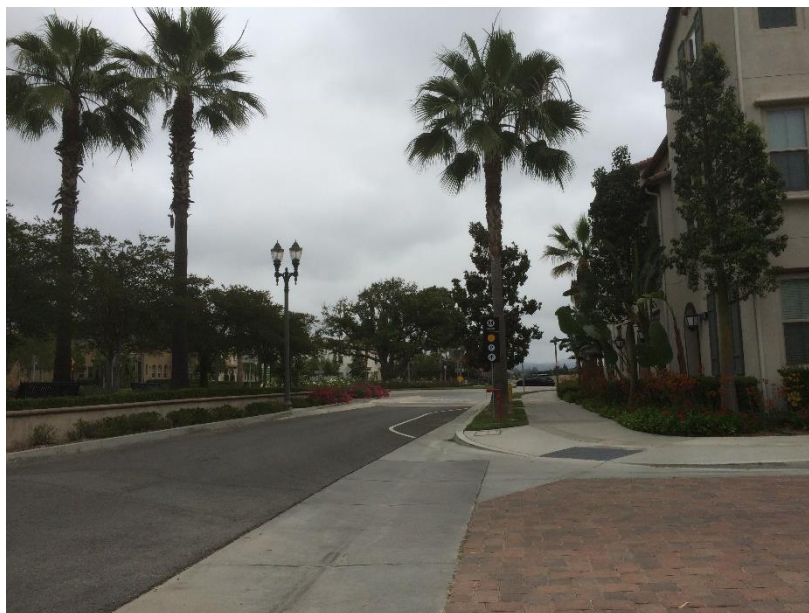
For drivers originating to the west, there is parking wayfinding signage directing drivers eastbound on East Promenade. For drivers originating to the east along West Foothill Blvd., there is parking wayfinding signage southbound on North Citrus Ave. to westbound East Foothill Blvd. and northbound North Palm Drive. For drivers originating from the south, there is parking wayfinding signage on northbound North Citrus Ave. directing towards westbound East Foothill Blvd.

Photo 116: Signage along East Promenade Directing to Station and Parking

Parking wayfinding signage will need to be incorporated to direct drivers northbound on North Citrus Ave. now that the St. extension is open, providing direct access to the parking structure from West Foothill Blvd.

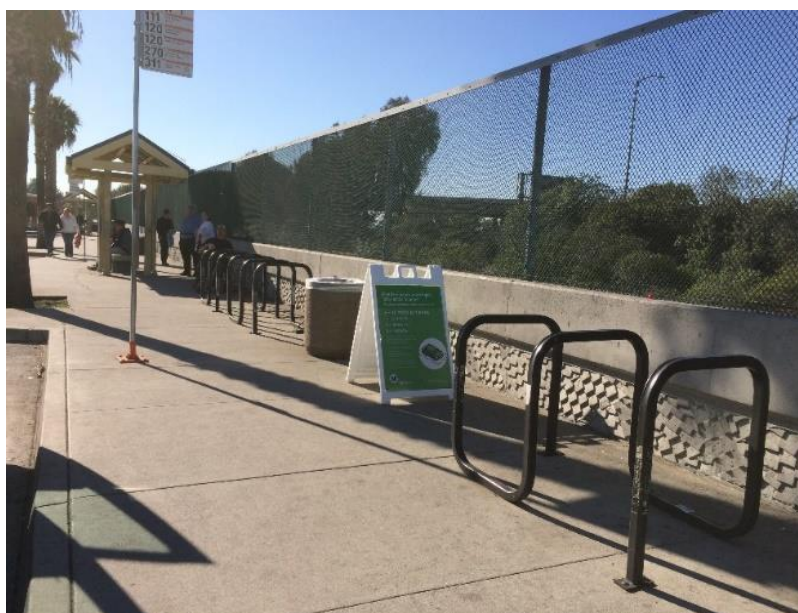
Photo 117: Bicycle Racks

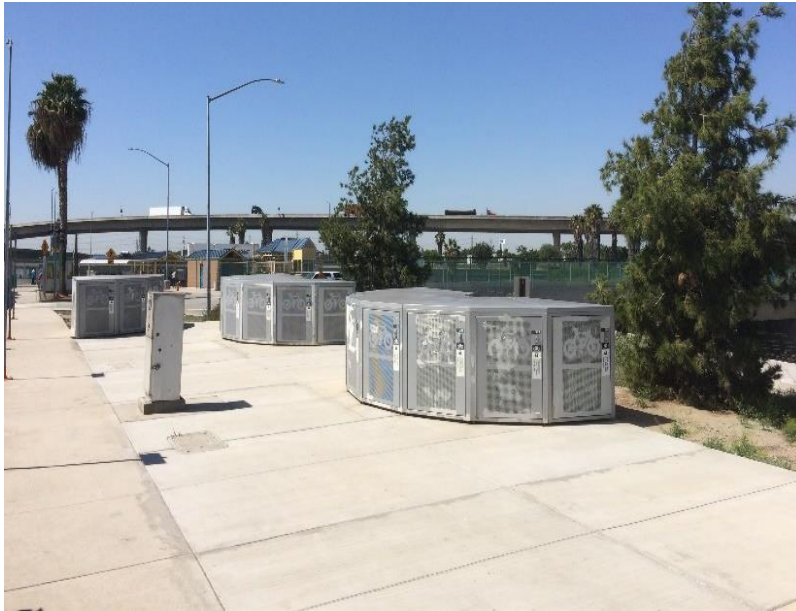
Photo 118: Bicycle Lockers

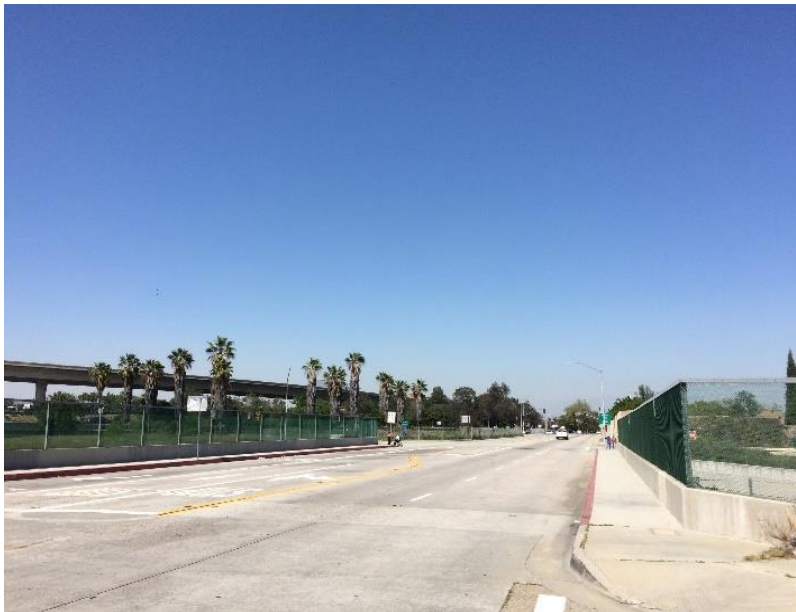
There is good pedestrian connectivity between the station and the surrounding area. However, there is only a continuous sidewalk on the east side of Hoxie Ave. between the East Lot and Imperial Highway. Pedestrians must cross the busy East Lot entrance/exit area. Some pedestrians park on Studebaker Road and walk along the I-105 eastbound off-ramp to access the station. There are barrier gates at Foster Road and Flatbush Ave., likely to prevent cut-through traffic and parking spillover onto residential streets.

Photo 119: Sidewalk along Hoxie Ave.

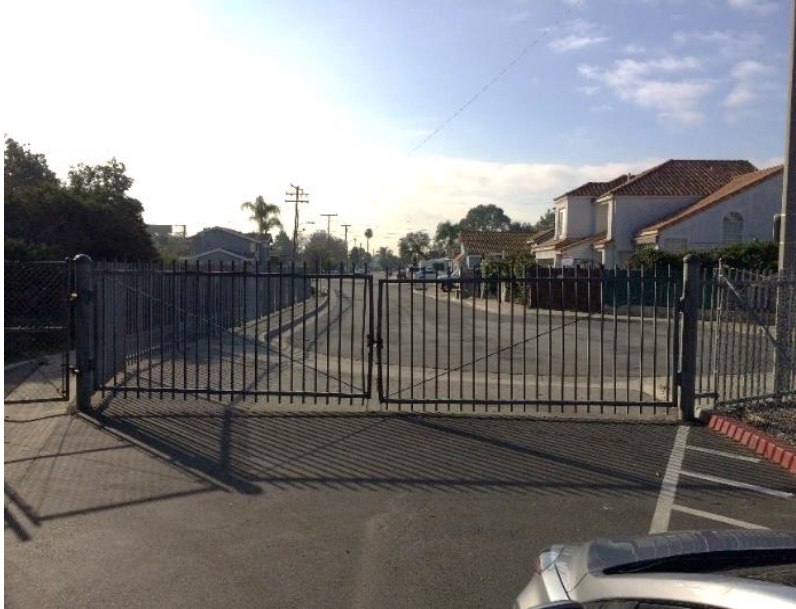
Photo 120: Barrier Gate at Flatbush Ave.

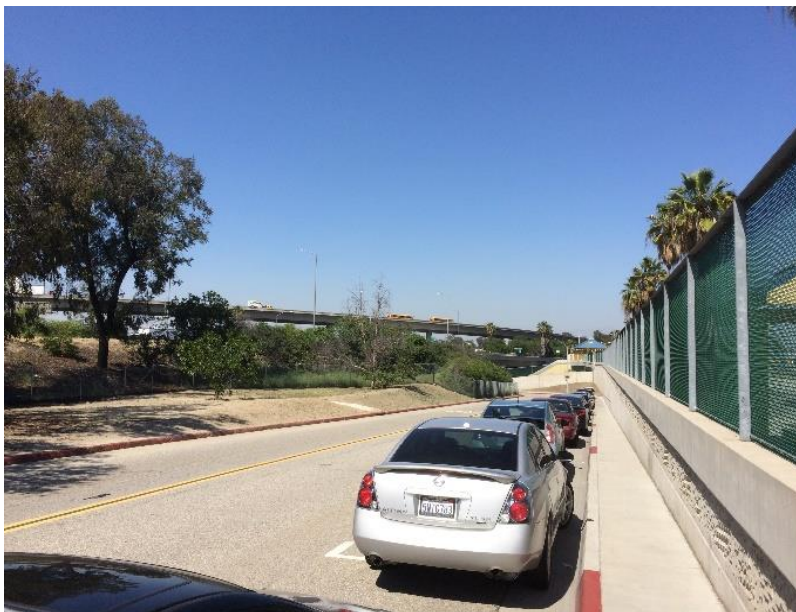
Limited parking wayfinding signage is visible on freeway off-ramps. There is also a small sign underneath the I-105 freeway entrance sign that is visible to drivers turning southbound on to Hoxie Ave. from westbound Imperial Highway. Upon entering the East Lot drivers will see the station monument sign and the parking lot. Finding the access road spaces and West Lot is not clear when driving from the East Lot. Similarly, for those who enter the West Lot from the I-105 off-ramp, it is not clear how to find the access road spaces, East Lot and exit.

Photo 121: On-Street Spaces along Access Road Connecting the Two Lots

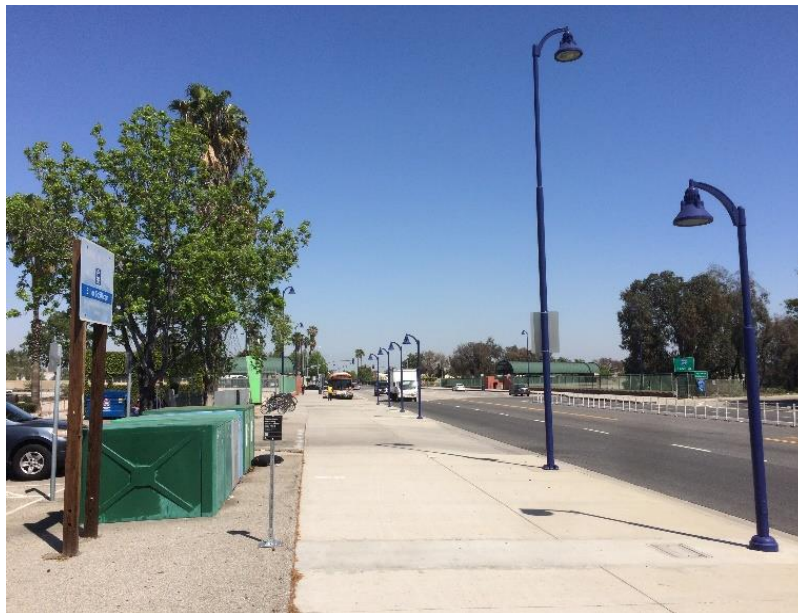
Photo 122: Bicycle Lockers Adjacent to Sidewalk

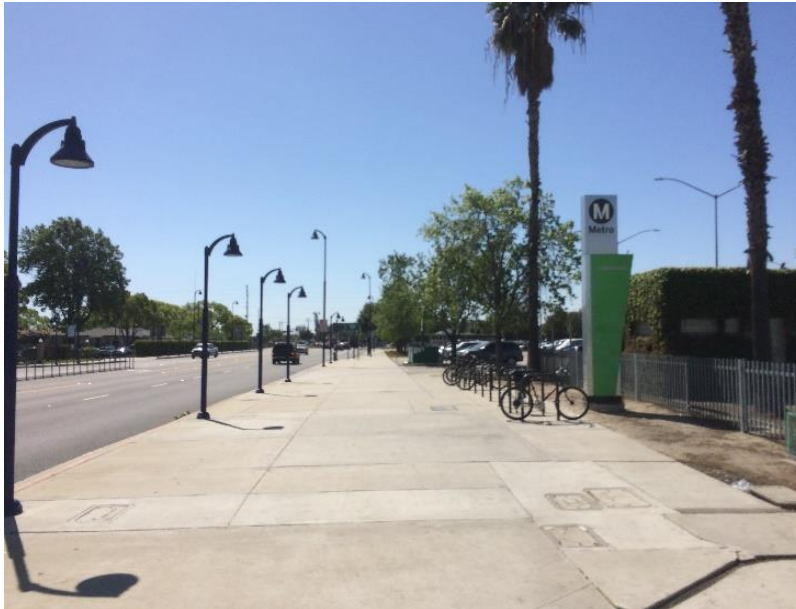
Photo 123: Bicycle Racks Adjacent to Station Monument Sign

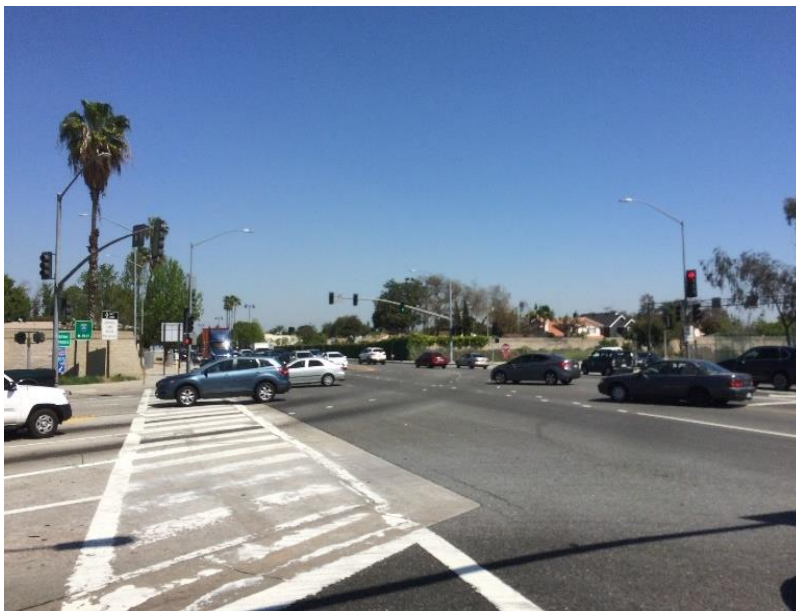
There is adequate pedestrian connectivity to the station. The sidewalks are in good condition and are wide. However, if a driver parks in the North Lot, the driver must cross a wide freeway entrance and exit to reach the station platform. This crosswalk is signalized.

Photo 124: Crosswalk at I-105 Entrance/Exit

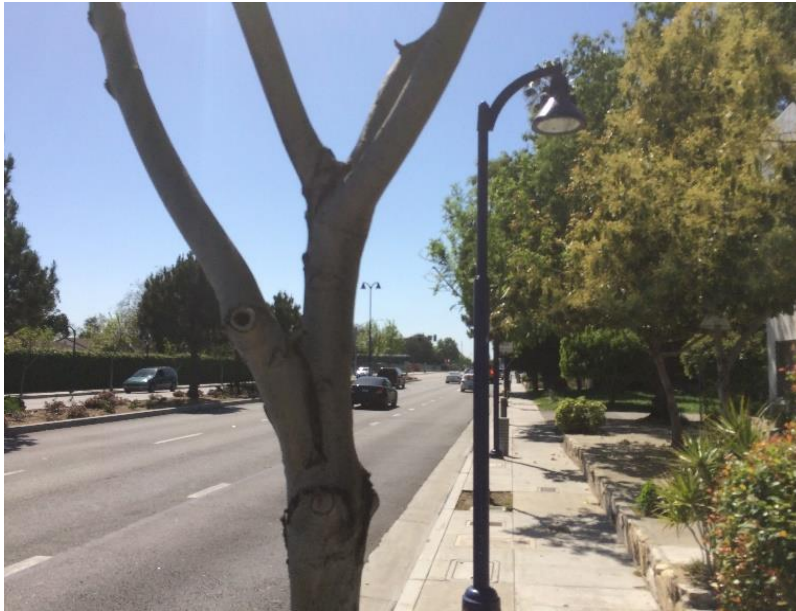
Photo 125: Sidewalk along Lakewood Blvd.

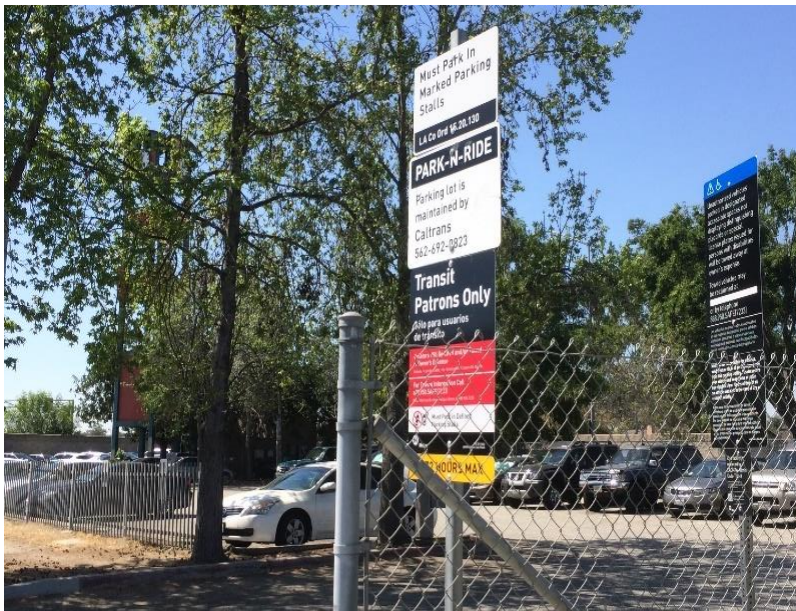
There is minimal parking wayfinding signage. There is a Park-and-Ride sign on the freeway off-ramp and a small sign at entrance to the North Lot. There are no obvious signs indicating that these are Metro parking facilities.

Photo 126: Sign at Entrance to North Lot
