Supportive Transit Parking Program

A key first step of the STPP Master Plan effort was the collection of quantitative data regarding how Metro’s parking spaces and qualitative information related to their condition and access. The purpose of the Facility Assessment effort was to understand current system operation and performance, which served as baseline information required to recommend future policy and operational changes, and to recommend and quantify the cost of improving the parking facilities.

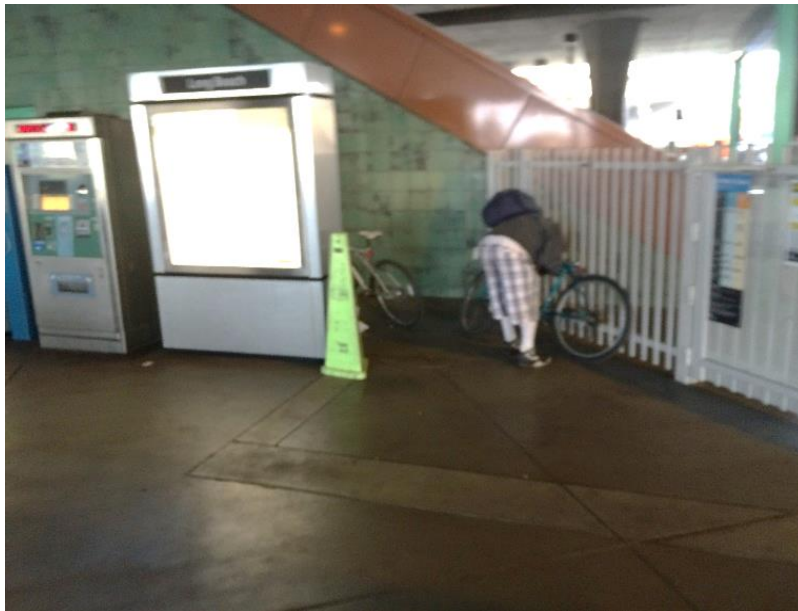
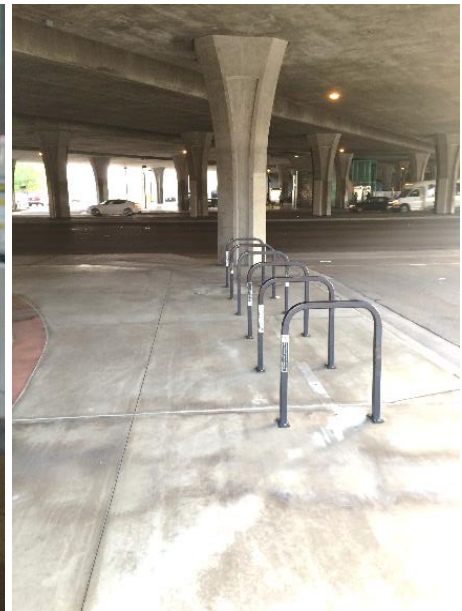
There are no Class I or Class II bicycle facilities within one block of the station. There are some bike racks in the West Lot, but there are no bike racks in the East Lot. The location of the racks may also be inconvenient, as some passengers locked their bikes to the fences.

Photo 128: Bikes Locked to Fence (L); Bike Racks (R)

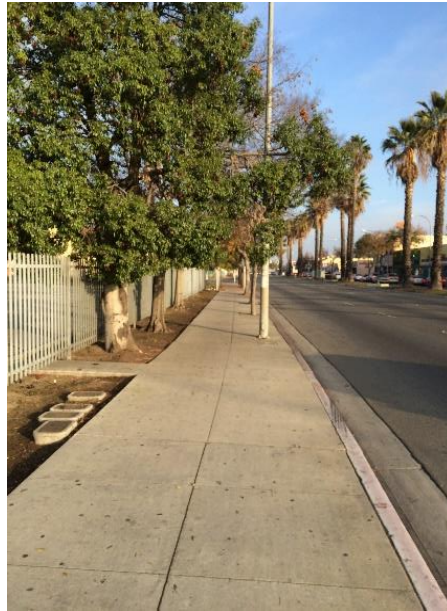
Photo 129: Sidewalk along Long Beach Blvd.

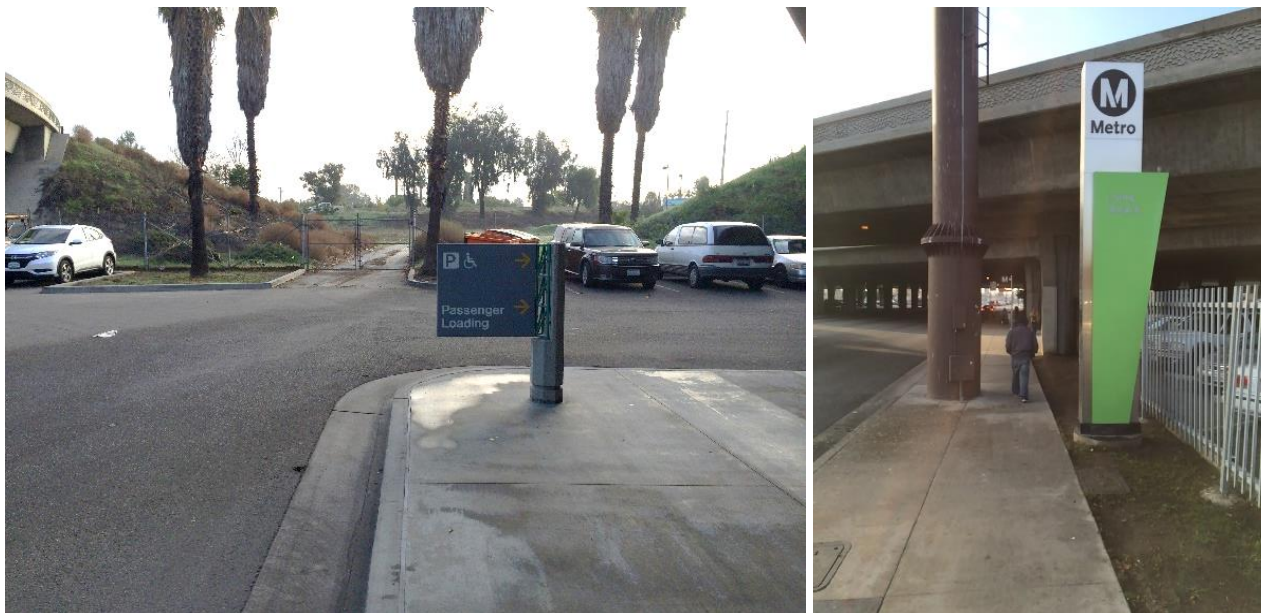
There are some parking wayfinding signs on the 105 Freeway at the off-ramps and a monument sign. There is an opportunity to place a parking wayfinding sign on the traffic signal pole or at a light pole near the entrance to the West Lot. There are no signs indicating Metro parking at the lot entrances.

Photo 130: Minimal Signage at Lot Entrance (L); Station Monument Sign (R)

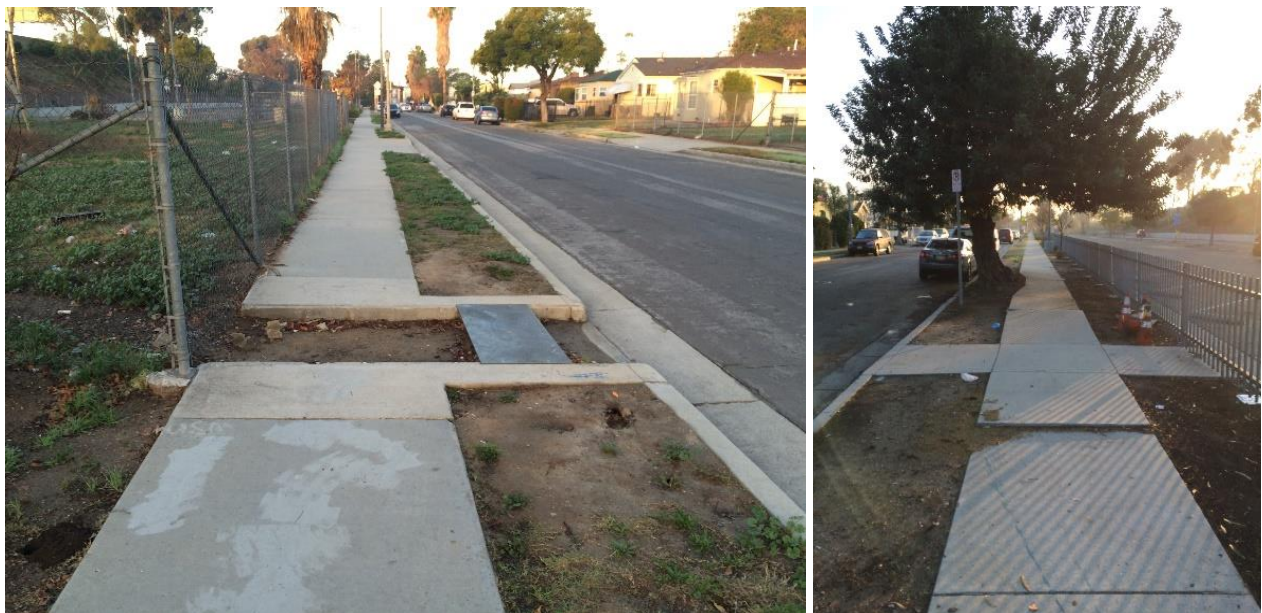
Pedestrian connectivity between the station and surrounding areas could be improved. There are uneven sidewalks along the south side of 116th Place adjacent to the parking lots. As seen in the images below, there are even breaks in the pavement that make it difficult to navigate.

Photo 133: Sidewalk along 116th Place Looking West (L); Sidewalk along 116th Place Looking East (R)

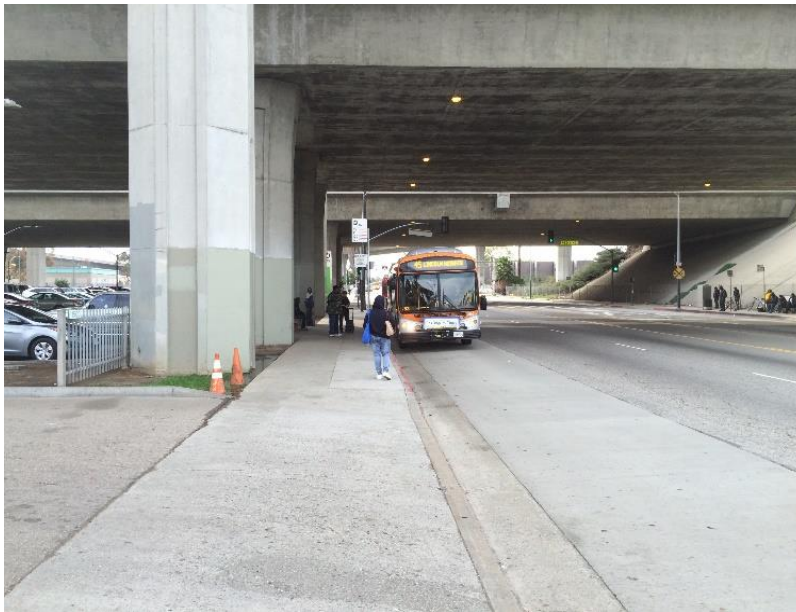
Pedestrian connectivity between the station and surrounding area is limited. There is one signalized crosswalk spanning Figueroa on the block between Imperial Highway and West 117th St. Sidewalks on Figueroa St. are in good condition. There is a striped walkway through the parking lot between the bus stops on Figueroa and the platform.

Photo 139: Sidewalk along Figueroa St.

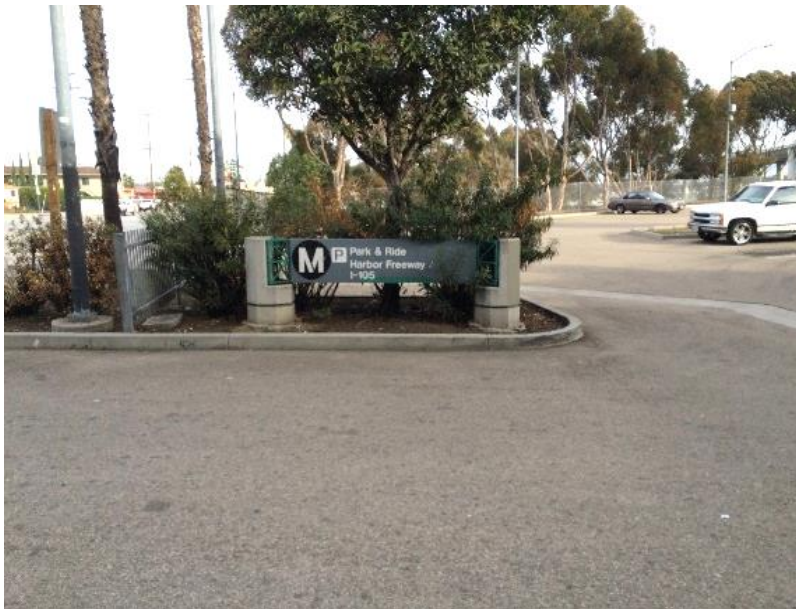
No parking wayfinding signs at the lots except for monument signs at the entrances which are low and may be difficult to see. These are only partially visible from Figueroa as they are set back from the sidewalk and not very visible to passing motorists. There is a Caltrans Park-and-Ride on the fence outside the lot; this sign is not oriented to face passing motorists.

Photo 140: Monument Sign at Entrance to Parking Lot

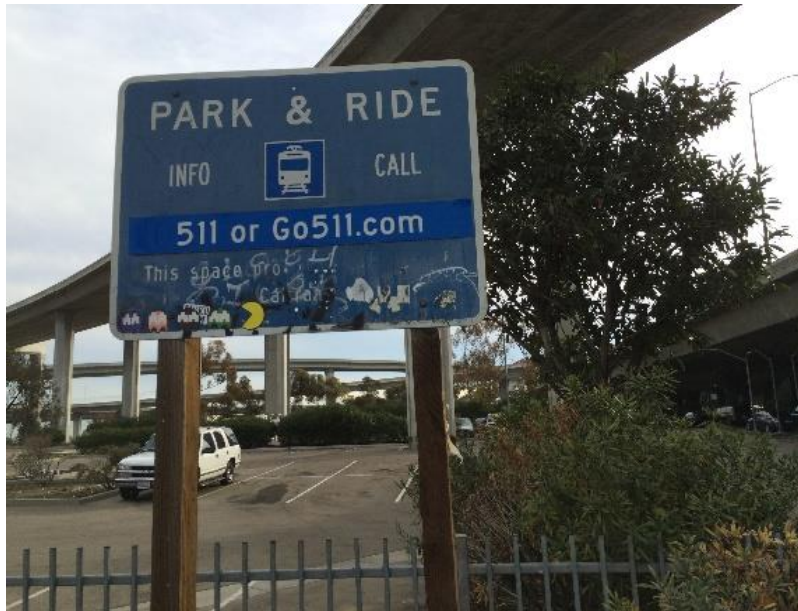
Photo 141: Park and Ride Sign

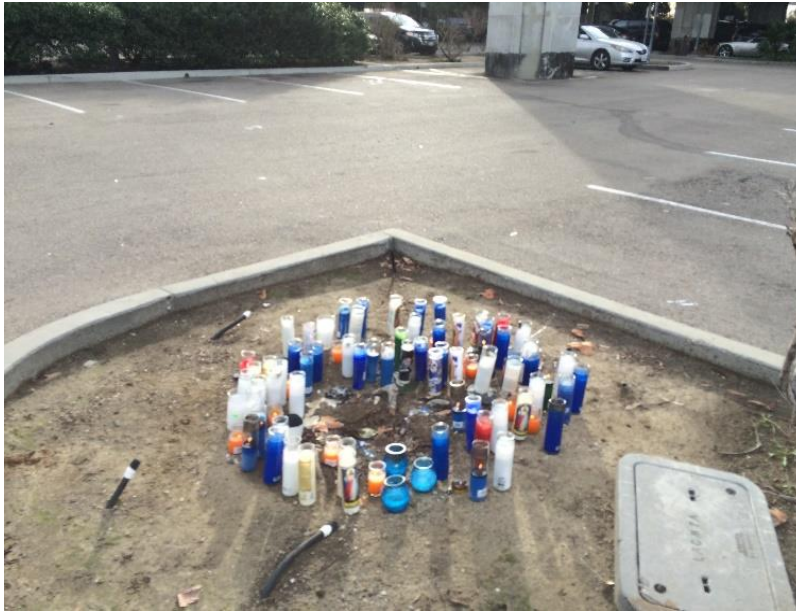
Photo 142: Memorial Candles in a Landscaped Area

No current security concerns were observed, although a memorial was observed in a landscaped area.

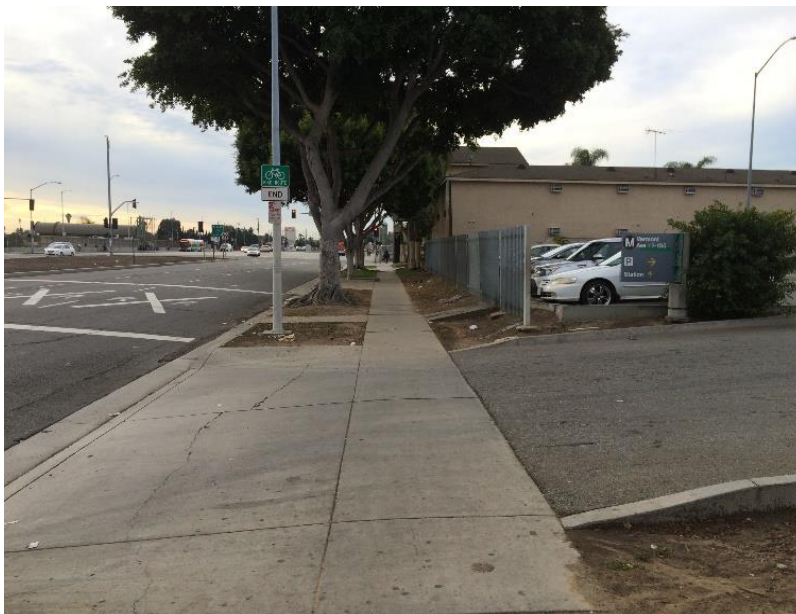
Due to a shortage of crosswalks, there is limited pedestrian connectivity between the station and surrounding area. There are wide sidewalks on Vermont Ave., although there is some buckling due to tree roots.

Photo 143: Sidewalk along Vermont Ave.

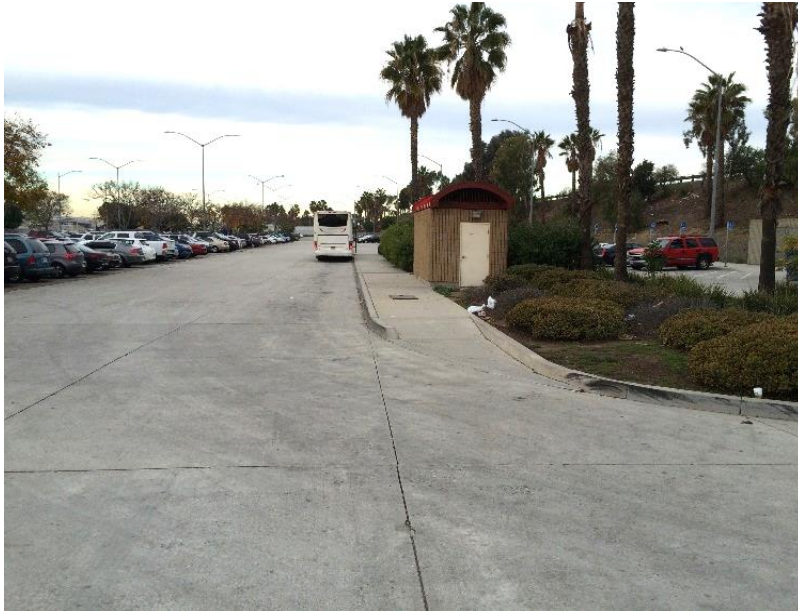
Photo 150: No Signage at Entrance to Lot

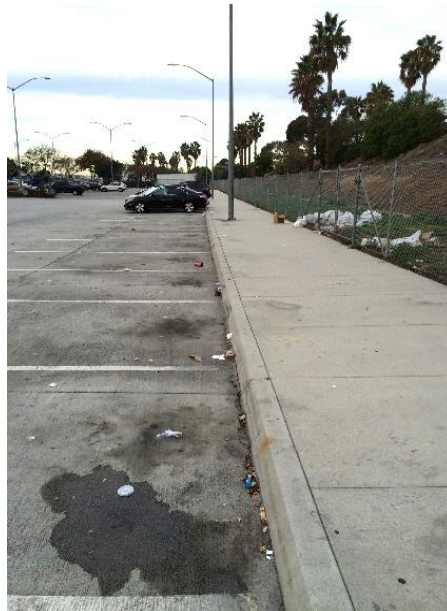
Photo 151: Litter in the Parking Lot

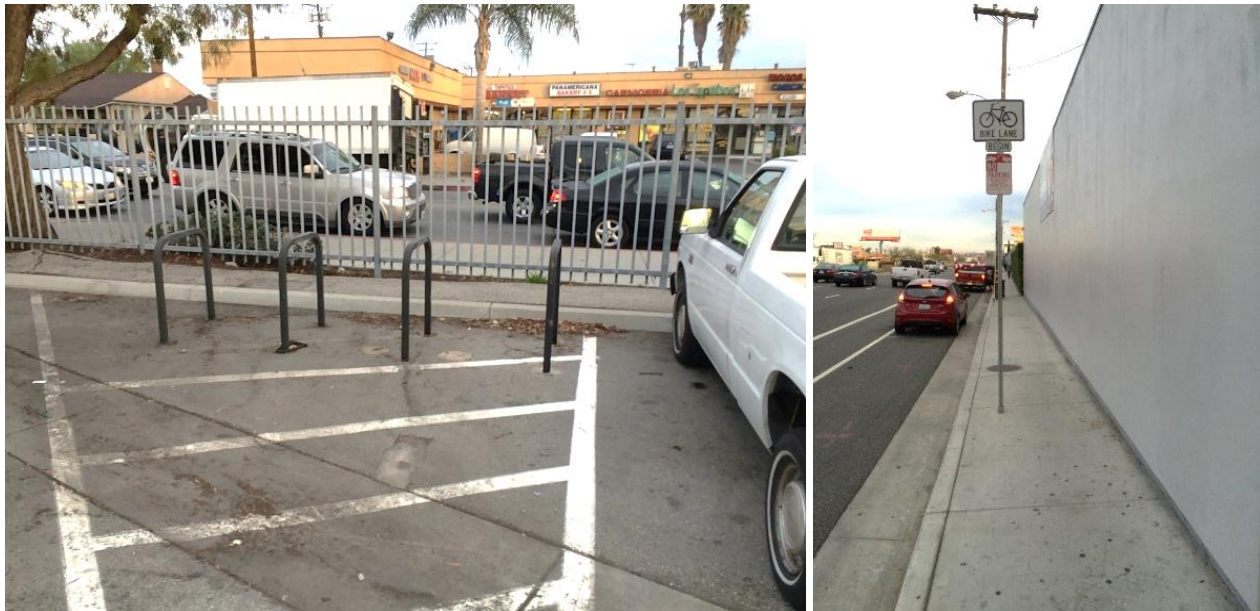
There are no Class I or Class II bicycle facilities within one block of the station. There are bike lanes on Hawthorne Blvd. north of West 111th St., but they don't connect with the station. The only parking provided for bikes are racks for eight bikes, none of which were in use at the time of observations. These racks should be relocated out of the parking lot and closer to the platform.

Photo 152: Bike Racks in Parking Lot that should be Relocated (L); Bike Lane on Hawthorne Blvd. (R)

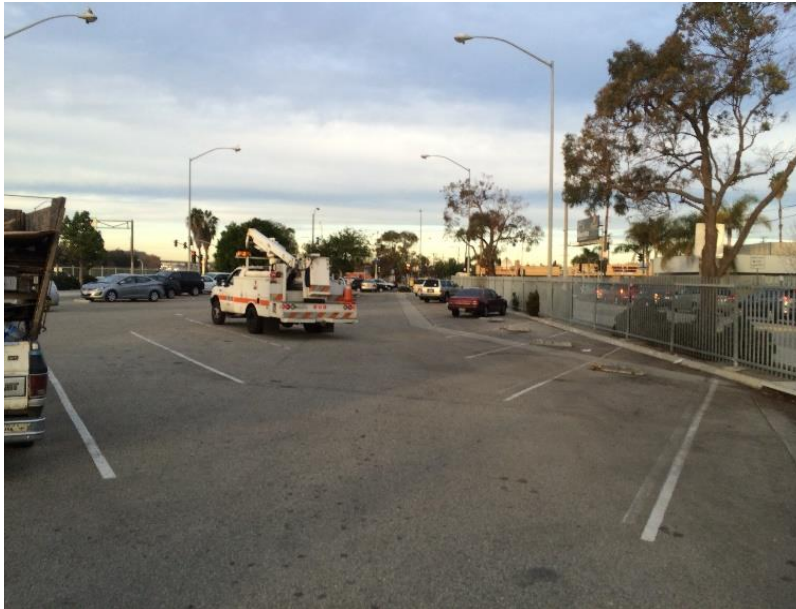
Pavement conditions were generally good. Some striping is faded.

Photo 154: Faded Striping

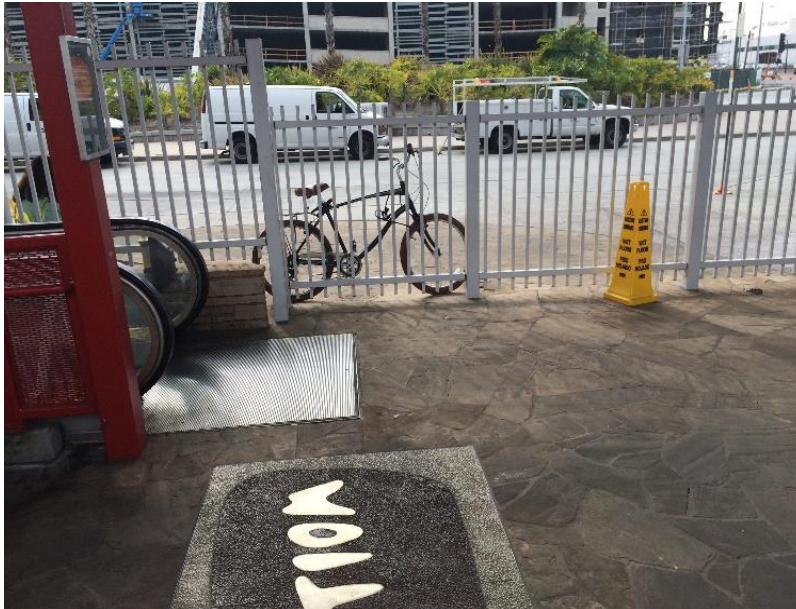
Although there are bike lockers and bike racks available at the station, arrival via bike is difficult as no Class I or Class II bicycle facilities are within a block of the station. Neither Imperial nor Aviation have bike paths or lanes, and vehicles along these streets travel at high speeds making biking challenging. A bike was locked to the fence when we did our site visit.

Photo 156: Bike Illegally Locked to Fence

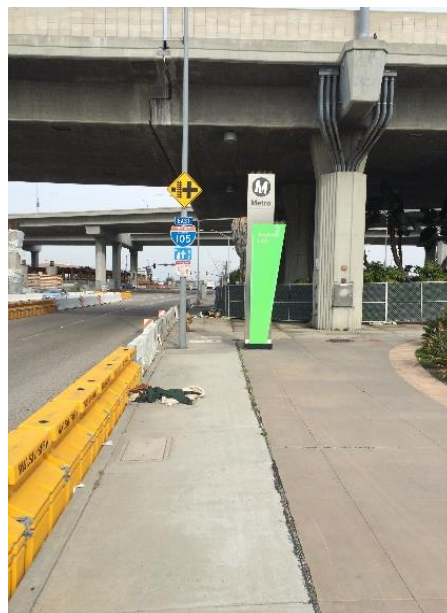
While the station area has reasonable pedestrian connectivity, the sidewalks along Aviation Blvd. adjacent to the station are in poor condition. There are no walkways leading to the station from the parking lot.

Photo 157: Sidewalk along Aviation Blvd.

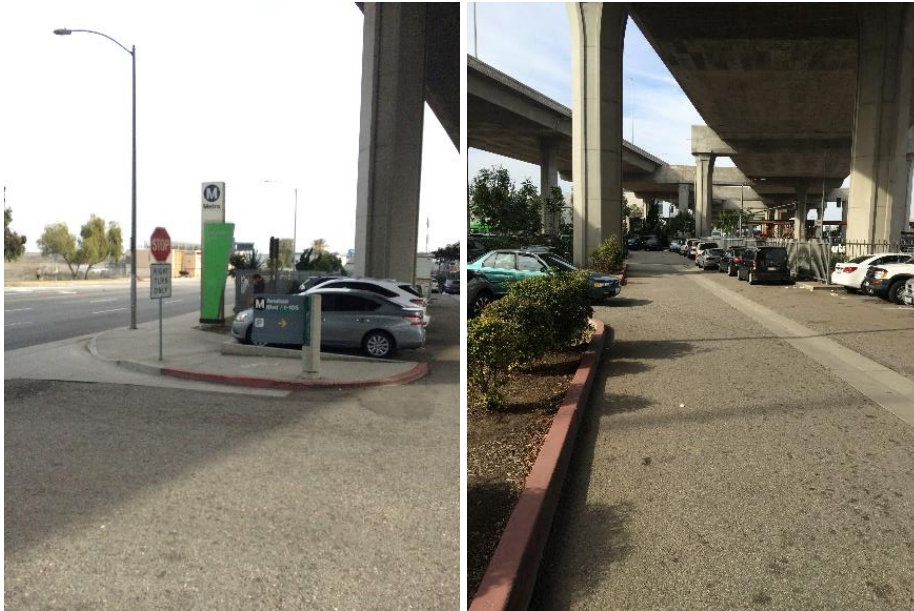
Photo 158: Station Monument Sign (L); Possible Kiss and Ride Area but Unclear Signage (R)

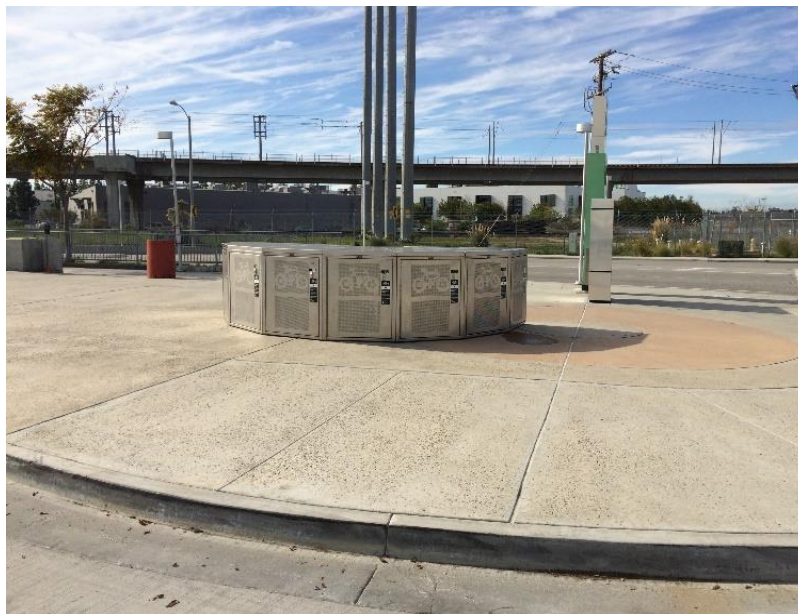
There are no Class I or Class II bicycle facilities within one block of the station. The bike racks are not readily visible while some of the bike lockers are currently in the parking lot, a long distance from the platform.

Photo 163: Bike Lockers

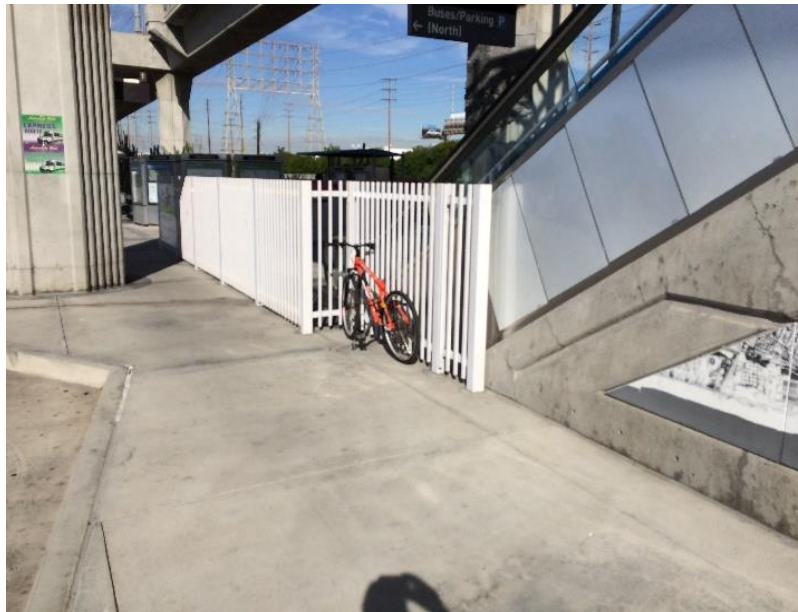
Photo 168: Bike Locked to Fence

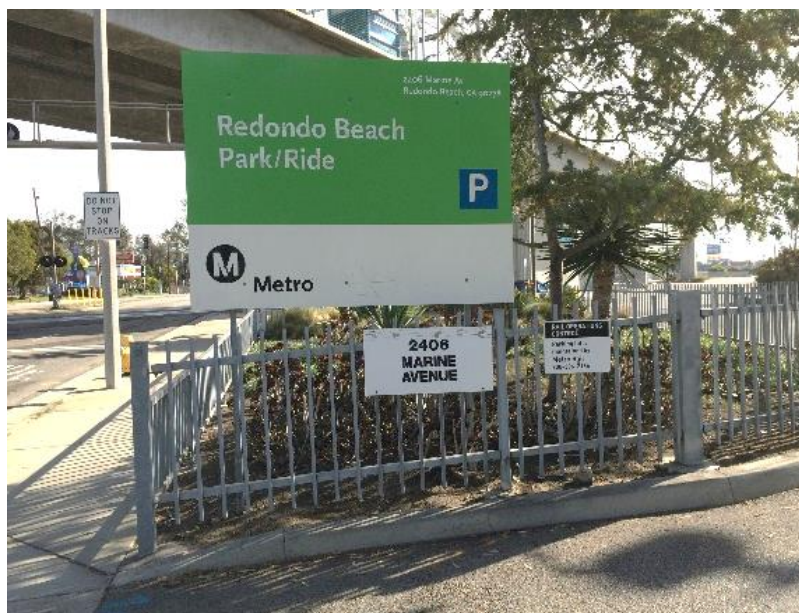
No parking wayfinding signage in the surrounding vicinity; however, the monument sign on Marine is within the sidewalk right-of-way and very visible to passing motorists. The bus-only entrance is poorly signed, with the sign saying 'buses only' tiny and faded. There is a big sign for the south lot on eastbound Marine, which could use a directional arrow pointing to the driveway. However, this lot was empty, and the north lot was not full.

Photo 171: South Lot Entrance Sign

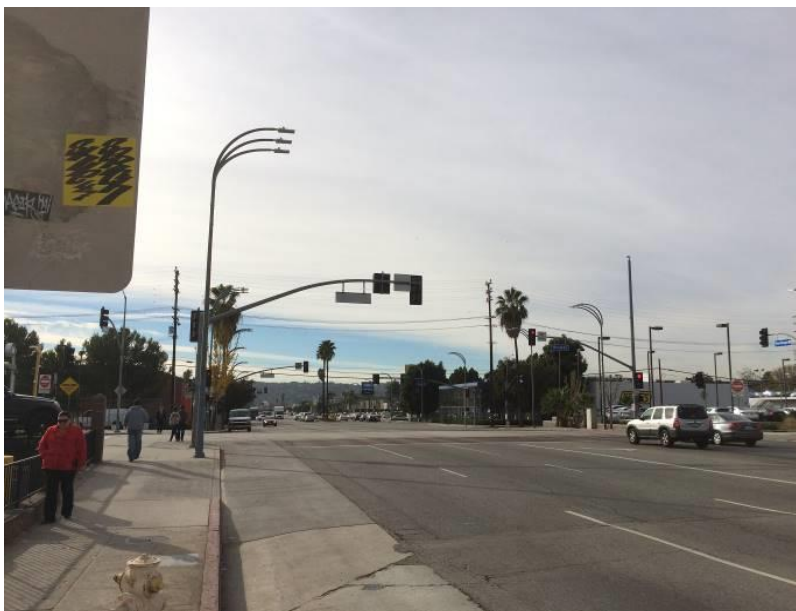
Photo 178: No Wayfinding Signage along Van Nuys Blvd.

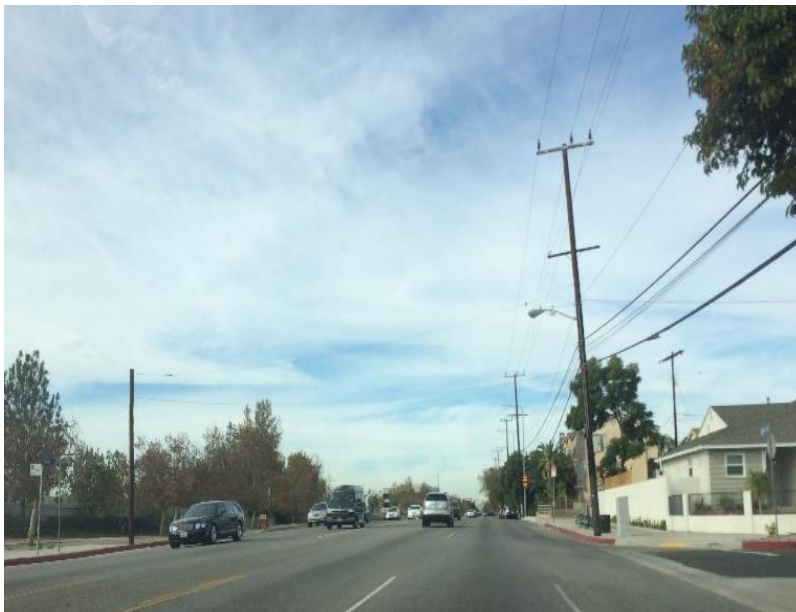
The monument sign on Balboa Blvd. is partially obscured by a tree. There are a small signs at both lot entrances. There are no parking wayfinding signs on Balboa or Victory. The station is in particular need of a sign on Westbound Victory Blvd. directing patrons to turn left into the parking lot; if this turn is missed, patrons have to turn left onto southbound Balboa Blvd. and then make a U-turn at the park entrance road.

Photo 183: No Wayfinding along Westbound Victory Blvd.

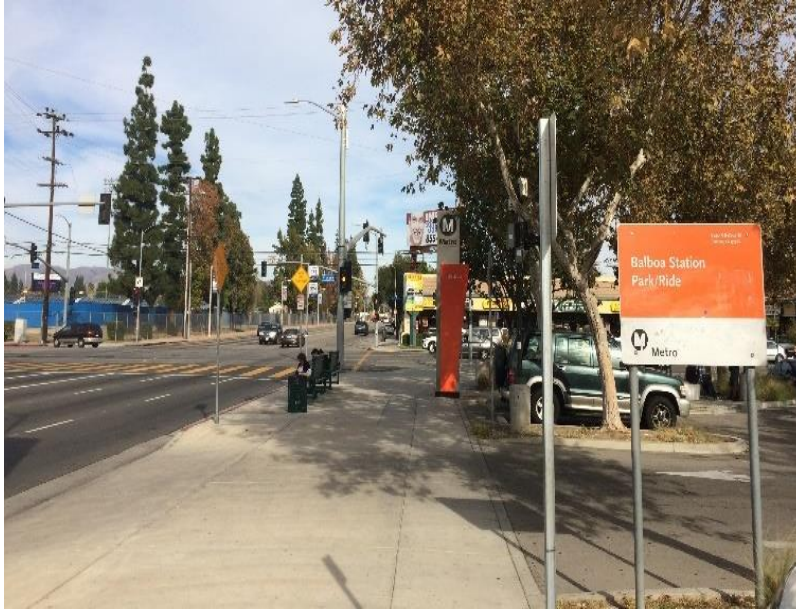
Photo 184: Station Monument Sign and Sign at Parking Lot Entrance

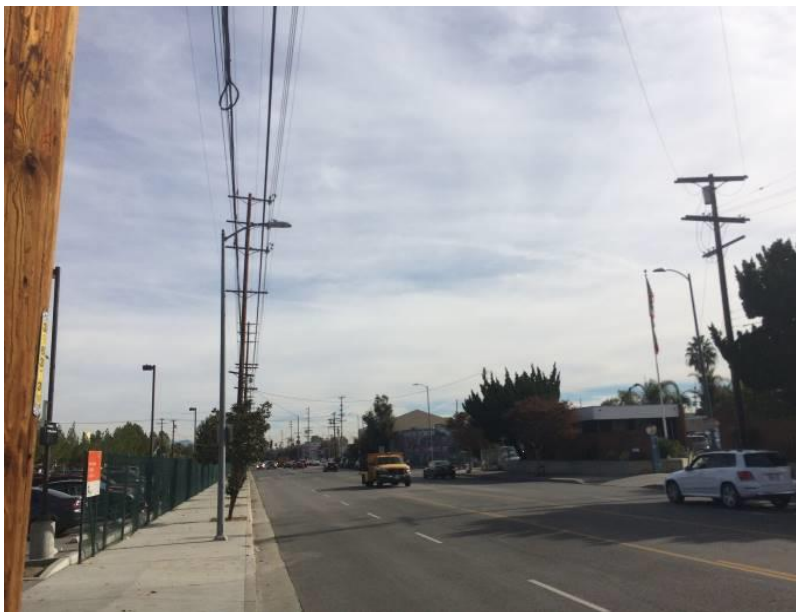
There are no parking wayfinding signs outside of the two station monument signs on Reseda, both of which are visible and placed in good locations. Both of the monument signs are on Sherman Way and not visible from Canoga Ave. There are no parking wayfinding signs on Reseda, Oxnard and Topham indicating that Metro parking facilities are nearby. There are small signs posted at the entrance to each parking lot.

Photo 188: No Wayfinding Signage along Oxnard St.

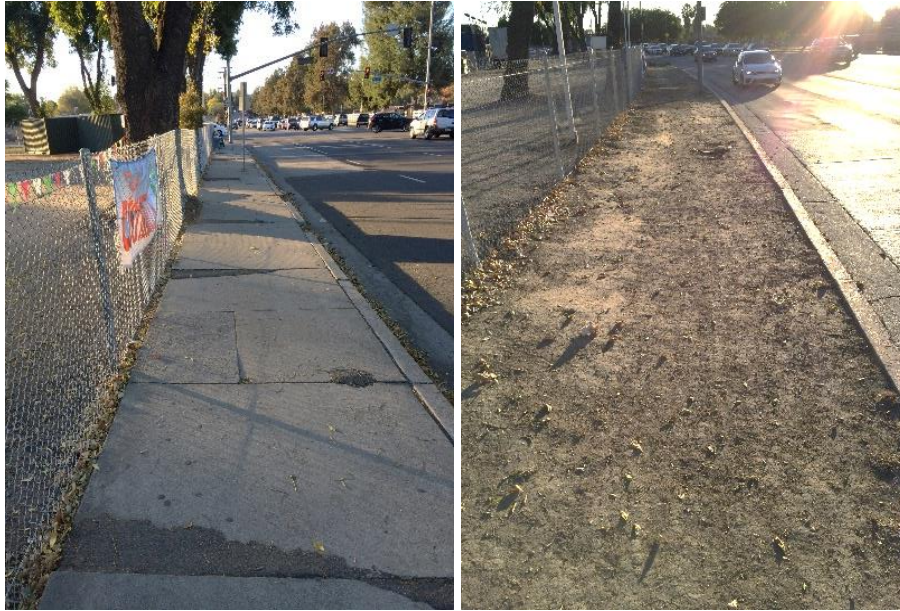
There is good pedestrian connectivity between the station and surrounding area. The sidewalks are in okay condition, however on the east side of Winnetka Ave. north of Victory Blvd. tree roots have caused the sidewalks to buckle. The sidewalk on the north side of Victory Blvd. east of Winnetka Ave. ends approximately 30 feet east of the intersection.

Photo 190: Buckled Sidewalk near Station (L); Where Sidewalk Ends on Victory Blvd. east of Winnetka Ave. (R)

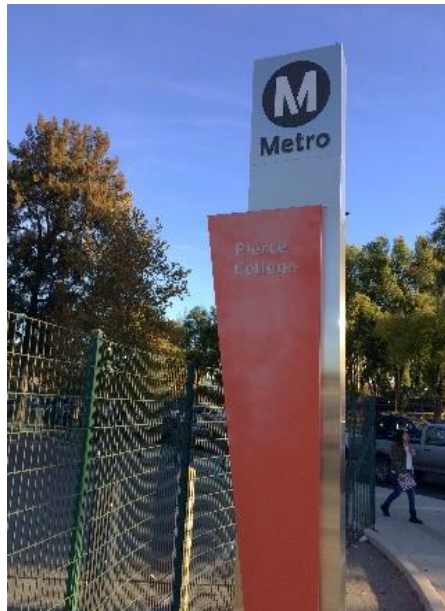
The monument sign outside the station is faded. There are no parking wayfinding signs on the streets in the vicinity of the station. There are small signs at parking lot entrances. There is cut-through traffic that speeds through the lot. Motorists turn right into the driveway on Winnetka Ave., and drive through the lot and make a right-turn onto Westbound Victory, avoiding some congestion at the intersection. This lot has an irregular shape with an abundance of drive aisles. The drive aisle on the south edge of the lot serves almost no parking spaces and functions more as a two-lane road. There are also odd internal drive-aisle merge points.

Photo 191: Station Monument Sign

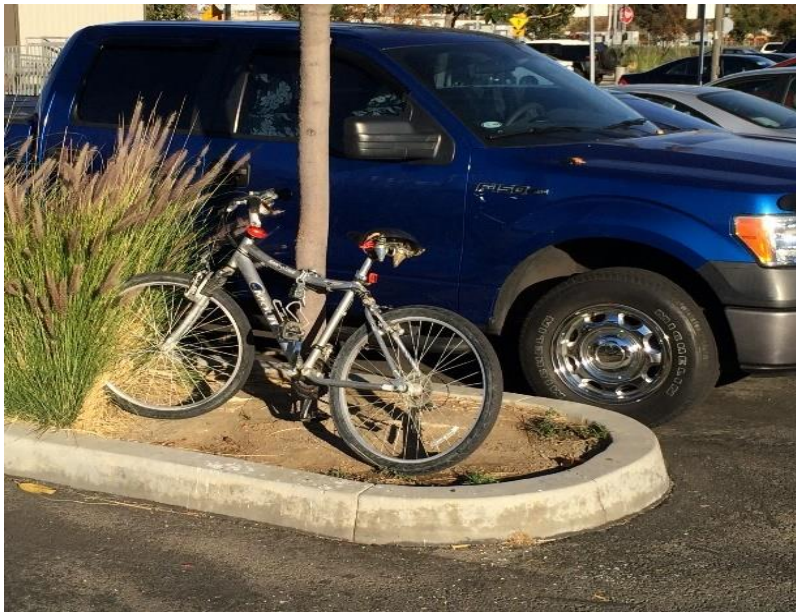
Photo 193: Bike Attached to a Tree

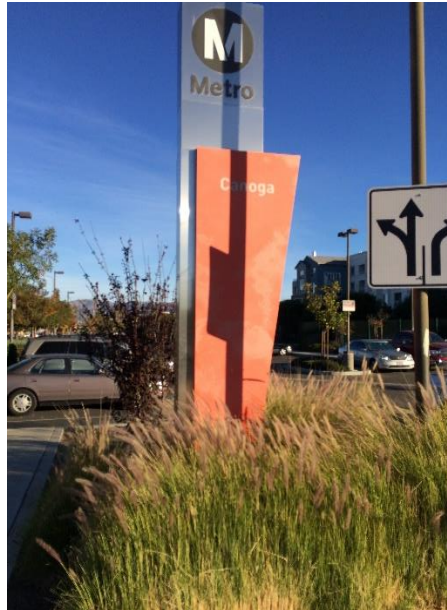
There are no parking wayfinding signs outside of a single monument sign on Canoga Ave. The monument sign is set back from the sidewalk and is located in the parking lot, making it difficult for passing motorists to see. There are no wayfinding signs on Canoga Ave. or Vanowen St. indicating a Metro parking facility. There are no signs at the parking lot entrances to indicate Metro parking.

Photo 195: Station Monument Sign

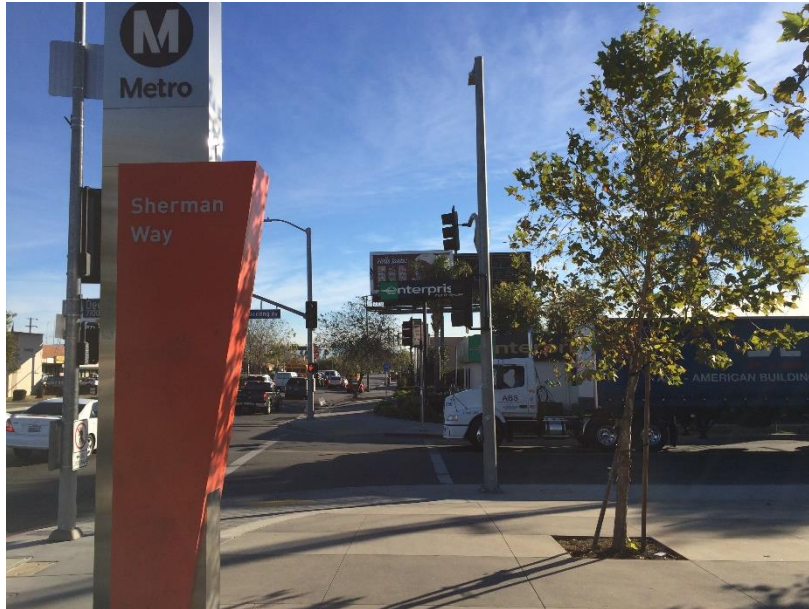
Photo 198: Monument Sign at Sherman Way

There are no parking wayfinding signs outside of the two station monument signs on Sherman Way. Both of the monument signs are on Sherman Way and not visible from Canoga Ave. The monument signs are set back from the sidewalk, making them more difficult for motorists to see. There are no wayfinding signs on Canoga Ave. or Sherman Way indicating a Metro parking facility. Only small signs at the entrance to each lot.

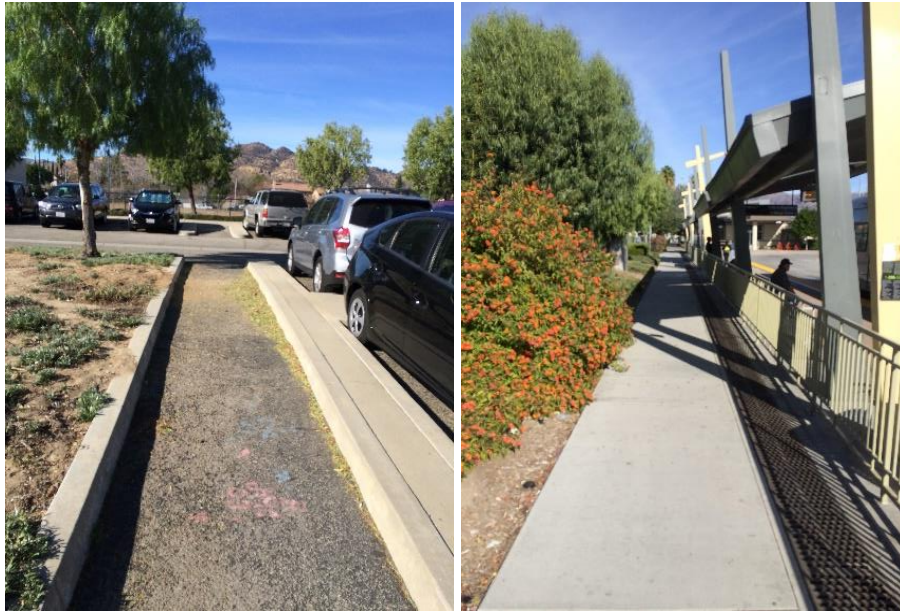
Sidewalks are in good shape around the station area. There are generally good internal sidewalks and connections within the station area and parking lots, with the exception of the internal sidewalk running down the center of the north lot that is discontinuous, being often broken up by landscaping.

Photo 202: Internal Pedestrian Walkway within Lot (L); Walkway Adjacent to Station Platform (R)

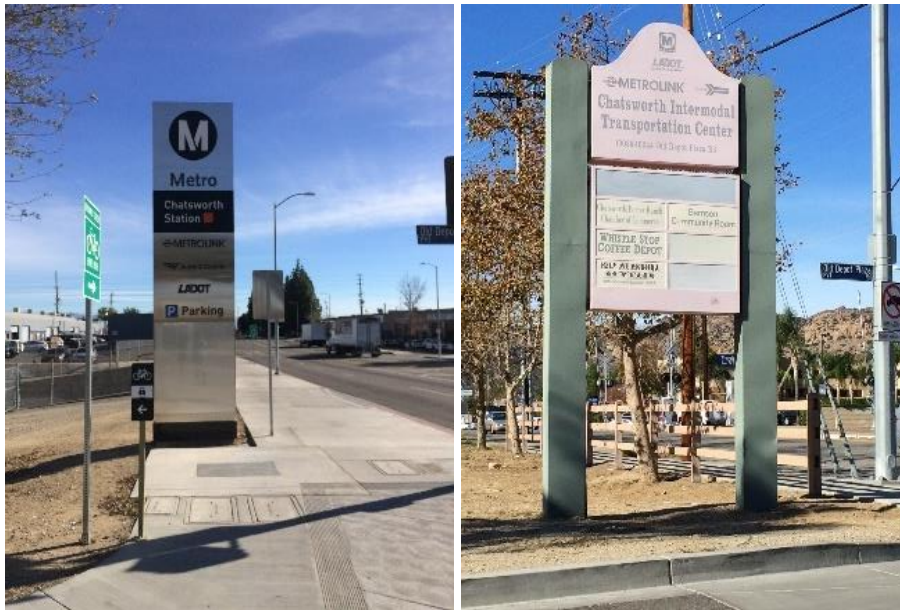
Because the Chatsworth station is a multimodal facility with Metrolink Rail and Amtrak connections, there are large monument signs for this station on both Devonshire St. and Lassen St. Aside from these signs, there are no parking wayfinding signs on the St. to direct patrons to the lots. Once on Old Depot Plaza Road, there is an abundance of wayfinding signs that are generally good, except for the bicycle parking signs that appear to point to the ground.

Photo 203: Station Monument Signs

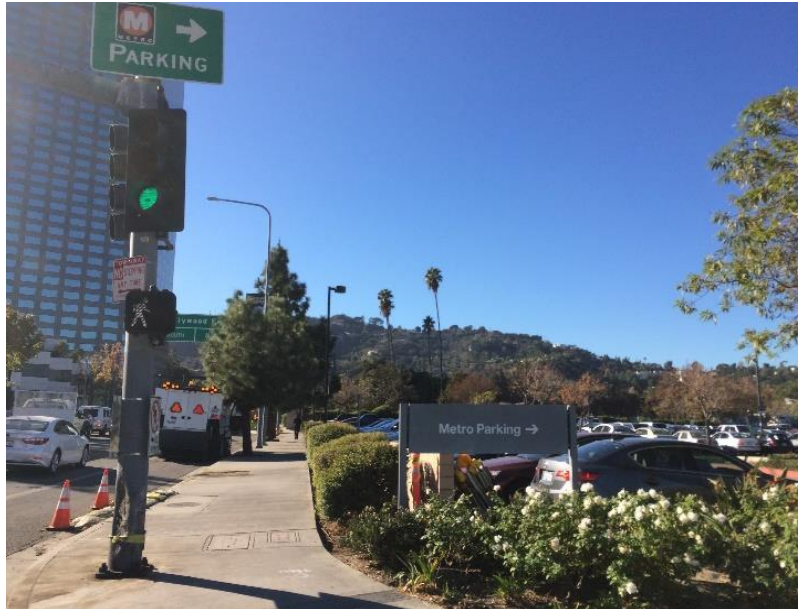
Sidewalks provide good connectivity between the station and surrounding area. The sidewalks leading to the station are wide and in good condition. Riders who park in the South and West Lots must walk under I-101 to access the station and there is no signage to direct them.

Photo 210: Sidewalk along Lankershim Blvd. Facing South

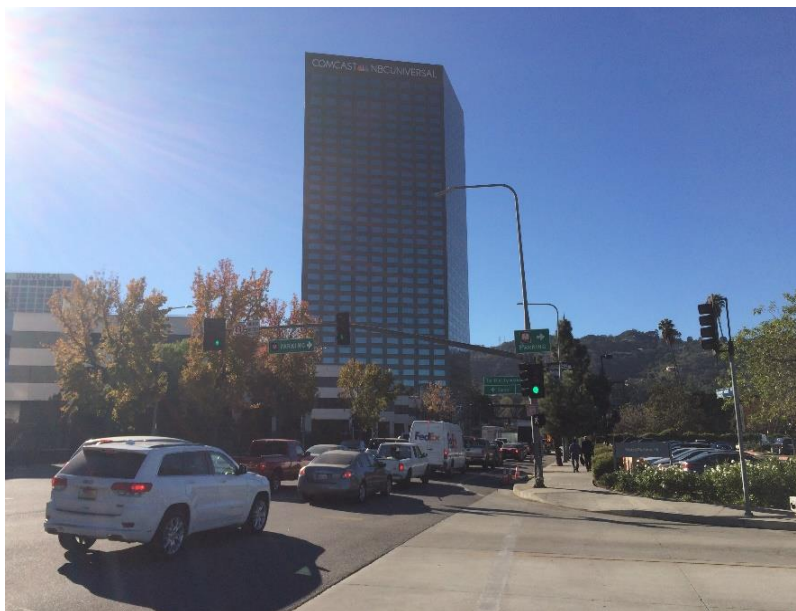
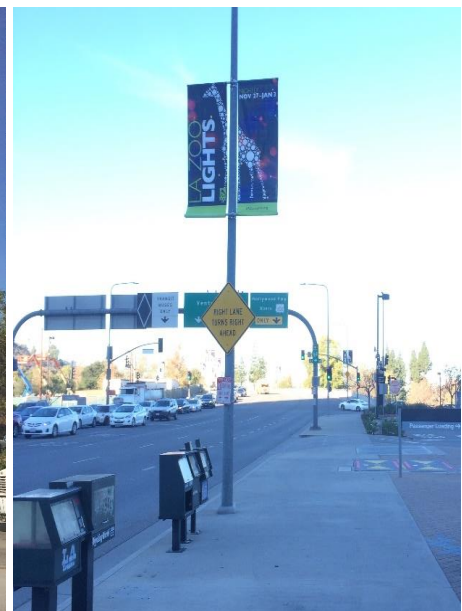
There are small parking wayfinding signs directing Metro riders who park to the North Lot from both Lankershim and Campo De Cahuenga. There is minimal parking wayfinding signage along Ventura Blvd. directing Metro riders who park to the West and South Lots. West and South entrances are not readily visible. There is no signage at parking lot entrances to indicate Metro parking.

Photo 211: Wayfinding Sign along Lankershim Blvd. (L); Wayfinding Sign along Campo De Cahuenga (R)

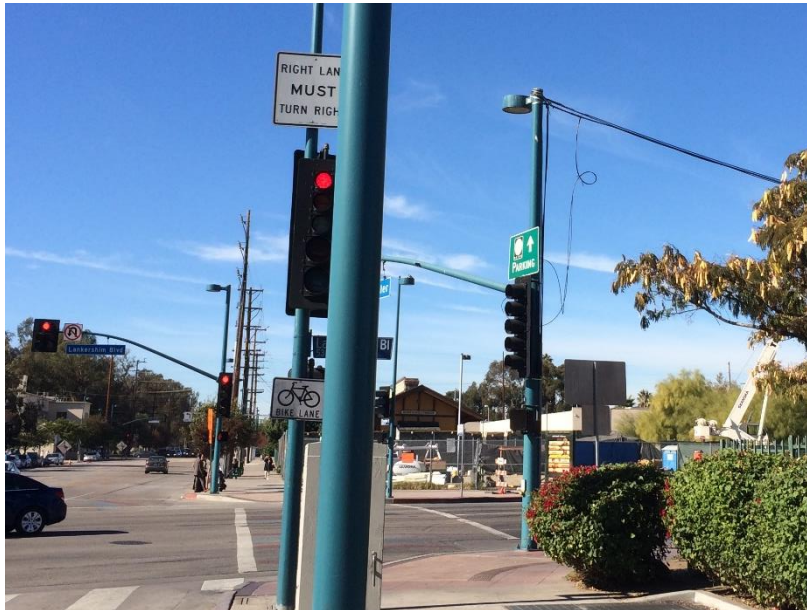
There are small parking wayfinding signs along northbound and southbound Lankershim Blvd. that direct drivers to parking in the North and South Lots. The sign on southbound Lankershim Blvd. is partially obscured by a tree. No parking wayfinding signs are present on Chandler Blvd. There is a small sign on westbound Cumpston St. and lot signage along Fair Ave. There are no signs directing drivers to the Chandler Lot or West Lot. There is no signage at lot entrances to indicate Metro parking.

Photo 214: Wayfinding Sign on Lankershim Blvd.

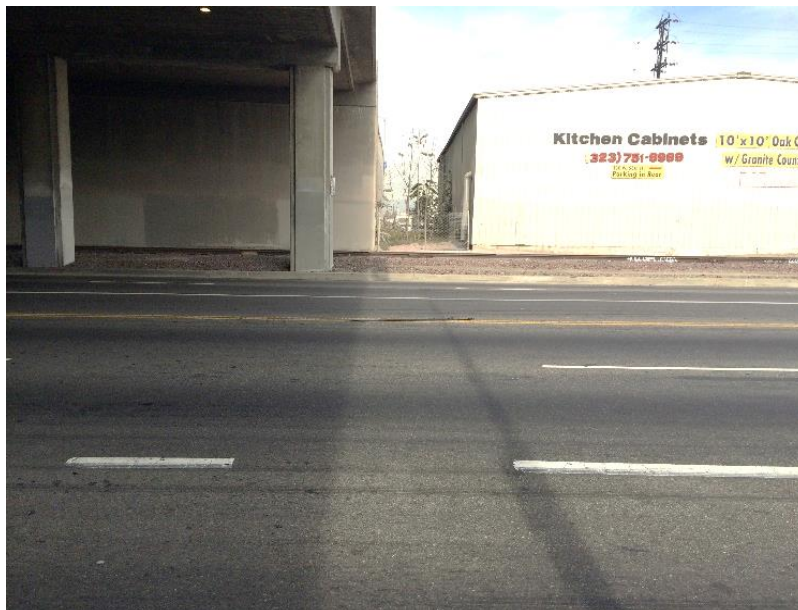
The main entrance to the platform is on Slauson under I-110. There is no sidewalk on the north side of Slauson Ave. due to the railroad right-of-way. East/west crosswalks are present but no north/south crosswalks. A staircase in the East Lot also provides access to the platform.

Photo 217: No Sidewalk on North Side of Slauson Ave.

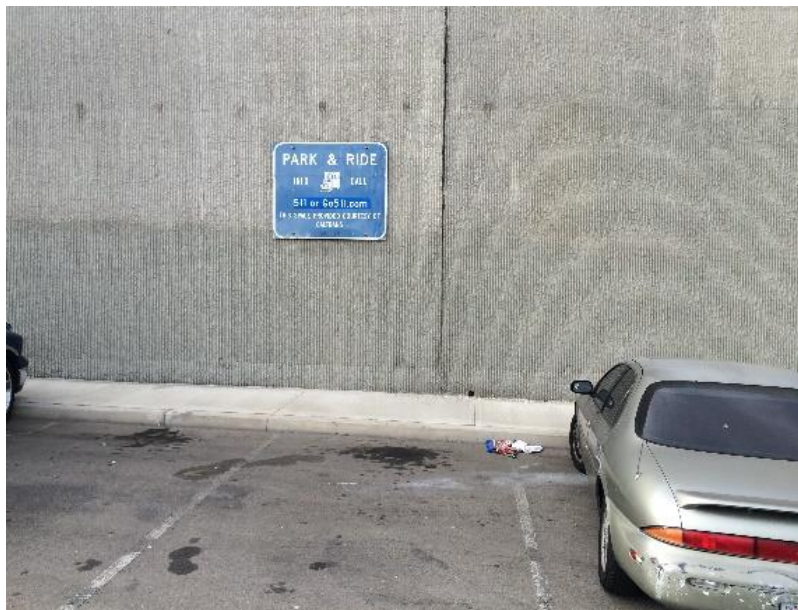
There are no parking wayfinding signs for this station, and no signs at entrances to the lots themselves denoting them as Metro parking facilities. There is one Caltrans sign in the east lot bolted to the freeway retaining wall directing people to call 511 for more info about park-and-ride.

Photo 219: Caltrans Park and Ride Sign

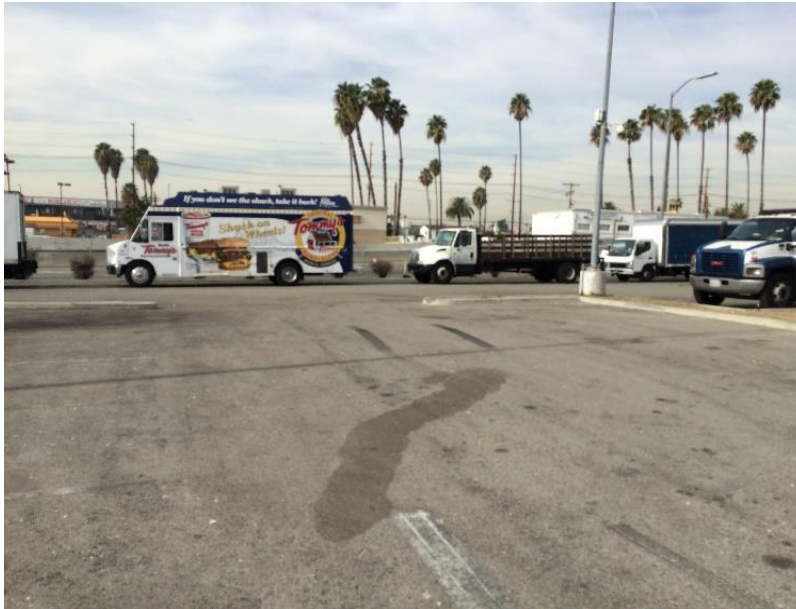
- Metro transit riders
- Local businesses park their box trucks in the West Lot during the day

Photo 222: Trucks from Adjacent Businesses Parked in West Lot

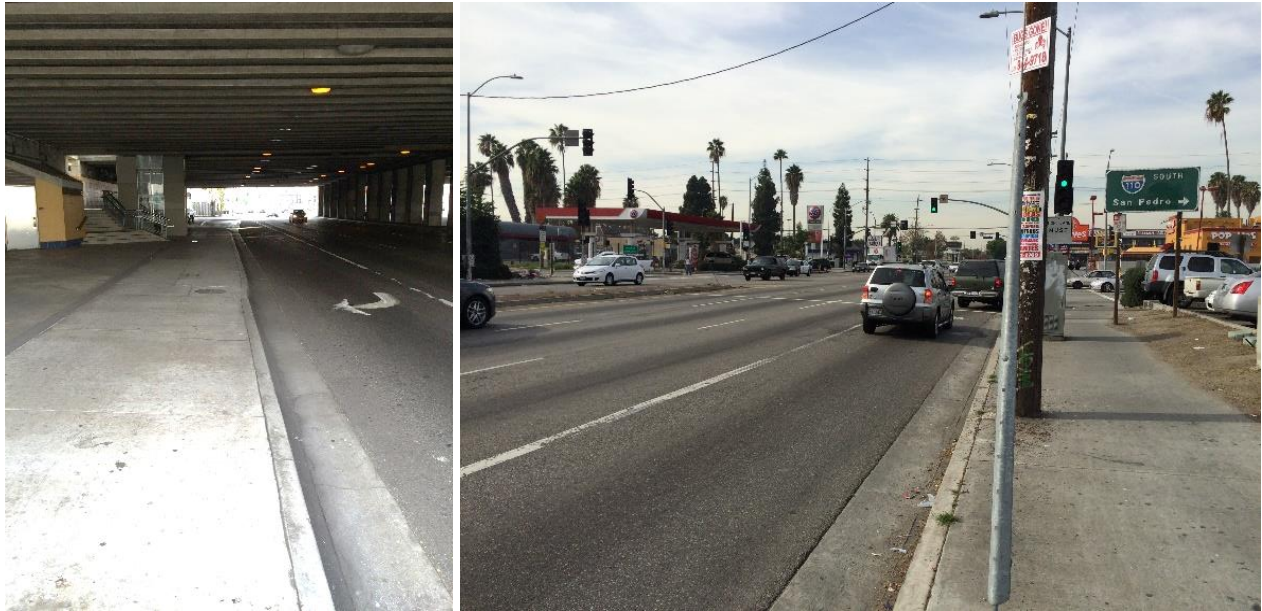
Photo 223: Sidewalk along Manchester Ave. (L); Shortage of Crosswalks at Intersection of Manchester Ave. and I-110 South On-Ramp (R)

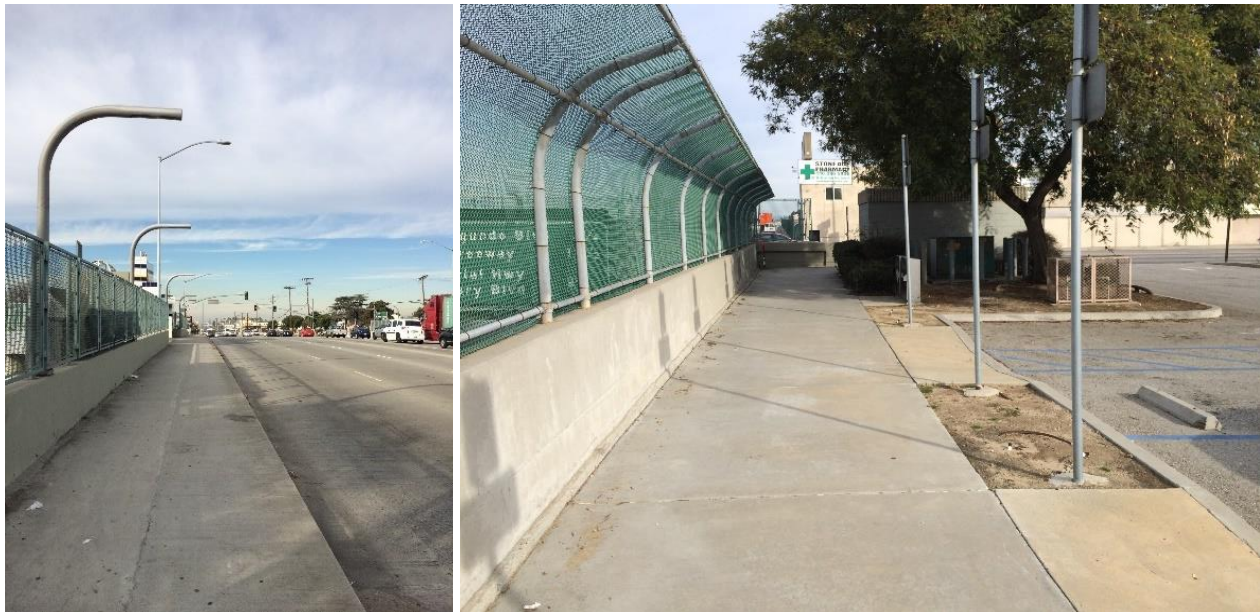
Sidewalks are present on Rosecrans and are of an adequate width. There was trash on the sidewalks on Rosecrans over the I-105 freeway.

Photo 225: Trash on Sidewalk along Rosecrans Ave. (L); Sidewalk within Parking Lot (R)
