Supportive Transit Parking Program

A key first step of the STPP Master Plan effort was the collection of quantitative data regarding how Metro’s parking spaces and qualitative information related to their condition and access. The purpose of the Facility Assessment effort was to understand current system operation and performance, which served as baseline information required to recommend future policy and operational changes, and to recommend and quantify the cost of improving the parking facilities.

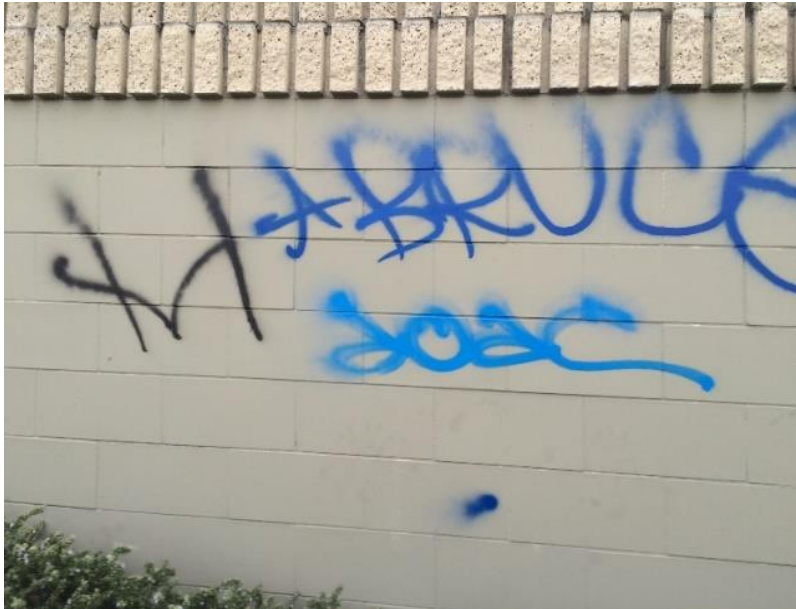
Photo 227: Graffiti on side of Utility Building

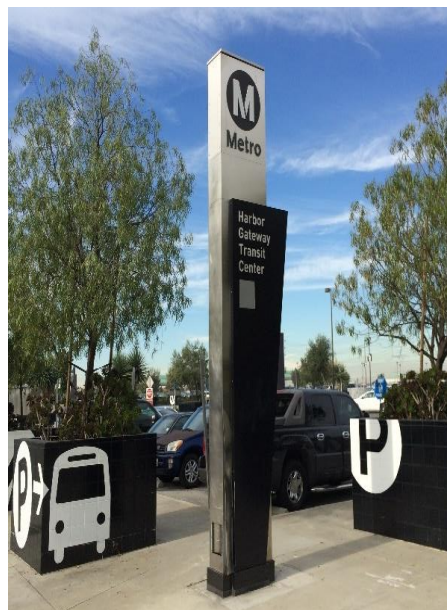
There is good parking wayfinding signage along 182nd St. although minimal signage elsewhere. A couple small parking wayfinding signs are located along Vermont Ave. and 182nd St. but are obscured by a chain link fence. There are no signs at lot entrances to denote that it is a Metro parking facility.

Photo 231: Station Monument Sign

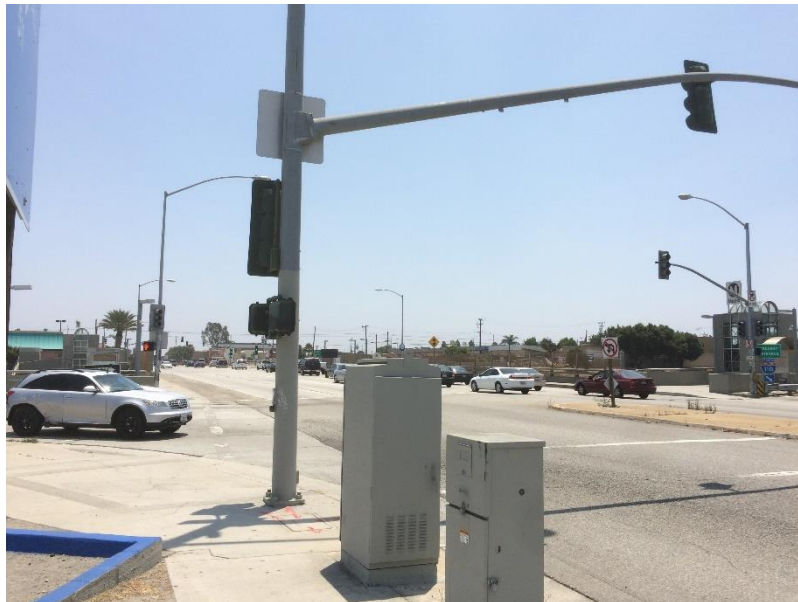
The station is well-connected by sidewalks along Carson St. There is a heavy volume of vehicles turning right onto Carson St. from the I-110 southbound off-ramp, who are often looking to turn right on red, in potential conflict with a pedestrian walk sign.

Photo 235: Intersection of I-110 and Carson St.

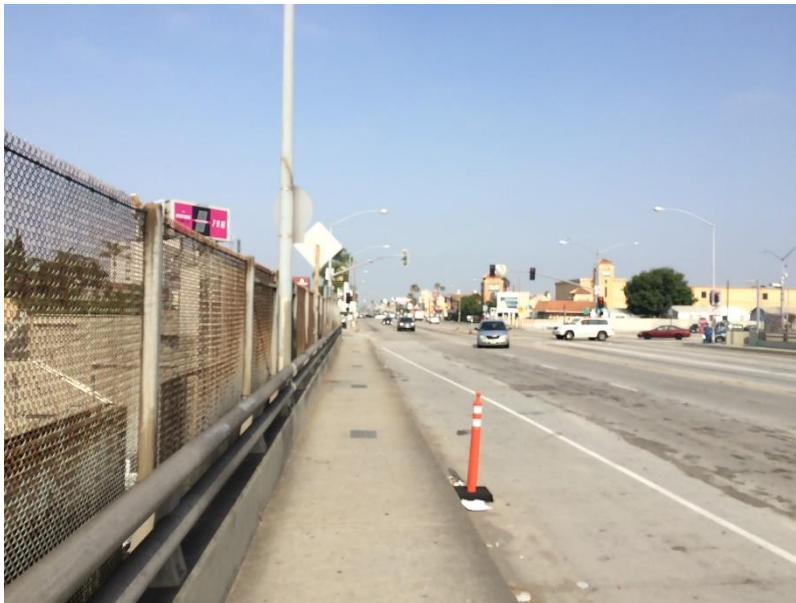
Photo 236: Sidewalk along Carson St.

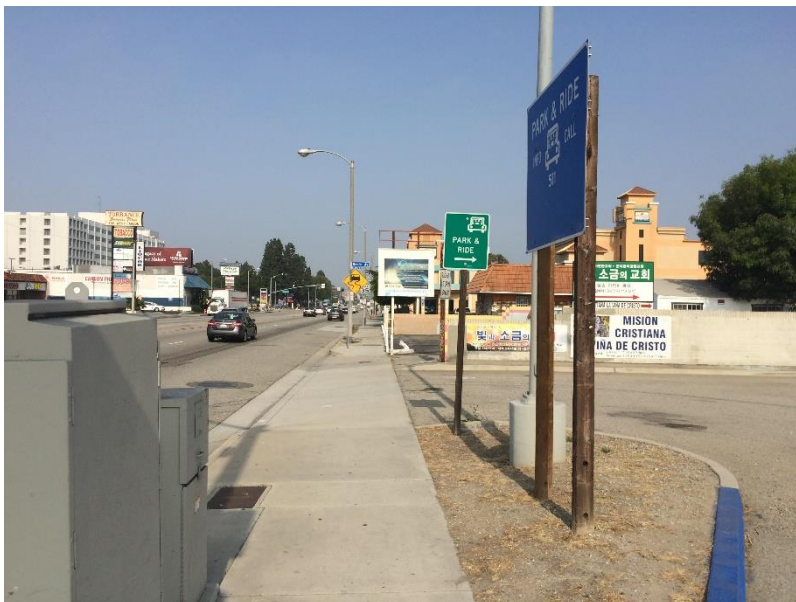
There are Park-and-Ride signs on the I-110 freeway in both directions in advance of the Carson St. exit, as well as small parking wayfinding signs on the off-ramps. There is no parking wayfinding signage on the local streets. There is also a Park-and-Ride sign on Carson St. at the entrance to the parking lot but nothing to identify the lot as a Metro parking facility.

Photo 237: Park and Ride Signage at Entrance to Lot

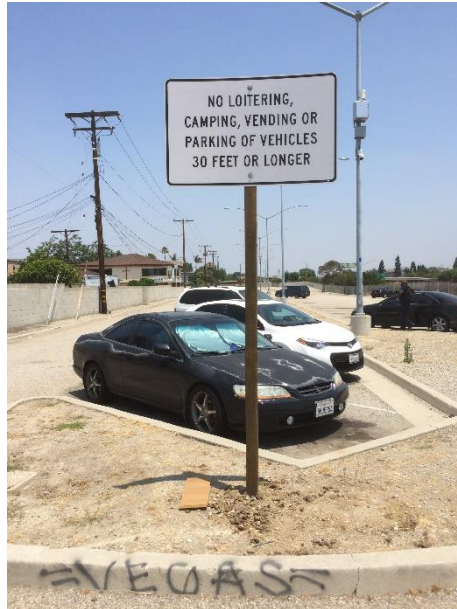
The parking lot had some graffiti and debris/litter. There was also broken glass in the landscaped area next to the entrance.

Photo 239: Graffiti in Parking Lot

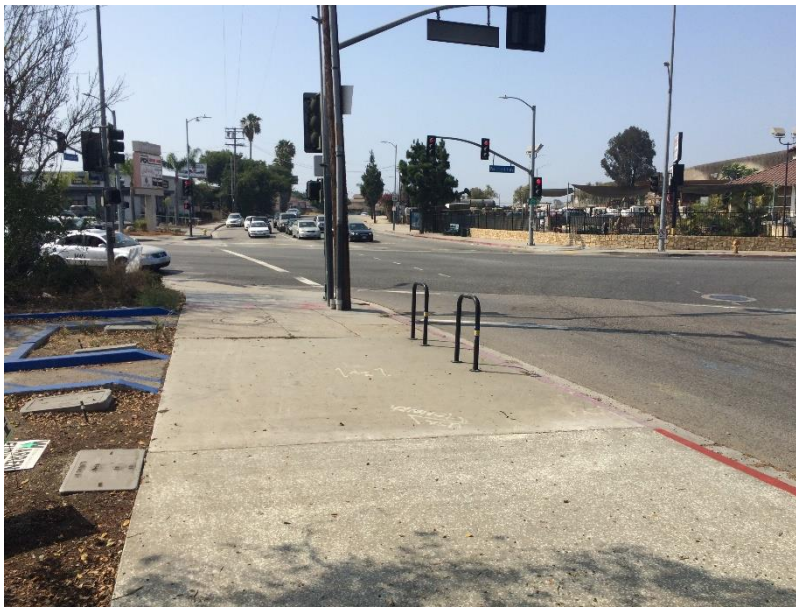
There are no bicycle lanes on Figueroa St. or Pacific Coast Highway. The station does not have bike lockers. Bike racks are provided on the sidewalk on Figueroa St.

Photo 240: Bike Racks along Figueroa St.

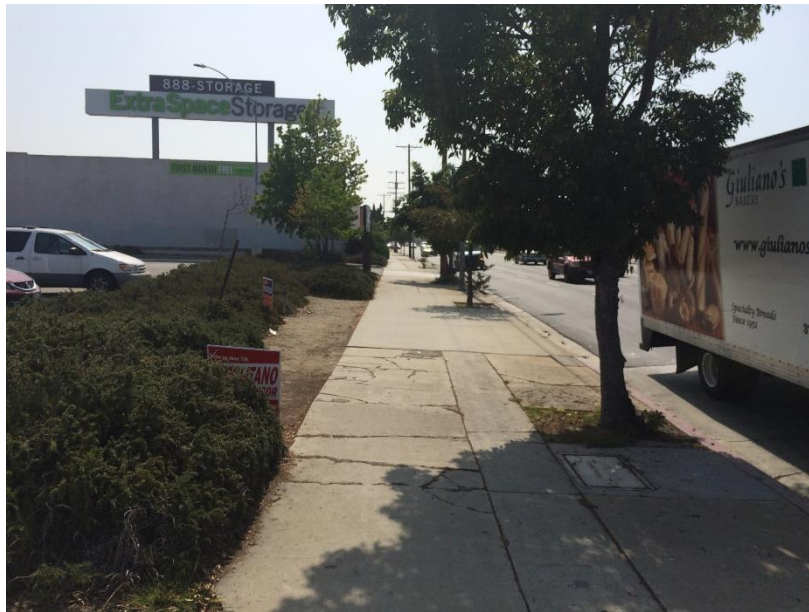
Photo 241: Sidewalk along Pacific Coast Highway

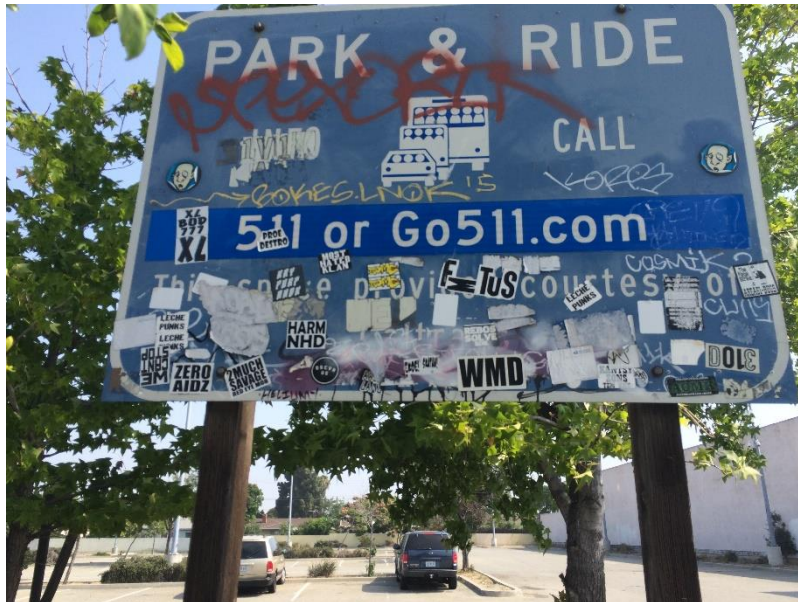
Photo 242: Graffiti on Park and Ride Sign next to the Entrance on Pacific Coast Highway

While it is located on a busy corner, the parking lot is large. During site observations, taggers were observed placing graffiti on one of the light poles in the parking lot, as well as St. signs on Pacific Coast Highway adjacent to the parking lot. There were two shopping carts filled with what appeared to be personal items next to one of the station signs under the I-110 freeway on Pacific Coast Highway.

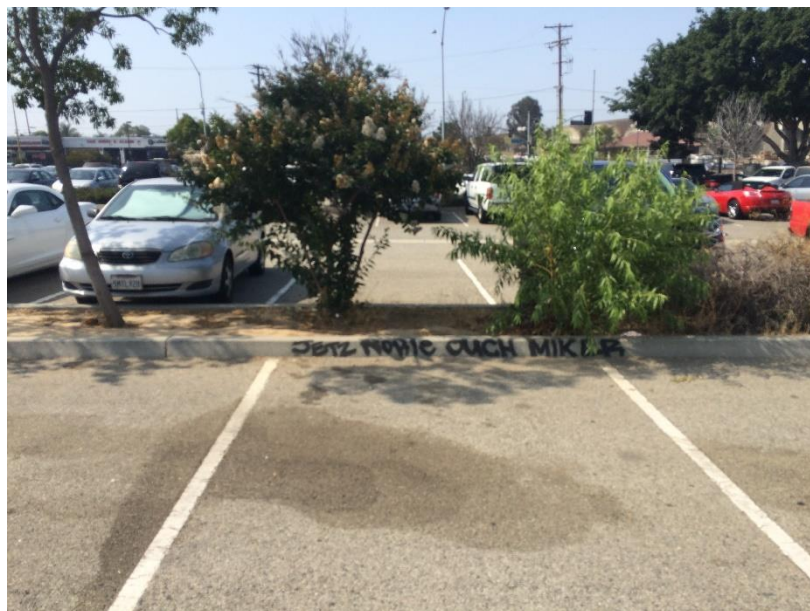
Photo 243: Graffiti on Curb in Parking Lot
