# Los Angeles County Metropolitan Transportation Authority

WESTSIDE PURPLE LINE EXTENSION, SECTION 3 STATIONS

VA STATION MURAL FINE ARTS REPORT

VA STATION MURALS CONDITIONS ASSESSMENT – MARCH 20, 2020

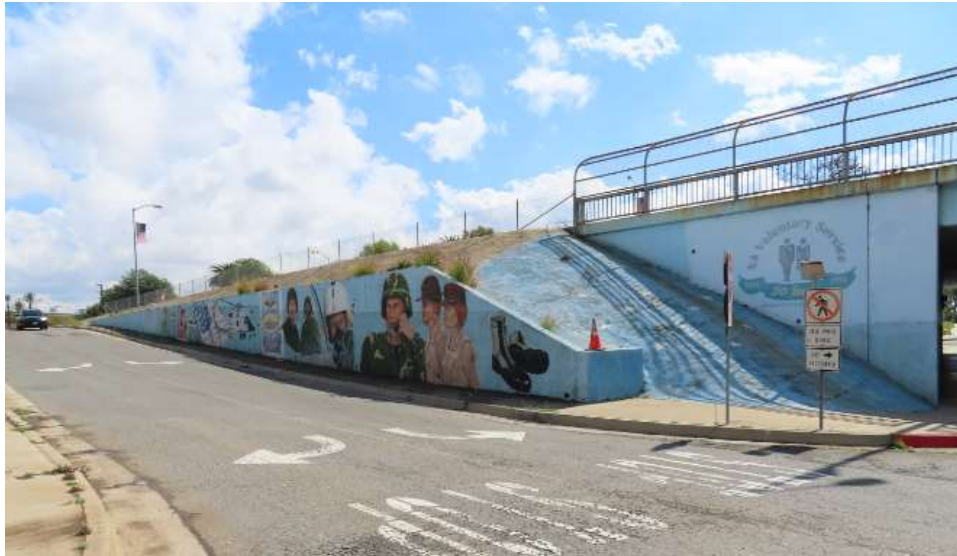
Figure 9 – Northeast retaining wall and corner slope (Wilshire Blvd. off-ramp, westbound).  
(source: ARG)

The project will demolish the northeast retaining wall and its adjacent corner slope. These bear a portion of the *National Veterans Mural* comprising approximately ten (10) percent of the total mural

surface area. A new art wall will be constructed at the northeast corner of Bonsall Ave. and the westbound Wilshire Blvd off-ramp. The new art will replicate the original artwork from the retaining wall but will be rendered in mosaic tile rather than paint. The artwork at the corner slope, consisting of a blue background with white stars, will not be reconstructed or replicated. Design and details for the replica wall are to be provided by others. The design of the new wall is also subject to approval by Metro Art and the Los Angeles County’s Civic Art Program.

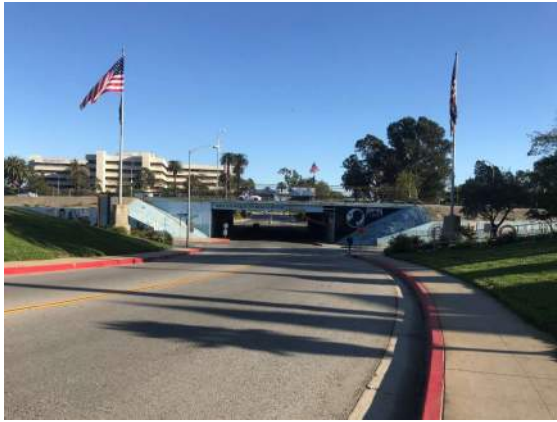
Photo 1: Wilshire Blvd. bridge crossing at Bonsall Ave. view south.

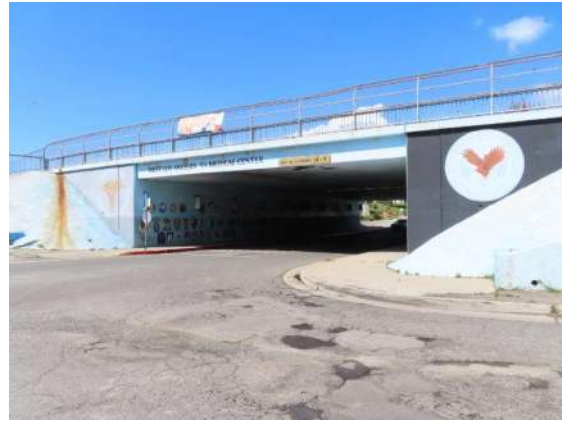
Photo 2: Wilshire Blvd. bridge, south elevation.

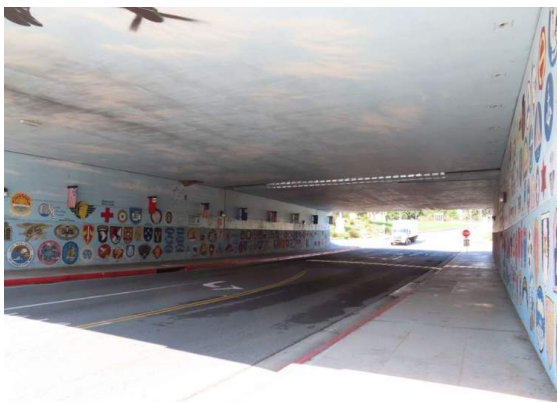
Photo 3: Bonsall Ave. underpass, view south; note murals on east and west elevations and ceiling above.

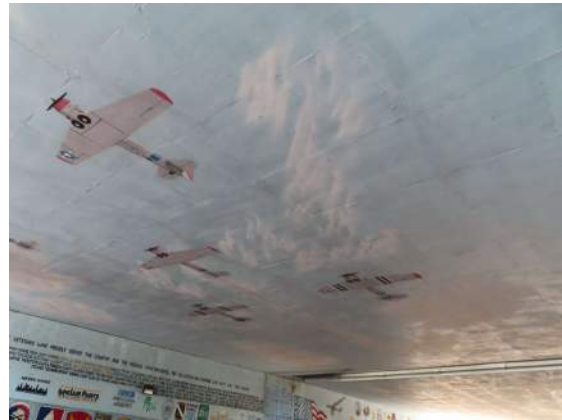
Photo 4: Bonsall Ave. underpass ceiling; note biplanes and clouds. Also note plywood sheet form lines at concrete slab.

The underpass ceiling should have no impact or risk of damage from adjacent construction activities. There is no additional protection recommended at this time. We recommend visual monitoring of ceiling surfaces at regular intervals during the construction process to check for damage, in particular following any activities which exceed stated vibration limits. Follow all specifications in the vibration monitoring program.

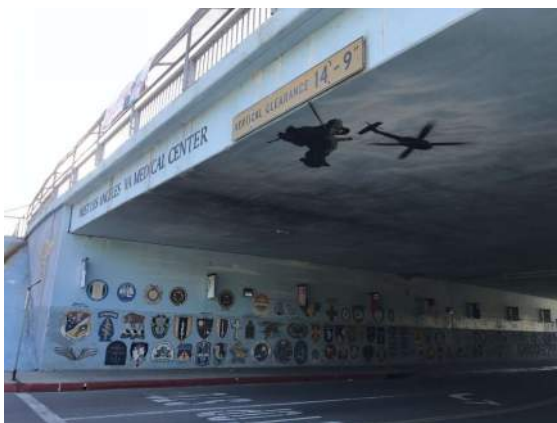
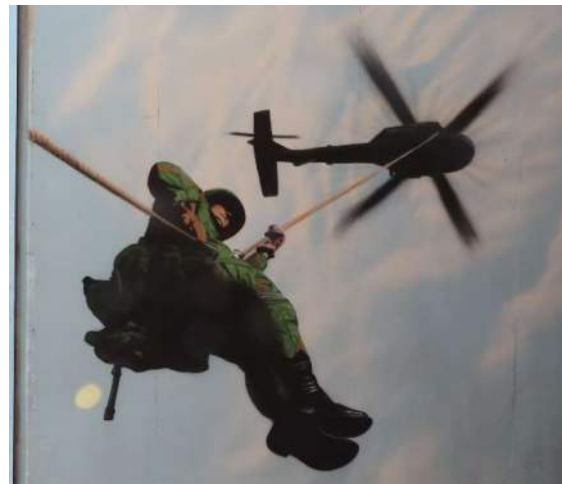
Photo 5: Bonsall Ave. underpass south entrance; note perspective mural on ceiling.

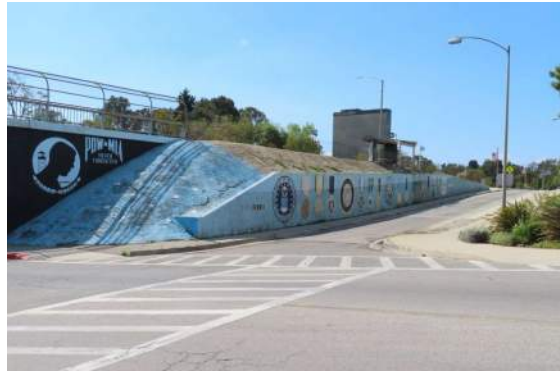
Photo 9: Northeast retaining wall (Wilshire Blvd. Off-Ramp, westbound).

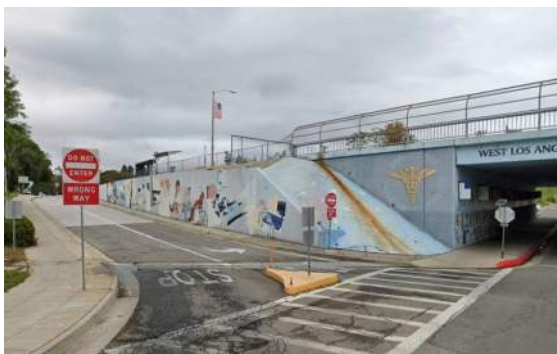
Photo 10: Northwest retaining wall (Wilshire Blvd. On-Ramp, westbound).

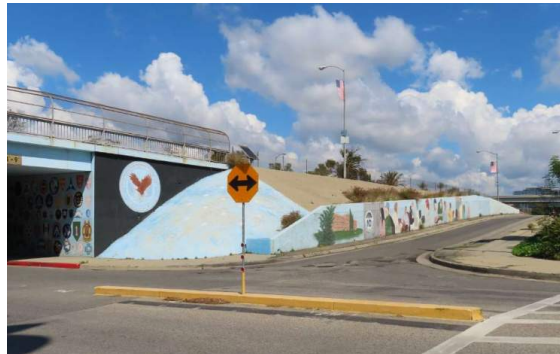
Photo 11: Southwest retaining wall (Wilshire Blvd. Off-Ramp, eastbound).

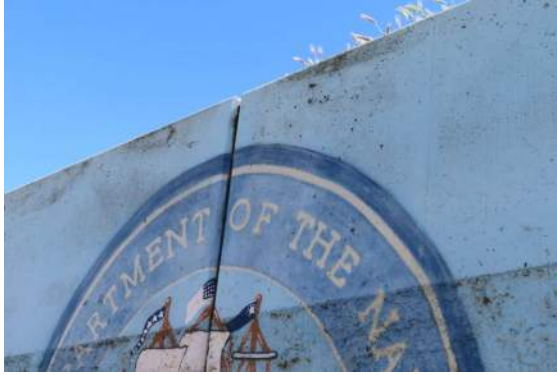
Photo 13: Detail of Navy insignia at northwest wall; note mural continues through vertical expansion joint.

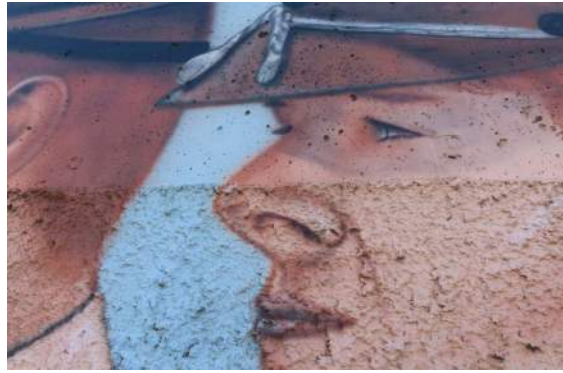
Photo 14: Detail of portrait at northeast wall; note mural work continues over both smooth and highly textured wall finishes.

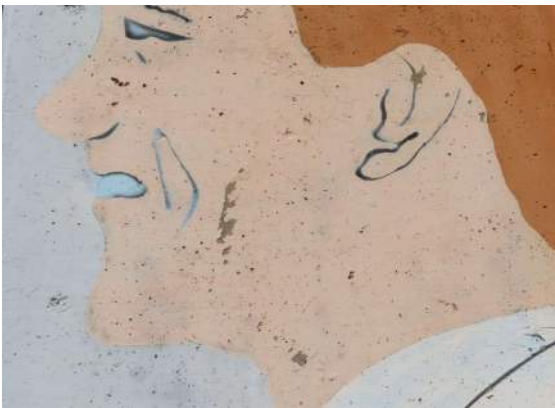
Painted surfaces appear to largely intact. ARG noted a few locations where there is cracking or peeling paint (see photo 22), or where there is paint loss (see photo 21). In some locations at the heavily textured surfaces, it is unclear if the paint loss is due to weathering and damage over time, or if the surfaces were incompletely painted originally due to the difficulty of covering the heavy texture (see photo 23). At one location on the southeast wall, it appears that the paint loss may be related to cleaning or removal of previous graffiti (see photo 24).

Photo 21: Detail at southwest wall; note paint loss at face.

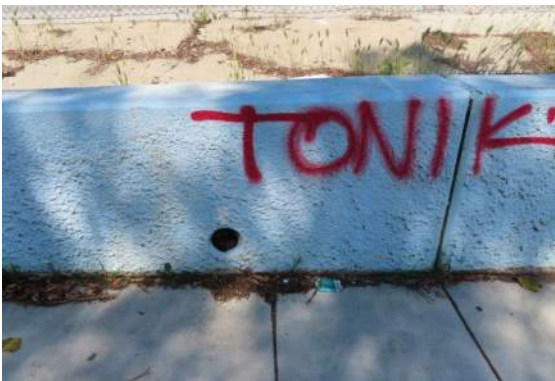
The murals have very little current damage from graffiti. Writing or pen marks were noted in two locations (Bonsall Ave. east elevation and northwest wall; see photo 30); and spray paint graffiti was noted in two locations (southwest and southeast walls; see photo 31). In other areas, it appears that previous graffiti has been painted over with non-matching paint (see photo 32 for an example).

Photo 31: Detail at end of southwest wall; note graffiti.

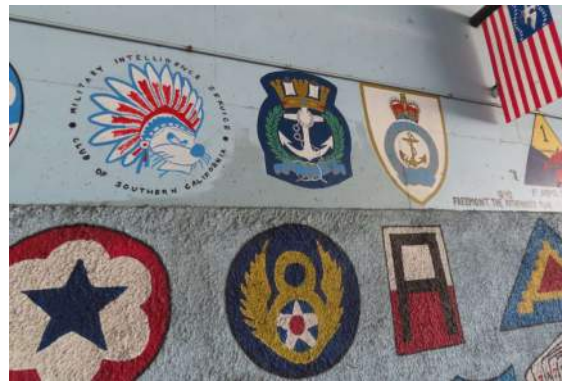
Photo 32: Detail at west elevation of Bonsall Ave. underpass; note overpaint, most likely to cover graffiti.

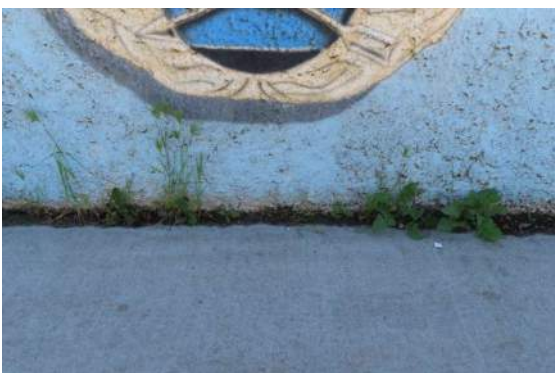
Plant growth was noted at the base of most retaining walls at the joint with the sidewalk (see photo 33). Growth was also noted at various crack locations in the concrete-covered corner slopes. Most surface areas appear to drain water well; however, standing water was noted at two of the four corners, at low spots behind the retaining walls. Also, at the southeast wall, there appears to be an issue of soil erosion at the soil-side of the retaining wall; piles of dirt were noted at each of the drain holes at the base of the wall (see photo 34).

Photo 33: Detail at northwest wall; note plant growth.

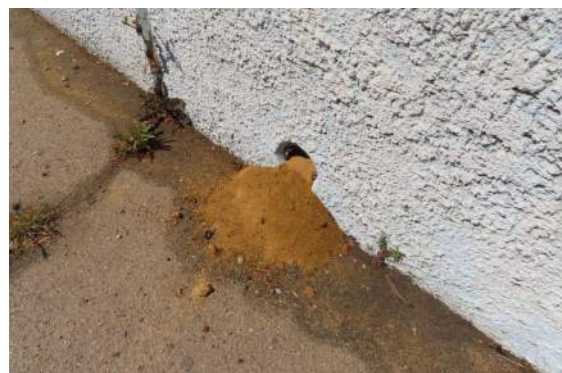
Photo 34: Detail at southeast wall; note soil erosion at drain hole.

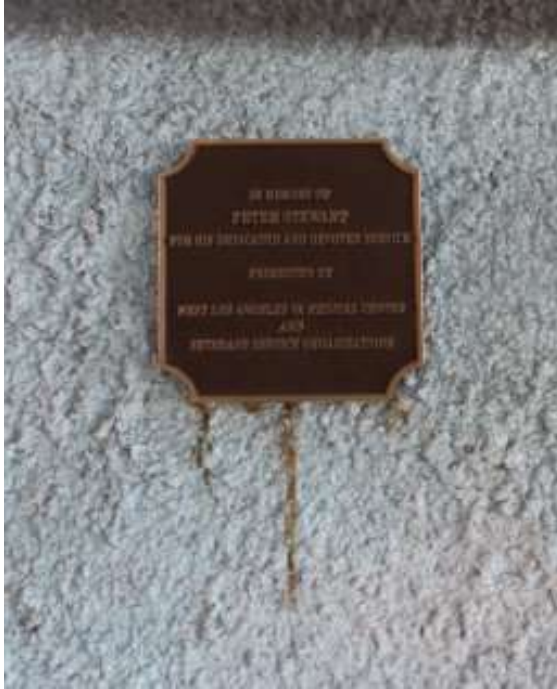
Several items are attached to mural surfaces at the Bonsall Ave. underpass. There is a bronze plaque mounted to the wall at the east elevation (see photo 35). At the west elevation, there is a row of flags supported on metal stanchions. Below the stanchions there is row of cut off steel angles suggesting that the flags were raised to a higher elevation at some point in time (see photo 36). Also attached to the walls and ceiling are several light fixtures and surface-mounted conduit (see photos 37-38).

Photo 35: Bronze plaque at east elevation of Bonsall Ave. underpass.

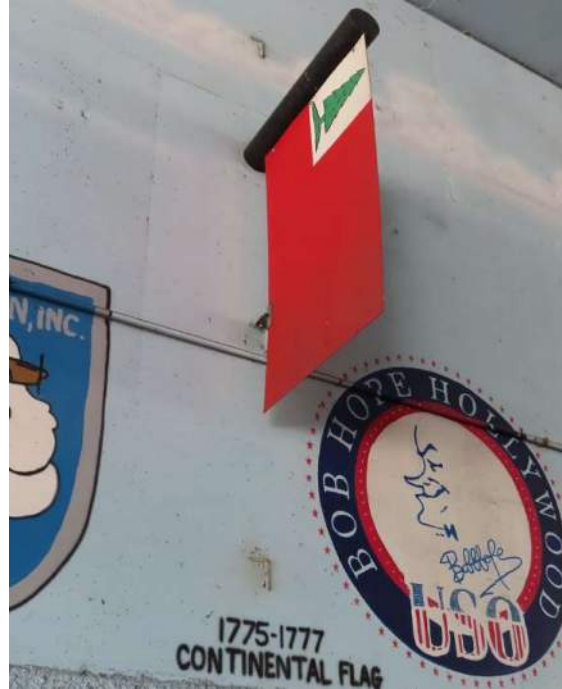
Photo 36: Flag on stanchion at west elevation of Bonsall Ave. underpass; note cut off angle below, indicating flag was raised.

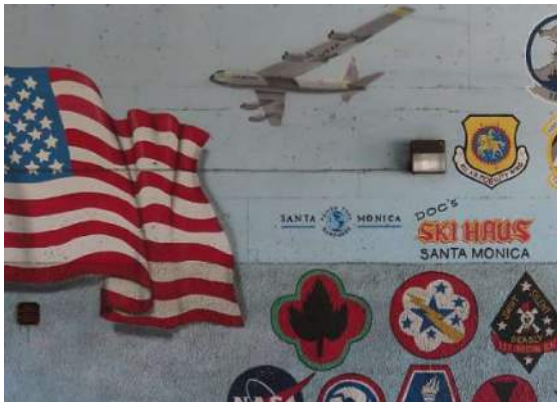
Photo 37: Detail of east elevation of underpass; note light fixture and surface-mounted conduit.

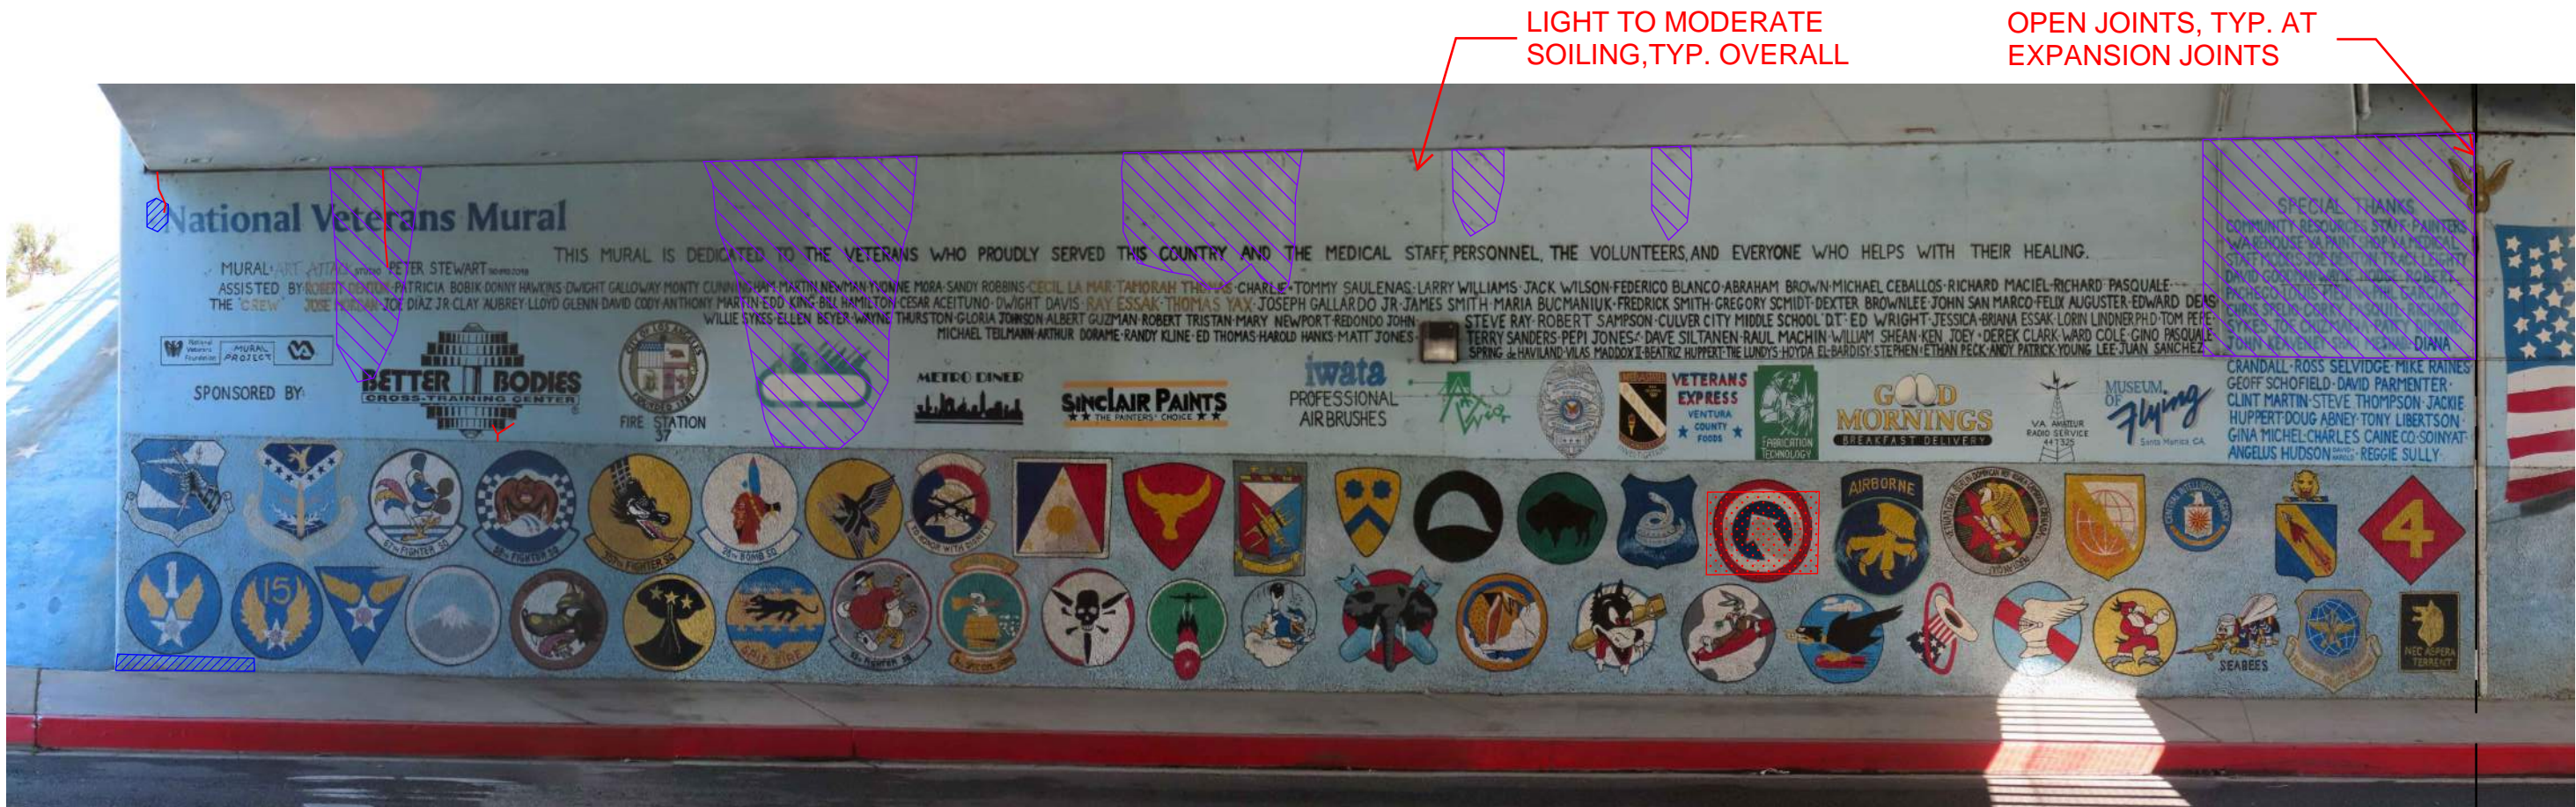
**1** BONSALL AVE. EAST ELEV. (PANEL 1)  
NOT TO SCALE

OPEN JOINTS, TYP. AT EXPANSION JOINTS

LIGHT TO MODERATE SOILING, TYP. OVERALL

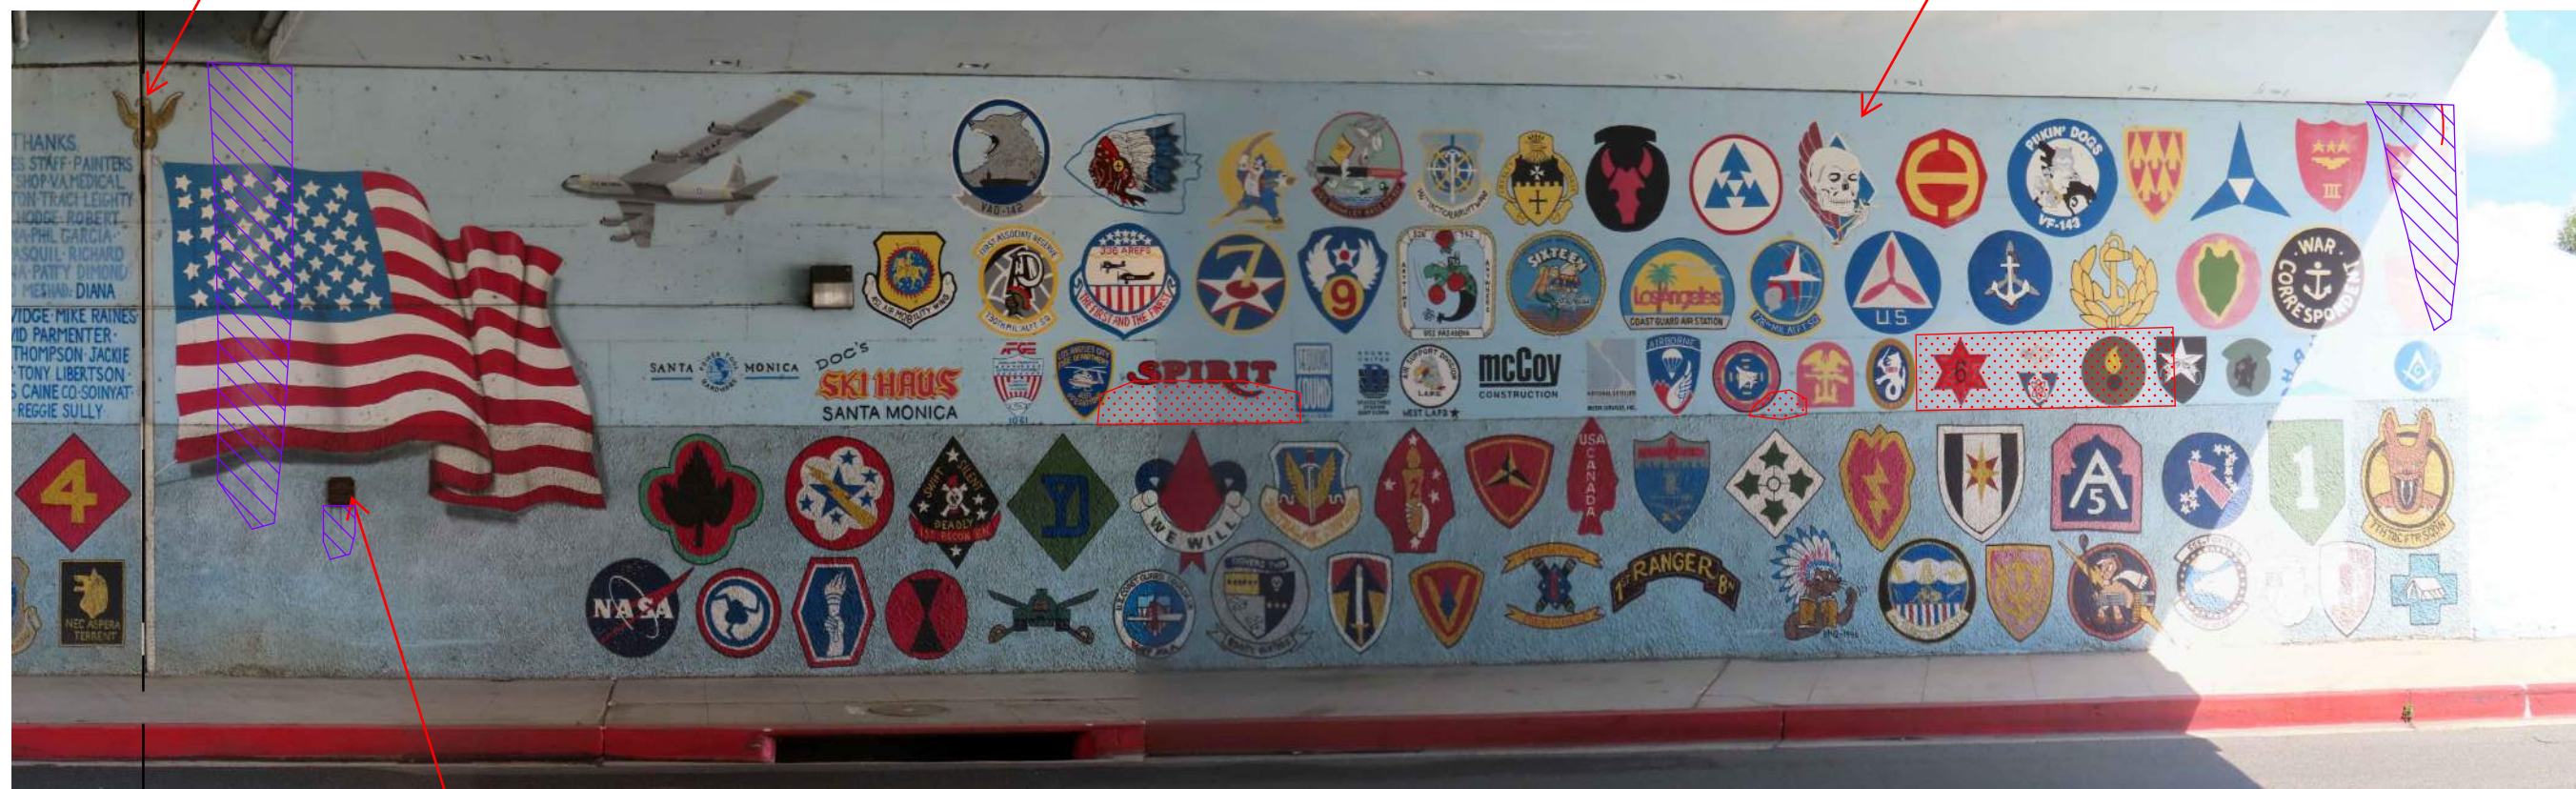
BRONZE PLAQUE

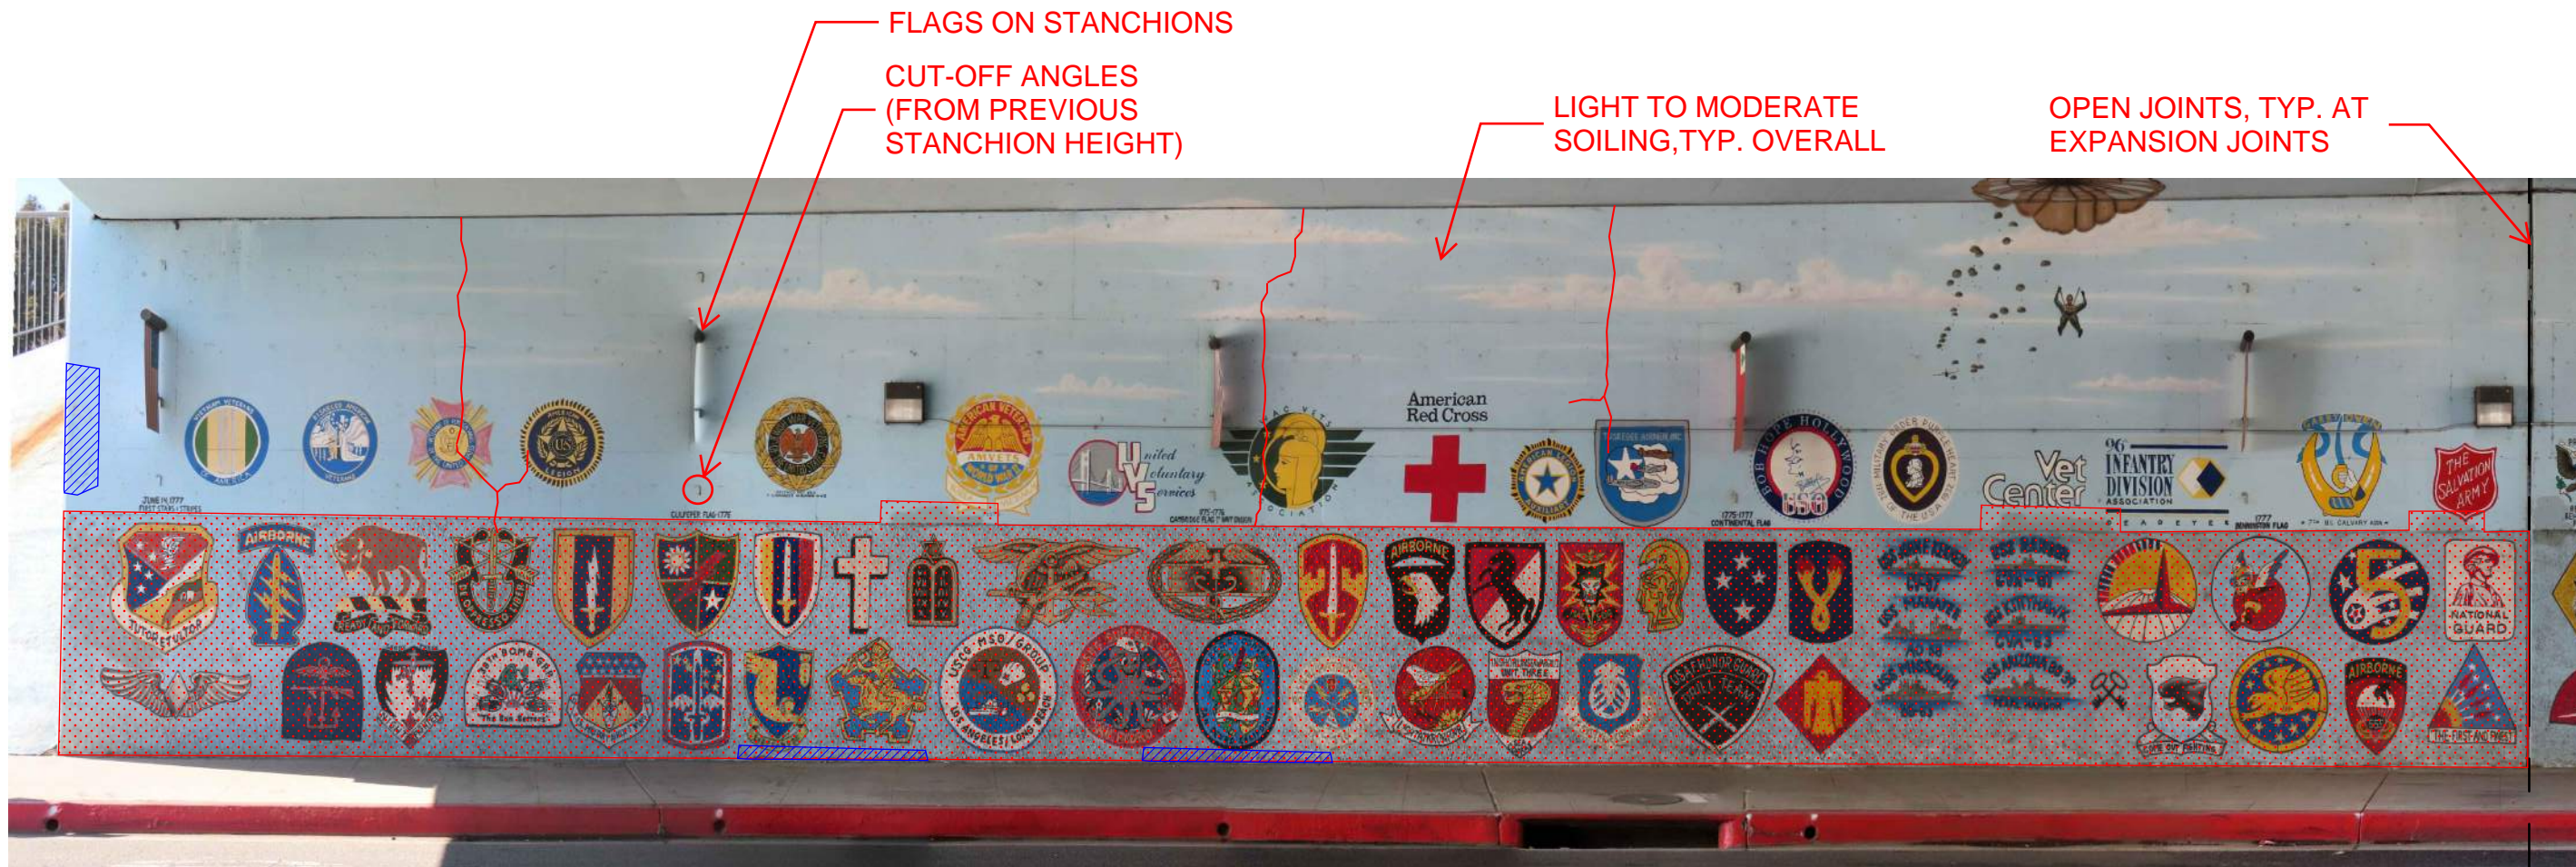
**1** BONSALL AVE. WEST ELEV. (PANEL 1)  
NOT TO SCALE

OPEN JOINTS, TYP. AT EXPANSION JOINTS

FLAGS ON STANCHIONS

CUT-OFF ANGLES (FROM PREVIOUS STANCHION HEIGHT)

LIGHT TO MODERATE SOILING, TYP. OVERALL

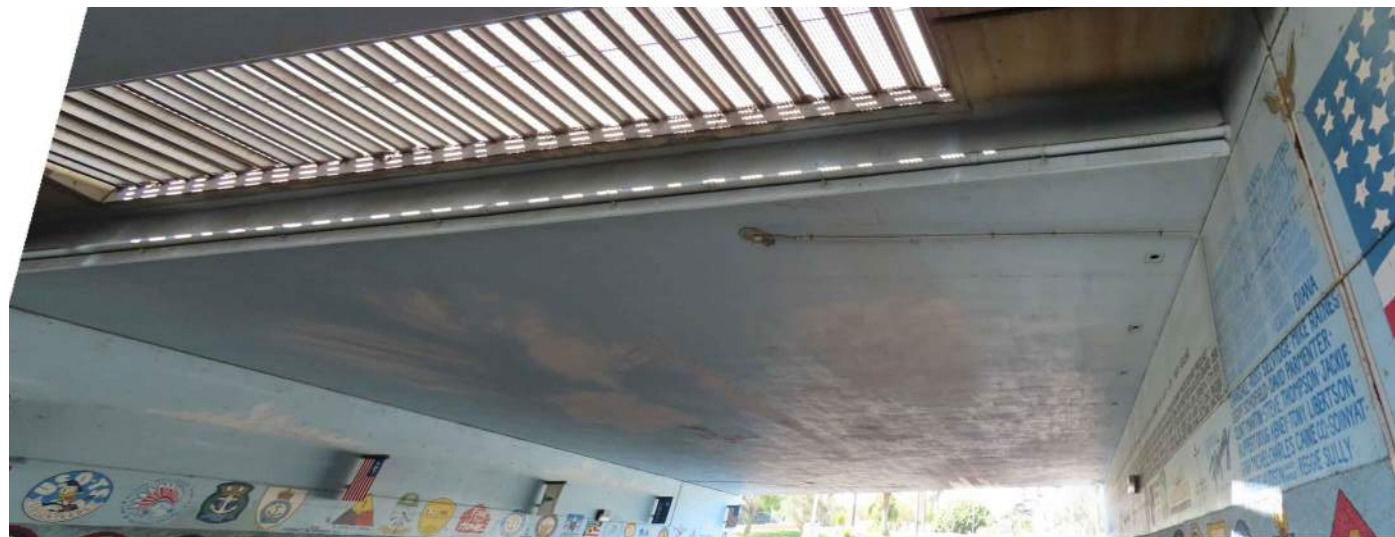
**1** UNDERPASS CEILING - VIEW NORTH  
NOT TO SCALE

ABRASION DAMAGE & CHIPPED EDGES FROM HIGH VEHICLES

SPALLS AT CONC. EDGE; REINFORCEMENT EXPOSED AND CORRODED

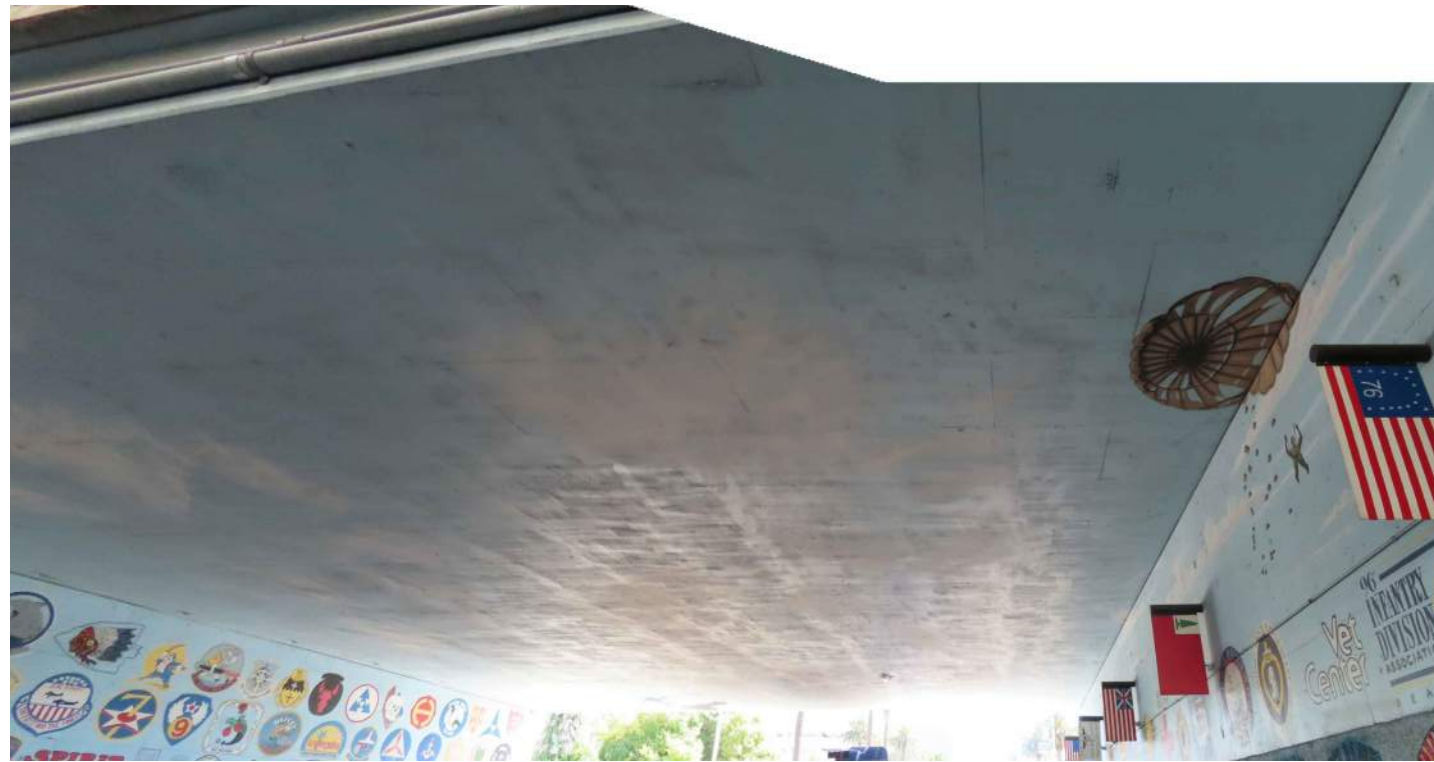
**1** UNDERPASS CEILING - VIEW SOUTH  
NOT TO SCALE

ABRASION DAMAGE & CHIPPED EDGES FROM HIGH VEHICLES

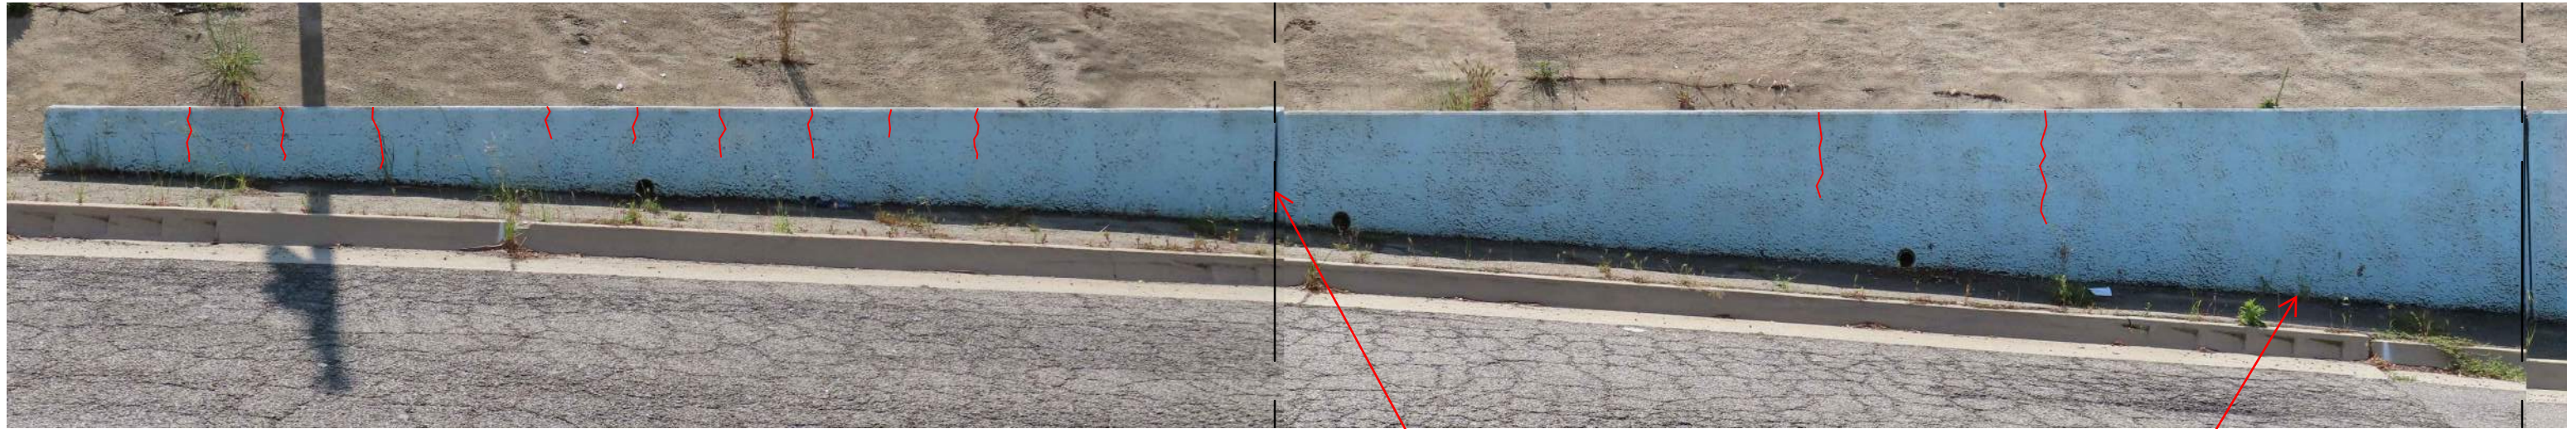
**1** WILSHIRE OFF-RAMP SOUTH ELEV. (PANELS 1-2)  
NOT TO SCALE

OPEN JOINTS, TYP. AT EXPANSION JOINTS

WEEDS, TYP. AT BASE OF WALLS

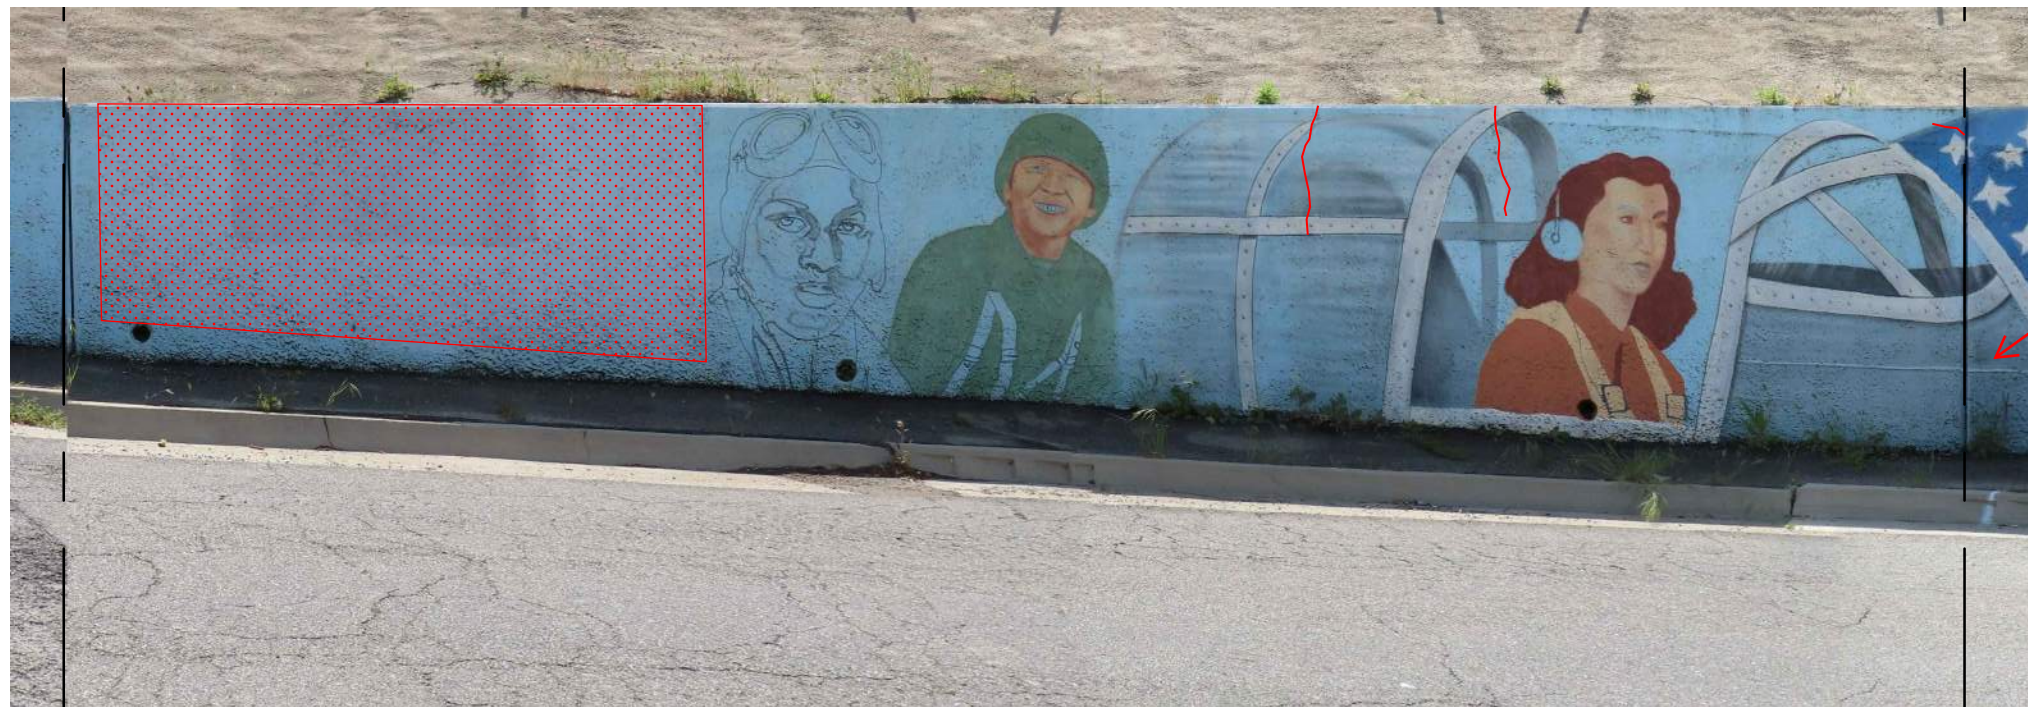
**2** WILSHIRE OFF-RAMP SOUTH ELEV. (PANEL 3)  
NOT TO SCALE

LIGHT TO MODERATE SOILING, TYP. OVERALL

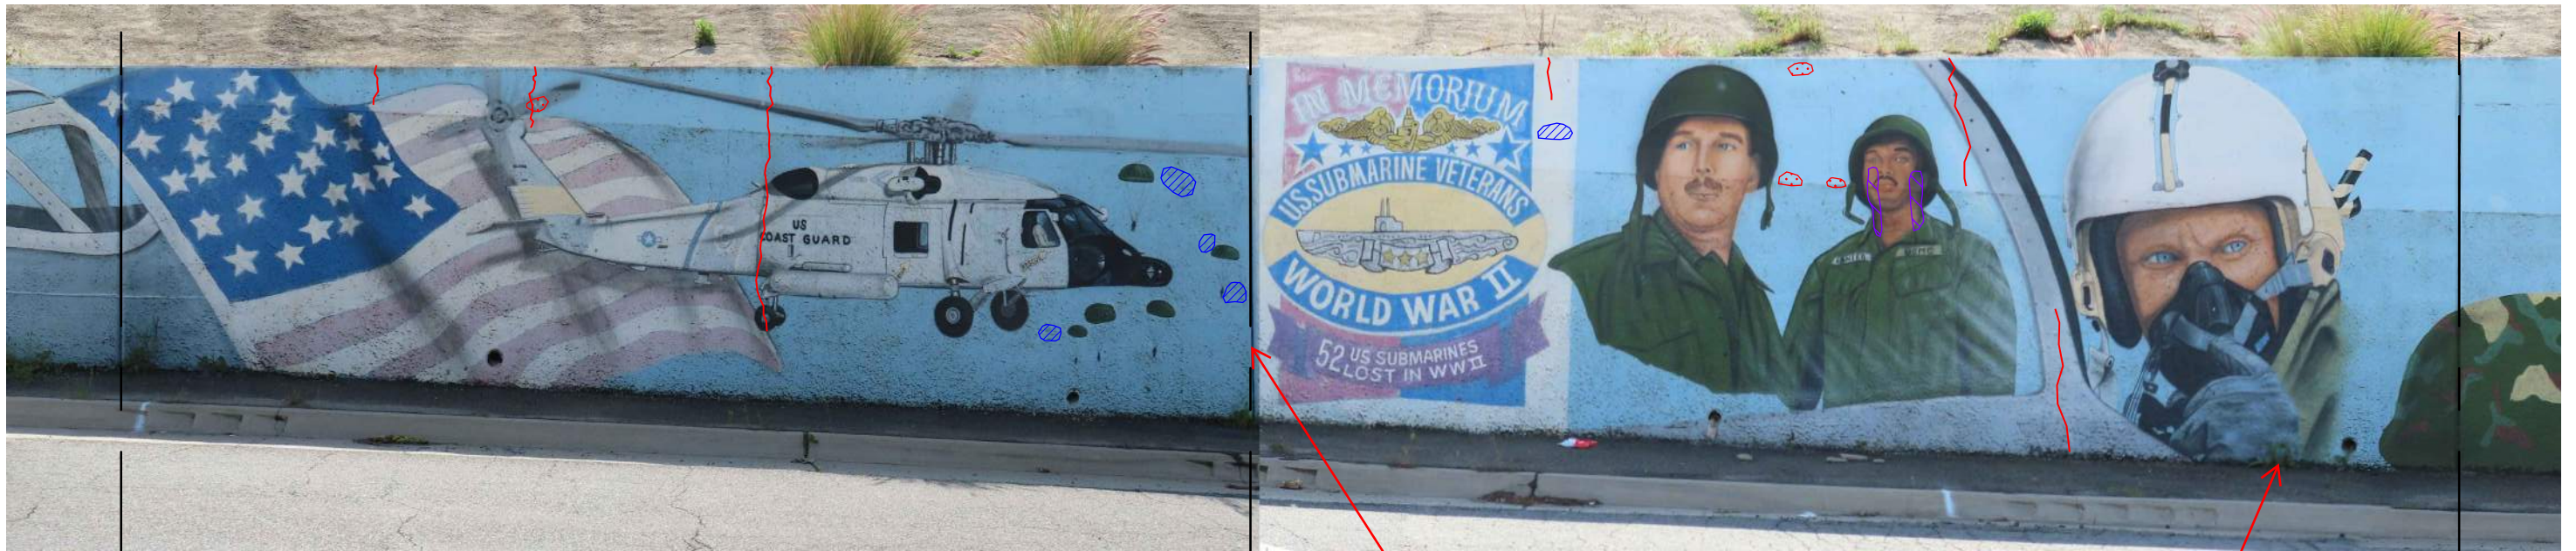
**1** WILSHIRE OFF-RAMP SOUTH ELEV. (PANELS 4-5)  
NOT TO SCALE

OPEN JOINTS, TYP. AT EXPANSION JOINTS

WEEDS, TYP. AT BASE OF WALLS

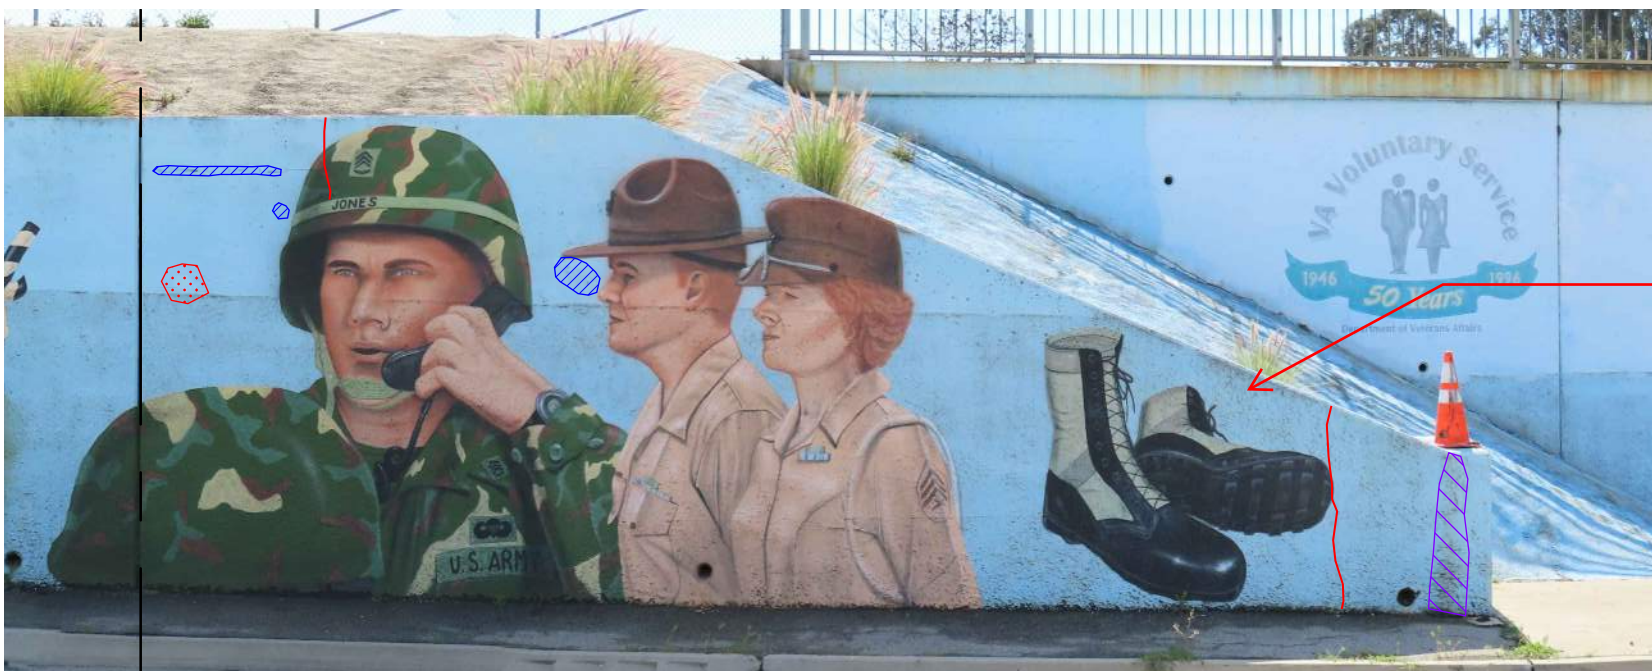
**2** WILSHIRE OFF-RAMP SOUTH ELEV. (PANEL 6)  
NOT TO SCALE

LIGHT TO MODERATE SOILING, TYP. OVERALL

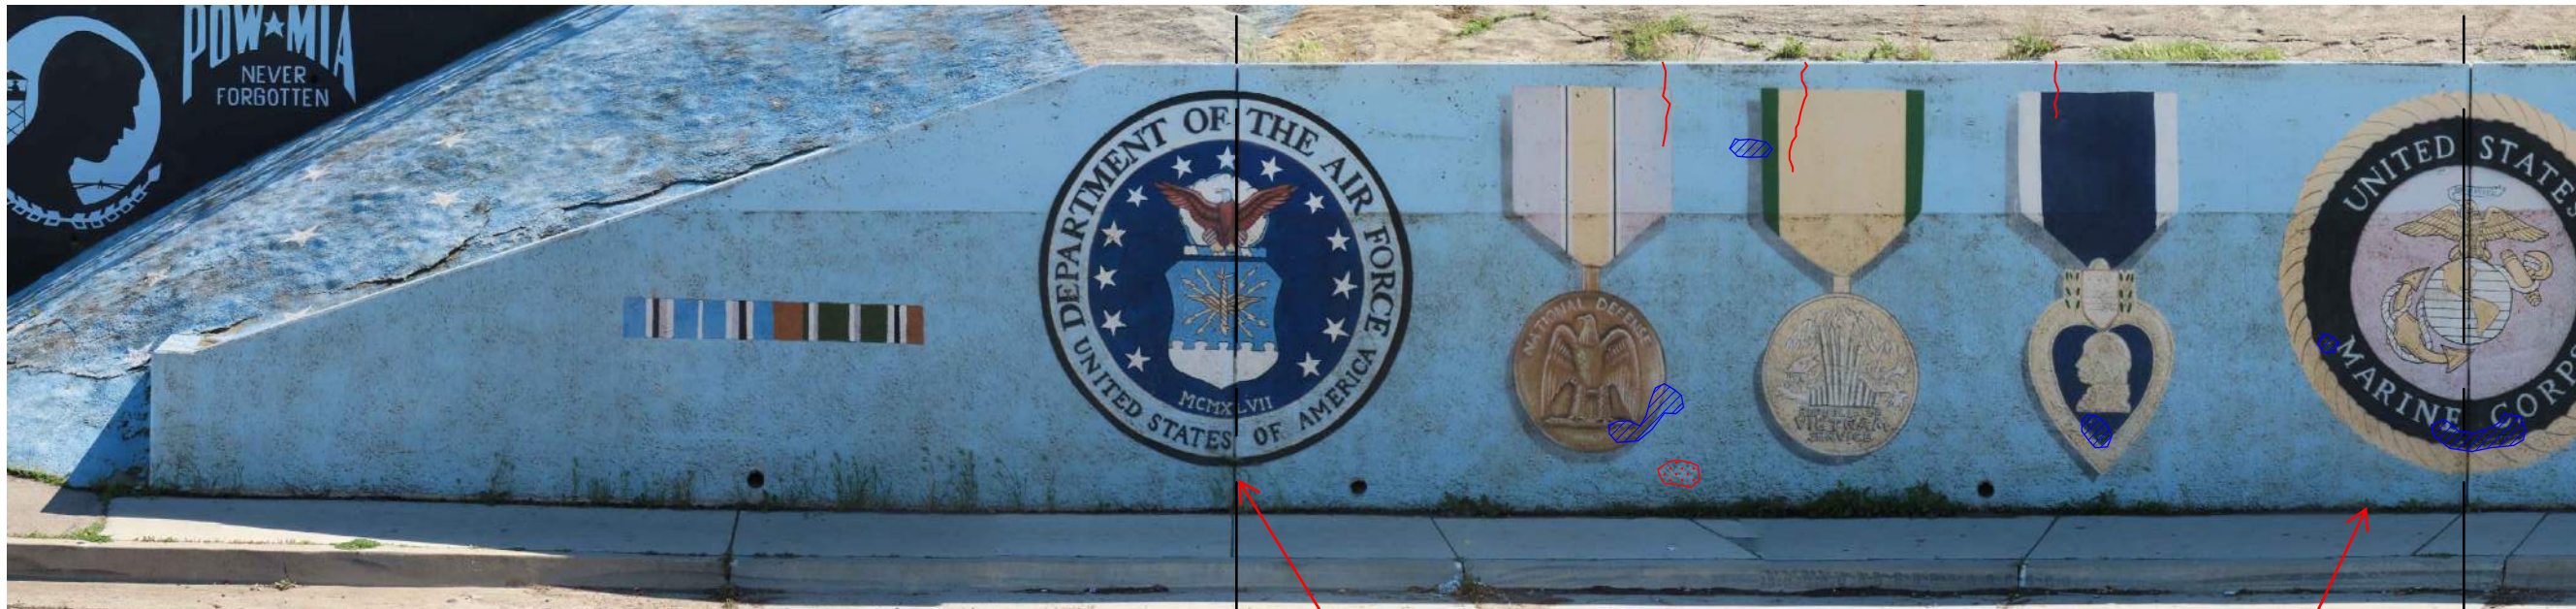
**1** WILSHIRE ON-RAMP SOUTH ELEV. (PANELS 1-2)  
NOT TO SCALE

OPEN JOINTS, TYP. AT EXPANSION JOINTS

WEEDS, TYP. AT BASE OF WALLS

LIGHT TO HEAVY SOILING, TYP. OVERALL

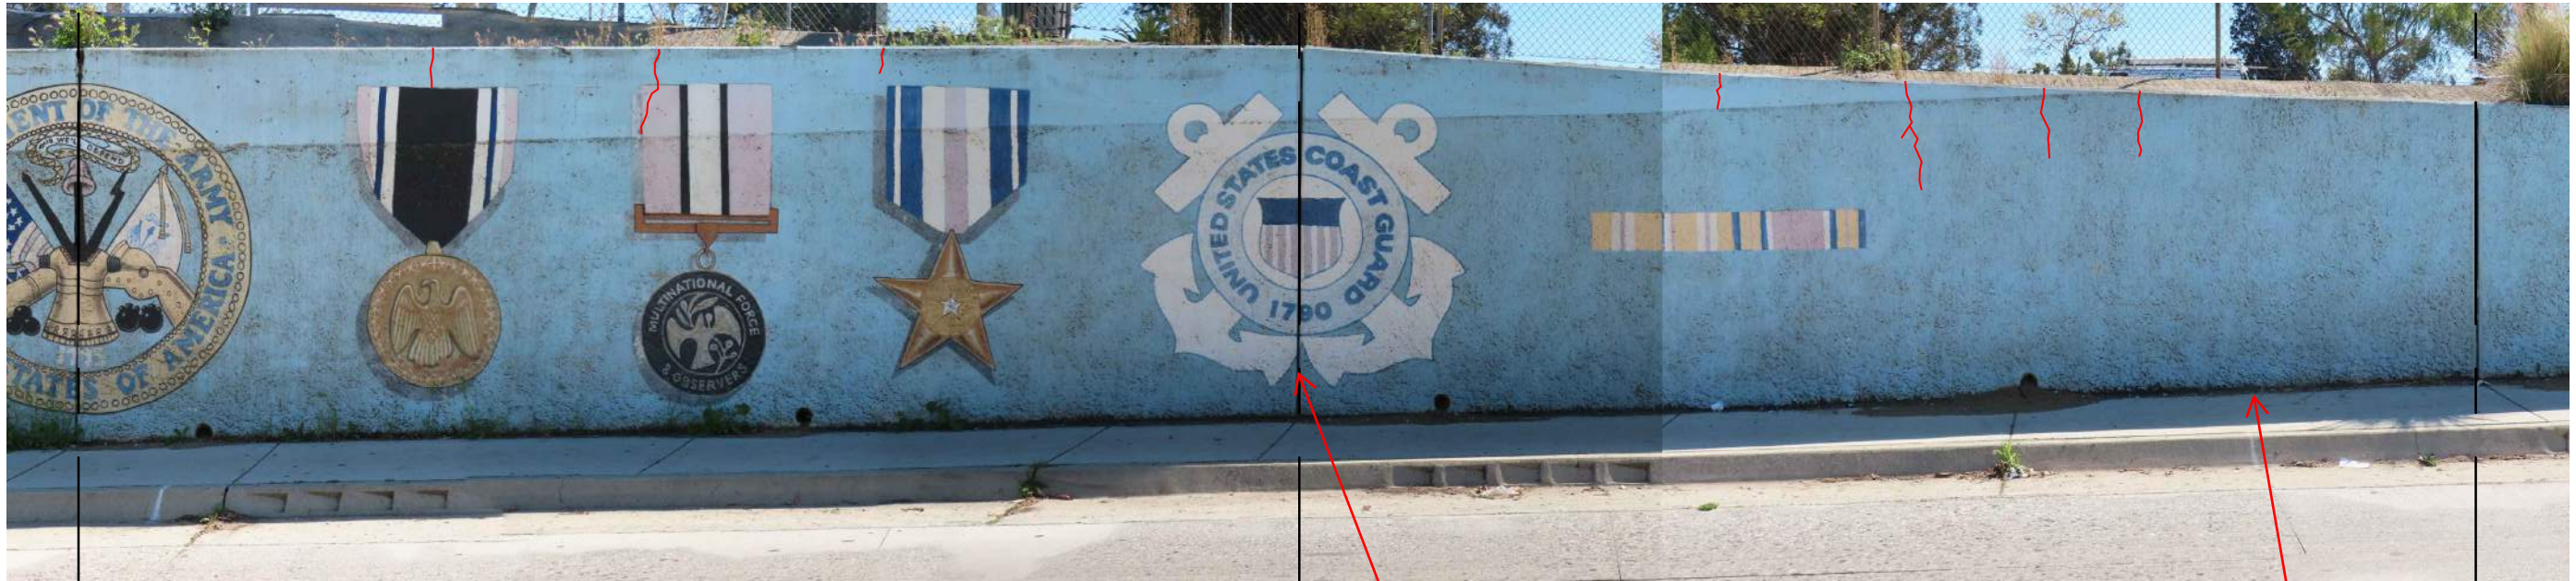
**1** WILSHIRE ON-RAMP SOUTH ELEV. (PANELS 5-6)  
NOT TO SCALE

OPEN JOINTS, TYP. AT EXPANSION JOINTS

CONC. FINISH SPALL AT END OF WALL
