# Los Angeles County Metropolitan Transportation Authority

WESTSIDE PURPLE LINE EXTENSION, SECTION 3 STATIONS

VA STATION MURAL FINE ARTS REPORT

VA STATION MURALS CONDITIONS ASSESSMENT – MARCH 20, 2020

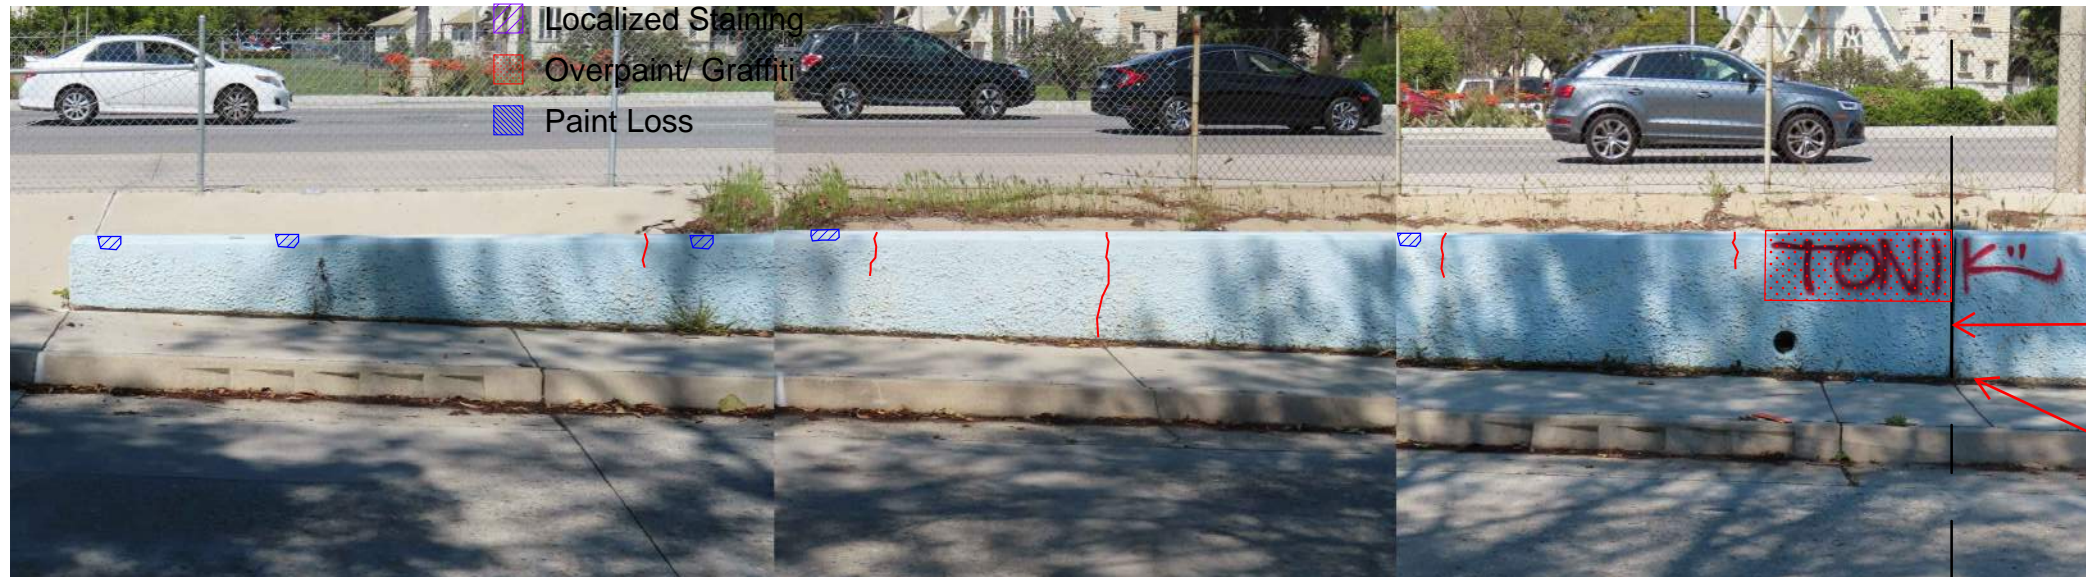
**1** WILSHIRE OFF-RAMP NORTH ELEV. (PANEL 1)  
NOT TO SCALE

OPEN JOINTS, TYP. AT EXPANSION JOINTS

WEEDS, TYP. AT BASE OF WALLS

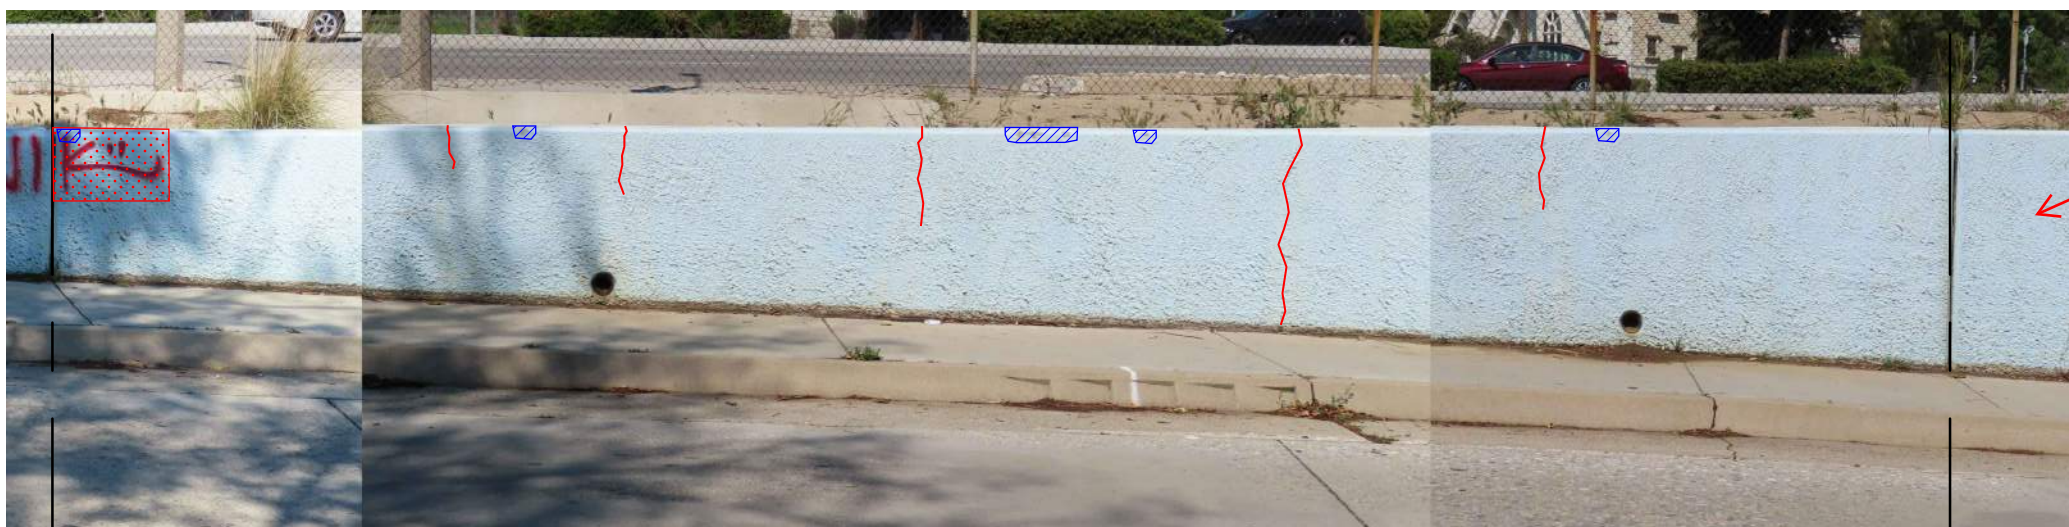
**2** WILSHIRE OFF-RAMP NORTH ELEV. (PANEL 2)  
NOT TO SCALE

LIGHT TO MODERATE SOILING, TYP. OVERALL

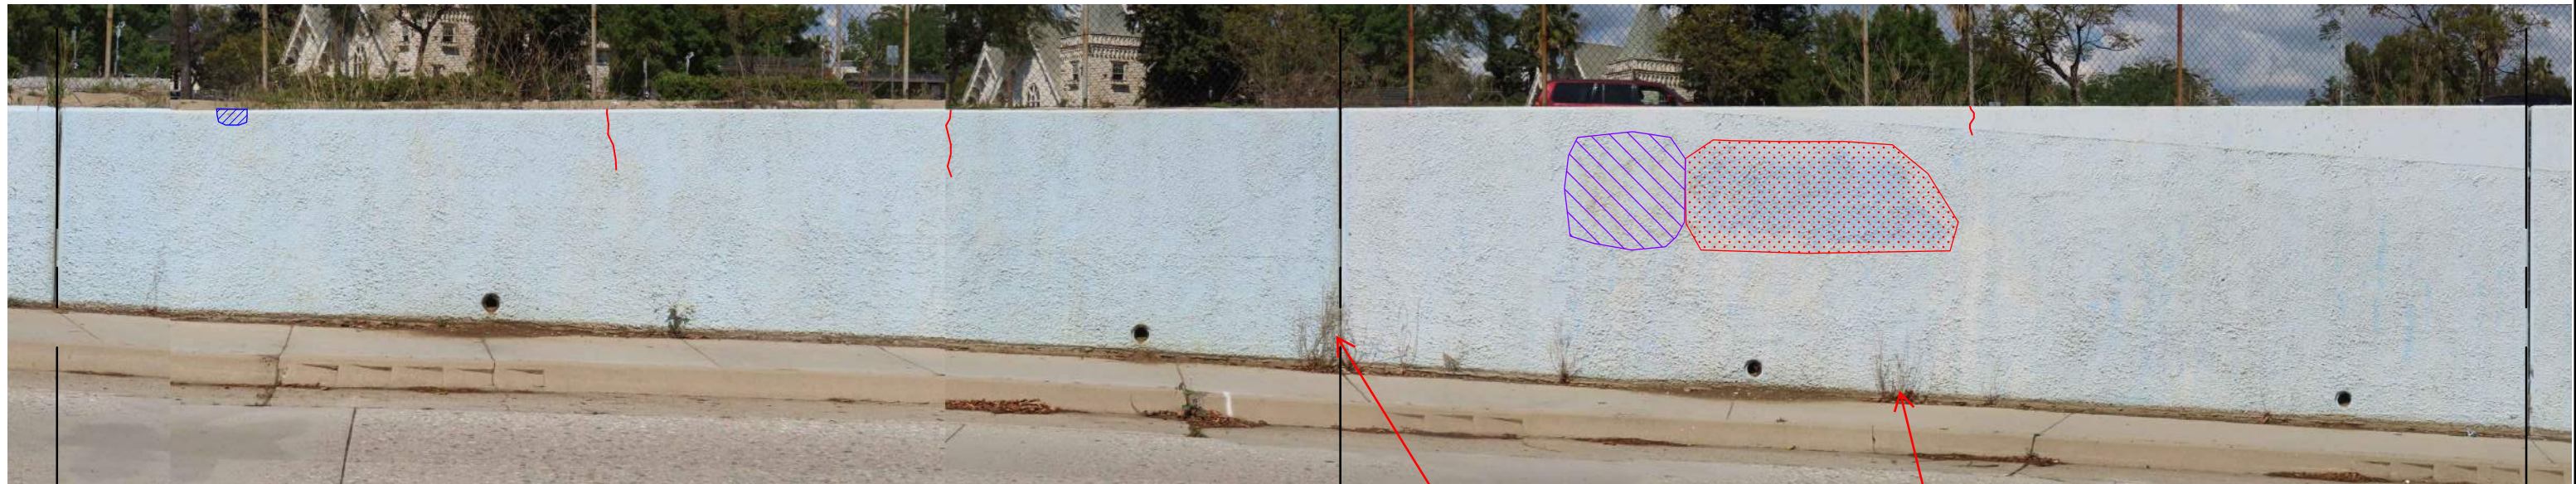
**1** WILSHIRE OFF-RAMP NORTH ELEV. (PANELS 3-4)  
NOT TO SCALE

OPEN JOINTS, TYP. AT EXPANSION JOINTS

WEEDS, TYP. AT BASE OF WALLS

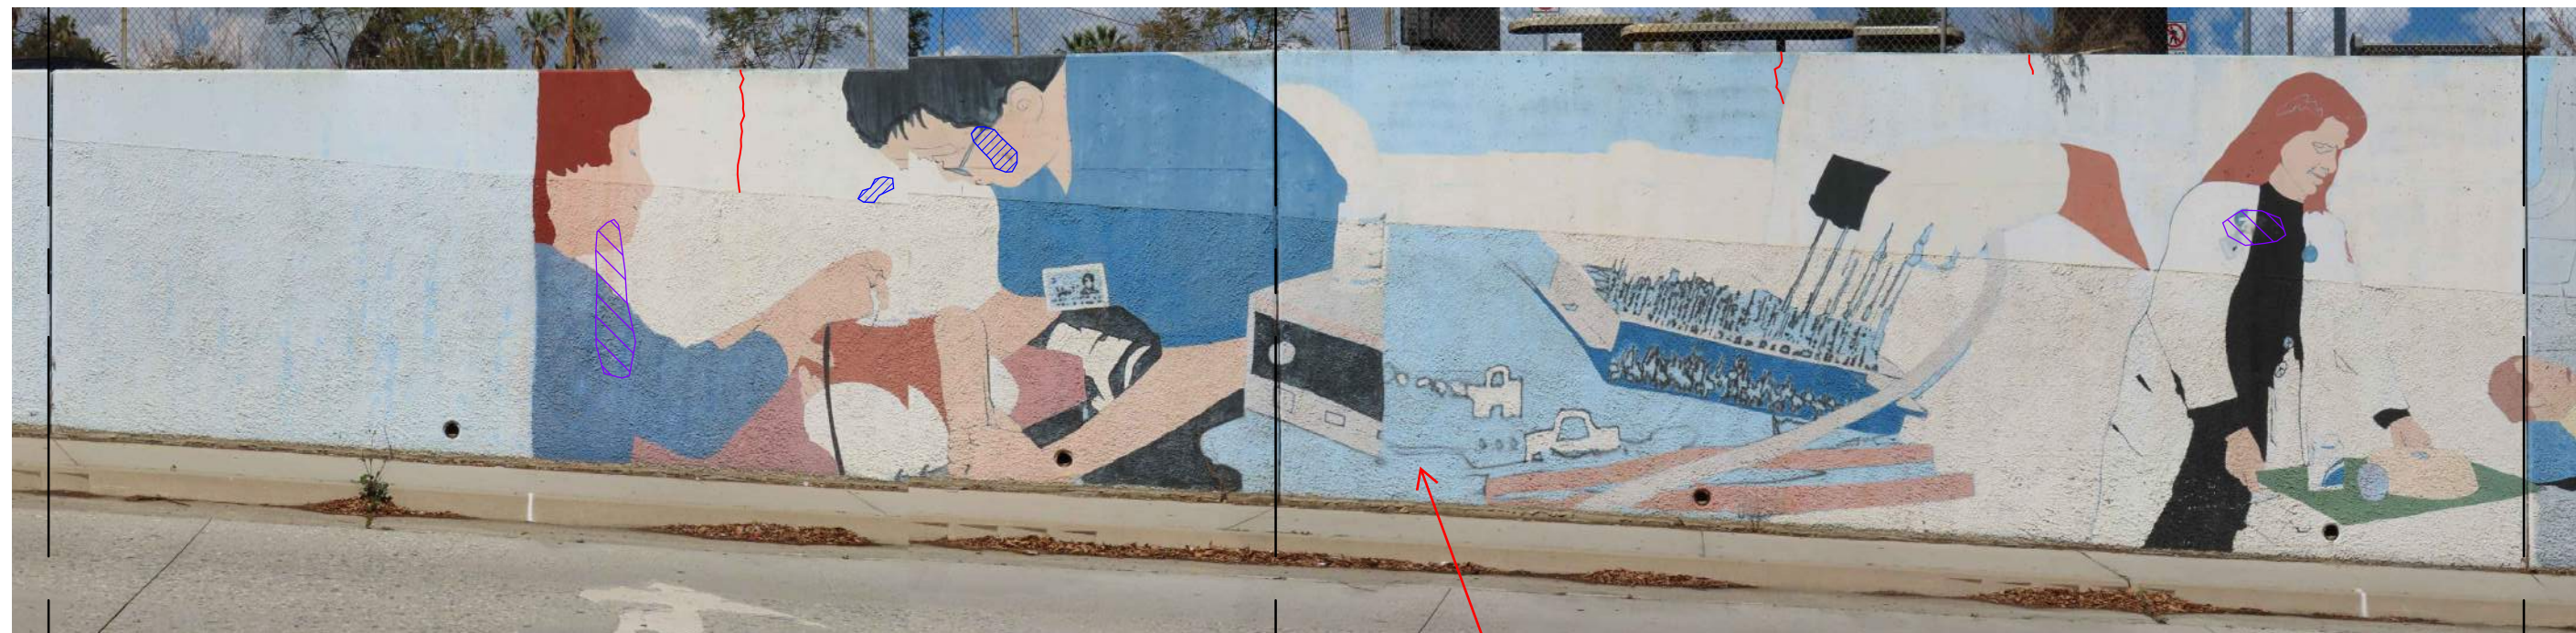
**2** WILSHIRE OFF-RAMP NORTH ELEV. (PANELS 5-6)  
NOT TO SCALE

LIGHT TO MODERATE SOILING, TYP. OVERALL

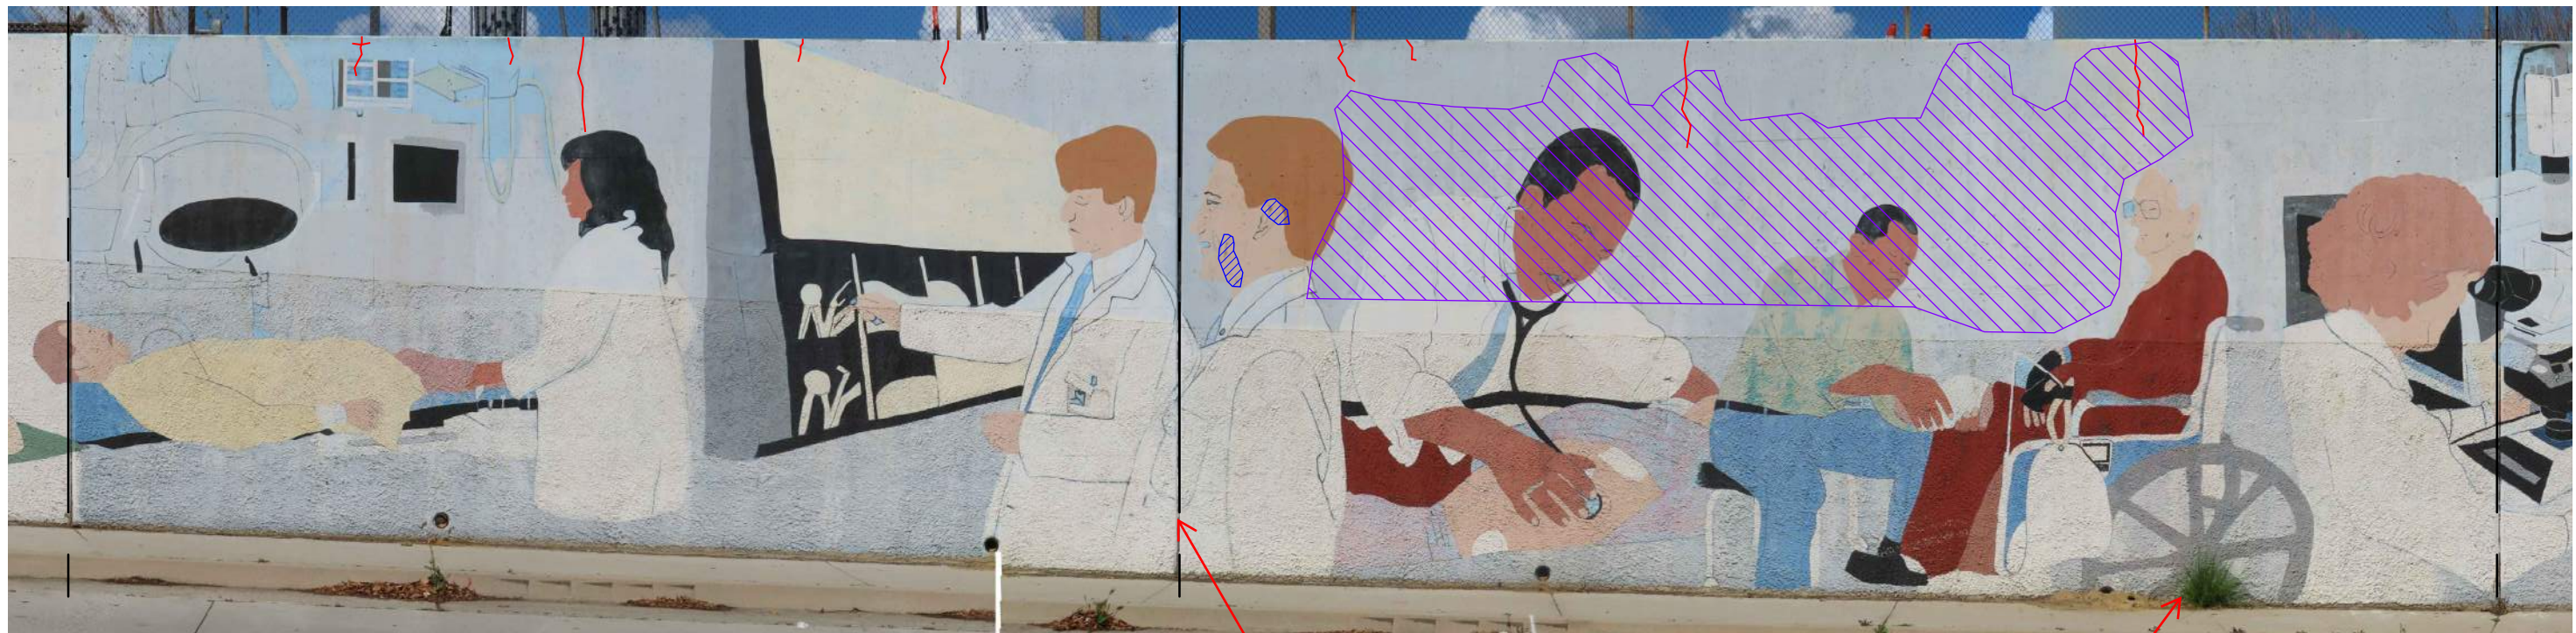
**1** WILSHIRE OFF-RAMP NORTH ELEV. (PANELS 3-4)  
NOT TO SCALE

OPEN JOINTS, TYP. AT EXPANSION JOINTS

WEEDS, TYP. AT BASE OF WALLS

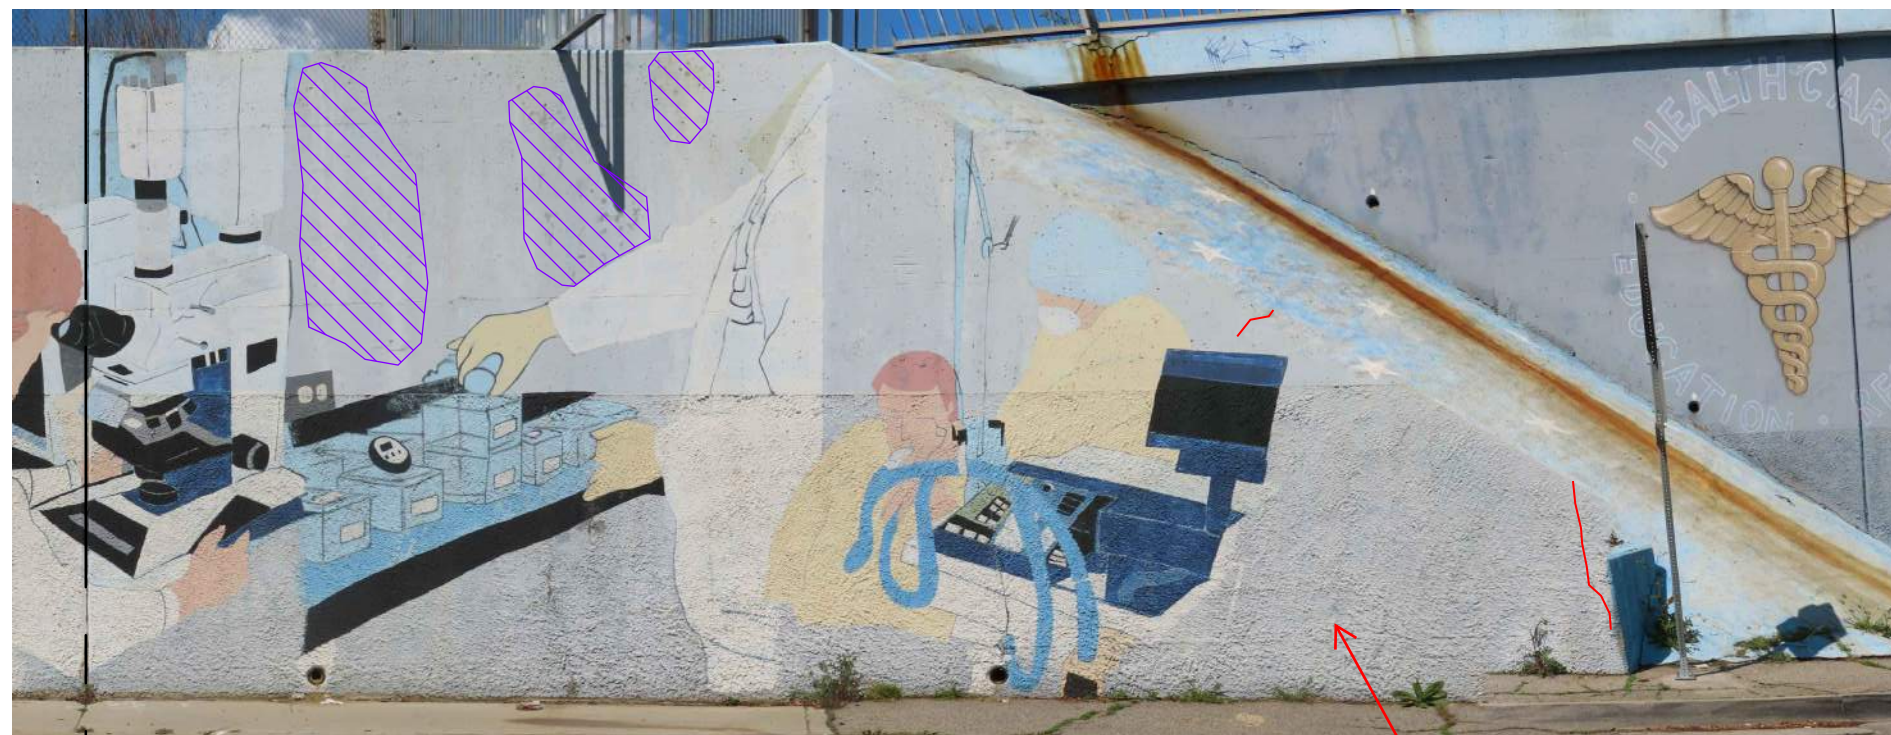
**2** WILSHIRE OFF-RAMP NORTH ELEV. (PANELS 5-6)  
NOT TO SCALE

LIGHT TO MODERATE SOILING, TYP. OVERALL

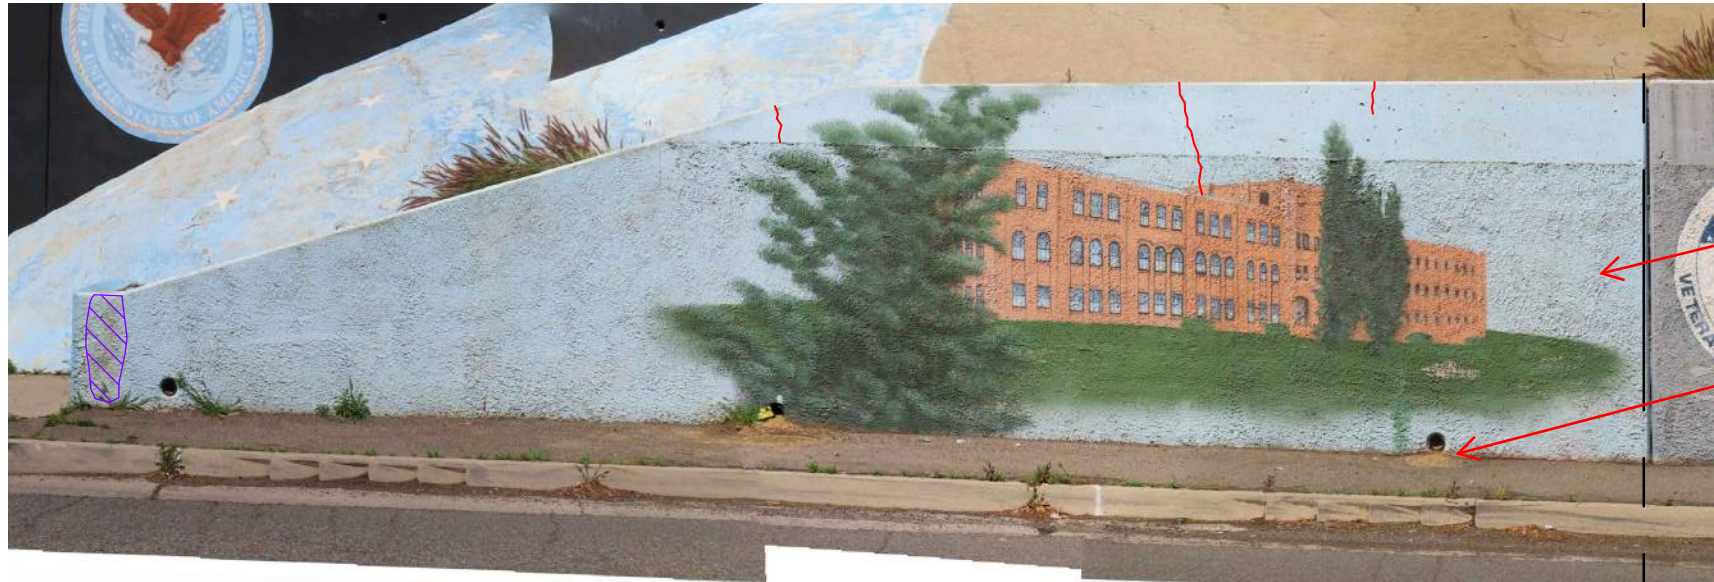
**1** WILSHIRE ON-RAMP NORTH ELEV. (PANEL 1)  
NOT TO SCALE

LIGHT TO MODERATE SOILING, TYP. OVERALL

SOIL EROSION, TYP.

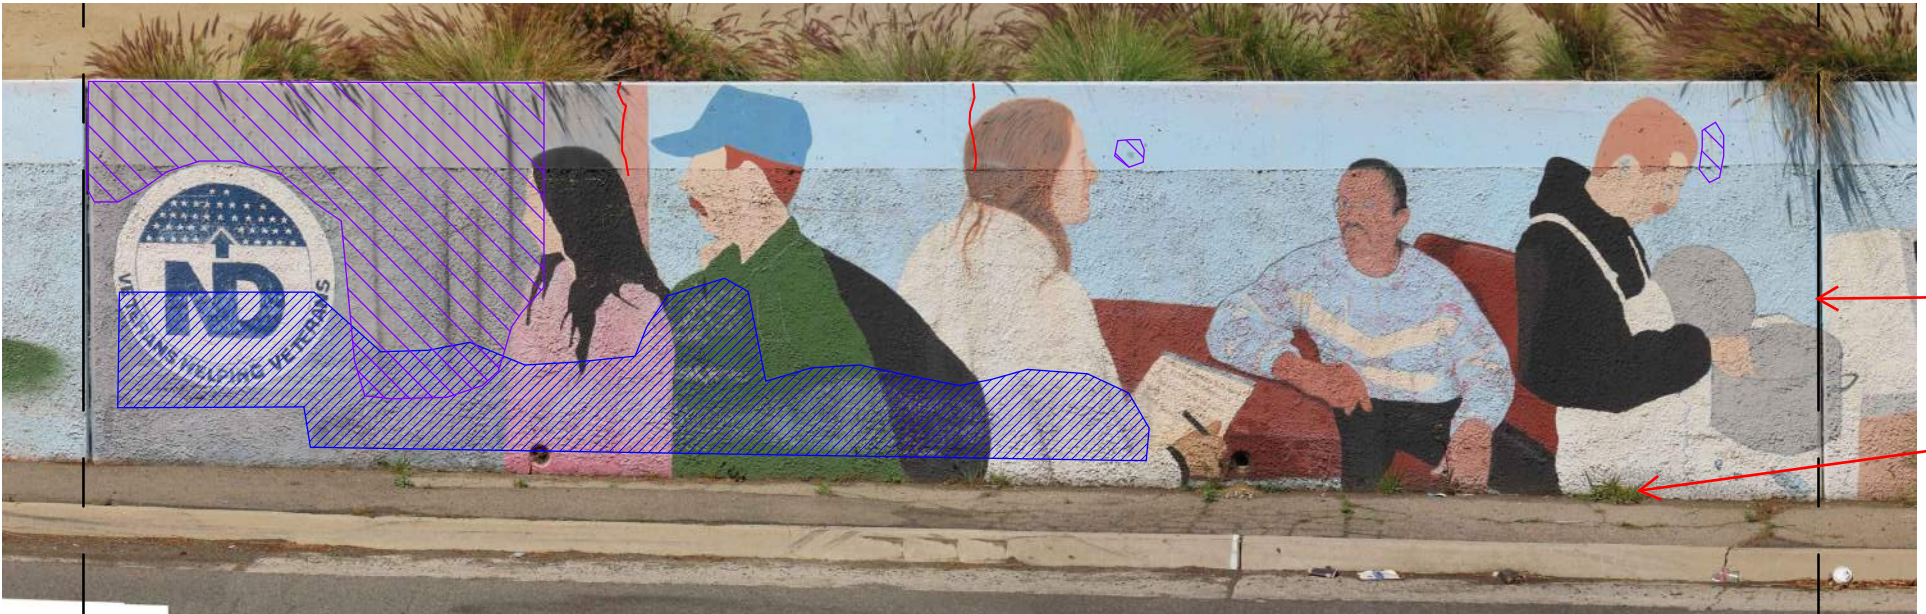
**2** WILSHIRE ON-RAMP NORTH ELEV. (PANEL 2)  
NOT TO SCALE

OPEN JOINTS, TYP. AT EXPANSION JOINTS

WEEDS, TYP. AT BASE OF WALLS

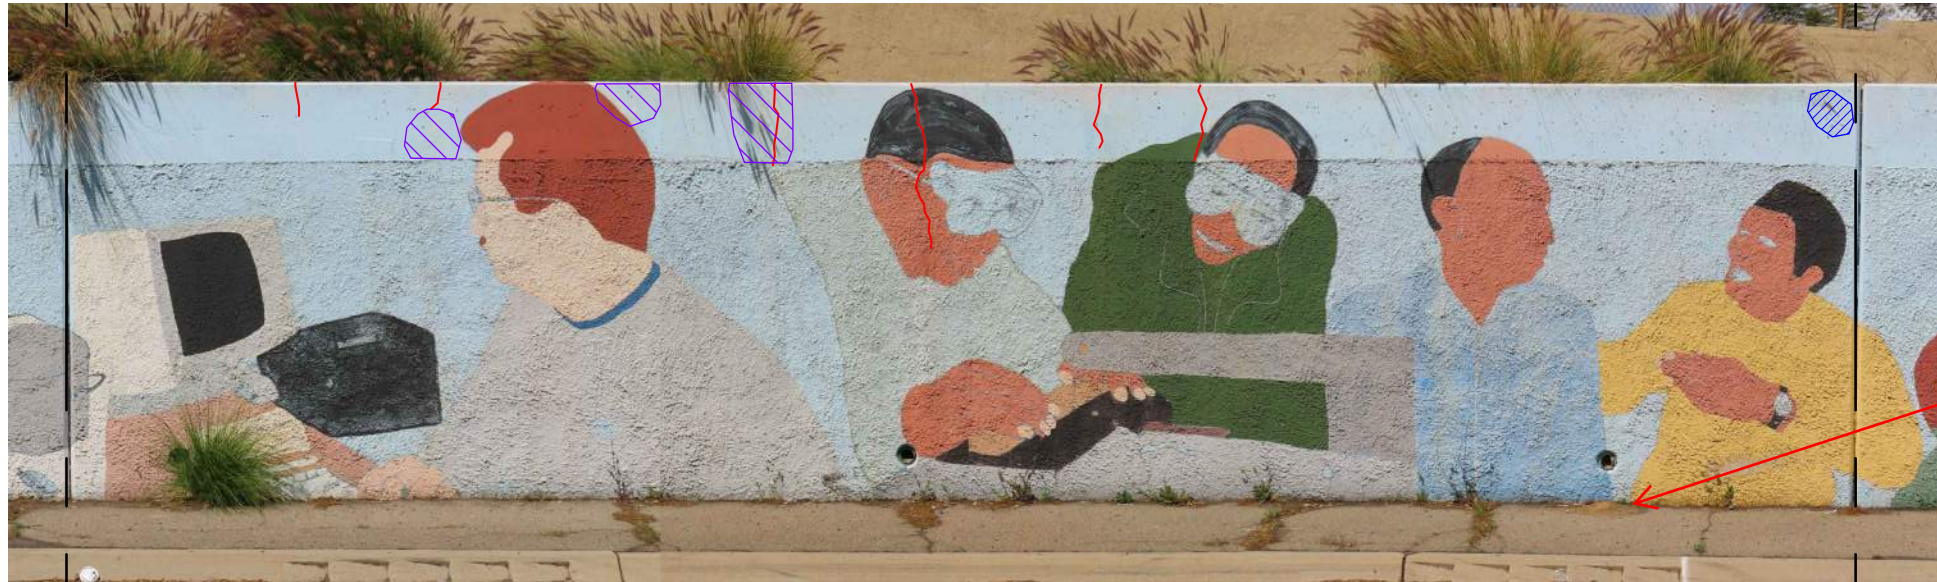
**1** WILSHIRE ON-RAMP NORTH ELEV. (PANEL 3)  
NOT TO SCALE

SOIL EROSION, TYP.

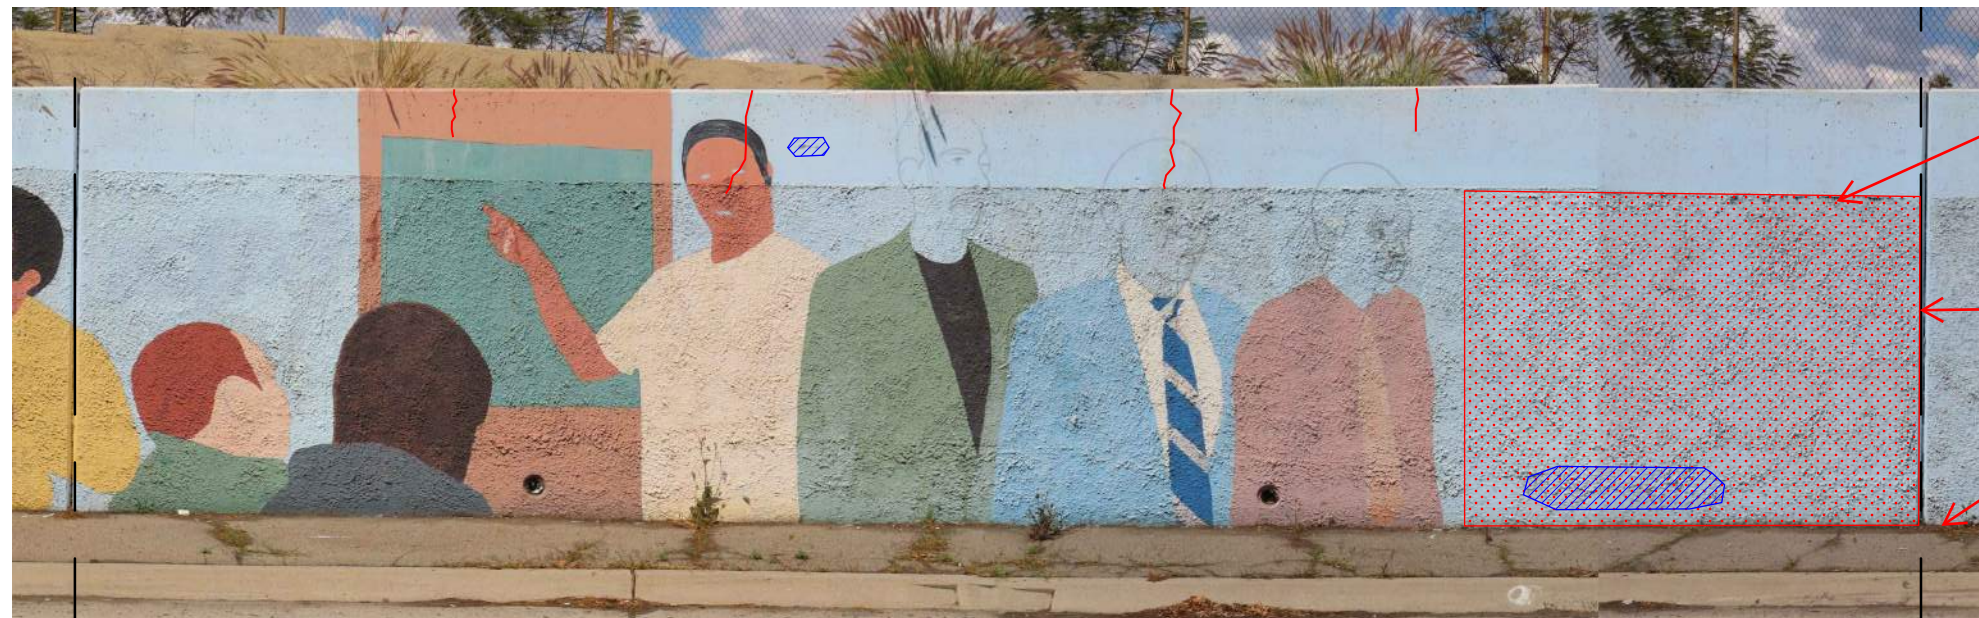
**2** WILSHIRE ON-RAMP NORTH ELEV. (PANEL 4)  
NOT TO SCALE

LIGHT TO MODERATE SOILING, TYP. OVERALL

OPEN JOINTS, TYP. AT EXPANSION JOINTS

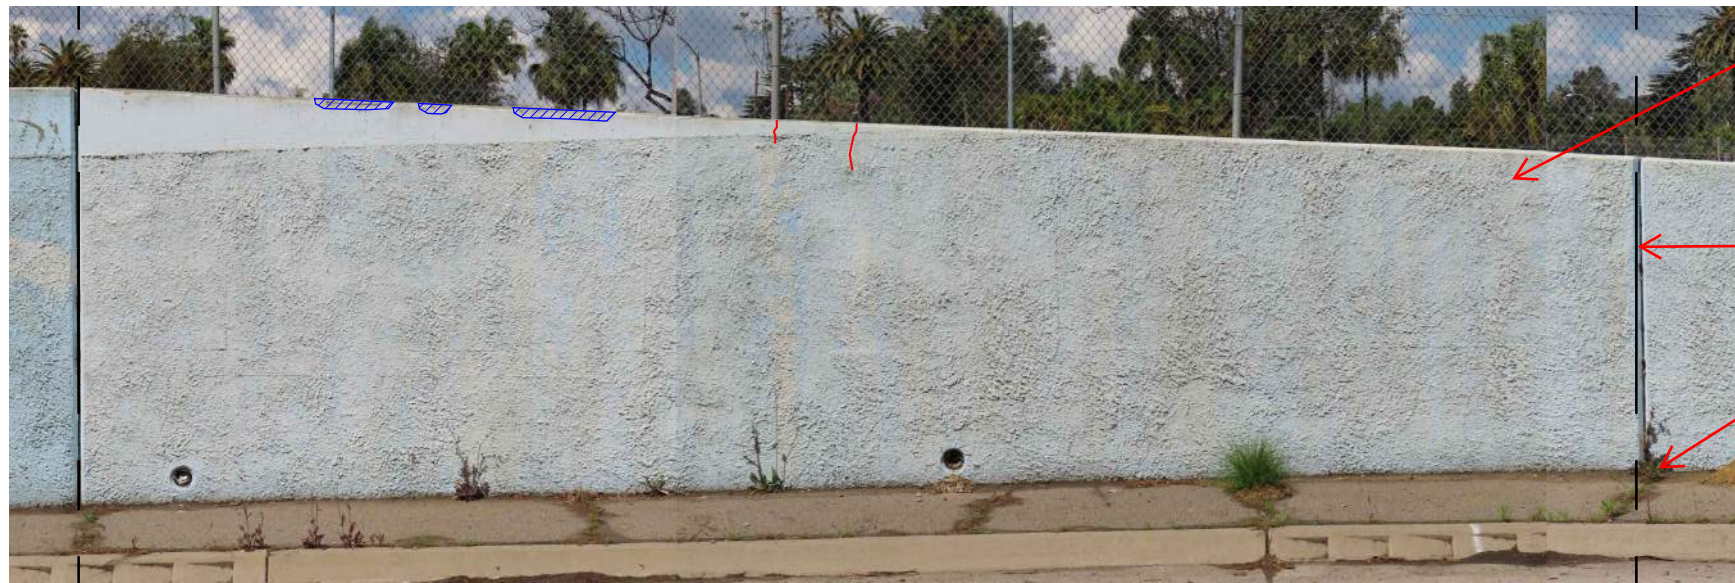
**2** WILSHIRE ON-RAMP NORTH ELEV. (PANEL 6)  
NOT TO SCALE

LIGHT TO MODERATE SOILING, TYP. OVERALL

OPEN JOINTS, TYP. AT EXPANSION JOINTS

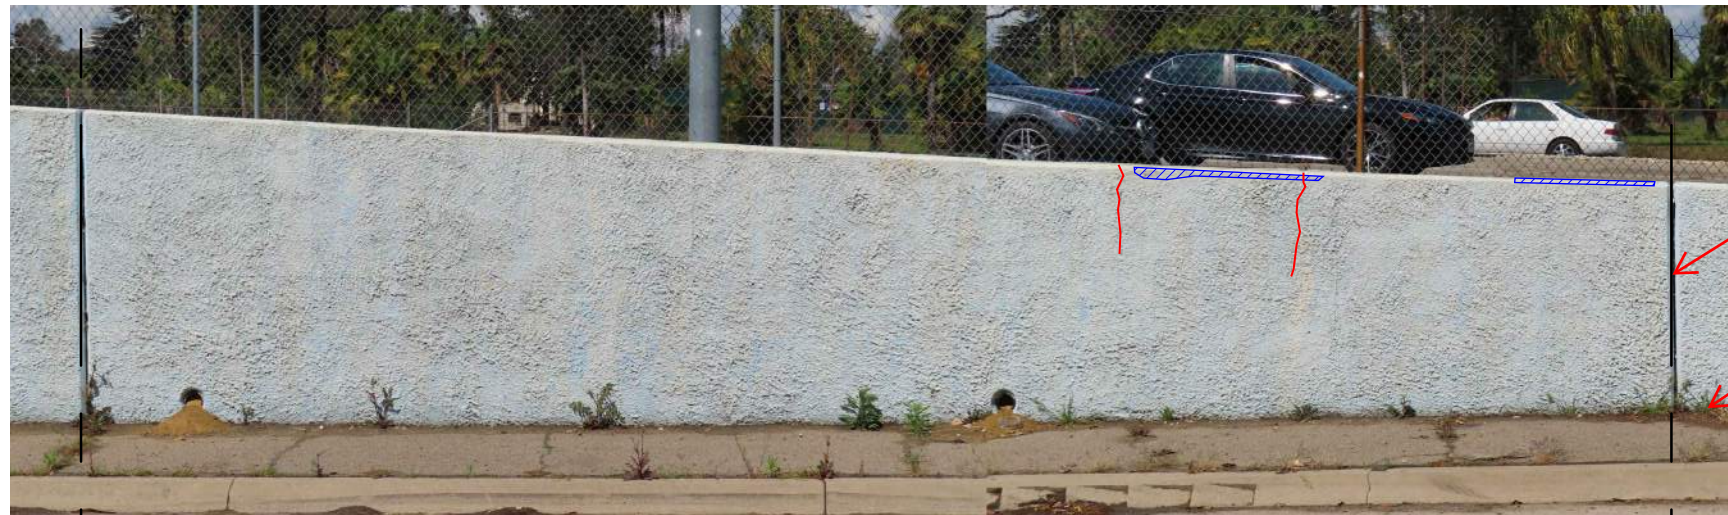
**1** WILSHIRE ON-RAMP NORTH ELEV. (PANEL 7)  
NOT TO SCALE

OPEN JOINTS, TYP. AT EXPANSION JOINTS

WEEDS, TYP. AT BASE OF WALLS

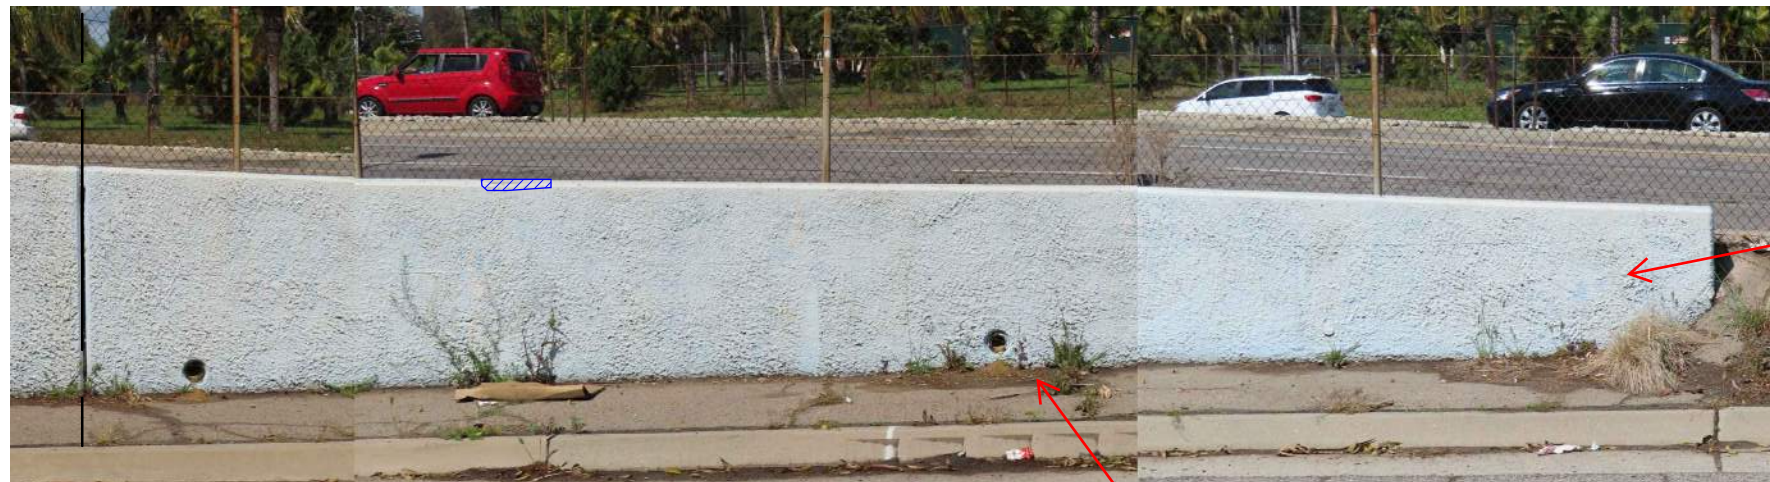
**2** WILSHIRE ON-RAMP NORTH ELEV. (PANEL 8)  
NOT TO SCALE

LIGHT TO MODERATE SOILING, TYP. OVERALL

SOIL EROSION, TYP.

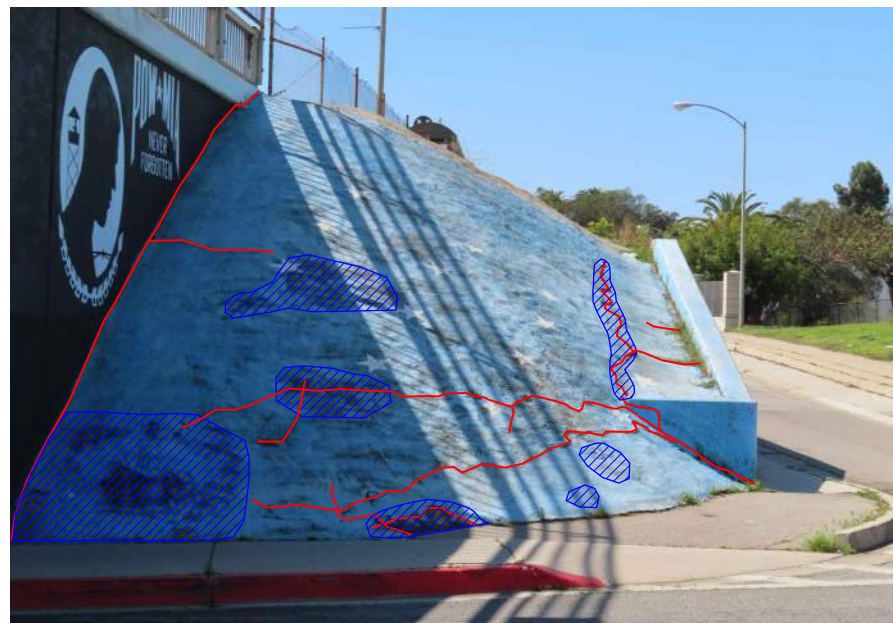
**1** NORTHWEST CORNER  
NOT TO SCALE

RUST STAINS  
CRACK AT WALL, TYP.

RUST STAINS

WEB-LIKE CRACKING, TYP.
