**EFFECTS OF PROPOSED
TUNNELING OPERATIONS
ON BUILDINGS
B221 ALIGNMENT**

H.J. DEGENKOLB ASSOCS, ENGINEERS

January 15, 1991

Reference: **EFFECTS OF TUNNELING OPERATIONS ON BUILDINGS
B221 TUNNEL ALIGNMENT
[DEGENKOLB JOB NO. 85005]**

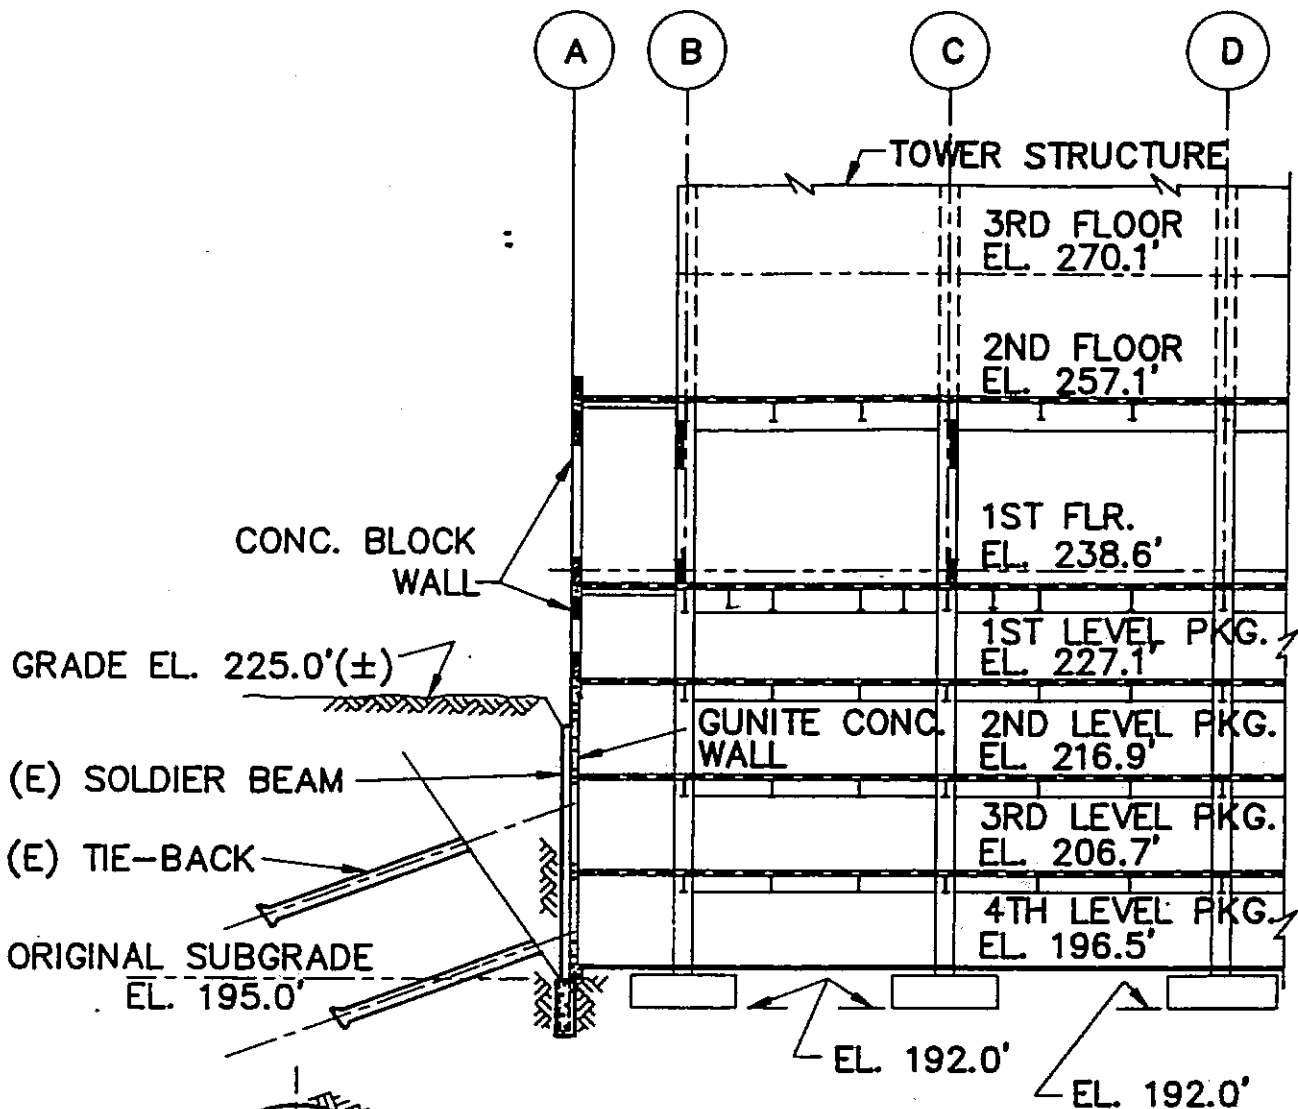
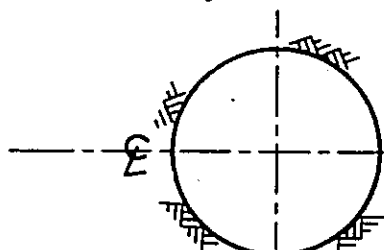
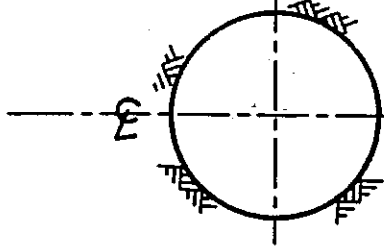
2-5 SECTION
1"=20'-0"

The structural drawings for the building indicate that the construction excavation for the structure was supported with soldier beams and tiebacks as shown on Plates 2-4 and 2-5. It appears that the tips of a few soldier beams will obstruct and interfere with the driving of the upper tunnel and must be demolished as the tunneling work progresses.

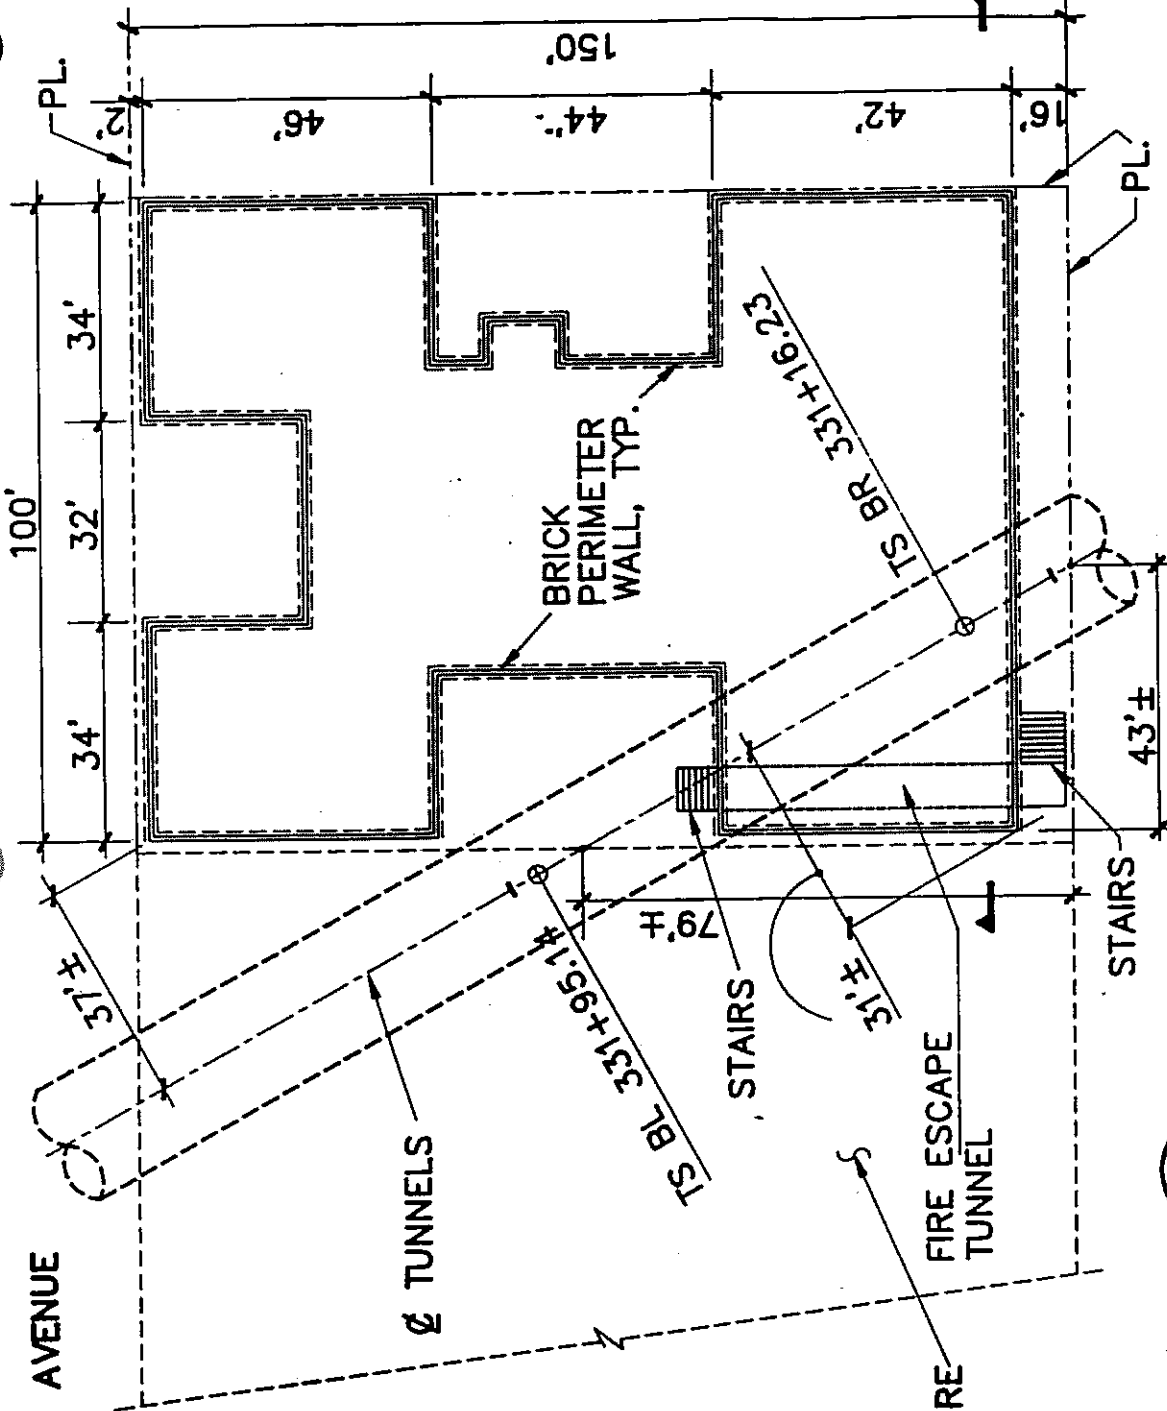
630 S. KENMORE
PLATE 3-2

We were unable to obtain drawings for the building. During our site visit we observed that the building is H-shaped in plan and has unreinforced masonry bearing walls around the entire perimeter of the structure. It measures approximately 132 feet by 100 feet in plan as shown on Plate 3-2. We were told by the building manager that the building was constructed in the late 1920s and has wood floors supported on steel beams and interior steel columns. The structure has no basement although there is a narrow below grade exit passageway for a stair shaft located in the southeast corner of the building.

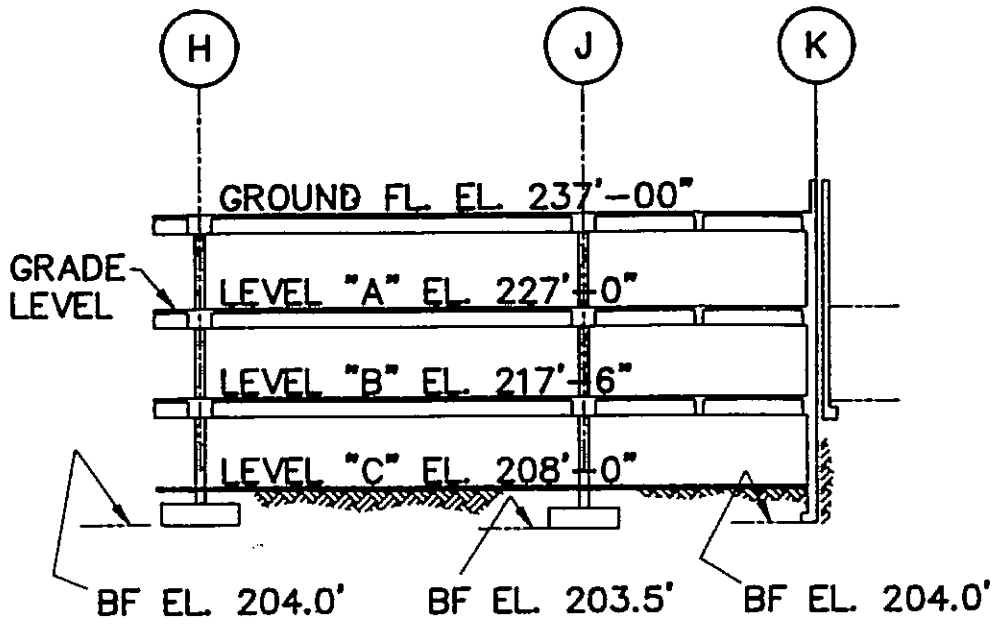
SEEPAGE THROUGH CRACKING
IN NORTH BASEMENT WALL,
PARKING LEVEL C
