METRO RED LINE, SEGMENT 2, CONTRACT B251

Investigation of Tunnel Collapse and Sinkhole

Wiss, Janney, Elstner Associates, Inc.

FINAL REPORT

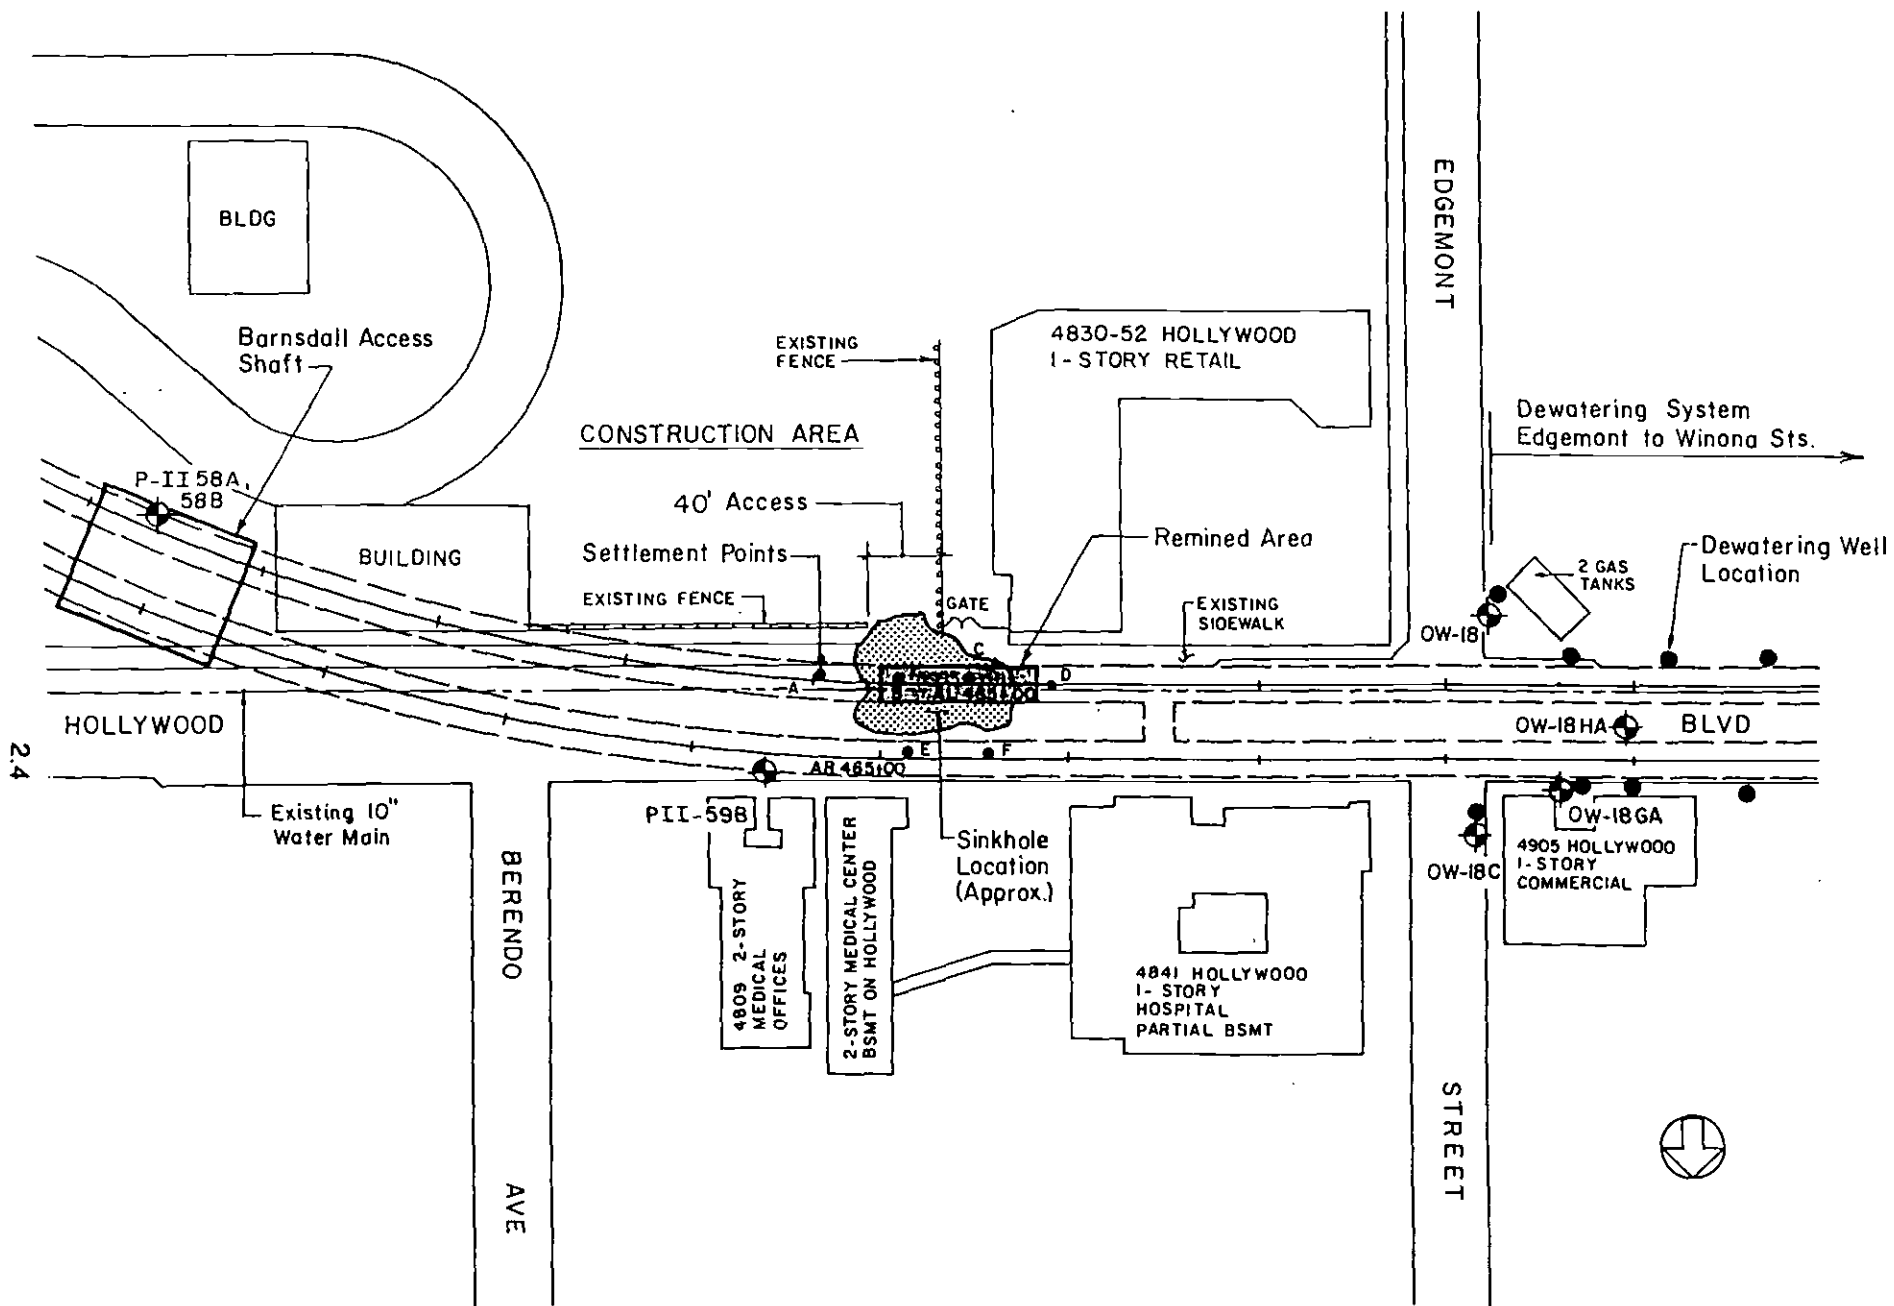
Fig. 2.2 Plan View of HAL Remined Area

Two exceptions were observed at ground point 48100005 and 48100006, points B and C in Fig. 2.2, located above the HAL tunnel at the location of the sinkhole. As indicated in Fig. 3.7, surface settlements were similar to the typical settlements immediately after shield passage, but subsequent incremental drops of about 1.5 in. were observed prior to the sinkhole collapse. These movements did not occur at the same time, but developed at least 5, and as many as 10, months apart. More accurate definition is precluded by the paucity of readings taken at these points. Total settlements prior to the start of the remaining operations were 2.7 and 2.6 in., respectively. These two anomalies may have been the result of very localized effects of water infiltration resulting in hydrocompression settlements, or

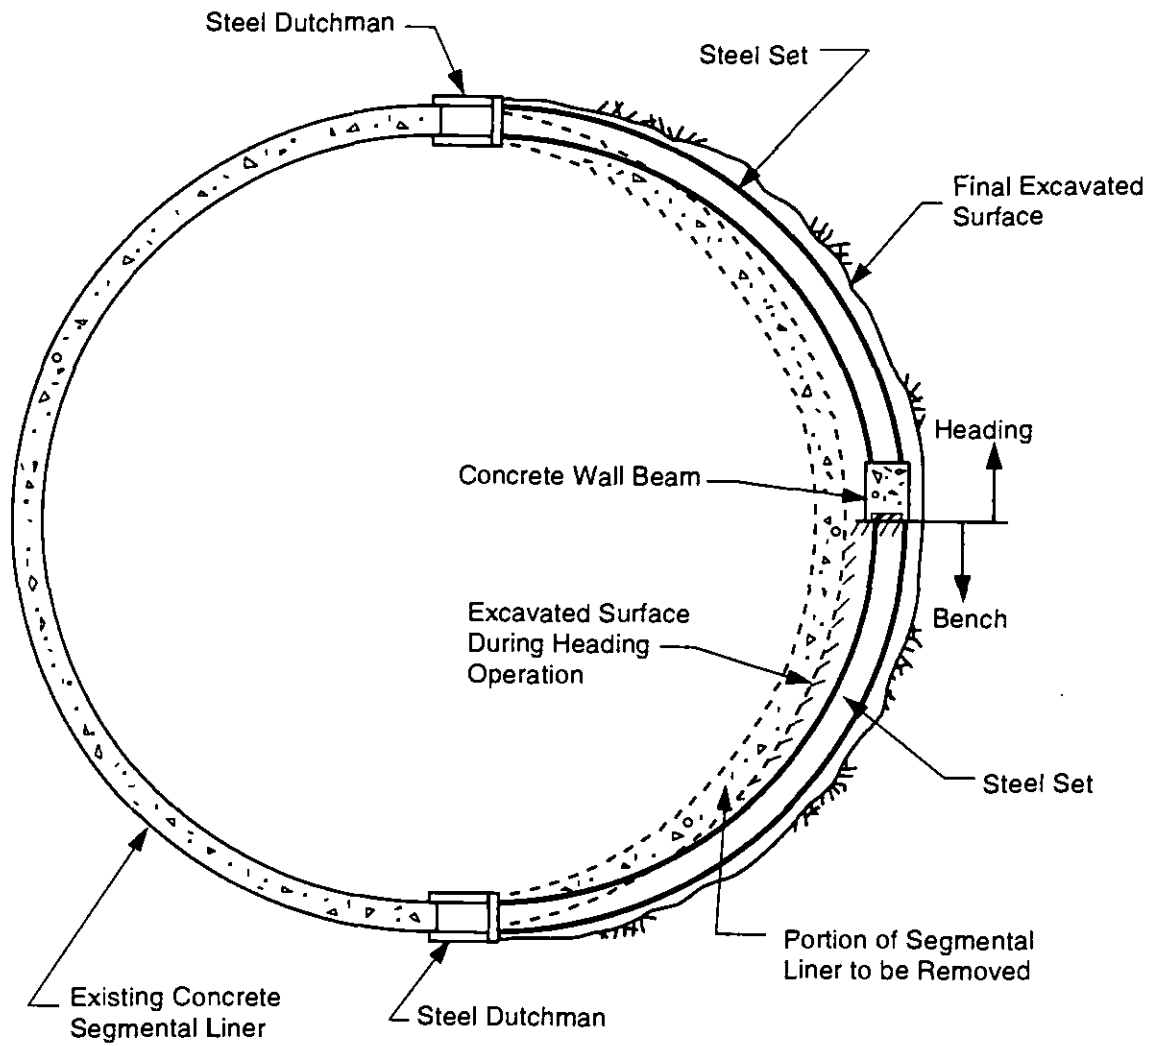
Figure 2.3 Temporary Support for Remimed Area

The re-mining procedure consisted of a heading and bench operation (Fig. 2.3). The heading operation consisted of removing the upper quadrant (12:00 o'clock to 3:00 o'clock portion) of the segmental concrete liner, excavating the exposed earth to accommodate the realignment, installing the steel sets, and placing lagging between the steel sets and the exposed earth. A concrete wall beam was placed at the bottom of the steel sets after several steel sets had been placed. After completion of the heading along the entire length of a re-mined area, the benching operation began. It consisted of removing the lower quadrant of the segmental concrete liner, excavating the exposed earth, installing the steel sets, and setting the lagging.

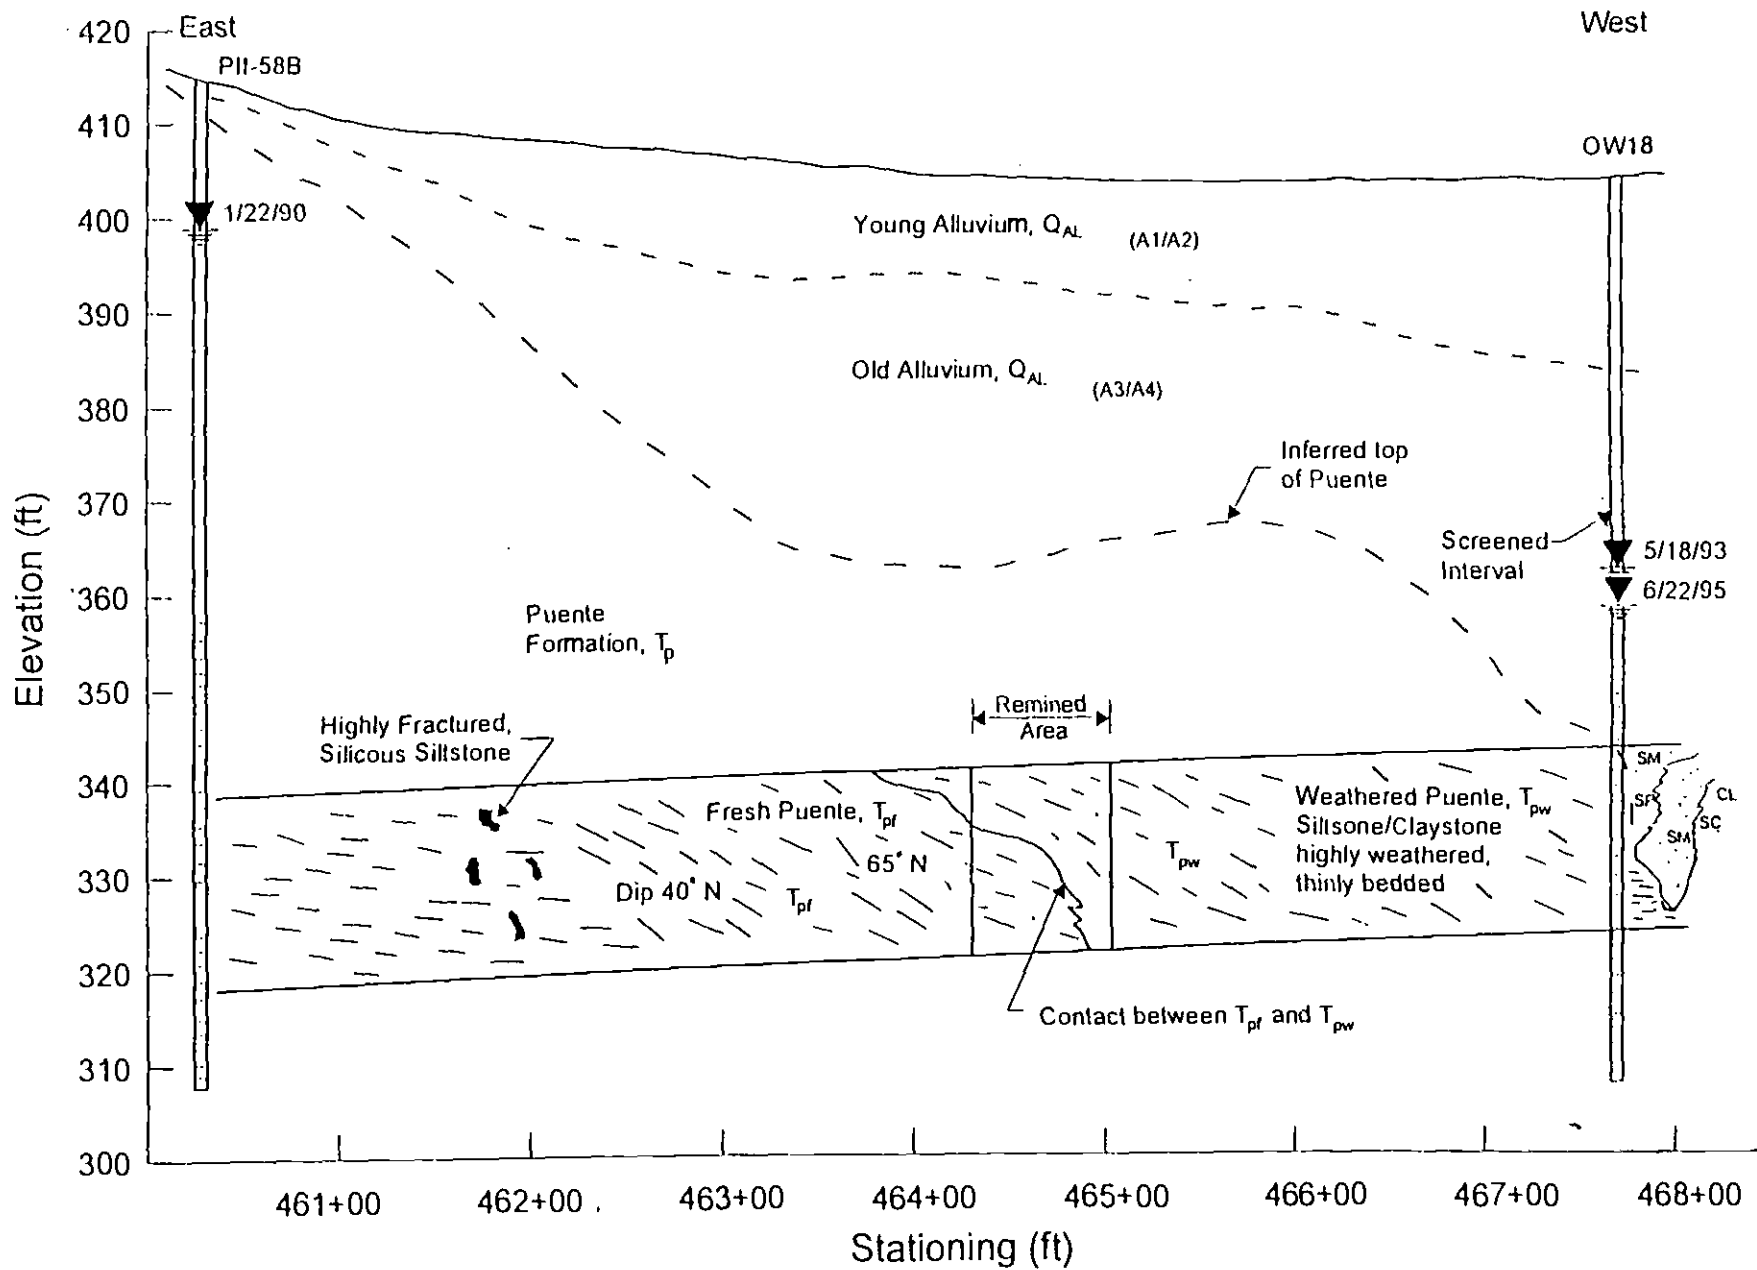
Fig 3.2 Subsurface Conditions Near HAL Remined Area

3.2.1 Stratigraphy near HAL remined area - Based on borings presented in the Geotechnical Report for the Vermont/Sunset Station and Adjacent Tunnel Segments, May 1990, prepared by The Earth Technology Corporation, hereafter referred to as the GRV/S Report, the subsurface conditions at this location consisted of approximately 45 ft of Young and Old Alluvium overlying the Puente formation (Fig. 3.2). A P-D drawing which summarized the face records from construction of the HAL tunnel provided the detail shown in this figure at the tunnel elevation. The crown of the tunnel was about 65 ft below the ground surface. Prior to construction, perched groundwater levels were located in the Alluvium. The tunnel in the sinkhole area was located entirely within the Puente formation. The material was easily excavated and, according to the face records (see Appendix B), consisted of weathered Puente (T_{pw}), oxidized Puente (T_{po}) and fresh Puente (T_{pf}), with an increasing amount of T_{pw} encountered in the face as the excavation proceeded westward. The T_{pw} was described in the face records as consisting of friable, interbedded siltstone/claystone with fine-grained sand beds, less than 1 in. thick. The apparent dip of the bedding was as much as 65 to 70 degrees from the horizontal. The T_{pw} was jointed, highly to moderately sheared, and slickensided. The T_{pf} was distinguished from the T_{pw} primarily on the basis of color, olive gray rather than red or orange brown, and on strength, "weak" rather than "very weak."

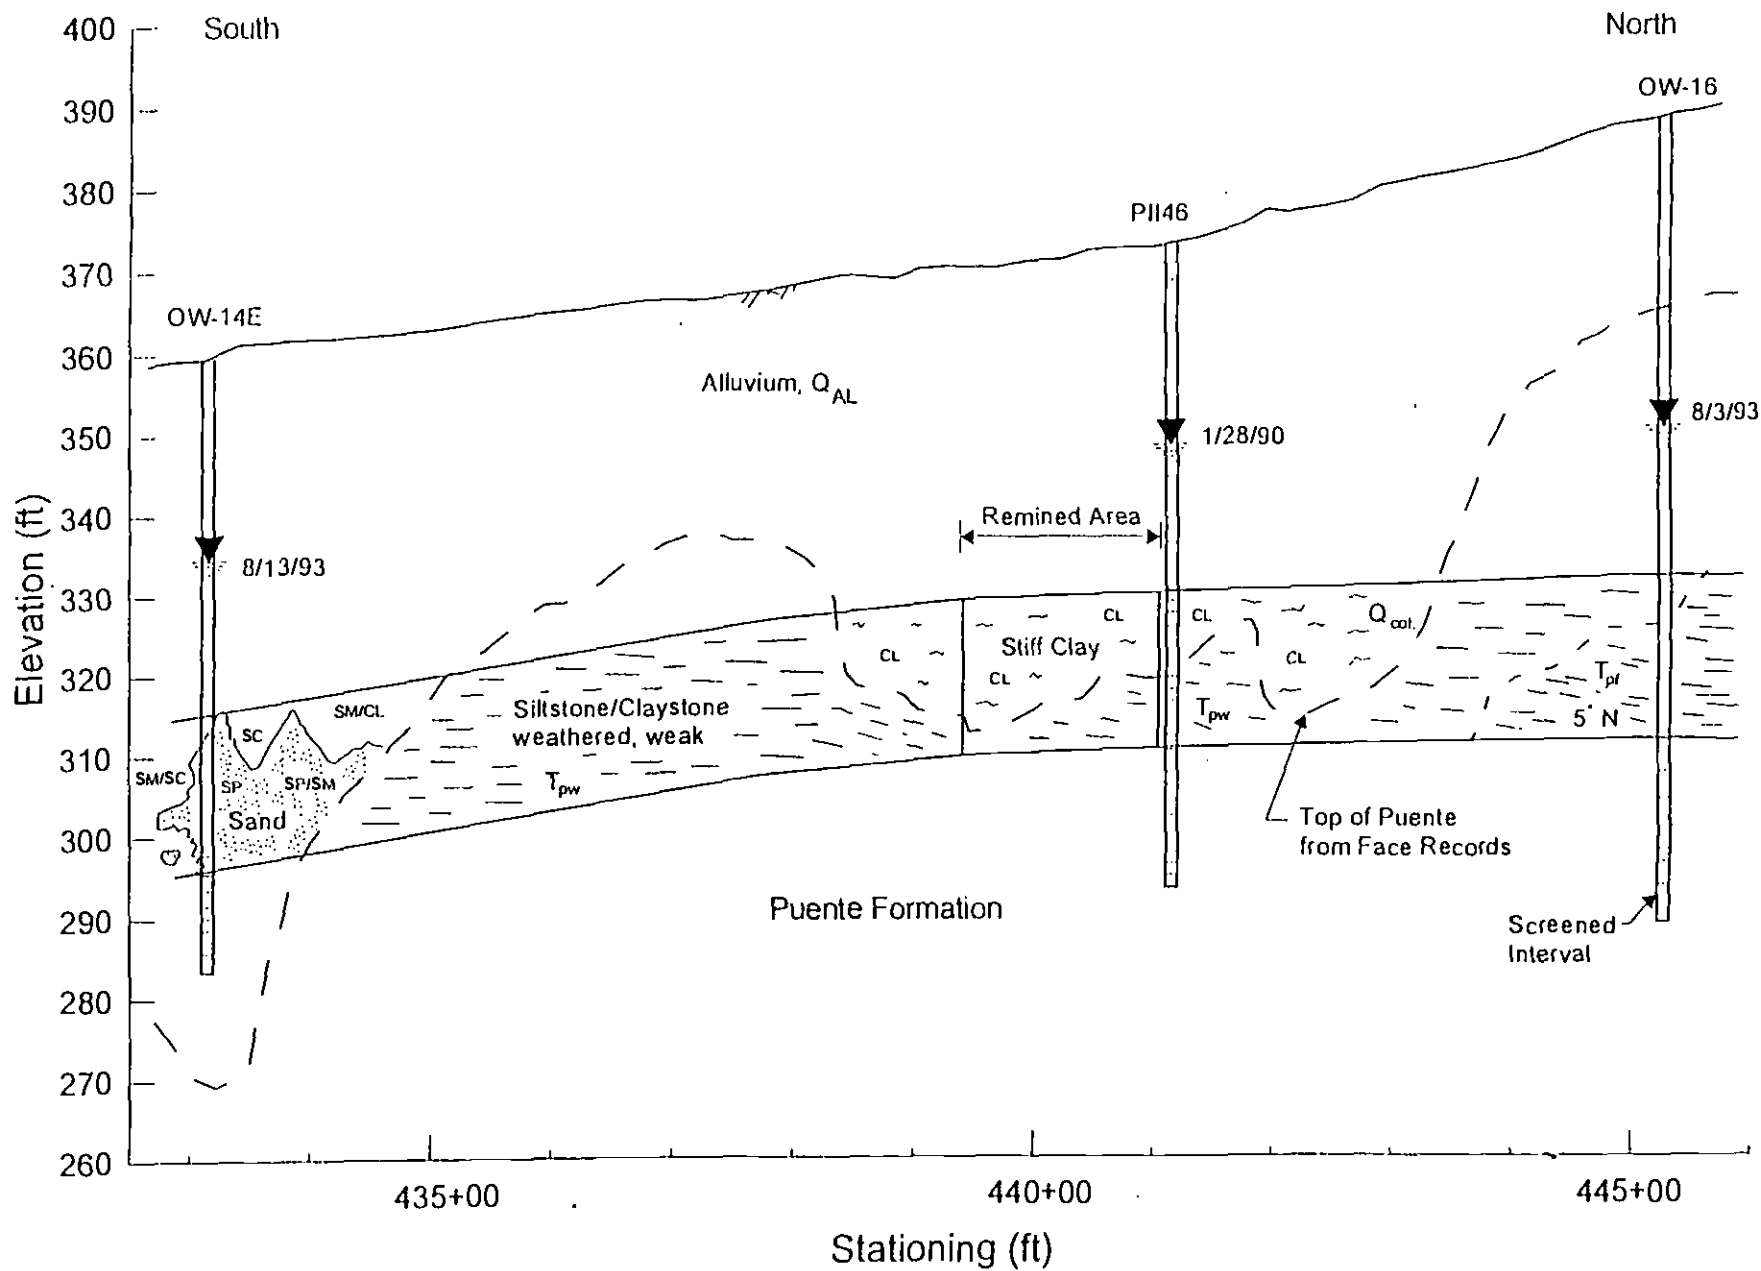
Fig. 3.4 Subsurface Conditions Near VAL Remined Area

3.2.3 Stratigraphy near VAL remined area - Based on borings presented in the GRV/S Report (1990) and on the face records obtained during excavation of the VAL tunnel, the subsurface conditions at this location consisted of approximately 50 ft of predominantly fine grained Old Alluvium overlying the Puente formation (Fig. 3.4). A P-D drawing which summarized the face records from construction of the VAL tunnel provided the detail shown in this figure at the tunnel elevation. The crown of the tunnel was approximately 42 ft below ground surface. Prior to construction, perched groundwater levels were located in the Alluvium. The tunnel in the remined area was located within either the Puente formation or both the alluvium and Puente formations, depending on the interpretation of the materials

The closest well was located 260 ft from the HAL site and 430 ft from the VAL site. Piezometer PII-46 was very near the VAL site (Fig. 3.4), but no data was collected after the initial site investigation, which occurred well before the tunneling began. Therefore the water conditions at both sites must be interpreted from wells located at some distance from each.

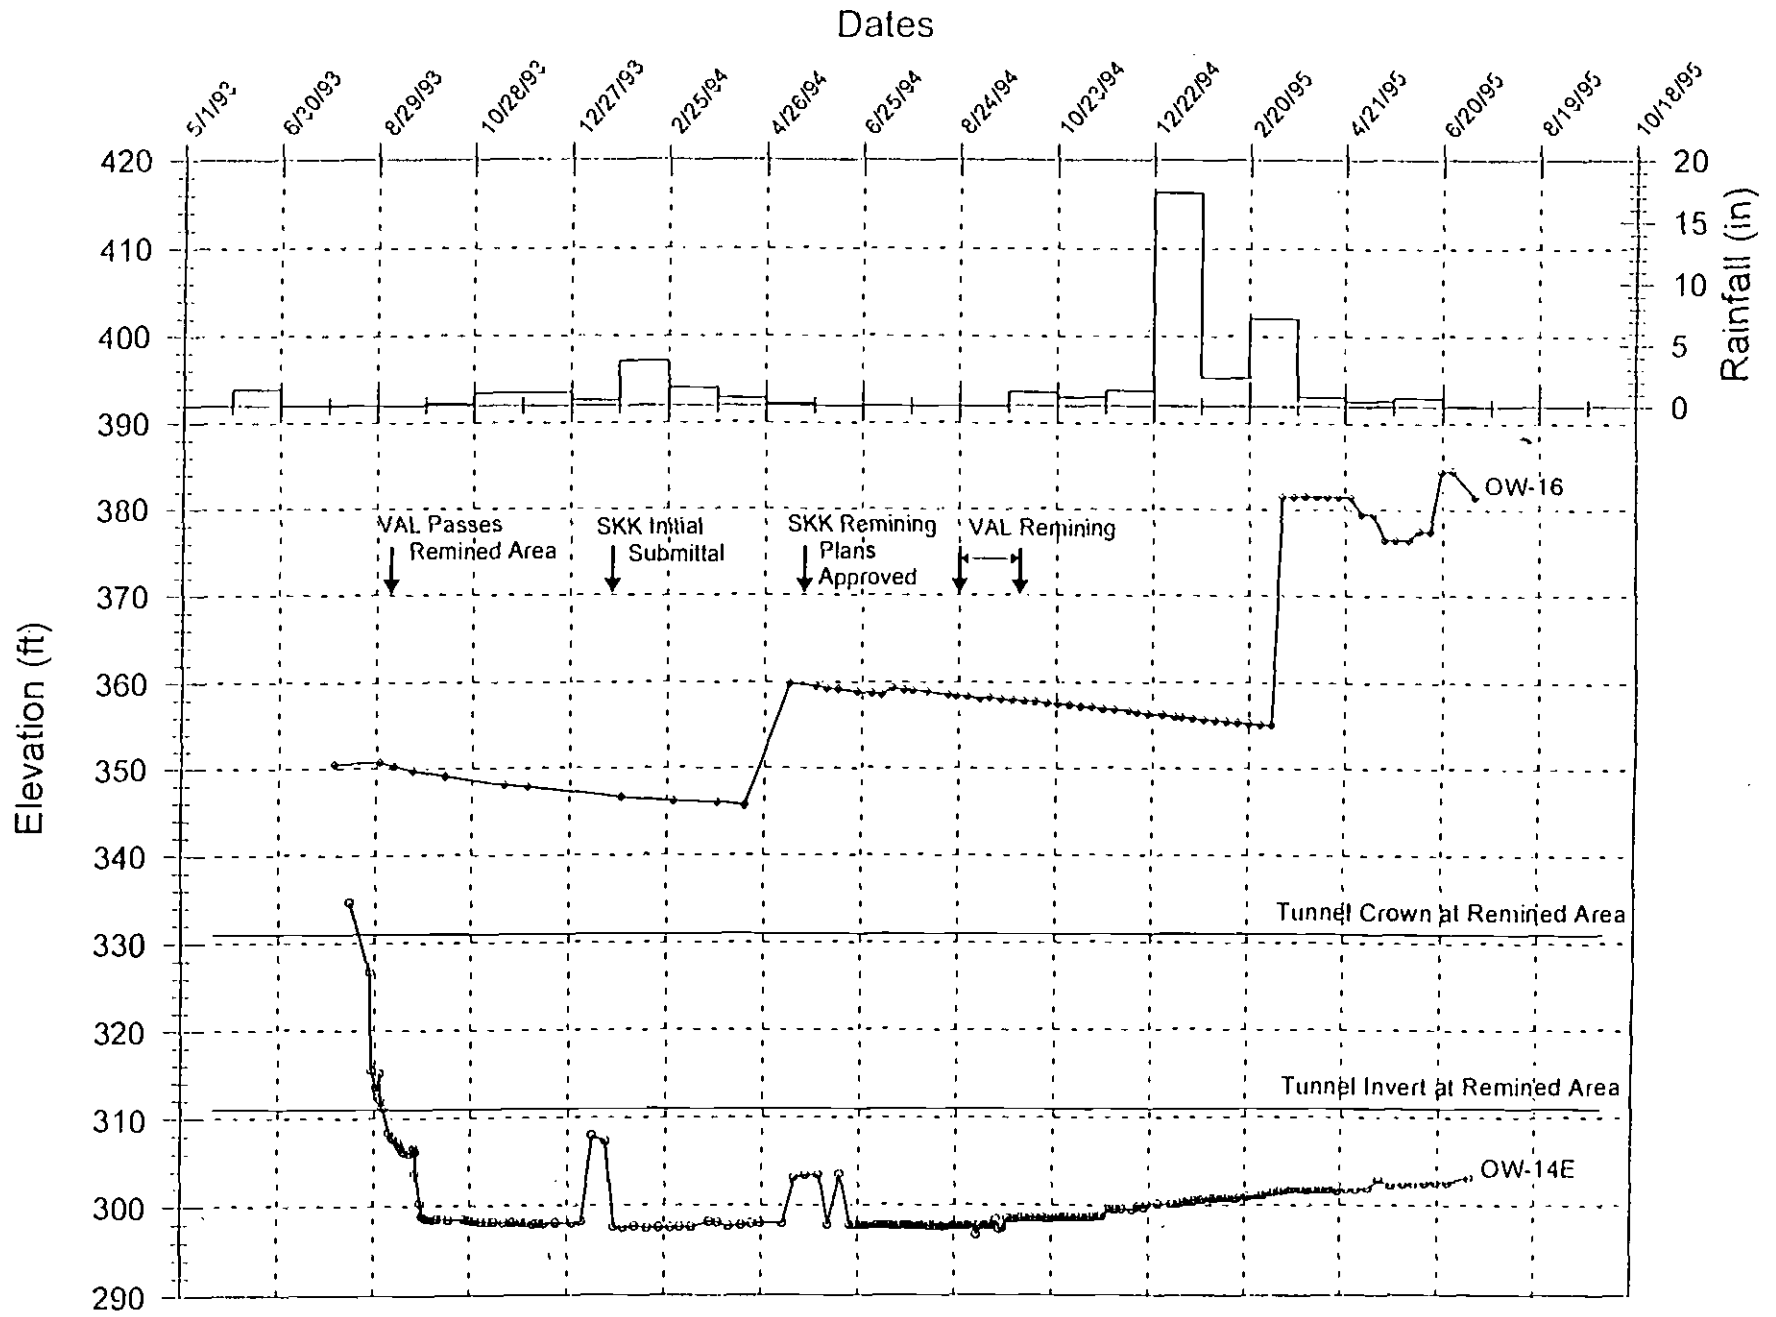
Fig. 3.5 Ground Water Levels Near VAL Remined Area

of the wells installed between Fountain and Lexington Avenues. Also shown are the data recorded at the Hollywood Dam rain gage by the LADWP. The OW-16 water levels vary over time, with two episodes of rapid groundwater rise after installation. The observation wells between Fountain and Lexington Avenues show no such variations and their responses are governed by the dewatering operation. The two rapid rises in OW-16 lag behind the peak rainfall in both 1994 and 1995 by about 60 days. As noted before, Bamsdall Park is the topographic high in the area, and is the recharge area for the local ground water which tends to flow away from the area along the alluvium and Puente formation interface. OW-16 is screened within the Puente, and it responds to the effects of recharge from precipitation. OW-16 is about 1200 ft away from the dewatering operation and is not affected to any great extent by the drawdown at that location, as indicated by the periods of slightly decreasing water levels observed as the dewatering system operated. It is somewhat surprising that OW-16 responded so quickly to the precipitation. The explanation may lie in the logs of the installation of OW-16 where it was noted that "intrusion problems and concern about pulling apart casing resulted in a 104 ft well depth." If the casing had slightly separated during installation, the well would be sensing water along its entire depth, because a gravel pack was placed above the bentonite seal. If that were the case, one would expect its response to precipitation to be similar to that of OW-18 since both wells are down gradient from the recharge area.

Similar estimates were made for conditions at the VAL remined area. There is more uncertainty in these estimated levels because of the greater distance to the observation wells near the remined area and the questions concerning the integrity of the bentonite seal at OW-16 (Section 3.2.4). In February 1994, when SKK made their initial remining submittal, the water level in OW-16 was approximately el. 346.6 ft (Fig. 3.5). When the submittal was approved in May 1994, the water level was el. 359.9 ft, and by the start of remining in September 1994, the water level was el. 358.1 ft. Assuming a gradient of 0.013, based on water levels between OW-16 and OW-14 before the dewatering system near OW-14E was in operation, the water levels in the area at each of these times are given in Table 6.1. These water levels were computed on the assumption that the dewatering near OW-14E had no effect on the water levels at the remined area. If it is assumed that the piezometric variation between OW-16 and 14E was linear at the time of the VAL remining, the corresponding water level at the VAL remined area would be close to the crown of the tunnel. The most likely scenario would place the water level somewhere between these limits, but conceivably as high as 22 ft above the crown. Thus the water levels were probably similar at the two sections when the remining was done at each.

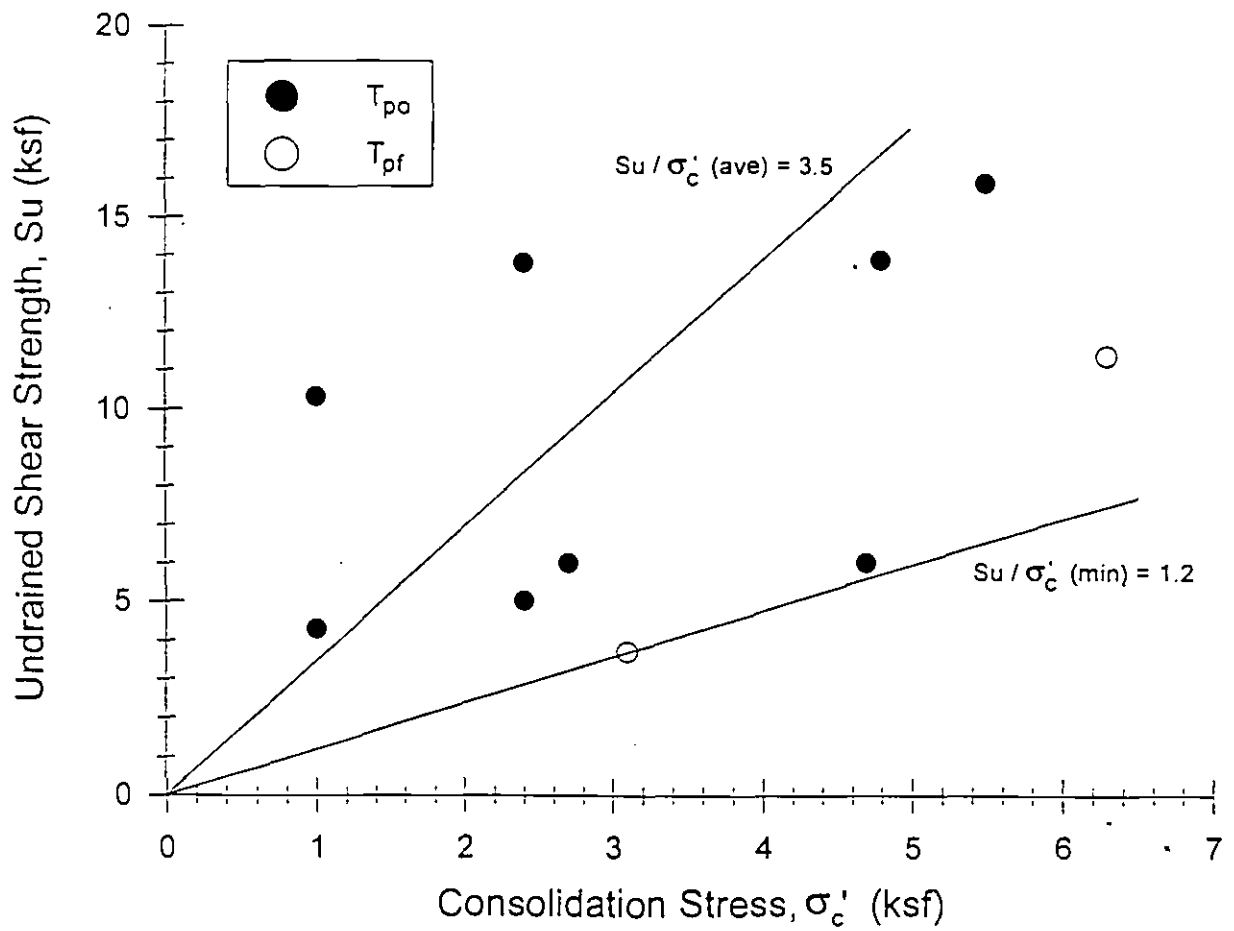
Fig. 3.6 Summary of Triaxial Test Data on Puente Specimens

The results of 10 isotropically consolidated, undrained triaxial compression tests on specimens obtained from the Puente formation are summarized on Figure 3.6. No tests were conducted on T_{pw} specimens. The data indicates that the laboratory values of S_u increase slightly with effective consolidation pressure, σ'_c , and are generally larger than those found in the U tests (Table 3.1), most likely as a consequence of the increased confinement in the triaxial tests. Again, no real distinction can be made between the strengths of the T_{po} and the T_{pf} specimens. To obtain a value of S_u for a given depth of cover, a value of S_u/σ'_c can be found, based on a slope through the data, and that ratio is multiplied by the corresponding vertical effective stress. Using the minimum value of S_u/σ'_c of 1.2, the corresponding value of S_u for the conditions at the HAL remining area is 7.4 ksf.

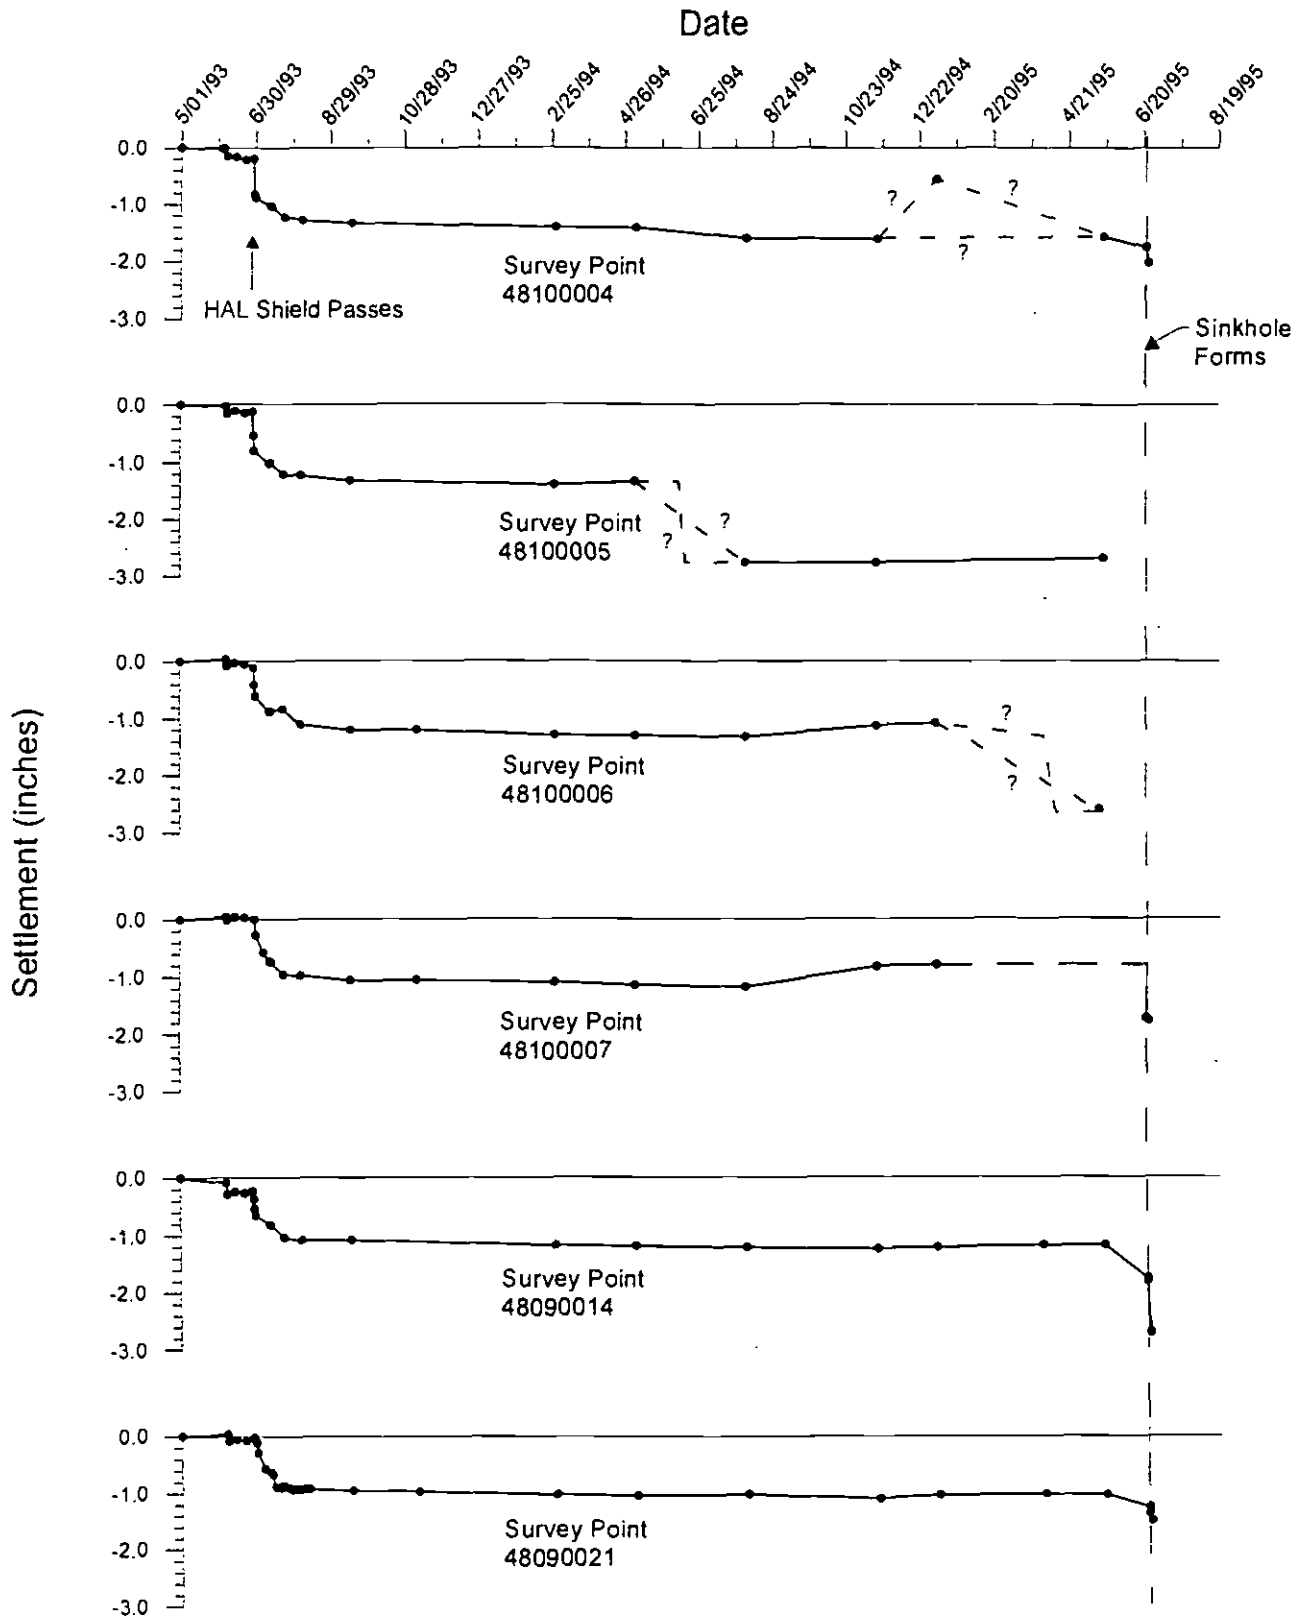
Fig 3.7 Ground Surface Settlements Near HAR Remined Area

WJE reviewed ground surface settlement records provided by P-D for locations near the sinkhole. Ground surface settlements within several hundred ft of the sinkhole area were 1 to 1.5 in. prior to the development of the sinkhole on June 22, as illustrated by the data from survey points 48100004, 48100007, 48090014 and 48090021 on Fig. 3.7. Locations of these points are shown in Fig. 2.2, and are labeled A, D, E and F, respectively. These survey points are typical of those in the vicinity. The majority of these settlements occurred as the HAR and HAL tunnels were driven in June of 1993.

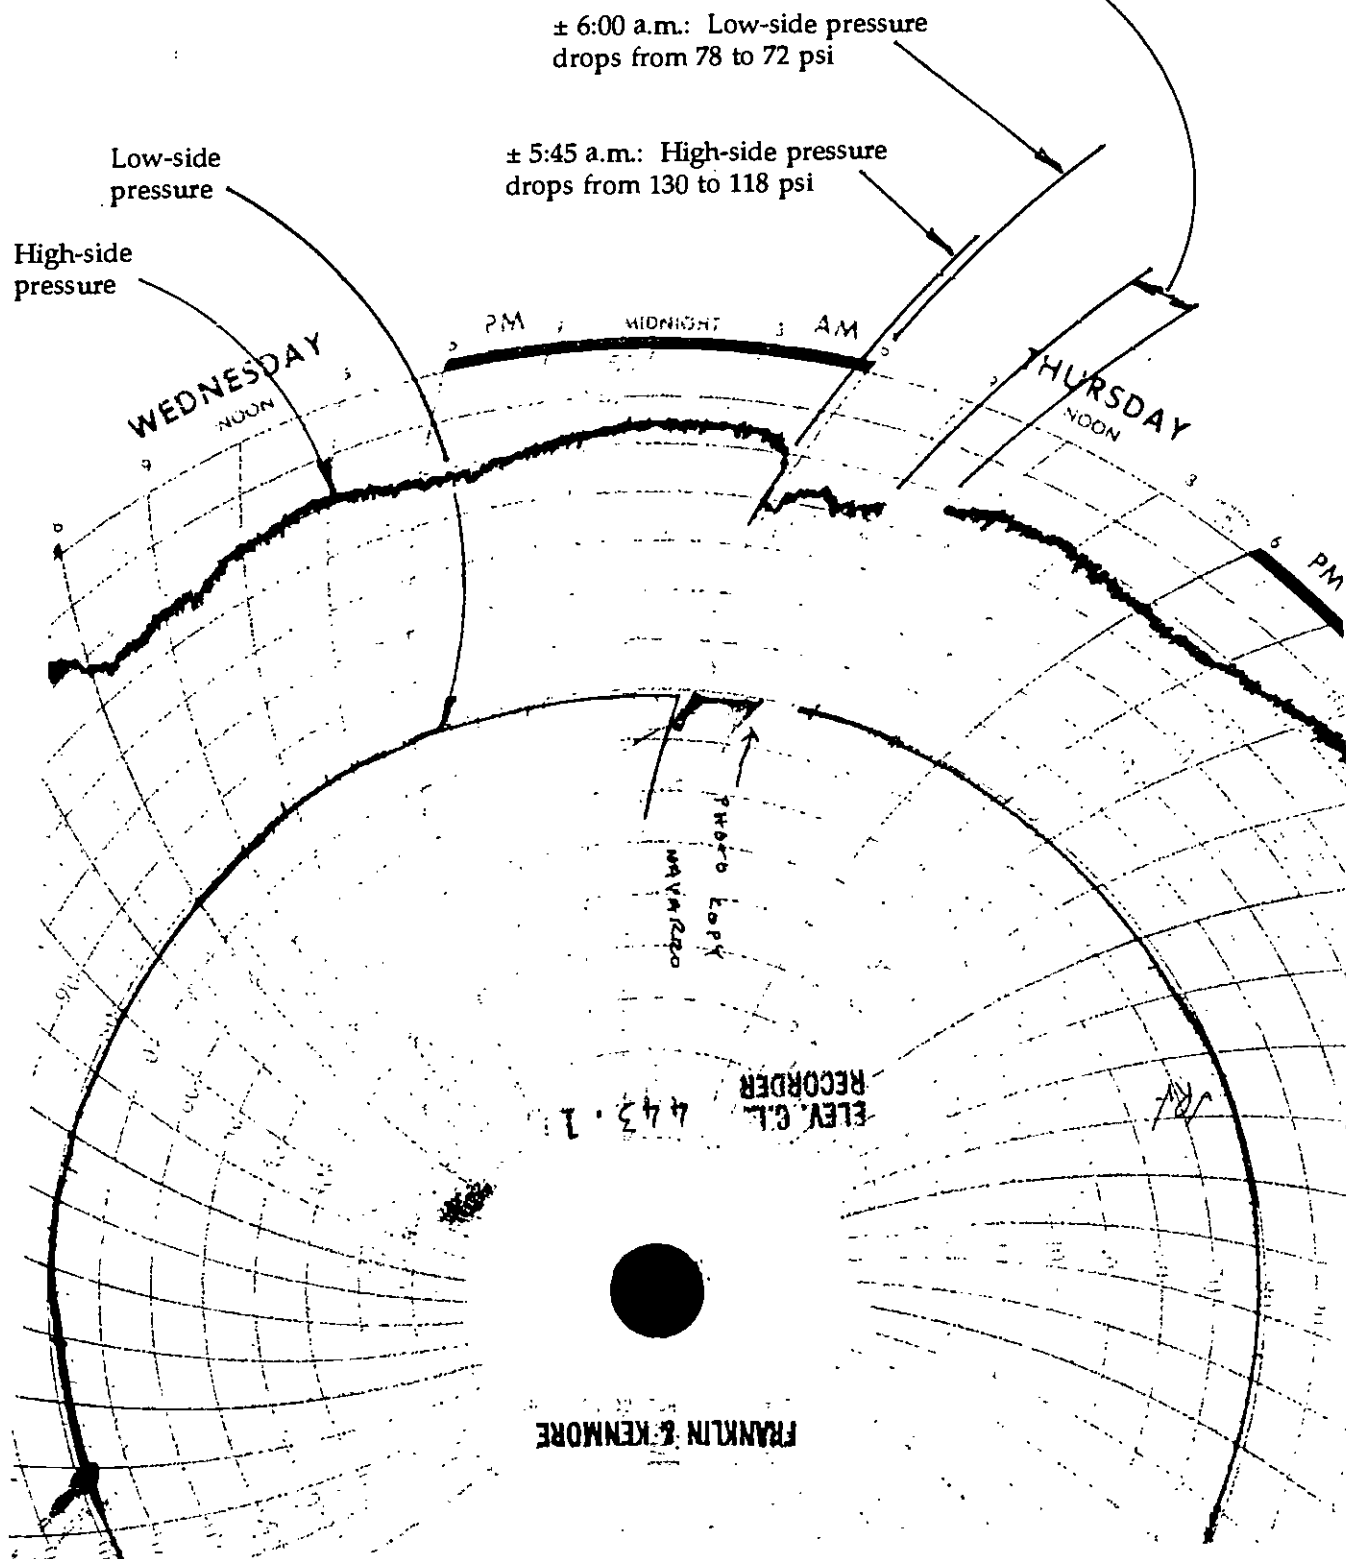
Fig. 3.8 - Franklin/Kenmore pressure record

The tunnel collapse and water main break were detected at the Franklin/Kenmore monitoring station. Pressure and flow chart records are provided in Figs. 3.8 and 3.9, respectively. At approximately 6:00 a.m. on June 22, flow increased from 10 to 24 cfs, a 14 cfs increase. The exact time is difficult to determine from the photocopy of the flow record. As can be seen in Fig. 3.8, low-side pressure dropped from 78 to 72 psi at 6:00 a.m. A sudden drop in the high-side pressure was recorded at about 5:45 a.m.

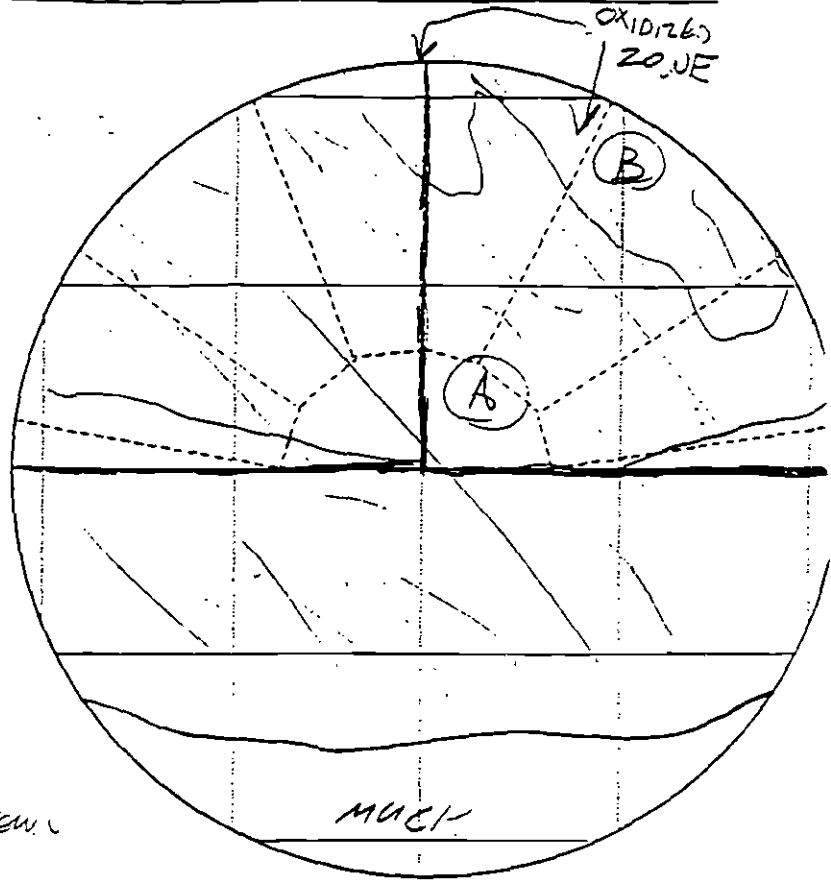
GREEN OXIDIZED TO REDDISH BROWN
MOIST. MODERATELY SHEARED
APPARENT DIP - 65° TRUE DIP NORTH WEST
SPLITTING IS DOWNWARD
PARALLEL TO FACE WITH WELL DEVELOPED SIDE SLOPES, OXIDIZED
ZONES NEAR CROWN DIP ALONG BEDDING. EAST MINING
PURE WITH FRAGILE, NO HARD ROCK

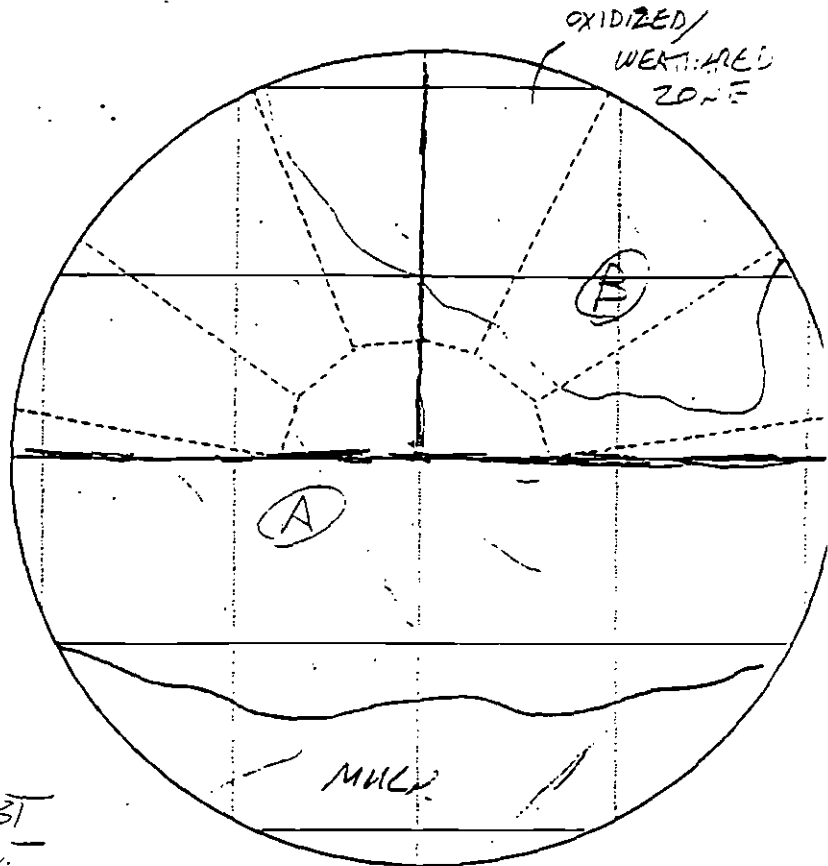
COMMENTS: PUEBLO FM, OLIVE

GRAY - YELLOW ROCK, MOIST
MODERATELY SHEARED APPARENT

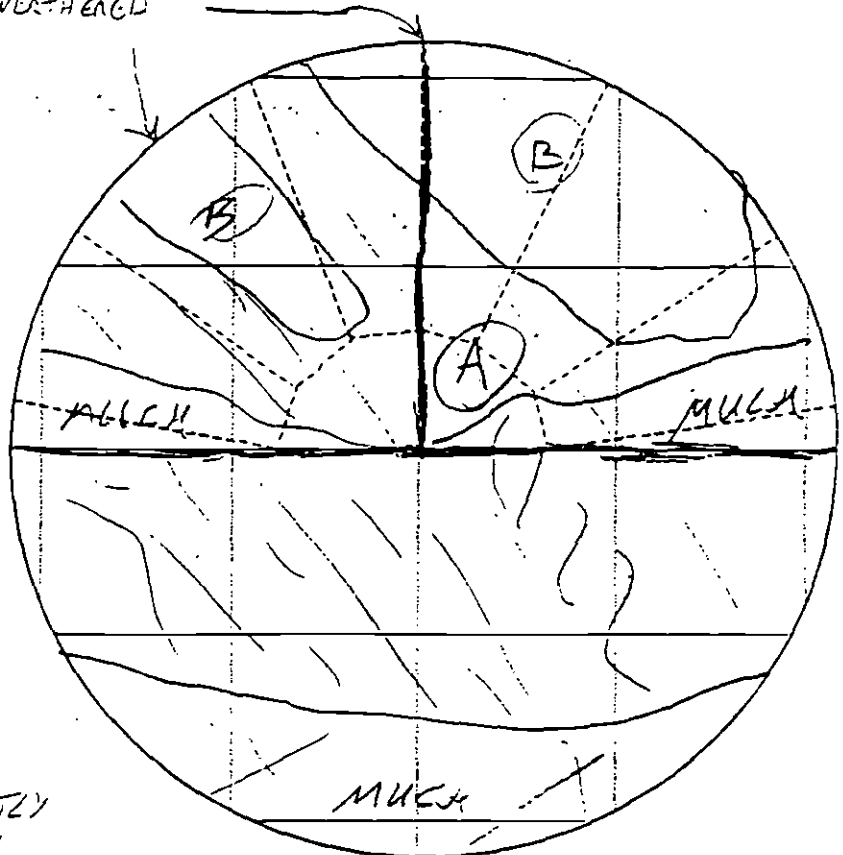
GRAY - ORANGE BROWN, MODERATELY
SHEARED BEDDING DIPS NW
@ ~ 45° (VARIABLE) WEATHERED
ZONES ALONG RING 79 AND

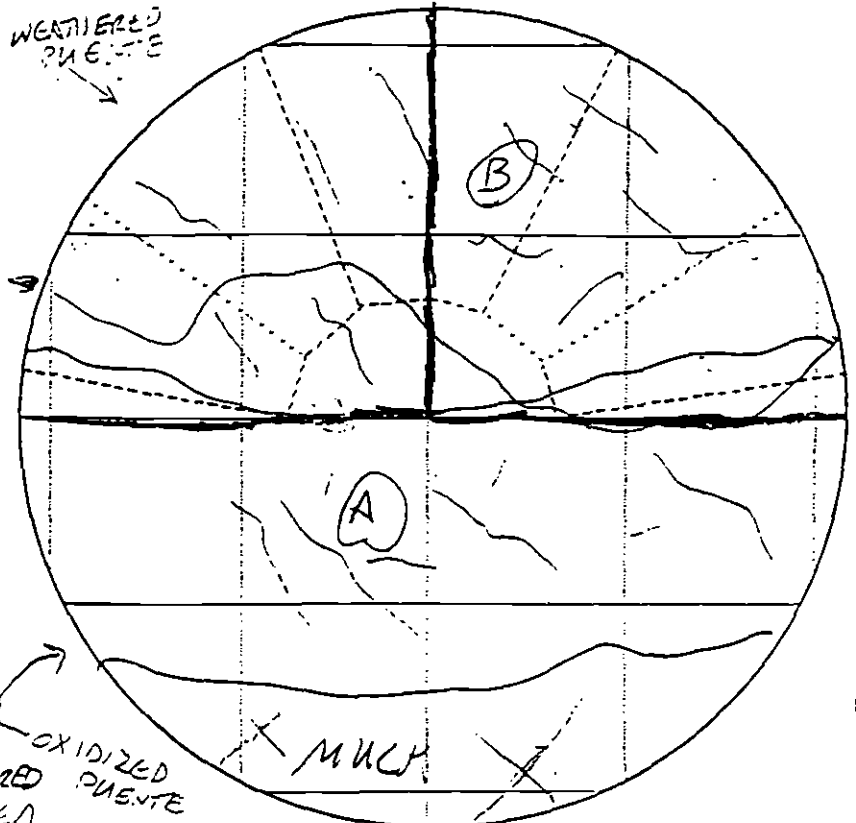
COMMENTS: PUENTE Fm ORANGE BROWN-GRAY GREEN, WEATHERED ABOVE SPRING LINE OXIDIZED REGION MODERATELY SHEARED WITH WELL DEVELOPED SLICKENSIDES BEDDING IF NOT DISTING, NO HARD ROCK, MATERIAL IS FRIABLE AND EASILY MINED BY TSM

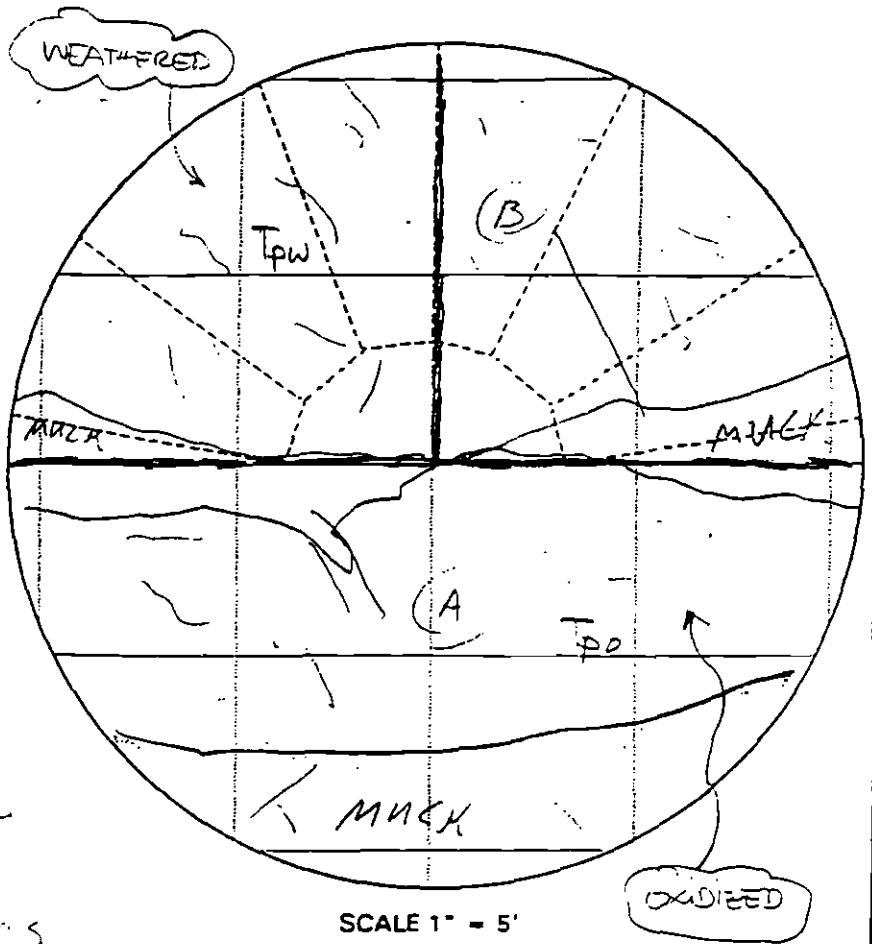
COMMENTS: PUKE-FE Fm ORANGE
BROWN - GRAY-GREEN, MOIST
MODERATELY SHEARED WITH
WELL DEVELOPED SLICKENSIDES
BEDDING IS ABSENT

NEAR CROWN & POORLY DEFINED NEAR INVERT, WEATHERED
ZONE (B) EXTENDS FROM CROWN TO JUST BELOW SPRING LINE
OXIDIZED ZONE (A) IS DARK GRAY AND OXIDIZED ALONG SO. N. OF
BEDDING PLANE. NO HARD ROCK EASILY MARKED BY T.P.W.
