METRO RED LINE, SEGMENT 2, CONTRACT B251

Investigation of Tunnel Collapse and Sinkhole

Wiss, Janney, Elstner Associates, Inc.

FINAL REPORT

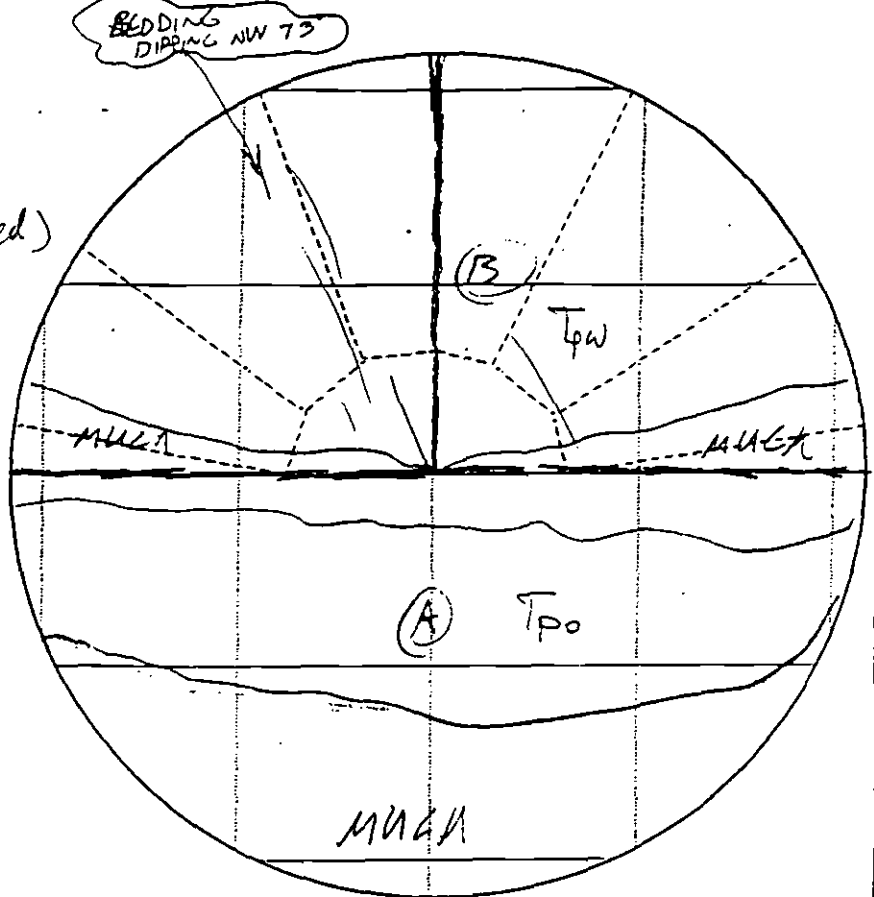
GRAY GREEN - ORANGE BROWN
MOIST, MODERATELY SHEARED
BEDDING DIPS NW @ 73°
STRIKE ~ 3° SOUTH OF HEADING

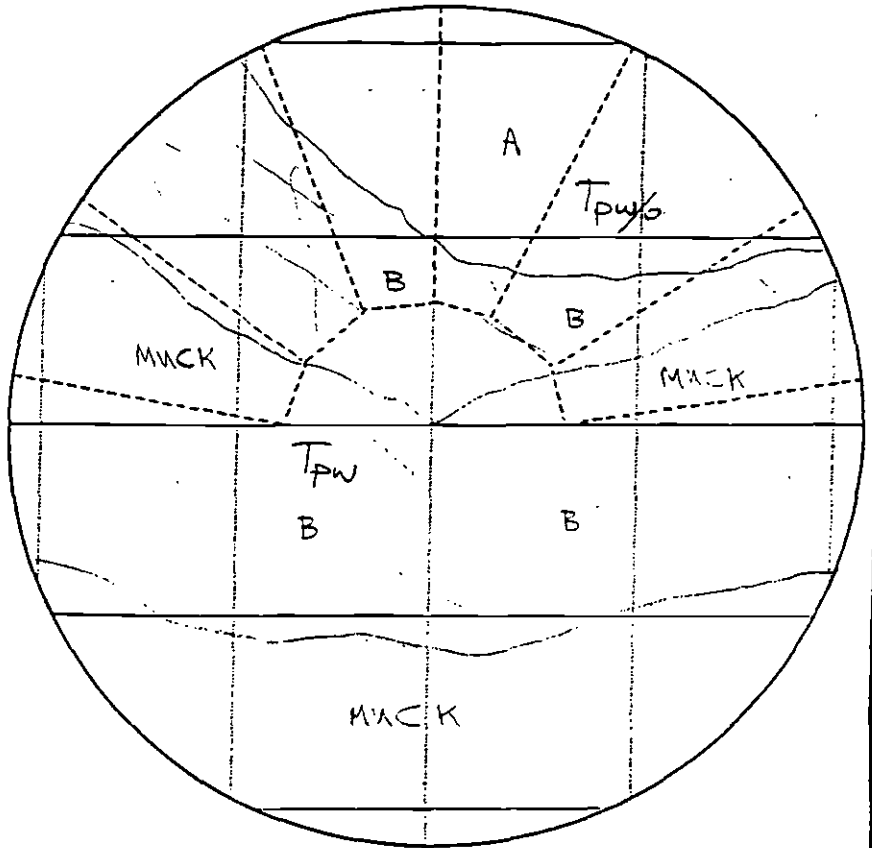
A. Brownish yellow oxidized Pnecite.

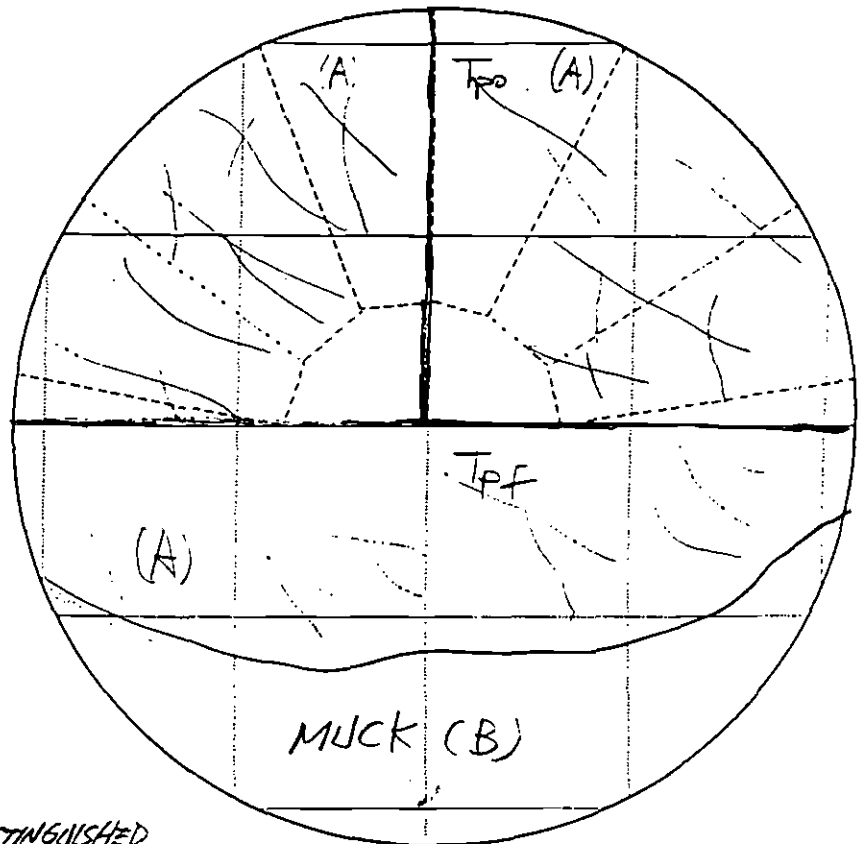
(A) - HIGHLY SHEARED AND JOINTED
 PUENTE FM. BEDDING IS UNDISTINGUISHED.
 OXIDIZED PUENTE IS PRESENT AT
 THE CROWN AREA. EASY TO
 EXCAVATE. NO WATER SEEPING OUT OF FACE.
 (B) - MUCK EXCAVATED FROM FACE

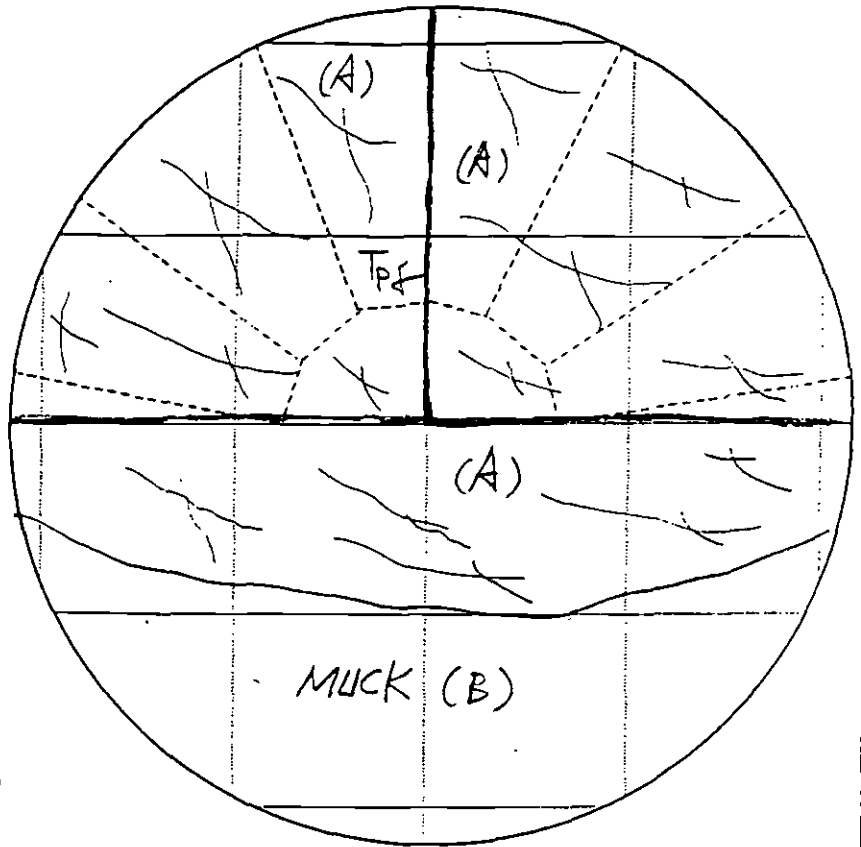
(A) - HIGHLY SHEARED AND JOINTED
 PUENTE FM. SOME OXIDIZED
 PUENTE IS PRESENT AT THE
 CROWN AREA (YELLOWISH BROWN
 IN COLOR). FACE IS EASY TO EXCAVATE.
 NO WATER SEEPING OUT OF FACE
 (B) - MUCK EXCAVATED FROM FACE

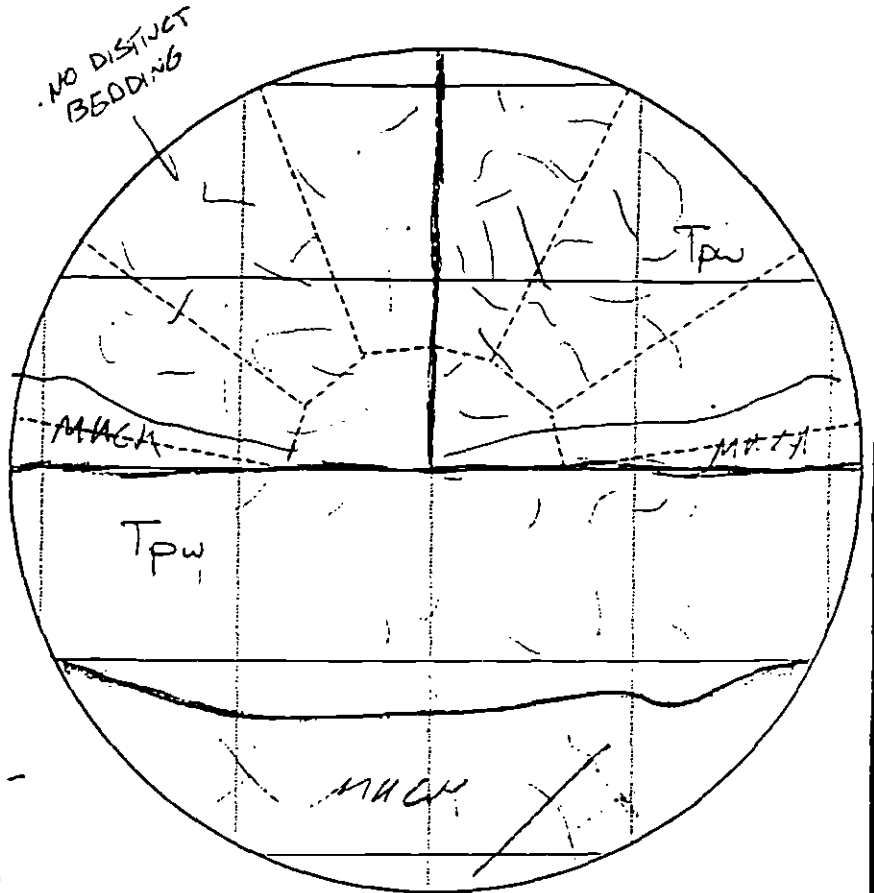
COMMENTS: PUEBLO Fm, ORANGE-BROWN, MOIST MODERATELY SHEARED WITH WELL DEVELOPED SLIP SURFACES, WEATHERED OVER ENTIRE FACE, BEDDING IS HIGHLY DISRUPTED AND NOT DISTINCT, NO HARD ROCK, MATERIAL IS FRAGILE AND EASILY MINED BY TSM

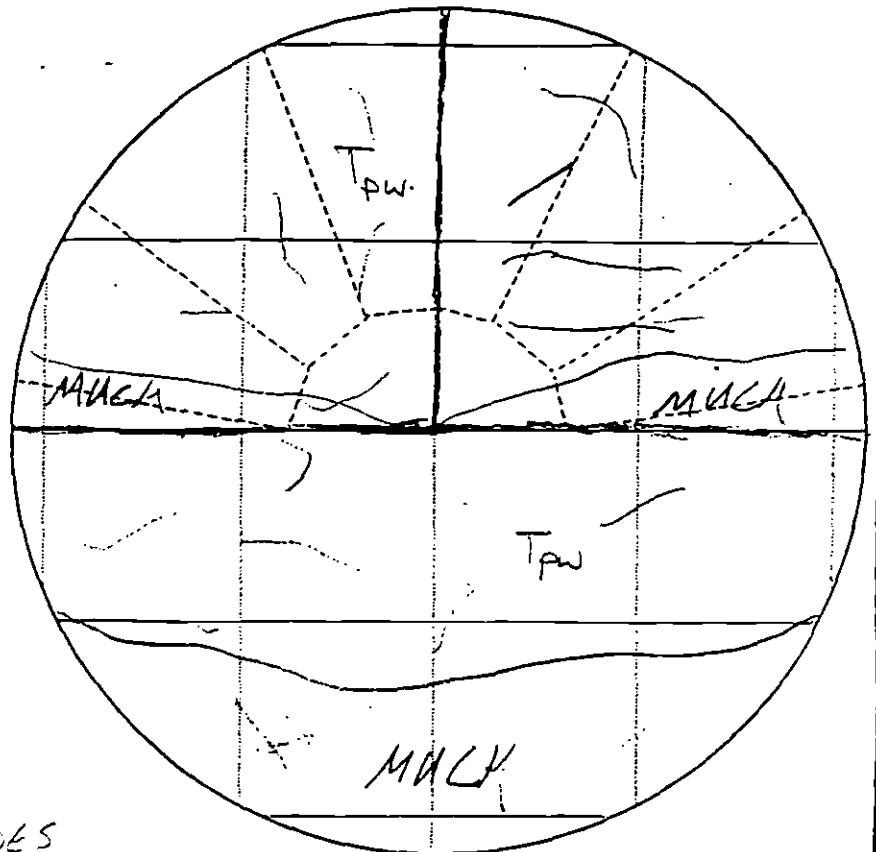
COMMENTS: PUEBLO Fin, ORANGE
BROWN, MODERATELY SHEARED
WITH CLOSELY SPACED SLICKEN SIDES
HIGHLY WEATHERED, NO BEDDING
APPARENT, PUEBLO IS
FRIABLE AND EASILY MOULDED BY TSM

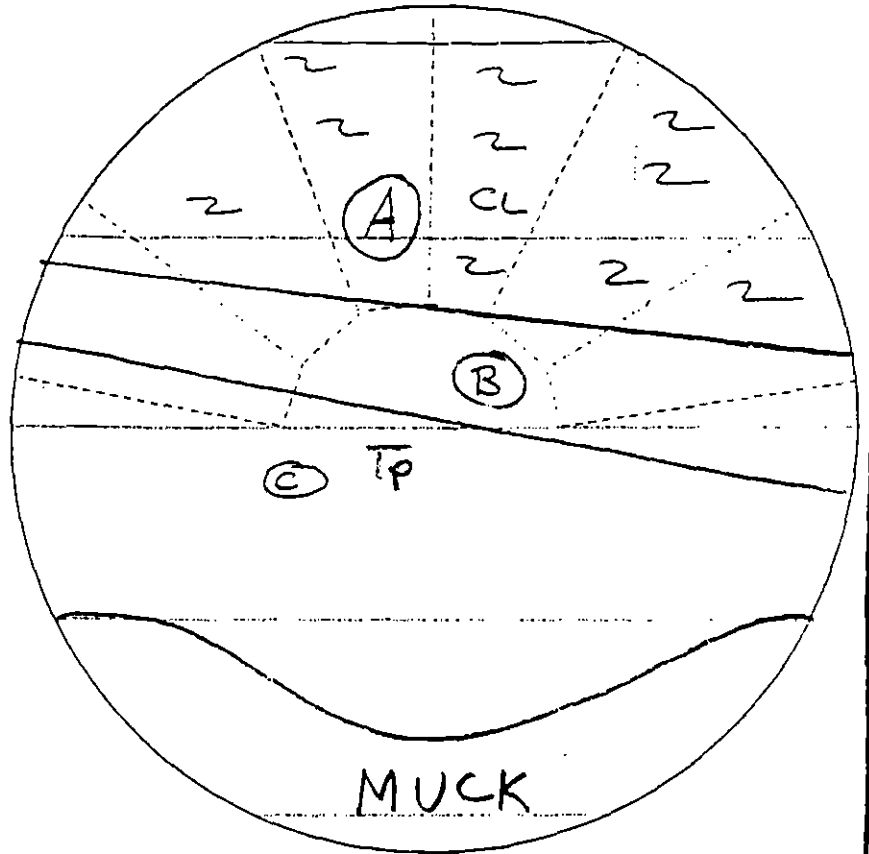
CLAY, Low Plasticity
medium stiff, moist
ravels during mining
B. Colluvium - same as
A with 20% chunks of weathered Puente

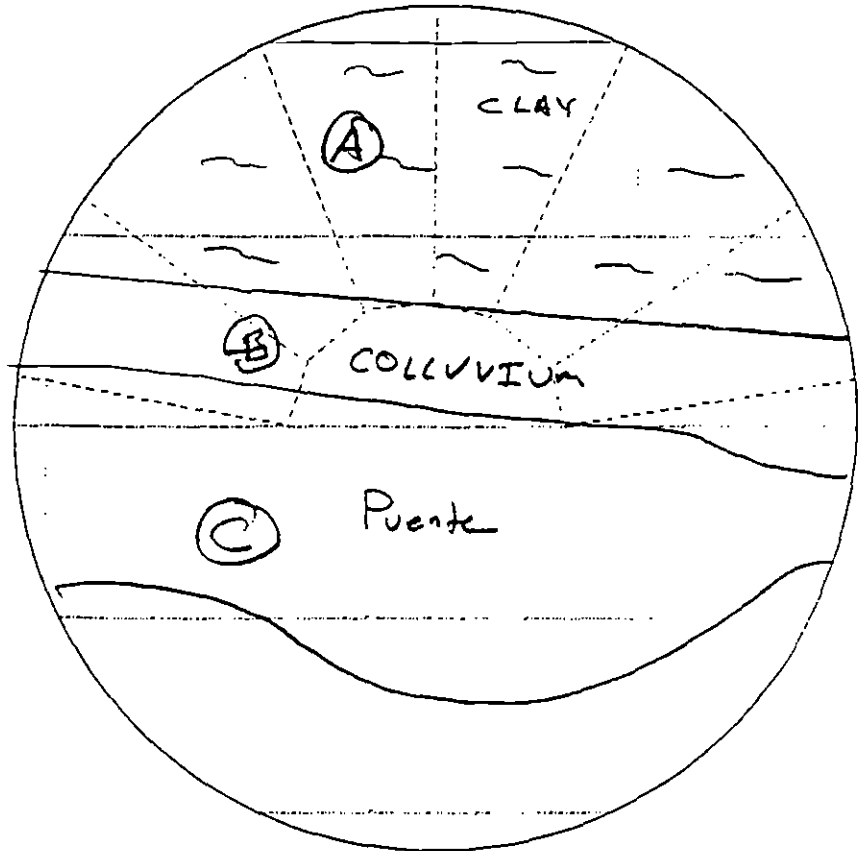
A. Reddish Brown CLAY
medium stiff, moist low plasticity

B. Colluvium - Reddish brown
CLAY with 10% chunks of weathered Puente, moist medium stiff

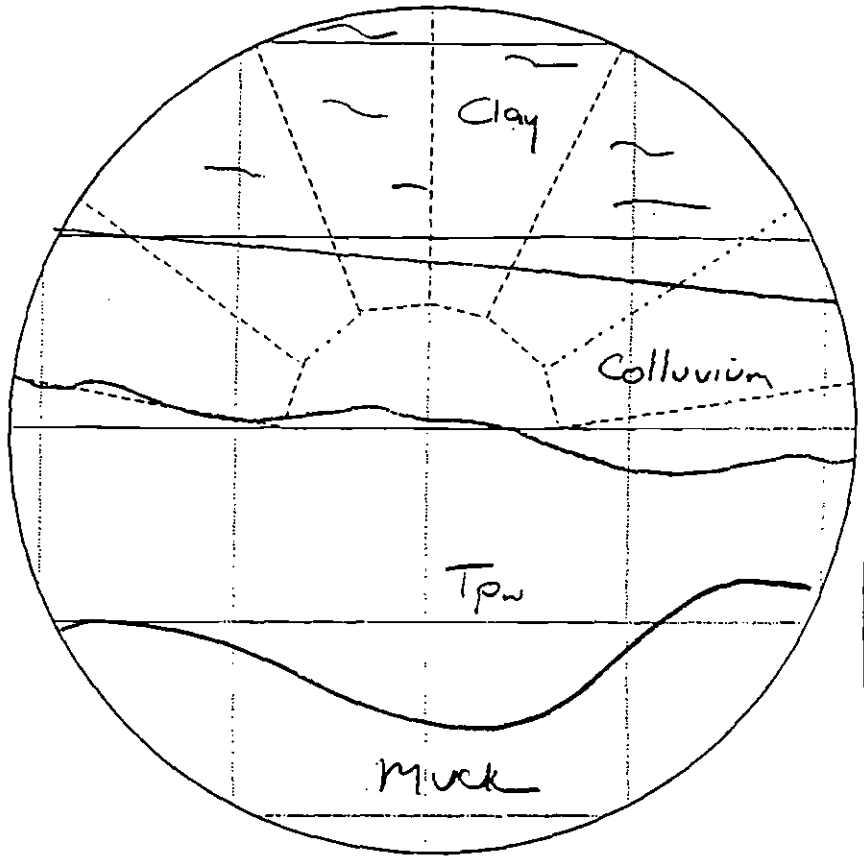
A. Reddish Brown CLAY
 moist, medium stiff low
 plasticity.

B. Colluvium - Reddish brown CLAY moist, medium stiff contains
 10-20% pieces of weathered puenete

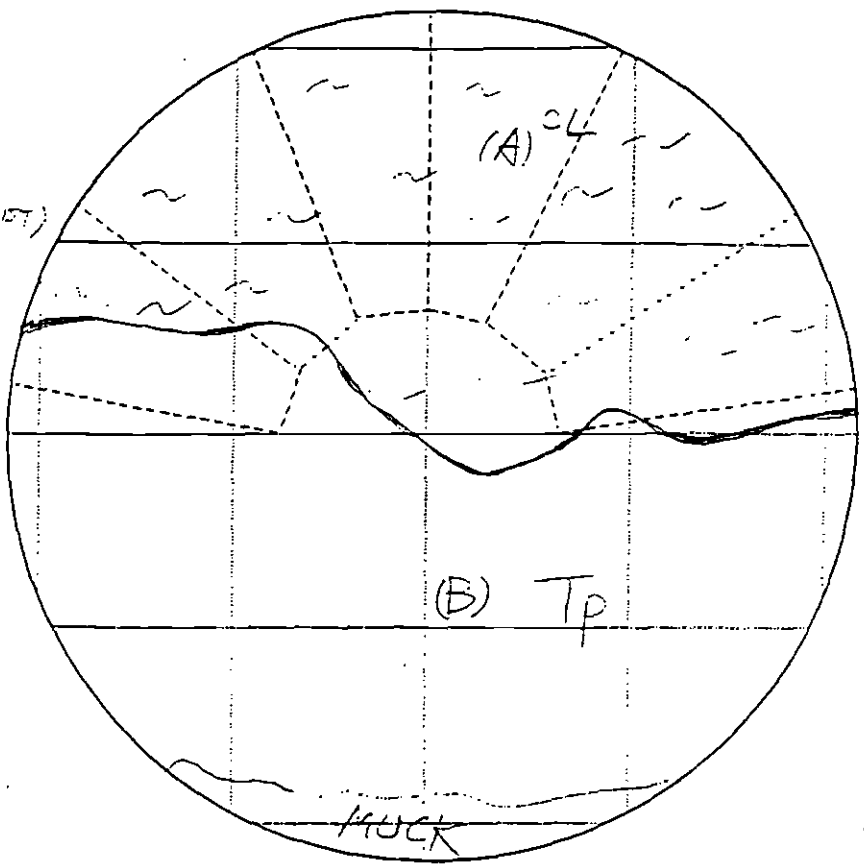
(A) ALLUVIUM - CLAY (CL). OLIVE GREEN
 IN COLOR. MEDIUM STIFF.
 1.5' ST.

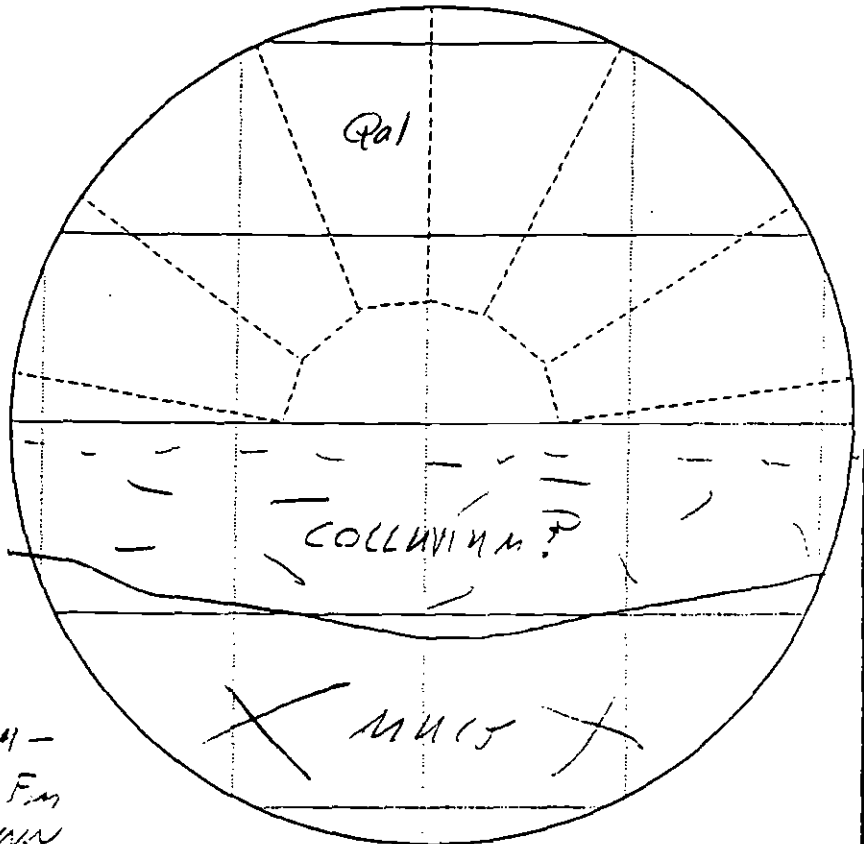
COMMENTS: ALLUVIUM / COLLUVIUM -
- HIGHLY WEATHERED PUENTE F.M.
ALLUVIUM IS REDDISH-BROWN
MOTTLED, CLAY (CL) MOIST,
STIFF, NO WATER SEEPAGE
COLLUVIUM IS HIGHLY WEATHERED PUENTE CLAY, GREEN-
BROWN, MOTTLED BEDDING IS IRREGULAR

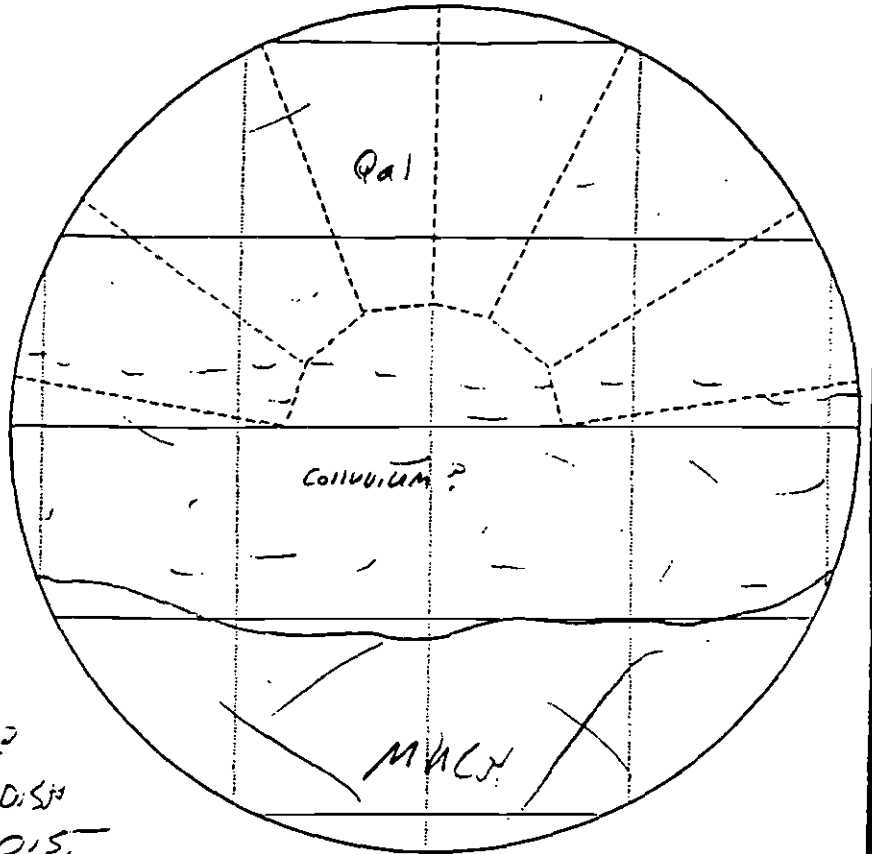
COMMENTS: ALLUVIUM / COLLUVIUM?
ALLUVIUM IS MOTTLED REDDISH
BROWN CLAY (CL) STIFF, MOIST,
NOT (AYERED), COLLUVIUM IS
BROWN / GREEN MOTTLED WITH
IRREGULAR BEDDING - CLAY (CL)

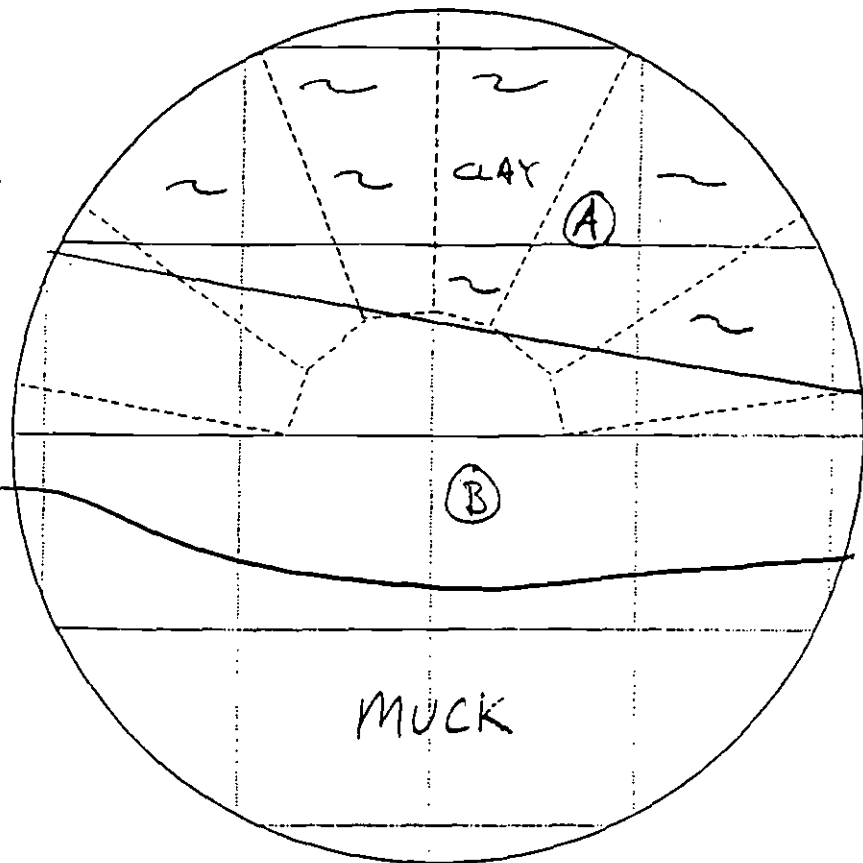
A. Reddish Brown CLAY
Low Plasticity, Medium stiff
raveling, moist. Trace of
wet areas on face
