**U N I O N S T A T I O N
L O S A N G E L E S**

**INITIAL STUDY
FOR
REHABILITATION
AND
REUSE**

SURVEY OF CONDITIONS

**PREPARED FOR CATELLUS DEVELOPMENT CORPORATION
HARDY HOLZMAN PFEIFFER ASSOCIATES
AUGUST 1991**

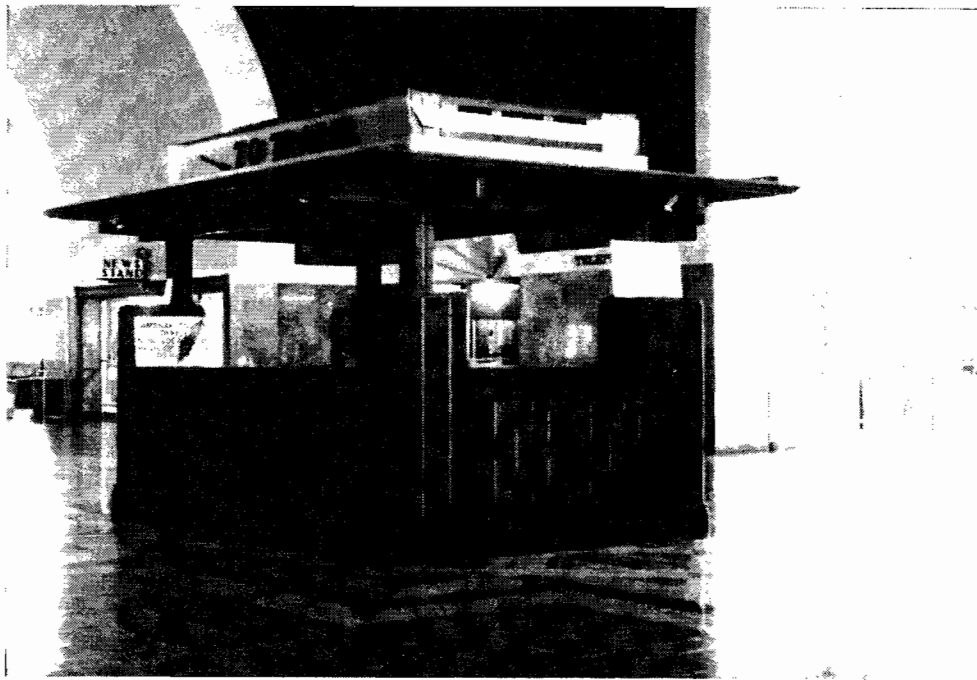
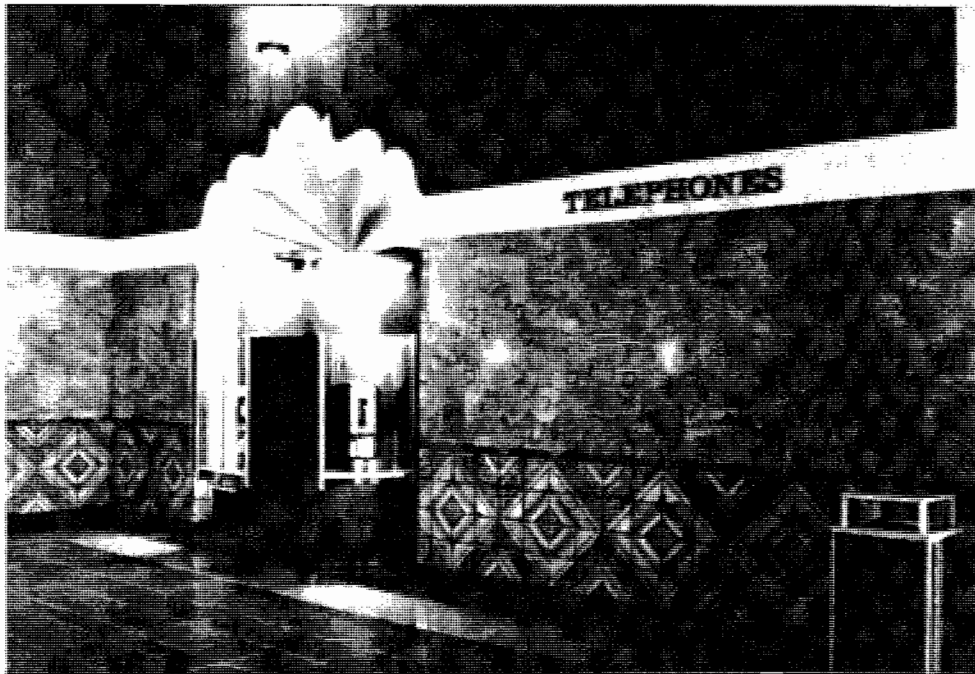
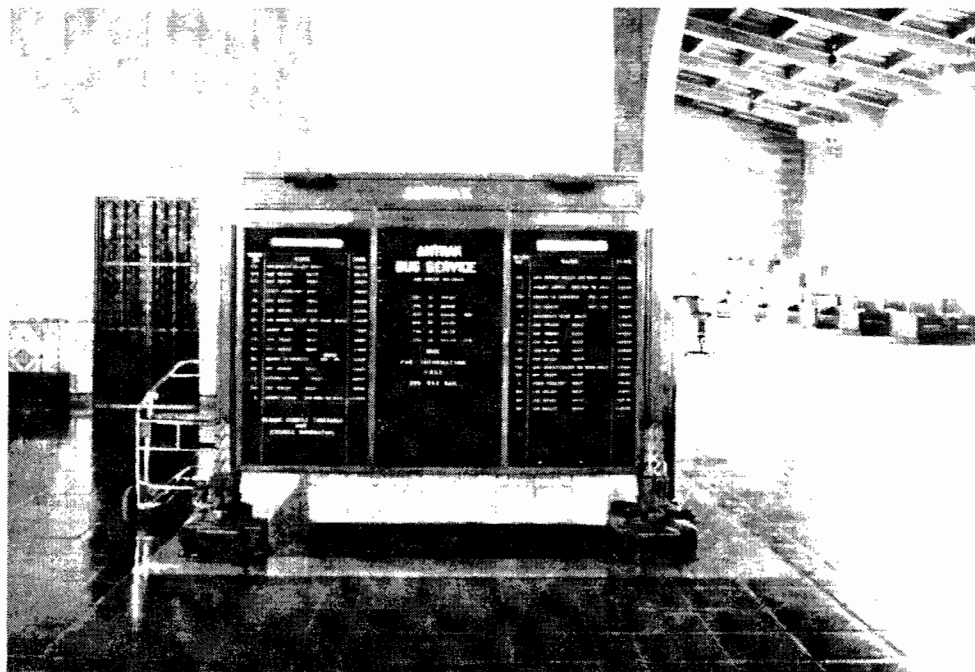
5. CONDITIONS - The Information Desk at the center of the room has been vacated. The absence of someone to direct visitors leaves the vestibule feeling empty and abandoned. The wood on the booth is worn and scarred and the tile base is broken in several places. The acoustic tiles on upper walls appear dirty. Lower tile and terrazzo walls are in good condition but require cleaning. The mortar between floor tiles is dirty and worn away.

11. SIGNAGE - Inconsistent signage at telephones. Original signage missing over Information Booth.
12. STRUCTURAL ISSUES - Not applicable.
13. MECHANICAL ISSUES - HVAC not apparent; if future use included computerized information terminals then air conditioning would be desirable.

19. RECOMMENDATIONS FOR HISTORIC UPGRADE - Match and replace the tile base at the Information Booth. Remove inconsistent elements. Research original signage and match signage with historic type and style. Research original trash containers and replace with similar contemporary bins. Clean and repair wood on the Information Desk and restaff. Clean and upgrade the lighting fixtures.
20. ONGOING WORK - Not currently applicable.
21. IMPACT ON OPERATIONS - Not applicable.

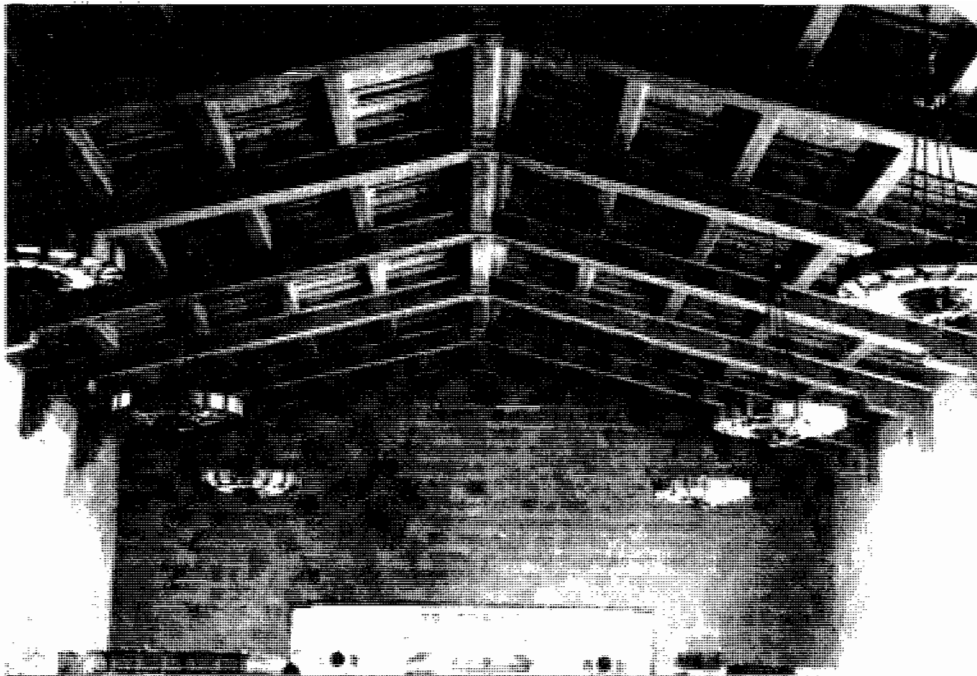
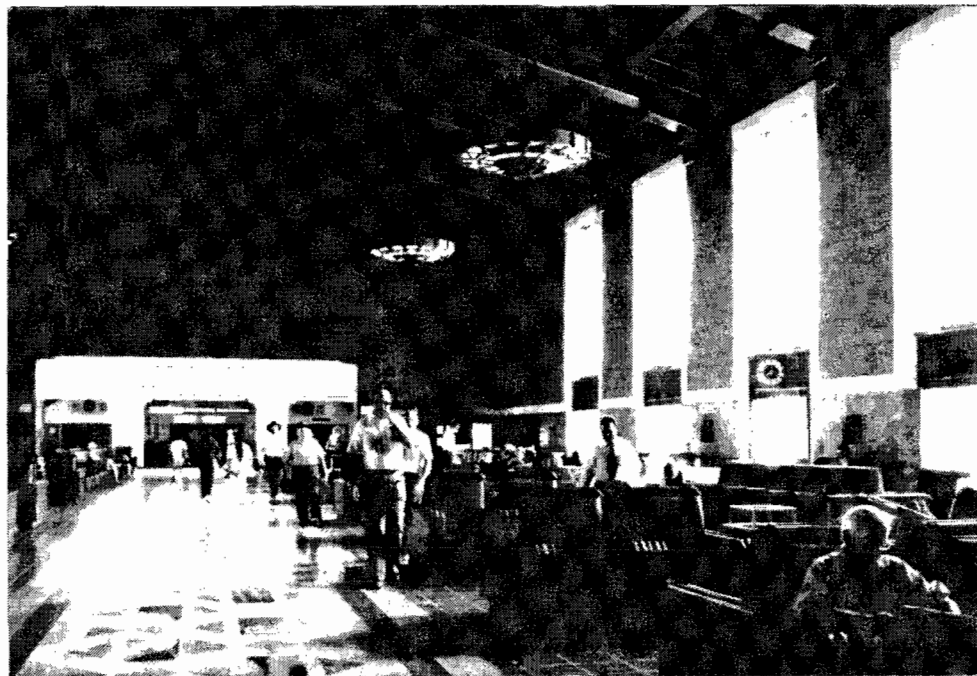
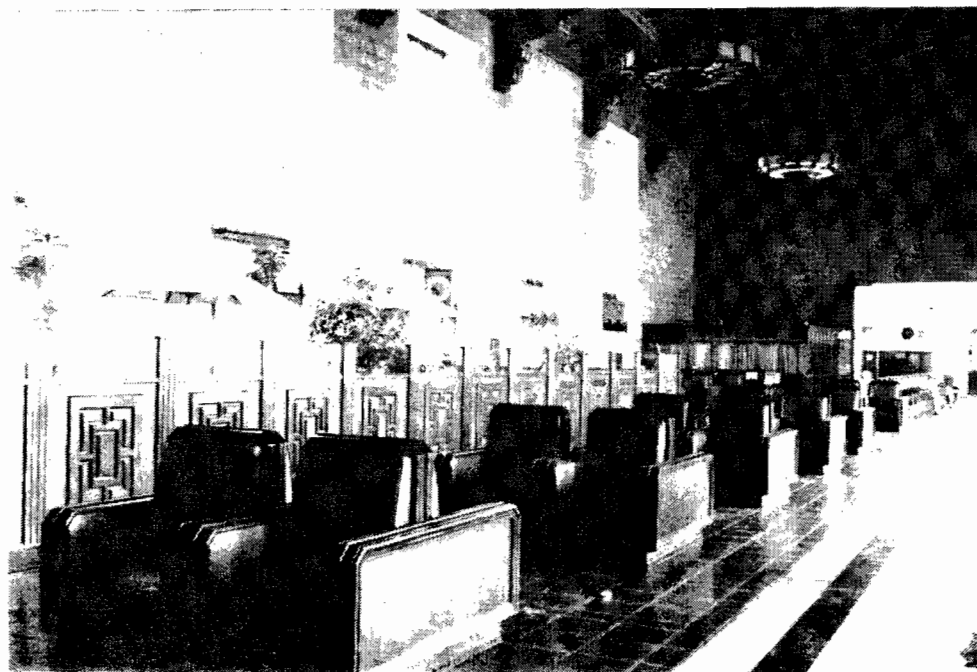
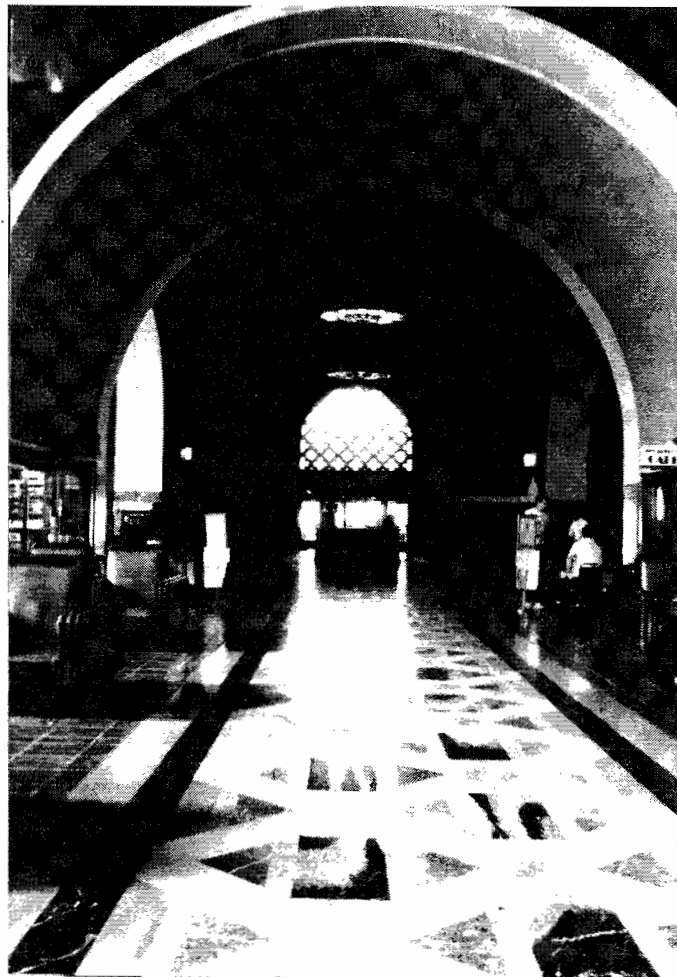
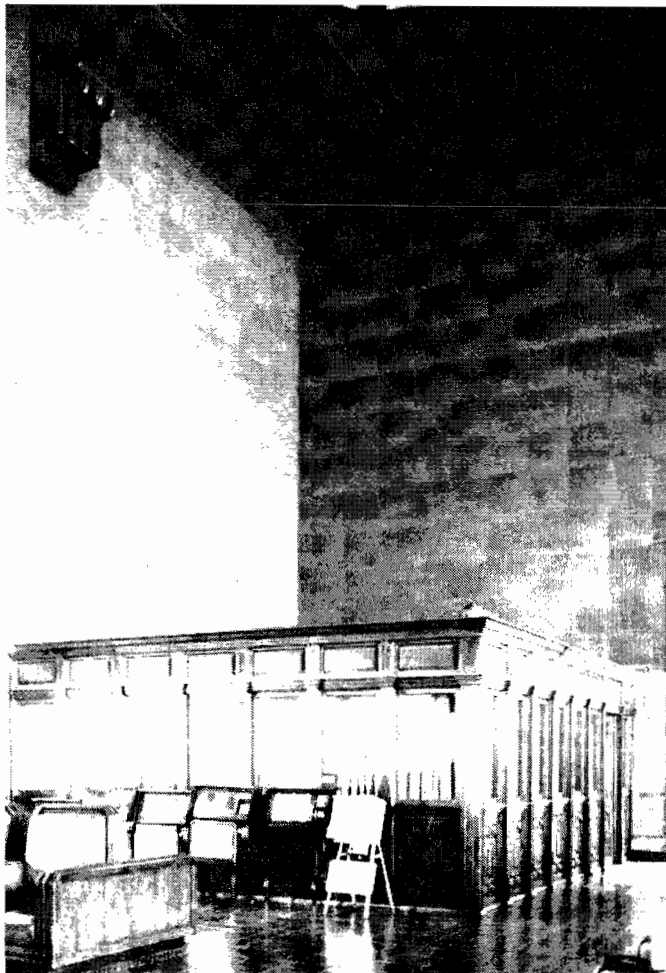
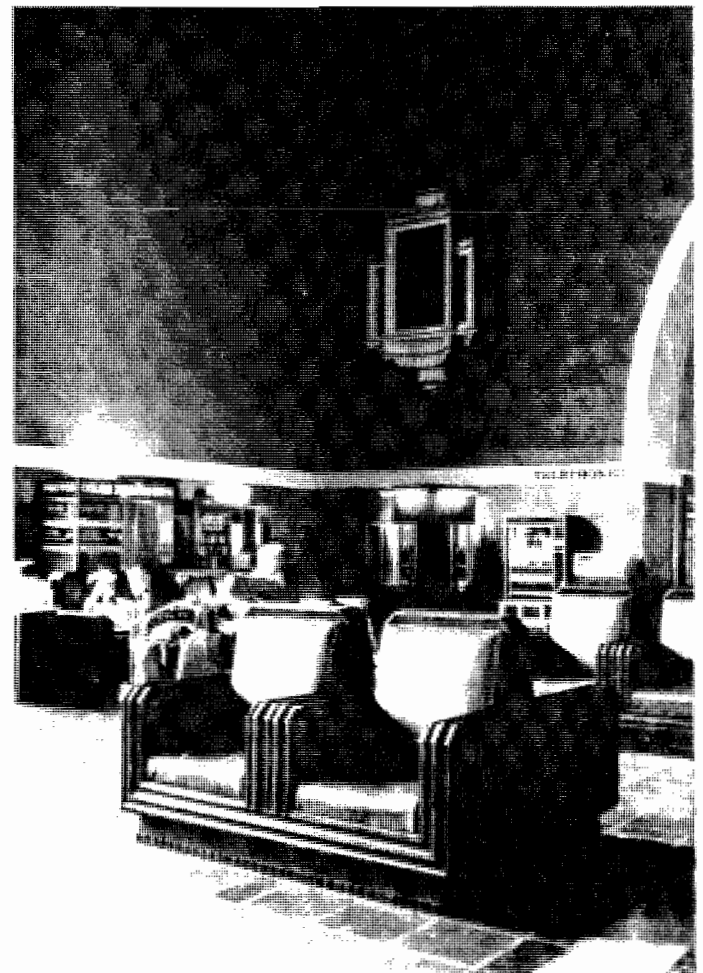
UNION STATION
A2 - MAIN WAITING ROOM

3. CURRENT USE - Main Waiting Room
4. ORIGINAL USE - Main Waiting Room
5. CONDITIONS - The wooden panels in the northwest corner of the room, (surrounding McCarthy's Cafe seating) were added at a later date. The panelling does not appear in historic photographs.

The acoustic panels on the upper walls are dirty, especially the west wall. Stencilled ceiling panels are dim and yellowed. The wooden seats are worn and scarred and the original leather was replaced with brown Naugahyde. Many of the covers are torn and worn out. Mortar between the floor tiles is worn unevenly. Many glass panes are missing from chandeliers. Ornamental speakers require cleaning.

19. RECOMMENDATIONS FOR HISTORIC UPGRADE - Venetian blinds need cleaning and replacement with screens or motorized blinds. Upper wall panels on the east wall need cleaning and repair. On the west wall two unused speaker holders require removal and the spray paint requires removal. Bulbs in chandeliers need replacement and fixtures require cleaning and upgrade. Remove inconsistent elements: soda machines, photo booths and non-historic wood partitions. Repair, refinish and recover wooden seats. Reconfigure wooden seats to original plan. Remove trash bins and replace with bins similar to historic. Limit access of motorized carts to exterior areas only, in order to prevent further damage to the ceramic tile wainscot, wood seats and marble floors.

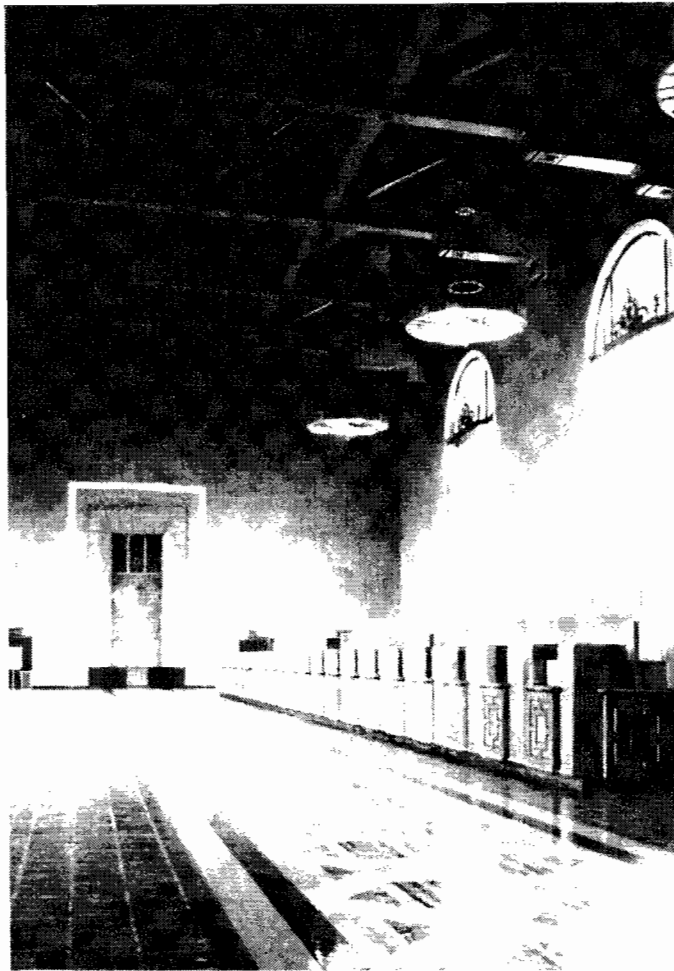
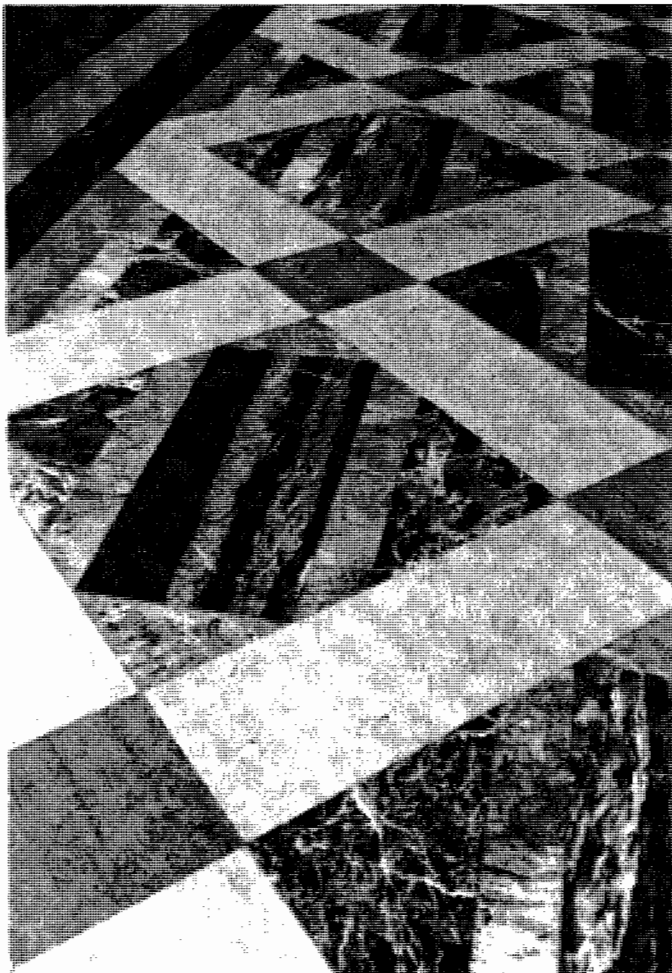
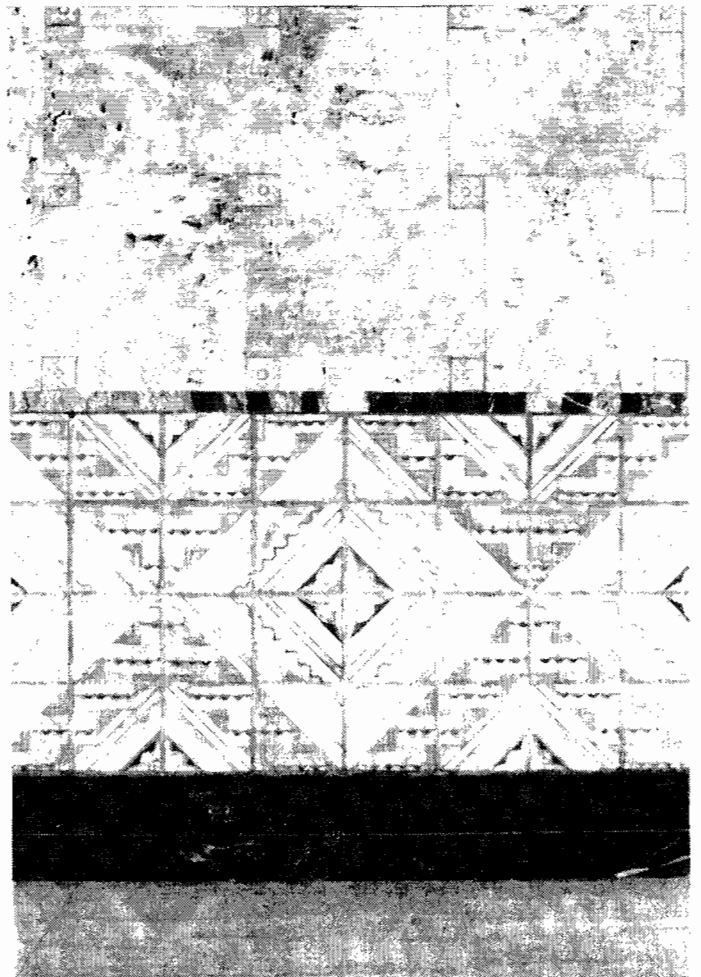
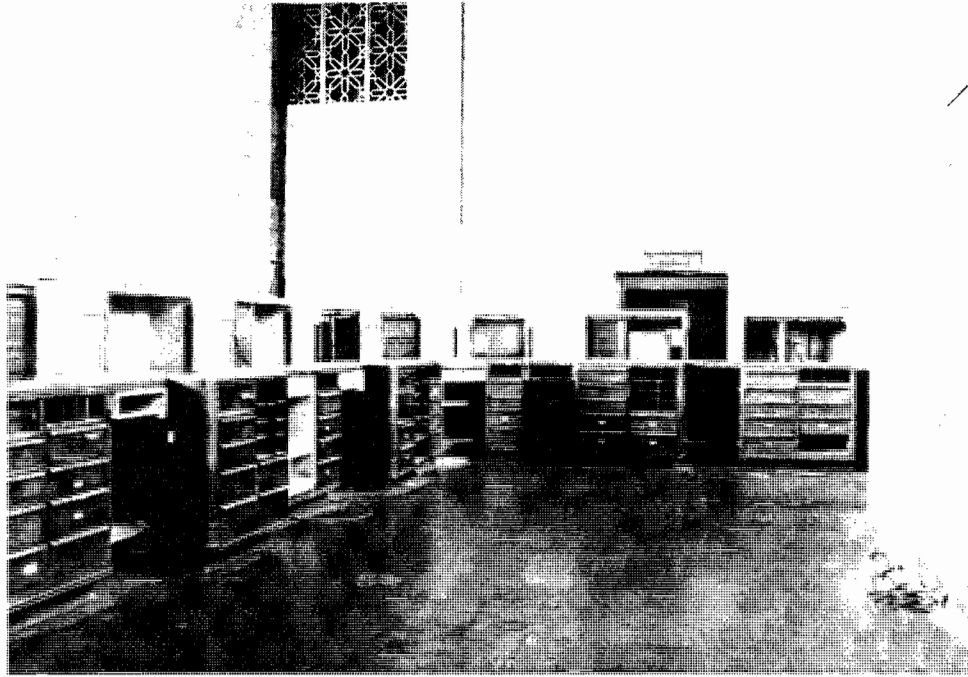
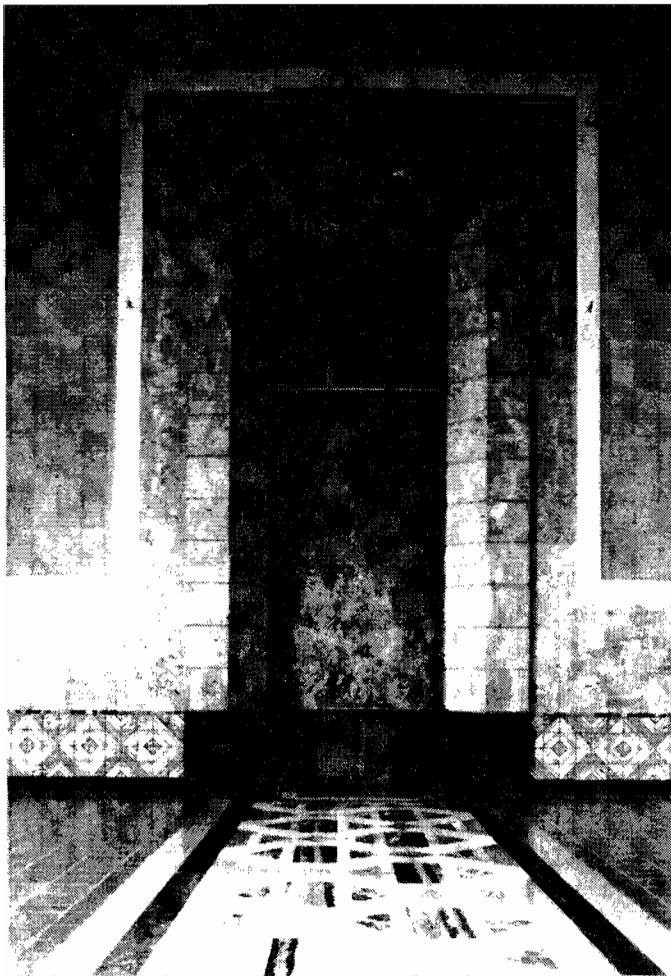
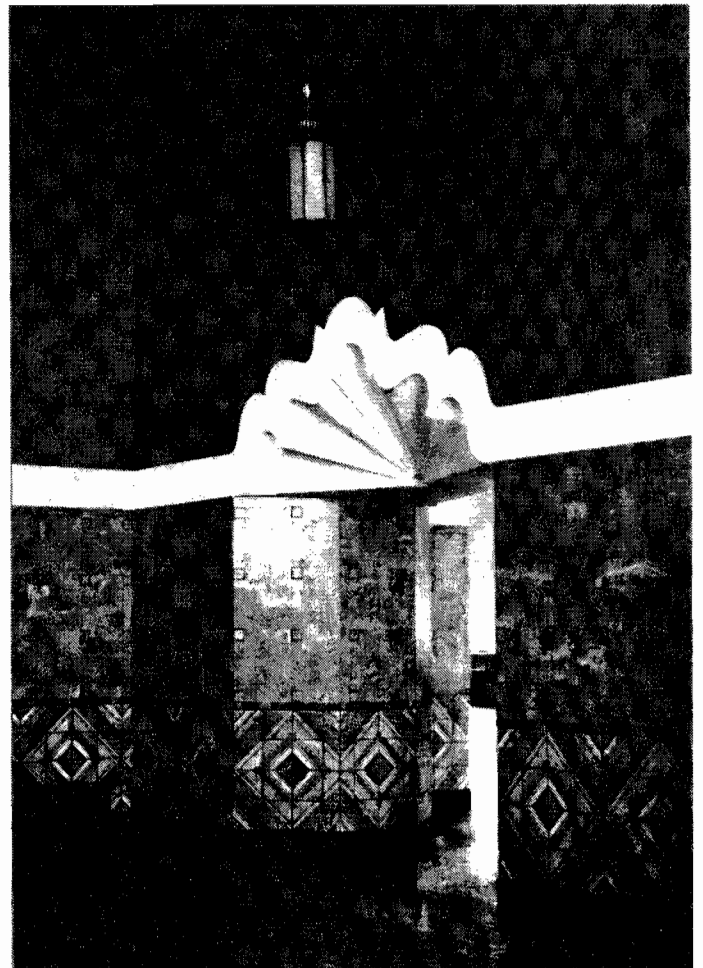
UNION STATION
A3 - MAIN CONCOURSE

4. ORIGINAL USE - Ticket counter and waiting area.
5. CONDITIONS - Floors and tile walls remain in good condition but require cleaning. The wood on the ticket counter appears worn and dry. The truss beams are stained with pigeon droppings and the stencils appear dark and faded. The Venetian blinds are in disrepair. Many window panes have been replaced with mismatched panes which appear yellow. The rooms behind the ticket booths are in disrepair. The mortar between the floor tiles is blackened and worn unevenly. The acoustic panels are blackened and damaged.

10. ARTWORK - Stencilled pattern ceiling by Herman Sachs. Ceramic pattern tile wainscot and mosaic marble floor pattern.
11. SIGNAGE - Inconsistent signage marking fire alarm. Exit signs missing except one, wooden stand with movable letters lists Amtrak schedules. Original signage above ticket counter missing.

19. RECOMMENDATIONS FOR HISTORIC UPGRADE - Research historic signage and repair and replace missing signs. Restore and replace wood seats. Clean and match, glass window panes, replace broken Venetian blinds with motorized blinds or screens. Clean and repair brass doors. Clean ceramic tile. Repair and refinish ticket counters for adaptive reuse. Upgrade lighting levels, clean and repaint trusses. Clean ceiling. Research original trash receptacles and replace existing with style similar to original.

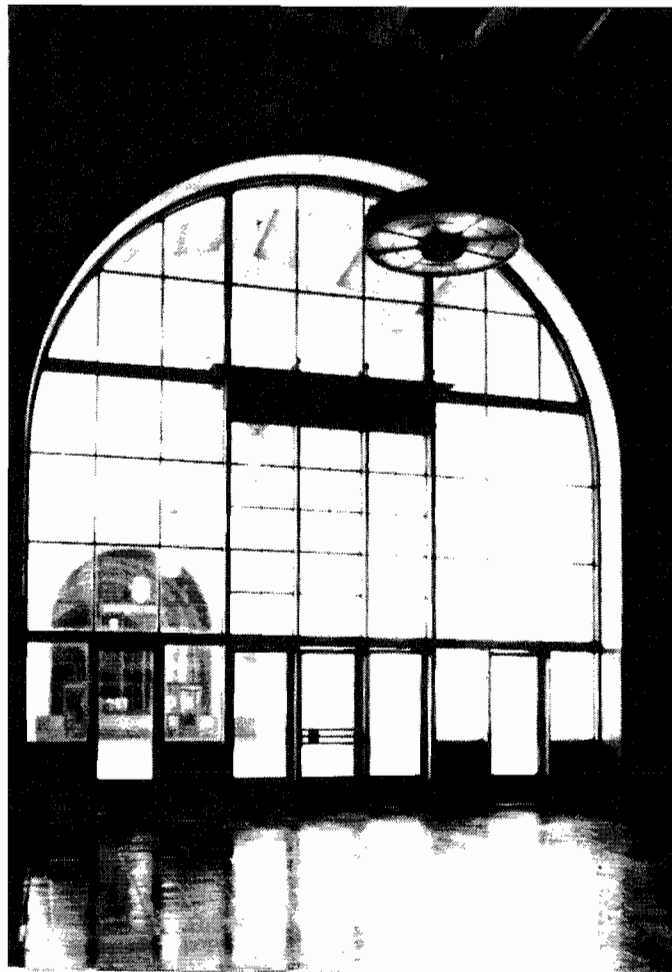
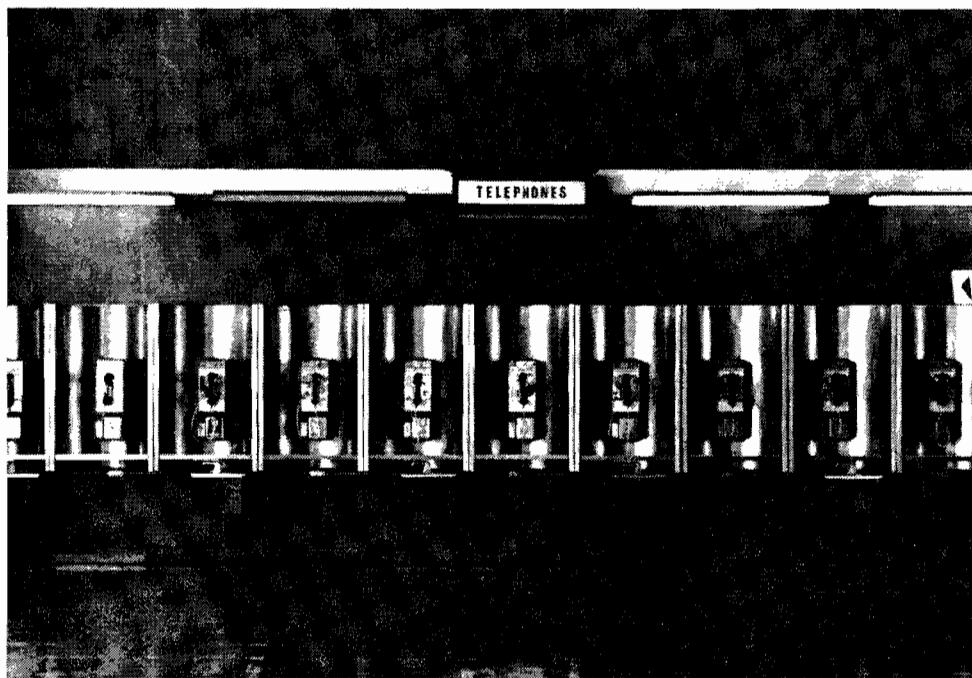
UNION STATION
A4 - SOUTH PASSAGE

5. CONDITIONS - Stencilled ceiling patterns are yellowed and the acoustic panels on upper walls are dirty and mismatched. Brass doors and window trim require cleaning. Door hardware is missing. Ceramic tiles on the lower walls need cleaning. The telephone sign frame has been relocated.

19. RECOMMENDATION FOR HISTORIC UPGRADE - Clean and repair brass doors. Clean ceramic tile. Upgrade lighting. Patch and repair wall behind telephone sign. Restore telephone/telegraph area and restore passageway to that area.

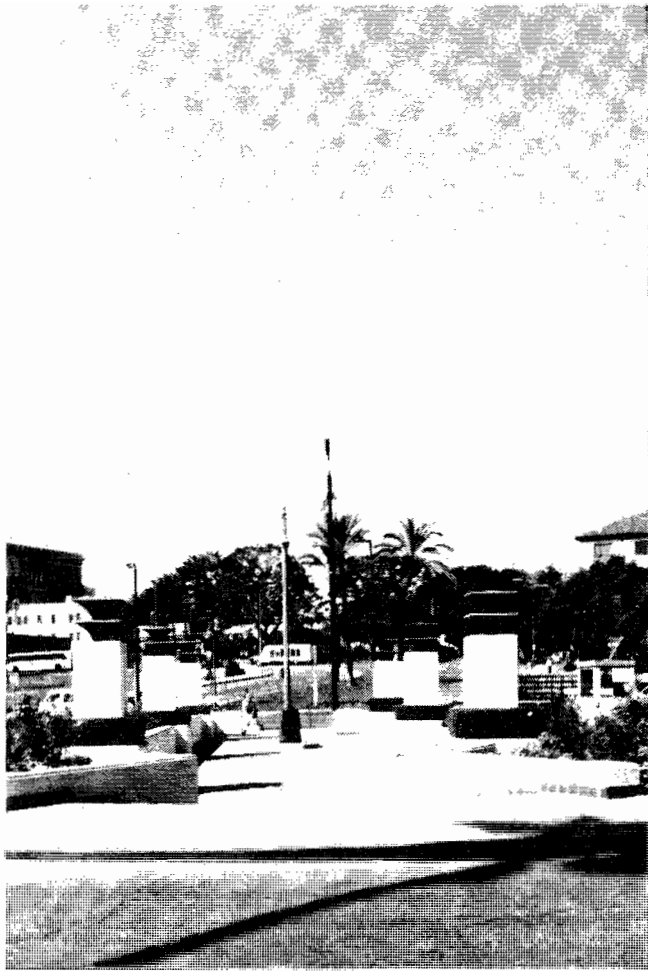
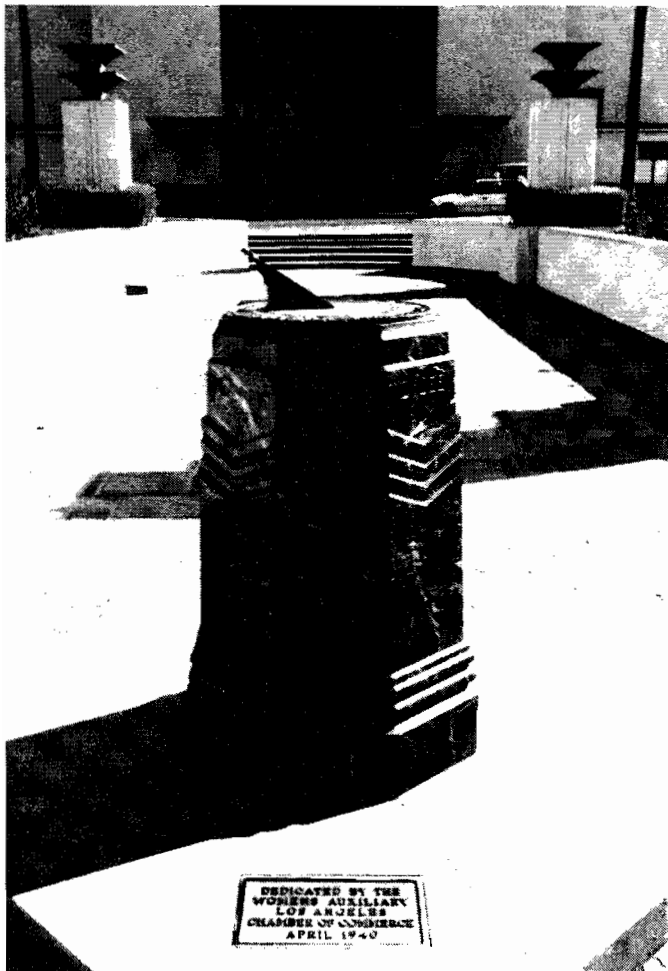
FORE COURT

4. ORIGINAL USE - Forecourt.
5. CONDITIONS - Landscaping is well maintained.
6. LIGHTING - Six light pedestals provide nighttime lighting.
7. LANDSCAPE ELEMENTS - Light pedestals, paving pattern, sundial, low walls around planting areas.

13. INCONSISTENT ELEMENTS - Not applicable.
14. AREAS FOR RESEARCH/TESTING - Research original landscaping intentions.
15. FUTURE USES - Undetermined.
16. RECOMMENDATIONS FOR HISTORIC UPGRADE - Match or use landscaping similar to original.

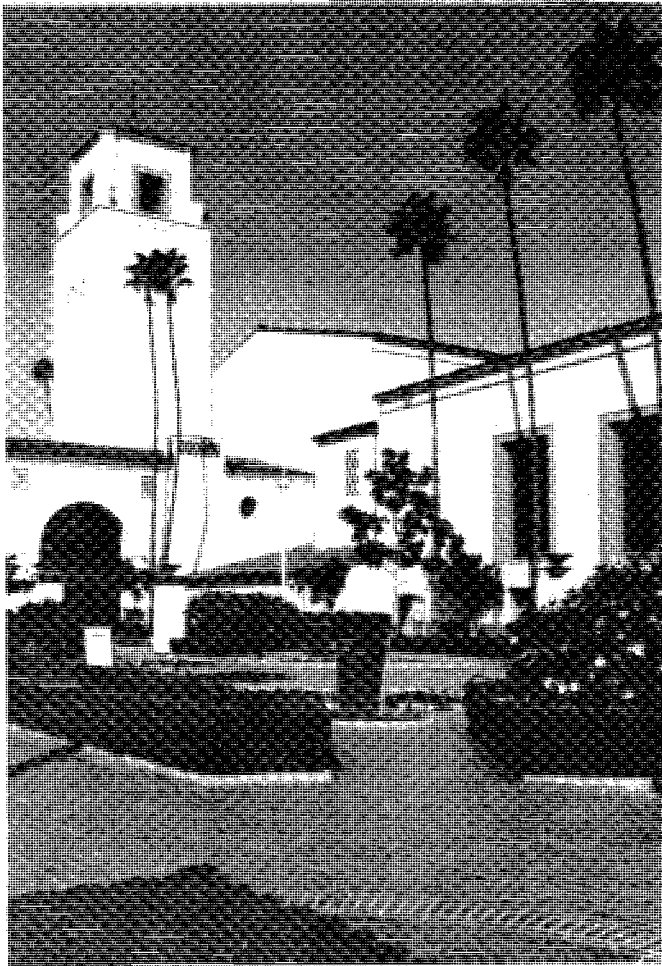
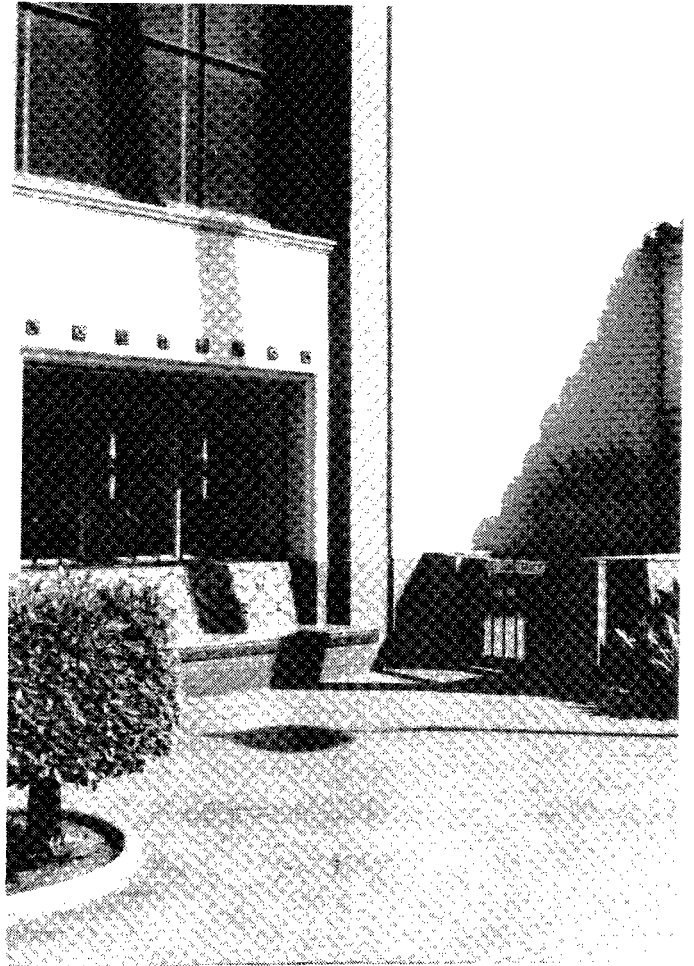
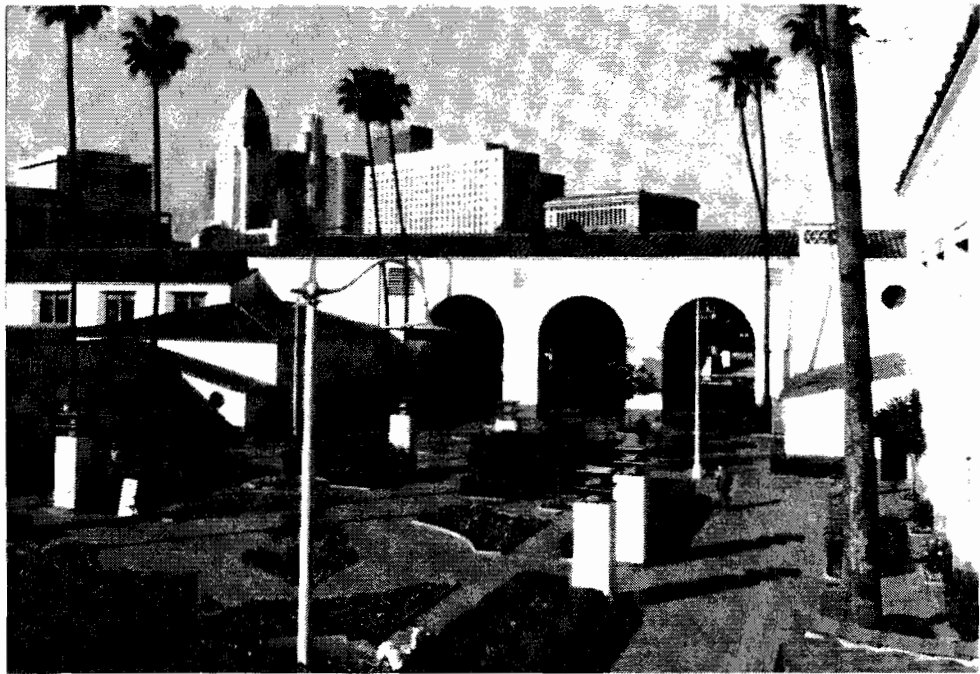
SOUTH PATIO

5. CONDITIONS - Landscape is similar to original plan, but the trees are much smaller than intended.
6. LIGHTING - Four pairs of light pedestals and four lamp posts in the corners comprise the elements in this area.

13. INCONSISTENT ELEMENTS - The new doors on Amtrak building, trash bins, and the trees are smaller than originally intended.
14. AREAS FOR RESEARCH/TESTING - Further research on the original planting and plant materials.
15. FUTURE USES - Undetermined.
16. SUMMARY OF HISTORIC UPGRADE - Match and replace square, decorative medallions above the windows and door to the main waiting room. Upgrade lighting.
17. ONGOING WORK - Not applicable.
18. IMPACT ON OPERATIONS - Not applicable.

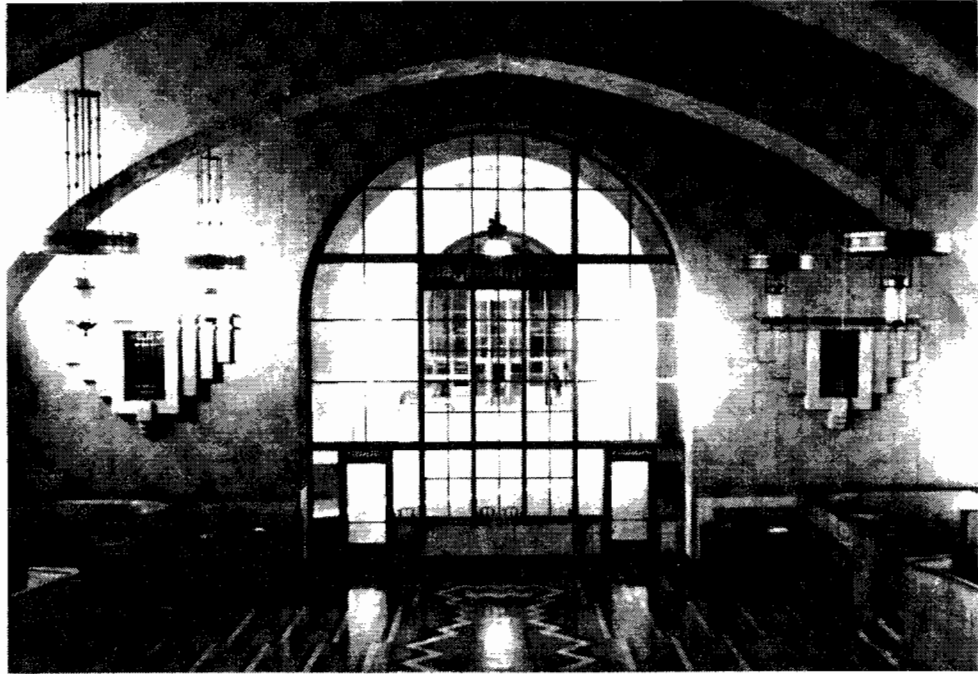
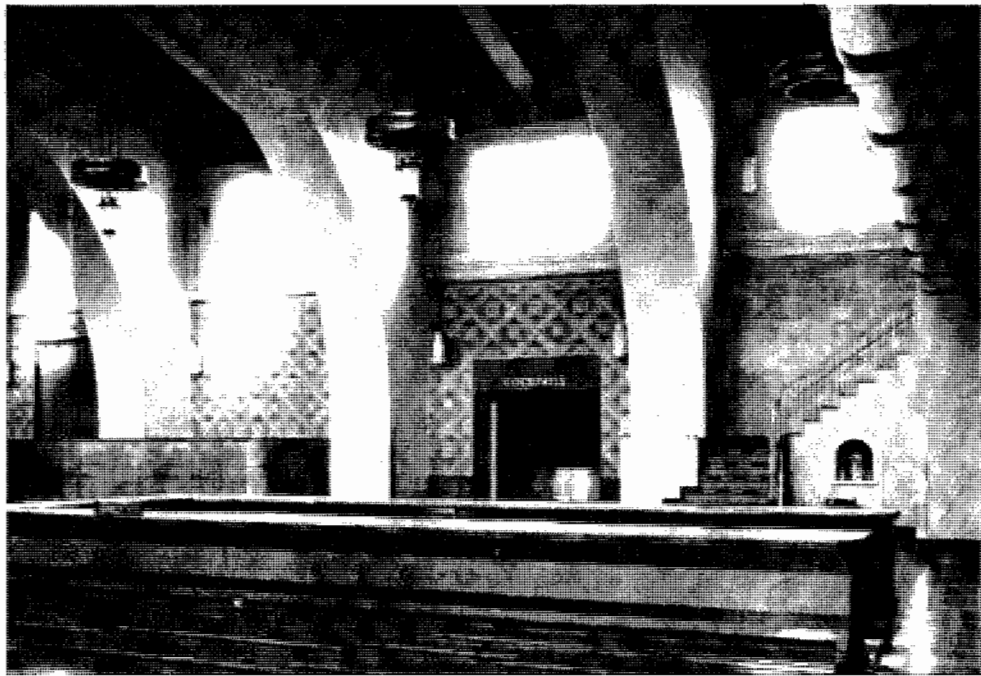
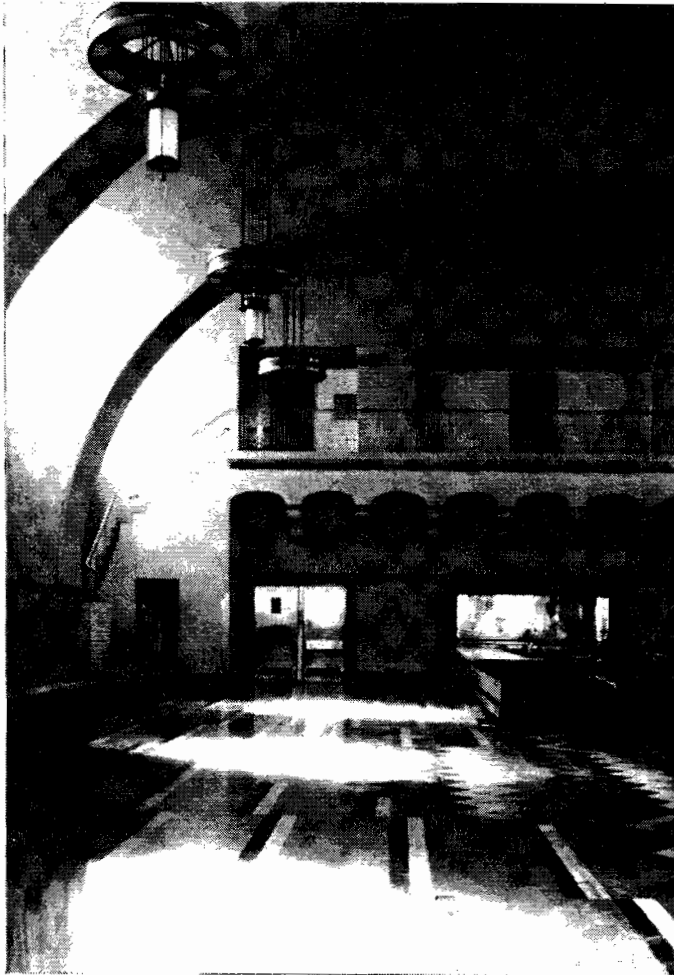
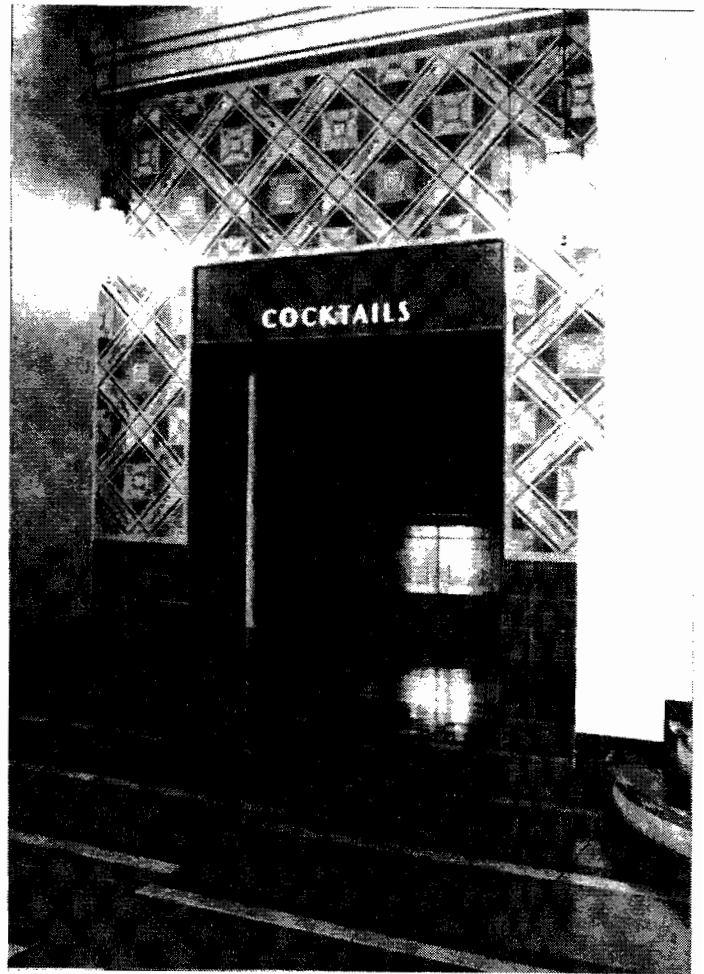
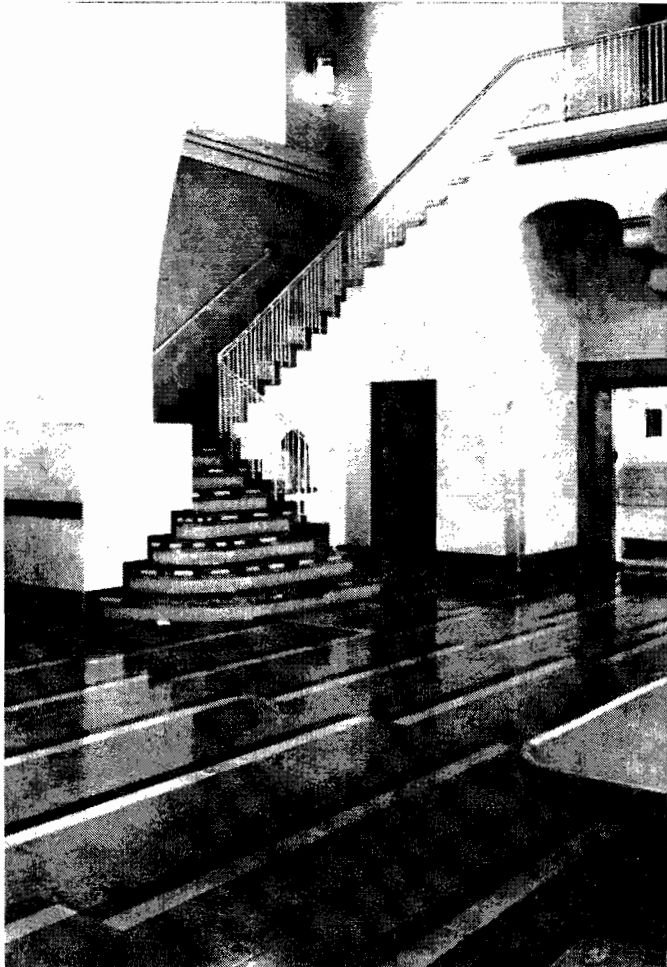
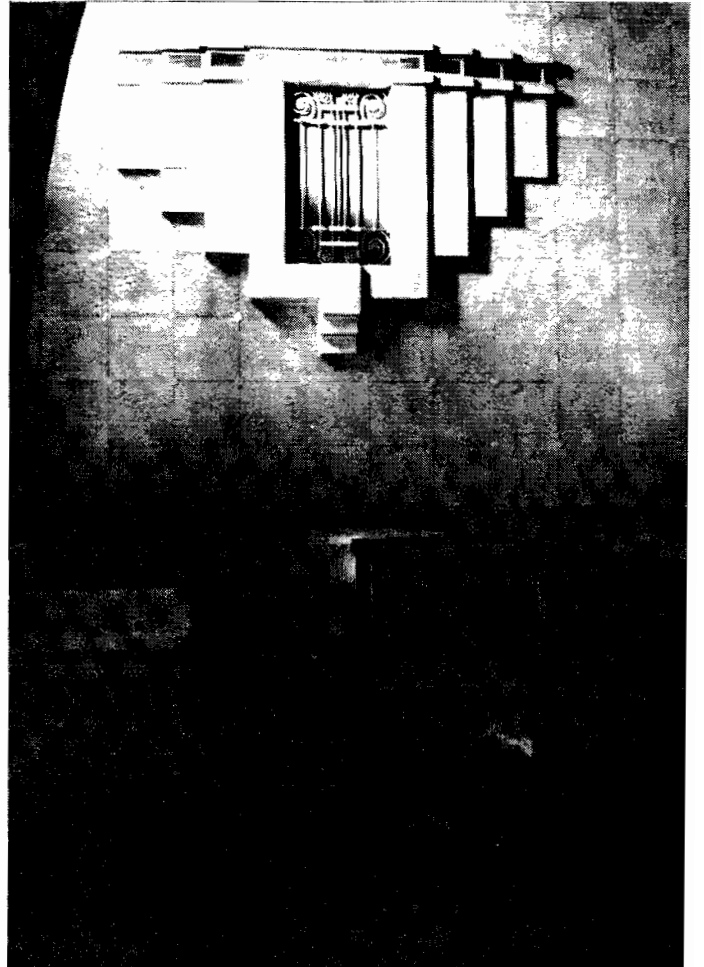
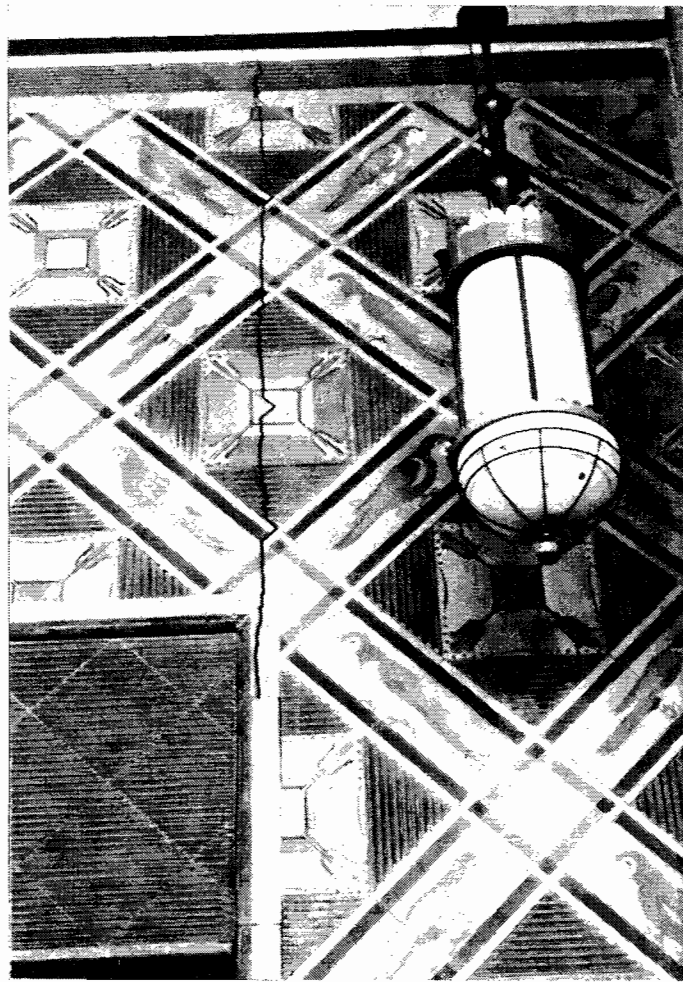
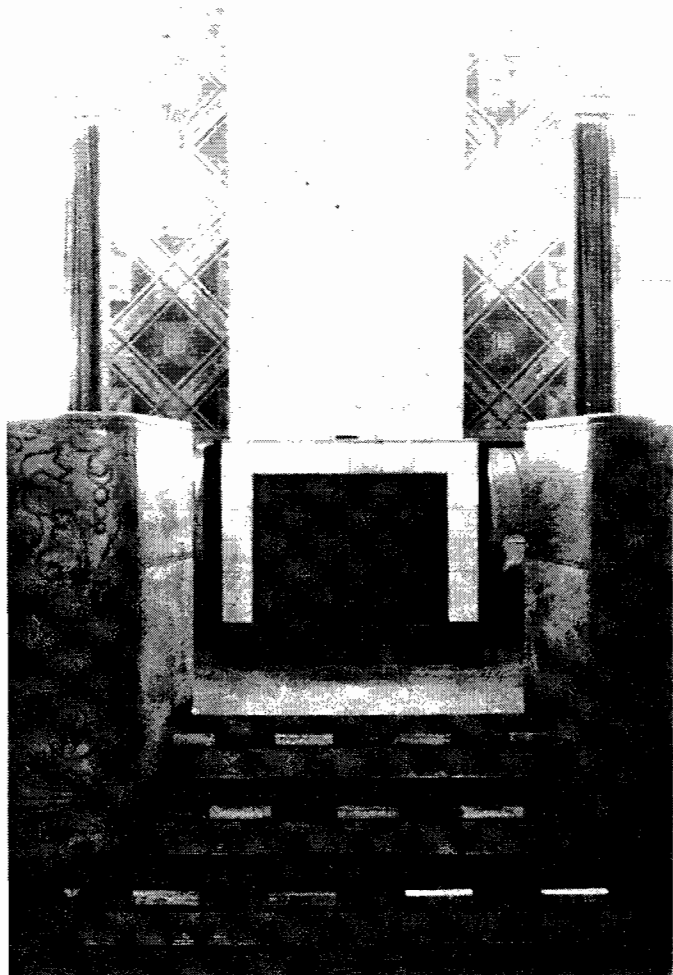
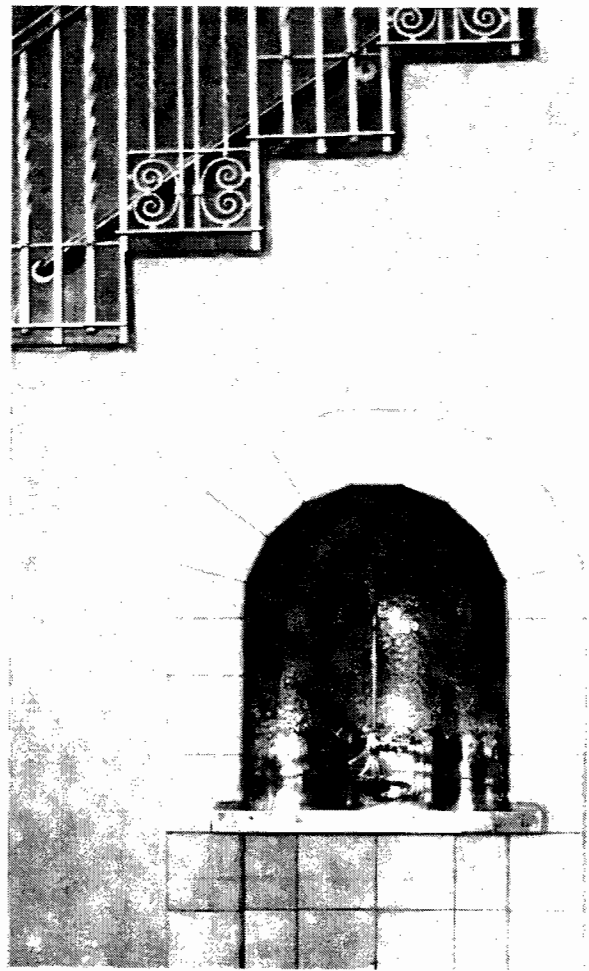
MAIN DINING

5. CONDITIONS - The acoustic tiles are dirty; the ceramic wall tiles are cracked near the windows and doorways. The wall beneath the balcony is dirty. The floors are yellowed and stained. The leather studded half walls are dry and worn.

- . Test cleaning/repair of ceramic tiles.
 - . Test cleaning of light fixtures.
 - . Test cleaning/refurbishing of leather studded walls.
18. FUTURE USES - Recommended for use as a restaurant. This area retains much of its original historic character which could be restored. An operating restaurant would complement the needs of the passengers and overall character of the building.

19. RECOMMENDATIONS FOR HISTORIC UPGRADE - Clean the floor of wax build-up and test cleaning and repainting of stucco surfaces. Repair and replace wooden bench to front area. Repair and recover other built-in seats. Salvage and/or replace built-in seats at counter. Repair tile base of counter and repaint counter. Patch and repair ceramic tiles as required.
20. ONGOING WORK - Not applicable.
21. IMPACT ON OPERATIONS - Not applicable.
