**U N I O N S T A T I O N
L O S A N G E L E S**

**INITIAL STUDY
FOR
REHABILITATION
AND
REUSE**

SURVEY OF CONDITIONS

**PREPARED FOR CATELLUS DEVELOPMENT CORPORATION
HARDY HOLZMAN PFEIFFER ASSOCIATES
AUGUST 1991**

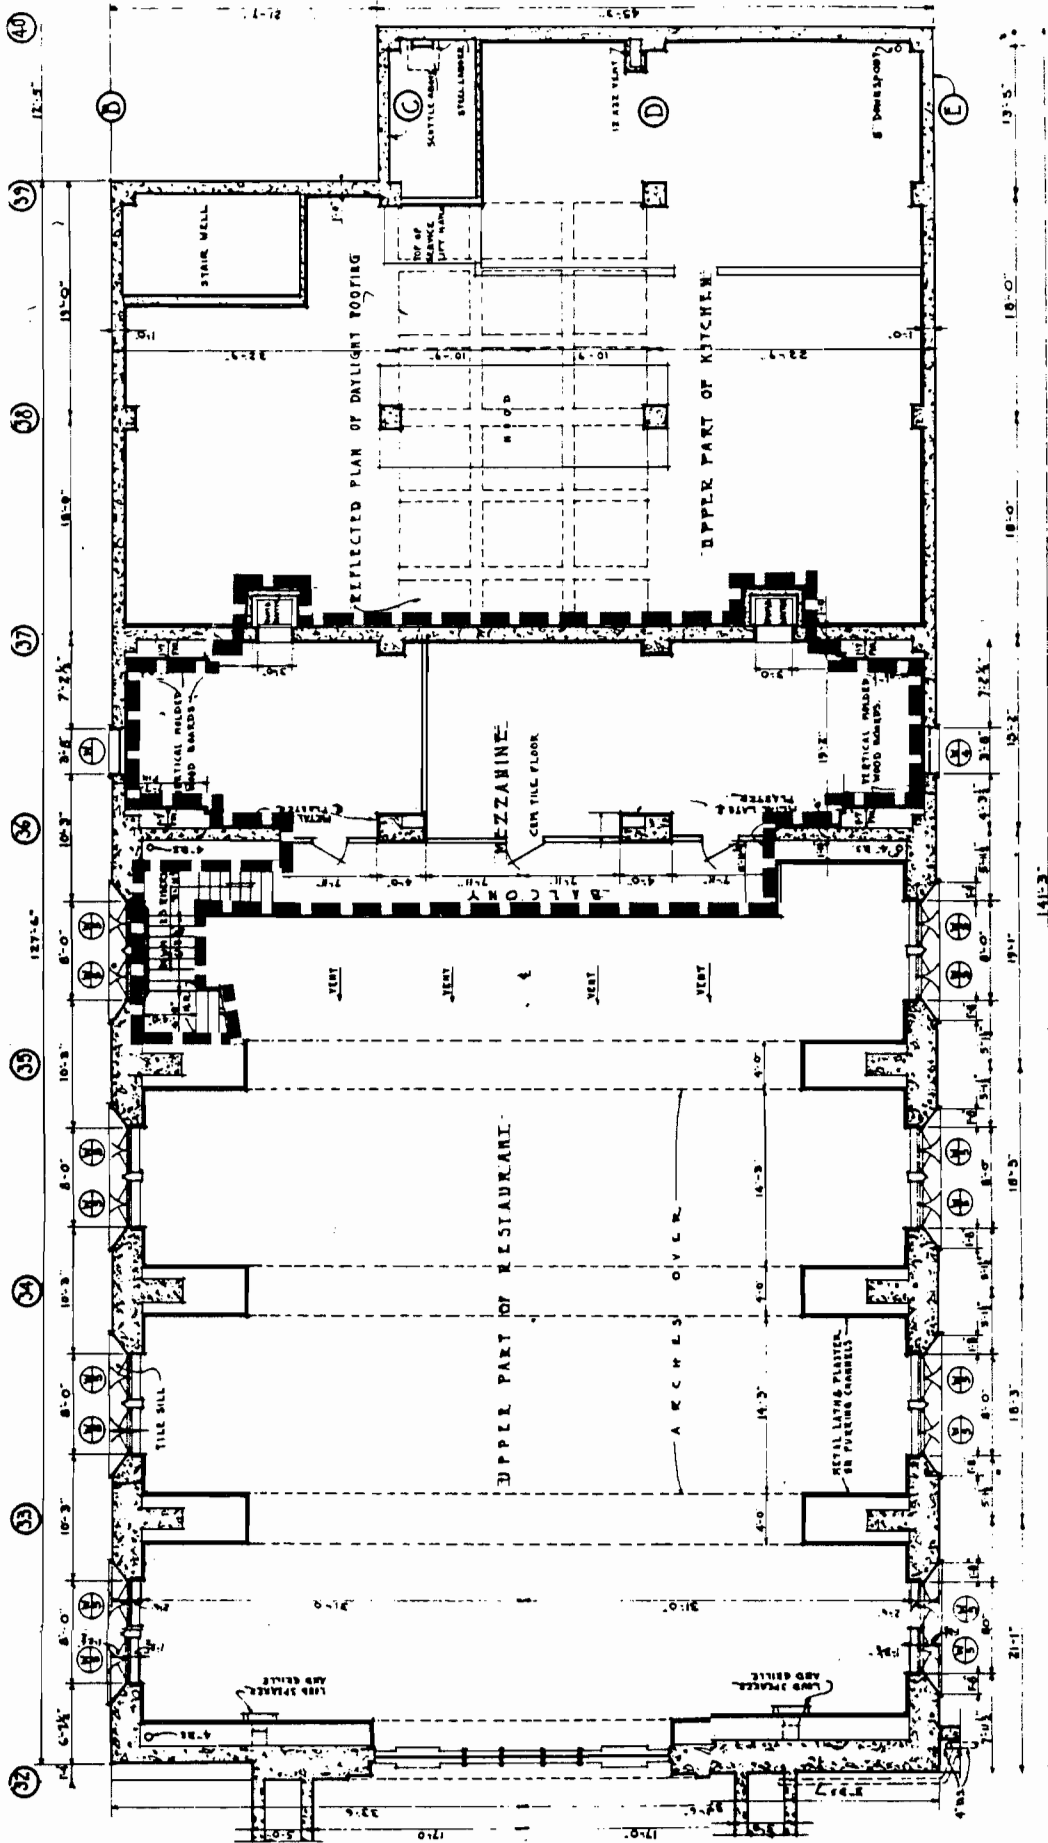
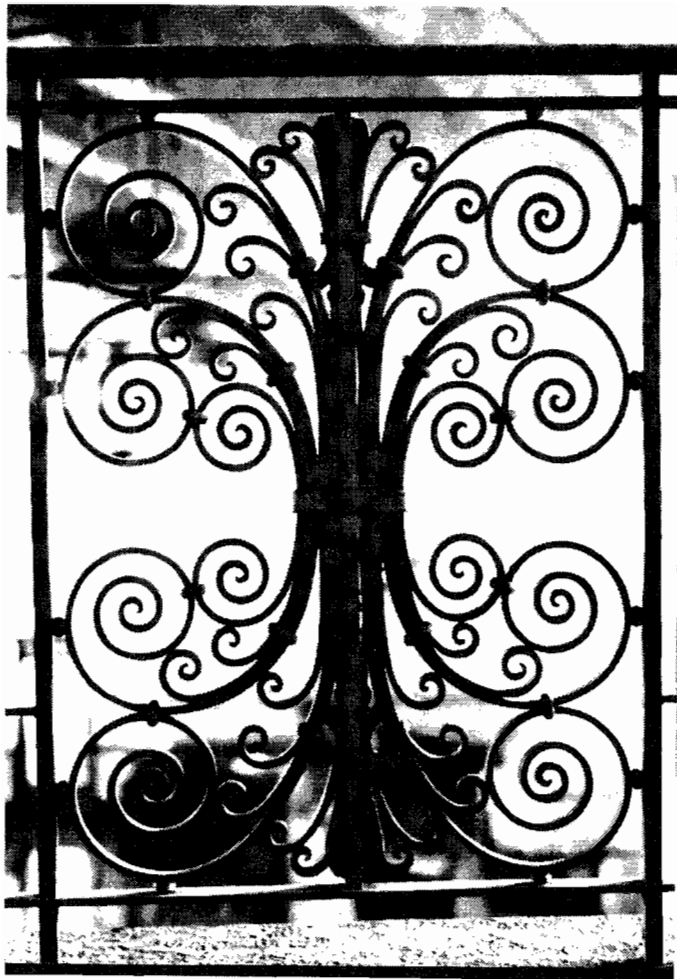
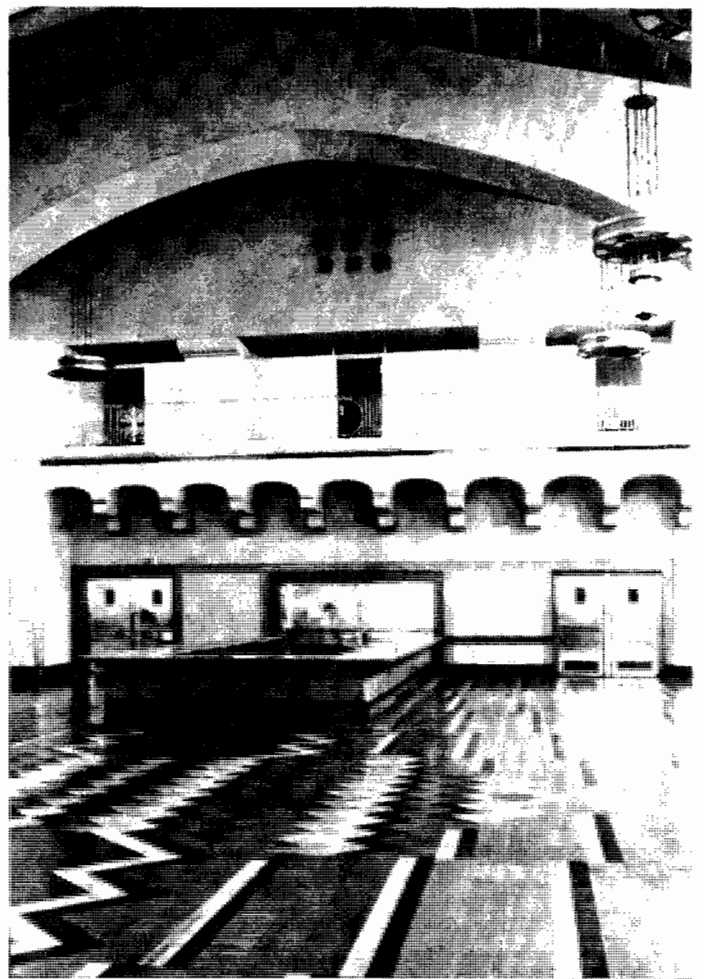
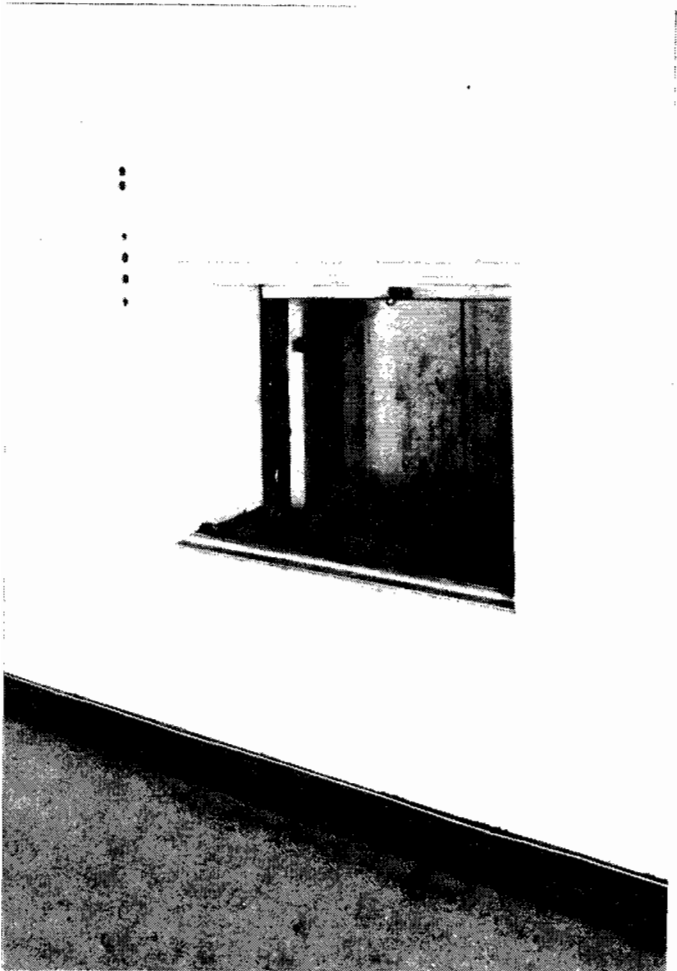
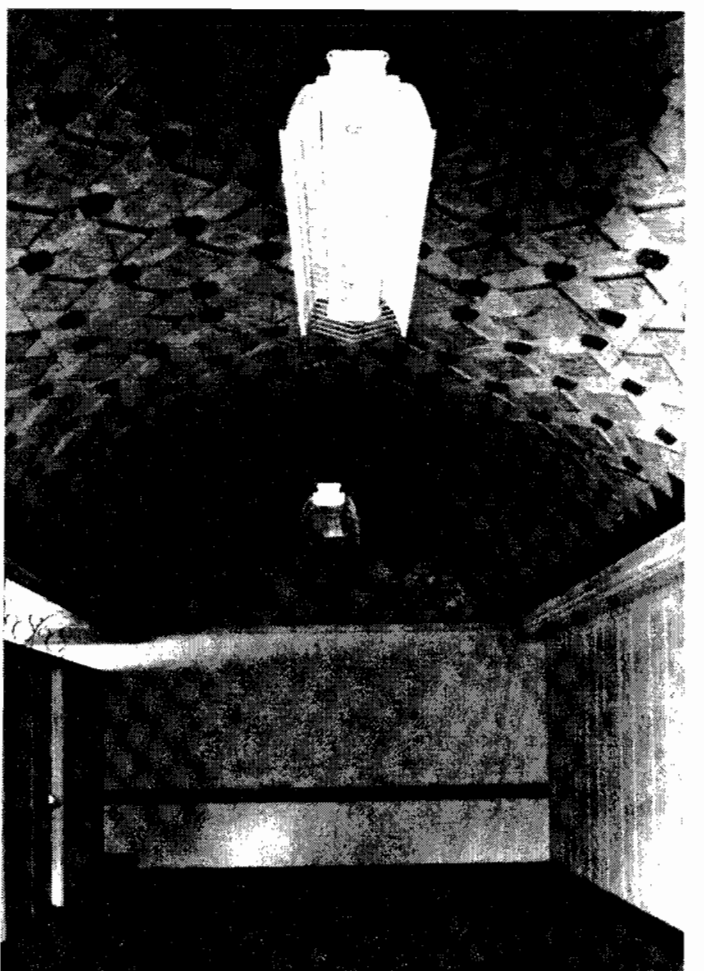
MEZZANINE

5. CONDITIONS - The ceilings in the two rooms are badly blackened, particularly in the area of the hung fans. A plywood sheet covers a hole in the non-historic wall along the balcony. Stair treads are broken and tiles have been replaced with plywood in several areas.

19. RECOMMENDATIONS FOR HISTORIC UPGRADE - Clean and replace ceiling tiles as necessarily. Replace floor with material more similar to original. Remove fans and install new HVAC/ventilation system. Clean and repaint walls as required. Consider removing wall partitions separating rooms from balcony or patch wall to match existing. Patch and replace tiles in stair treads. Restore and repair dumb waiters as required. Clean balcony floors. Strip, clean and repaint historic handrails as necessary. Research historic clock which was formerly located in balcony handrail. Repair operable small side windows.

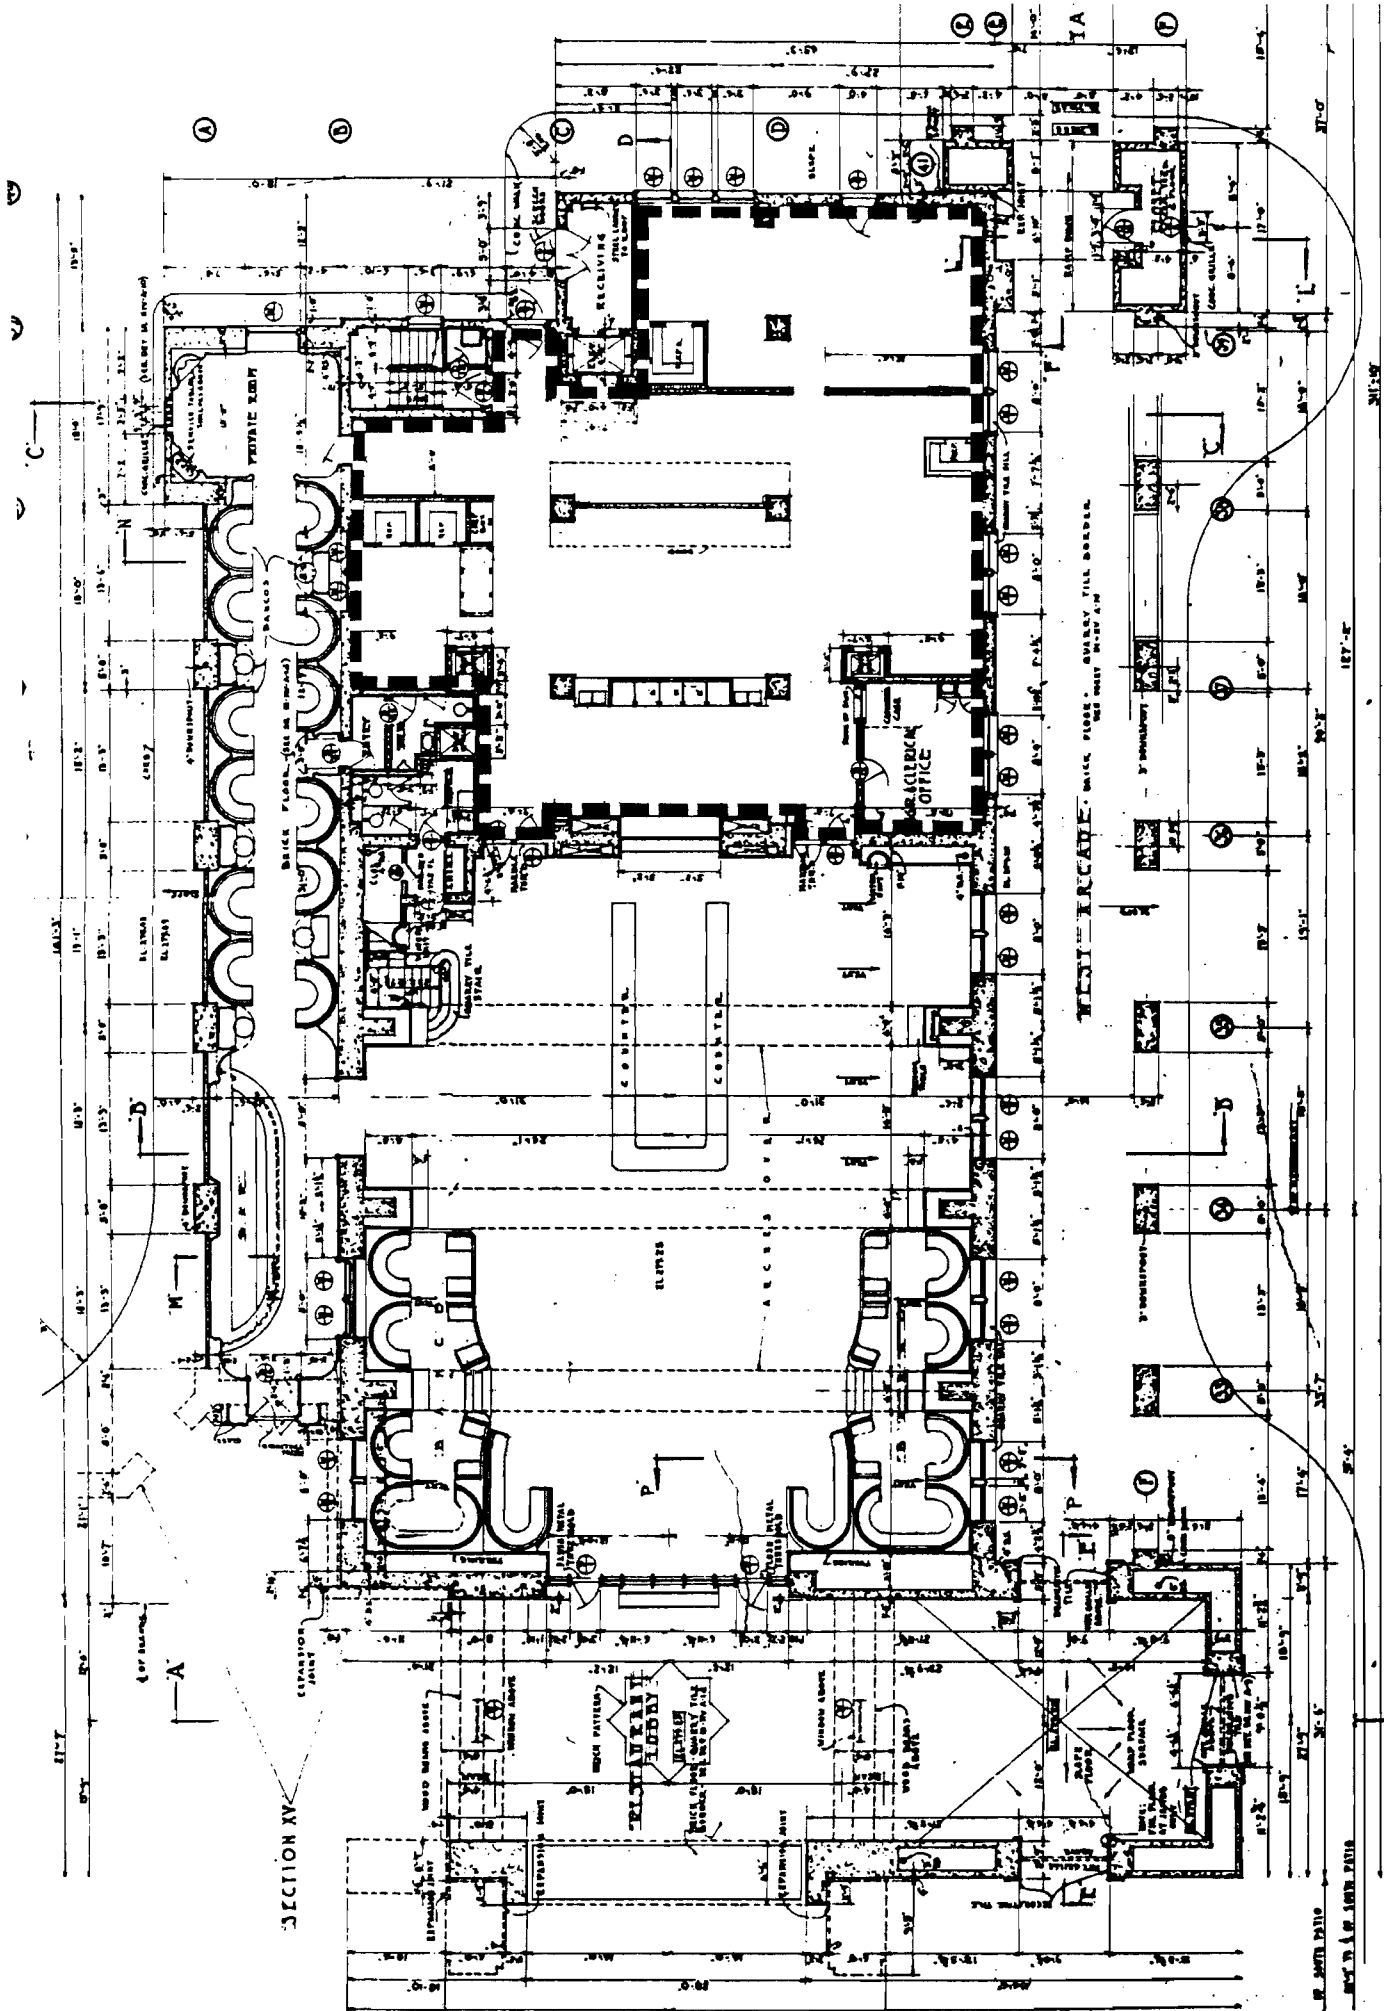
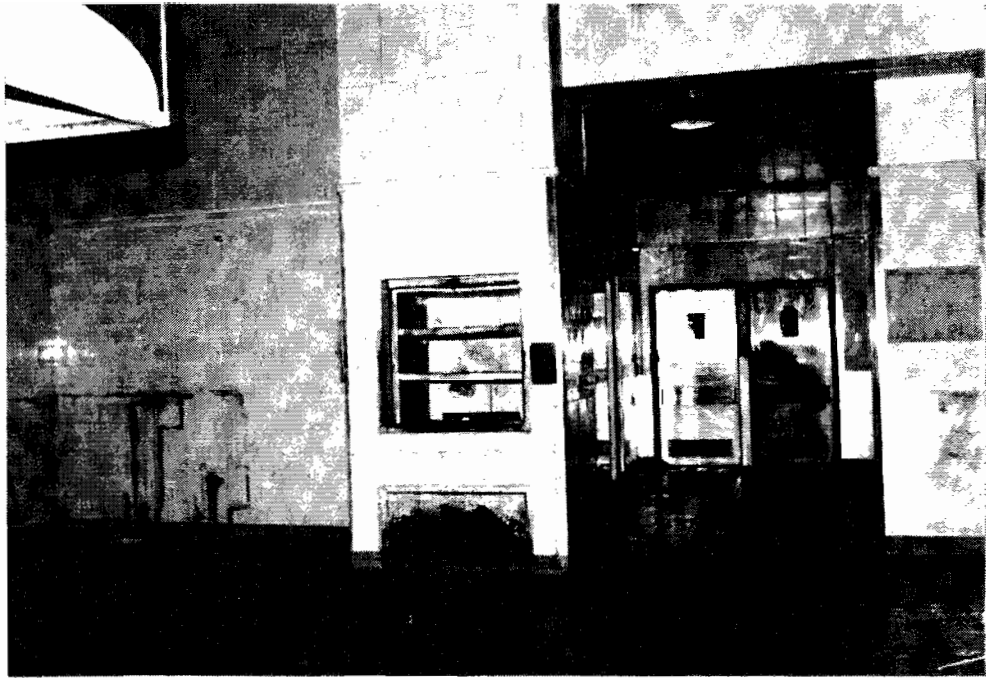
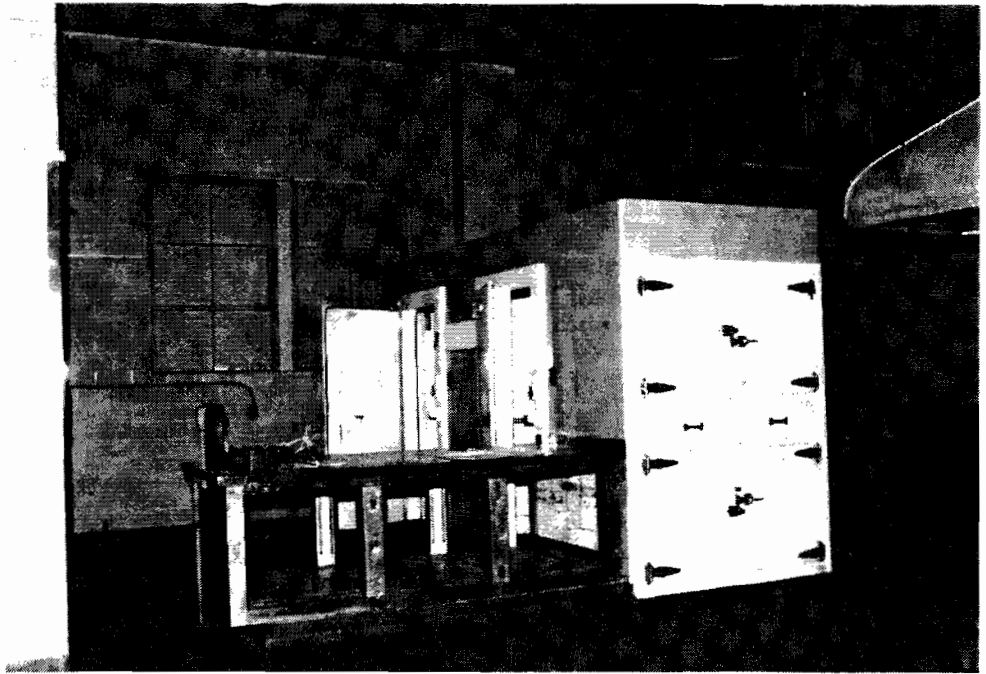
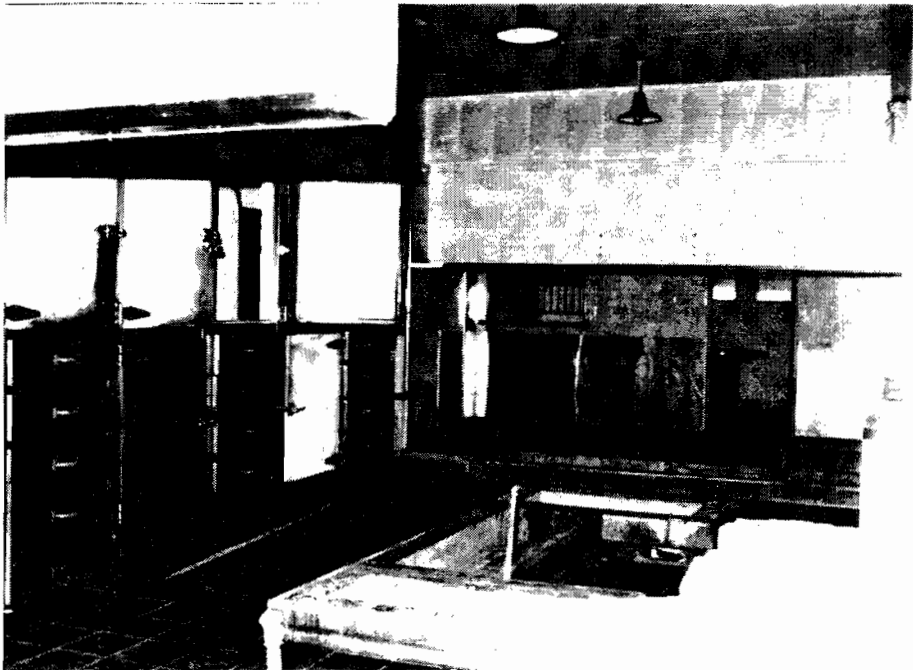
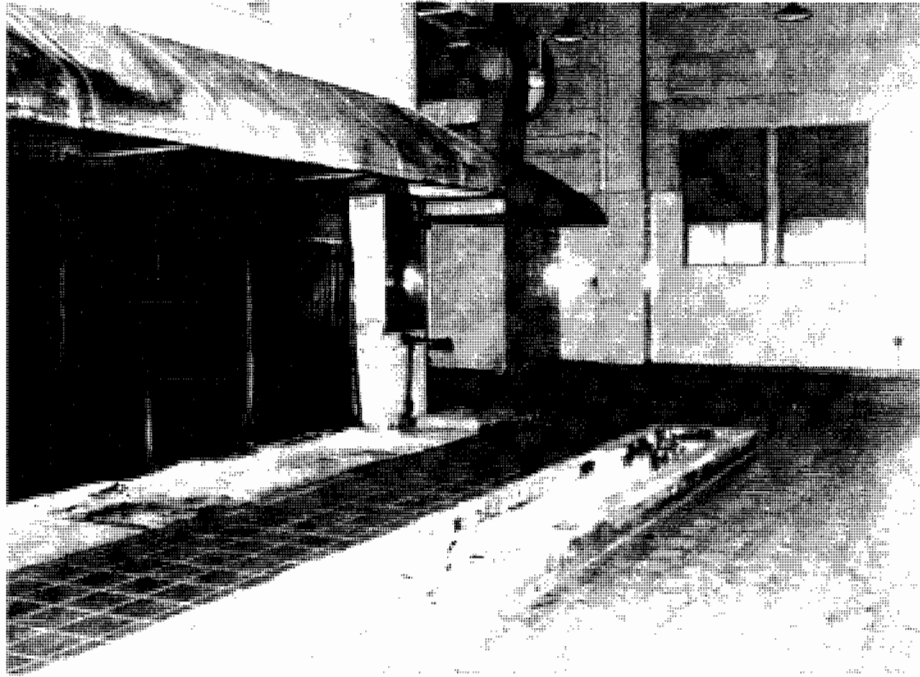
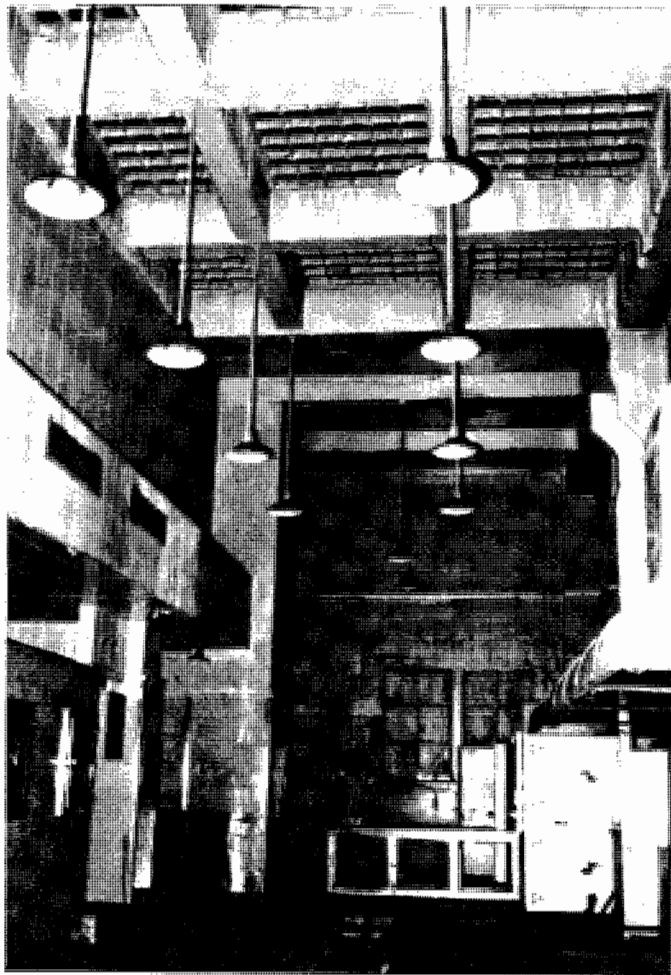
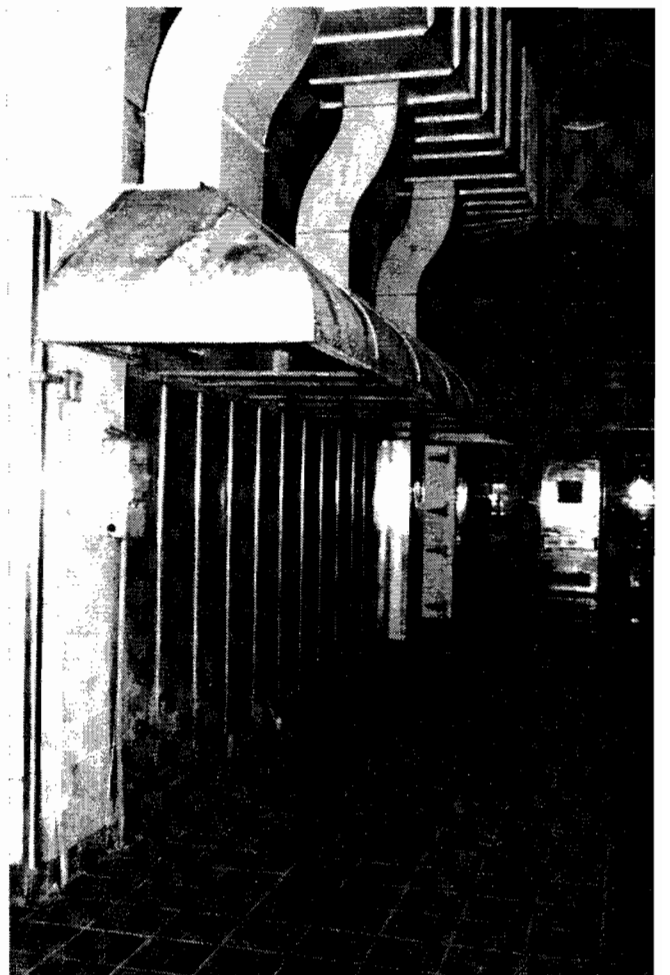
KITCHEN - RESTAURANT BUILDING

5. CONDITIONS - The walls, floors, vents and ceiling require cleaning. The refrigerators are not operating. The skylight leaks and is currently covered over.

10. ARTWORK - None.
11. SIGNAGE - None.
12. STRUCTURAL ISSUES - Skylight construction leaks.
13. MECHANICAL ISSUES - Working condition of ventilation system unknown, drainage and condition of pipes unknown.

19. RECOMMENDATIONS FOR HISTORIC UPGRADE - This area is recommended for adaptive reuse. Fire/Life Safety Codes would require more permanent resolution. The existing industrial equipment, if not utilized in the new area should be labeled, stored and catalogued for potential reuse. Existing turquoise tile wainscot and the skylight should be incorporated into a new design if possible. Otherwise, the tile should either be covered over or labeled, stored and catalogued. The skylight should be repaired or domed over with a second skylight to protect the existing skylight from rain.

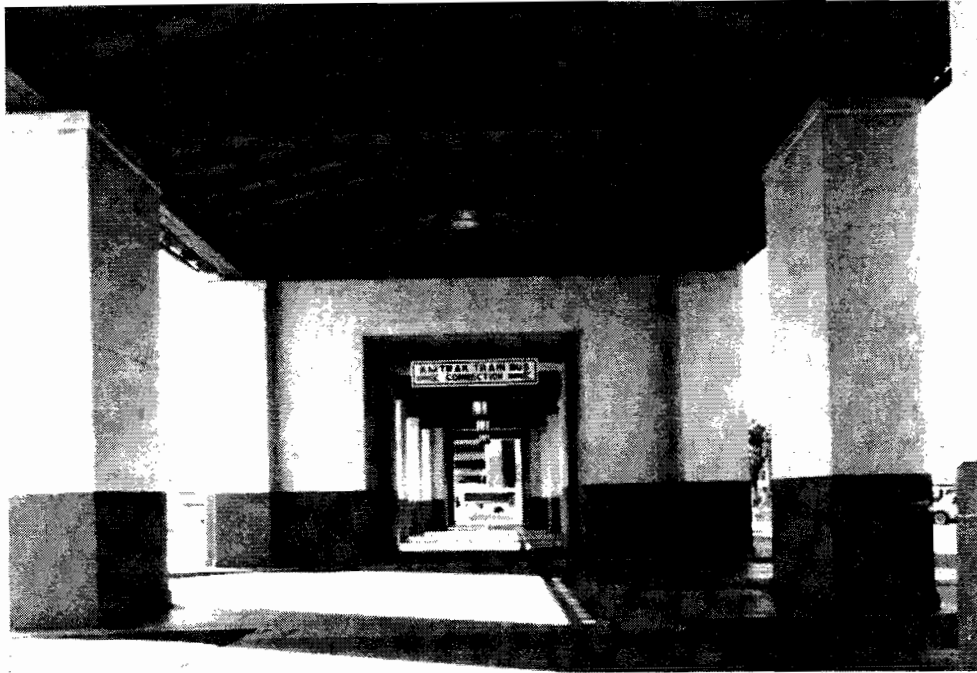
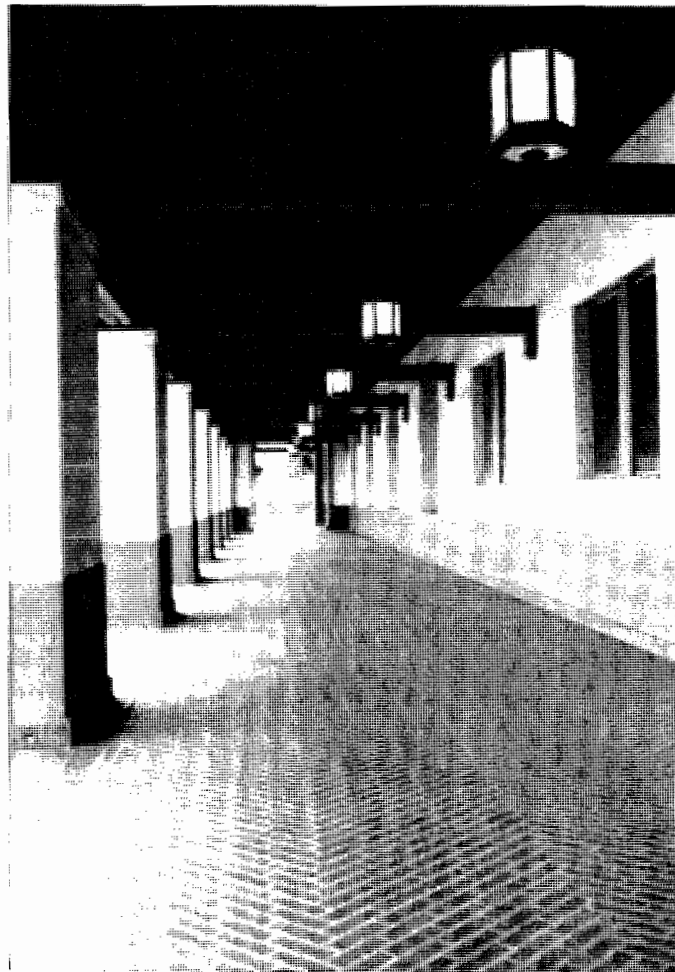
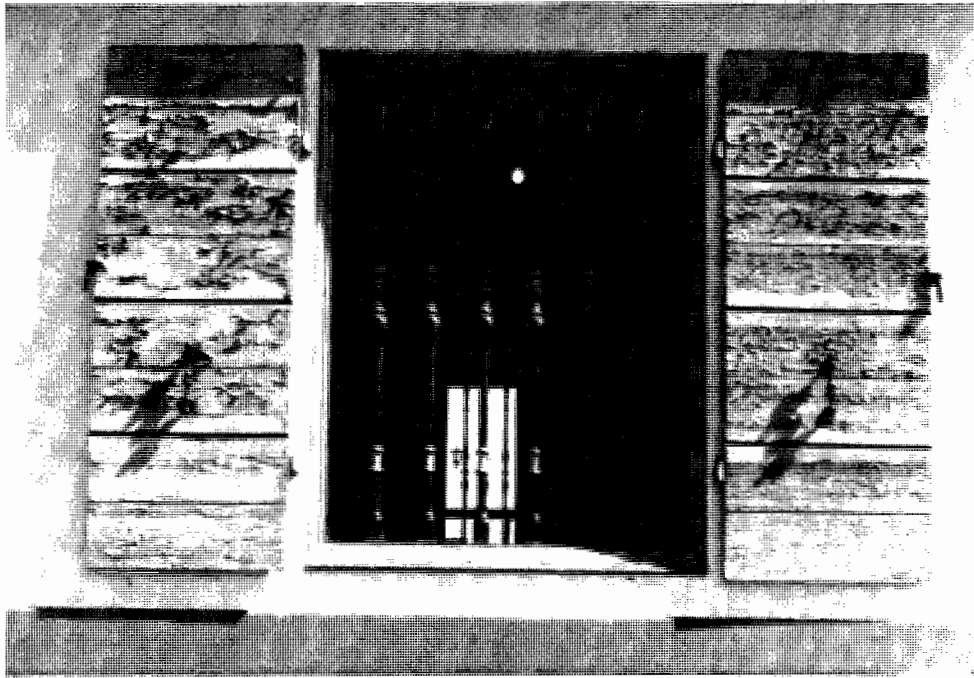
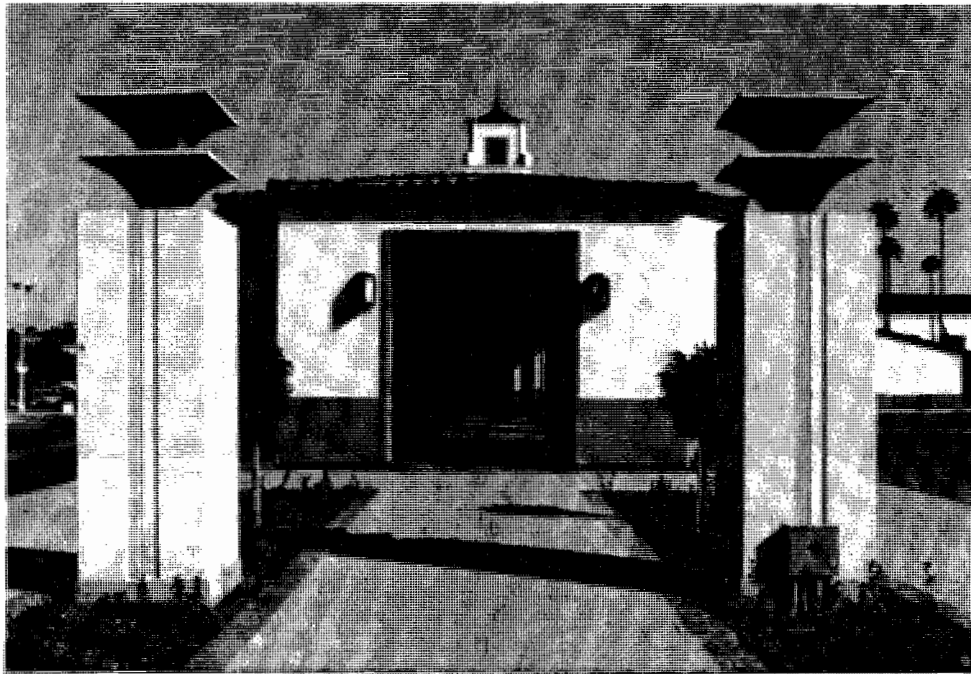
UNION STATION
D3 - EXIT ARCADE

3. CURRENT USE - Passageway to Amtrak ticket office
4. ORIGINAL USE - Exit arcade for arriving passengers to taxi stand.
5. CONDITIONS - Dirty walls, floors, beams, and broken and dirty lighting fixtures.

10. SIGNAGE - Non-historic arrow pointing to trains
11. SYSTEMS ISSUES - Upgrade lighting fixtures. Repair drainage pipes.
12. CODE - Handicap curb access.

16. RECOMMENDATIONS FOR HISTORIC UPGRADE - Clean and repaint surfaces as required. Clean, repair and upgrade historic lighting fixtures. Replace trash bins with type similar to original. Match signage to more historic type.
17. ONGOING WORK - Handicap curb cuts to be installed under contractor's supervision.
18. IMPACT ON OPERATIONS - The entryway to the Amtrak ticket counter will become handicap accessible when work is completed.

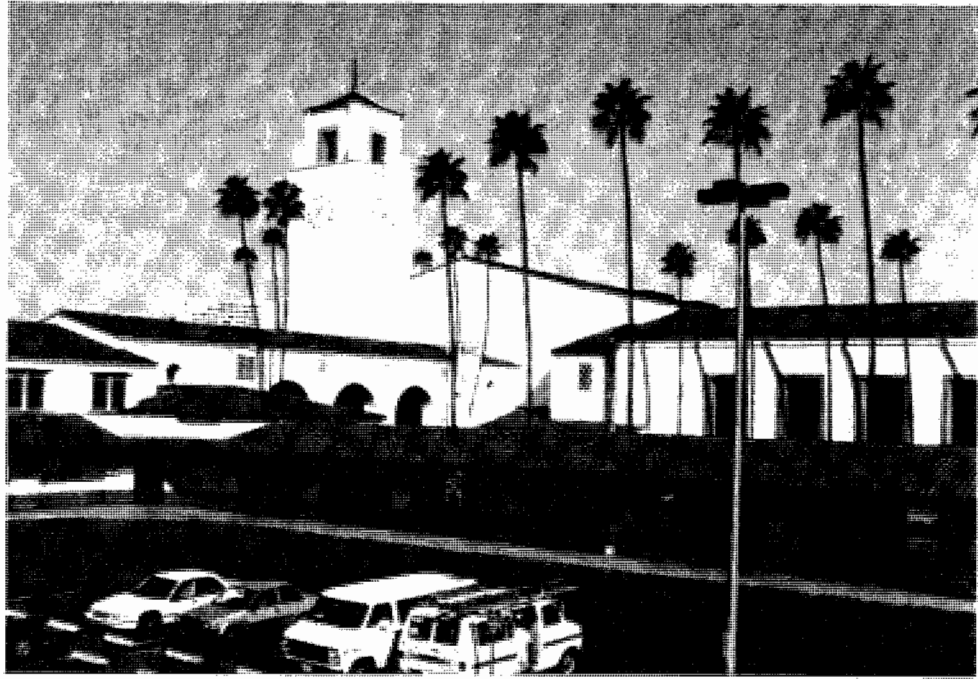
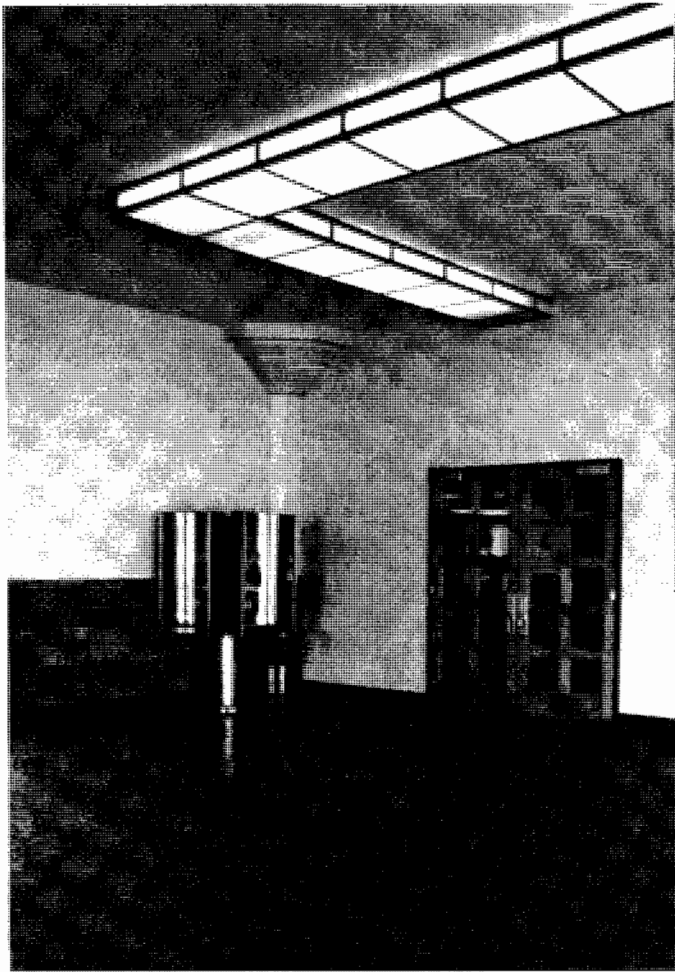
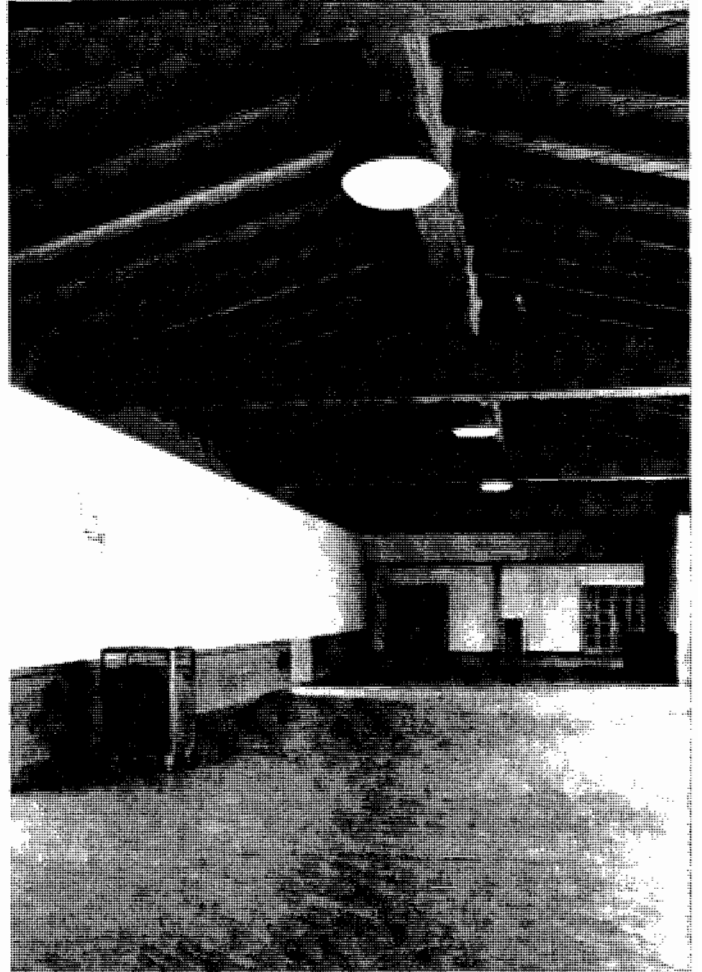
UNION STATION
D4 - RESTAURANT LOBBY

3. CURRENT USE - Passageway from Amtrak trains to the buses.
4. ORIGINAL USE - Restaurant lobby and passageway to restaurant.
5. CONDITIONS - Both oculii are dirty. The floor is worn and the walls are dirty. The tile base is broken and dirty. The bronze frame and glass doors and windows require cleaning.

13. INCONSISTENT ELEMENTS - The signage and the trash bins are out of character.
14. AREAS FOR RESEARCH/TESTING
 - . Research paint colors on ceilings
 - . Test cleaning of bronze frames
15. FUTURE USES - Undetermined. If the restaurant is reopened then this area will be used by greater numbers of people. It could be used as a waiting/overflow area for the restaurant.
16. RECOMMENDATIONS FOR HISTORIC UPGRADE - Clean and repaint surfaces as required. Clean, patch and replace ceramic tile as required. Clean and upgrade light fixtures. Clean bronze frames and doors as required.
17. ONGOING WORK - Not applicable.
18. IMPACT ON OPERATIONS - Not applicable.

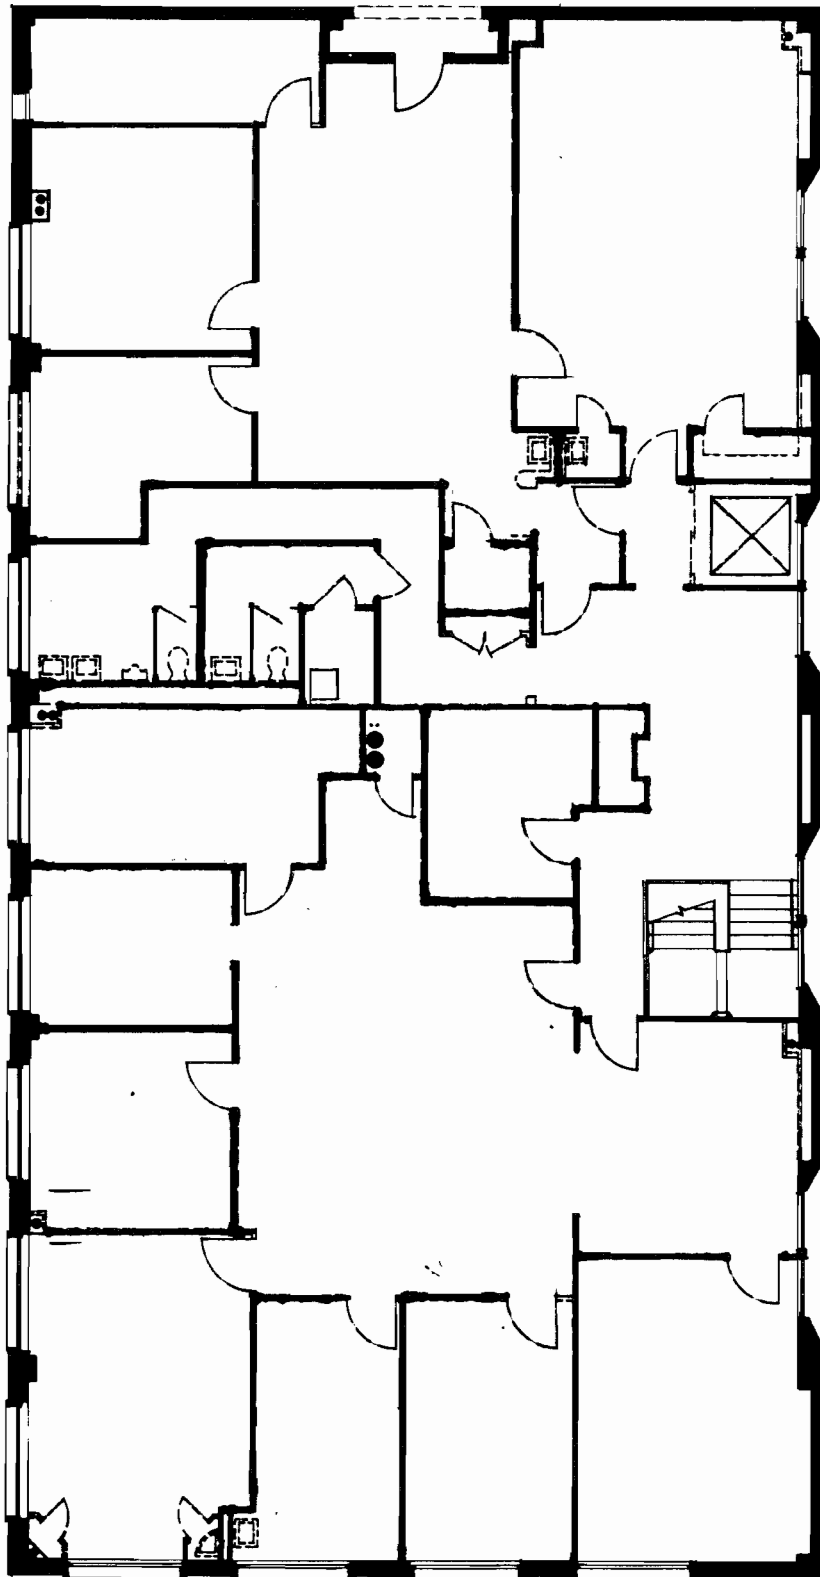
EXISTING SECOND FLOOR PLAN

5. CONDITIONS - The entire second floor has been remodeled to accommodate Amtrak offices. The small reception area is dark and dingy. The floors are worn and the walls are yellowed. The Xerox room to the left is unsightly, as is the mechanical equipment in the hallway next to the Conference Room. The original Toilet Room has been divided by a wall into separate Men's and Women's facilities. The original floor of gray, black, white-speckled and ocre tiles remains intact. The ceramic tile wainscot is ocre and yellow on three of the four walls. The Men's Restroom has original pattern tile floors, black tile base and yellow and ocre wainscot. The floor is brown linoleum. The toilet and lavatory fixtures are not properly maintained and need repair/replacement.

14. ELECTRICAL ISSUES - Upgrade lighting and wiring.
15. CODE - Consider a second means of egress.
16. INCONSISTENT ELEMENTS - Office wall paneling, carpet, suspended ceilings, air conditioning units in the upper windows, and fluorescent lights. The Xerox room and mechanical equipment off of the entry foyer are unsightly.

12. STRUCTURAL ISSUES - Not applicable.
13. MECHANICAL ISSUES - Relocate mechanical equipment now located off of the foyer area. Consider new HVAC system and the condition and use of the boiler in the basement.

17. AREAS OF RESEARCH/TESTING - Not applicable.
18. FUTURE USES - Offices of Catellus Development Inc.
19. RECOMMENDATIONS FOR HISTORIC UPGRADE - The Amtrak remodel of this area has altered the original layout. Only the Rest Rooms demonstrate significant historic character with original wall and floor materials. Originally one Rest Room, this area has been divided by a wall into separate facilities. The office areas and conference rooms have been remodeled in a manner inconsistent with the character of the station. This area was originally designed for private offices for which little or no general public use was intended and the original has been radically altered. Therefore, this area would likely benefit from adaptive reuse. The current layout is inefficient and the interior finishes and materials are dirty, worn and in need of replacement. Preferably the original restroom floor and wall tiles could be incorporated in the adaptive reuse. The outside windows would benefit from removal of the air conditioning units and new glass panes installed. The use of the original concrete stair case is recommended.

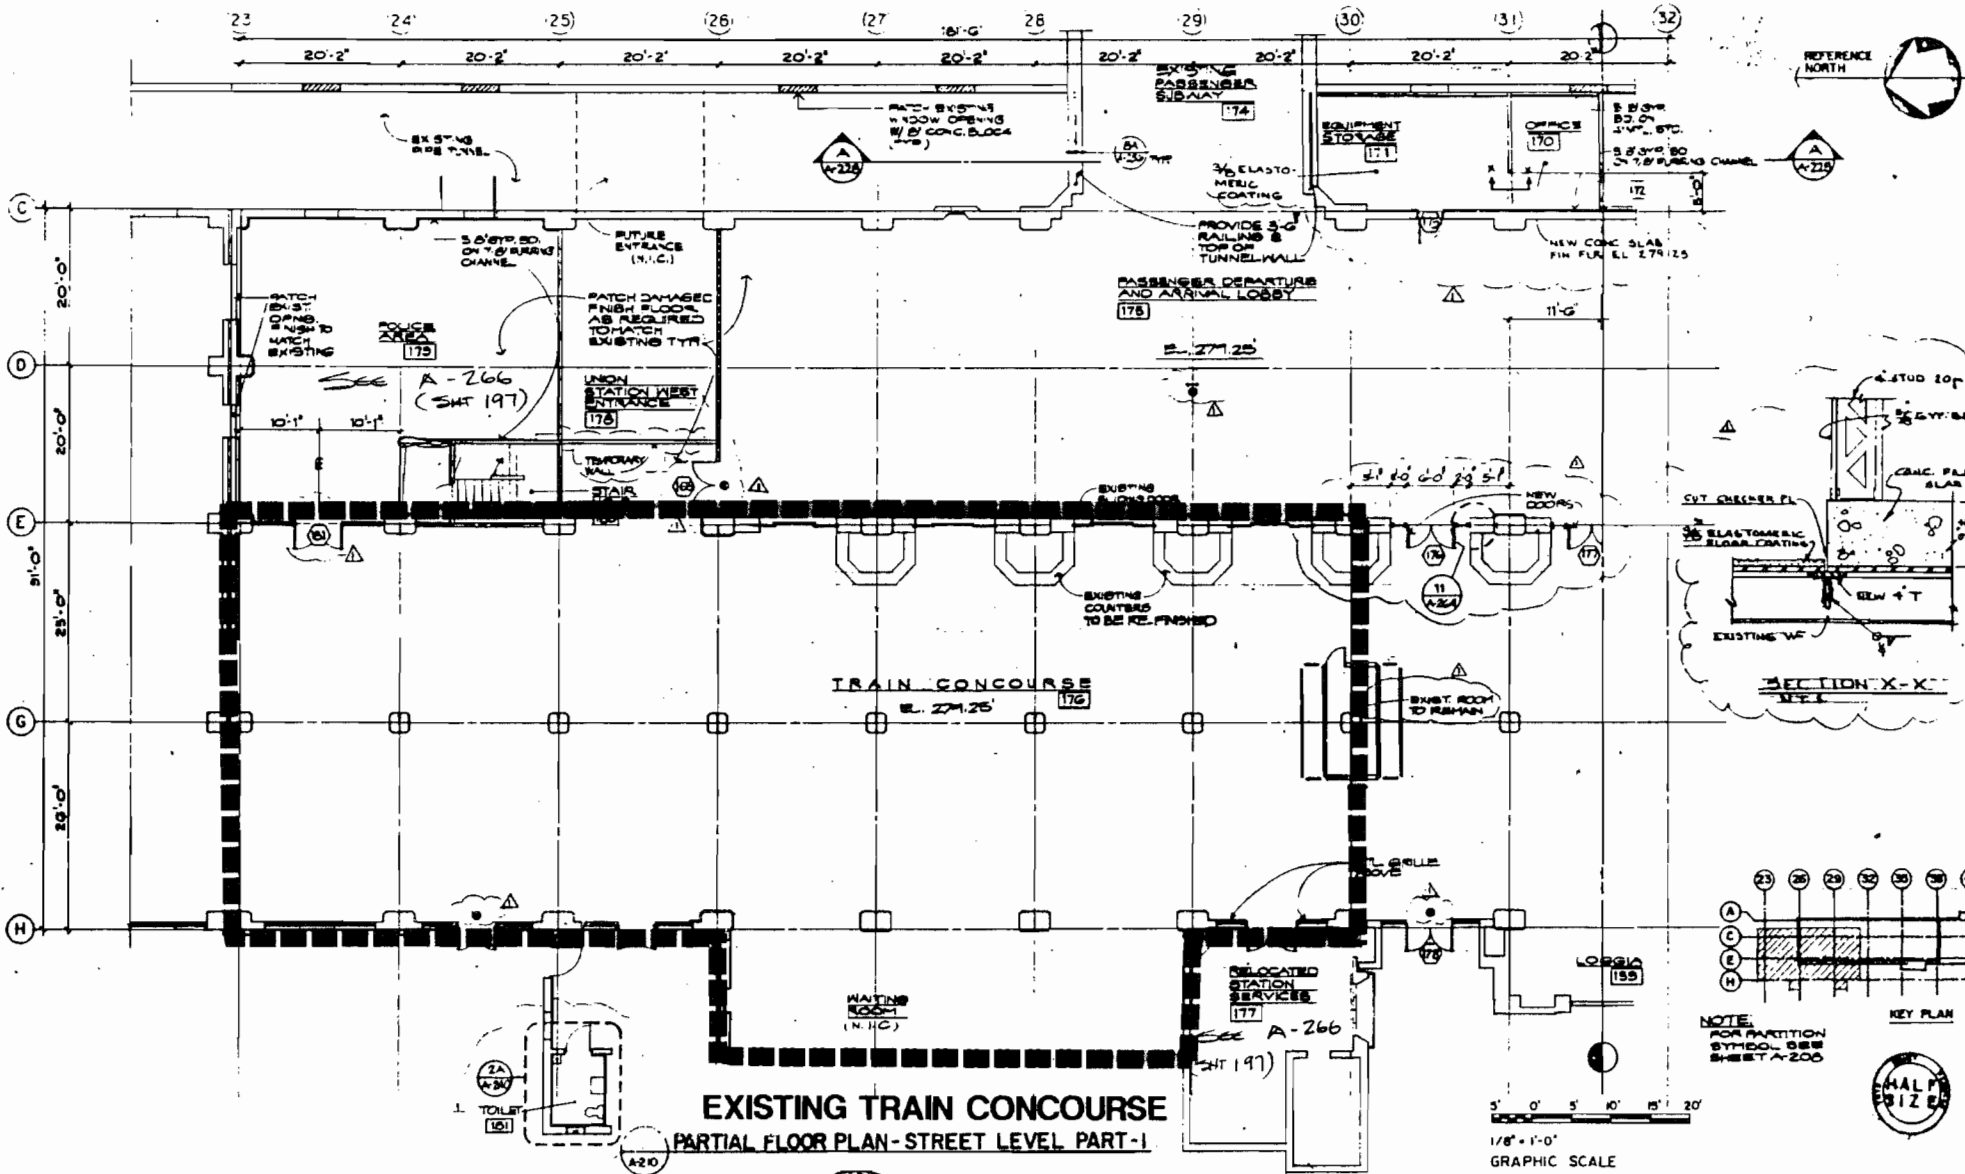
EXISTING TRAIN CONCOURSE
PARTIAL FLOOR PLAN - STREET LEVEL PART - I

5. CONDITIONS - The floors are dirty and cracked. Historic cement floor tiles are chipped and mismatched in areas of the metro rail passage, where wooden desks have been removed. At the northern end of the room, near the baggage room, the floors and some wall surfaces are similar but not original. Two doors to the north patio are broken and the glass is cracked. Non-historic naguehyde chair covers are torn and the wood frames are scarred. The wooden desks are scraped and worn. Gate signs and doors are in disrepair. Fans are dirty and exposed. The acoustic panels in the upper walls are severely damaged and worn. The ceramic tiles are damaged on the corners and need replacement. In the north end of the train concourse there are two garage doors along which the walls are damaged and the paint is peeling. Also the ceramic tile wainscot is missing in several areas at the metro rail passage and the door to the stairs. The skylight in the train concourse foyer is extremely dirty and leaks. Several panels in the light fixtures are darkened.

18. FUTURE USES - In the future this area will serve as a major waiting area and passageway to Amtrak trains and Metro Rail.
19. RECOMMENDATIONS FOR HISTORIC UPGRADE - Clean existing tile, match existing and repair broken tiles. Install new ceramic tiles to match historic at north end and around new stairway door and RTD passage. Coordinate signage. Repair or replace and match historic wooden doors to north patio. Eliminate or relocate vending machines and baggage cart dispensers. Remove unused, non-historic speaker holders at north end. Patch, repair and repaint walls at north end. Upgrade lighting fixtures, remove non-historic trash bins and replace with containers similar to historic. Clean and repair skylight in foyer. Match and replace acoustic tile in passageway into main waiting area. Clean and repair historic gate signs and backlit signs.
