**U N I O N S T A T I O N
L O S A N G E L E S**

**INITIAL STUDY
FOR
REHABILITATION
AND
REUSE**

SURVEY OF CONDITIONS

**PREPARED FOR CATELLUS DEVELOPMENT CORPORATION
HARDY HOLZMAN PFEIFFER ASSOCIATES
AUGUST 1991**

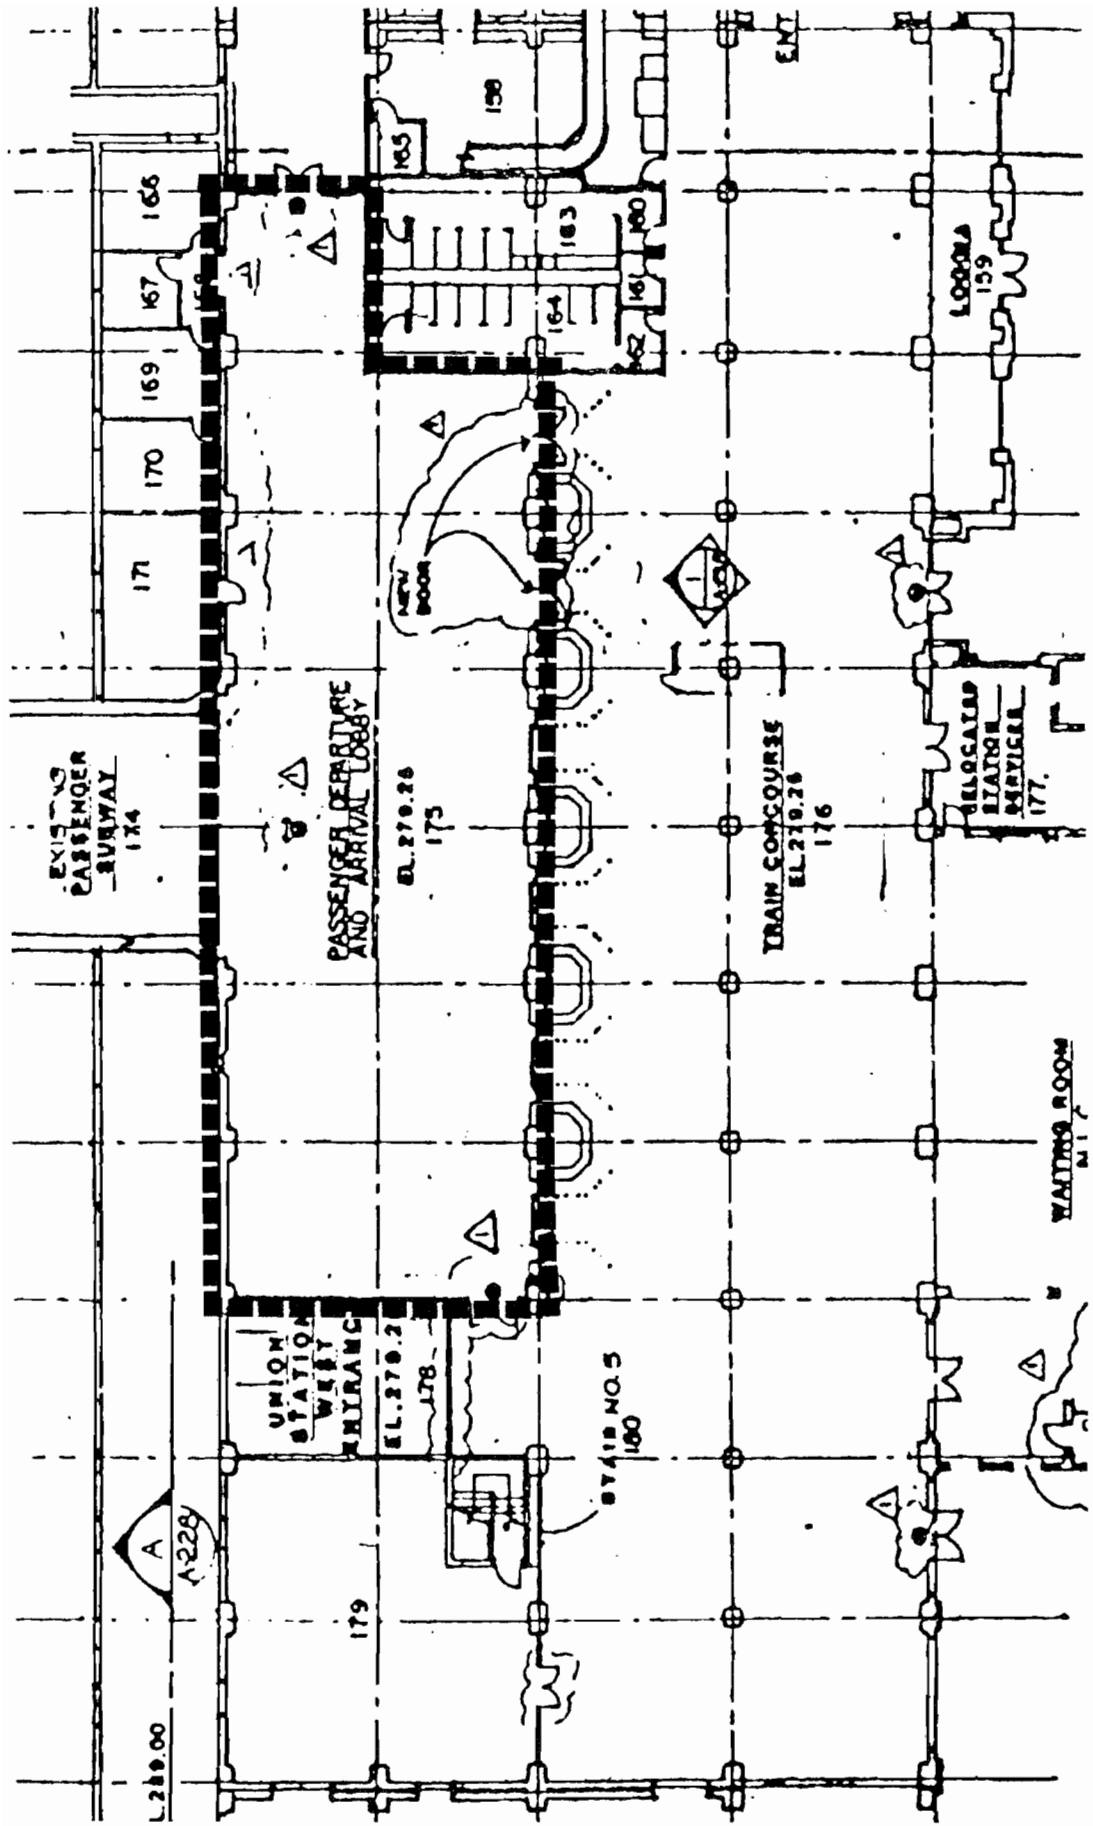
PASSENGER ARRIVAL AND DEPARTURE LOBBY

3. CURRENT USE - Passageway for arriving and departing passengers and waiting area.
4. ORIGINAL USE - Passageway for arriving and departing passengers. This area was originally at one bay longer towards the north. A new wall was constructed to enclose the Metro Rail tunnel.
5. CONDITIONS - The ceiling area adjacent to the fans is dirty. There is graffiti scratched on the walls. The paint is dirty. The floors are dull and the lighting is dim. The wood panels on either side of the door are not historic. The ceramic tile wainscot is dirty, chipped and worn in many places. The original exit sign and taxi cab sign are in disrepair.

19. RECOMMENDATIONS FOR HISTORIC UPGRADE - Clean and repaint wall surfaces as required, especially in fan area. Enclose fans. Upgrade lighting fixtures. Repair, refinish and recover wood seats. Clean floor tiles. Clean and repair ceramic tiles as required. Repair broken signage and coordinate inconsistent styles.

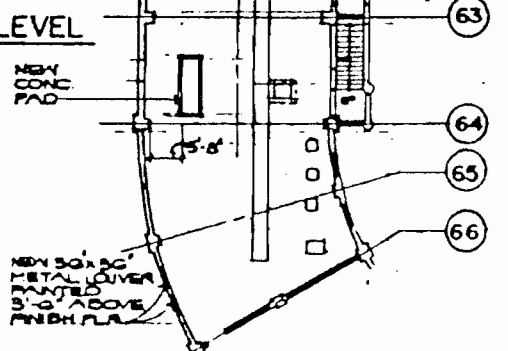
EXIT CONCOURSE

5. CONDITIONS - Clean but somewhat sterile.
6. LIGHTING - Fluorescent ceiling panels which brightly illuminate this area.
7. ACOUSTICS - Quiet area. No echo from footsteps or voices.

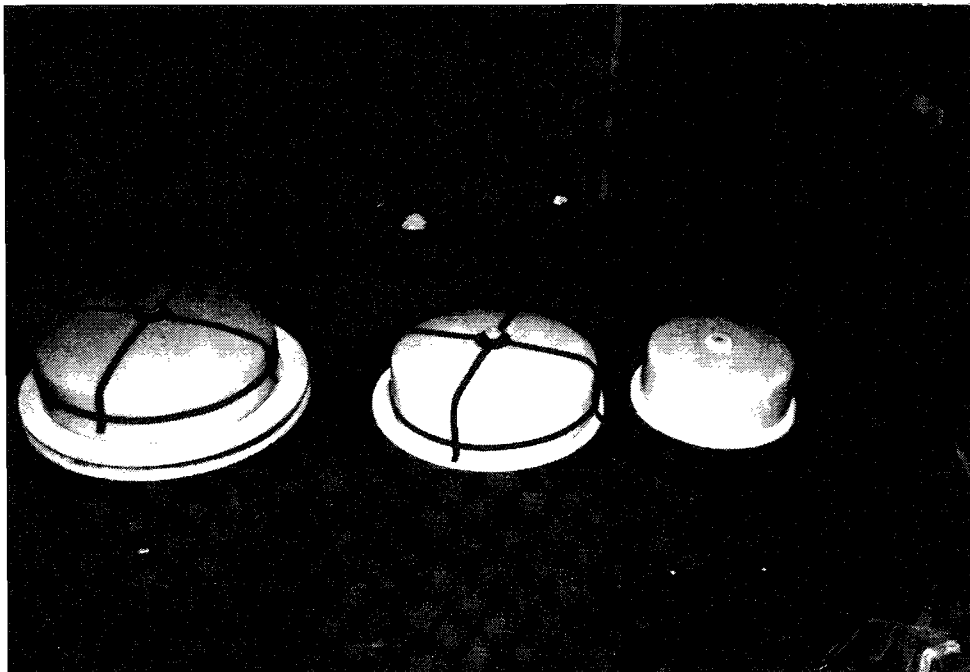
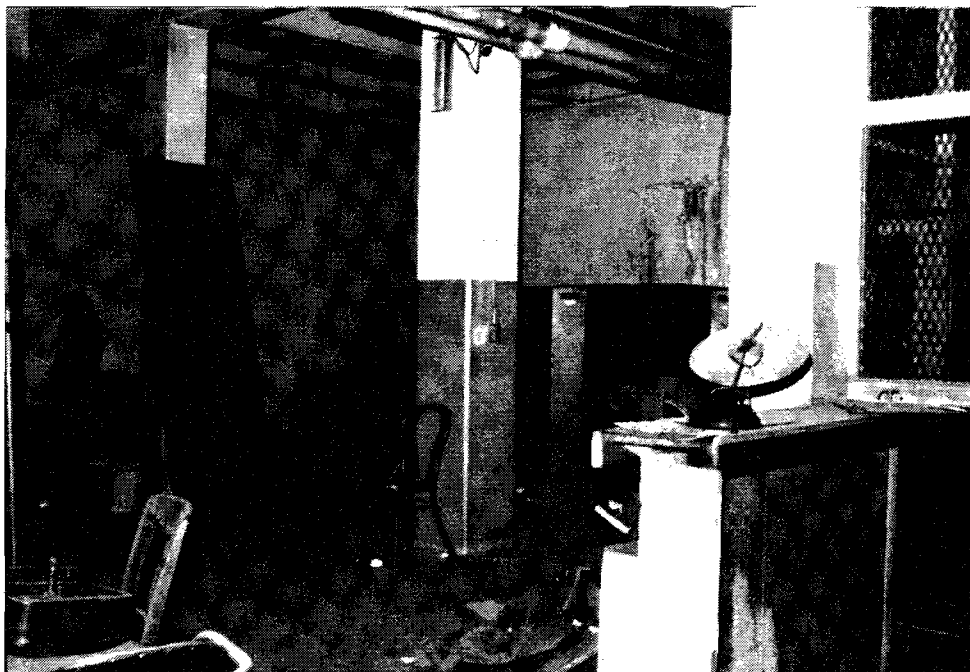
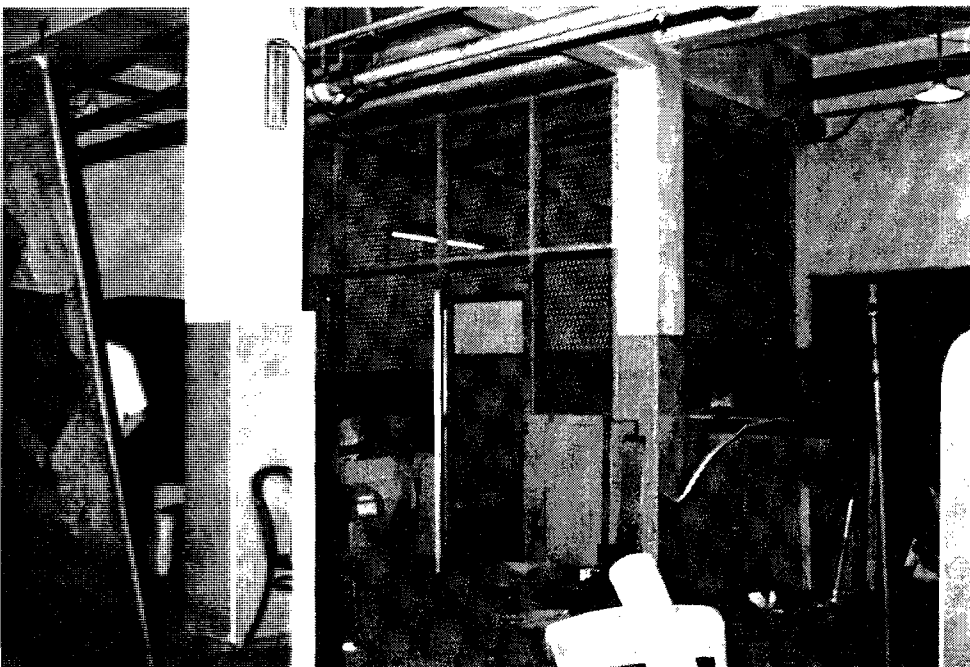
PARCEL CHECK BASEMENT

4. ORIGINAL USE - Parcel Check basement.
5. CONDITIONS - This area is dark, dirty and in general disarray.
6. LIGHTING - Hanging fluorescent fixtures with only one working bulb.

10. ARTWORK - None.
11. SIGNAGE - None.
12. STRUCTURAL ISSUES - Not applicable.
13. MECHANICAL ISSUES - Working condition of the elevator is undetermined and the ventilation is not apparent.

14. ELECTRICAL ISSUES - Upgrade lighting fixtures and wiring.
15. CODE - Not applicable.
16. INCONSISTENT ELEMENTS - Not applicable.
17. AREAS OF RESEARCH/TESTING - Not applicable.
18. FUTURE USES - Leaseable storage space for tenant in area above.
19. RECOMMENDATIONS FOR HISTORIC UPGRADE - Furniture stored in this area should be identified, tagged, and catalogued. Lighting requires upgrading and overall cleaning and repainting of walls, and ceiling is required.
20. ONGOING WORK - Not applicable.
21. IMPACT ON OPERATIONS - Not applicable.

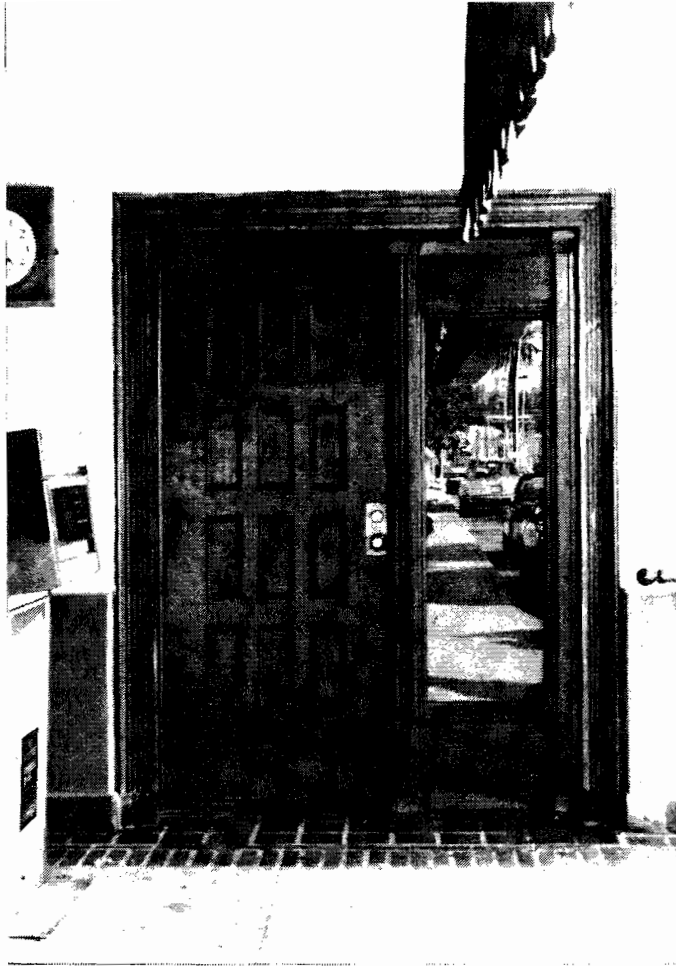
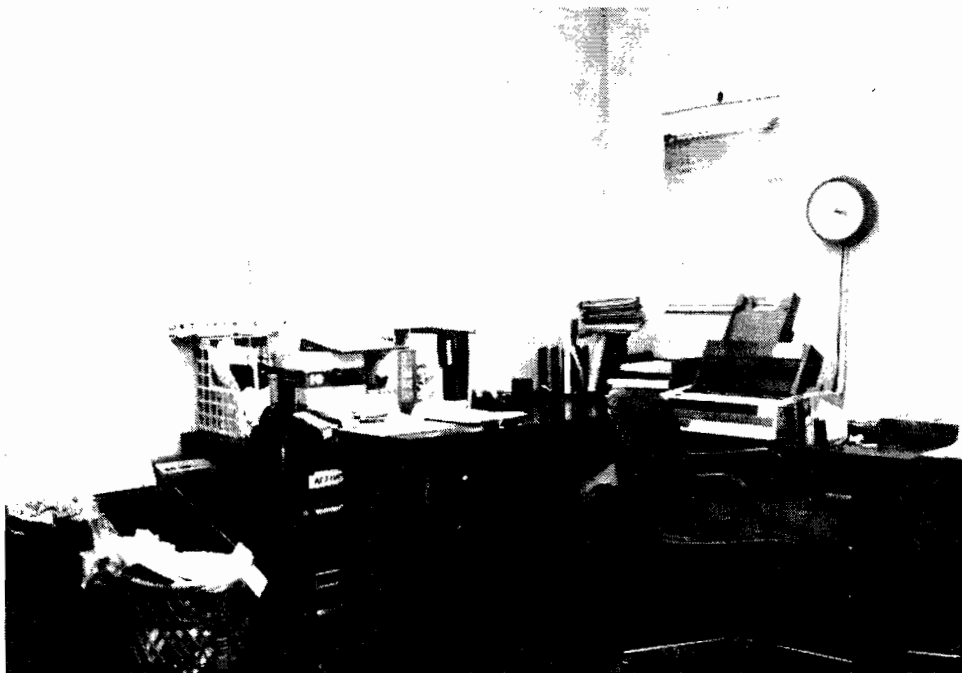
5. CONDITIONS - The lighting is dim and the area is filled with desks and file cabinets.
6. LIGHTING - Hanging fluorescent fixtures.
7. ACOUSTICS - Not applicable.

11. SIGNAGE - None.
12. STRUCTURAL ISSUES - Not applicable.
13. MECHANICAL ISSUES - Ventilation and air conditioning not apparent.
14. ELECTRICAL ISSUES - Upgrade lighting and check wiring.

19. RECOMMENDATIONS FOR HISTORIC UPGRADE - Depending upon the future use of this space, the walls requires cleaning and repainting, the floor covering needs cleaning/replacement, and the front door needs refinishing.

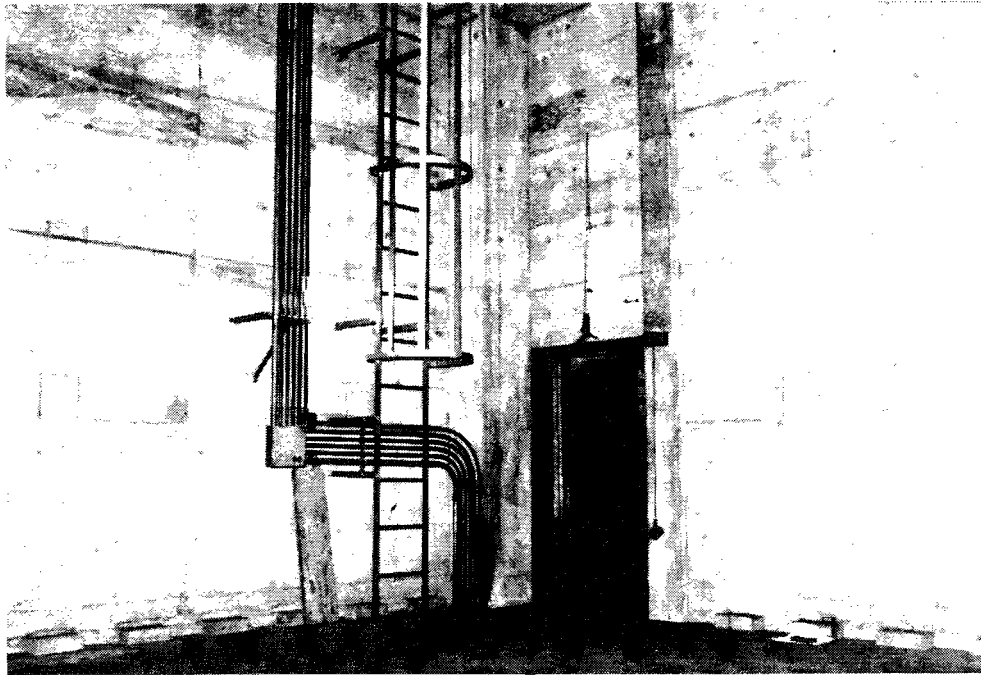
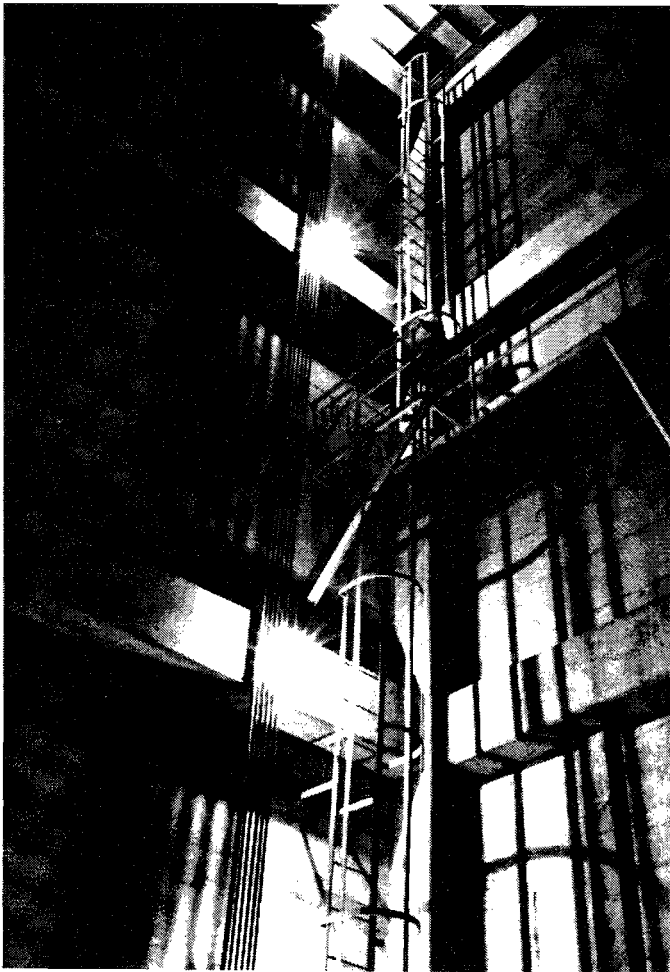
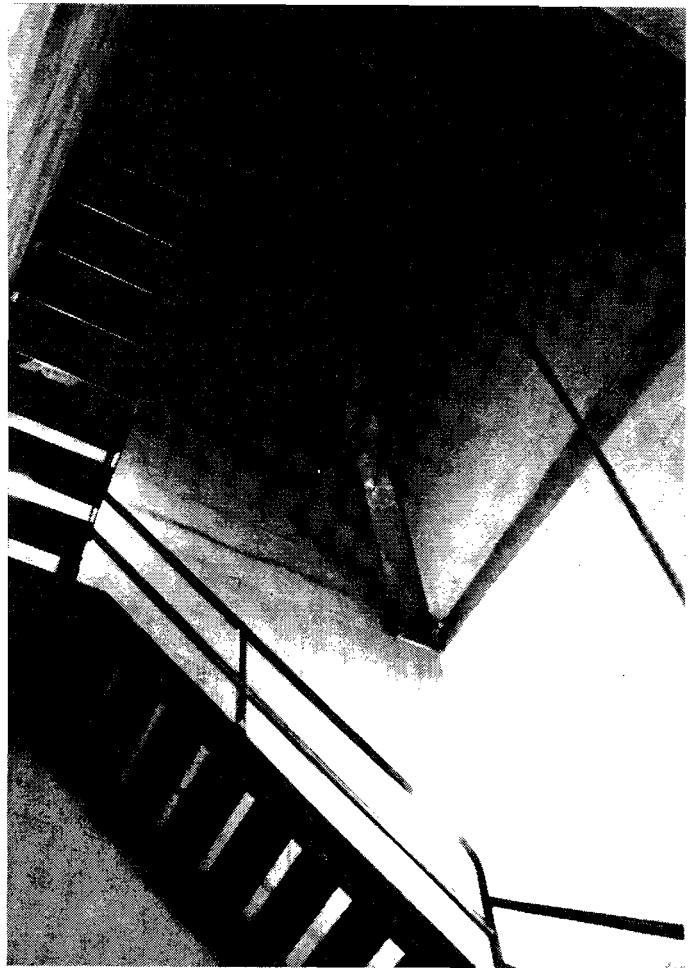
CLOCK TOWER INTERIOR

3. CURRENT USE - Clock tower.
4. ORIGINAL USE - Clock tower.
5. CONDITIONS - Lower areas have recently been cleaned of debris. Upper vestibule windows are broken, and cannot be fixed shut, bird droppings and carcasses are abundant. The ceramic tile around the windows is very dirty.

14. ELECTRICAL ISSUES - Upgrade and repair lighting at the top of the tower.

15. CODE - Not applicable.
16. INCONSISTENT ELEMENTS - Not applicable.
17. AREAS OF RESEARCH/TESTING
 - . Test cleaning of ceramic tiles in upper vestibule.
18. FUTURE USES
19. RECOMMENDATIONS FOR HISTORIC UPGRADE - While the majority of this space is for mechanical use, the upper vestibule requires cleaning and the windows require repair in order to maintain the integrity of the elevations.
20. ONGOING WORK - Not applicable.
21. IMPACT ON OPERATIONS - Not applicable.

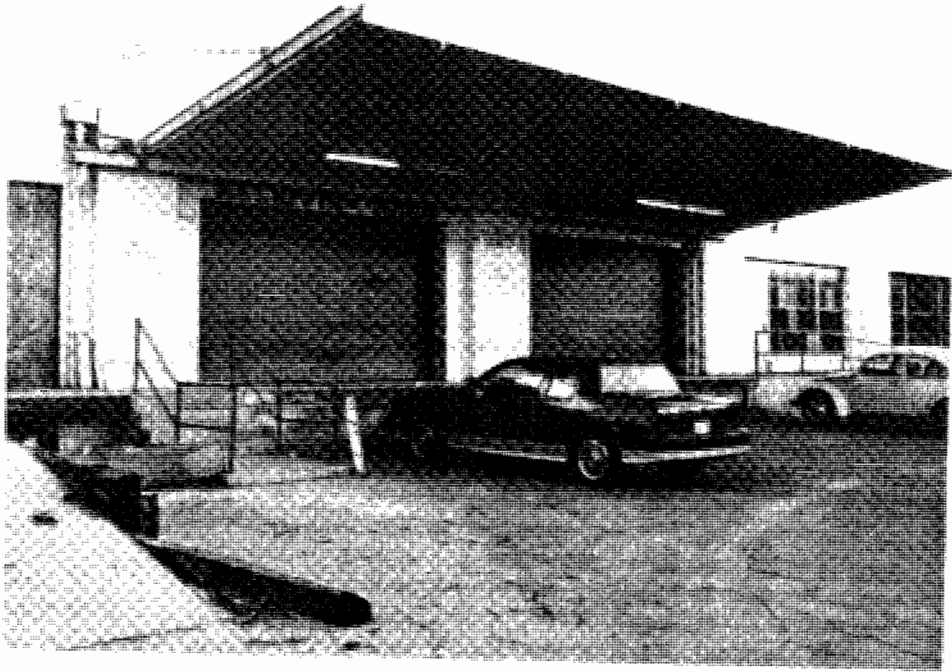
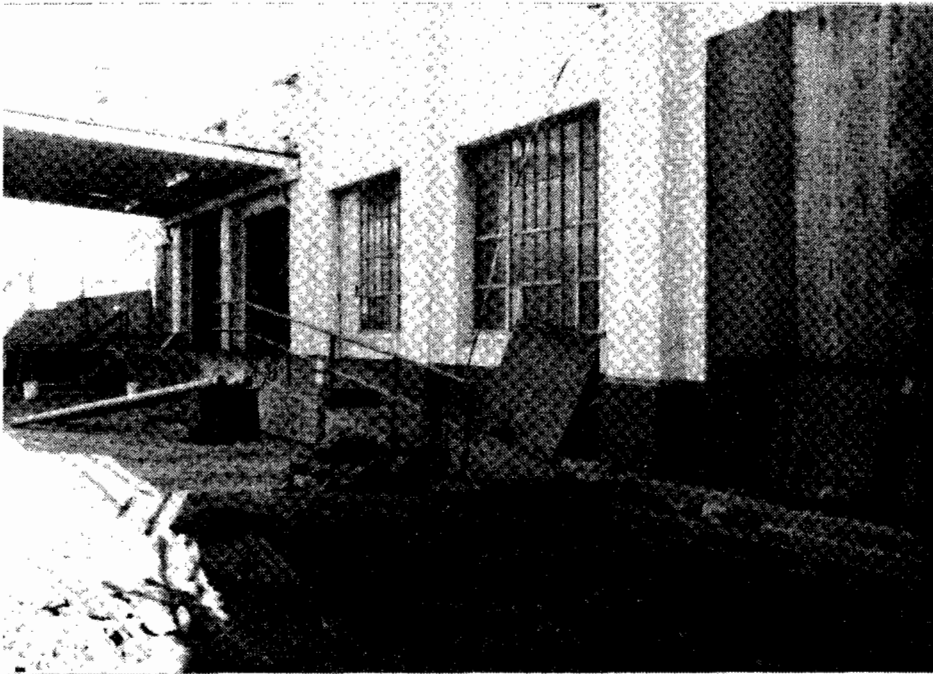
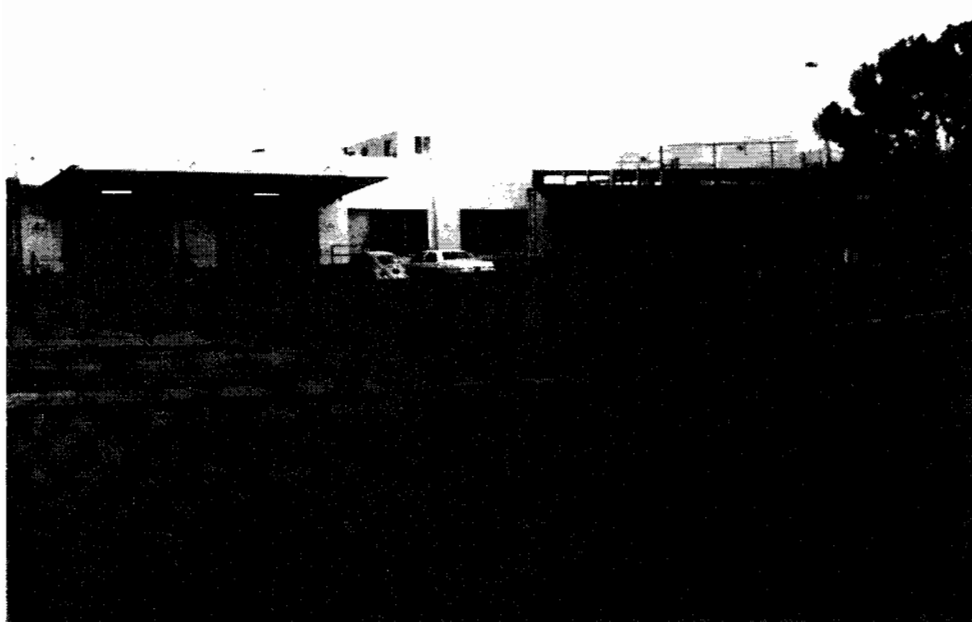
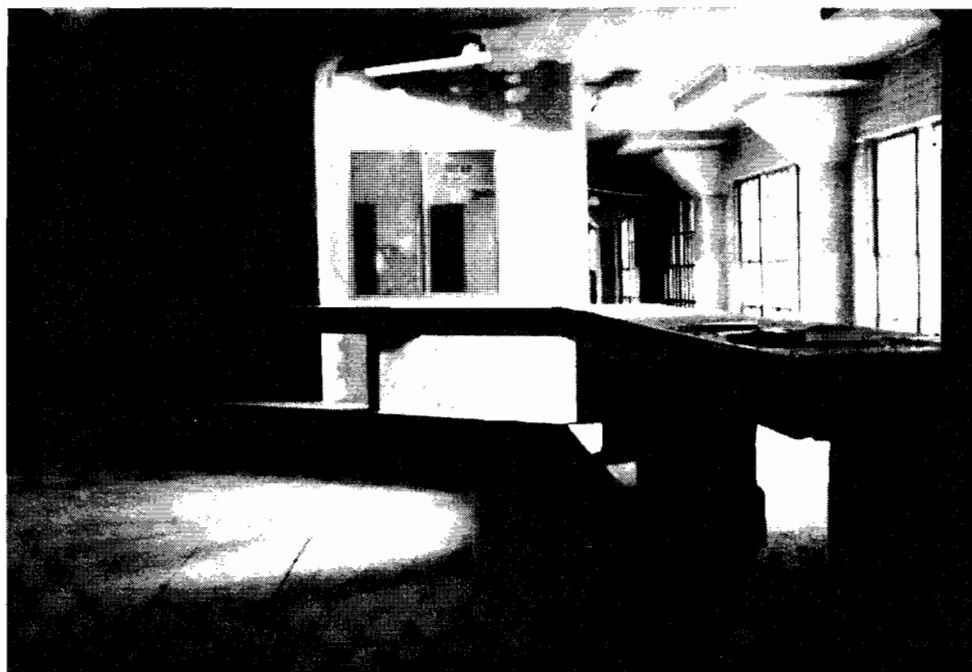
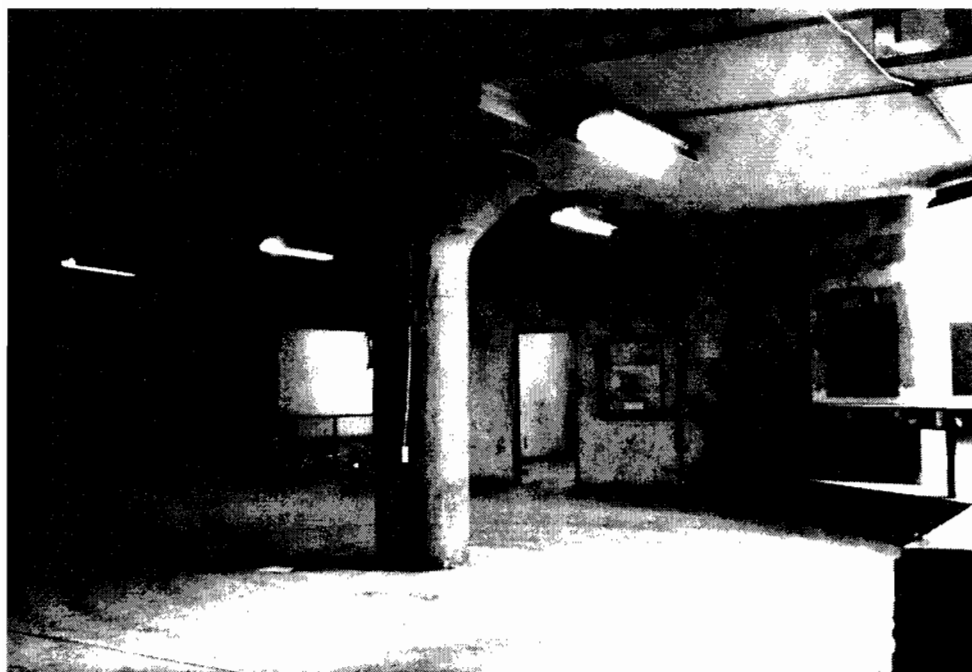
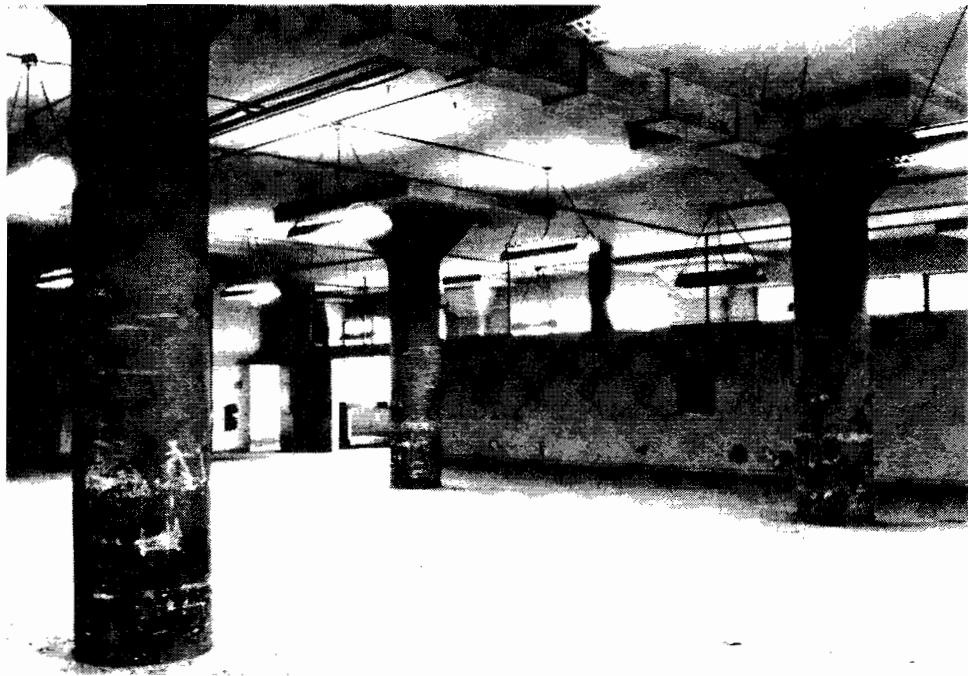
**FORMER
BAGGAGE**

3. CURRENT USE - None. Area is currently vacant.
4. ORIGINAL USE - Baggage area.
5. CONDITIONS - The area is dirty and empty and the bathrooms are in disrepair. The historic wooden doors to the north patio are broken and in disrepair.

17. AREAS OF RESEARCH/TESTING - Not applicable.
18. FUTURE USES - This area may be converted into a food court and restaurant area to service the passengers using the metro rail.
19. RECOMMENDATION FOR HISTORIC UPGRADE - Cleaning and repainting as required. The restrooms are in general disrepair and show little evidence of historic fabric.
20. ONGOING WORK - The north wall to this building was added when Metro Rail demolished the north end of the building in order to build the Metro Rail Station below.
21. IMPACT ON OPERATIONS - Since this building was not being used there was no impact on operations. However, the resulting space is irregularly shaped.

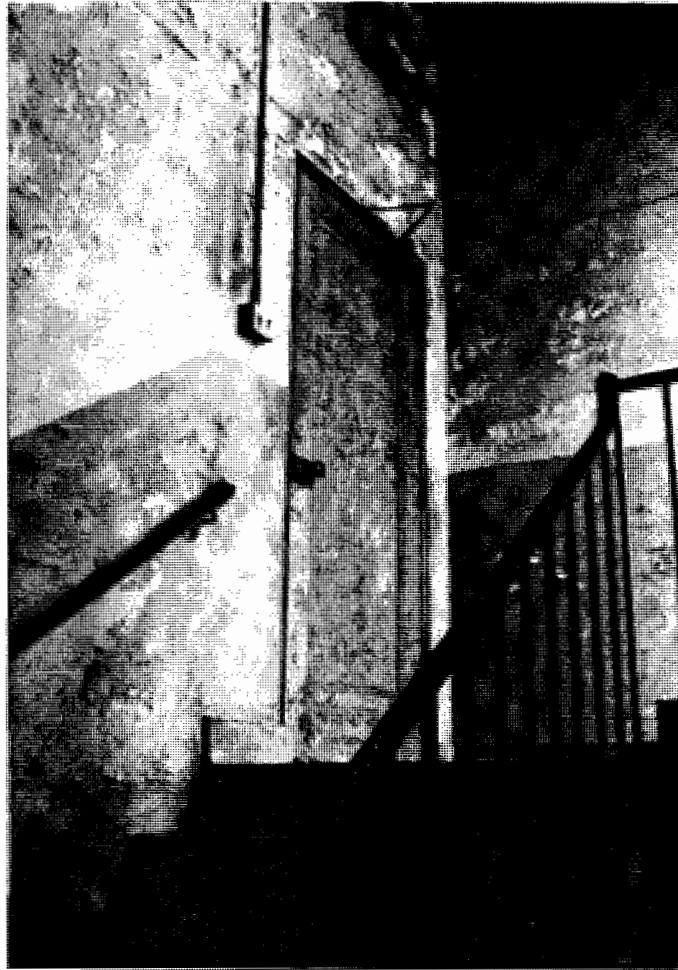
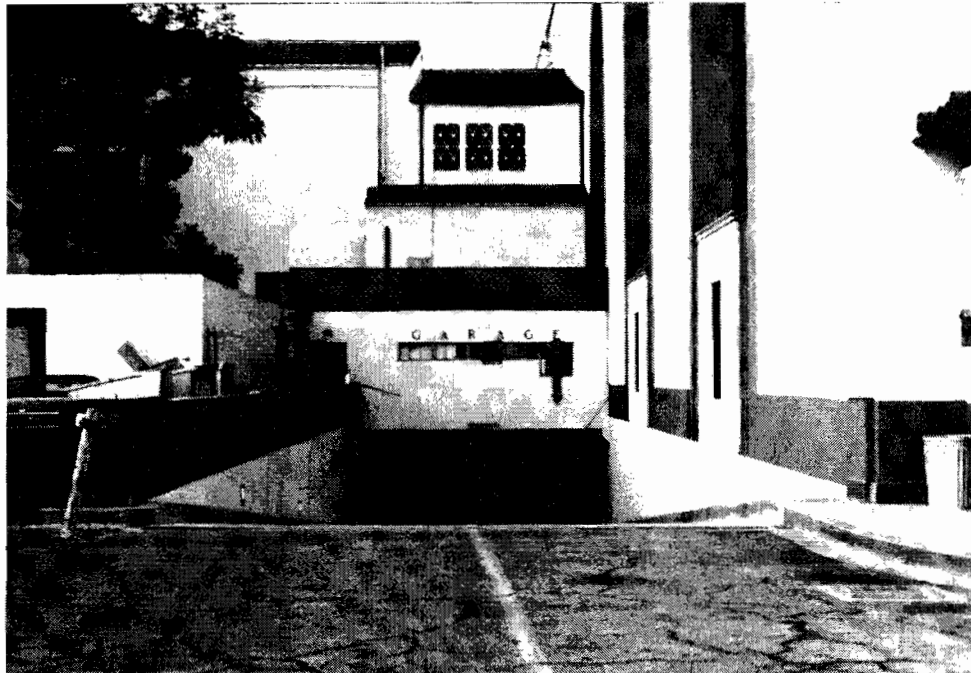
4. ORIGINAL USE - Parking garage originally 134 spaces.
5. CONDITIONS - The lighting is dim, the floors are dirty, and the paint is old and chipped in places.

18. FUTURE USES - Garage.
19. RECOMMENDATIONS FOR HISTORIC UPGRADE - Clean and repaint as required and upgrade lighting and provide additional signage.
20. ONGOING WORK - Not applicable.
21. IMPACT ON OPERATIONS - Not applicable.

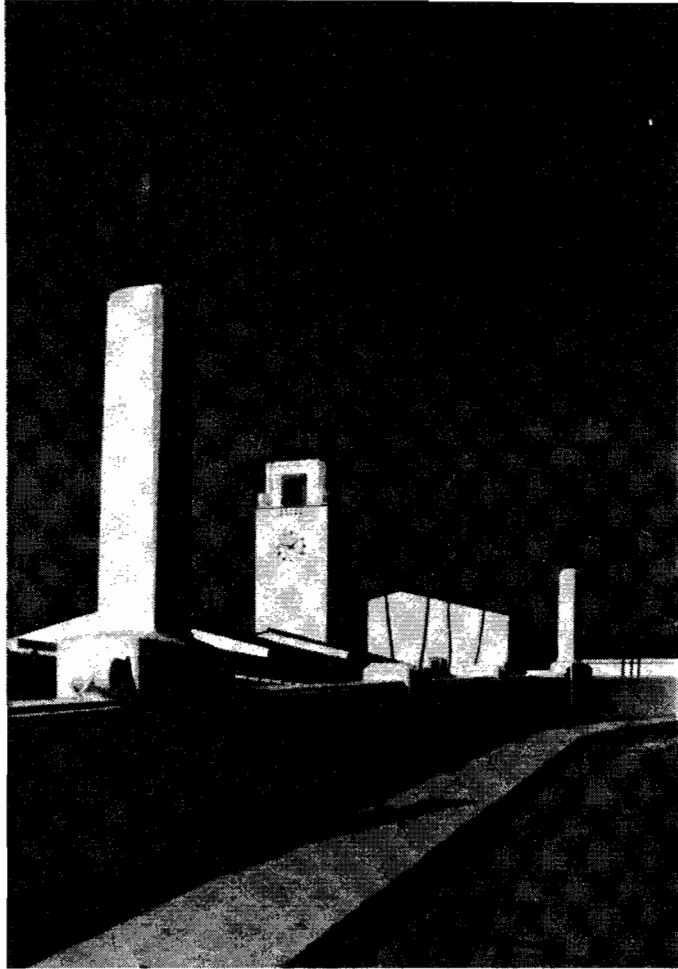
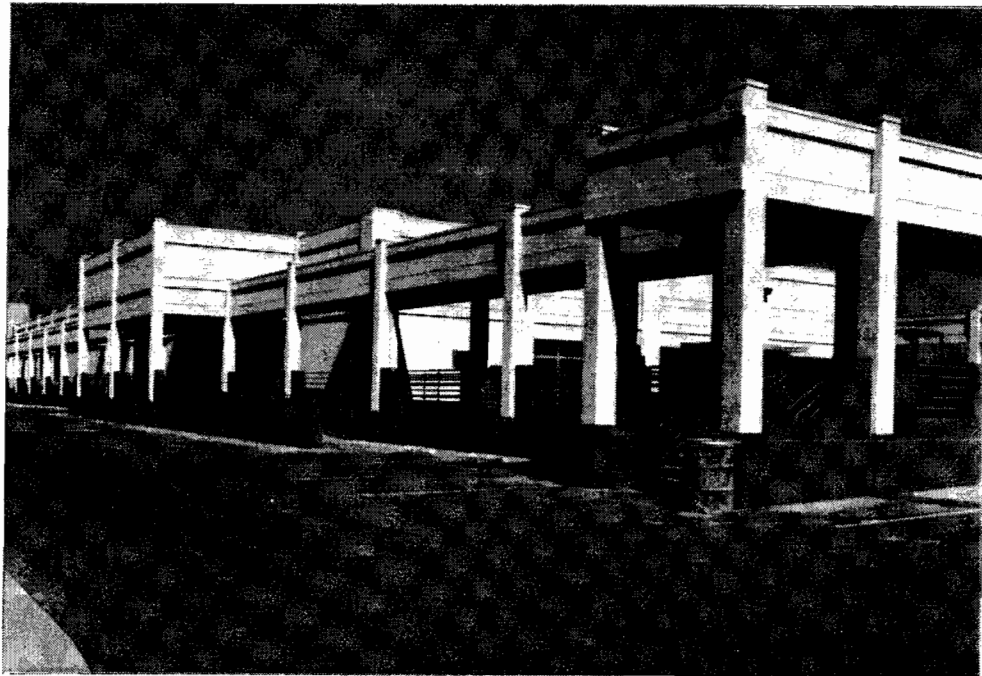
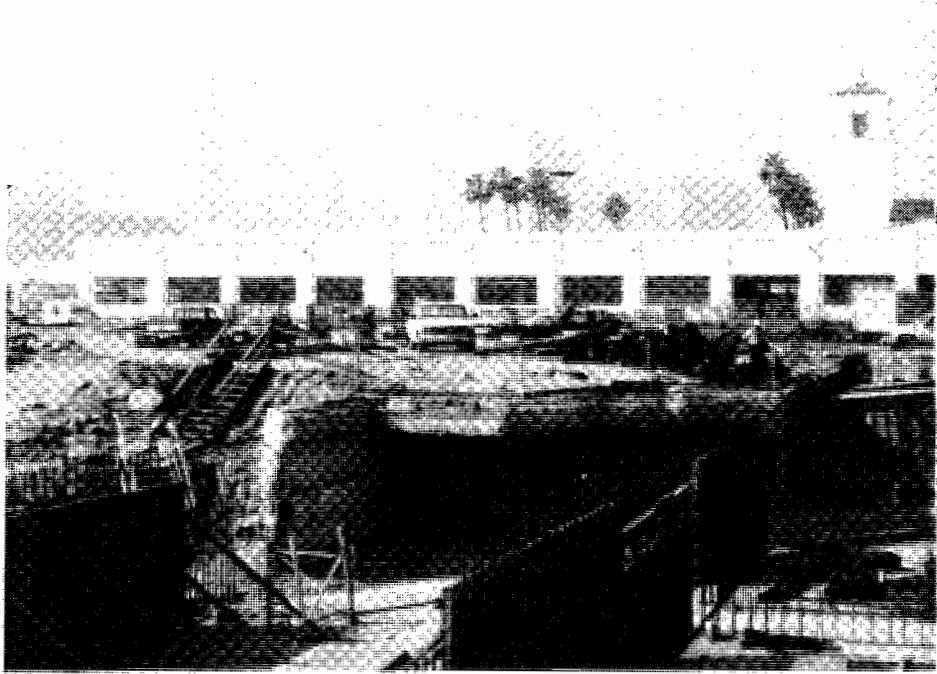
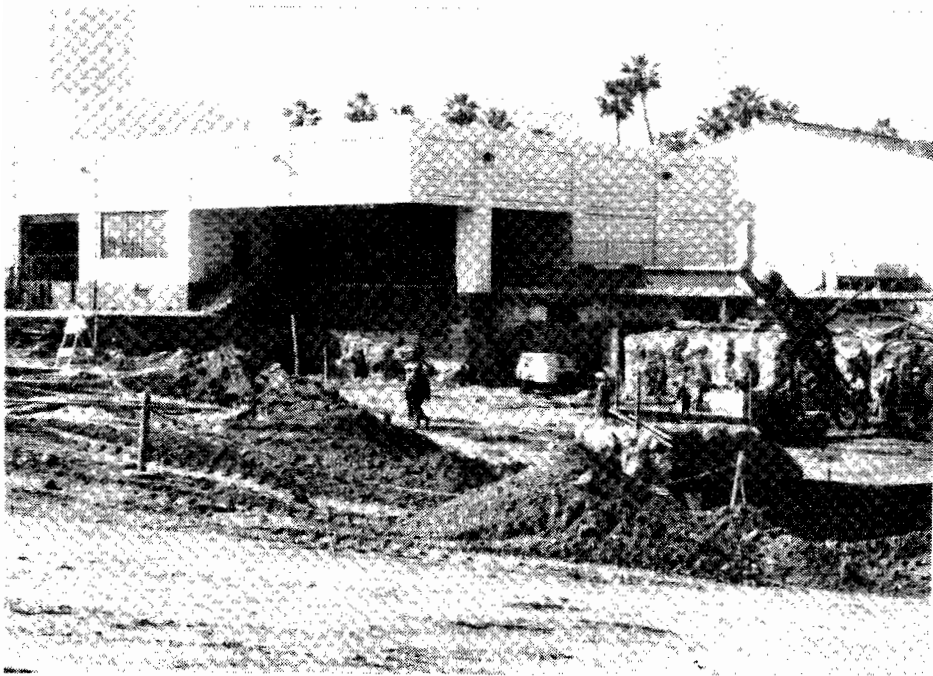
**UNION STATION
F8 - SOUTH GARAGE**

1. ARCHITECTURAL CHARACTER - Parking garage.
2. ENCLOSURE
Floors: Concrete
Walls and Columns: Reinforced concrete
Ceilings: Exposed concrete
3. CURRENT USE - Parking garage.
4. ORIGINAL USE - To be determined.
5. CONDITIONS - Lighting dim.
6. LIGHTING - Hanging fluorescent fixtures.
7. ACOUSTICS - Not applicable.
8. FURNITURE - Not applicable.
9. ARTIFACTS - A variety of artifacts are kept in a storage area within this structure.
10. ARTWORK - Not applicable.
11. SIGNAGE - Not applicable.
12. STRUCTURAL ISSUES - Not applicable.
13. MECHANICAL ISSUES - Not applicable.
14. ELECTRICAL ISSUES - Upgrade lighting.
15. CODE - Not applicable.
16. INCONSISTENT ELEMENTS - Not applicable.
17. AREAS OF RESEARCH/TESTING - Not applicable.

18. FUTURE USES - Undetermined.
19. RECOMMENDATIONS FOR HISTORIC UPGRADE - Research and catalogue items in storage. Upgrade lighting and signage.
20. ONGOING WORK - Not applicable.
21. IMPACT ON OPERATIONS - Not applicable.

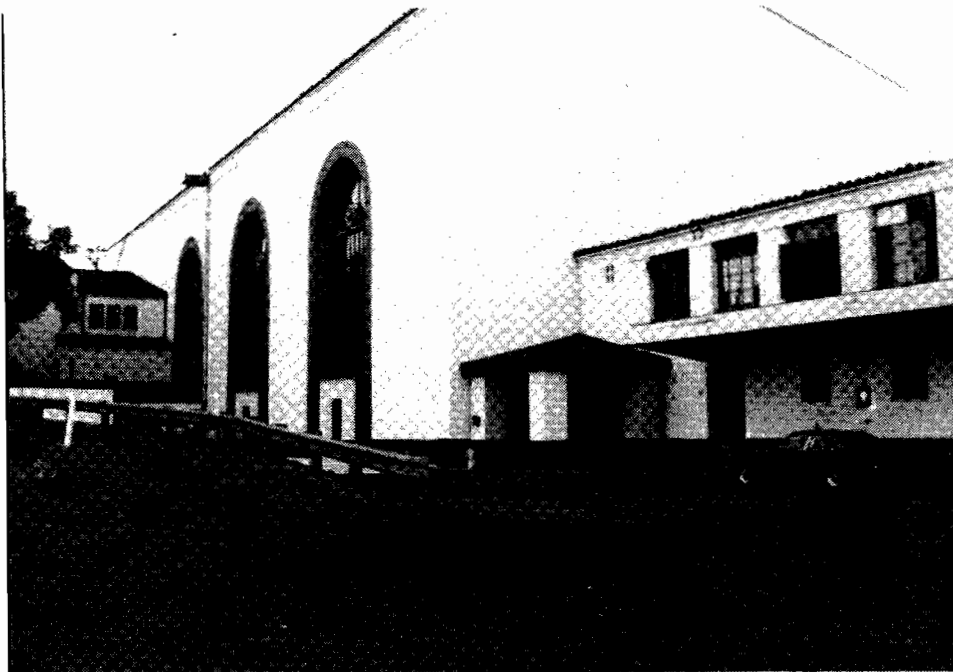
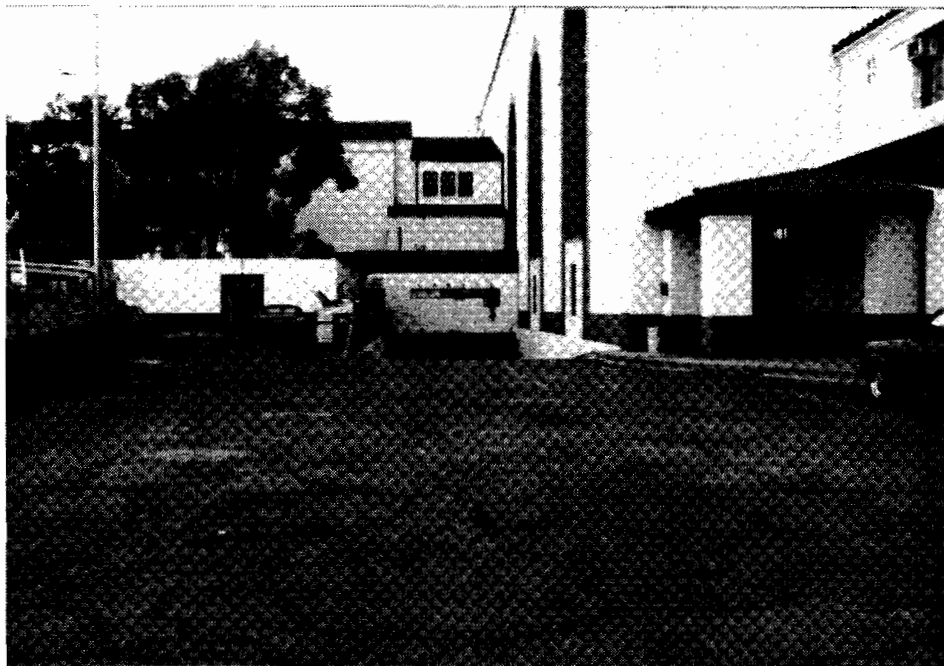
TRUCKING YARD

5. CONDITIONS - The ramp to the upper level has been removed. This area is part of the construction site for metro rail.
6. LIGHTING - Lantern beneath entrance to main concourse. Other lighting not apparent and will need consideration once construction is complete.

15. FUTURE USES - This area could potentially be used for new construction and/or additional open space.
16. RECOMMENDATIONS FOR HISTORIC UPGRADE - This area was originally a service area used for loading and currently under utilized. Therefore adaptive reuse of this area is recommended.

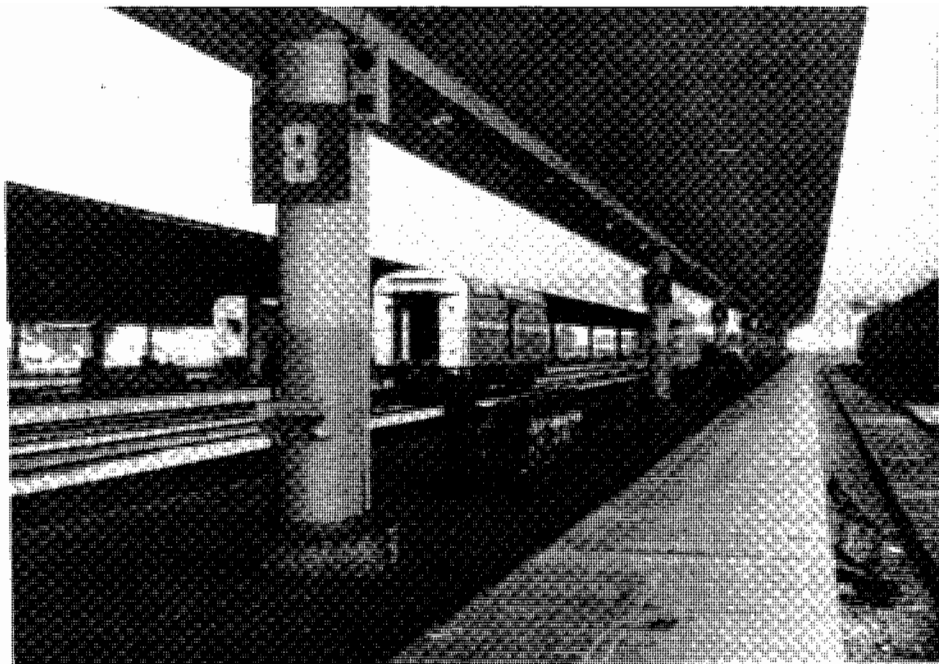
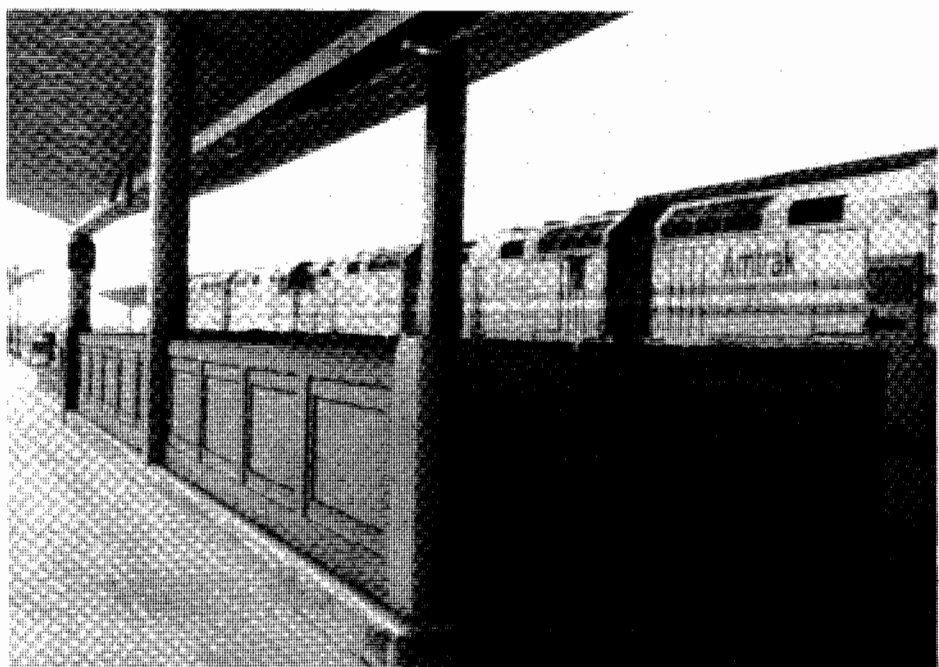
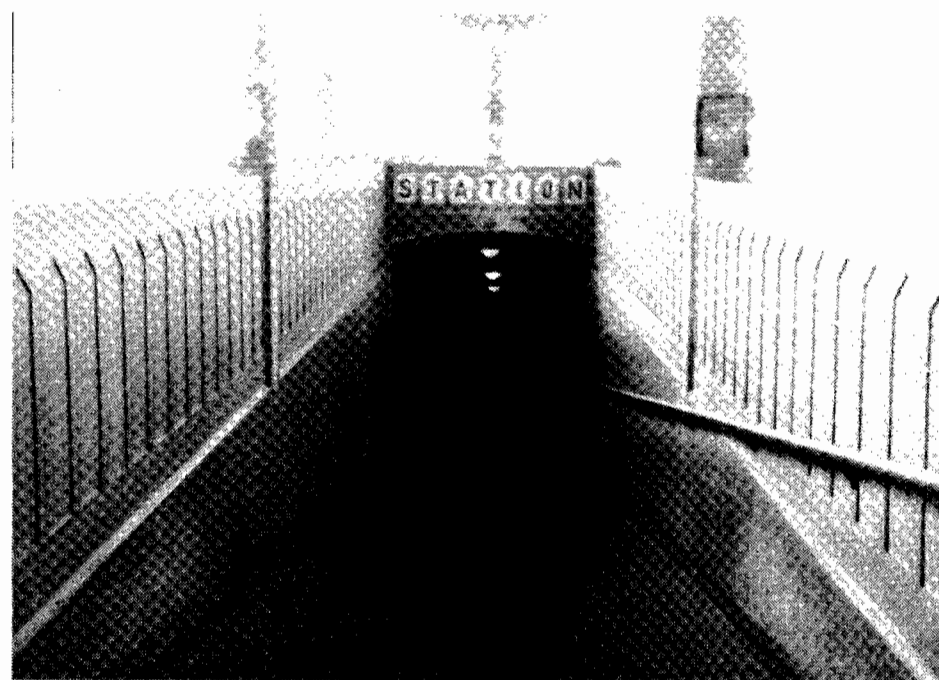
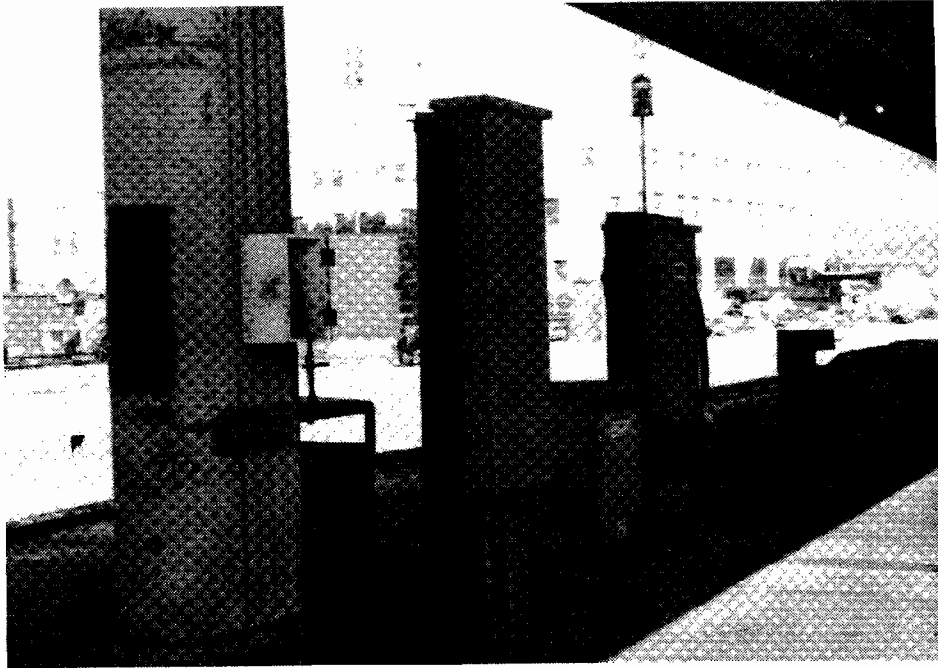
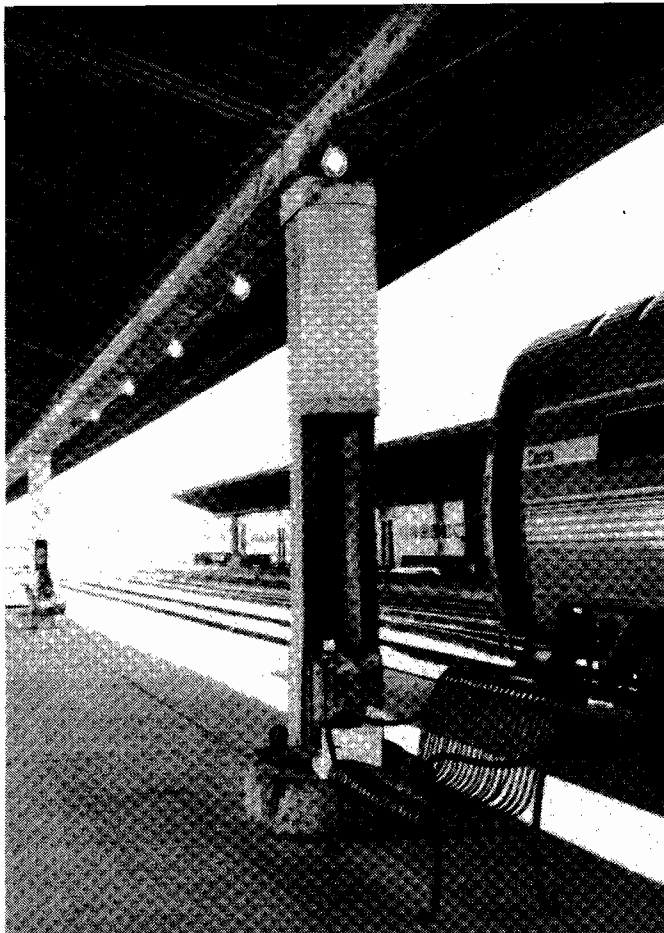
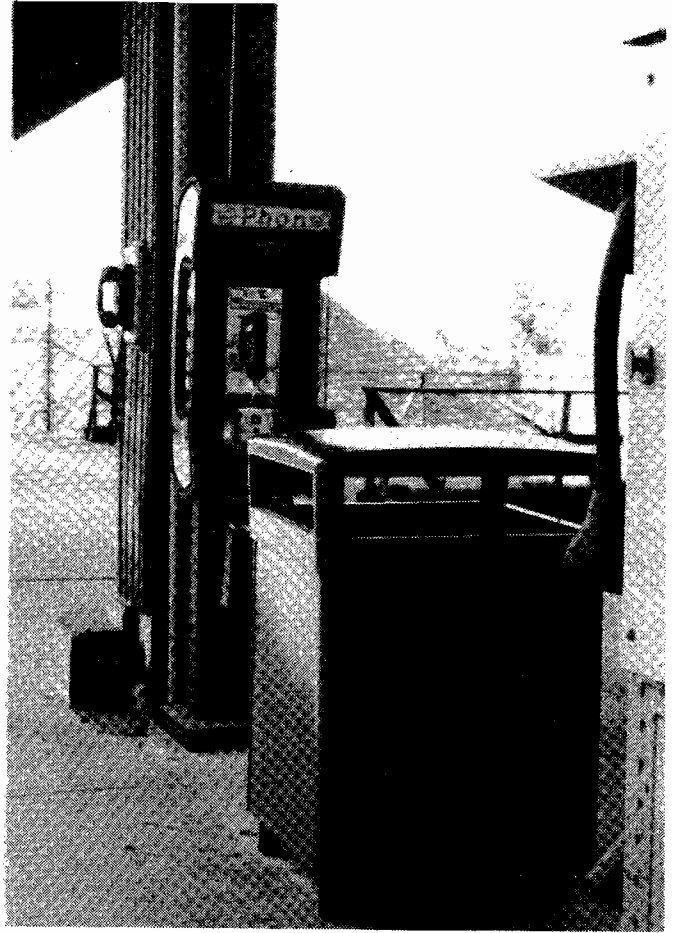
PLATFORM AREA

4. ORIGINAL USE - Loading platforms for train passengers.
5. CONDITIONS - The steel canopies are in severe disrepair and are badly rusted, except for one which was painted by a movie company.

15. FUTURE USES - Same as present. Possibly to serve light rail passengers also.
16. RECOMMENDATIONS FOR HISTORIC UPGRADE - Canopies require repair or replacement. Guardrails are chipped and damaged at the corners. Signage and lighting require upgrade.
