**U N I O N S T A T I O N
L O S A N G E L E S**

**INITIAL STUDY
FOR
REHABILITATION
AND
REUSE**

SURVEY OF CONDITIONS

**PREPARED FOR CATELLUS DEVELOPMENT CORPORATION
HARDY HOLZMAN PFEIFFER ASSOCIATES
AUGUST 1991**

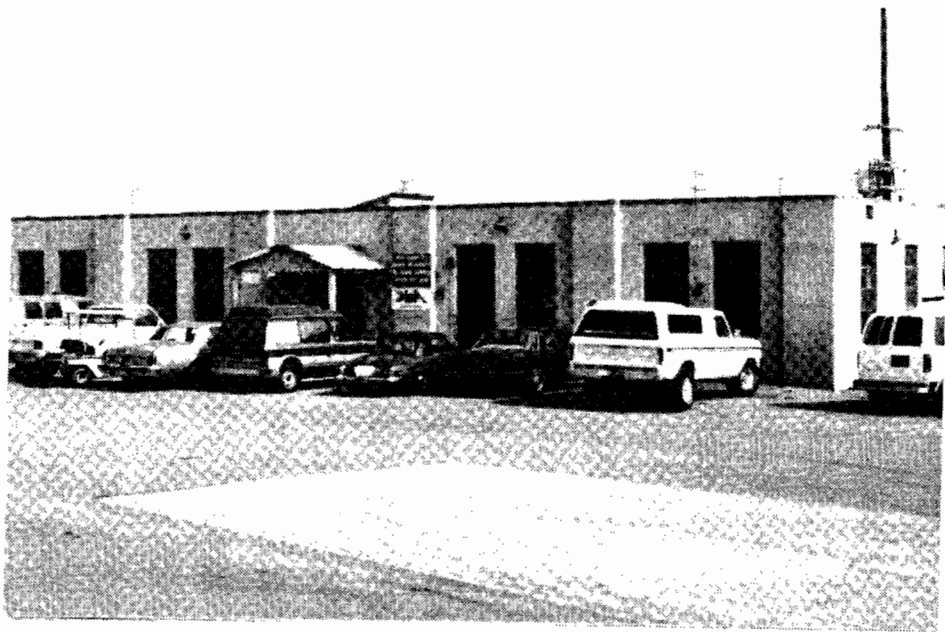
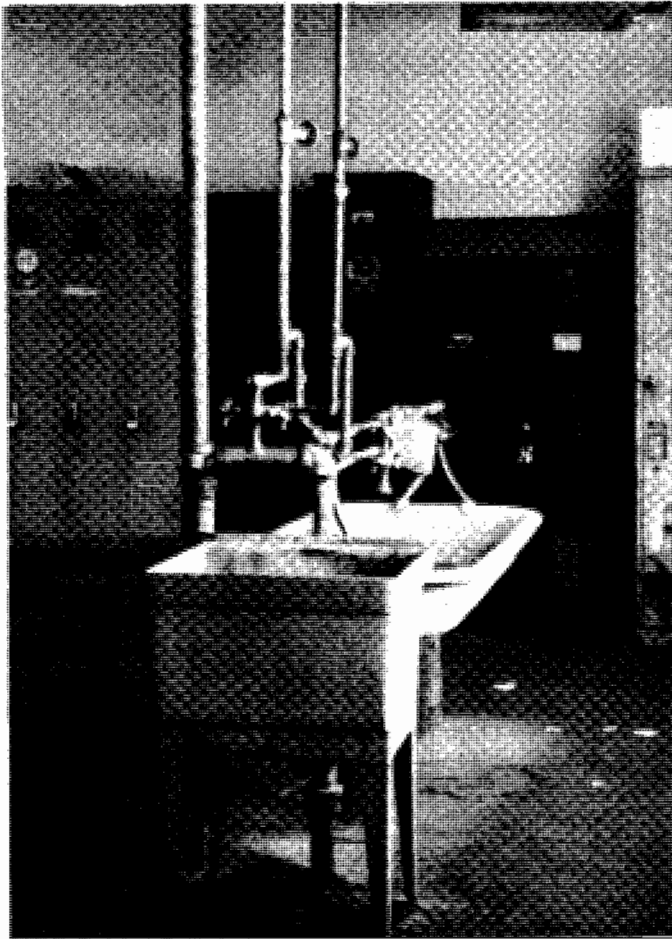
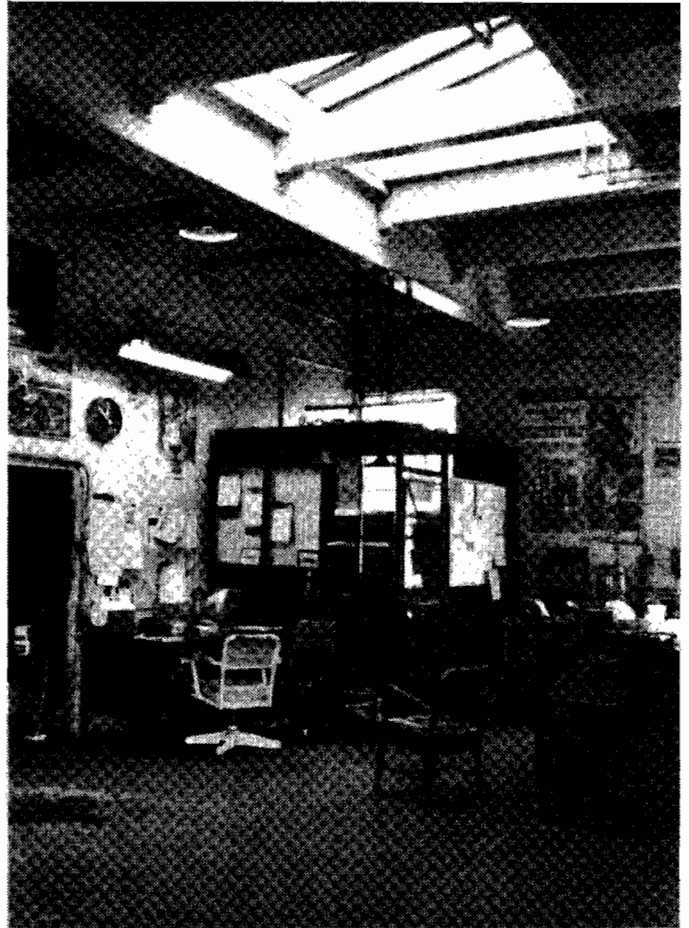
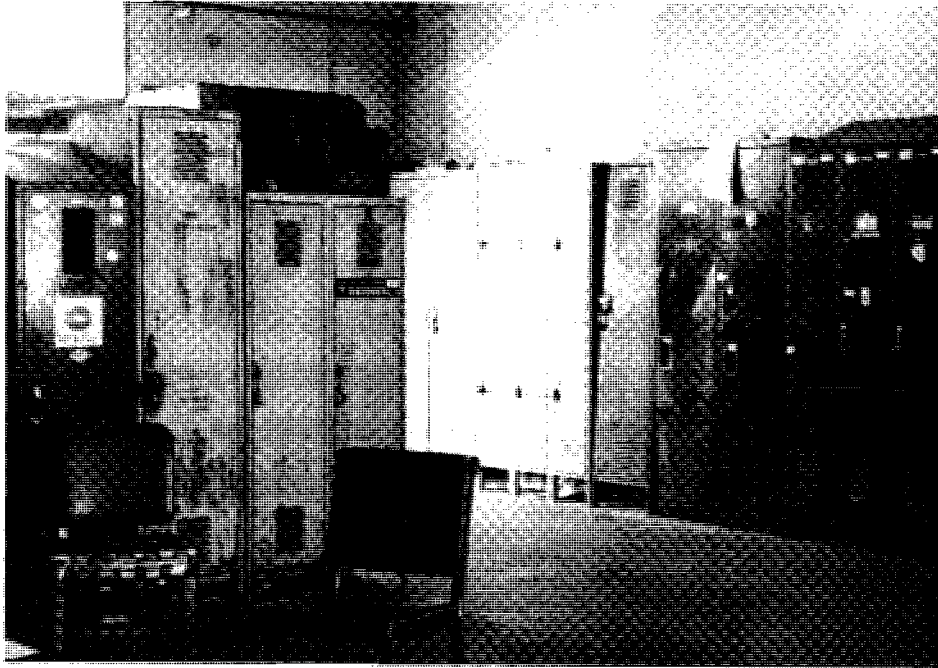
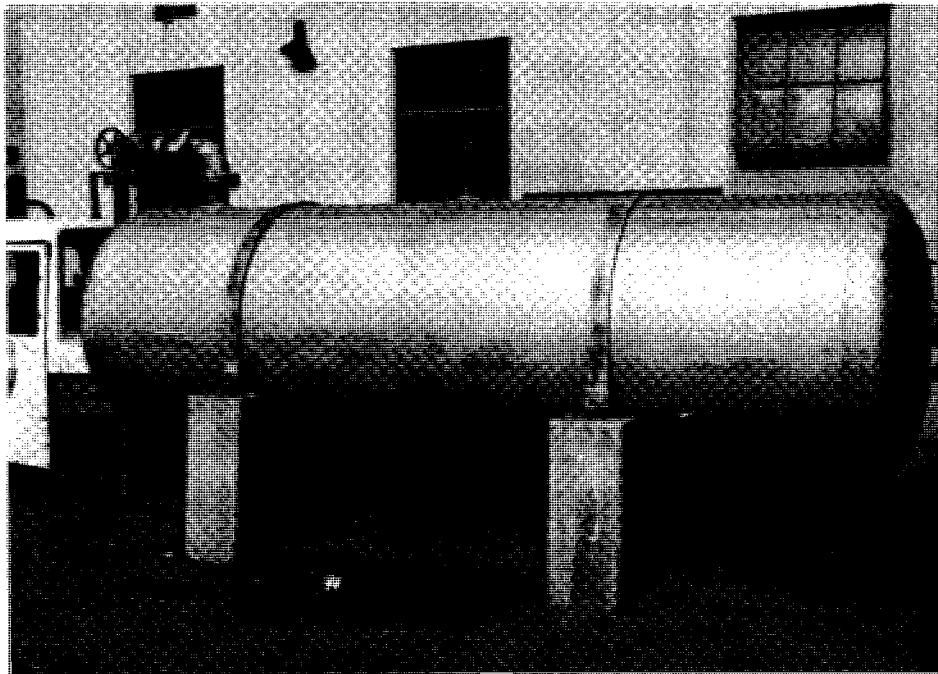
UNION STATION
G2 - CAR SUPPLY/REPAIR SHOP

2. ENCLOSURE - Poured-in-place concrete construction.
3. CURRENT USE - Repair shop for train cars.
4. ORIGINAL USE - Same
5. CONDITIONS - The bathrooms and locker rooms are dirty and in disrepair. The building is dirty and industrial in character.

19. RECOMMENDATIONS FOR HISTORIC UPGRADE - This building should be cleaned. Repainted, and toilet and locker facilities remodeled.
20. ONGOING WORK - None.

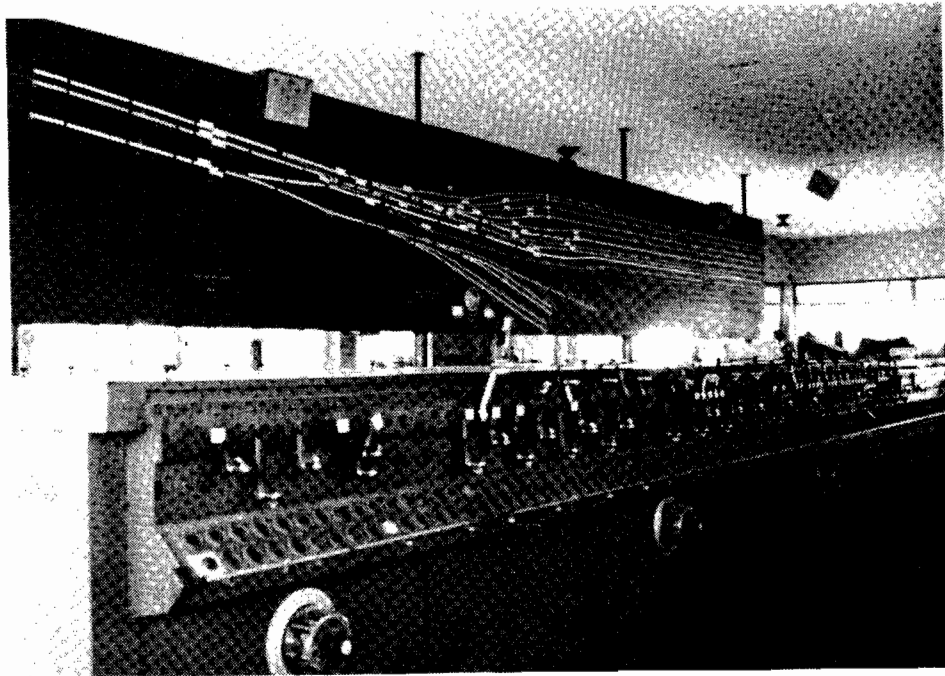
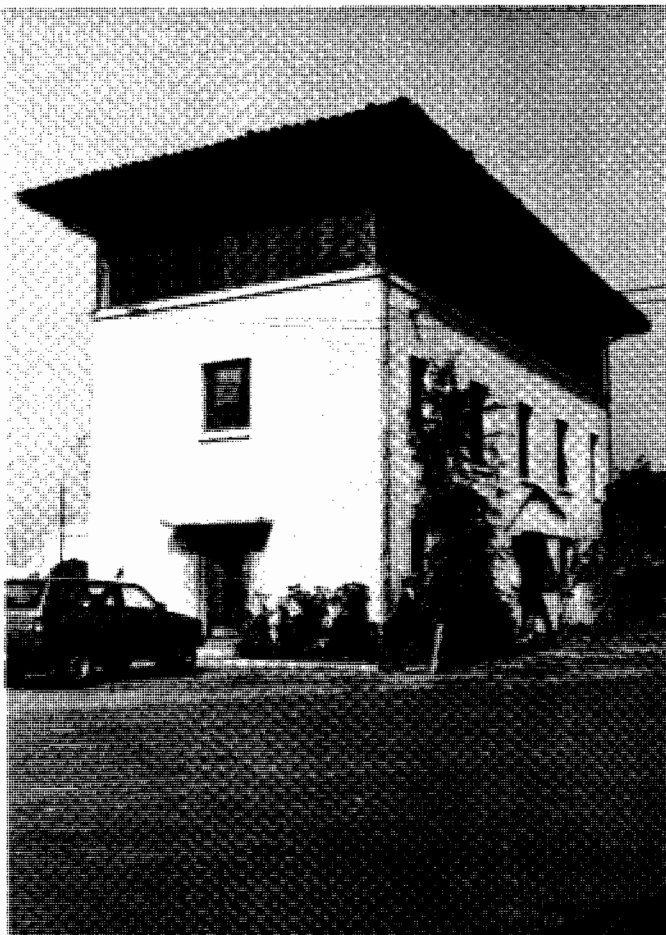
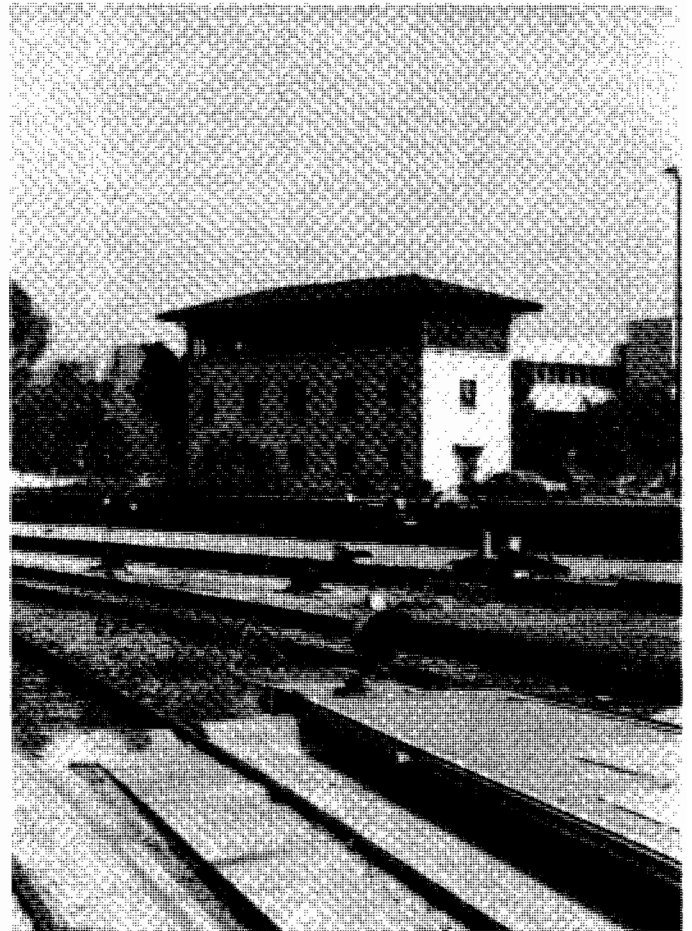
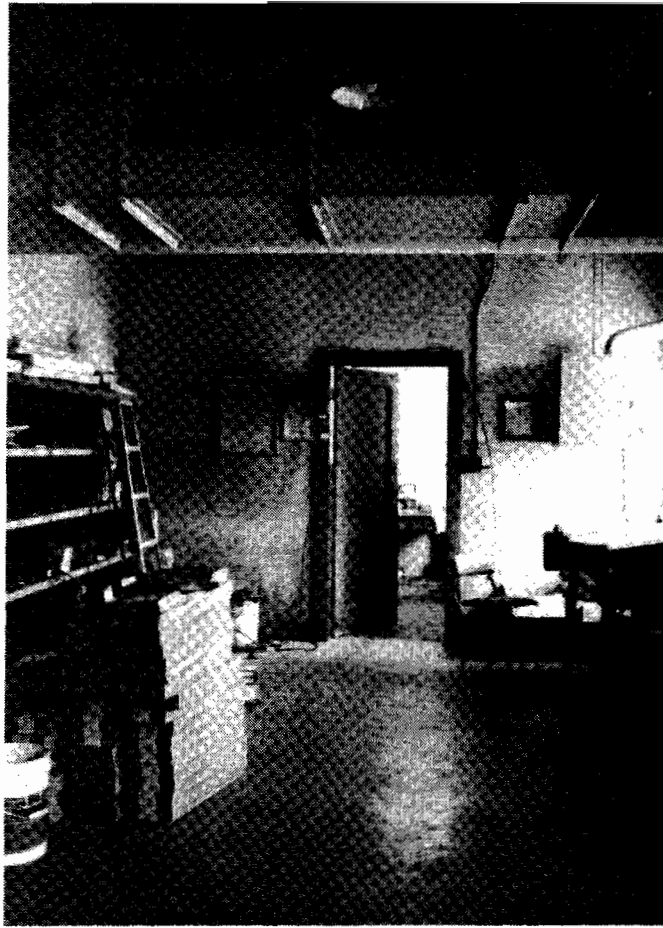
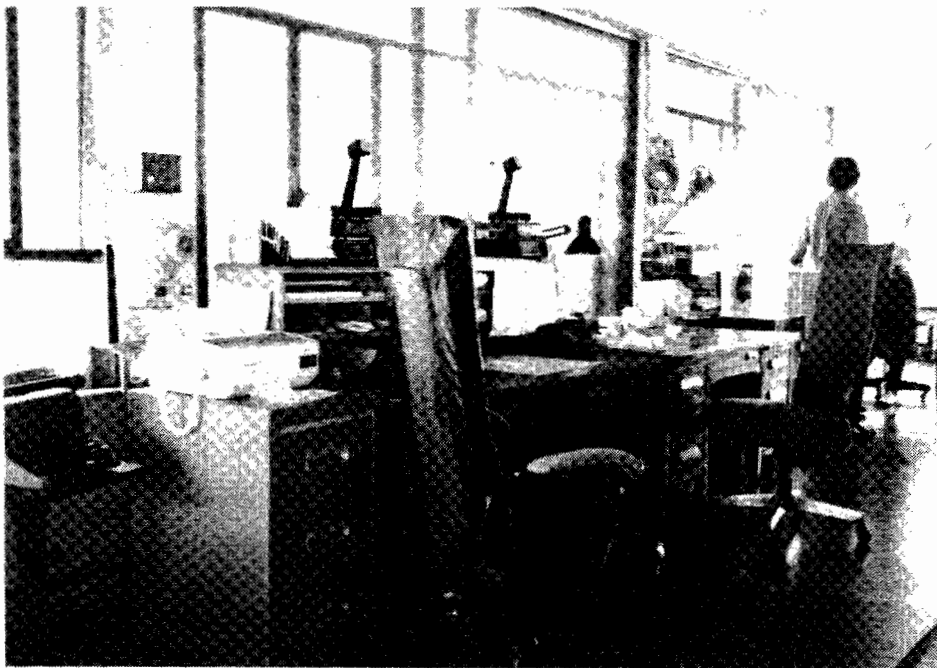
2. ENCLOSURE - Three-story poured in place, concrete construction.
3. CURRENT USE - Switching tower.
4. ORIGINAL USE - Same.
5. CONDITIONS - Industrial in character. This building serves a utilitarian function. Surfaces need general cleaning and repainting.

10. ARTWORK - Not applicable.
11. SIGNAGE - Not applicable.
12. STRUCTURAL ISSUES - Not applicable.
13. MECHANICAL ISSUES - Heating in basement is broken.

18. FUTURE USES - Not applicable.
19. RECOMMENDATIONS FOR HISTORIC UPGRADE - This building could use a fresh coat of paint.
20. ONGOING WORK - Not applicable.

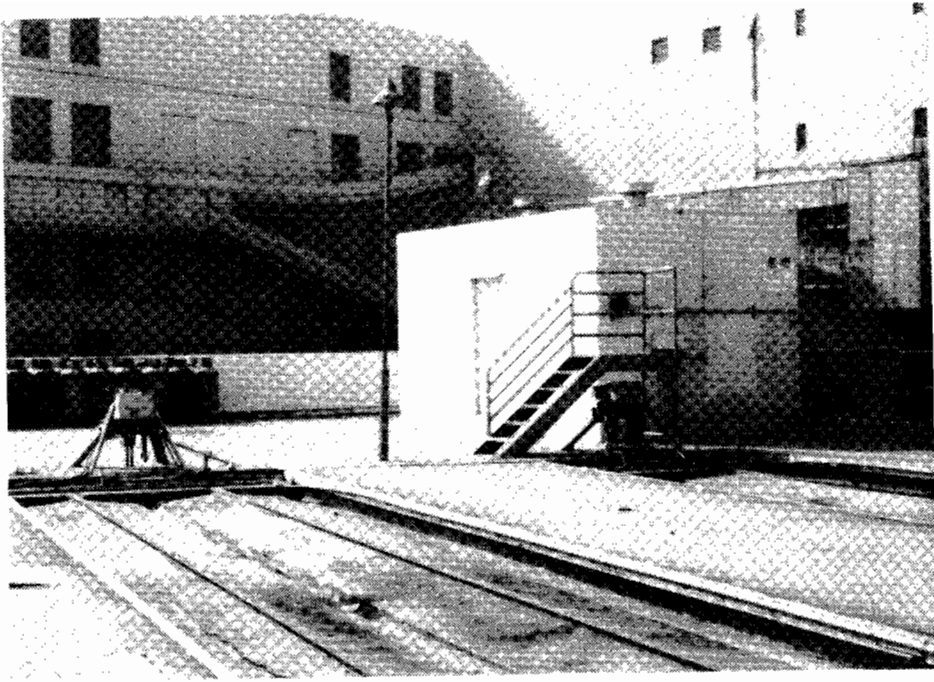
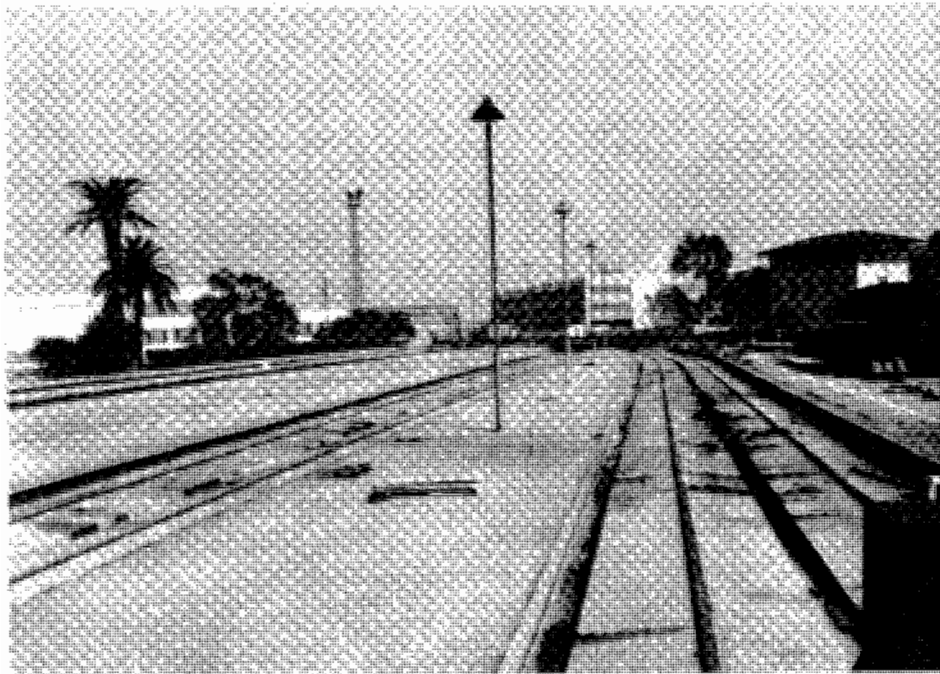
UNION STATION
G5 - PRIVATE TRAIN CAR AREA

5. CONDITIONS - Area is free of debris.
6. LIGHTING - Not applicable.
7. LANDSCAPE ELEMENTS - Parking area below with curbs and sidewalk is free of debris.

19. RECOMMENDATIONS FOR HISTORIC UPGRADE - Repaint and upgrade lighting.
20. ONGOING WORK - Metro rail construction.
21. IMPACT ON OPERATIONS - Only one ramp out of tunnel is open.
